Building and Timber Pest Inspection Report

Inspection Date: Fri, 13 Feb 2026

Property Address: 3 Elmslie Cct, West Wodonga VIC 3690,
Australia

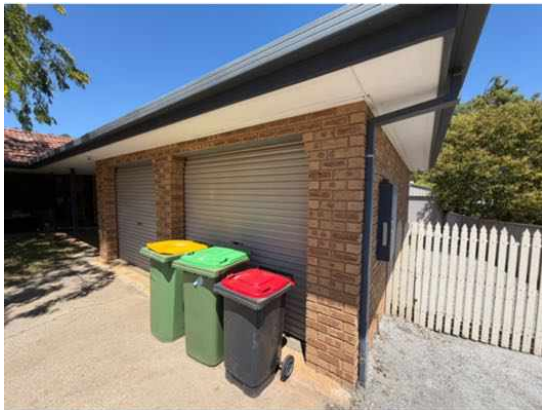
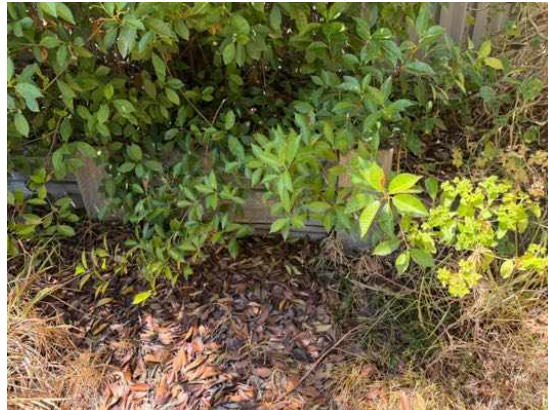
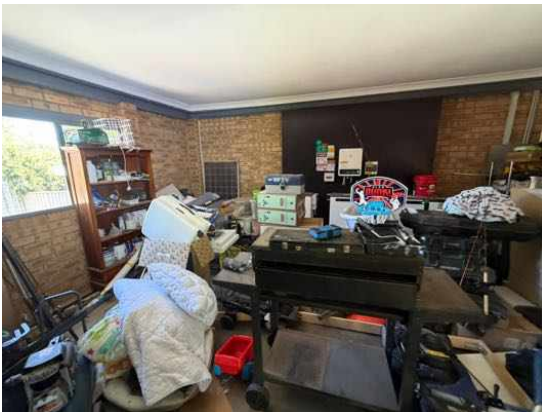
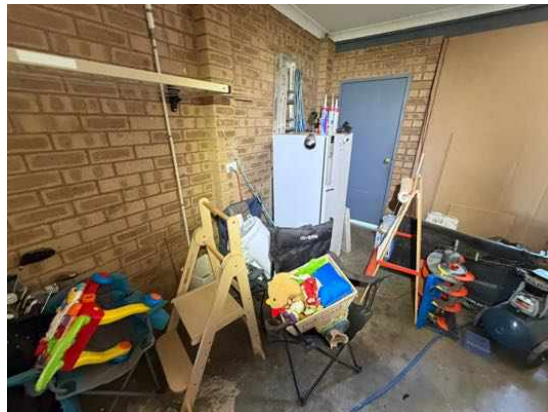
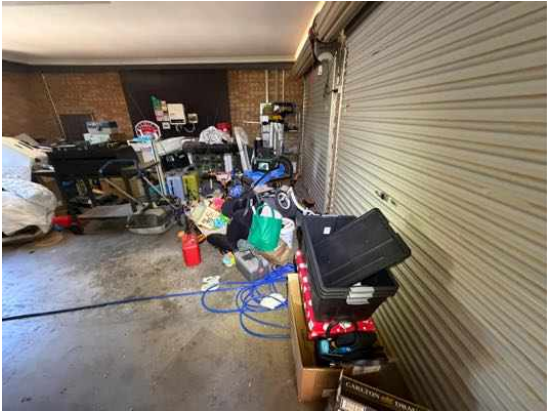
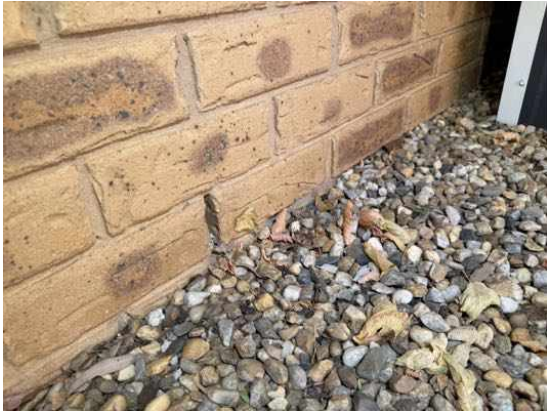
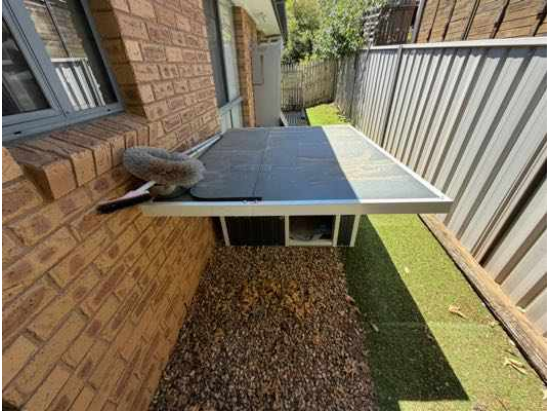
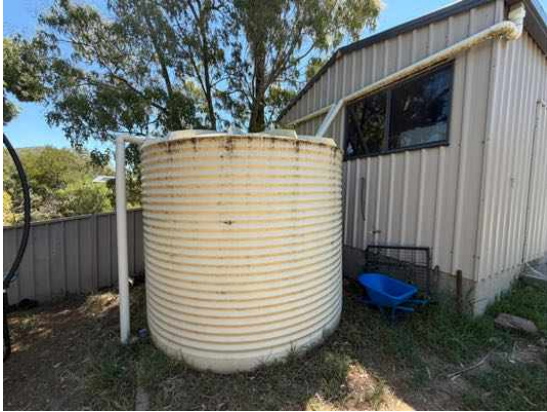
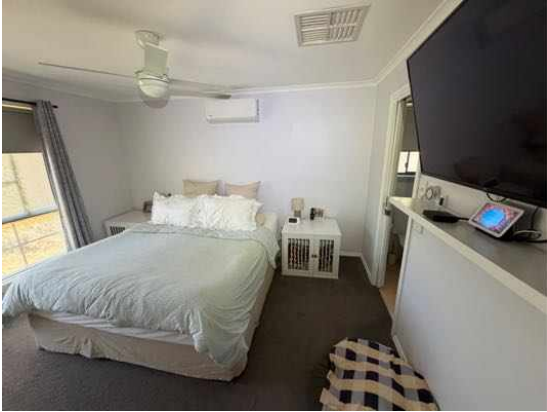
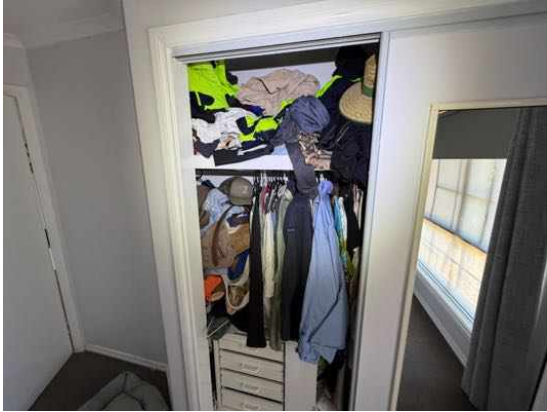
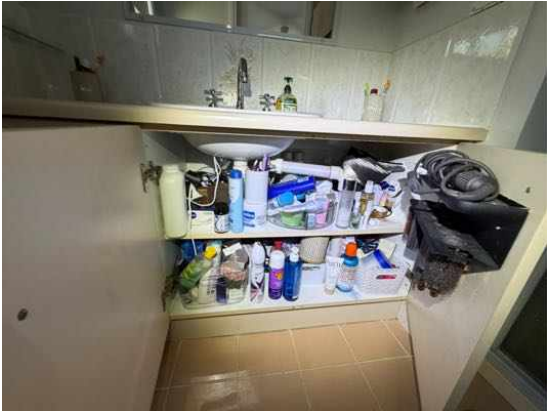
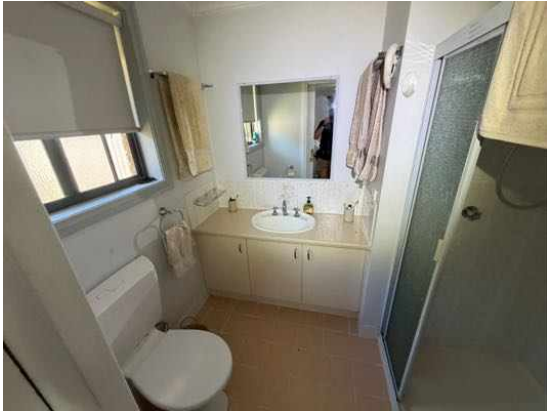
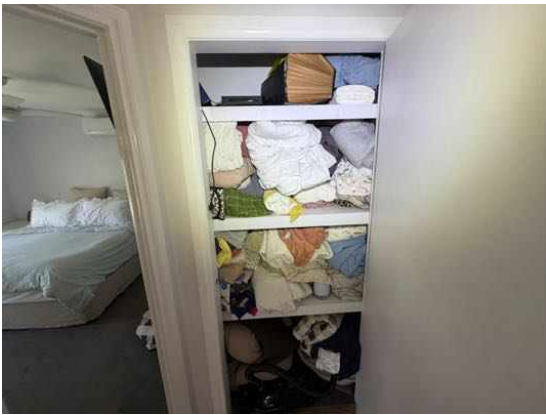
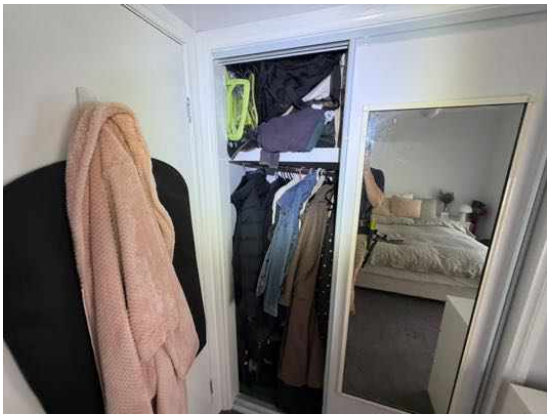
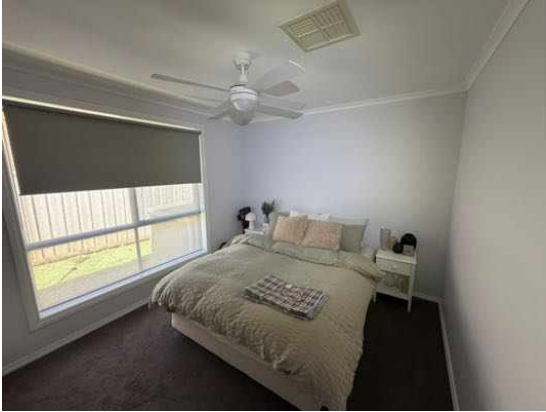
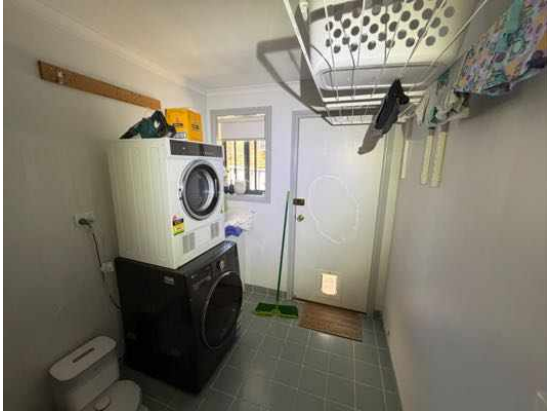
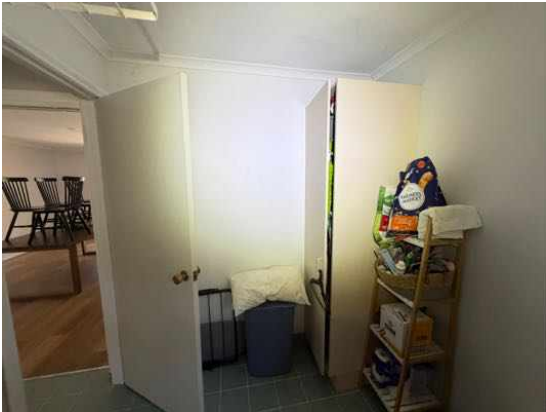
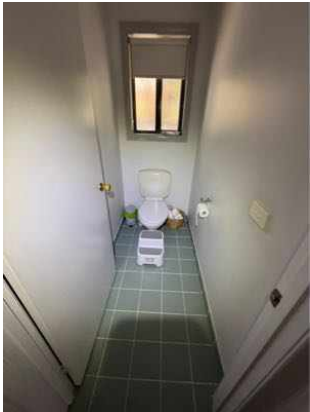
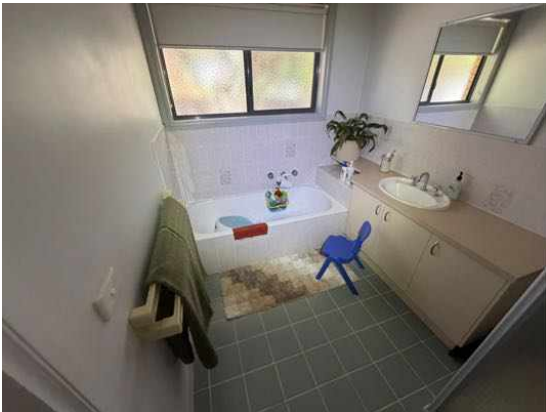
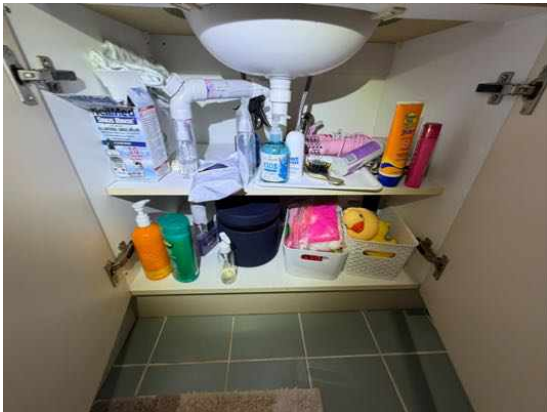
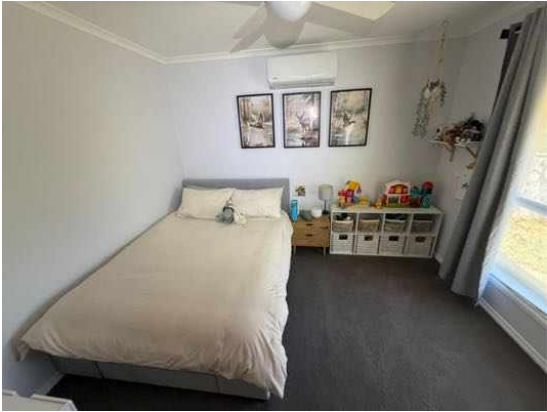
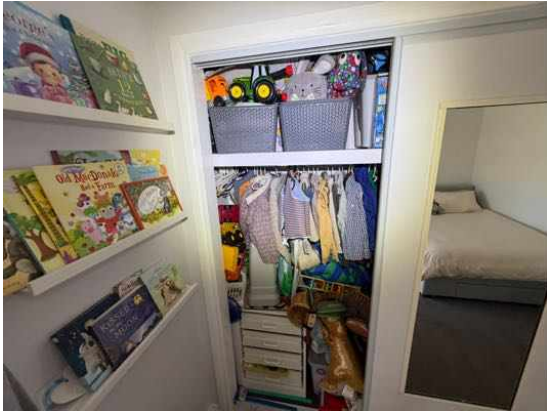
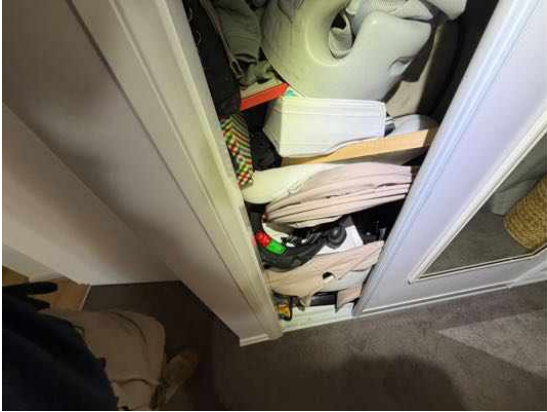
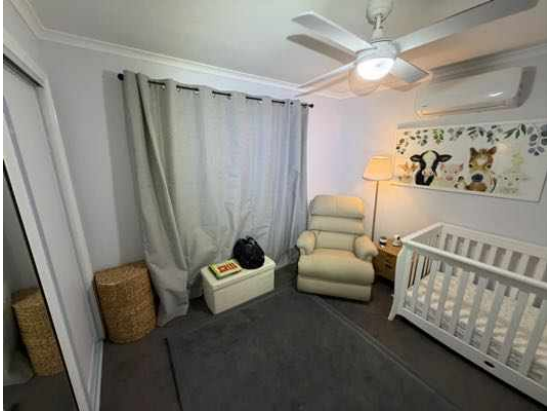
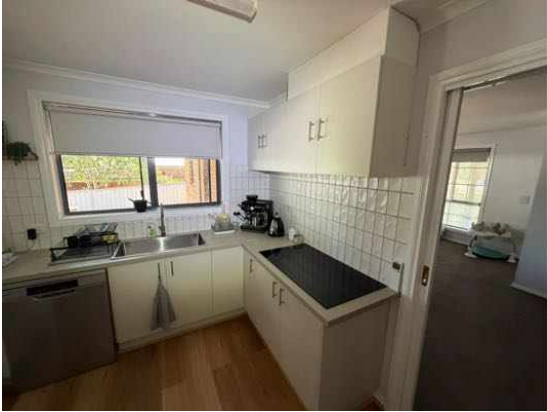
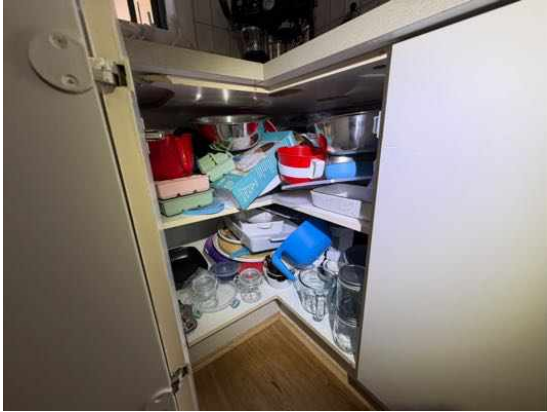
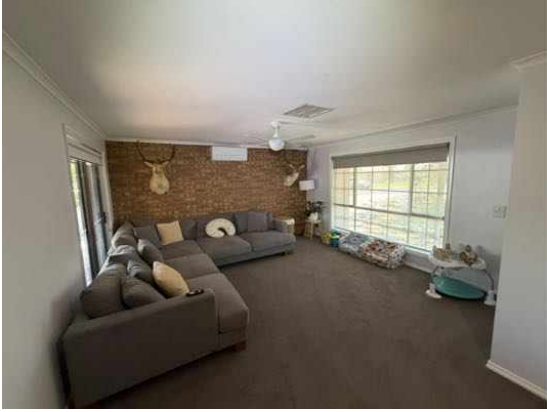
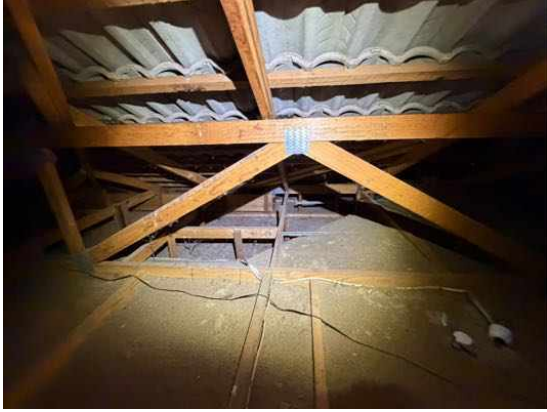
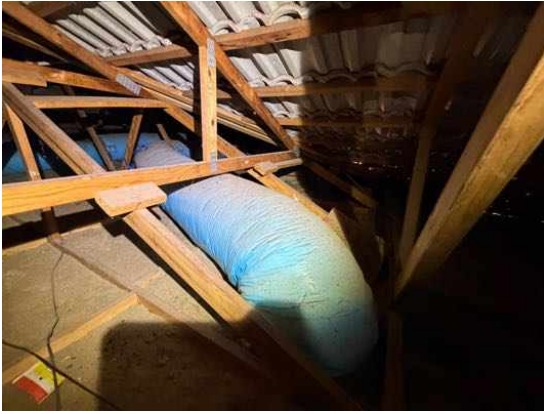
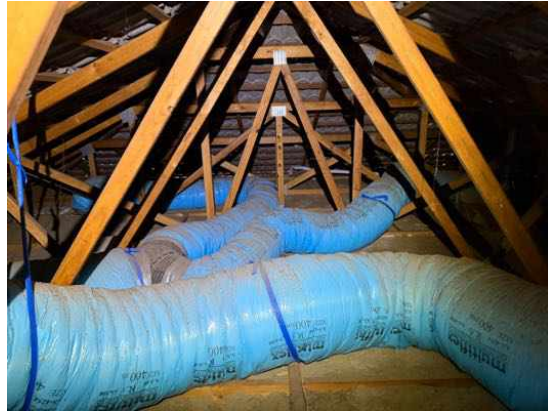
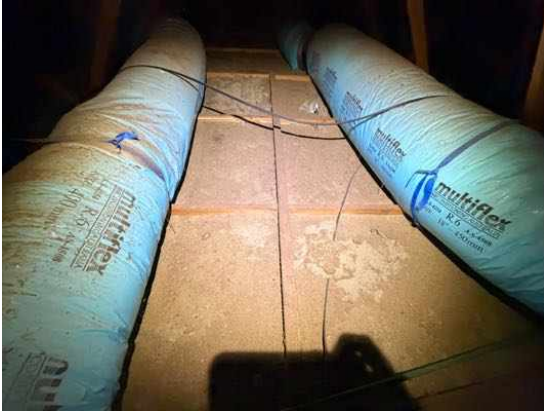
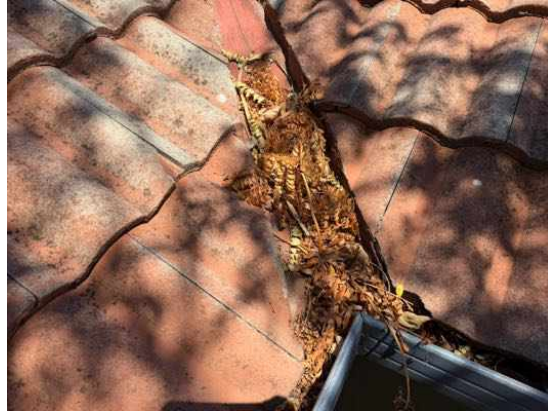
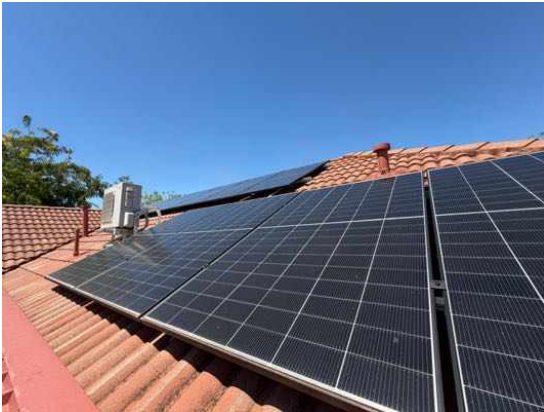
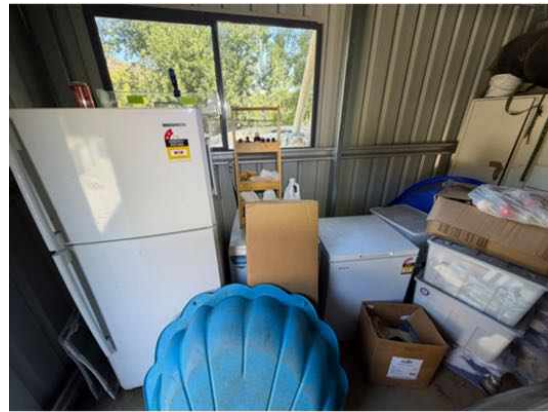
Building: Main Building
Location: All Areas
Finding: Additional Photos - Obstructions and Limitations
Information: These photographs are an indication of the obstructions and limitations which impeded full inspection of the property at the time of inspection. These obstructions can hide an array of defects and should be removed to allow full inspection to be carried out. A re-inspection is recommended once the areas are made accessible.
