Building and Timber Pest Inspection Report

Inspection Date: Tue, 10 Mar 2026

Property Address: 16 Greygums Road, Cranebrook NSW 2749

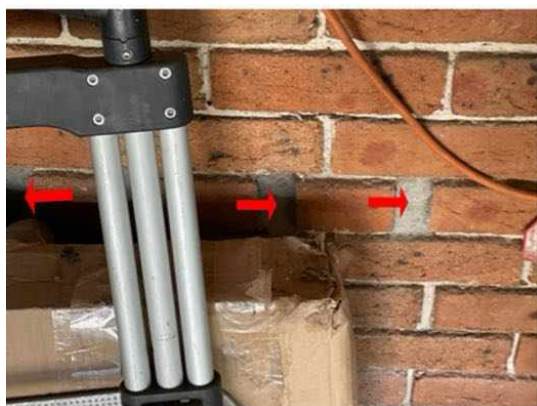
Finding 3.05

Building: Main Building
 Location: Exterior walls - rear
 Finding: Masonry – Salt Attack / Fretting of Brickwork
 Information: Location: Lower sections of external brickwork

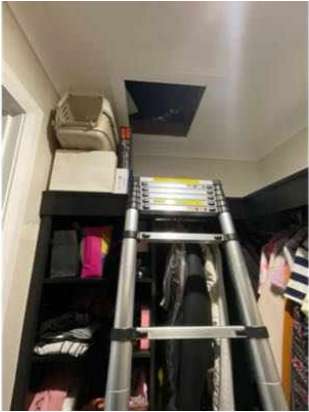
Noted Item

Building: Main Building
 Location: Roof Void
 Finding: Roof Void – Limited Accessibility..
 Information: Observation:

Installation of an additional manhole is recommended to facilitate a re-inspection and enable a more thorough assessment of the roof void in the future. This will help ensure that all structural elements and concealed areas are properly evaluated.
