## Building Inspection Report

Inspection Date: Tue, 13 Jan 2026

Property Address: 12 Ferntree Ave, WARBURTON, VIC, 3799,  
Australia

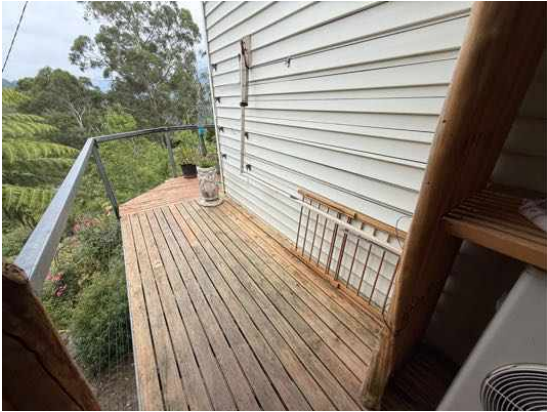
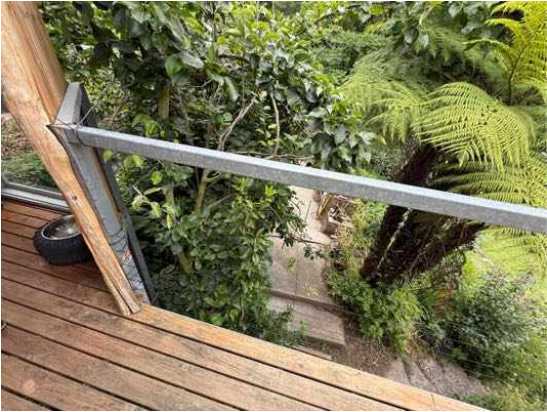
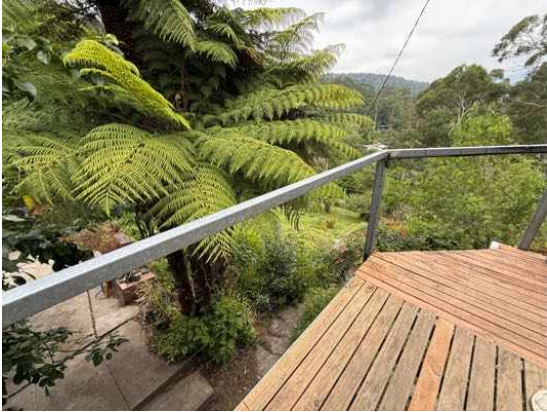
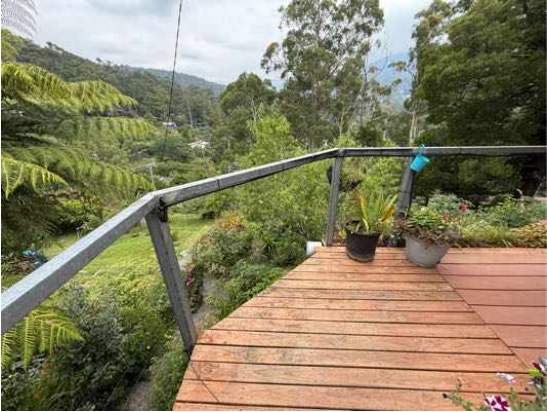
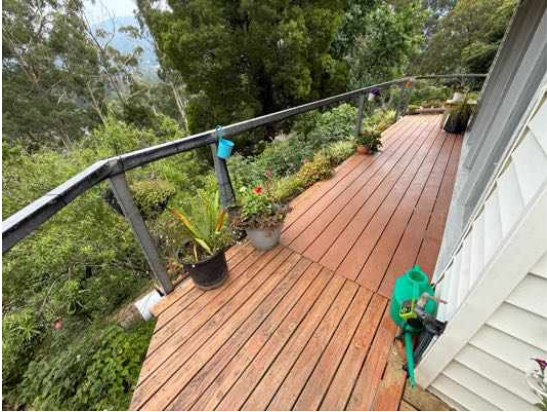
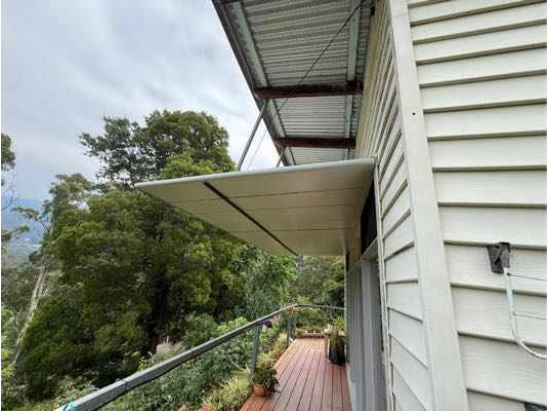
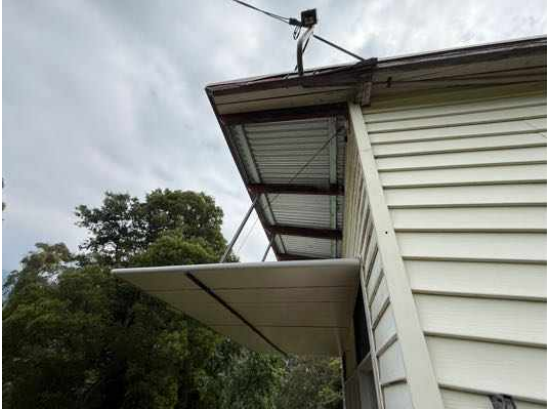
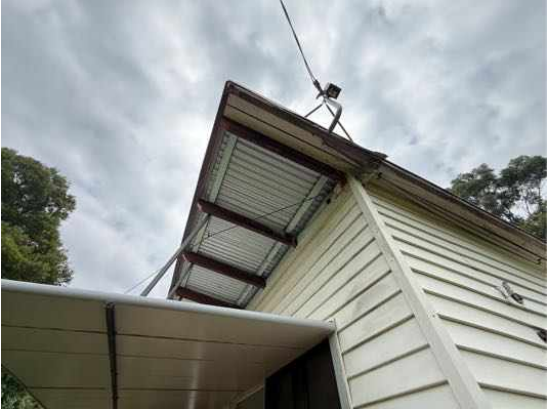
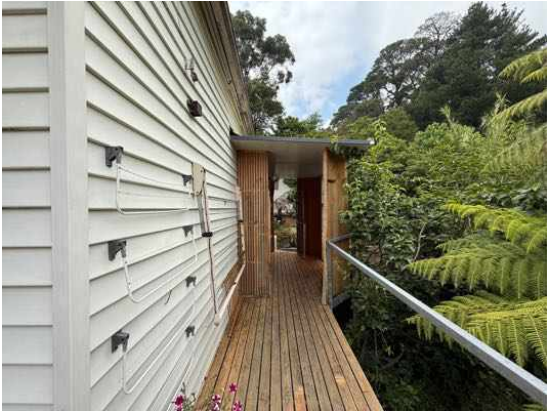
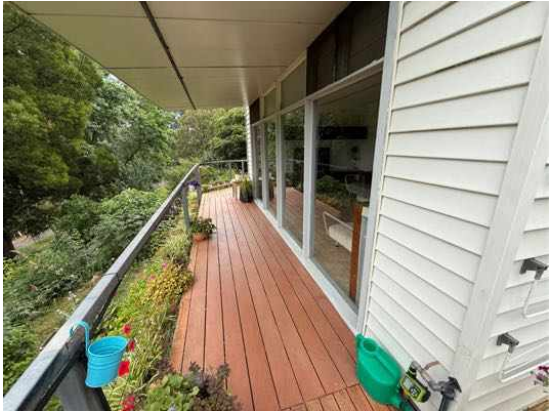
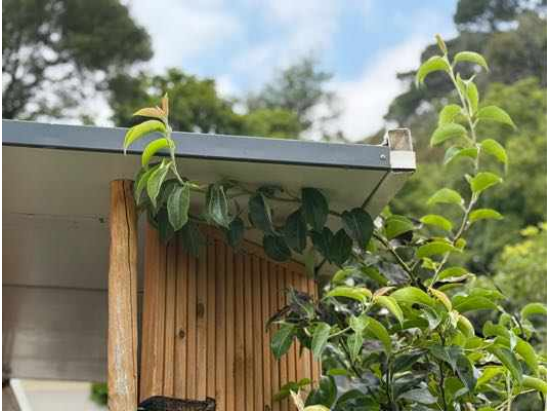
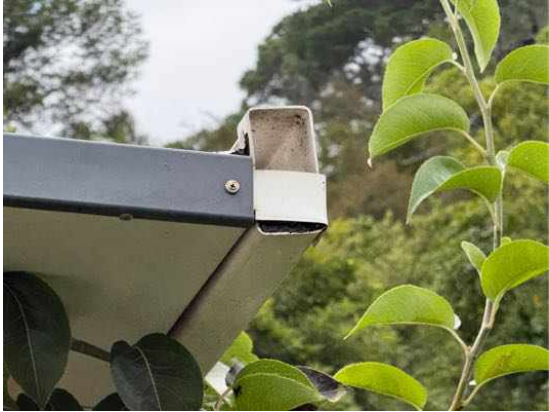
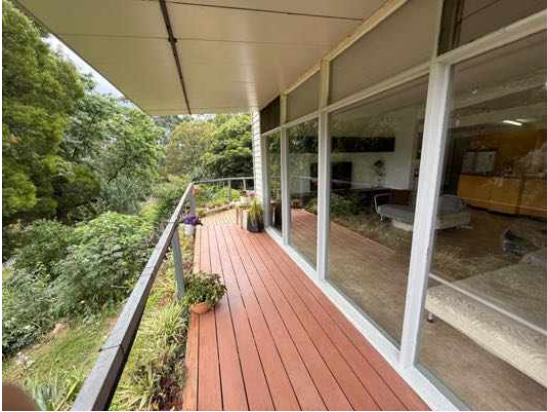
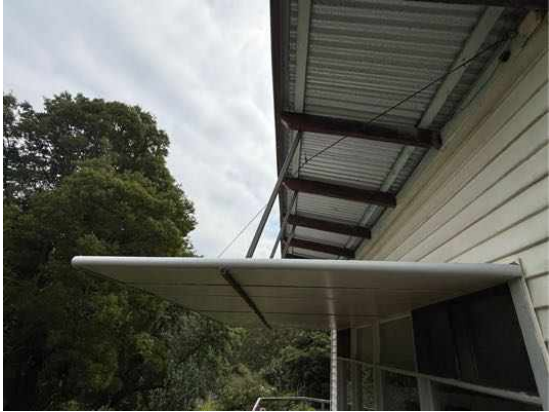
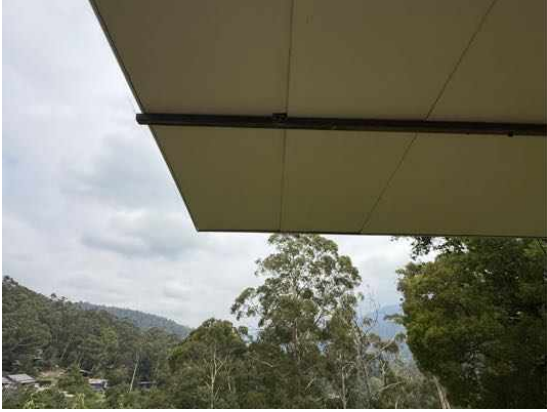
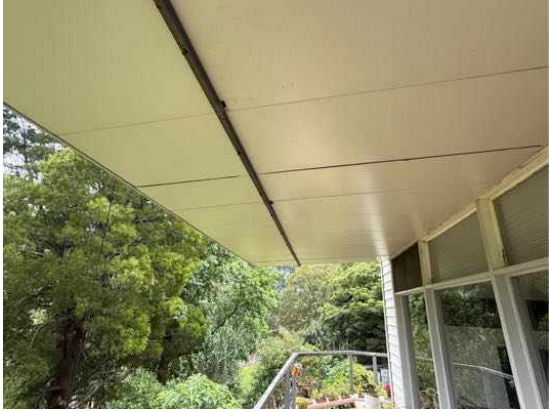
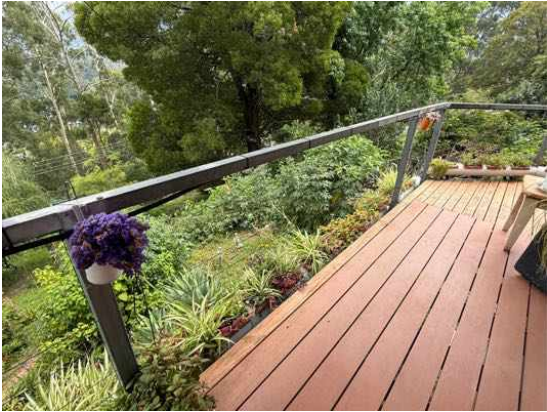
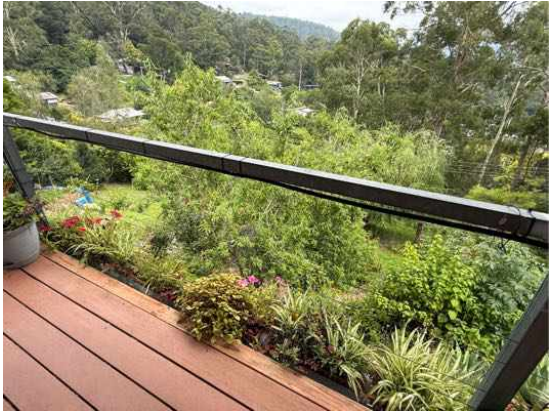
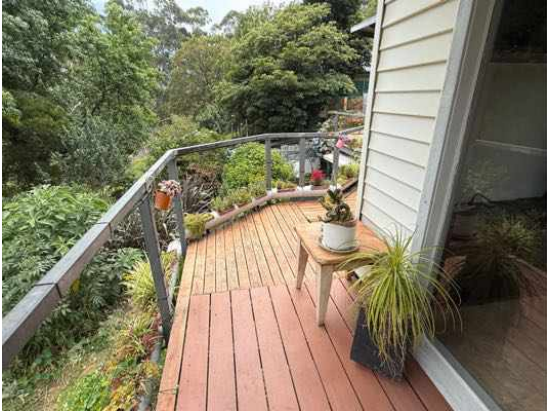
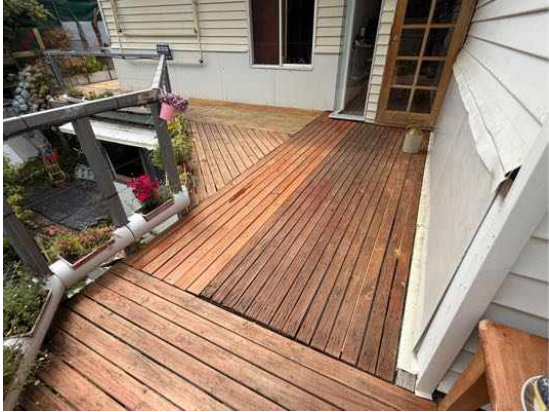
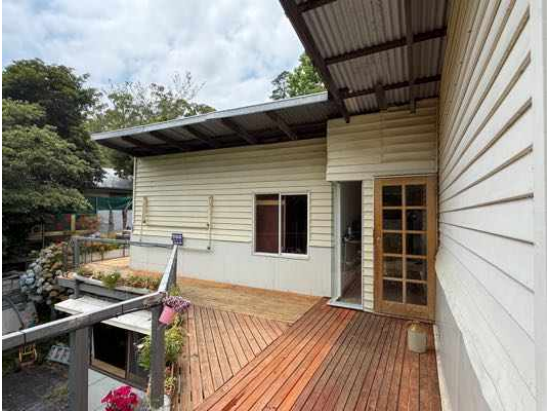
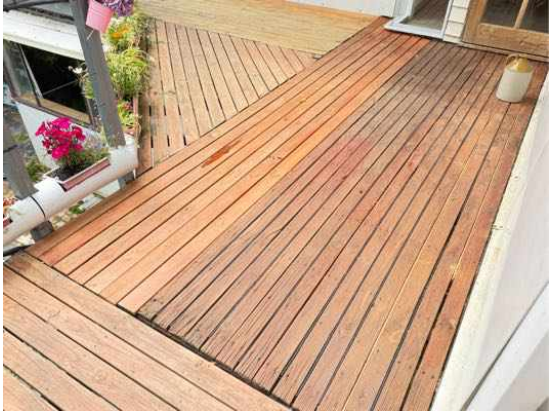
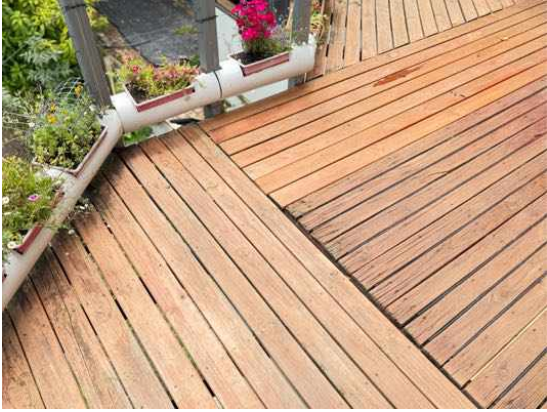
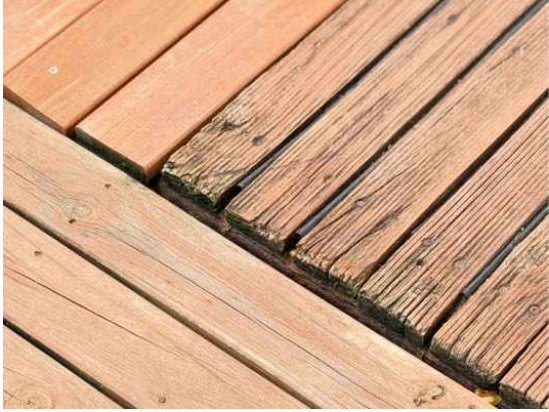
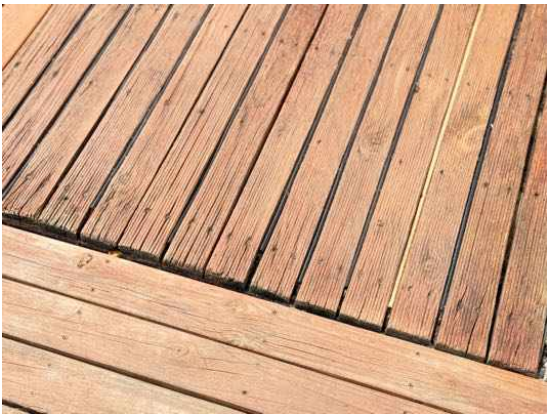
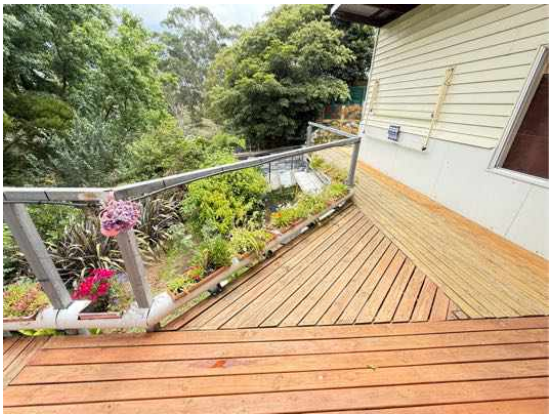
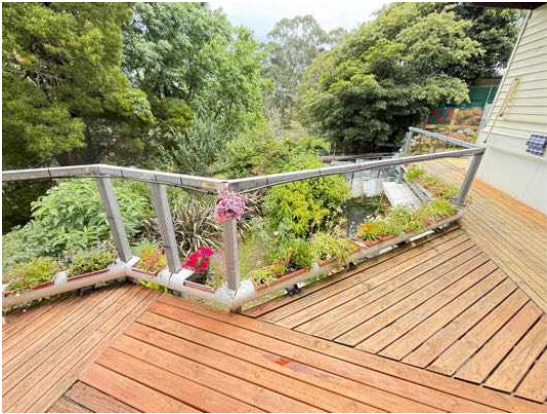
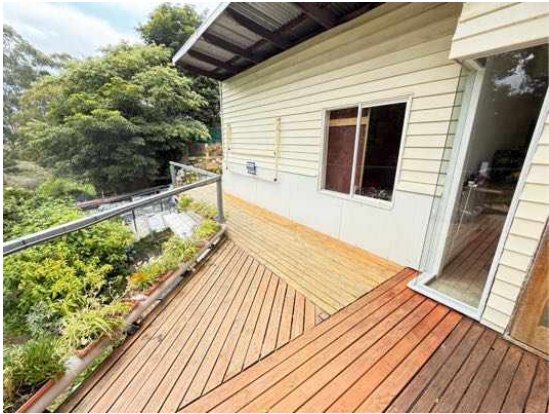
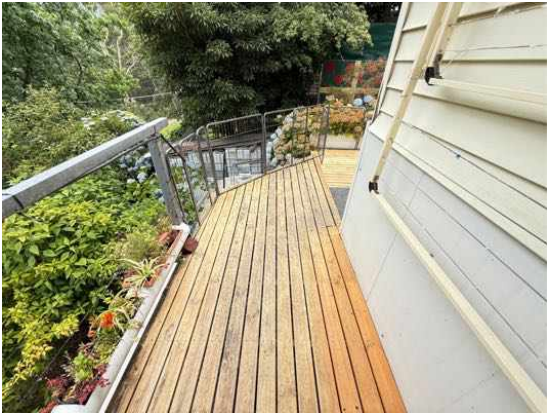
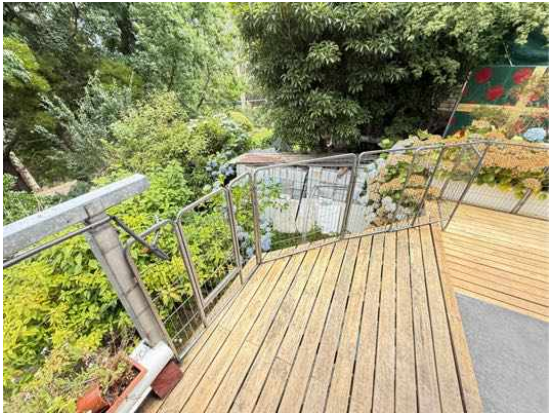
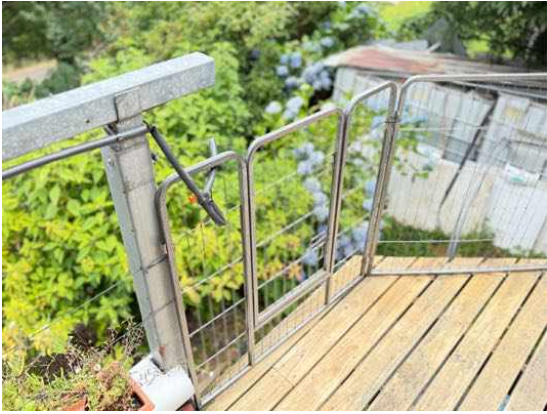
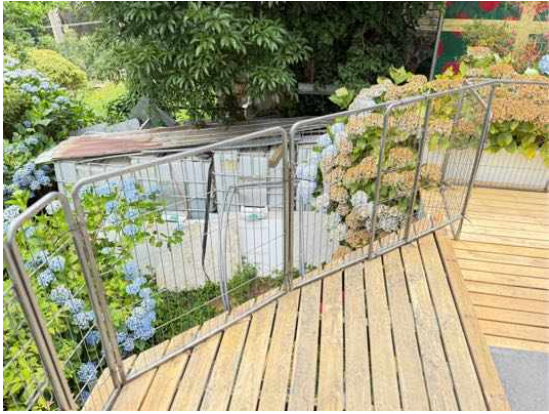
#### Defects 2.01

Building:	Building 1
Location:	Upper front deck and balustrade and roof over > All Areas
Finding:	Front deck - balustrading and roof
Information:	The front deck area balustrade and roof over showed signs of poor building practices and were highly suspected to be not built to meet the National construction code (NCC) and Australian Standards. This report does not cover non-compliance issues however it is the opinion of the inspector that the front balcony deck, balustrade and roof do not appear to have been built or inspected by the relevant authorities. These areas are deemed to be unsafe for occupants and young children and will require action and remedial work to rectify to ensure the front deck, balustrade and roof over meets the required compliance and building codes.

Poor trade practices are generally cause of these types of suspected structural defects and issues. Further inspection will be required by a structural engineer and licensed builder, they should be appointed to further inspect the structural integrity of the affected areas and to assess the safety of the associated structures. The engineer can also nominate a scope of works required for rectification and the licensed builder can appoint the relevant contractors to provide the necessary works to all of these areas deemed to be necessary.

Deck areas, balustrades and roof areas throughout the property: - This inspection of the front deck areas, balustrade and roof does not in any way indicate that these areas has or has not been built with council approval or to the Australian building standards at the time of this inspection. The deck, balustrade and roof structure over these areas, whilst appearing to be providing enough adequate structural support, did not appear to be in a stable condition, it is highly suspected that these areas will not hold the amount of persons the decks total area would hold.

The client is highly recommended to ensure these deck, balustrade and roof structures be inspected by Structural engineer to ensure that these areas complies and meets all council requirements, all contemporary building practices and the current Australian building Standards.

Where any elevated structures, such as a (deck, balustrading, balcony, verandah, stairs etc) are present, these types of structures are designed to accommodate people. Client is therefore highly recommended to, and **MUST** ensure this structure has been checked by an engineer or other suitably qualified person to ensure it is suitable for purpose. Client is also recommended to ensure that any maintenance or other building elements, that may be required or deemed necessary, is rectified immediately or in the very short term future. Care must be taken, not to overload these areas and structures.

Deck structures, balustrades stairs etc, should be checked on a yearly basis to ensure that the structural integrity does not falter over time.

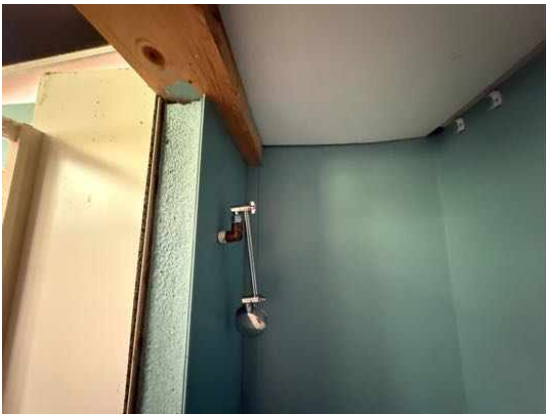
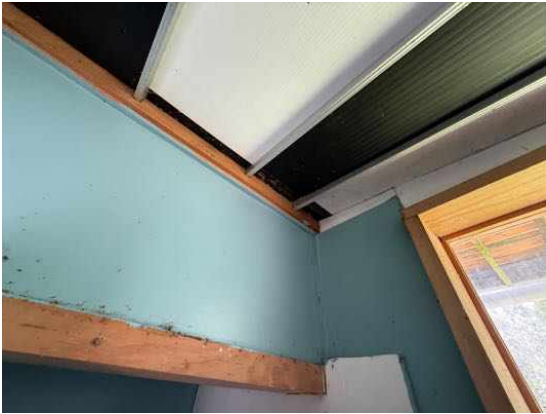
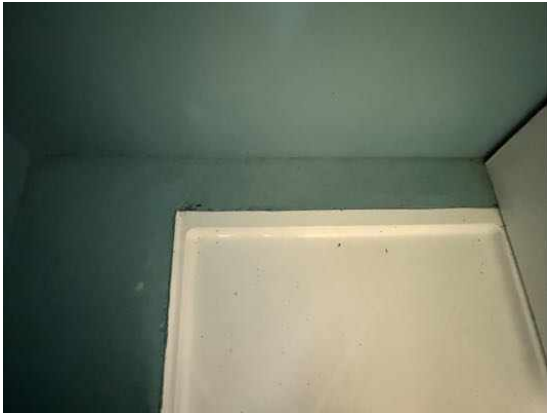
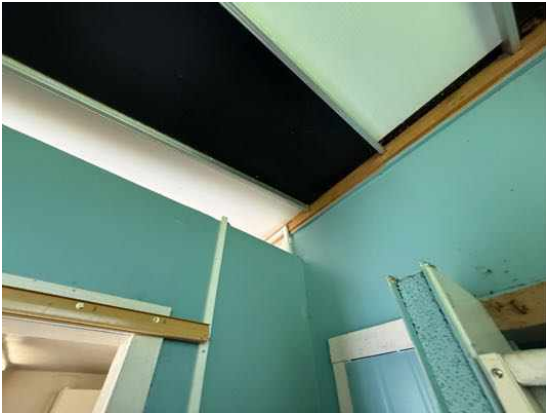
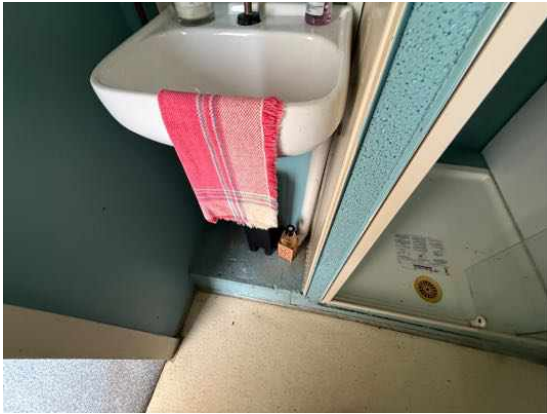
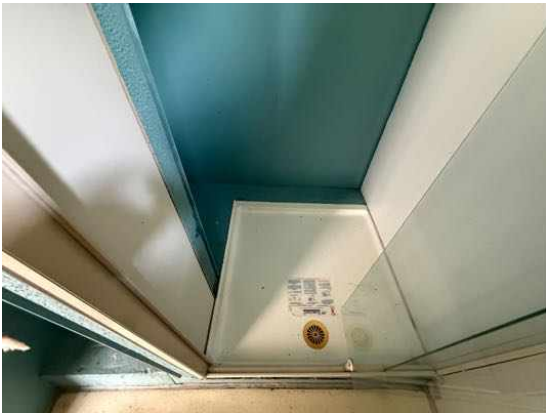
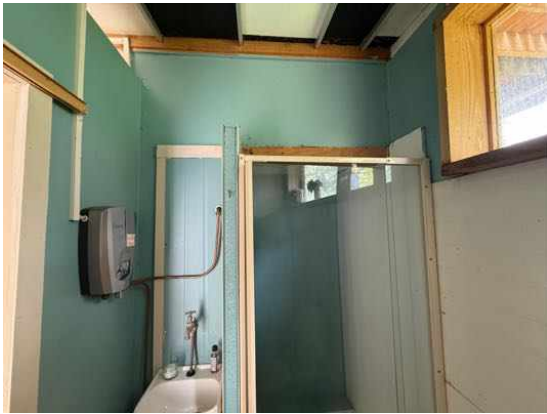
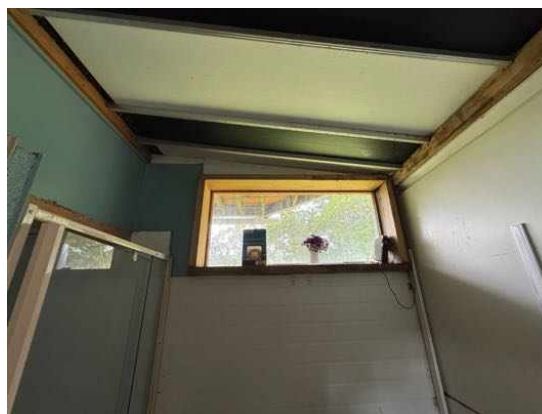
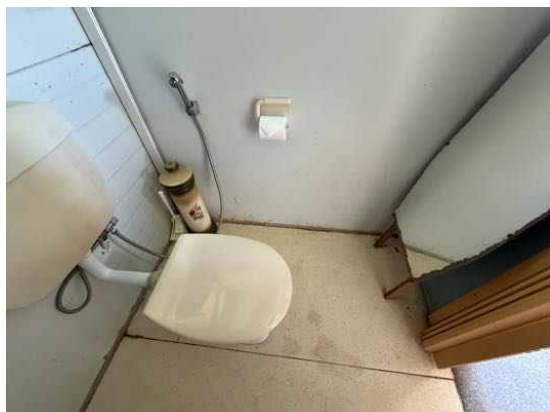
**Defects 2.02**

Building: Building 1  
Location: Lower storey bathroom > All Areas  
Finding: Lower bathroom was not adequately waterproof and does not meet Australian standards  
Information: The lower bathroom was observed to not be tiled or adequately sealed or waterproofed to meet current Australian standards and requirements. The lower bathroom areas require remedial work to prevent major structural damage and structural issues overtime. It is highly recommended that the client appoint a licensed builder to carry out remedial work to rectify to meet current building standards.

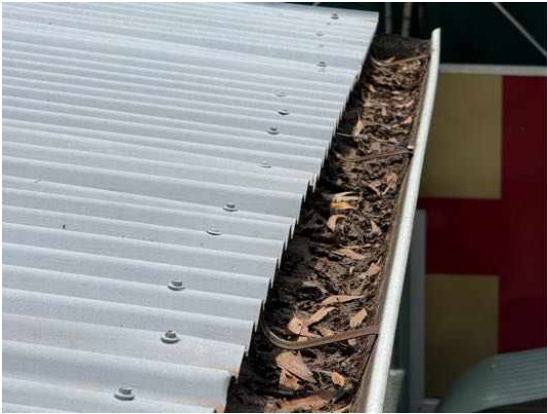
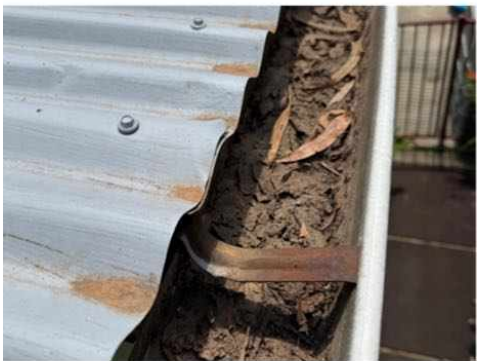
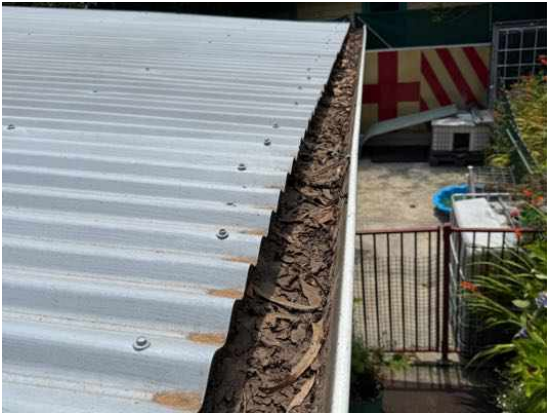
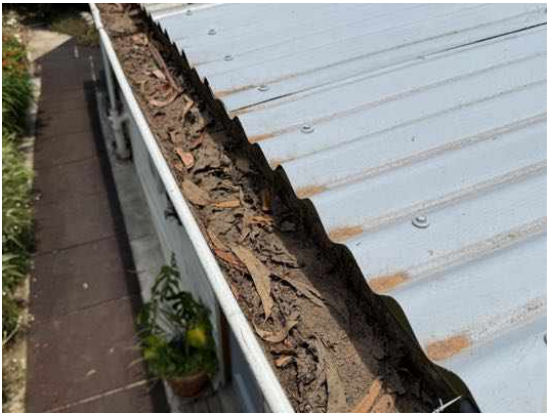
### Defects 3.01

Building:	Building 1
Location:	All Areas > All Areas
Finding:	Gutters
Information:	Upon inspection of the roof gutters were observed to have excessive leaf matter and debris. Roof plumbing structures, such as guttering and downpipes, should be free of all debris to prevent blockages. Blockages of the guttering and downpipes will lead to pooling and accumulated water overflows, which is likely to subsequently flood eaves and exterior walls.

Blocked gutters are likely to lead to high levels of moisture in the affected areas. Such moisture will not only cause rust and decay of the associated building materials, but can also provide conditions that are conducive to termite and timber pest activity. Blockages in gutters should therefore be removed immediately to ensure dry conditions are maintained. Consultation with a licensed roof plumber for further specific advice on remedial works that may be required. In the interim, it is highly advised that blocked gutters be removed by the homeowner or a relevant tradespersons in the near future.

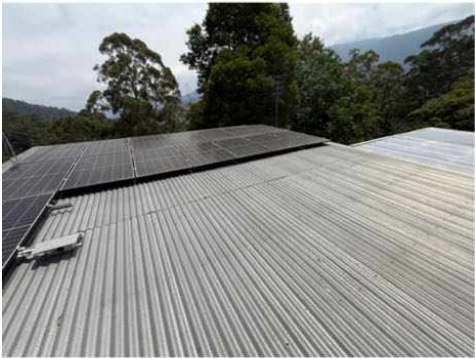
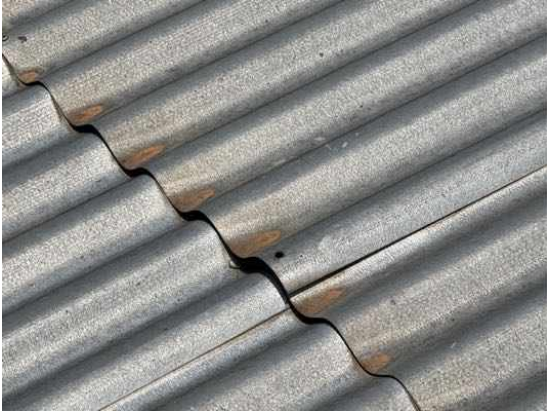
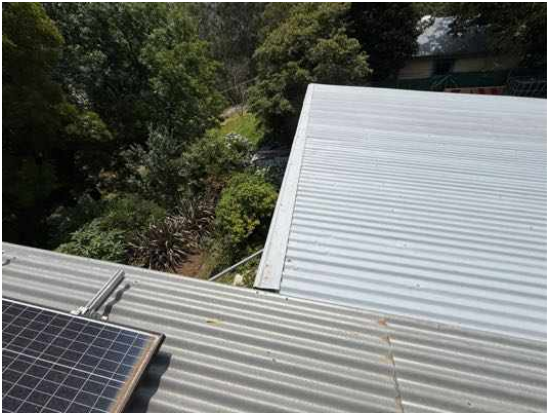
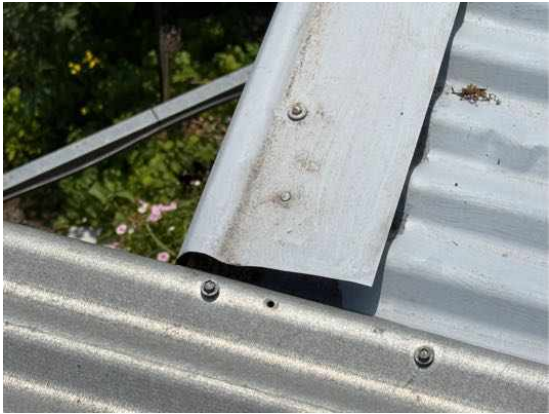
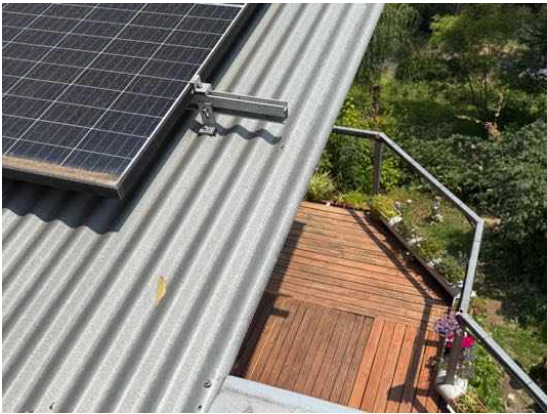
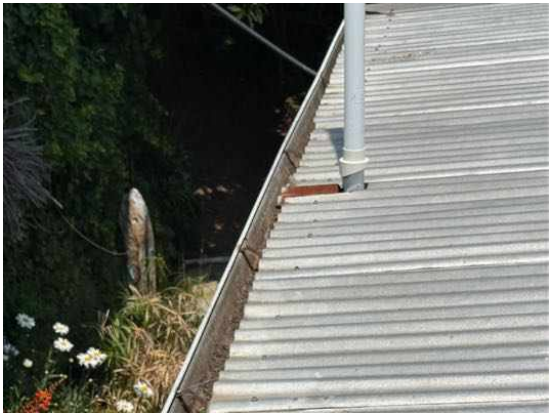
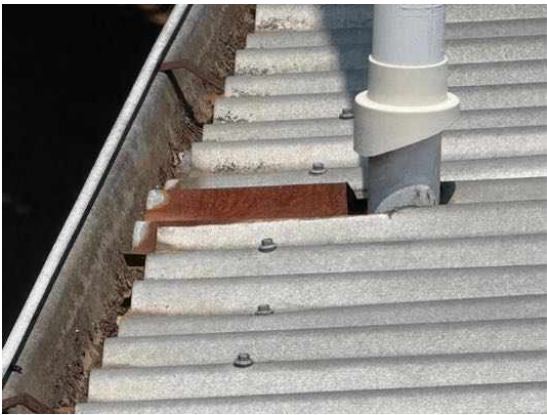
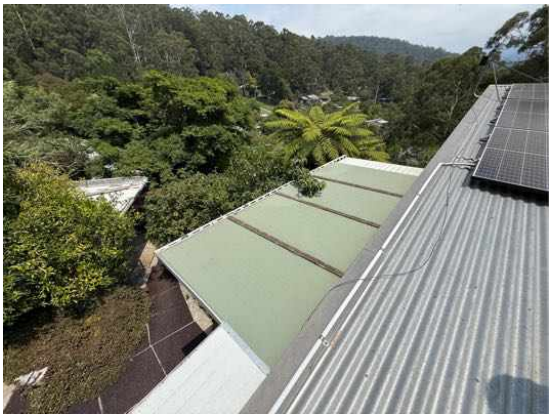
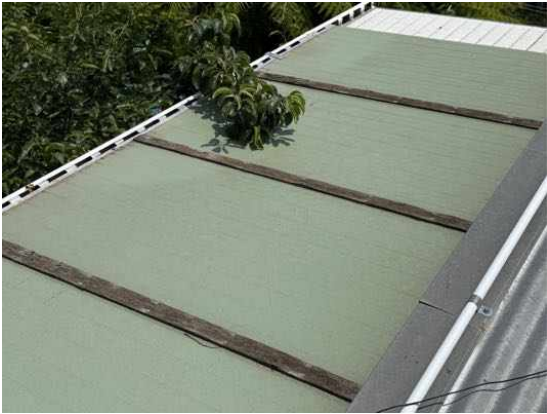
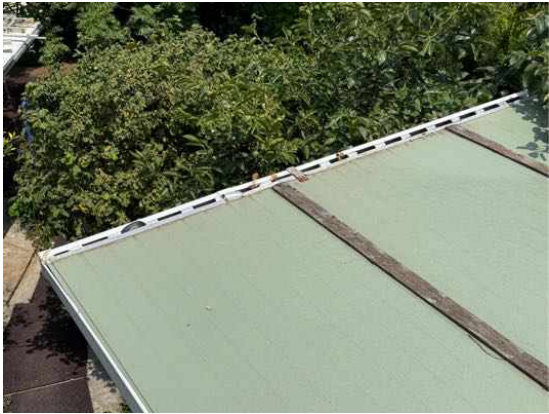
Defects 3.02

Building: Building 1  
Location: All Areas > All Areas  
Finding: Roof sheets - Not secure  
Information: Upon inspection of the exterior roofing it was found that the roof sheets have had previously been fixed, however these fixings have been dislodged and the roofing iron is no longer adequately secured to the adjoining roof structure. Loose roof sheets are susceptible to water penetration, exposing the surrounding associated area to internal roof leaks and water damage.

Adequate fixing of all loose roof sheets should be conducted as soon as possible to ensure no further damage is incurred in the future. The client should appoint a roof plumber or engage the appropriate tradesperson to perform necessary works deemed to be necessary to rectify these areas. This is required in the short term future.

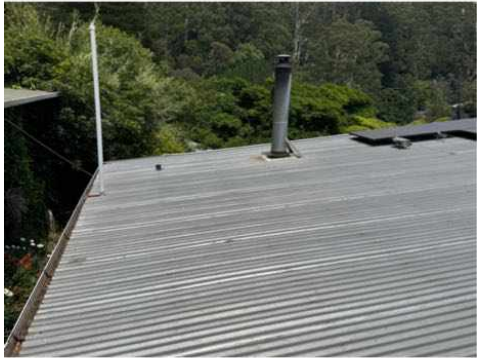
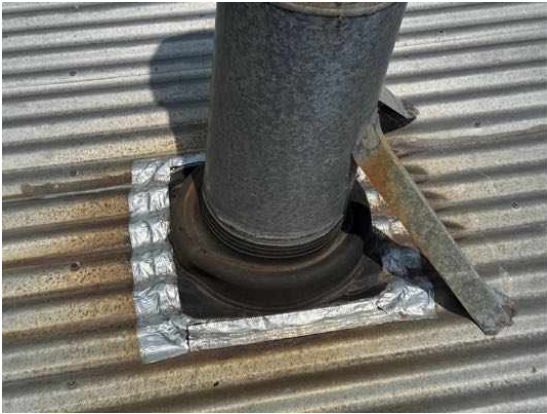
**Defects 3.03**

Building: Building 1  
 Location: All Areas > All Areas  
 Finding: Roof flashing - non-standard  
 Information: The roof flashing that has been installed fireplace chimney roof pipe is not the correct flashing that should be used and not considered to be adequate as a chimney flashing. This type of flashing is normally used as a bottom timber window flashing, it is not suitable as a roof flashing. However at the moment the roof flashing does appear to be in an acceptable condition, (fulfilling its purpose for the moment) in ensuring the roof covering is weather-tight. Client should appoint a roof plumber to remove and replace this flashing as soon as possible, in the short term future.

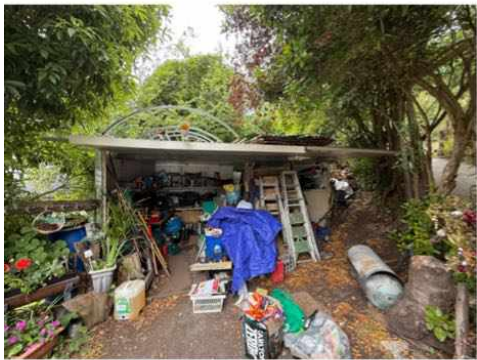
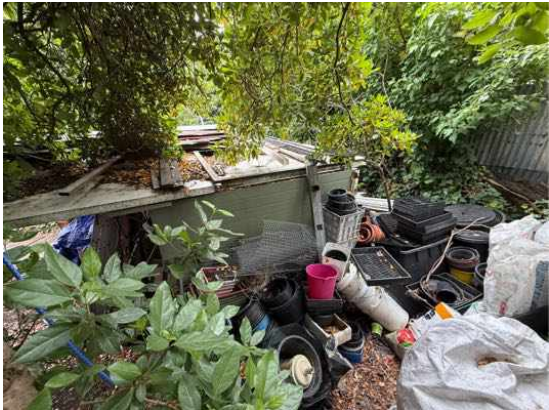
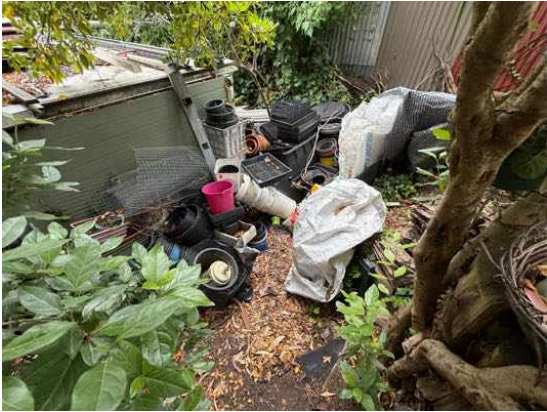
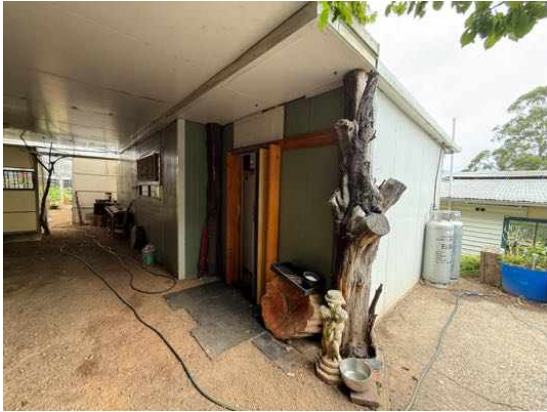
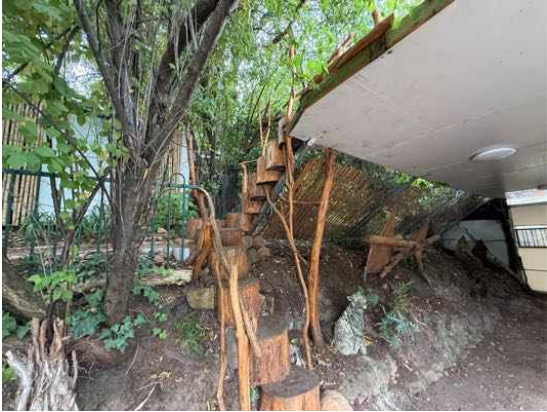
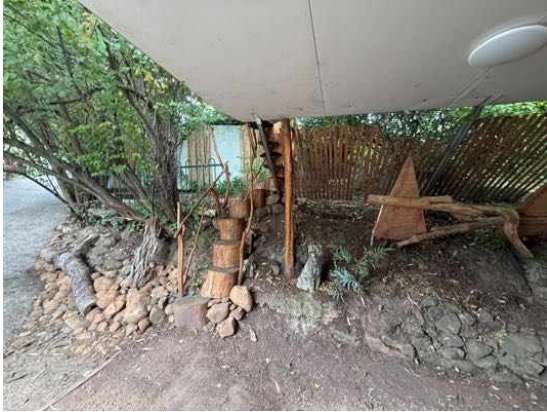
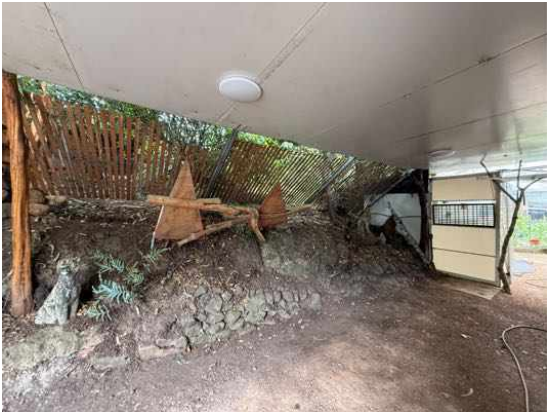
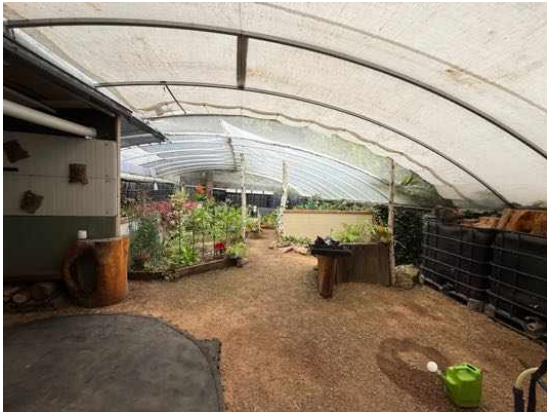
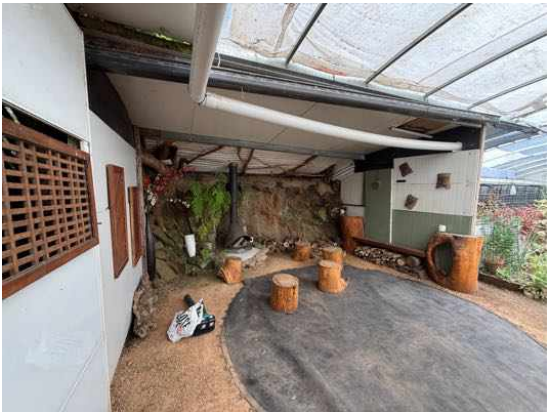
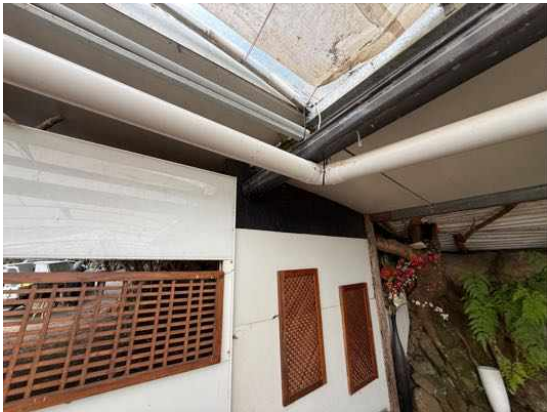
**Defects 3.04**

Building: Building 1  
Location: All Areas > All Areas  
Finding: Flashings, gutter and downpipe missing  
Information: Numerous flashings, gutters and downpipes to numerous structures throughout the property were observed not to have been installed and missing Flashing, gutters and downpipes are designed to keep under roof areas water tight and to direct water flow from the roof structures away and into the stormwater drainage system to prevent excess water and moisture away from the exterior of the home, subfloor and surrounding areas.

Where flashings, gutters and downpipes have not been fitted or are missing, these roof structures will not adequately sealed against water and external weather conditions. It is therefore always necessary to ensure flashings, gutters and downpipes and other relevant drainage is installed around your home.

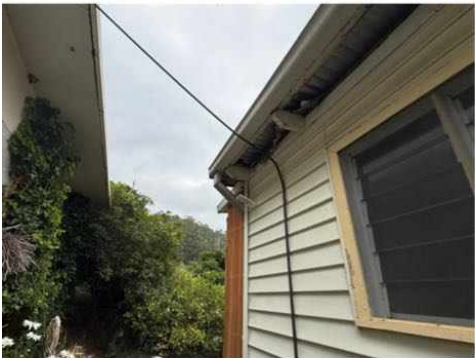
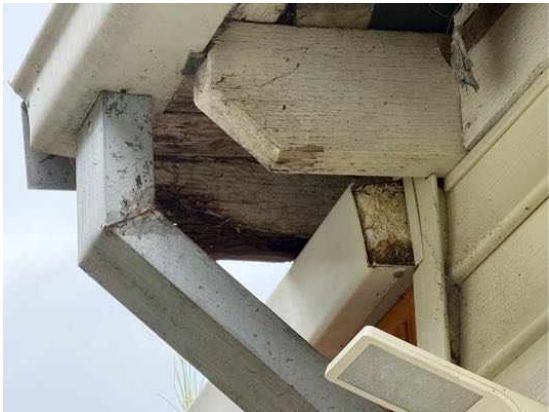
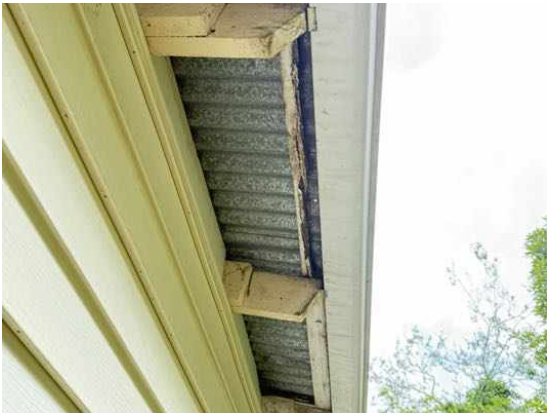
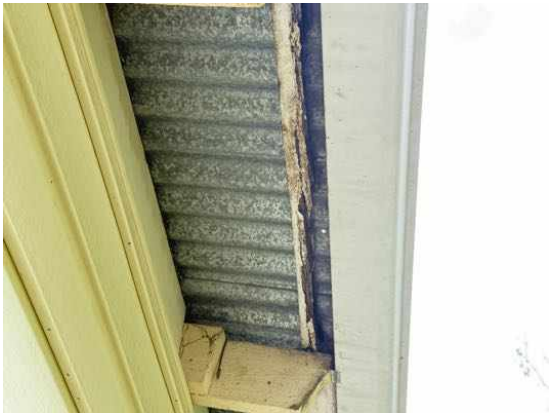
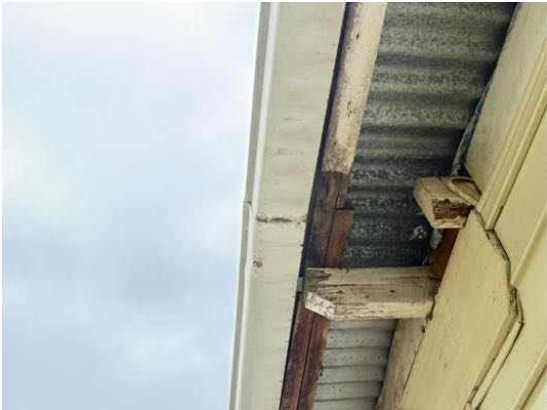
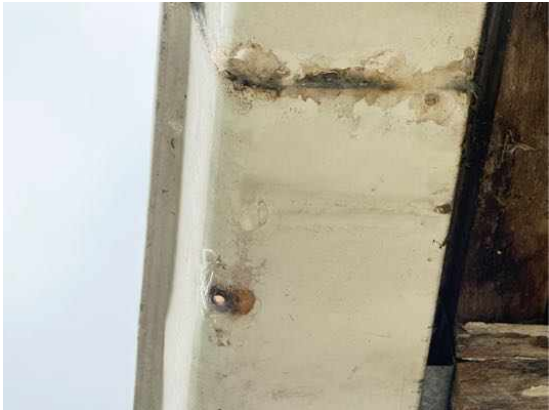
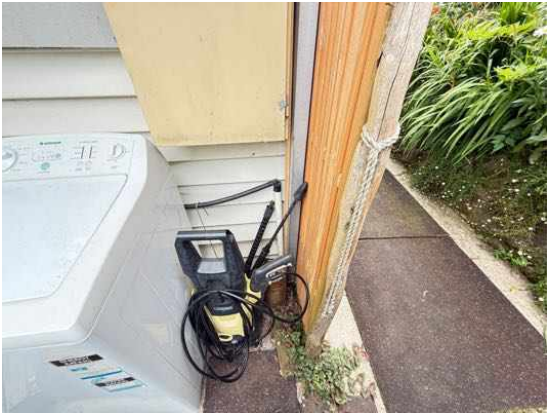
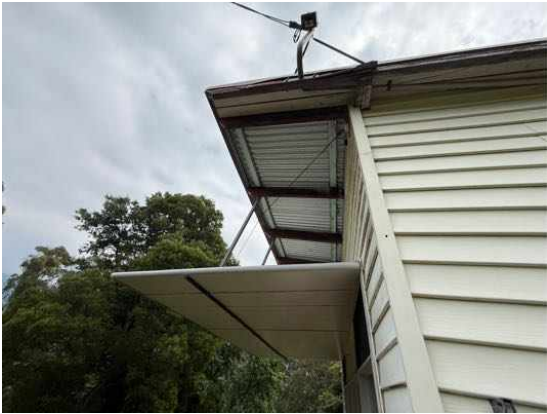
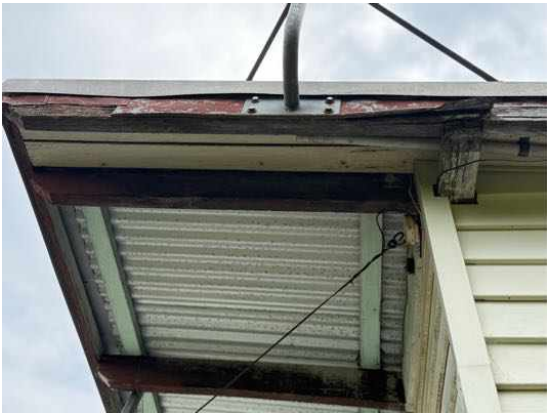
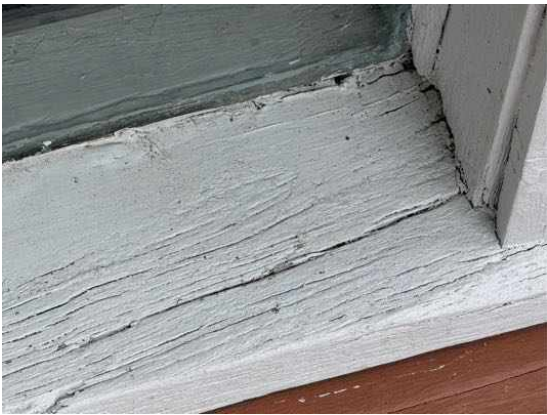
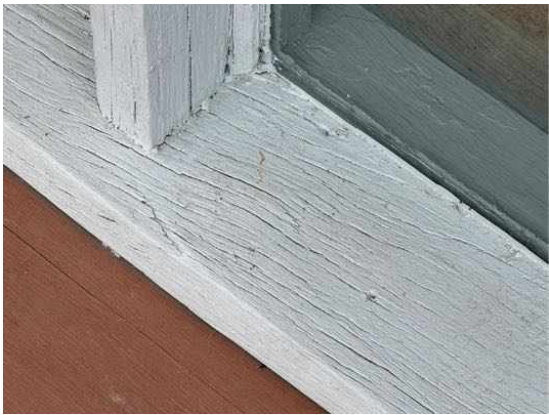
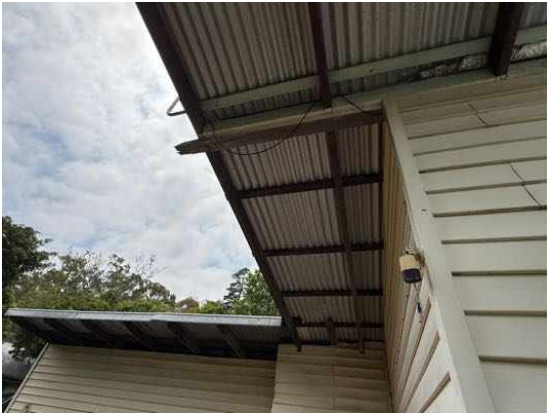
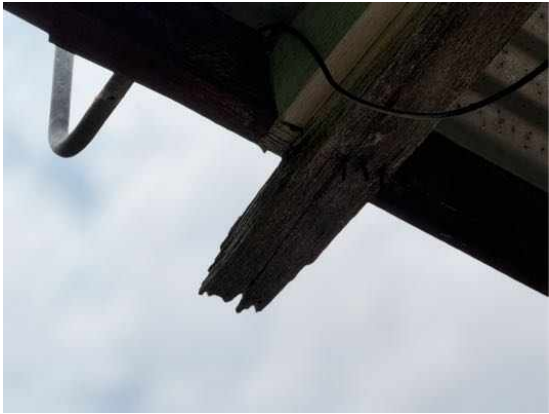
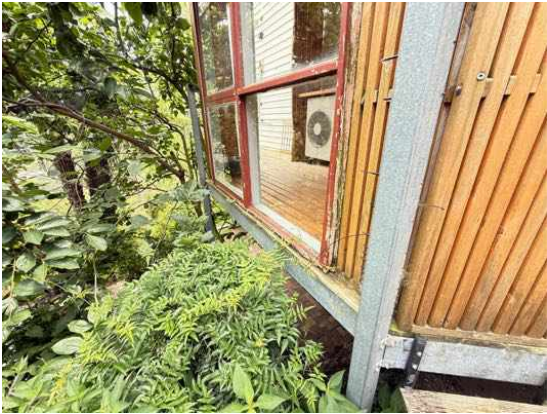
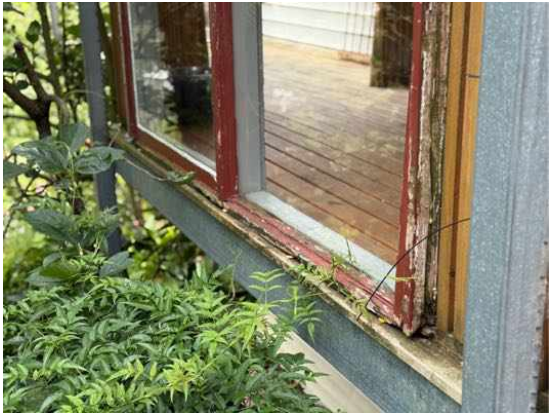
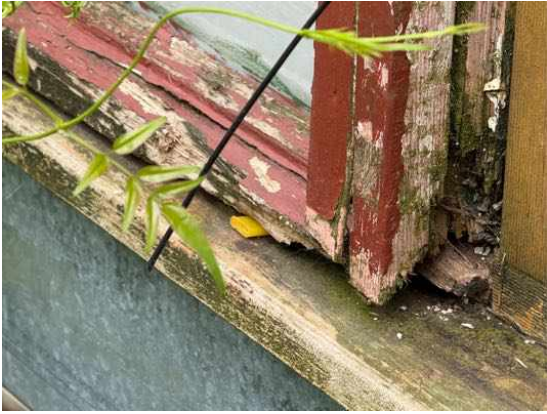
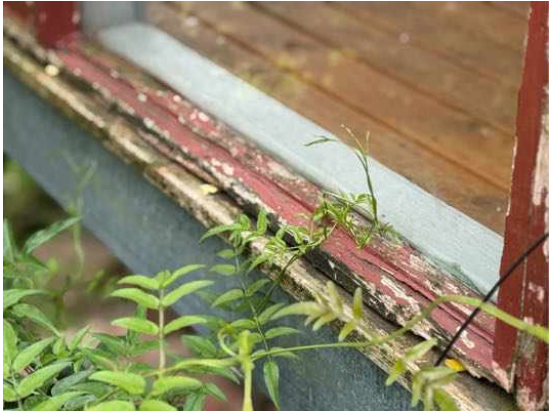
### Defects 3.05

Building:	Building 1
Location:	All Areas > All Areas
Finding:	Building elements that are rusted, corroded and or show wood rot
Information:	Some exterior building elements and materials that show evidence of rust, corrosion or wood rot has likely developed as a result of excessive exposure to moisture, harsh weather conditions and or inadequate coatings. A surface that is found to be rusted or wood rot has damage and is deteriorating, is likely to worsen if not addressed and left unmanaged, it is therefore recommended that the relevant tradespersons remove and rectify these areas as much as possible, clean and re-paint these areas.

Wood rot is suspected to be affecting building elements around the exterior areas. Wood rot, also known as Fungal Decay, occurs when timbers and other cellulose building materials are exposed to damp conditions on an ongoing basis. it is

suspected to be due to frequent exposure to rain and other weather conditions that make these building elements susceptible to accelerated deterioration.

Where possible, the use of galvanized (treated) metals or aluminium coated metals aid in rust prevention, as does regular general maintenance. Rust formation can be controlled with coatings, such as paint, that isolate the iron from the environment. Rusting and corrosion should be managed by ideally removing or limiting the affected surface from exposure to moisture and harsh weather conditions. A qualified painter or other relevant tradespersons may be appointed to paint affected areas and a qualified carpenter to replace any building elements that have been severely affected by rust or water damage.

Early intervention and regular maintenance such as painting will prolong the useful life of these building elements. Prior to any works being performed, the cause of the moisture that has created the wood deterioration or rot should be identified and addressed in a suitable manner. Replacement of the affected building elements may be a necessary step in protecting surrounding areas from secondary defects and deterioration. A qualified carpenter or registered builder may also be required to replace affected building materials deemed to be necessary.
