## Building Inspection Report

Inspection Date: Tue, 13 Jan 2026

Property Address: 12 Ferntree Ave, WARBURTON, VIC, 3799,  
Australia

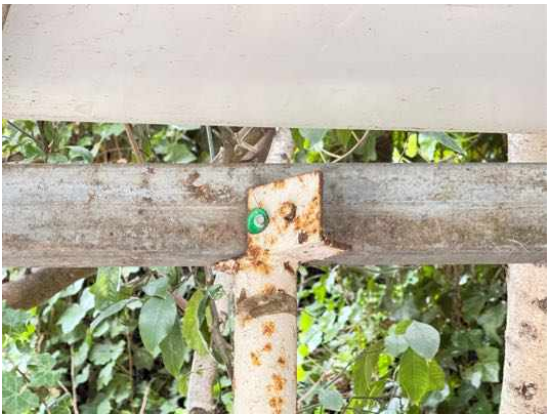
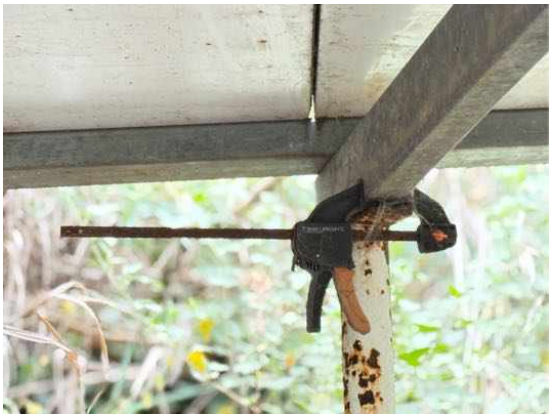
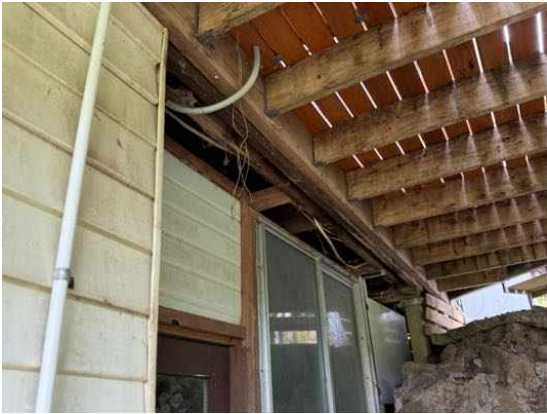
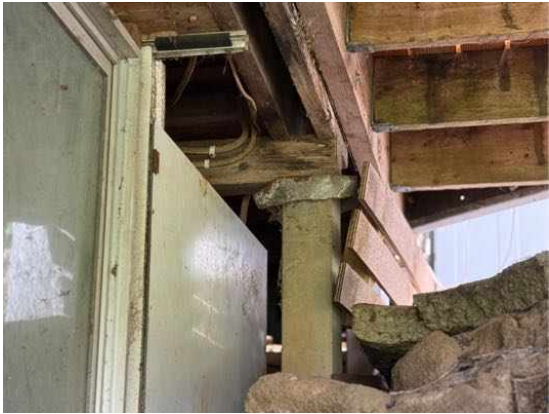
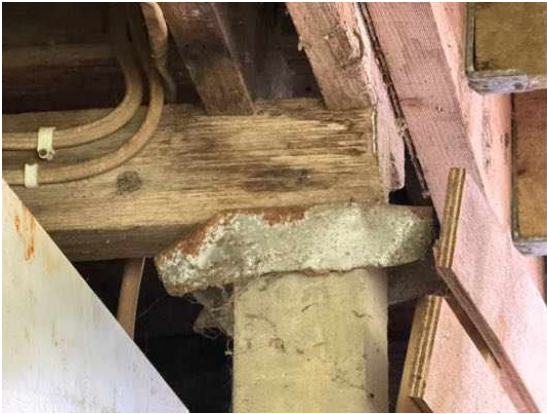
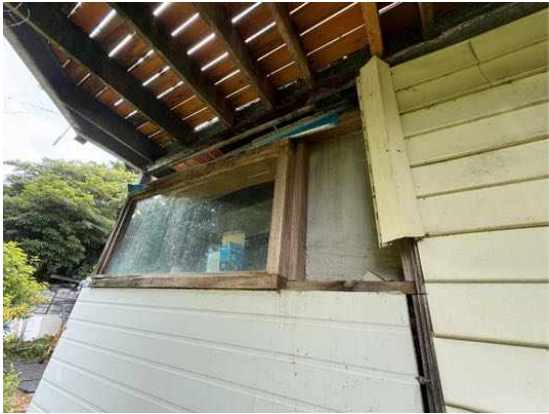
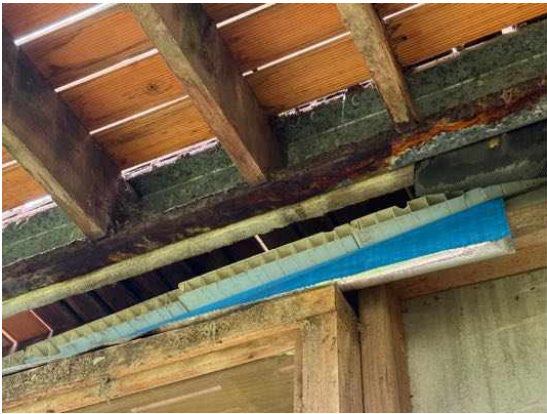
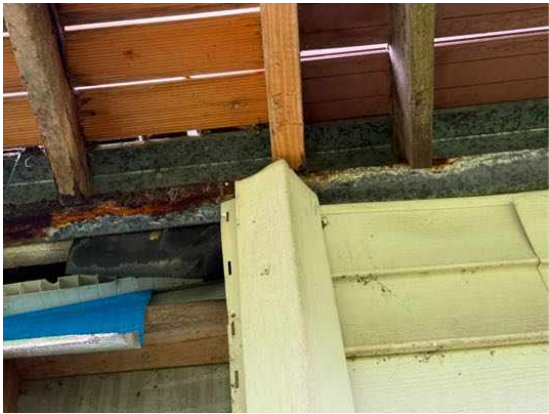
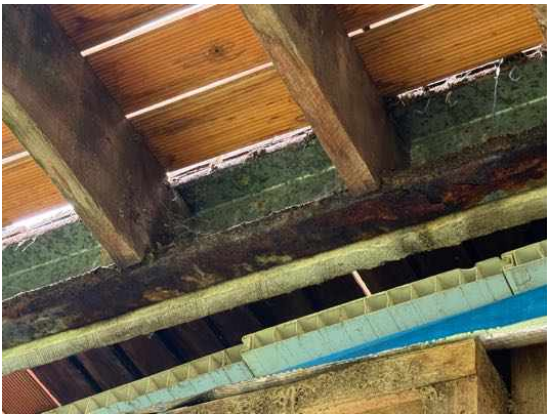
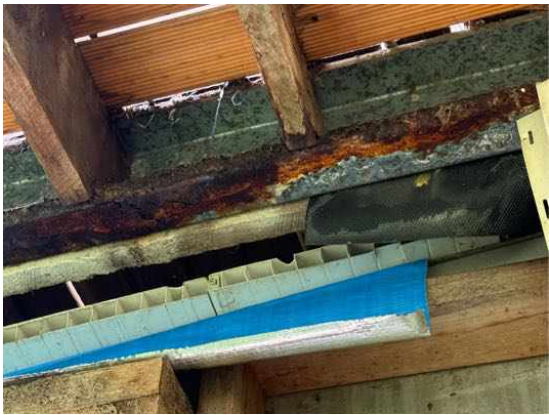
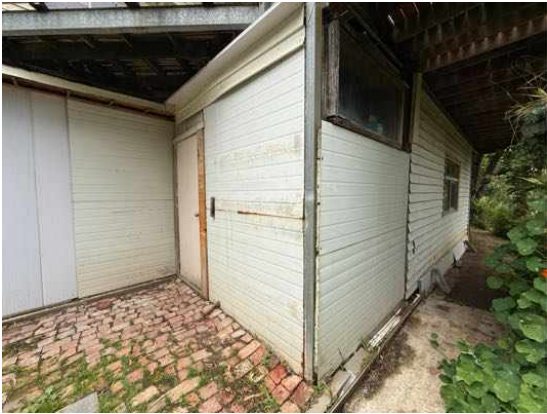
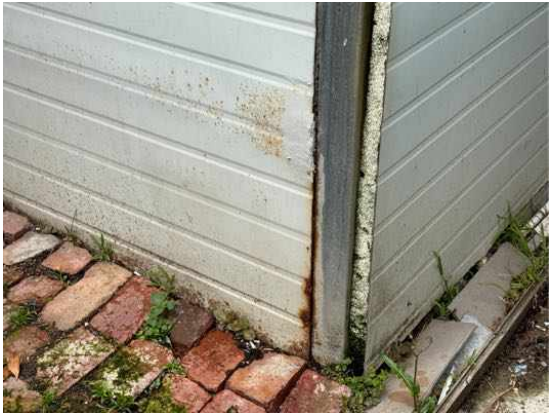
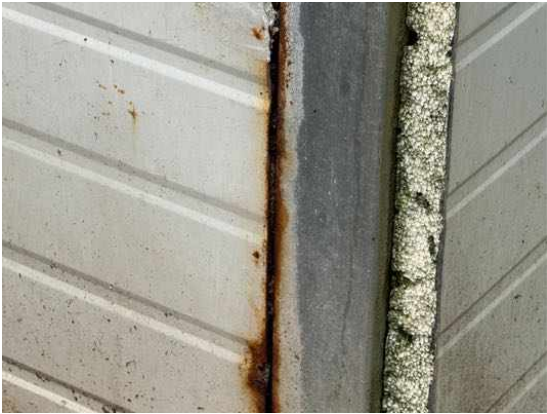
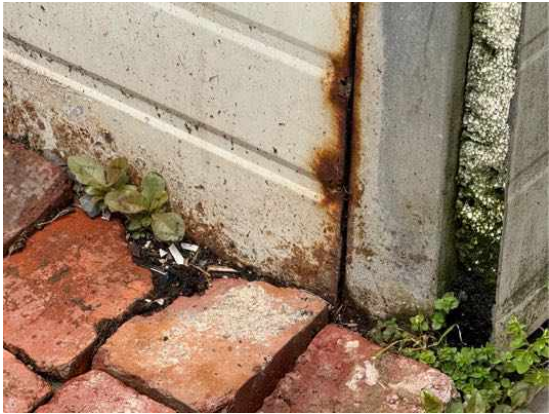
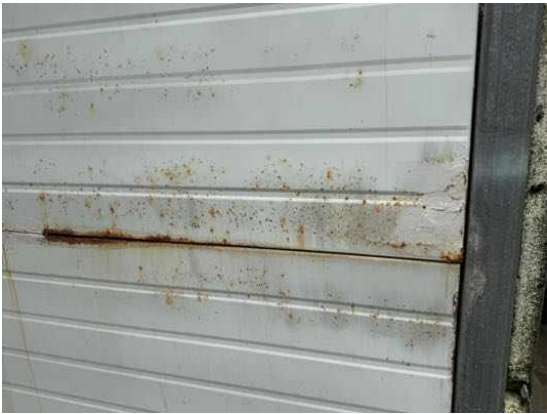
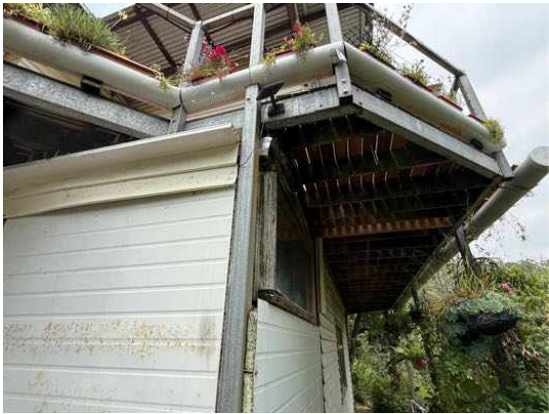
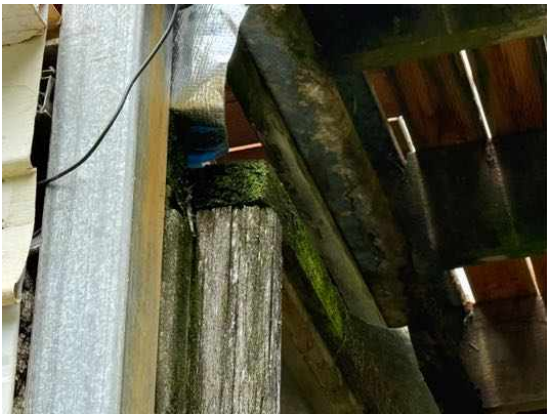
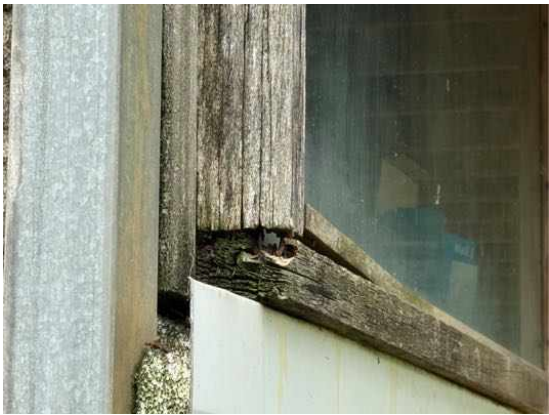
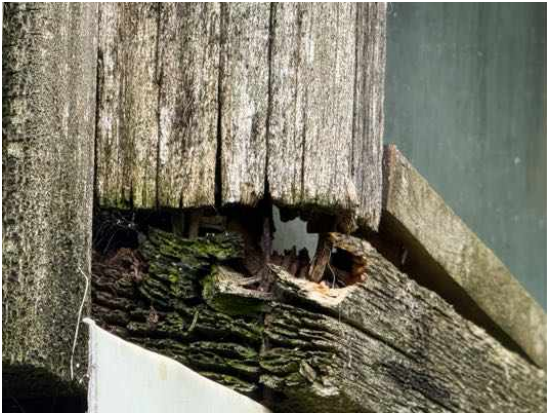
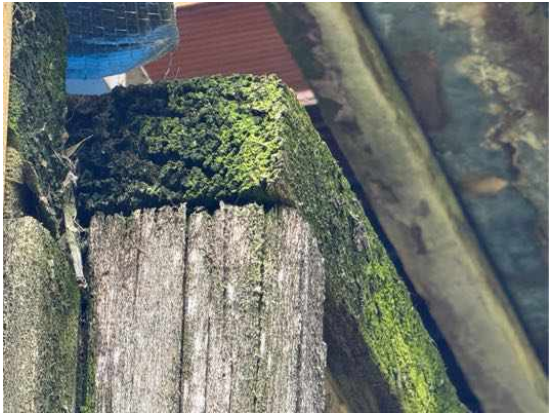
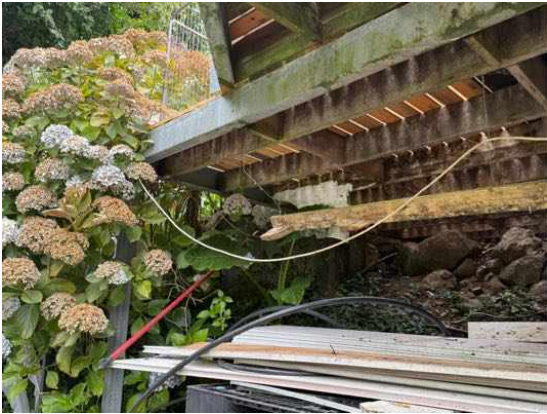
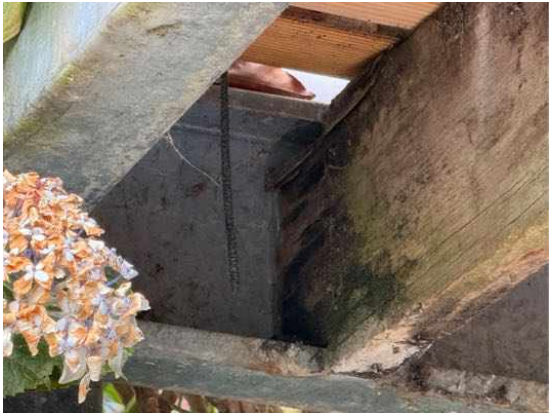
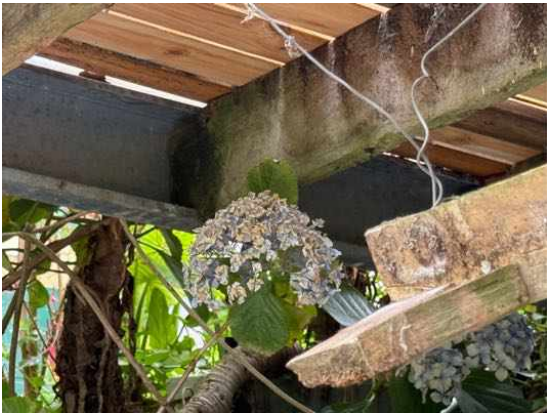
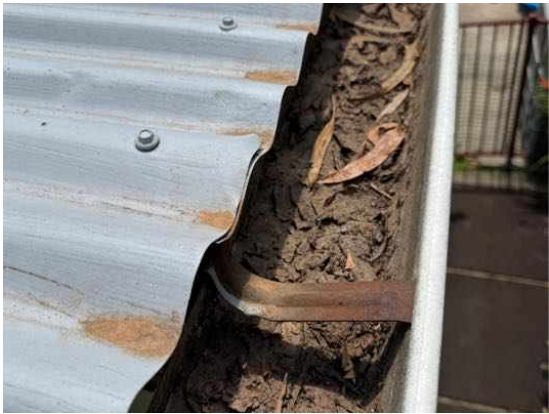
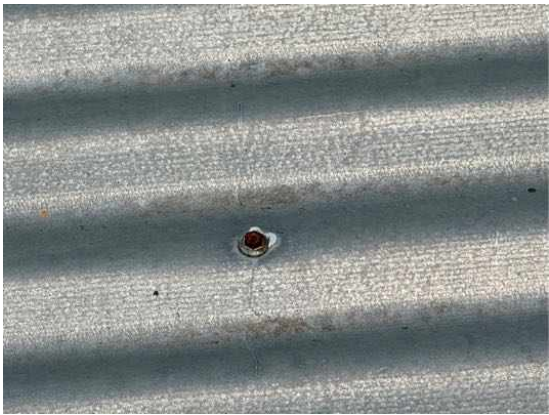
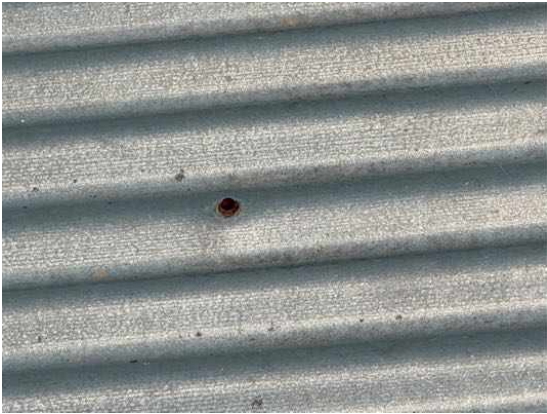
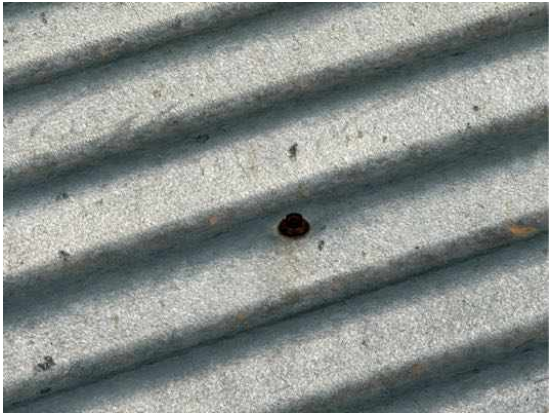
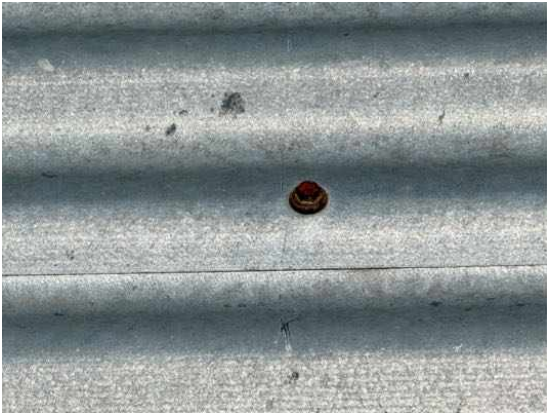
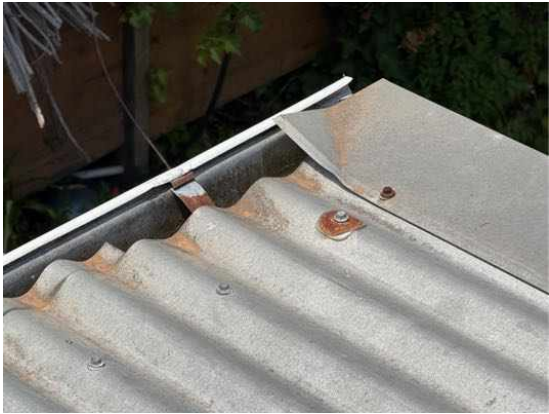
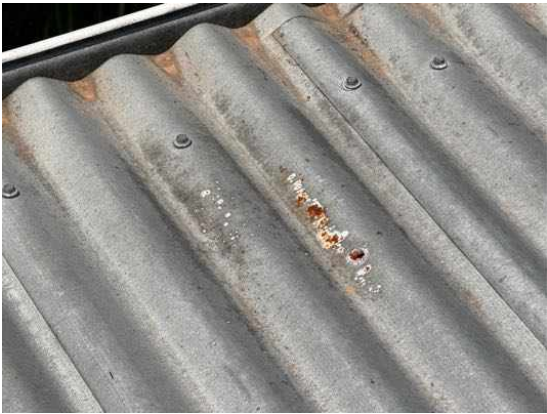
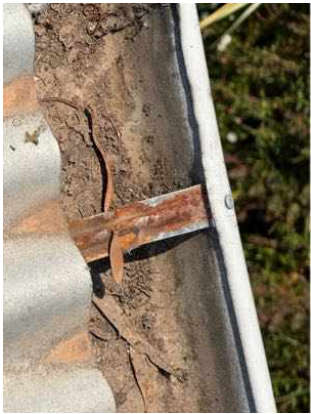
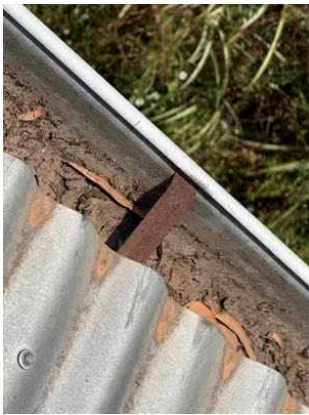
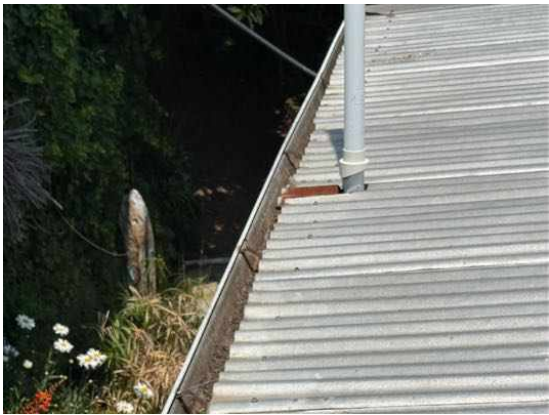
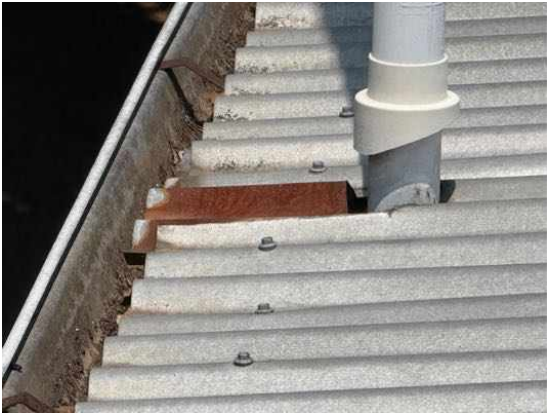
### Defects 3.05

Building:	Building 1
Location:	All Areas > All Areas
Finding:	Building elements that are rusted, corroded and or show wood rot
Information:	Some exterior building elements and materials that show evidence of rust, corrosion or wood rot has likely developed as a result of excessive exposure to moisture, harsh weather conditions and or inadequate coatings. A surface that is found to be rusted or wood rot has damage and is deteriorating, is likely to worsen if not addressed and left unmanaged, it is therefore recommended that the relevant tradespersons remove and rectify these areas as much as possible, clean and re-paint these areas.

Wood rot is suspected to be affecting building elements around the exterior areas. Wood rot, also known as Fungal Decay, occurs when timbers and other cellulose building materials are exposed to damp conditions on an ongoing basis. it is

suspected to be due to frequent exposure to rain and other weather conditions that make these building elements susceptible to accelerated deterioration.

Where possible, the use of galvanized (treated) metals or aluminium coated metals aid in rust prevention, as does regular general maintenance. Rust formation can be controlled with coatings, such as paint, that isolate the iron from the environment. Rusting and corrosion should be managed by ideally removing or limiting the affected surface from exposure to moisture and harsh weather conditions. A qualified painter or other relevant tradespersons may be appointed to paint affected areas and a qualified carpenter to replace any building elements that have been severely affected by rust or water damage.

Early intervention and regular maintenance such as painting will prolong the useful life of these building elements. Prior to any works being performed, the cause of the moisture that has created the wood deterioration or rot should be identified and addressed in a suitable manner. Replacement of the affected building elements may be a necessary step in protecting surrounding areas from secondary defects and deterioration. A qualified carpenter or registered builder may also be required to replace affected building materials deemed to be necessary.

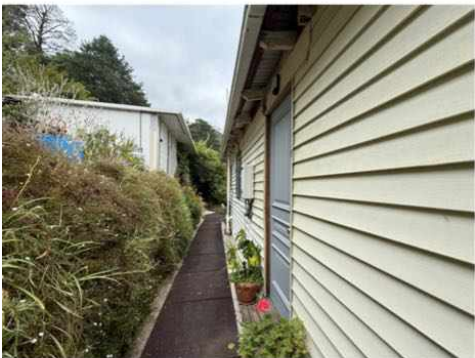
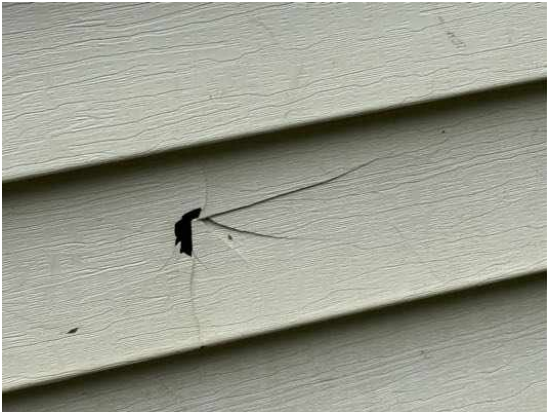
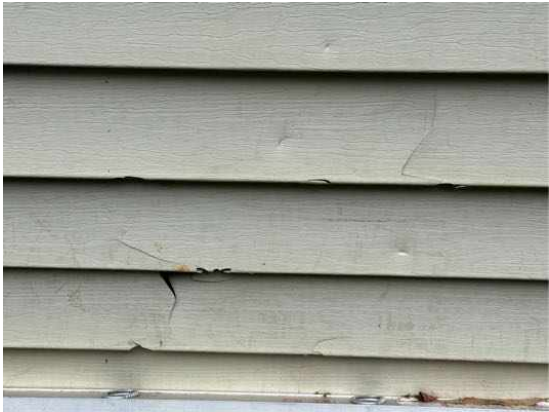
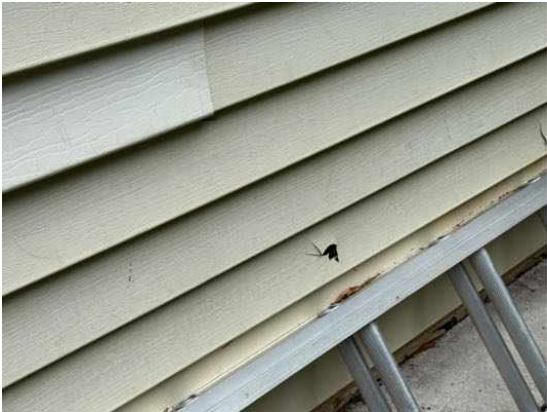
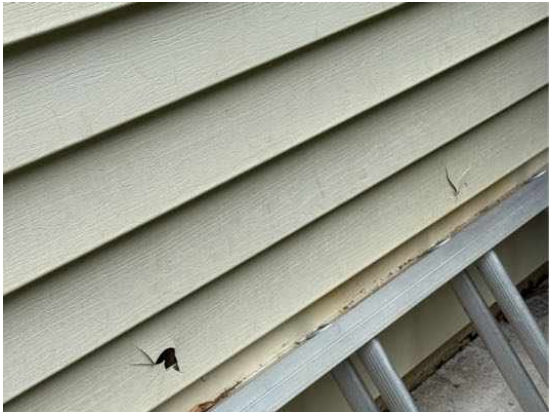
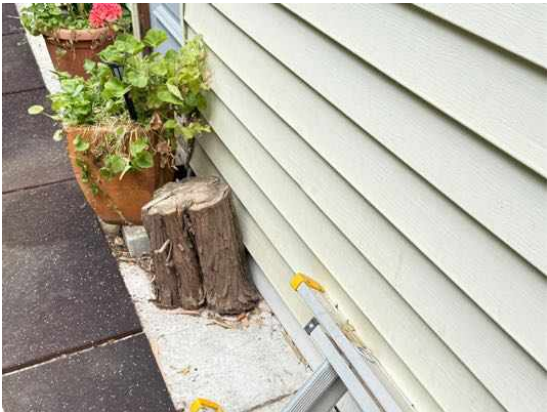
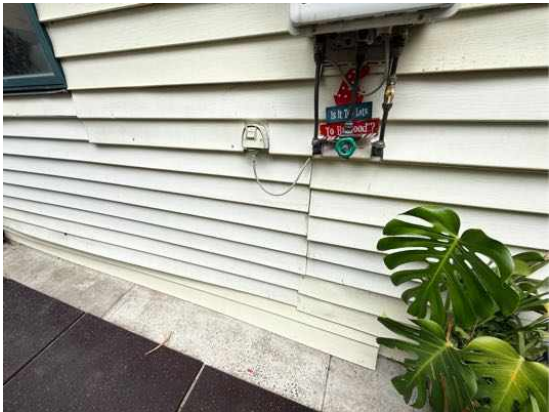
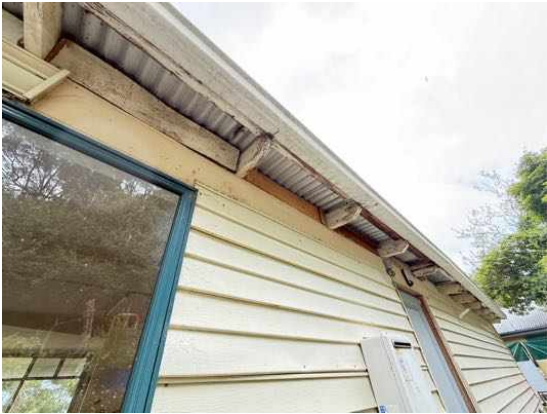
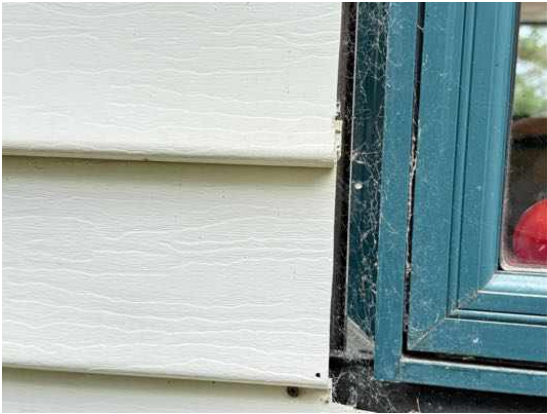
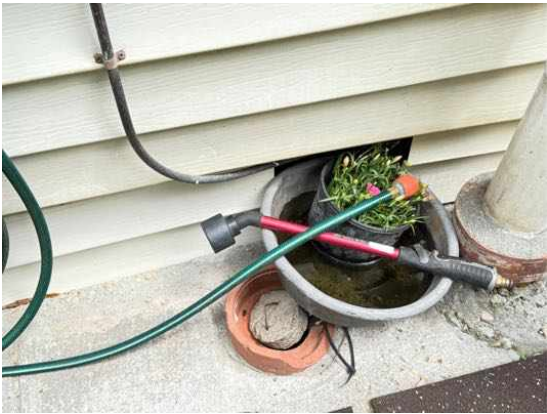
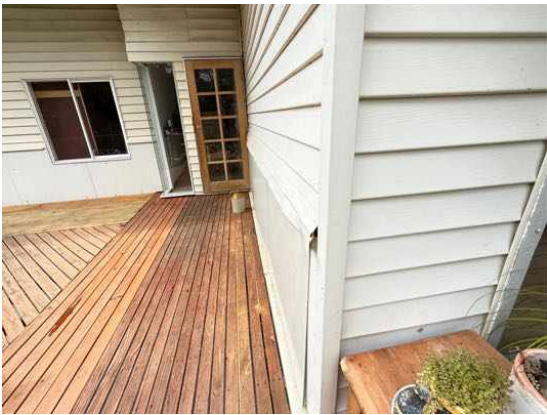
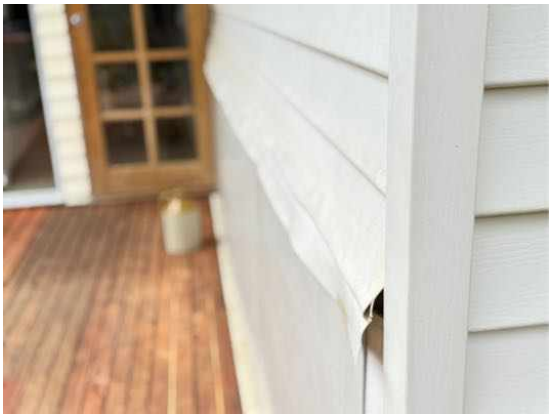
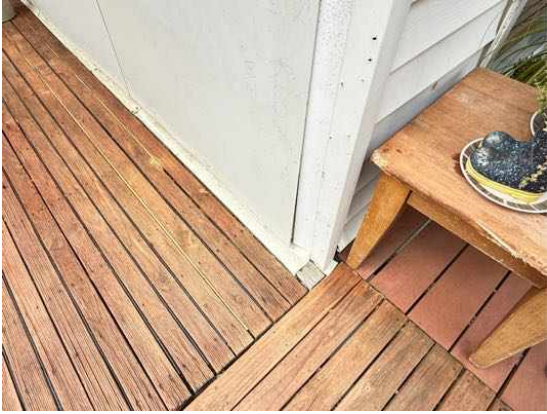
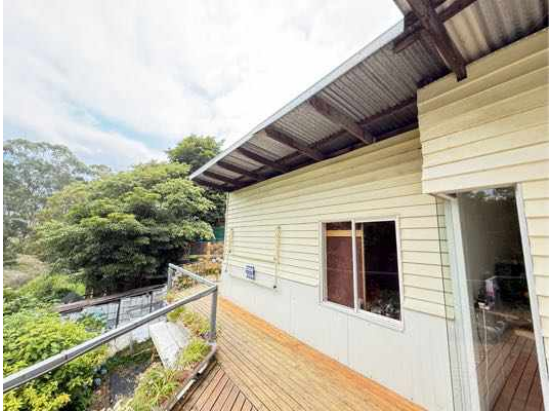
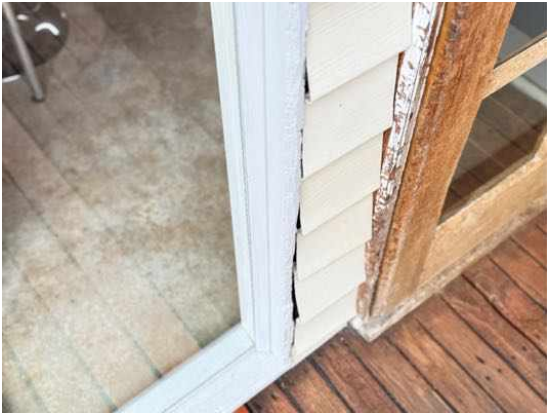
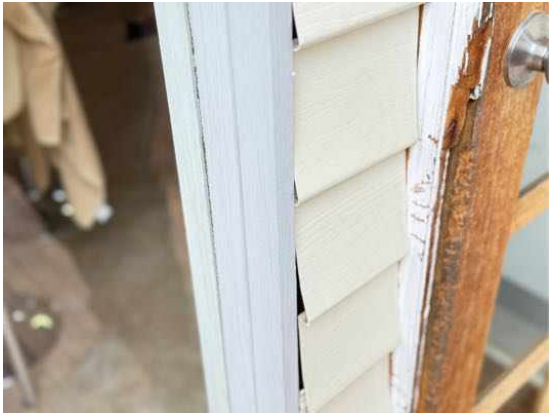
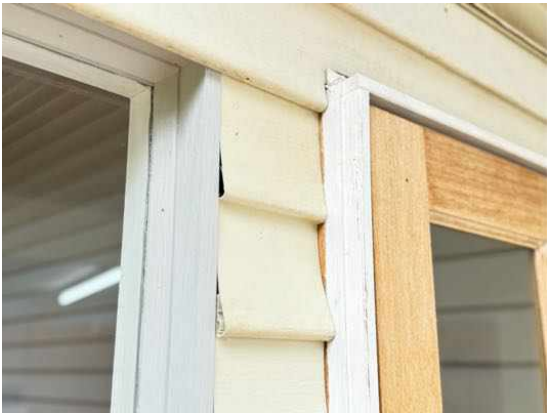
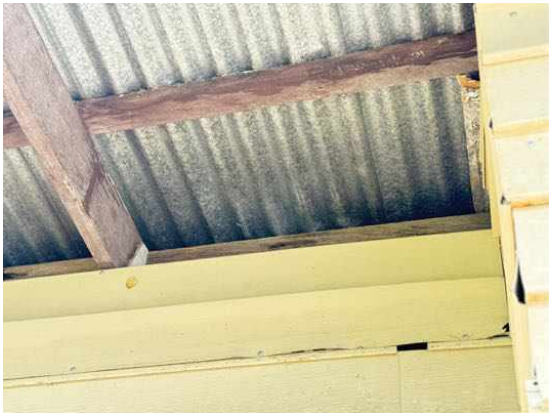
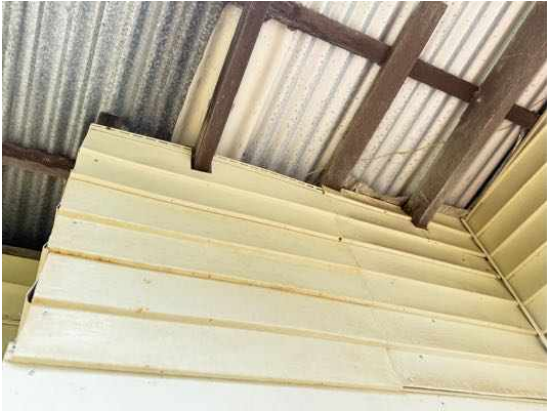
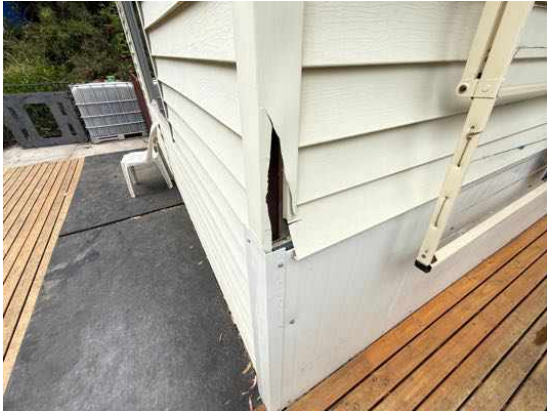
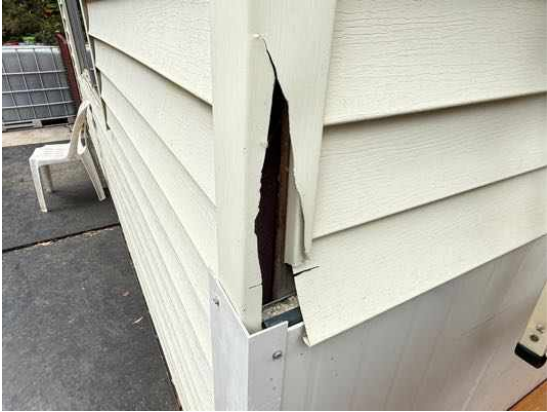
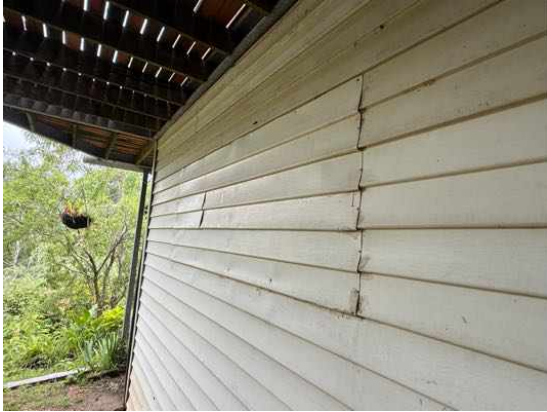
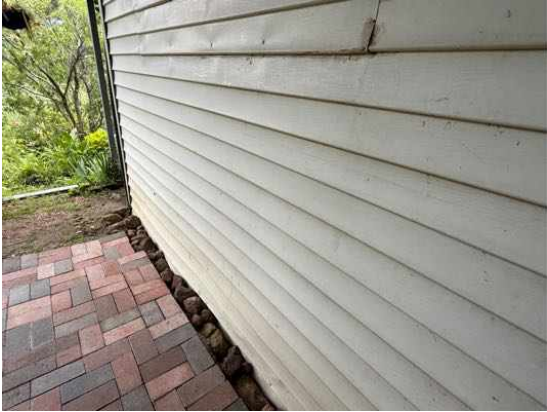
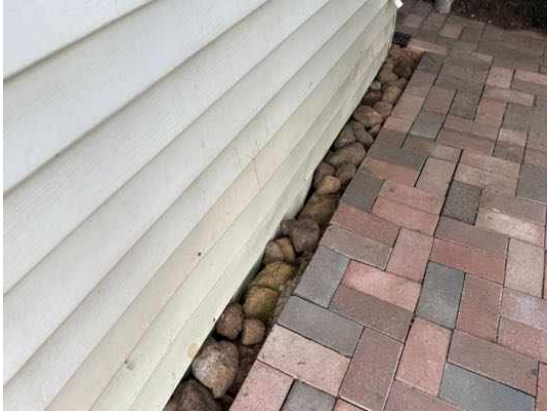
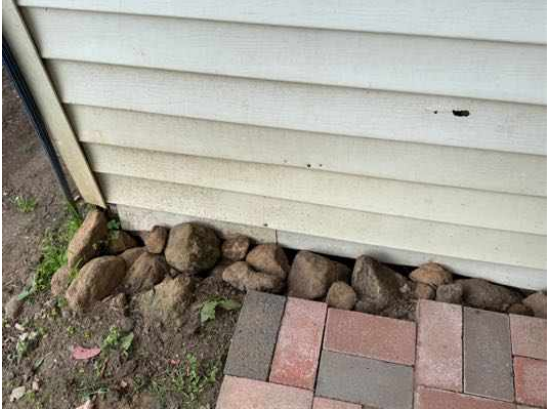
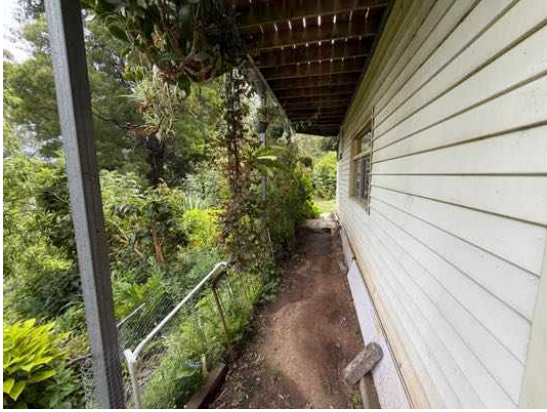
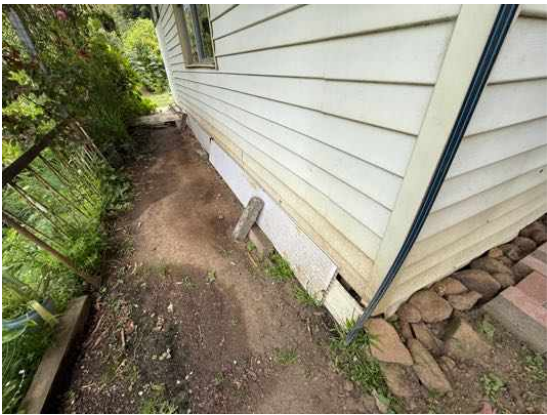
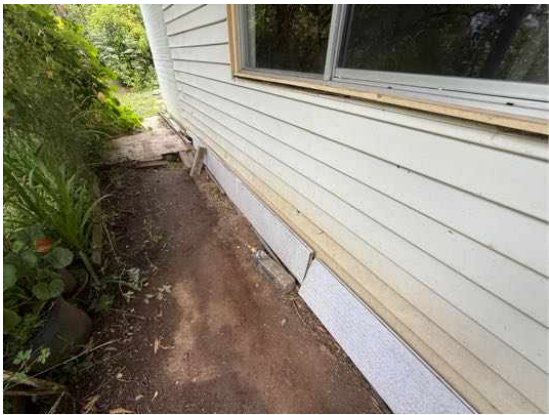
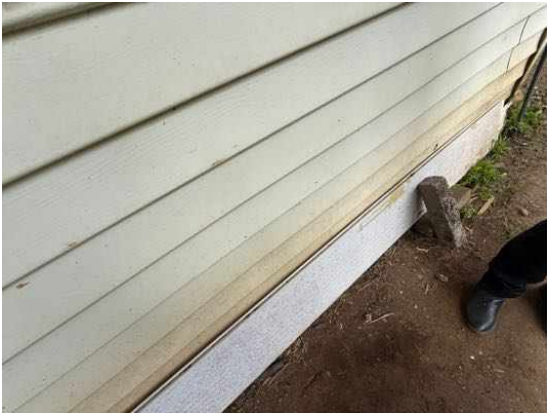
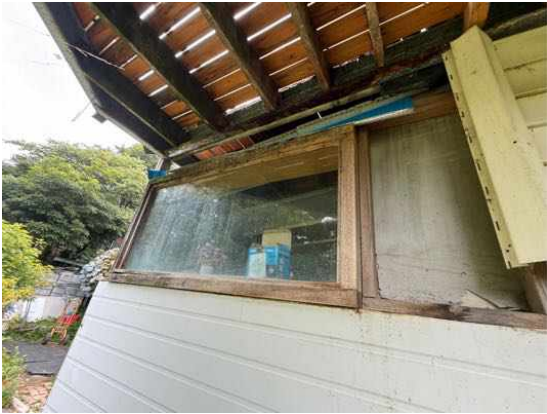
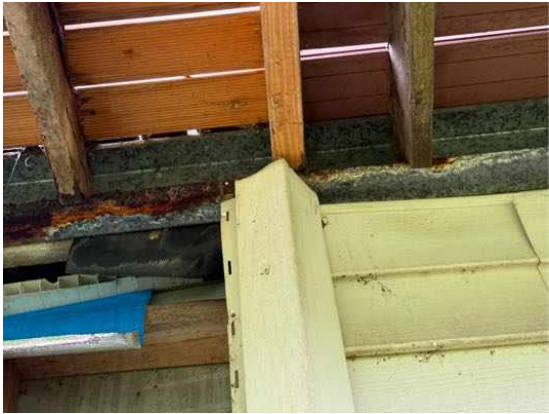
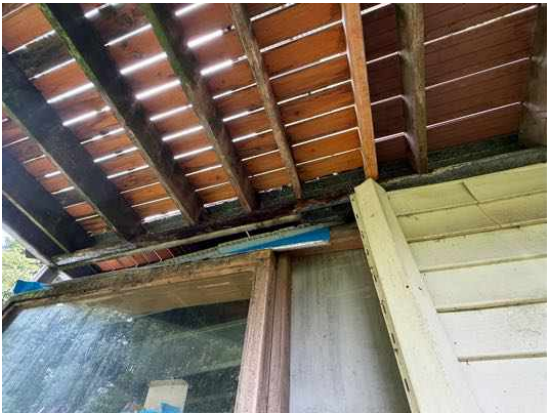
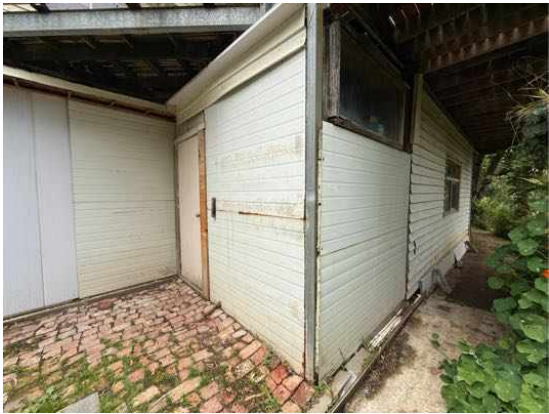
**Defects 3.06**

Building: Building 1  
Location: All Areas > All Areas  
Finding: Numerous broken, dislodged and deteriorated wall linings  
Information: The back room wall linings to the rear of the home, are suspected to have been constructed with the use of a plastic weatherboard construction material. The observable areas of wall sheeting showed numerous areas of observed damage, dislodged or deterioration, indicating that wall linings are not currently adequately sealed and protected from the ingress of vermin, spiders, insects and other pests.

Where the client elects to leave these damaged and deteriorated wall linings, further damage or deterioration to the wall and floor structures is suspected. Remedial work is required to repair these areas in the short- to medium-term as solution to reduce the risk presented by excessive water and moisture.

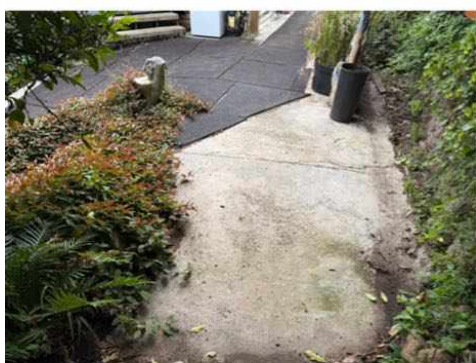
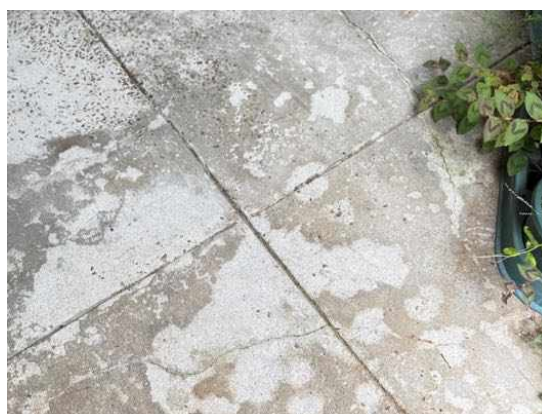
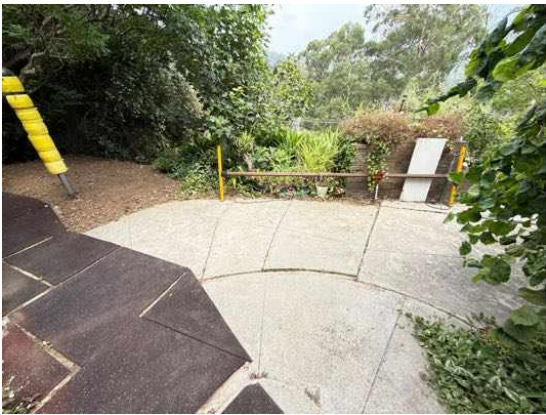
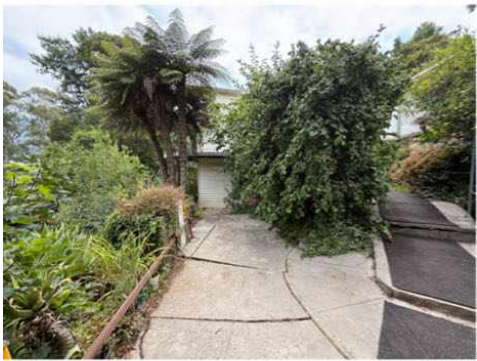
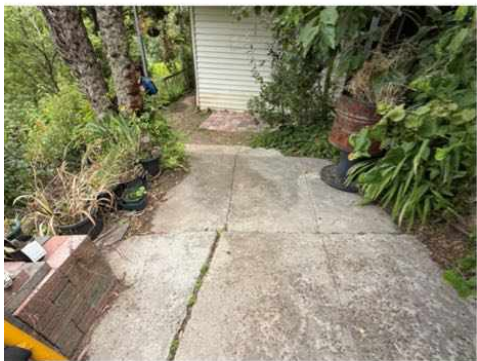
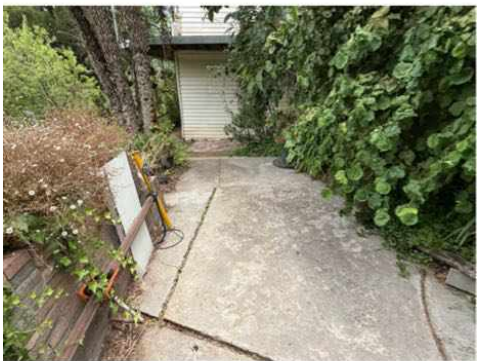
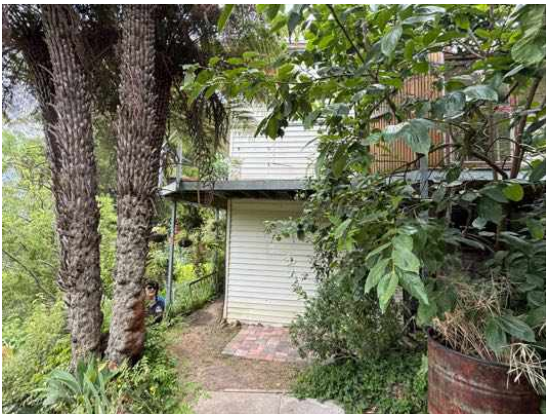
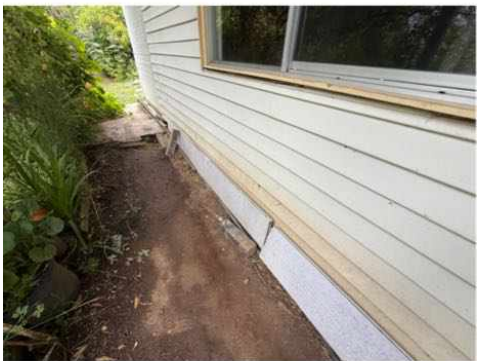
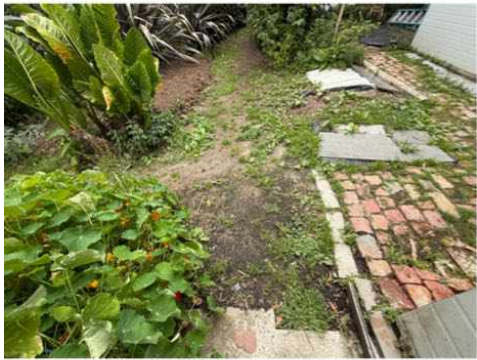
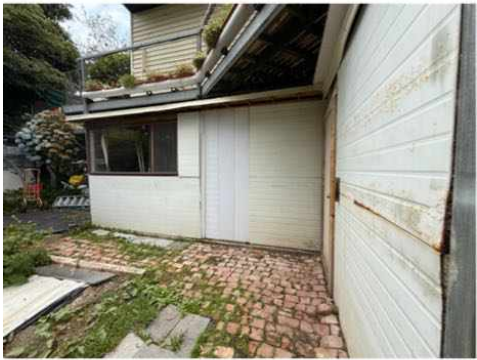
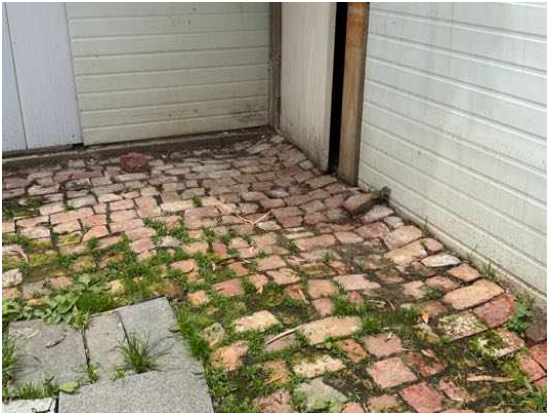
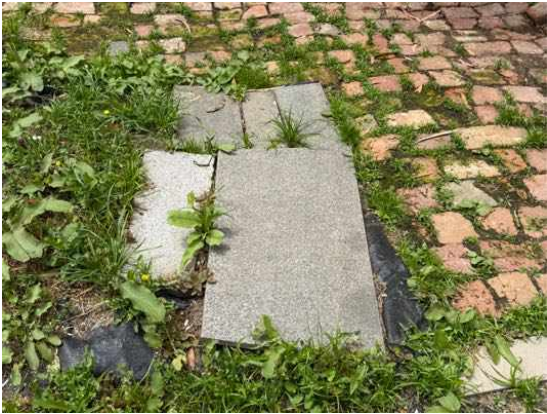
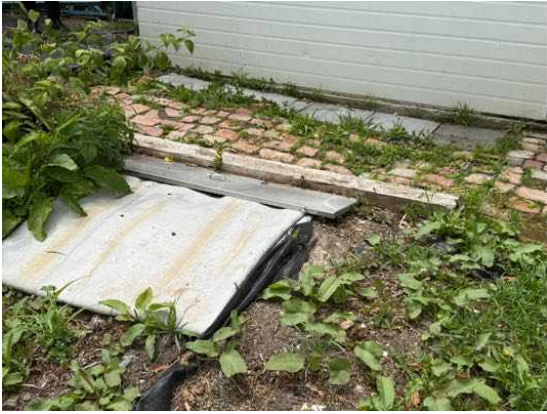
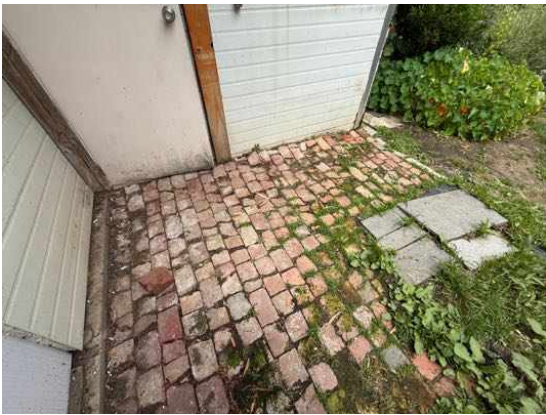
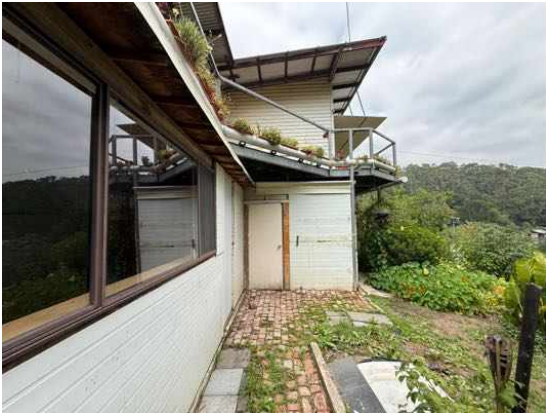
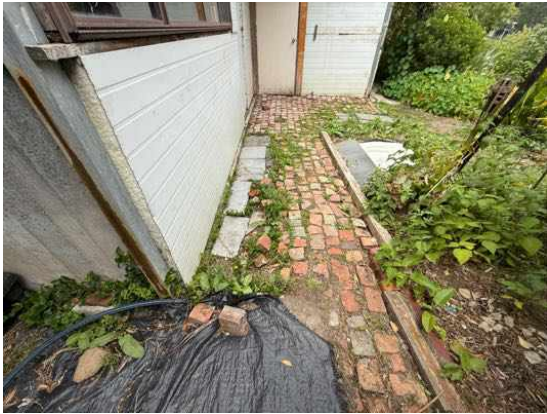
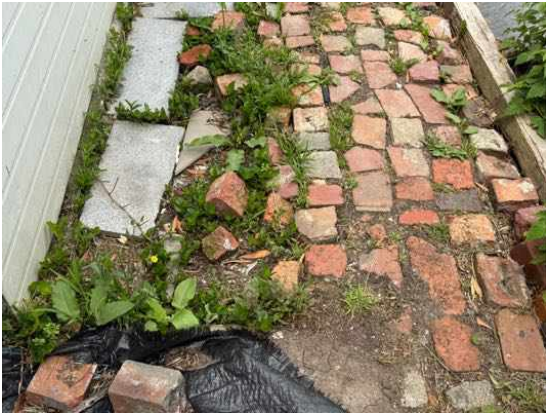
### Defects 3.07

Building:	Building 1
Location:	All Areas > All Areas
Finding:	Exterior paving - Numerous areas of unevenness and undulations
Information:	Numerous areas throughout the exterior areas of paving and paths showed numerous areas of unevenness and undulations. These numerous areas of the external paths and paving were considered to be creating potential trip hazards for children and occupants in these areas. These areas are suspected to have been subjected to tree roots, poor installation, or paving sections have dropped or lifted due poor preparation in the substrate before paving is laid.

Where paving creates a trip hazard, personal injury may ensue if due caution is not taken by occupants and all other persons within this area. Client may consider re-paving of these areas, where required or deemed necessary to remedy these types of situations. Further consultation with a landscaper or other specialists in these areas is recommended.

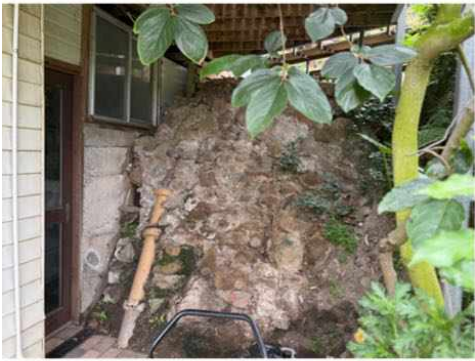
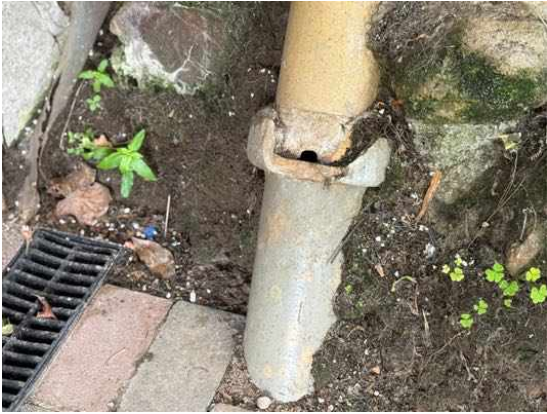
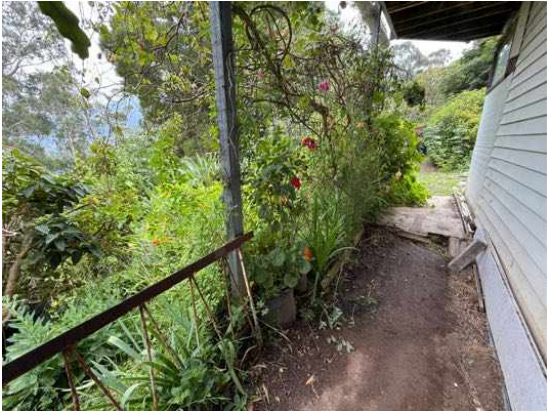
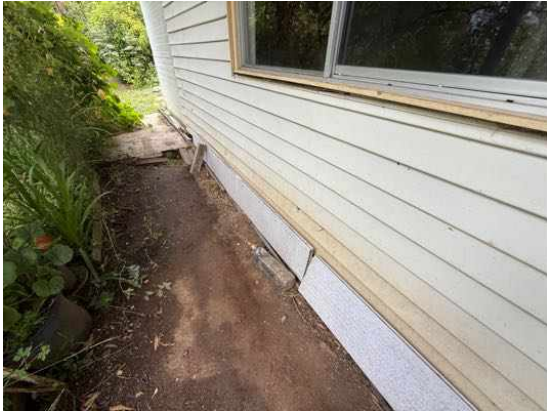
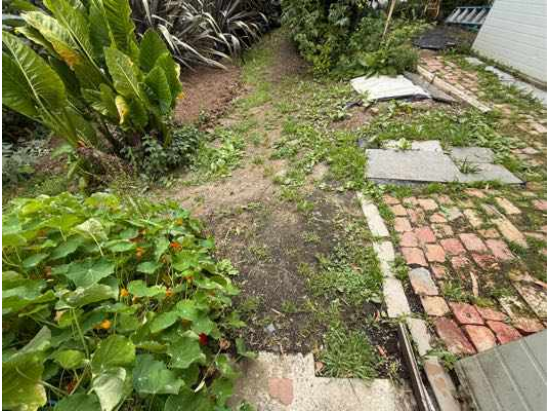
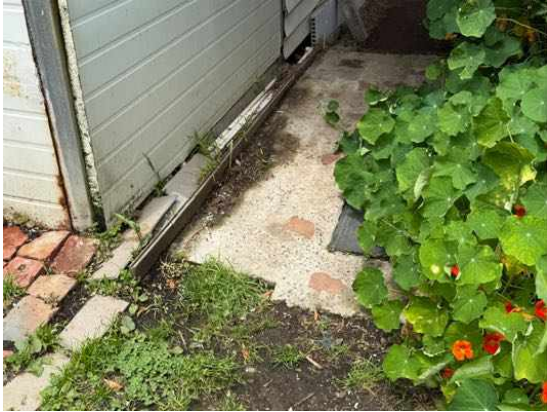
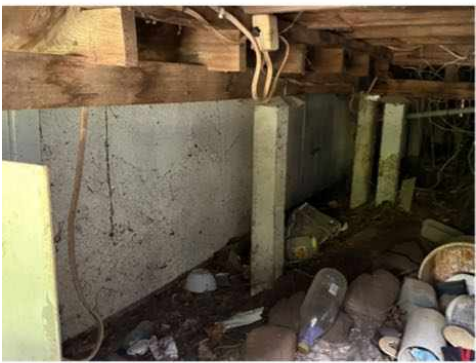
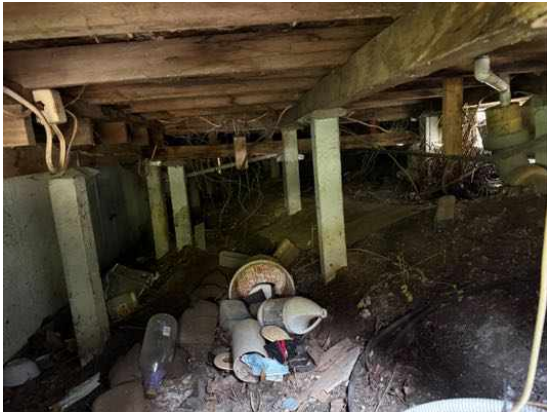
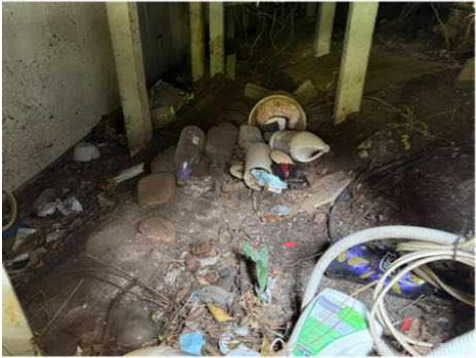
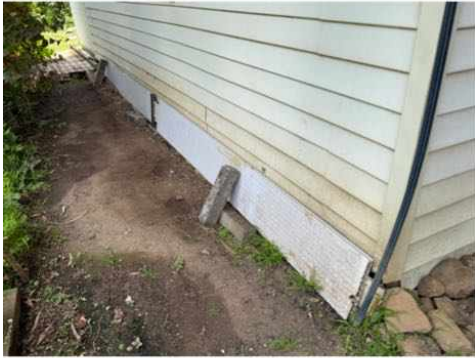
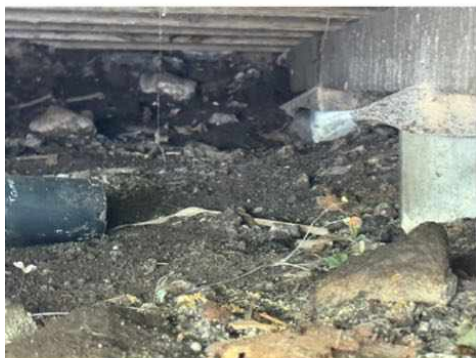
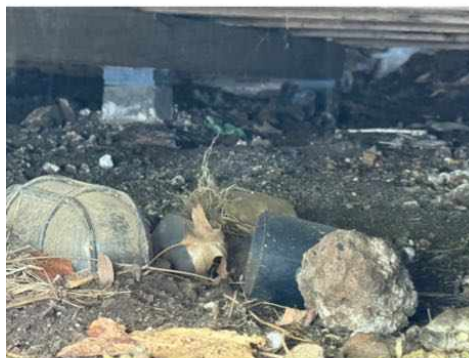
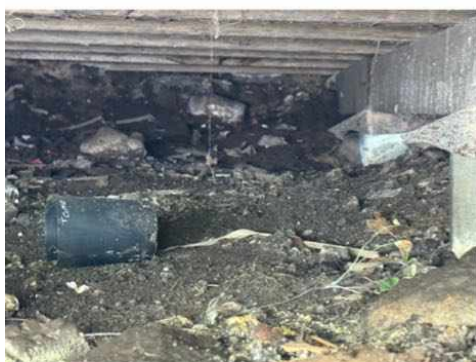
**Defects 3.08**

Building: Building 1  
Location: All Areas > All Areas  
Finding: Site stormwater drainage  
Information: Due to the numerous levels throughout the property, it is important for the excess water and moisture to be drained into exterior perimeter aggy drains or stormwater drainage system. If excessive water and moisture is not restricted it is highly suspected that it will travel under the home and throughout the subfloor areas. It is highly recommended that the client ensure that site drainage is working and free from excess leaf matter, dirt and debris.

suspected to be travelling throughout the subfloor areas. The subfloor areas were not able to be accessed at the time of the inspection, making it impossible to see if adequate stormwater drainage had been installed. These areas are suspected to be highly susceptible to excessive water and moisture from the hill run- off, it will therefore require adequate stormwater drainage - aggy drains directed away from these perimeter exterior walls.

These aggy and stormwater drainage will need to be cleared periodically, all surface drainage and sub soil drainage systems must be protected from debris, soil, sand or any other material which may impede the operation of the site drainage. The purpose of the stormwater drainage is to drain off ground, surface and some sub-surface water and moisture and ensure it gets carried away from areas where secondary defects are possible if left unmanaged.
