## Building Inspection Report

Inspection Date: Tue, 13 Jan 2026

Property Address: 12 Ferntree Ave, WARBURTON, VIC, 3799,  
Australia

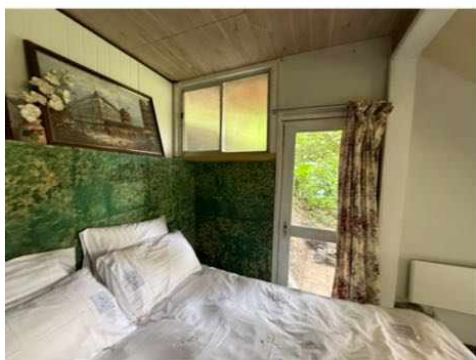
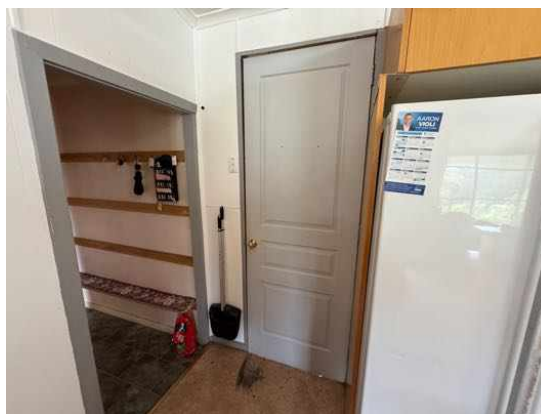
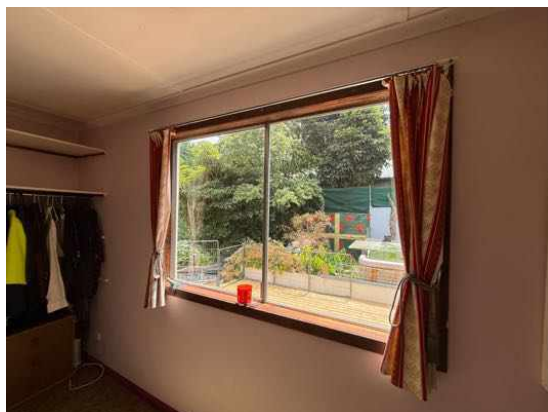
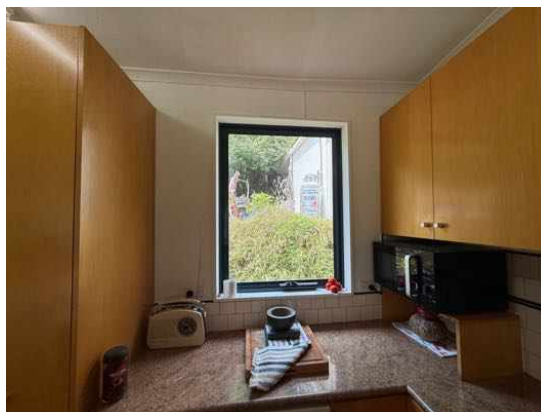
### Defects 3.09

Building:	Building 1
Location:	All Areas > All Areas
Finding:	Flyscreens
Information:	Numerous flyscreens were found to be missing to the windows throughout the home at the time of inspection. Whether the flyscreens have not been installed or have been removed for maintenance and or painting purposes, this missing building element detracts from the operational state of the window.

Where not replaced, missing flyscreens allow pest and insect ingress into the adjoining room/s. It is advised that all missing building elements be installed or replaced in order to ensure the full function of all building structures.

A qualified carpenter may be appointed to replace flyscreens at the discretion of the client.

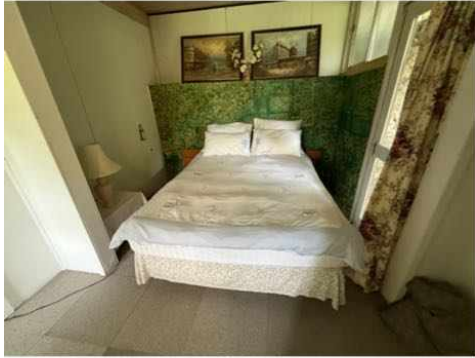
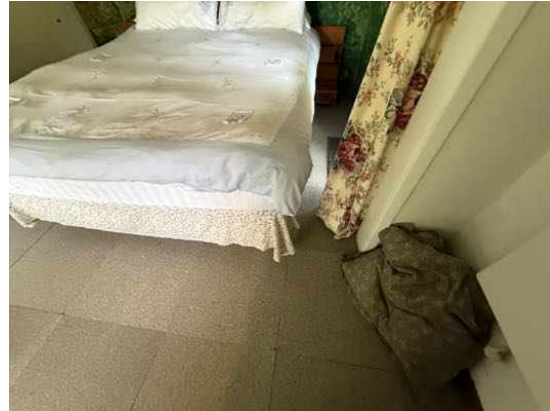
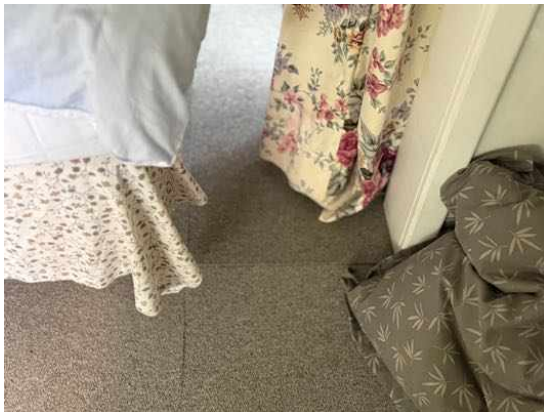
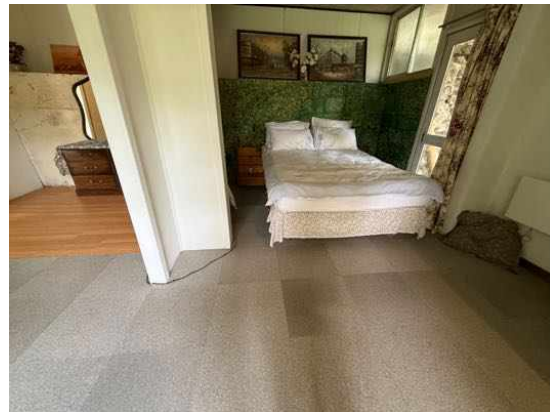
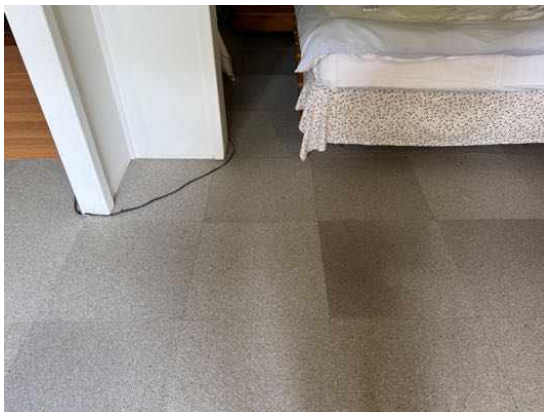
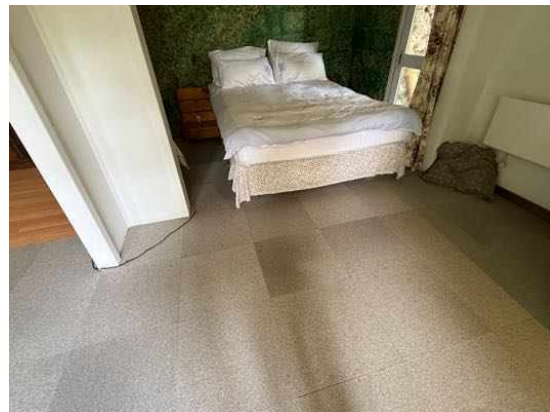
### Defects 3.10

Building:	Building 1
Location:	Lower bottom storey areas > All Areas
Finding:	Floor levels
Information:	The lower storey floors throughout the lower areas of the home were observed to be showing signs of dips, minor movement, out of level and uneven. Uneven and out of level floors in some areas were considered excessive and are considered to require an immediate invasive inspection to ascertain the extent of any defects and problems. The uneven and out of level floors is highly likely to indicate, poor subfloor structure, subsidence and or movement in the associated subfloor structures.

Floor levels can have complex and varying causes, which will influence the required remedial works. It is highly recommended to begin by consulting a registered builder to determine the required scope of works that may be deemed necessary when an invasive inspection is carried out. This may include remedial work and some floor replacement in some areas, at the same time as addressing the underlying cause of the uneven and out of level floors. Client may also consider consultation with a geotechnical engineer to understand what and how the surrounding soil is reacting to surrounding moisture.

A Registered Builder would generally carry out these types of works or can be guided and advised by an geotechnical or structural engineer where deemed to be required. If left unmanaged it is recommended that the floors be closely monitored to identify any

further defects. Where floors become uneven further or show excessive movement, an invasive inspection of the subfloor and floor structures is immediately recommended and required. Where these types of defects are encountered it is highly likely to require floor coverings and flooring to be removed due to the close proximity to the ground.

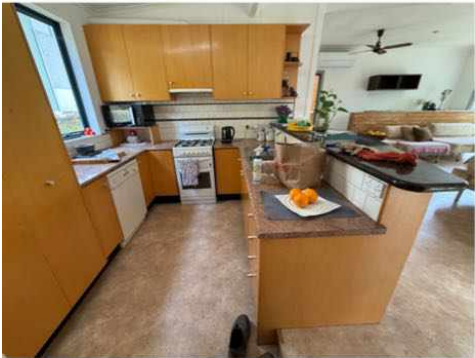
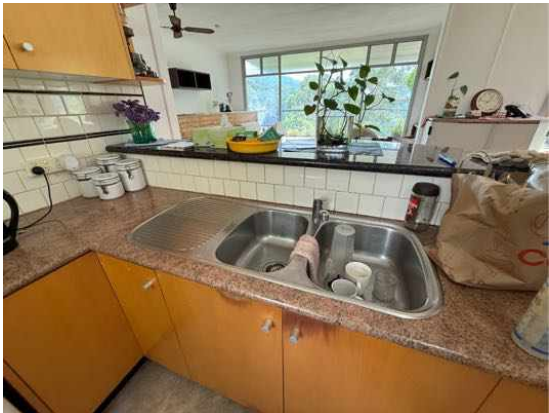
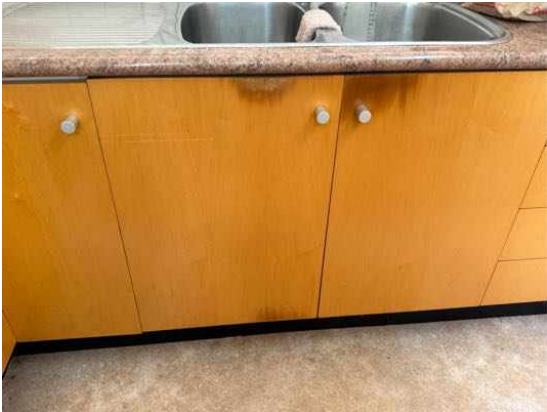
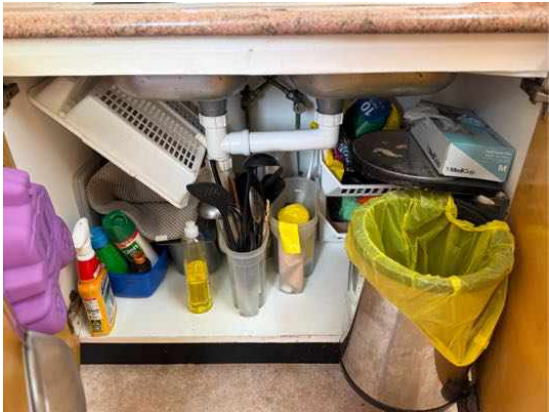
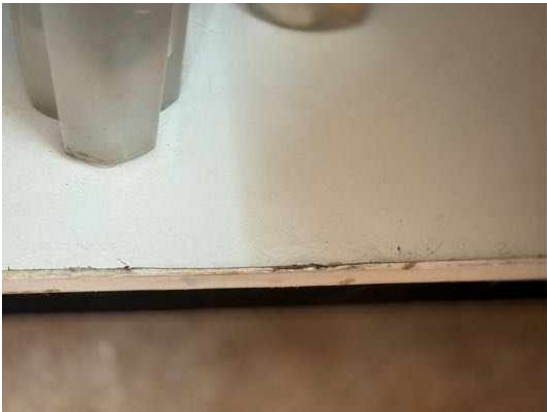
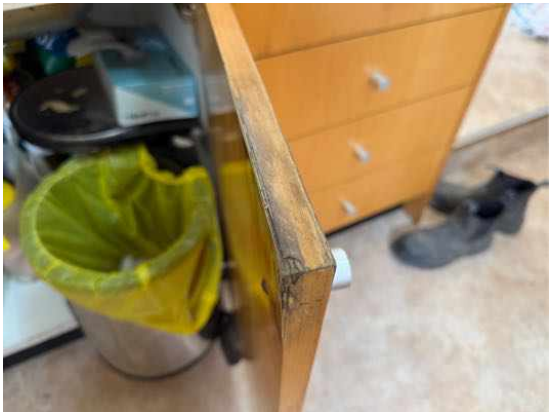
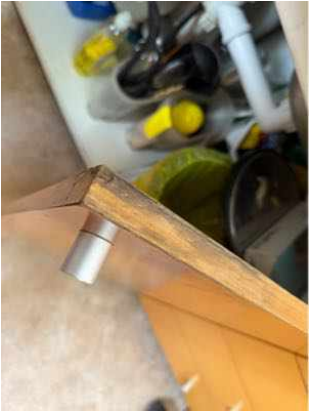
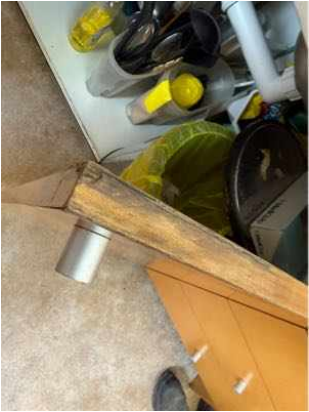
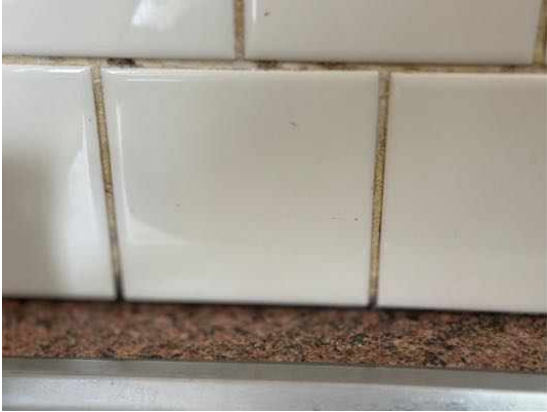
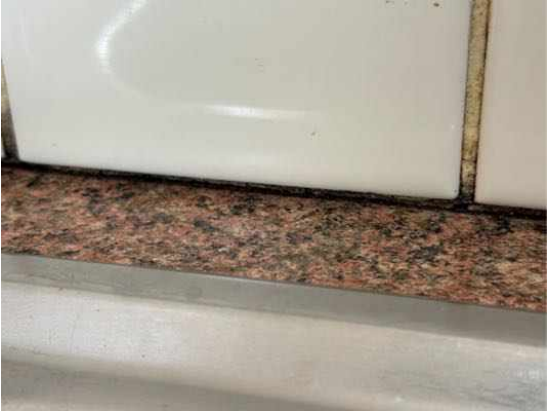
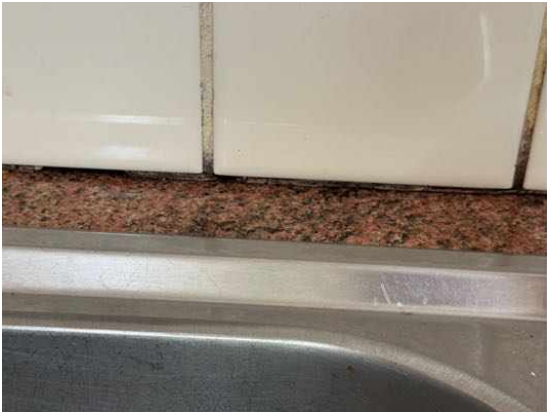
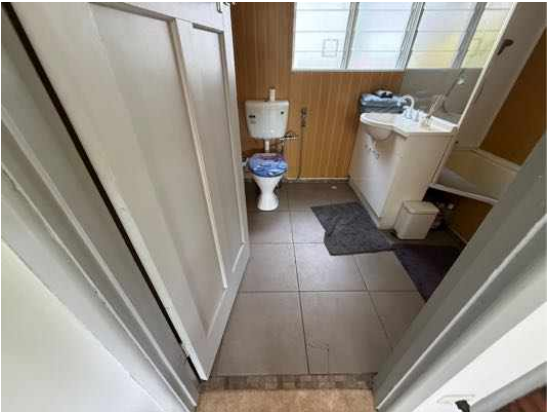
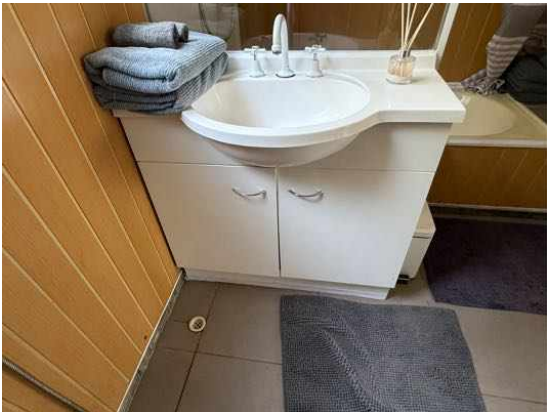
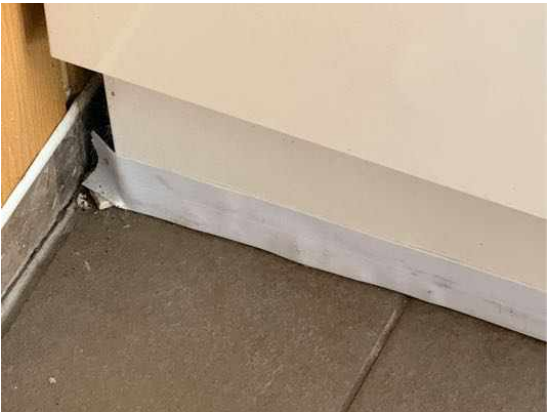
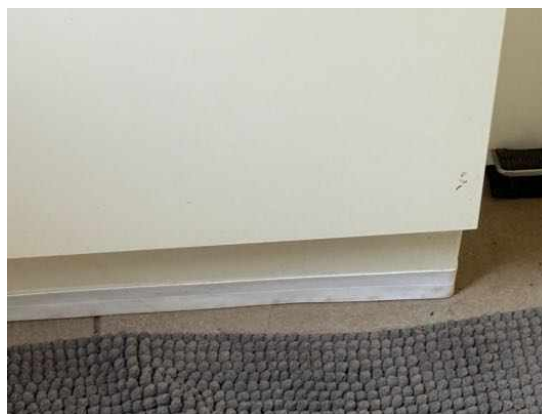
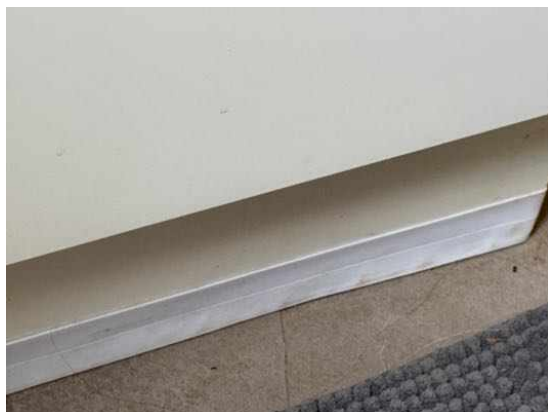
### Defects 3.11

Building:	Building 1
Location:	Kitchen > All Areas
Finding:	Kitchen cabinet doors.
Information:	Several kitchen cabinet doors are showing signs of moisture damage and minor misalignment. While this may detract from the appearance of the cabinetry, the

operational state of the cabinetry appears to be working correctly. To improve operation of the affected cabinets, a qualified cabinet maker may be appointed to provide maintenance and repair where deemed to be necessary. Such works can be completed at discretion of the client.

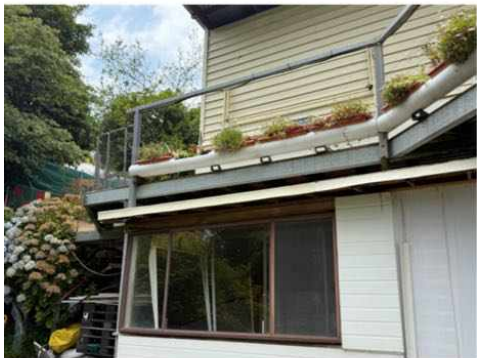
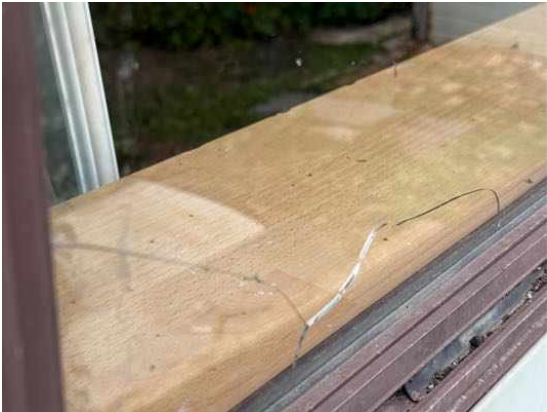
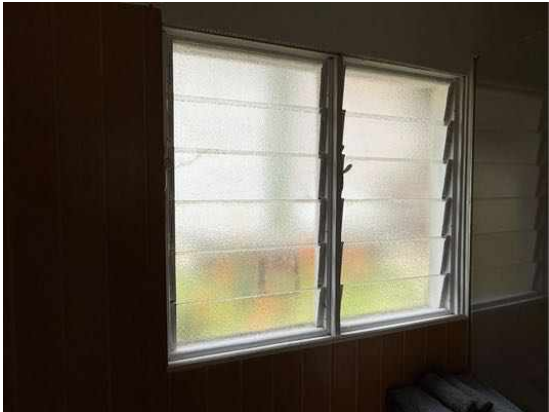
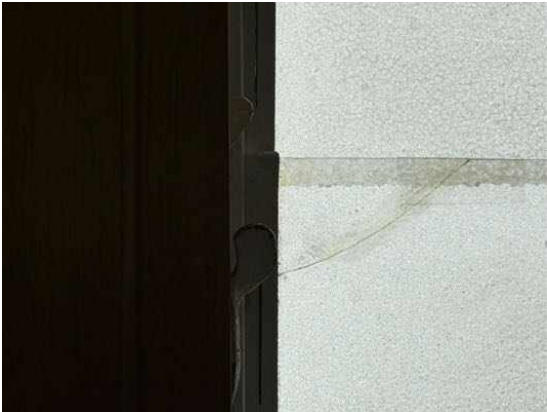
### Defects 3.12

Building:	Building 1
Location:	All Areas > All Areas
Finding:	Broken and cracked glass
Information:	Broken and cracking glass was observed at the time of inspection, this damage is suspected to have been from impact damage at sometime. While the cracked or broken window may be in some cases considered to be minor, any further impact damage sustained to the glass may lead further damage and deterioration or more serious injury to occupants and or additional cracking.

As the cracking provides potential secondary damage to the glass or associated building elements and building materials, repair of the glass may be deemed necessary in the future. Consultation with a glazier to repair or replacement or other remedial works may be required to protect against any further damage.

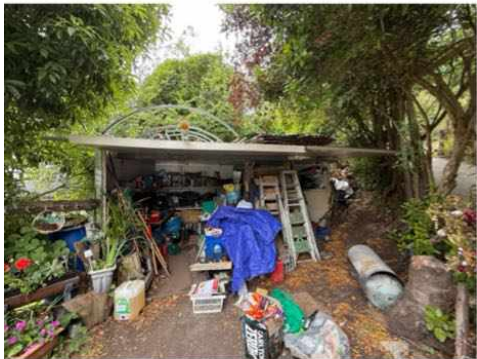
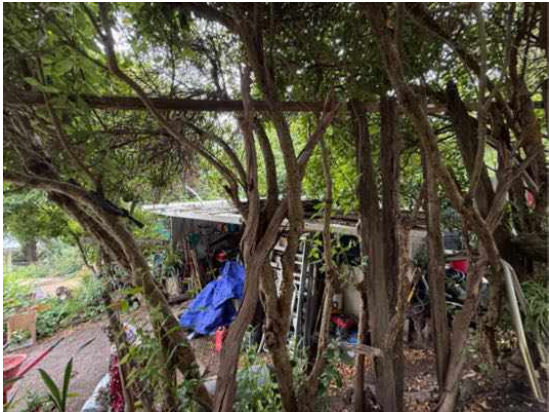
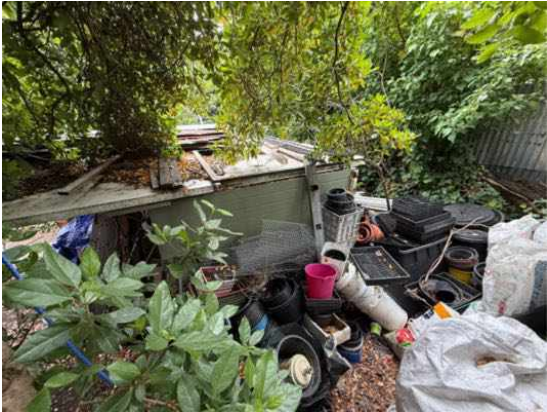
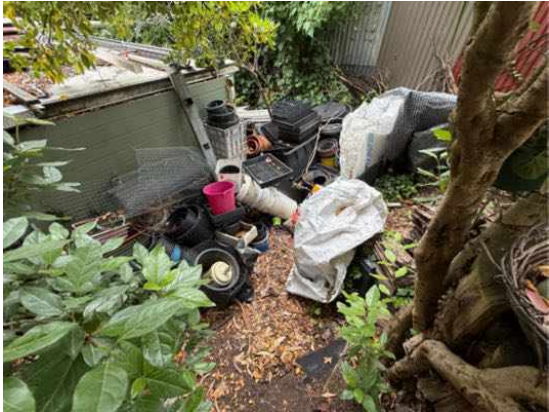
#### Noted Item

Building: Building 1  
Location: All Areas > All Areas  
Finding: Additional Photos  
Information: Additional photos are provided for either future maintenance items for clients attention and or general reference. Arrows may have been included to highlight areas of importance. Please discuss these photos with your building consultant for clarification.

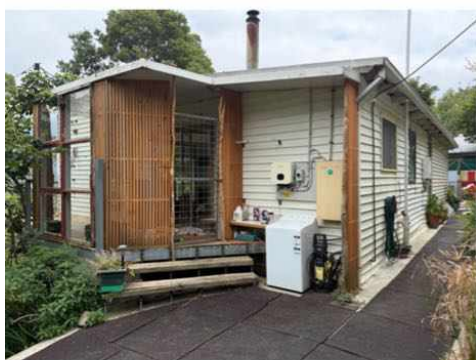
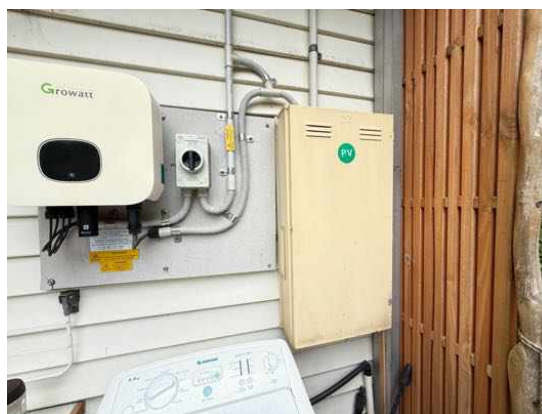
Building: Building 1  
 Location: All Areas > All Areas  
 Finding: Termite Management System  
 Information: At the time of the inspection, an existing application which was installed during the construction of the home was observed at the time of the inspection. Barrier will only be effective for X number of years and client is advised to keep these treatments current and or according to the termite company's recommendations or the durable notice in the meter box. Such barriers are highly effective in preventing termite attack on any timber and other building elements throughout the property.

A durable notice was observed to be placed in the in the meter box area that should indicate when the termite barrier is current to. At the client's discretion, client may make contact with the termite company to ensure home is protected into the future and the procedures involved with the future protection and or reapplication.

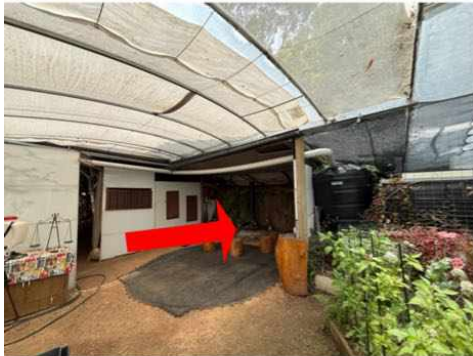
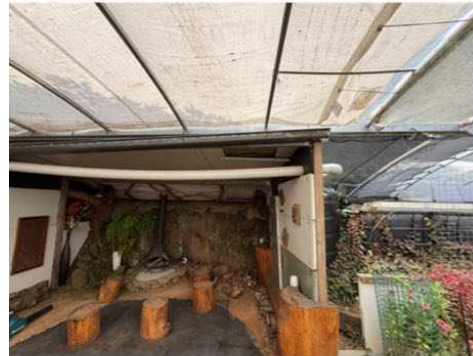
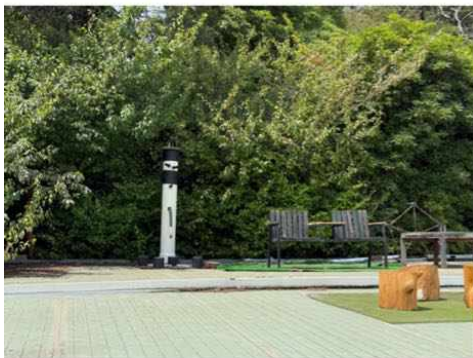
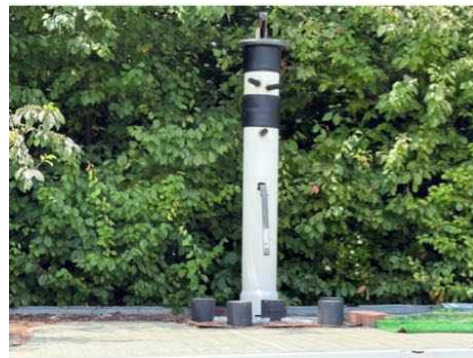
Building: Building 1  
 Location: All Areas > All Areas  
 Finding: Fireplace and chimney sweep  
 Information: Reporting on the fireplace and or the associated chimneys, including as to whether they are working or not and their legislative requirements, is outside the Scope of this Report. Please note that this is highlighted as a caution only. It is highly recommended

the fireplaces and associated chimneys get checked periodically and even before use when they may not have been used in a while. If left unmaintained and not cleaned adequately a fireplace and chimneys may be or become a fire hazard.

We suspect, based on our experience in the building industry, that fireplaces and the associated chimneys get over looked and do not get chimney swept or any maintenance for long periods of time. The chimney may therefore be in a poor condition, so we recommend that they always ensure that these areas be addressed prior to their use, this is to ensure home and occupant safety.

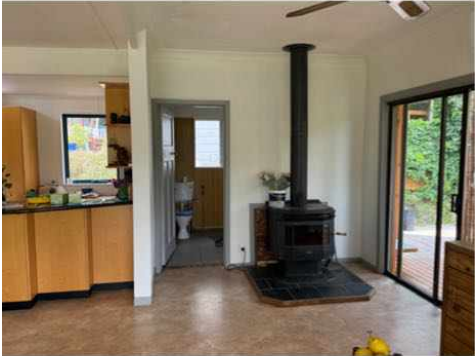
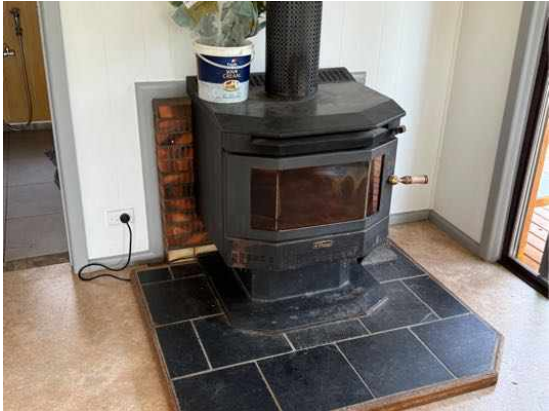
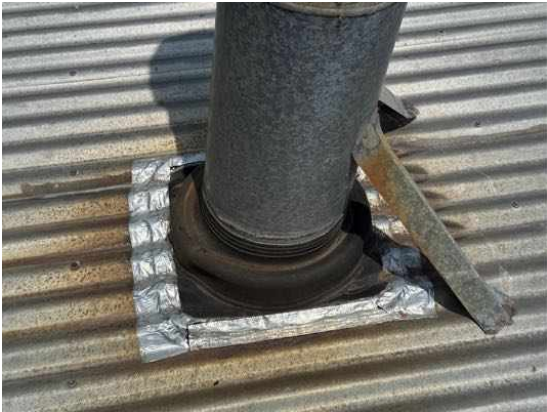
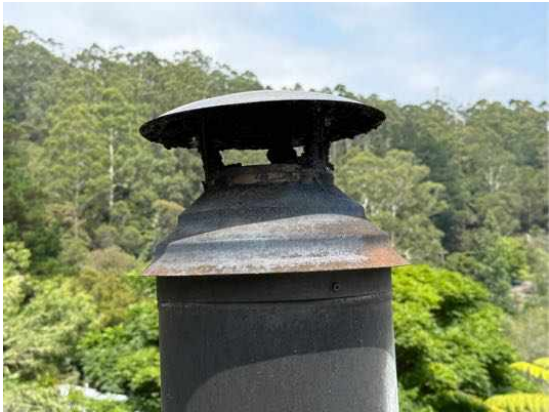
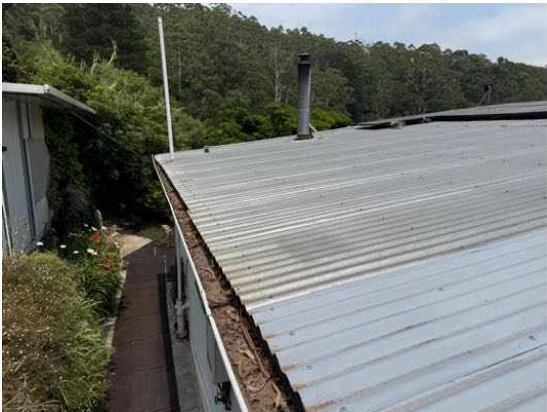
Building:	Building 1
Location:	All Areas > All Areas
Finding:	Fireplace and chimney sweep
Information:	Reporting on the fireplace and or the associated chimneys, including as to whether they are working or not and their legislative requirements, is outside the Scope of this Report. Please note that this is highlighted as a caution only. It is highly recommended the fireplaces and associated chimneys get checked periodically and even before use when they may not have been used in a while. If left unmaintained and not cleaned adequately a fireplace and chimneys may be or become a fire hazard.

We suspect, based on our experience in the building industry, that fireplaces and the

associated chimneys get over looked and do not get chimney swept or any maintenance for long periods of time. The chimney may therefore be in a poor condition, so we recommend that they always ensure that these areas be addressed prior to their use, this is to ensure home and occupant safety.

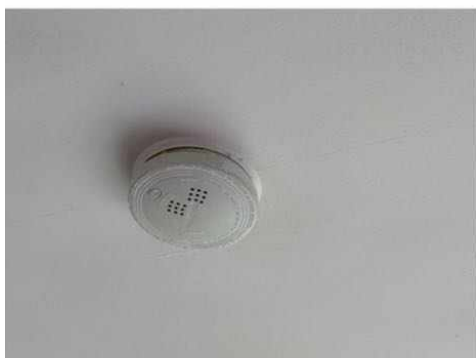
Building: Building 1  
Location: All Areas > All Areas  
Finding: Smoke detectors and alarms  
Information: Reporting on Smoke Detectors or Alarms, including hard wired smoke detection systems and their legislative requirements, is outside the Scope of this Report. Please

note that this defect is highlighted as a caution only. We suspect, based on our experience in the building industry, that smoke detectors are sometimes get overlooked, or they may be in a poor condition, so we recommend that they always should be addressed prior to occupation to improve occupant safety.

Always ensure sufficient working and suitable smoke detectors are installed prior and during to occupying any building. Additionally, it is advised that all smoke detectors be tested by the homeowner on a monthly basis.

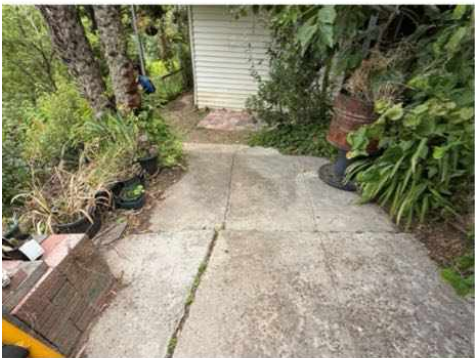
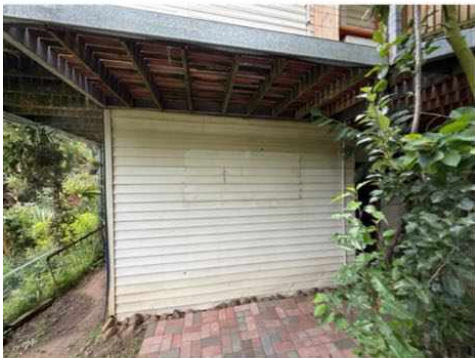
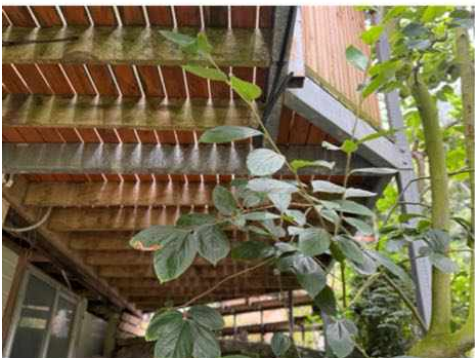
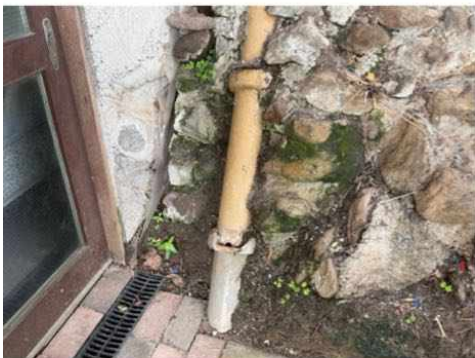
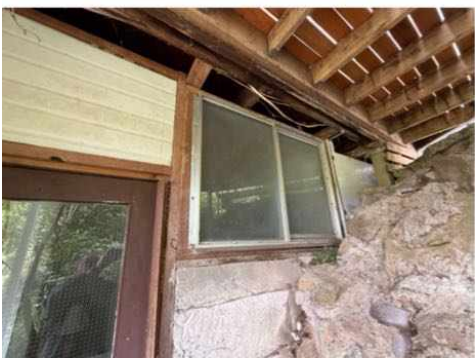
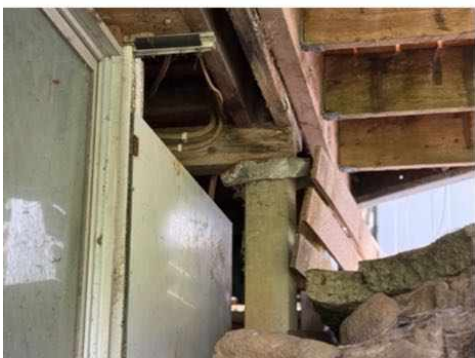
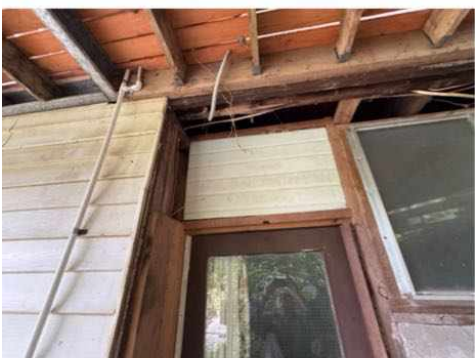
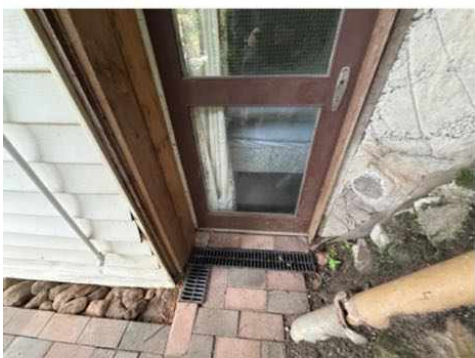
Where these areas are suspected not to meet the Australian building codes and standards they are deemed to be a major defect which may have serious defects and safety issues when uncovered. These types of issues will affect the over all performance in these areas.

These areas showed numerous areas of poor trade practices that will require solutions involving building surveyors, local council authorities. These are suspected to at sometime impact property resale in the future.
