# Building and Timber Pest Inspection Report

Inspection Date: Fri, 13 Feb 2026

Property Address: 5 Hildale Cres, Morayfield QLD 4506,  
Australia

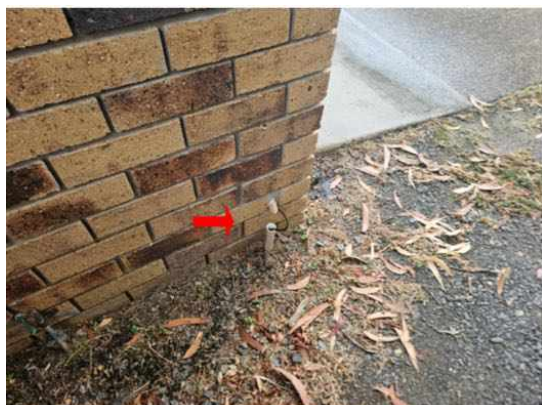
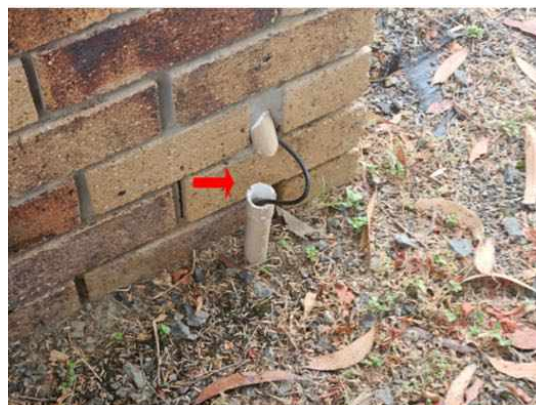
### Finding 3.02

Building: Main Building  
Location: Front left corner  
Finding: Damaged communications conduit

Information: During the inspection of the front of the building, it was noted that the communications conduit was damaged at the entry into the building.

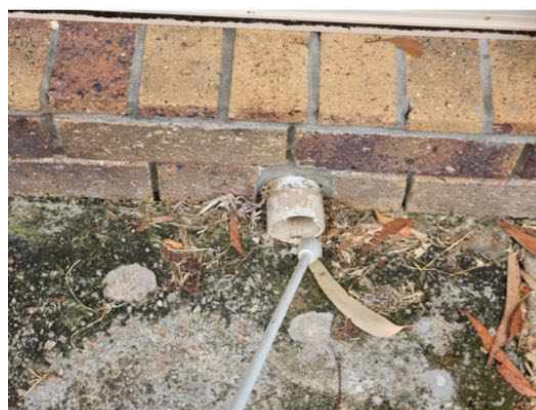
### Finding 3.03

Finding: Dry waste vermin flap - broken

Information: The floor waste in the laundry is a dry waste and the exit point is adjacent to the sliding glass door of the laundry. These waste exit points have a vermin proof flap attached to the external opening.

The flap on the is waste is missing. A replacement should be fitted at the clients discretion to prevent vermin from entering the property.

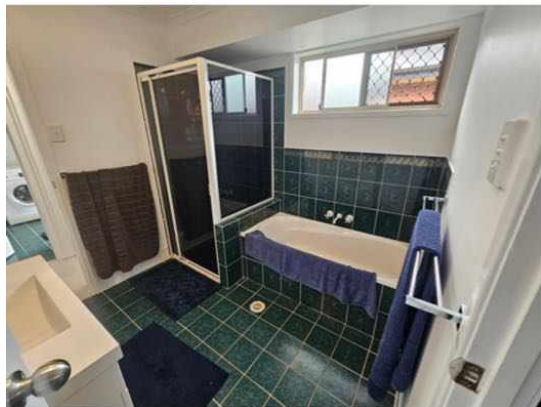
Elevated moisture can attract timber pests and vermin, and produce conditions that promote timber pest attack, fungal growth and wood decay.

It is recommended that this be investigated further to assess the cavity moisture levels and the tap set.

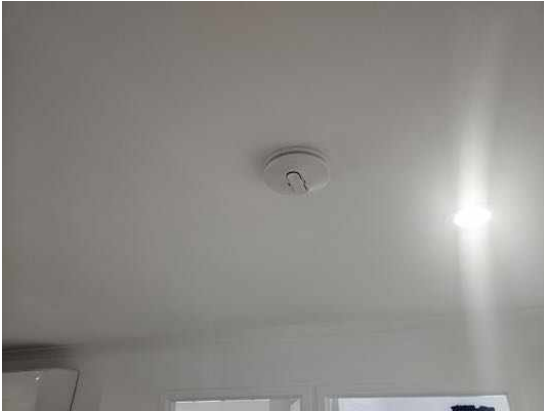
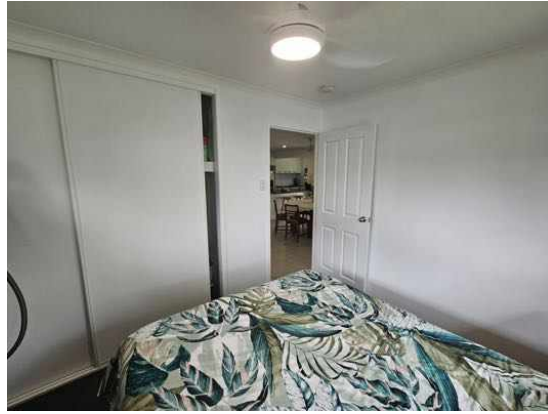
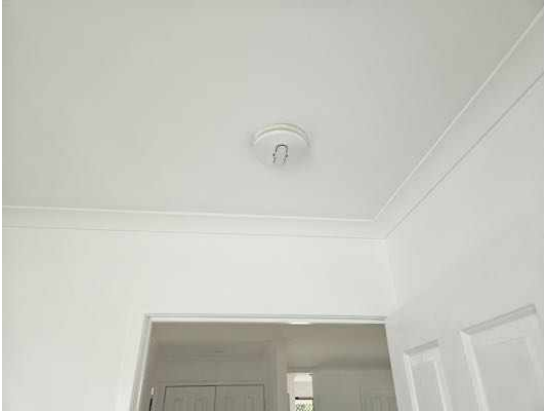
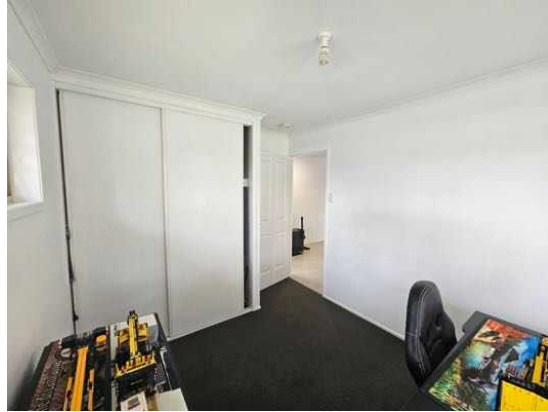
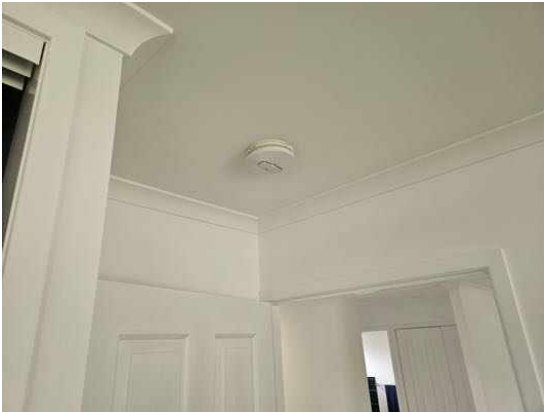
400mm of an air-conditioning vent

Avoid installing smoke alarms in dead air space. This is an area in which trapped hot air will prevent smoke from reaching the alarm. The space generally occurs at the apex of cathedral ceilings, the corner junction of walls and ceiling, and between exposed floor joists.

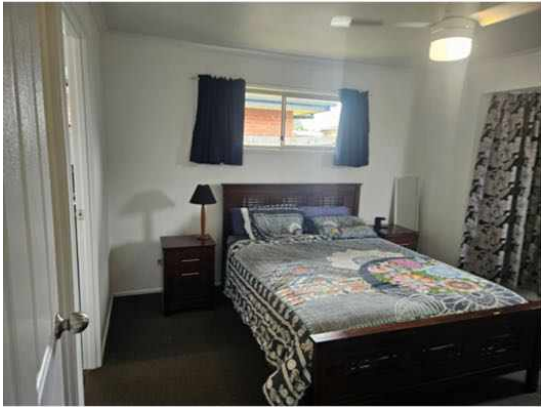
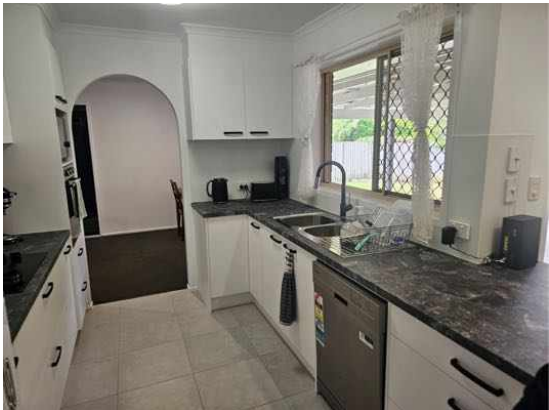
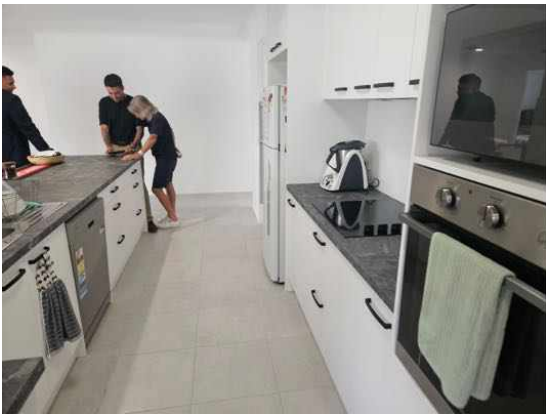
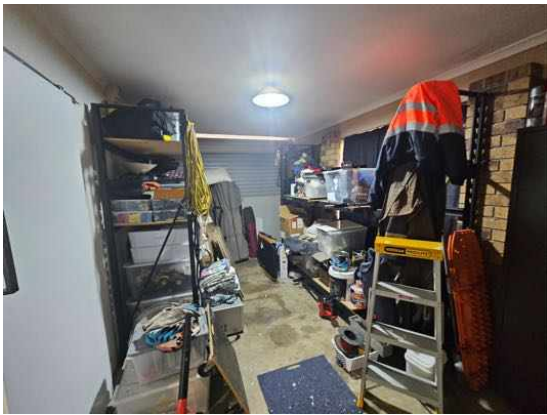
Finding: Additional Photos - Obstructions and Limitations

Information: These photographs are an indication of the obstructions and limitations which impeded full inspection of the property at the time of inspection. These obstructions can prevent full inspections of the areas shown.

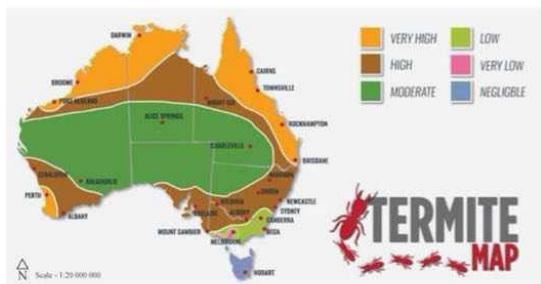
Review the attached map for Australia's termite zones and their risk profile.

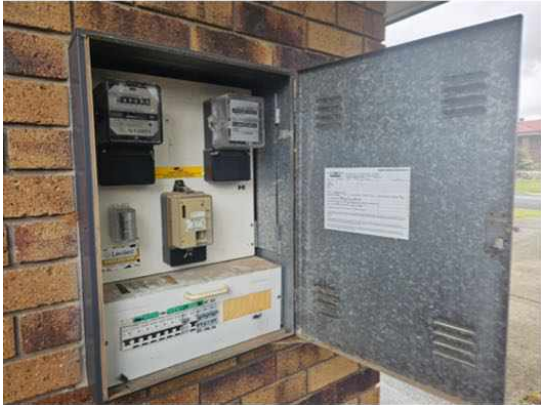
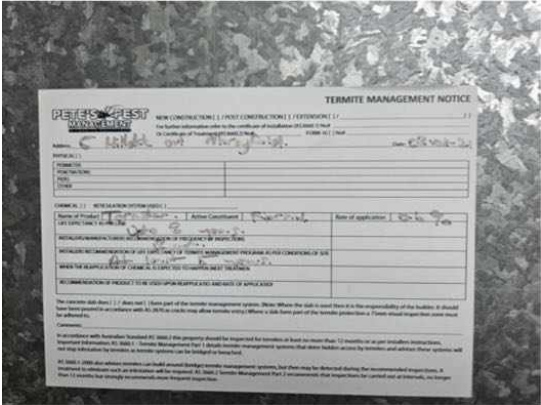
The building employs a chemical drill and inject barrier system to the perimeter. The durable notice shows a renewal date of 2029. In order for a barrier system to be effective, the property must have regular inspections at intervals of not greater than 12 months. Depending on the risk profile attributed to the property, these inspections may be recommended at lesser time periods.
