# Building and Timber Pest Inspection Report

Inspection Date: Thu, 26 Mar 2026

Property Address: 10 Hibiscus Ave, North Avoca NSW 2260,  
Australia

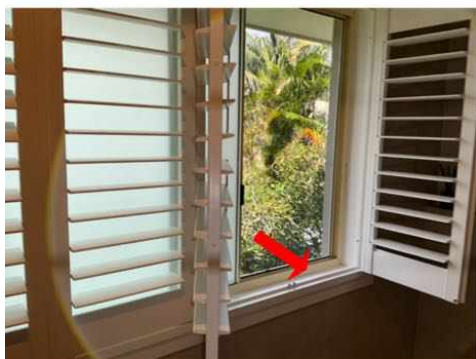
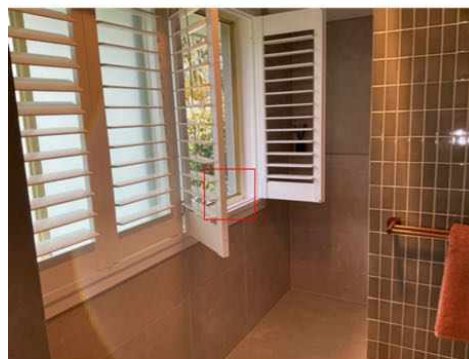
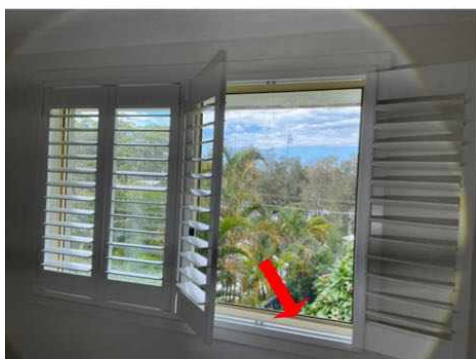
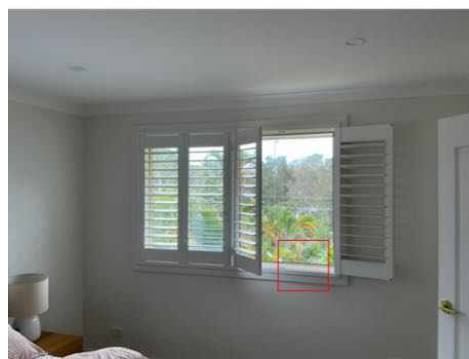
Building: Main Building  
Location: Bedroom - Master, Master En-suite  
Finding: Window Restrictors - Recommended  
Information: Upstairs windows did not have window restrictors installed. Although not a requirement at the time of construction, it is advisable to install window opening restrictors on all second storey windows with sill heights below 1.7 meter and potential fall of 2 meters or more.

If you live in a strata scheme, window safety devices must be installed on all applicable windows by 13 March 2018. Residents with safety devices installed can still fully open their windows but it's recommended that devices be engaged whenever children are present, to prevent falls.

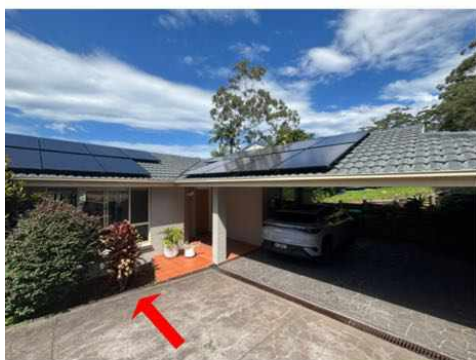
Building:	Main Building
Location:	Yard - Front
Finding:	Inadequate Site Drainage - Exterior Areas
Information:	At the time of inspection, inadequate site drainage was observed around the perimeter of the building, which can lead to water pooling and insufficient runoff management.

This condition may result in moisture being absorbed by the foundation or lower walls, potentially leading to rising damp, cracks in brickwork, erosion of the soil around the building, or structural issues over time. Water pooling can also create ideal conditions for mould growth, contribute to the deterioration of exterior materials, and act as conducive conditions for termite activity, as termites are attracted to areas with elevated and persistent moisture levels.

It is recommended that proper site drainage be installed, such as redirecting water flow away from the building or incorporating drainage systems, to prevent further damage and ensure the long-term stability of the structure.

To address the inadequate site drainage, a qualified landscaper or drainage specialist should be engaged to design and install appropriate drainage solutions, such as grading the ground away from the building or installing French drains, surface drains, or downspout extensions. If more complex issues are present, such as damage to the foundation or moisture entering the walls, a structural engineer may need to assess the situation, and a builder may be required for repairs.

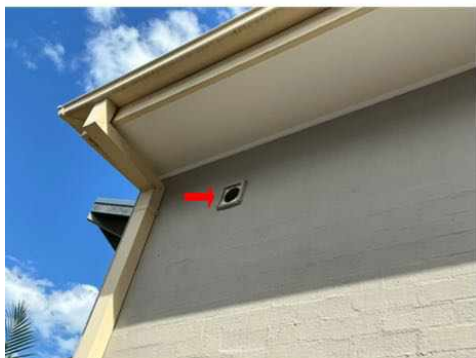
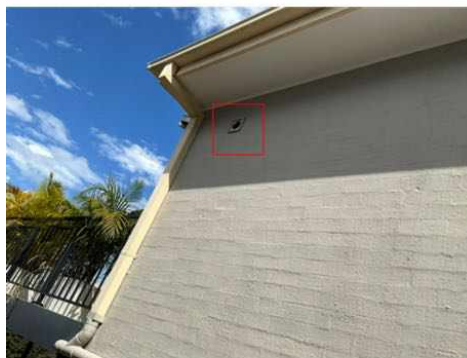
### Finding 3.02

Building:	Main Building
Location:	Exterior walls - left side
Finding:	Vent Covers - Missing
Information:	At the time of inspection, a vent opening to the external wall was observed without a

If left unaddressed, this condition may lead to moisture ingress, internal damage, or pest infestation within the structure.

It is recommended that a suitable vent cover be installed by a qualified tradesperson like handyman to adequately seal and protect the opening.

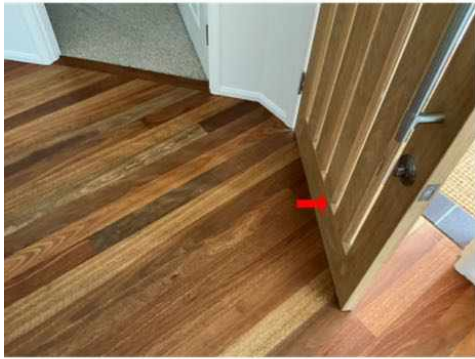
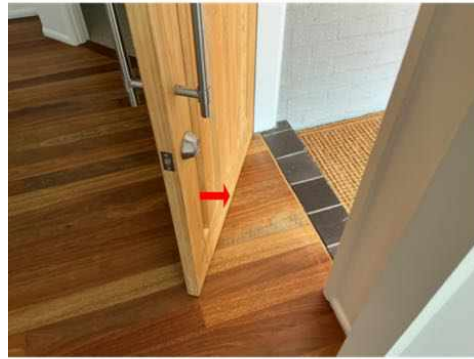
### Finding 3.03

Building:	Main Building
Location:	Entry
Finding:	Door Weatherstrip - Missing
Information:	It was noted at the time of inspection, the door weatherstrip was missing.

The absence of a door weatherstrip could be due to wear and tear, improper installation, or deliberate removal. The implications include increased energy loss, reduced insulation, potential water leaks during rain, and a compromised seal, allowing drafts and noise to enter the space. Replacing the missing weatherstrip is advisable to maintain energy efficiency, weather protection, and overall comfort within the enclosed area.

A general handy man should be appointed to install the weatherstrip at owners discretion.

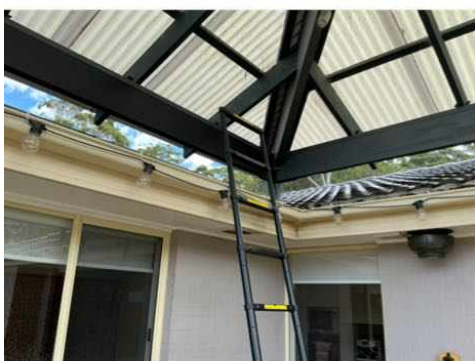
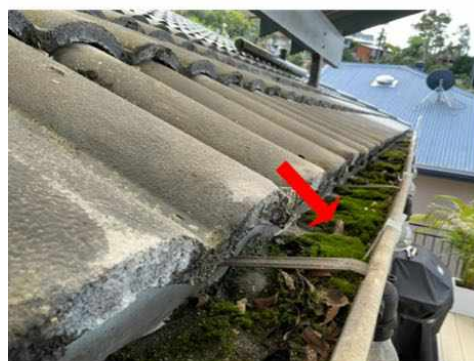
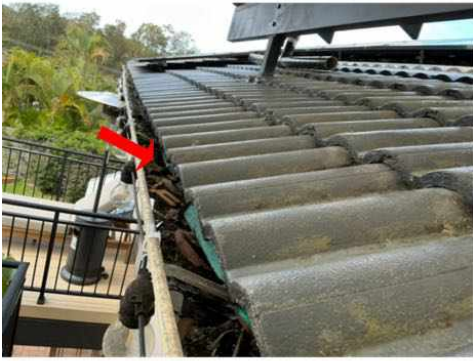
### Finding 3.04

Information: At the time of inspection, water pooling and organic matter build-up (including debris and vegetative growth) were noted within the gutters. This condition indicates inadequate drainage and suggests that sections of the guttering may not be correctly aligned to allow proper water flow towards the downpipes.

If left unaddressed, this may lead to accelerated deterioration of the gutter system, overflow during rainfall, and potential water ingress into the building.

It is recommended that a suitably qualified tradesperson be engaged to clean all gutters and remove accumulated debris. In addition, a gutter installation specialist should be engaged to inspect and realign the guttering to ensure appropriate fall and effective drainage, preventing future water pooling.

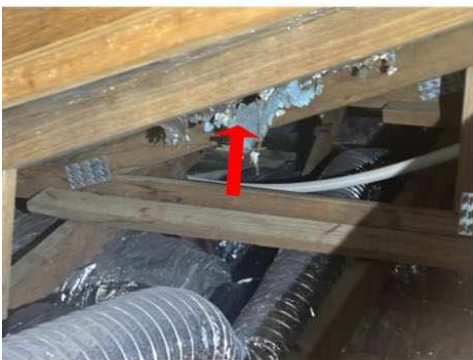
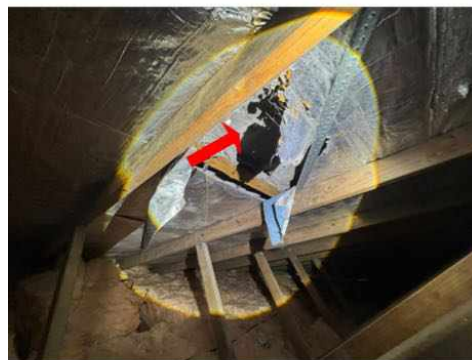
### Finding 3.05

Building:	Main Building
Location:	Roof Void
Finding:	Sarking - Damaged
Information:	Sarking, a laminated aluminium foil applied to the interior of the roof covering, assists in insulating the property and acting as a vapour-barrier to the roof void and, subsequently, to the household.

Where sarking is damaged, both insulation and moisture protection of the property are inhibited. This creates a loss of energy and thus negatively impacts the energy efficiency of the property, allowing potential for moisture ingress from condensation or leaking roof tiles.

It is important to repair any holes or damaged sections of sarking to ensure that the building material is fully functional. A registered roofer should be consulted to provide further advice on this defect and to perform rectification works at client discretion.

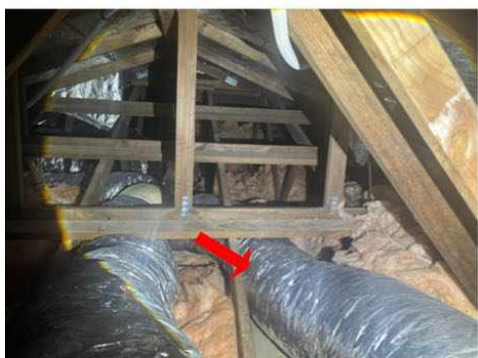
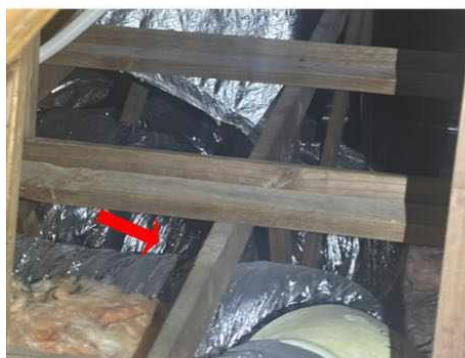
### Finding 3.06

Building:	Main Building
Location:	Roof Void
Finding:	Air Conditioning Duct Installation – Direct Contact with Plasterboard
Information:	At the time of inspection, air conditioning ducting within the roof space was observed to be in direct contact with the plasterboard ceiling lining. This installation is considered substandard, as ductwork should be adequately insulated and supported to prevent direct contact with the ceiling surface.

Direct contact may lead to condensation forming on the ducting, which can transfer moisture to the plasterboard over time. This may result in future moisture damage, staining, deterioration of ceiling materials, and potential mould growth.

It is recommended that an air conditioning specialist be engaged to rectify the installation.

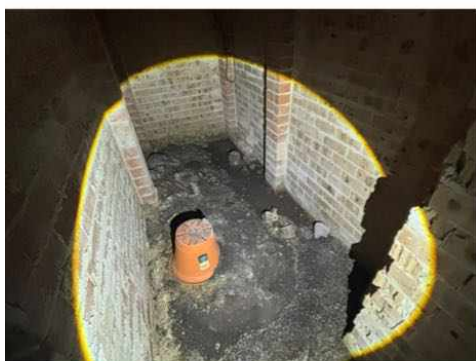
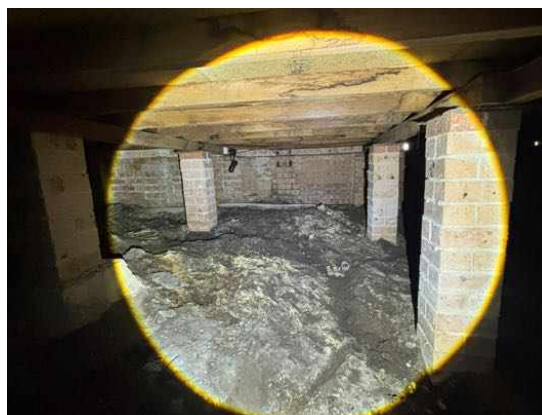
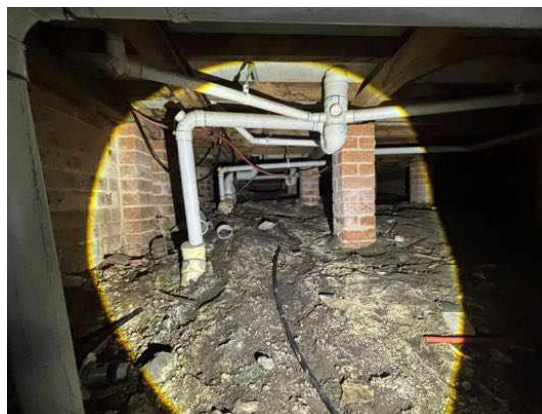
### Finding 3.07

Building:	Main Building
Location:	Subfloor
Finding:	Subfloor Site Drainage - Inadequate
Information:	At the time of inspection, inadequate site drainage was observed under the subfloor,

allowing water to accumulate and fail to drain effectively, creating a hazardous condition. This is a common defect in houses constructed on brick stumps, where poor site grading and limited subfloor ventilation can contribute to ongoing moisture retention. The resulting water pooling may lead to structural deterioration from prolonged dampness, mould and mildew growth, and create conditions conducive to termite activity. These issues can also impact indoor air quality and pose safety risks to occupants.

The client is advised to engage a licensed plumber or builder experienced in drainage and foundation work to assess and implement suitable solutions, such as improving site grading, installing appropriate drainage systems, and enhancing moisture barriers. In addition, the installation of mechanical subfloor ventilation is recommended to improve air circulation, assist with moisture control, and reduce the risk of ongoing damp-related issues.

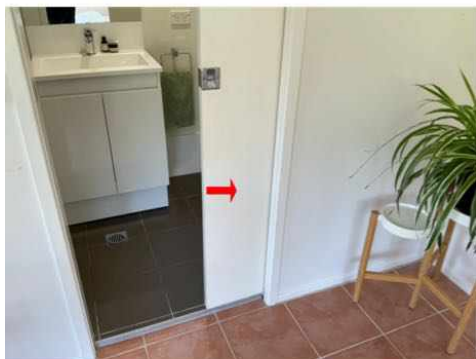
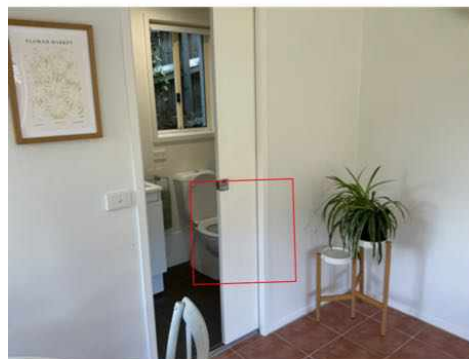
### Finding 3.08

Building:	Main Building
Location:	Bedroom 5 en-suite
Finding:	Sliding Door - Stiff to Slide
Information:	At the time of inspection, the sliding door was noted to be stiff to operate, which may be due to worn rollers, misalignment, or debris within the track.

The client is advised to engage a handyman to inspect, service, and adjust the sliding door to restore smooth operation and prevent further wear.

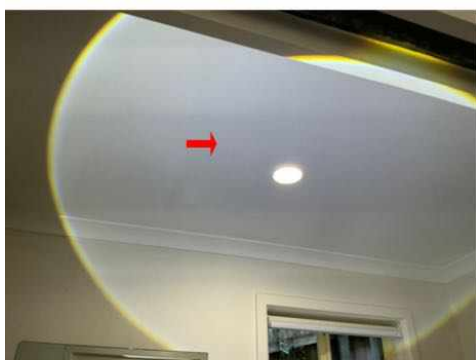
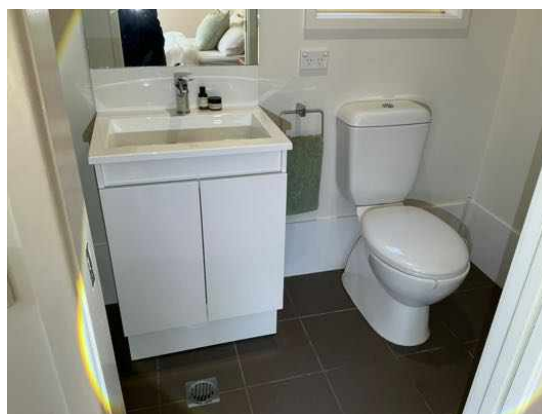
### Finding 3.09

Building:	Main Building
Location:	Bedroom 5 en-suite
Finding:	Exhaust Fan Missing - Bathroom
Information:	At the time of inspection, an exhaust fan was found to be missing in the bathroom.

Adequate ventilation is essential in wet areas to prevent moisture build-up, which can lead to mould growth, dampness, and potential damage to fixtures and finishes.

It is recommended that a licensed electrician be engaged to install a compliant exhaust fan to improve air circulation and maintain healthy indoor air quality.

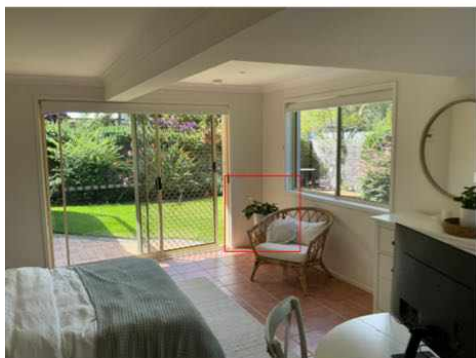
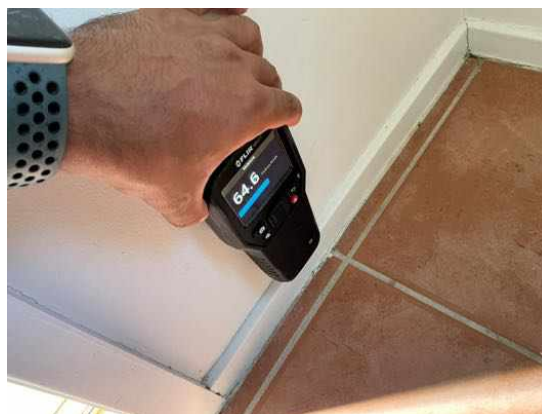
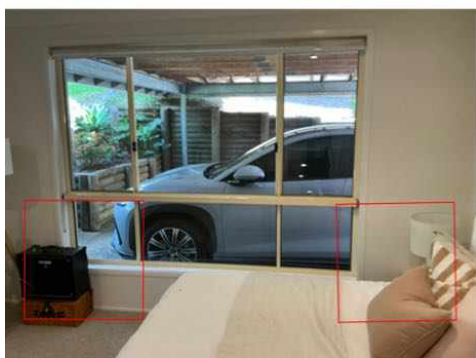
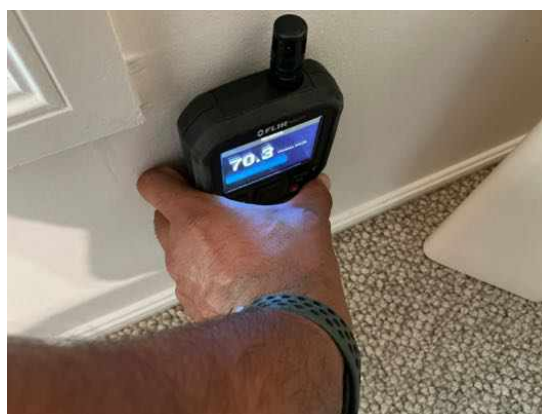
### Finding 3.10

Building:	Main Building
Location:	Front Bedroom, Bedroom 5
Finding:	Damp - Rising (Drainage Issue)
Information:	At the time of inspection, evidence consistent with rising damp was observed. External ground levels were noted to be sloping towards the building, which may facilitate

moisture migration into the lower sections of the walls and flooring.

This condition can contribute to dampness, deterioration of building materials, and ongoing moisture-related issues if not addressed.

It is recommended that external ground levels be reduced where necessary and that site drainage be improved to ensure surface water is directed away from the building. The client is advised to monitor the affected areas over a 12-month period for any signs of progression.

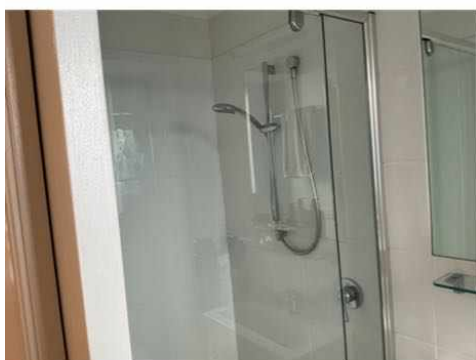
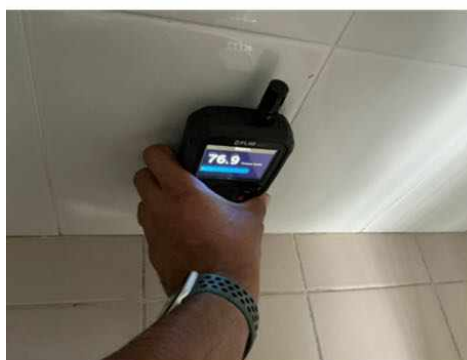
### Finding 3.11

Location: Front Bedroom En-suite  
 Finding: Excessive Moisture - Shower Damp  
 Information: At the time of inspection, excessive moisture was noted within the shower area, which is a common issue in wet areas due to the continual exposure to water. This condition is typically caused by moisture seeping through grout lines and settling behind tiles, resulting in localised high-moisture zones. Provided there is no evidence of water staining or elevated moisture readings on the opposite side of the wall, this is considered a minor defect.

However, persistently damp conditions may act as conducive conditions for termite activity, as termites are strongly attracted to moisture-rich environments. It is recommended that the client ensures regular use of the exhaust fan and maintains adequate ventilation after shower use to promote drying and reduce long-term moisture build-up, thereby also reducing the risk of attracting termites.

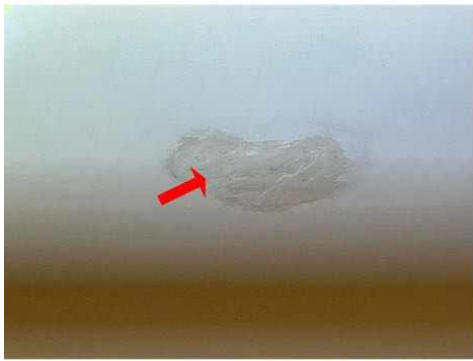
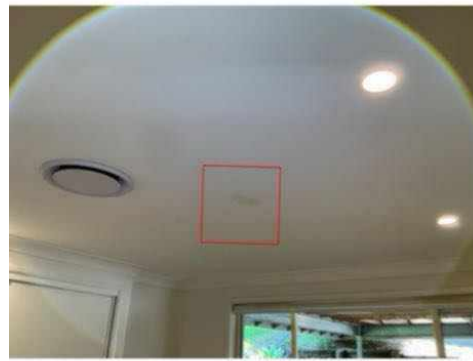
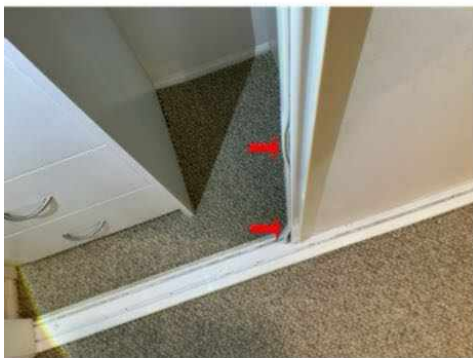
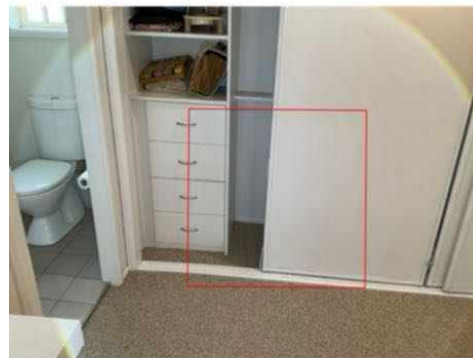
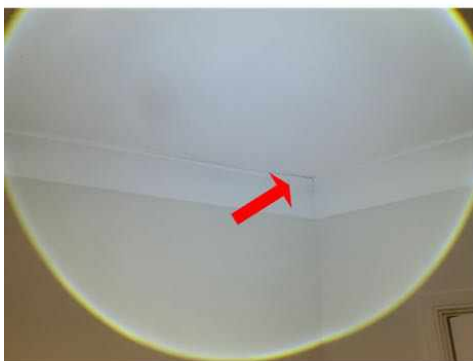
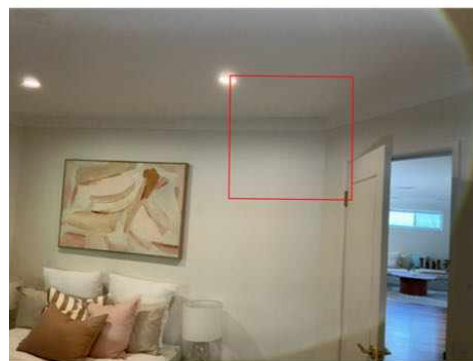
### Finding 3.12

Building: Main Building  
 Location: Front Bedroom  
 Finding: Maintenance and/or Wear and tear on building elements  
 Information: It was observed at the time of inspection that some building elements and areas around the property require general maintenance and/or exhibit signs of wear and tear. These typically include minor imperfections such as paint scuff marks, scratches on surfaces, small chips, nails or hooks left in walls from previous picture hanging, and other superficial blemishes.

These are generally considered minor items that are common in established homes. While they may be noticeable on visual inspection, they do not affect the structural integrity or functionality of the property. In most cases, these issues can be easily addressed by a qualified handyman as part of routine maintenance.

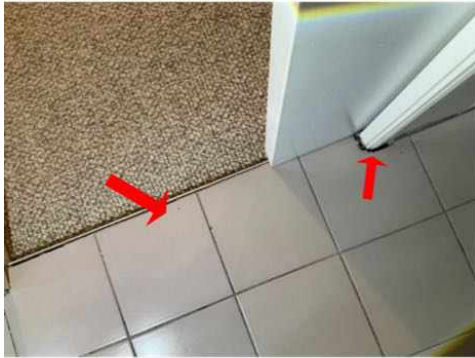
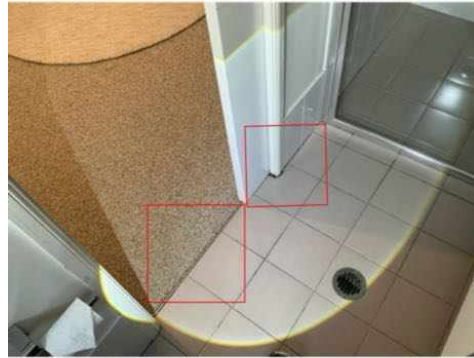
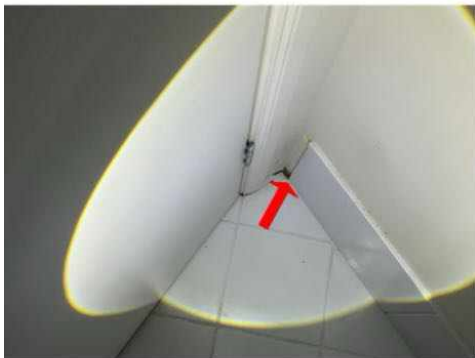
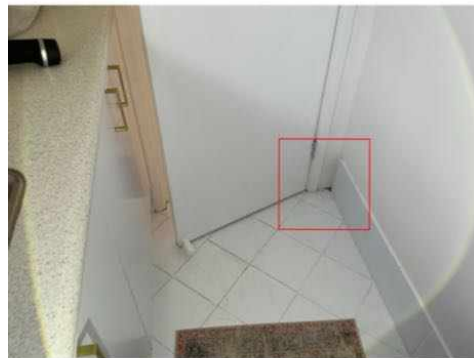
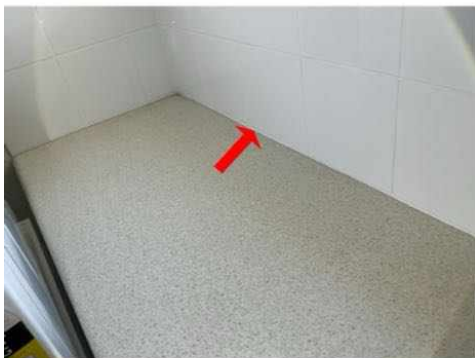
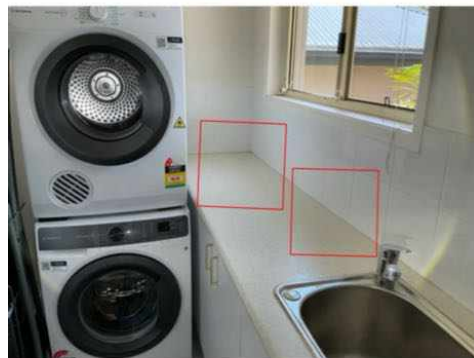
Finding: Sealant/Grouting - Missing or Damaged

Information: At the time of inspection, areas of missing and/or deteriorated sealant and grout were noted in this area. This condition can allow water to penetrate behind finishes, which may lead to moisture ingress, deterioration of waterproofing membranes, mould growth, and potential leaks into adjoining areas over time. If left unaddressed, this may result in costly repairs and hidden water damage.

It is recommended that a licensed plumber (or suitably qualified tradesperson experienced in wet area sealing) be engaged to assess the affected areas and

reinstate compliant waterproof sealant and grout as required, ensuring all junctions are properly sealed to prevent further water ingress.

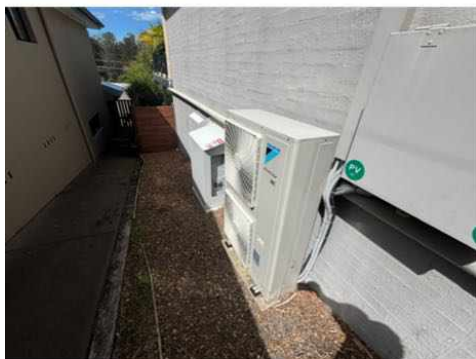
Where any part of an attachment to a building is not isolated and is not provided with a clear gap of not less than 25mm from the building, bridging occurs. Attachments to buildings such as hot water services, downpipes, verandahs, decks, steps, fences, service conduits and the like provide the opportunity for concealed entry.

Building attachments of this nature need to be frequently inspected for termite activity by a qualified inspector.

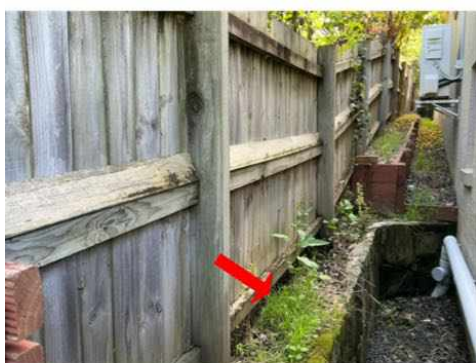
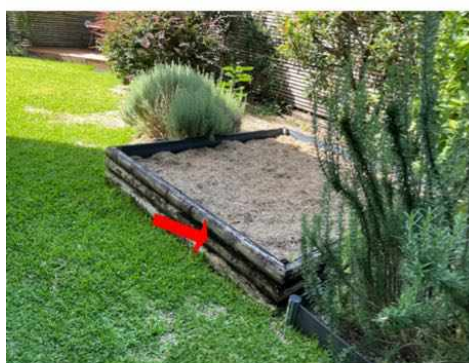
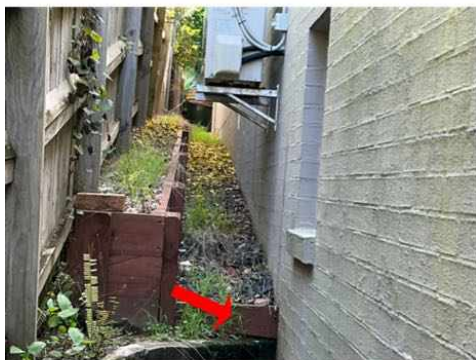
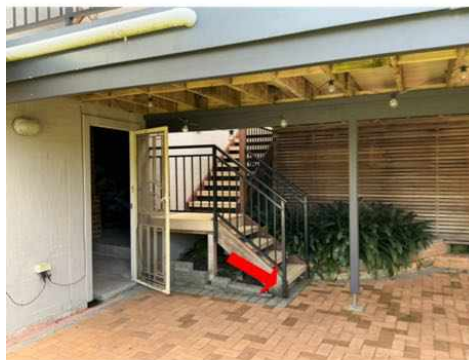
## Finding 6.02

Building:	Yard
Location:	All Areas
Finding:	Building Materials in Direct Ground Contact - Conducive to Termites
Information:	Timber elements that are in direct contact with the ground and exposed to moisture or damp conditions are highly conducive to termite activity. This susceptibility arises because timber, when in contact with soil and dampness, creates an environment that is particularly attractive to termites, encouraging infestation and potential structural compromise. Whether the timber is used as a part of the building's construction or incorporated into fencing, its presence near or on the ground can become a pathway for termites to access and damage the property.

When exposed to excessive moisture, timber begins to deteriorate, developing conditions such as wood decay and rot. These compromised areas of timber are even more appealing to termites, as they are easier to infest and consume. This is especially true for untreated or non-durable timber, which lacks the protective treatments that can deter or withstand termite attacks. Termites can use these weakened, moisture-laden elements as a bridge into other parts of the structure, creating an entry point for potential infestations that can spread and cause extensive damage if left unchecked.

For any timber in direct contact with the external ground, special attention is required. The combination of moisture, untreated wood, and direct ground contact not only accelerates the decay process but also provides subterranean termites with a straightforward means of ingress into the structure. This entry can lead to termites moving undetected into other vulnerable areas, resulting in potentially significant structural issues and costly repairs.

necessary for use should be made durable through appropriate treatments and maintained to ensure they do not create conditions conducive to termites. Additionally, the client is advised to schedule regular termite treatments to maintain an effective barrier against infestations and ensure ongoing protection.

The client is strongly advised to assess the property for any timber elements that may be in direct contact with the ground and ensure prompt action is taken to remove or treat them effectively. Regular inspections, proactive maintenance, and consistent termite treatment are essential steps in minimising the risk of termite attack and protecting the structural integrity of the property. Taking these preventive measures is crucial for maintaining a termite-free environment and avoiding potentially costly damage and future repairs.

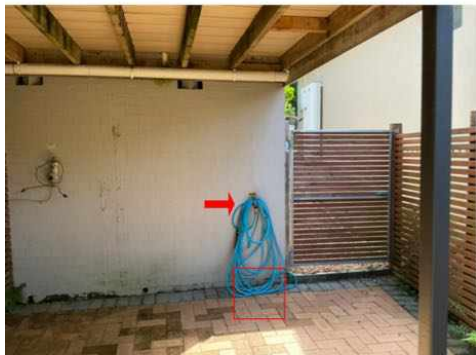
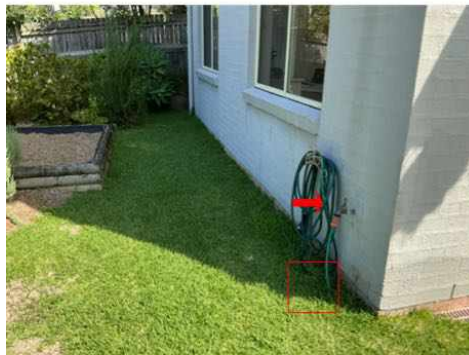
### Finding 6.03

Building:	Main Building
Location:	Yard - Back
Finding:	No Stormwater Drain - Under Exterior Tap
Information:	The inspection identified that the exterior tap is not connected to a stormwater drainage system, allowing water to pool around the base. This can lead to moisture-related issues such as deterioration of nearby building materials, mould growth, and increased risk of termite activity—each of which may compromise the property's structural integrity and create health or safety concerns.

To prevent these risks, it is strongly recommended that a licensed plumber be engaged to assess the area and install appropriate drainage, such as a stormwater connection or splash block, to redirect water away from the property. Ongoing maintenance and monitoring of external water sources are also advised to ensure long-term protection.

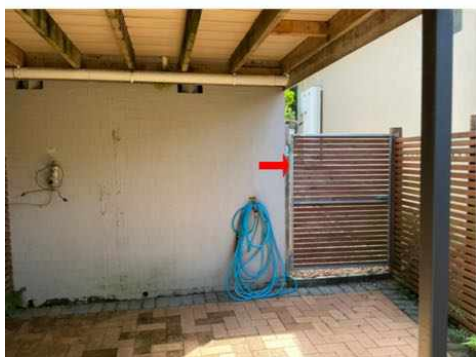
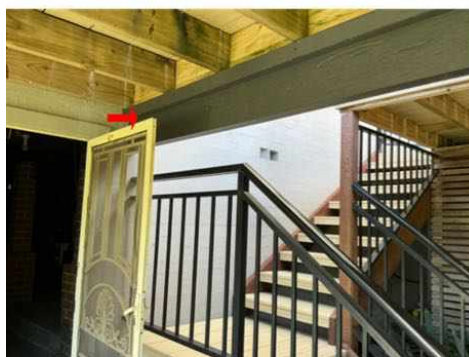
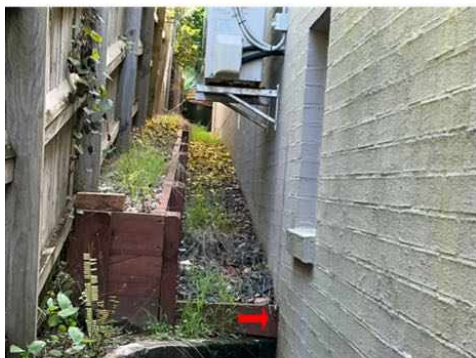
### Finding 6.04

Building: Main Building  
 Location: All Areas  
 Finding: Timber Directly Attached to Building  
 Information: At the time of inspection, timber materials were noted to be directly attached to the external wall of the dwelling. This practice is considered a conducive condition for termite activity, as it provides both a potential food source and concealed entry point for termites into the structure.

It is recommended that the timber be removed, isolated, or appropriately treated to reduce the risk of termite infestation. A licensed pest management specialist should be consulted for further assessment and advice in line with AS 3660.2 (Termite Management).

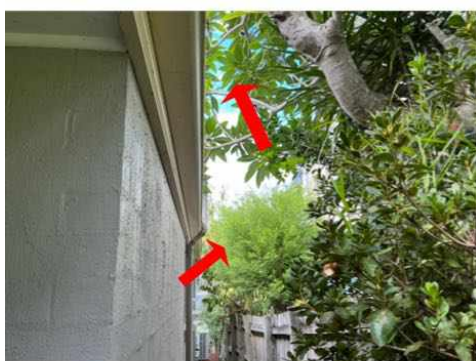
### Finding 6.05

Building:	Main Building
Location:	Yard - Side
Finding:	Overhanging Trees/Branches/Roots
Information:	Overhanging trees and exposed roots were noted near the property, which pose potential risks to the structure and surrounding areas.

The overhanging branches can cause damage to the roof, gutters, or walls, particularly during storms or high winds. Additionally, the roots may pose a threat to the foundation by causing ground movement, leading to cracks or uneven settling over time. The accumulation of leaves and debris in gutters and drainage systems can also lead to blockages, contributing to water overflow and potential water damage.

It is recommended that a qualified arborist be engaged to prune back the overhanging branches and assess any potential risks posed by the tree roots to prevent further damage to the property. It is advised to get this fixed as soon as possible. Regular maintenance should be carried out to ensure the trees are managed effectively and the property remains safe.

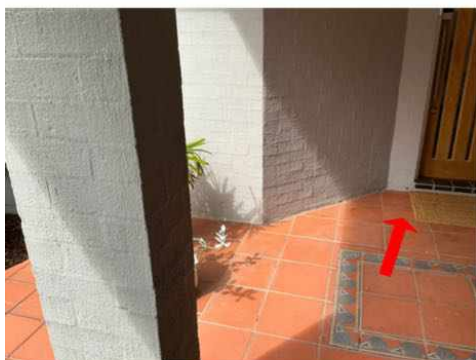
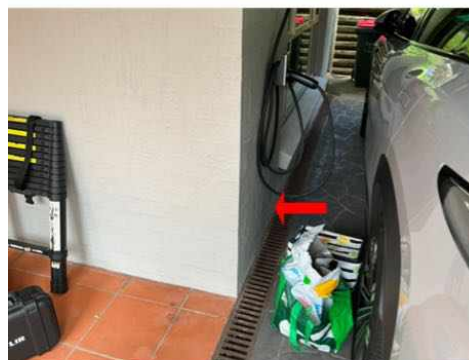
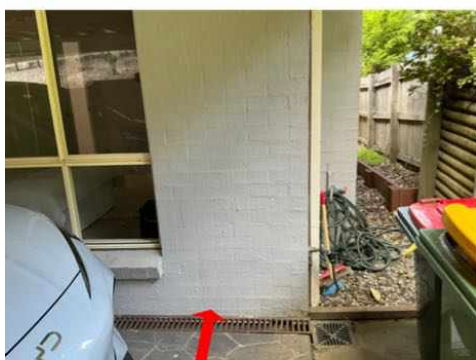
### Finding 6.06

Building:	Main Building
Location:	Exterior walls - front

It is important for internal flooring to be raised above adjacent external ground levels. Where external ground levels are above internal flooring, water pooling and subsequent internal flooding is likely to occur which may attract termite activity to the internal area.

It is highly advised that a landscaper or paver be appointed to lower external grounds that are raised above adjacent internal flooring. Alternatively if external grounds and internal flooring is level installation of a raised door sill may be appropriate in preventing any water pooling in the area.

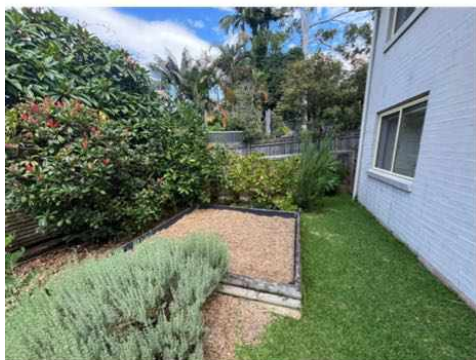
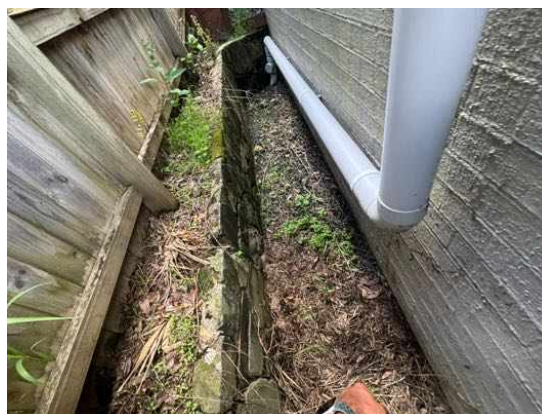
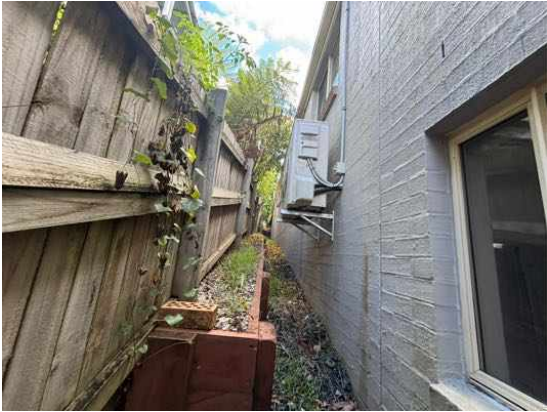
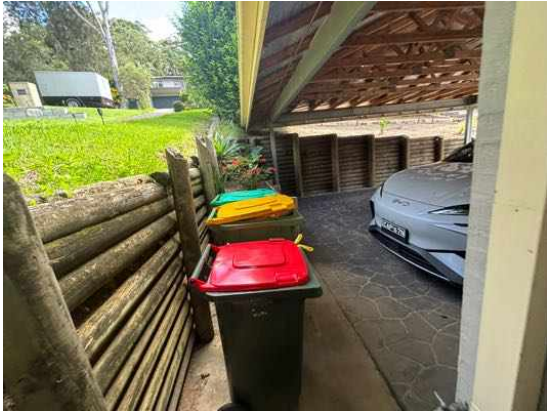
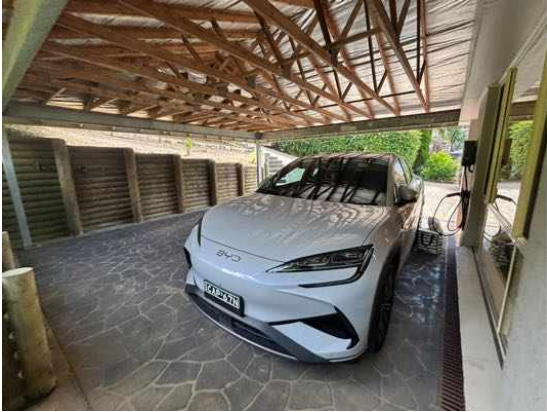
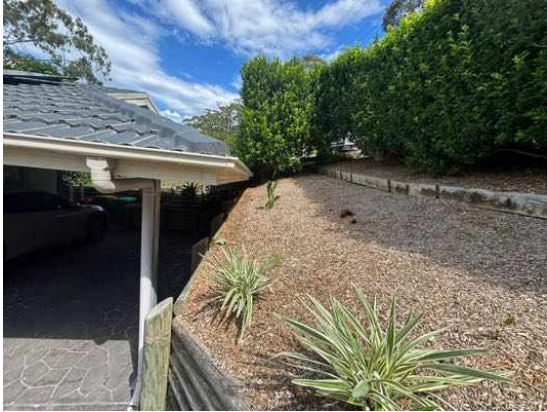
Building: Main Building  
Location: All External Areas  
Finding: Obstructions and Limitations - External Areas  
Information: The attached photographs provide a visual representation of the obstructions and limitations that impeded a full inspection of the external areas of the property at the time of assessment. These obstructions, which may include vegetation, stored items, debris, or other physical barriers, can obscure potential defects and prevent a thorough evaluation of the property's condition. Obstructions of this nature can conceal a wide range of issues, such as structural damage, water ingress, pest infestations, or deteriorating building materials, which may not be visible during the initial inspection.

It is essential that these obstructions be cleared to allow for a comprehensive inspection of the external areas. Removing these barriers will enable a more accurate assessment of the property's condition and allow any hidden defects to be identified and addressed promptly. Failure to do so could result in undetected issues worsening over time, potentially leading to more costly repairs in the future.

Therefore, it is strongly recommended that the obstructions be removed and a re-inspection be scheduled once the affected areas are made fully accessible. This will ensure a complete evaluation of the property's exterior and provide the client with a clear understanding of any potential issues that may have been concealed during the initial inspection.

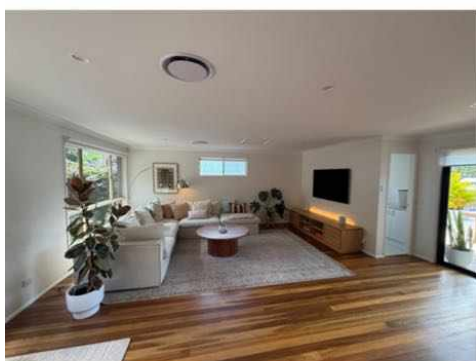
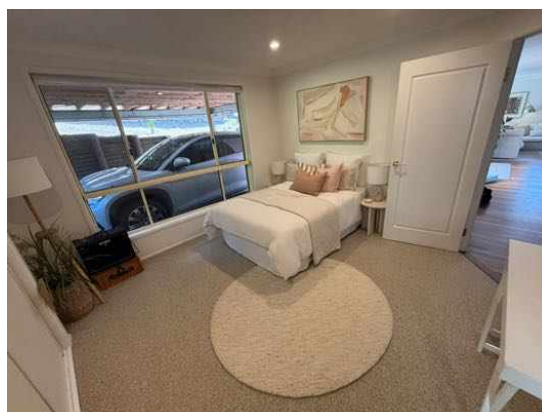
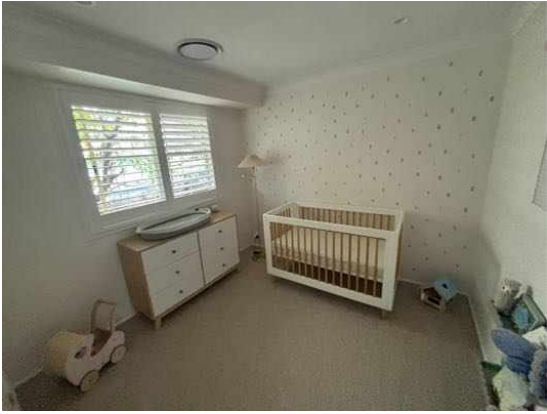
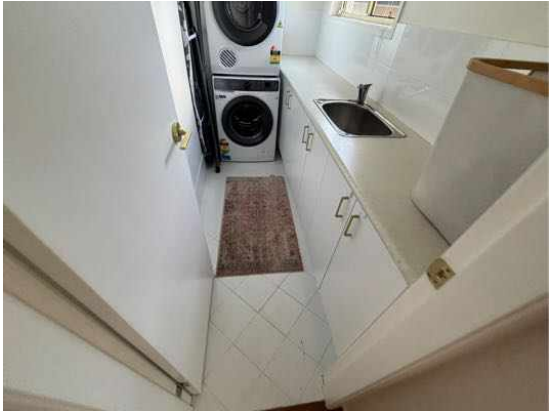
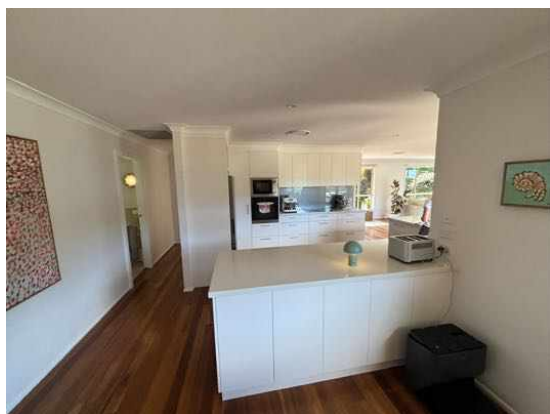
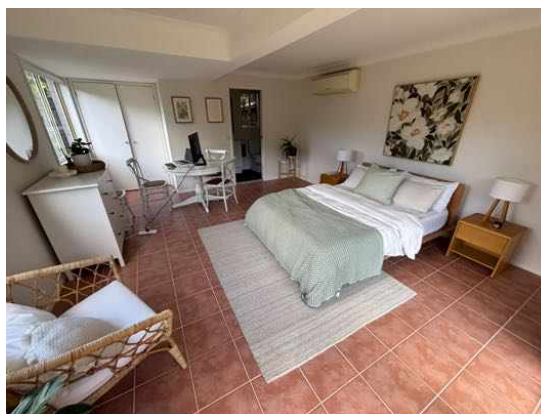
Noted Item

Building:	Main Building
Location:	All Internal Areas
Finding:	Obstructions and Limitations - Internal Areas
Information:	<p>The accompanying photographs provide clear evidence of the obstructions and limitations that restricted a comprehensive inspection of the internal areas of the property at the time of assessment. These obstructions, which may include furniture, personal belongings, stored items, or structural elements such as wall coverings and built-ins, significantly hindered the ability to thoroughly evaluate these areas. It is important to note that such obstructions can potentially conceal a wide array of defects, ranging from hidden structural damage, water leaks, pest infestations, or electrical issues, to deteriorating materials that may not be visible during the initial inspection.</p>

The presence of these impediments means that critical areas of the property were not accessible, and therefore, any underlying defects that may affect the integrity and safety of the property could remain undetected. These hidden defects, if left unaddressed, could worsen over time and may result in costly repairs or pose potential safety hazards to the occupants.

It is highly recommended that all obstructions be cleared to facilitate a complete and thorough inspection of the internal areas. Once the obstructions have been removed and full access is available, a re-inspection should be carried out to ensure that any previously concealed issues can be properly identified and rectified. This follow-up inspection will provide a more accurate assessment of the property's internal condition and help the client make informed decisions about any necessary repairs or maintenance.

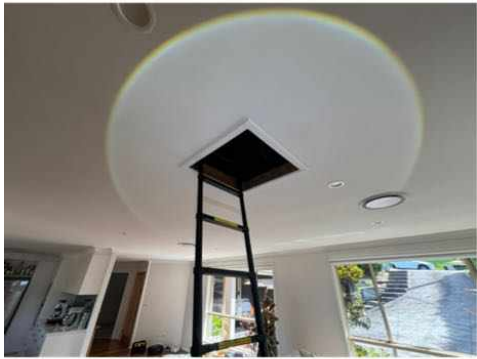
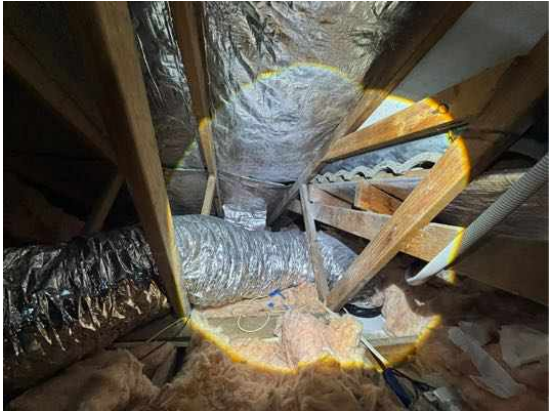
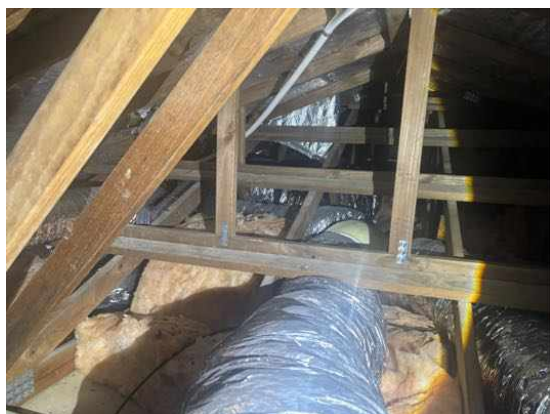
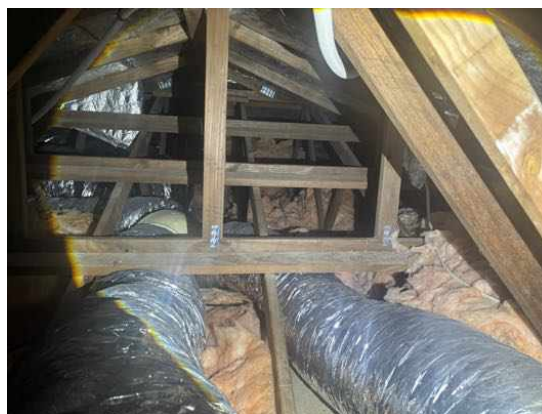
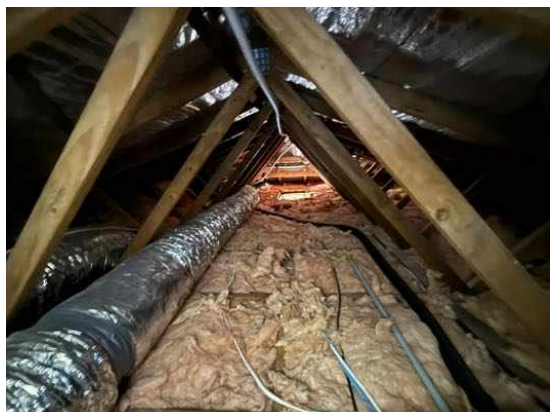
Building: Main Building  
 Location: Roof Void  
 Finding: Obstructions, Limitations, and General Roof Space Condition  
 Information: The photographs provided document both the general condition and the obstructions and limitations that were present in the roof cavity of the main building at the time of inspection. These obstructions—such as insulation materials, stored items, structural elements, or electrical wiring—restricted safe and adequate access to key areas within the roof space. As a result, a comprehensive inspection of all components could not be completed.

Obstructions of this nature may conceal a variety of potential defects, including damaged framing, compromised insulation, evidence of moisture ingress, pest activity, or electrical hazards. While no major issues were observed in the visible areas, the presence of these limitations means that some defects may remain undetected.

It is recommended that these barriers be removed or repositioned to facilitate full and safe access to the roof space. Once clear, a follow-up inspection should be conducted to allow for a thorough assessment of all concealed areas. This will help ensure that the condition of the roof cavity is accurately evaluated and any hidden issues are appropriately identified and addressed.
