# Building and Timber Pest Inspection Report

Inspection Date: Thu, 26 Mar 2026

Property Address: 10 Hibiscus Ave, North Avoca NSW 2260,  
Australia

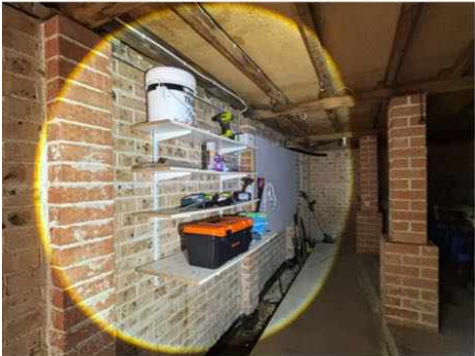
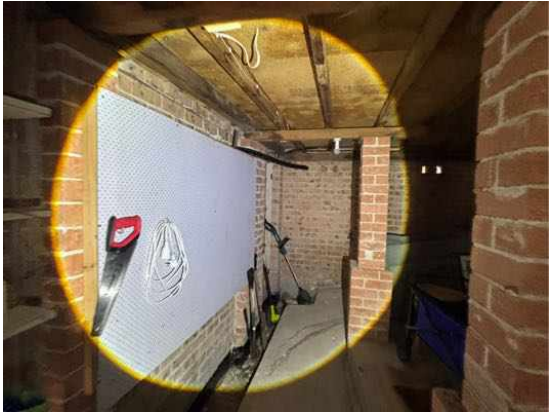
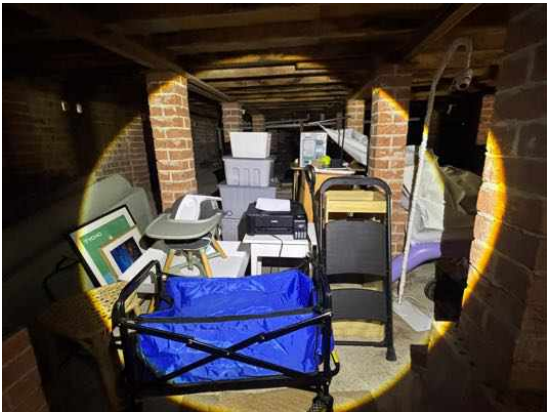
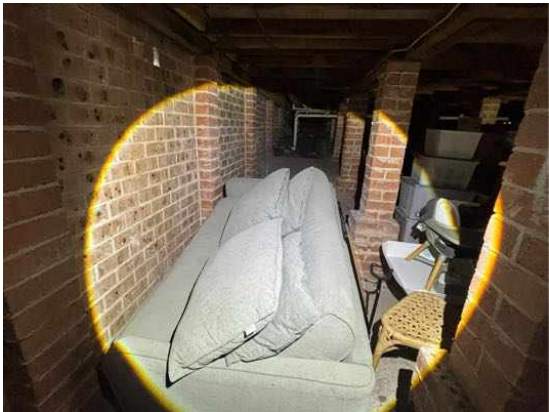
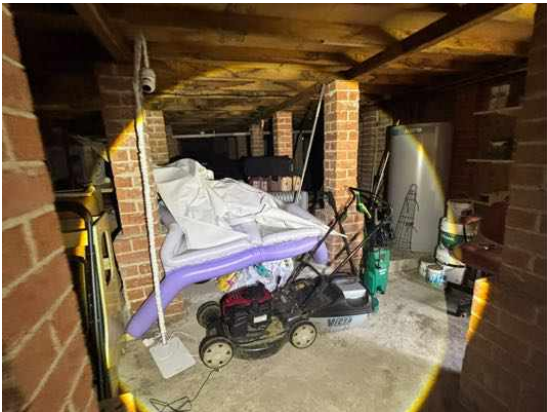
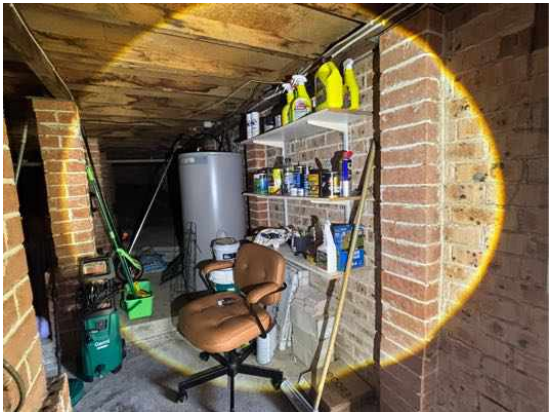
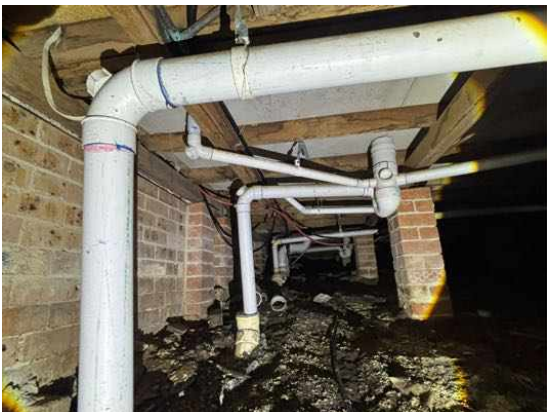
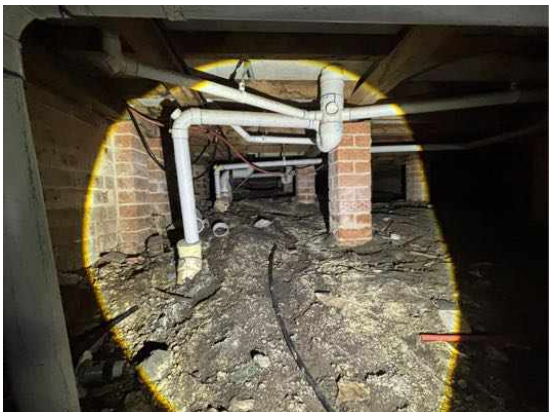
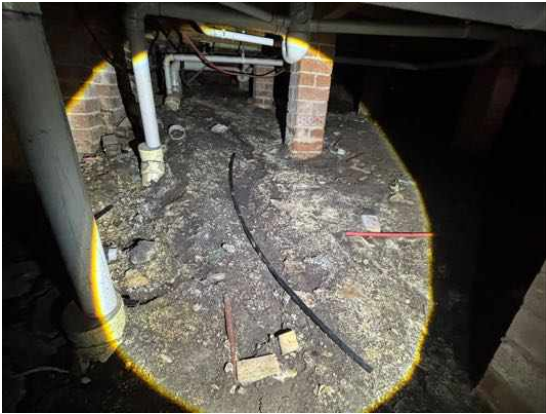
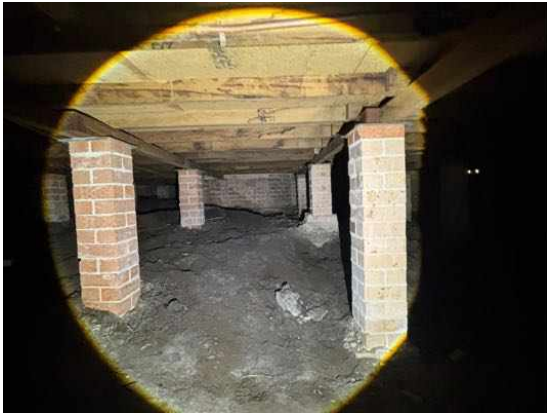
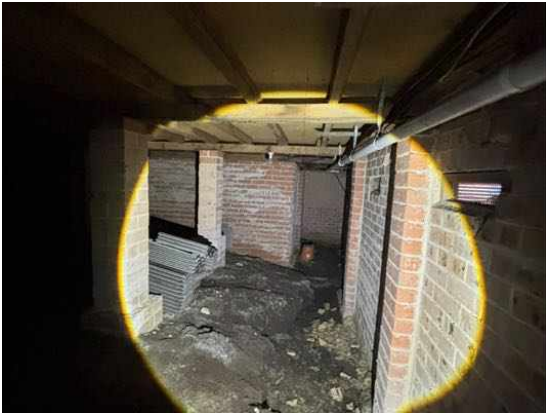
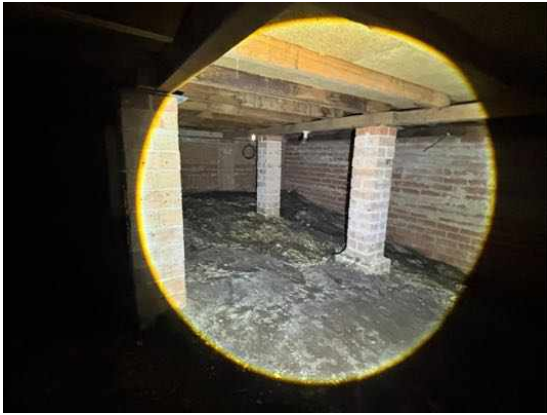
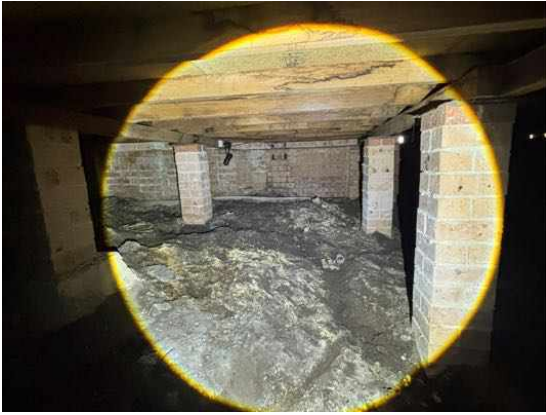
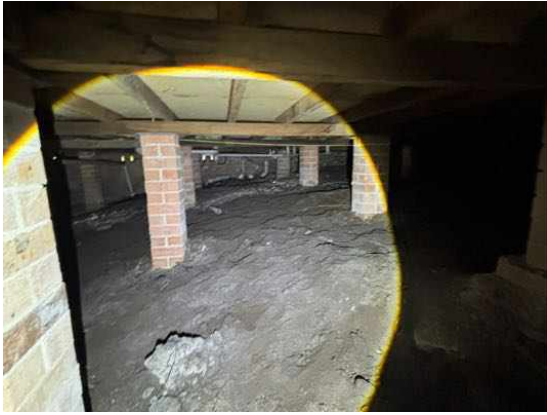
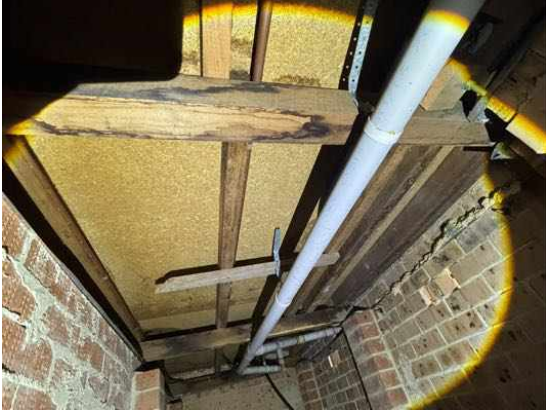
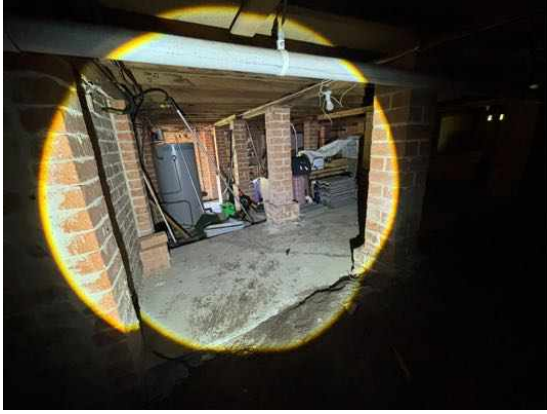
Building: Main Building  
 Location: Subfloor  
 Finding: Obstructions, Limitations, and General Subfloor Condition  
 Information: The attached photographs illustrate the obstructions and access limitations that restricted a full inspection of the subfloor area of the main property at the time of assessment. Items such as stored materials, construction debris, low-hanging services, and insulation impeded movement and visibility within key sections of the subfloor. In addition, the limited crawl height further restricted safe access to inspect critical structural components.

Restricted access and confined spaces can significantly hinder the ability to evaluate important elements such as floor joists, bearers, stumps, drainage, subfloor ventilation, and signs of moisture or pest activity. These obstructions may also conceal defects such as timber decay, water ingress, termite damage, inadequate support, or ventilation issues that are not immediately visible during a limited inspection.

While no major concerns were identified in the accessible areas, a full and unobstructed inspection is necessary to properly assess the overall condition of the subfloor. It is recommended that obstructions be removed and access improved where possible. Once adequate clearance is provided, a re-inspection should be arranged to ensure that any concealed defects can be identified and addressed accordingly. This will assist in providing a more comprehensive understanding of the

subfloor's condition and reduce the risk of unforeseen issues.

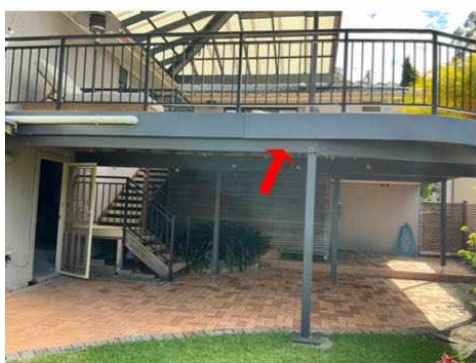
Nothing contained in this report should be taken as an indicator that an assessment has been made, on any elevated structure, as suitable for any specific number of people or purpose. This can only be done by a qualified engineer. For the purpose of this report, the Structure includes elevated decks, verandah, pergolas, balconies, handrails, stairs and children's play areas.

You should also arrange annual inspections of the structure by an engineer or other suitably qualified person to ensure any maintenance, that may become necessary, is identified. Care must be taken not to overload the structure.

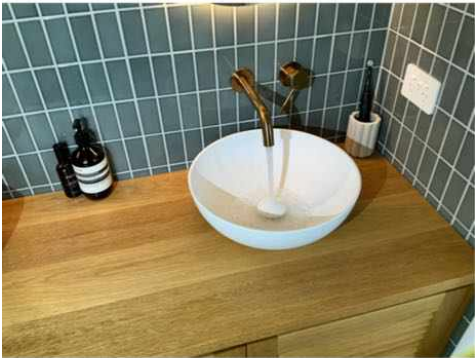
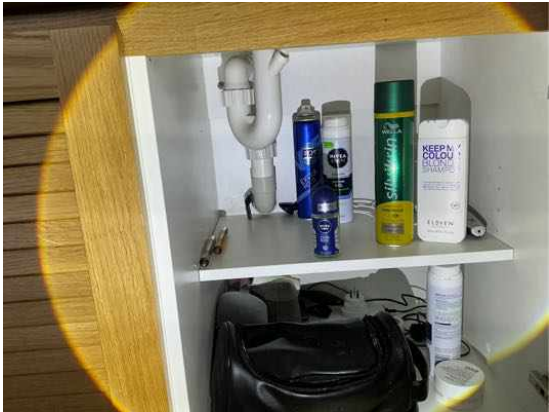
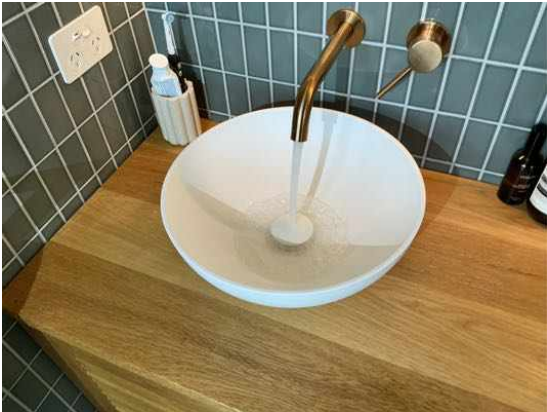
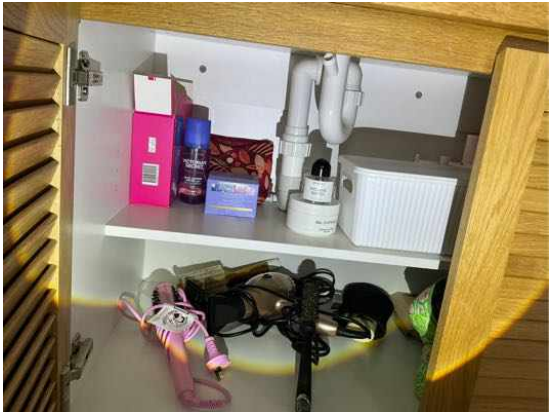
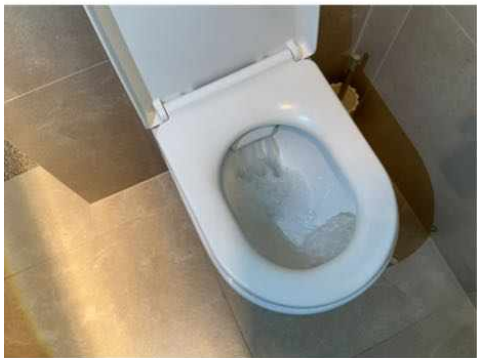
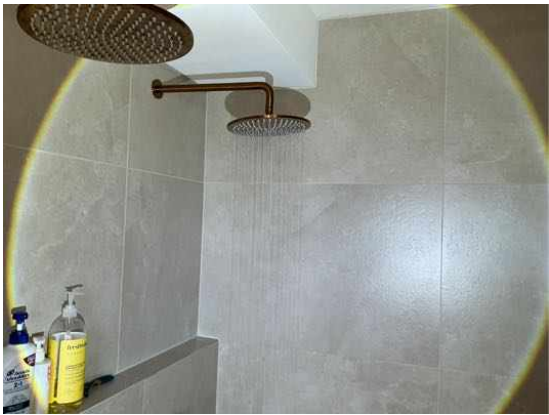
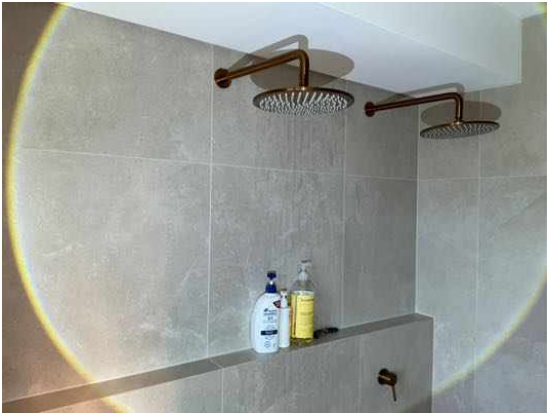
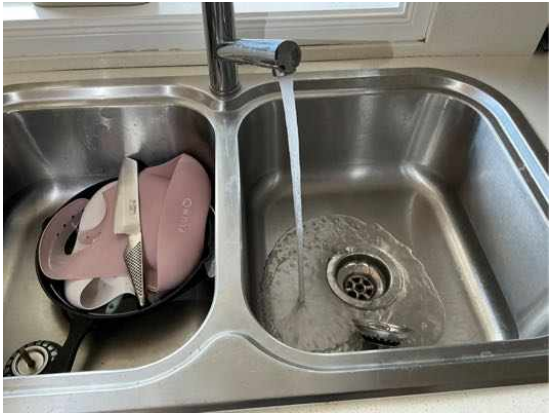
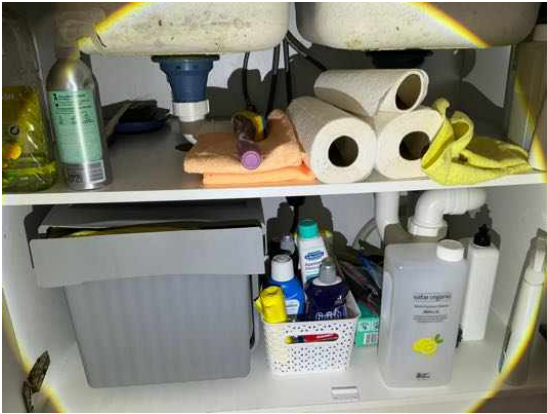
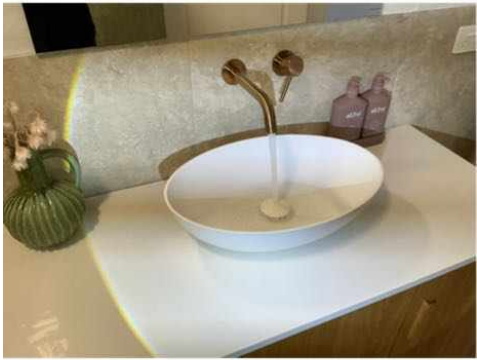
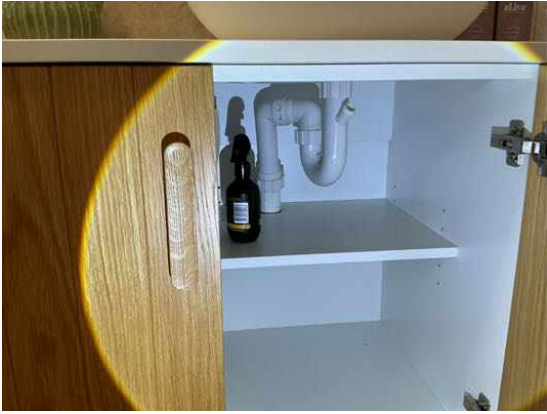
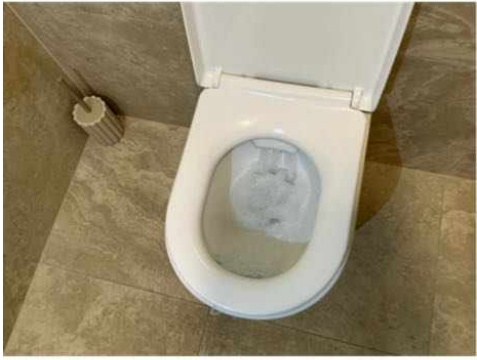
Building: Main Building  
 Location: All Areas  
 Finding: FYI - Taps, Drainage & Toilets Tested and Cabinetry Obstructions

During the inspection, all accessible taps, drainage systems, and toilets were tested for water flow and drainage efficiency, and checked for any visible signs of leakage. At the time of the inspection, no issues were noted in these areas. Unless highlighted in a separate defect statement, no immediate remedial work appears necessary. Supporting images may be found in the additional photos section for reference.

It is important to note that while a visual inspection of cupboards and cabinetry beneath sinks and vanities was undertaken, stored personal items and fixtures presented obstructions that limited full visibility of the internal areas. As per standard inspection practices, inspectors are not permitted to move or disturb personal belongings during the inspection process. Therefore, only visible and accessible sections were inspected, and concealed water damage or plumbing defects may not have been detected.

Given this, a re-inspection is recommended after all obstructions have been cleared to allow for a comprehensive assessment of these areas. Regular maintenance and monitoring of plumbing and drainage systems is also advised to ensure ongoing functionality and early detection of potential issues.

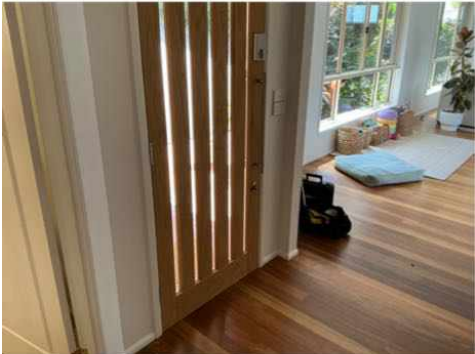
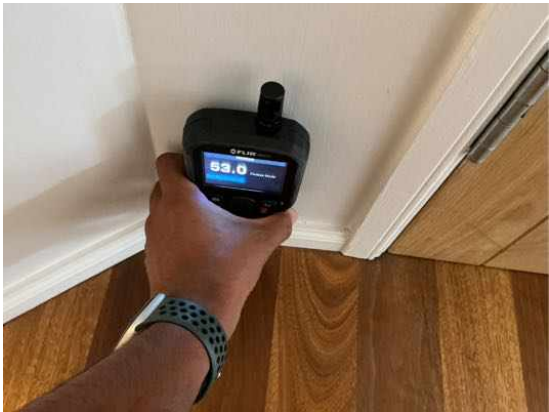
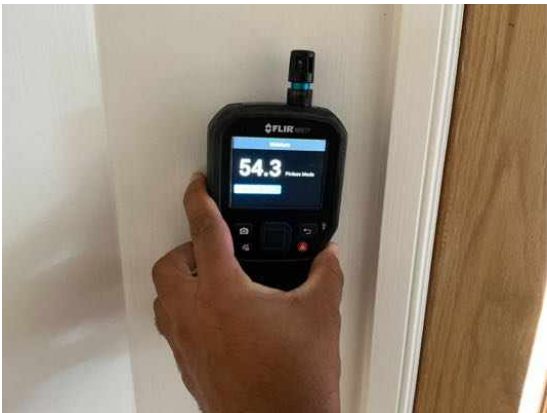
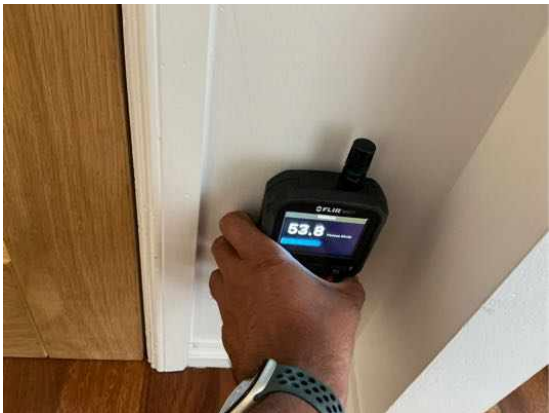
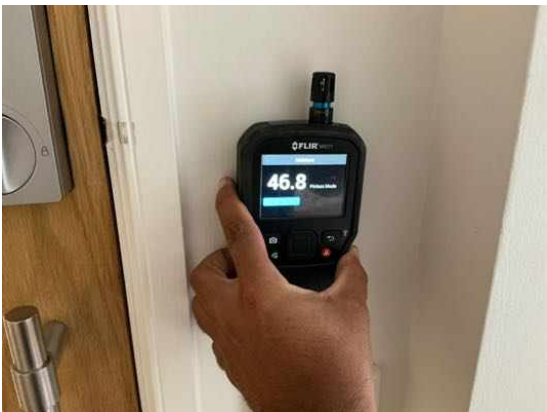
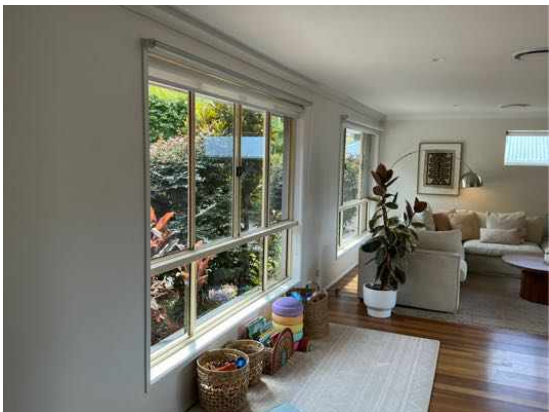
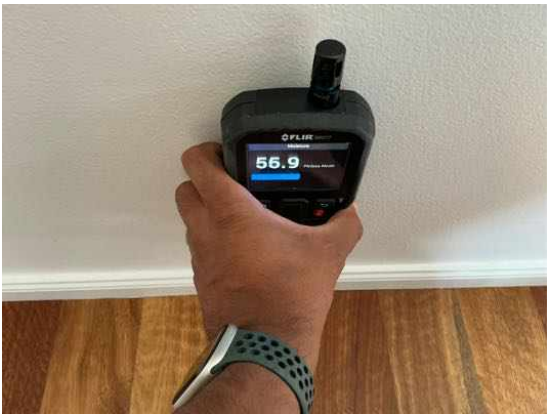
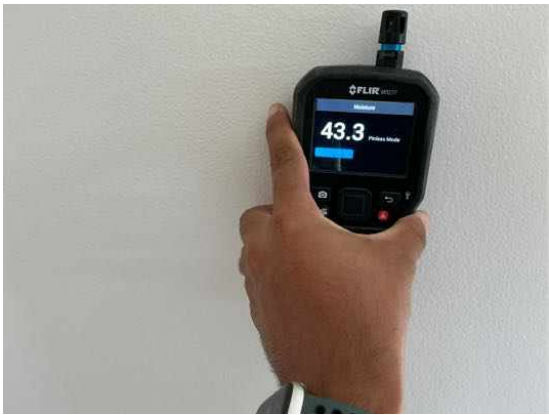
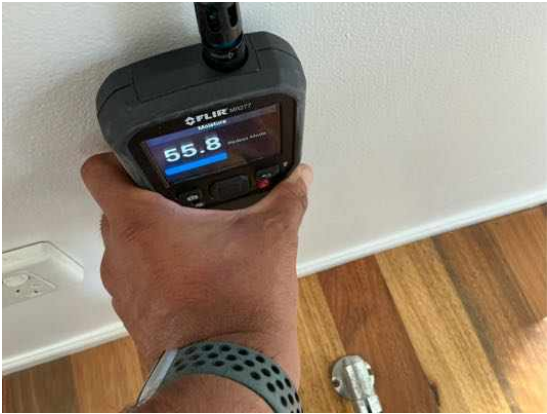
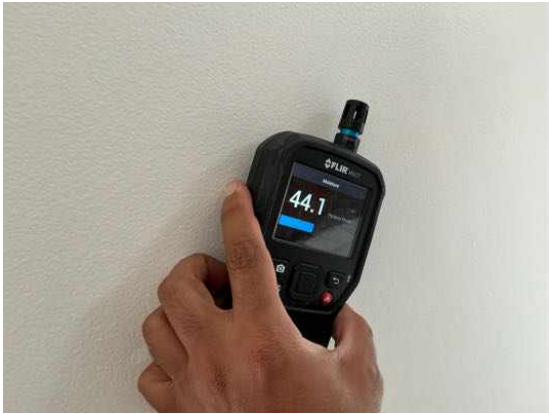
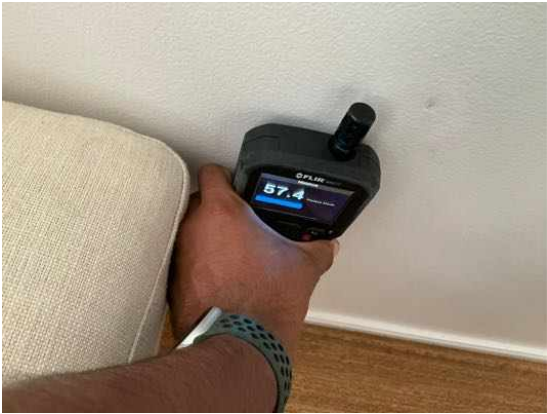
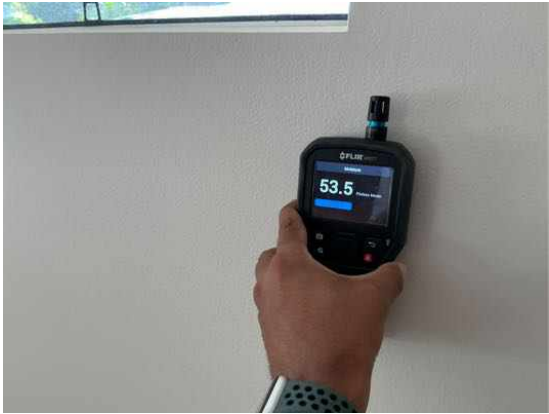
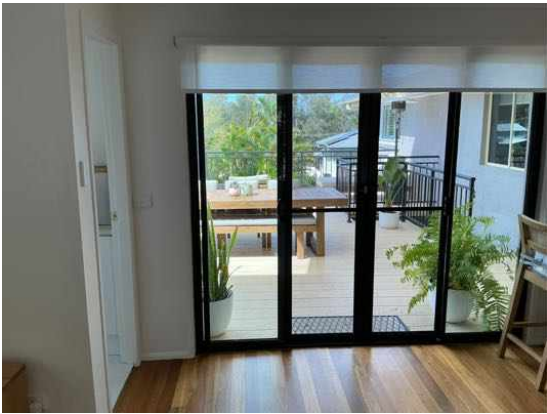
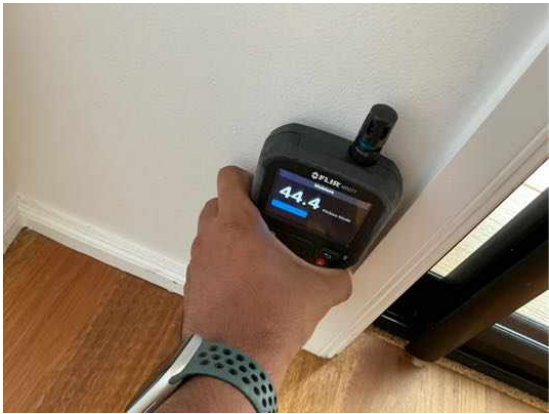
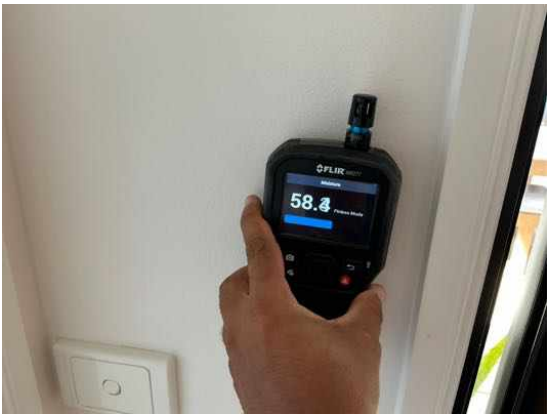
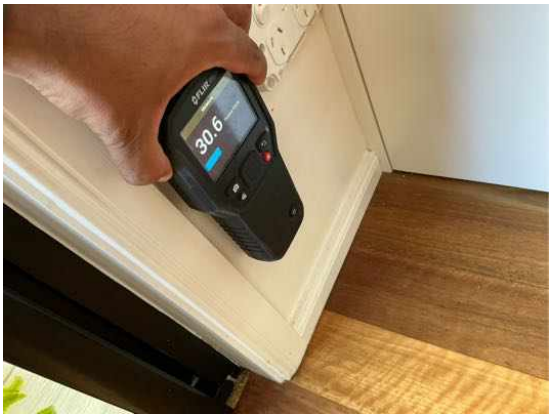
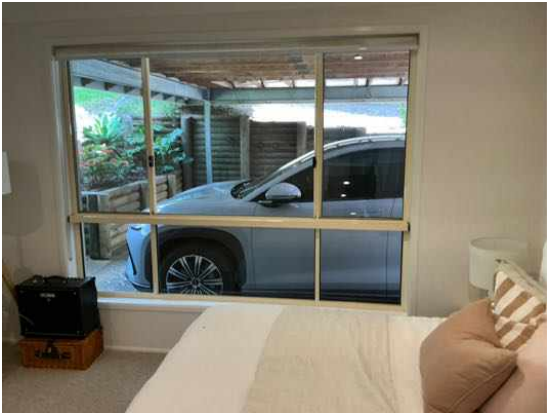
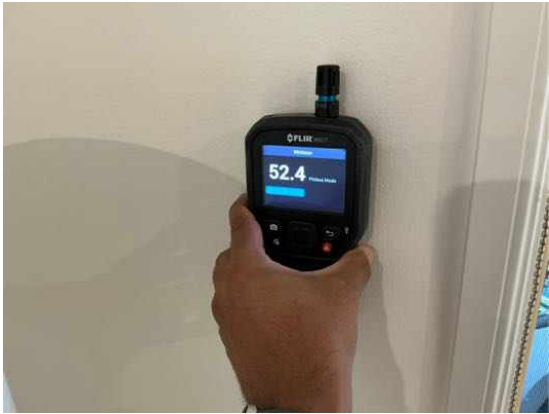
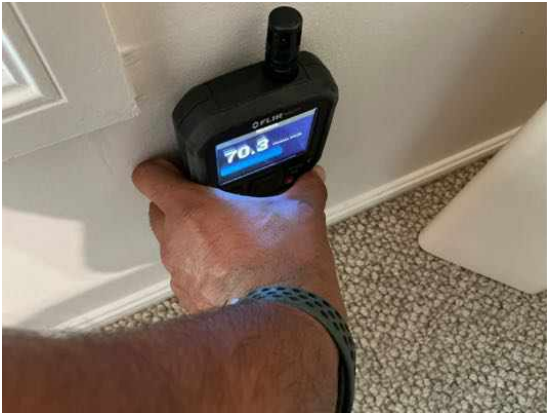
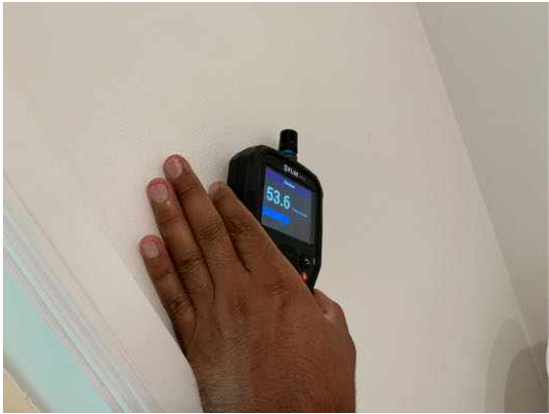
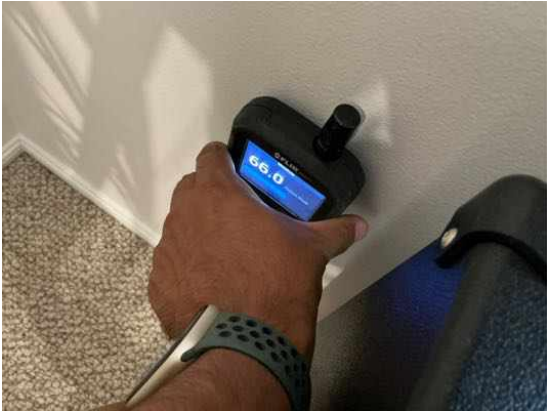
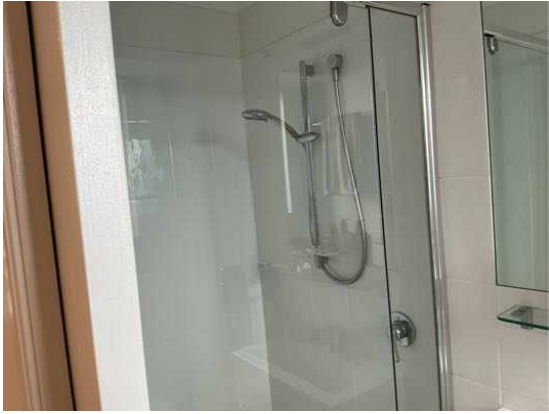
Building:	Main Building
Location:	All Areas
Finding:	Additional Photos - Moisture Meter Readings
Information:	Additional moisture meter reading photos have been provided for the property to offer further clarity on areas tested during the inspection. These photos are intended to give a visual reference for the specific locations where moisture levels were measured. These readings were taken at the time of the inspection to assess any potential moisture-related issues within the property. Any defects related to moisture that were identified during the inspection have been separately mentioned in the defect statements within the report.

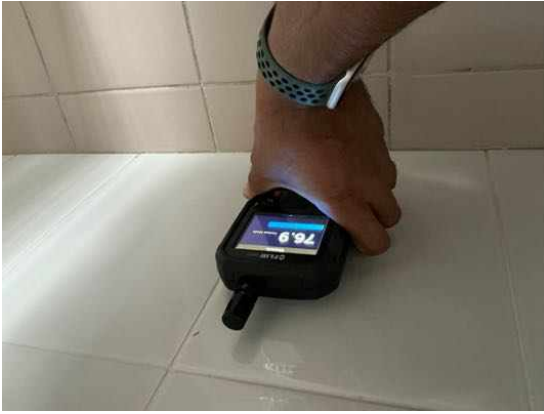
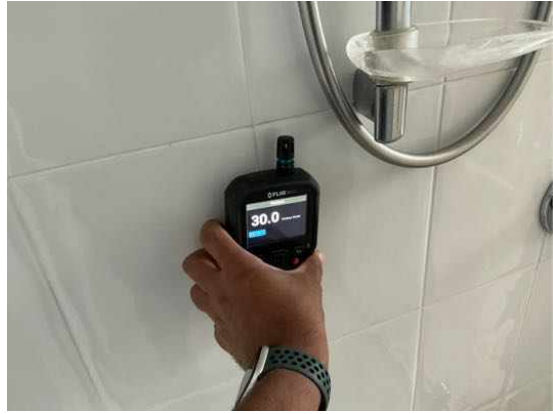
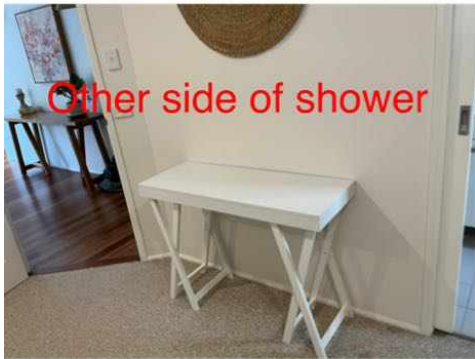
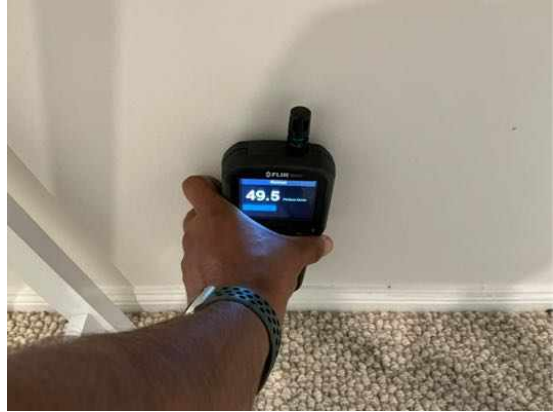
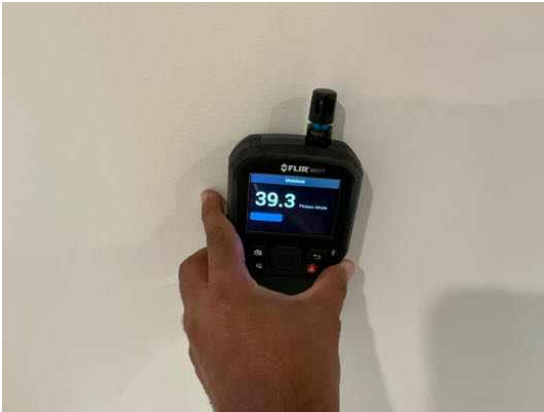
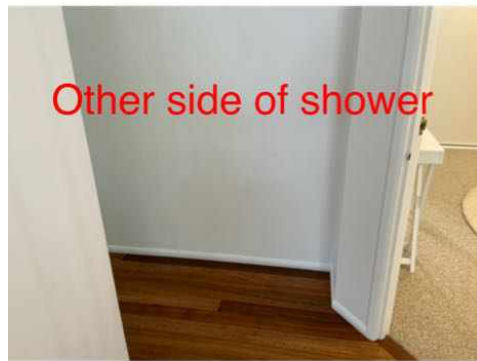
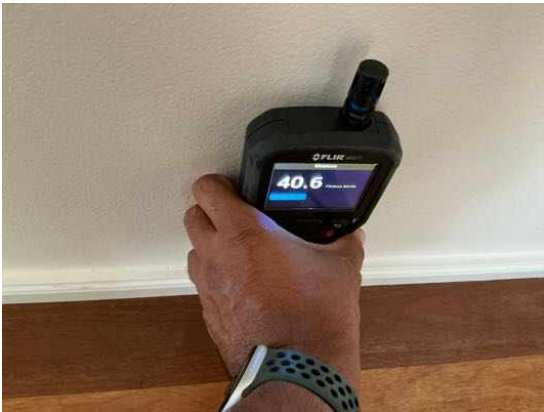
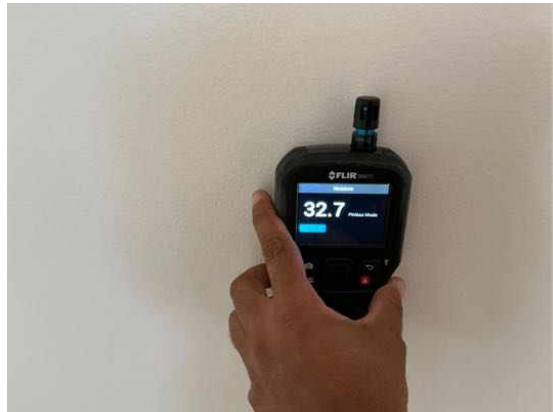
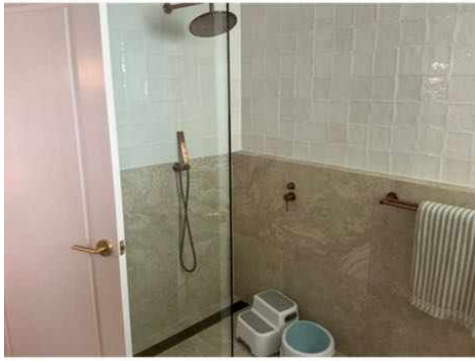
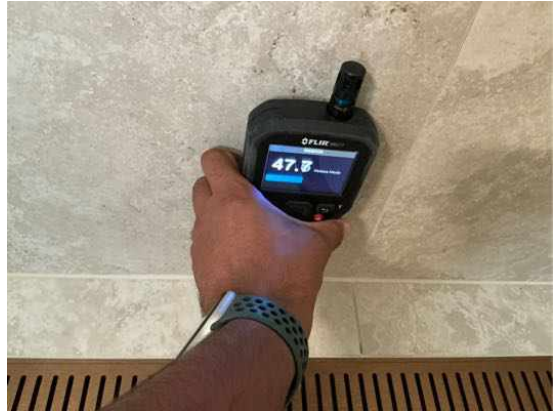
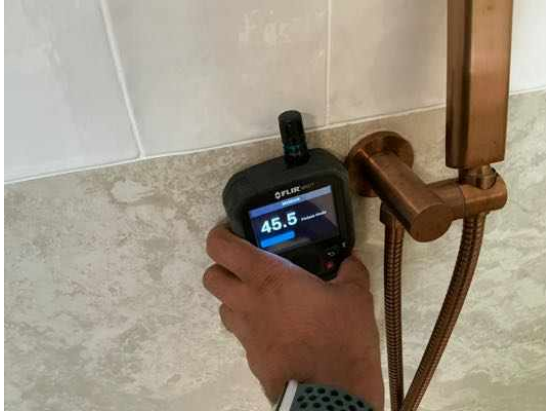
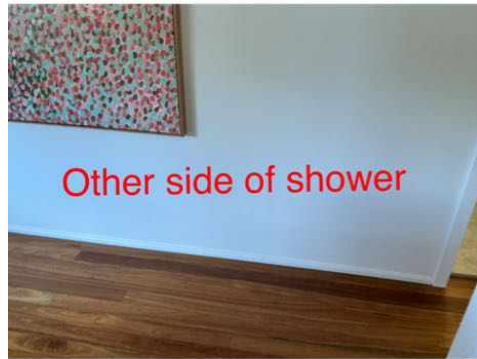
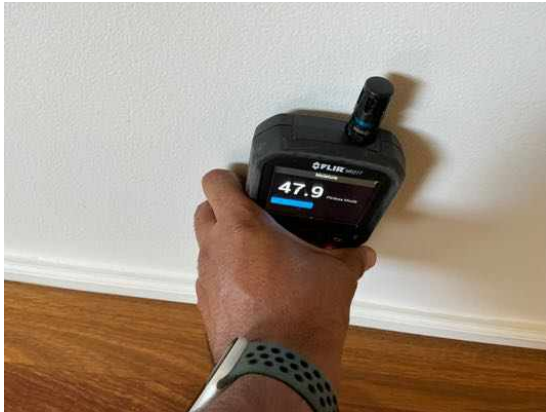
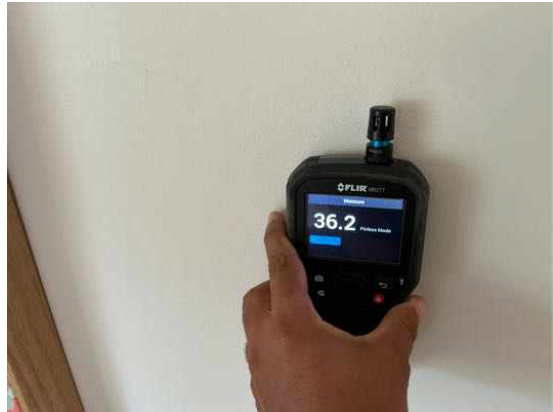
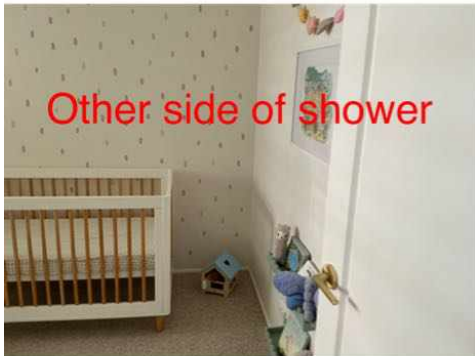
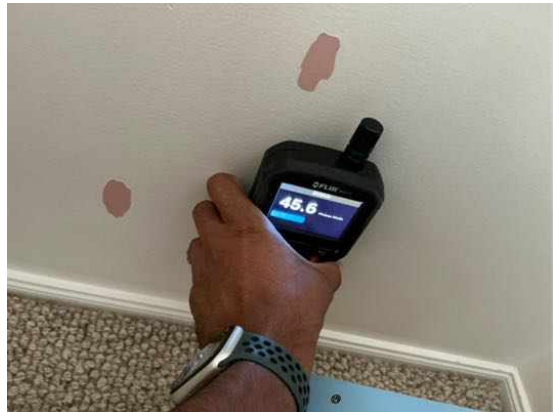
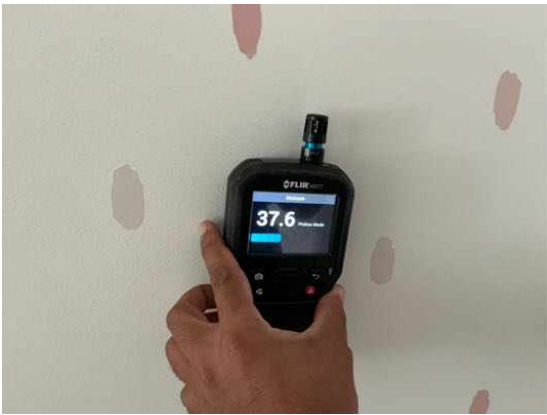
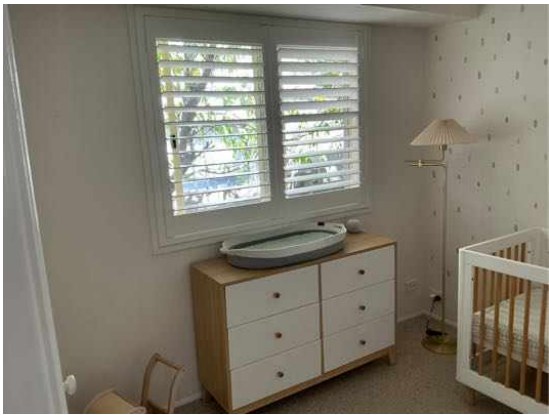
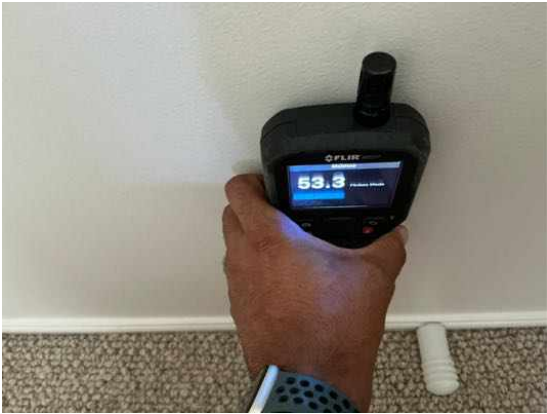
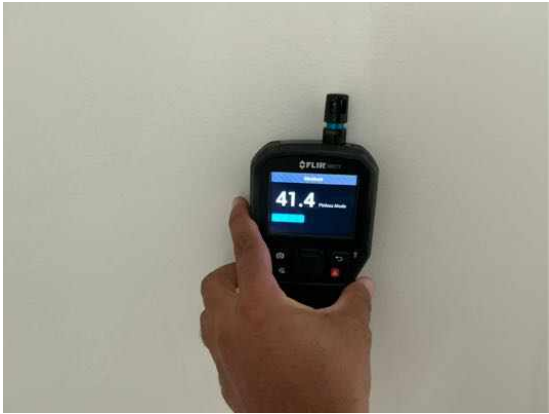
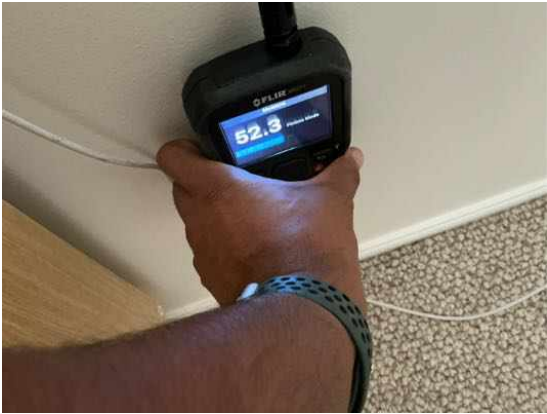
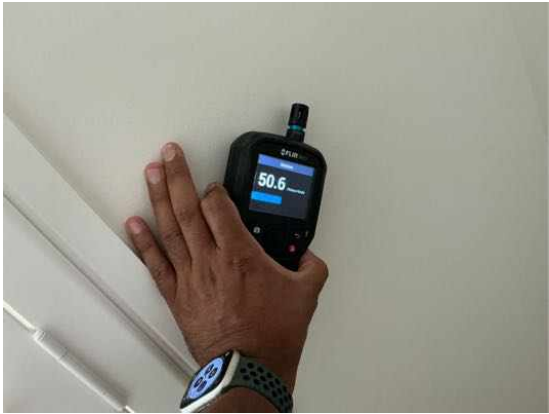
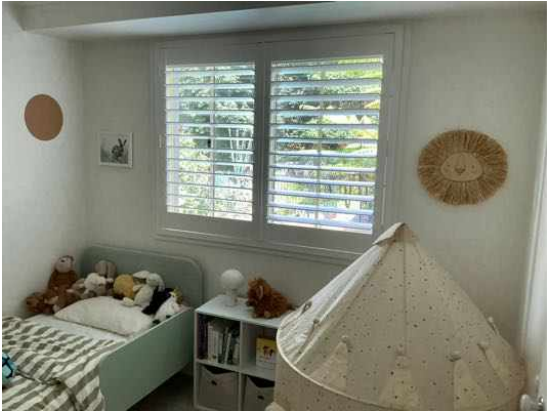
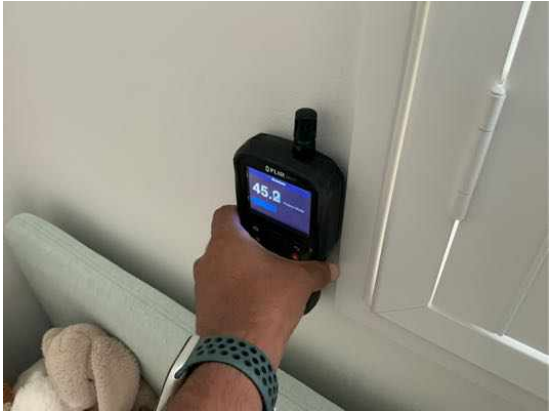
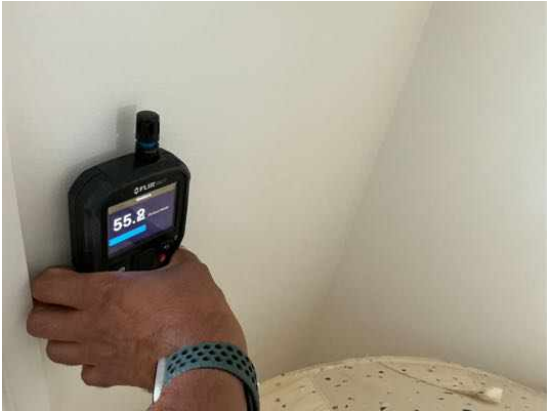
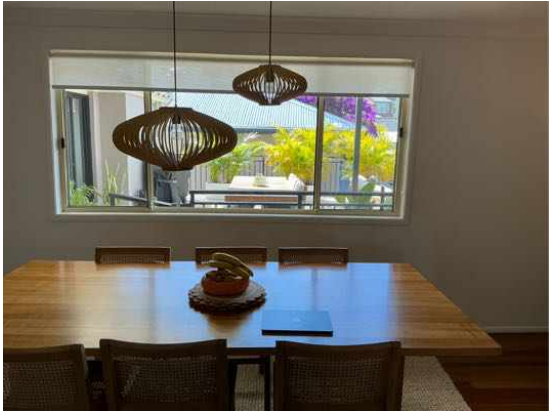
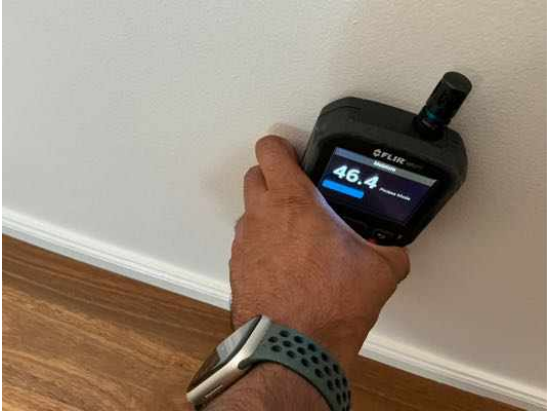
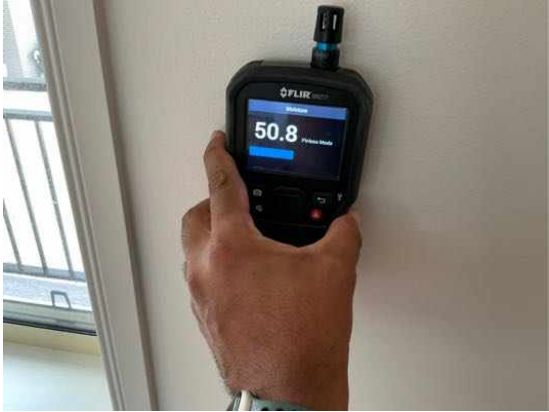
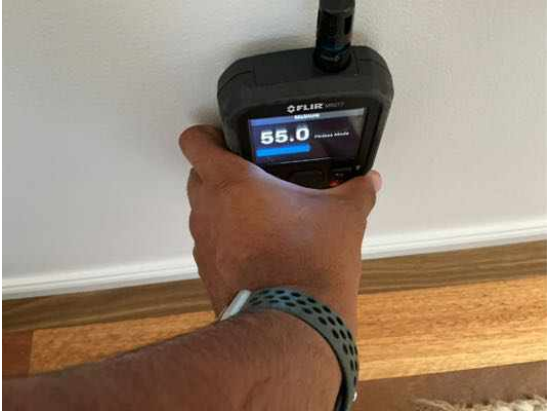
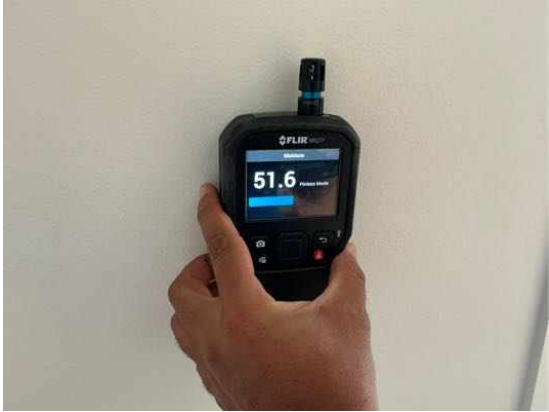
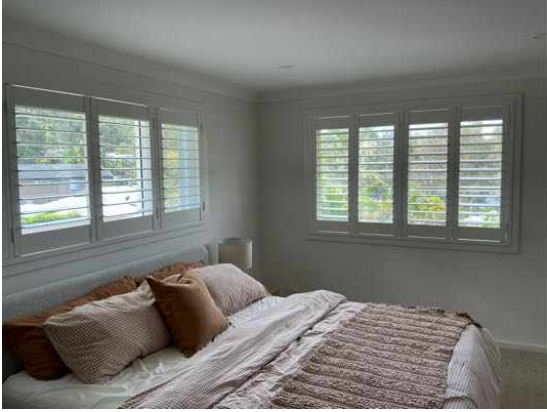
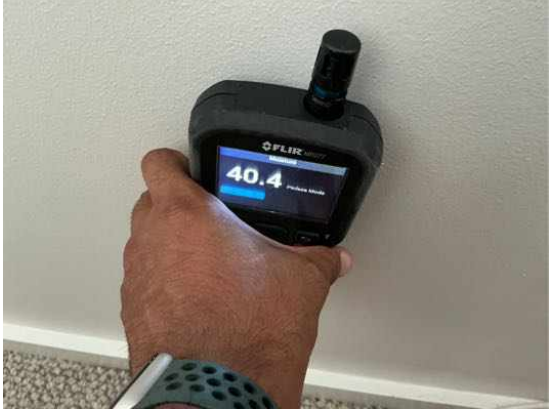
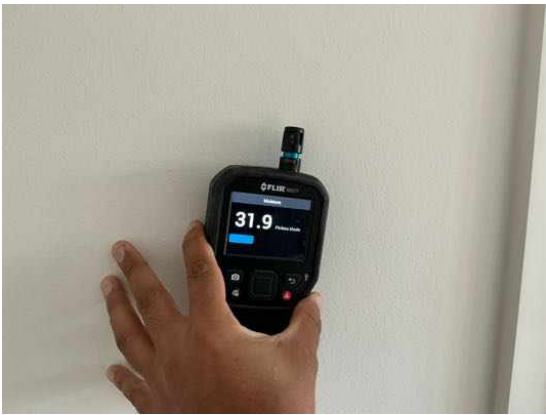
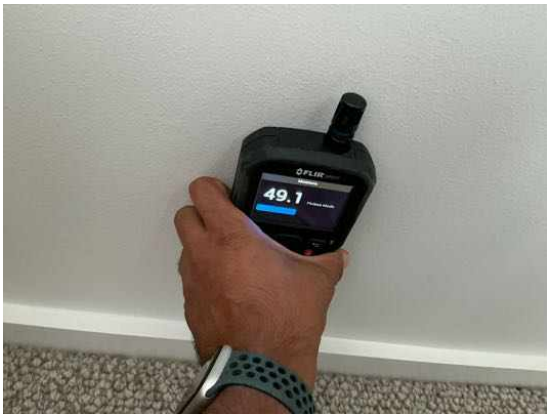
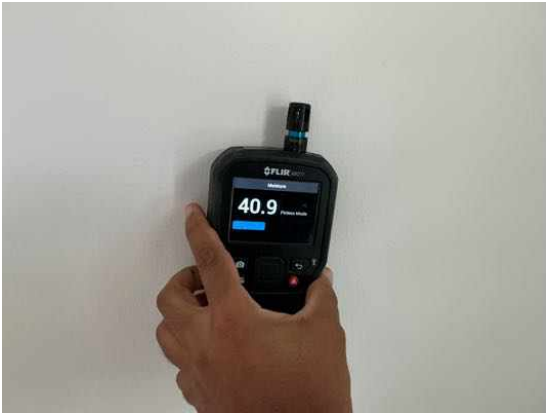
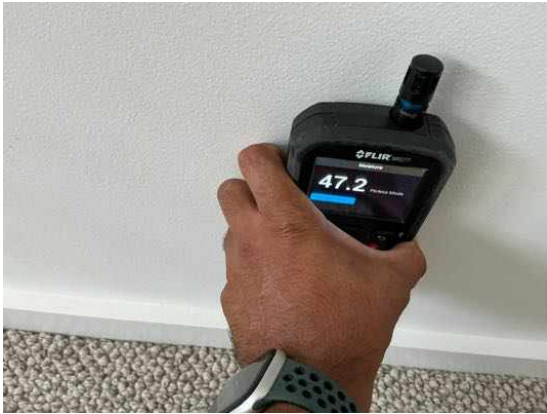
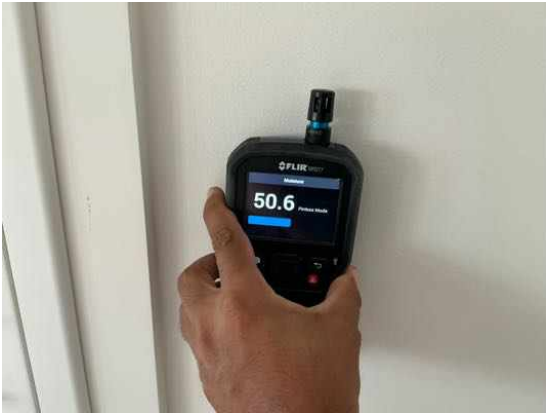
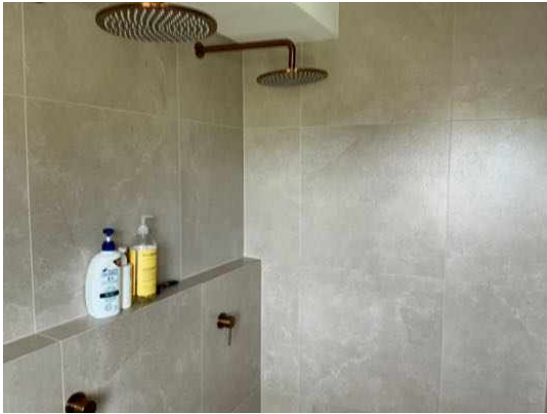
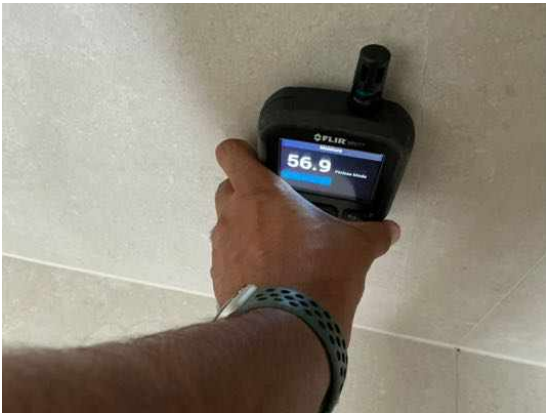
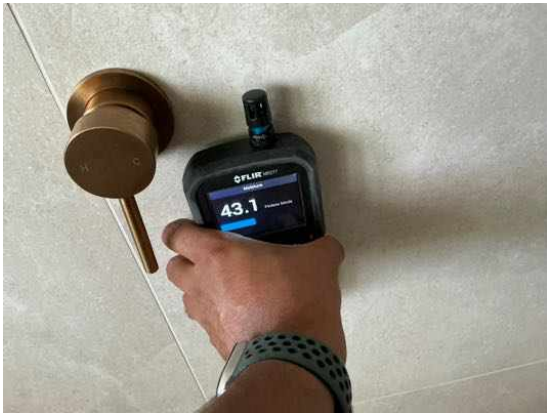
It is important for the client to understand that moisture levels can fluctuate over time due to various factors, including changes in weather, humidity, and environmental conditions. While the readings reflect the property's moisture levels during the inspection, they may not represent future conditions, and increased moisture could lead to issues such as dampness, mould growth, or deterioration of building materials if left unmonitored.

For further clarification or additional information regarding the moisture readings, the client is encouraged to contact the building inspector directly. Regular monitoring of moisture-prone areas is recommended to ensure any emerging concerns are addressed promptly, particularly during wetter seasons or in high-humidity conditions.

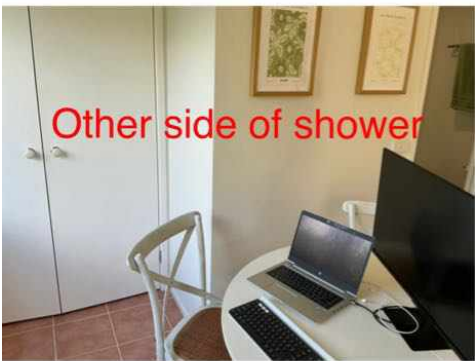
Other side of shower

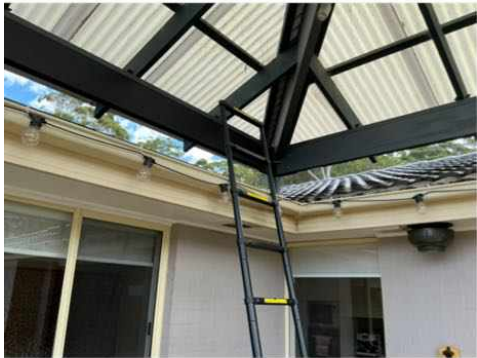
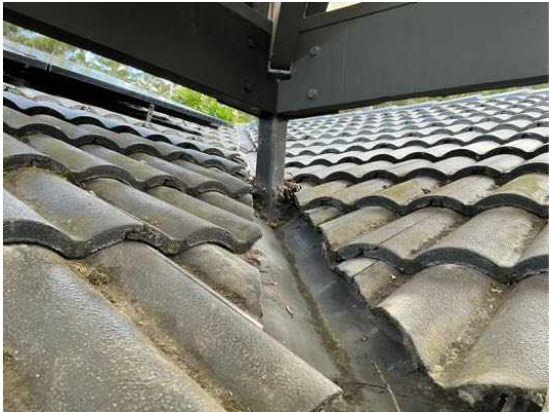
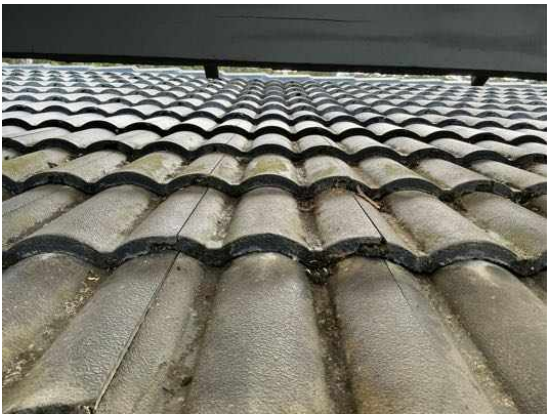
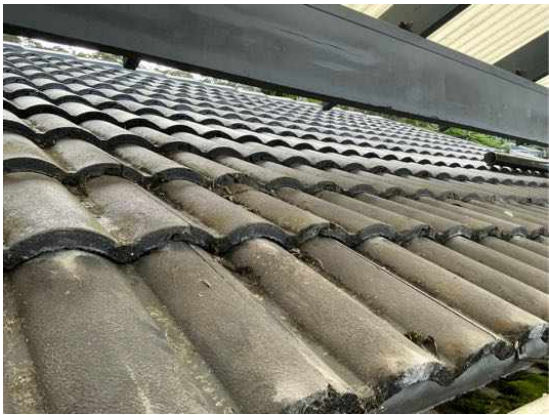
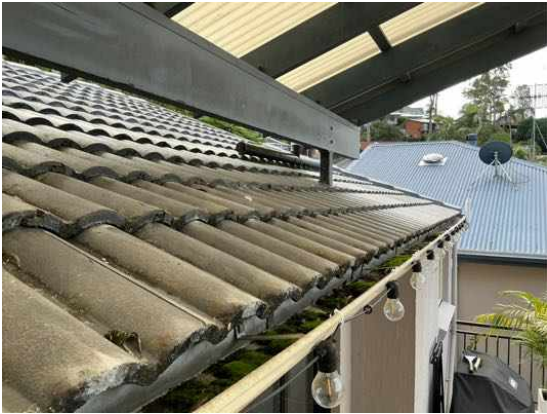
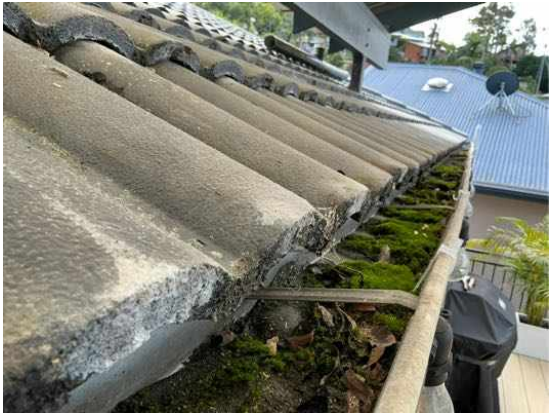
Building: Main Building  
Location: Roof Exterior  
Finding: Additional Roof Photos  
Information:

As part of the information provided, please note that the attached roof photos represent the condition of the roof at the time of inspection. These photos are for visual reference only and do not constitute a detailed roofing assessment. Any defects or issues identified with the roof are mentioned separately in the defect statements. It is strongly recommended that the client engage a qualified roofer to conduct a thorough inspection of the roof, ensuring that any potential issues, such as leaks, structural integrity, or wear and tear, are properly identified and addressed.

Additionally, the condition of the roof may change over time due to weather, natural wear, or other unforeseen factors. Regular maintenance and inspections by a licensed professional are advised to ensure the roof remains in good condition and to avoid costly repairs in the future. The information provided in these photos should be considered a snapshot of the roof's condition during the time of inspection and not a guarantee of its future performance.
