# Building and Timber Pest Inspection Report

Inspection Date: Thu, 26 Mar 2026

Property Address: 10 Hibiscus Ave, North Avoca NSW 2260,  
Australia

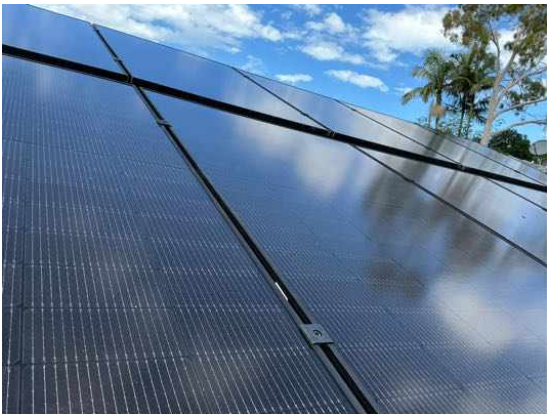
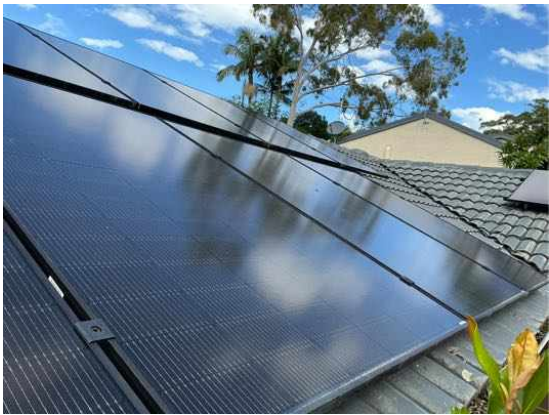
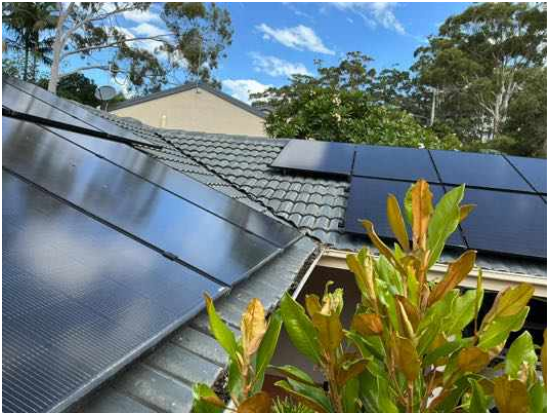
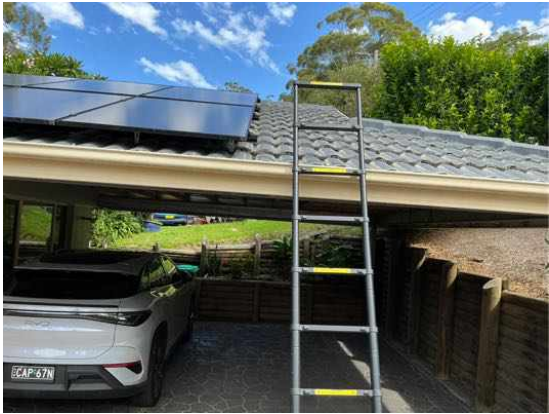
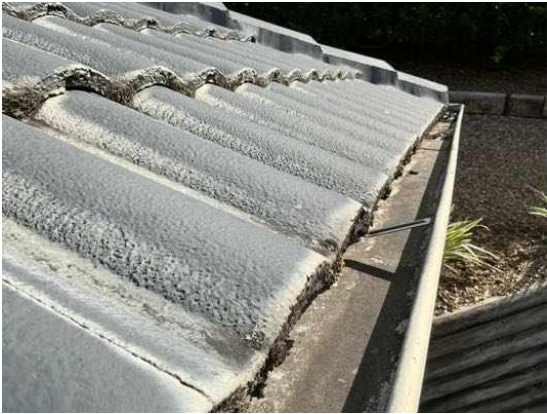
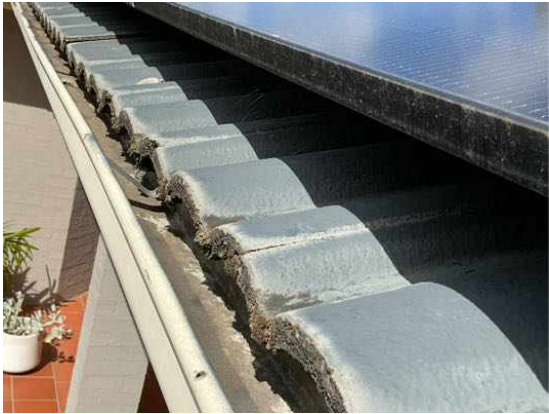
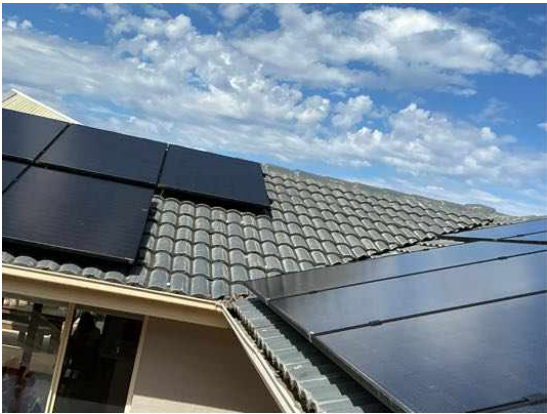
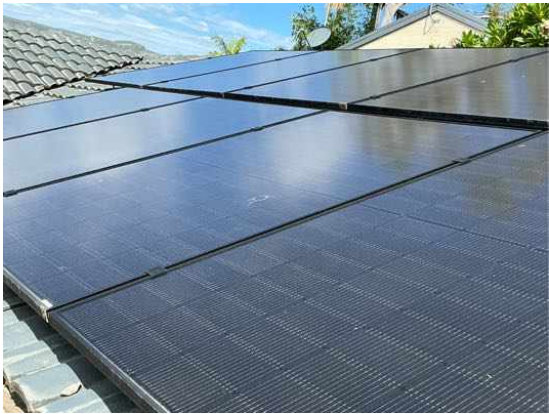
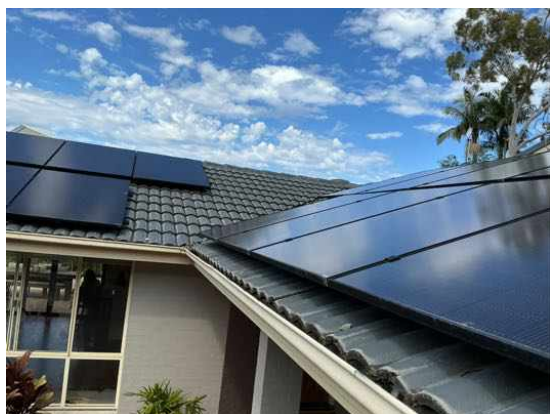
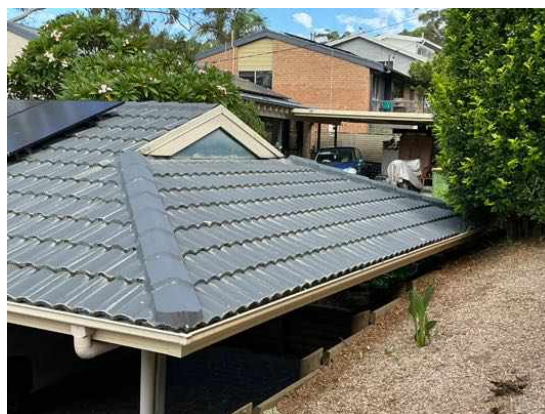
As part of the information provided, please note that the attached roof photos represent the condition of the roof at the time of inspection. These photos are for visual reference only and do not constitute a detailed roofing assessment. Any defects or issues identified with the roof are mentioned separately in the defect statements. It is strongly recommended that the client engage a qualified roofer to conduct a thorough inspection of the roof, ensuring that any potential issues, such as leaks, structural integrity, or wear and tear, are properly identified and addressed.

Additionally, the condition of the roof may change over time due to weather, natural wear, or other unforeseen factors. Regular maintenance and inspections by a licensed professional are advised to ensure the roof remains in good condition and to avoid costly repairs in the future. The information provided in these photos should be considered a snapshot of the roof's condition during the time of inspection and not a guarantee of its future performance.

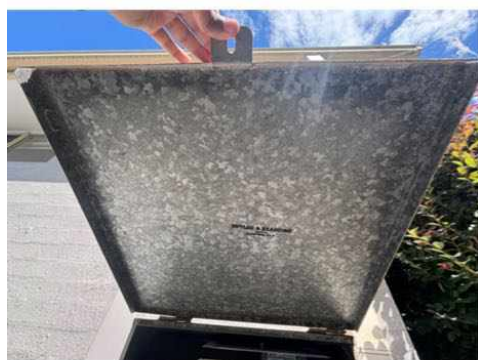
Building: Main Building  
Location: Meter Box  
Finding: Termite Management Recommendation – No Evidence of Chemical Installation  
Information: At the time of inspection, there was no visible evidence of a chemical termite management system installed around the property. Chemical barriers are a key component of termite protection and are particularly important in preventing concealed termite entry into timber elements of the structure.

In accordance with standard requirements, a durable notice should be located within the electrical switchboard to detail any termite protection systems applied, including chemical treatments. No such notice was observed during the inspection.

It is recommended that the client engage a licensed pest controller to assess the suitability of installing a chemical barrier, and to provide advice on associated costs and procedures. This should be considered a short-term priority, particularly if the property has any history of termite activity or is located in a high-risk area.

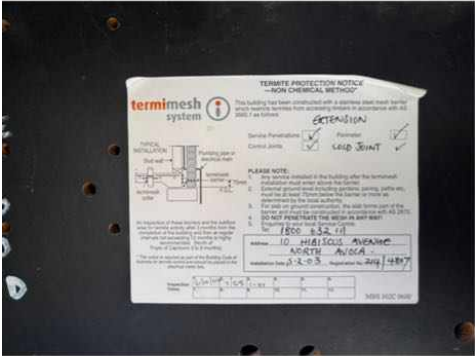
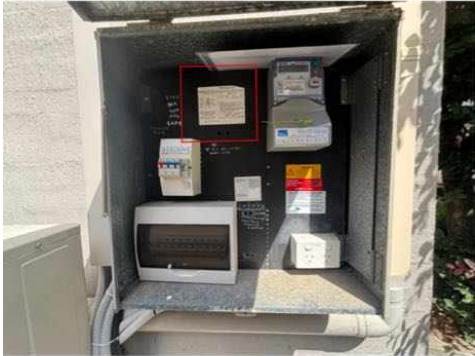
Where a Termite Management System has been identified you should refer to the type of barrier date of installation warranty conditions and any documentation provided by a builder or past owner. Consult the company who installed the barrier to confirm whether the system is still under warranty.

Most chemical termite management systems expire and require replenishment and all physical systems are primarily designed to prevent concealed entry.
