Building and Timber Pest Inspection Report

Inspection Date: Wed, 18 Mar 2026

Property Address: 75 Kavanagh Rd, Wishart QLD 4122,
Australia

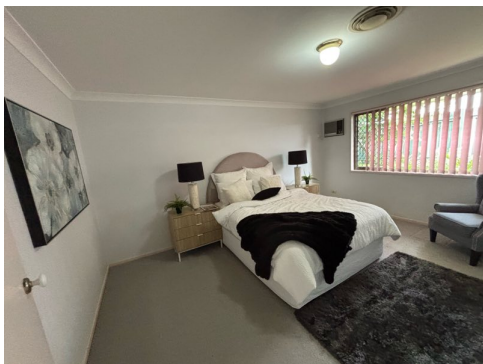
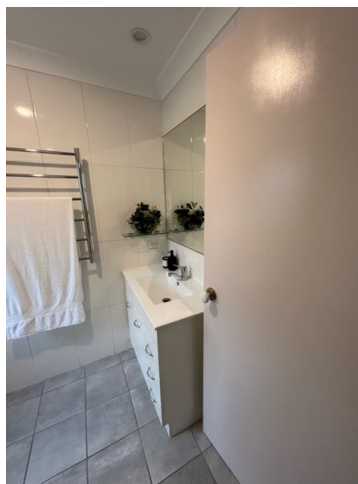
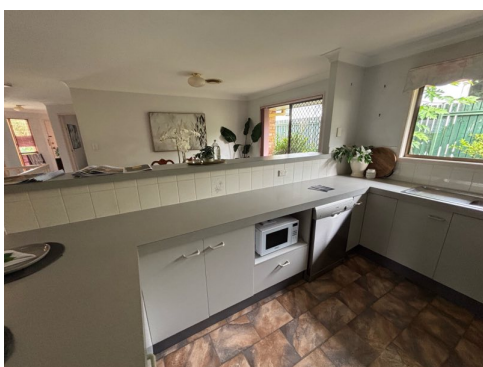
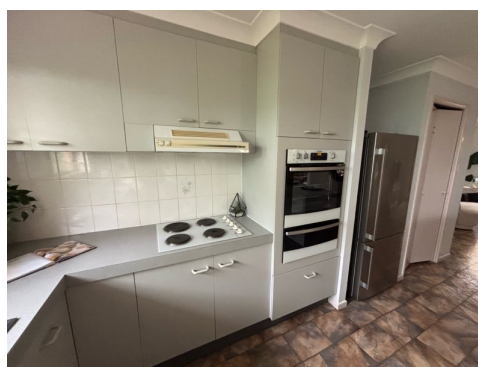
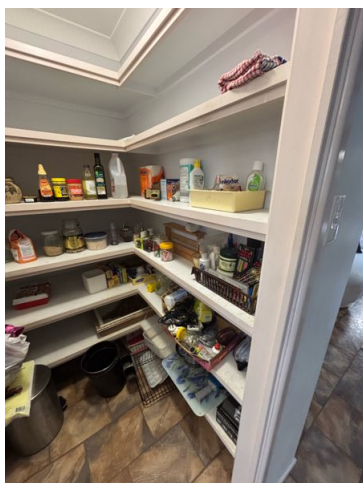
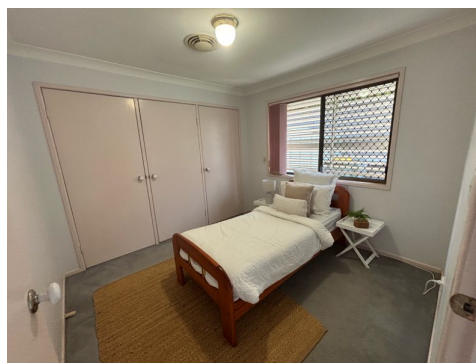
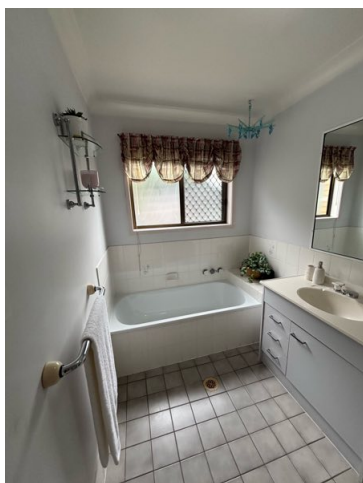
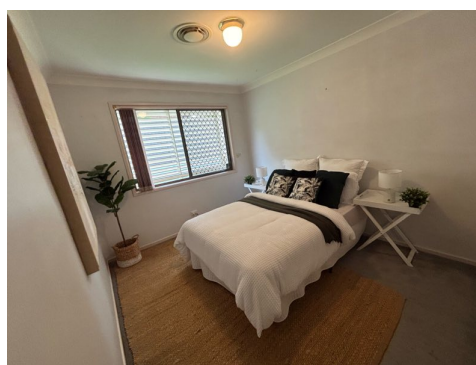
Finding: Obstructions and Limitations - Internal areas

Information: These photographs are an indication of the obstructions and limitations which impeded full inspection of the property of the internal areas at the time of inspection. These obstructions can hide an array of defects and should be removed to allow full inspection to be carried out. A re-inspection is recommended once the areas are made accessible.

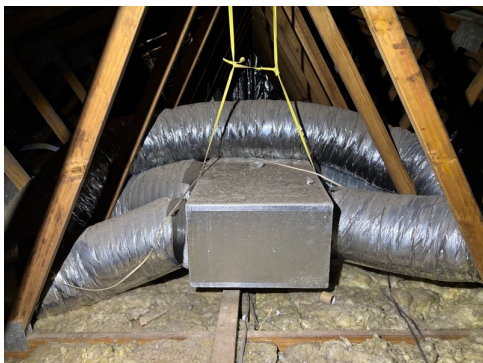
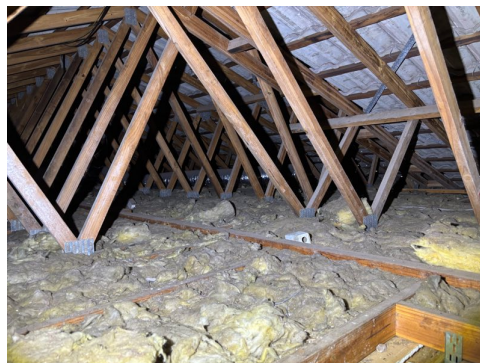
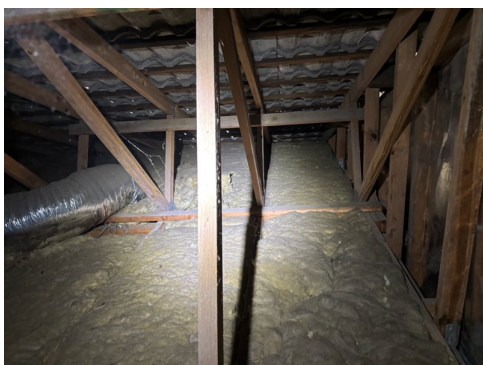
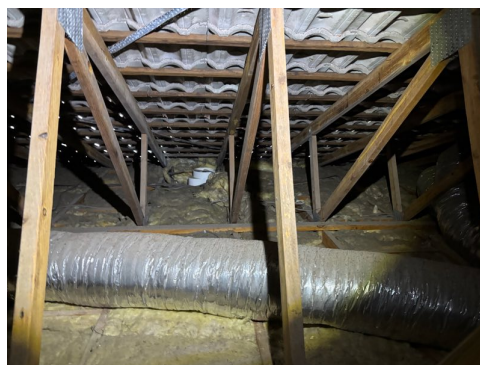
Finding: Obstructions and Limitations - Roof cavity

Information: These photographs are an indication of the obstructions and limitations which impeded full inspection of the property of the roof cavity at the time of inspection. These obstructions can hide an array of defects and should be removed to allow full inspection to be carried out. A re-inspection is recommended once the areas are made accessible.

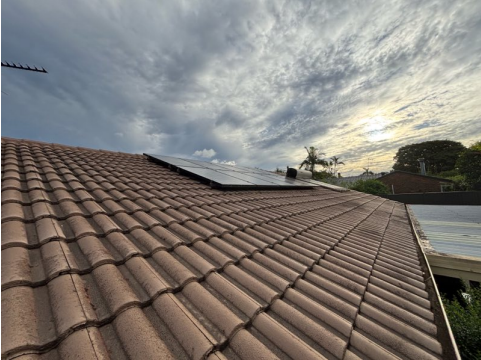
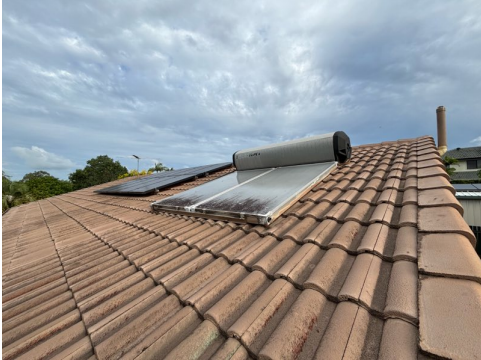
Finding: Obstructions and Limitations - Roof exterior

Information: These photographs are an indication of the obstructions and limitations which impeded full inspection of the property of the roof exterior at the time of inspection. These obstructions can hide an array of defects and should be removed to allow full inspection to be carried out. A re-inspection is recommended once the areas are made accessible.
