## Building Inspection Report

Inspection Date: Wed, 28 Jan 2026

Property Address: 167B Glenwood Park  
Dr, GLENWOOD, NSW, 2768, Australia

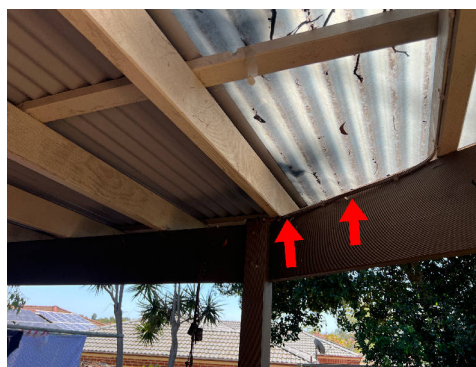
#### Defects 1.01

Building:	Main Building
Location:	Yard - Back
Finding:	Electrical Wiring Not Installed Within Protective Conduit (External Covered Area)
Information:	Electrical wiring was observed installed without protective conduit to the underside of the roof structure within the external covered area. The wiring was visibly exposed and not adequately protected against mechanical damage or environmental factors, which is not consistent with good electrical installation practices.

Unprotected electrical wiring is vulnerable to damage from movement, moisture exposure, pests, or accidental contact, increasing the risk of electrical faults, shock, or fire. Electrical cabling in accessible or semi-exposed locations should be adequately enclosed within approved conduit for protection. It is recommended that a licensed electrician assess the installation and carry out rectification works as required. This defect is considered moderate and should be addressed in a timely manner to reduce safety risks.

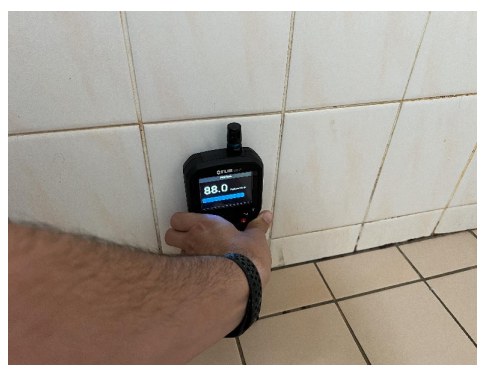
#### Defects 2.01

Finding: Elevated Moisture Readings to Shower Wall Tiles

Information: Elevated moisture readings were recorded to the lower sections of the shower wall tiles when tested using a non-invasive moisture meter, with readings reaching high levels at the time of inspection. The testing was carried out to the tiled wall surfaces within the shower area. It should be noted that the shower appeared to have been recently used prior to the inspection, which is likely to have influenced the moisture readings obtained.

While elevated readings in recently used shower areas can be expected, the presence of other defects within the shower area, including missing sealant and cracked tiles, increases the potential risk of moisture penetration beyond the tiled surface. It is recommended that the shower area be monitored and, if elevated readings persist once the area has had sufficient time to dry, further assessment by a suitably qualified bathroom or waterproofing specialist may be warranted. Rectification of associated defects is recommended to reduce the risk of ongoing moisture-related issues.

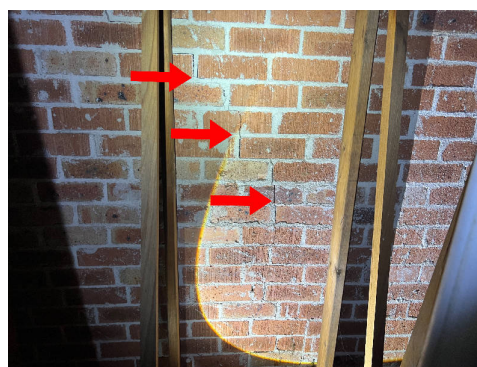
## Defects 2.02

Finding: Major Cracking to Masonry Party Wall Within Roof Space

Significant cracking was observed to the masonry party wall within the roof space at the time of inspection. The cracking follows a stepped pattern through the brickwork and mortar joints and is visible across multiple courses. This condition was observed adjacent to roof framing members and is considered more than minor or cosmetic cracking.

Cracking of this nature may be indicative of structural movement, differential settlement, thermal movement, or load-related stresses affecting the party wall. Due to the location and extent of the cracking, further investigation is warranted to determine the cause and assess the structural implications. It is recommended that a suitably qualified structural engineer or experienced builder assess the party wall and provide advice on any required repairs or monitoring. This defect is considered significant and should be addressed as a priority.

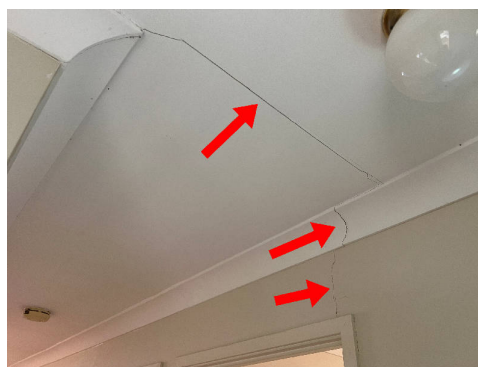
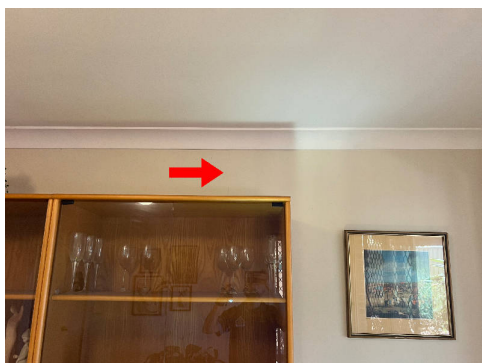
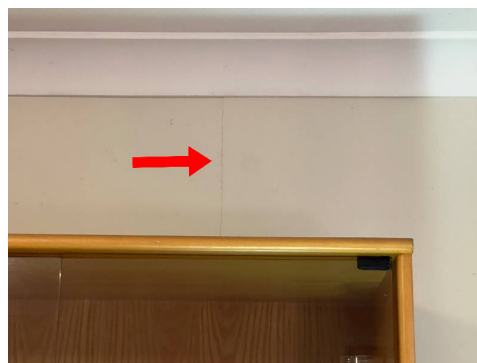
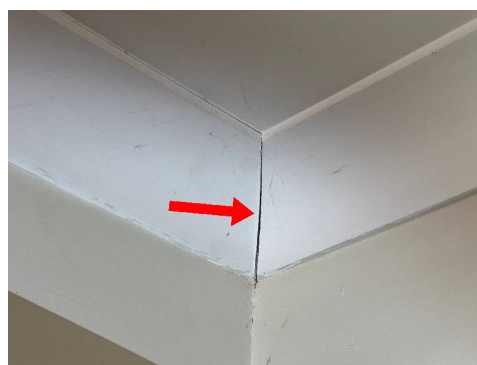
### Defects 3.01

Building:	Main Building
Location:	All Internal Areas
Finding:	Internal Cracking to Ceiling and Wall Junctions

Cracking was observed to the internal ceiling lining and extending down the adjacent wall surface at the junctions between the ceiling, cornice, and wall. The cracking follows ceiling sheet joints and continues vertically down the wall below. This condition is commonly associated with building movement, minor settlement, or thermal expansion and contraction of materials. While this type of cracking is often cosmetic in nature, it can indicate ongoing movement if it continues to worsen or reappears after repair.

It is recommended that the cracking be assessed by a licensed plasterer or suitably qualified builder to confirm whether the issue is cosmetic only or if further investigation is required. Monitoring is advised in the short term, with repairs to be undertaken if the cracking increases, reopens after patching, or if cosmetic improvement is desired.

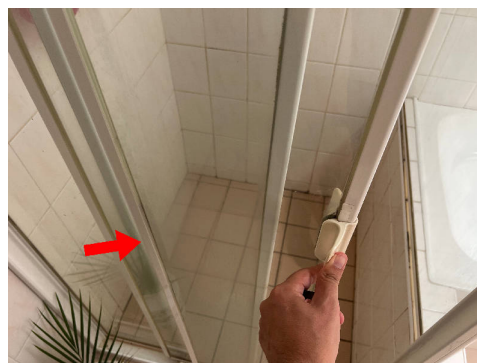
### Defects 3.02

Information: The shower screen door was observed to become stuck and does not open or close smoothly during operation. The door appears to bind within the frame and tracks, which may be due to misalignment, wear to the rollers or guides, or a build-up of debris within the track. This condition affects the normal operation of the shower screen and may lead to further wear or damage if continued to be forced during use.

It is recommended that a suitably qualified glazier or bathroom repair specialist assess the shower screen door to determine the cause of the obstruction and carry out the necessary adjustments or repairs. Rectification is recommended in the short term to restore proper operation and prevent further deterioration of the door components.

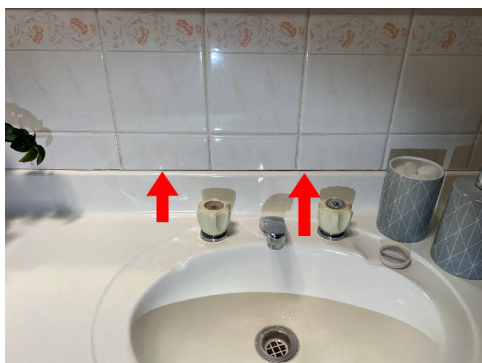
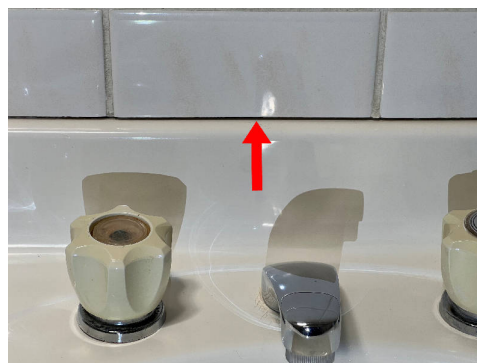
### Defects 3.03

Finding: Missing and Deteriorated Sealant to Bathroom Wet Area Junctions

Information: Missing and deteriorated sealant was observed at multiple wet area junctions within the bathroom, including the shower wall to floor junction, around the bath tub perimeter, and to the vanity splashback and adjacent junctions. Sealant in these locations is intended to provide a flexible, water-resistant barrier to prevent moisture from penetrating behind tiled finishes and fixtures. The absence or failure of sealant at these junctions compromises this barrier and allows water to migrate into concealed areas.

This condition increases the risk of moisture ingress, deterioration of waterproofing membranes, and concealed damage to wall and floor substrates over time, particularly in regularly used wet areas. It is recommended that a suitably qualified tiler or bathroom repair specialist reapply appropriate waterproof sealant to all affected junctions as a single scope of works. Rectification is recommended in the short term to reduce the risk of ongoing moisture-related issues and potential future damage.

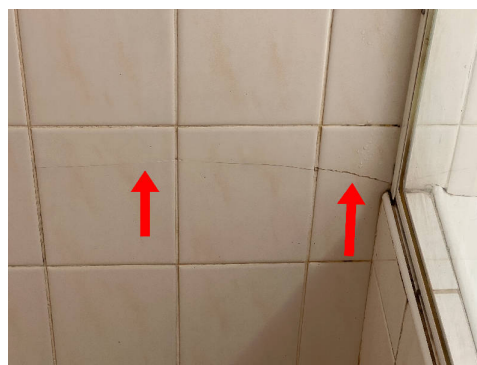
### Defects 3.04

Finding: Cracked Wall Tile Within Shower Area

Information: A cracked wall tile was observed within the shower area, located to the tiled wall adjacent to the shower screen. The cracking runs through the tile surface and compromises the integrity of the tile finish. Cracked tiles in wet areas can occur due to building movement, impact damage, or stress within the substrate behind the tile.

This condition may allow moisture to penetrate behind the tiled surface, increasing the risk of water ingress, deterioration of the waterproofing membrane, and concealed moisture damage over time. It is recommended that a suitably qualified tiler assess the affected area and replace the cracked tile in the short term to maintain the integrity of the shower waterproofing system and prevent further deterioration.

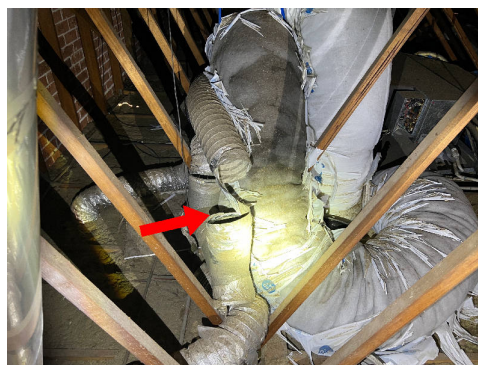
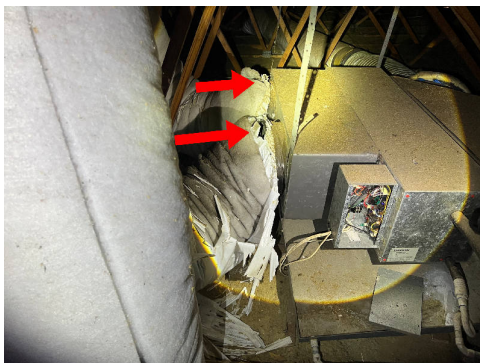
### Defects 3.05

Finding: Disconnected and Damaged Air Conditioning Ductwork Within Roof Space

Information: Disconnected ductwork and tearing to sections of the air conditioning ducts were observed within the roof space at the time of inspection. The affected ducts appear to be partially detached from the main system and show visible damage to the flexible duct material. This condition was identified adjacent to the air handling unit and associated duct runs.

Disconnected and damaged ductwork can significantly reduce the efficiency and effectiveness of the air conditioning system by allowing conditioned air to escape into the roof space rather than being delivered to internal rooms. This may result in poor system performance, increased running costs, and uneven temperature control throughout the dwelling. It is recommended that a suitably qualified air conditioning technician assess and repair or replace the affected ducting as required in the short term to restore proper system operation.

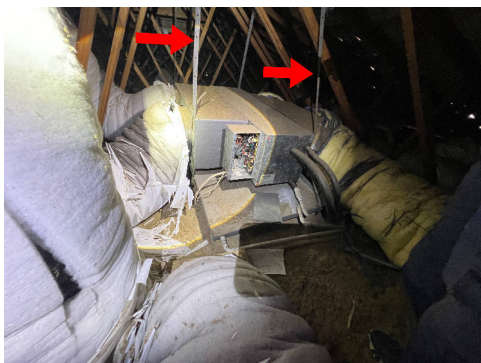
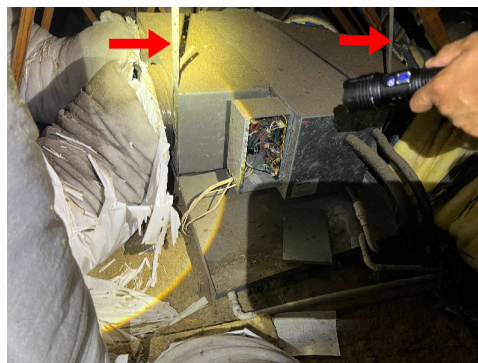
### Defects 3.06

Finding: Air Conditioning Unit Not Securely Fixed Within Roof Space

Information: The air conditioning indoor unit was observed to be inadequately secured within the roof space at the time of inspection. The unit exhibited noticeable movement and was able to swing when lightly contacted, indicating that the supporting fixings or hanging straps are insufficient or not properly secured.

An unsecured air conditioning unit may place strain on associated ductwork, refrigerant lines, and electrical connections, increasing the risk of damage, disconnection, or reduced system performance over time. It is recommended that a suitably qualified air conditioning technician assess the installation and securely fix the unit in accordance with manufacturer requirements. Rectification is recommended in the short term to prevent further movement and potential damage to the system components.

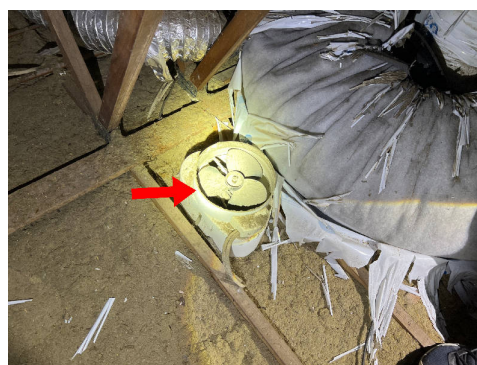
### Defects 3.07

Information: The bathroom exhaust fan was observed to discharge air directly into the roof void rather than being ducted to an external vent. The fan unit and associated ducting were located within the roof space, with no effective connection to an external outlet evident at the time of inspection.

Venting moist air into the roof space can lead to a build-up of condensation, which may contribute to moisture-related issues such as mould growth, deterioration of insulation, and potential damage to roof timbers over time. It is recommended that a suitably qualified contractor or electrician install appropriate ducting to vent the bathroom exhaust fan to the exterior of the building. Rectification is recommended in the short to medium term to reduce the risk of ongoing moisture-related issues within the roof space.

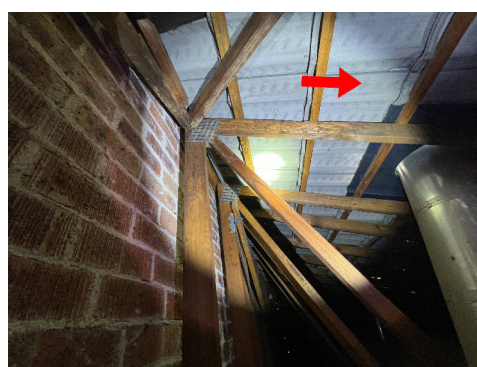
### Defects 3.08

**Information:** No sarking was observed beneath the roof covering within the roof space at the time of inspection. The underside of the roof tiles and roof battens were visible, with no reflective foil or breathable membrane installed. This condition appears consistent with the original method of construction for dwellings of this age and type.

While sarking is not always required in older homes, the absence of sarking can allow wind-driven rain, dust, and condensation to enter the roof space and may reduce thermal efficiency. It is recommended that this condition be noted for future reference, particularly if roof works or re-roofing are undertaken, at which time the installation of sarking could be considered to improve weather protection and energy performance.

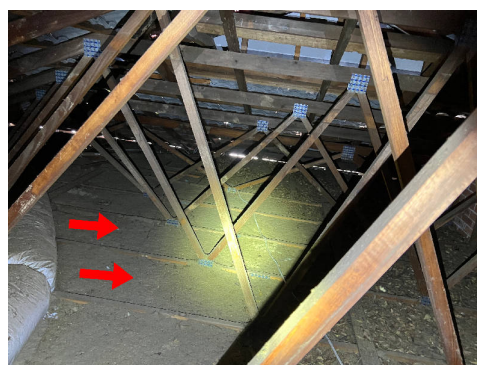
### Defects 3.09

**Building:** Main Building  
**Location:** Roof Void  
**Finding:** Inadequate Ceiling Insulation Within Roof Space

**Information:** Ceiling insulation within the roof space was observed to be limited and uneven in coverage at the time of inspection, with areas of the ceiling lining either insufficiently insulated or not insulated at all. This condition was evident across multiple sections of the roof space and appears consistent with older-style construction or insulation that has not been upgraded over time.

While this condition does not present a structural concern, inadequate insulation may reduce the thermal efficiency of the dwelling and contribute to increased heating and cooling costs. It is recommended that the insulation be upgraded or supplemented to improve energy efficiency and internal comfort. This item is considered a minor defect and is noted for client awareness and future improvement.

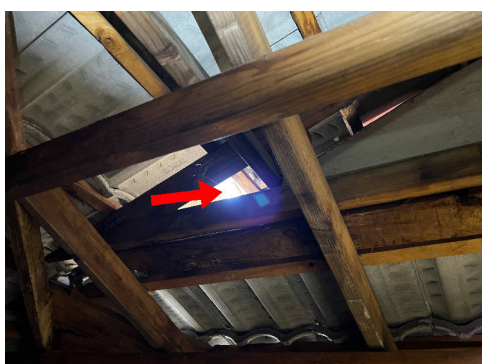
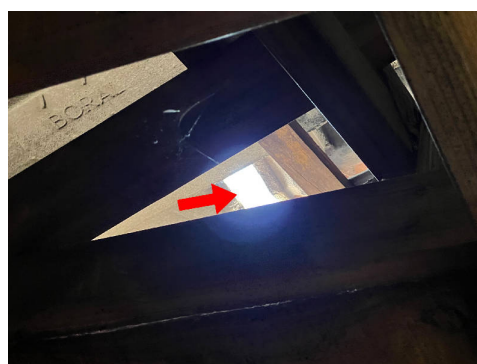
### Defects 3.10

Information: A visible gap was observed through the roof tile covering within the roof space, allowing daylight to be seen between tiles. This condition indicates that roof tiles are either displaced, inadequately overlapped, or missing in this area. The gap was evident from within the roof void during the inspection.

Gaps in roof tile coverage can allow wind-driven rain, dust, pests, and debris to enter the roof space and may increase the risk of moisture-related damage over time. It is recommended that a licensed roofing contractor assess the affected area and reinstate proper tile positioning or replace any damaged or missing tiles as required. Rectification is recommended in the short term to maintain the weatherproof integrity of the roof covering.

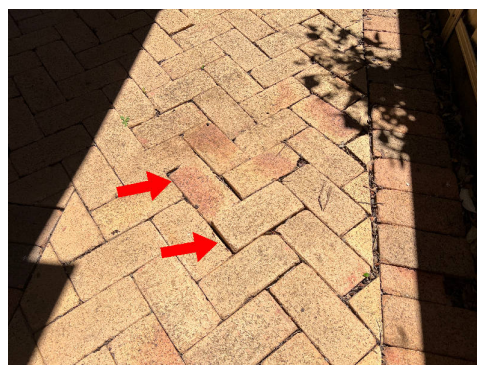
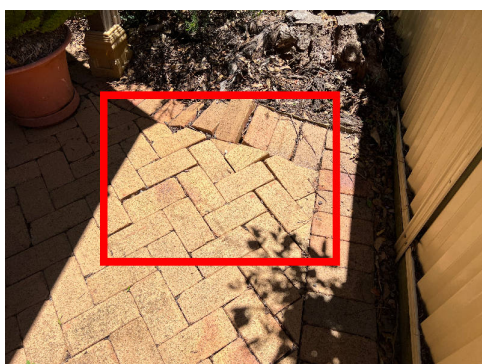
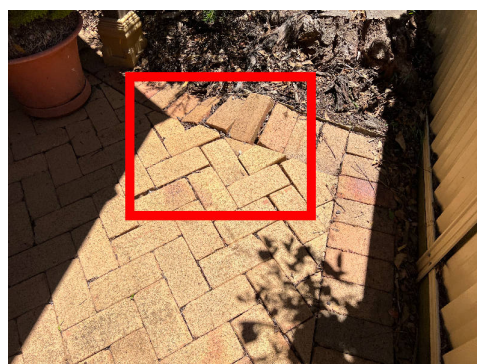
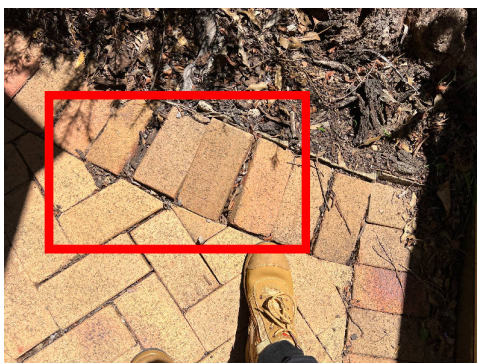
### Defects 3.11

Information: Several areas of the paved surface within the rear yard were observed to be uneven, with individual pavers having settled or become displaced over time. This condition was evident across multiple sections of the paved area, resulting in an inconsistent walking surface and visible gaps between some pavers.

Uneven pavers may present a minor trip hazard and can worsen over time due to ground movement, tree root activity, or inadequate base preparation. It is recommended that a suitably qualified landscaper or paving contractor re-level and re-bed the affected pavers to improve safety, functionality, and appearance. This item is considered a minor defect and is noted for maintenance and future rectification.

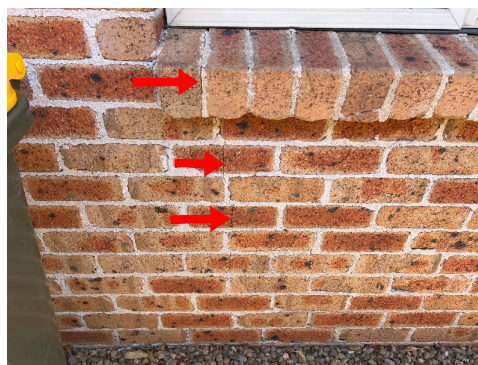
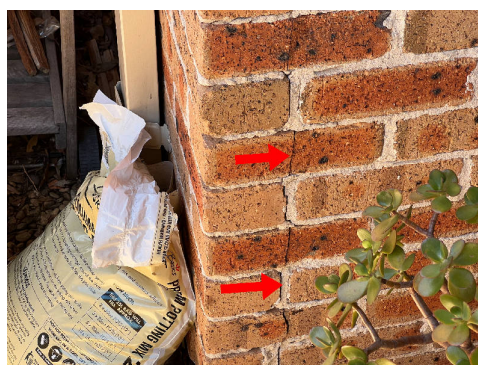
### Defects 3.12

Finding: Cracking to External Brickwork at Rear Corner and Side Elevation

Information: Cracking was observed to the external brickwork at the rear corner and along the side elevation of the dwelling at the time of inspection. The cracking appears predominantly vertical and extends through several courses of masonry, including areas beneath a window opening. The cracking was visible externally and appears consistent with movement-related stresses rather than isolated mortar shrinkage.

Cracking of this nature may be associated with footing movement, soil reactivity, thermal expansion, or long-term settlement. While no immediate signs of structural failure were evident at the time of inspection, the extent and location of the cracking warrant further assessment to determine the cause and whether repairs or monitoring are required. It is recommended that a suitably qualified builder or structural engineer inspect the affected areas and provide advice on appropriate rectification. This defect is considered moderate and should be addressed to prevent further deterioration.

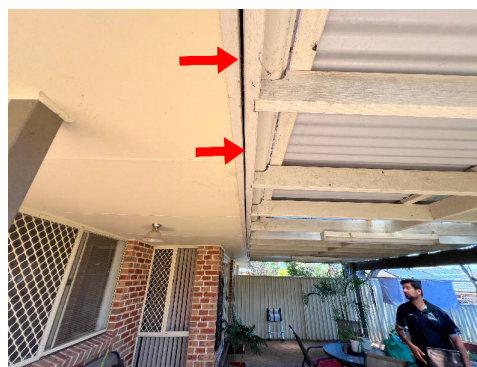
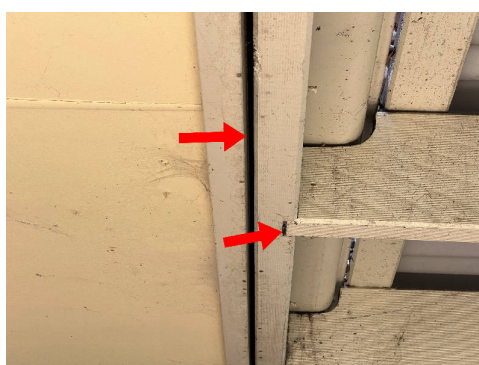
### Defects 3.13

Building: Main Building  
Location: Yard - Back  
Finding: Pergola Structure Not Adequately Secured

The pergola structure was observed to be inadequately secured at the time of inspection, with visible gaps and insufficient fixing between the pergola framing members and the adjacent structure. The connection appears loose, and movement was evident, indicating the pergola is not firmly anchored as intended.

An inadequately secured pergola may become unstable over time and could pose a safety risk, particularly during strong winds or adverse weather conditions. It is recommended that a suitably qualified carpenter or builder inspect the pergola and install appropriate fixings or bracing to ensure the structure is securely anchored and compliant with expected construction practices. This defect is considered moderate and should be rectified to reduce the risk of movement or damage.

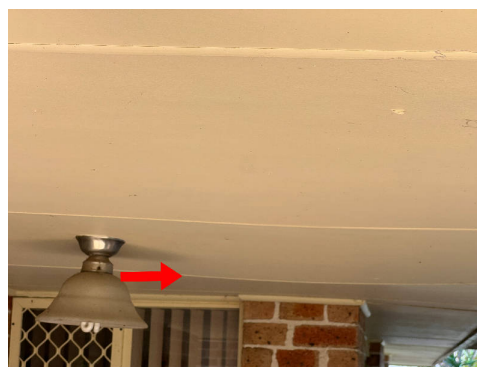
Information: The ceiling lining to the external covered area was observed to be sagging and uneven at the time of inspection. This condition indicates that the lining has lost rigidity and may no longer be adequately supported or fixed to the framing above. The issue was visually evident across the affected section of the ceiling.

Sagging ceiling linings can occur due to age-related deterioration, moisture exposure, or failure of fixings, and may worsen over time if not addressed. There is a risk that sections of the lining could further deform or detach. It is recommended that a suitably qualified carpenter or builder inspect the ceiling structure to determine the cause and carry out appropriate repairs or replacement as required. This defect is considered minor and should be rectified to prevent further deterioration and potential safety concerns.

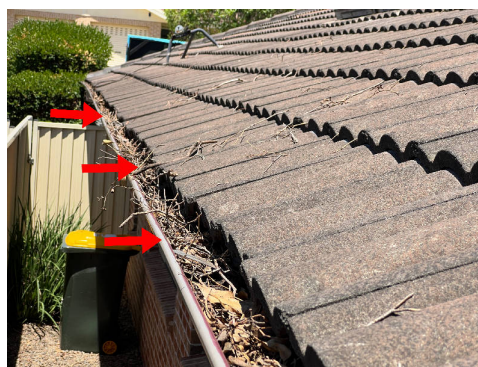
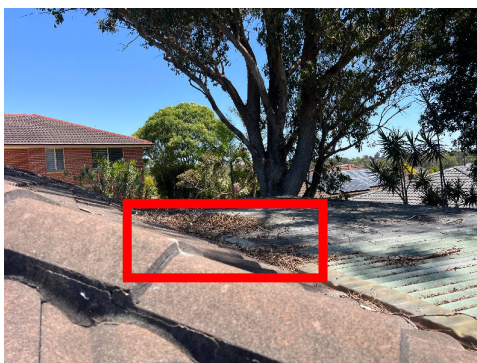
### Defects 3.15

The roof gutters were observed to be significantly blocked with accumulated leaves and organic debris along sections of the roof perimeter at the time of inspection. This condition restricts the effective flow of rainwater and prevents the guttering system from operating as intended.

Blocked gutters can lead to water overflow during rainfall, which may contribute to moisture penetration to eaves, fascia boards, external walls, and potentially internal areas over time. Ongoing blockage may also accelerate deterioration of gutter components. It is recommended that the gutters be cleaned and maintained by a suitably qualified contractor or competent person. Regular maintenance should be undertaken, particularly in areas surrounded by vegetation, to prevent recurrence. This item is considered a maintenance defect and should be addressed in the short term.

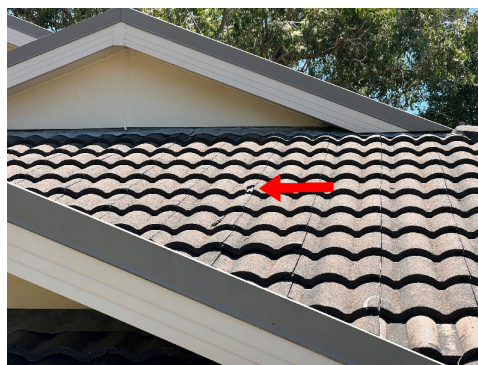
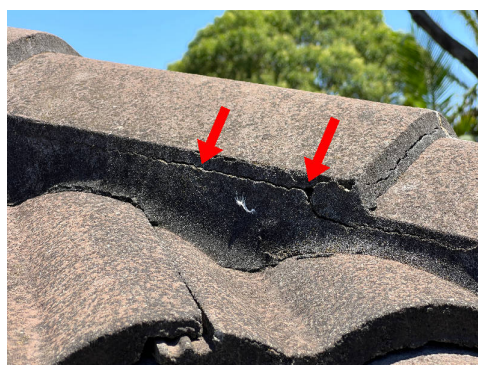
### Defects 3.16

Information: The exterior tiled roof covering was generally observed to be in fair condition for its apparent age; however, isolated deterioration was noted to the mortar bedding and pointing, particularly within valley areas. Minor cracking and areas of loose or degraded mortar were evident at the time of inspection, indicating that previous pointing materials have begun to break down due to age and weather exposure.

Deteriorated or cracked mortar within roof valleys can compromise the weatherproofing performance of the roof covering and may allow water ingress during heavy rainfall. If left unaddressed, this condition may lead to secondary defects such as minor roof leaks and moisture exposure to internal roofing components. Re-pointing and re-sealing of affected areas may be considered as an interim maintenance measure to assist in preserving and extending the service life of the existing roof tiles. It is recommended that a suitably qualified roofing contractor assess the roof and provide advice regarding appropriate remedial works required in the short to medium term.

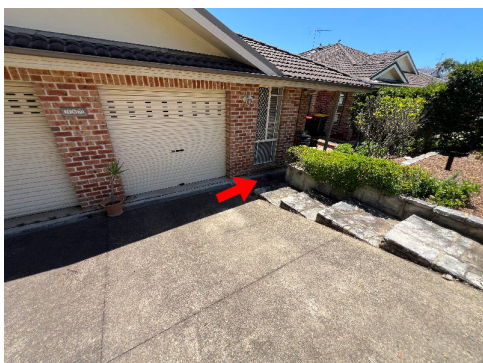
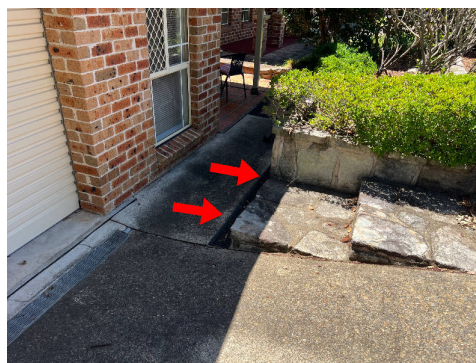
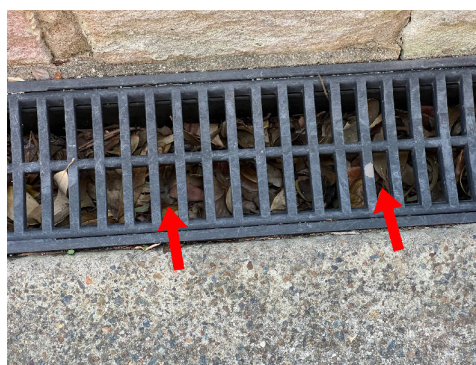
### Defects 3.17

Information: The surface drainage system adjacent to the dwelling was observed to be impeded at the time of inspection due to drainage grates being blocked with accumulated leaf debris. This was noted along the paved pathway adjoining the external wall, where water runoff is directed toward the drains.

Blocked drainage points may prevent effective removal of surface water during rainfall, which can result in water ponding against paving and external walls. Prolonged moisture exposure in these areas may contribute to deterioration of finishes and increase the risk of moisture ingress over time. It is recommended that the drains be cleared of debris and maintained on a regular basis to ensure effective surface water discharge. This item is considered a maintenance issue and should be addressed in the short term.

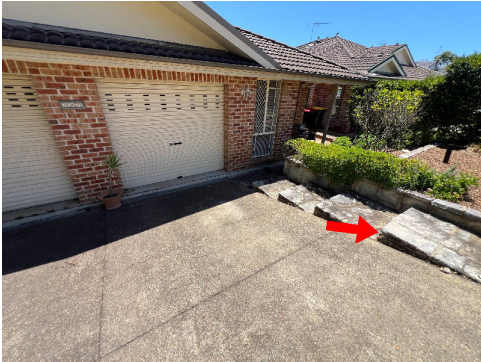
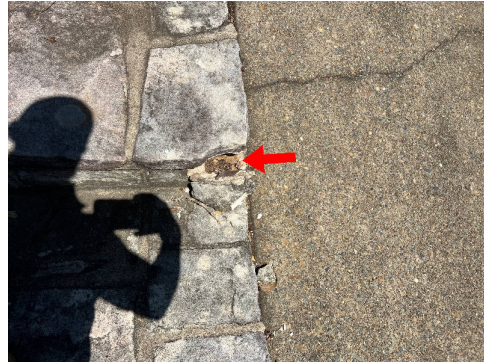
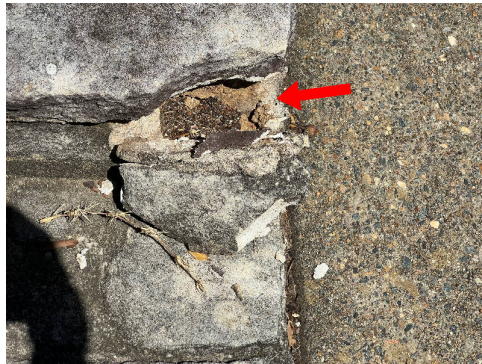
### Defects 3.18

Finding: Damaged Stone Step

Information: The corner stone to one of the external steps was observed to be cracked and partially broken. The defect is located to the edge of the stone step adjacent to the paved walkway in the front yard area. This damage presents a potential trip hazard to occupants and visitors, particularly where the broken edge is uneven and not readily visible when approaching the step.

If left unattended, the damaged stone is likely to continue deteriorating due to foot traffic and weather exposure, increasing the risk of injury and further material breakdown. It is recommended that a suitably qualified landscaper or concreter repair or replace the damaged stone section to reinstate a safe and even walking surface. Remedial works should be carried out in the short term.

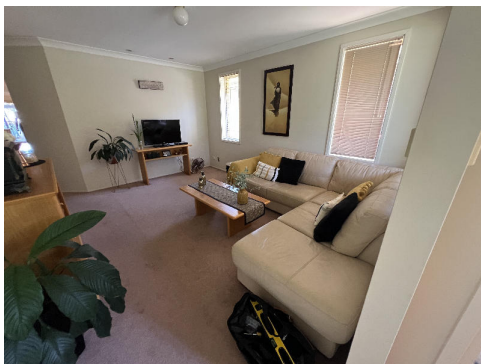
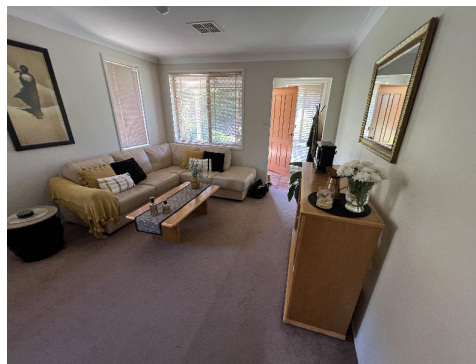
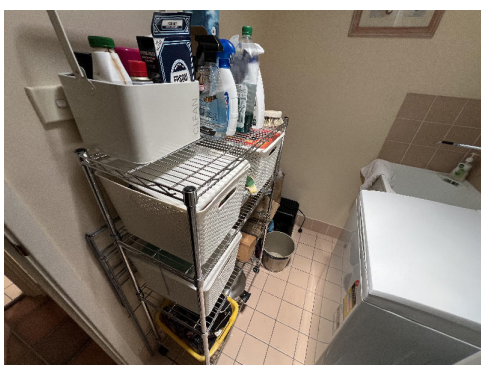
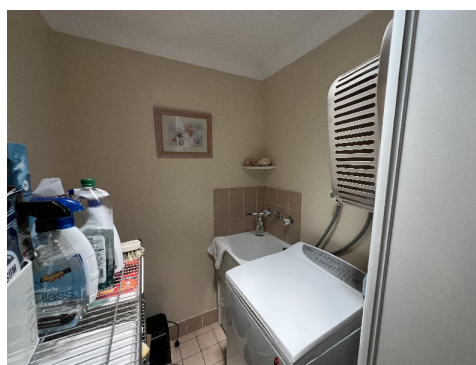
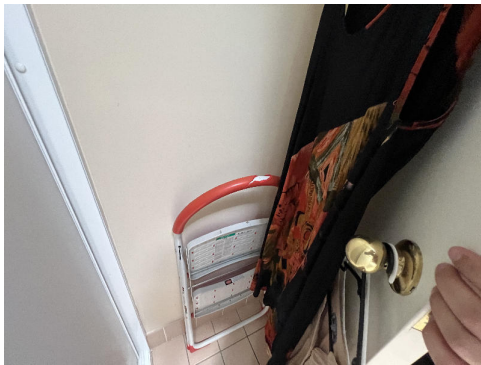
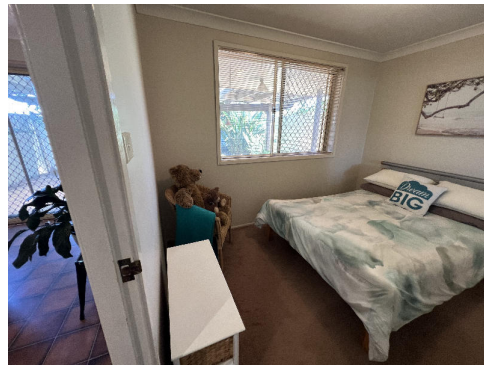
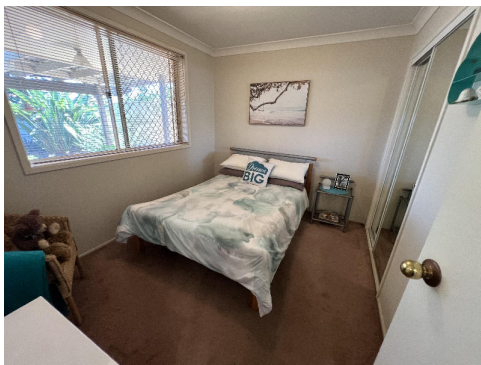
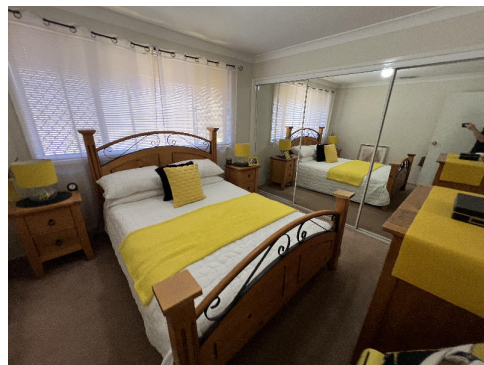
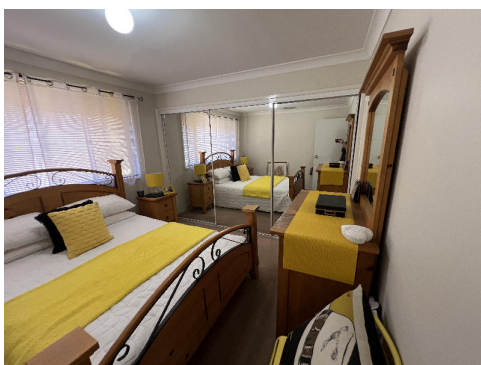
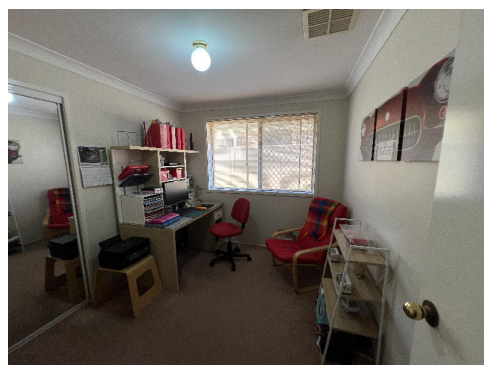
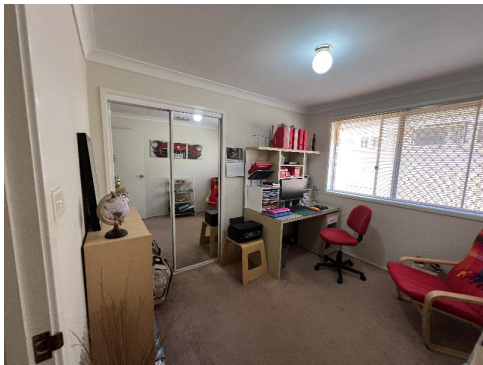
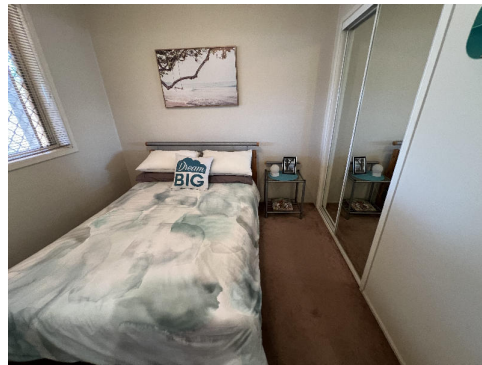
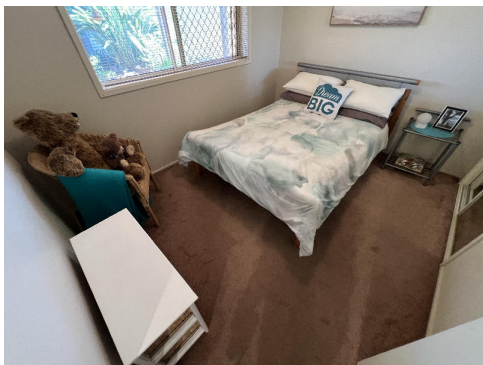
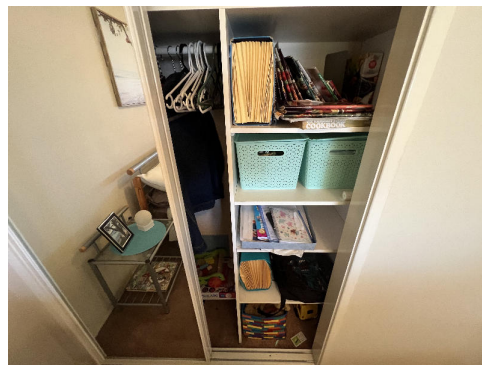
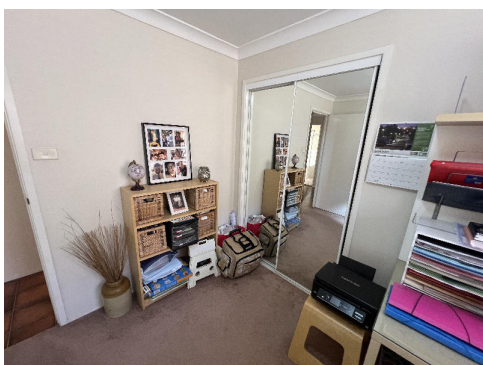
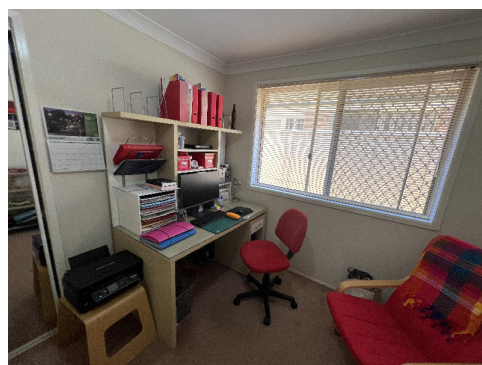
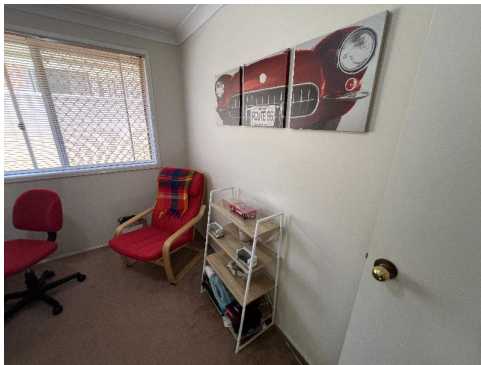
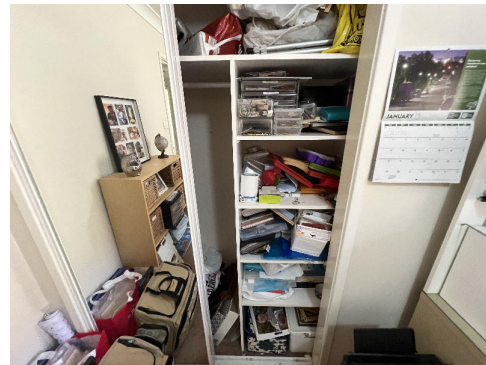
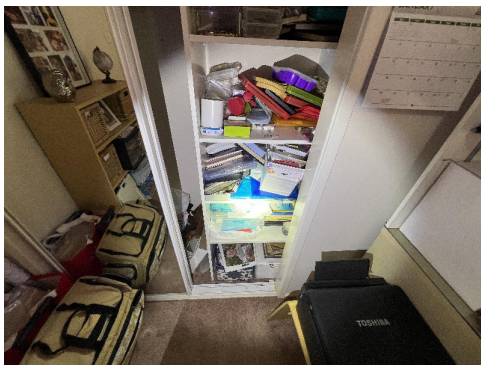
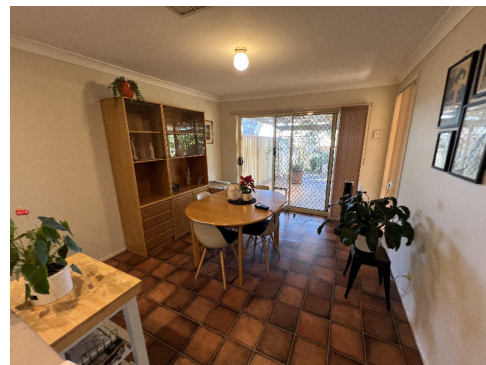
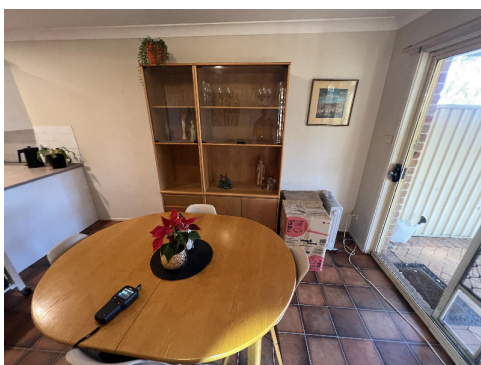
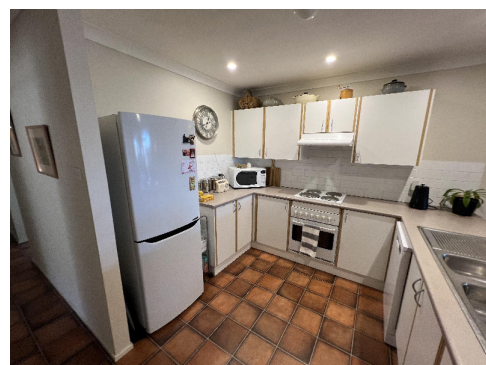
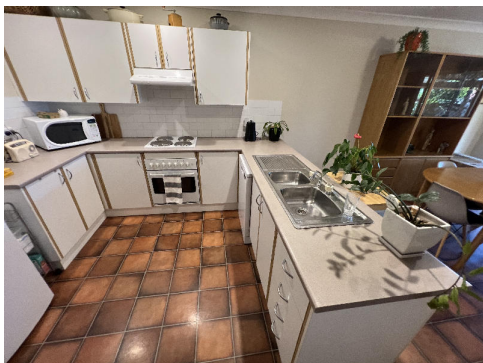
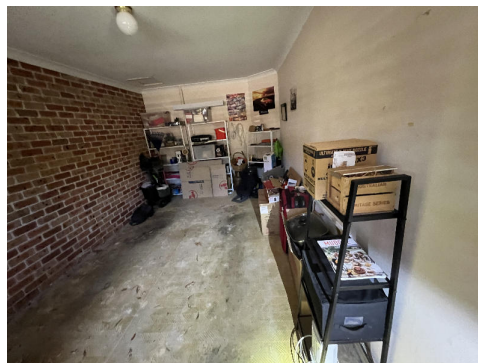
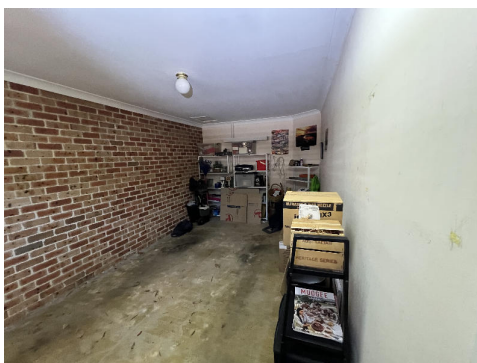
Finding: Additional Photos - Obstructions and Limitations

Information: These photographs are an indication of the obstructions and limitations which impeded full inspection of the property at the time of inspection. These obstructions can hide an array of defects and should be removed to allow full inspection to be carried out. A re-inspection is recommended once the areas are made accessible.

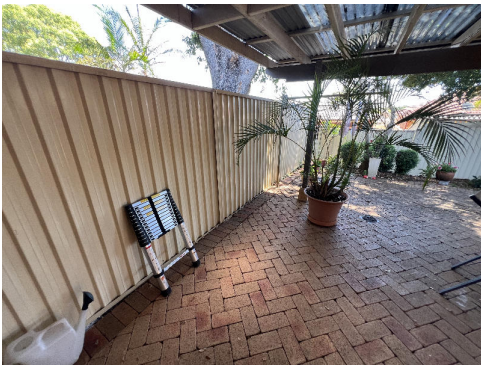
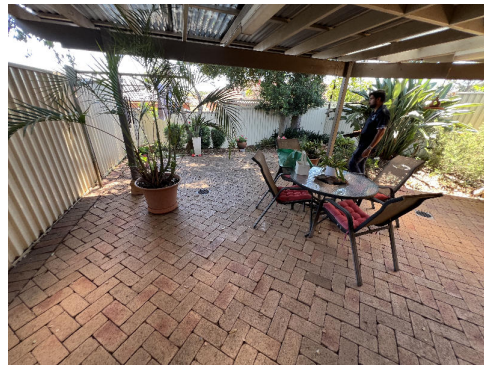
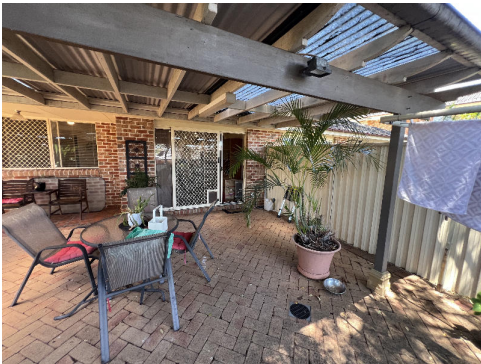
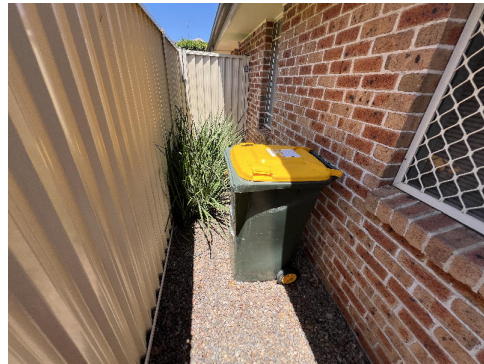
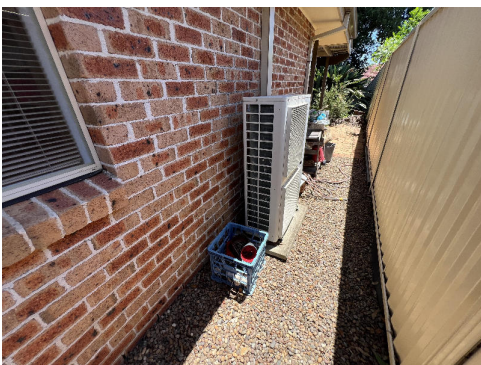
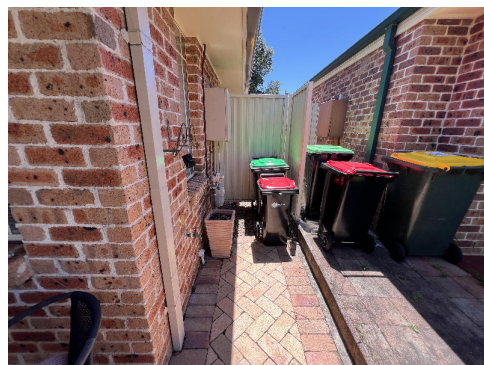
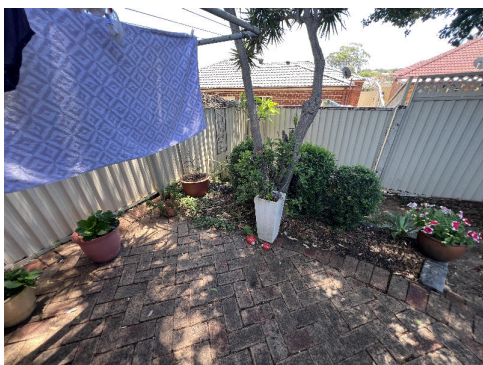
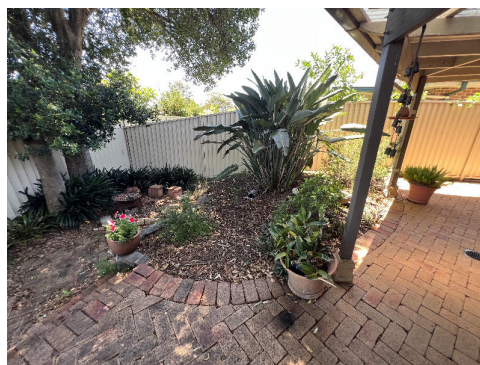
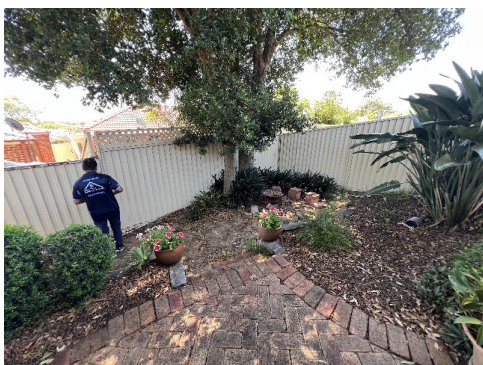
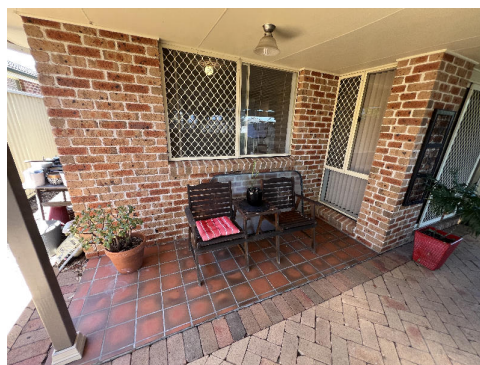
Finding: Additional Photos - Obstructions and Limitations

Information: These photographs are an indication of the obstructions and limitations which impeded full inspection of the property at the time of inspection. These obstructions can hide an array of defects and should be removed to allow full inspection to be carried out. A re-inspection is recommended once the areas are made accessible.

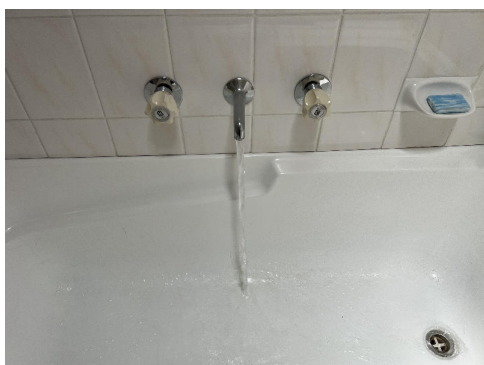
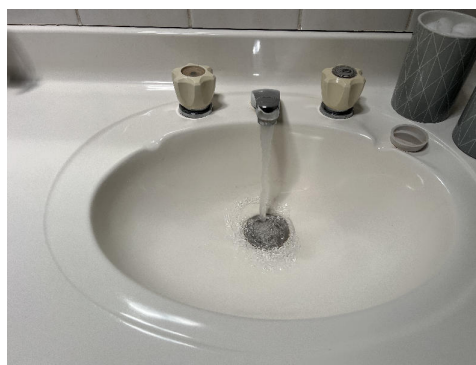
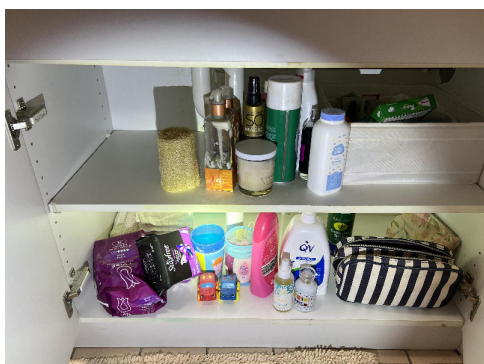
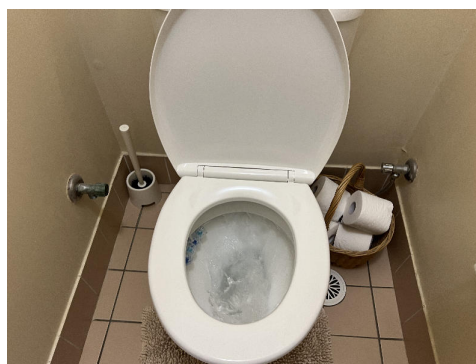
Information: At the time of inspection, all readily accessible plumbing fixtures, including basin mixers, shower mixers, toilets, and visible waste traps, were operated and tested for functionality. All fixtures tested were observed to be functioning as intended, with no visible leaks, blockages, or abnormal operation noted at the time of inspection.

Moisture testing was also carried out to shower walls and adjacent areas using a non-invasive moisture meter. It should be noted that testing is limited to the time of inspection and accessible areas only, and concealed defects may exist that were not evident at the time of inspection.

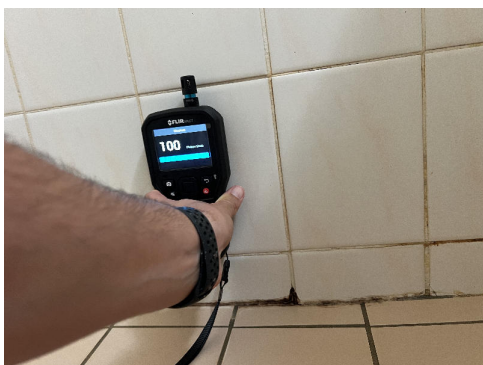
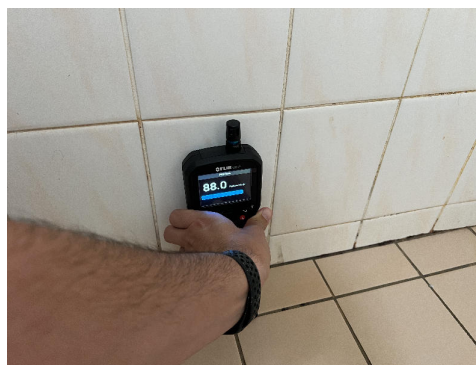
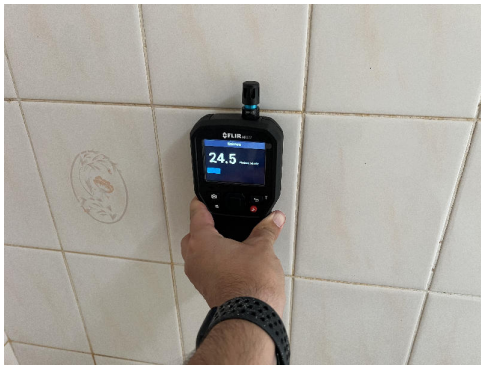
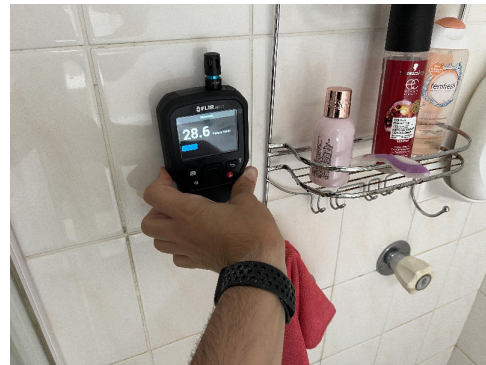
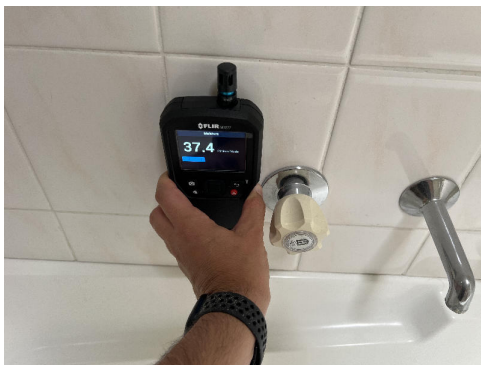
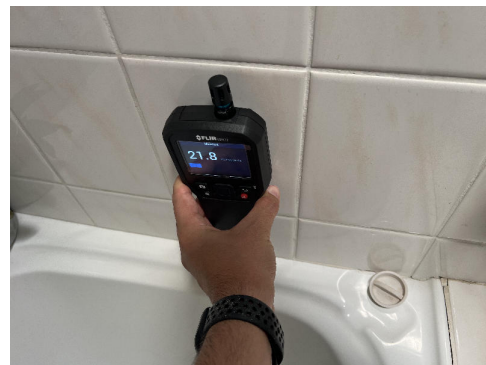
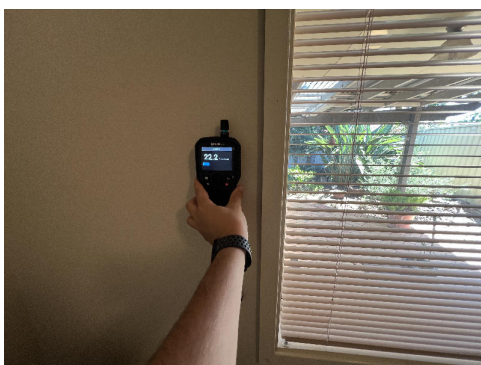
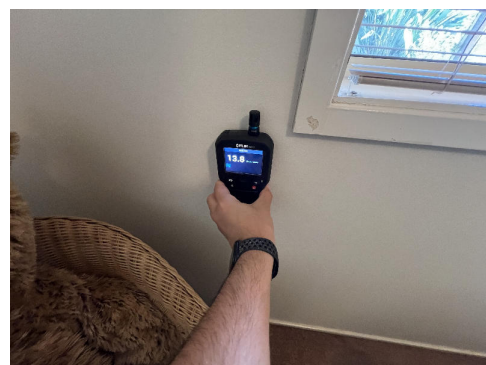
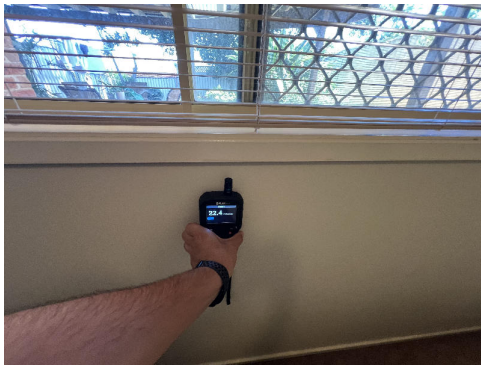
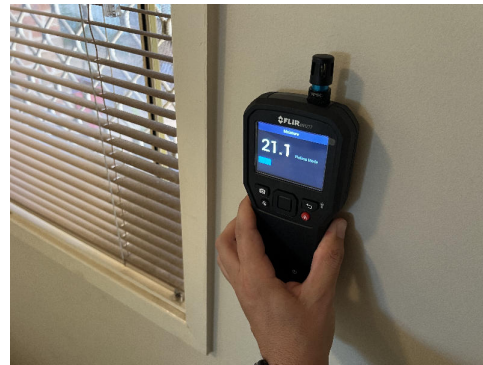
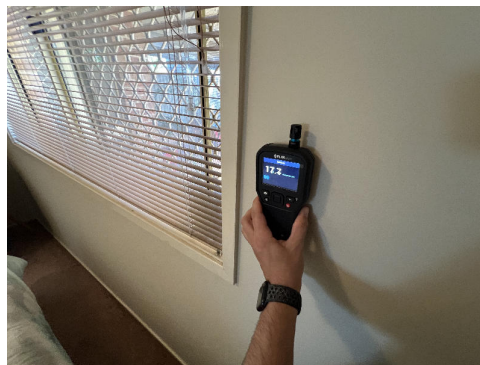
Finding: Moisture Meter Readings - For Information Only

Information: Moisture testing was undertaken to selected accessible internal surfaces using a noninvasive moisture meter at the time of inspection. Readings obtained provide an indicative assessment only and are intended as a guide to assist in identifying areas that may warrant further investigation.

No invasive testing was carried out, and moisture readings can be influenced by a range of factors including material type, surface finishes, environmental conditions, and recent use of wet areas. As such, the results are provided for information purposes only and do not constitute a definitive assessment of concealed moisture conditions. Concealed defects may exist that were not evident at the time of inspection.

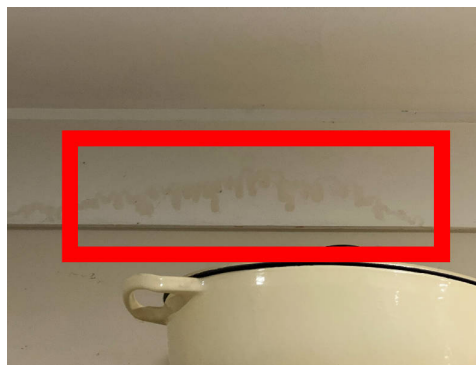
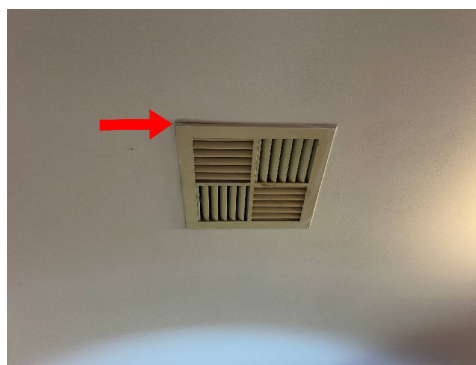
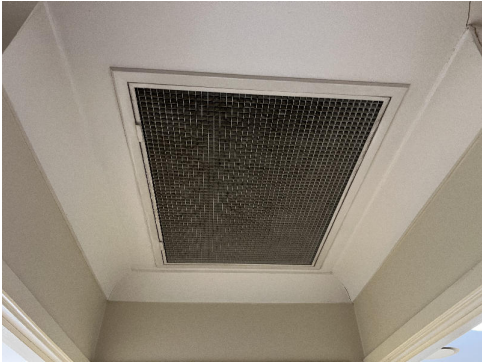
Building: Main Building  
Location: All Internal Areas  
Finding: General Maintenance Items Observed

Several general maintenance-related items were observed throughout the property at the time of inspection. These included staining to the ceiling above the kitchen area consistent with a build-up of cooking vapours, the absence of a door stop to one of the bedroom doors, and air conditioning components requiring attention, including a loose ceiling vent and a dirty return air grille and visible ducting. These conditions are commonly associated with normal wear, use, and routine maintenance items rather than structural defects.

While no immediate safety or structural concerns were identified in relation to these items, addressing them would improve the overall presentation, functionality, and longevity of the building components. It is recommended that these matters be attended to as part of routine maintenance, including improving kitchen ventilation where possible, installing an appropriate door stop, securing the air conditioning vent, and cleaning or servicing the air conditioning system as required.
