Building and Timber Pest Inspection Report

Inspection Date: Wed, 18 Feb 2026

Property Address: 7/3 Prince

St,OATLANDS,NSW,2117,Australia

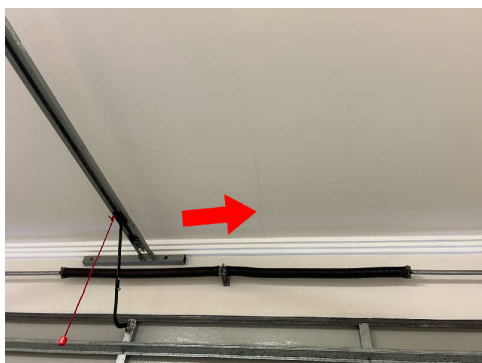
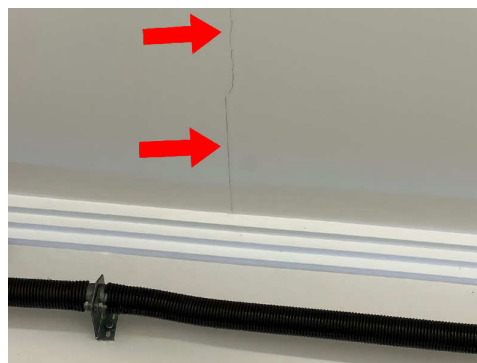
Information: Minor cracking was observed to the garage ceiling lining and to internal wall surfaces in multiple locations. The cracks appear fine and consistent with typical shrinkage or minor movement; however, they indicate some degree of building movement or material settlement.

Although the cracking currently appears cosmetic in nature, such movement-related cracking can worsen over time if underlying causes persist. No significant displacement or structural distortion was noted at the time of inspection. Monitoring is recommended, and if cracking increases in width, length, or frequency, further assessment should be undertaken. Repairs can be carried out by a qualified plasterer as required.

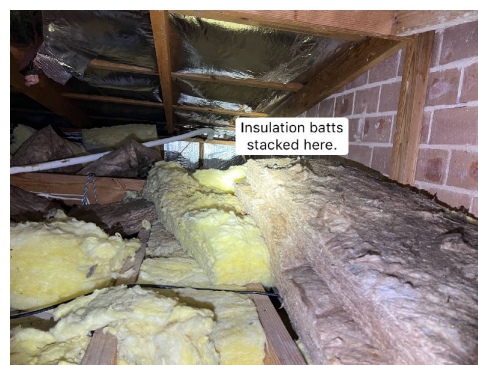
Finding 3.04

Finding: Displaced / Missing Roof Insulation

Information: Sections of ceiling insulation within the roof space were observed to be displaced and not evenly covering the ceiling area. It appears insulation batts may have been moved during previous works and not reinstated to their original position.

Gaps or displaced insulation reduce the thermal efficiency of the dwelling and may contribute to heat gain or loss. While this does not represent a structural issue, reinstatement is recommended to maintain energy efficiency and comfort. A suitable tradesperson or insulation contractor should reposition and ensure full coverage to the affected areas.

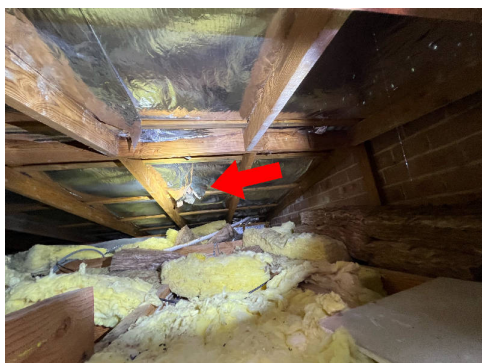
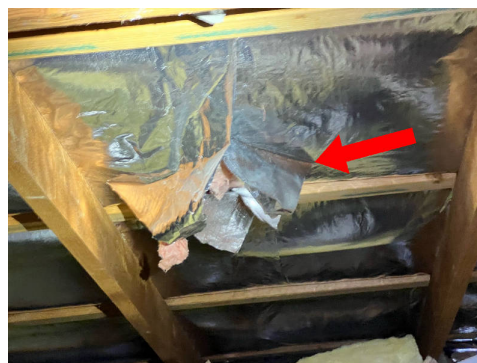
Finding 3.05

Finding: Damaged Roof Sarking – Roof Void

Information: Sections of the reflective roof sarking were observed to be torn and displaced within the roof void space. The sarking is intended to act as a secondary moisture barrier and assist with thermal performance beneath the roof covering. Damage to this material may reduce its effectiveness in directing incidental moisture towards the gutter line and may also impact insulation performance.

The damage appears localised and may have occurred during previous trade access within the roof space. While no active moisture ingress was noted at the time of inspection, compromised sarking can allow condensation or minor water entry to affect ceiling linings or insulation over time. It is recommended that a qualified roofing contractor assess and repair or reinstate the affected sections as required.

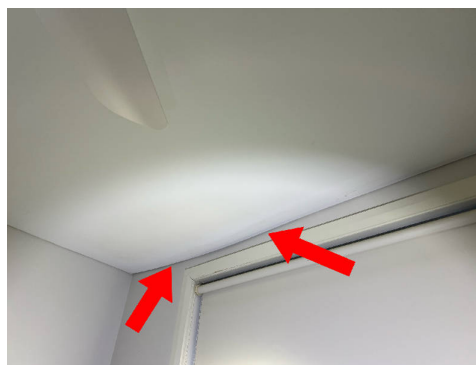
Finding 3.06

Information: Sagging to the ceiling lining was observed in Bedroom 2, with a noticeable dip to the plasterboard sheeting. The owner advised that a roof leak had previously occurred in this area and has reportedly been repaired. Sagging ceilings typically occur where plasterboard has been affected by moisture, which can cause loss of structural integrity, softening of the board and potential loosening of fixings over time.

Although the leak is reported to have been repaired, the ceiling lining remains visibly deformed and may deteriorate further if not properly rectified. Moisture-affected plasterboard can fail without warning in some circumstances. It is recommended that a licensed plasterer assess the ceiling and carry out repairs or replacement as required. Confirmation that the source of the leak has been permanently rectified should also be obtained.

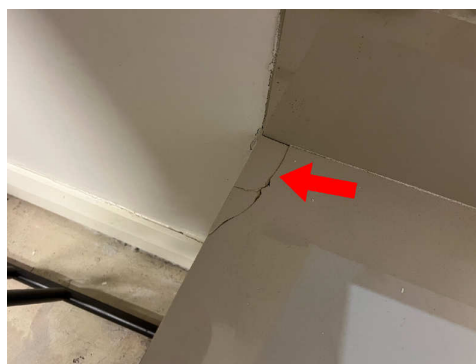
Finding 3.07

Finding: Cracked Tile to Garage Step

Information: A floor tile located to the step within the garage is observed to be cracked through its surface. The cracking appears localised to a single tile at the step junction and is visible along the tile face extending toward the corner. Cracked tiles can worsen over time due to foot traffic and minor movement, potentially leading to loose sections or sharp edges, and may allow moisture penetration into the substrate if left unaddressed.

It is recommended that a licensed tiler assess the affected tile and replace as necessary to prevent further deterioration. Repairs should be carried out in the short term to maintain serviceability and reduce the likelihood of further damage.

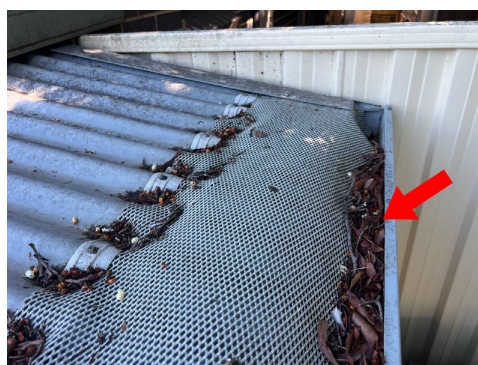
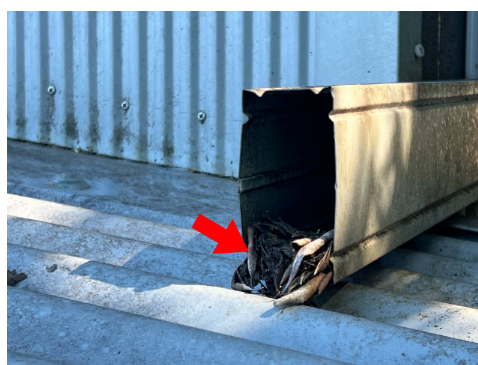
Finding 3.08

Information: Leaves and organic debris were observed accumulating along the gutter guard and at the downpipe entry points to the roof drainage system. This was noted to the external roof line as shown in the attached images. The buildup of debris can restrict the free flow of rainwater, potentially leading to water ponding, overflow into the roof cavity, and increased moisture exposure to fascia and roofing components if not maintained.

It is recommended that the gutters, gutter guard and downpipe inlets be cleaned and cleared by a licensed roof plumber or suitable contractor, and that a regular maintenance schedule be implemented to reduce the likelihood of future blockages. Maintenance should be carried out in the short term.

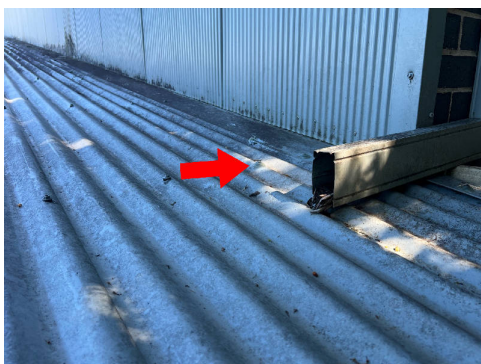
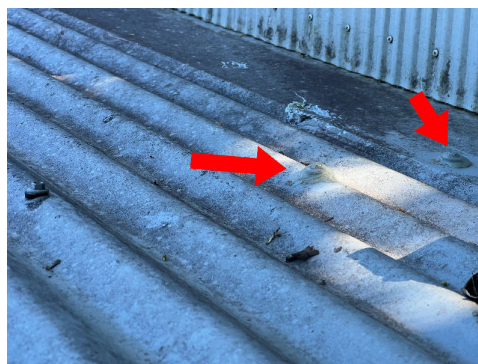
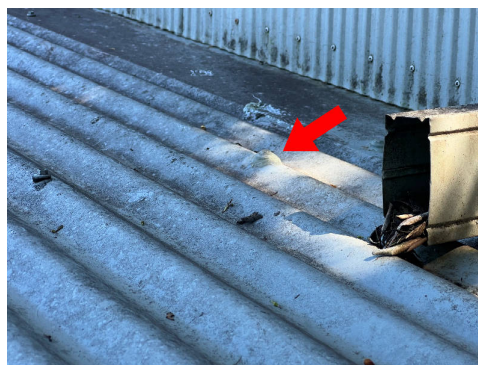
Finding 3.09

Finding: Temporary Sealant Repairs to Roof Fixings

Information: Sealant has been applied over multiple roof screw fixings to the metal roof sheeting, observed externally near the wall junction and beneath the window area. This appears to have been installed as a repair following a reported roof leak. While sealant can provide a short-term reduction in water ingress, it is generally considered a temporary measure and may deteriorate over time due to weather exposure, movement of the roof sheeting, and thermal expansion and contraction.

If the underlying cause of the leak (such as failed washers, loose fixings, or flashing deficiencies) has not been permanently rectified, water penetration may reoccur. A licensed roofing contractor should assess the affected area to confirm that the repair is adequate and durable, and carry out more permanent rectification works if required. This is considered a minor defect, however monitoring is recommended, particularly during heavy rainfall.

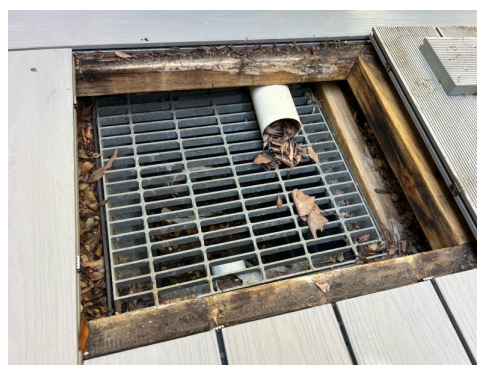
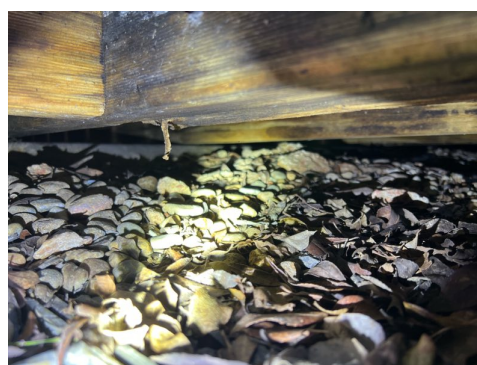
The subfloor area beneath the rear deck was observed to have restricted ventilation, with limited clearance between the ground surface and structural timbers. Accumulation of leaf litter and organic debris was noted on the ground surface, and sections of the supporting timber framing exhibited moisture staining. The limited air movement and build-up of organic material create a damp micro-environment beneath the deck structure.

Inadequate ventilation and the presence of organic debris are conducive to elevated moisture levels, which may increase the risk of timber deterioration, fungal decay and potential termite activity over time. While no active structural failure was observed at the time of inspection, the current conditions are considered unfavourable for long-term durability of the timber elements.

It is recommended that the debris be removed and that subfloor ventilation be improved where practicable to promote adequate airflow. Consideration should be given to consultation with a licensed builder or carpenter to assess options for increasing ventilation openings or modifying the deck configuration if required.

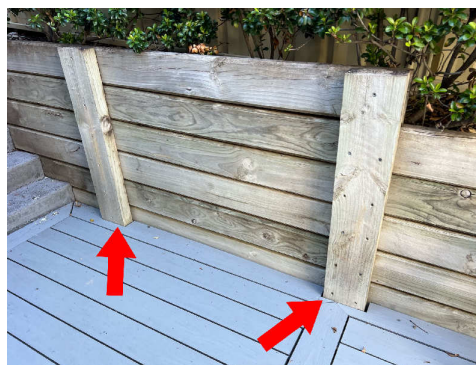
Finding 6.03

Information: Timber components of the rear retaining wall and garden bed were observed to be in direct contact with soil and garden materials. This was noted along the boundary side of the rear deck area, where treated timber sleepers and posts are retaining soil and supporting planted hedging. Timber elements in constant ground contact are exposed to ongoing moisture and may be susceptible to premature deterioration over time.

Direct soil contact can contribute to timber decay and may create conditions conducive to termite activity, particularly where moisture is retained against structural elements. Although no active timber pest attack was identified at the time of inspection, the current configuration increases long-term risk. It is recommended that a suitably qualified landscaper or builder assess the installation and implement appropriate separation or protective measures. Rectification should be carried out in the short to medium term to reduce the risk of deterioration.

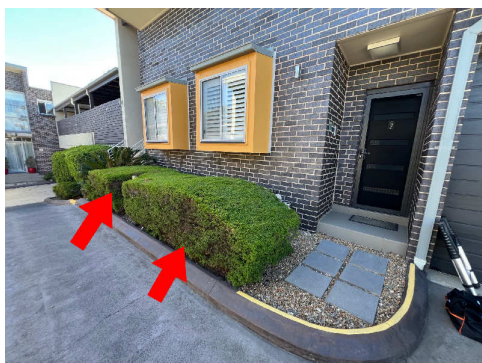
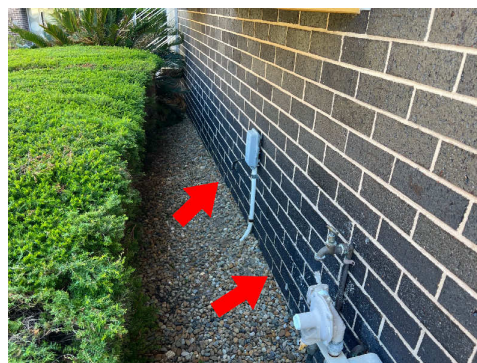
Finding 6.04

Information: A garden bed containing soil, decorative pebbles and dense vegetation is installed directly against the external brickwork to the front elevation of the dwelling. The landscaping appears to be built up against the base of the wall and in close proximity to the slab edge and weep holes. Garden beds in direct contact with external walls can retain moisture, restrict ventilation and potentially bridge damp-proof courses or weep holes, increasing the risk of rising damp, moisture ingress and concealed termite activity.

This condition was observed to the front of the property along the external wall. While no active damage was noted at the time of inspection, the current arrangement presents a conducive environment for moisture-related issues and timber pest activity. It is recommended that a licensed landscaper or builder assess and modify the garden bed to ensure appropriate clearance is maintained between soil levels and the brickwork, including keeping weep holes clear and visible. Rectification should be undertaken in the short to medium term as a preventative measure.

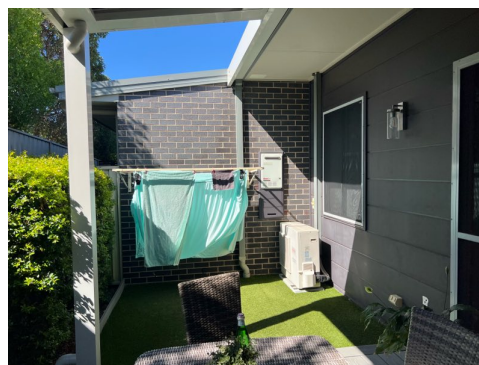
Building: Main Building
Location: Rear Elevation
Finding: Air Conditioning Condensate Discharge

Information: The external air conditioning condenser unit is installed to the rear of the dwelling. At the time of inspection, the condensate discharge point was not clearly visible and it could not be confirmed whether the unit drains to an approved stormwater connection or discharges directly onto the surrounding surface. Where condensate is not properly connected to a suitable drainage point, ongoing discharge can contribute to excess moisture accumulation, staining, deterioration of adjacent materials and potential slip hazards.

This condition was observed to the rear external area adjacent to the outdoor living space. Although no active moisture damage was noted at the time of inspection, the drainage arrangement could not be verified. It is recommended that a licensed plumber or suitably qualified air conditioning technician confirm that the condensate line is connected to an appropriate drainage point and modify if required. This should be addressed in the short term as a preventative measure.

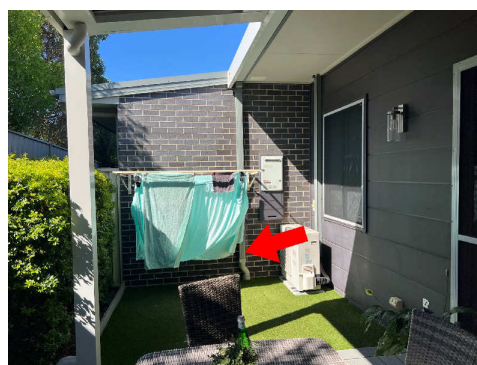
Finding 6.07

Building: Main Building
Location: Rear Elevation
Finding: Bridging to External Walls and Service Penetrations

At the external wall adjacent to the rear patio and stair area, service pipes and conduits have been installed in direct contact with the brickwork and extend from ground level upward, creating potential bridging points over the slab edge. These penetrations and fittings may allow concealed termite entry pathways by bypassing the visible inspection zone. Termite management systems rely on maintaining a clear and unobstructed inspection gap at the slab perimeter; however, the current arrangement reduces visibility and may conceal termite activity.

This condition was noted to the side wall near the hose connection and service meter location. While no active termite activity was observed at the time of inspection, the configuration presents conducive conditions for concealed entry and future infestation. It is recommended that a licensed pest control specialist assess the area and advise on appropriate rectification measures to reinstate a compliant and visible inspection zone. Any necessary modifications should be carried out in conjunction with a licensed plumber if relocation or adjustment of services is required. Rectification should be undertaken in the short term to reduce risk.

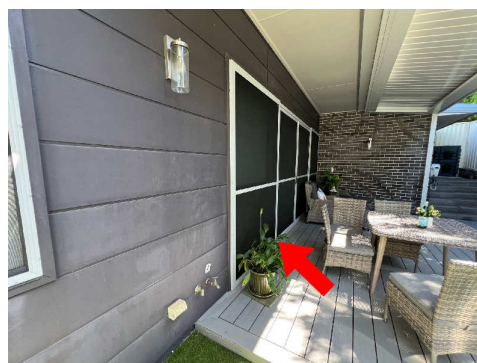
Finding 6.08

Building:	Main Building
Location:	Rear Elevation
Finding:	Bridging and Reduced Slab Edge Clearance

At the rear patio area, the external decking and artificial turf have been installed at a height that appears close to the internal finished floor level and slab edge. This configuration reduces the visible slab inspection zone and may constitute bridging over the damp-proof course/termite barrier line. Adequate clearance between external finished ground levels and the internal floor level is required to allow visual inspection for termite activity and to reduce the risk of moisture ingress.

The condition was observed along the rear elevation adjacent to the sliding doors and wall cladding. While no active moisture penetration or termite activity was identified at the time of inspection, the reduced clearance presents a potential risk by limiting inspection visibility and increasing the likelihood of concealed termite entry or moisture-related deterioration over time.

It is recommended that the external surface levels be reviewed and adjusted as necessary to reinstate appropriate slab edge exposure in accordance with current standards. A licensed builder and/or pest control specialist should be consulted to advise on suitable rectification. Works should be undertaken in the short to medium term to minimise ongoing risk.

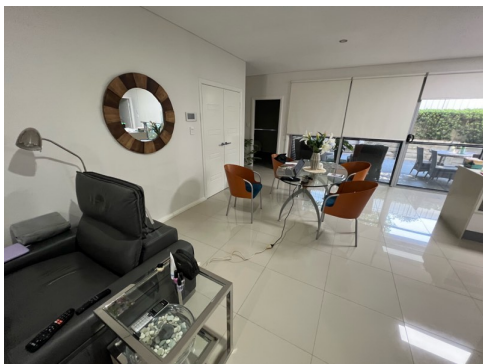
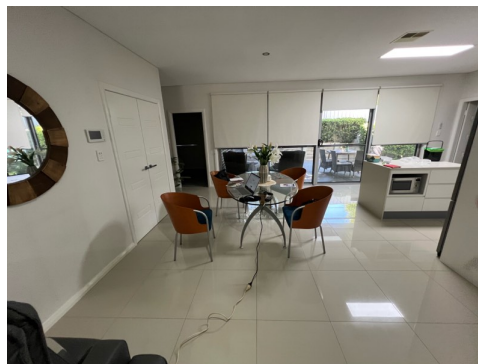
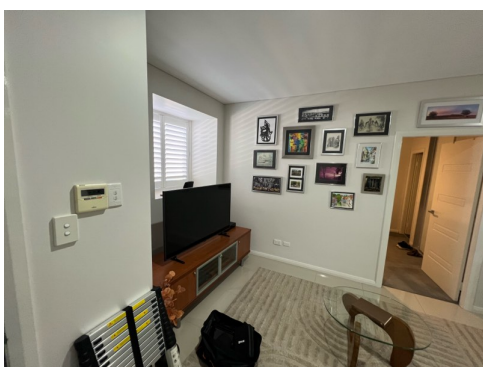
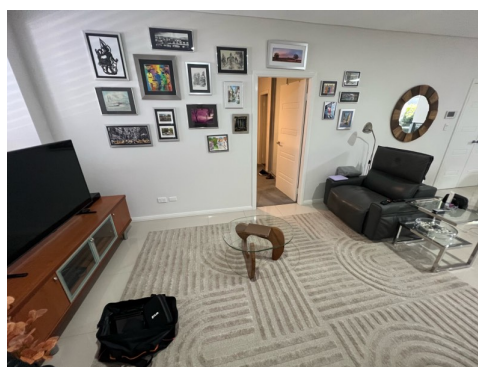
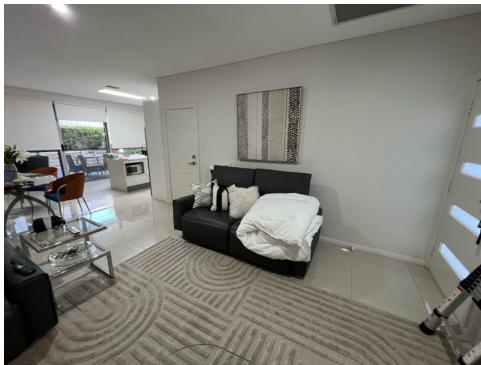
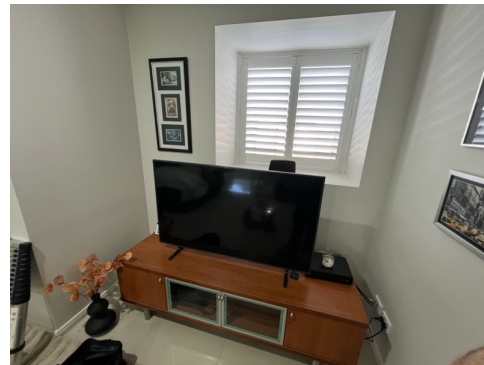
Finding: Additional Photos - Obstructions and Limitations

Information: These photographs are an indication of the obstructions and limitations which impeded full inspection of the property at the time of inspection. These obstructions can hide an array of defects and should be removed to allow full inspection to be carried out. A re-inspection is recommended once the areas are made accessible.

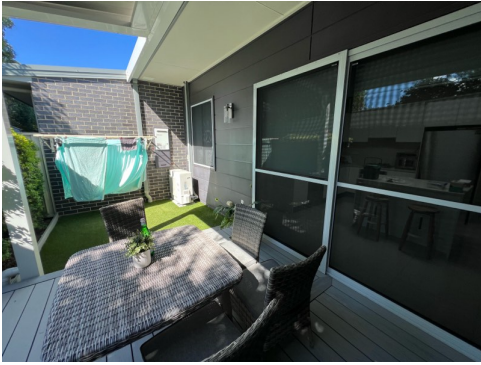
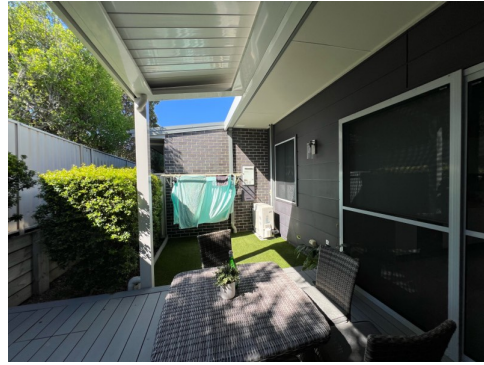
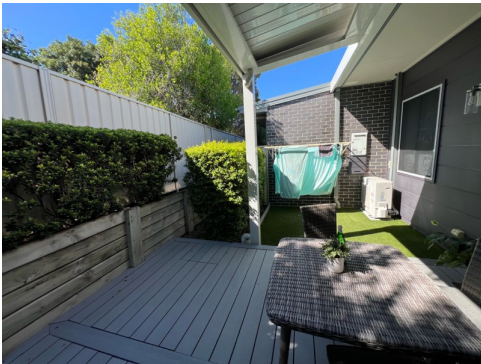
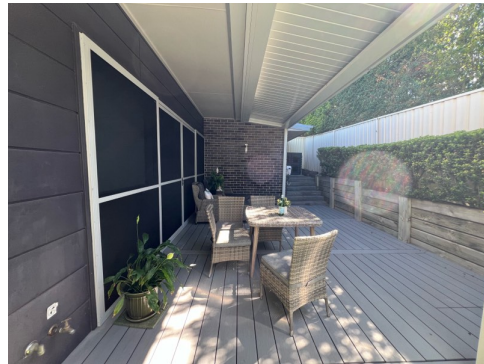
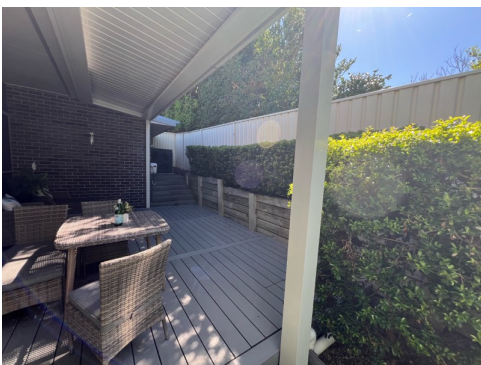
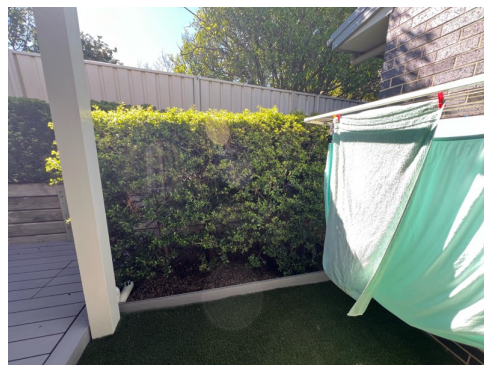
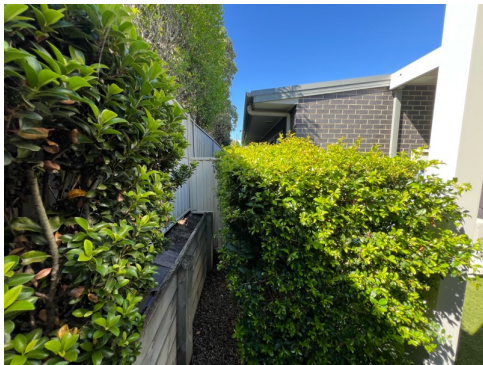
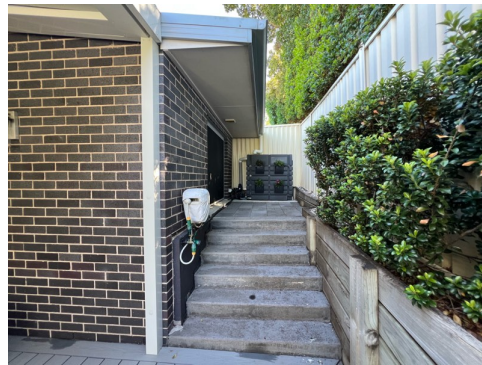
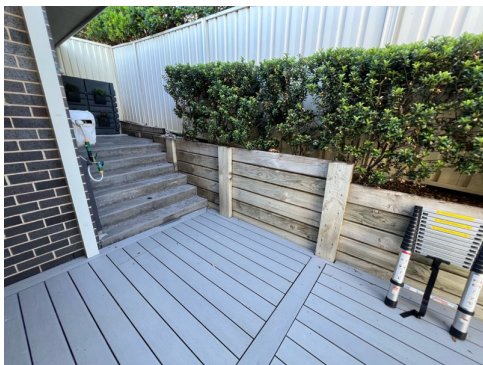
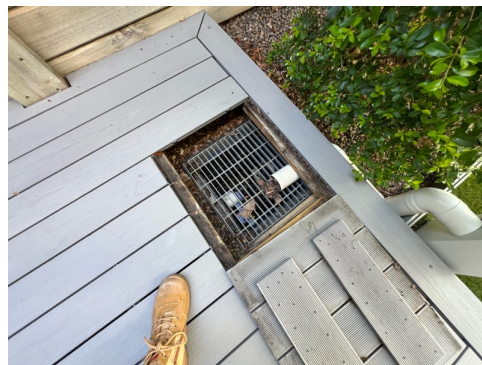
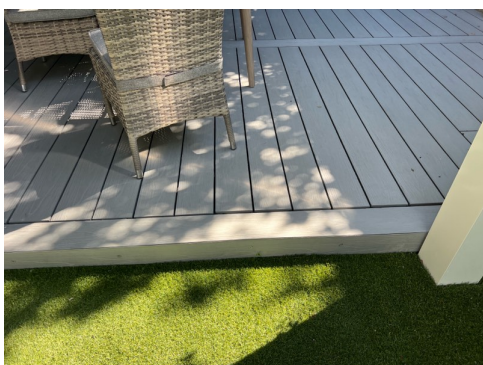
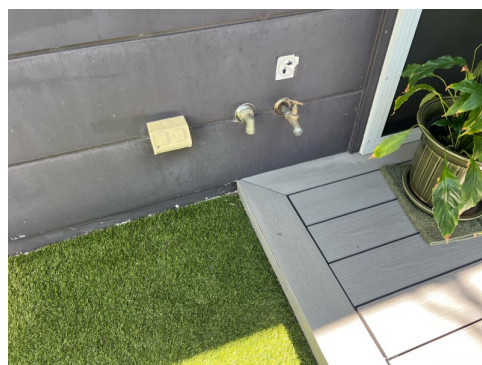
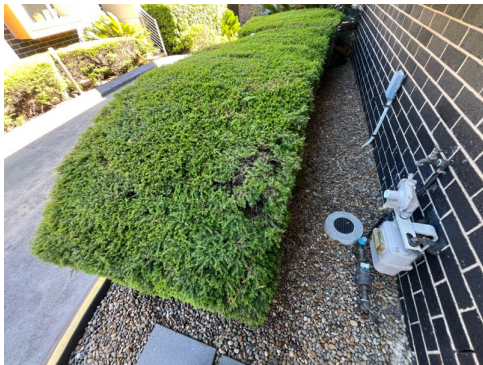
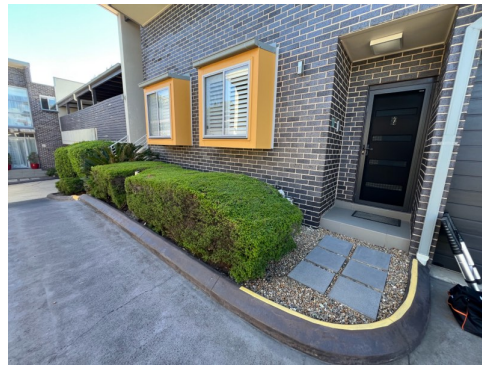
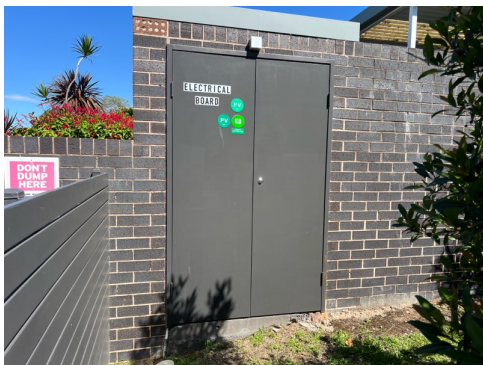
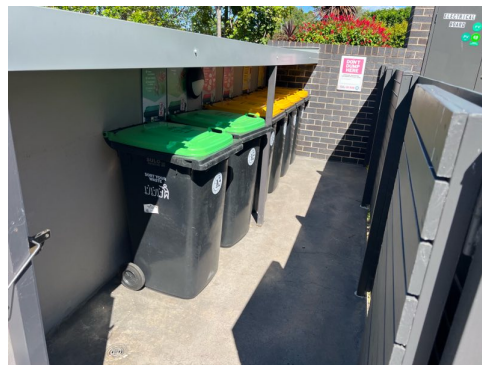
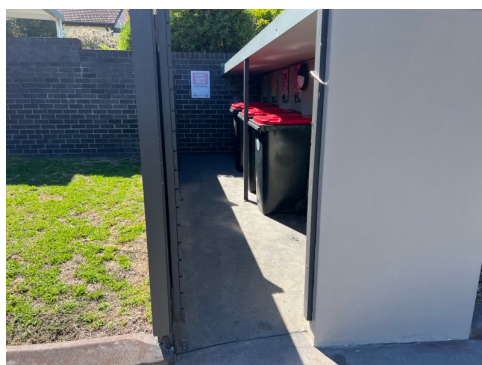
Finding: Additional Photos - Obstructions and Limitations

Information: These photographs are an indication of the obstructions and limitations which impeded full inspection of the property at the time of inspection. These obstructions can hide an array of defects and should be removed to allow full inspection to be carried out. A re-inspection is recommended once the areas are made accessible.

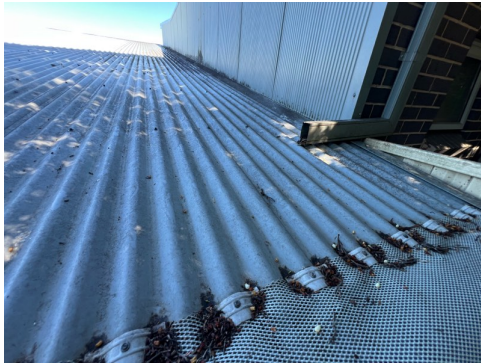
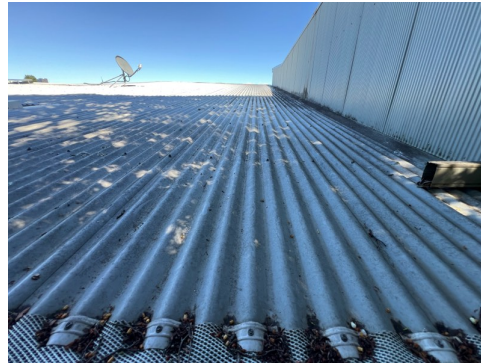
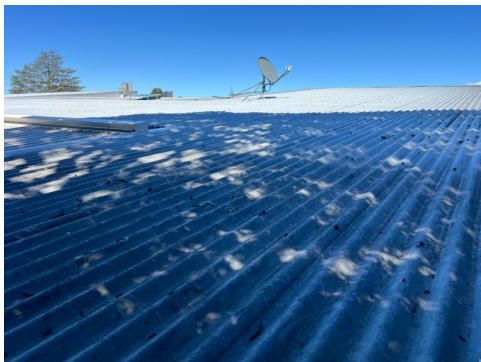
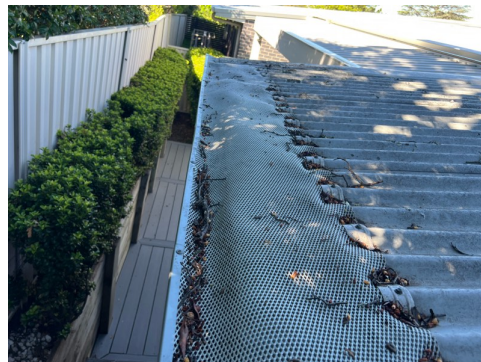
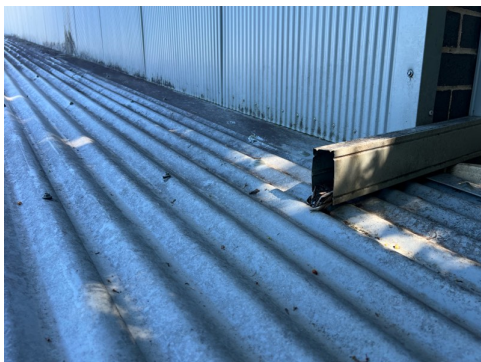
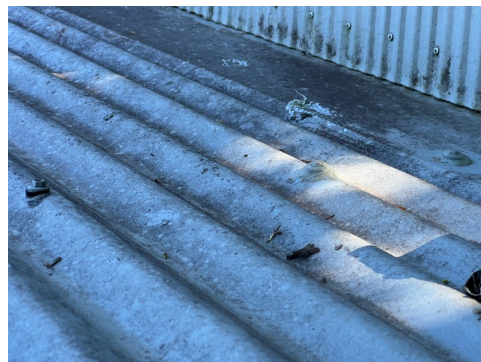
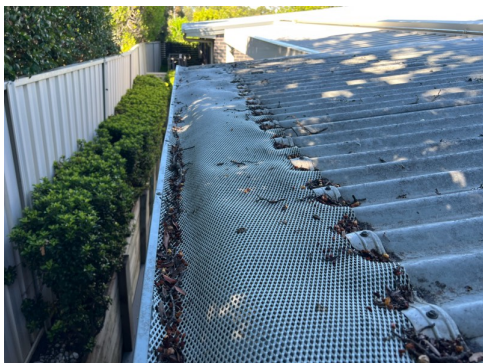
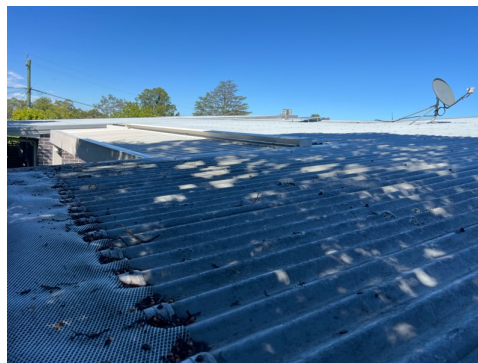
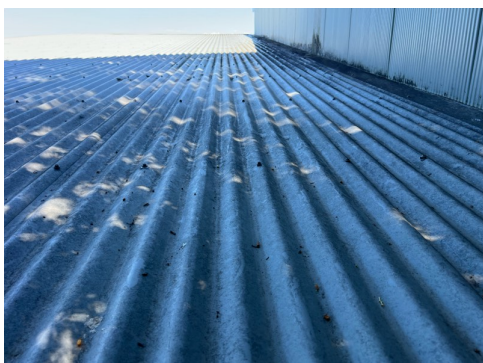
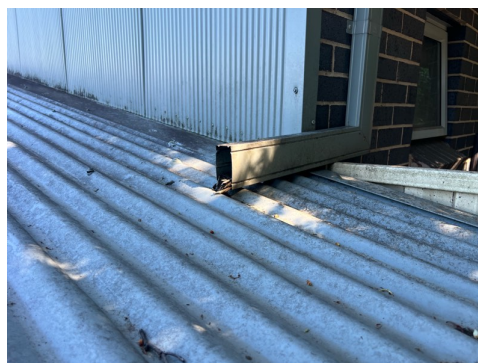
Finding: Additional Photos

Information: Additional photos are provided for your general reference

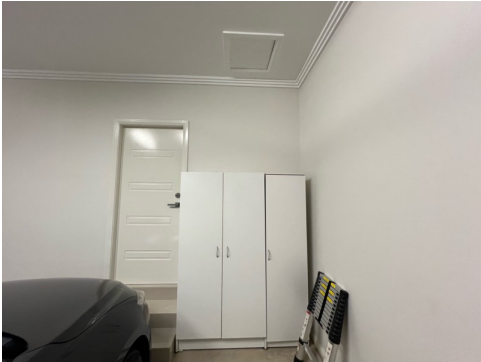
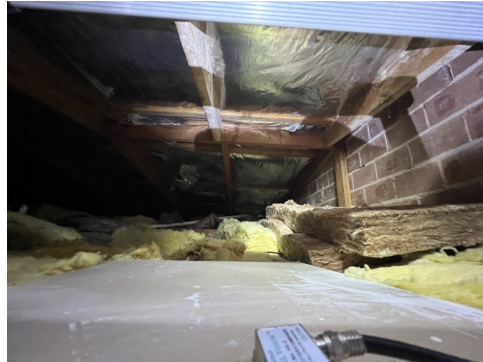
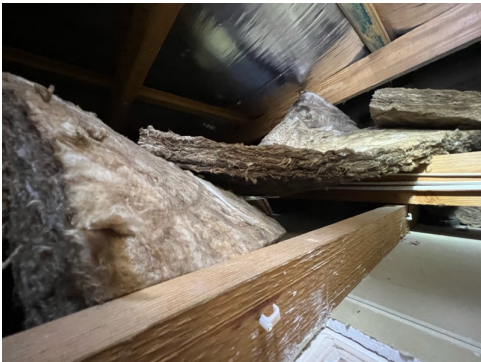
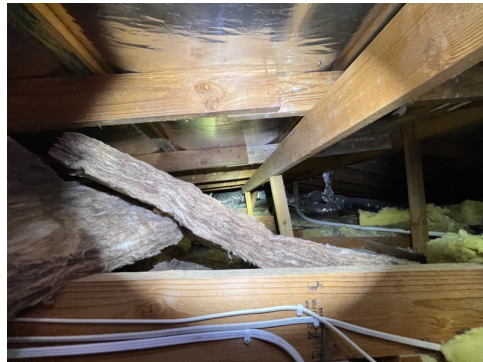
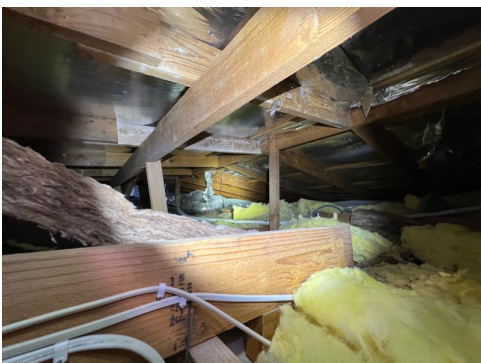
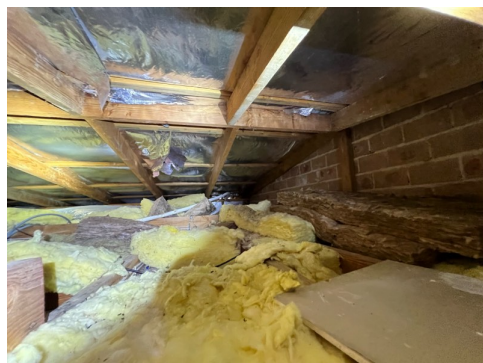
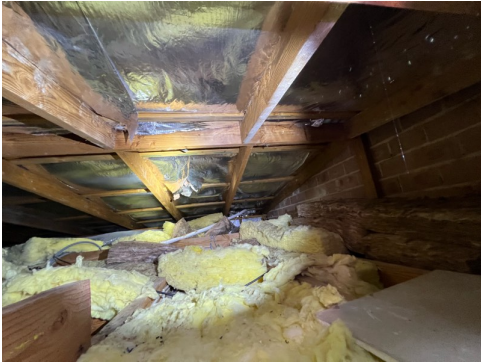
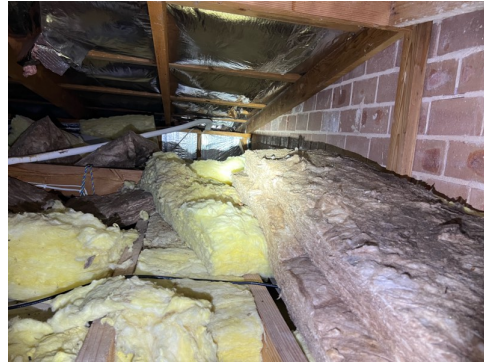
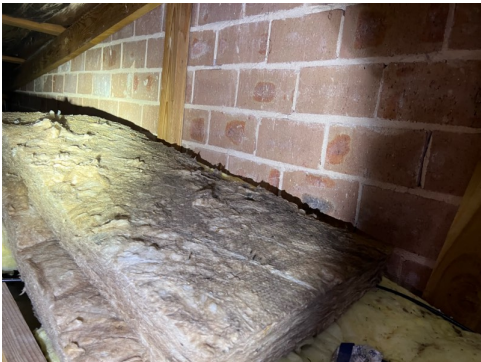
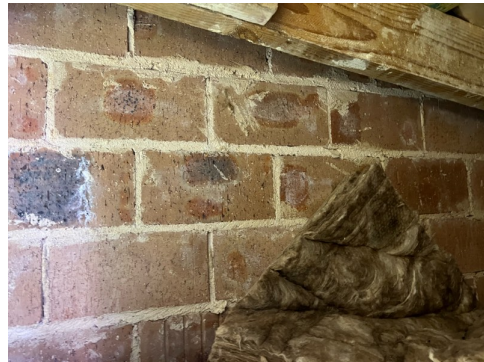
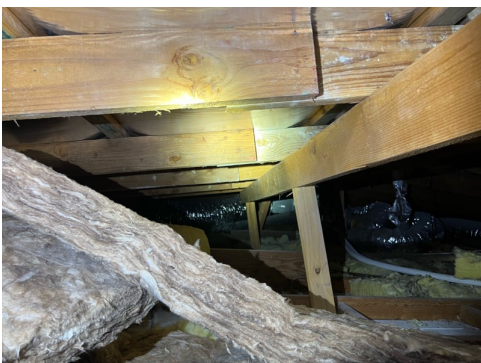
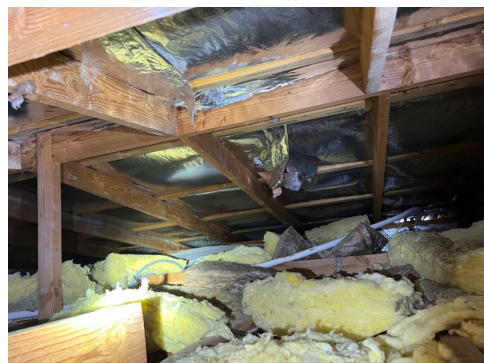
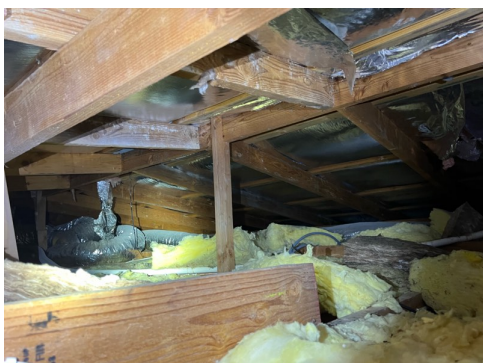
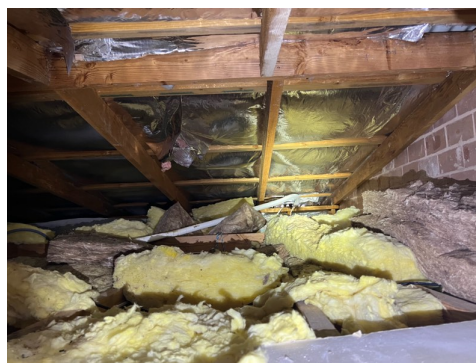
Finding: Additional Photos - Obstructions and Limitations

Information: These photographs are an indication of the obstructions and limitations which impeded full inspection of the property at the time of inspection. These obstructions can hide an array of defects and should be removed to allow full inspection to be carried out. A re-inspection is recommended once the areas are made accessible.

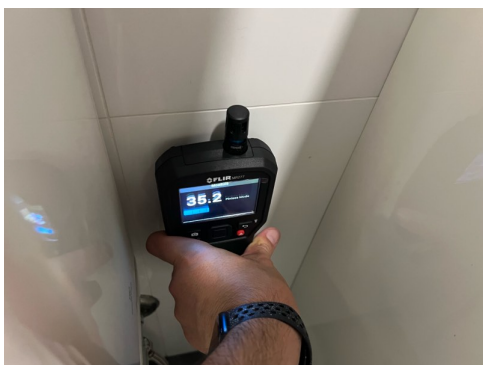
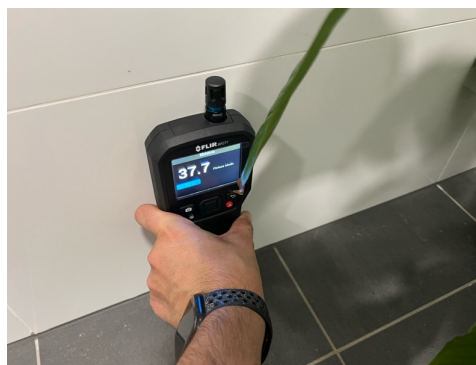
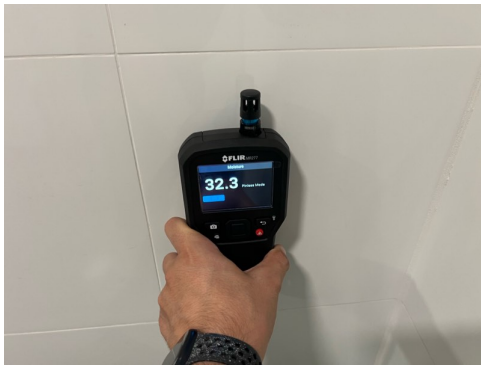
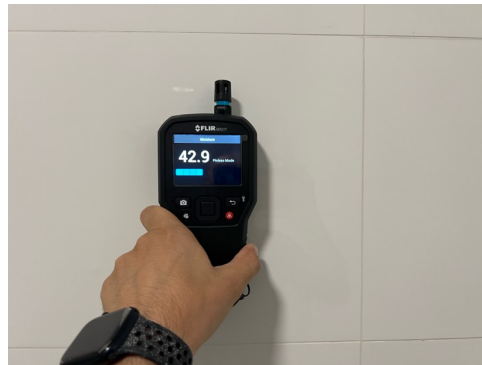
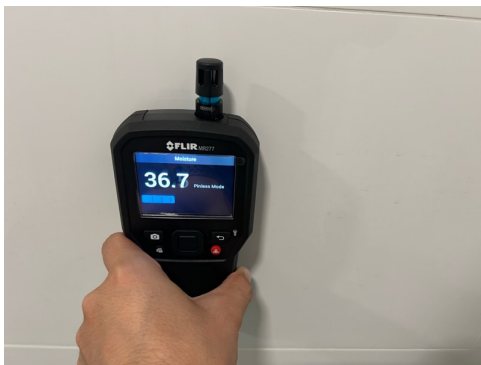
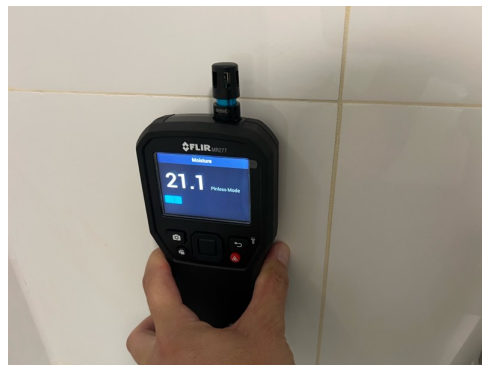
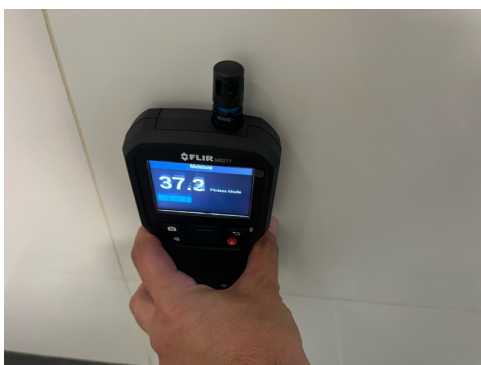
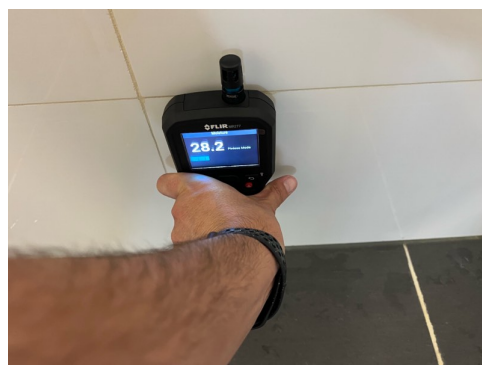
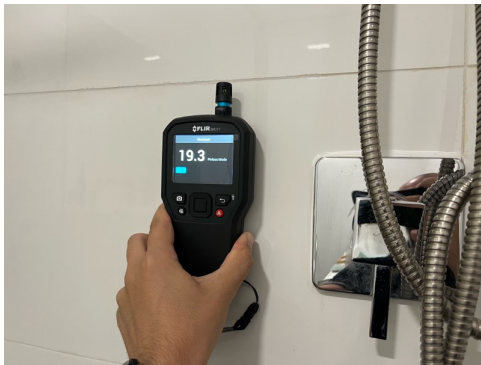
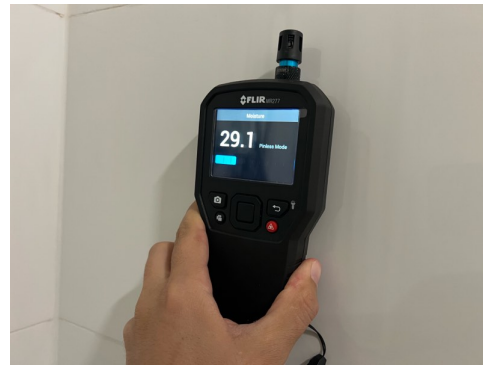
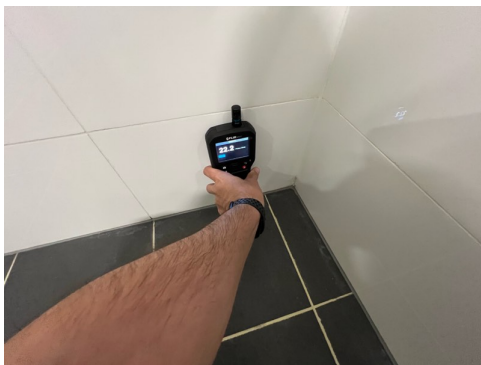
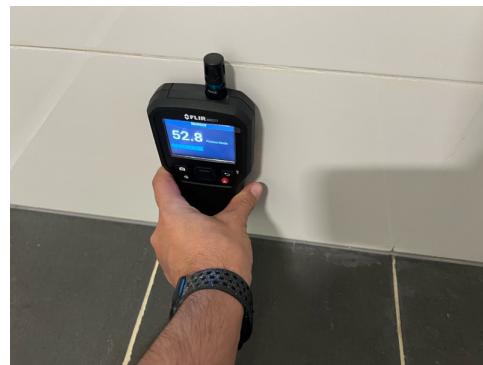
Finding: Moisture Meter Readings - For Information Only

Information: Moisture testing was undertaken to selected accessible internal surfaces using a noninvasive moisture meter at the time of inspection. Readings obtained provide an indicative assessment only and are intended as a guide to assist in identifying areas that may warrant further investigation.

No invasive testing was carried out, and moisture readings can be influenced by a range of factors including material type, surface finishes, environmental conditions, and recent use of wet areas. As such, the results are provided for information purposes only and do not constitute a definitive assessment of concealed moisture conditions. Concealed defects may exist that were not evident at the time of inspection.

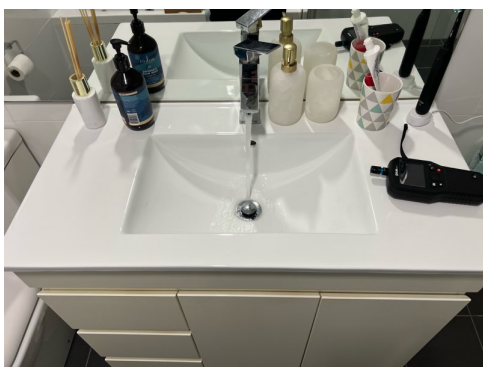
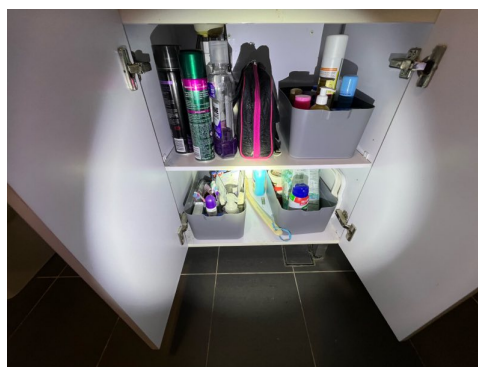
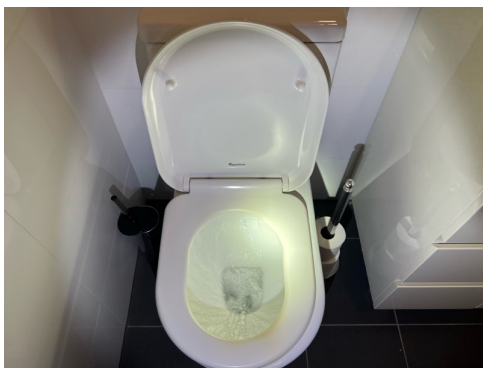
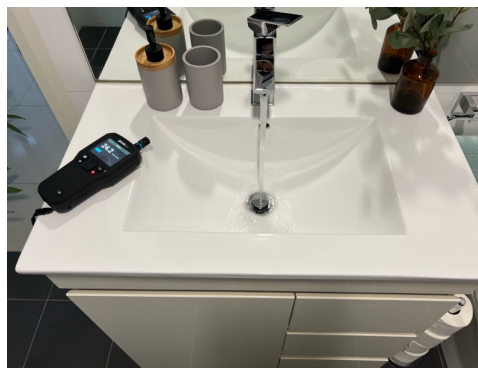
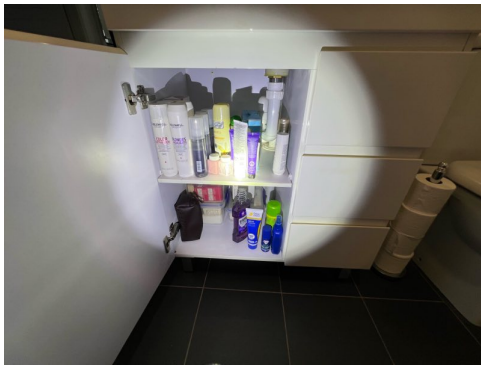
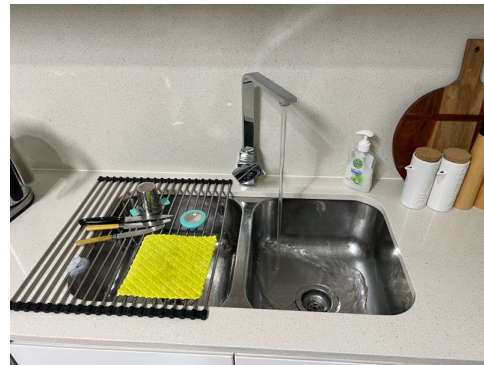
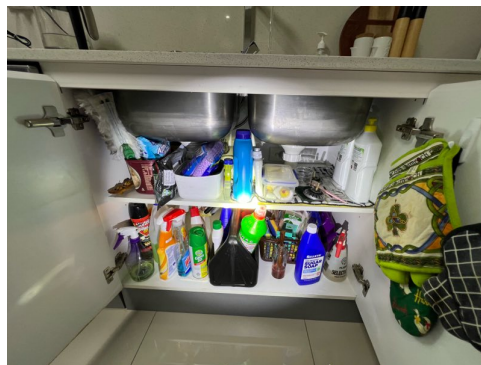
All taps, mixers, and toilets were tested for correct operation, except where access was restricted. The shower recess waterproofing was assessed by conducting noninvasive moisture readings to the walls in and around the shower recess. No abnormal or significant moisture variations were detected within the areas tested. In addition, a visual inspection of the surrounding wall surfaces did not reveal any visible signs of recent or ongoing water damage where inspection was possible.

Based on the above observations, there is no conclusive evidence to suggest the presence of an active shower recess leak at the time of inspection, other than any issues already identified elsewhere in this report. It is therefore reasonable to assume that the shower waterproofing is currently performing as intended. However, it should be noted that if the shower has not been used for an extended period prior to the inspection, moisture readings may not accurately reflect underlying conditions and may result in misleading outcomes. As this inspection is limited to visual and noninvasive methods in accordance with pre-purchase inspection standards, it is not possible to definitively confirm the absence of leaks. If a higher level of certainty is required, a specialist invasive inspection is recommended.
