Building and Timber Pest Inspection Report

Inspection Date: Thu, 12 Mar 2026

Property Address: 60 Hay Street, Lawson NSW 2783

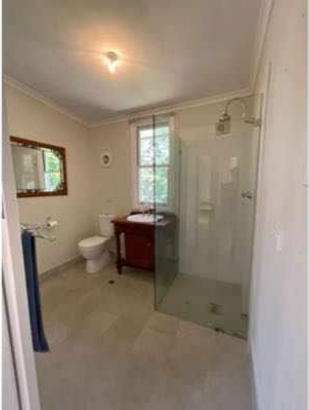
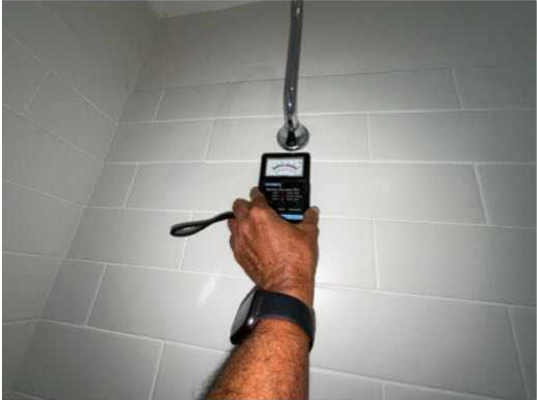
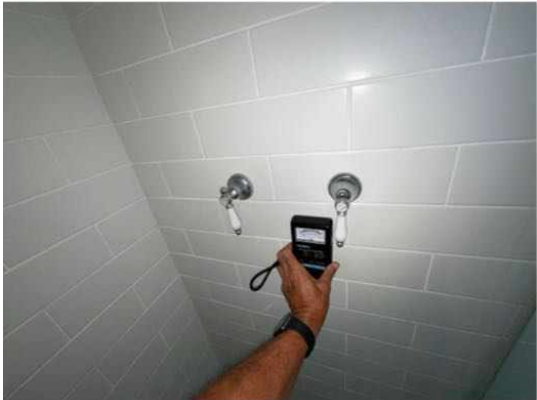
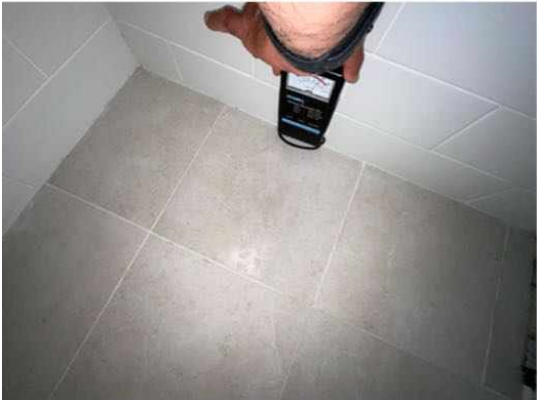
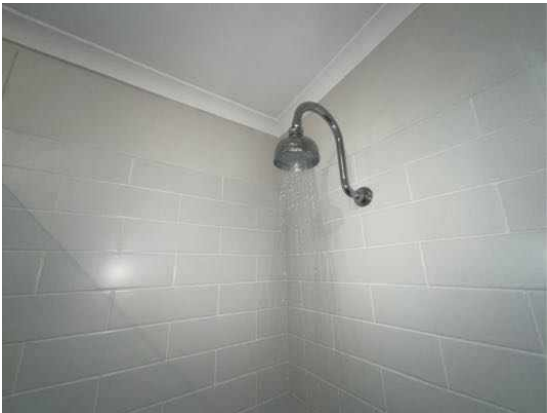
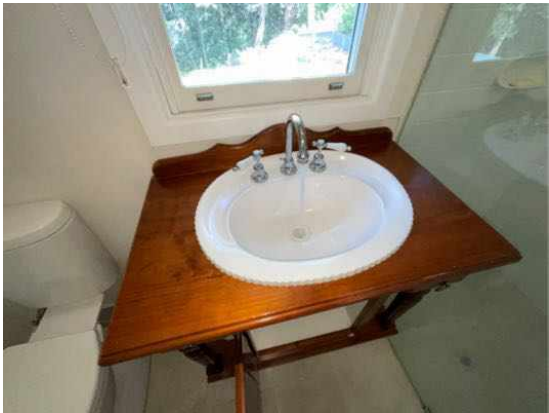
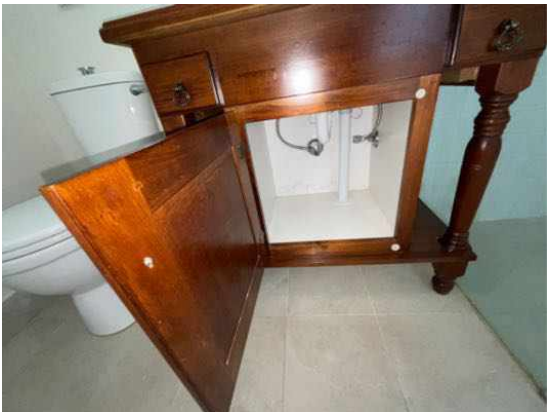
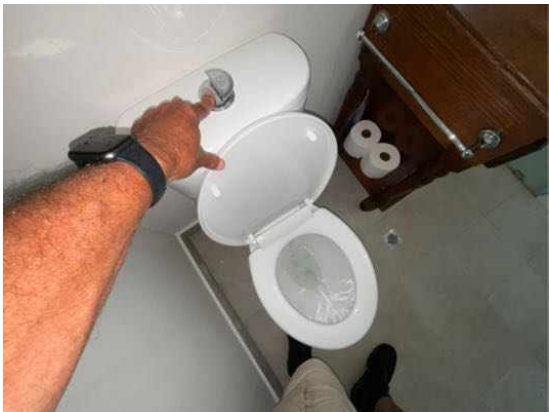
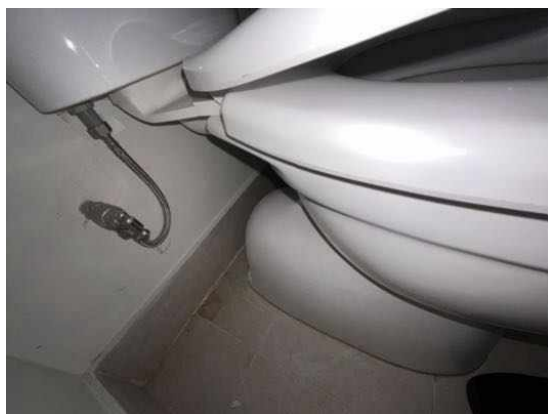
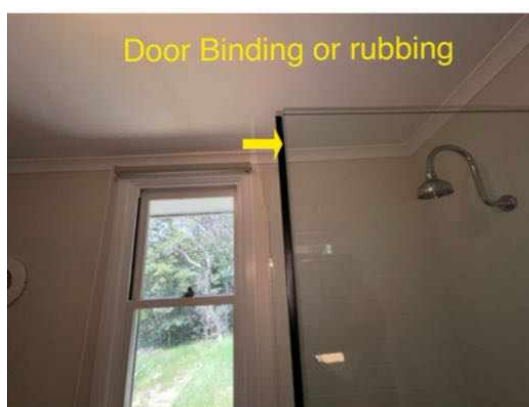
Building: Main Building
 Location: All Areas
 Finding: Ceiling Condition & Observations.
 Information: All areas of the dwelling were inspected, with particular attention given to the ceilings. These were closely assessed for any signs of moisture staining, damage, or visible anomalies that could indicate leaks or other issues.
