# Building and Timber Pest Inspection Report

Inspection Date: Thu, 12 Feb 2026

Property Address: 166 Connells Point Rd, Connells Point NSW  
2221, Australia

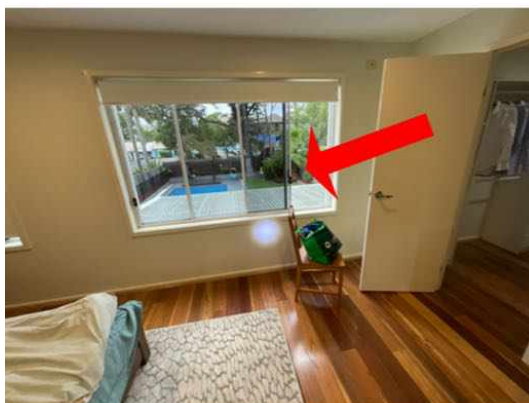
#### Finding 1.01

Building:	Main Building
Location:	Bedroom - Master
Finding:	Window restriction - missing stopper to bedroom
Information:	<p>The handle to the window was missing at the time of the inspection. Absence of the window stopper limits the operation of the window and may pose as a safety risk. Installation of the stopper should be conducted as soon as possible. A general handy person or qualified carpenter should be appointed to perform these works to improve the operational state of the affected window and improve the safety of the internal area. The NCC sets the minimum requirements for the design, construction and performance of buildings throughout Australia. To limit the risk of a child falling through an openable window, the NCC states that if the floor below the window in a bedroom is 2.0 m or more above the surface beneath and the lowest level of the window opening is less than 1.7 m above the floor, a restriction (device or screen) is required to:</p> <ul style="list-style-type: none"><li>• Restrict window openings to less than 125mm; to not permit a sphere of 125mm diameter to pass through the window opening or barrier screen; while resisting an outward horizontal force through the opening of 250 newtons (equivalent to 25.49Kg) while the window is restrained by a restriction device or barrier screen protecting the opening.</li><li>• Have a child resistant release mechanism, thus the screen or device is unable to be removed, unlocked or overridden.</li></ul>

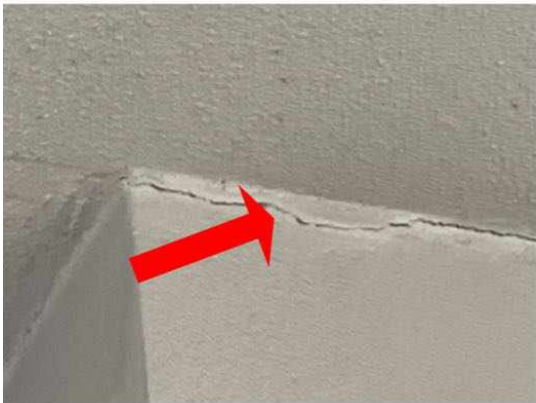
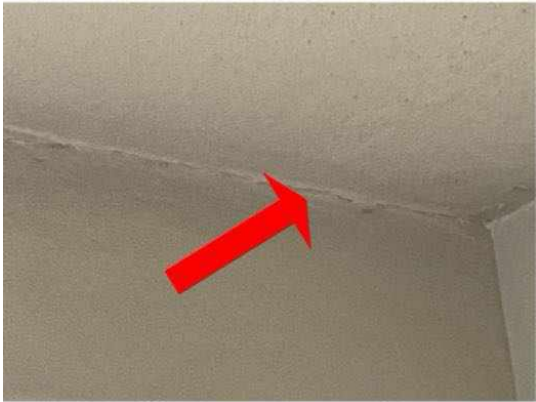
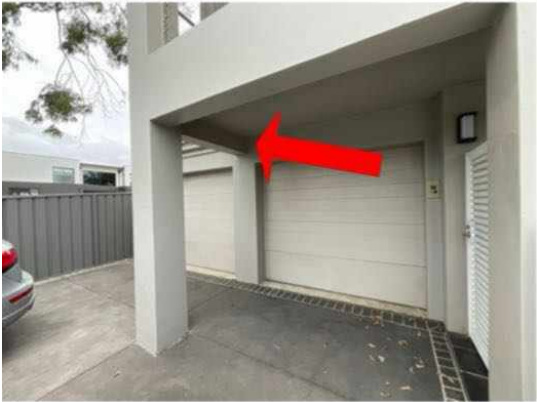
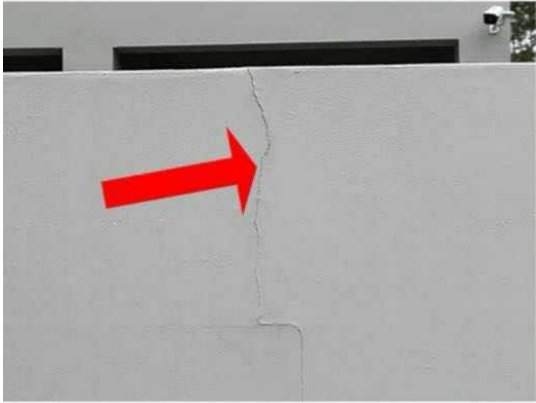
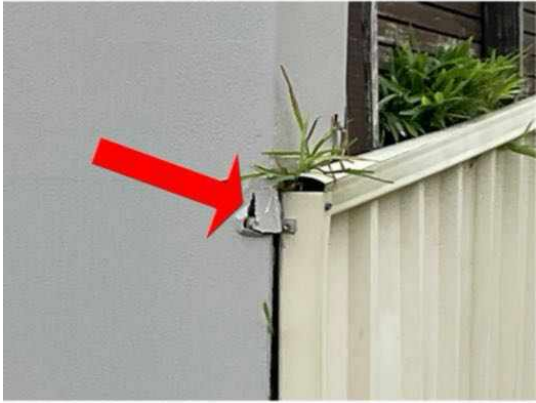
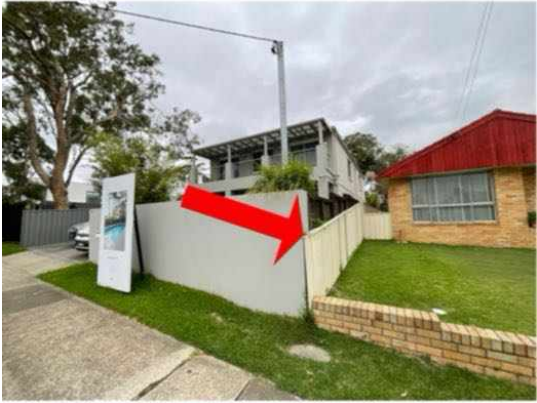
Building: Main Building  
Location: Exterior walls  
Finding: Cracks to external render - Category 1  
Information: It has been observed that cracking to external rendered surfaces has occurred. The degree of damage falls within Category 1, described as fine cracks that do not need repair and which are less than 1.0mm in width limit.

Damage of this category is not considered a defect for rectification. Always contact your building inspector should cracks widen, lengthen, or become more numerous.

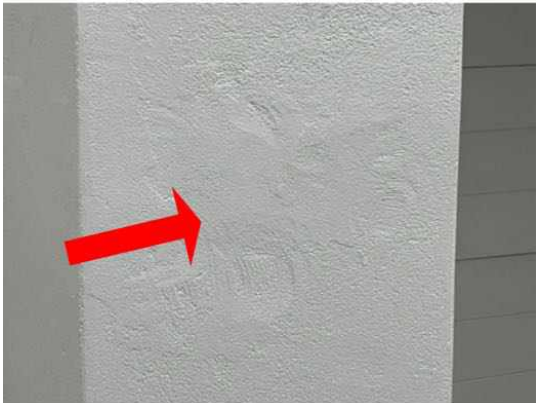
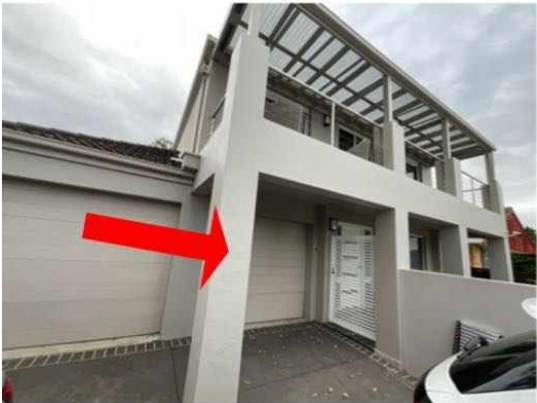
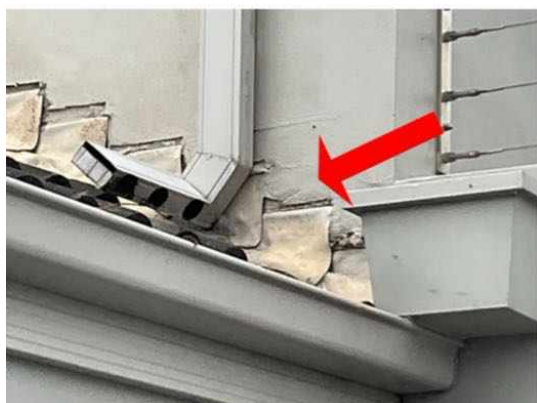
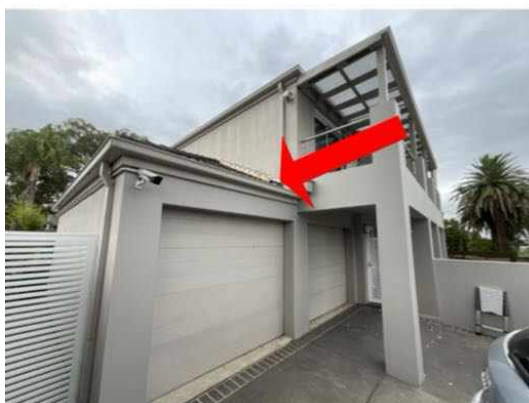
**Finding 3.02**

Building: Main Building  
Location: Exterior walls  
Finding: Rendered or hard plastered surfaces - defective  
Information: It is observed that the rendered and / or hard plastered surfaces are defective as they do not confirm to the documented surface sample and / or description.

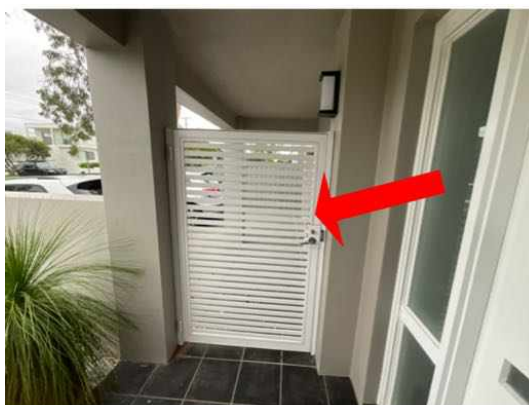
### Finding 3.03

Building:	Main Building
Location:	All External Areas
Finding:	Gate - Binding / Jamming
Information:	Binding and/or jamming of this gate is evident during standard operation. This defect inhibits the functionality of the affected gate as well as creating potential for secondary defects to associated building elements, such as damage to the walls. A gate that binds to gate frame may have several causes, ranging from minor defects, such as poor installation of the gate or deteriorated hinges, through to major structural issues, such as damage to post or wall structures. For minor causes, a qualified carpenter or general handyperson should be appointed to perform minor rectification works at client discretion.

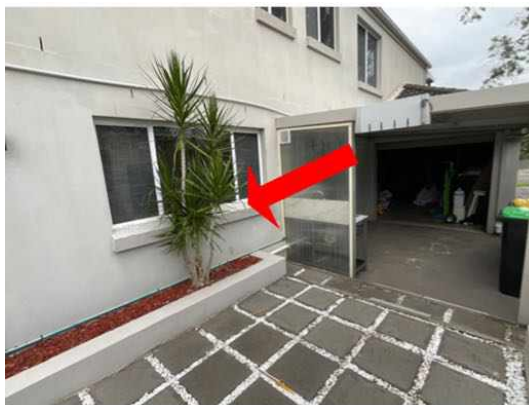
### Finding 3.04

Building:	Main Building
Location:	All External Areas
Finding:	Building element - Rusted or corroded
Information:	This building element shows evidence of rusting and corrosion, which is likely to have developed as a result of excessive exposure to moisture and or inadequate coatings.  As surface rust provides no protection to the underlying iron, the deteriorating

condition is likely to worsen if not addressed in the short-term future.

Where possible, the use of galvanized (treated) metals or aluminium coated metals aid in rust prevention, as does regular general maintenance. Rust formation can be controlled with coatings, such as paint, that isolate the iron from the environment.

Rusting and corrosion should be managed by ideally removing or limiting the affected surface from exposure to moisture. A registered builder may be appointed to replace any building elements that have been severely affected by rust or water damage.

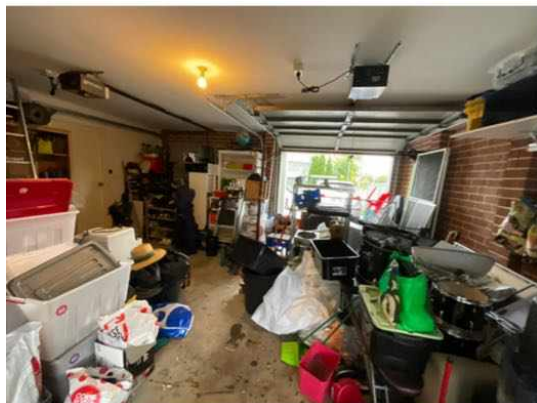
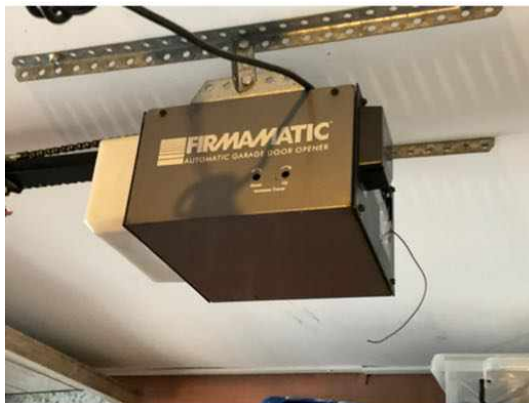
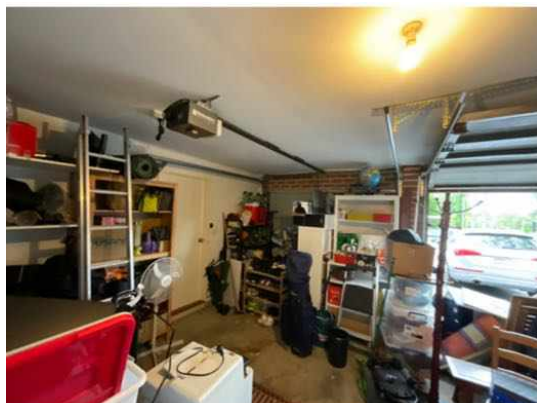
### Finding 3.05

Building:	Main Building
Location:	Garage
Finding:	Garage Door - not working properly
Information:	At the time of the inspection, Garage roller doors can fail when the building materials have aged with some concerns as below:

**Spring Tension:** If the springs responsible for counterbalancing the weight of the door are too loose or too tight, it can affect the door's operation. Adjusting the spring tension to the manufacturer's specifications can help resolve this issue.

Repair of the two garage doors would improve the condition of the garage but certainly not an urgent item

A qualified roller door installer or supplier should be engaged to check out the operation and overall condition of the doors to determine if repair is an option otherwise replacement may need to be considered.

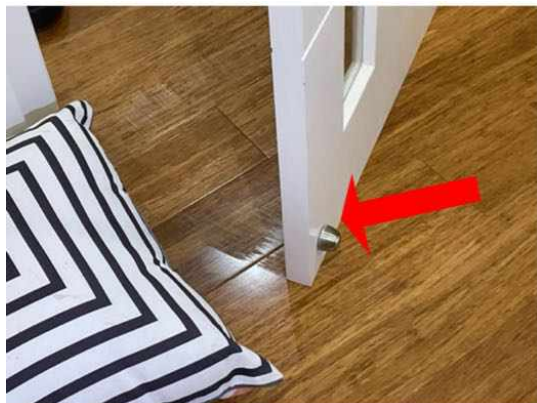
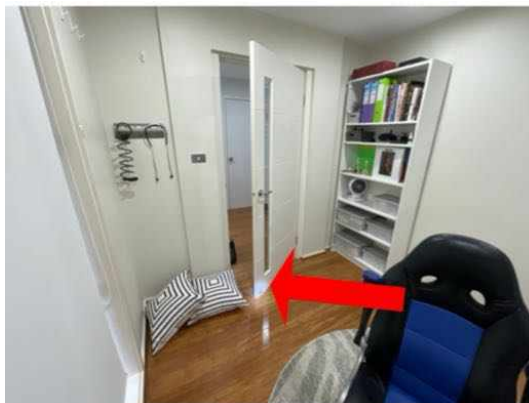
### Finding 3.07

Building:	Main Building
Location:	All External Areas
Finding:	Door - Binding/jamming
Information:	Binding and/or jamming of this door is evident during standard operation. This defect inhibits the functionality of the affected door as well as creating potential for secondary defects to associated building elements, such as damage to the floor covering.

A door that binds to flooring or to the associated door frame may have several causes, ranging from minor defects, such as poor installation of the door or deteriorated hinges, through to major structural issues, such as damage to subfloor structures.

Where door binding/jamming appears to indicate major structural issues, a registered builder specialising in re-stumping should be appointed to provide an estimate on the cost of rectification.

For minor causes, a qualified carpenter or general handyperson should be appointed to perform minor rectification works at client discretion.

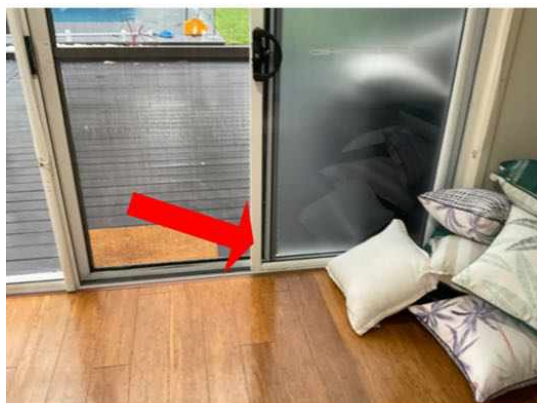
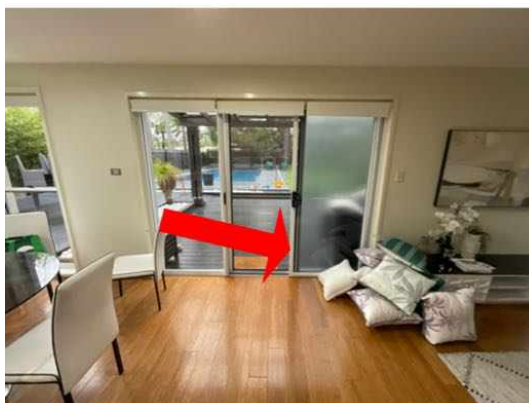
### Finding 3.08

Building:	Main Building
Location:	Dining Room
Finding:	Sliding Door - Stiff to slide
Information:	The door in this area was jammed and difficult to slide along the associated tracks at the time of the inspection. Restricted function of the affected door may pose as a potential safety hazard if required for emergency egress from the building.

Generally, factors such as general age of the building element and a lack of maintenance are the usual causes for this type of defect.

Replacement of door hardware or tracks may be required, as well as minor repairs and cleaning. A registered builder or general handy person will be required to repair the affected doors.

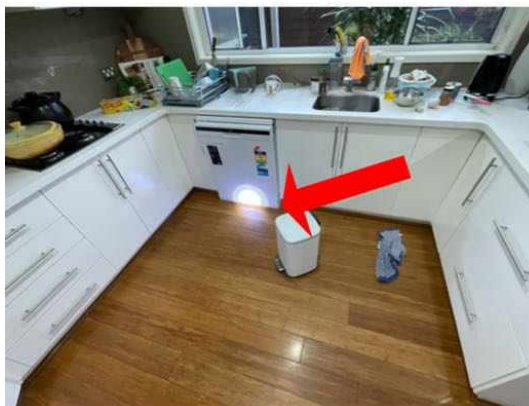
### Finding 3.09

Building:	Main Building
Location:	Kitchen
Finding:	Float Timber flooring - damaged / gap
Information:	Damages / gaps to float laminate flooring were found during inspection. The laminate timber flooring is typically resistant to water damage, but standing water and large

amount of moisture that gets under the floor (as the water has no place to evaporate) can eventually destroy the floor and delaminate the product.

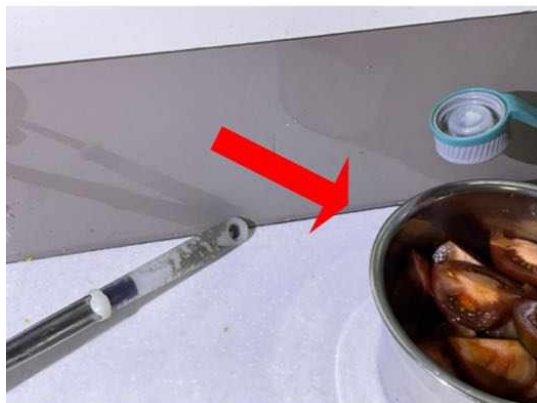
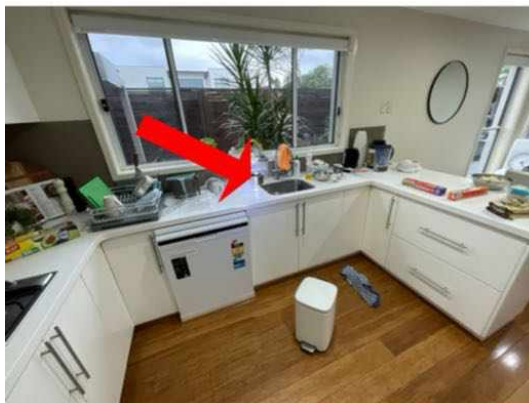
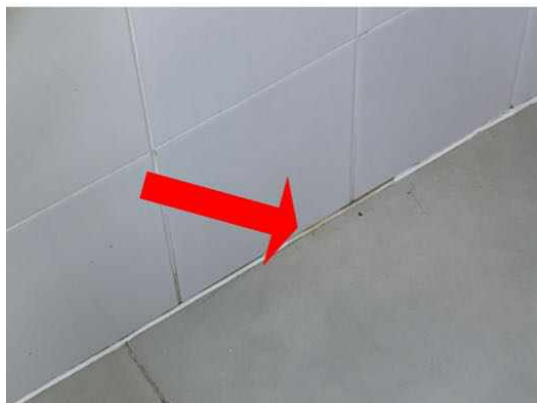
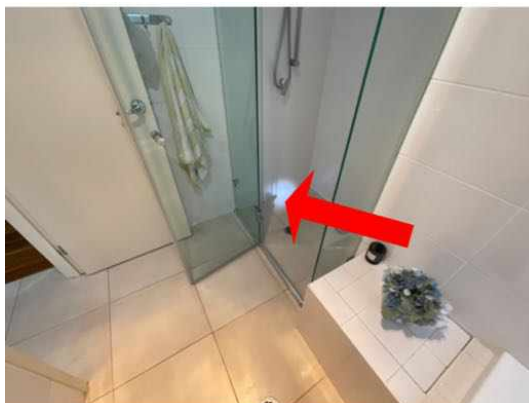
Building:	Main Building
Location:	Kitchen / Bathrooms
Finding:	Sealant and grouting - Missing or damaged
Information:	It was noted on inspection that sealant or grout is degraded to the tiled shower alcove and or other areas of the bathroom.

Different materials and floor areas move at different rates, generally causing cracking to grout or sealant at this point. A flexible sealant is required to allow for expected expansion and contraction, while keeping the joint water tight and protective of all associated building materials.

There appears to be excessive mould to the sealant and grout which will likely require scraping out and replacement.

Flexible and mould resistant materials should be applied to affected areas to prevent any subsequent water damage that is likely to occur. Regular maintenance and replacement of damage or missing or damaged sealant and grout is highly recommended to the wet areas, as this is a regular wear and tear defect. Sealant and grouting in areas that come into regular contact with water should be maintained for the long term care of your property.

A sealant specialist or tiling contractor should be appointed to complete these works as soon as possible

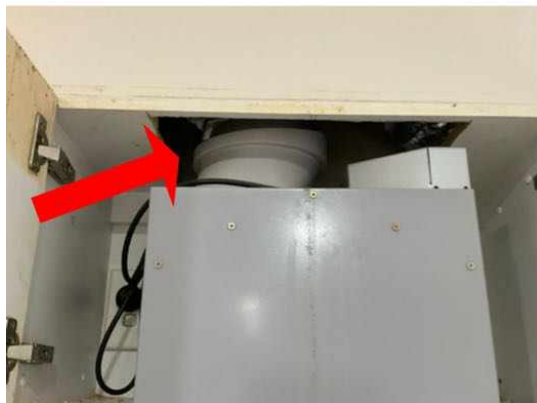
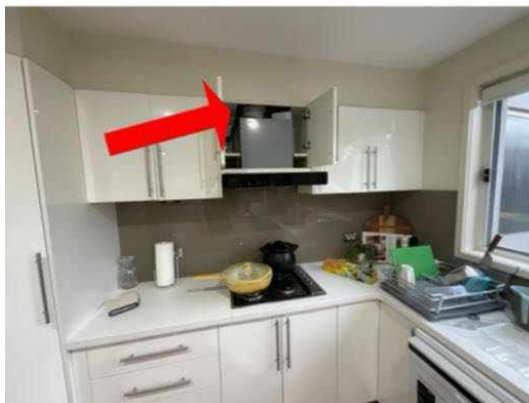
### Finding 3.11

Building:	Main Building
Location:	Kitchen
Finding:	Incomplete or substandard works - Rangehood
Information:	The works to this area appear to be incomplete or have been completed to a substandard level.

Works that have not been completed to a satisfactory level create potential for the development of building defects and may impede on the safety and integrity of the overall structure.

It is highly recommended that the relevant trades be appointed to complete these works and ensure the safety of the area and the longevity of all associated building elements.

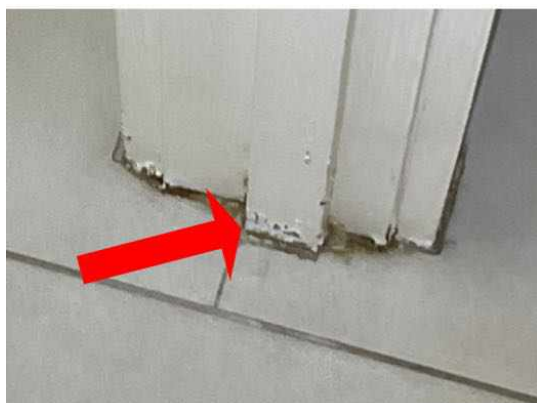
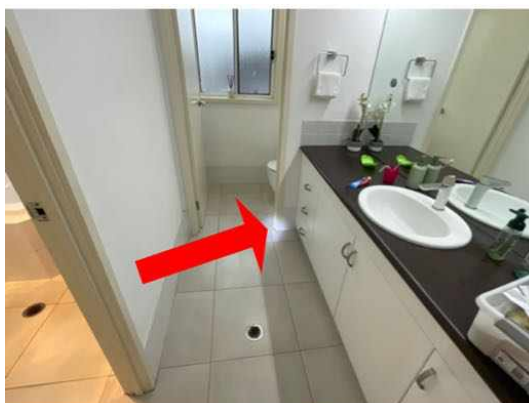
### Finding 3.12

Building:	Main Building
Location:	Toilet (WC) > Upstairs
Finding:	Timber decay and possible moisture ingress
Information:	The bottom section of the internal timber door frame exhibits clear signs of deterioration, including rot, paint delamination, and a physical hole at the base. The damage likely results from prolonged moisture exposure and may also indicate past or current timber pest activity.

The structural integrity of the door frame is compromised, and the defect may also be indicative of inadequate waterproofing or poor moisture control in the adjacent wet area.

A licensed builder or carpenter should be engaged to repair or replace the affected timber. Further investigation by a qualified pest inspector is recommended to rule out or confirm pest activity. Moisture management and waterproofing remediation may also be required.

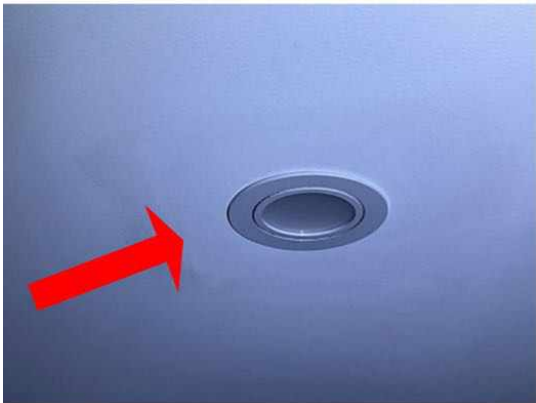
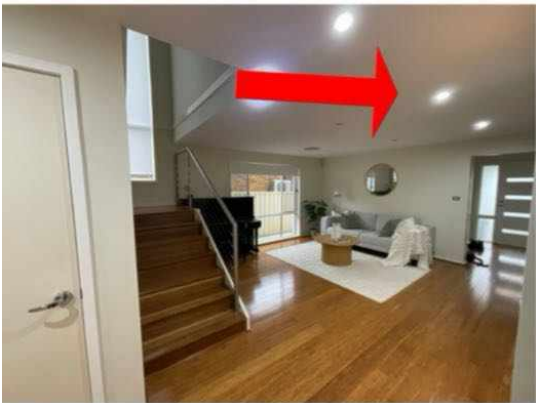
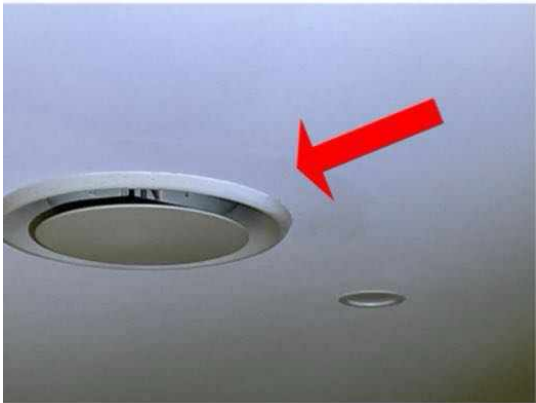
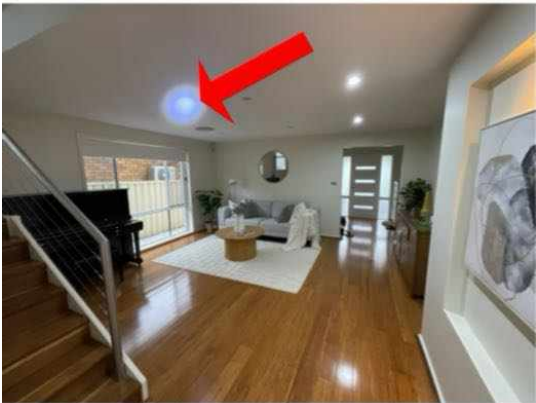
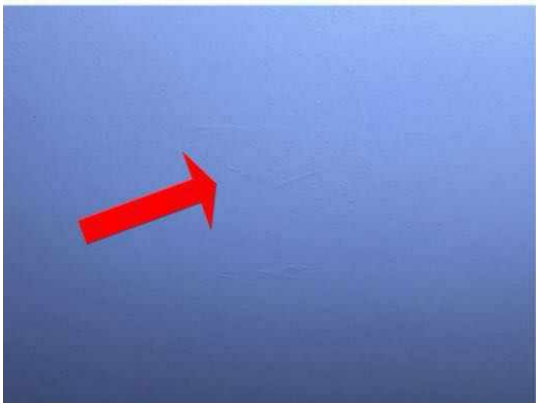
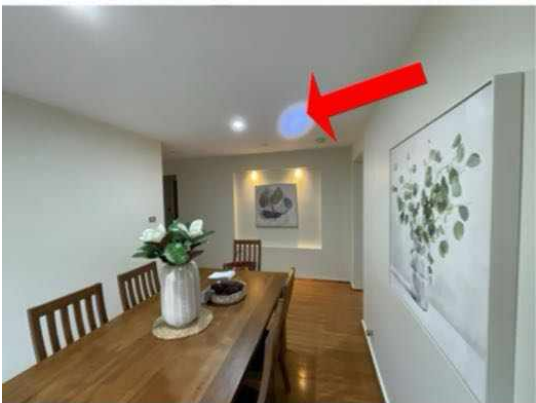
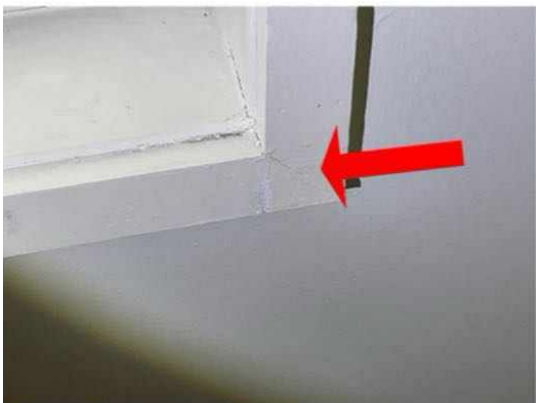
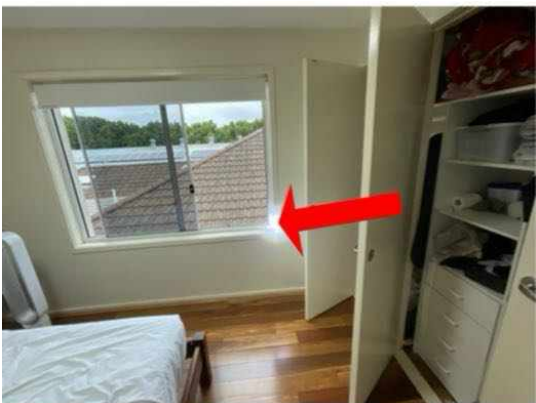
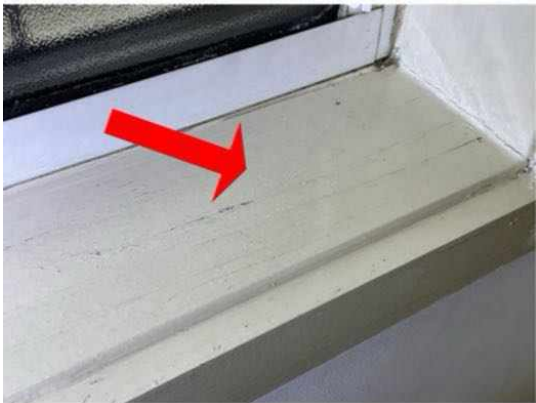
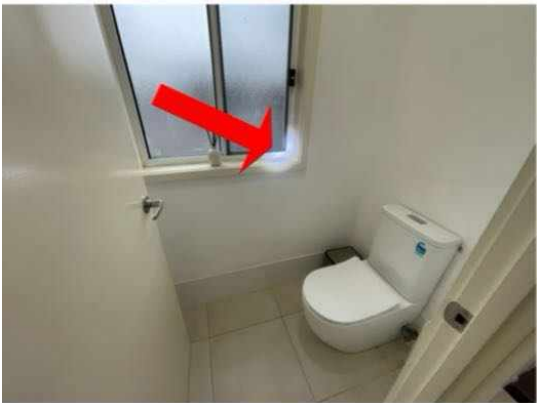
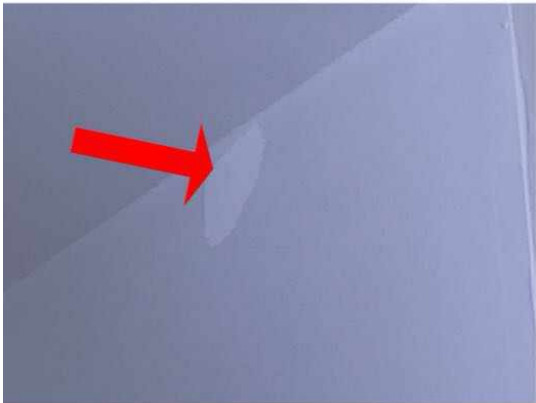
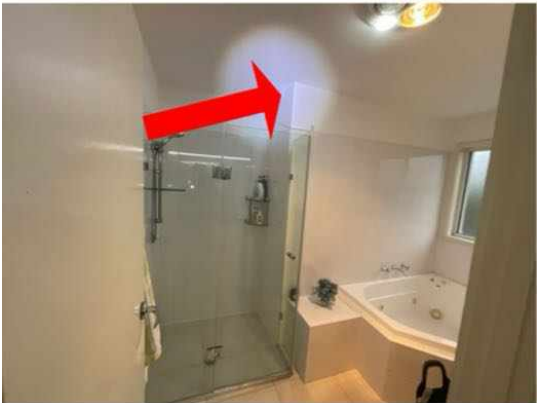
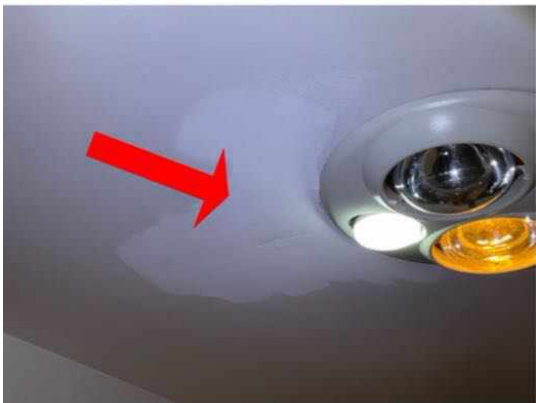
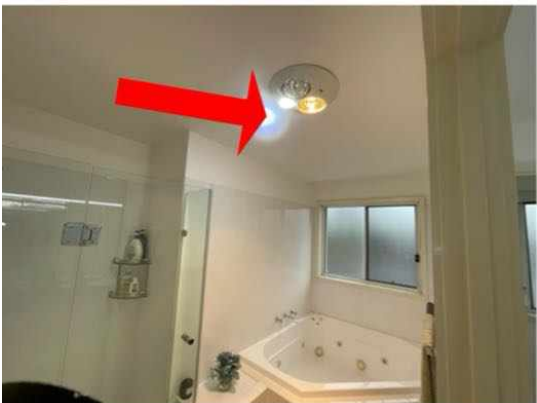
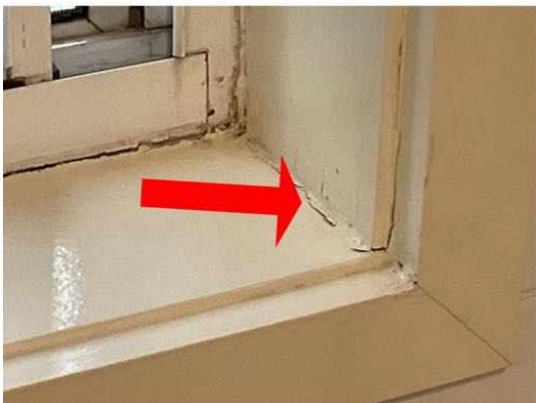
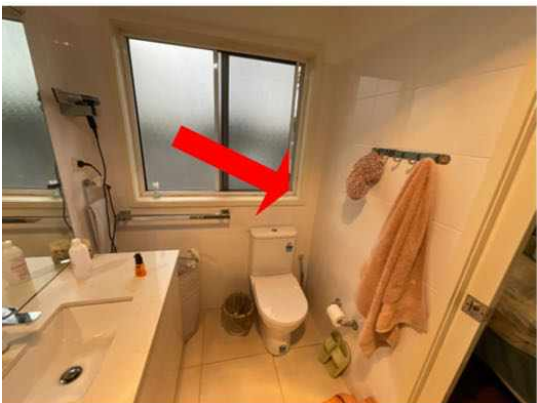
### Finding 3.13

Building:	Main Building
Location:	All Internal Areas
Finding:	Paint finish - Substandard, Wear and Tear
Information:	The paint finish in this area was found to have been completed to a substandard level or wear and tear as the normal deterioration of a property from ordinary, everyday use. Exposure to the elements, time, as well as day to day living can cause fair wear and tear.

If this applies, further areas of poor and incomplete finishes could develop over time. Furthermore, substandard, wear and tear paint finishes in areas exposed to moisture, e.g. external areas or wet areas, could lead to deterioration of underlying building materials.

Substandard, wear and tear paint finishes should be sanded back, filled, leveled and repainted, as applicable. Where inadequate paint protection has led to the deterioration of the associated building element, repair and/or replacement of this building element may be required.

A painting contractor should be appointed as soon as possible to perform necessary works to aid the appearance of the affected area and to ensure that the area is protected against further deterioration. Alternatively, the homeowner following manufacturer instructions may be able to provide this service.

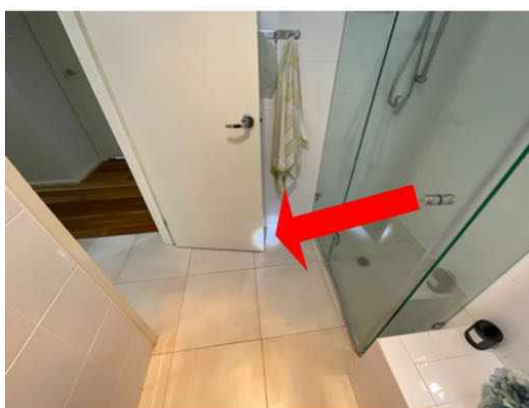
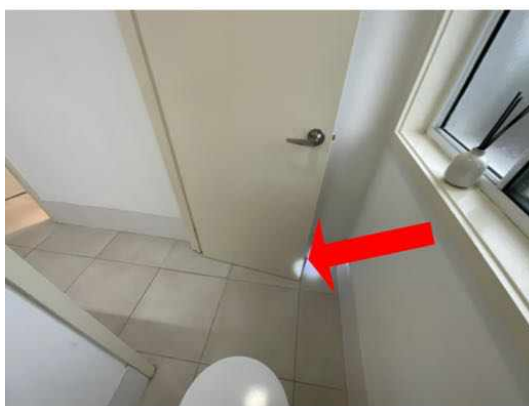
Finding 3.14

Building:	Main Building
Location:	All Internal Areas
Finding:	Door stop - Missing
Information:	The door stop is missing or is inadequate to stop the door handle from damaging the wall. Although some building elements may seem irrelevant or unnecessary, all building elements play a key role in the operation and function of the overall structure and its performance.

Re-installation or replacement of the door stop is advised as soon as possible to prevent any subsequent damage to the door or associated structures. A general handyman may be appointed to perform these works at client discretion.

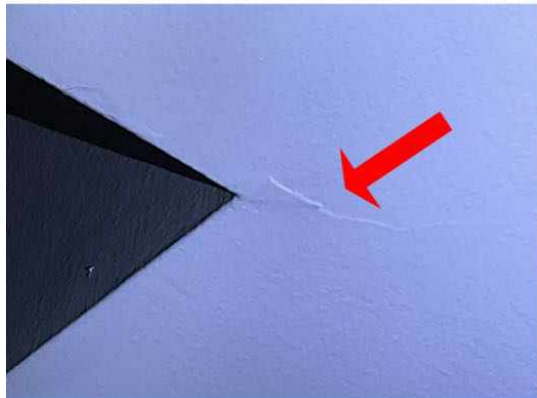
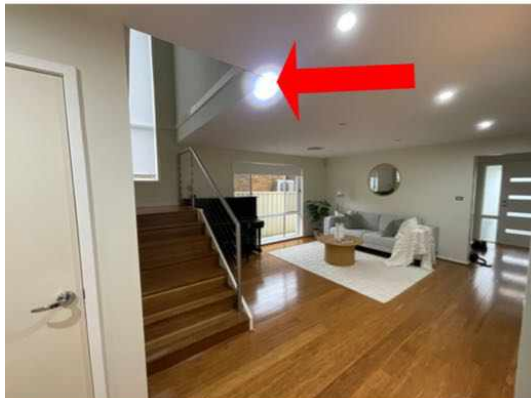
### Finding 3.15

Building:	Main Building
Location:	All Internal Areas
Finding:	Cracking - Damage Category 1 - Fine (up to 1mm)
Information:	Although fine cracks are quite noticeable, they are often only considered to be an appearance defect, and usually do not indicate any structural damage. Generally, the cause of a fine crack is indicative of a separation between building materials and finishes (e.g. paint, plaster, etc.) along joins.

Cracking of this nature can generally be repaired with minor sanding, filling and/or

repainting. Such works should be performed by a qualified painter or a general handyman.

Monitoring of all cracking should be conducted frequently. Always contact a building inspector should cracks widen, lengthen, or become more numerous.

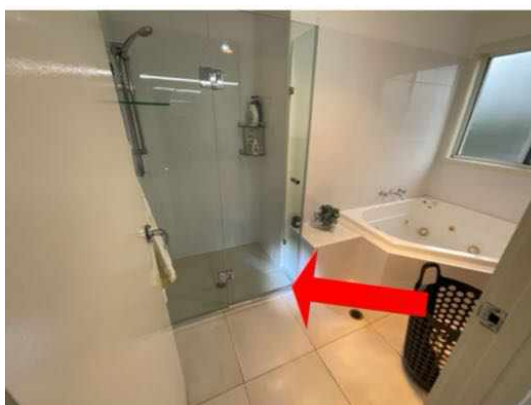
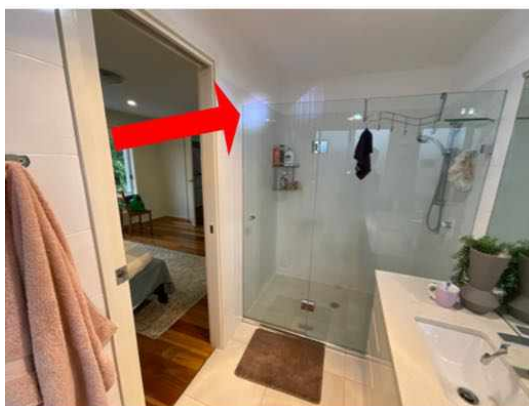
### Finding 3.16

Building:	Main Building
Location:	Bathroom
Finding:	Shower Screen Door - Jamming or Binding
Information:	Binding and/or jamming of this shower screen door is evident during standard operation. This defect inhibits the functionality of the affected door as well as creating potential for secondary defects to associated building elements, such as damage to the floor or crack to glass .

For minor causes, a qualified Glazier appointed to perform minor rectification works at client discretion.

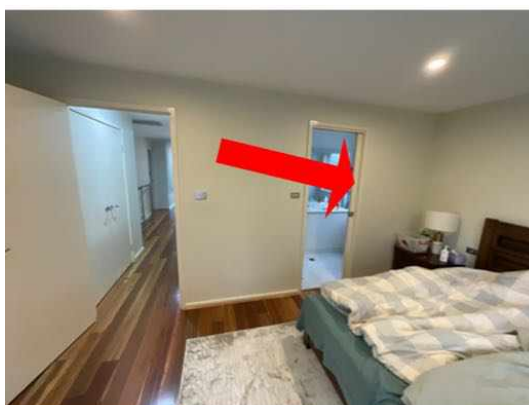
### Finding 3.17

Building: Main Building  
 Location: Bedroom - Master  
 Finding: Cavity Sliding door - defect  
 Information: Most of cavity sliding doors may have a ball bearing type system that runs along the track and this system may get the defects by installation and some other impacts.

The qualified carpenter should be nominated to repair the matter.

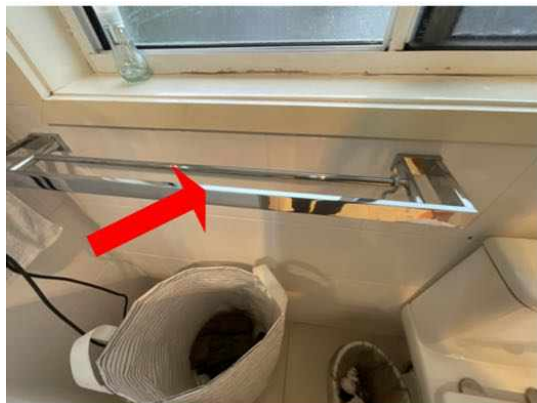
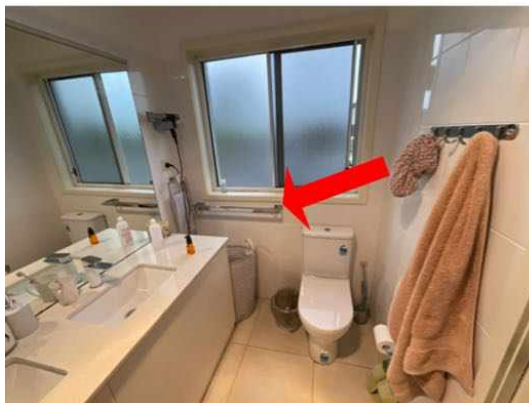
### Finding 3.18

Building: Main Building  
 Location: Ensuite  
 Finding: Bathroom holders - Loose  
 Information: The bathroom holder was found to be loose at the time of inspection. While not a major operational defect, function can deteriorate if the problem is left unmanaged.

It is advised that the homeowner performs remedial works to re-attach the bathroom holder to its original fixing. A general handyperson may be required to perform these works.

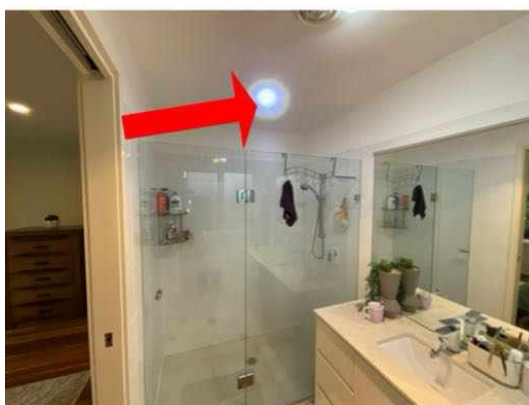
### Finding 3.19

Building:	Main Building
Location:	Ensuite
Finding:	Moisture Damage and Possible Mould – Bathroom Ceiling
Information:	Visible discolouration and patchy staining were observed on the bathroom ceiling, indicative of possible mould or mildew growth. This is likely caused by poor ventilation, inadequate exhaust fan performance, or excessive humidity from regular use of the bathroom.

Prolonged moisture exposure can lead to fungal decay, damage to plasterboard, or create conditions conducive to timber pest activity above the ceiling line.

- A licensed plumber or building professional assess for hidden water leaks.
- Exhaust fan performance and airflow be reviewed and upgraded if necessary.
- The affected area be cleaned, treated, and repainted with mould-resistant paint.
- The roof void or ceiling cavity above be inspected for hidden moisture or damage if accessible.

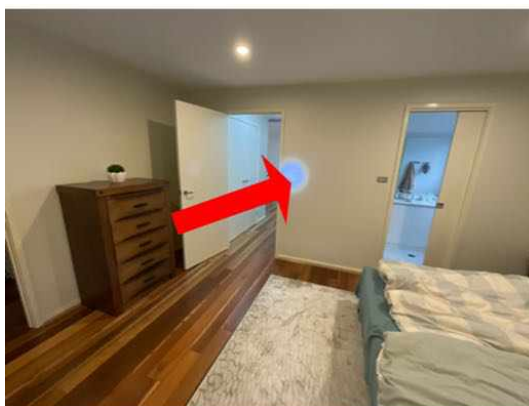
### Finding 3.21

Building:	Main Building
Location:	Bedroom
Finding:	Fitting (door handle) - Loose
Information:	The fitting in this area is loose and requires adjustment to tighten.

If left unmanaged, the fitting may further deteriorate, causing potential for the development of other minor secondary defects.

A relevant tradesperson should be appointed to perform these rectification works at discretion of the client.

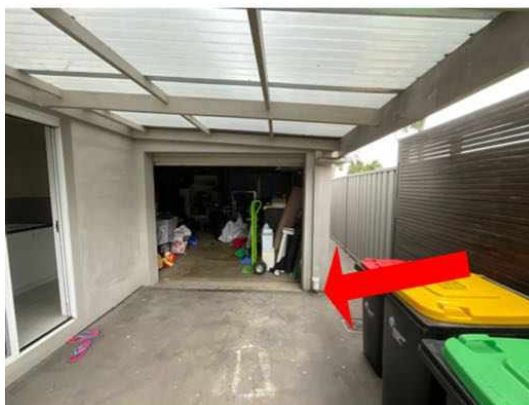
Building: Main Building  
 Location: All Areas  
 Finding: Overflow - Not plumbed for drainage  
 Information: The overflow is not plumbed or connected to suitable drainage, which has resulted in the surrounding area becoming excessively damp. These damp conditions can lead to secondary defects such as rot, rust or corrosion of associated building elements, the formation of fungal decay, or even the creation of potential slip hazards. When coupled with poor site drainage, pooling of water may also attract termite activity to this area. It is highly recommended that a qualified plumber be appointed to install adequate drainage to the overflow. These works will ensure that the area remains dry and free of

any secondary defects.

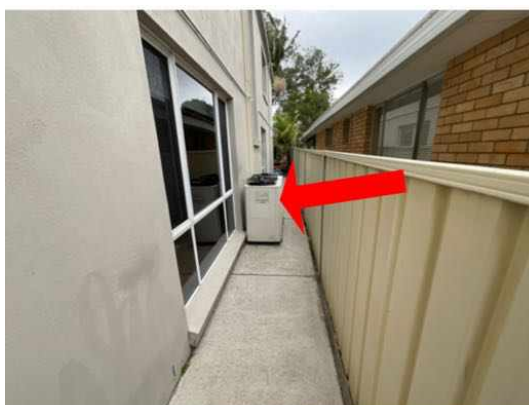
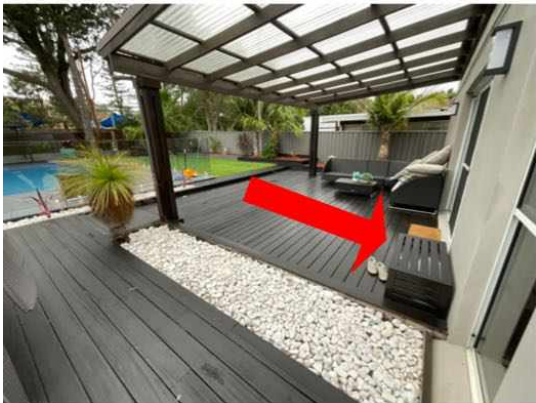
### Finding 6.03

Building:	Main Building
Location:	All Areas
Finding:	Bridging of termite barrier/inspection zones
Information:	Bridging is the spanning of a termite barrier or inspection zone so that subterranean termites are provided with passage over or around that barrier.

Where bridging has occurred, full inspection is prevented and termites may enter a property in a concealed or undetectable manner.

It is recommended that minimum 75mm clearance below the bottom of weep or ventilation holes be maintained where possible, otherwise annual inspections should be conducted by a licensed pest control company. Vegetation should also be kept clear of walls to allow regular inspection of all areas.

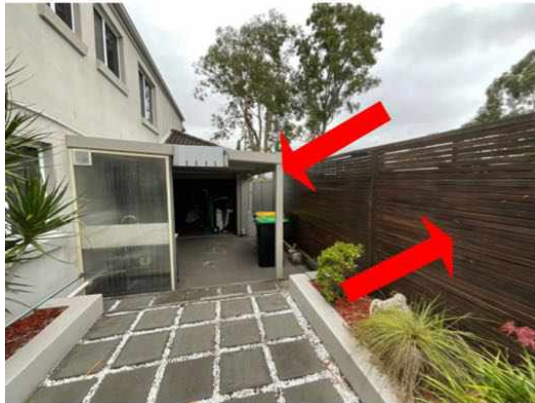
**Finding 6.04**

Building: Main Building  
Location: All Areas  
Finding: Timber - exposed to weather  
Information: External timbers that are frequently exposed to harsh weather conditions require adequate protection in order to maintain their condition. Where timbers have not been painted or treated adequately, general deterioration is likely to occur at an accelerated rate.

If left unattended, replacement of these timbers is likely to be necessary in the short-term future. Adequate treatment of these timbers is required as soon as possible by a painting contractor or general handyman.

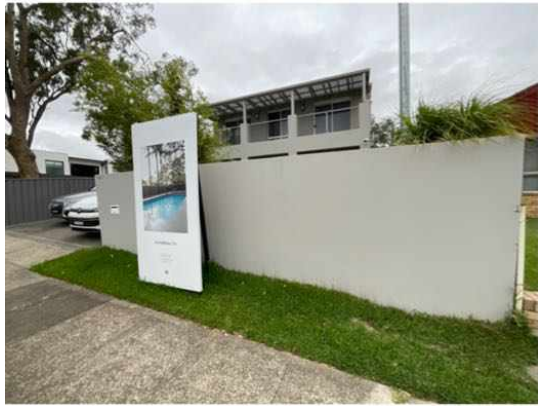
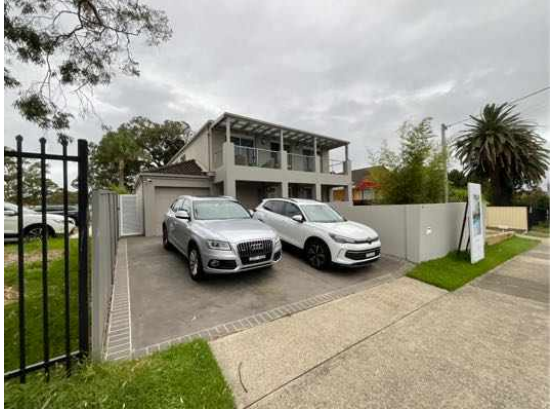
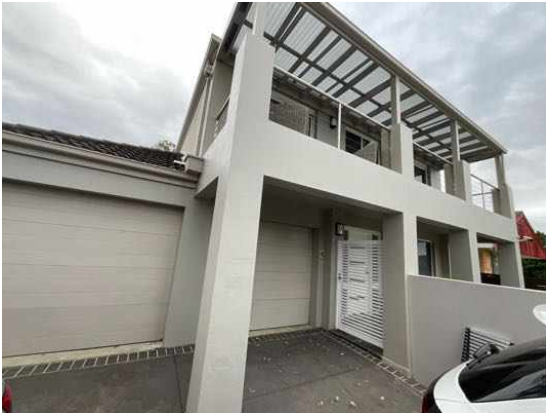
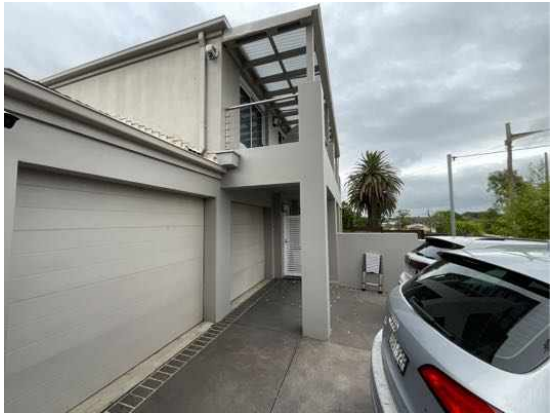
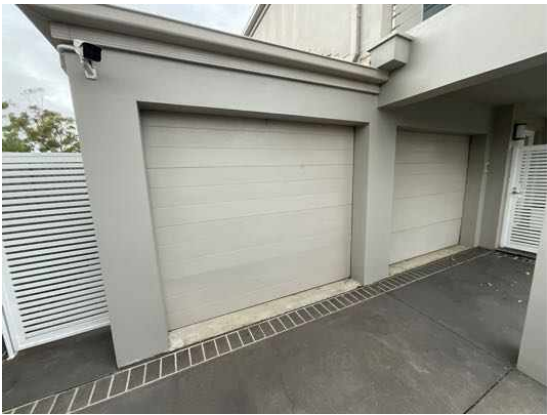
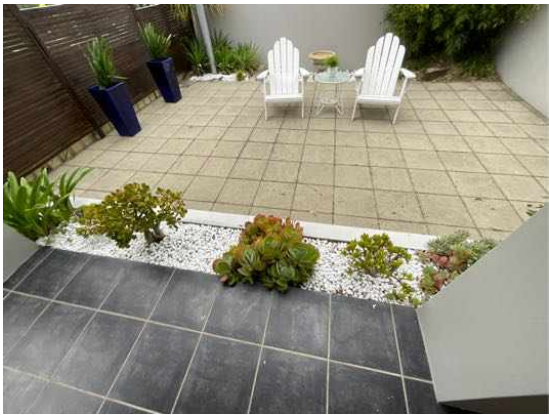
#### Noted Item

Building: Main Building  
Location: All Areas  
Finding: Additional Photos - Obstructions and Limitations  
Information: These photographs are an indication of the obstructions and limitations which impeded full inspection of the property at the time of inspection. These obstructions can hide an array of defects and should be removed to allow full inspection to be carried out. A re-inspection is recommended once the areas are made accessible.
