# Building and Timber Pest Inspection Report

Inspection Date: Thu, 12 Feb 2026

Property Address: 166 Connells Point Rd, Connells Point NSW  
2221, Australia

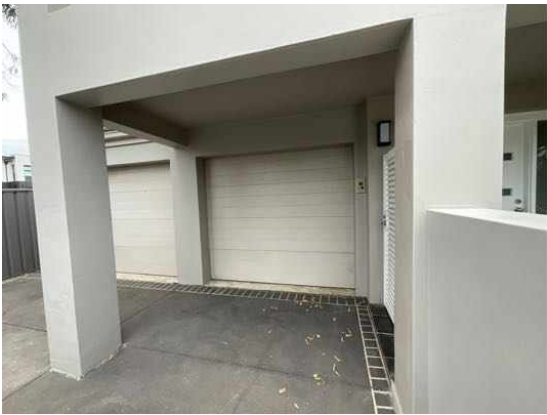
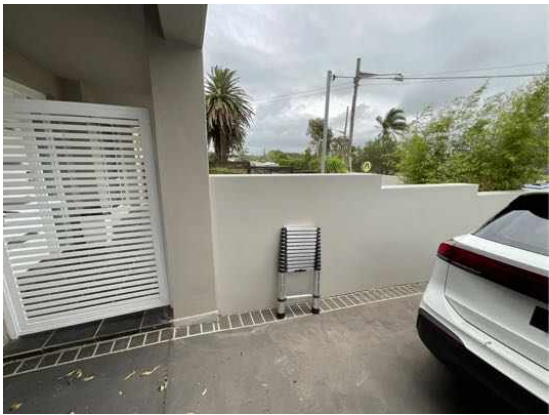
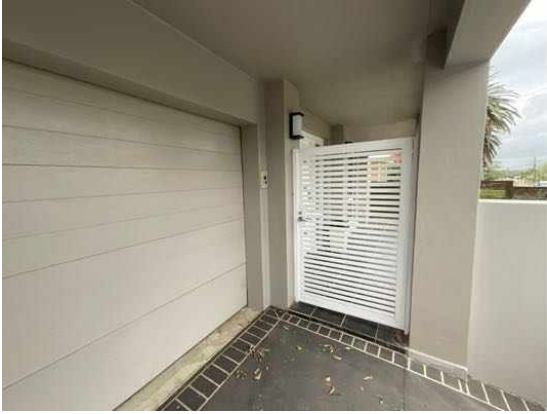
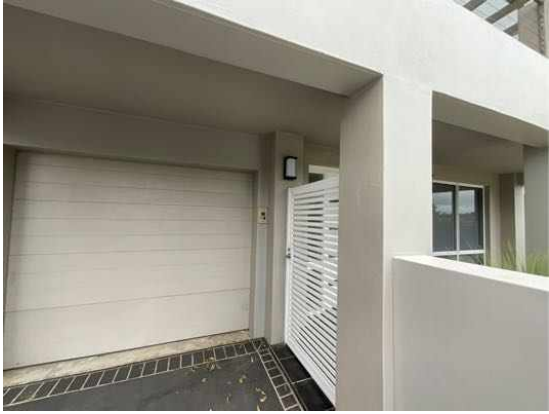
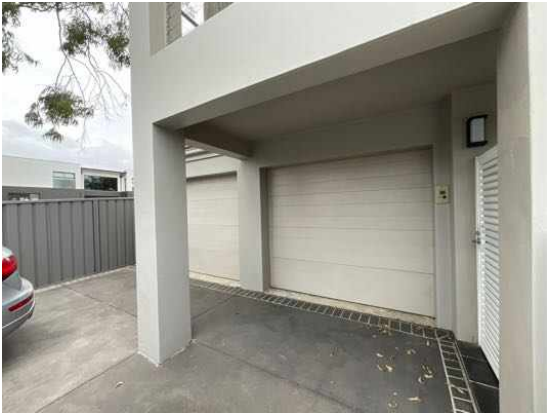
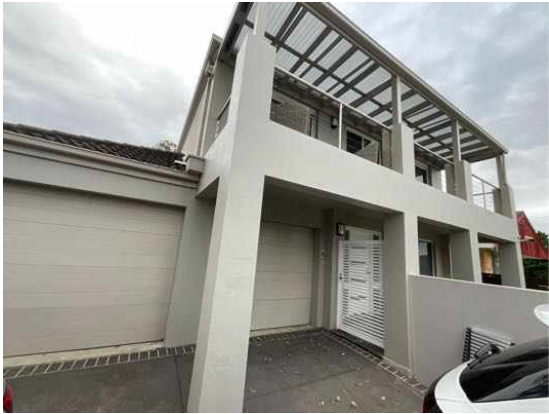
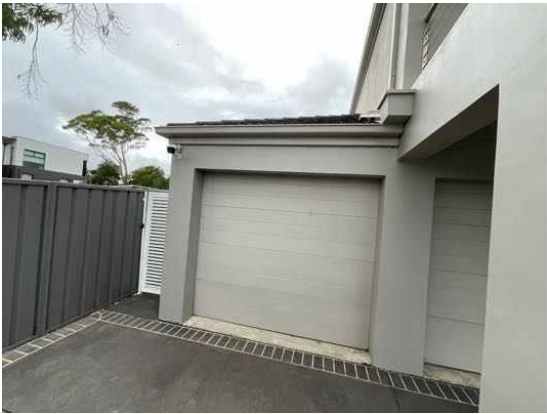
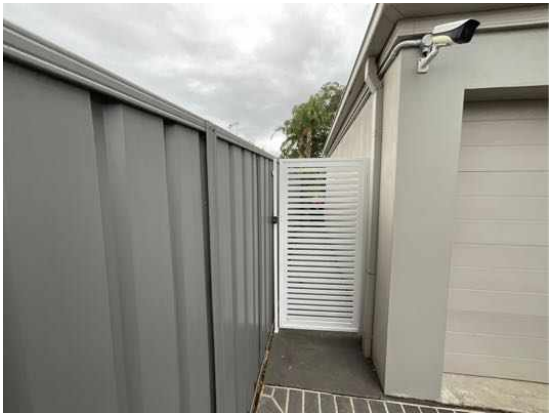
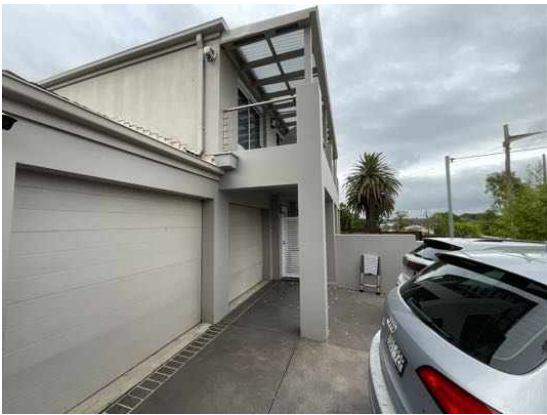
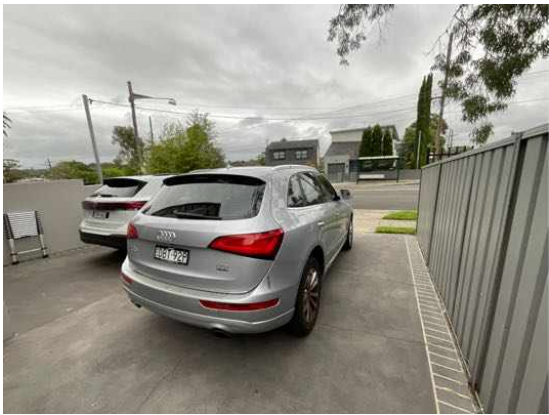
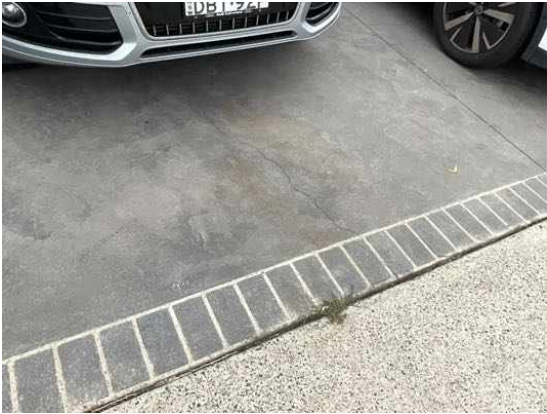
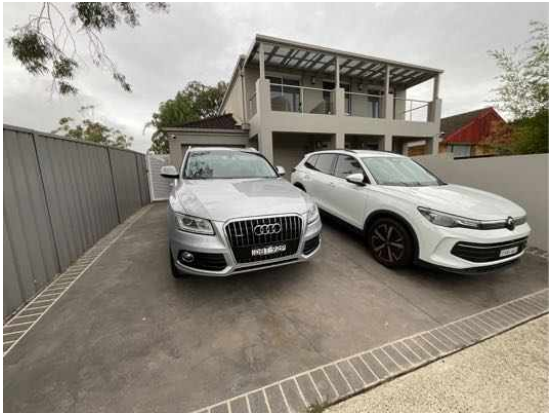
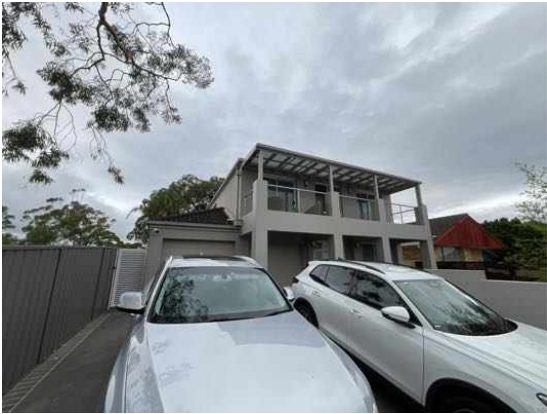
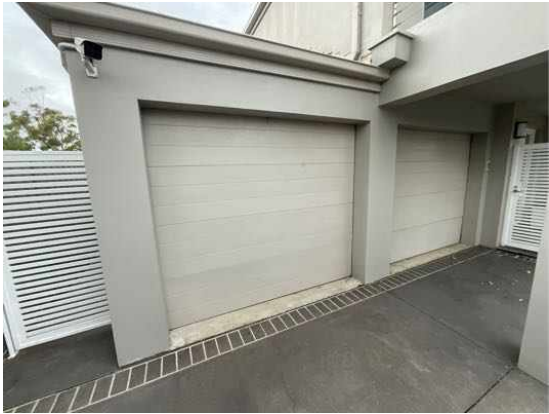
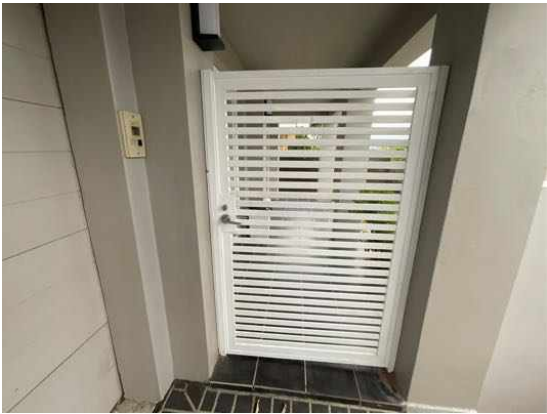
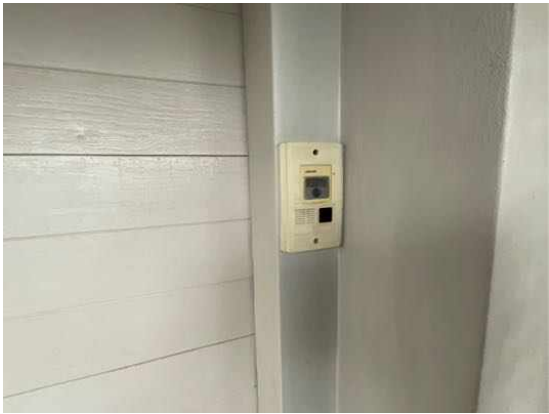
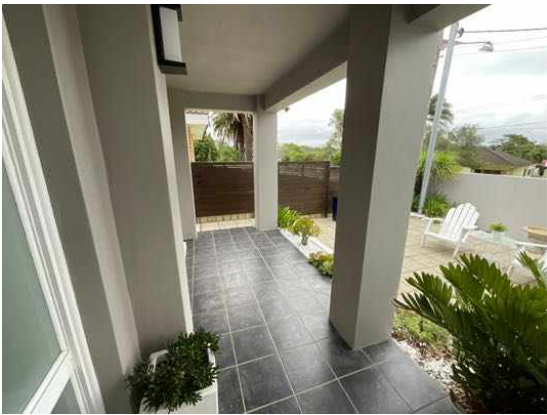
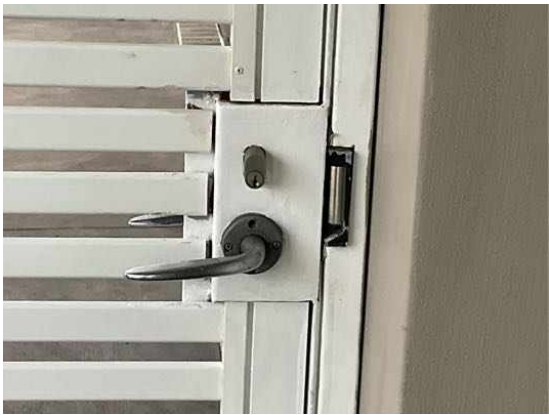
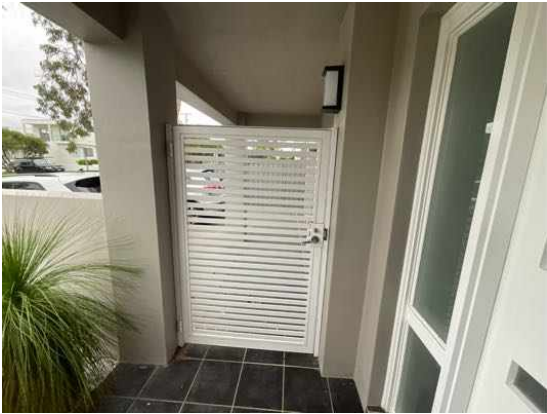
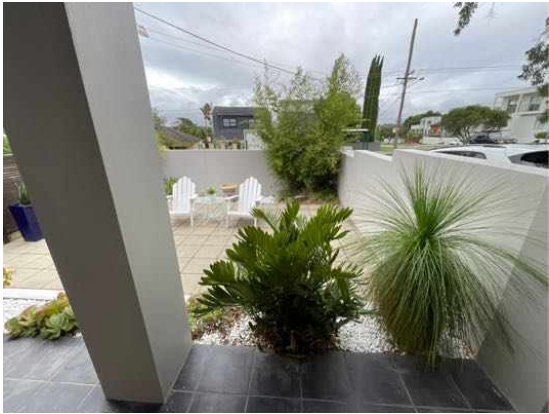
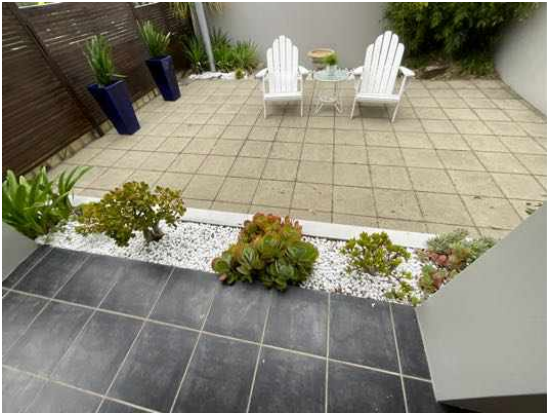
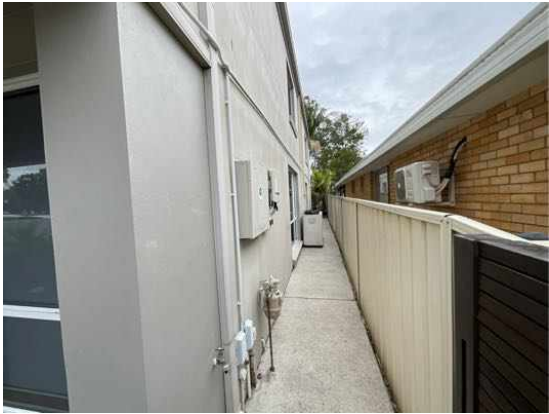
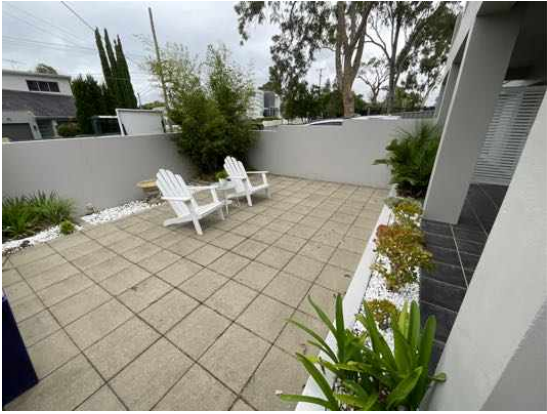
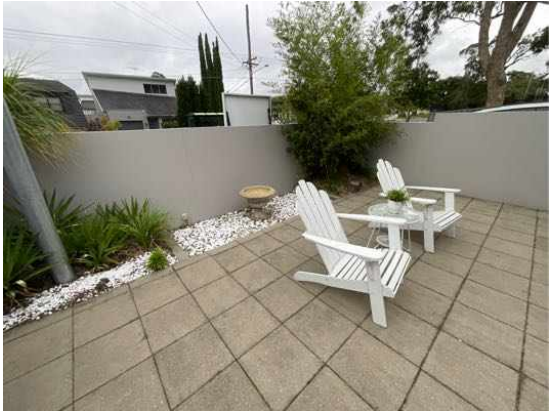
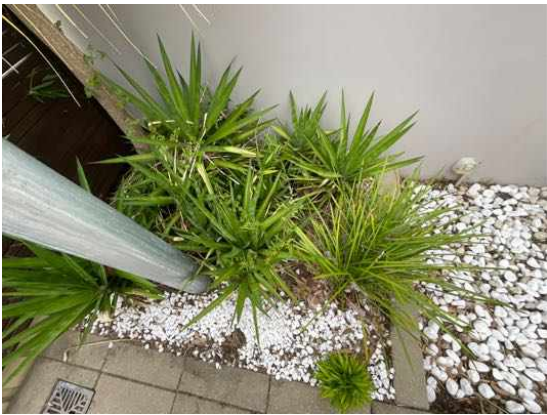
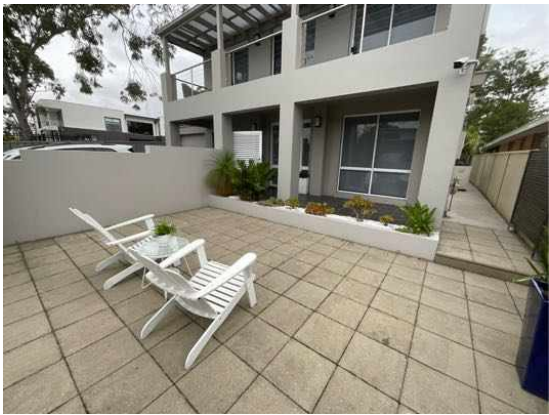
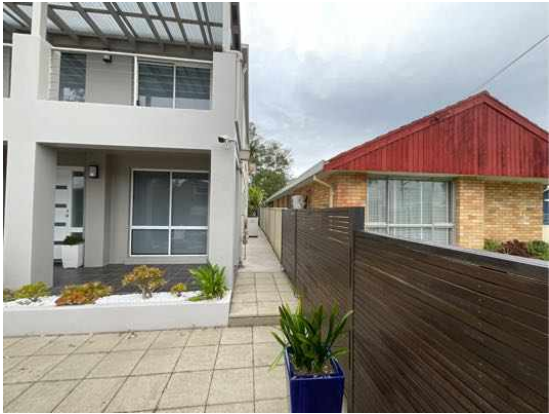
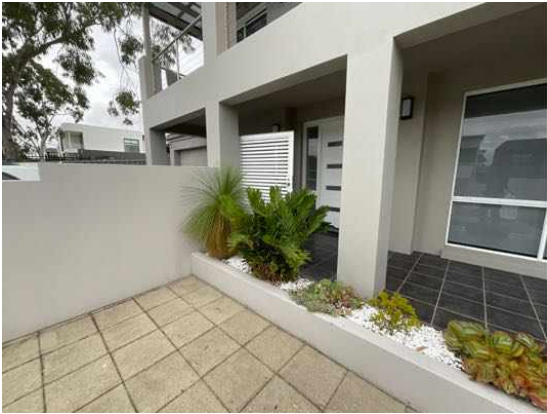
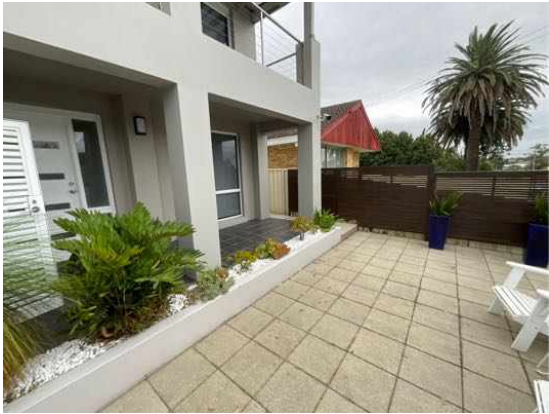
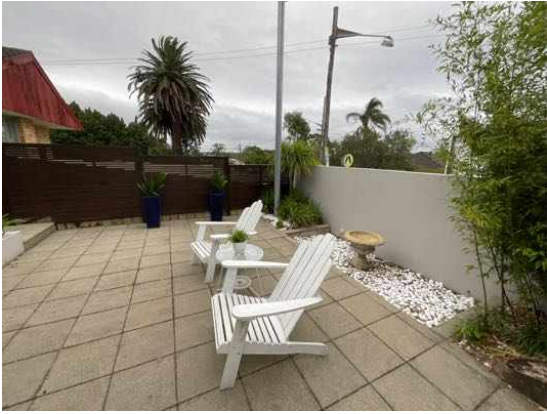
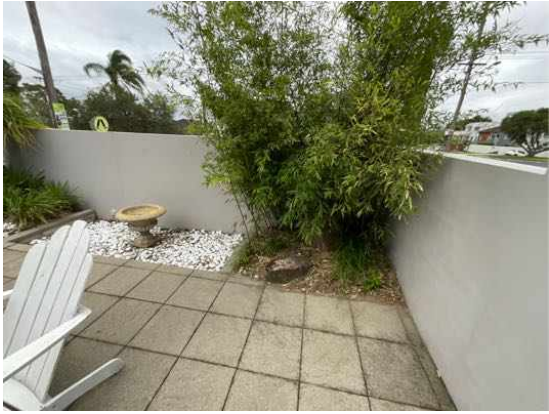
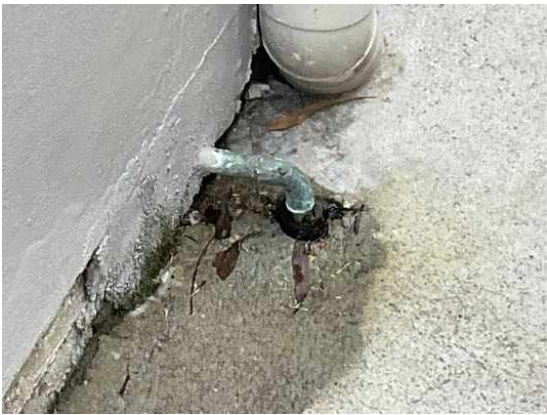
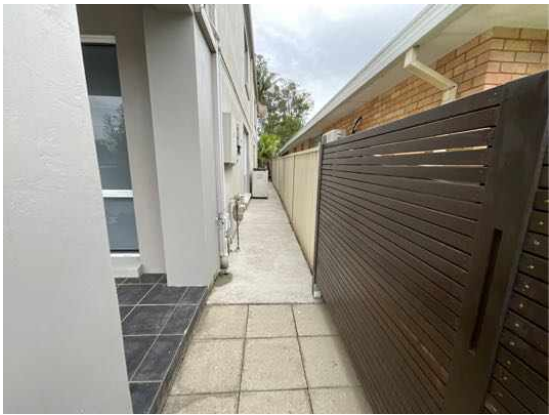
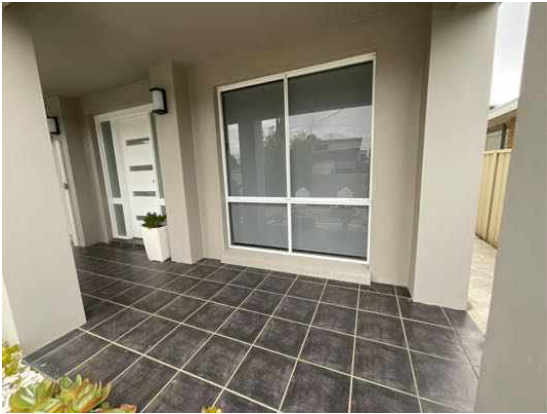
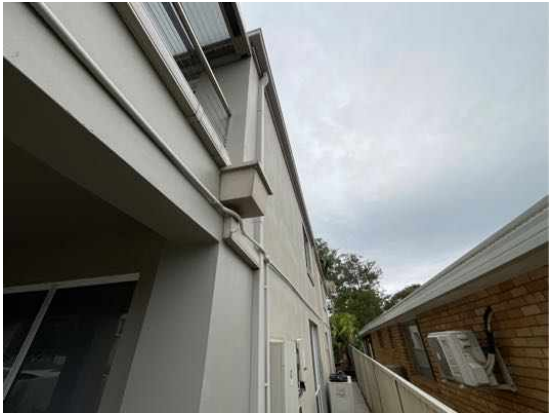
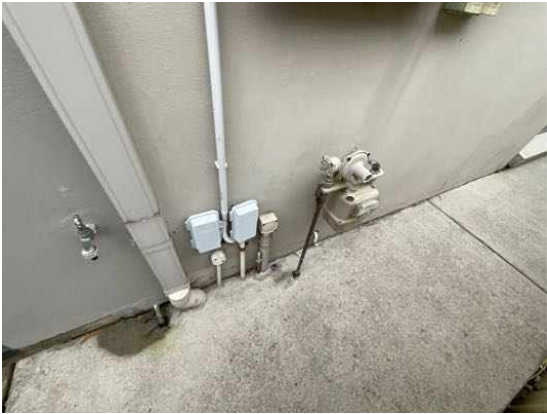
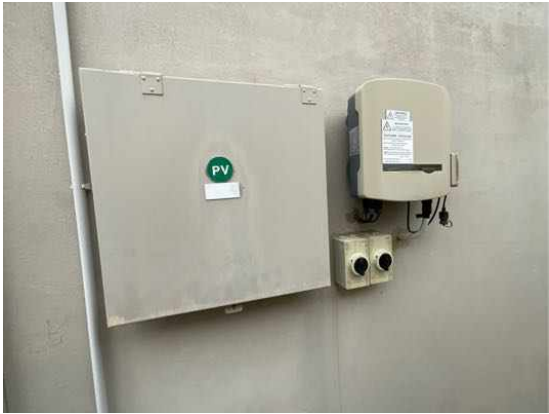
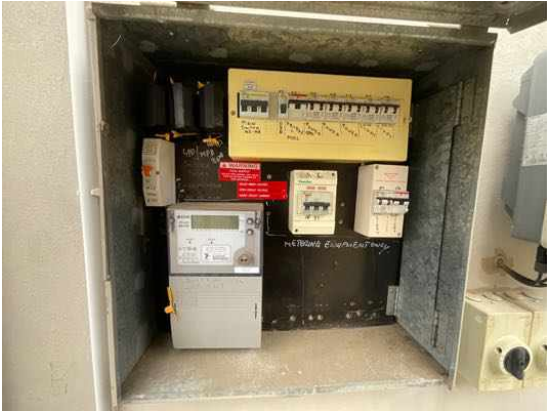
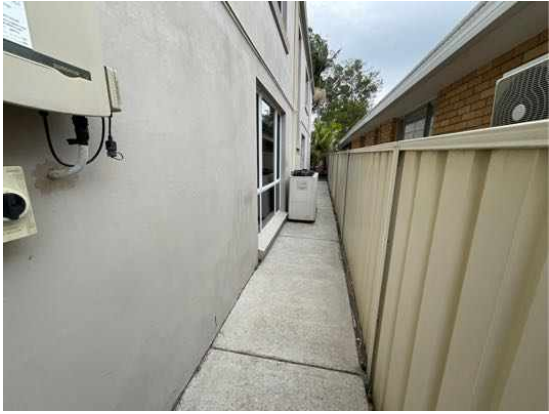
Building: Main Building  
Location: All Areas  
Finding: Additional Photos - Obstructions and Limitations  
Information: These photographs are an indication of the obstructions and limitations which impeded full inspection of the property at the time of inspection. These obstructions can hide an array of defects and should be removed to allow full inspection to be carried out. A re-inspection is recommended once the areas are made accessible.

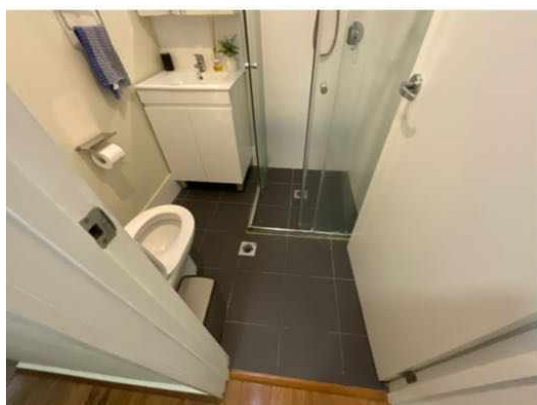
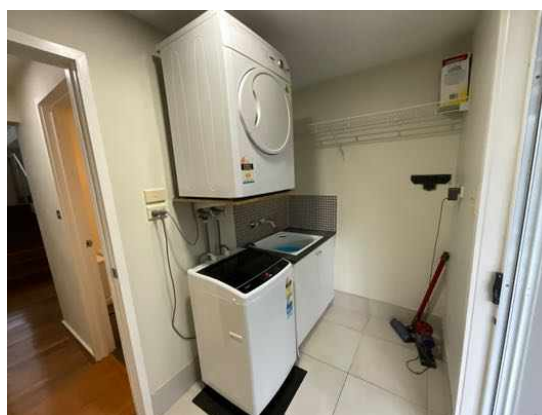
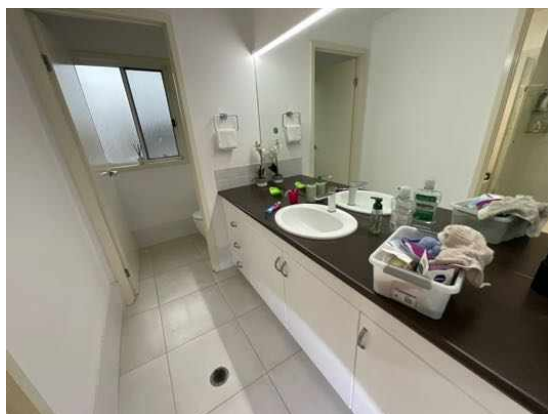
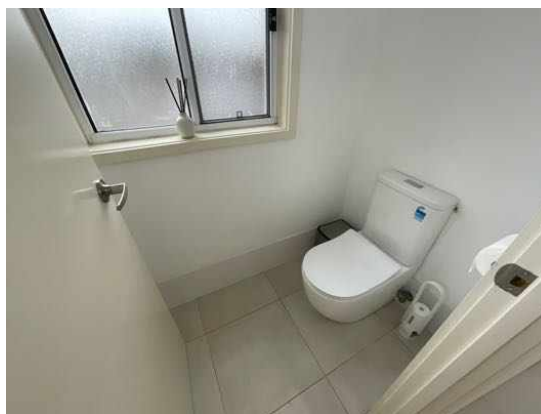
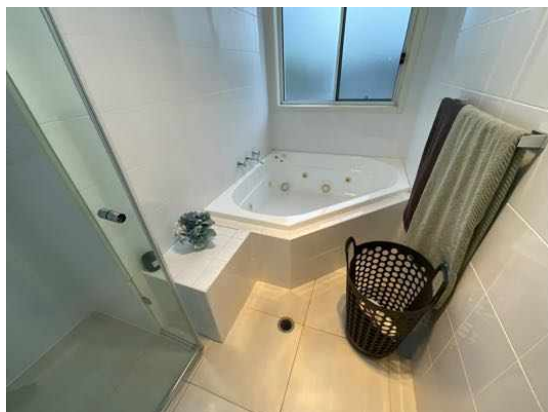
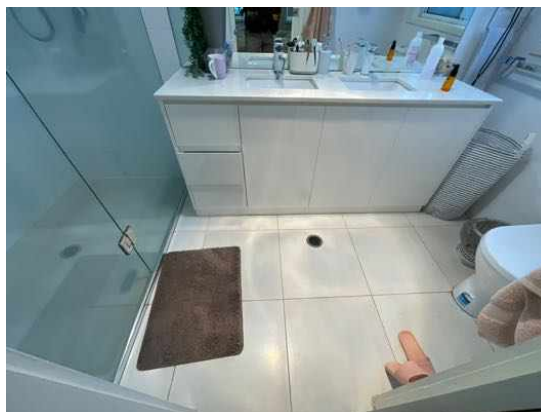
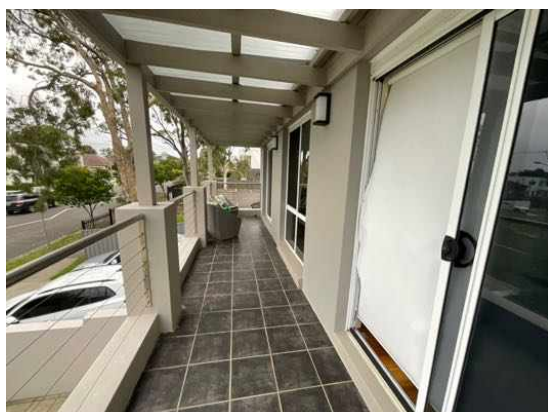
Building:	Main Building
Location:	All Areas
Finding:	Water Proofing Membranes - Information Only
Information:	<p>Internal Water Proofing Membranes, are crucial in preventing water ingress into the property is important to know that the Membrane System used is to Australian Standards and has been installed correctly. Please refer to the original Building Documents or Maintenance Schedule for the relevant information including; - Membrane used and Manufacturers Specifications. - The Installer and Installation Certification. Especially with older property's where this information is unavailable, all wet areas should be monitored. Generally new waterproofing with a certificate may only have a guarantee of 8yrs. If any leaks, water staining, peeling or bubbling of the paint become evident to any adjacent walls or ceilings below a licensed builder or waterproofing specialist is recommended to investigate further.</p>
