Building and Timber Pest Inspection Report

Inspection Date: Tue, 24 Mar 2026

Property Address: 4/53 Carruthers Dr, Modbury North SA
5092, Australia

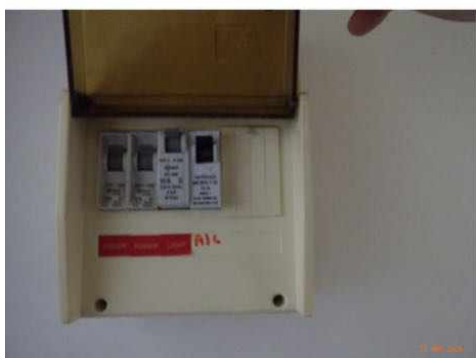
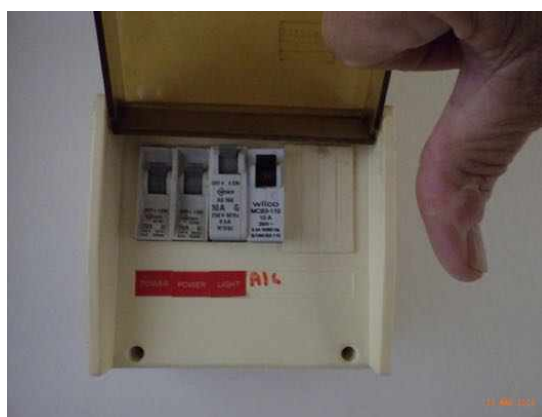
| Finding: | Electrical switchboard - Safety switch missing |

Generally, the switchboard is out-dated and should be fitted with a safety switch as soon as possible to improve the safety of the property. It is advised that a qualified electrician be contacted immediately to install a safety switch and provide any further advice on additional works that may be required in this State.

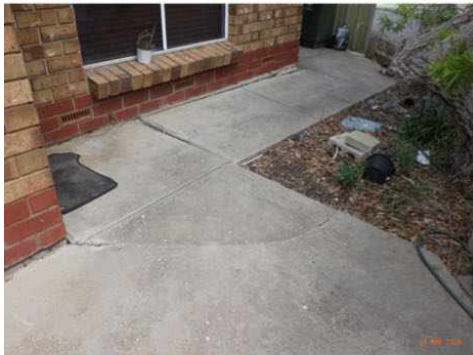
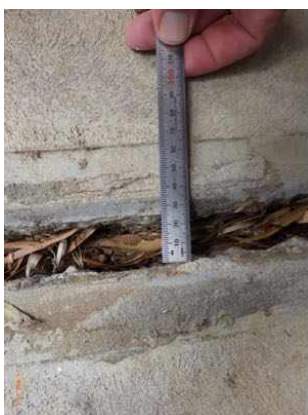
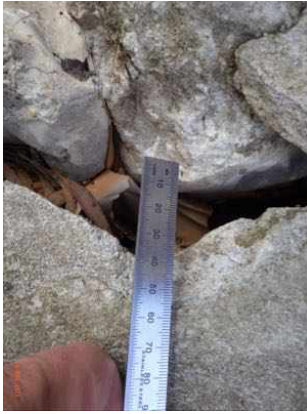
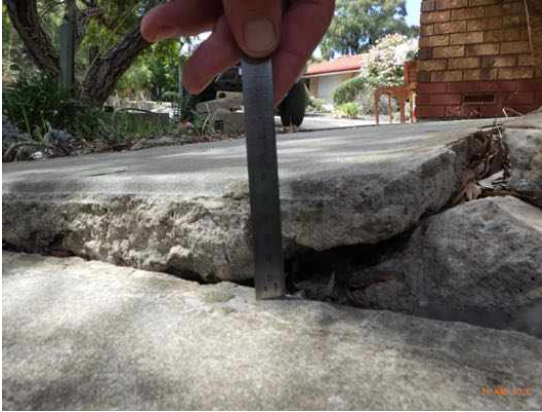
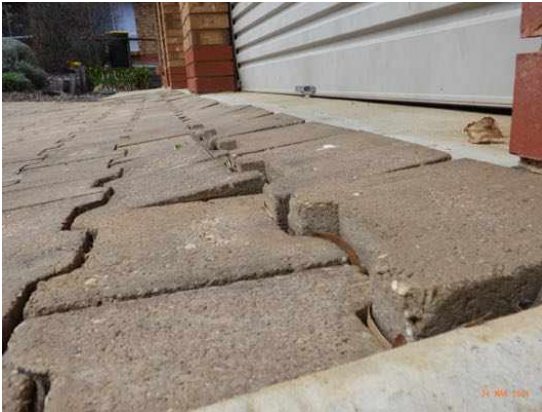
Finding 2.01

Finding: Cracking - External Concrete Paving Damage Category 4 - Gaps in Slab (4mm - 10mm +)

Information: Wide cracks/ movement was identified in external concrete paving to the front area at the time of inspection. The concrete movement along with the settlement of the dwelling are likely indicators of highly reactive soil/ foundation in the area.

Movement is significant and has lead to the development of a safety hazard.

General age and or deterioration of the paved areas is a common cause of this type of cracking. However, expansion and contraction of the slab may also have occurred due to environmental factors. Such factors include variable moisture and weather conditions, the presence of trees and their roots, poorly managed stormwater having a settling or lifting affect on the soil over a sustained period of time.

Cracking to this degree may also be due to poor original installation of the concrete. Factors such as poor compaction of the sub surface and/or inadequate reinforcing of the slab may create cracking and other secondary defects. Gaps in the concrete paving may also have a more significant structural cause, such as subsidence of soils.

Significant repair and likely replacement of the concrete paving is probable and should be conducted by a licensed concrete paving company.

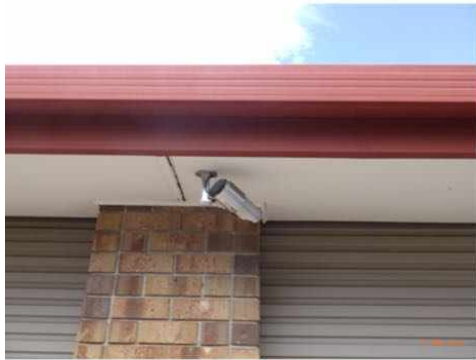
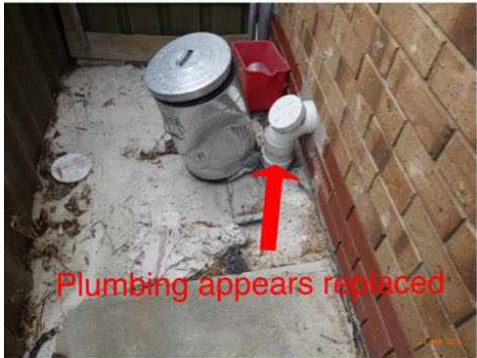
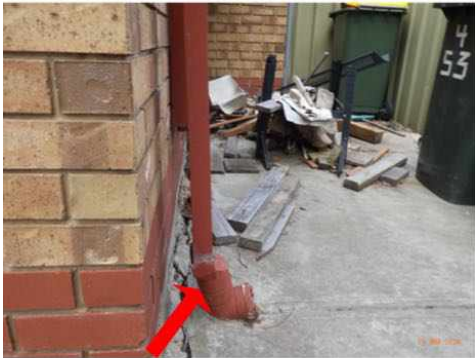
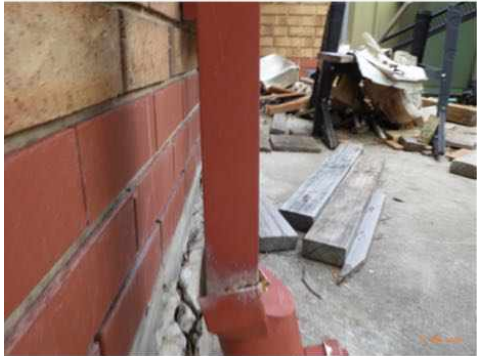
Finding 2.02

Building: Building 1
 Location: Exterior walls
 Finding: Brickwork / Eaves linings cracks and gaps >10mm
 Information: There are several minor cracks evident throughout the exterior of the dwelling at the rear right hand corner. These cracks are commonly less than 5mm in width and are expected in a property of this age and can be easily filled and monitored in the future.

Floors were found to be out of level by approximately 40mm over the bedroom and some brick walls were out of plumb by 30mm over the height of the wall.

There are also several larger more noticeable major cracks and all gaps around

windows and to eaves linings to the dwelling. These cracks usually coincide with openings (windows and doors) however they can present in other areas also. Cracks of this type are likely to have been caused by minor expected movement of building elements, but may also have a structural cause that is more significant.

Noticeable cracks in brickwork may develop if left unattended with the potential of necessitating remedial works or replacement of sections of brickwork. Always monitor these cracks and contact a building inspector should cracks widen lengthen or become more numerous.

Consultation with a structural engineer may be required where structural instability is found to be the underlying cause of the cracking. Following this repair works could be carried out by a structural repair company and may include some form of underpinning when this level of movement is observed. It is also prudent to have all plumbing in the area. Forensically checked to ensure that there is no damaged plumbing which could be exacerbating the movement to the dwelling.

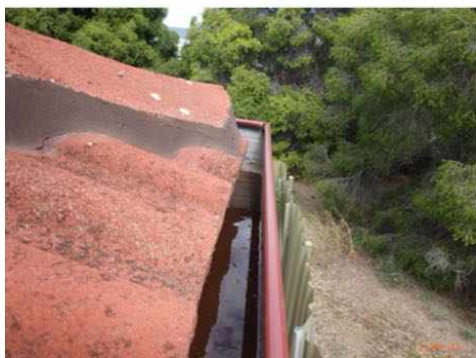
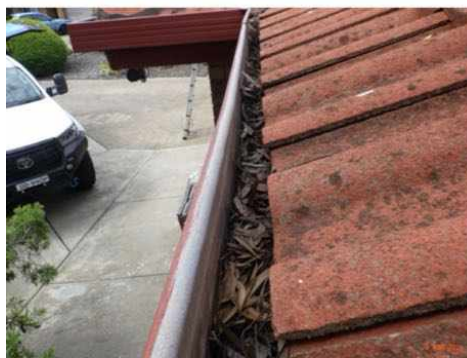
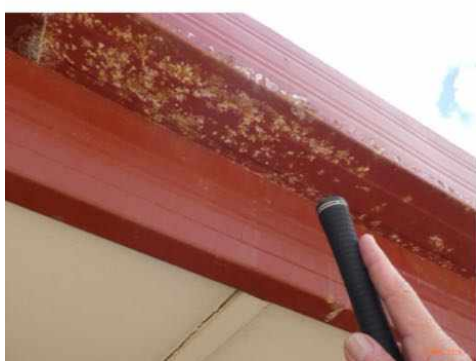
Finding 2.03

Building: Building 1
Location: Roof Exterior
Finding: Gutters - Water pooling
Information: Water was found to be pooling in sections of the roof guttering. This is generally a secondary defect caused by blocked or partially blocked gutters. Such blockages and subsequent water pooling are likely to lead to rust and water damage to associated structures if left unattended. They're also appears to be some rusted gutters.

It is quite likely that the subsidence of the building has caused gutters to be running out of level

Any areas of guttering that shows evidence of water pooling should be checked for partial or full blockages and any secondary damage that may have occurred as a result. Depending on the extent of the damage, building elements may require repair and/or replacement to ensure adequate roof drainage and function of exterior plumbing system.

A roofing plumber should be appointed as soon as possible to rectify this issue. It is highly advised that all gutters be maintained on a frequent basis to ensure the condition of roof plumbing.

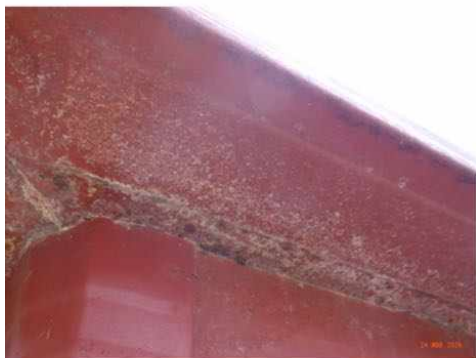
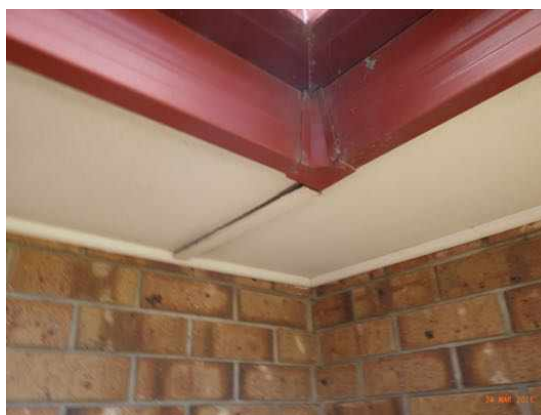
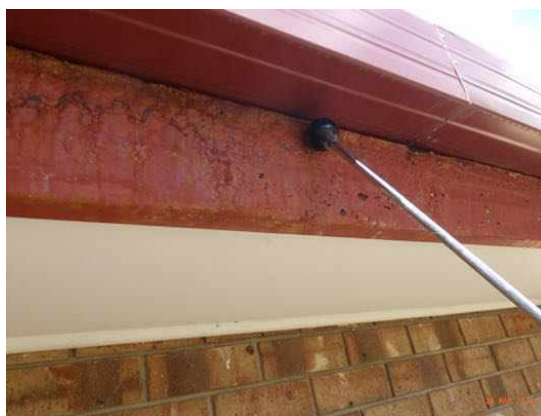
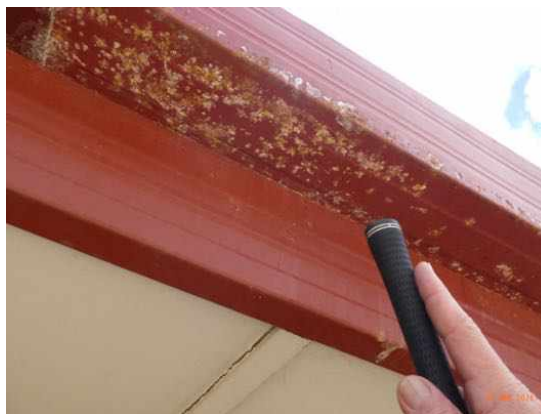
Finding 2.04

Building: Building 1
Location: Roof Exterior
Finding: Roof plumbing - Rusted or corroded
Information: The roof plumbing has areas of rust and corrosion. It is suspected that this has been caused by blockages, resulting in pooling or standing water, that have prematurely rusted elements of the roof plumbing.

Rusted roof plumbing will generally develop holes and leaks that can affect other building elements with poor drainage of storm water.

Poorly drained roof areas will also lead to damp conditions surrounding the base perimeter of the building which, if left unmanaged, can lead to a range of secondary building defects.

Repair and/or replacement of rusted roof plumbing is highly required in order to reinstate the roof drainage system to a fully operational level.

To further maintain these areas, gutters should be cleaned frequently, allowing the avoidance of any partial blockages.

A licensed plumber or specialist roof restoration company should be appointed to undertake these works. It is advised that such works be completed as soon as possible to prevent any further damage and deterioration.

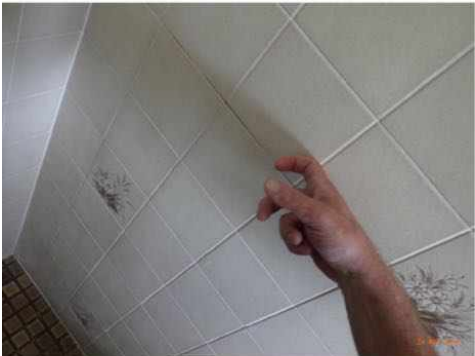
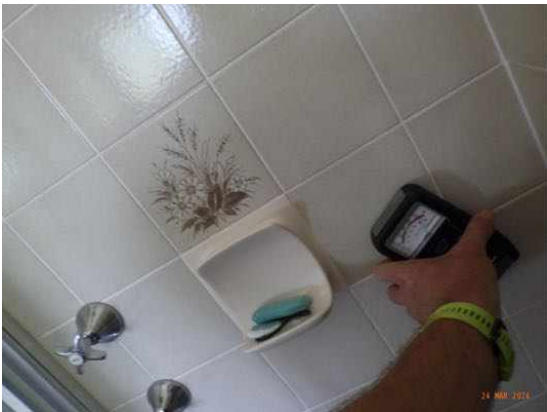
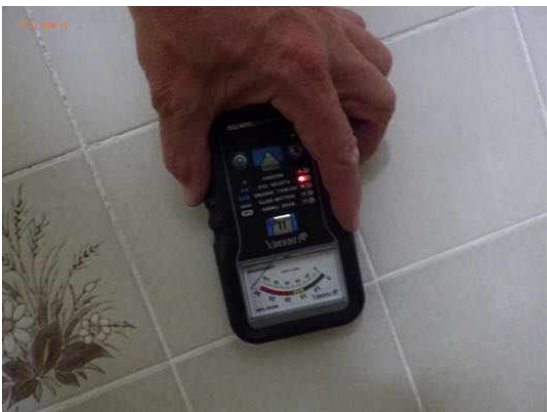
Finding 2.05

This defect is quite common, and is suspected to have been caused by moisture permeating through the tiling, grouting and or sealant in this area, which shows evidence of deterioration. There are also a few drummy tiles evident to the walls.

Leaking pipes within the adjoining wall is also a possible cause however it seems unlikely in this instance as there are only small areas of high moisture transferring to the other side of the wall

In the shower area, internal water leaks or other sources of excessive moisture are generally the cause of damp.

Unmanaged damp in the shower recess is likely to facilitate the formation and development of mould and fungi growth, decaying associated building materials and

compromising their structural integrity. High moisture around timber elements also creates an environment that is conducive to termite activity. Further investigation would likely uncover currently concealed defects.

Consultation with a qualified plumber or bathroom specialist is advised immediately to identify the cause of damp and to perform remedial works as required.

As the bathroom is getting quite old for bathroom renovation will likely be required in the Short to midterm

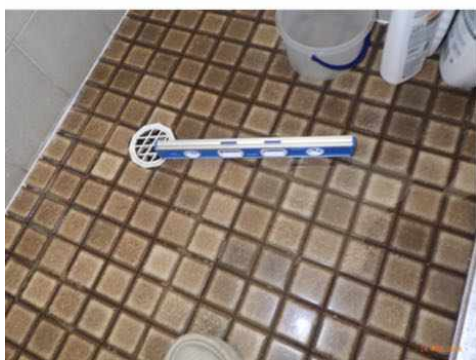
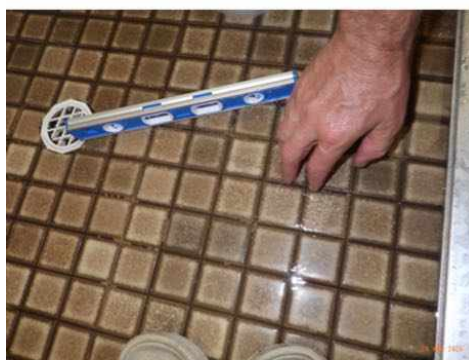
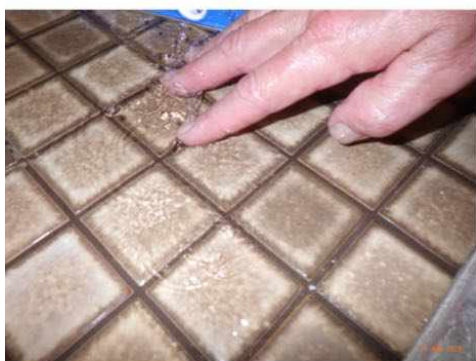
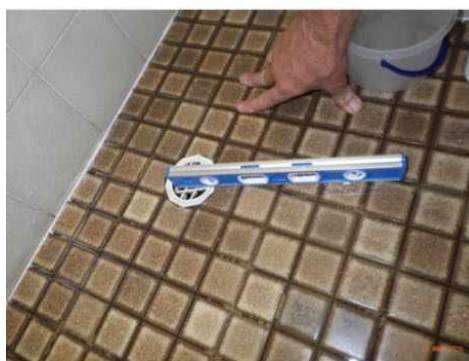
Finding 2.06

Building: Building 1
Location: Bathroom
Finding: Shower base - Water pooling
Information: Evidence of water pooling around the floor waste in the shower recess was noticed at the time of inspection. It is suspected that this excessive moisture is attributed to insufficient fall in the shower floor tiles.

This pooling is minor overall but is still considered unsatisfactory, as standard tiling practices would not permit this situation to occur. Pooling water around floor wastes can create a slip hazard in extreme cases and create conditions that are conducive to mould growth over time. Where left unmanaged, the degradation of sealant and grouting is also likely to occur, possibly necessitating further repair works.

It is possible that the incorrect fault is due to the subsidence of the right side of the building.

Remedial works may involve some sections of tiling and flooring repair and replacement. A tiling contractor or bathroom specialist should be appointed to provide further advice on reparation options and to perform works as necessary.

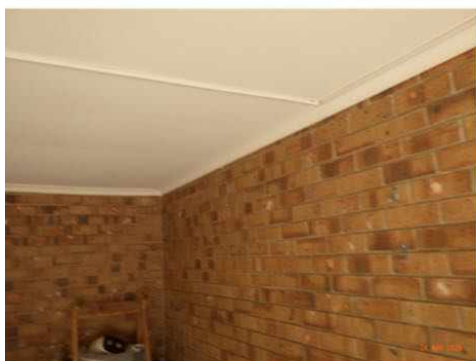
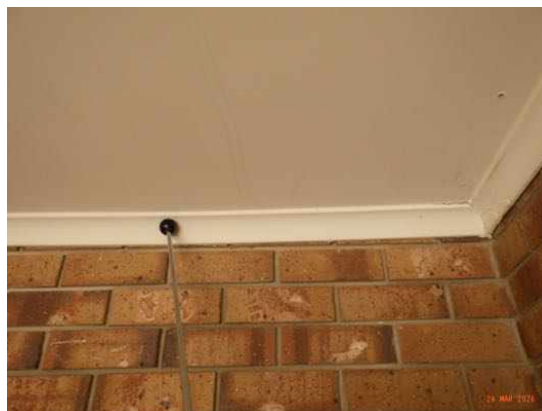
Finding 3.01

| Information: | Sections of the garage ceiling were found to be sagging at the time of inspection. Sagging to the fixed ceiling structure generally indicates that the building materials have swollen, due to contact with water, or that fixings (e.g. nails or glue) have become loose and require reattachment. |

Such works may be performed by relevant tradespeople, such as carpenters, plasterers and painters along with repairing the cracks.

It is recommended to insulate the area also to prevent further damage in the future.

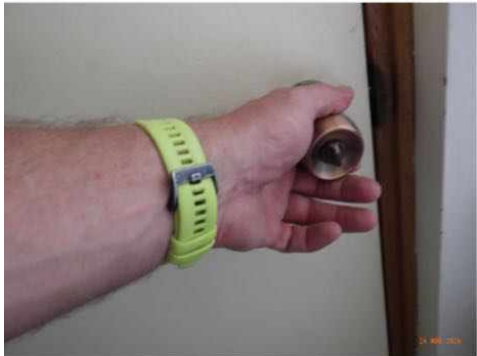
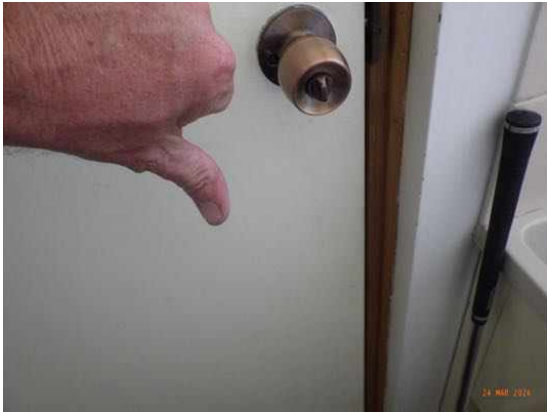
Finding 3.02

The lock in this area was not operational at the time of inspection. Where locks have deteriorated to a point where they are no longer usable, the security of the property is immediately compromised.

Repair or replacement of the lock is highly recommended. Consultation with a locksmith or general handyman is required to gain further advice on any added security that may be available for the area.

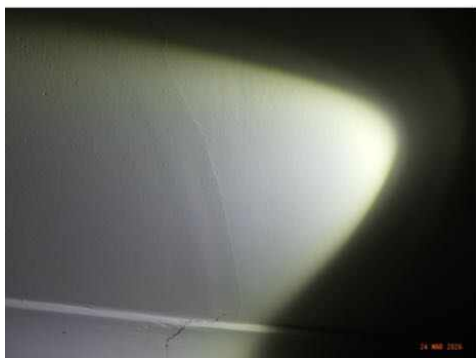
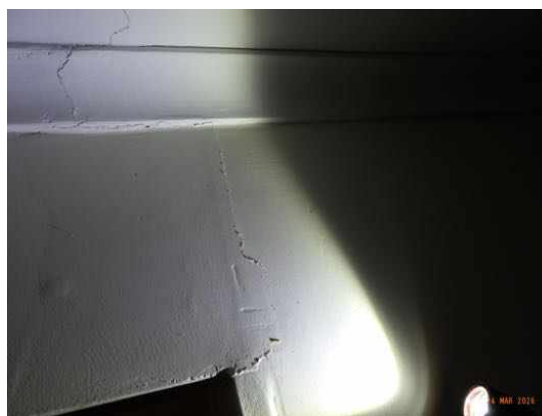
Finding 3.03

| Finding: | Cracking - Damage Category 2 - Noticeable (up to 5mm) |

Monitoring of all cracking should be conducted frequently. Always contact a building inspector should cracks widen, lengthen, or become more numerous. Additionally, your building inspector should also be contacted if associated building elements such as doors and windows become more difficult to operate over time.

Relevant tradespeople, such as carpenters, painters and plasterers, should be appointed to perform remedial works, as deemed necessary.

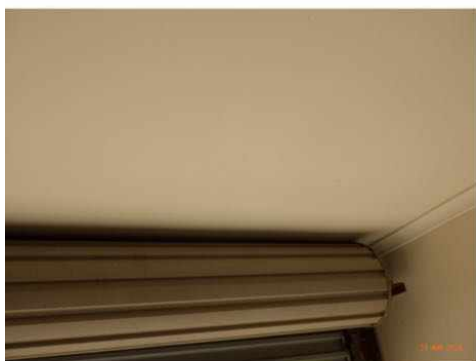
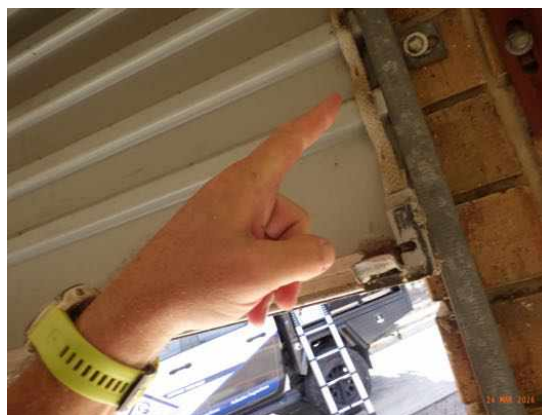
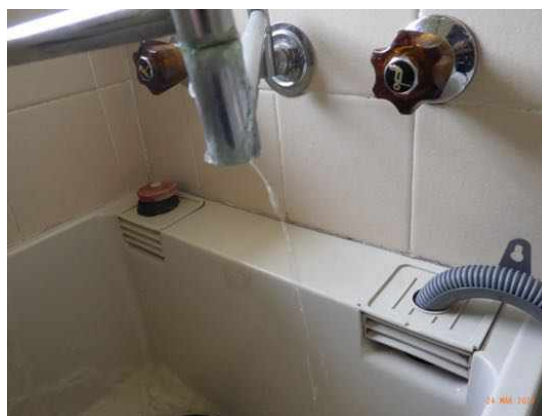
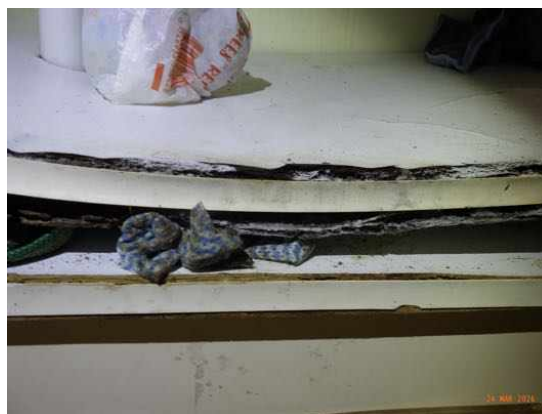
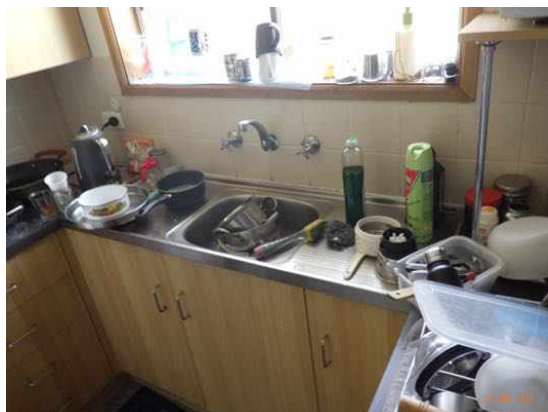
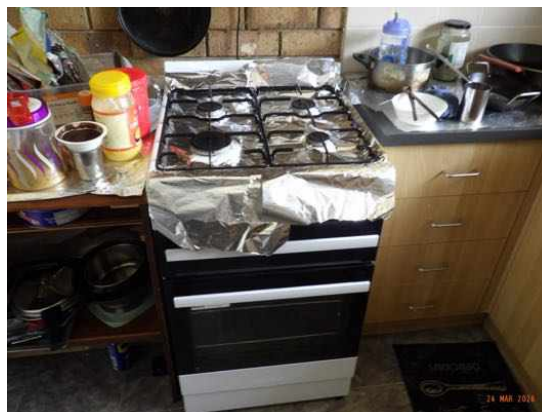
Finding 3.04

- Roller door opening has spread and door is out of track
- Leak to laundry tap
- Kitchen and vanity are deteriorated.

While these defects are not considered structurally significant at present, they should be addressed as part of routine and ongoing property maintenance to prevent further deterioration. Repairs and maintenance works should be carried out by appropriately licensed and qualified tradespeople to ensure the continued serviceability and longevity of the dwelling.

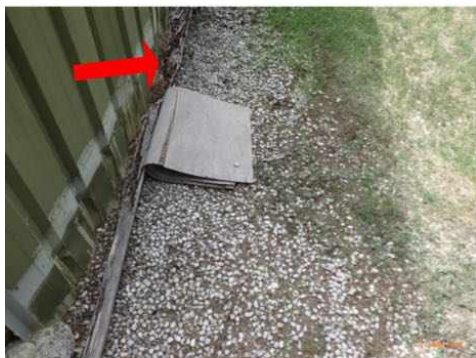
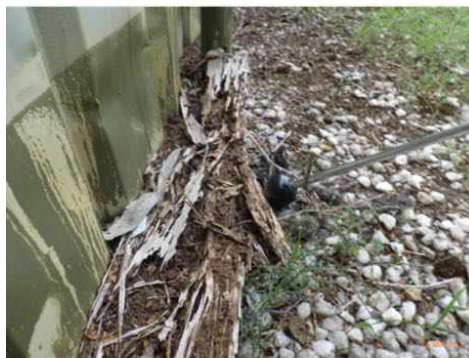
Building: Building 1
 Location: Yard - Back
 Finding: Evidence of termite damage - minor
 Information: Despite no live termite or timber pest activity being indicated, previous termite damage was found to have affected this area. This damage is considered to be inactive and is minor in nature.

It is advised that the area be visually inspected frequently to ensure that the condition of affected building materials does not worsen. At the time of inspection, damage is not structural and is only considered to be superficial.

A building contractor may be appointed to provide a further invasive inspection if further damage is evident.

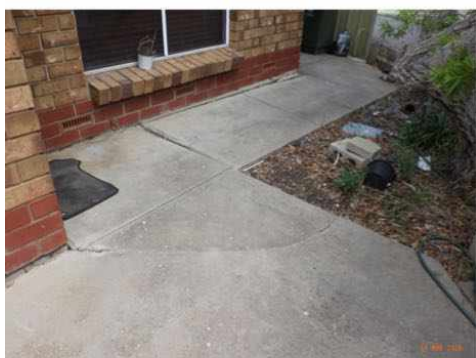
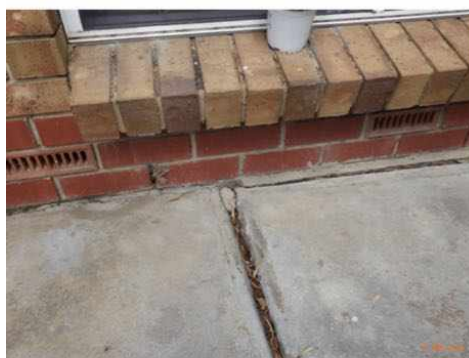
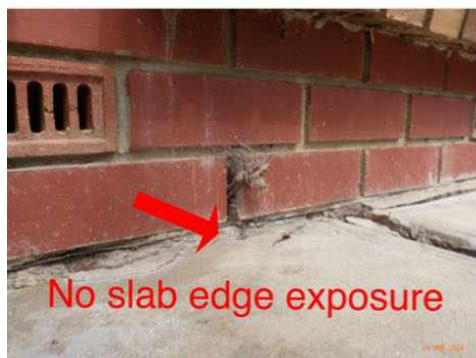
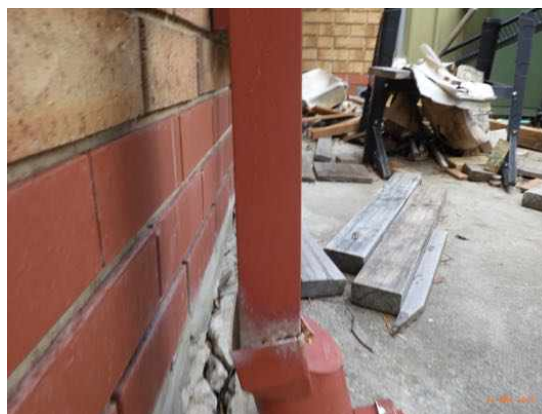
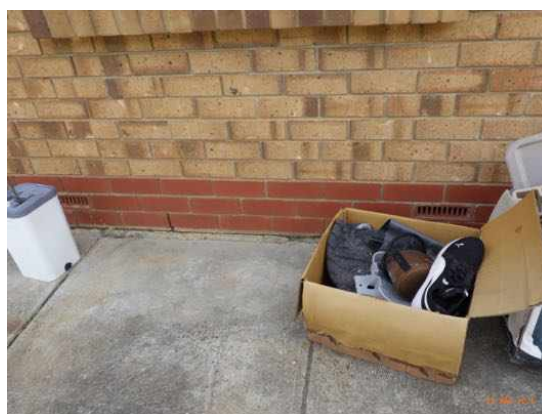
Finding 6.01

If the slab edge is not properly exposed there is a high risk of concealed termite attack which your inspector will likely not be able to see. Sometimes, in order to determine the type of slab, a suitably qualified person such as an architect or builder may be required to consult construction plans.

Where the slab edge cannot be properly inspected, it is highly recommended that termite or timber pest inspections be carried out every 6-12 months to aid protection of the property against infestation and termite treatment advice is followed closely.

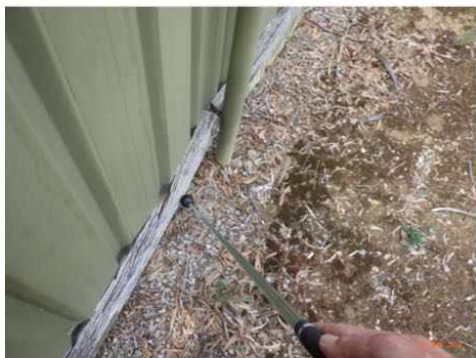
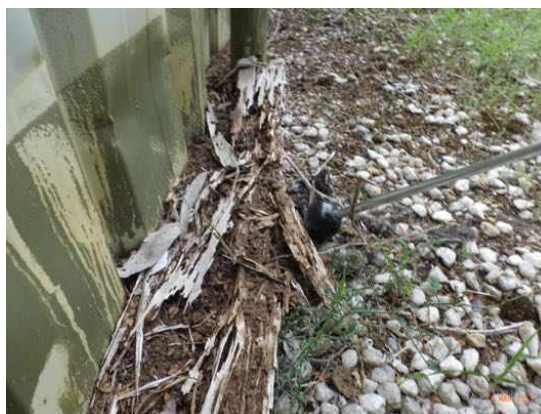
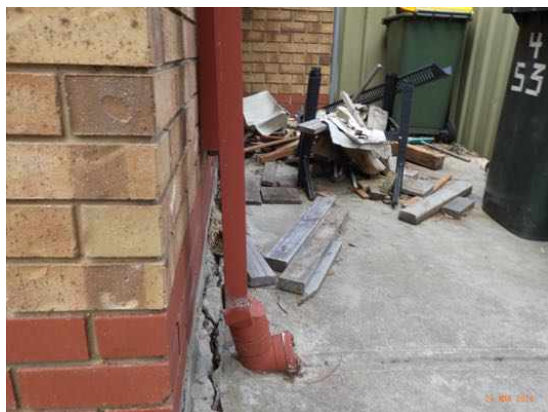
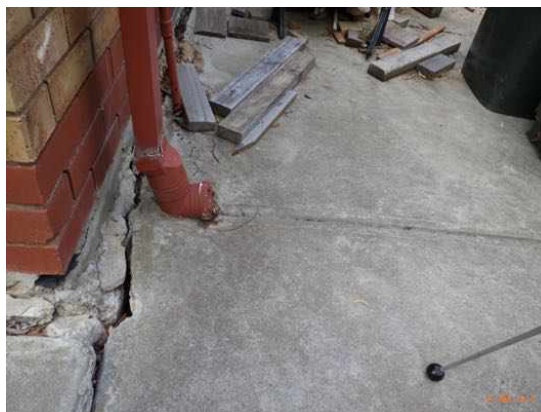
Finding 6.02

| Finding: | Untreated or non-durable timbers in a hazardous environment |
| Information: | To reduce the risk of timber pest attack it is essential that timber used in a hazardous environment (e.g. in direct contact with the ground or frequently exposed to damp conditions) is of sufficient durability and/or is adequately preservative treated. Additionally any timber lying around or timber stumps should be removed. |

Untreated timbers in direct contact with the ground are likely to develop severe wood rot and/or fungal decay if left unattended creating attraction for subterranean termites to infest the timbers from surrounding areas.

If untreated or non-durable timbers are found to be in a hazardous environment it is highly advised that replacement of these building elements be performed as soon as possible to aid the protection of the property against termite / timber pest attack. Failing this close monitoring is recommended in an attempt to identify termite infestation at an early stage.

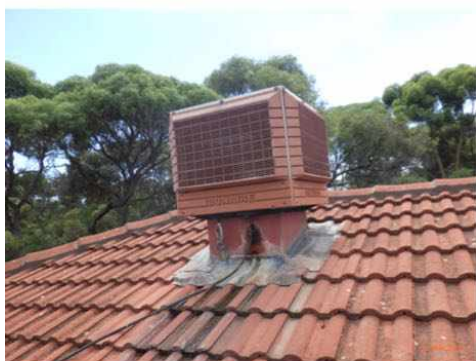
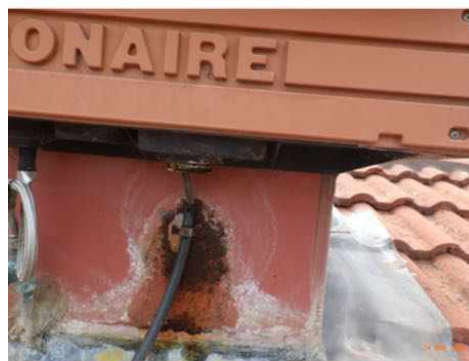
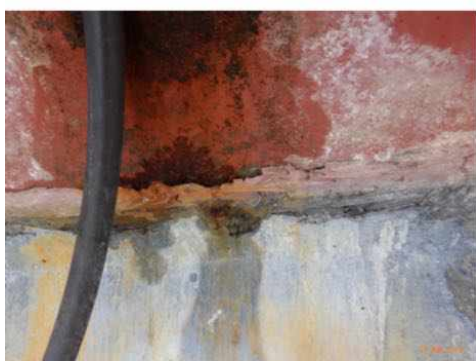
Finding: Air conditioner, Stormwater and or external tap - No drainage
 Information: Moisture around the building should be minimised to ensure that the area is kept dry and stable which in turn reduces the risk of water damage and termite infestation.

Several issues exist with regard to drainage including but not limited to exterior taps with no drains.

It is recommended that a licensed plumber be appointed to set up drainage in order to prevent such an environment from being created.

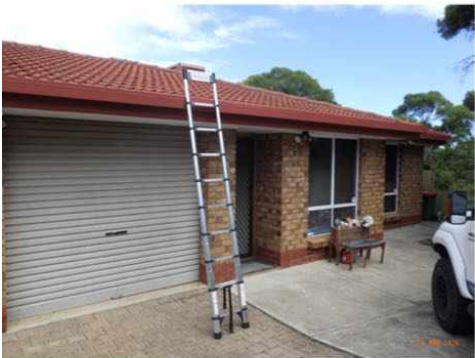
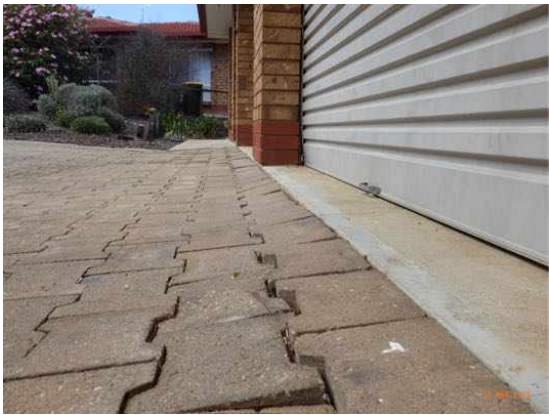
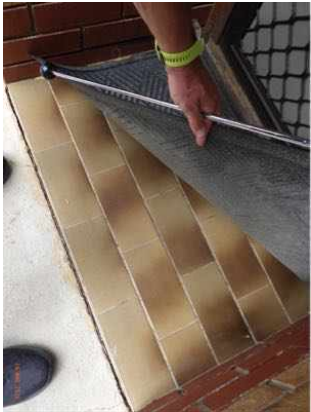
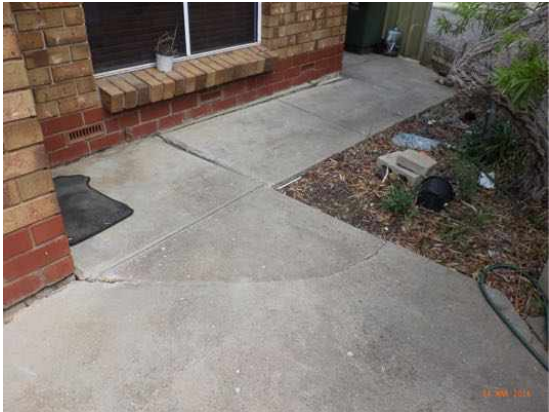
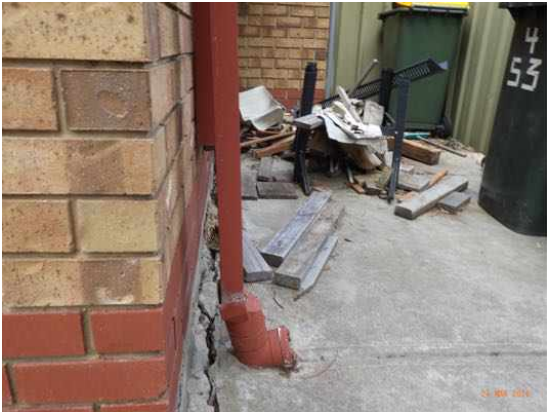
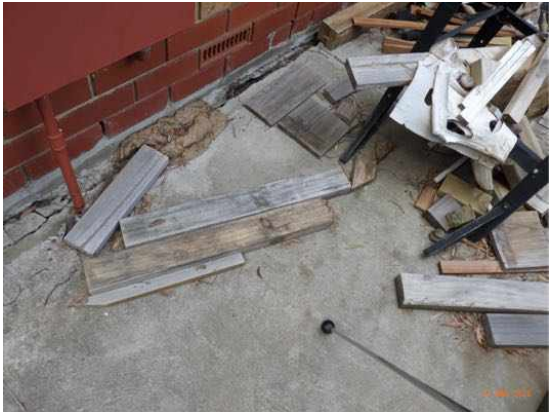
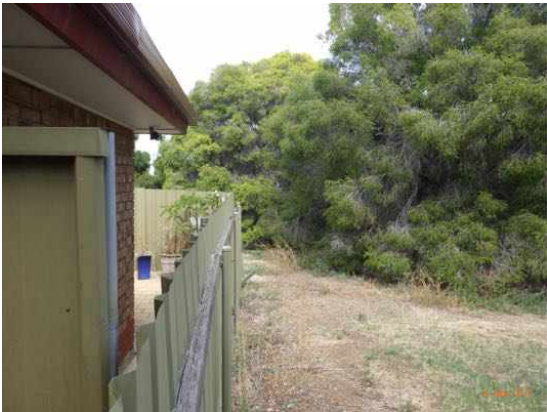
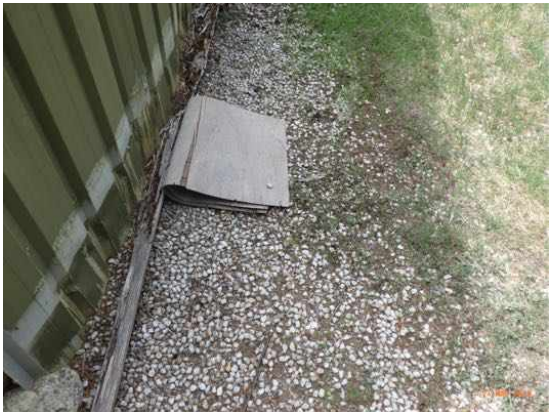
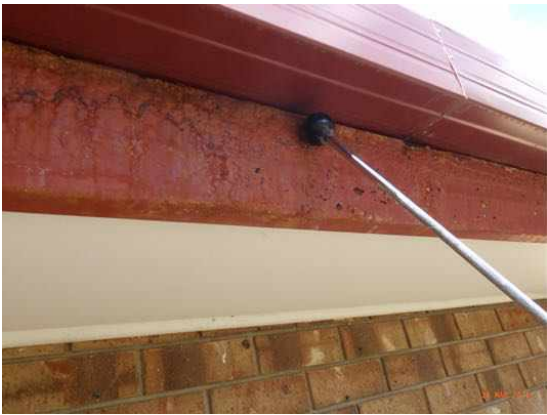
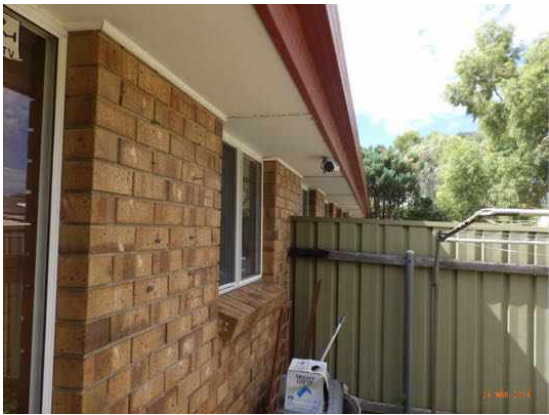
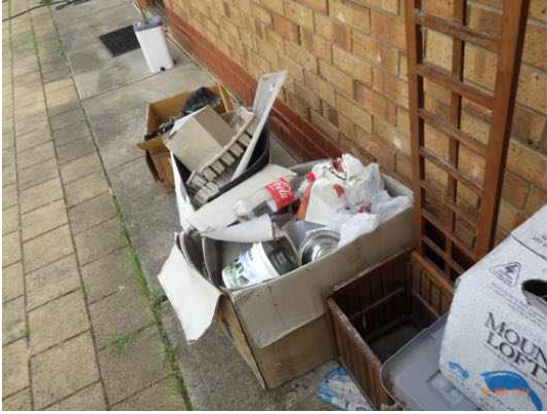
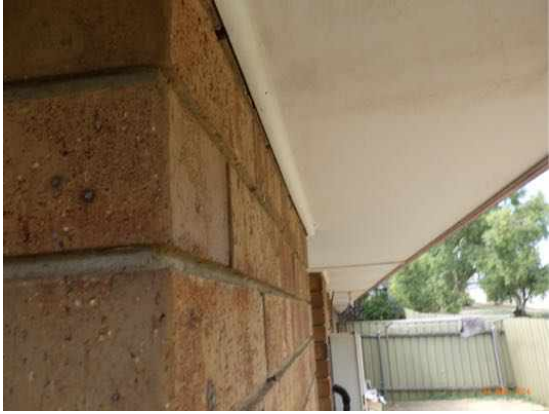
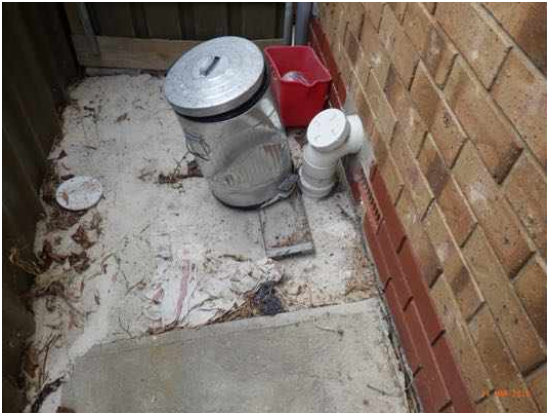
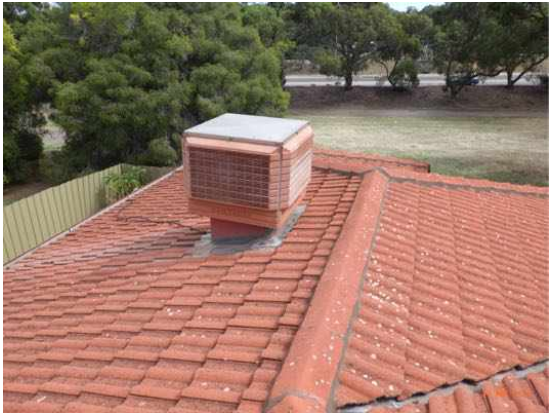
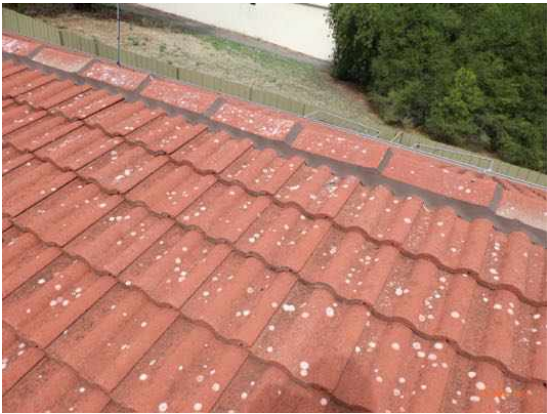
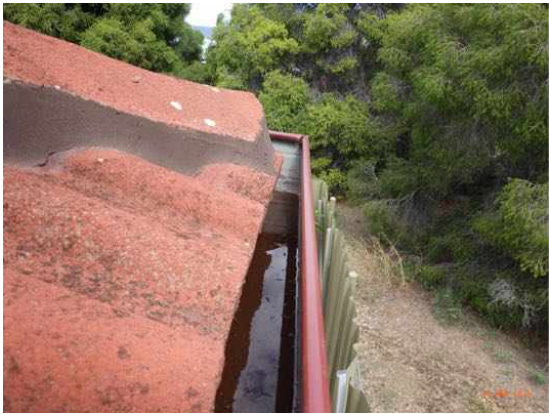
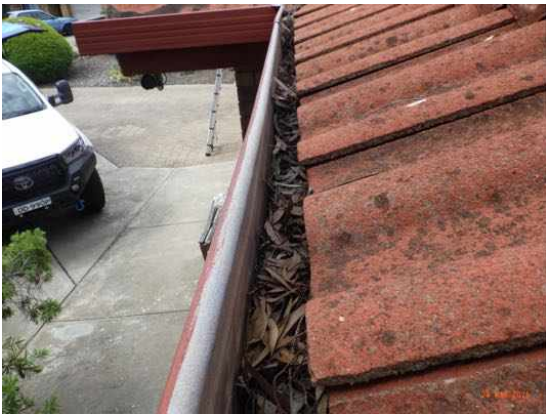
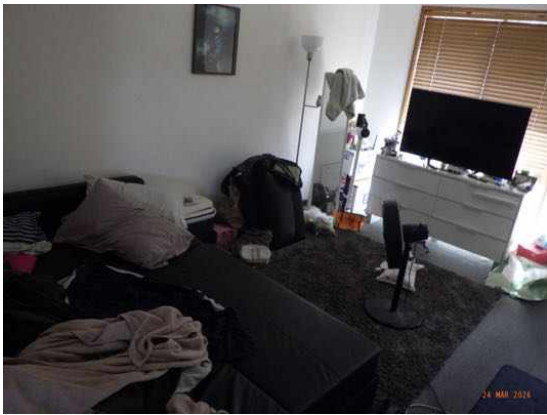
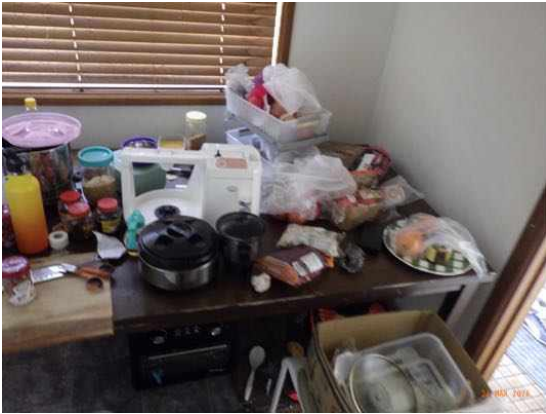
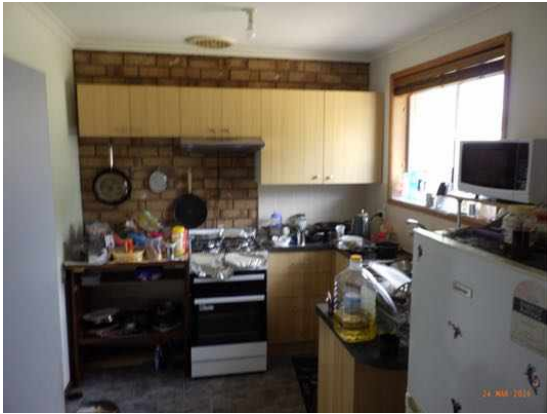
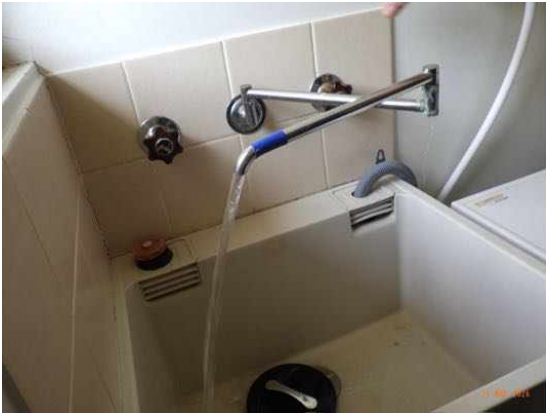
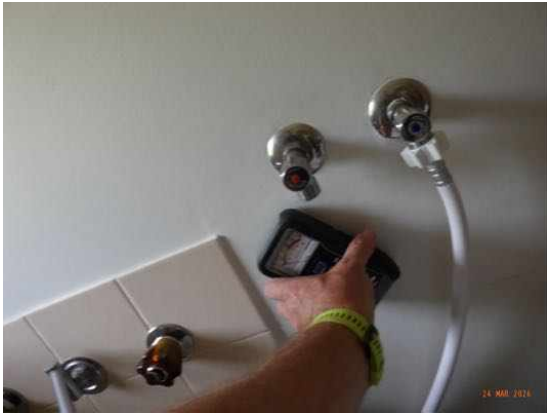
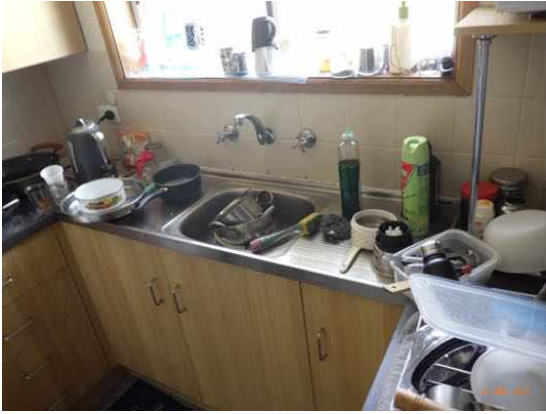
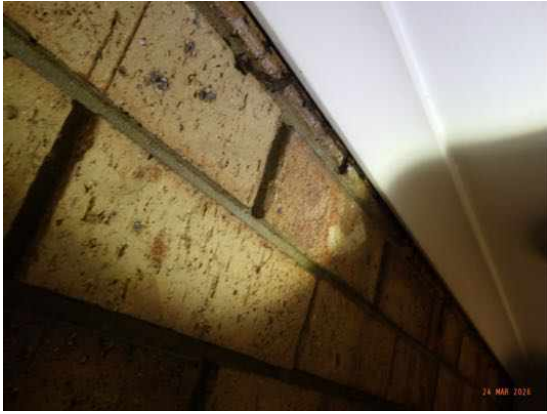
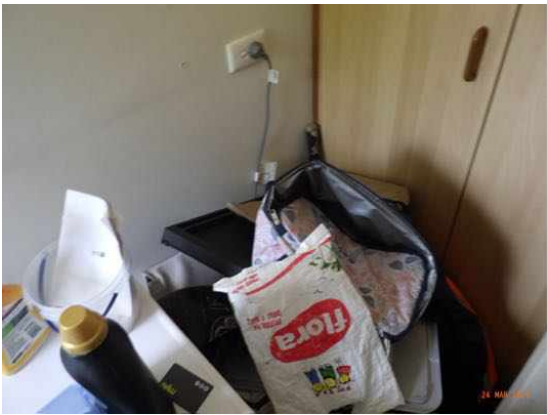
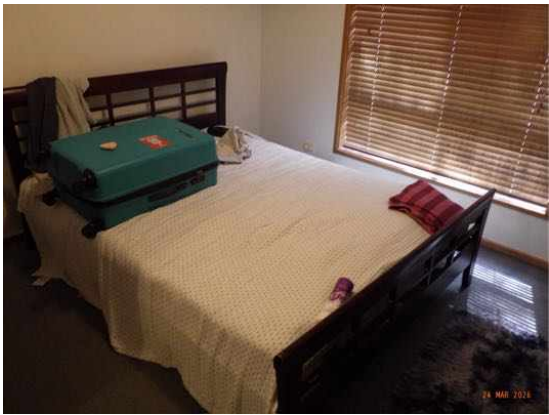
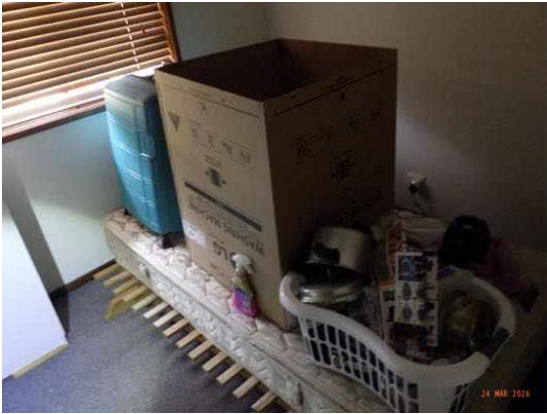
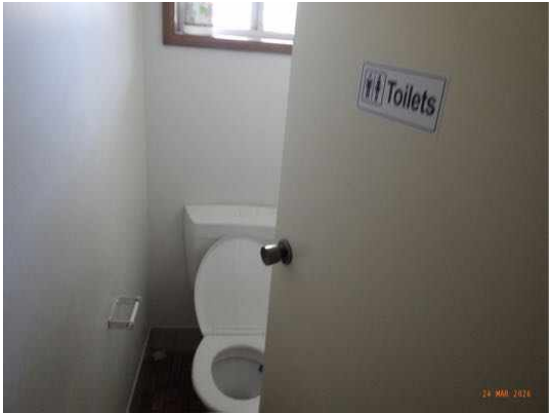
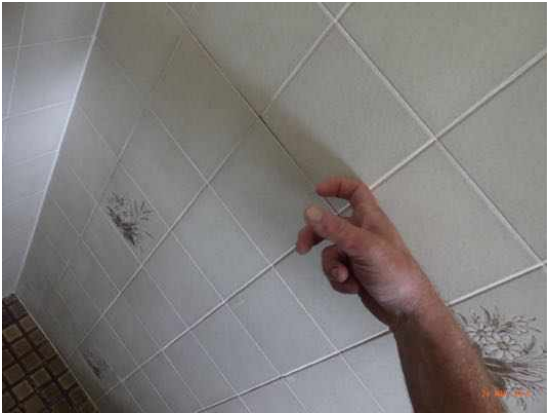
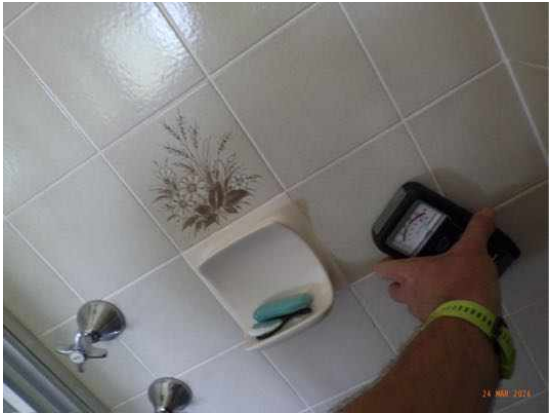
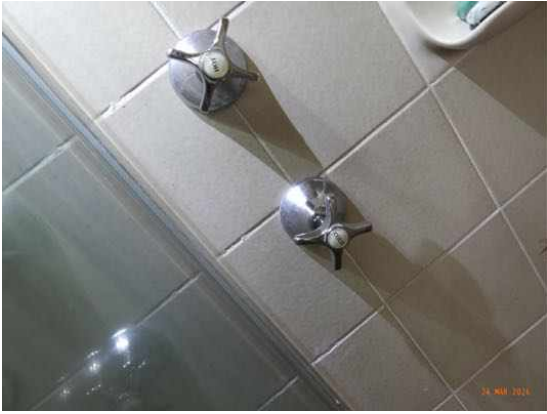
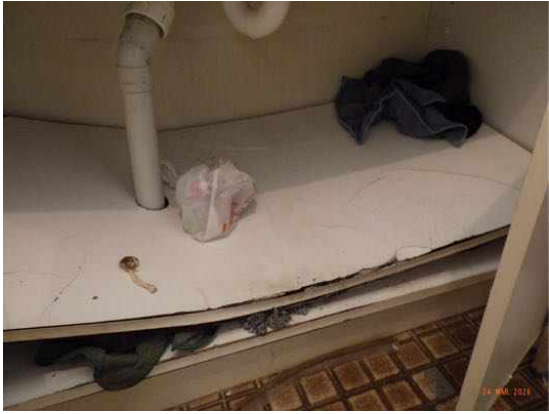
Building: Building 1
 Location: All Areas
 Finding: Additional Photos - Obstructions and Limitations
 Information:

These photographs are an indication of the obstructions and limitations which impeded full inspection of the property at the time of inspection. These obstructions can hide an array of defects and should be removed to allow full inspection to be carried out.
