Building and Timber Pest Inspection Report

Inspection Date: Tue, 24 Mar 2026

Property Address: 4/53 Carruthers Dr, Modbury North SA
5092, Australia

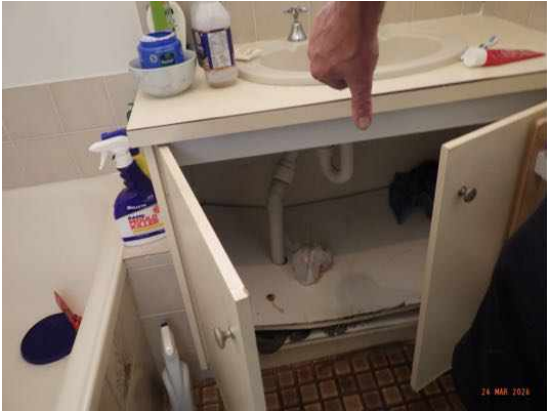
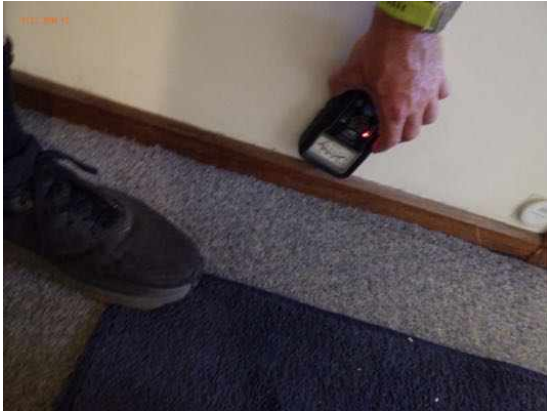
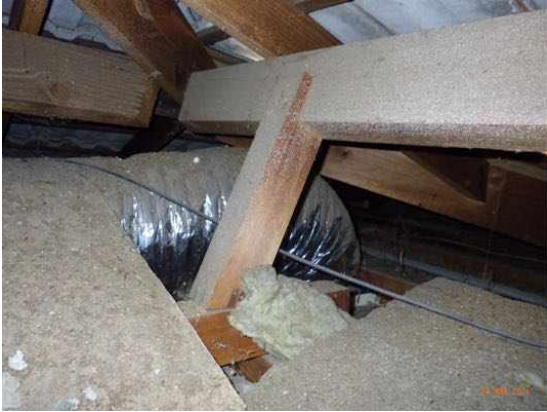
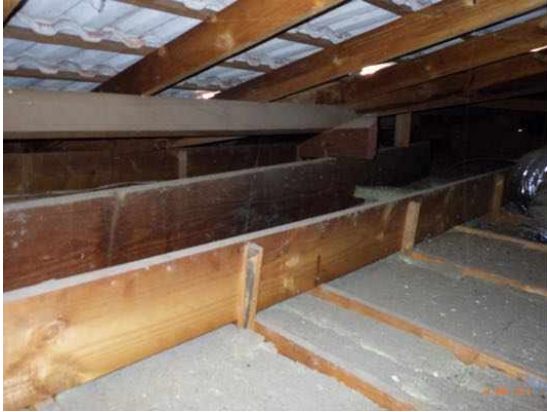
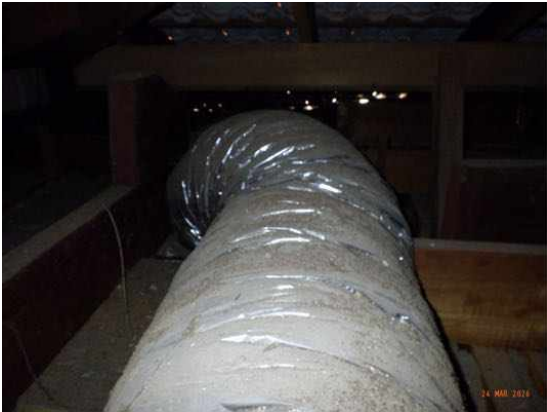
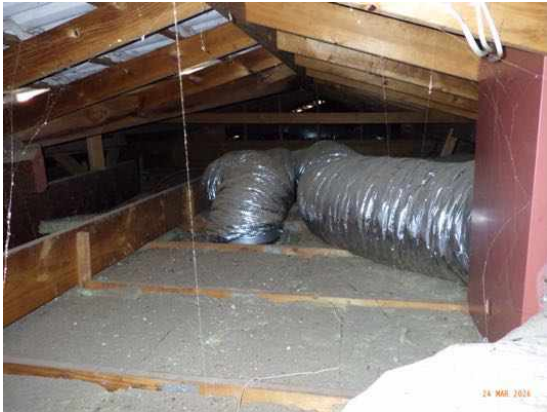
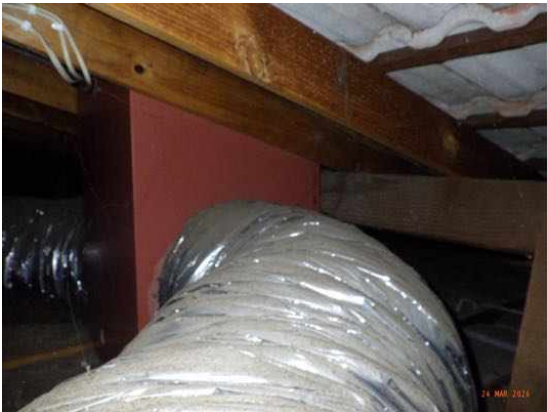
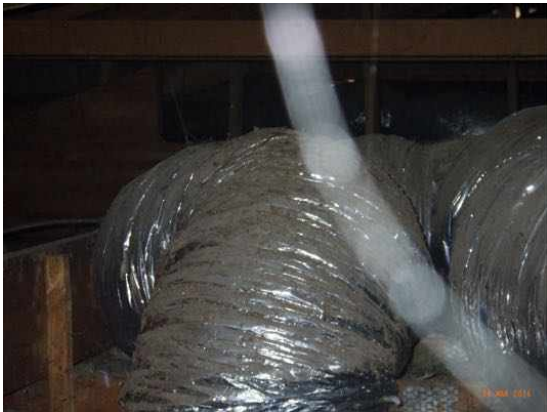
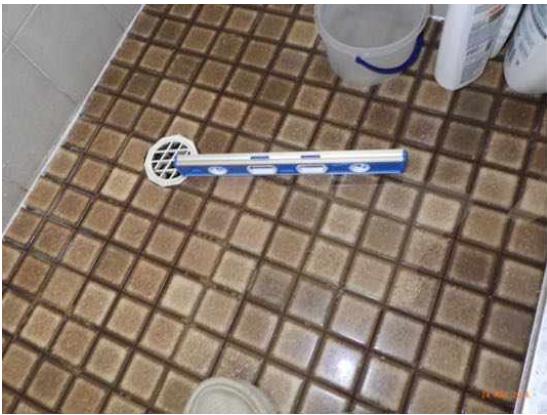
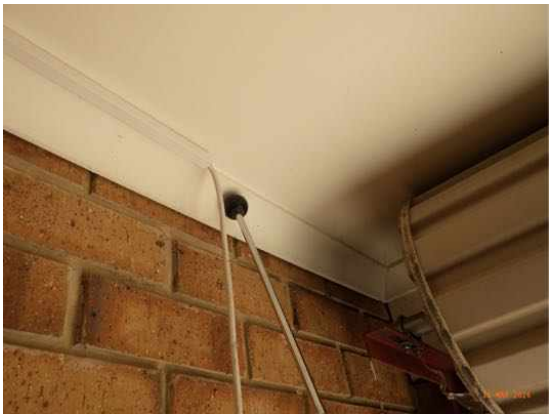
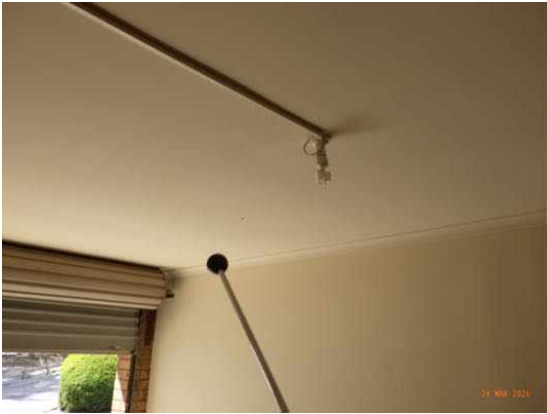
These photographs are an indication of the obstructions and limitations which impeded full inspection of the property at the time of inspection. These obstructions can hide an array of defects and should be removed to allow full inspection to be carried out.
