Building and Timber Pest Inspection Report

Inspection Date: Sat, 7 Mar 2026

Property Address: 1 Mayo Ct, Golden Square VIC 3555,
Australia

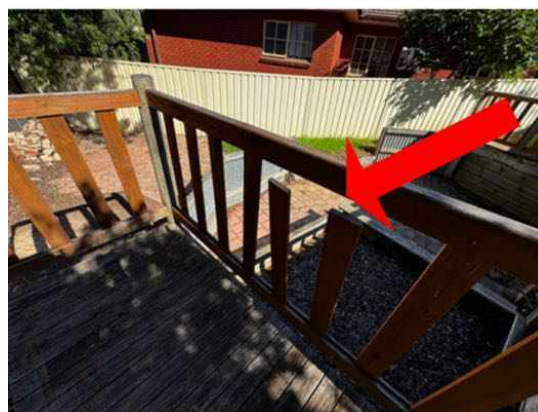
Building: Main Building
 Location: Yard - Back > Rear
 Finding: Safety Hazards – Rear Yard Paving and Decking
 Information: Safety hazards were observed in the rear yard area during the inspection. Sections of paving were found to be uneven, with some pavers noticeably lifted above the surrounding surface. This condition presents a trip hazard for occupants and visitors when walking through the area.

In addition, a makeshift timber decking and boardwalk structure was observed in the rear yard. This structure appeared to be of do-it-yourself construction, and some balustrade sections were found to be broken. Damaged balustrade components creates a potential fall hazard, as the decking area is elevated above the surrounding ground level.

In accordance with the defect definitions outlined in AS 4349.1-2007, conditions that present a risk of injury to occupants or visitors are considered Safety Hazards.

It is recommended that the uneven paving be lifted and relaid or otherwise rectified to provide a level walking surface. The decking and boardwalk structure should be assessed for structural integrity, including reinstating the missing or damaged balustrade sections to restore adequate edge protection.

Immediate, as these conditions present potential trip and fall hazards to occupants and visitors.

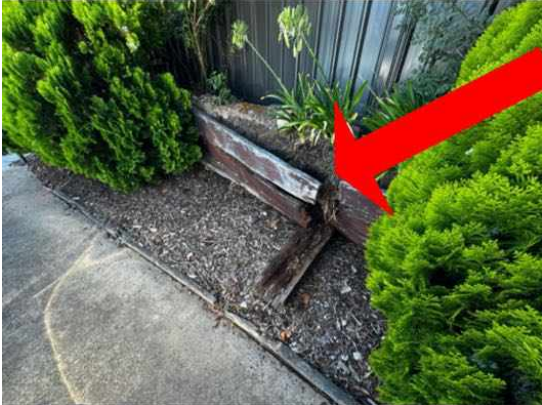
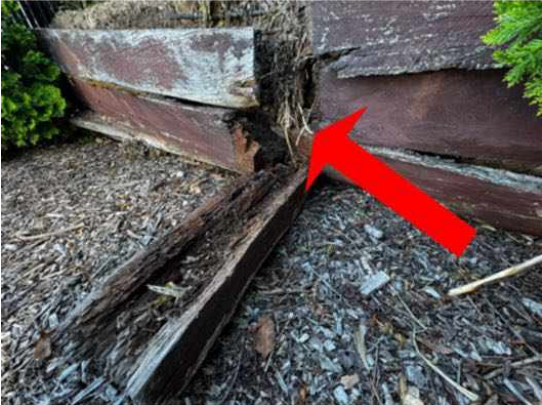
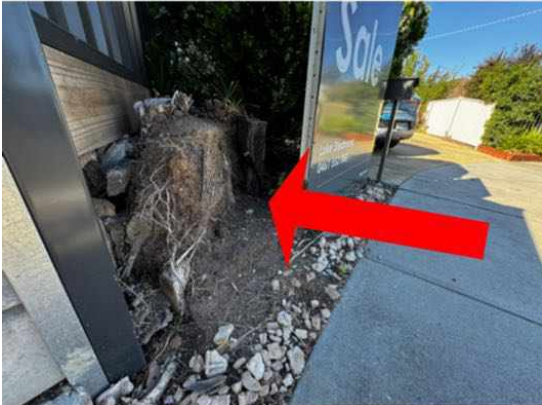
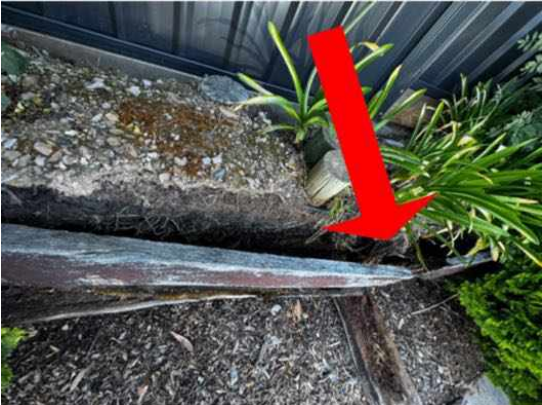
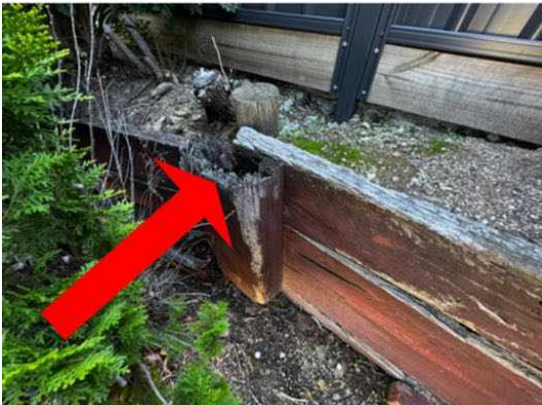
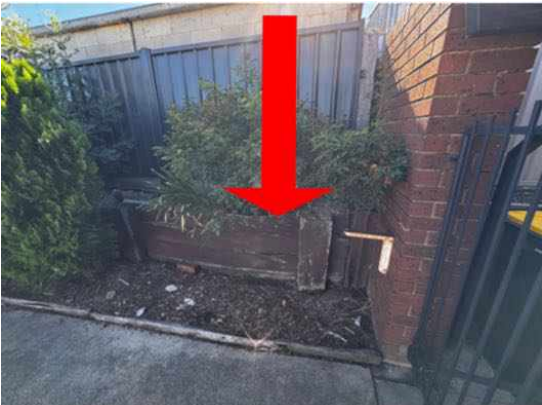
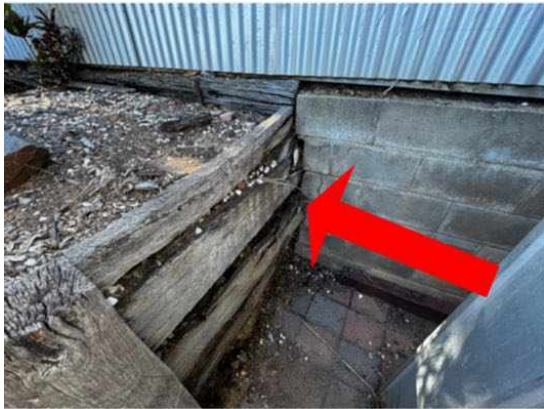
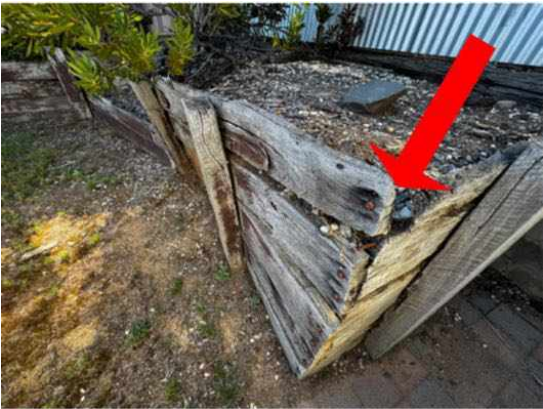
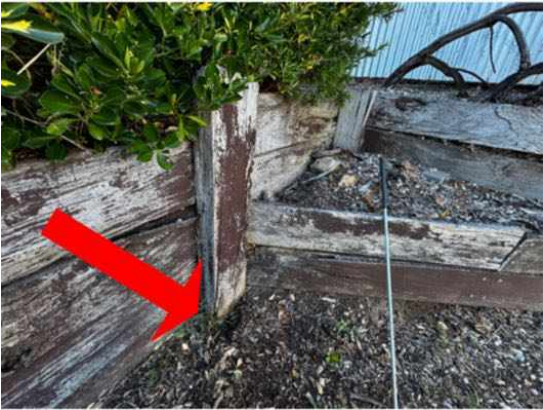
Finding 2.01

In summary, the building, compared to others of similar age and construction is in fair to good condition for the age of the building with some minor defects and maintenance items. There was one Major Defect found to the retaining walls.

Immediate, as the retaining walls are structurally compromised and may continue to deteriorate or collapse, potentially causing soil movement and further damage to surrounding landscaping areas.

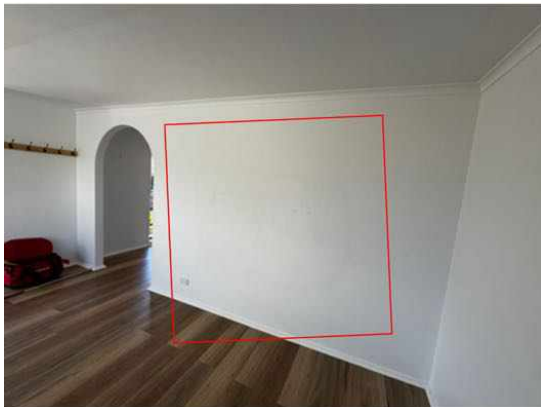
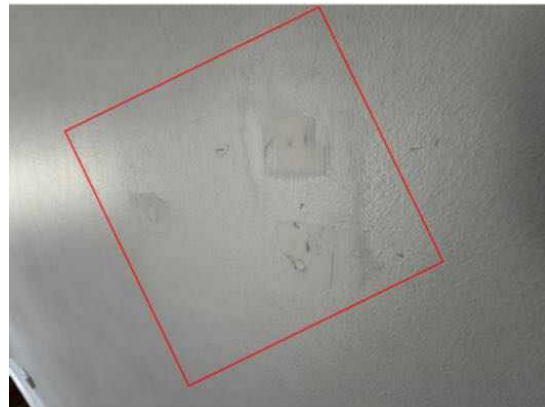
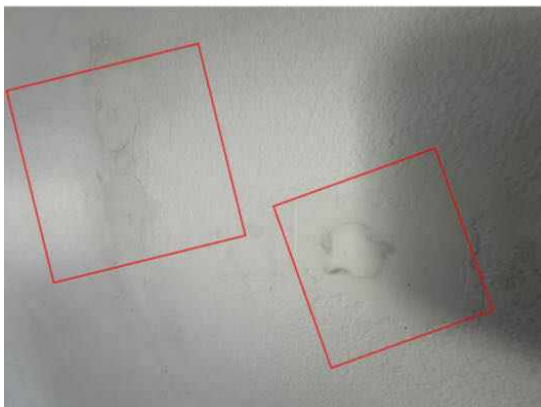
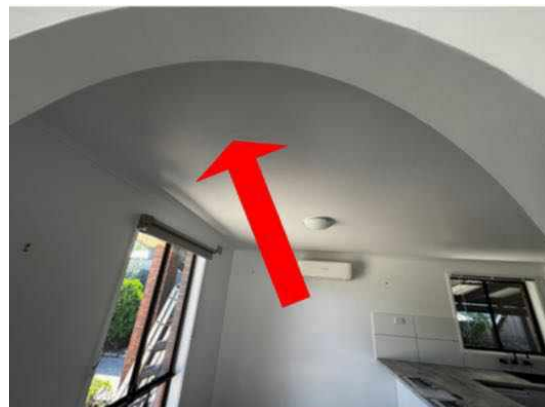
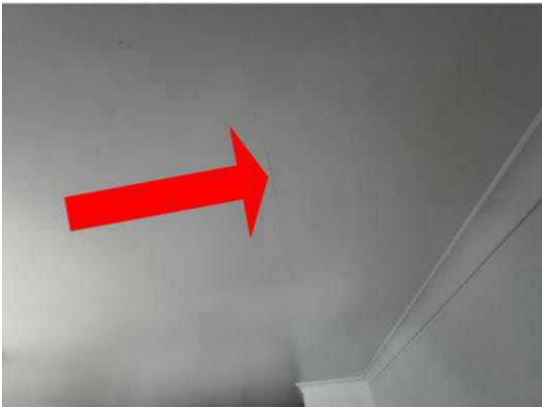
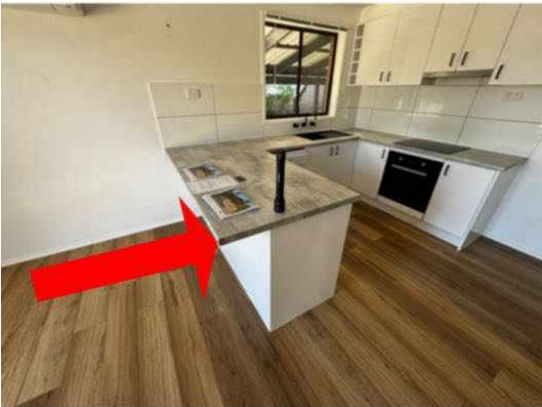
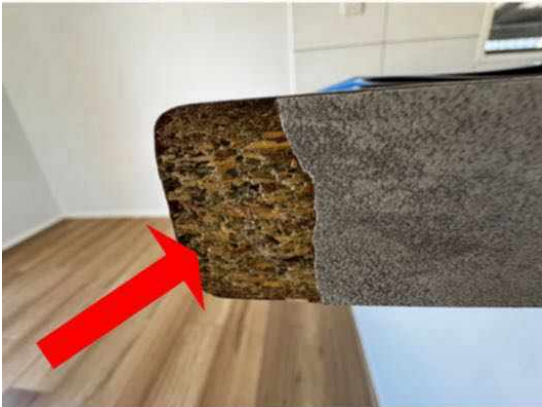
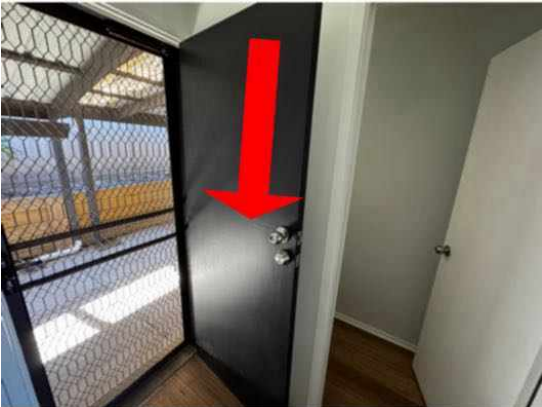
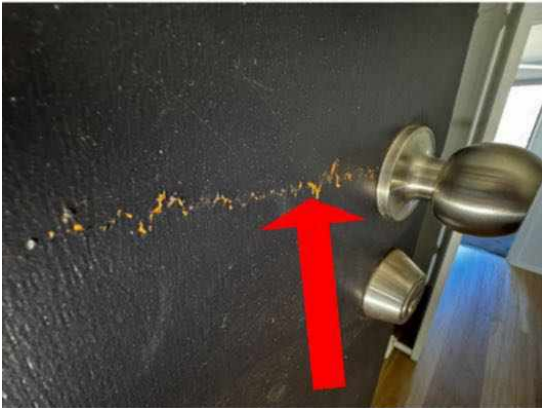
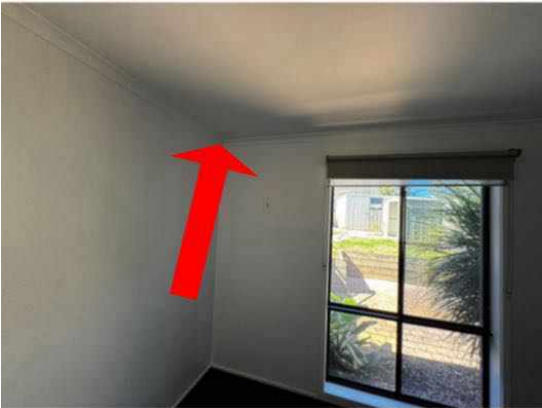
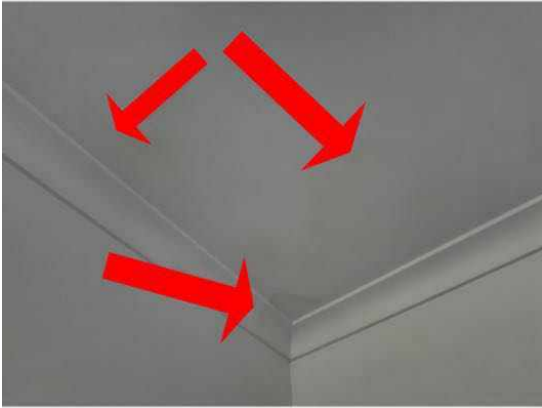
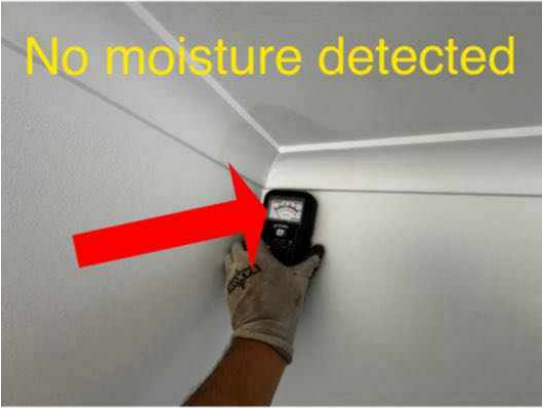
Finding 3.02

Building:	Main Building
Location:	All Areas > All Areas
Finding:	Internal Building Defects
Information:	Several minor internal defects were observed during the inspection. Evidence of previous plaster repair work was noted to a wall in the living room area. The repaired section appears unfinished and requires painting to achieve a consistent finish with the surrounding wall surfaces.

Maintenance recommended in the short to medium term.

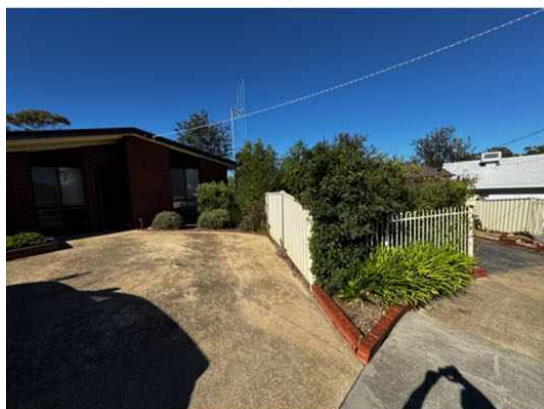
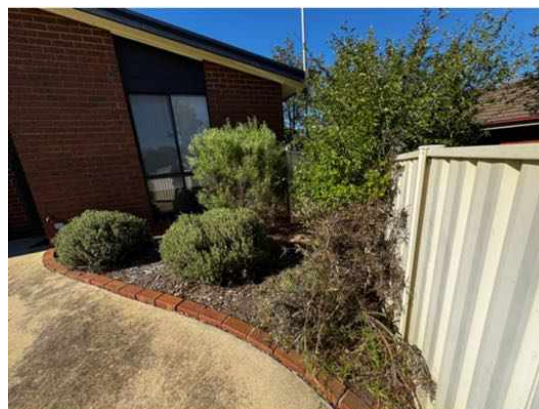
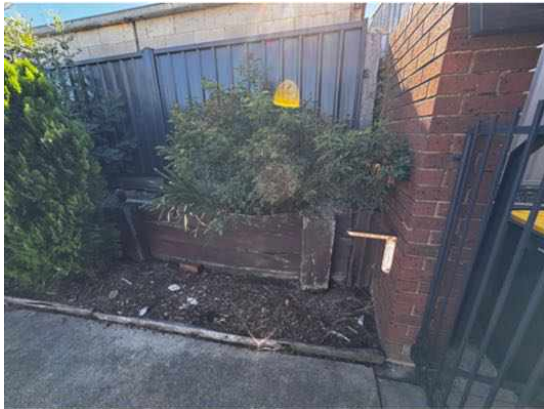
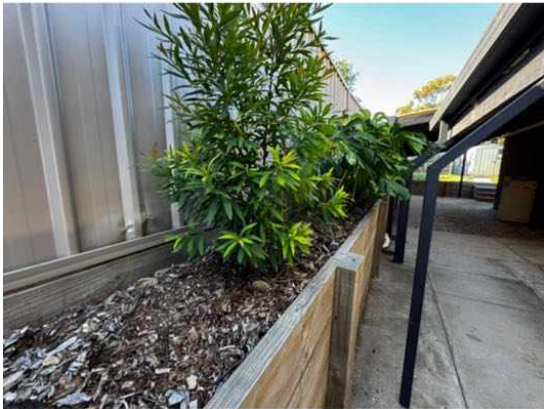
Building:	Main Building
Location:	All Areas > All Areas
Finding:	Landscaping & vegetation increasing termite risk (TP)
Information:	At the time of inspection, landscaping, vegetation and mulching was observed around the property, including multiple garden beds, shrubs and plants in close proximity to the dwelling and mature trees located along the outside boundary of the property.

Environmental conditions that promote moisture retention, provide concealed shelter, or support termite foraging activity are recognised as increasing termite risk to existing buildings. Mature trees, mulched garden beds, irrigation systems can all maintain damp soil conditions and may harbour termite colonies, allowing concealed termite activity to develop and potentially extend toward the building without early detection.

As a result, the extent of vegetation and moisture-retaining landscaping is considered to significantly increase the overall risk of termite activity to the property. It is recommended that a licensed termite management or pest control contractor be engaged to assess the site conditions and provide advice on appropriate risk reduction measures, which may include managing vegetation and mulch, controlling moisture sources, and integrating suitable termite management strategies appropriate for the existing building and site conditions.

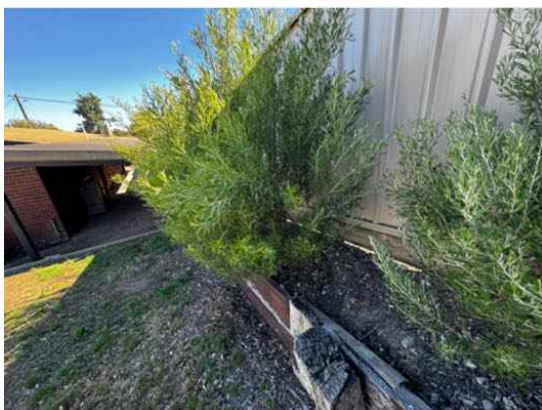
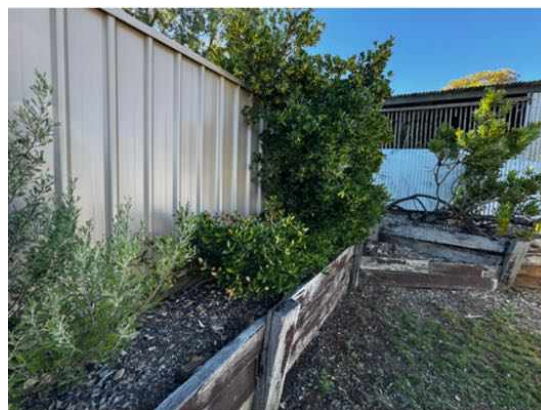
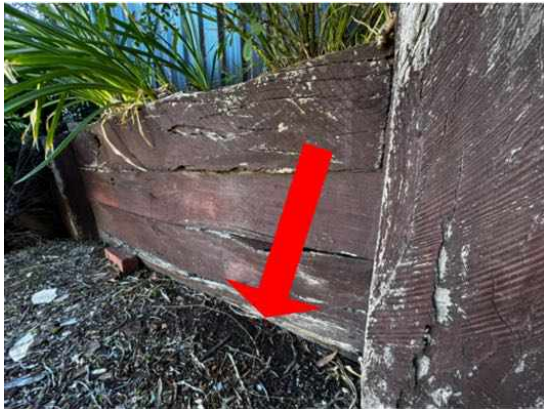
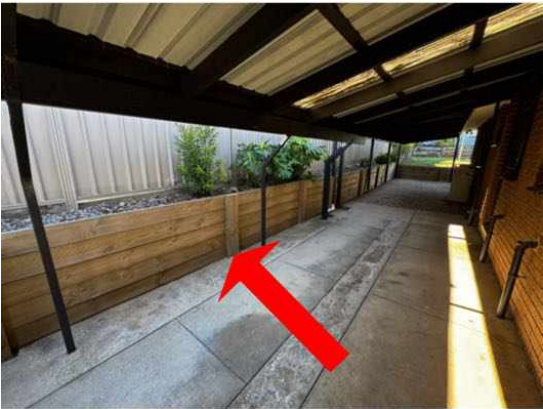
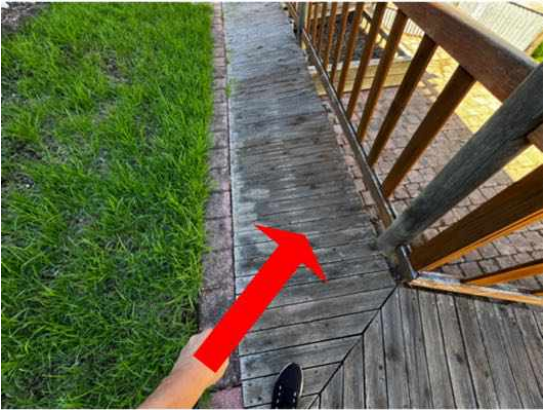
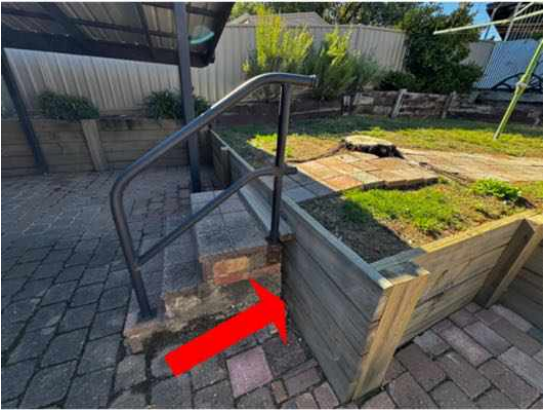
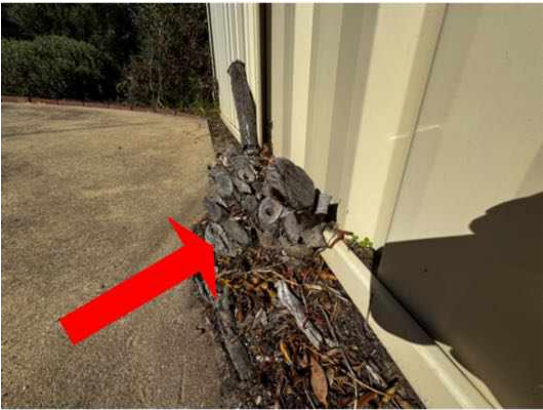
Finding 6.03

Building:	Main Building
Location:	All Areas > All Areas
Finding:	Inground timber contact (TP)
Information:	At the time of inspection, in-ground timber contact was observed to the front, side and rear yards, including timber garden edging, planter boxes, decking, timber retaining walls, and dead tree stumps all in direct contact with the ground. These timber elements are positioned within the soil zone and in close proximity to the building and associated structures.

In accordance with AS 3660.2, conditions that facilitate termite access or provide a direct food source are recognised as increasing the risk of termite activity to existing buildings. Timber elements in direct contact with the ground are particularly vulnerable, as they can attract subterranean termites and support concealed foraging activity, potentially allowing termite colonies to establish and migrate toward nearby structures without early detection.

As a result, the presence of in-ground timber elements is considered to increase the risk of termite activity to the property. It is recommended that a licensed termite management or pest control contractor be engaged to assess these conditions and provide advice on appropriate risk mitigation measures, which may include removal or replacement of timber elements with non-susceptible materials, isolation of timber from soil contact, and integration of suitable termite management measures to suit the existing site conditions.

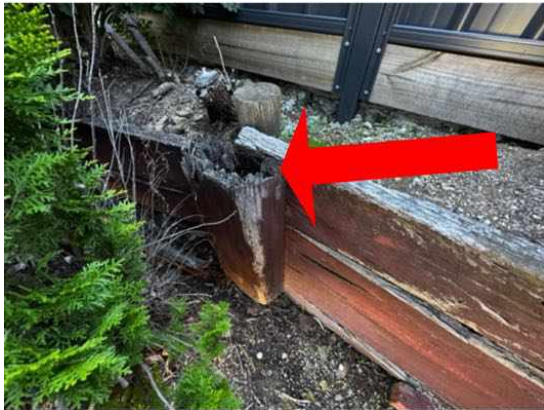
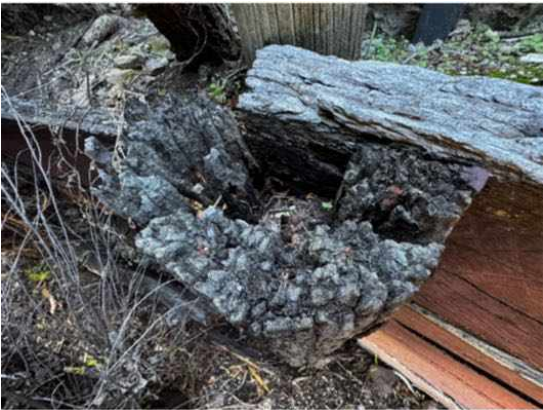
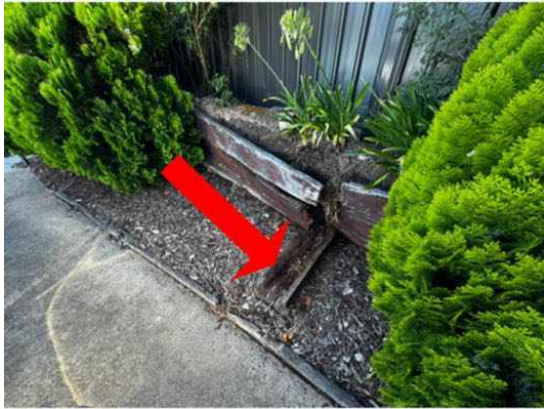
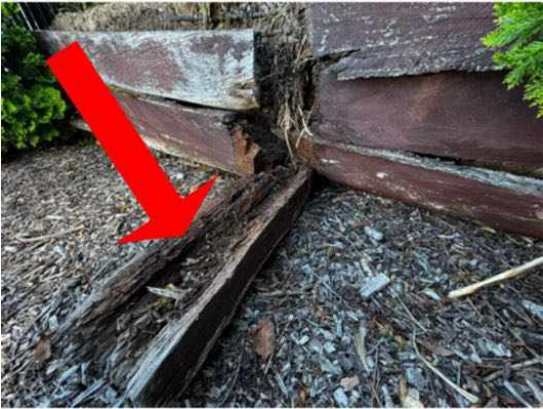
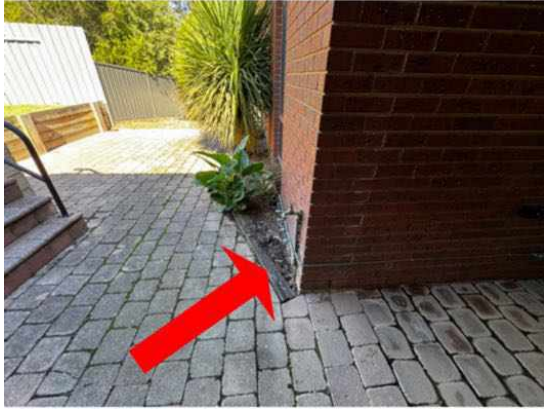
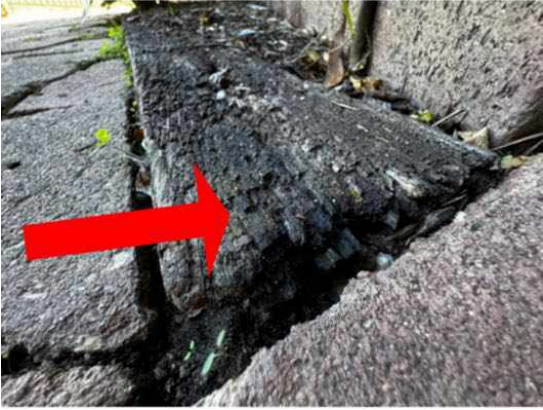
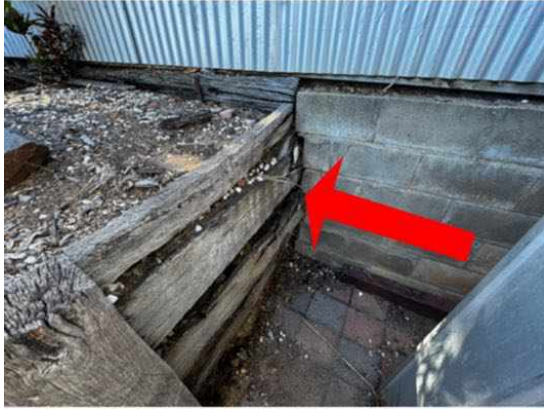
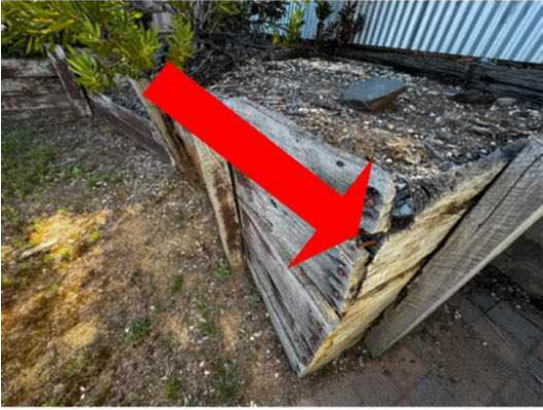
Building:	Main Building
Location:	All Areas > All Areas
Finding:	Timber decay & rot - Conducive conditions (TP)
Information:	At the time of inspection, timber decay and rot was observed to the front and rear retaining walls as well as to some garden edging to the rear yard.

These conditions are suspected to have developed over time due to prolonged moisture exposure and a lack of appropriate timber maintenance, allowing moisture ingress and decay to progress within the timber elements. In accordance with AS 3660.2, deteriorated and moisture-affected timber is recognised as increasing the risk of termite activity, as decayed timber can attract termites and may provide concealed access or harbourage, particularly where defects are obscured by finishes such as paint.

As a result, these conditions are considered to present an elevated risk of ongoing deterioration and potential termite susceptibility. It is recommended that an appropriately qualified builder or carpenter be engaged to further assess the extent of timber decay, remove any concealed deteriorated material, and undertake suitable repairs or replacement, with consideration also given to advice from a licensed termite

management or pest control contractor where termite risk is identified.

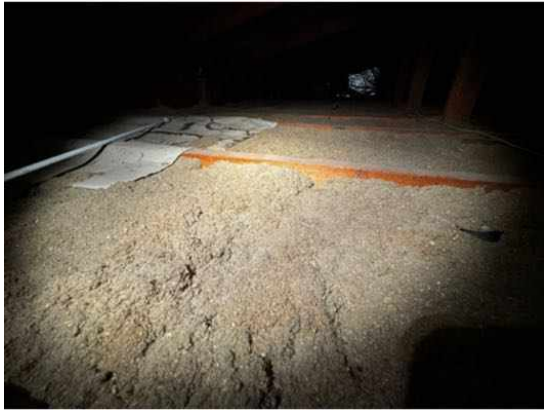
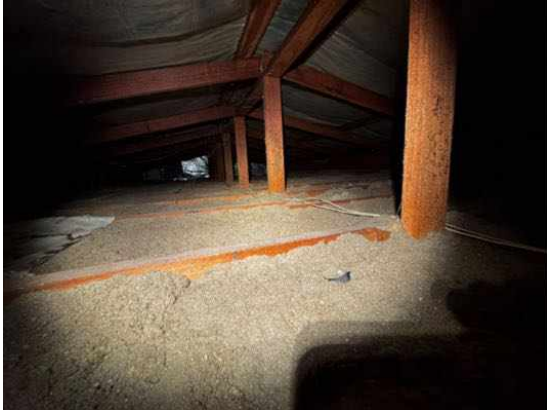
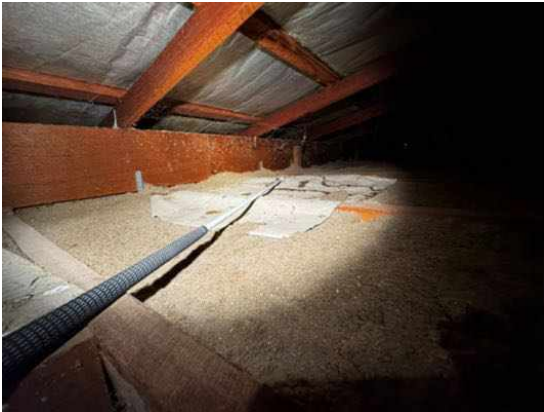
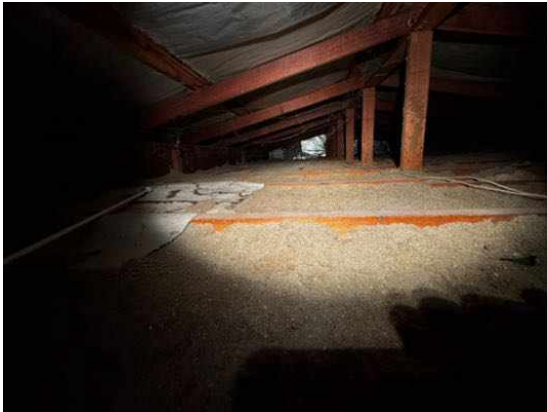
Building: Main Building
Location: All Areas > All Areas
Finding: Additional Photos - Obstructions and Limitations
Information: These photographs are an indication of the obstructions and limitations which impeded full inspection of the property at the time of inspection. These obstructions can hide an array of defects and should be removed to allow full inspection to be carried out. A re-inspection is recommended once the areas are made accessible.

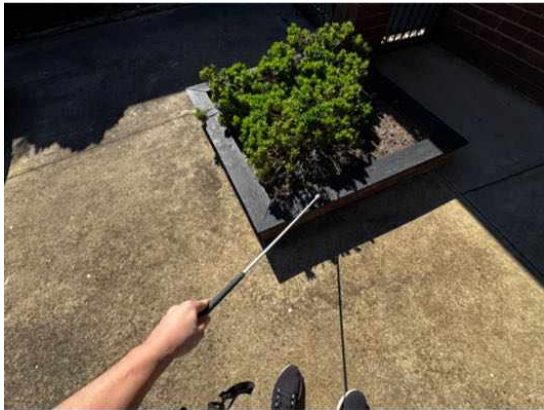
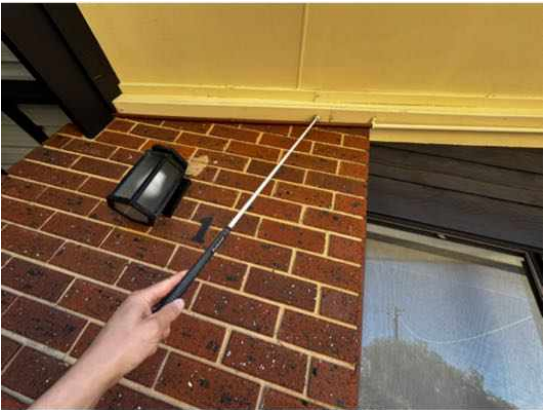
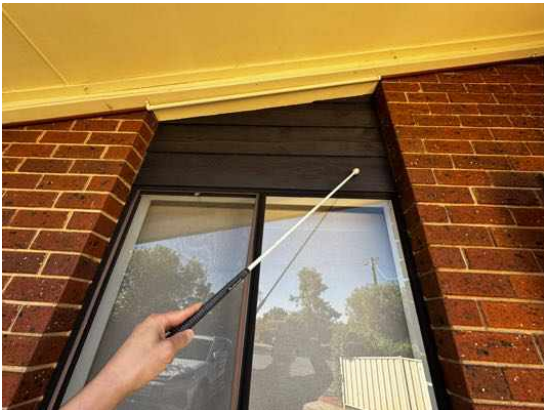
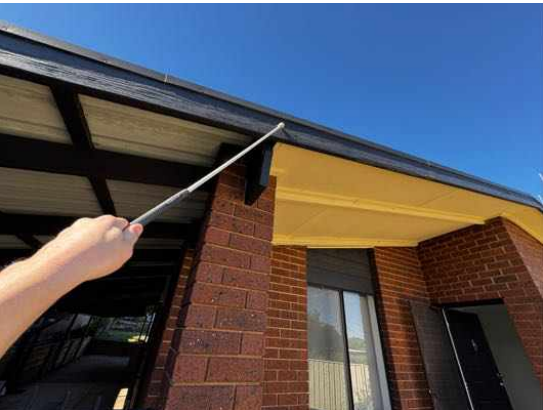
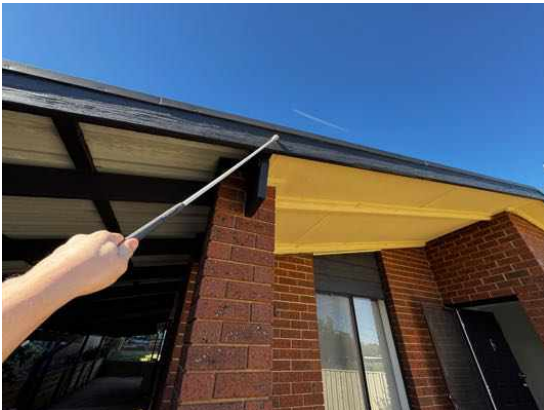
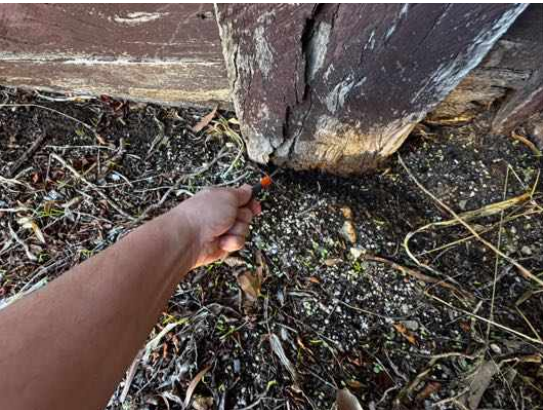
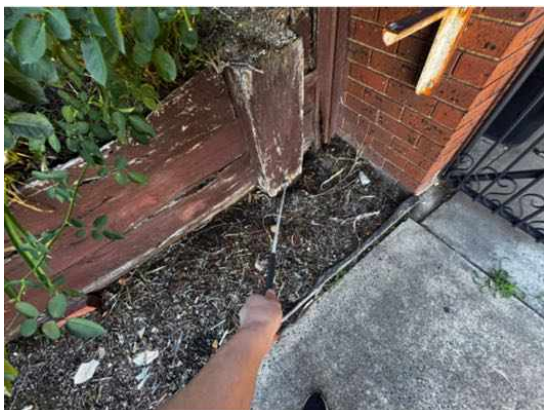
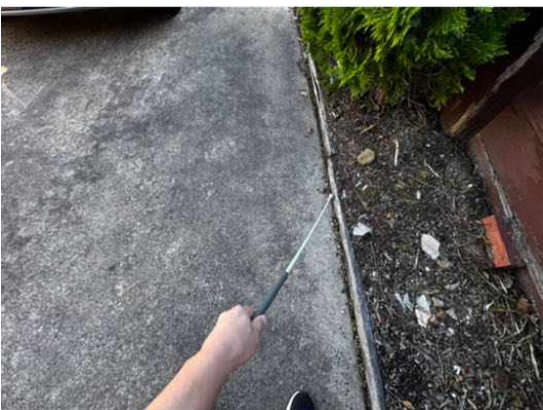
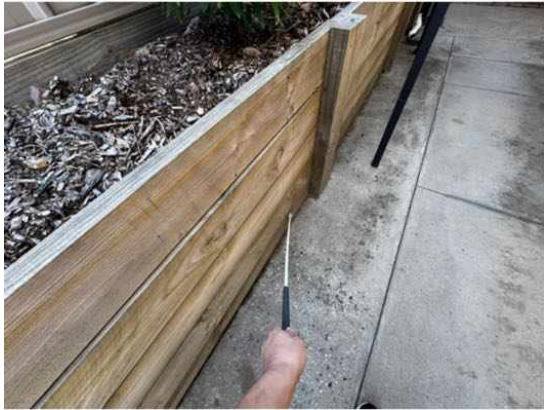
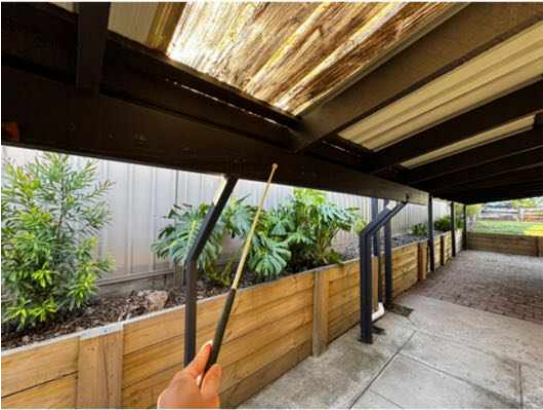
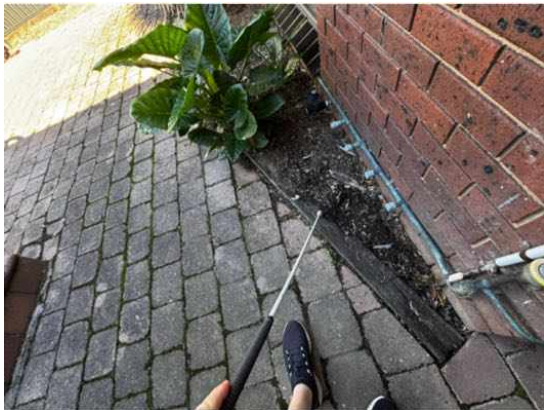
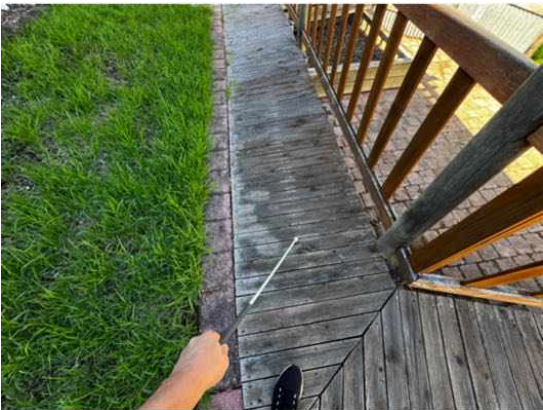
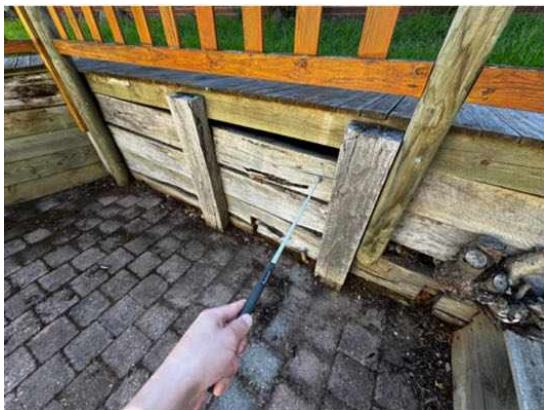
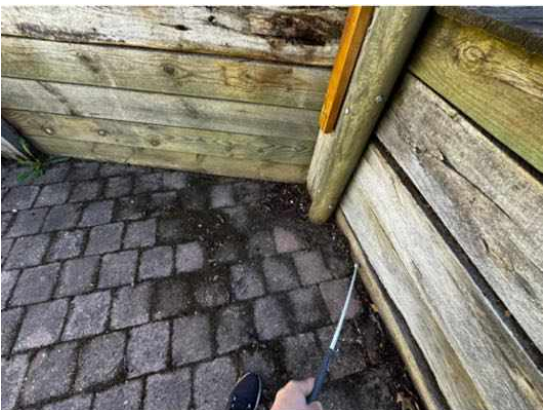
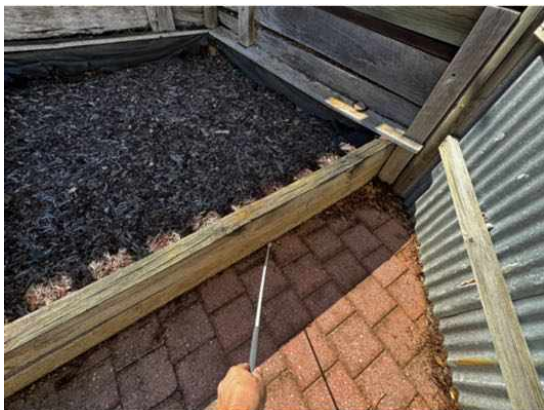
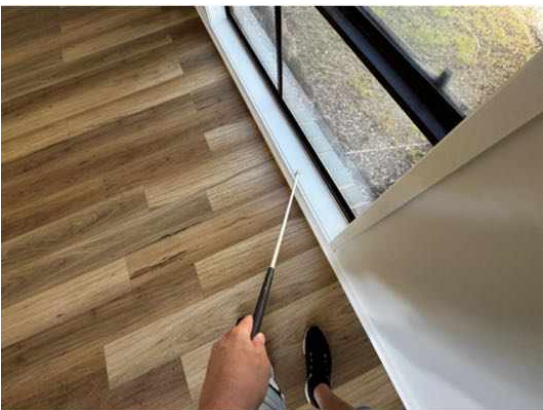
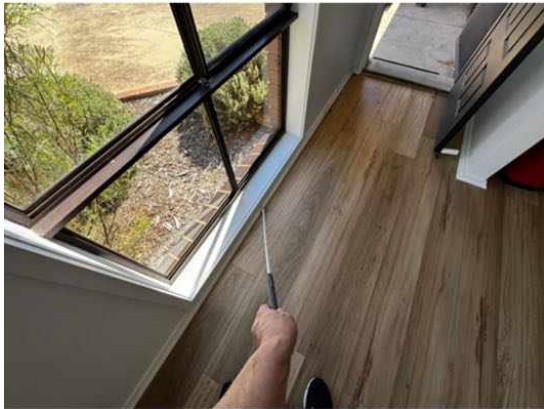
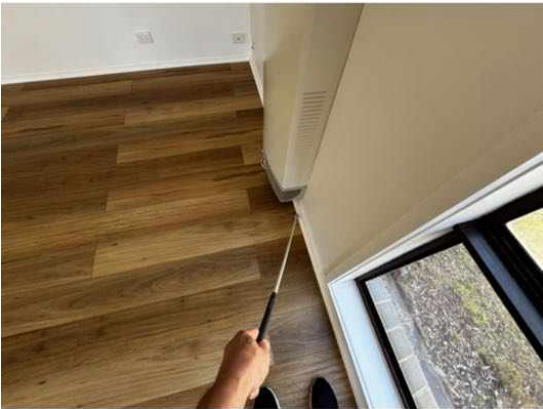
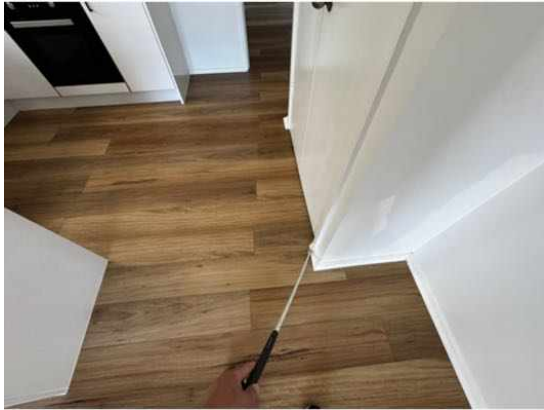
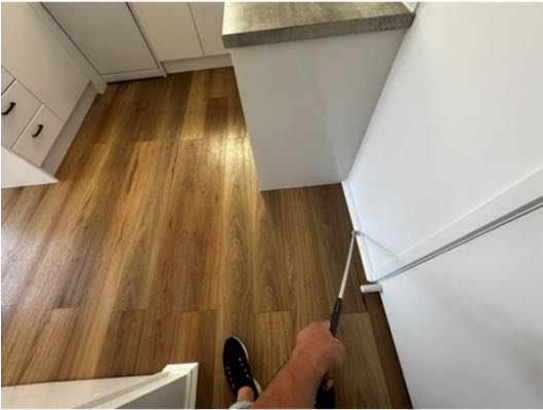
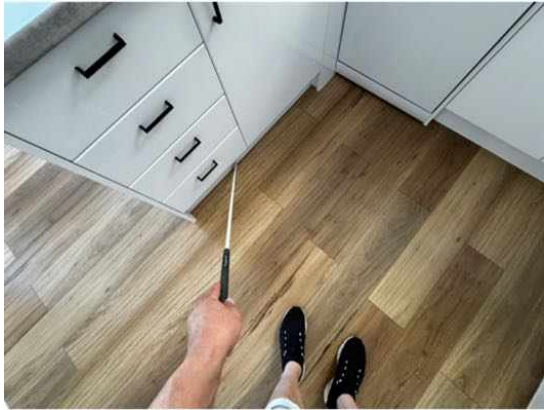
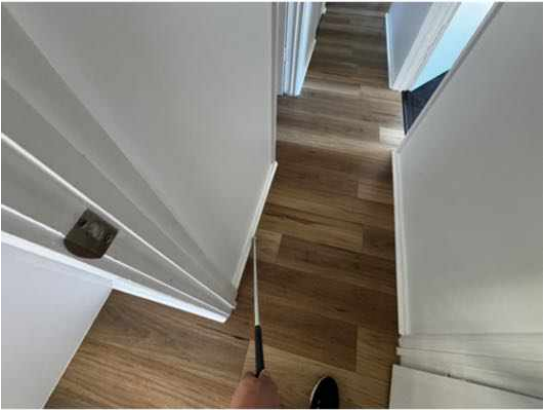
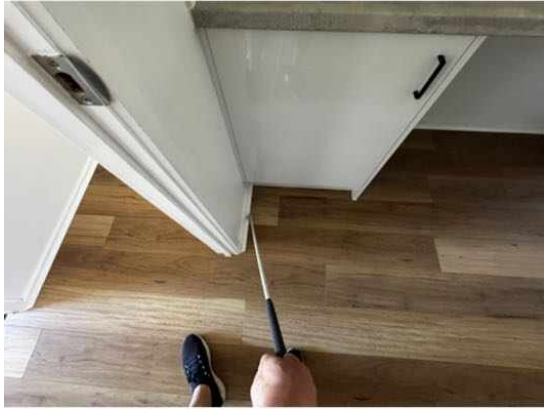
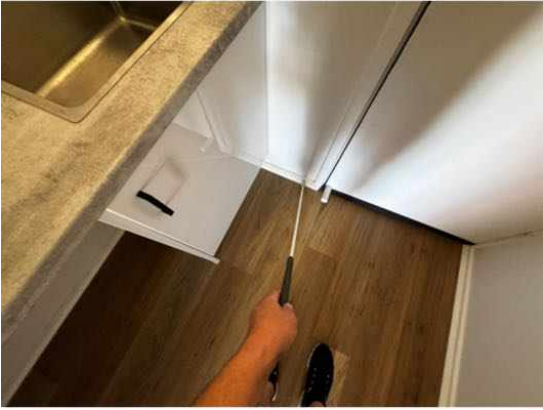
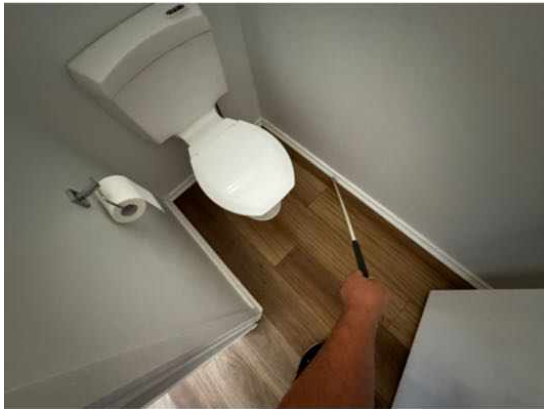
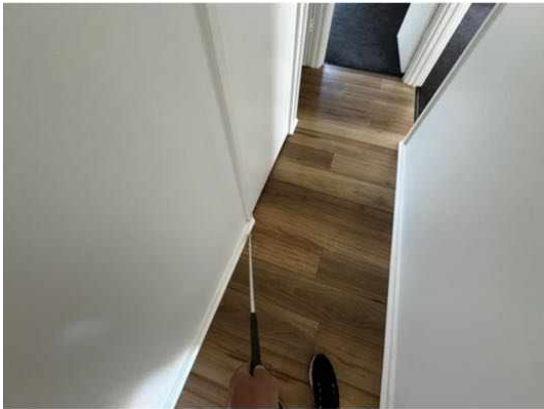
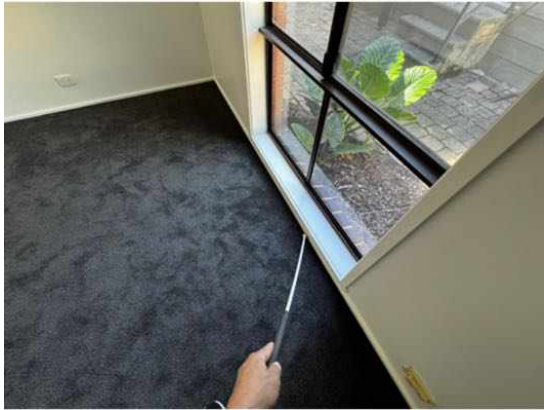
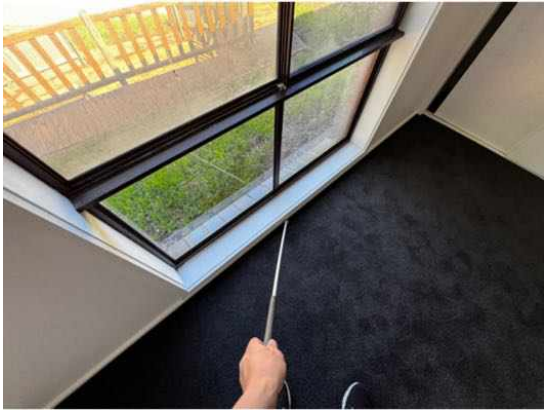
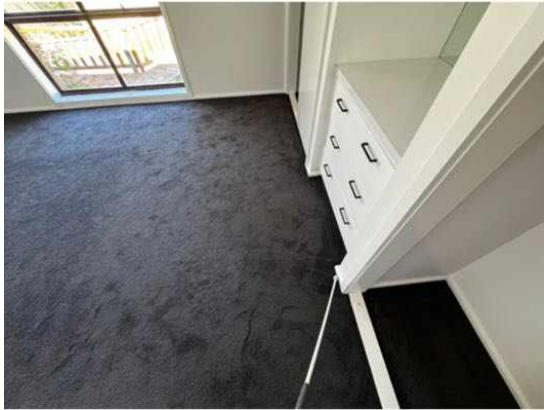
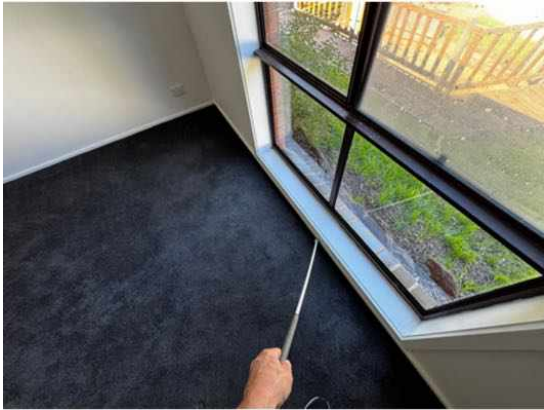
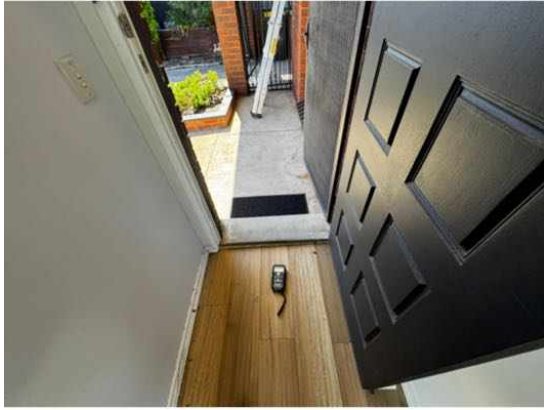
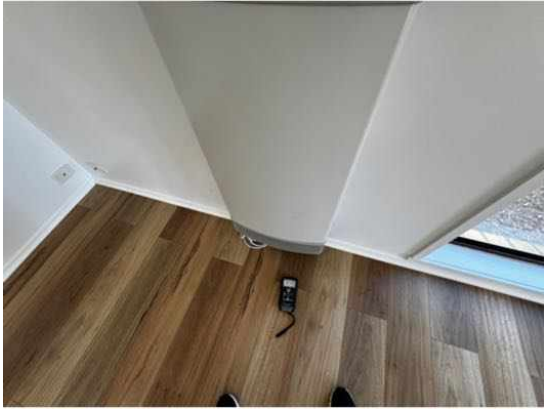
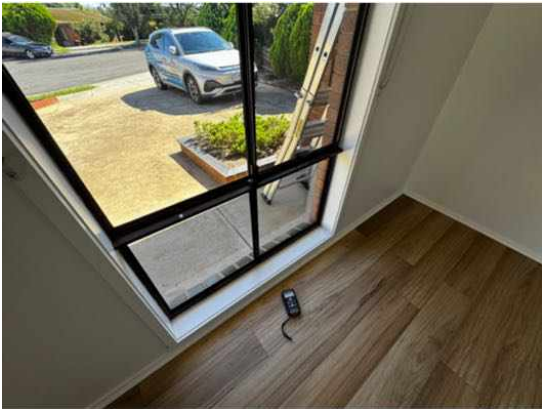
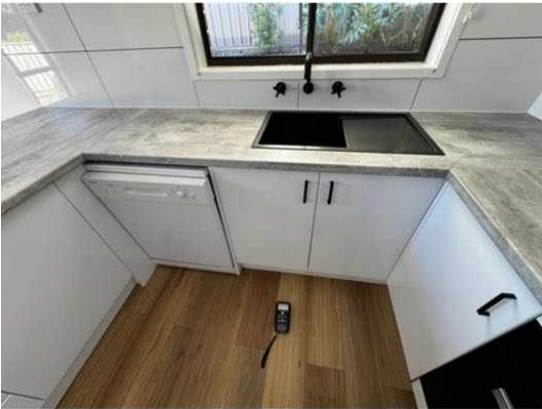
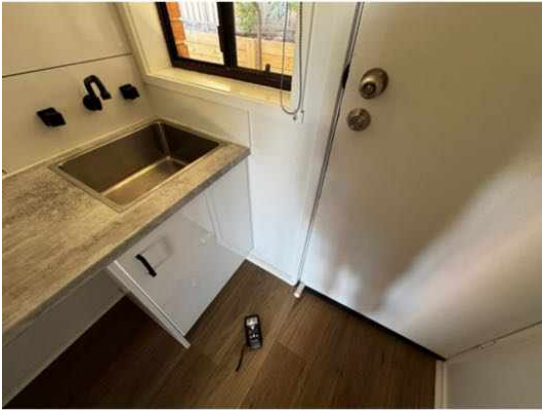
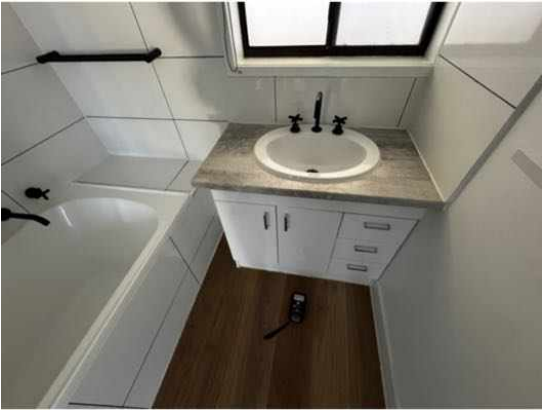
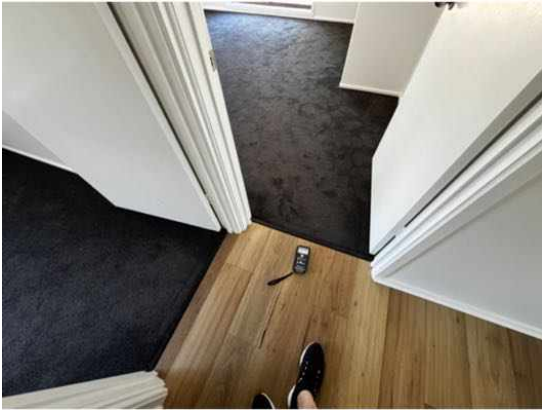
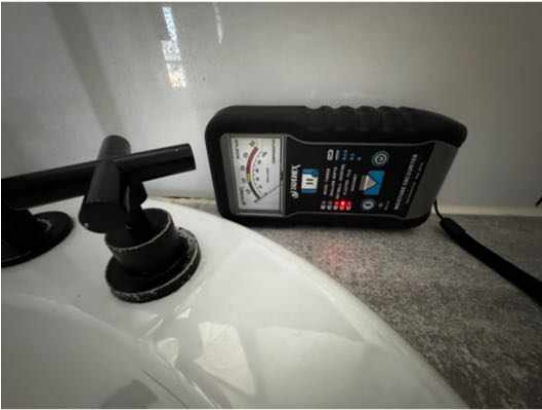
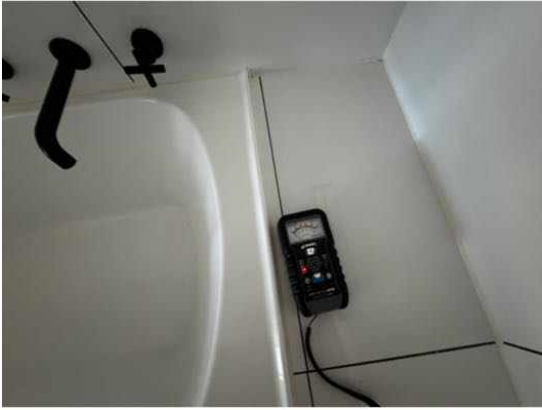
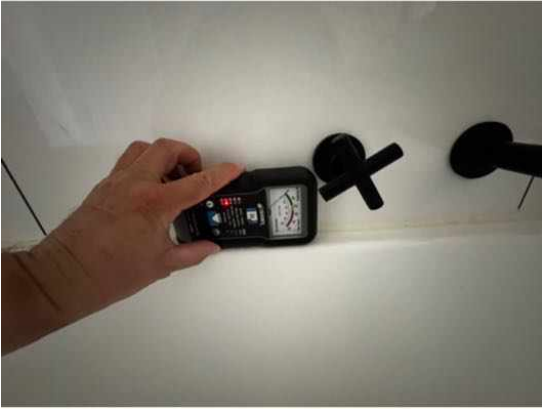
Noted Item

Building:	Main Building
Location:	All Areas > All Areas
Finding:	Termite investigation techniques (TP)
Information:	All accessible areas of the dwelling were inspected, with particular attention paid to wet areas, which were closely assessed for elevated moisture levels and temperature anomalies that may indicate conditions conducive to termite activity.

In an attempt to identify concealed or hidden timber pest activity, a range of inspection techniques were adopted. These included the use of a moisture meter to assess susceptible areas, sounding of timber elements using a handheld probing device, and visual assessment of materials for signs commonly associated with termite activity. These signs include moisture-related deterioration, deformation of timber, termite mud leads or bridging, and irregular or regular shaped holes within timber elements that may indicate pest-related damage.

It is noted that termite activity can generate increased moisture and localized temperature variations, and where such irregularities are detected, further investigation may be warranted. However, it is also acknowledged that certain obstructions, including floor coverings, wall linings, wall tiles, and fixed cabinetry such as bathroom fit-offs, can conceal termite activity and limit the effectiveness of visual inspection. As a result, the absence of visible evidence at the time of inspection does not eliminate the possibility of concealed termite activity within inaccessible or

obstructed areas of the building.
