Building Inspection Report

Inspection Date: Thu, 5 Feb 2026

Property Address: 6 Queenie Wy, Cranbourne West VIC 3977,
Australia

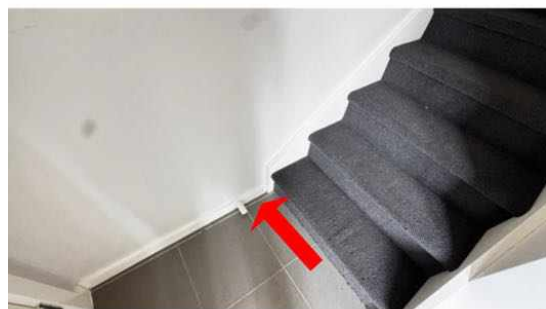
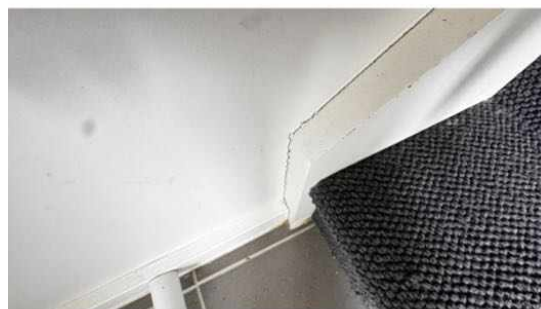
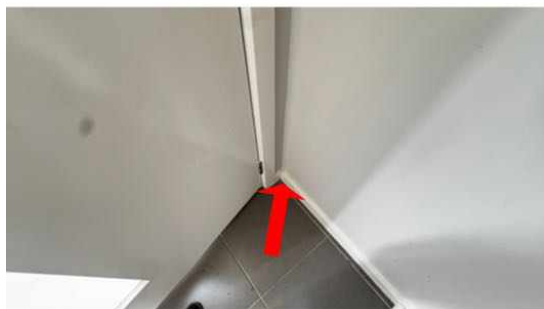
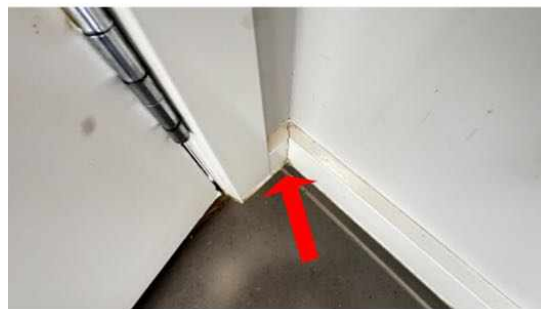
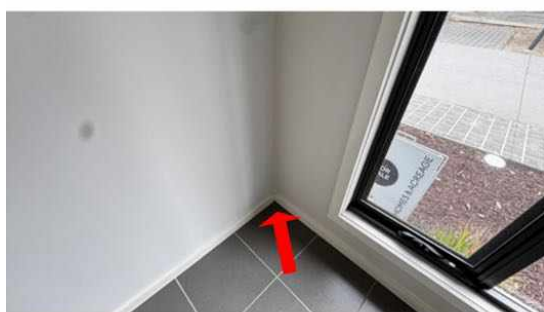
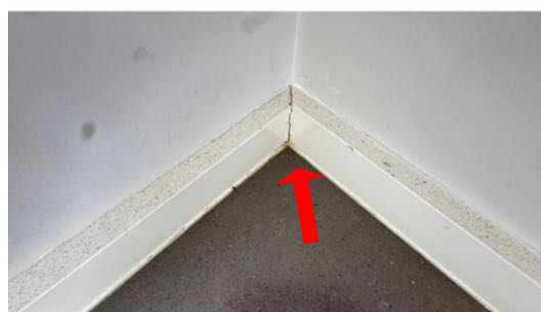
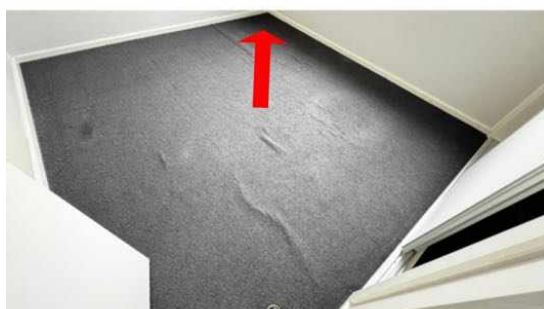
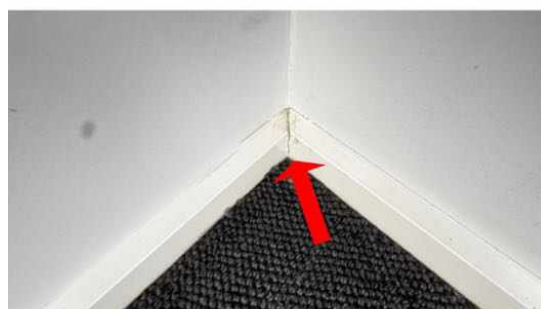
Defects 3.01

Building:	Main Building
Location:	All Areas
Finding:	Architraves & Skirting Boards - Minor Movement
Information:	Minor movement was noted in the architraves and skirting boards in this area, with small gaps at joints, slight separations from adjoining surfaces, and minor cracking in paint and sealant. This movement appears superficial and is generally related to normal timber behaviour or minor building settlement.

Common causes include seasonal timber shrinkage or expansion, slight building settlement, historic moisture or thermal movement, or insufficient fixing during installation. While largely cosmetic, these gaps and cracks can affect the appearance of finishes. If left unaddressed, minor deterioration may continue over time.

When practical, a qualified painter should be engaged to fill and repaint affected areas, to restore a neat finish.

Ongoing monitoring is advised, especially after seasonal changes. If movement worsens, a structural engineer should be consulted immediately to assess and recommend any necessary repairs.

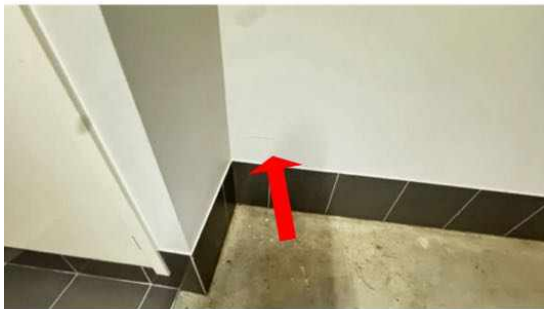
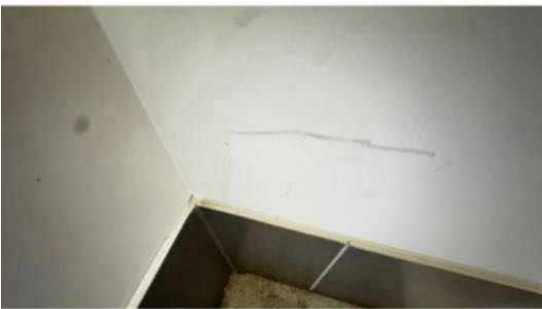
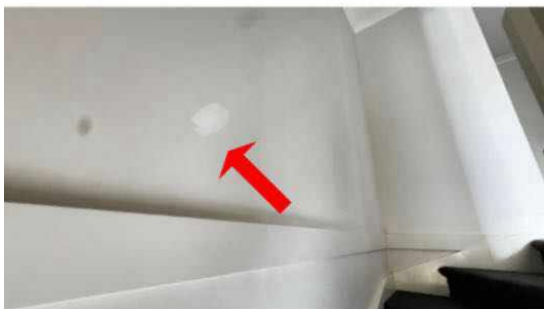
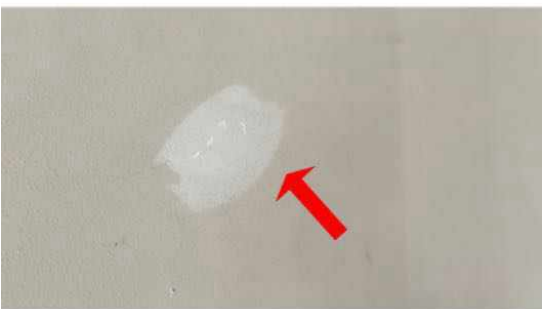
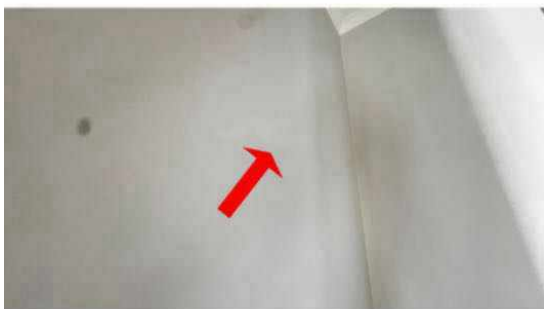
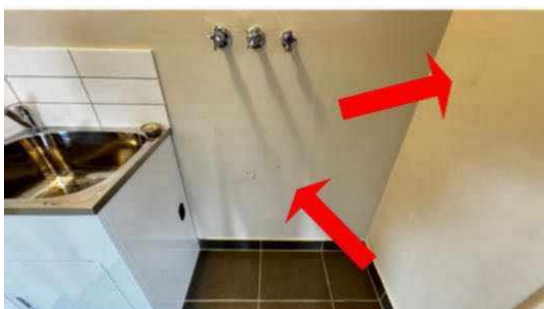
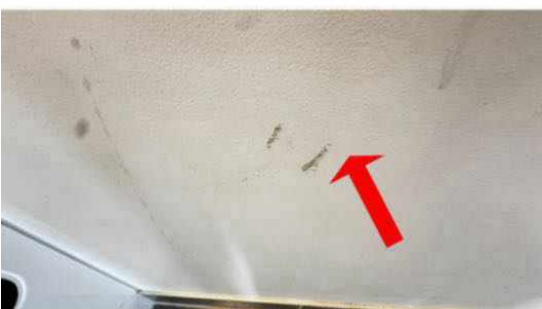
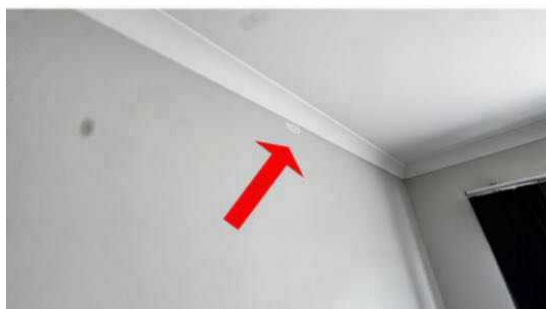
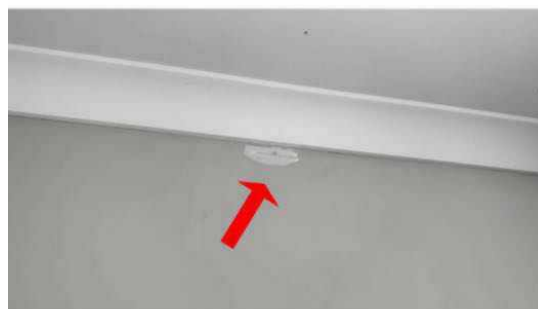
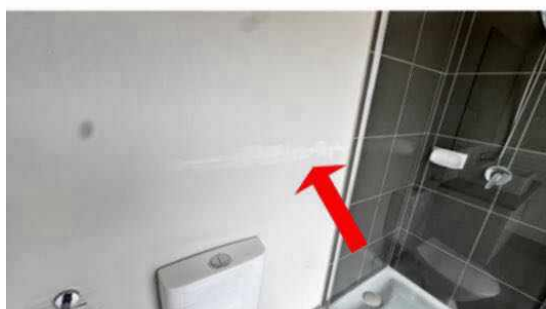
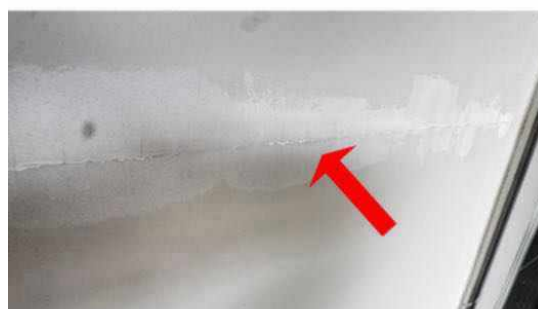
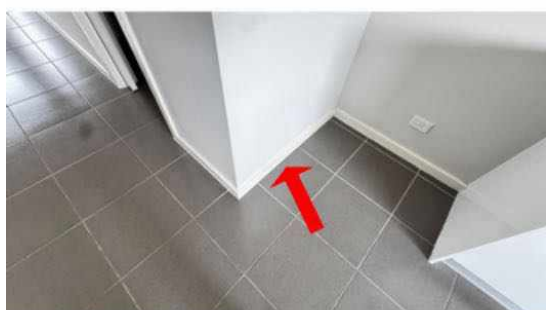
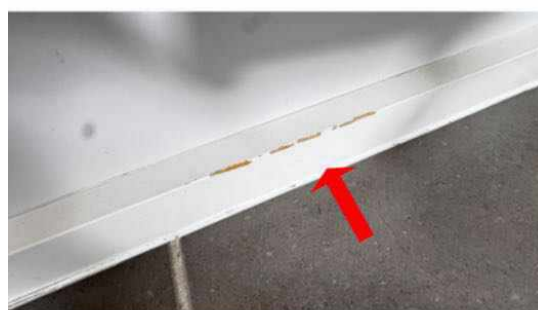
Defects 3.02

Building:	Main Building
Location:	All Internal Areas >
Finding:	Walls - Paint Finishes Discolouration
Information:	The walls were inspected for paint condition, and discolouration was observed in this area.

While primarily a cosmetic issue, the affected paint may indicate age-related wear, poor surface preparation, or previous repairs.

When practical, a qualified painter should be engaged to prepare and repaint the affected areas. Addressing paint deterioration will improve the appearance of the

ceilings and help protect the surfaces from further wear.

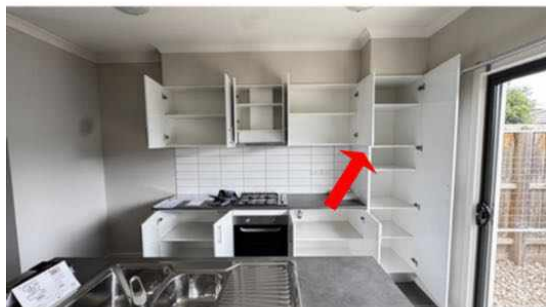
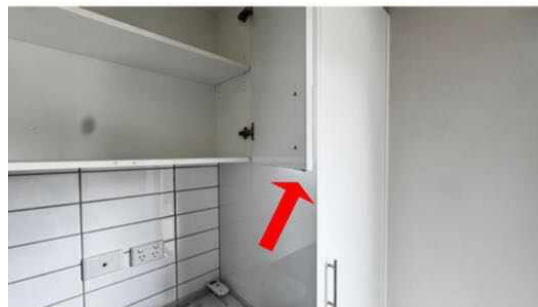
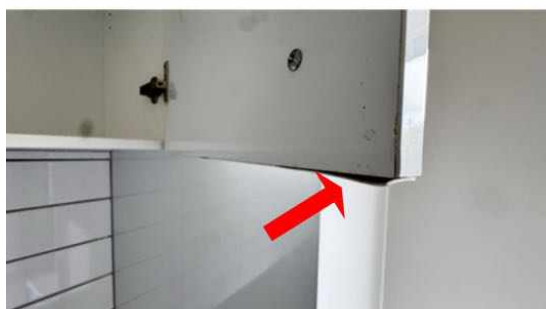
Defects 3.03

Building:	Main Building
Location:	All Areas >
Finding:	Kitchen - Cupboards - Damaged
Information:	<p>The inspection identified kitchen cupboards with visible damage. Defective cupboards can compromise usability, hygiene, and, over time, may deteriorate further if exposed to moisture.</p> <p>The issue may be caused by age-related material deterioration, poor installation practices or impact damage from daily use.</p>

A licensed carpenter, joiner, or kitchen specialist should be engaged without delay to assess, repair, or replace the affected cupboards. Remedial works may include re-gluing, re-sealing, replacing damaged sections, or full replacement if structural integrity is compromised. Prompt rectification will restore functionality, prevent further deterioration, and maintain hygiene and appearance.

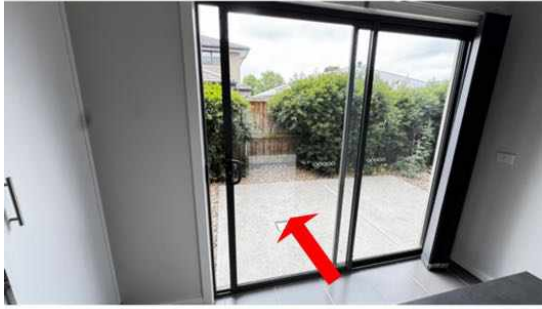
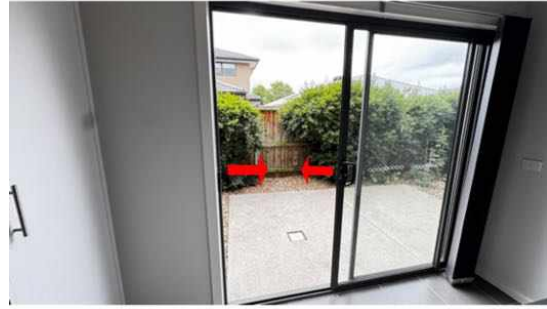
Defects 3.04

Building:	Main Building
Location:	All Areas >
Finding:	Flyscreens - Missing
Information:	Flyscreens were found to be missing to the windows or sliding doors in this area at the time of inspection. Whether the flyscreens have not been installed or have been removed post-installation, this missing building element detracts from the operational state of the window.

Where not replaced, missing flyscreens allow pest and insect ingress into the adjoining room/s. It is advised that all missing flyscreens be replaced in order to ensure the full function of all building structures.

A general handyman may be appointed to install flyscreens at the discretion of the client.

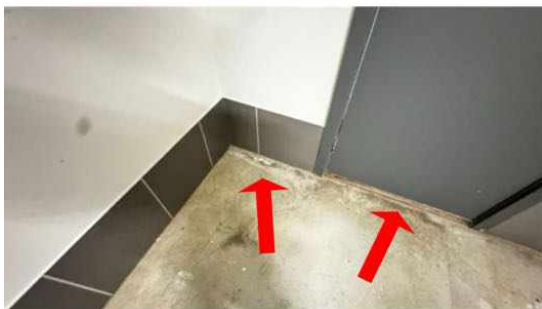
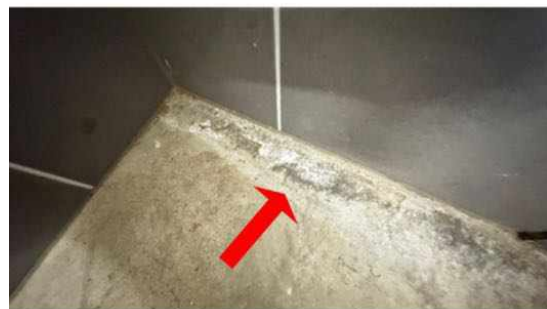
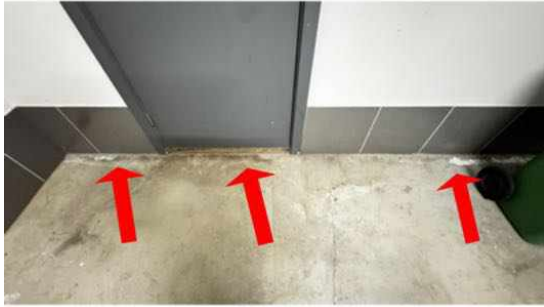
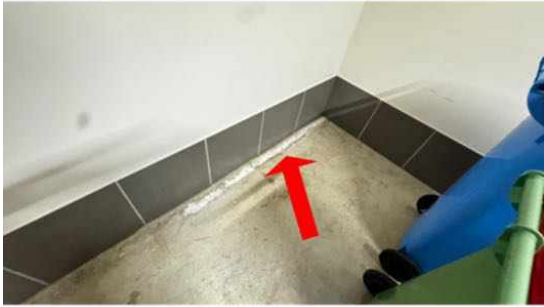
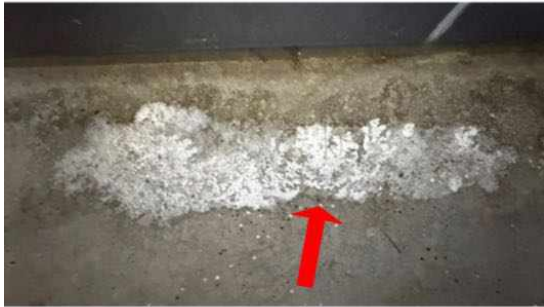
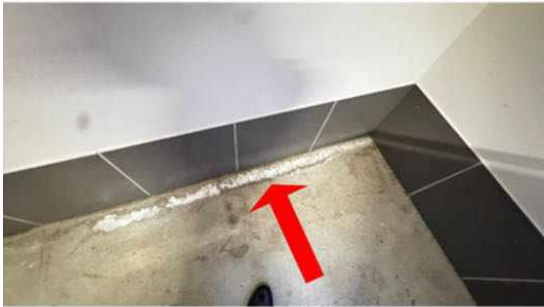
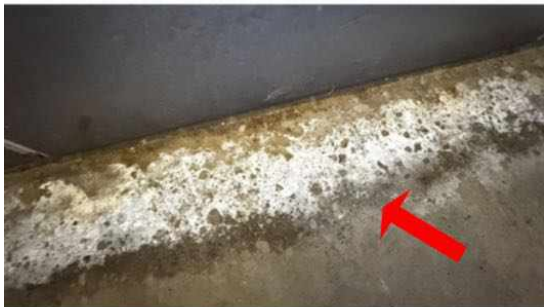
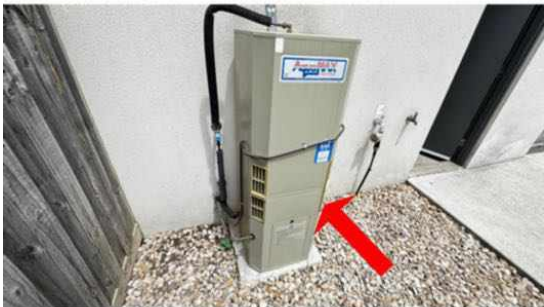
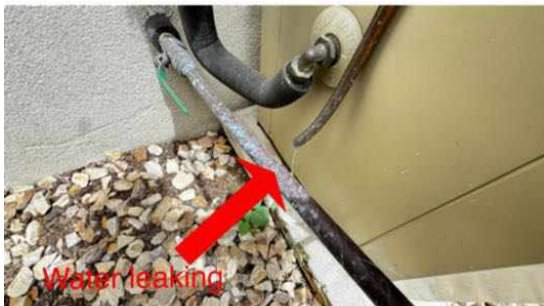
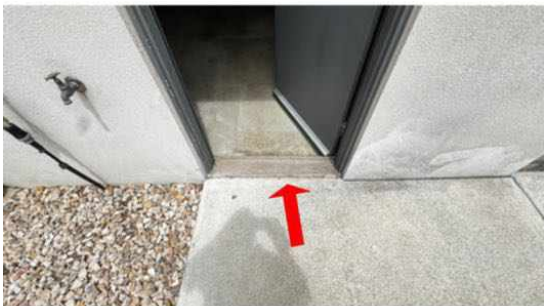
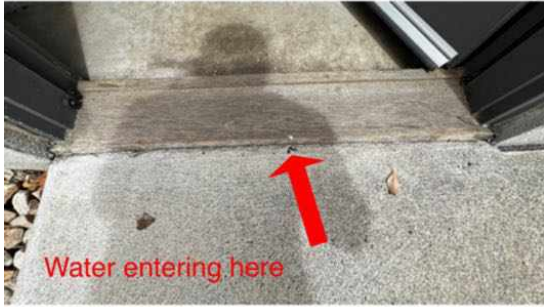
Defects 3.05

Information: Dampness, staining, efflorescence, and other moisture-related deterioration was observed in the concrete floors in this area. Persistent moisture may reduce the durability of the slab, affect floor finishes, accelerate reinforcement corrosion, and, in severe cases, compromise structural integrity, creating a potential safety hazard.

The moisture may be caused by rising damp from inadequate damp-proof courses or barrier failures, penetrating water from leaking plumbing or drains, poor subfloor drainage, water pooling adjacent to the slab, condensation in enclosed areas with insufficient ventilation, or previous water damage that was not properly remediated.

A registered builder or licensed plumber should be engaged immediately to identify the source of moisture, implement remedial works, and restore the integrity and safety of the concrete floors. Prompt action will help prevent further deterioration and protect occupant safety.

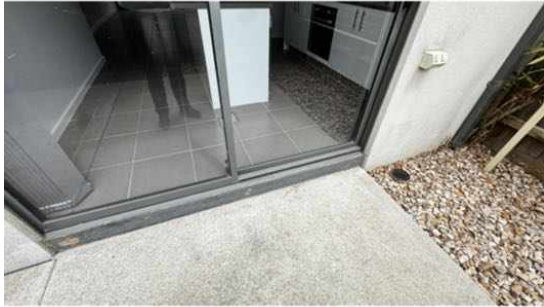
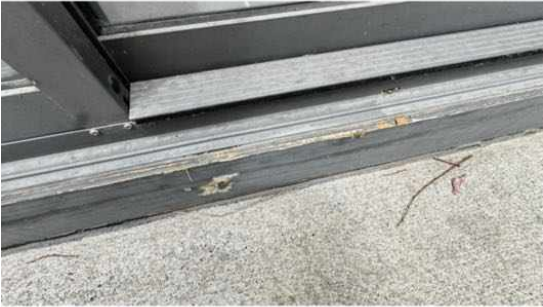
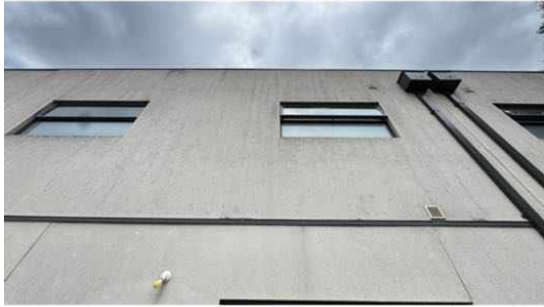
Defects 3.06

Building: Main Building
Location: All External Areas
Finding: External Walls - Paint Finishes Discolouration
Information: The external walls were inspected for paint and or surface condition, and discolouration was observed in this area.

While primarily a cosmetic issue, the affected areas may indicate age-related wear, poor surface preparation, or previous repairs.

When practical, a qualified painter should be engaged to prepare and repaint the affected areas. Addressing paint deterioration will improve the appearance of the ceilings and help protect the surfaces from further wear.

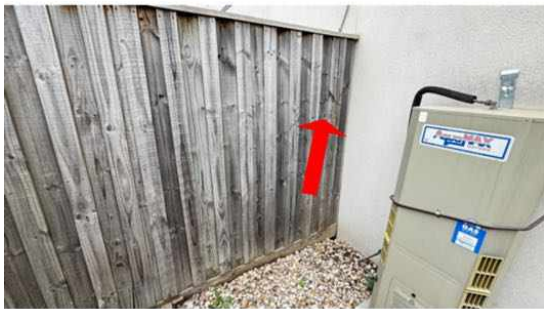
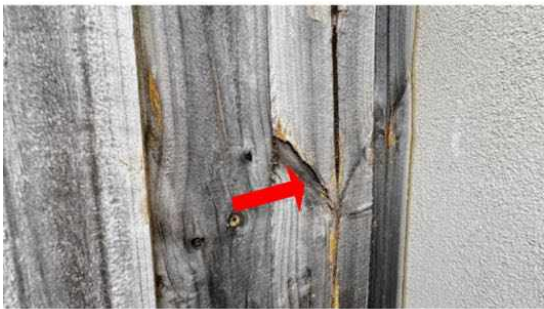
Defects 3.07

Building:	Main Building
Location:	All External Areas
Finding:	Fencing - Deteriated
Information:	Timber fencing was inspected and deterioration was observed in this area. Deteriorated fencing can compromise structural stability, reduce privacy, and may allow pest ingress or accelerated decay if left unaddressed.

Possible causes include age-related timber decay, prolonged exposure to moisture or sunlight, poor maintenance, or impact damage.

When practical, a qualified carpenter or fencing specialist should be engaged to repair or replace affected sections, and a qualified painter should be engaged to restore protective finishes. Prompt rectification will maintain structural performance, improve appearance, and extend the lifespan of the fencing.

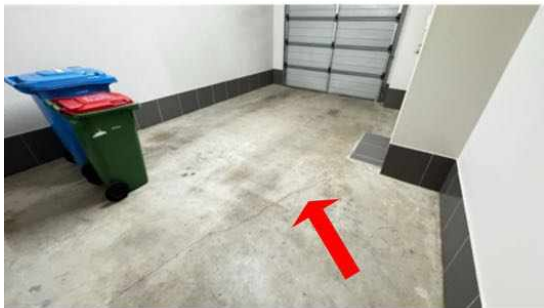
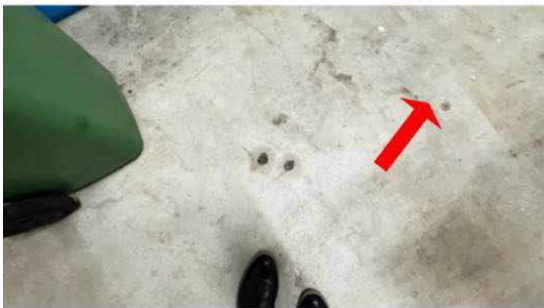
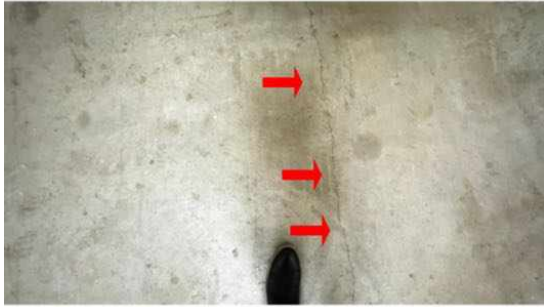
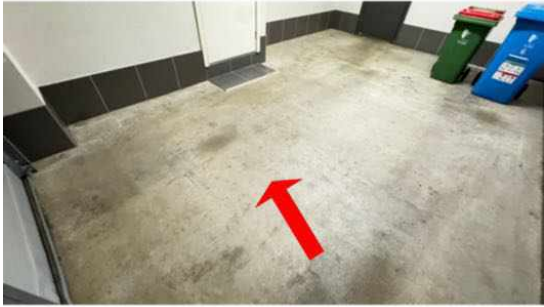
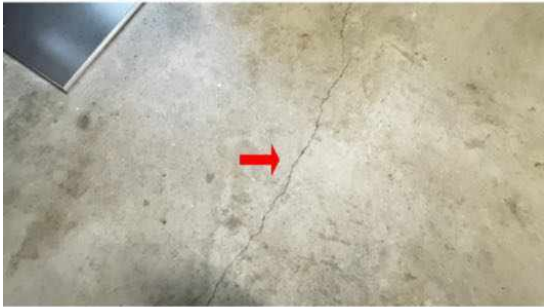
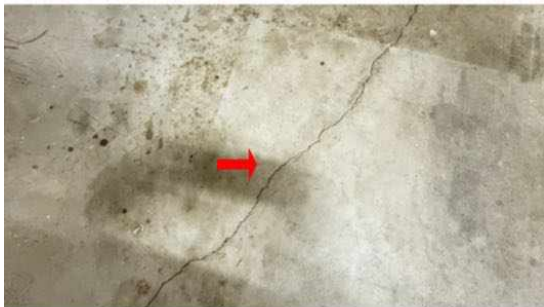
Defects 3.08

Building: Main Building
Location: All Areas
Finding: Concrete - Minor Cracking & Surface Imperfections
Information: Concrete surfaces were visually inspected in this area. Cracking, surface settlement, and minor unevenness were observed. While these defects do not currently compromise structural safety, they may affect long-term durability, appearance, and vehicle access.

These issues may be caused by age-related wear, soil movement or settlement beneath the surface, possible tree root intrusion, or inadequate original construction or reinforcement.

A qualified concreter should be engaged when practical to repair or resurface affected areas. Prompt rectification will restore a smooth surface, improve appearance, and prevent further deterioration.

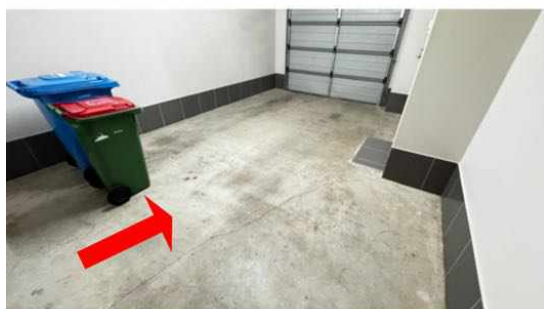
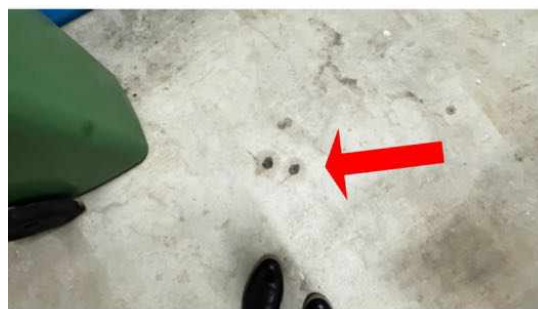
Defects 3.09

Building:	Main Building
Location:	All Areas
Finding:	Garage - Oil Stains To Concrete Slab
Information:	The garage floor was observed to have oil stains in this area. While primarily a cosmetic issue, these stains can reduce slip resistance and may indicate leaks from vehicles or stored equipment.

The staining appears to be caused by spillage or leakage from vehicles, machinery, or general maintenance activities.

When practical, a qualified cleaning or maintenance professional should be engaged to remove the oil stains using appropriate methods. Regular cleaning and monitoring will help maintain the appearance of the floor, reduce slip hazards, and minimise potential long-term damage to the concrete surface.

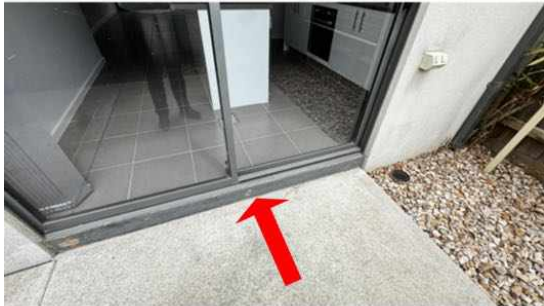
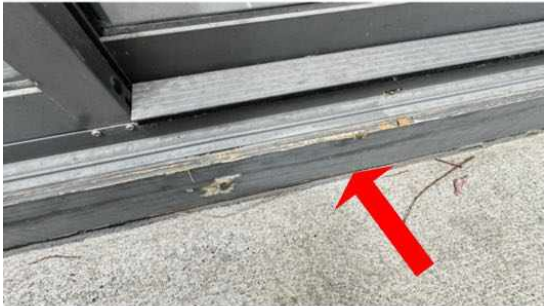
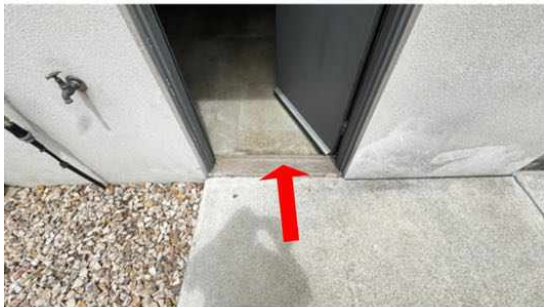
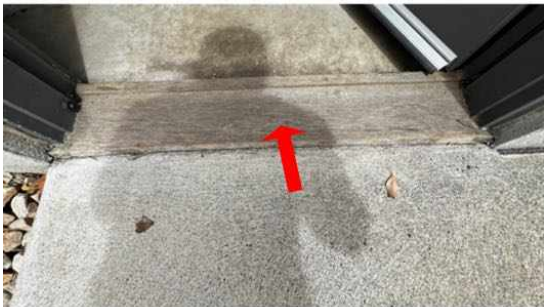
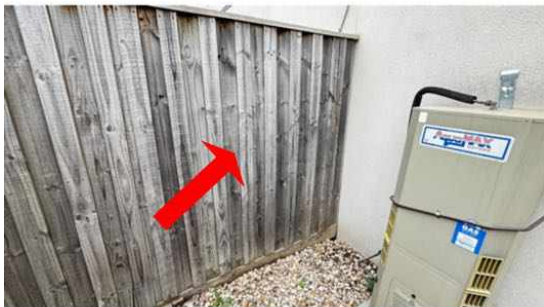
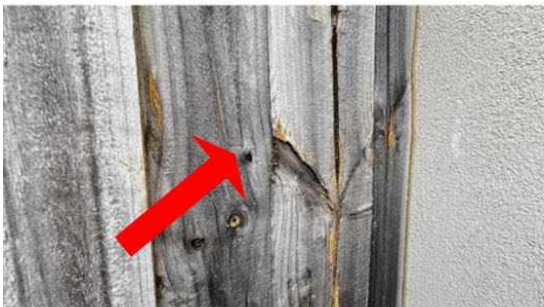
Defects 3.10

Building:	Main Building
Location:	All Areas >
Finding:	External Timber - Timber Rot
Information:	Timber elements including wall claddings, timber rails & posts, landscaping timbers, and other external timber surfaces were inspected and show signs of rot, decay and fungal attack in these areas. Softening, discoloration, splitting, and moisture penetration indicate ongoing timber degradation.

This is likely caused by prolonged moisture exposure, inadequate protective coatings or maintenance, direct contact with soil or water, or poor detailing that traps water or limits ventilation.

If left unaddressed, the affected timber may lose structural integrity, leading to progressive decay, potential collapse of walls, decks, or landscaping features, mould growth, and reduced durability and appearance of the building exterior.

A registered builder or timber specialist should inspect the affected areas immediately to determine the extent of damage. Damaged timbers should be repaired or replaced,

protective treatments applied, and drainage or detailing corrected to prevent recurrence. Ongoing monitoring and urgent remedial action are required to prevent further deterioration.

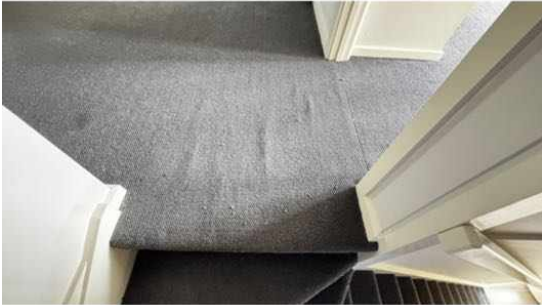
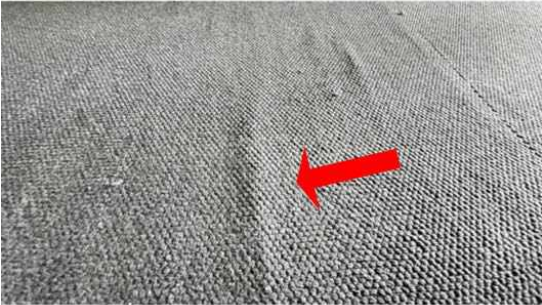
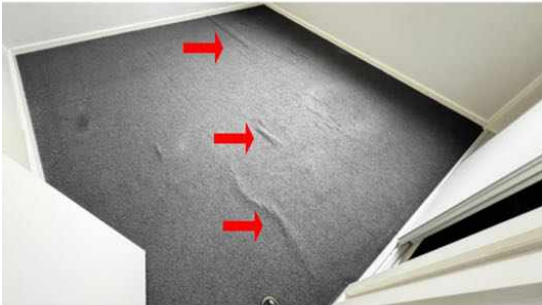
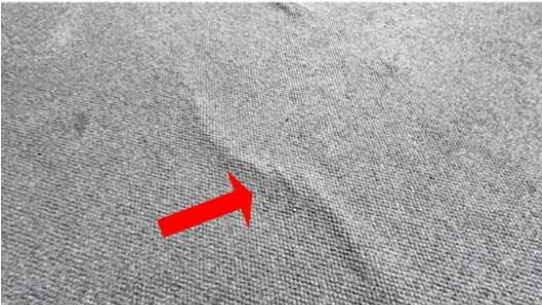
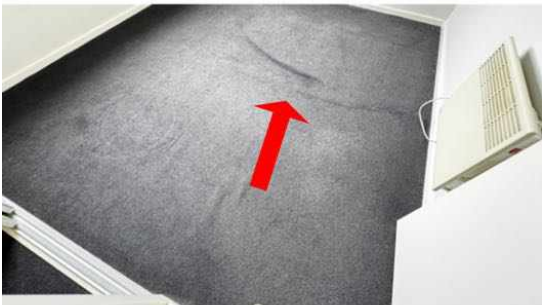
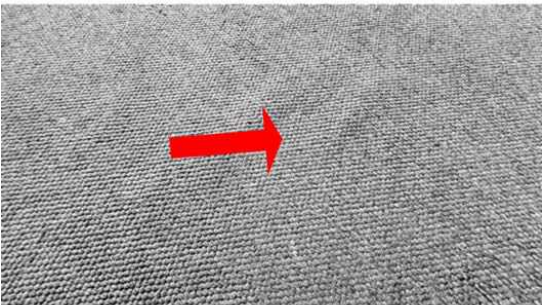
Defects 3.11

Building: Main Building
Location: All Areas >
Finding: Floors - Carpet Deteriated
Information: The carpet was inspected and found to be deteriated in this area, with signs of wear and staining. Damaged carpet can reduce comfort, detract from the appearance of the space, and, over time, expose the subfloor to additional wear or moisture.

This condition may result from everyday use, accidental impact, or age-related deterioration.

A qualified flooring installer should be engaged when practical to clean, repair and or replace the affected carpet. Timely attention will restore visual appeal, comfort, and the longevity of the flooring.

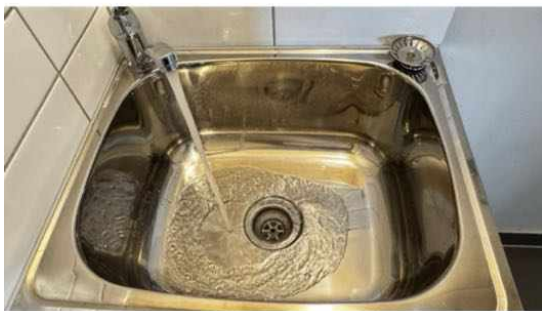
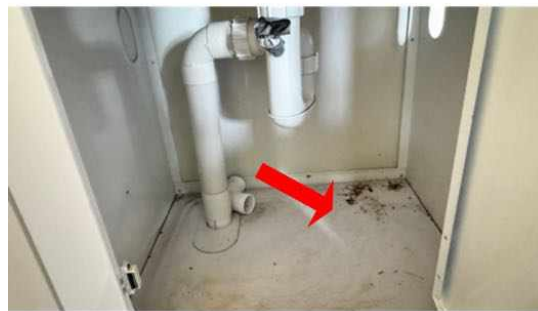
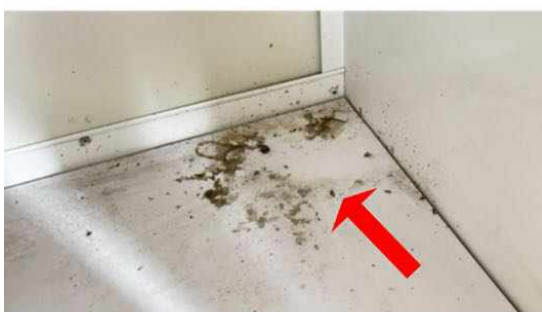
Defects 3.12

Building:	Main Building
Location:	Laundry
Finding:	Laundry Tubs - Deteriorated
Information:	The laundry tub was inspected and signs of deterioration was observed. This included wear to surfaces consistent with age and ongoing use. Deteriorated laundry tubs can reduce functionality, affect hygiene, and increase the likelihood of leaks or water damage to surrounding cabinetry, walls, or floor finishes.

This condition may be due to age-related wear, prolonged exposure to historic moisture, or a lack of routine maintenance.

A licensed plumber should be engaged immediately to assess the condition of the laundry tub and associated fittings. Remedial works may include repair, resealing, or replacement of the tub and related components. Addressing this issue will restore functionality, maintain hygiene, and help prevent further deterioration or water-related damage.

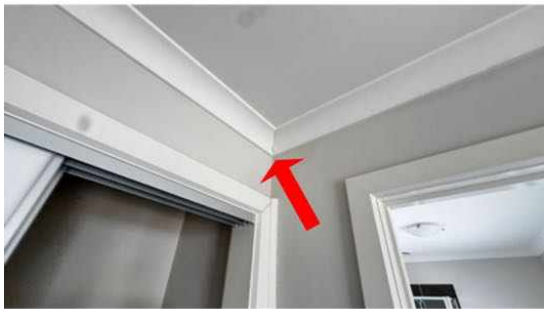
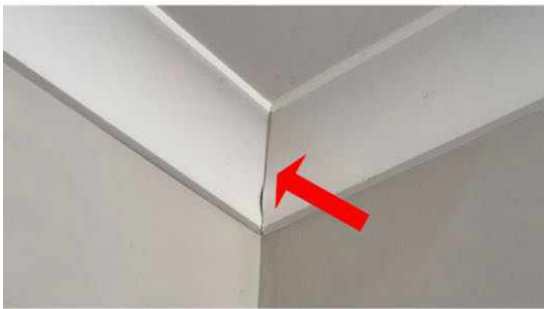
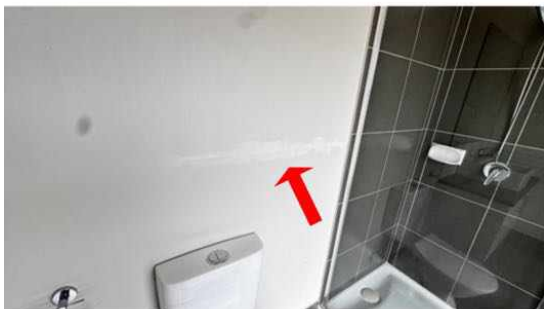
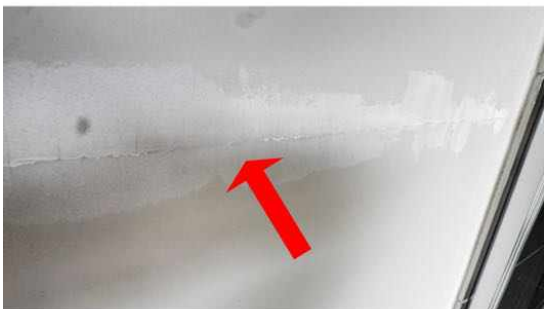
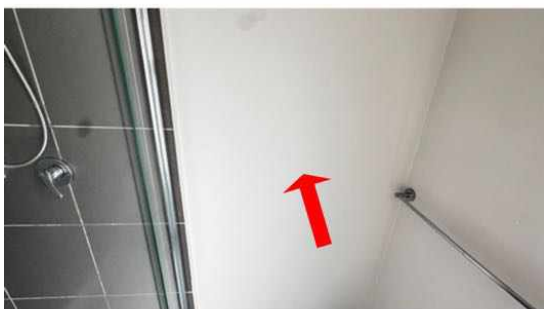
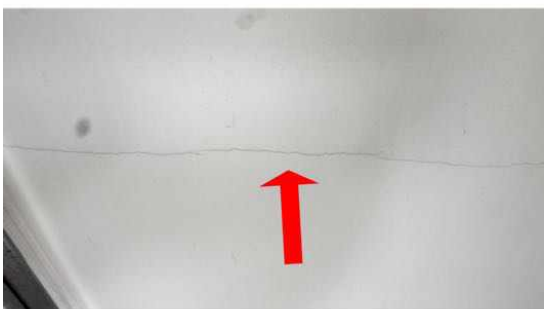
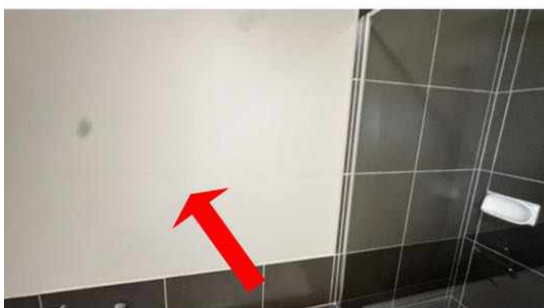
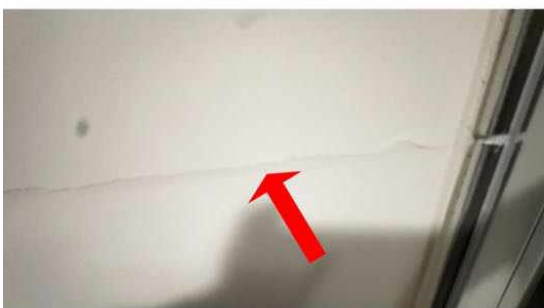
Defects 3.13

Building:	Main Building
Location:	All Areas >
Finding:	Plaster - Minor Plaster Cracking
Information:	Cracking was observed to the plaster in this area. While generally cosmetic in nature, plaster cracks can result from minor building movement, seasonal expansion and contraction, or poor jointing and finishing at the time of construction.

Possible causes may include normal building settlement and movement, seasonal expansion and contraction of building materials and or poor installation or finishing of plasterboard joints.

Cracking should be monitored over time to assess whether movement is ongoing. Where cracking is purely cosmetic, patching and repainting may be undertaken as part of routine maintenance by a qualified plasterer.

*If cracks widen, reoccur after repairs, or appear in conjunction with other structural signs, further investigation by a registered builder or structural engineer is recommended immediately.

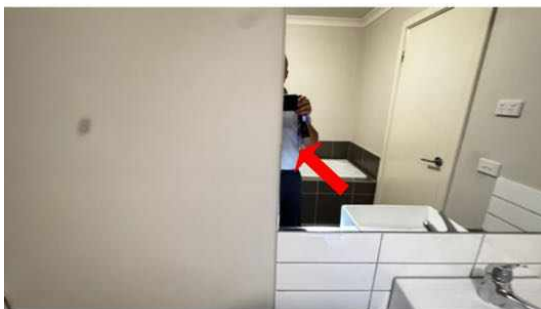
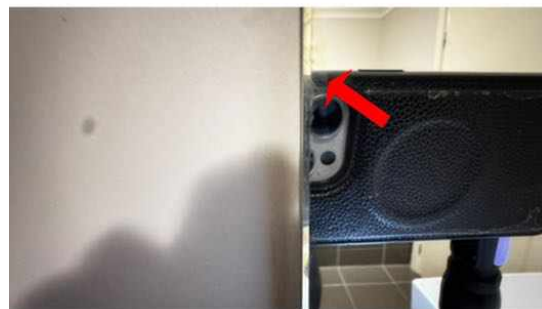
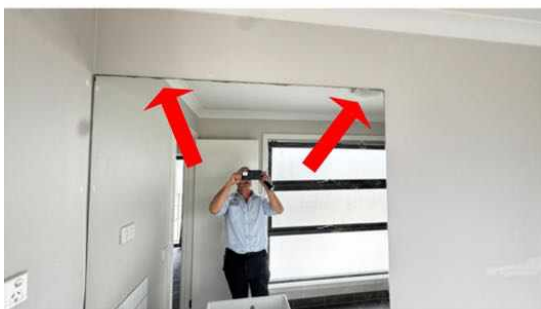
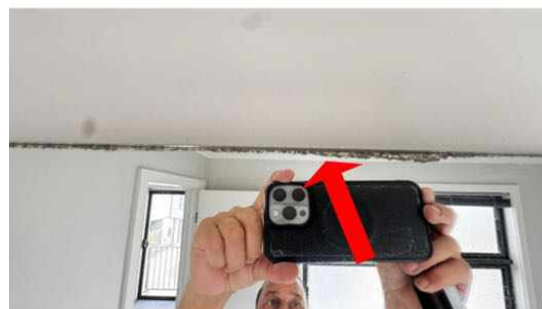
Defects 3.14

Building: Main Building
 Location: Bathroom 1 and 2 >
 Finding: Bathroom Mirrors - Edge Deterioration
 Information: Mirrors were observed to have edge deterioration in this area. Damaged mirrors can be a safety hazard due to sharp edges, reduce visual appeal, and affect functional use.

This may be due to age-related wear, poor installation, or exposure to moisture causing edge damage.

A qualified glazier or bathroom specialist should be engaged without delay to inspect and repair or replace the damaged mirrors. This may include replacing affected mirrors, securing the mounting, and ensuring edges are properly sealed. Prompt action will help prevent injury, restore functionality, and maintain appearance.

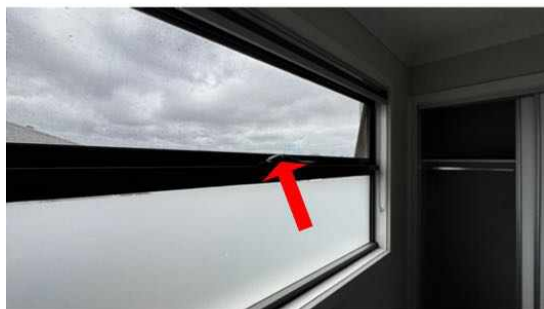
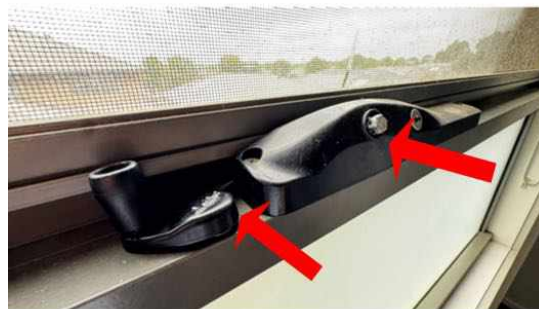
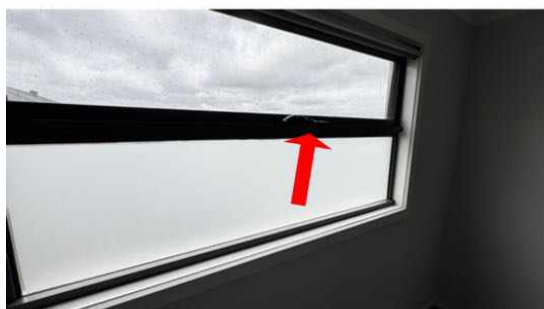
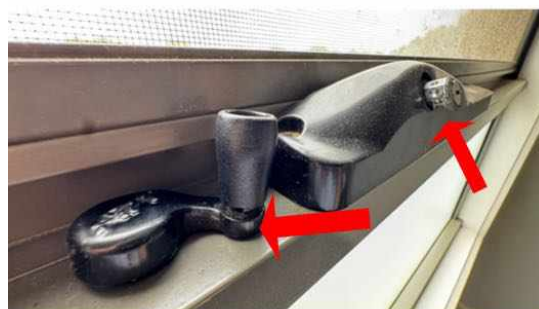
Defects 3.15

Building: Main Building
 Location: Bedroom 1 and 2 >
 Finding: Windows - Fittings & Hardware Deteriorated
 Information: Window fittings and hardware in this area were observed to be deteriorated. Deterioration of fittings and hardware can affect the functionality of the windows, reduce security, and, in some cases, make the windows difficult to open, close, or

Possible causes include age-related wear, corrosion from moisture or environmental exposure, mechanical stress from repeated use, and lack of maintenance over time.

It is recommended that a window specialist or registered builder be engaged to assess the affected windows and replace any deteriorated fittings and hardware to restore proper function, security, and appearance.

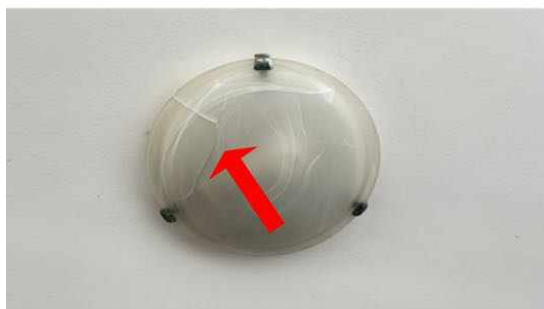
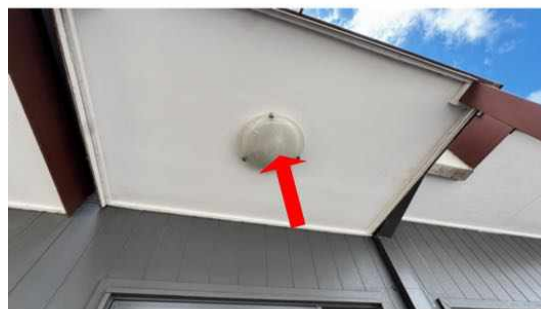
Defects 3.16

Building:	Main Building
Location:	Entry >
Finding:	Ceilings - Light Fittings Damaged
Information:	The ceilings were inspected and damaged light fittings were observed in this area. Defective light fittings can pose electrical hazards, increase the risk of fire, and create potential injury risks if fixtures detach.

This may be due to age-related deterioration of fixings, poor installation, mechanical impact or vibration, or lack of regular inspection and maintenance.

A licensed electrician should be engaged immediately to inspect, repair, or replace affected light fittings. Prompt action will prevent electrical hazards and ensure safe operation of ceiling-mounted fixtures.

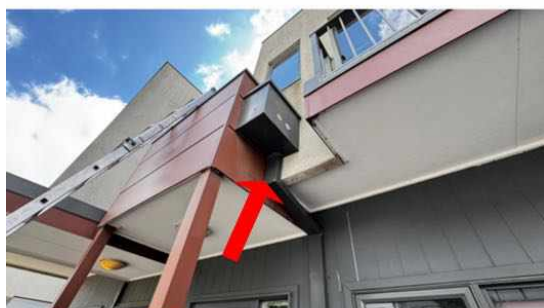
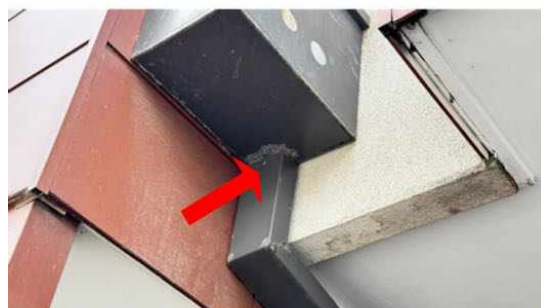
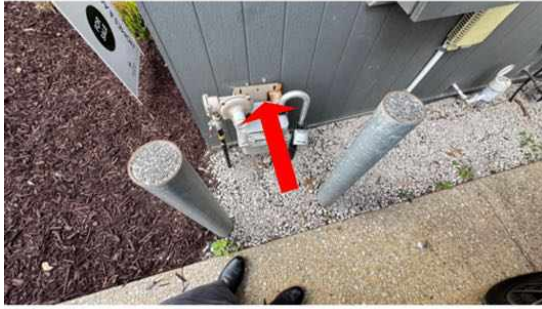
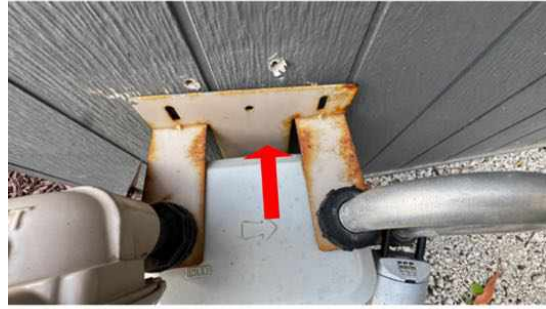
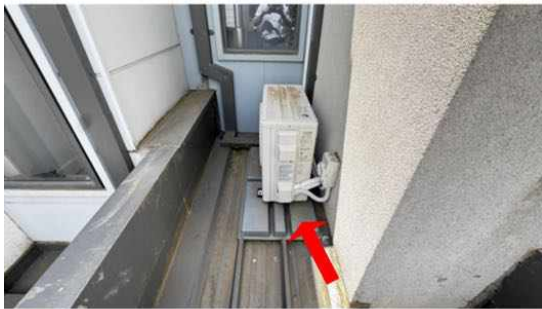
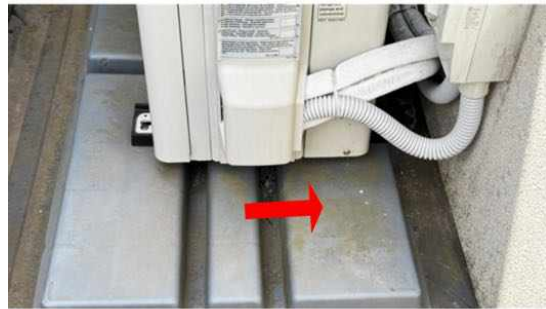
Defects 3.17

Building:	Main Building
Location:	All External Areas
Finding:	Building Element Hardware - Rust & Corrosion
Information:	This building element shows evidence of rusting and corrosion, which is likely to have developed as a result of excessive exposure to moisture and or inadequate coatings. As surface rust provides no protection to the underlying iron, the deteriorating condition is likely to worsen if not addressed in the short-term future.

These items can sometimes be treated but more than likely will require replacement. Where possible, the use of galvanized (treated) metals or aluminium coated metals aid in rust prevention, as does regular general maintenance. Rust formation can be controlled with coatings, such as paint, that isolate the iron from the environment.

Rusting and corrosion should be managed by ideally removing or limiting the affected surface from exposure to moisture. A qualified handyman or carpenter may be appointed to replace any building elements that have been affected by rust or water damage.

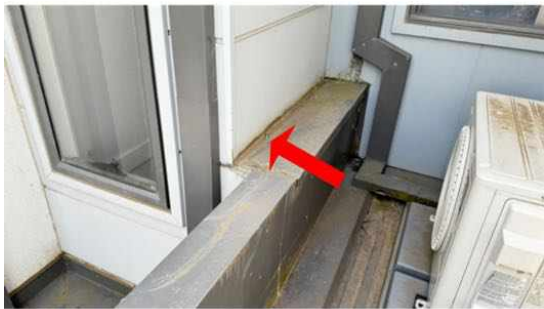
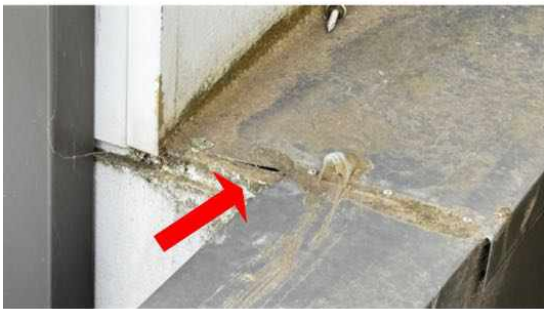
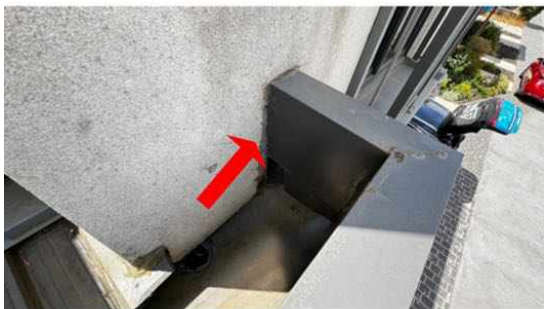
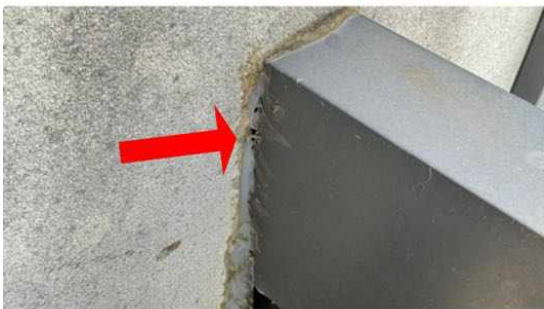
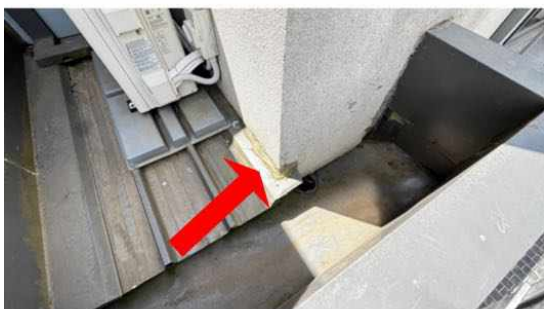
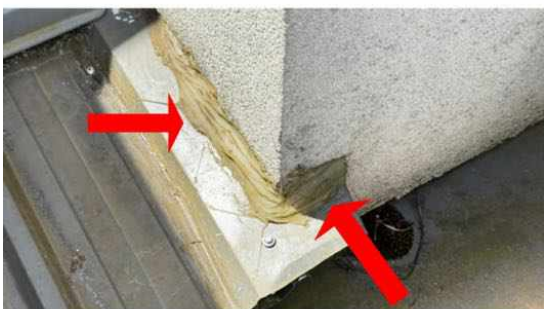
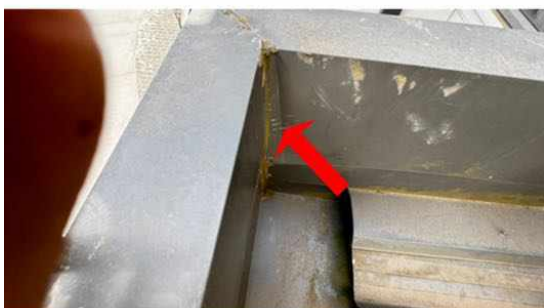
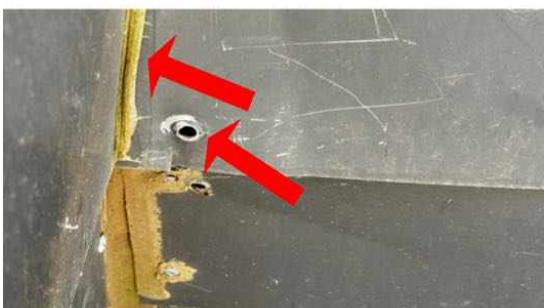
Defects 3.18

Building:	Main Building
Location:	Roof Exterior
Finding:	Roof Plumbing - Inadequate Sealant At Junctions
Information:	The junctions in this area were inspected, and inadequate and deteriorated sealant was observed. Missing or compromised sealant can allow moisture ingress, promote mould growth, and reduce the durability of surfaces and underlying substrates.

This condition may be due to age-related wear, poor initial application, or lack of maintenance.

A licensed roof plumber or competent caulking specialist should be engaged immediately to remove old sealant and apply new, compliant materials. Prompt rectification will protect the building elements, maintain hygiene, and prevent possible water-related damage.

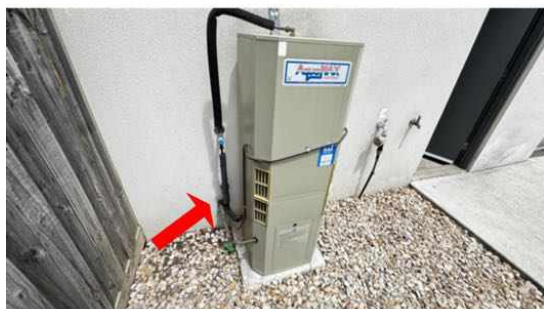
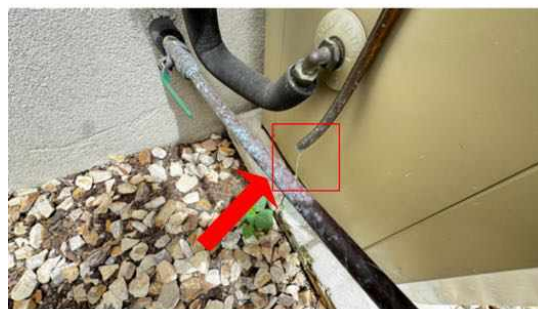
Defects 3.19

Building:	Main Building
Location:	All External Areas
Finding:	HWS - (T&P) Valve Not Connected To Storm Water
Information:	The Hot Water System (HWS) Temperature & Pressure Relief (T&P) valve discharge pipe was observed to be disconnected from stormwater drainage.

When not properly connected, discharged water can create damp conditions around the HWS, potentially leading to secondary defects such as timber rot, corrosion of nearby metal components, mould growth, or slip hazards. Prolonged exposure to moisture in this area may also attract termite activity and contribute to long-term deterioration of surrounding building elements.

A licensed plumber should be engaged immediately to connect the T&P discharge pipe to a suitable stormwater outlet or floor waste. Prompt rectification will ensure safe operation of the HWS, protect surrounding structures, and reduce potential health and safety risks.

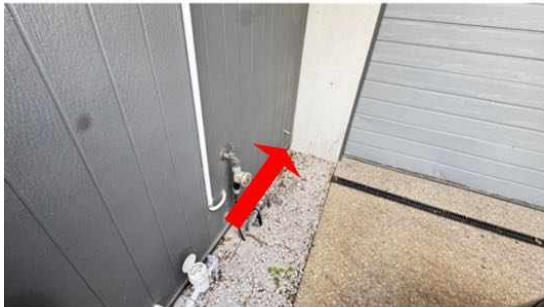
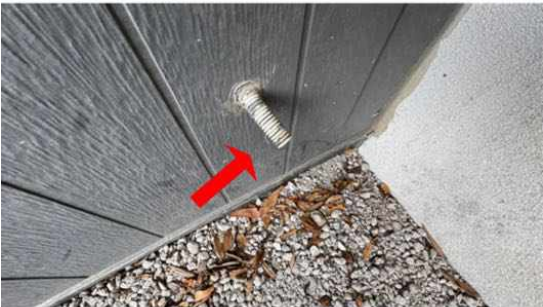
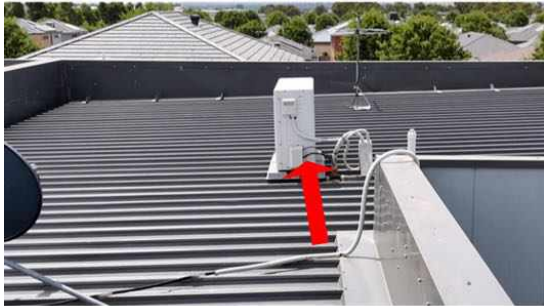
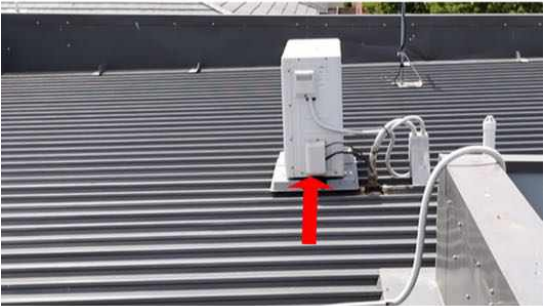
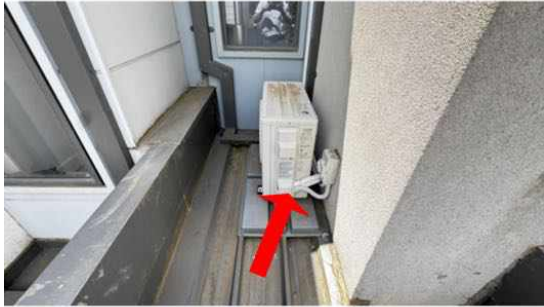
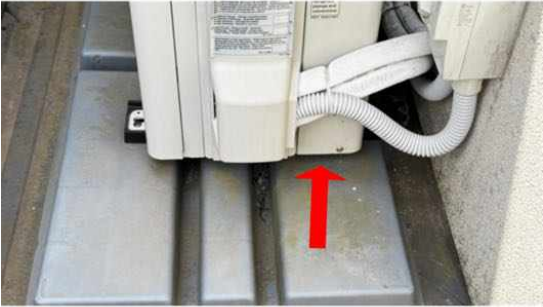
Defects 3.20

Building:	Main Building
Location:	All External Areas >
Finding:	AC Condensate Drain - Not Connected To Storm Water
Information:	The air conditioning condensate drain in this area was observed to be disconnected from stormwater drainage.

When condensate is not properly directed to a stormwater outlet, water can accumulate around the building or air conditioning unit, creating damp conditions that may lead to secondary defects such as timber rot, corrosion of nearby metal components, mould growth, or slippery surfaces. Prolonged pooling of water may also attract termites and contribute to long-term deterioration of surrounding building elements.

A qualified HVAC technician or licensed plumber should be engaged immediately to connect the condensate drain to a suitable stormwater outlet. Prompt rectification will

ensure proper drainage, protect the building fabric, and reduce potential health and safety risks.

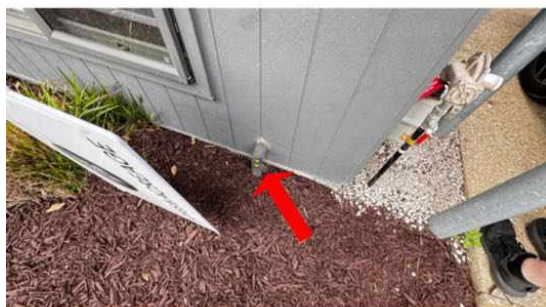
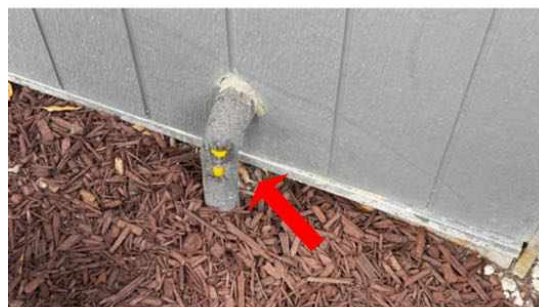
Defects 3.21

Building: Main Building
Location: All External Areas
Finding: Building Element - Deteriated
Information: Gas mains lead in - Deterioration occurs generally when the building materials have either aged and decayed, or as a result of damage (accidental or deliberate).

Repair and/or replacement of this building element is advised to ensure that additional

secondary defects do not arise as a consequence. Such works are necessary, as all building elements play a key role in the operation and function of the overall structure and its performance.

A registered plumber should be appointed to repair or replace the affected building element immediately.
