Building Inspection Report

Inspection Date: Thu, 5 Feb 2026

Property Address: 6 Queenie Wy, Cranbourne West VIC 3977,
Australia

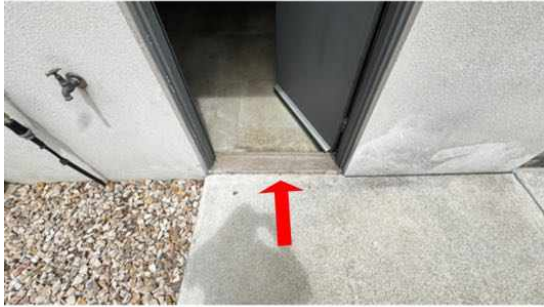
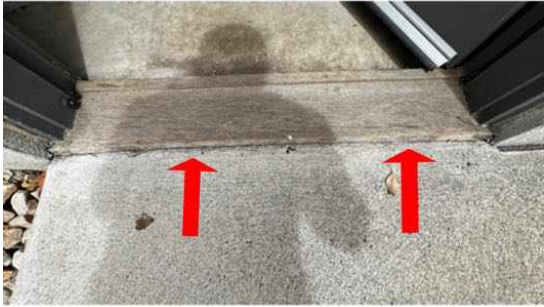
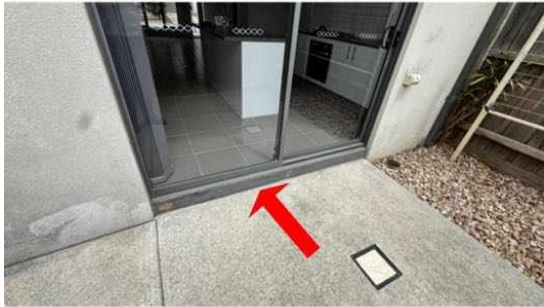
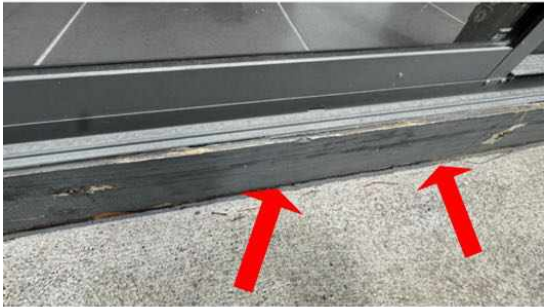
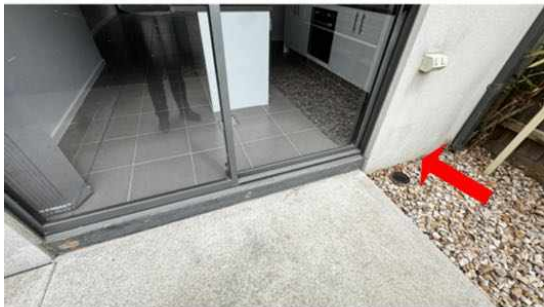
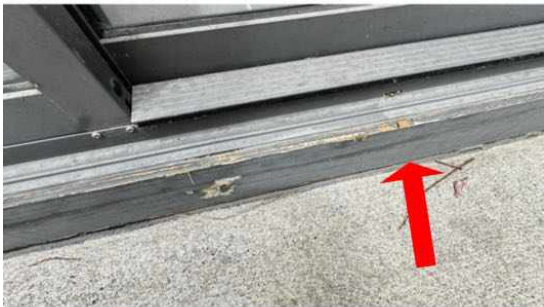
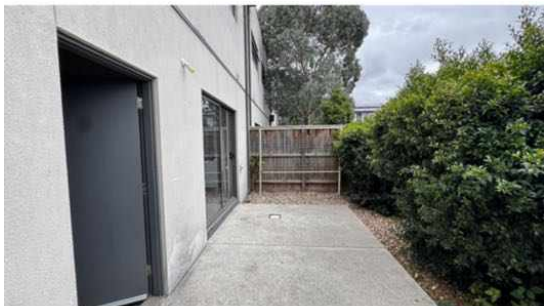
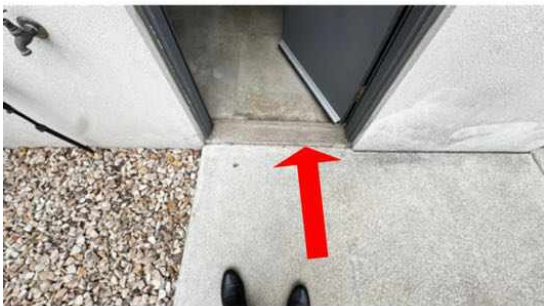
Defects 3.22

Finding: Site Drainage - Inadequate

Information: The overall site drainage was observed to be inadequate at the time of inspection. Poor drainage can cause water to pond near external walls, increasing the risk of rising damp, foundation movement, timber decay, and deterioration of associated building elements.

Ground levels should slope away from the dwelling to direct water from walls and footings. Downpipes must be properly connected to the stormwater system and should not discharge directly onto walls, paving, or plinths. Stormwater should be directed away from the property through adequately sized and maintained drains. Where ground levels are too high and cover the damp-proof course (DPC), lowering the levels may be necessary to expose the DPC and allow effective drainage.

A licensed plumber should be engaged promptly to investigate and recommend suitable remedial works, which may include the installation of an agricultural (aggie) drain or other site drainage improvements. Immediate action is strongly recommended, as inadequate drainage can lead to progressive water damage and secondary building defects over time.

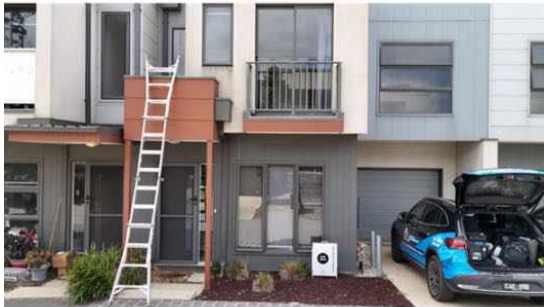
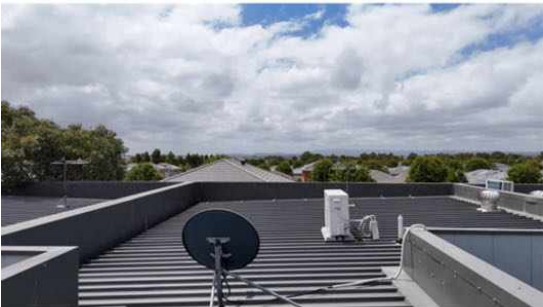
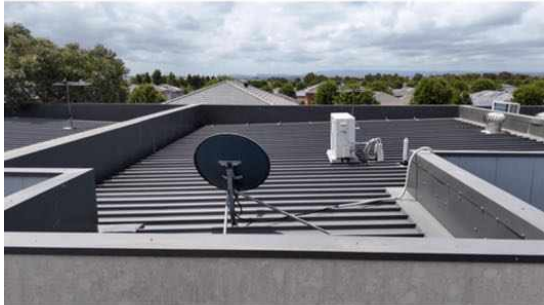
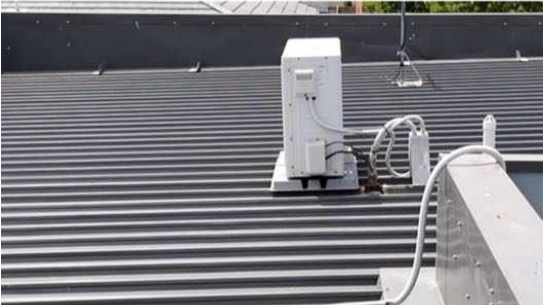
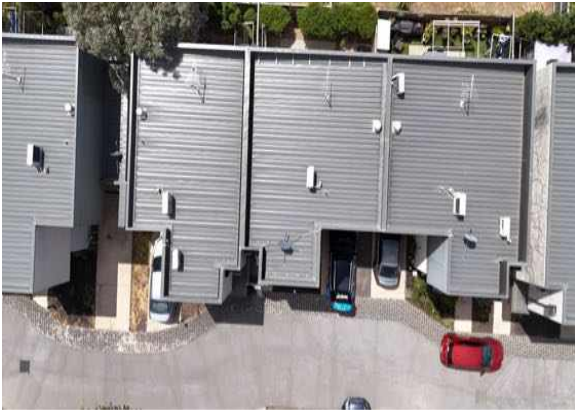
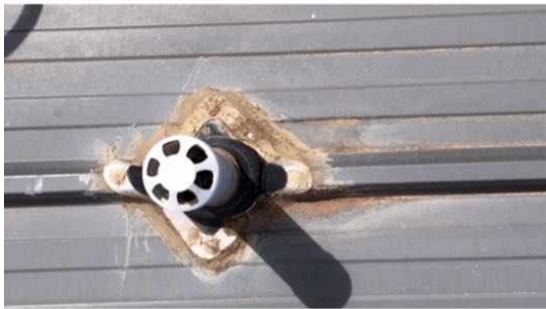
Noted Item

Building: Main Building
Location: All External Roofing Areas
Finding: Roof Plumbing - Images For Your Information
Information:

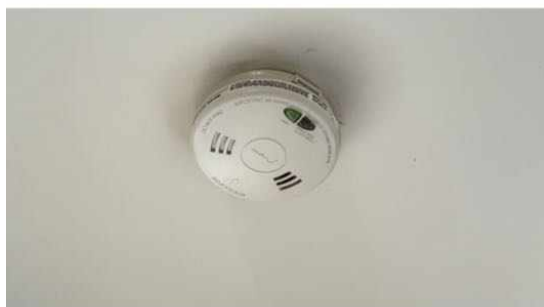
Noted Item

Building: Main Building
 Location: All Internal Areas
 Finding: Smoke Detectors - Advisory
 Information: During the inspection, smoke detectors were noted for advisory purposes only. The operation, age, type, and compliance of smoke detectors could not be fully verified as part of this inspection.

Smoke detectors are critical life-safety devices, and non-compliant, outdated, or non-operational units may not provide adequate warning in the event of a fire.

It is recommended that a licensed electrician be engaged immediately to test, service, and upgrade smoke detectors as required to ensure correct operation and compliance with current safety requirements.

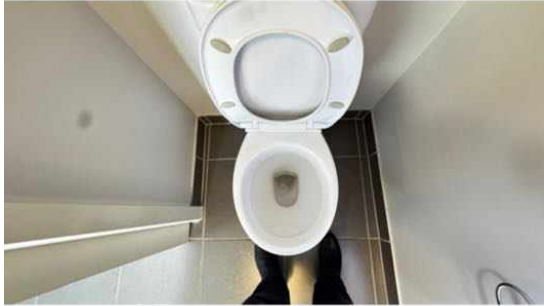
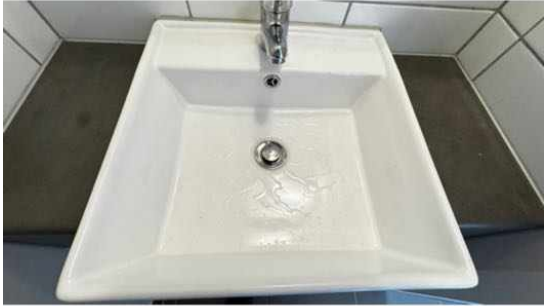
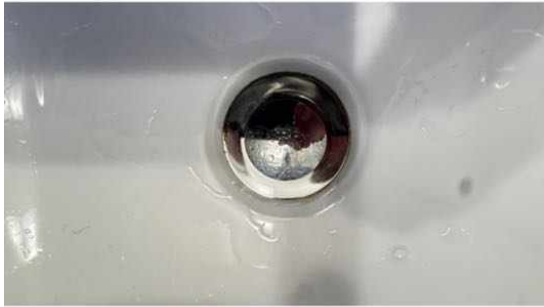
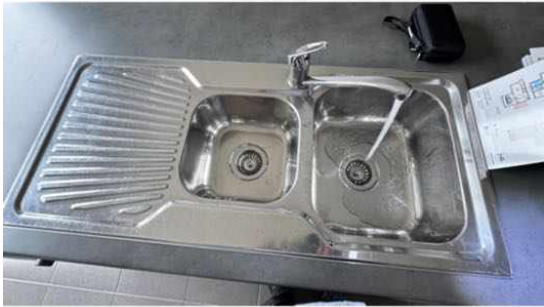
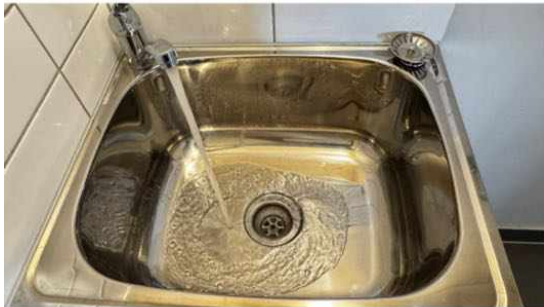
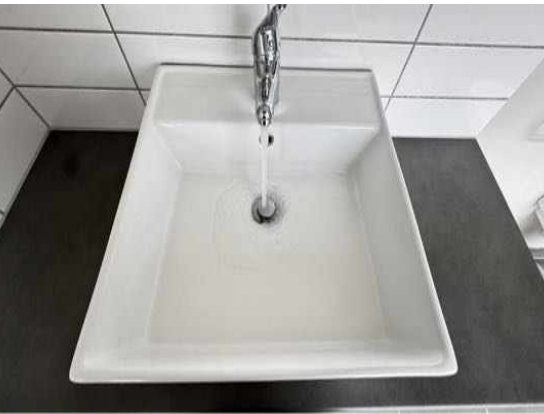
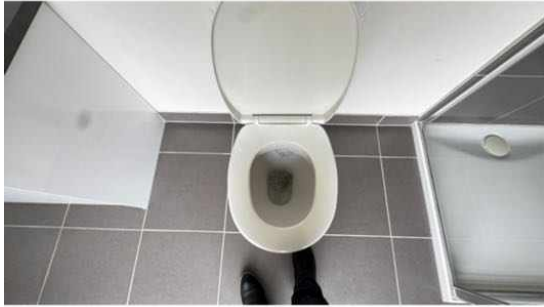
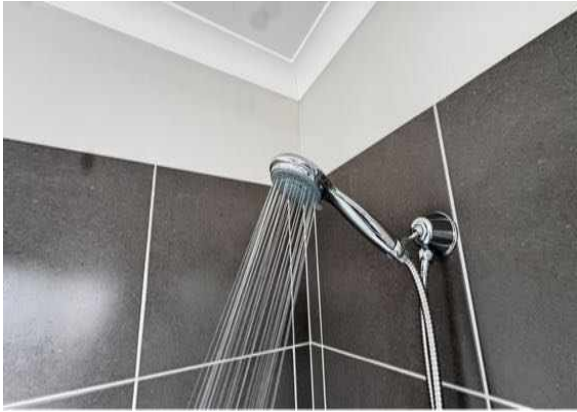
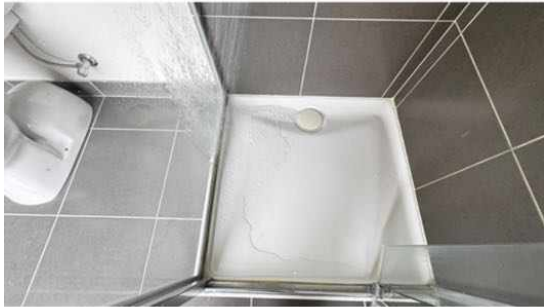
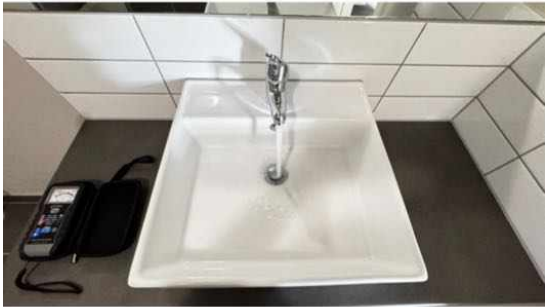
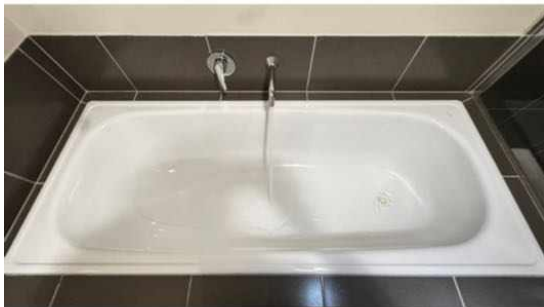
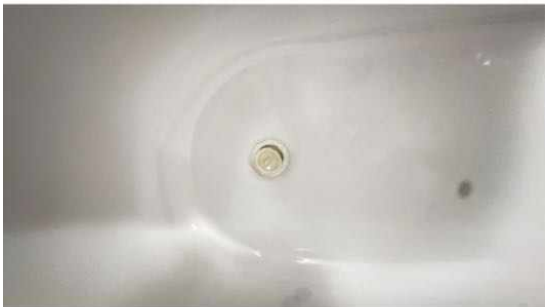
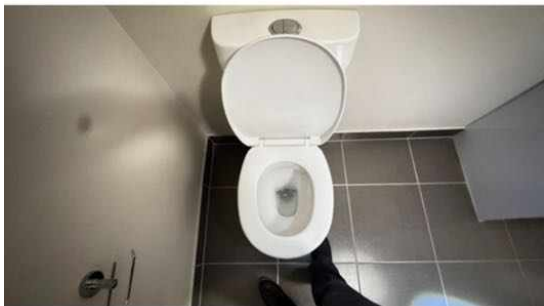
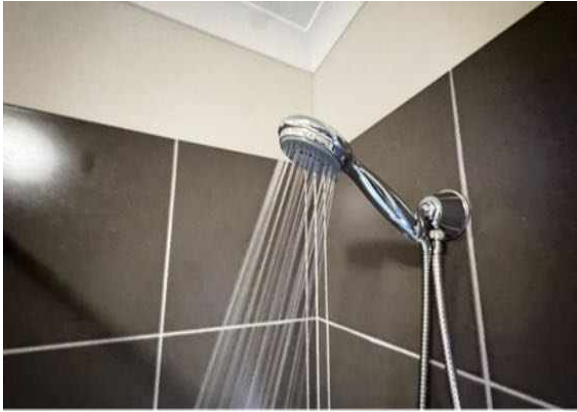
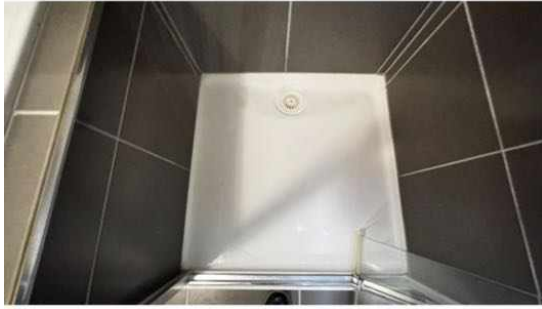
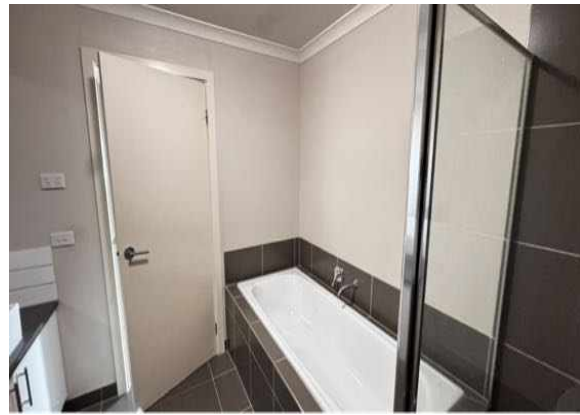
Noted Item

Building: Main Building
 Location: All Internal Areas
 Finding: Water Supply & Drainage - Shower, Basins, Toilets, & Plumbing Fixtures
 Information: The shower recess was tested, and no visible water penetration to surrounding areas was observed at the time of inspection, except where noted as a separate defect elsewhere in this report. Water appeared to flow freely toward the floor waste. Moisture detected to the shower walls is documented separately in the report. The shower floor waste appeared clear during inspection.

Flushing the toilet revealed no visible leaks, and the fixture appeared to operate normally unless otherwise noted as a separate defect. No water damage was observed to the vanity unit unless specifically stated elsewhere in the report. Basins, bathtubs, laundry tubs, vanities, and sinks were tested and inspected with no evidence of leaks, blockages, or drainage issues at the time of inspection unless otherwise noted. All internal taps and shower heads were tested with no leaks observed, unless documented as a separate defect.

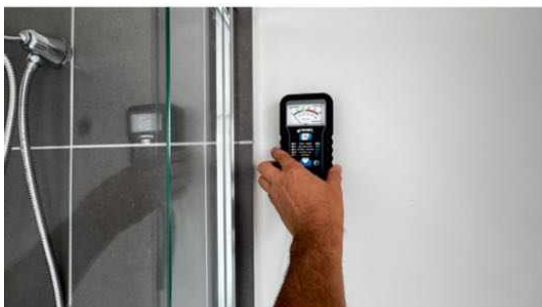
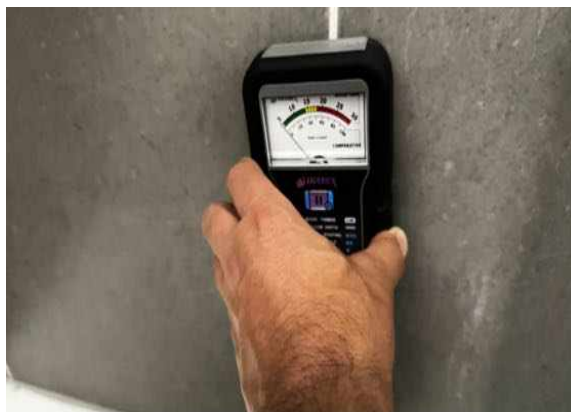
Noted Item

Building: Main Building
 Location: All Areas Interior & Exterior
 Finding: Moisture Levels - Advisory - No Elevated Moisture Levels Present
 Information: At the time of inspection, no elevated moisture levels were detected in these areas. Moisture readings were taken (using a Tramex Moisture Meter) and non-invasive testing methods and reflect conditions present at the time of inspection only. This item is noted for advisory purposes and should not be relied upon as a guarantee that moisture issues are not present elsewhere or may not occur in the future.

Ongoing monitoring of the property is recommended, and further investigation by a qualified tradesperson should be considered if signs of water ingress, dampness, staining, mould growth, or material deterioration become apparent.

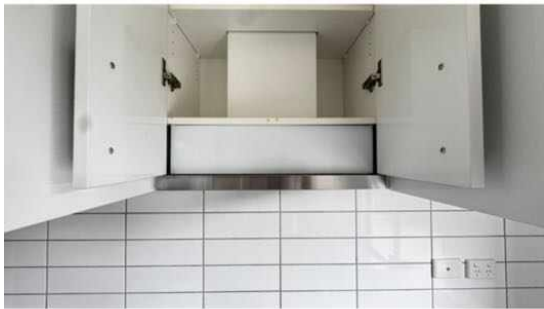
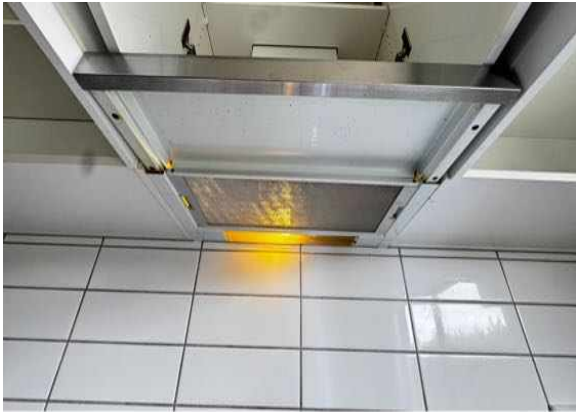
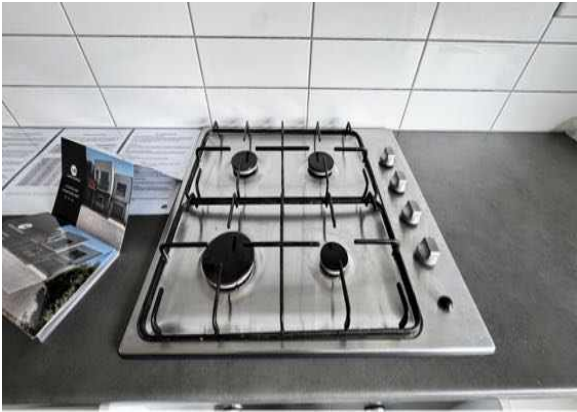
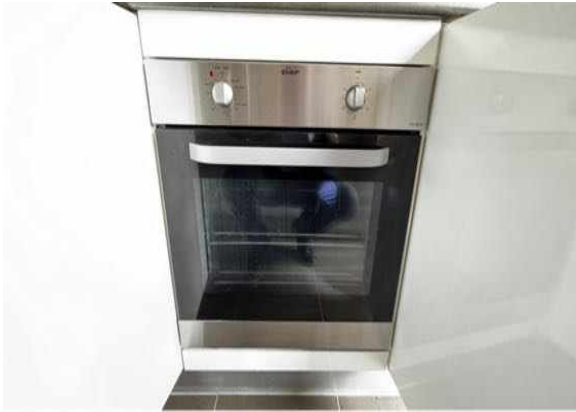
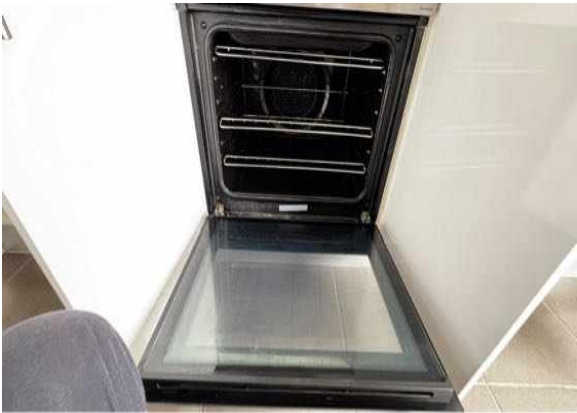
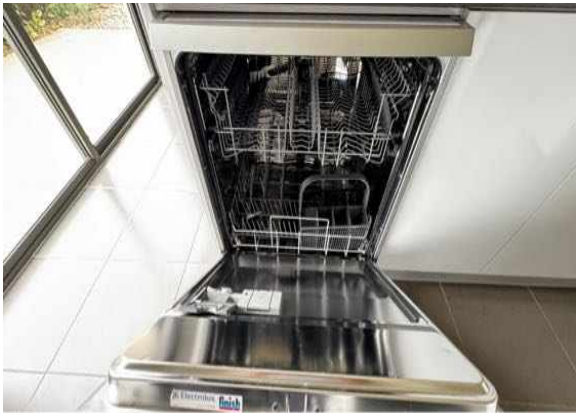
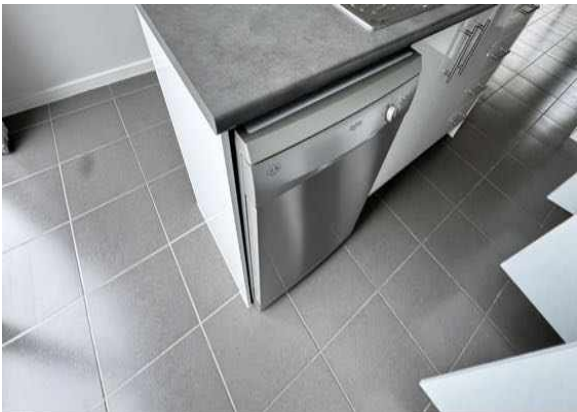
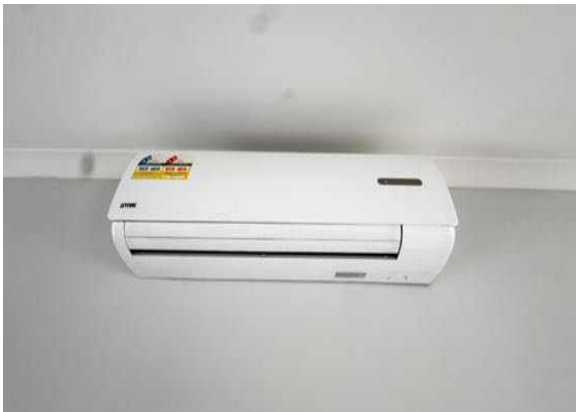
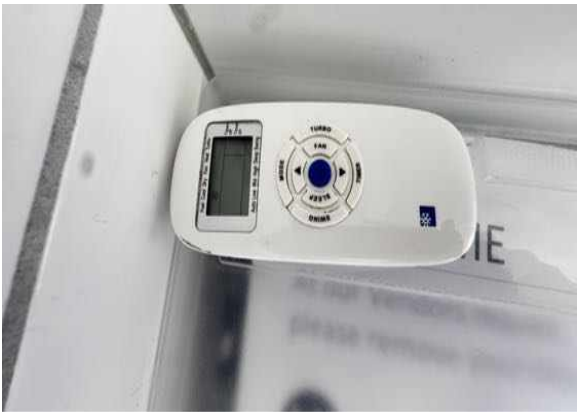
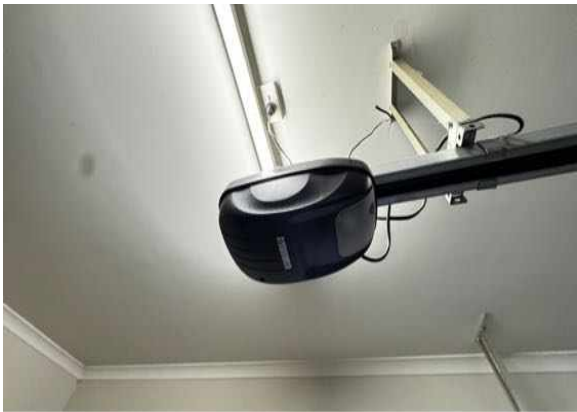
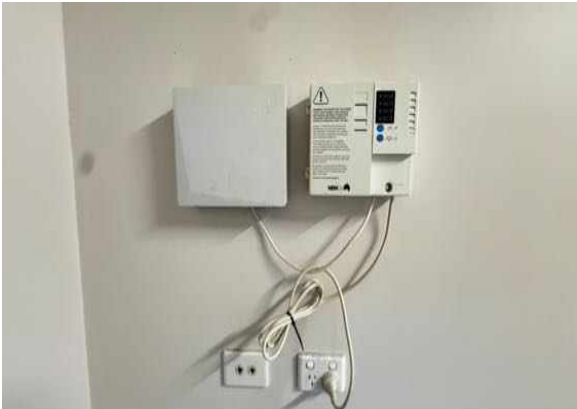
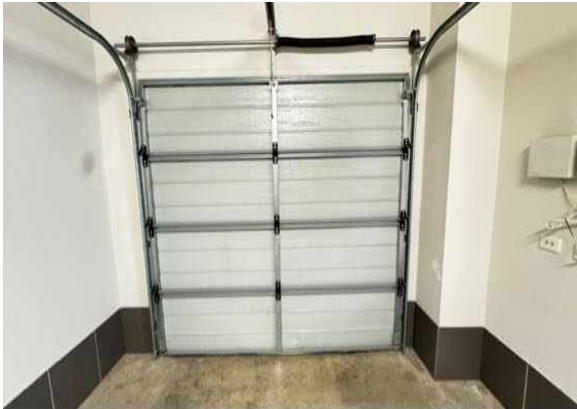
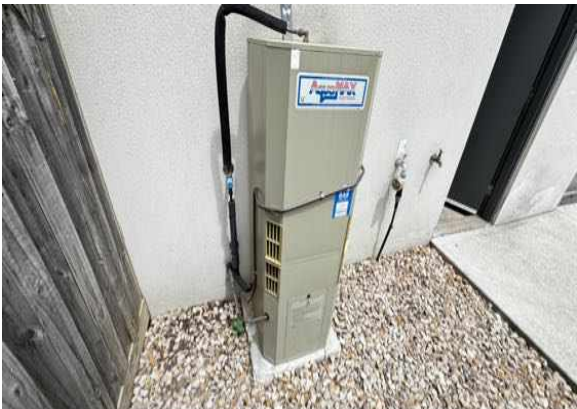
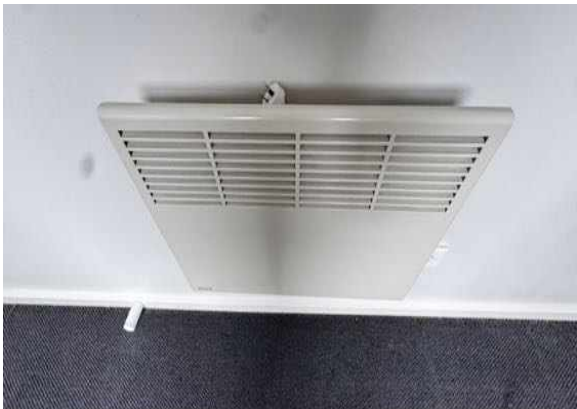
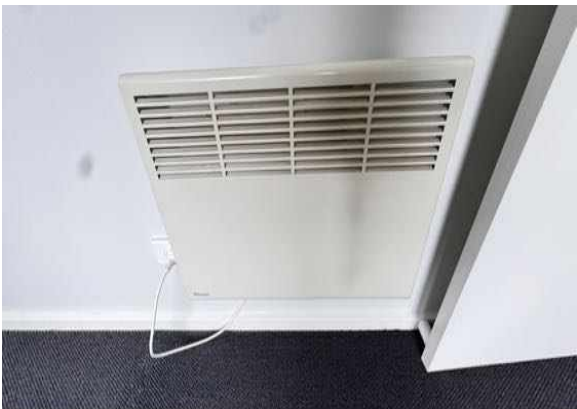
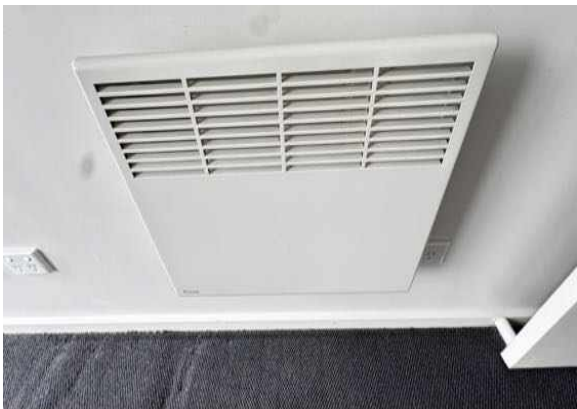
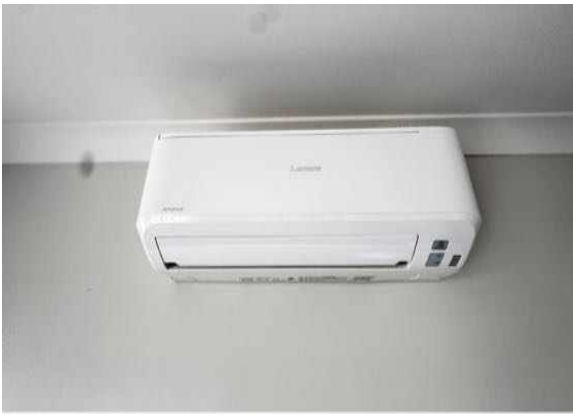
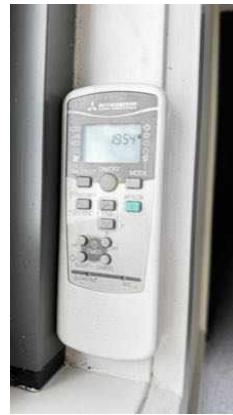
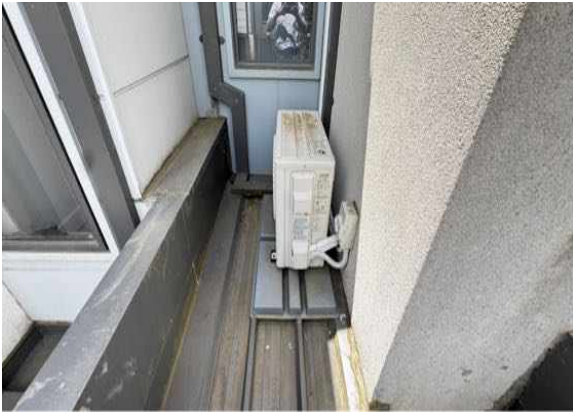
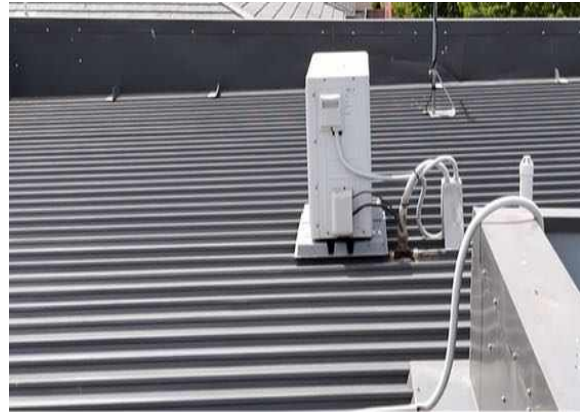
Building:	Main Building
Location:	All Areas, Interior & Exterior
Finding:	Appliances, Heating & Cooling Systems, Mechanical Systems, Plumbing, Electrical, Fireplaces - Advisory
Information:	The inspection did not include testing, operation, safety, or assessment of any installed or portable appliances or mechanical systems. This includes, but is not limited to, ovens, cooktops, microwaves, rangehoods, dishwashers, ducted vacuum systems, air-conditioning units, heating systems, hot water services, ceiling fans, exhaust fans, intercoms, security systems, fireplaces, and solid fuel heaters.

Where appliances are beyond their warranty period, the owner should be prepared for potential costs of repair or replacement at any time. The operation of these appliances cannot be guaranteed, and further inspection by a licensed tradesperson may be required. Many appliances are only covered by limited manufacturer or installer warranties. Confirming warranty status is strongly recommended prior to purchase, as out-of-warranty items may require servicing, replacement, or certification by a qualified technician.

Appliances may be worn, damaged, or malfunctioning. Electrical or gas appliances can pose serious safety hazards if incorrectly installed or maintained.

Observations and images of appliances are for informational purposes only and do not form part of the formal building inspection.

Service, repair, or replace equipment as necessary, particularly where service history or warranty coverage is unknown.

Inspect any water, gas, or electrical connections associated with appliances to ensure safety and compliance.

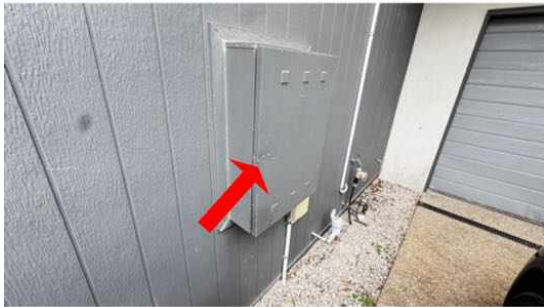
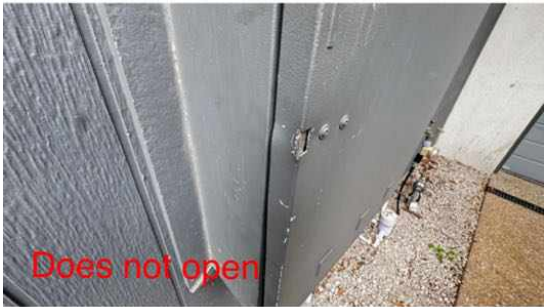
Building: Main Building
 Location: All External Areas >
 Finding: Electrical - Switch Board Location
 Information: For your information, the main electrical switchboard was visually inspected. No intrusive testing or detailed electrical assessment was performed as part of this inspection.

(AS 4349.1-2007: Electrical Switchboard & meter inspections are for your information only, as functional testing is outside the scope of a standard pre-purchase building inspection.)

For full compliance and safety verification, a licensed electrician should be engaged to inspect the switchboard, test all circuits, and ensure all components are functioning correctly. This will help maintain electrical safety and prevent potential hazards.

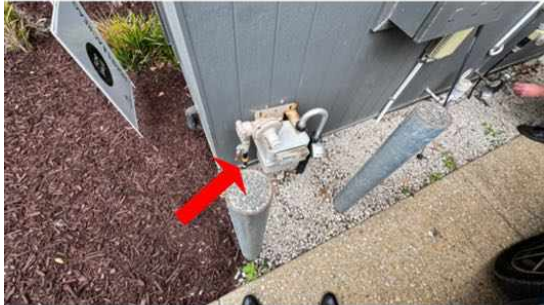
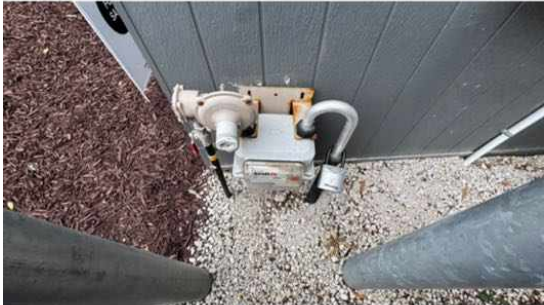
Building: Main Building
Location: All External Areas
Finding: Gas Meter - Location For Your Information
Information: The gas meter was inspected and photographed for reference and location purposes only.

Gas meters can be affected over time by age, environmental exposure, or accidental impact, which may lead to corrosion, physical damage, leakage, or non-compliance with current regulations. Regular checks are recommended to ensure ongoing safe operation.

(AS 4349.1–2007: Gas meter images are for your information only, as functional testing is outside the scope of a standard pre-purchase building inspection.)

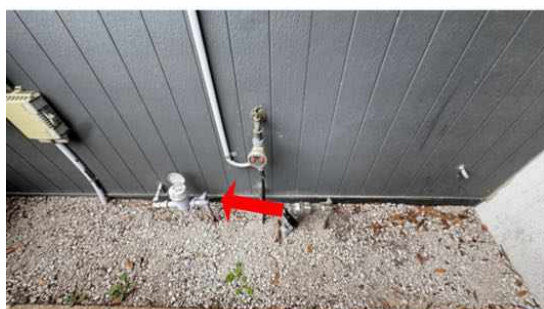
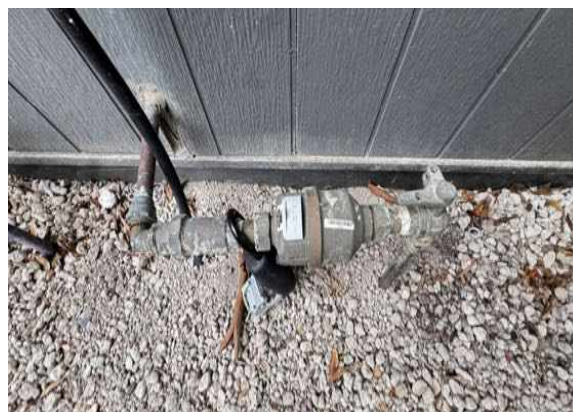
Building: Main Building
 Location: All External Areas
 Finding: Water Meter - Location For Your Information Only
 Information: The water meter was photographed at the time of the inspection. The meter is included for reference & location purposes only.

Water meters can be affected over time by age, environmental exposure, accidental impact, or poor maintenance. Potential issues could include leaks, corrosion, or malfunction that may impact water supply or cause water damage.

(AS 4349.1-2007: Water meter images are for your information only, as functional testing is outside the scope of a standard pre-purchase building inspection.)

It is recommended that a licensed plumber carry out routine inspections and maintenance to ensure continued safe and compliant operation. Observations are for informational purposes only and do not form part of a full safety or compliance inspection.

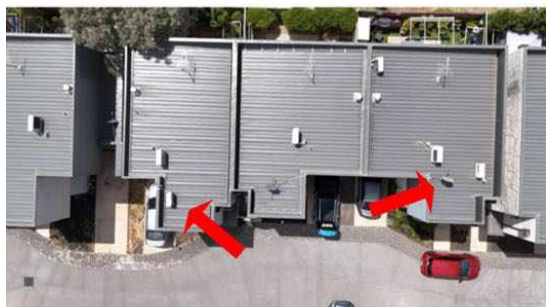
Building:
 Location: All External Areas
 Finding: Neighbouring Properties - For Your Information
 Information: Neighbouring properties were visually inspected from publicly accessible areas. No detailed structural, noise, or compliance testing was performed as part of this inspection.

(AS 4349.1-2007: inspection of neighbouring properties is not included in standard pre-purchase building inspections; this statement is for your information only.)

Recommendation: For concerns regarding noise, encroachments, or structural issues affecting neighbouring properties, it is recommended to engage relevant specialists (e.g., acoustic consultant, building surveyor, or a registered builder) and/or contact the local council.

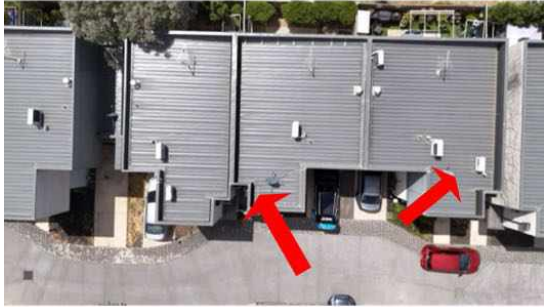
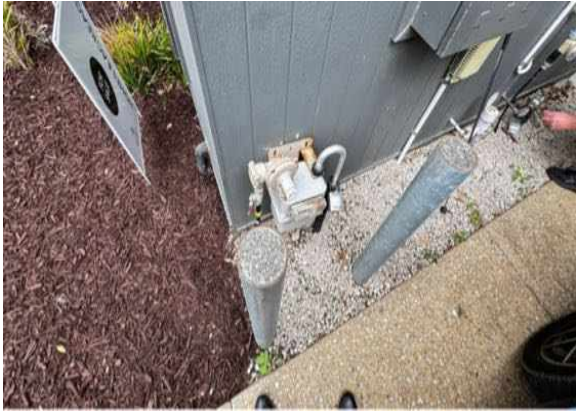
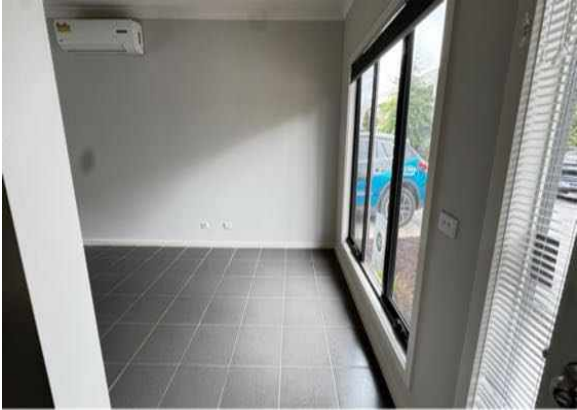
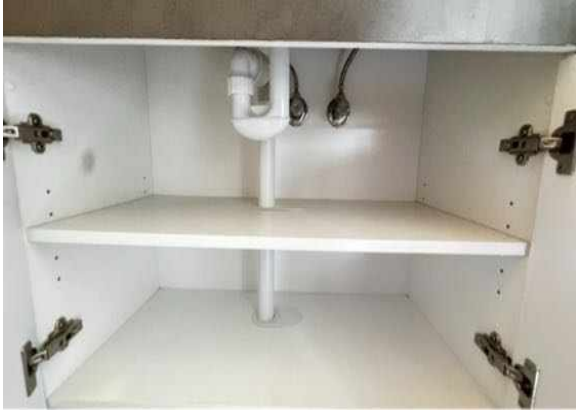
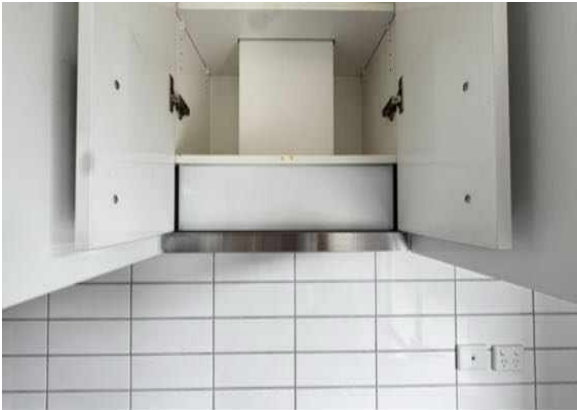
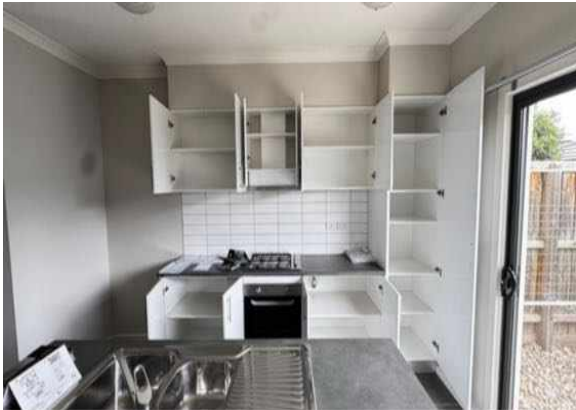
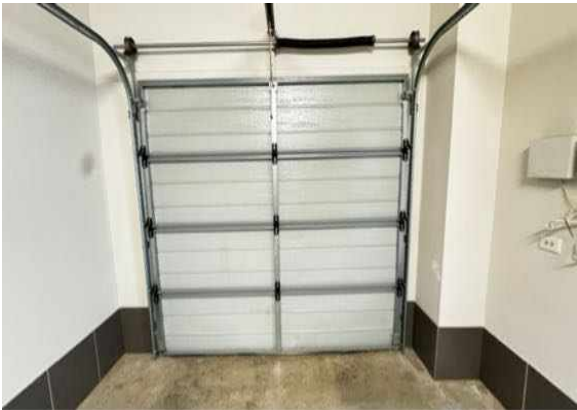
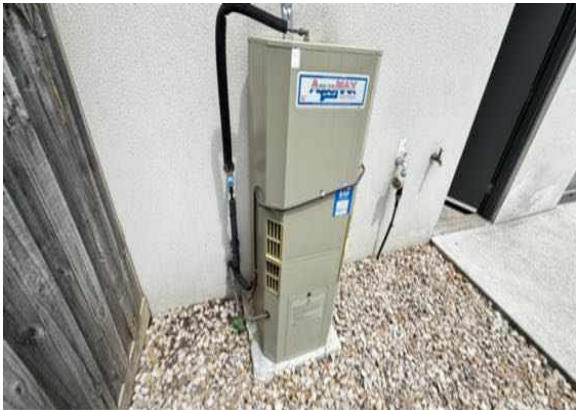
It is important to note that these restrictions can conceal a wide range of building defects, including but not limited to:

Structural damage such as cracking or movement in walls, floors, or ceilings.

Pest activity such as termites or timber decay.

Electrical, plumbing, or safety hazards.

Because these areas could not be visually assessed, no comment can be made on their condition within this report.

It is strongly recommended that obstructions be removed and concealed areas made fully accessible immediately. A re-inspection should then be carried out to allow a complete assessment of the property's condition. This is particularly important prior to purchase, as defects in concealed areas can carry significant rectification costs.
