Building Inspection Report

Inspection Date: Thu, 22 Jan 2026

Property Address: 30 Croziers Rd, Jaspers Brush NSW 2535,
Australia

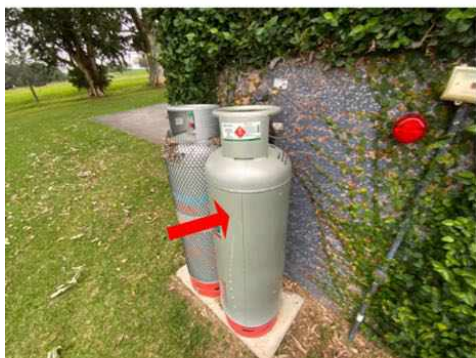
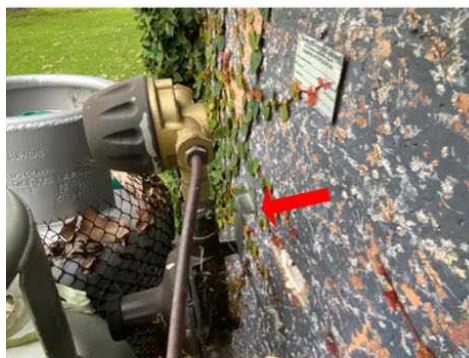
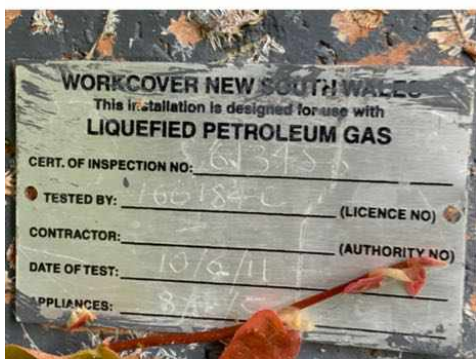
Defects 1.02

Building:	Main Building
Location:	Exterior walls - left side
Finding:	Gas Bottle - Non-compliant (Compliance plate missing)
Information:	In the opinion of the inspector, the gas bottle regulator is non compliant. However, in relation to gas and related gas plumbing, you should always consult a licensed plumber/gas fitter for further advice.

Unfinished and substandard building works are likely to degrade more quickly and may create potential for secondary defects to associated building elements, as well as a potential safety hazard in the case of gas service management.

The findings are that there appears to be no compliance plate to the gas installation. Where installation is substandard and/or incomplete, the client should contact the responsible trade (gas plumber) to undertake rectification.

Building:	Main Building
Location:	Exterior walls - rear
Finding:	Gas Bottle - Non-compliant (secure chain missing & regulator loose)
Information:	In the opinion of the inspector, the gas bottle regulator is non compliant. However, in relation to gas and related gas plumbing, you should always consult a licensed plumber/gas fitter for further advice.

Unfinished and substandard building works are likely to degrade more quickly and may create potential for secondary defects to associated building elements, as well as a potential safety hazard in the case of gas service management.

The findings are that there appears to be no secure chain and the bottles are not securely fastened. Where installation is substandard and/or incomplete, the client should contact the responsible trade (gas plumber) to undertake rectification.

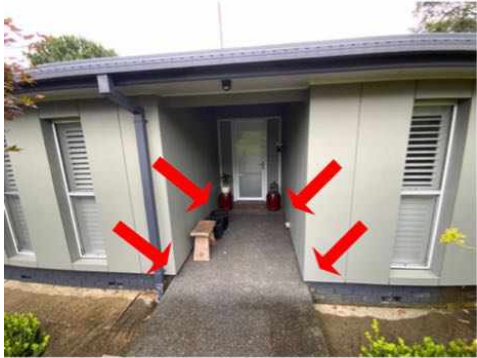
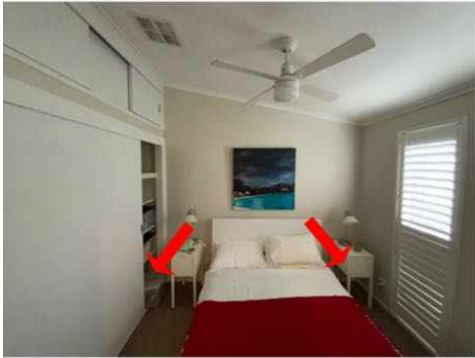
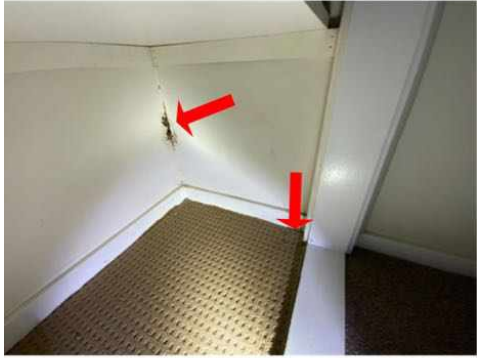
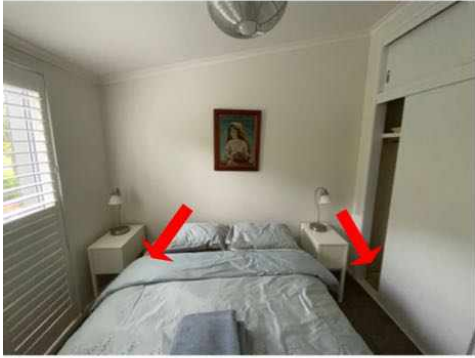
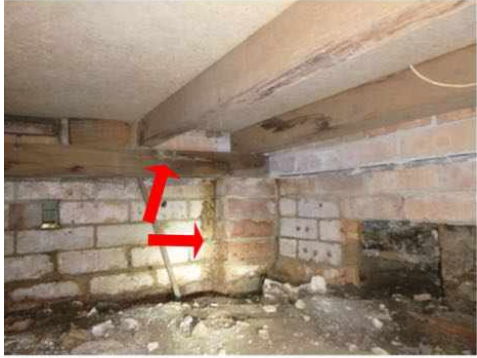
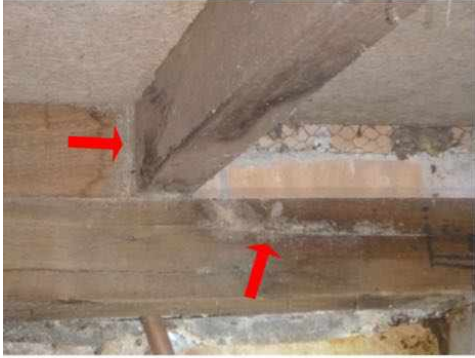
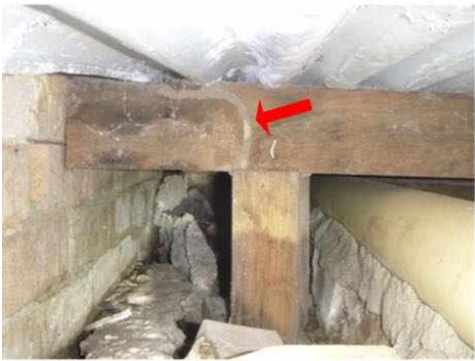
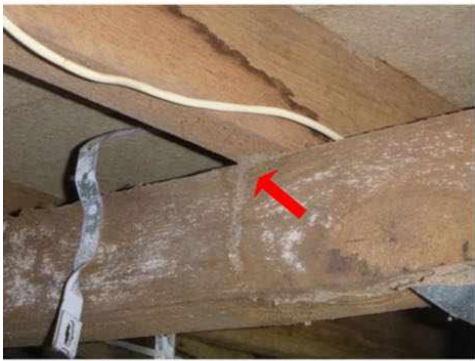
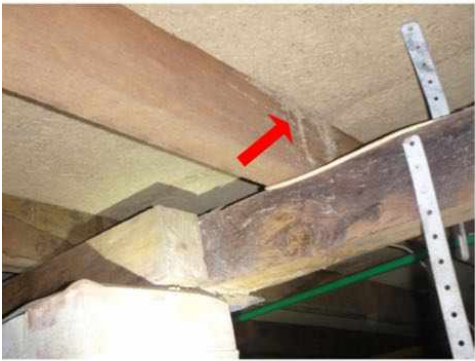
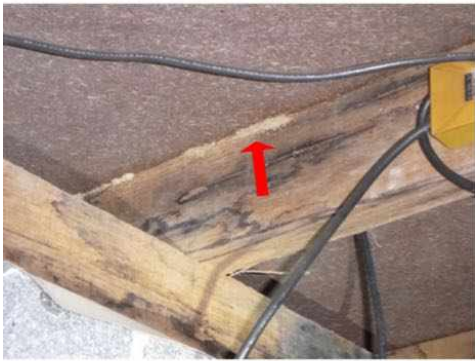
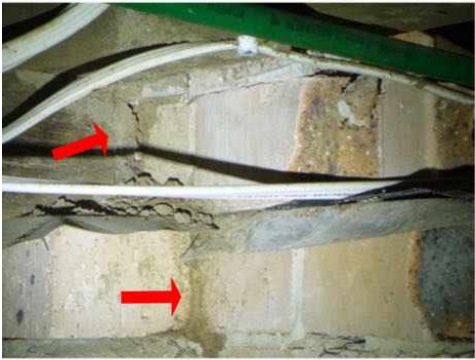
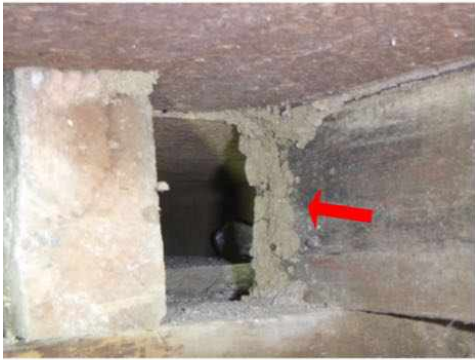
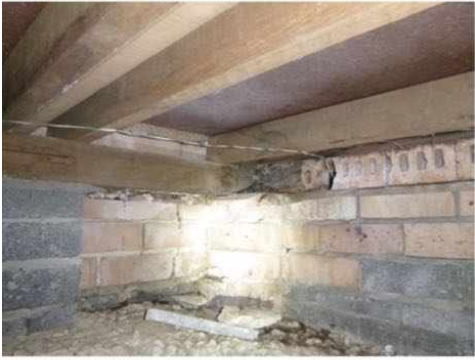
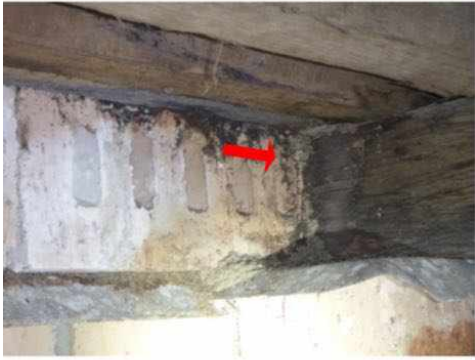
Defects 2.01

Building:	Main Building
Location:	Subfloor and Internal
Finding:	Evidence of termite damage - structural
Information:	Despite no live termite or timber pest activity being identified, previous termite damage and activity was evident to the walls either side of the entry (and bedrooms adjoining) and to the walls surrounding the bathroom. This damage is considered to be major and structural in nature. Such damage creates a potential safety hazard, and is likely to worsen and cause further damage to adjoining building materials.

As these walls could be load bearing walls, if left unattended, this damage creates an unsafe environment and is likely to lead to the need for major structural works.

A building contractor should be appointed immediately for a further invasive inspection to determine the extent of the damage and to advise on repair costs to all affected

building materials. Until such time, caution should be taken by all people coming into contact with these building elements and this area.

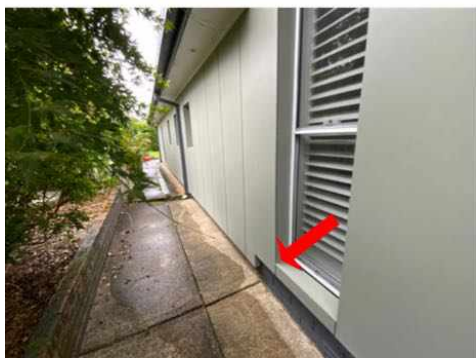
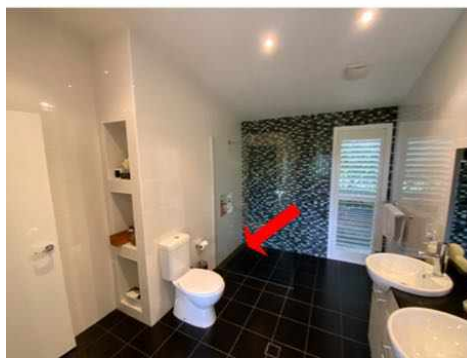
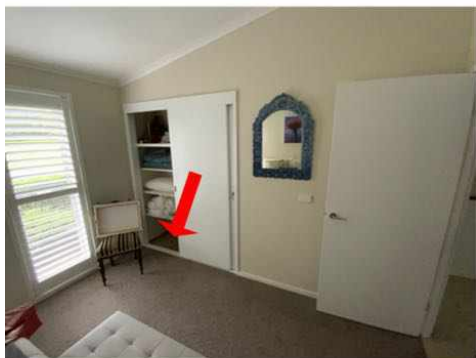
Defects 2.02

Building:	Main Building
Location:	Subfloor
Finding:	Wood rot to end of bearer timber (to front wall, below back of bathroom shower - reinforcing recommended)
Information:	This building element shows evidence of wood rot due to a previous leaking shower. Wood rot, also known as Fungal Decay, occurs when timbers and other cellulose building materials are exposed to damp conditions on an ongoing basis. This could be the result of exposure to weathering over a prolonged period of time, or the attraction of excessive moisture from other abutting building materials. Contributing factors also include poor air ventilation in the area.

Wood rot is often associated with general damp problems and is evidenced by a 'musty' smell or mould and mildew occurring on surfaces. If left unmanaged, damp conditions can lead to further health problems and the decay of timbers will continue.

Early intervention and regular maintenance, particularly of exterior timbers, will prolong the useful life of these building elements. Prior to any works being performed, the cause of the moisture that has created the visible wood rot should be identified and addressed in a suitable manner. Replacement of affected timbers may then be a necessary step in protecting surrounding building elements from such deterioration.

A qualified plumber may be appointed to assess the cause of excessive moisture and to provide advice on any remedial works as required. A qualified carpenter or registered builder may also be required to replace affected building materials.

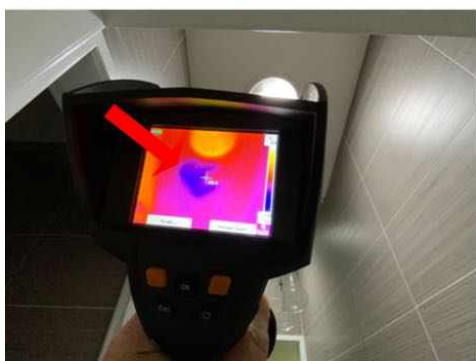
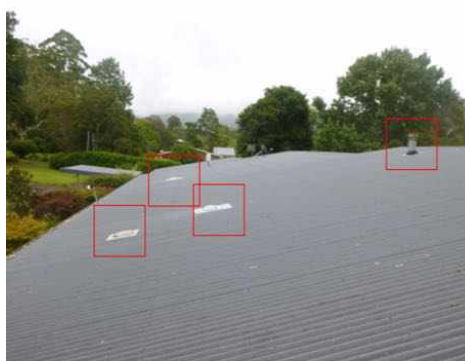
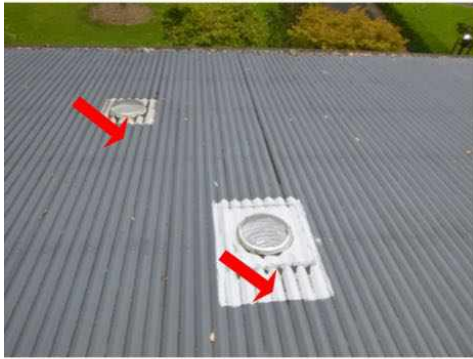
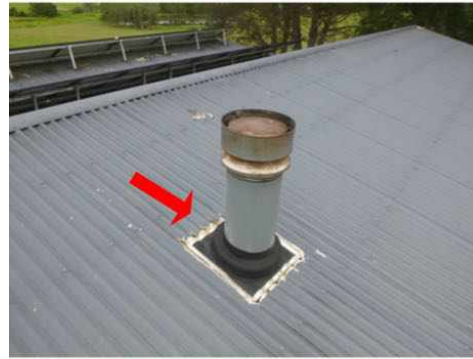
Defects 2.03

Building:	Main Building
Location:	Roof Exterior
Finding:	Roof plumbing - Flashing inadequate (Top flashing to skylights, chimney and roof penetrations should be continuous to the ridge to avoid water leaks)
Information:	Some sections of the roof are missing or have inadequate roof flashings. Flashings are metal and other materials which are applied to seals and intersections between roof coverings and building elements. They are designed to aid in weatherproofing of roof joints. A water leak was evident to the entry and skylight to the toilet at the time of the inspection.

Premature ageing and secondary building defects are imminent where roof plumbing is missing or inadequately installed. Additionally, water pooling also creates an environment that is susceptible to termite and pest infestation.

A roofing plumber should be appointed as soon as possible to install relevant roof plumbing materials, ensuring that no further damage is sustained.

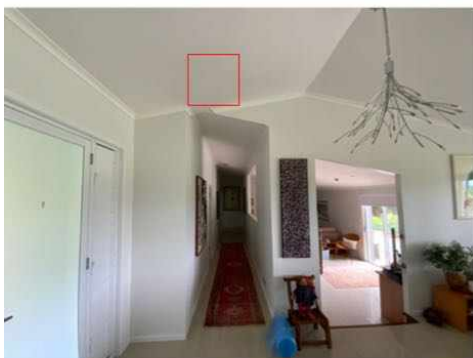
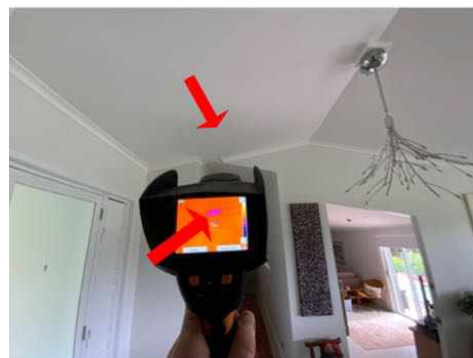
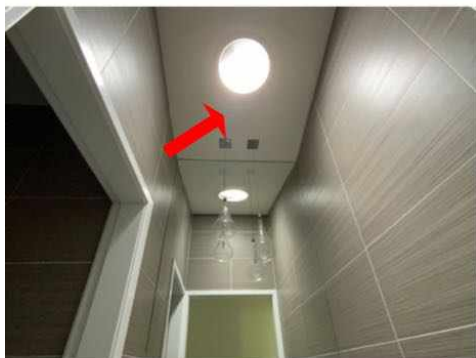
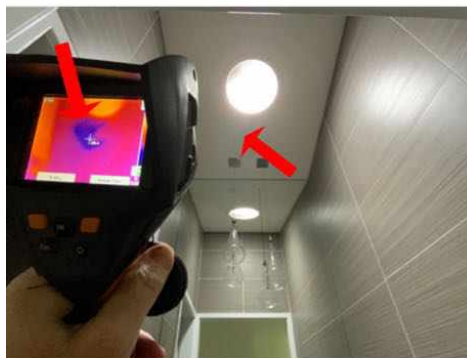
Defects 2.04

Building:	Main Building
Location:	Entry & Toilet
Finding:	Water leaks - Internal (to entry ceiling and toilet ceiling due to substandard roof flashings)
Information:	A water leak was found in this area at the time of inspection. Internal water leaks can be detrimental to surrounding building elements; their potential causes include damage to plumbing fittings and fixtures, through to water damage and deterioration of associated building elements.

Rust, corrosion, decay and water damage are potential outcomes where a minor water leak is left unattended. More serious defects may also result, such as electrical hazards, or water damage to structural building elements.

In extreme cases, structural damage may develop due to a prolonged water leak. It is highly advised that internal water leaks be addressed by a licensed plumber as a matter of relative urgency.

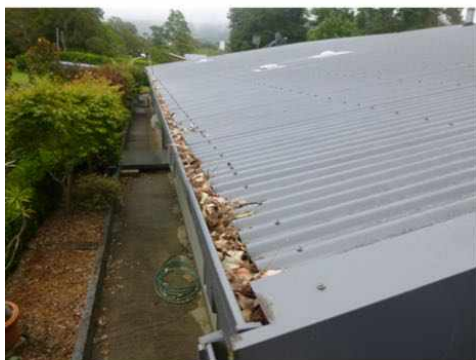
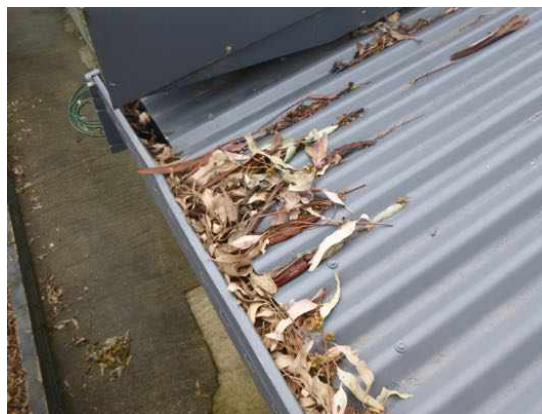
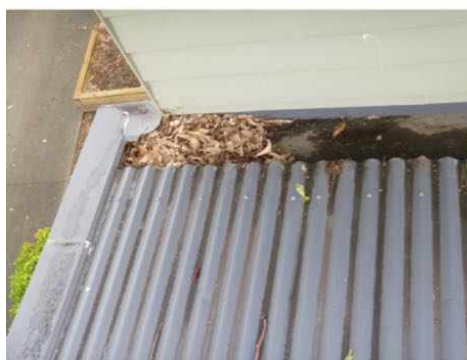
Defects 3.02

Building: Main Building
Location: Roof Exterior

Blocked gutters are likely to lead to high levels of moisture in the affected areas. Such moisture will not only cause rust and decay of the associated building materials, but can also provide conditions that are conducive to termite and timber pest activity. Blockages in gutters should therefore be removed immediately to ensure dry conditions are maintained.

Consult a Licensed Plumber for further specific advice on remedial works that may be required. In the interim, it is highly advised that blocked gutters be removed by the homeowner or a general handyperson as a matter of urgency.

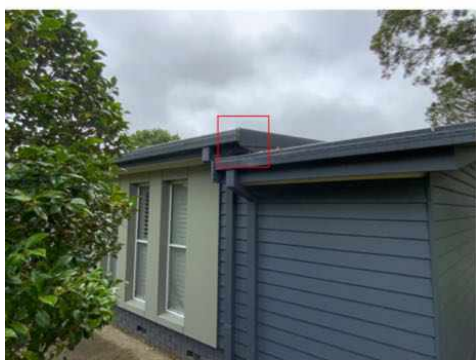
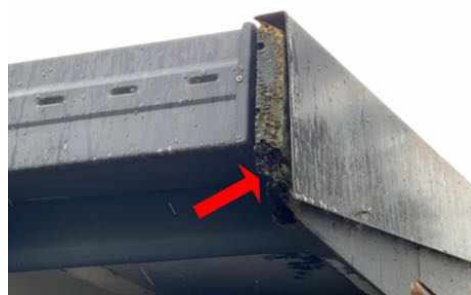
Defects 3.03

Building: Main Building
 Location: Roof Exterior
 Finding: Fascias - Wood rot to some areas

Information: Wood rot was found to be affecting fascias and barges in this area, evidenced by the presence of mould on the surface in some areas. Wood rot, also known as Fungal Decay, occurs when timbers and other cellulose building materials are exposed to damp conditions on an ongoing basis.

It is likely that this wood rot has developed as a result of faults in the roof plumbing, creating excessive moisture in this areas. Frequent exposure to rain and other weather conditions also make fascias and barges susceptible to accelerated deterioration.

Early intervention and regular maintenance will prolong the useful life of these building elements. Prior to any works being performed, the cause of the moisture that has created the visible wood rot should be identified and addressed in a suitable manner.

It is advised that a roof plumber be appointed to inspect all roof plumbing and subsequently identify the cause of the wood rot. Replacement of affected fascias and barges may then be a necessary step in protecting surrounding building elements from such deterioration.

A qualified plumber may be appointed to assess the cause of excessive moisture and to provide advice on any remedial works as required. A qualified carpenter or registered builder may also be required to replace affected building materials.

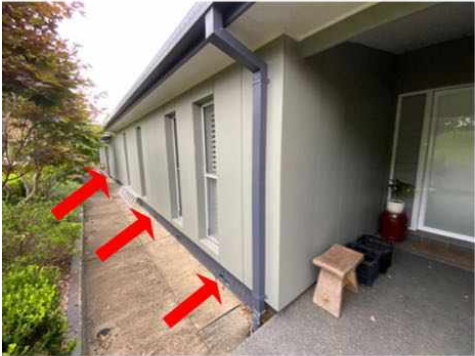
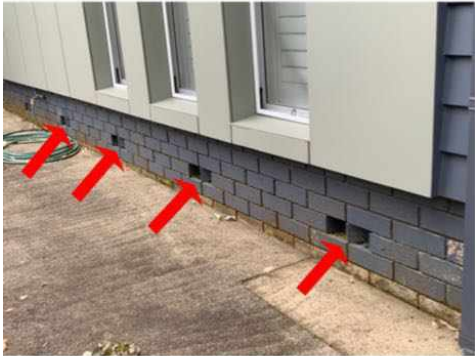
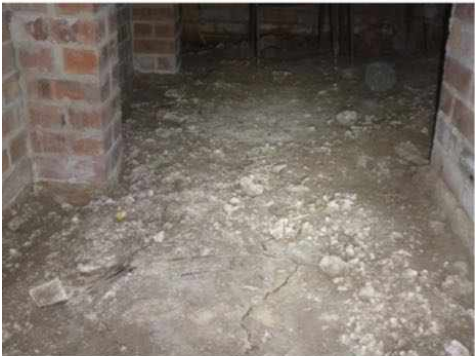
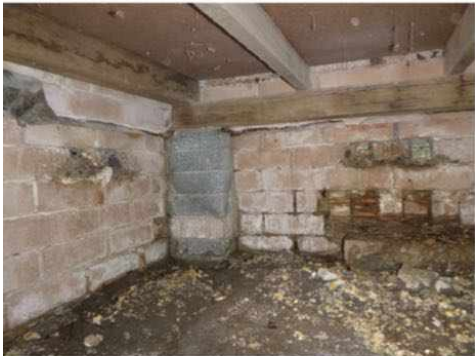
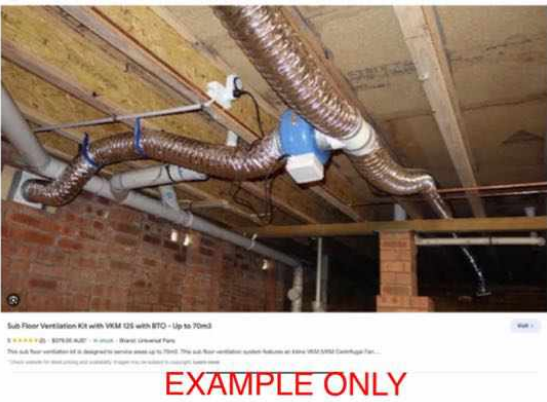
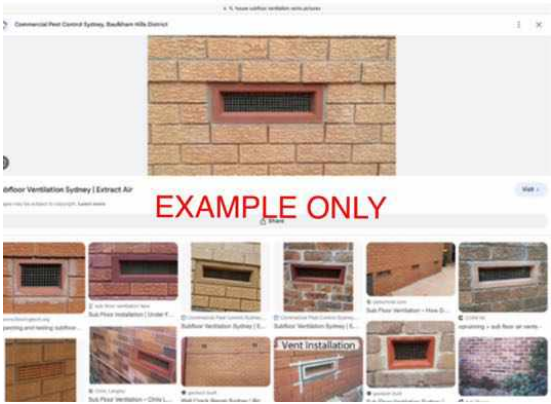
Defects 3.04

Building: Main Building
Location: Subfloor
Finding: Subfloor Ventilation - Inadequate (mouldy subfloor soil to some areas)
Information: Adequate subfloor ventilation and drainage aids in preventing excessive moisture, mouldy subsoil, wood rot and termite activity by ensuring a dry subfloor environment.

Where ventilation is substandard it is usually caused by factors such as failure to install adequate vents during construction, subsequent building works or earth and vegetation covering over vents, low subfloor clearance and items or debris in the subfloor restricting airflow.

Subfloor ventilation can be improved in most cases by addressing the causes such as exposing subfloor vents, replacing access doors with a gauze or slat door, installing additional new vents (large gauze type is best- 2 bricks high x 2 bricks wide), installing mechanical (forced airflow) ventilation and removing debris & obstructions to air flow from the subfloor.

A registered builder or sub floor ventilation specialist should be appointed as soon as possible to look at improving ventilation & drainage to the perimeter of the building and to perform these works as necessary.

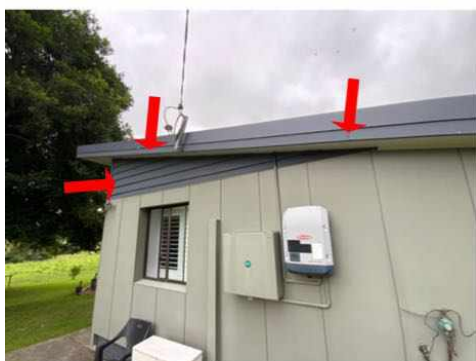
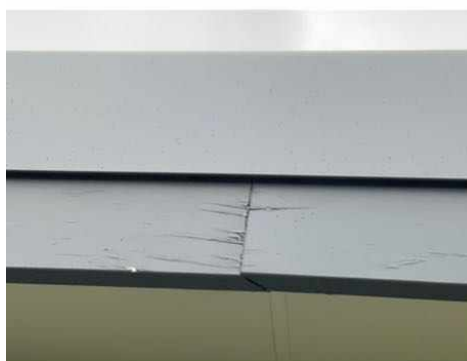
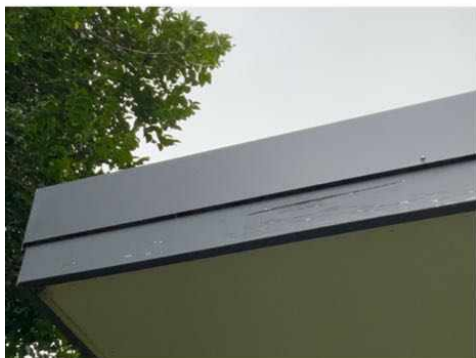
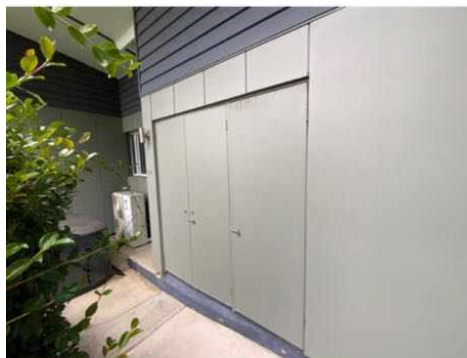
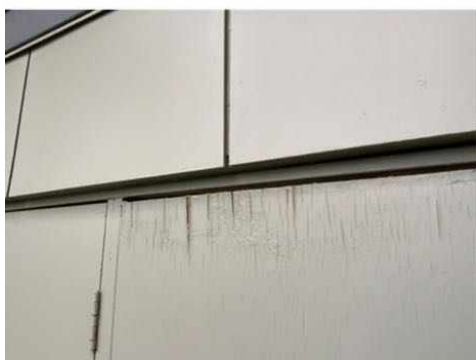
Defects 3.05

Building:	Main Building
Location:	All Areas
Finding:	External paint to timbers - deteriorated to several areas
Information:	Much of the external paintwork including but not limited to external timbers and trims have been neglected and require attention to prepare and re-paint.

Whilst incomplete or missing paint finish is generally an appearance defect, it can also lead to the development of secondary building defects over time. Incomplete areas of paint finish expose the area to moisture, potentially accelerating the deterioration of underlying building materials.

Degraded paint finishes should be sanded back, filled, leveled and painted, as applicable. Where inadequate or missing paint protection has led to the deterioration of the associated building element, repair and/or replacement of this building element may be required.

A painting contractor should be appointed as soon as possible to perform necessary works to aid the appearance of the affected area and to ensure the area is protected against further deterioration. Alternatively, the homeowner following manufacturer instructions may perform these works.

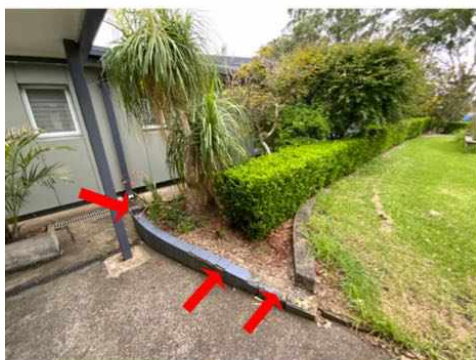
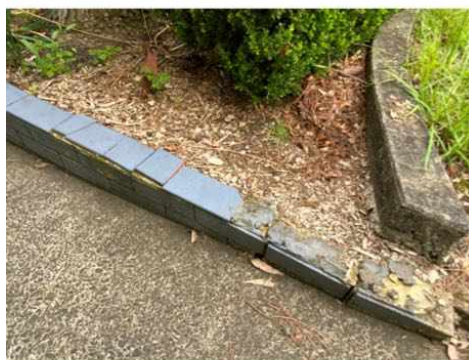
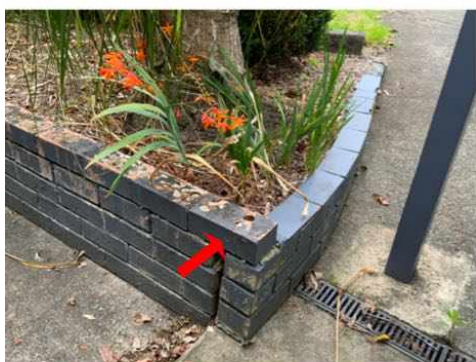
Defects 3.06

Building:	Main Building
Location:	Yard - Front
Finding:	Building element - Damaged (tiles & bricks to retaining wall to some areas)
Information:	Breakage occurs generally when the building materials have either aged and decayed, or as a result of damage (accidental or deliberate).

Repair and/or replacement of broken elements is advised to ensure that additional secondary defects do not arise as a consequence. Such works are necessary, as all building elements play a key role in the operation and function of the overall structure and its performance.

A relevant tradesperson should be appointed to repair or replace the affected building element prior to any subsequent damage being caused.

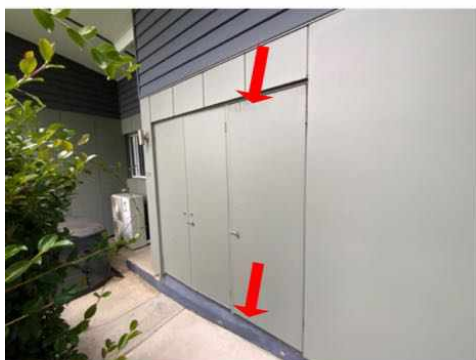
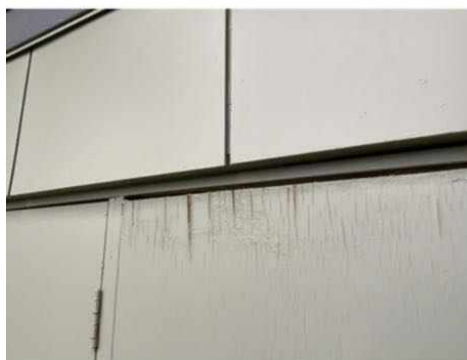
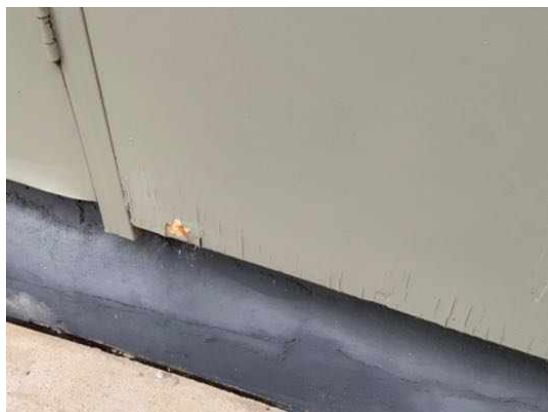
Defects 3.07

Building:	Main Building
Location:	Exterior walls - rear
Finding:	Delamination of timbers to external timber doors
Information:	Delamination is one means by which composite materials (e.g. layered timber composites) may fail over time. In laminated materials, repeated cyclic stresses may lead to the formation of mini-structures of separate layers, with significant loss of mechanical toughness. Water penetration or the presence of excessive moisture also generally contributes to delamination.

Where building materials have become delaminated, they lose their structural strength, and are likely to have a variety of appearance and serviceability defects as a result.

Delamination of timbers may be repaired where the area affected is minor and/or easily accessible, by gluing and screwing layers back together. However, this is an interim repair, and where delamination has occurred, the client should plan for the replacement of affected timbers sooner than would otherwise be expected.

All timber structures affected by delamination should be replaced as soon as possible to avoid any further damage. Repair and replacement estimates should be sought from a registered builder or qualified carpenter.

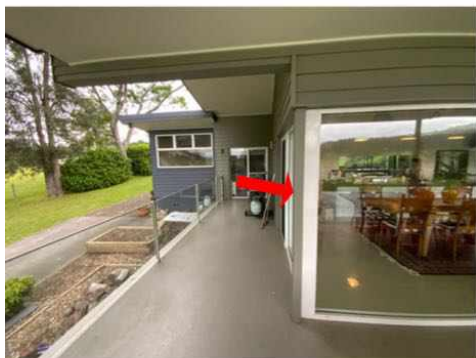
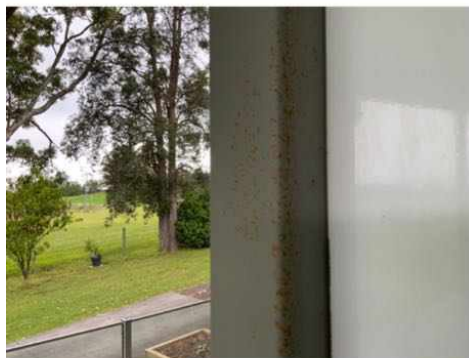
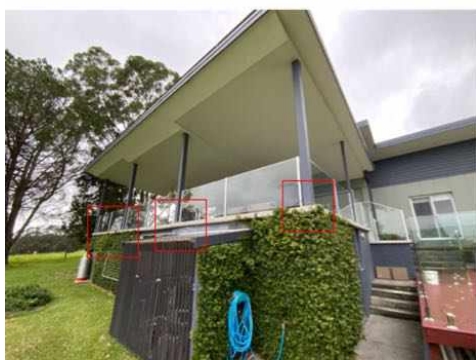
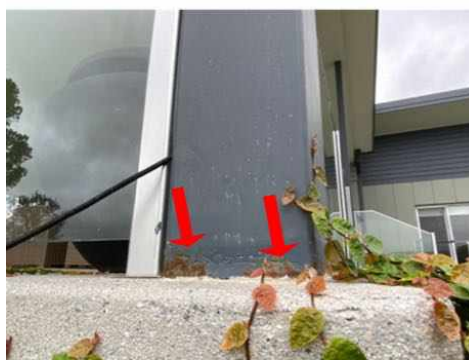
Defects 3.08

Building:	Main Building
Location:	Exterior walls - rear
Finding:	Building element - Rusted or corroded (metal posts to some areas)
Information:	This building element shows evidence of rusting and corrosion, which is likely to have developed as a result of excessive exposure to moisture and or inadequate coatings.

As surface rust provides no protection to the underlying iron, the deteriorating condition is likely to worsen if not addressed in the short-term future.

Where possible, the use of galvanized (treated) metals or aluminium coated metals aid in rust prevention, as does regular general maintenance. Rust formation can be controlled with coatings, such as paint, that isolate the iron from the environment.

Rusting and corrosion should be managed by ideally removing or limiting the affected surface from exposure to moisture. A registered builder may be appointed to replace any building elements that have been severely affected by rust or water damage.

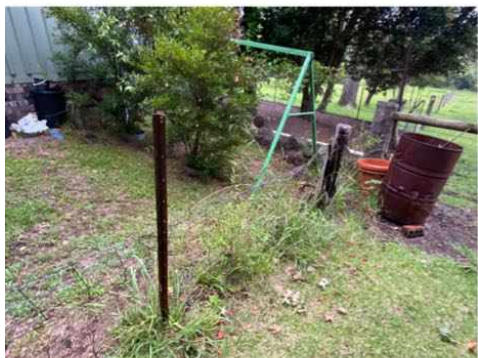
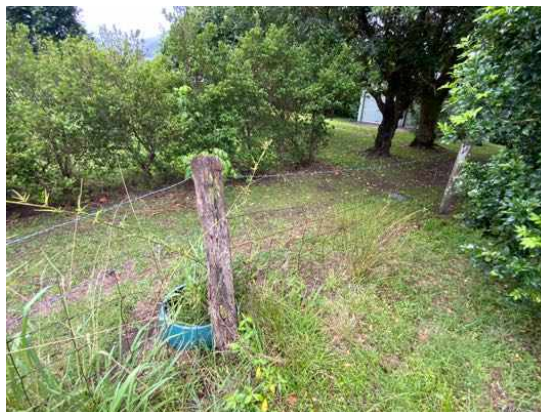
Defects 3.09

Building:	Main Building
Location:	Yard - Side
Finding:	Fencing - Deteriorated (left side)
Information:	It was noted at the time of inspection that sections of the fencing throughout the property have deteriorated. Typically fencing deteriorates due to age and or wear, rot and or rust which is generally expected for a structure of this age, due to prolonged exposure to weather conditions. Sometimes inadequate installation or maintenance can be to blame.

If left unattended, it is likely that further damage will occur. It is suspected that repair of several elements of the fencing may be required however replacement may be a consideration of the client also.

A licensed fencing contractor should be appointed to provide further advice and perform rectification works as necessary.

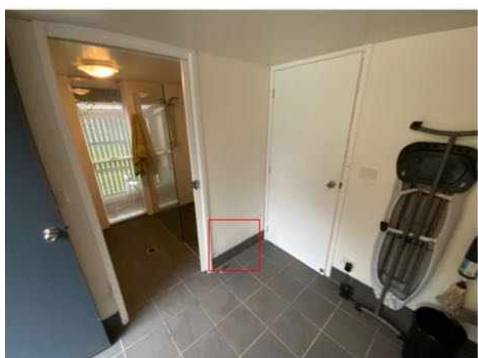
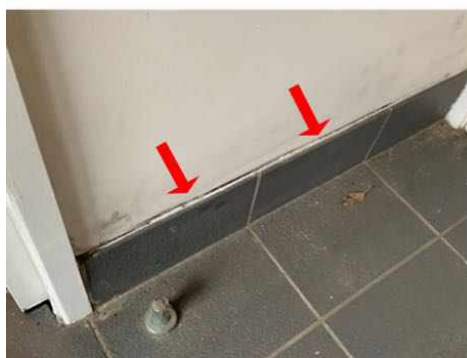
Defects 3.10

Building:	Main Building
Location:	Garage - Laundry
Finding:	Tiles - Drummy (skirting tiles)
Information:	Drummy tiled areas were identified at the time of inspection. The term 'drummy' refers to tiles that have become detached from their fixing, despite otherwise being in relatively good condition. Such defects are generally caused by physical or moisture damage to the area. Drummy tiled areas may also be a direct result of poor workmanship during the construction process.

Tiled areas may swell and shrink with changes in air humidity if the area has sustained moisture damage. Any exposure to moisture is capable of causing tiled areas to become drummy and/or cracked over a prolonged period of time. Drummy tiled areas generally require removal and replacement of affected tiles, with adequate sealant and grouting.

Specialist trades are available for these types of services. A registered builder may be required to undertake works if damage is extensive or if secondary building defects have resulted. Otherwise, it is advised that a tiling contractor be appointed to perform works as necessary. Immediate action is recommended to ensure that no further damage is sustained in the affected area.

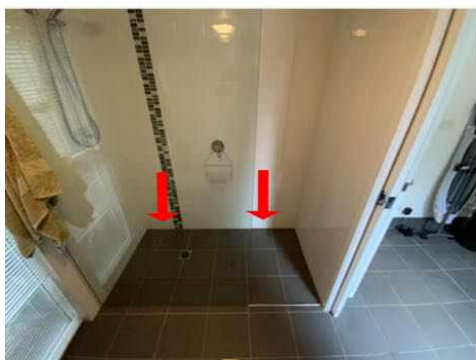
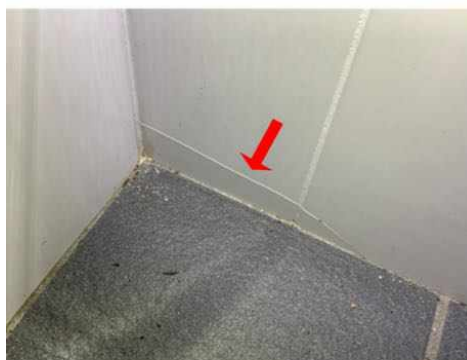
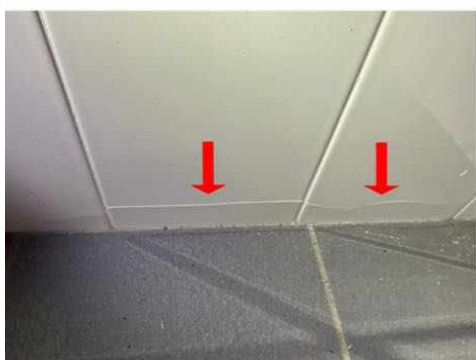
Defects 3.11

Building: Main Building
Location: Garage - Bathroom
Finding: Tiles - Cracked or damaged
Information: Cracking was evident to the tiling in this area at the time of inspection. While the cracking appears to be minor, this area is frequently exposed to water, allowing potential for water penetration into adjoining sections of walls or flooring.

If left unmanaged, water penetration to these areas may lead to subsequent water damage, which is likely necessitate repair work to affected building elements.

A tiling contractor should be appointed to ensure that no further water damage occurs. The re-application of silicone and grouting throughout remaining tile work is also advised, to further protect the area against water penetration.

Where water penetration has led to water damage, appointment of a relevant tradesperson may be required to repair damaged building elements.

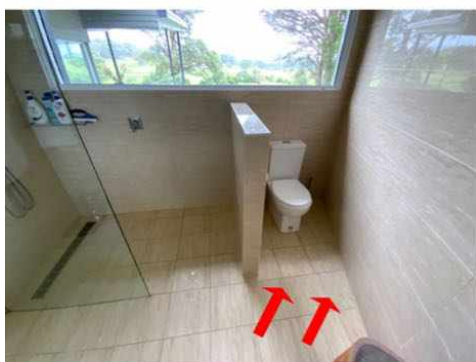
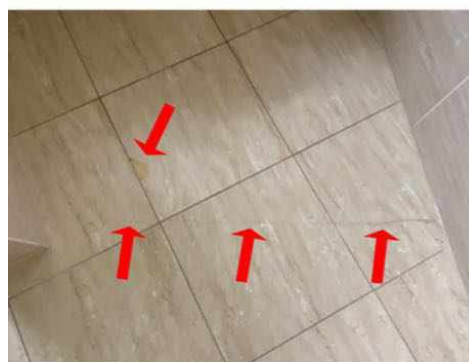
Defects 3.12

Building: Main Building
Location: Ensuite - Master

Finding:	Tiles - Cracked or damaged
Information:	Cracking was evident to the tiling in this area at the time of inspection. While the cracking appears to be minor, this area is frequently exposed to water, allowing potential for water penetration into adjoining sections of walls or flooring. If left unmanaged, water penetration to these areas may lead to subsequent water damage, which is likely necessitate repair work to affected building elements. A tiling contractor should be appointed to ensure that no further water damage occurs. The re-application of silicone and grouting throughout remaining tile work is also advised, to further protect the area against water penetration. Where water penetration has led to water damage, appointment of a relevant tradesperson may be required to repair damaged building elements.

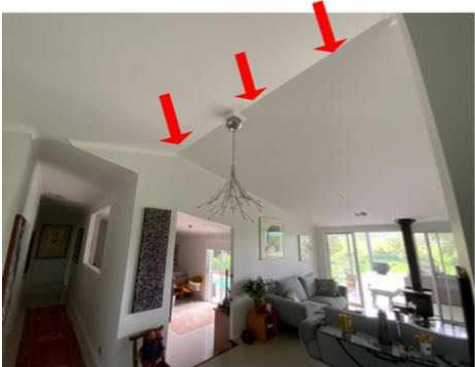
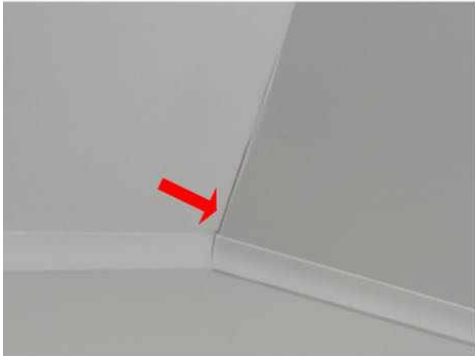
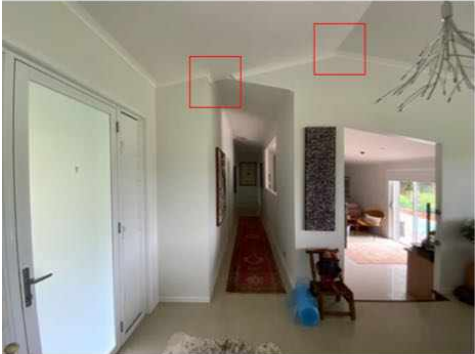
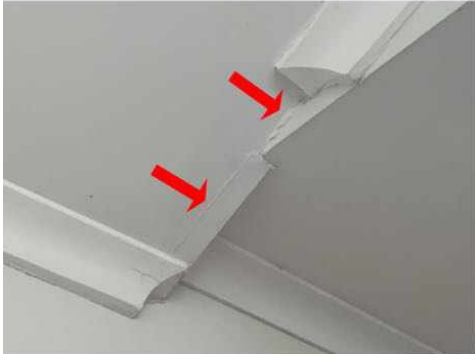
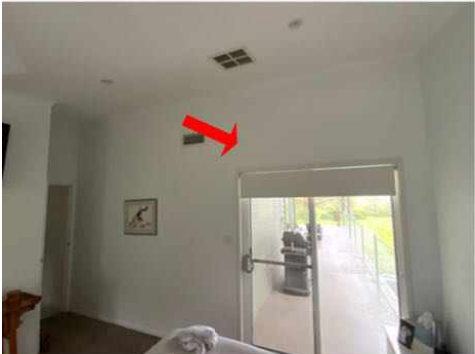
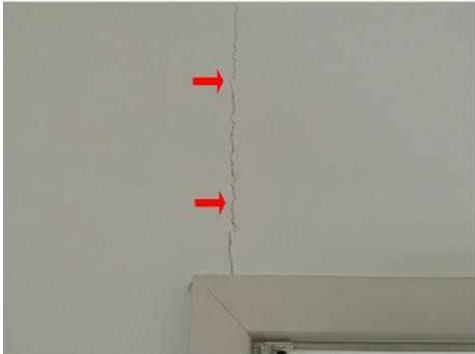
Defects 3.13

Building:	Main Building
Location:	All Areas
Finding:	Cracking - Damage Category 2 - Noticeable (up to 5mm) to several areas
Information:	Noticeable cracks are a common occurrence as a result of many primary defects. Such causes may include age, general wear and tear, expected building movement, general expansion/contraction of building materials in different weather conditions, and/or minor failings in the installation or application of building materials. Noticeable cracks may result in minor sticking or jamming of associated doors and windows, which require easement. However, noticeable cracks are easily filled and repaired. A plasterer can be consulted to install an expansion joint at this point to allow for this movement during different weather conditions. Monitoring of all cracking should be conducted frequently. Always contact a building inspector should cracks widen, lengthen, or become more numerous. Additionally, your building inspector should also be contacted if associated building elements such as doors and windows become more difficult to operate over time.

Relevant tradespeople, such as carpenters, painters and plasterers, should be appointed to perform remedial works, as deemed necessary.

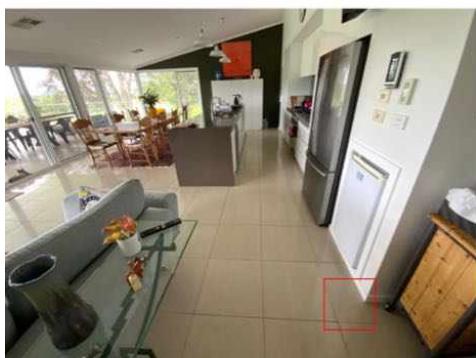
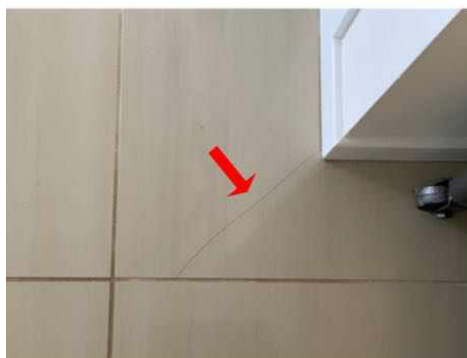
Defects 3.14

Building:	Main Building
Location:	Kitchen
Finding:	Cracked floor tiles to some areas
Information:	Cracking in the floor tiles was evident in this area at the time of inspection. It is suspected that this cracking has occurred as a result of minor settlement or shrinkage of the slab.

Cracked tiles throughout the household detract from the overall appearance of the affected areas however it is unlikely to create or lead to any secondary defects.

While not considered a matter of urgency, replacement of cracked floor tiles is recommended at the clients discretion. A tiling contractor may be appointed to perform these works. Where cracks become more numerous, contact a licensed building inspector for further investigation.

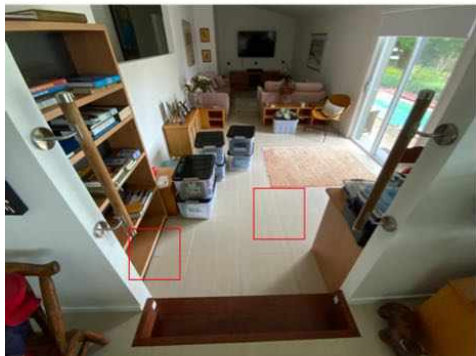
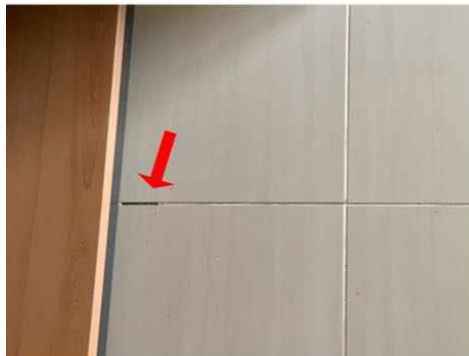
Defects 3.15

Building:	Main Building
Location:	Lounge Room
Finding:	Grout - Missing to some areas
Information:	Grout is missing in this area. Grout is used to protect gaps and crevices in building

materials to ensure that they are water-tight and prevent water penetration to the associated structures.

Where grout is missing, a tiling contractor should be appointed immediately to apply grout and re-apply any silicone where necessary. Failure to do so is likely to lead to water damage to the surrounding area.

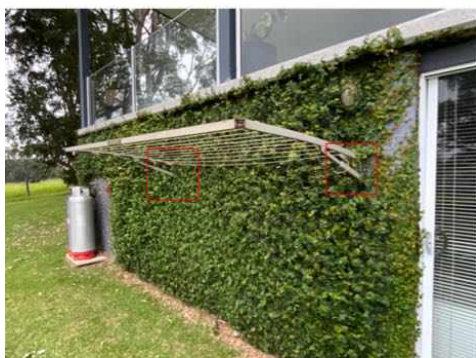
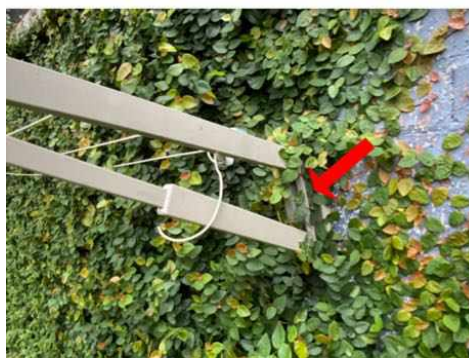
Defects 3.16

Building:	Main Building
Location:	Exterior walls - rear
Finding:	Building element - Damaged (Clothesline brackets loose)
Information:	Breakage occurs generally when the building materials have either aged and decayed, or as a result of damage (due to age or poor installation).

Repair and/or replacement of broken elements is advised to ensure that additional secondary defects do not arise as a consequence. Such works are necessary, as all building elements play a key role in the operation and function of the overall structure and its performance.

A relevant tradesperson should be appointed to repair or replace the affected building element prior to any subsequent damage being caused.

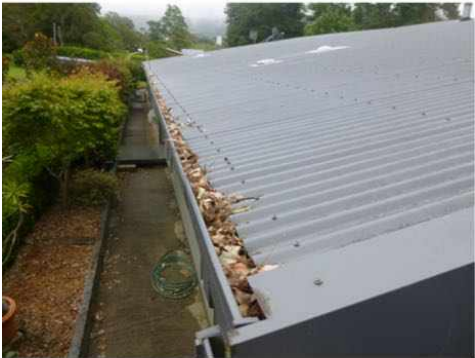
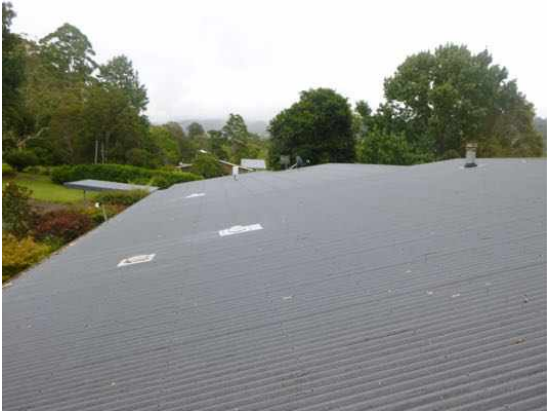
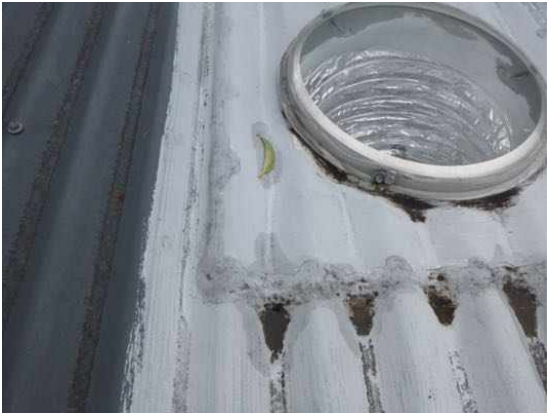
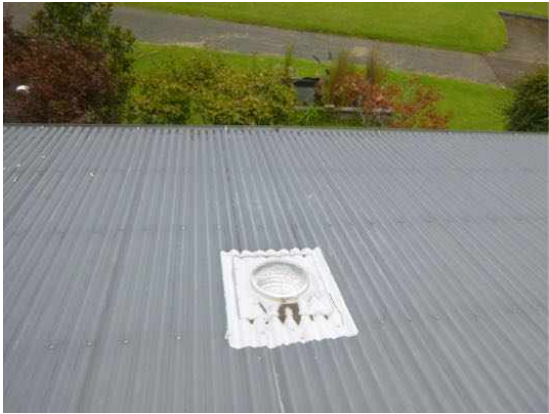
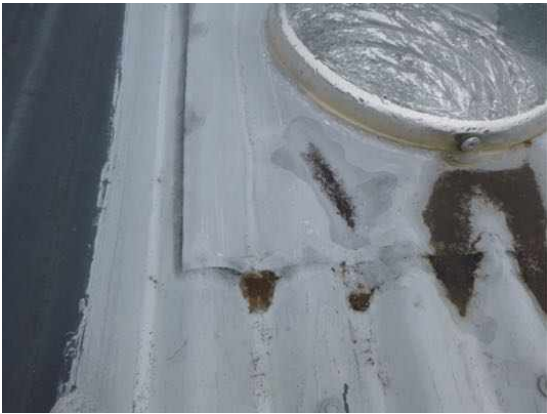
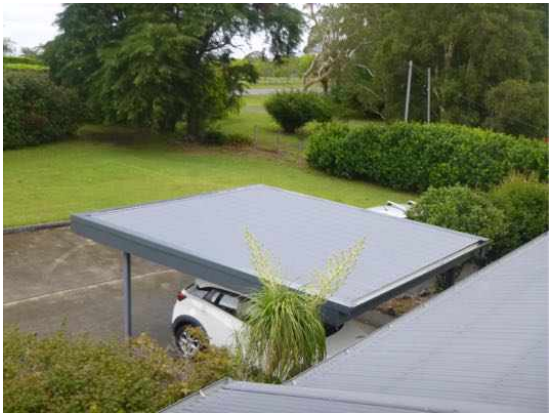
Building: Main Building
Location: Roof Exterior
Finding: Additional Photos - Obstructions and Limitations
Information: These photographs are an indication of the obstructions and limitations which impeded full inspection of the property at the time of inspection. These obstructions can hide an array of defects and should be removed to allow full inspection to be carried out. A re-inspection is recommended once the areas are made accessible.

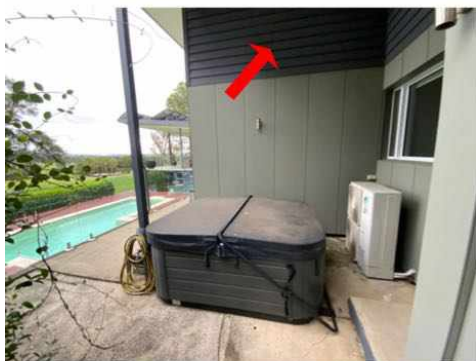
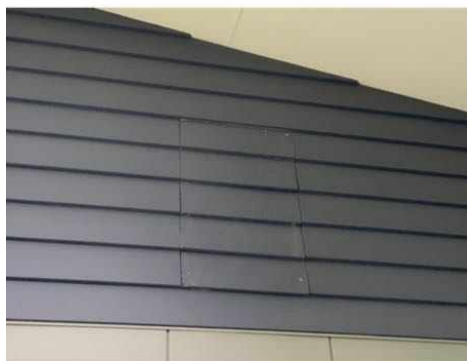
Building: Main Building
 Location: Roof Void
 Finding: Additional Photos - Obstructions and Limitations
 Information: These photographs are an indication of the obstructions and limitations which impeded full inspection of the property at the time of inspection. These obstructions can hide an array of defects and should be removed to allow full inspection to be carried out. A re-inspection is recommended once the areas are made accessible.

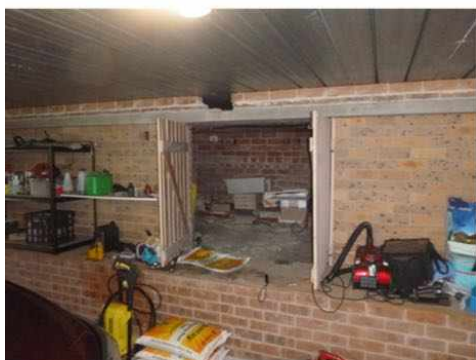
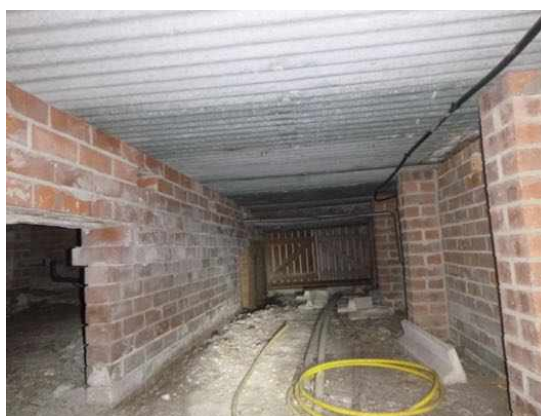
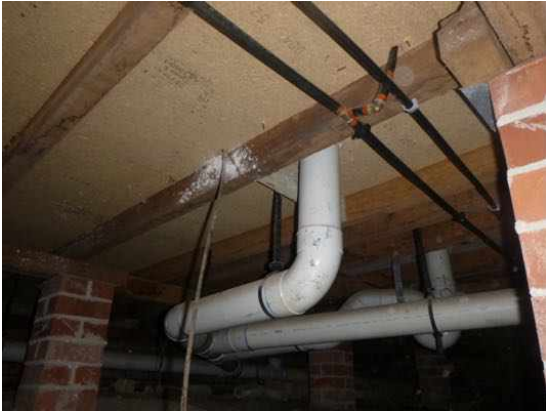
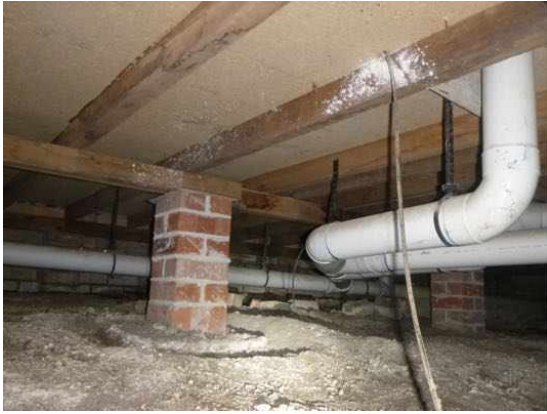
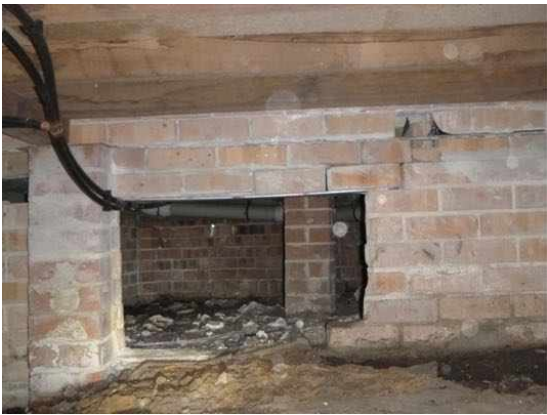
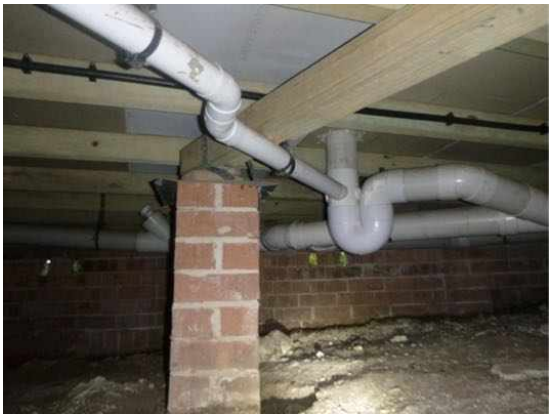
Building: Main Building
 Location: Subfloor
 Finding: Additional Photos - Obstructions and Limitations
 Information: These photographs are an indication of the obstructions and limitations which impeded full inspection of the property at the time of inspection. These obstructions can hide an array of defects and should be removed to allow full inspection to be carried out. A re-inspection is recommended once the areas are made accessible.
