Building Inspection Report

Inspection Date: Thu, 22 Jan 2026

Property Address: 30 Croziers Rd, Jaspers Brush NSW 2535,
Australia

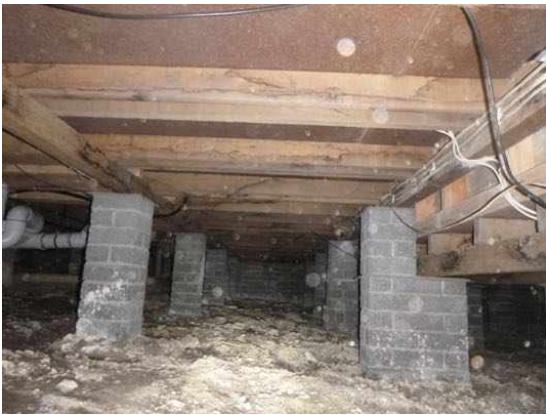
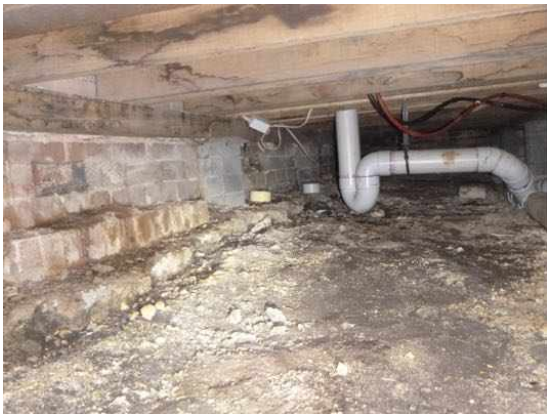
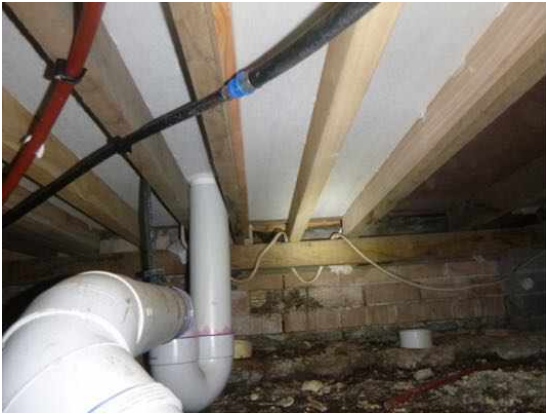
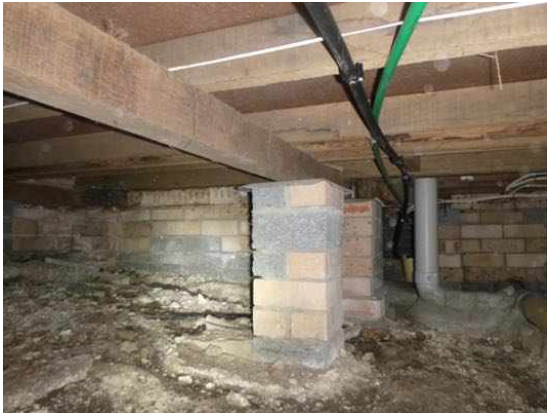
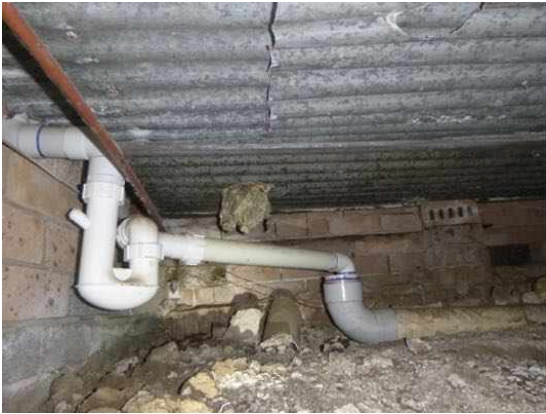
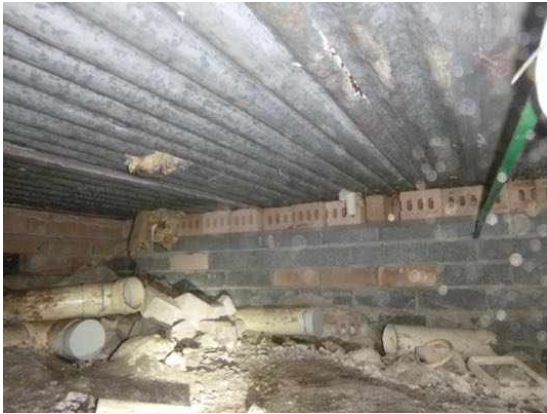
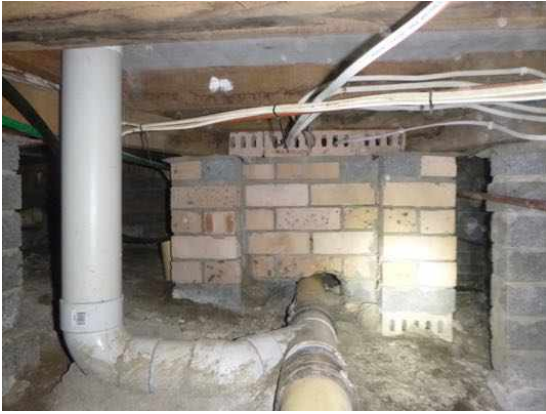
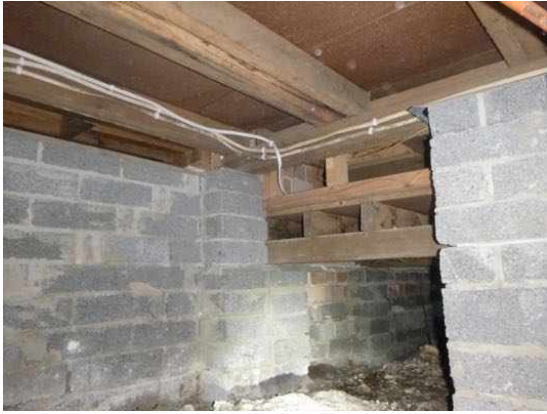
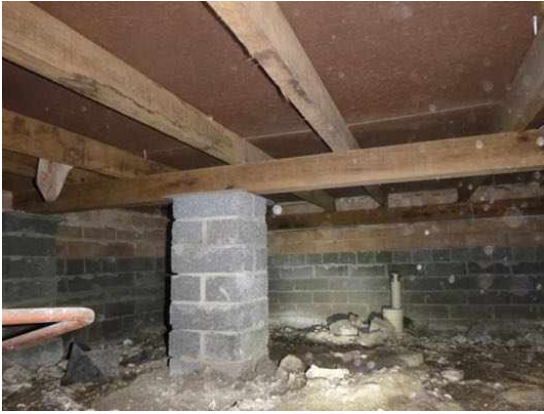
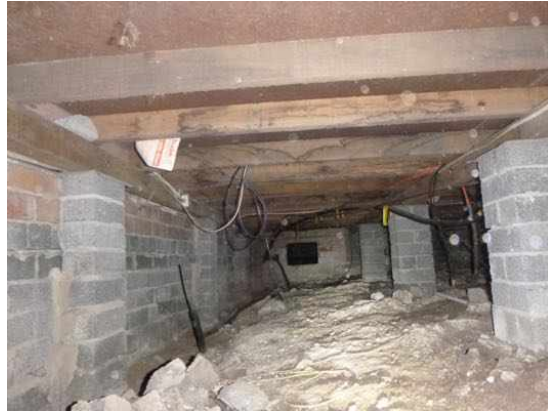
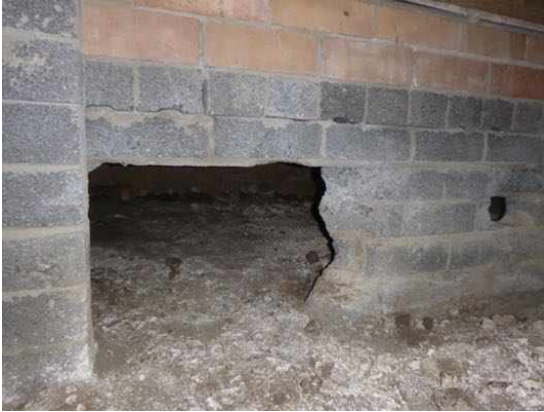
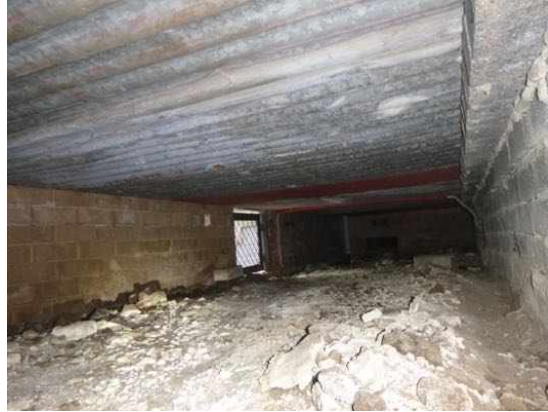
Building: Main Building
 Location: Subfloor
 Finding: Additional Photos - Obstructions and Limitations
 Information: These photographs are an indication of the obstructions and limitations which impeded full inspection of the property at the time of inspection. These obstructions can hide an array of defects and should be removed to allow full inspection to be carried out. A re-inspection is recommended once the areas are made accessible.

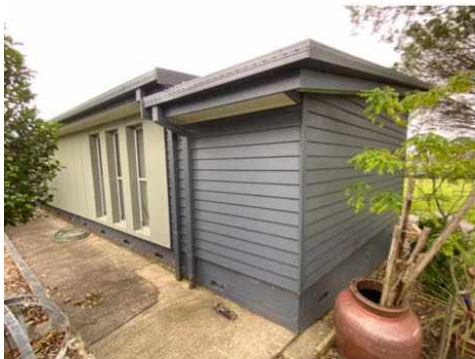
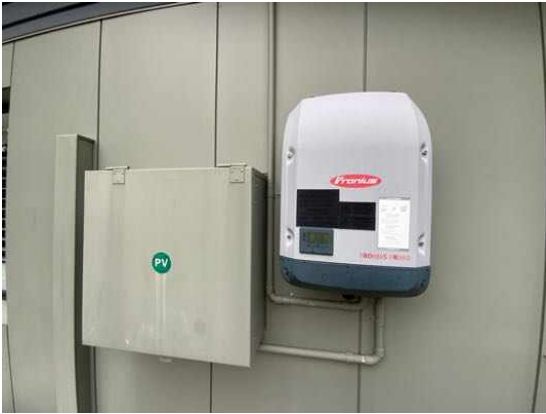
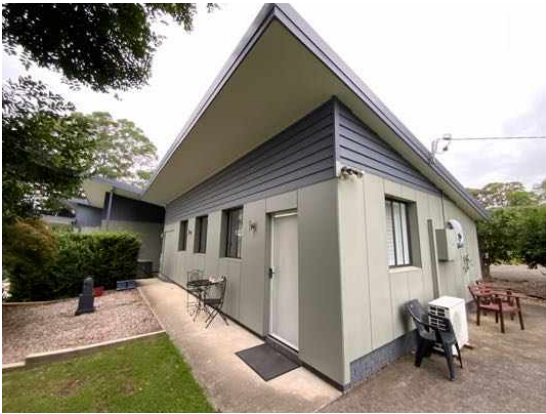
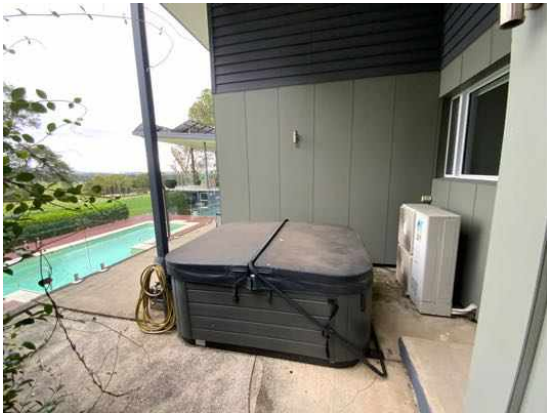
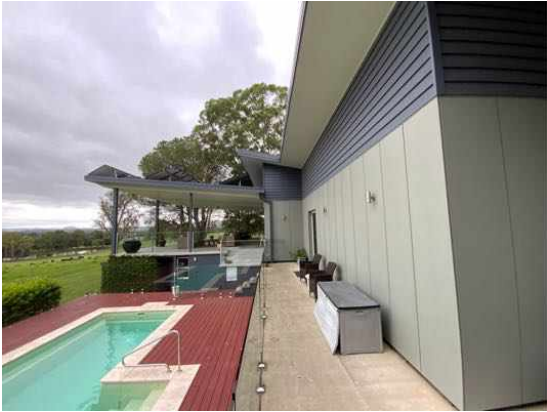
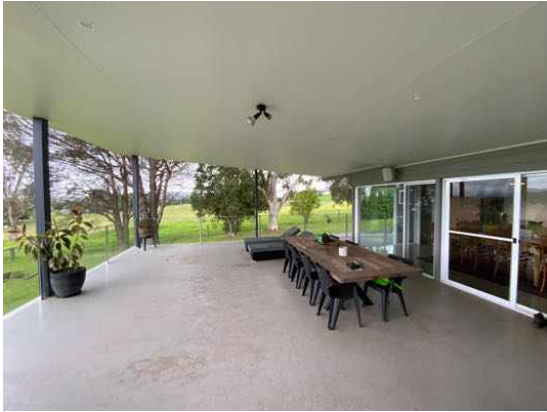
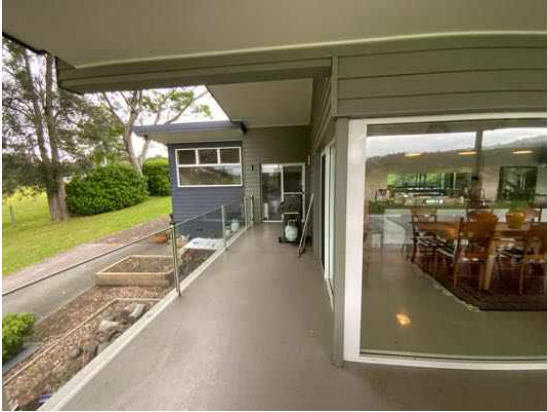
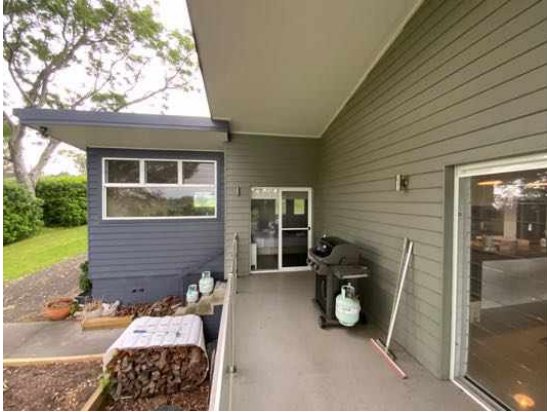
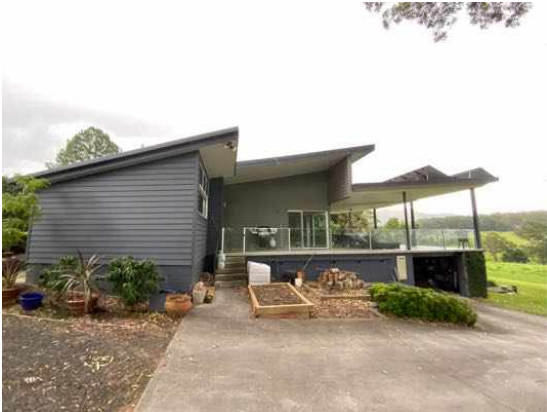
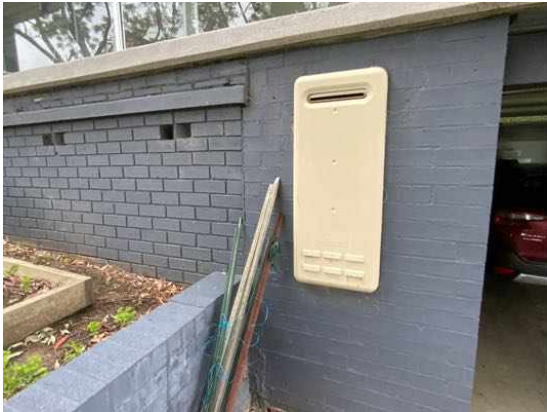
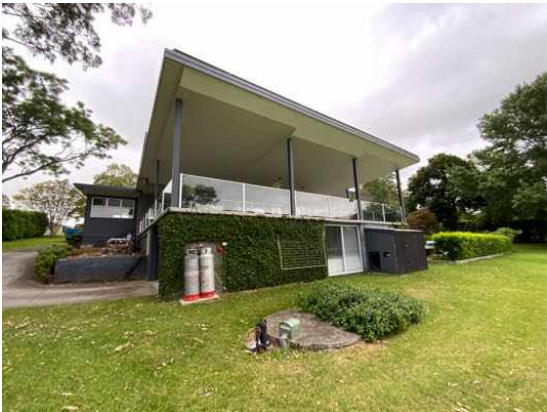
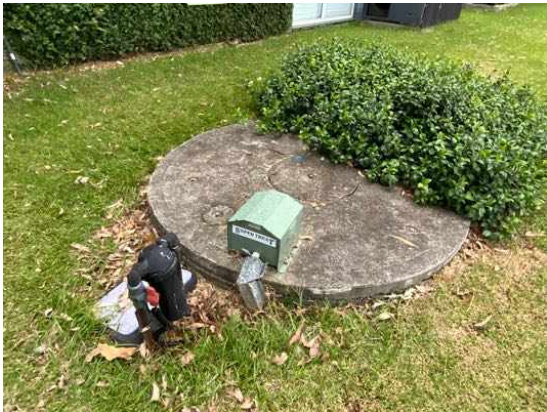
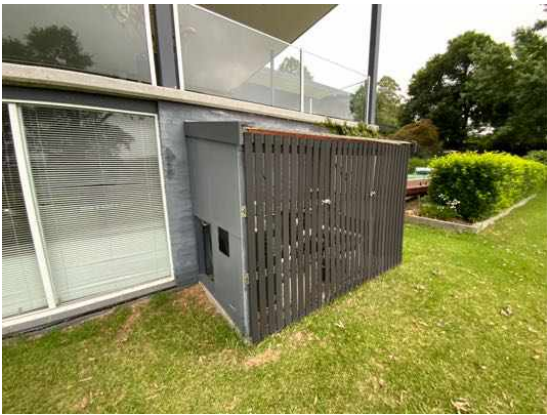
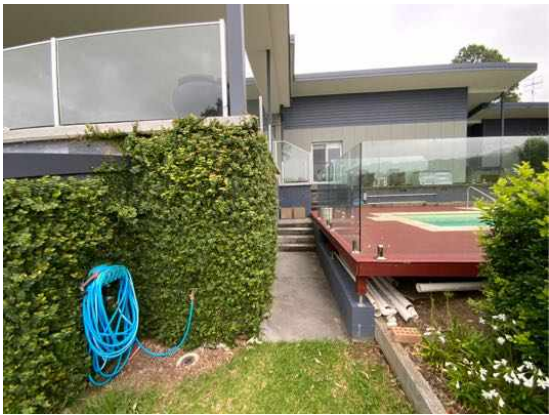
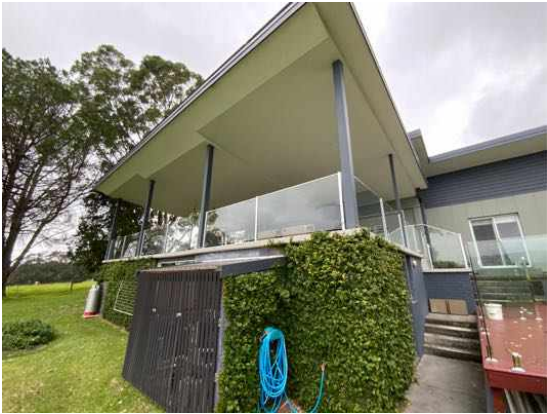
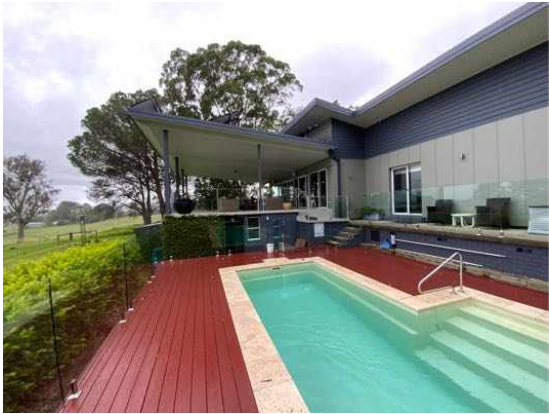
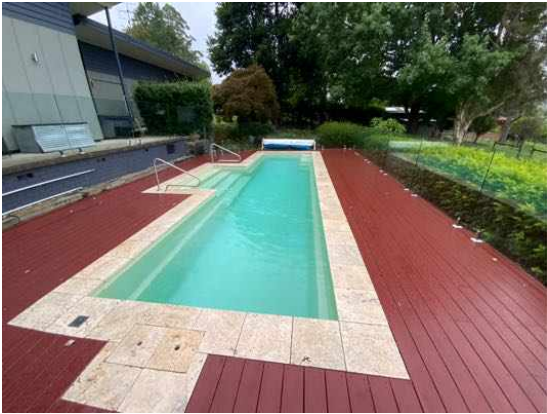
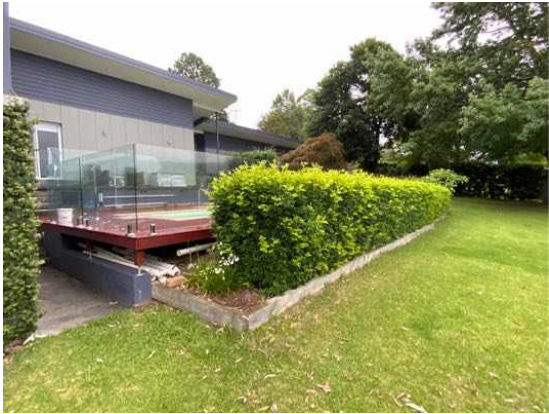
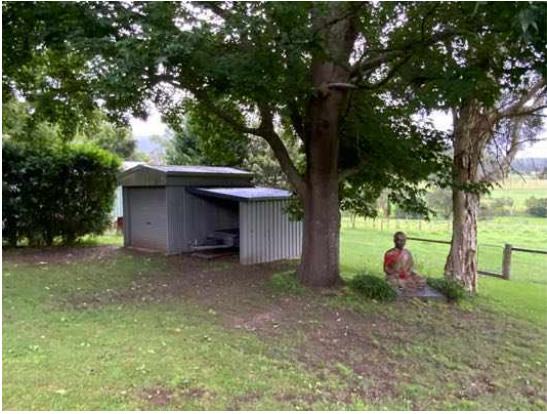
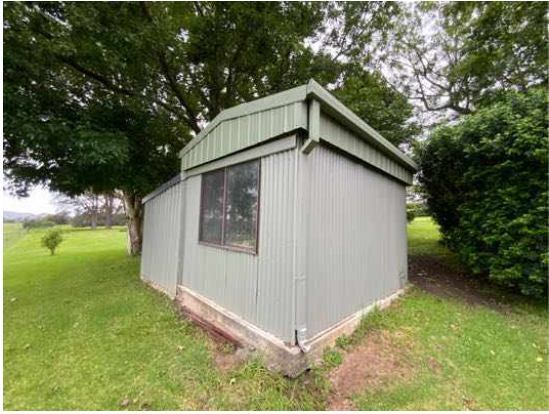
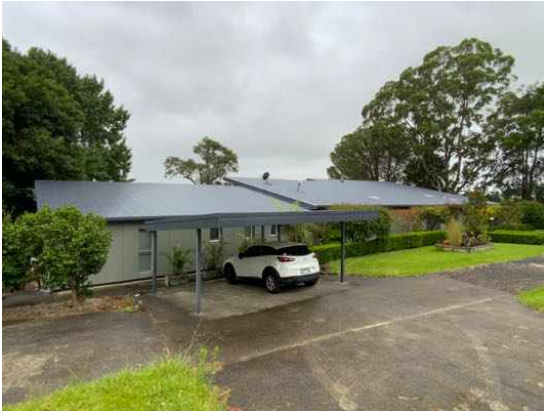
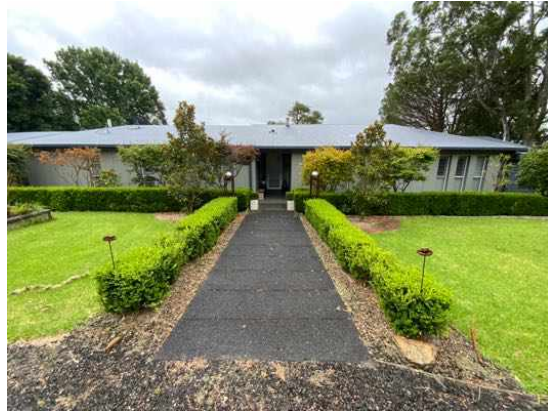
Building: Main Building
 Location: All Areas
 Finding: Additional Photos - Obstructions and Limitations
 Information: These photographs are an indication of the obstructions and limitations which impeded full inspection of the property at the time of inspection. These obstructions can hide an array of defects and should be removed to allow full inspection to be carried out. A re-inspection is recommended once the areas are made accessible.

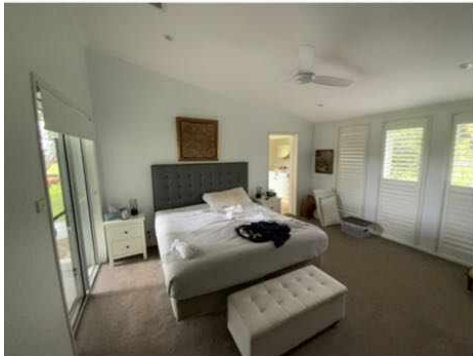
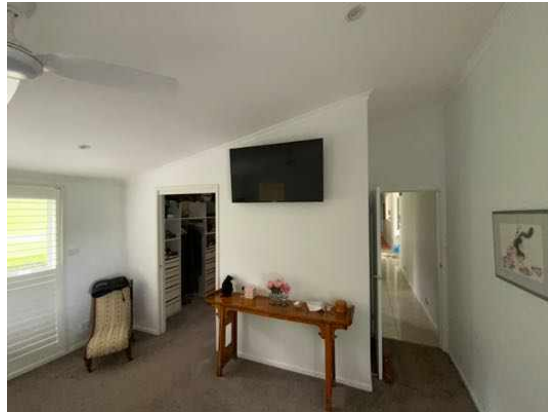
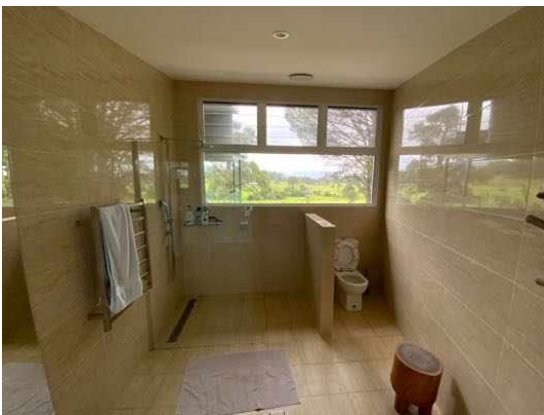
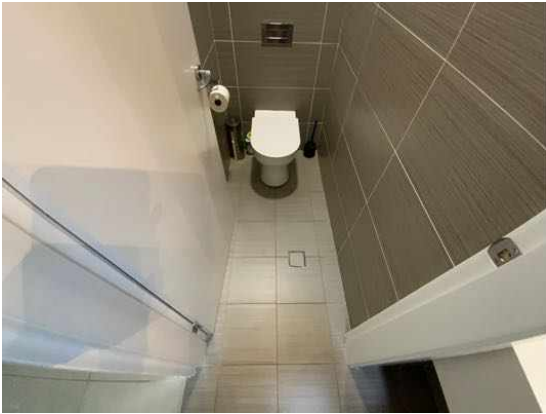
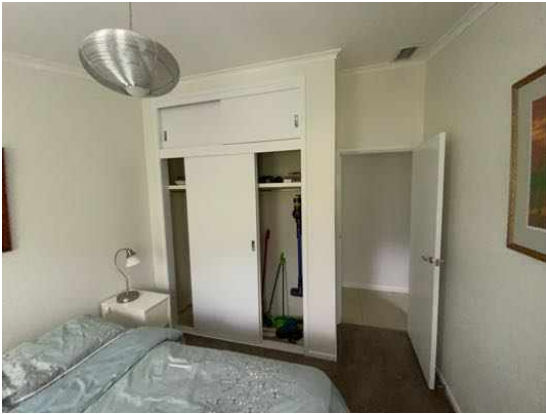
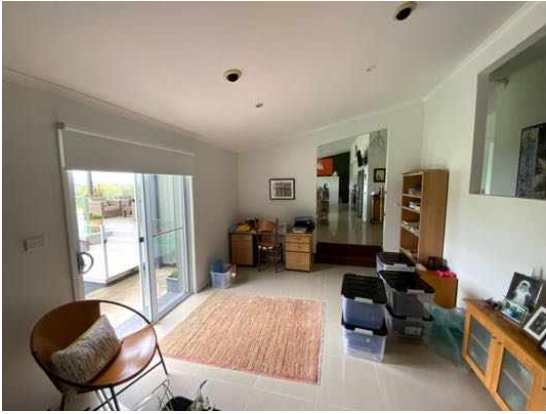
Building: Main Building
 Location: All Areas
 Finding: Additional Photos - Obstructions and Limitations
 Information: These photographs are an indication of the obstructions and limitations which impeded full inspection of the property at the time of inspection. These obstructions can hide an array of defects and should be removed to allow full inspection to be carried out. A re-inspection is recommended once the areas are made accessible.

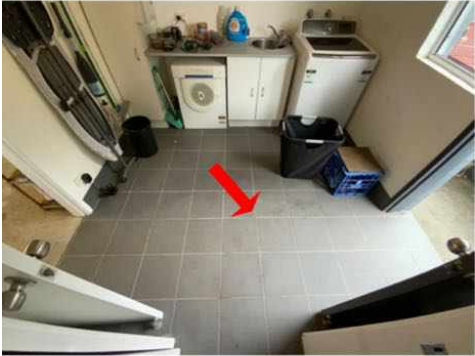
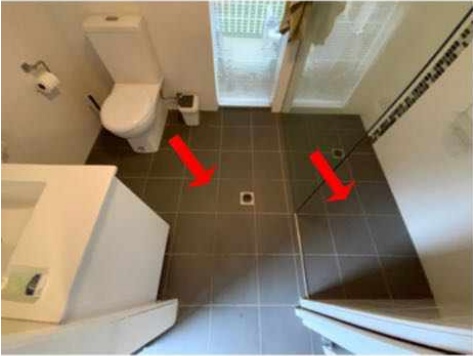
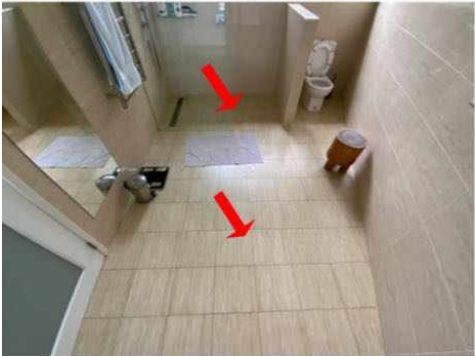
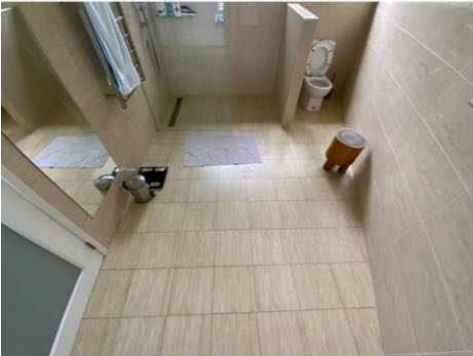
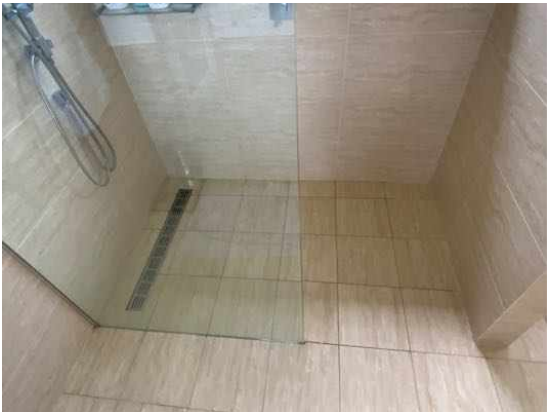
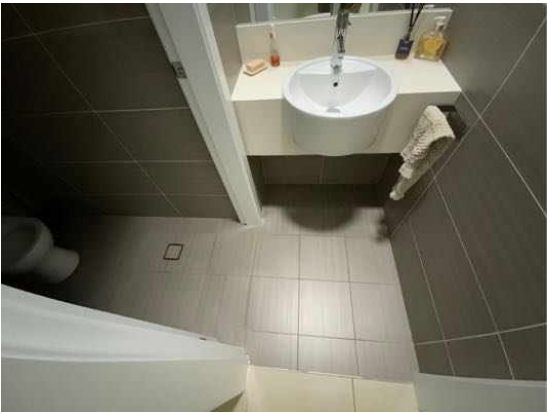
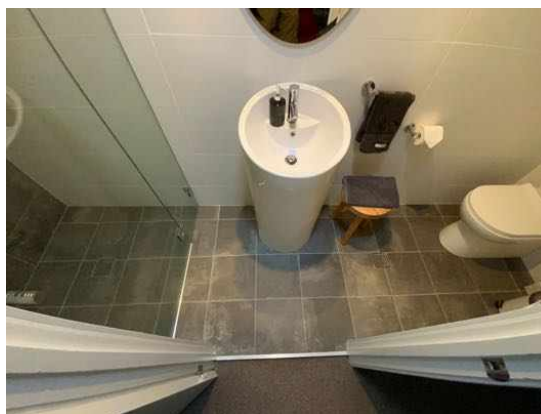
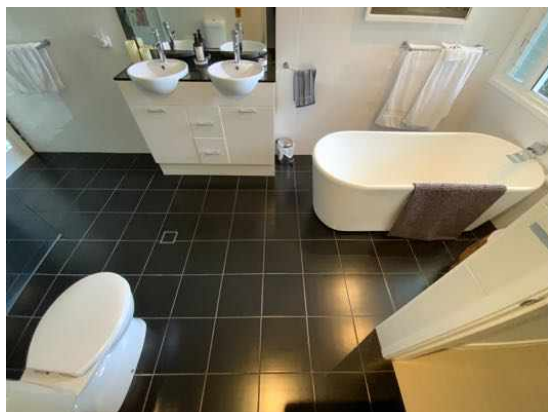
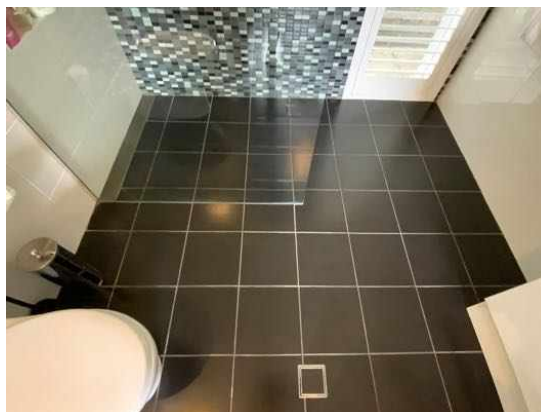
Building: Main Building
 Location: All Wet Areas
 Finding: Water Proofing Membranes - Information Only
 Information: Internal Water Proofing Membranes, are crucial in preventing water ingress into the property is important to know that the Membrane System used is to Australian Standards and has been installed correctly.

With older property's where this information is unavailable all wet areas should be monitored. Generally waterproofing certificates are only valid for approximately 7-8yrs. If any leaks, water staining, peeling or bubbling of the paint become evident to any adjacent walls or ceilings below a licensed builder or waterproofing specialist is recommended to investigate further.

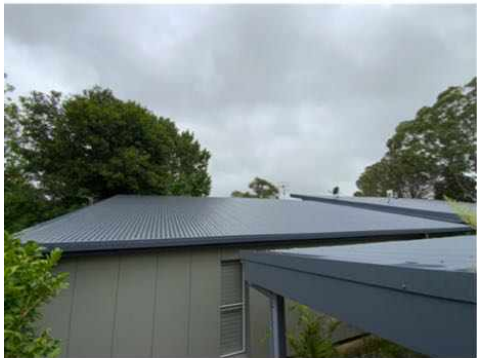
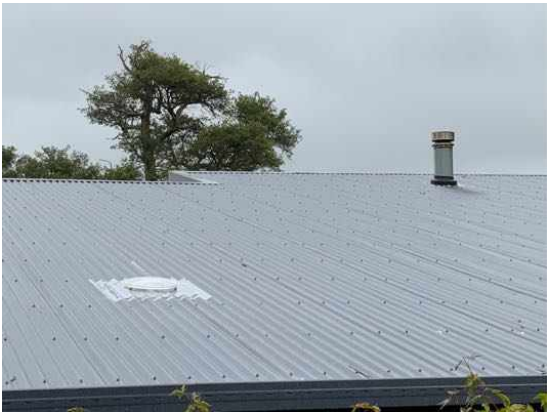
Building: Main Building
 Location: Roof Exterior
 Finding: External Roof Coverings & Plumbing
 Information: The New South Wales area experiences major weather events annually. These periods of storms and torrential & driving rains from certain angles can overwhelm residential roofs, waterproofed areas, skylights, flashings & guttering causing water ingress into properties that other wise would not happen in normal rain conditions. Therefore no guarantee can be given against any future roof leak.

All roof coverings & plumbing, flashings, exterior guttering, box gutters and downpipes, even with gutter guard products installed, should remain free of all debris and possible blockages. Blockages may lead to pooling, accumulated water overflows, possible water ingress and the associated damage to adjoining building elements. Any areas of missing or aged/corroded guttering should be replaced.

A further inspection by a Licensed Roofing contractor is recommended to go over the complete roof covering and advise on the extent of replacement/ repair &

maintenance items.
