# Building and Timber Pest Inspection Report

Inspection Date: Mon, 23 Mar 2026

Property Address: 50 Vista Ave, Copacabana NSW 2251,  
Australia

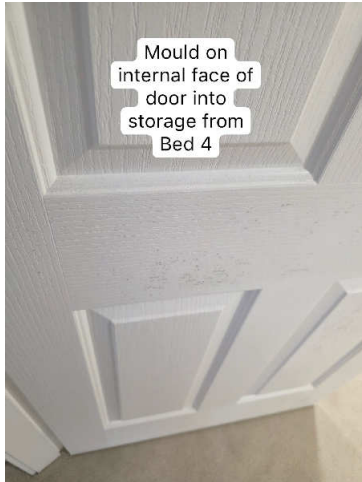
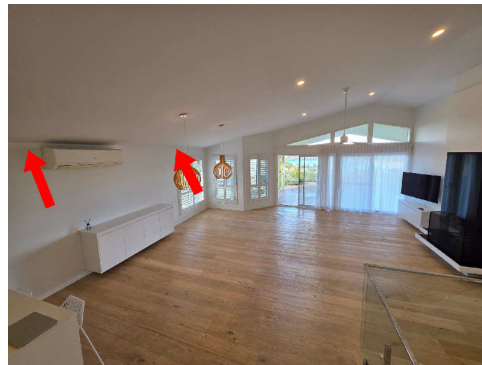
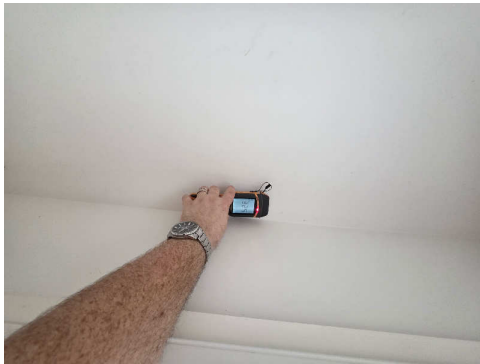
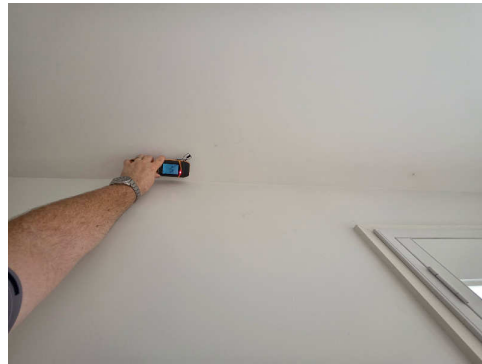
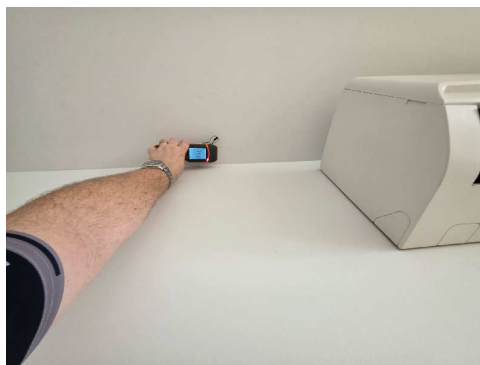
Building:	Main Building
Location:	Multiple Areas
Finding:	Internal moisture, mould growth and ventilation concerns – Multiple areas
Information:	<p>Elevated moisture readings were recorded across multiple internal wall surfaces, with visible mould growth observed to areas including window reveals, internal doors, and fittings. Moisture readings taken to the raked ceiling in the living area were generally consistent, with elevated readings noted toward the lower sections where the ceiling meets the wall. A musty odour was noted to enclosed areas, particularly to the under-stairs area and storage areas in bedrooms 3 and 4. The dwelling was vacant at the time of inspection, which may contribute to reduced ventilation. The exact source of moisture could not be confirmed.</p> <p>Prolonged elevated moisture levels may contribute to ongoing mould growth and deterioration of finishes and materials. While no single source was confirmed, the issue appears widespread and may involve ventilation or building envelope factors. A licensed builder should be engaged to assess, investigate and advise on rectification as required. This should be done as soon as practicable.</p>

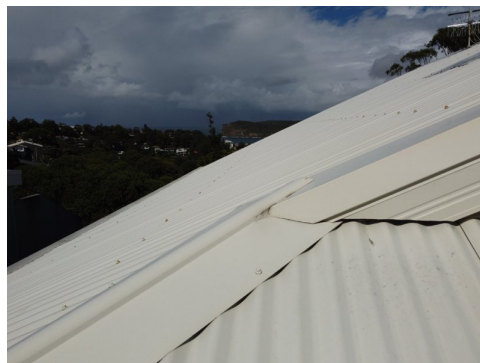
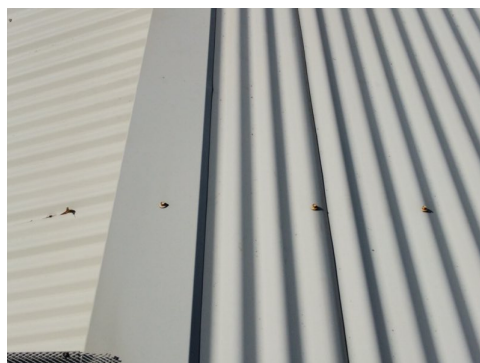
**Finding 3.02**

Finding: Defective roof flashings, sheeting and drainage – Main roof / Lifted flashing – Garage roof

Information: Multiple defects were observed to the roof, including incorrectly installed flashings, inadequate detailing at junctions, corrosion to fixings, and debris build-up at gutter joints. The roof sheeting appears to be lapped in the incorrect direction, which may allow wind-driven rain to enter. Fibre cement sheeting above the deck roof is in direct contact with flashing, with visible discolouration consistent with moisture wicking. A section of flashing to the garage roof was also observed to be lifted and not sitting as intended. This appears consistent with poor installation, although the flashing appeared stable at the time of inspection.

The client has advised me that a previous water stain and mould growth had been observed to the living room ceiling, which was reportedly cleaned following an alleged repair of a minor leak. No visible evidence of staining, moisture ingress or active leakage was observed at the time of inspection. However, the adequacy of any prior repairs if carried out could not be verified. Given the defects noted to the roof coverings and flashings, further investigation is recommended to confirm the roof is performing as intended as intermittent leaks may still be present.

These conditions may allow water ingress and contribute to progressive deterioration of roofing and adjacent materials. The defects are widespread and affect the overall performance of the roof system. A licensed roofer should be engaged to carry out further investigation and rectify as required. This should be done as soon as practicable.

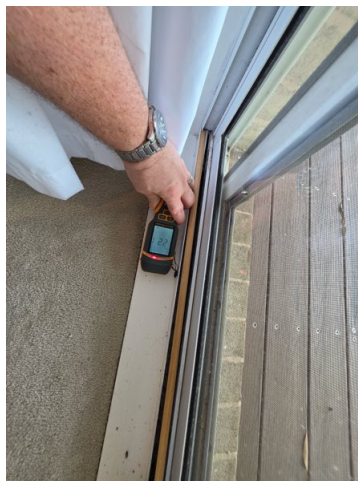
**Finding 3.03**

Finding: Elevated moisture to sliding door reveals – Multiple areas

Information: Elevated moisture readings were recorded to the sliding door reveals and sill areas in both the main living area and bedroom 2. Higher readings were noted to the lower sections, particularly on the lock side in bedroom 2. The source of moisture could not be confirmed from the visible inspection.

These conditions may indicate moisture ingress at door thresholds and may lead to deterioration of adjacent materials over time. Concealed damage cannot be ruled out. A licensed builder should be engaged to carry out further investigation and rectify as required. This should be done as soon as practicable.

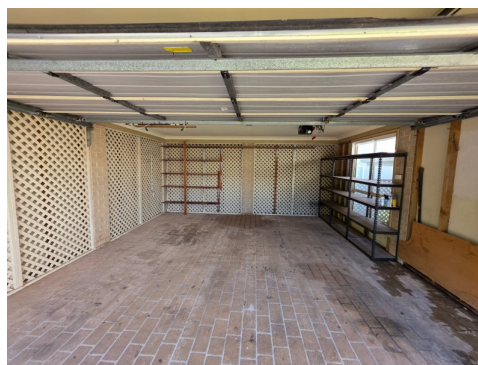
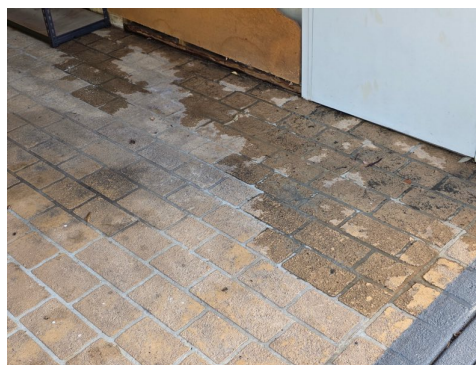
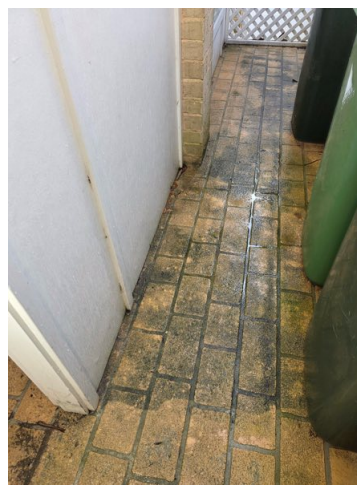
### Finding 3.04

Information: The garage walls have been infilled without visible waterproofing measures along the bottom, and water ingress was observed entering beneath the wall along the side of the garage. The wall appears to be in direct contact with the ground without a physical barrier, which is not appropriate and may allow moisture to track into the wall structure.

Ongoing water entry may lead to deterioration of wall materials and adjacent areas. A licensed builder should be engaged to investigate and rectify as required. This should be done as soon as practicable.

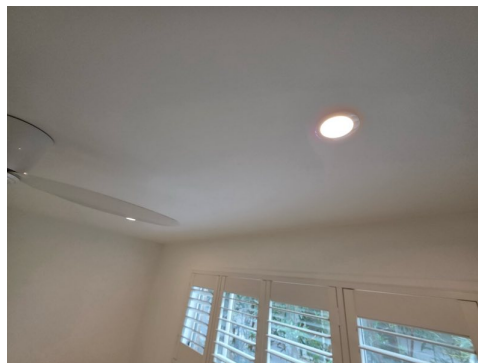
### Finding 3.05

Information: Multiple LED lights were observed to flicker intermittently across different areas of the property. Flickering appeared to shift between lights, with one downlight stopping as another in the same room began, and additional flickering noted in a separate room when lights were switched off. This pattern suggests a broader electrical issue rather than an isolated fitting fault.

Intermittent faults may worsen over time and may indicate underlying electrical concerns. A licensed electrician should be engaged to investigate and rectify as required. This should be done as soon as practicable.

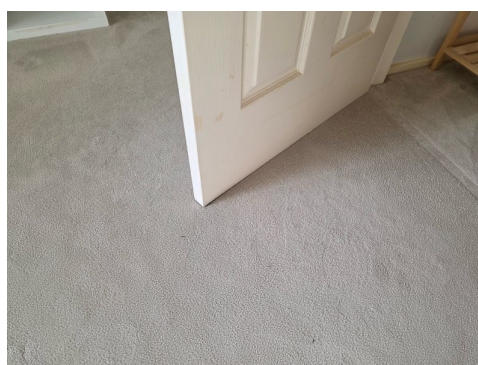
### Finding 3.06

Information: Multiple internal doors were observed to be rubbing against floor coverings, and several door handles were loose at the time of inspection. These conditions are consistent with minor wear and general use.

If left unaddressed, wear to door edges, finishes, and hardware may continue. A qualified carpenter should be engaged to adjust and secure components as required. This should be done as soon as practicable.

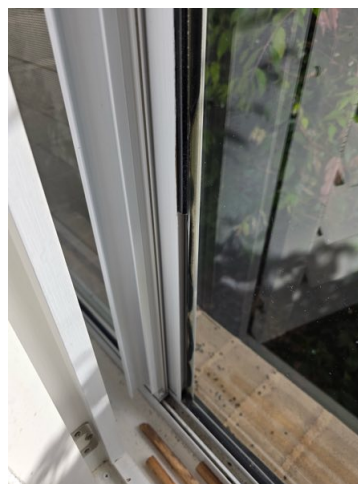
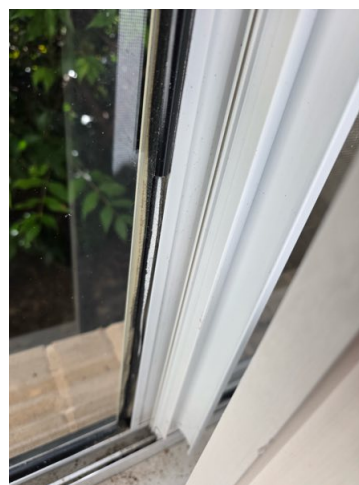
**Finding 3.07**

Finding: Damaged window seals – Bedroom 1

Information: The rubber seals to one bedroom window were observed to be damaged and partially missing. This appears consistent with age-related wear.

This may reduce the effectiveness of the window seal against weather and air infiltration. A qualified carpenter should be engaged to assess and replace seals as required. This should be done as soon as practicable.

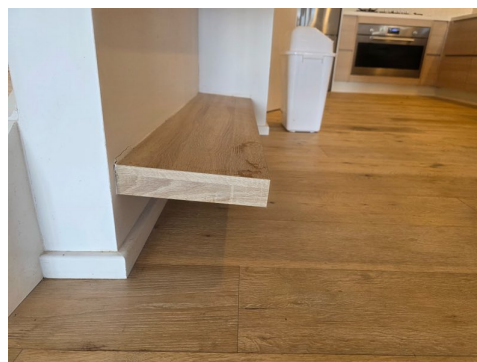
### Finding 3.08

Finding: Damaged and unstable floating shelf – Kitchen

Information: A floating shelf in the kitchen was observed to be damaged, not level, and pulling away from the wall. This may be due to inadequate fixings or loading over time.

The shelf may continue to loosen and could detach if not addressed. A qualified carpenter should be engaged to secure or replace as required. This should be done as soon as practicable.

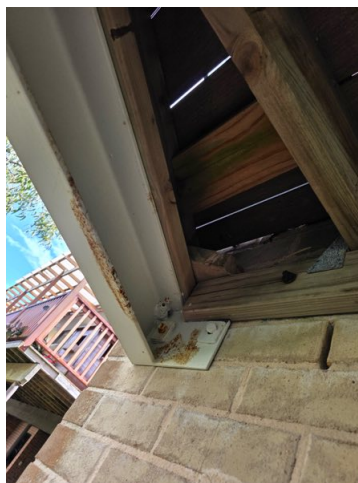
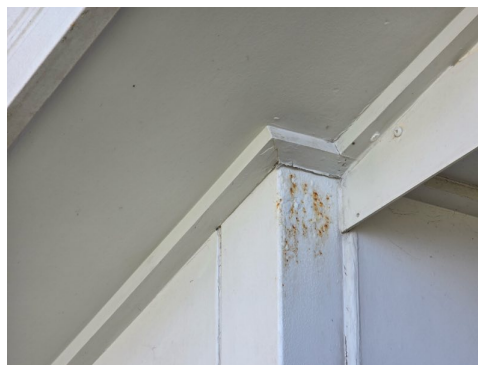
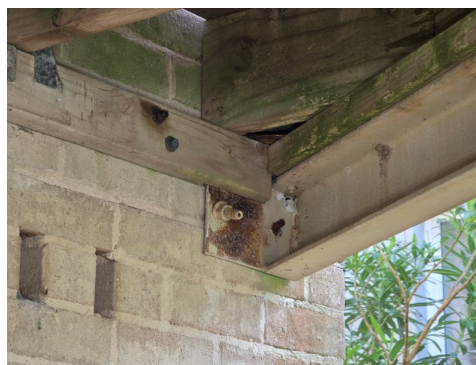
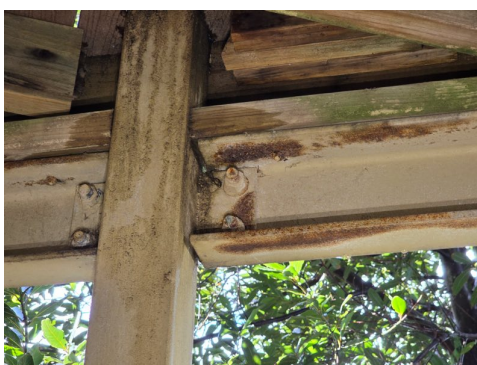
Finding: Surface rust to steel elements – Deck structure

Information: Surface rusting was observed to steel components within the deck structure. No significant section loss was evident.

If left untreated, corrosion may progress over time. A licensed builder should be engaged to treat and protect affected elements. This should be done as soon as practicable.

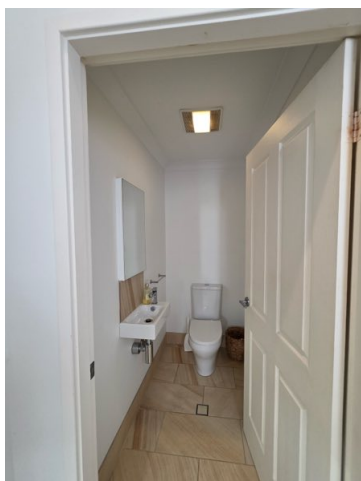
### Finding 3.11

Building:	Main Building
Location:	Toilet (WC)
Finding:	Continuous filling toilet cistern – Upper level WC
Information:	The toilet cistern continued to fill after flushing.

This may result in unnecessary water usage and wear on components. A licensed plumber should be engaged to repair as required. This should be done as soon as practicable.

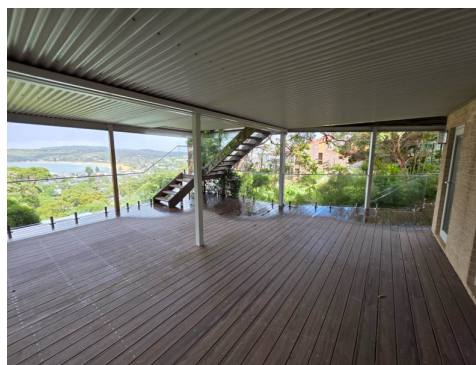
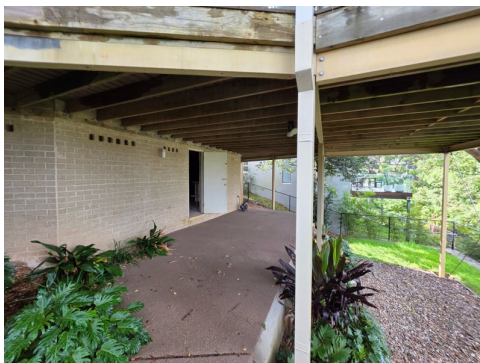
### Finding 3.12

Information: An elevated external deck was observed at the property. Even if the structure appears sound or recently built, it may still pose a safety risk if inadequately supported. A detailed structural assessment is required to confirm its stability and load-bearing capacity.

A structural engineer should be engaged to carry out a structural assessment of the decks. Until this has been completed and any necessary rectification works undertaken, users should take care not to overload the structure.

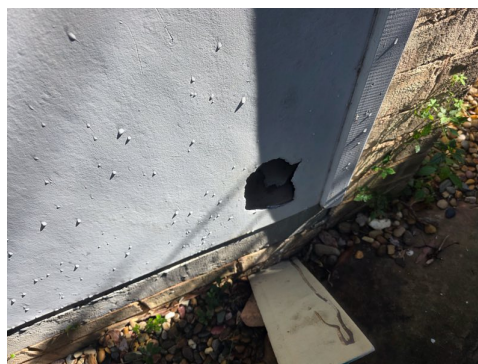
### Finding 3.13

Finding: Damaged wall sheeting – Garage rear wall

Information: A hole was observed in the garage wall sheeting with framing exposed.

This may allow moisture entry and pest access if left unaddressed. A qualified carpenter should be engaged to repair the wall. This should be done as soon as practicable.

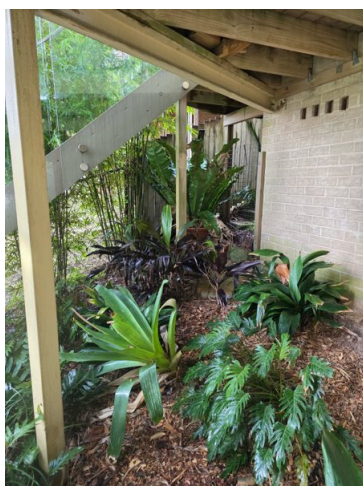
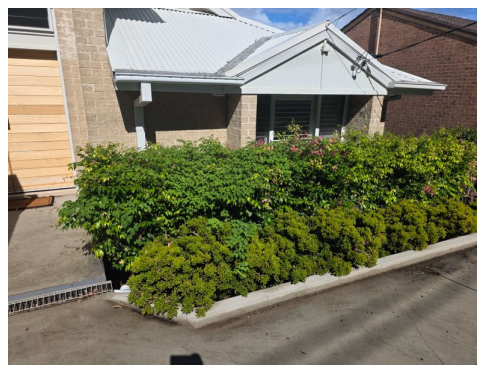
Building:	Main Building
Location:	Yard - Front, Back
Finding:	Garden Beds - Conditions Conducive to Termites
Information:	Garden beds, particularly those constructed from untreated timber, were noted adjacent to the dwelling. These create a highly conducive environment for termite activity due to the combination of retained soil moisture from watering, direct soil contact, and the organic material in the soil and timber edging. Such conditions increase the risk of concealed termite ingress into the property, as termites can travel through the garden beds and enter the structure undetected.

Where practical, garden beds should be removed, relocated, or modified so that they do not abut the dwelling. Where this is impractical or undesirable, the risk of concealed termite activity remains. In these cases, a licensed pest controller should establish an ongoing termite management plan, and regular timber pest inspections should be carried out every 6–12 months to assist in protecting the property against infestation.

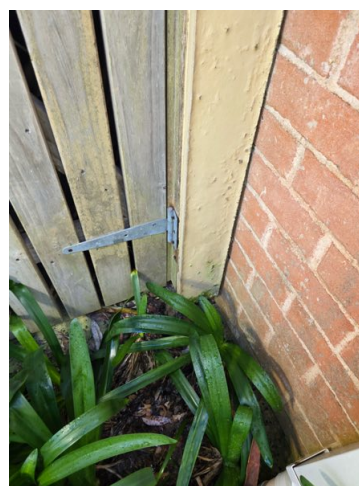
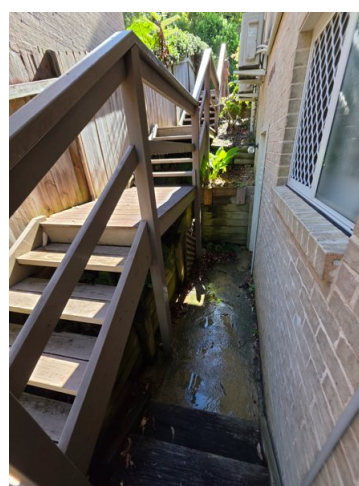
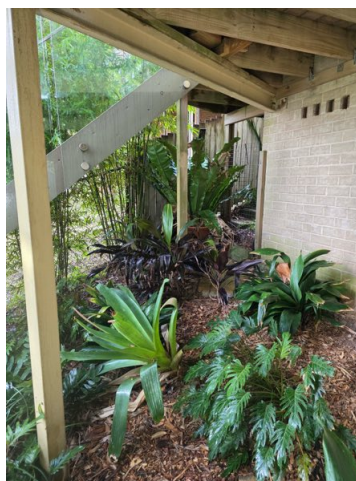
### Finding 6.02

Building:	Main Building
Location:	Yard
Finding:	Ground - Timber materials in direct ground contact

Timber elements in direct contact with the ground, and consequently exposed to moisture or dampness, create conditions conducive to termite activity. Whether timber is used as part of a building structure, such as a fence or retaining wall, or stored as unused material, it can attract termite infestations.

When exposed to excessive moisture, timber begins to decay and develop wood rot. Any timber in direct contact with the ground - especially untreated or non-durable timber - provides an easy entry point for subterranean termites into the material.

To minimize the risk of termite attack, it is recommended to remove any materials that could foster termite activity. If removal is impractical or undesirable, it is strongly advised that termite or timber pest inspections be conducted every 6 to 12 months to protect the property from potential infestation.

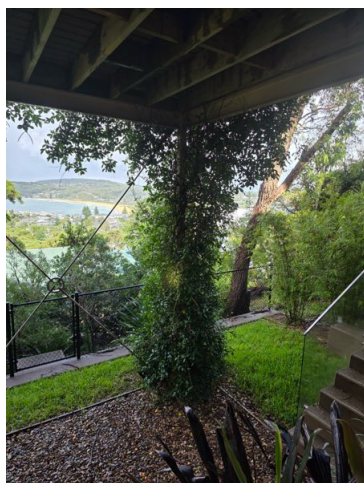
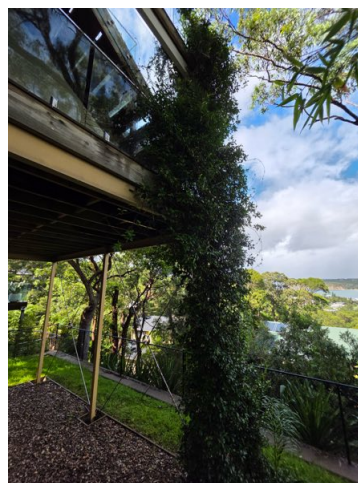
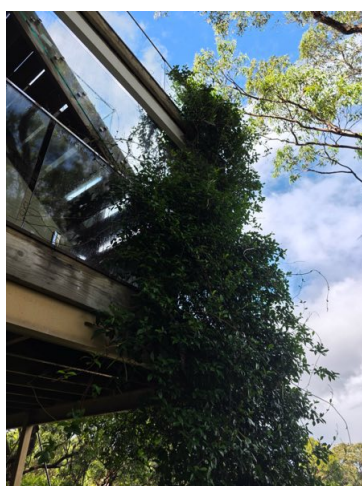
### Finding 6.03

Information: Where vegetation obstructs inspection of building elements, also known as bridging as it provides a bridging point for the access of termites, full inspection can not be achieved. Consequently moisture or dampness may be present and the areas becomes conducive to termite activity. Plants against or very close to buildings provide cover, shade and can provide an environment that is attractive to termite infestation.

The removal and replanting of species that do not provide "cover" or cutting back of existing vegetation will assist greatly in preventing Bridging from occurring.

The removal of any such materials that may be conducive to termite activity should be carried out as soon as possible and arrange re inspection to minimize the risk of termite attack.

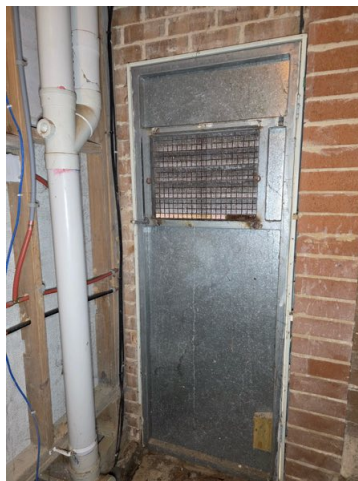
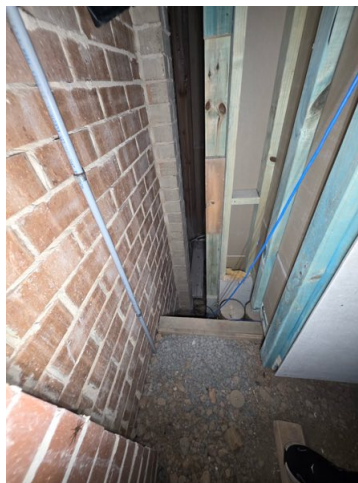
#### Finding 6.04

Finding: Ventilation - Inadequate subfloor ventilation

Information: Subfloor ventilation appears to be inadequate in one or more areas beneath the dwelling. Poor airflow can result in elevated moisture levels, which in turn create conditions conducive to fungal decay and termite activity. Signs of dampness or musty odours may also indicate restricted air movement.

Improved cross-ventilation should be established to help manage moisture and reduce the risk of concealed timber pest attack. A licensed builder should assess the subfloor and install additional vents or mechanical ventilation as needed. This should be addressed as soon as practicable.

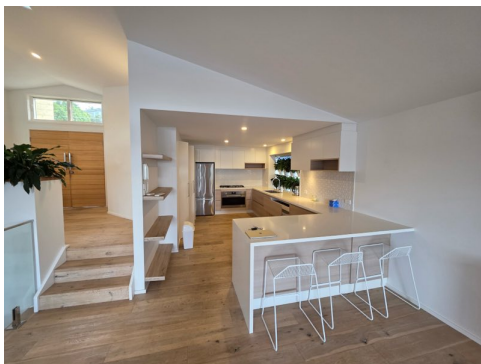
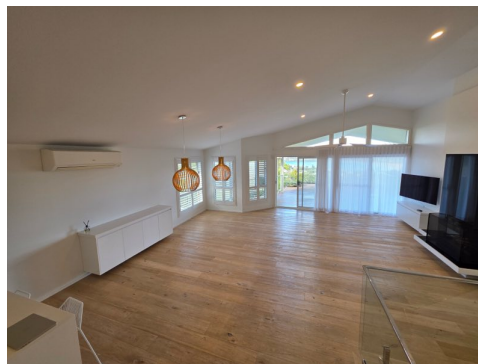
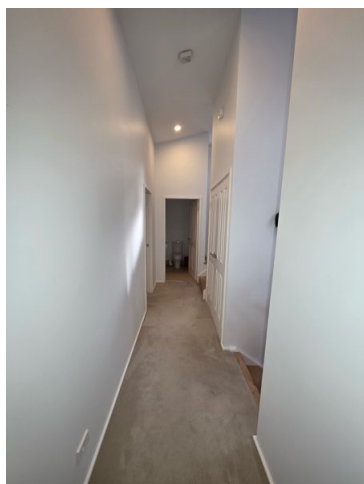
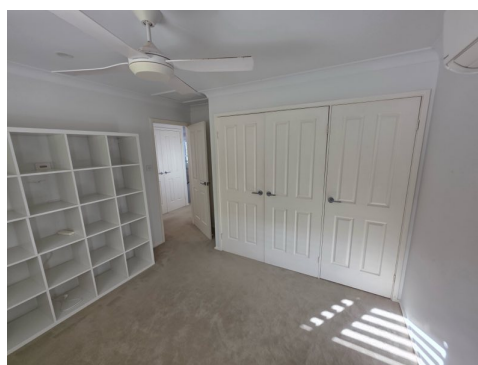
Finding: Additional Photos - Obstructions and Limitations

Information: These photographs are an indication of the obstructions and limitations which impeded full inspection of the property at the time of inspection. These obstructions can hide an array of defects and should be removed to allow full inspection to be carried out. A re-inspection is recommended once the areas are made accessible.

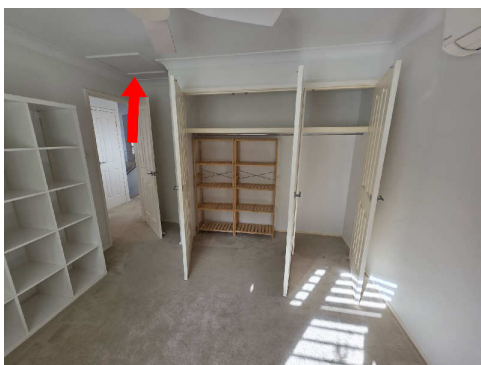
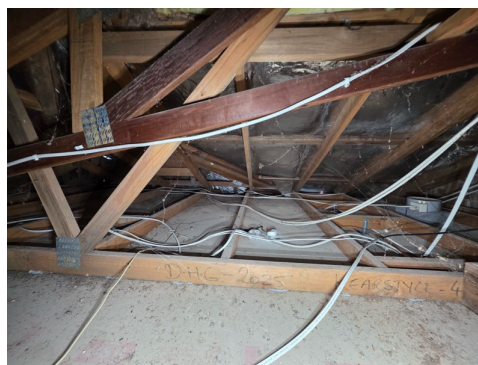
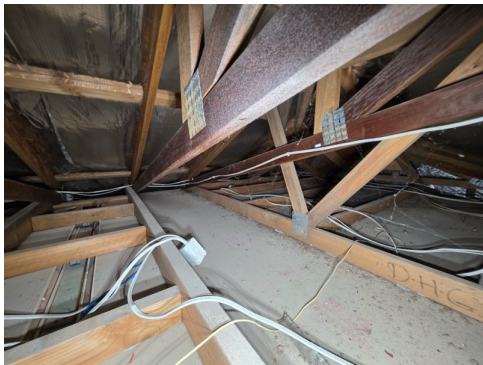
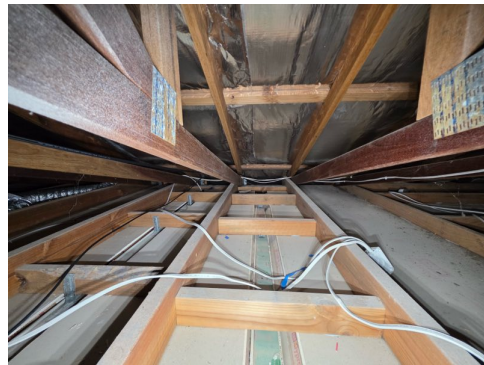
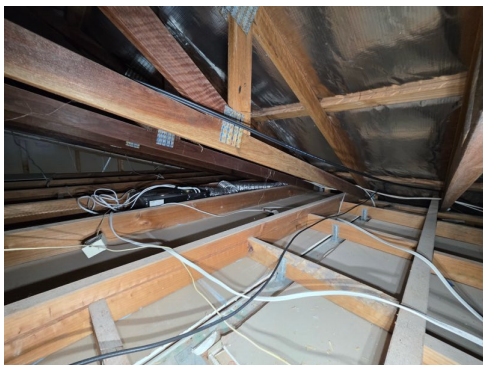
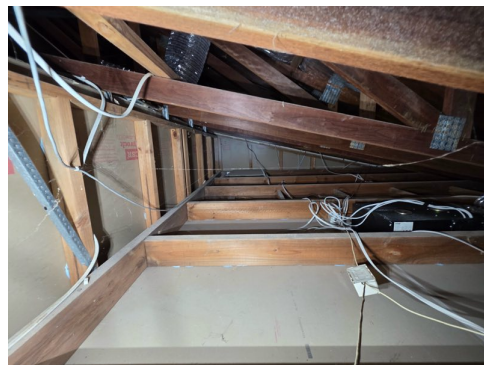
Information: The roof void was accessed via the ceiling hatch; however, due to the truss configuration, access was restricted and only one side of the roof space was able to be viewed from this vantage point at the time of inspection.

As a result, areas beyond the line of sight were not visible and could not be assessed. Conditions or defects may exist in concealed or obstructed sections of the roof void that were not observable. This should be taken into consideration when relying on this report.

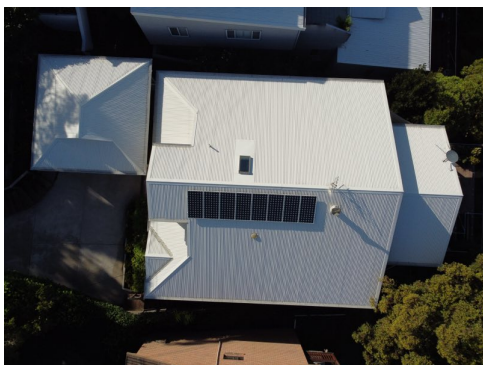
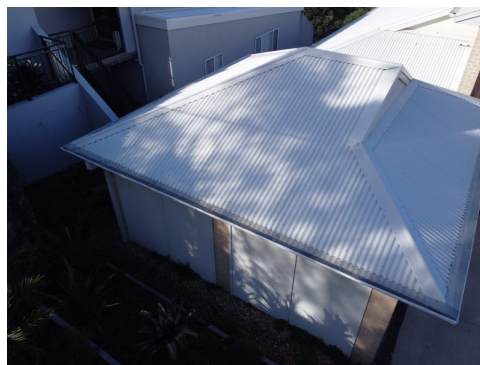
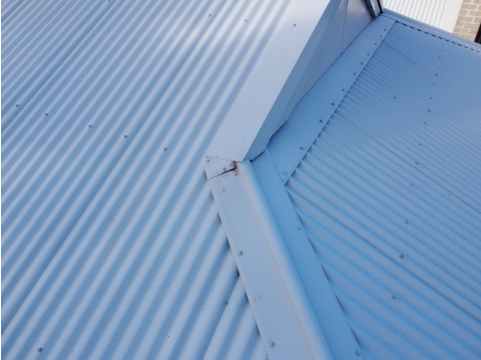
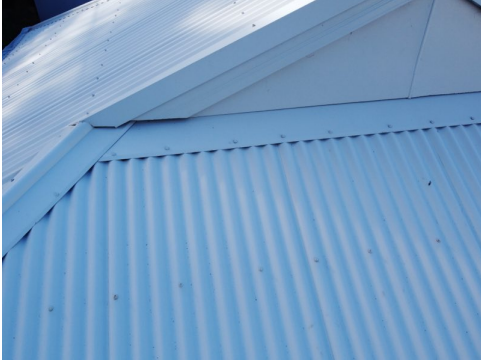
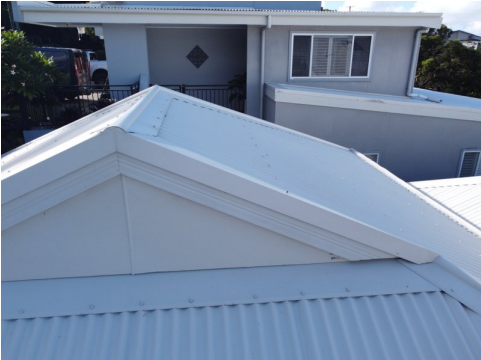
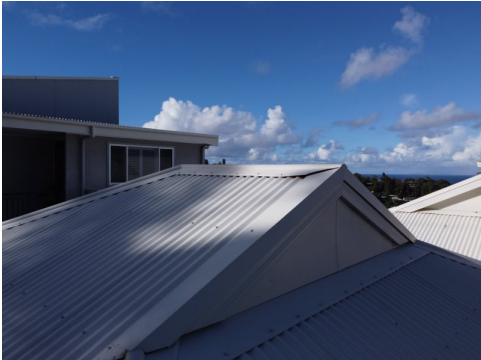
Finding: Additional Photos - Roof Exterior

Information: Additional photos of the roof exterior are provided for your general reference

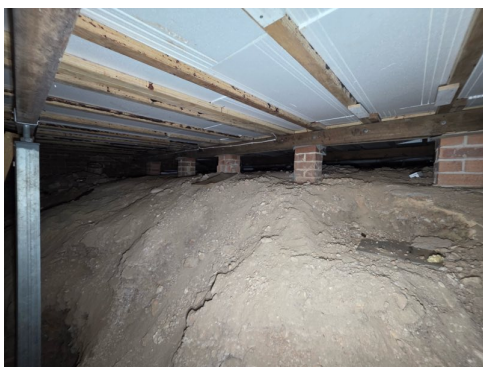
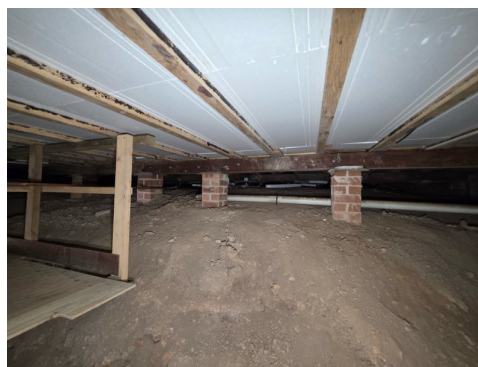
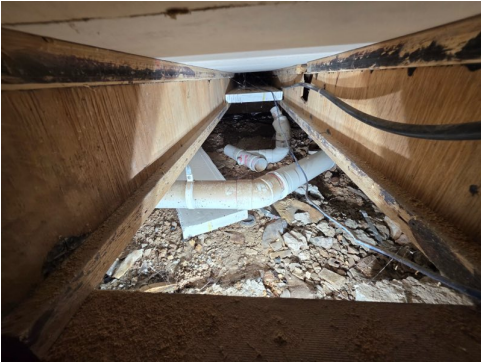
Finding: Access - Subfloor partially inaccessible

Information: The subfloor was partially inaccessible due to restricted access and crawl space at the time of inspection. As a result, concealed structural defects, timber damage, or conditions conducive to deterioration could not be ruled out in this area.
