Building and Timber Pest Inspection Report

Inspection Date: Thu, 26 Feb 2026

Property Address: 1691 Coramba Rd, Megan NSW 2453,
Australia

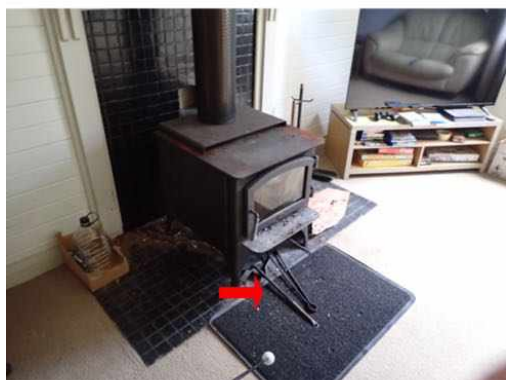
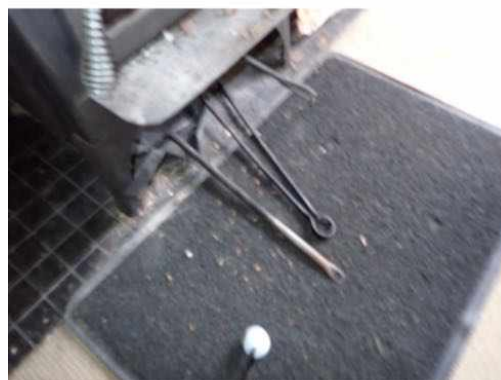
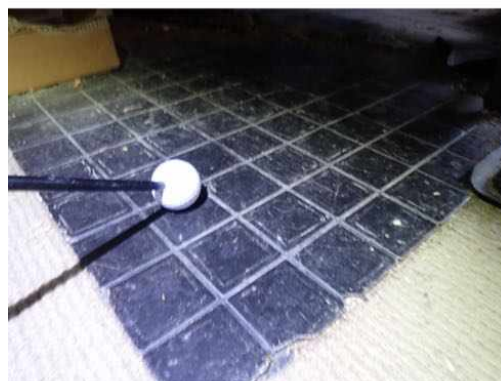
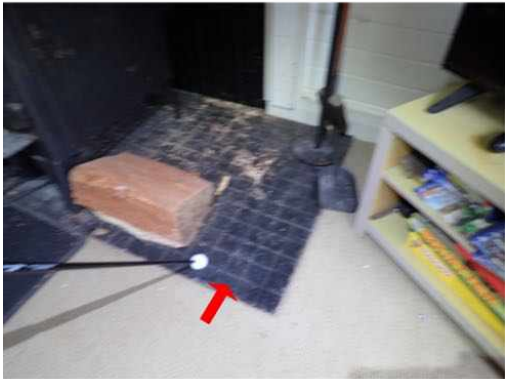
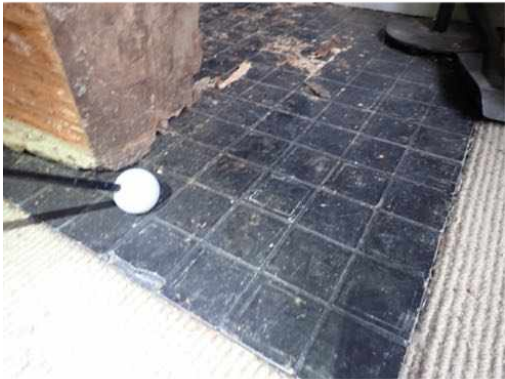
Finding 1.01

Building: Main Building
Location: Living Room
Finding: Insufficient Fireplace Hearth and Damaged Tiles
Information: The fireplace hearth was found to be too small and does not appear to extend sufficiently beyond the fireplace opening in accordance with current safety requirements. Damaged and cracked tiles were also noted to the hearth surface. In simple terms, the hearth in front of the fireplace is too small and the tiles are damaged. An undersized hearth may not provide adequate protection to surrounding flooring from heat or embers. It is recommended that a qualified builder assess and enlarge the hearth to meet current standards, and that a licensed tiler replace the damaged tiles as required. Rectification should be undertaken to improve safety and durability and can be arranged at the owner's discretion.

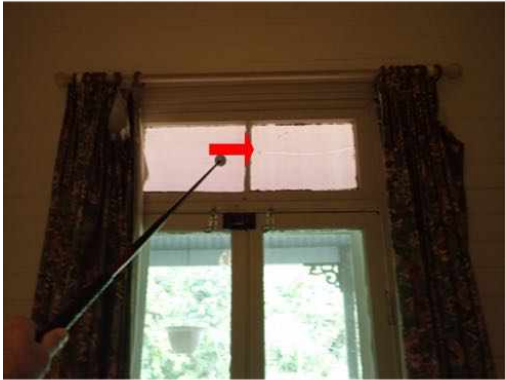
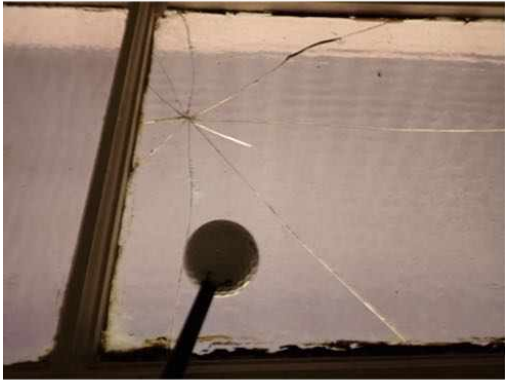
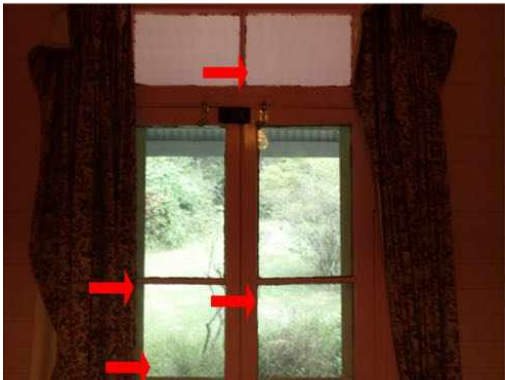
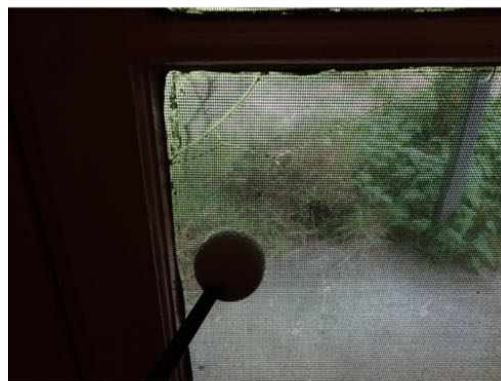
Finding 1.02

Finding: Cracked Window Panes to Bedroom Doors

Information: Cracked glass panes were identified to the window sections within the bedroom doors. The glazing is fractured and may be weakened, increasing the risk of further cracking or breakage. In simple terms, the glass in the bedroom doors is cracked. This type of damage is commonly caused by impact or stress to the glass. Cracked glazing may present a safety concern if it shatters. It is recommended that a qualified glazier remove and replace the damaged panes. Repairs can be undertaken at the owner's discretion to restore safety and functionality.

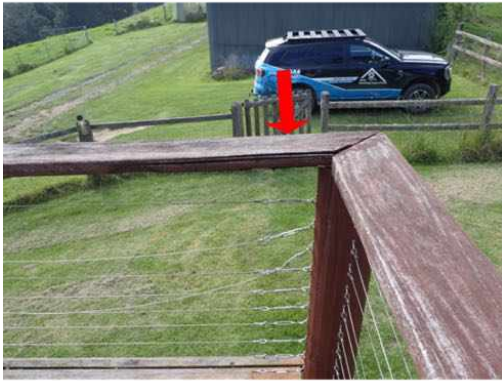
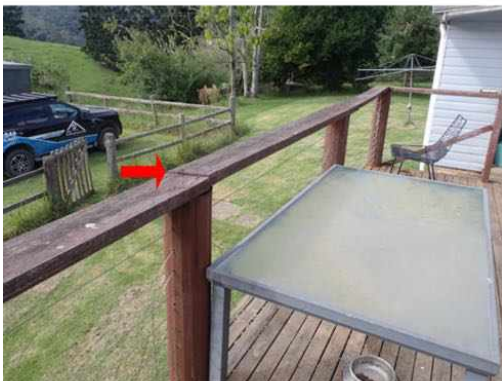
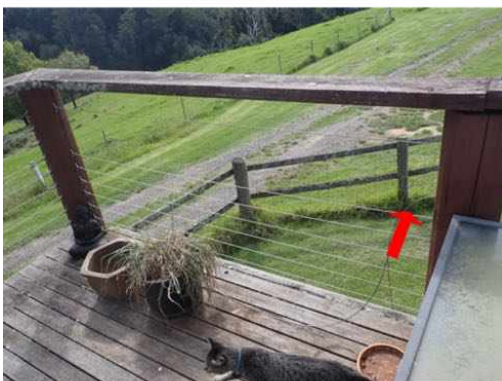
Finding 1.03

Building:	Main Building
Location:	Rear timber patio area
Finding:	Timber Patio Handrail/Balustrade Weathered with Two Broken Stainless Steel Wires
Information:	The timber patio handrail/balustrade was observed to be in a weathered condition, with two broken stainless steel wire infill strands identified. Deterioration of balustrade components and broken wires may reduce the effectiveness and safety of the barrier system. In plain terms, the patio railing is worn from weather exposure and two of the steel wires are broken, which may pose a safety concern. Possible causes include prolonged exposure to the elements, tension fatigue in the wires, corrosion at fixings, and lack of maintenance. It is recommended that the broken wires be replaced and the timber components repaired, re-coated, or replaced as required to maintain safety and durability. Works should be carried out by a licensed builder or suitably qualified carpenter. Rectification is recommended at the owner's discretion.

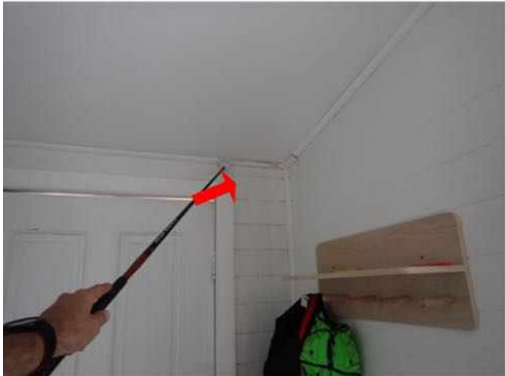
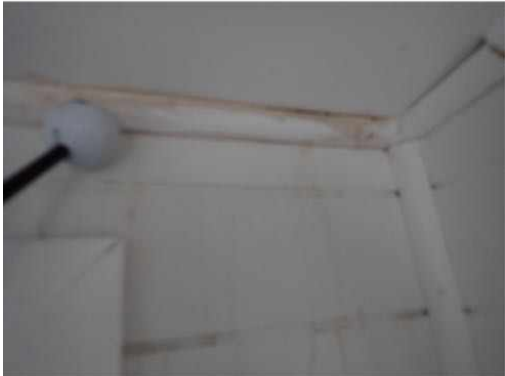
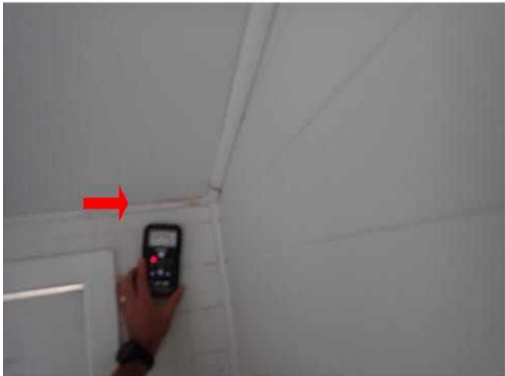
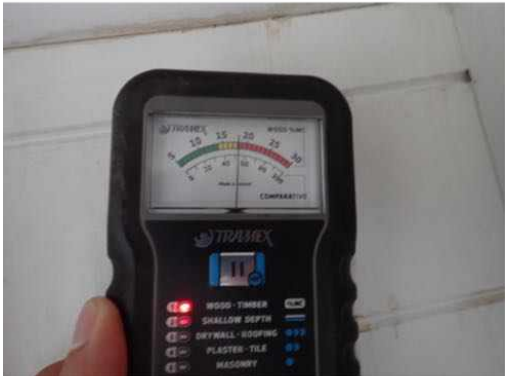
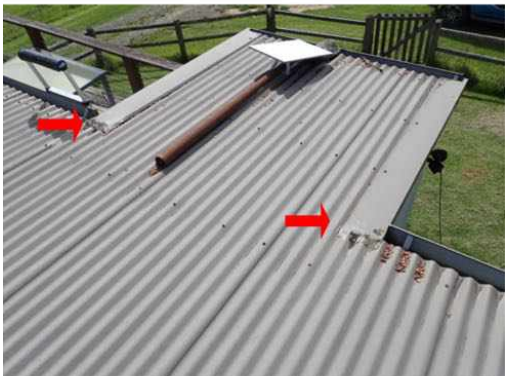
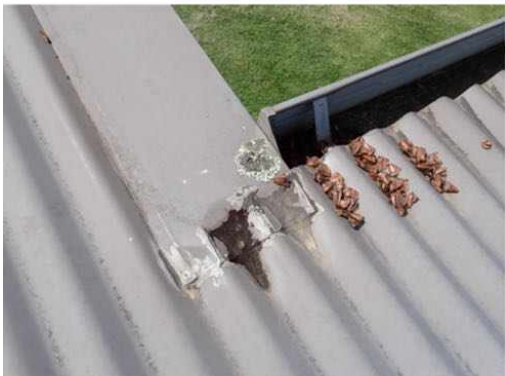
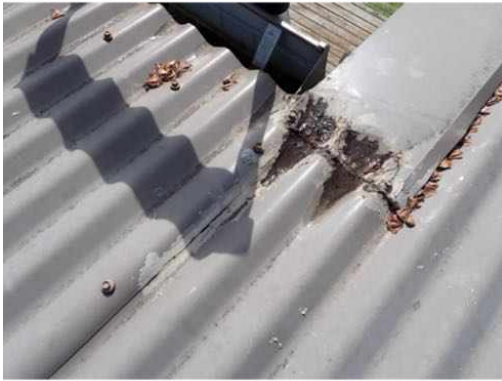
Finding 2.01

Building:	Main Building
Location:	Entry door
Finding:	Elevated Moisture Readings and Possible Water Staining – Back Entry Door Area
Information:	Higher than normal moisture meter readings were recorded to the wall and ceiling behind and around the back entry door, with possible water staining noted to the same area. In simple terms, elevated moisture levels were detected near the back door and there are signs that water may have been present. Silicone sealant work was

observed to the roof cladding above this location, which may indicate previous attempts to address a leak. The source and extent of moisture ingress could not be fully determined at the time of inspection. If ongoing, moisture ingress may result in deterioration of wall linings, framing and finishes. It is recommended that a licensed roofing contractor inspect the roof cladding and flashing above the affected area to confirm watertightness, and that a qualified builder investigate the internal moisture source and carry out repairs as required. Further investigation should be undertaken to determine whether the issue is active or historical, with rectification arranged at the owner's discretion.

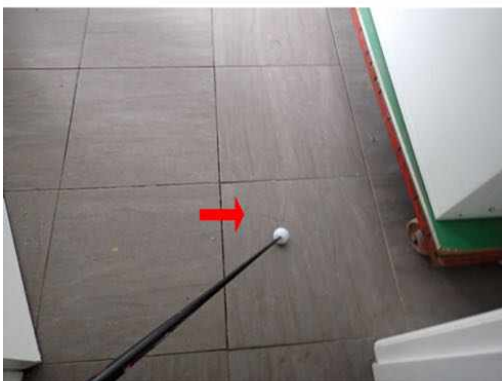
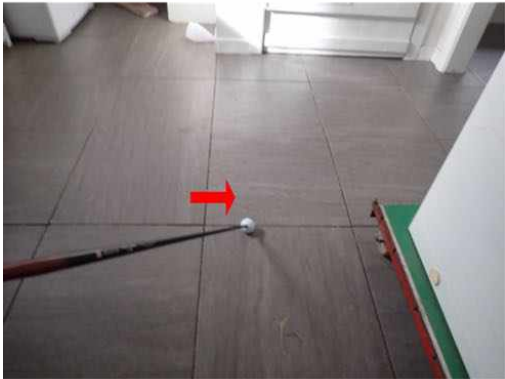
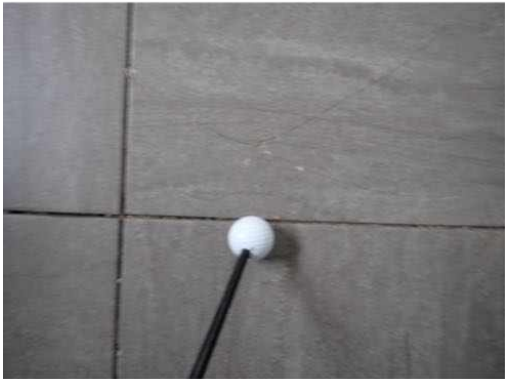
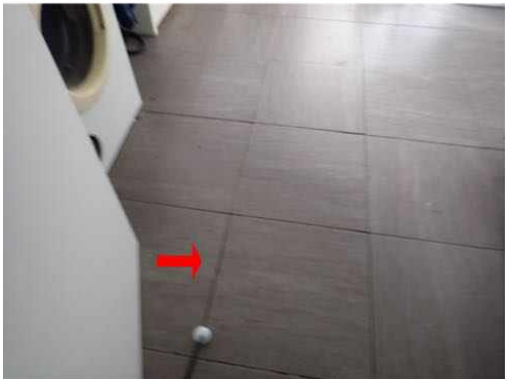
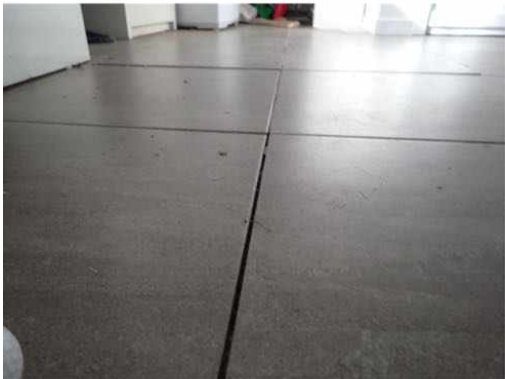
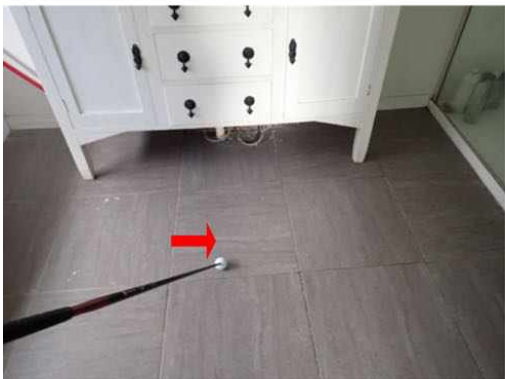
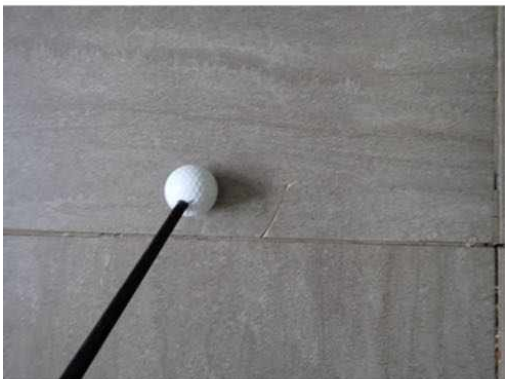
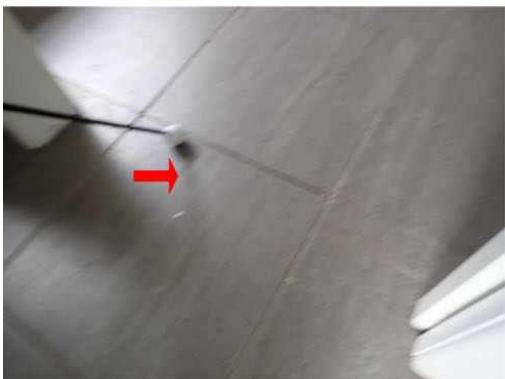
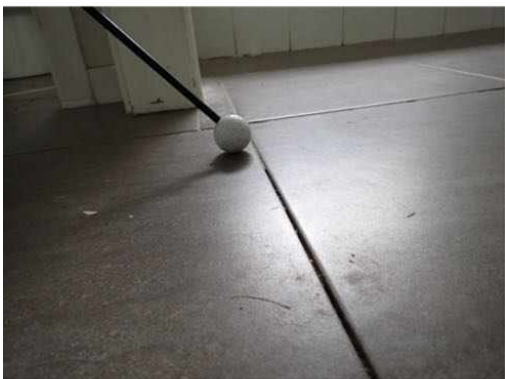
Finding 2.02

Building:	Main Building
Location:	Laundry, toilet, and entry hall
Finding:	Cracked and Drummy Floor Tiles with Missing/Deteriorated Grout – Bathroom, Laundry and Entry Hall
Information:	Cracked and drummy (hollow sounding) floor tiles were identified to the bathroom, laundry and entry hall, along with areas of missing and deteriorated grout. The hollow sound indicates possible loss of adhesion between the tiles and the underlying substrate. In simple terms, some tiles are cracked, sound hollow underfoot and the grout between them is missing or breaking down. This condition is commonly associated with substrate movement, inadequate adhesive coverage, age-related wear and moisture exposure. If left unaddressed, tiles may loosen further, crack or allow moisture to penetrate beneath the tiled surface. It is recommended that a licensed tiler assess the affected areas, replace damaged or loose tiles and reinstate grout as required. Rectification should be undertaken to prevent further deterioration and can be arranged at the owner's discretion.

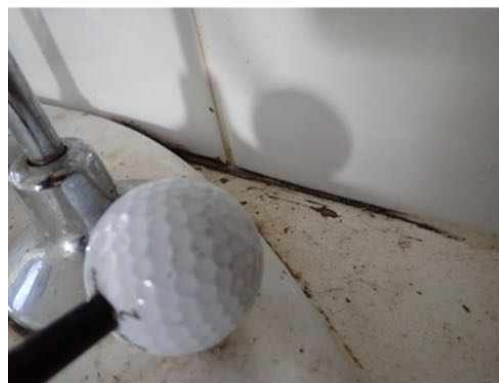
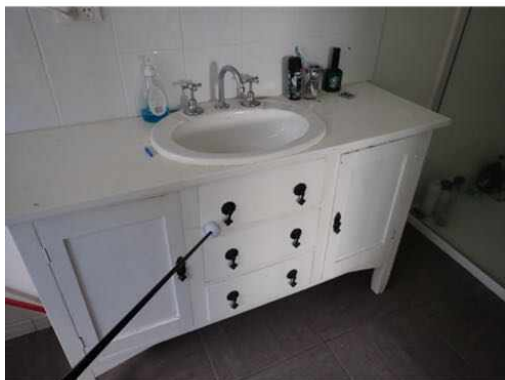
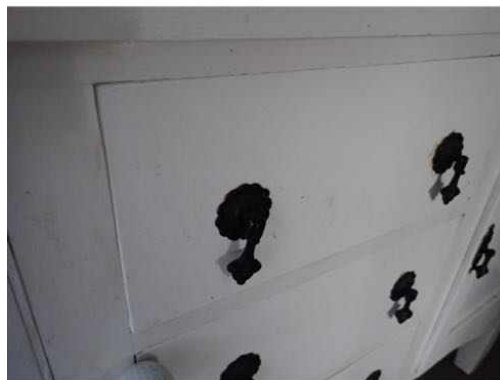
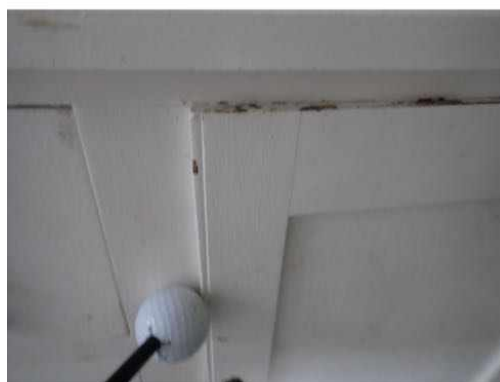
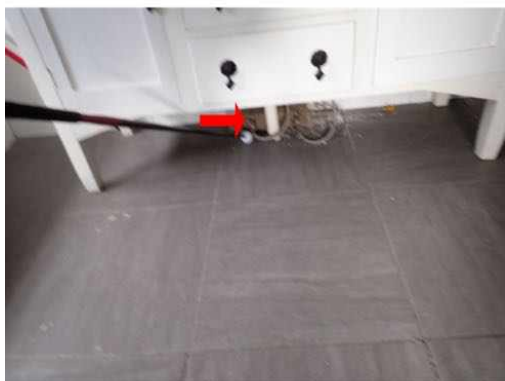
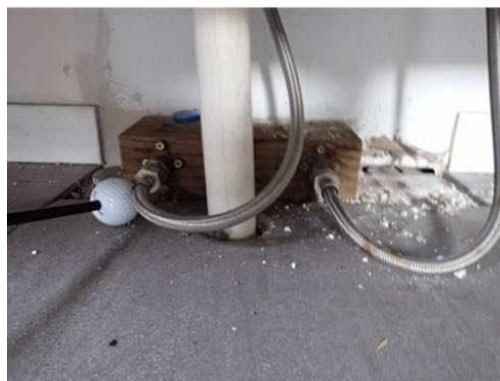
Finding 2.04

Building:	Main Building
Location:	Bathroom
Finding:	Bathroom Vanity Cupboard in Poor Condition
Information:	The bathroom vanity cupboard was found to be in poor condition. Defects observed include deteriorated silicone, drawers and doors that are difficult to open, poorly installed plumbing, and missing tiles where plumbing penetrations have been carried out. In simple terms, the vanity unit is run down, the silicone is failing, the drawers and doors don't operate properly, the plumbing installation appears substandard and tiles are missing around pipework. This condition is commonly associated with poor workmanship and age-related wear. If left unaddressed, continued deterioration and potential moisture ingress may occur within the cabinet and surrounding wall areas. It is recommended that a licensed plumber rectify the plumbing installation, that a licensed tiler reinstate missing tiles and sealing, and that a qualified cabinetmaker or carpenter repair or replace the vanity unit as required. Rectification can be undertaken at the owner's discretion to restore functionality and prevent further deterioration.

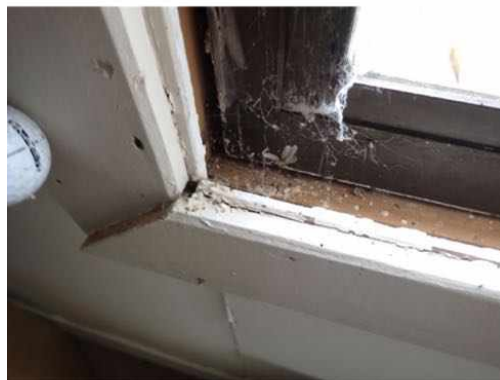
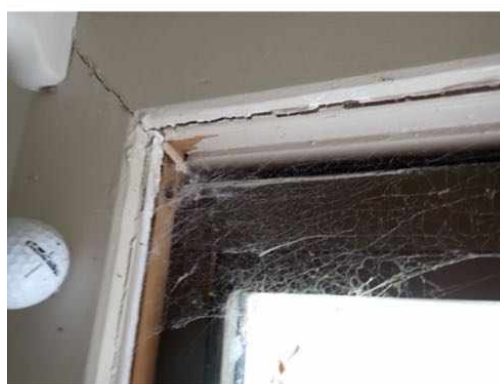
Finding 2.05

Finding: Replacement Aluminium Window Poorly Installed

Information: A replacement aluminium window was observed to be poorly installed. The installation appears substandard, with deficiencies noted in alignment, finishing and/or sealing. In simple terms, the window has not been fitted properly. Poor installation may affect weatherproofing, operation and long-term performance of the window assembly. If left unaddressed, defects in installation may allow moisture ingress or lead to movement and further deterioration. It is recommended that a qualified builder or window installer assess the installation and carry out rectification works to ensure the window is

properly secured, sealed and compliant with relevant standards. Rectification can be undertaken at the owner's discretion.

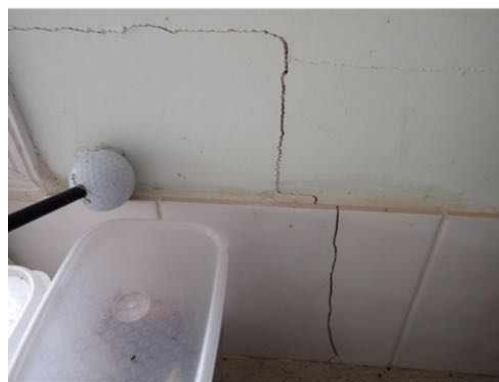
Finding 2.06

Building:	Main Building
Location:	Kitchen
Finding:	Crack to Kitchen Tiled Splashback and Plaster Above
Information:	<p>A crack was identified to the kitchen tiled splashback and the plaster wall above. Cracking in these areas may be associated with building movement, substrate movement, or shrinkage and, if left unaddressed, may allow moisture ingress behind the tiled surface. In plain terms, there is a visible crack in the kitchen tiles and the wall above, which could worsen over time and allow water to get in. Possible causes include settlement, movement in the wall framing, or poor installation. It is recommended that the crack be further assessed and repaired as required, with tiles re-fixed and plaster patched as necessary. Repairs should be carried out by a licensed builder or suitably qualified tiler and plasterer. Rectification is recommended at the owner's discretion to prevent further deterioration.</p>

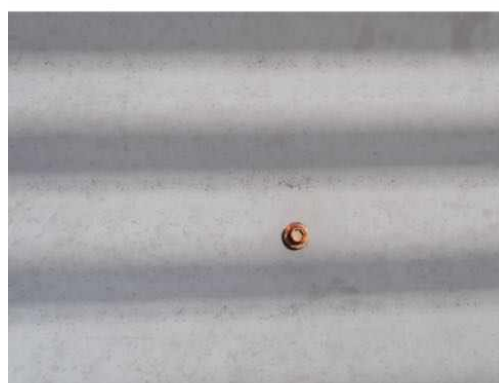
Finding 2.07

Building:	Main Building
Location:	Roof Exterior
Finding:	External Roof Cladding in Fair Condition – Although Defects Identified.
Information:	The majority of the external roof cladding was found to be in fair condition; however, rusted screw heads and multiple silicone patch repairs were identified. Rusted fixings may deteriorate over time and compromise the effectiveness of the roof sheeting, and silicone patching is generally considered a temporary repair method. In plain terms, the roof is generally okay but some screws are rusting and there have been patch-up repairs using silicone. Possible causes include age-related deterioration, weather exposure, and previous leak repairs. It is recommended that rusted fixings be replaced and patched areas monitored and properly repaired as required to ensure ongoing weatherproofing. Works should be carried out by a licensed roof plumber or suitably qualified roofing contractor. Rectification is recommended at the owner's discretion to prevent further deterioration.

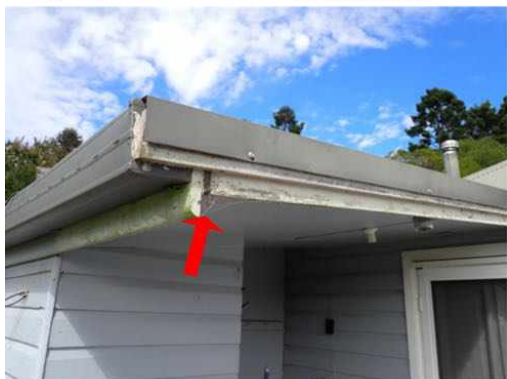
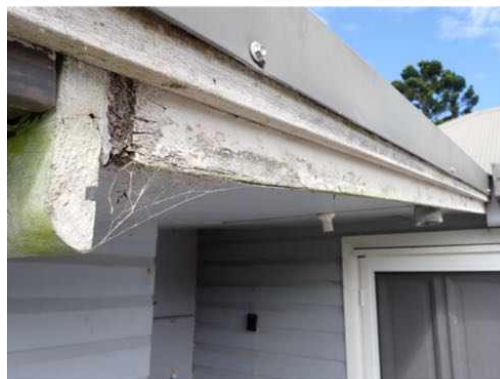
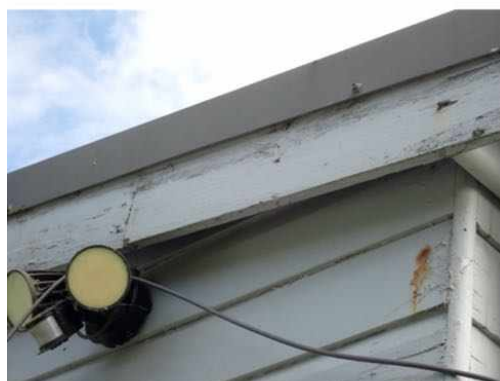
Finding 3.13

Building:	Main Building
Location:	External walls
Finding:	Timber Cladding in Fair Condition for Age
Information:	The timber cladding was found to be in fair condition for the age of the building; however, several areas of age-related deterioration were observed. Deterioration of external cladding may include surface weathering, minor splitting, paint breakdown, or early-stage decay and may worsen over time if not maintained. In plain terms, the cladding is generally reasonable for its age but shows signs of wear and ageing in a few areas. Possible causes include prolonged exposure to sun and moisture, natural ageing, and lack of regular maintenance. It is recommended that the affected areas be prepared, repaired, and re-coated as required, and that any deteriorated sections be

replaced where necessary. Works should be carried out by a licensed builder or suitably qualified carpenter. Maintenance and any repairs are recommended at the owner's discretion to prevent further deterioration.

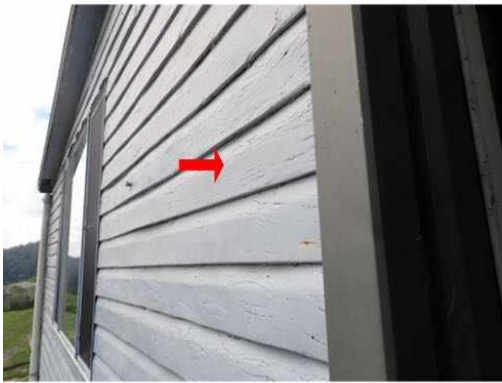
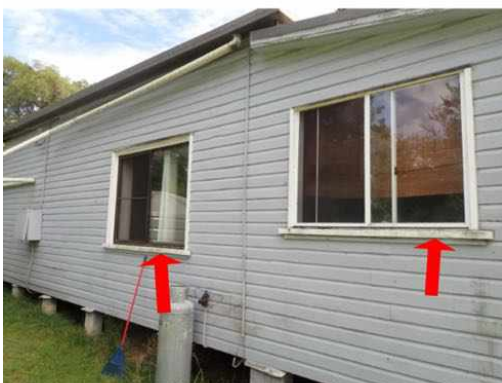
Finding 3.14

Finding: Timber Windows – Age-Related Deterioration

Information: The timber windows were observed to have age-related deterioration, including surface weathering and general wear consistent with the age of the building. Deterioration of timber windows may lead to paint failure, minor splitting, or early-stage decay if not maintained. In plain terms, the timber windows are showing signs of ageing and wear and will continue to deteriorate without upkeep. Possible causes include prolonged exposure to sun and moisture and lack of regular maintenance. It is recommended that the windows be prepared and re-coated, and that any deteriorated sections be repaired or replaced as required. Works should be carried out by a licensed builder or suitably qualified carpenter. Maintenance and any repairs are recommended at the owner's discretion to prevent further deterioration.

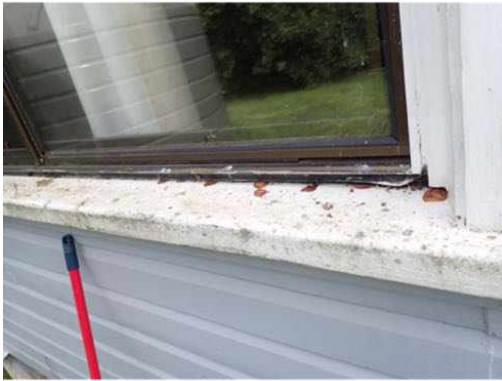
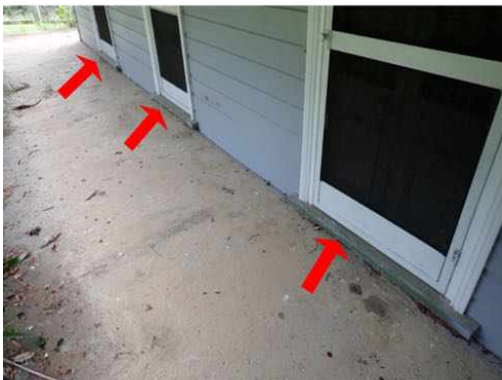
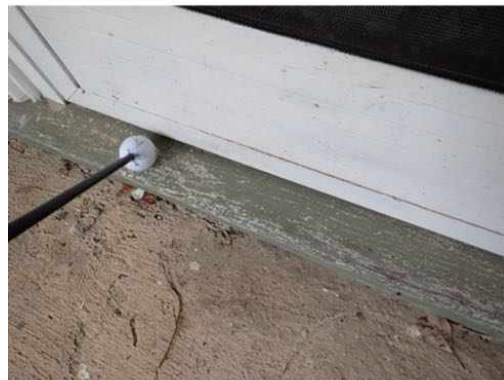
Finding 3.15

Building:	Main Building
Location:	Front door and bedroom doors
Finding:	Front and Bedroom Door Sills in Weathered Condition
Information:	<p>The front door and bedroom door sills were observed to be in a weathered condition with surface deterioration consistent with age, foot traffic and exposure to the elements. Weathered sills may continue to deteriorate over time and can lead to paint failure, minor splitting or decay if not maintained. In plain terms, the bottoms of the door frames are worn and showing signs of ageing and use. Possible causes include regular use, moisture exposure and lack of maintenance. It is recommended that the affected sills be prepared and re-coated, and any deteriorated sections repaired or replaced as required. Works should be carried out by a licensed builder or suitably qualified carpenter. Maintenance and any repairs are recommended at the owner's discretion to prevent further deterioration.</p>

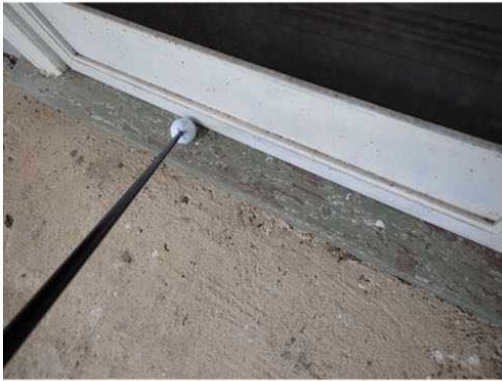
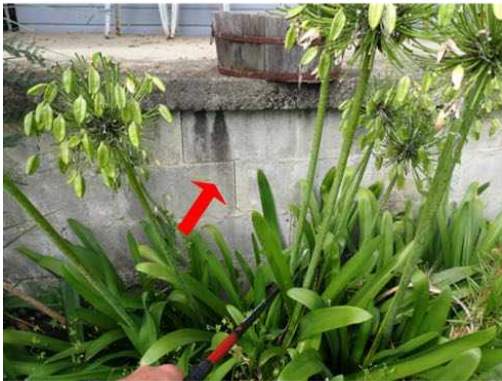
Finding 3.16

Building:	Main Building
Location:	Left hand side of building
Finding:	Minor Step Cracking to Blockwork – Left Hand Side of Building
Information:	<p>Minor step cracking was identified in the blockwork to the left-hand side of the building. Step cracking in masonry can be associated with movement in the footing, foundation settlement, or thermal expansion and contraction. In plain terms, there is a small crack following the mortar joints in the block wall on the left side of the house. Possible causes include minor ground movement, footing movement, or normal material movement over time. It is recommended that the cracking be monitored for any signs of progression and repaired as required to prevent moisture ingress. Repairs should be carried out by a licensed builder or suitably qualified bricklayer. Rectification and monitoring are recommended at the owner's discretion.</p>

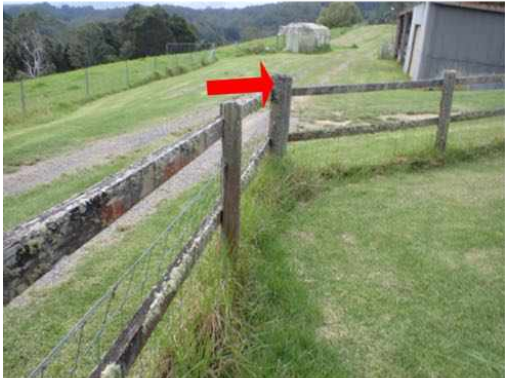
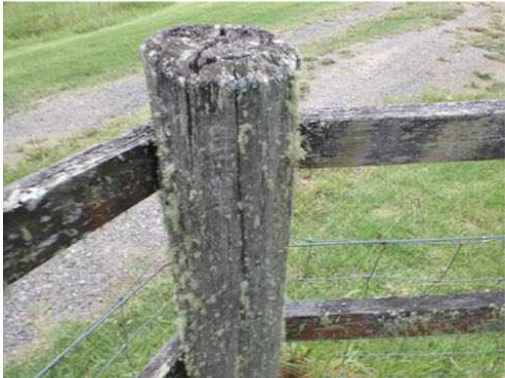
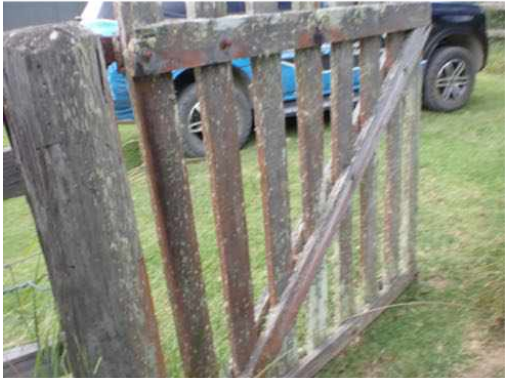
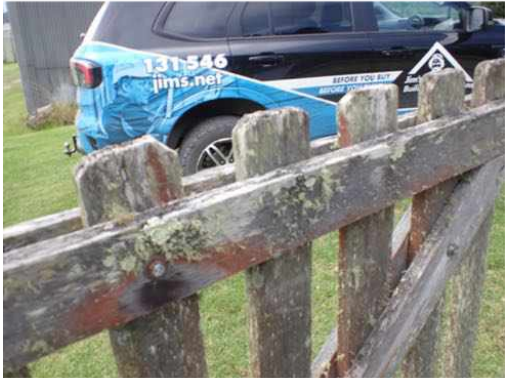
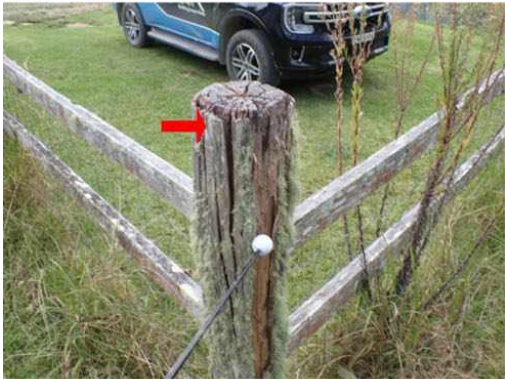
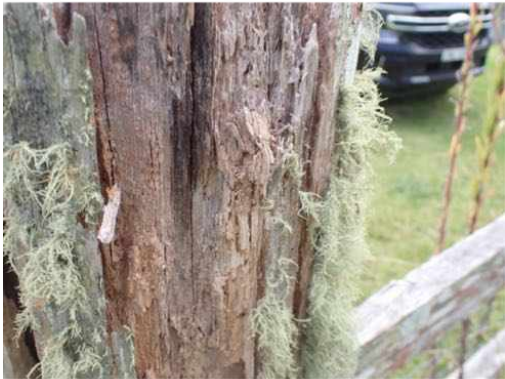
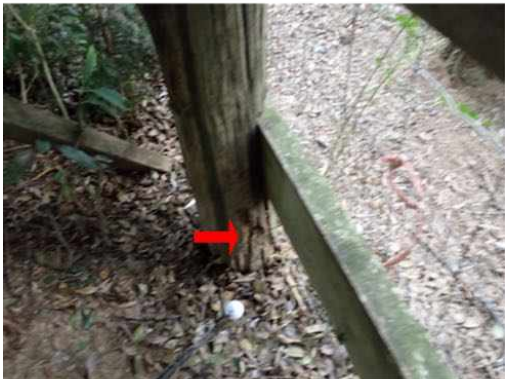
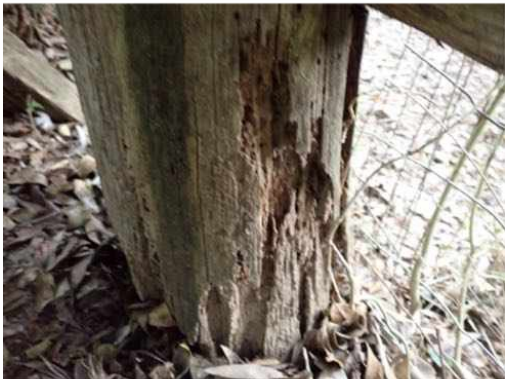
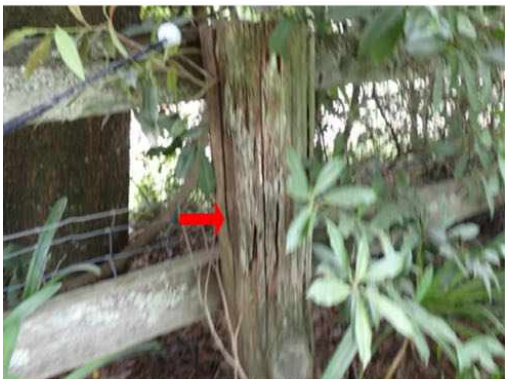
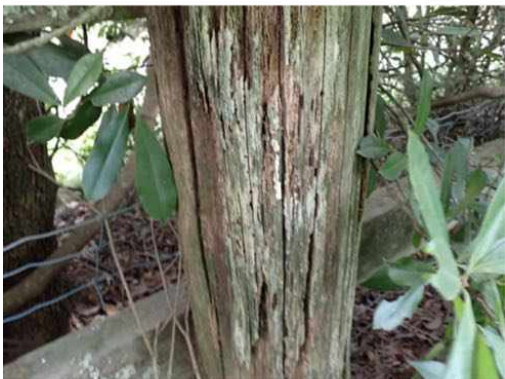
Finding 5.01

Building: Main Building
Location: Timber fence around building
Finding: Timber Fence in Poor Condition – Timber Pest Damage and Wood Rot
Information: The timber fence surrounding the building was standing at the time of inspection; however, it was observed to be in poor condition with evidence of timber pest damage and wood rot. This condition is common with a property of this age. Deterioration of fencing timbers may lead to reduced stability and ongoing decay if not addressed. In plain terms, the fence is still upright but is in rough shape, with rot and insect damage present, which is typical for an older fence. Possible causes include prolonged exposure to the elements, ground contact, age-related deterioration, and timber pest activity. It is recommended that the fence be repaired or replaced as required. Works should be carried out by a licensed builder or suitably qualified fencing contractor. Rectification is recommended at the owner’s discretion to maintain safety and durability.

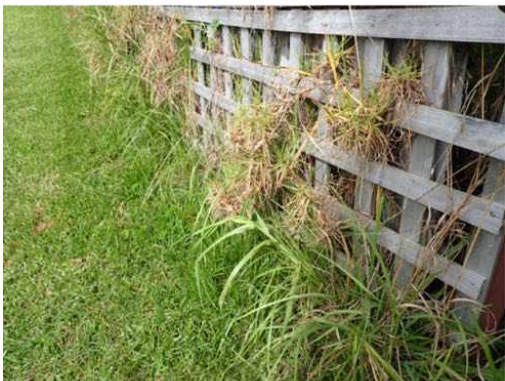
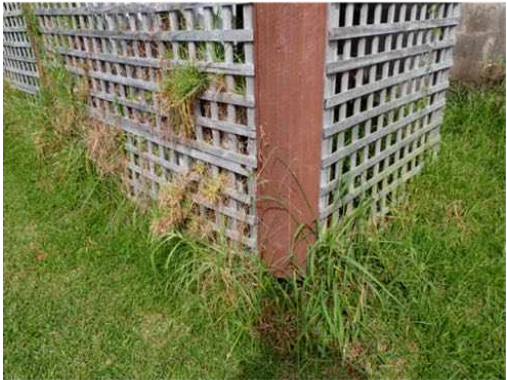
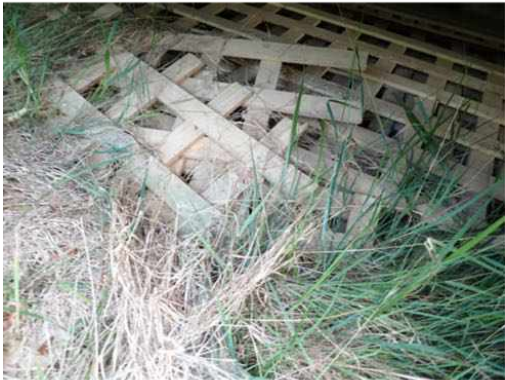
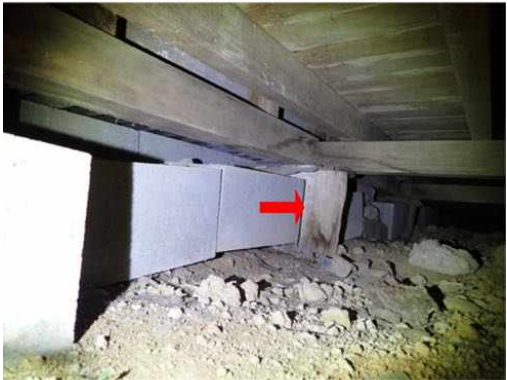
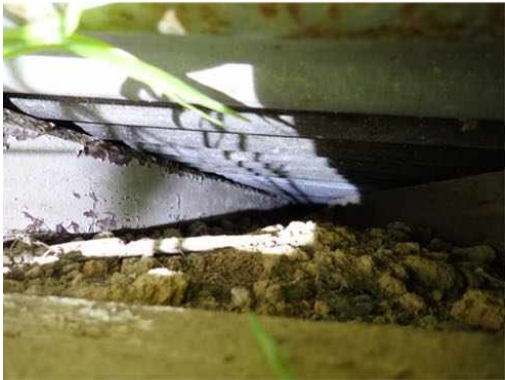
Finding 6.01

Building: Main Building
Location: Subfloor and perimeter of building
Finding: Timber in Direct Contact with Ground and Stored Timber – Conditions Conducive to Timber Pest Attack
Information: Areas were identified where timber elements, including timber stumps, are in direct contact with the ground, and stored timber was also noted in contact with soil. Timber-to-ground contact and stored timber against or on the ground create

conditions conducive to timber pest attack and increase the risk of decay due to moisture exposure. In plain terms, some structural timbers and stored wood are touching the soil, which makes them more likely to attract termites and rot over time. Possible causes include original construction methods, landscaping changes, ground level build-up, or storage practices. It is recommended that adequate ground clearance be established and maintained between soil and timber components, and that stored timber be removed or relocated off the ground and away from the building. A licensed builder should address any affected structural elements, and a licensed timber pest specialist should assess and advise as required. Rectification is recommended at the owner's discretion to reduce the risk of timber pest attack and deterioration.

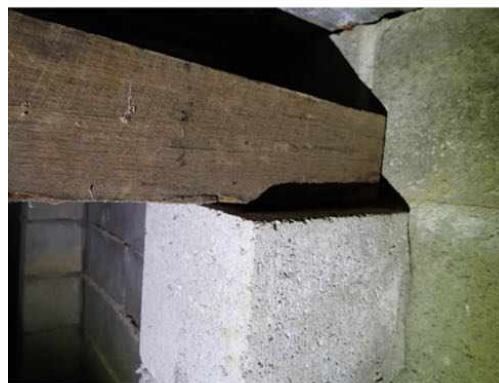
Finding 6.02

Building:	Main Building
Location:	Subfloor
Finding:	Missing Ant Caps – Multiple Locations
Information:	Ant caps were not present at multiple locations to timber supports. The absence of ant caps reduces the ability to detect and deter concealed termite entry into the building. In plain terms, there are no visible termite barriers on several timber supports, which can make it easier for termites to enter unnoticed. Possible causes include original construction practices, alterations, or removal during past works. It is recommended that appropriate termite management measures be installed in accordance with current standards. Works should be carried out by a licensed builder in conjunction with a licensed timber pest specialist. Rectification is recommended at the owner's discretion to reduce the risk of concealed timber pest attack.

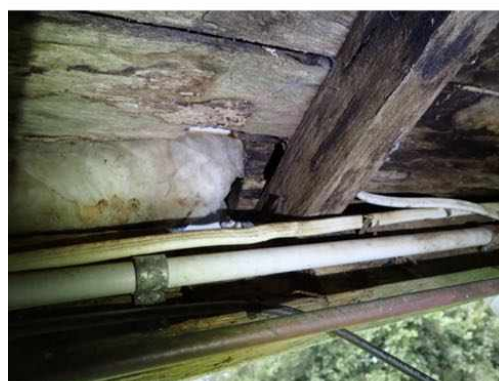
Finding 7.01

Building:	Main Building
Location:	Subfloor
Finding:	Minor Isolated Wood Rot to Subfloor Flooring – Bathroom Area

Information: Isolated areas of timber decay were identified to the subfloor flooring system, particularly beneath the bathroom area. Timber deterioration in wet areas is commonly associated with prolonged moisture exposure and is a common defect in homes of this age. If left unaddressed, decay may progress and impact the structural integrity of the flooring system. In plain terms, some of the timber under the bathroom has rotted, likely due to moisture over time, and could worsen if not repaired. Possible causes include historical or ongoing moisture ingress, inadequate ventilation to the subfloor, plumbing leaks, or failed waterproofing. It is recommended that the affected timbers be further assessed and repaired or replaced as required, and that the moisture source be identified and rectified. Repairs should be carried out by a licensed builder, with plumbing assessed by a licensed plumber if leaks are suspected. Rectification is recommended at the owner's discretion to prevent further deterioration.

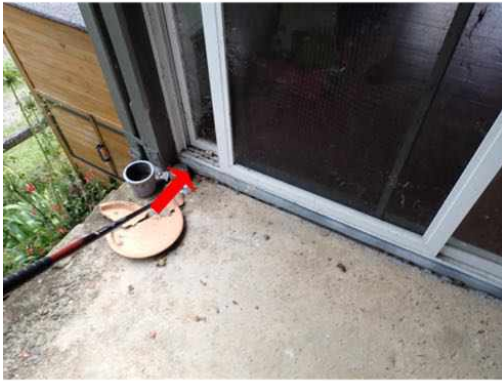
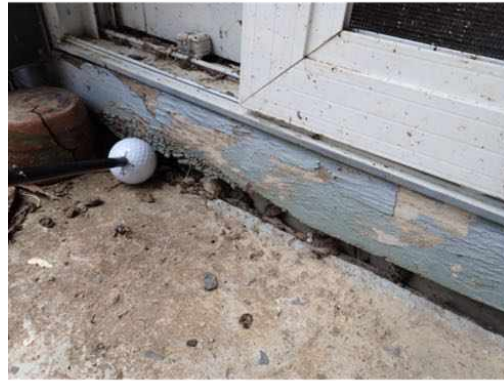
Finding 7.02

Building: Main Building
 Location: Side sliding door
 Finding: Wood Rot to Base of Sliding Door Architrave
 Information: Timber decay was identified to the lower section of the sliding door architrave. Wood rot in this area is commonly associated with prolonged moisture exposure and may continue to deteriorate if not addressed. While architraves are generally non-structural, ongoing decay can affect appearance and may indicate moisture ingress issues. In plain terms, the bottom of the sliding door trim has rotted due to moisture and will worsen if not repaired. Possible causes include water ingress, failed seals, or lack of maintenance. It is recommended that the affected architrave be repaired or replaced as required and that the moisture source be identified and rectified. Works should be carried out by a licensed builder or suitably qualified carpenter. Rectification is recommended at the owner's discretion to prevent further deterioration.

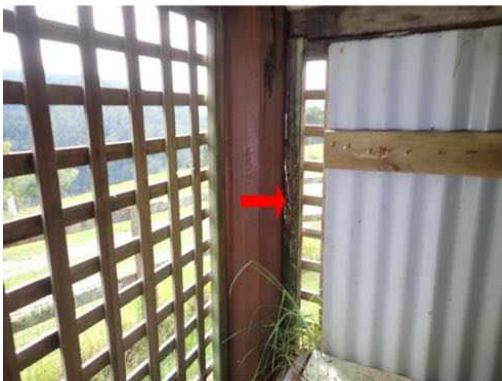
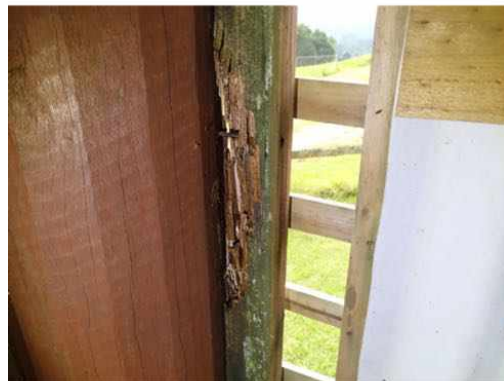
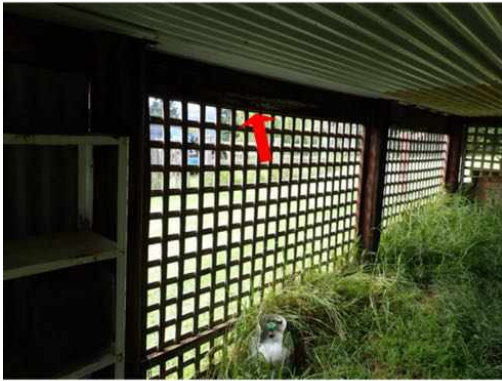
Finding 7.03

Finding: Wood Rot to Timber Lattice and Surrounding Framing

Information: Timber decay was identified to the lattice and adjacent timber framing. Wood rot in these areas is commonly associated with prolonged moisture exposure and lack of maintenance and may continue to deteriorate if not addressed. In plain terms, the lattice and the timber around it have rotted and will worsen over time if not repaired. Possible causes include weather exposure, water runoff, ground moisture, and failed coatings. It is recommended that the affected lattice and framing be repaired or replaced as required and that protective coatings be reinstated. Works should be carried out by a licensed builder or suitably qualified carpenter. Rectification is recommended at the owner's discretion to prevent further deterioration.

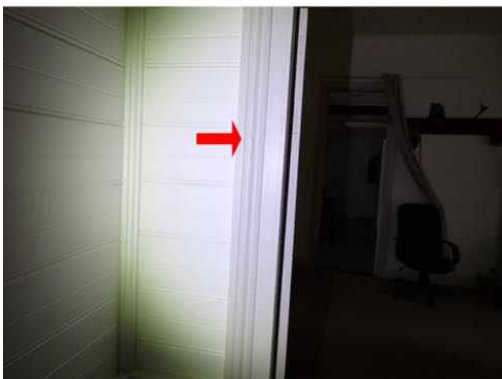
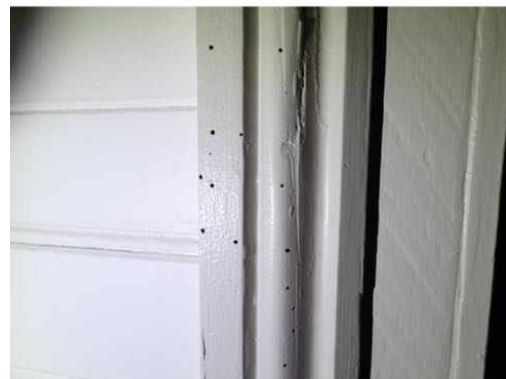
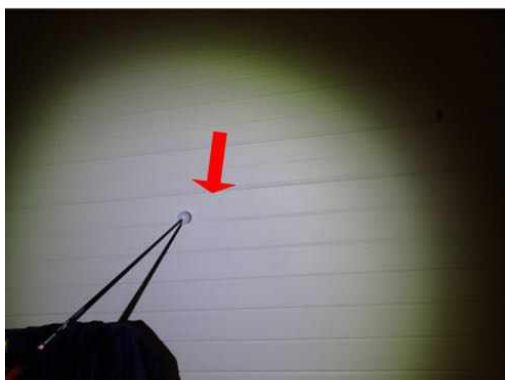
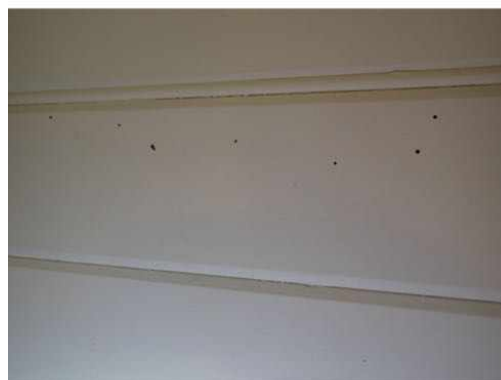
Finding 8.01

Building:	Main Building
Location:	All Areas
Finding:	Minor Timber Borer Damage to Internal Architraves and Cladding
Information:	<p>Minor timber borer damage was identified to internal architraves and wall cladding at several areas. Evidence of small flight holes and surface damage was observed consistent with past or possible timber borer activity. In simple terms, there are small holes in some of the internal timber trims and wall boards caused by borers. This condition is commonly found in older timber elements. The activity appeared minor at the time of inspection; however, the current activity status could not be fully confirmed. It is recommended that a licensed timber pest controller assess the affected areas to determine whether the infestation is active and provide treatment recommendations if required. Localised timber repairs or replacement by a qualified carpenter may also be necessary depending on the extent of damage. Rectification can be undertaken at the owner's discretion.</p>

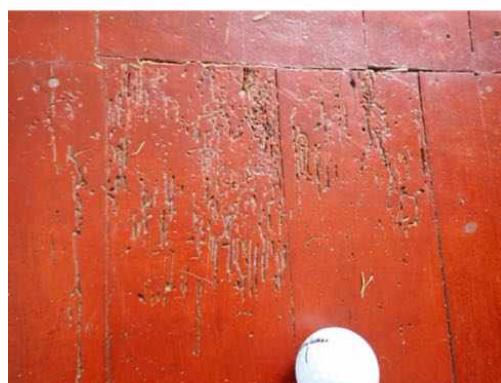
Finding 8.02

Building:	Main Building
Location:	Kitchen
Finding:	Wood Borer Damage to Kitchen Floorboards
Information:	Evidence of timber borer activity was identified to the upper surface of the kitchen floorboards. Timber pest damage can weaken the affected boards and, if active, may continue to cause deterioration. In plain terms, small insects have damaged the timber flooring and it may worsen if not treated. Possible causes include past or current timber borer infestation, elevated moisture levels, or untreated timber. It is recommended that the affected area be assessed to determine whether the infestation is active and treated if required, with damaged boards repaired or replaced as necessary. A licensed timber pest specialist should assess and treat, with repairs carried out by a licensed carpenter. Rectification is recommended at the owner's discretion.

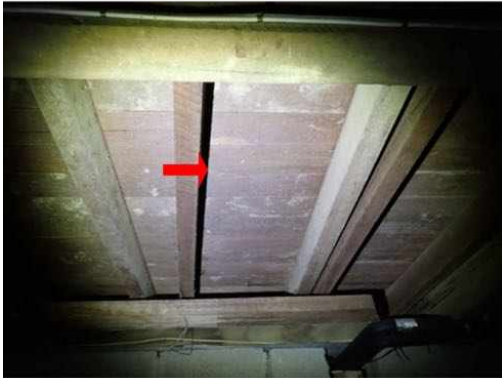
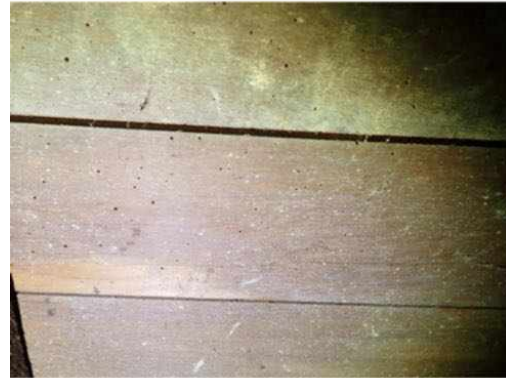
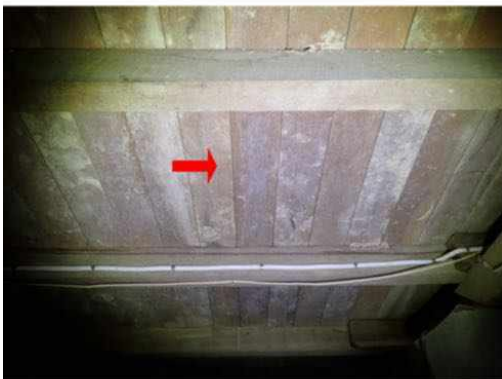
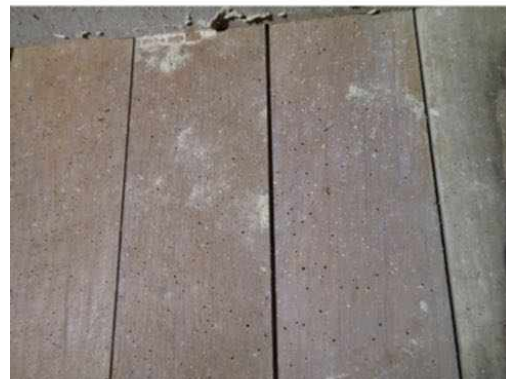
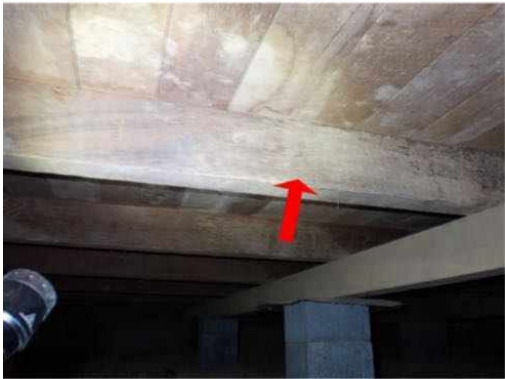
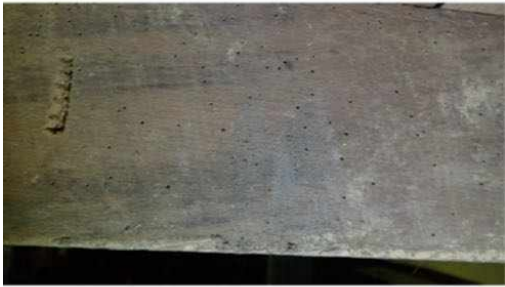
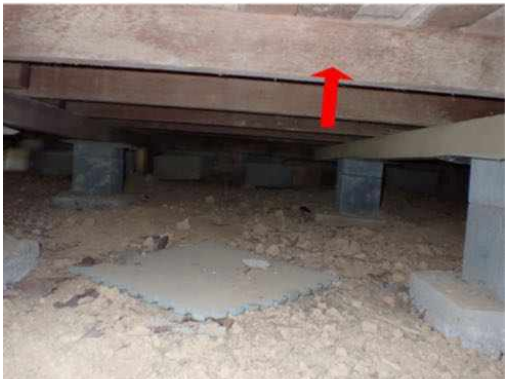
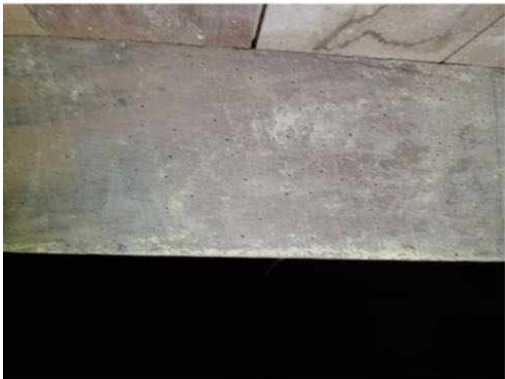
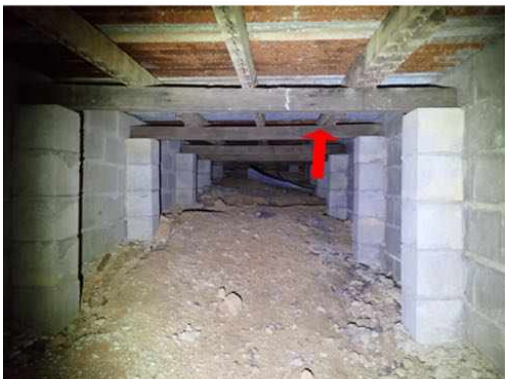
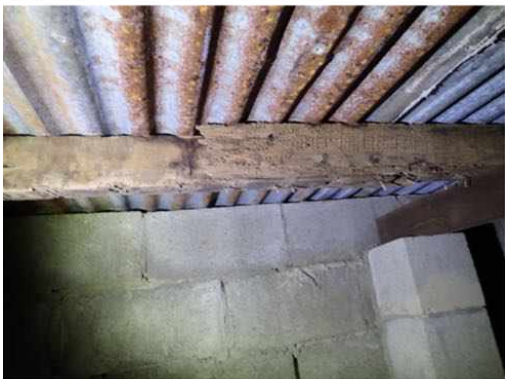
Building:	Main Building
Location:	Subfloor
Finding:	Wood Borer Activity to Subfloor Timbers and Floorboards
Information:	Wood Borer Activity to Subfloor Timbers and Floorboards

Evidence of timber borer activity was identified to subfloor timbers and floorboards at multiple locations spread throughout the subfloor area, with a greater degree of damage than typically considered isolated. Timber pest damage of this nature may significantly reduce the integrity of affected members and, if active, may continue to cause further deterioration. In plain terms, there is widespread insect damage to a number of timbers under the house and this can weaken the flooring system if not properly treated and repaired. Access to some areas of the subfloor was restricted due to inadequate clearance, and as such, the full extent of damage may not have been visible at the time of inspection. Possible causes include prolonged elevated subfloor moisture levels, inadequate ventilation, untreated timber, or long-term infestation. It is recommended that a licensed timber pest specialist assess the extent of activity to determine whether it is current and carry out appropriate treatment. All compromised timbers should be repaired or replaced as necessary by a licensed builder. Rectification is recommended as soon as possible to prevent further deterioration.
