Building and Timber Pest Inspection Report

Inspection Date: Thu, 26 Feb 2026

Property Address: 1691 Coramba Rd, Megan NSW 2453,
Australia

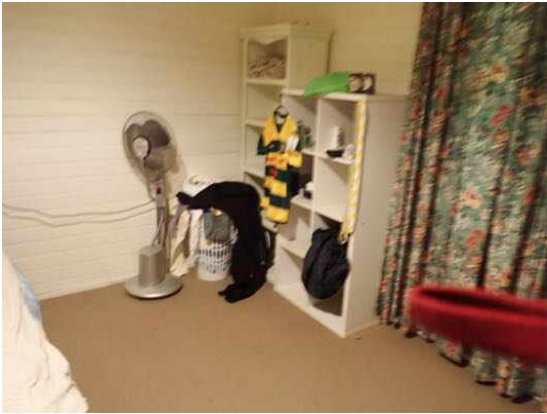
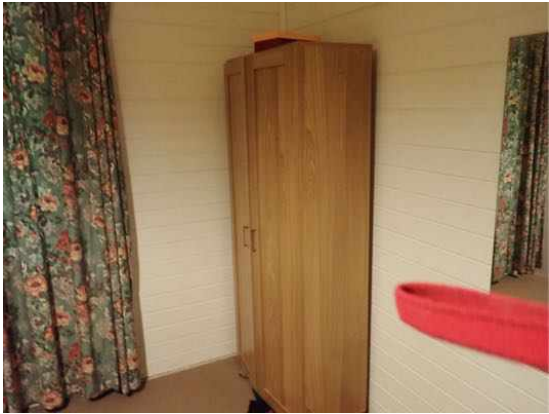
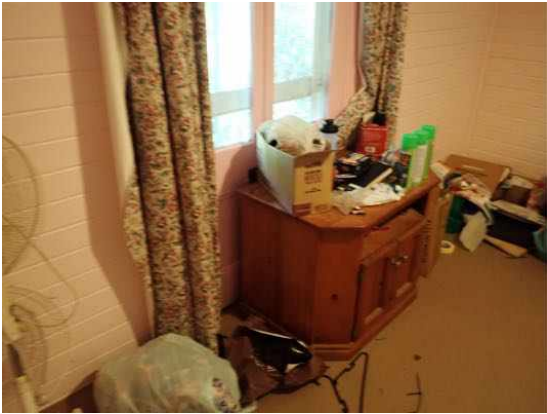
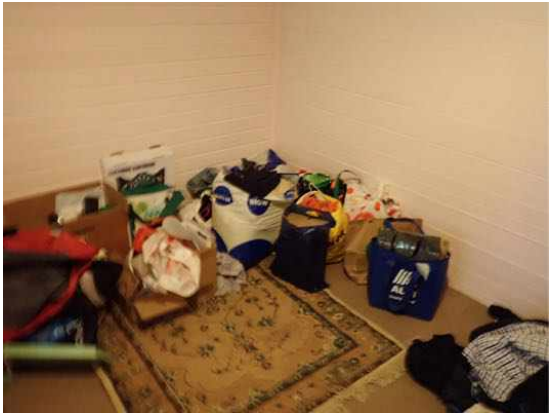
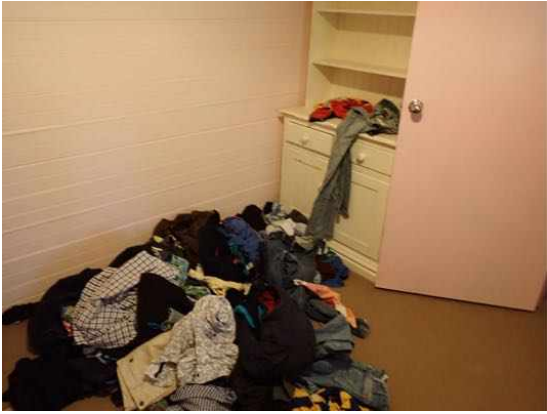
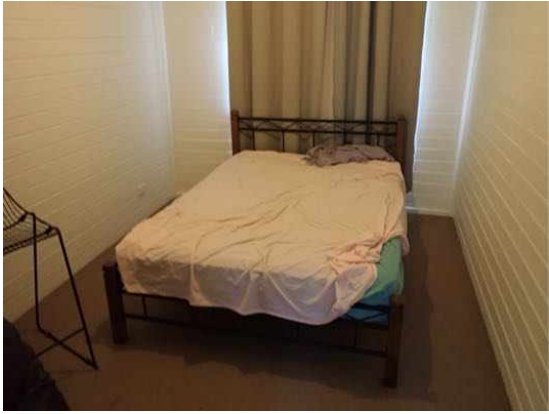
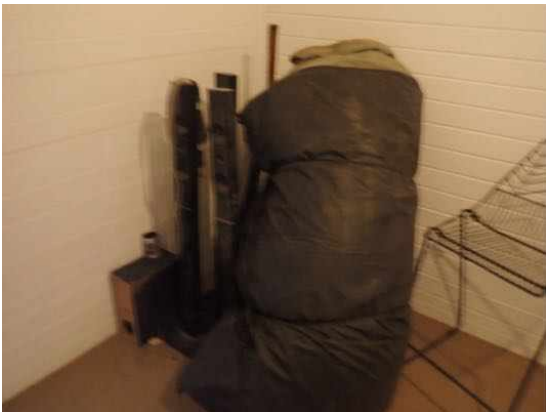
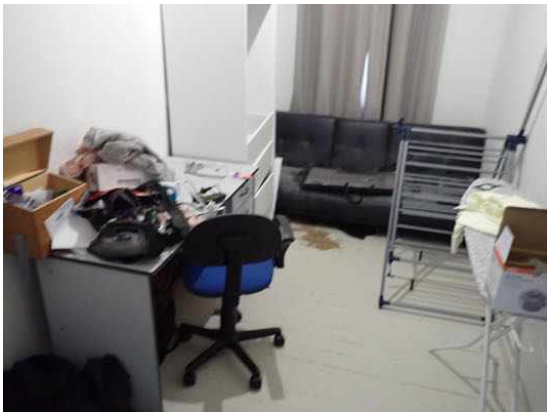
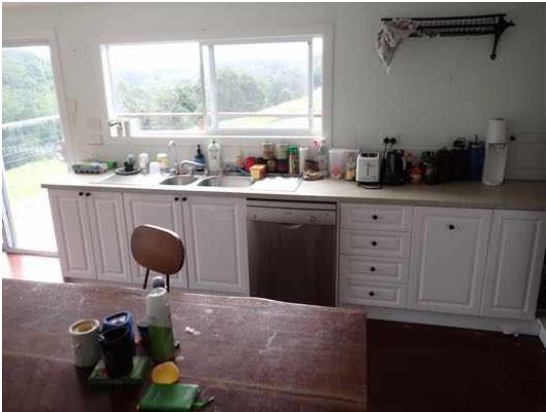
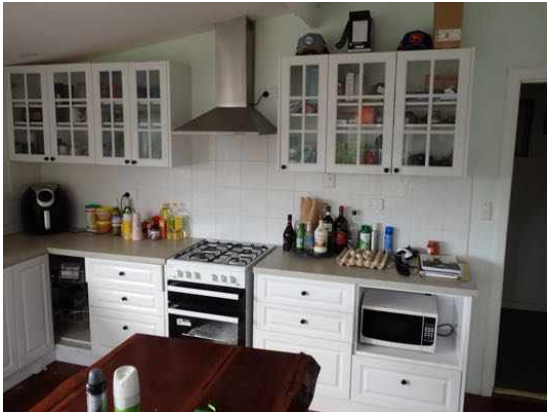
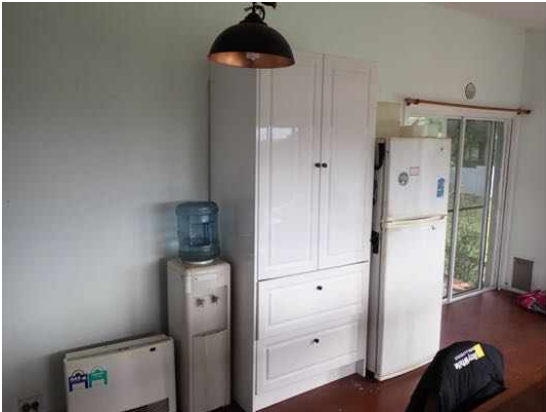
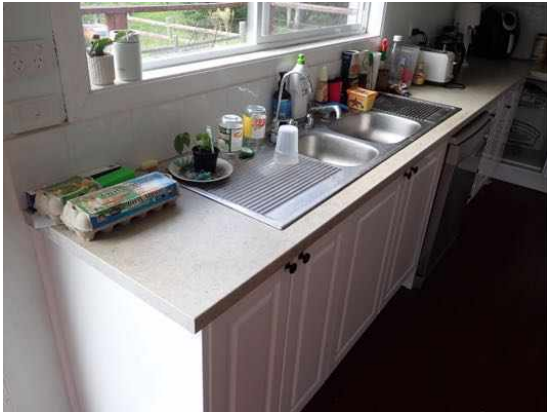
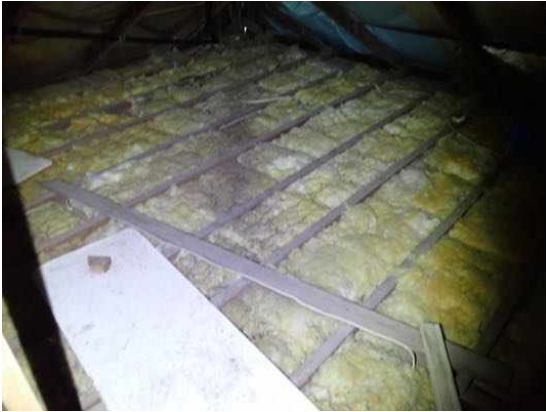
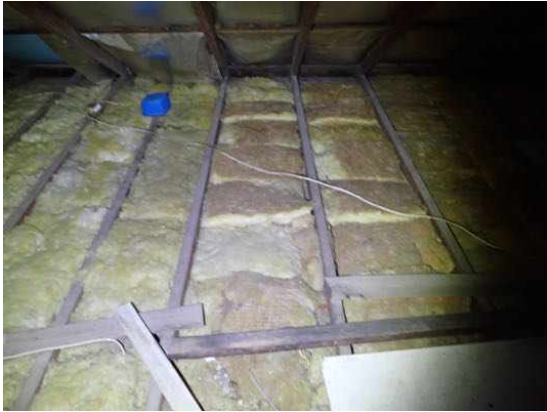
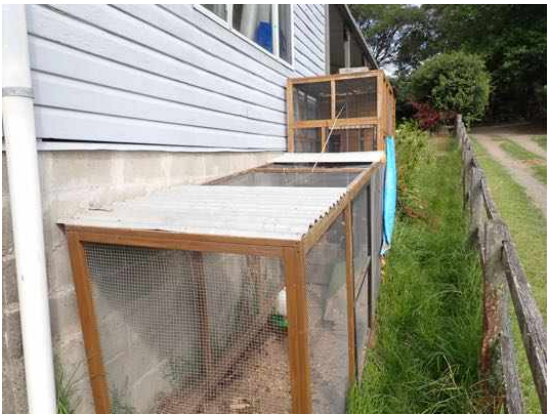
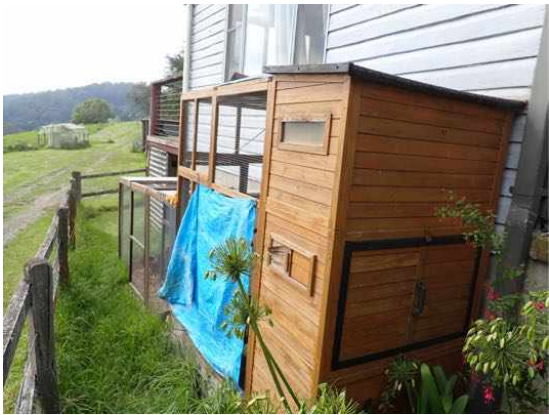
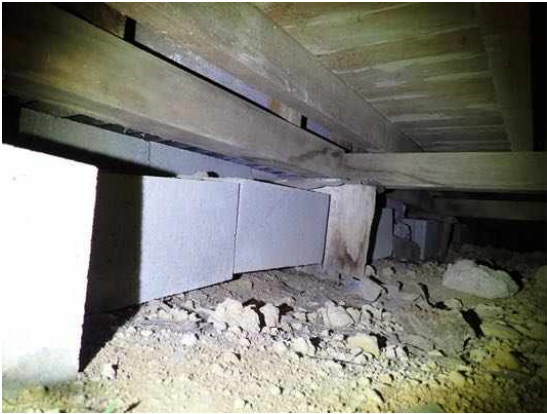
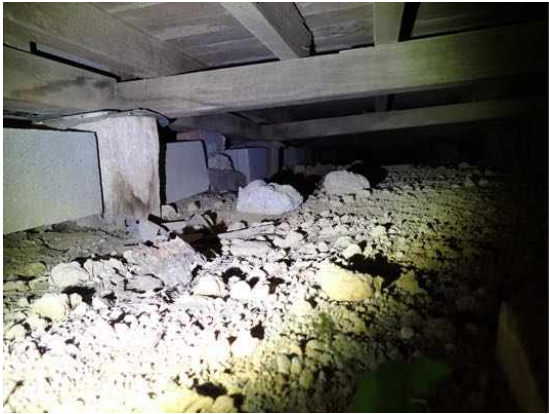
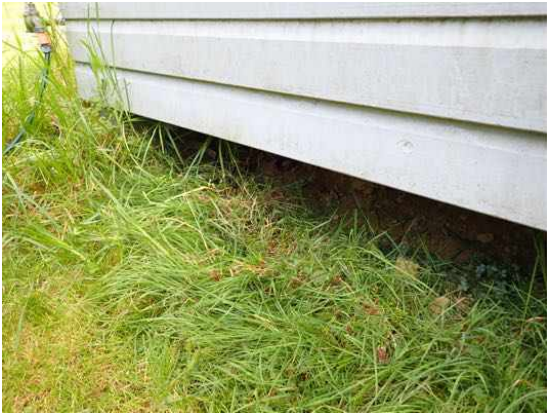
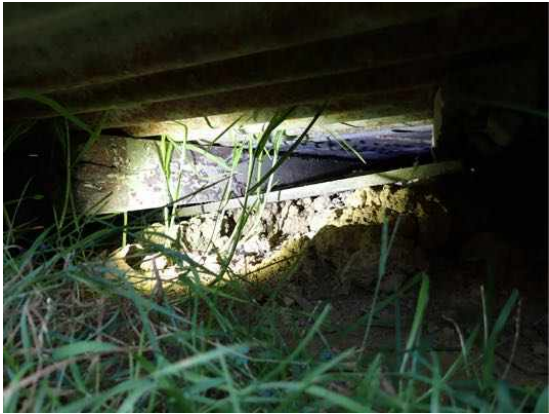
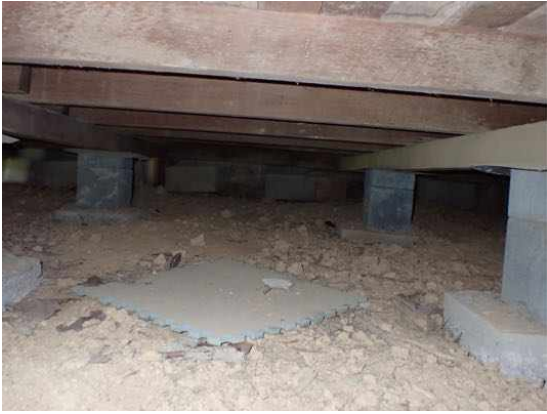
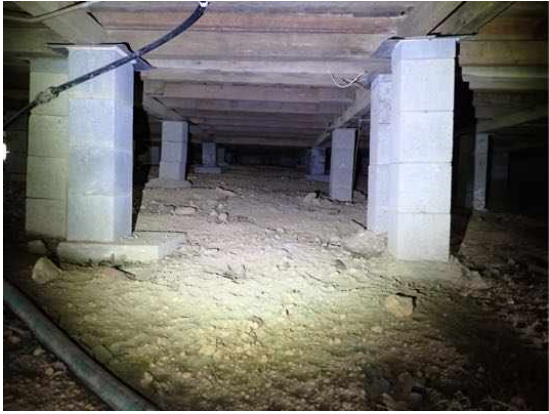
Building: Main Building
Location: All Areas
Finding: Additional Photos - Obstructions and Limitations
Information: These photographs are an indication of the obstructions and limitations which impeded full inspection of the area at the time of inspection. These obstructions can hide an array of defects and should be removed to allow full inspection to be carried out. A re-inspection is recommended once the areas are made accessible.

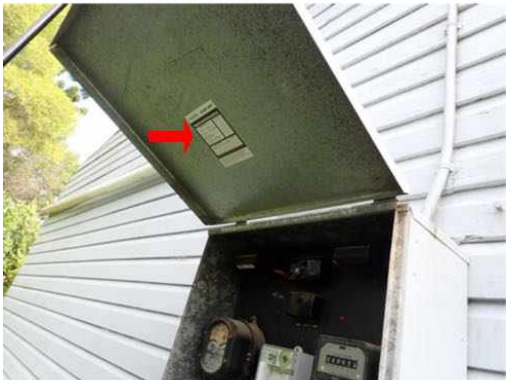
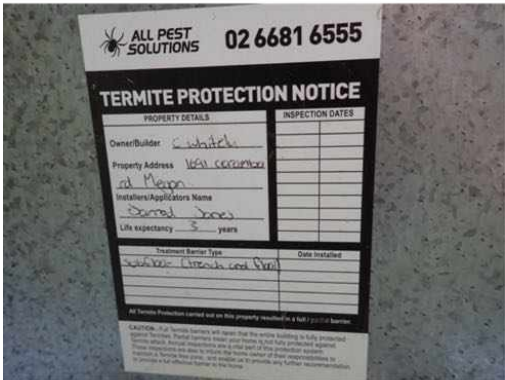
Building: Main Building
 Location: Electrical meter box
 Finding: Evidence of Timber Pest Treatment – No Installation Date Noted
 Information: Evidence of a timber pest treatment system was observed via a notice sticker located within the meter box; however, no installation date was recorded on the sticker. Without a clear installation date, the age and current effectiveness of the treatment system cannot be confirmed. In plain terms, there is a sticker showing termite treatment has been done, but it does not say when it was installed. Possible causes include incomplete documentation or replacement of the sticker. It is recommended that the owner obtain records from the installing company to confirm the installation date, warranty details, and ongoing service requirements. A licensed timber pest specialist should be contacted to verify the status of the system and carry out inspection and maintenance as required. Further clarification and maintenance are recommended at the owner’s discretion.
