Building and Timber Pest Inspection Report

Inspection Date: Thu, 15 Jan 2026

Property Address: 2/243 Tongarra Rd, Albion Park NSW 2527,
Australia

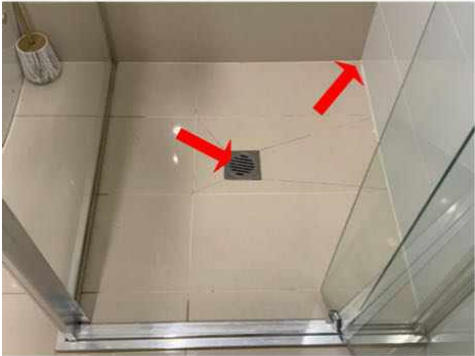
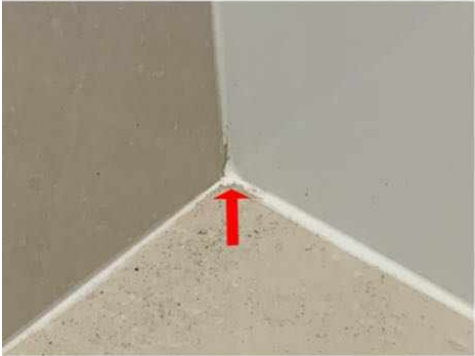
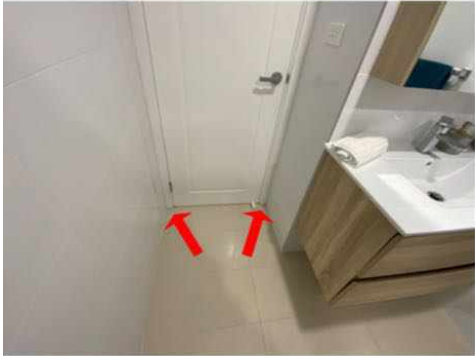
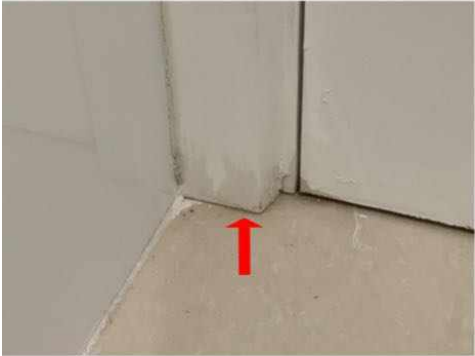
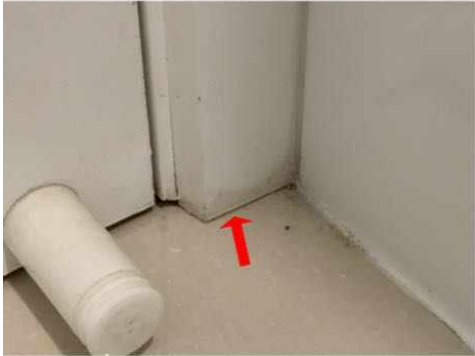
Building:	Main Building
Location:	All Wet Areas
Finding:	Sealant or Grout - Deteriorated, Missing or substandard installation
Information:	Sealant appears to be inadequate to these tiled areas. The different materials and floor areas move at different rates therefore cracking the grout at this point. A flexible sealant is required to allow for this expansion & contraction while keeping the joint water tight and without holes for long term care of all building materials.

Apply a flexible sealant to match the grout that is best suited to the purpose as per product specifications. Regular maintenance &/or replacement of damage or missing sealant is highly recommended to the kitchen benches/splashbacks, vanity top to wall/splashback, laundry tub edge/splashback, wet areas floor edges and the shower floor & wall corners for the long term care of your property.

As a main priority remove damaged grout where applicable and thoroughly clean the area from old sealant, grout and soap scum. (Mouldy sealant is usually caused by dirt & scum sitting behind the sealant from the sealant not sticking adequately to the dirty surfaces).

spray area with spray & wipe (or similar to avoid sealant smearing up the wall) then finally run your finger over the sealant to give a smooth final finish.

Regular maintenance &/or replacement of damage or missing sealant is highly recommended for the long term care of your property.

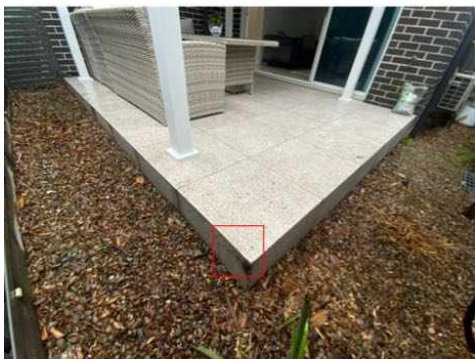
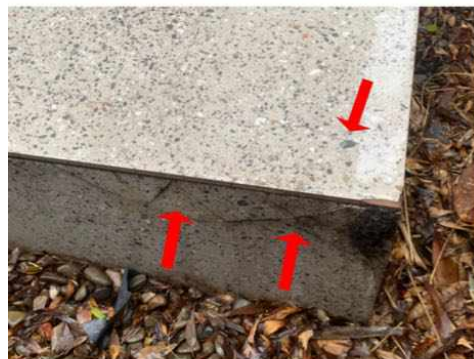
Finding 3.10

Information: The installation of this building element appears to have been completed to a substandard level of workmanship or is incomplete. Generally substandard repairs or installation are related to poor workmanship, the use of inappropriate materials, or a failure to complete installation to a suitable standard.

Where installation is substandard and/or incomplete, the client should contact the responsible trade to undertake rectification. Unfinished and substandard building works are likely to degrade more quickly and may create potential for secondary defects to associated building elements.

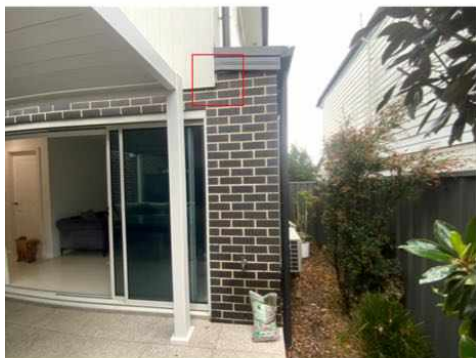
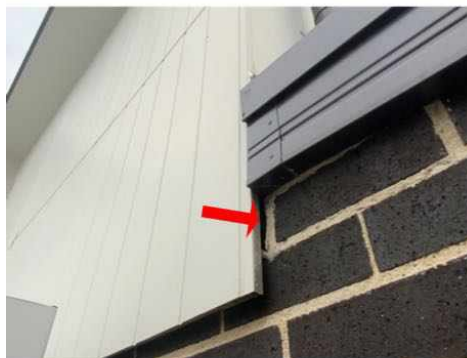
Finding 3.11

Building: Main Building
Location: All Areas
Finding: Cracking - Damage Category 1 - Fine (up to 1mm)
Information: Although fine cracks are quite noticeable, they are often only considered to be an appearance defect, and usually do not indicate any structural damage. Generally, the cause of a fine crack is indicative of a separation between building materials and finishes (e.g. paint, plaster, etc.) along joints.

Cracking of this nature can generally be repaired with minor sanding, filling and/or repainting. Such works should be performed by a qualified painter or a general handyman.

Monitoring of all cracking should be conducted frequently. Always contact a building inspector should cracks widen, lengthen, or become more numerous.

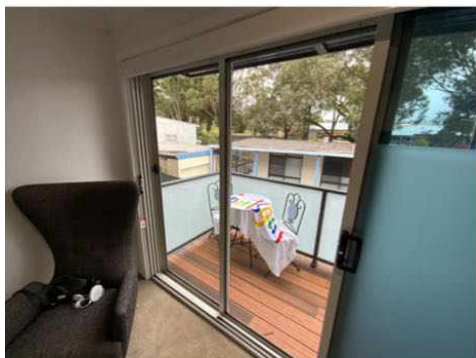
Finding 3.13

Building:	Main Building
Location:	Bedroom - Master
Finding:	Screen Doors - Stiff to slide
Information:	Several doors throughout the property were jammed and difficult to slide along the associated tracks at the time of the inspection. Restricted function of the affected

doors may pose as a potential safety hazard if required for emergency egress from the building.

Generally, factors such as general age of the building element and a lack of maintenance are the usual causes for this type of defect.

Replacement of door hardware or tracks may be required, as well as minor repairs and cleaning. A registered builder or general handy person will be required to repair the affected doors.

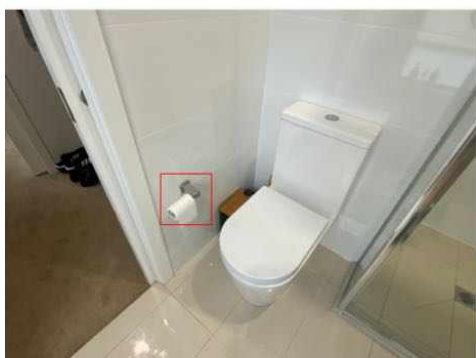
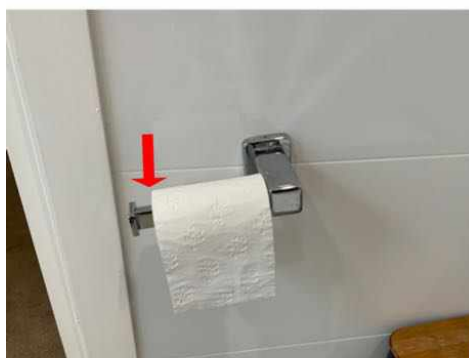
Finding 3.14

Building:	Main Building
Location:	All Areas
Finding:	Fitting or fixture - Loose (Toilet roll holders)
Information:	The fitting in this area is loose and requires adjustment to tighten.

If left unmanaged, the fitting may further deteriorate, causing potential for the development of other minor secondary defects.

A relevant tradesperson should be appointed to perform these rectification works at discretion of the client.

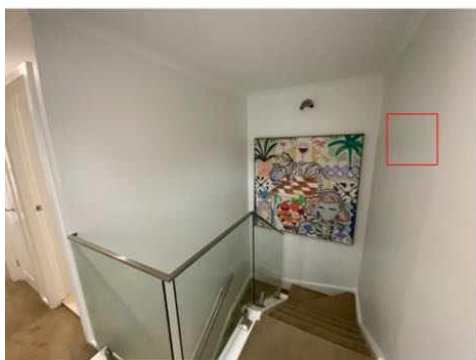
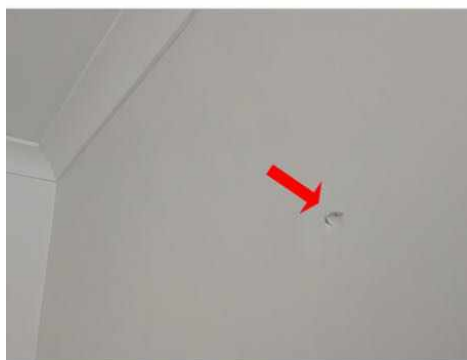
Finding 3.15

Building:	Main Building
Location:	Stairs - Internal
Finding:	Building element - Damaged (hole in wall)
Information:	Breakage occurs generally when the building materials have either aged and decayed, or as a result of damage (accidental or deliberate).

Repair and/or replacement of broken elements is advised to ensure that additional secondary defects do not arise as a consequence. Such works are necessary, as all building elements play a key role in the operation and function of the overall structure and its performance.

A relevant tradesperson should be appointed to repair or replace the affected building element prior to any subsequent damage being caused.

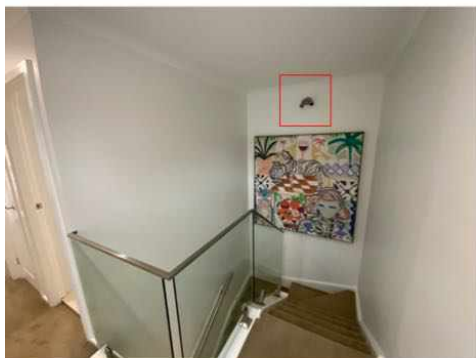
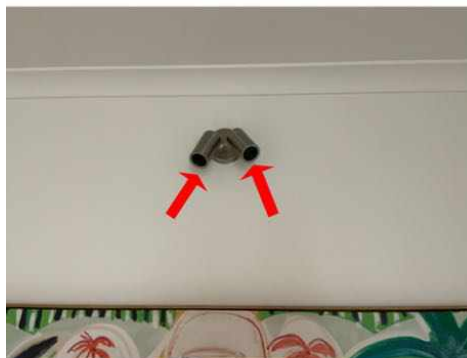
Finding 3.16

Building:	Main Building
Location:	Stairs - Internal
Finding:	Building element - Not operating (light fitting)
Information:	Non-operational items should be addressed to ensure that the full function of the building structure is available. Where some building elements are not operating as intended, it is possible that secondary building defects could arise due to their non-operation.

Repair and/or replacement of the faulty building element is recommended. It is highly recommended that the relevant tradesperson be engaged to perform any necessary works.

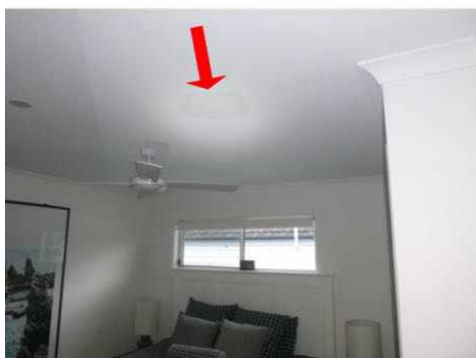
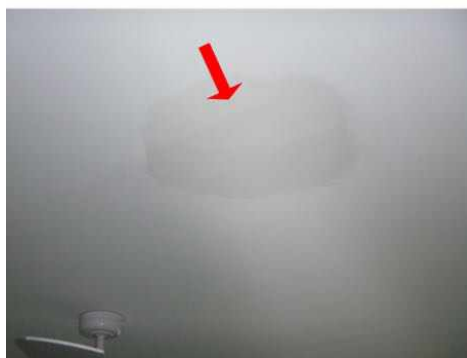
Finding 3.17

Building:	Main Building
Location:	Bedroom 2
Finding:	Ceiling - Patched (Stained)
Information:	Patching and or staining to ceiling linings in this area was evident at the time of inspection. Patching could indicate that the surface has been exposed to excessive moisture over time. The minerals and other elements in the water lead to staining, which may graduate to corrosion and deterioration if left unmanaged.

While mostly an appearance defect, water staining can be indicative of more serious defects, which may be currently concealed by interior ceilings. Monitoring of the area during periods or rain is highly recommended.

Where water staining is active, a licensed plumber must be consulted to identify the cause of the staining and to provide advice on any reparation works that may be required. Replacement of any damaged structures is advised.

Conversely, where water staining is old and inactive, affected building materials may be repaired or replaced at client discretion.

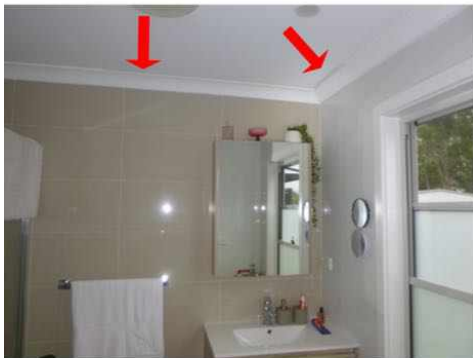
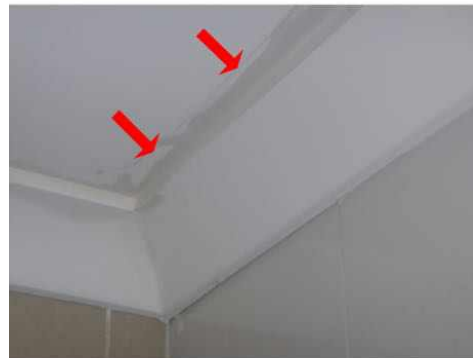
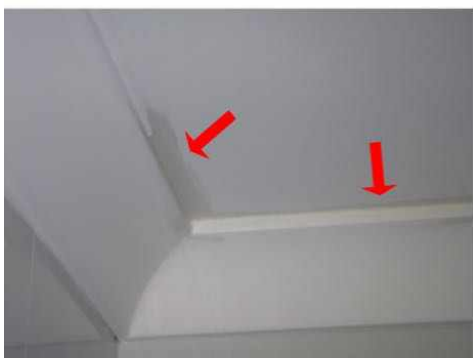
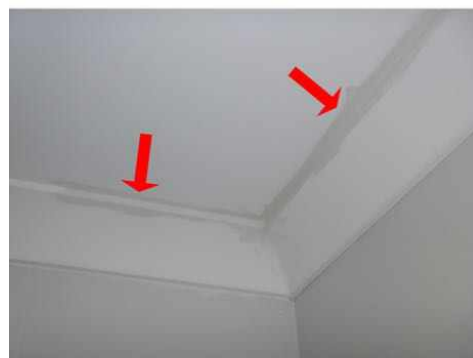
Finding 3.18

Location: Ensuite - Master
Finding: Paint finish - Substandard to ceiling cornices
Information: The paint finish in this area was found to have been completed to a substandard level. Substandard painting is generally classified as an appearance defect. However, the substandard appearance may also be indicative of poor surface preparation and substandard workmanship.

If this applies, further areas of poor and incomplete finishes could develop over time. Furthermore, substandard paint finishes in areas exposed to moisture, e.g. external areas or wet areas, could lead to deterioration of underlying building materials.

Substandard paint finishes should be sanded back, filled, leveled and repainted, as applicable. Where inadequate paint protection has led to the deterioration of the associated building element, repair and/or replacement of this building element may be required.

A painting contractor should be appointed as soon as possible to perform necessary works to aid the appearance of the affected area and to ensure that the area is protected against further deterioration. Alternatively, the homeowner following manufacturer instructions may be able to provide this service.

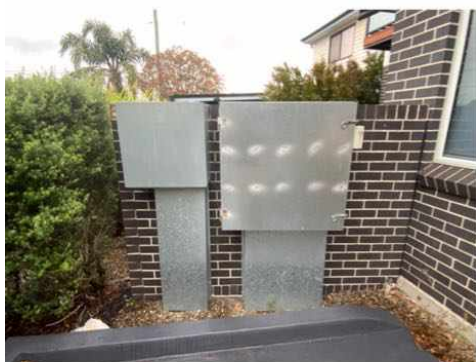
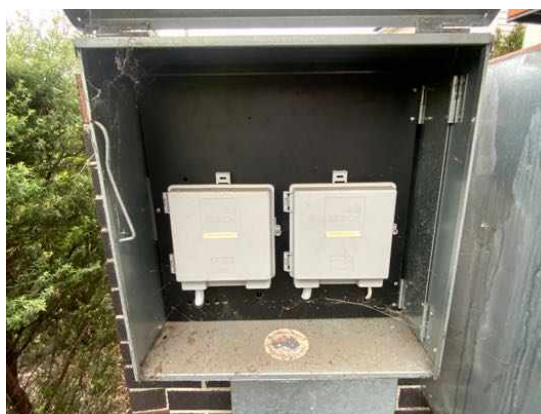
Building:	Main Building
Location:	All Areas
Finding:	Termite Management System - no evidence of a chemical installation
Information:	The application of a post-construction chemical termite barrier is highly recommended for all properties, particularly if live termite activity has been found on the site previously. Such barriers are highly effective in preventing termite attack on any timber building elements throughout the property.

A durable notice should be placed in the switchboard unit to indicate current termite barriers. At the time of inspection, it appeared as though no termite management system has been installed, with no evidence to suggest preventative works taking place.

The client may consider gaining further advice from a pest controller as to the costs and procedures involved with this application. It is recommended that obtaining such advice be a short-term priority.

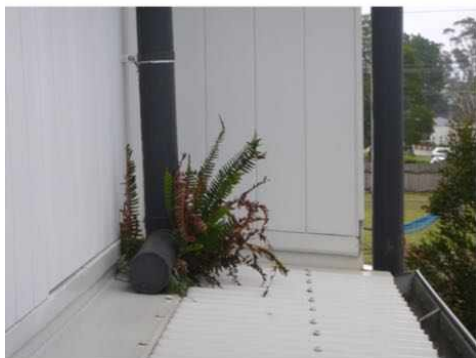
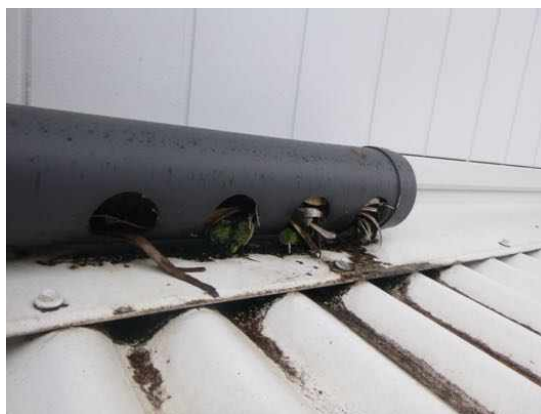
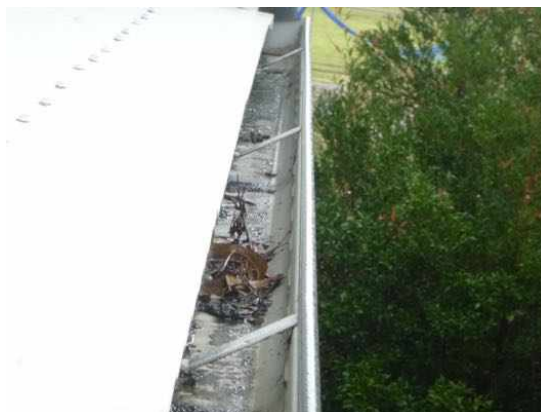
Finding 6.02

Blocked gutters are likely to lead to high levels of moisture in the affected areas. Such moisture will not only cause rust and decay of the associated building materials, but can also provide conditions that are conducive to termite and timber pest activity. Blockages in gutters should therefore be removed immediately to ensure dry conditions are maintained.

Consult a Licensed Plumber for further specific advice on remedial works that may be required. In the interim, it is highly advised that blocked gutters be removed by the homeowner or a general handyperson as a matter of urgency.

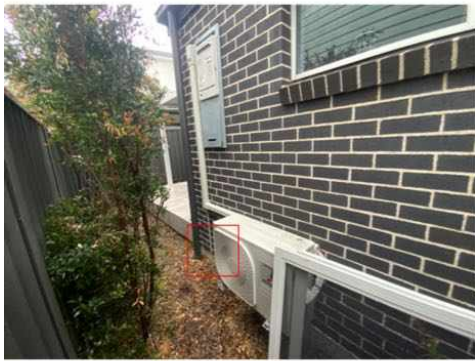
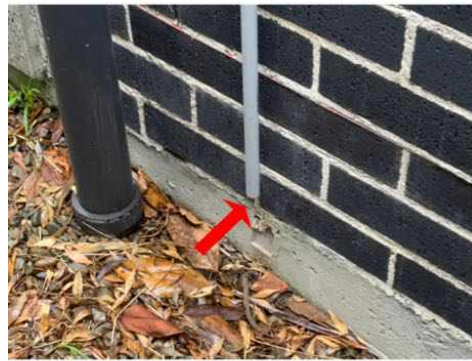
Finding 6.03

Building:	Main Building
Location:	All Areas
Finding:	Air conditioner - Disconnected overflow
Information:	The Air Conditioner (A/C) overflow was found to be disconnected from storm water drainage and is creating excessive moisture in the surrounding area.

Such leaking creates an environment which is conducive to an array of defects, including water damage to associated building elements and the attraction of termite or timber pest infestation.

It is highly recommended that a licensed plumber be appointed to connect the A/C overflow in order to prevent such an environment from being created. These minor works should be carried out as soon as possible.

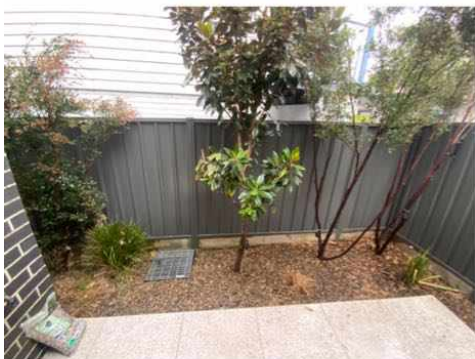
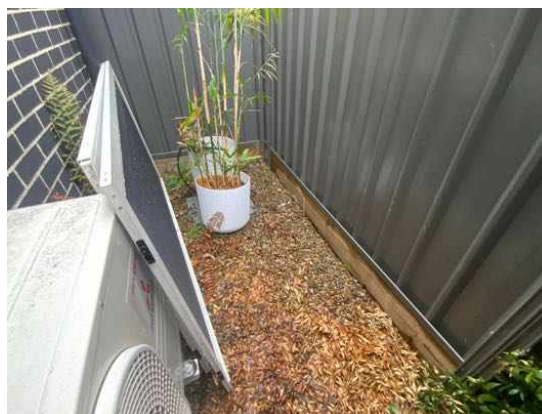
Finding 6.04

Building:	Main Building
Location:	All Areas
Finding:	Timber in ground contact
Information:	To reduce the risk of timber pest attack it is essential that timber used in a hazardous environment (e.g. in direct contact with the ground or frequently exposed to damp conditions) is of sufficient durability and/or is adequately preservative treated.

Untreated timbers in direct contact with the ground are likely to develop severe wood rot and/or fungal decay if left unattended creating attraction for subterranean termites to infest the timbers from surrounding areas.

If untreated or non-durable timbers are found to be in a hazardous environment it is highly advised that replacement of these building elements be performed as soon as possible to aid the protection of the property against termite / timber pest attack.

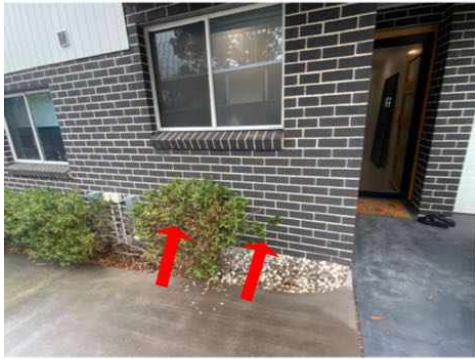
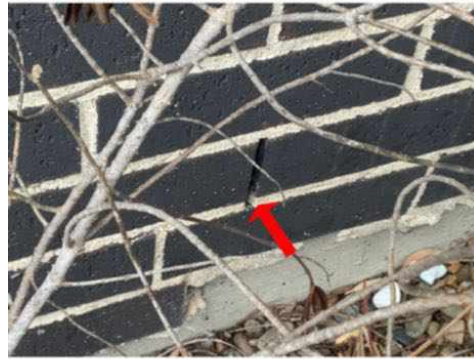
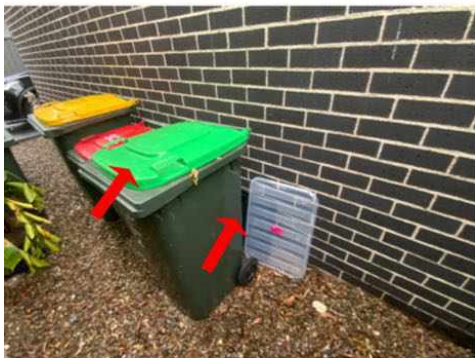
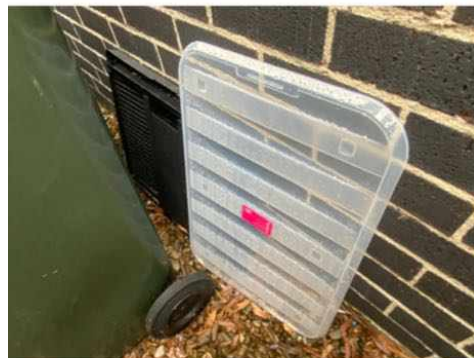
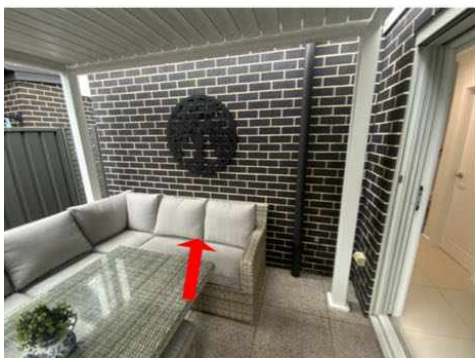
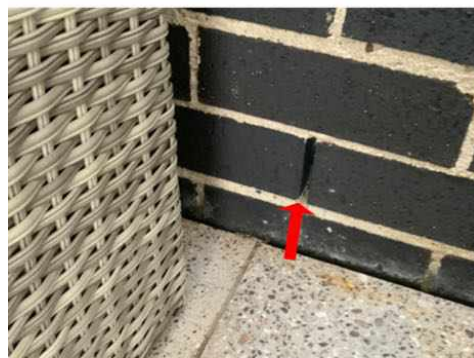
Finding 6.05

Building:	Main Building
Location:	Exterior walls
Finding:	Bridging or breaching of termite barriers - weep holes
Information:	Bridging is the spanning of a termite barrier or inspection zone so that subterranean termites are provided with passage over or around that barrier.

Weep holes in the exterior brickwork of the property are designed to allow condensation that may build up between the brickwork and subsequent timber framework to drain from within the wall hence preventing any deterioration of the timber building elements.

Additionally build-up of moisture is likely to occur if weep holes are covered further attracting termite activity to these areas.

It is highly recommended that weep holes are left exposed in all areas throughout the external property. Therefore if any termite activity leading into weep holes becomes easily detectable during frequent pest inspections.

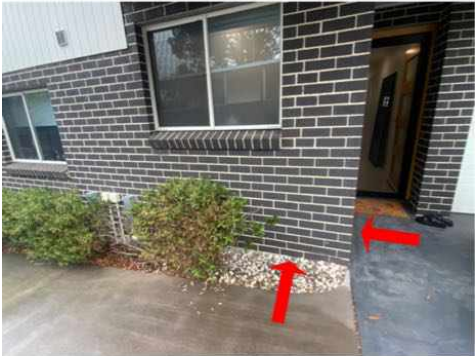
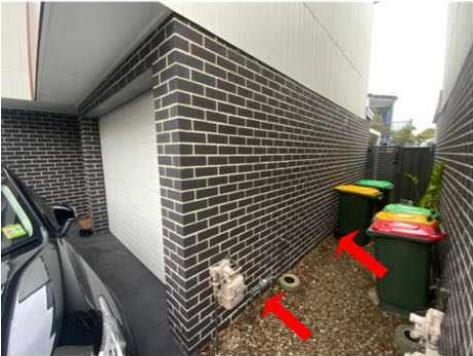
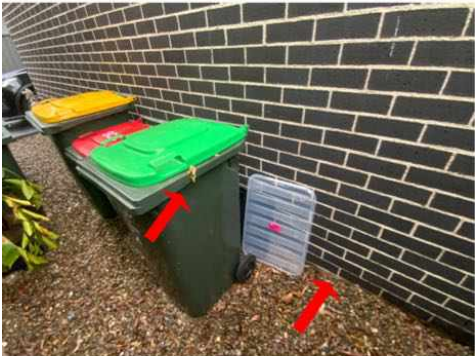
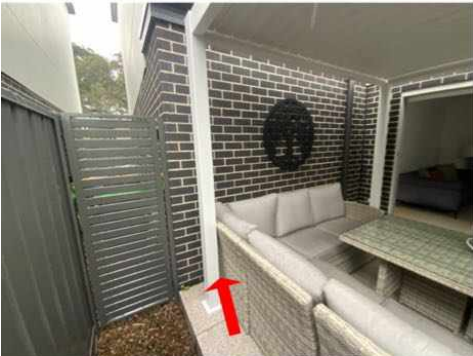
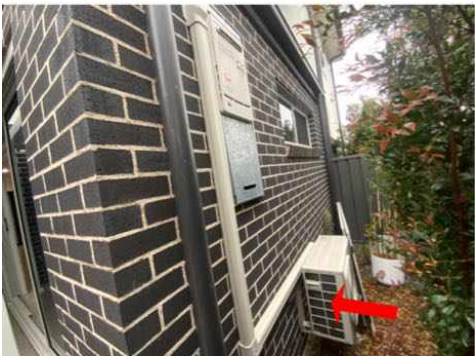
Finding 6.06

Sometimes, in order to determine the type of slab, a suitably qualified person such as an architect or builder may be required to consult the construction plans.

Where the slab edge cannot be properly inspected, it is highly recommended that termite or timber pest inspections be carried out every 6-12 months to aid protection of the property against infestation.

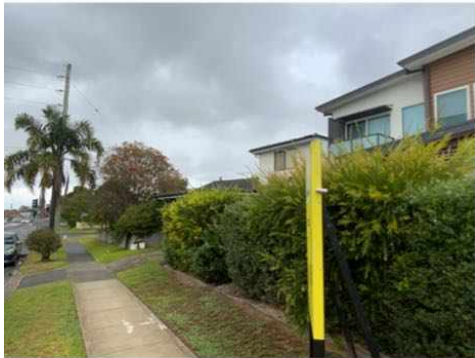
Finding 6.07

Building: Main Building
Location: All Areas
Finding: Trees within 50m of the property

Information: Trees within 50m of the property can be conducive to termite activity. It is recommended an invasive inspection of all trees with 50m to the property be carried out by a qualified pest control expert.

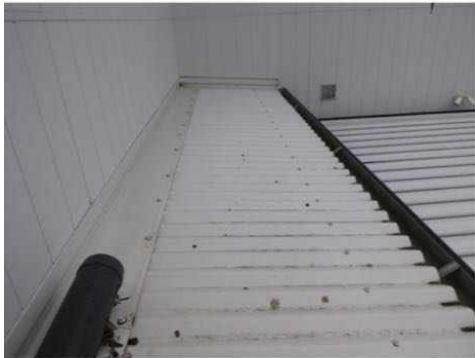
Noted Item

Building: Main Building
 Location: Roof Exterior
 Finding: Additional Photos - Obstructions and Limitations
 Information: These photographs are an indication of the obstructions and limitations which impeded full inspection of the property at the time of inspection. These obstructions can hide an array of defects and should be removed to allow full inspection to be carried out. A re-inspection is recommended once the areas are made accessible.

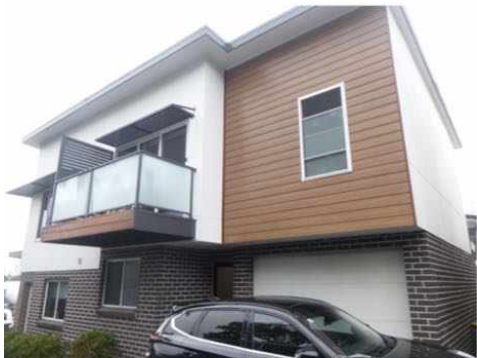
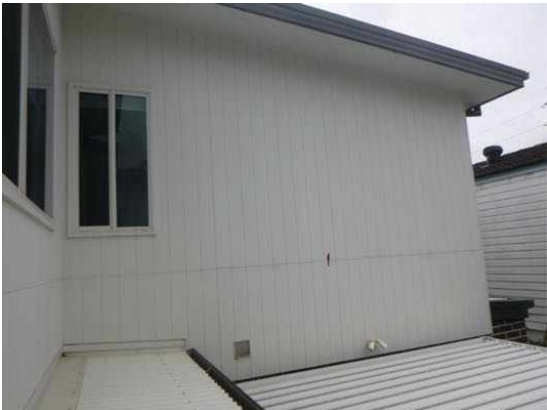
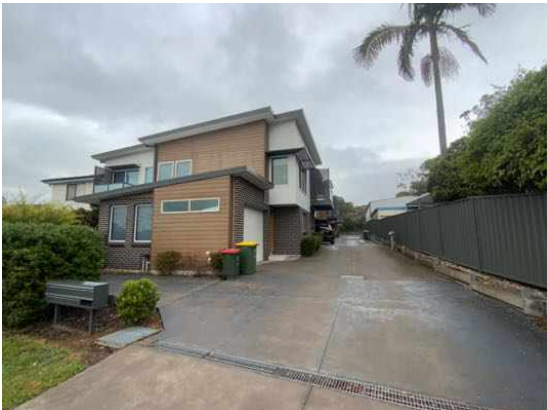
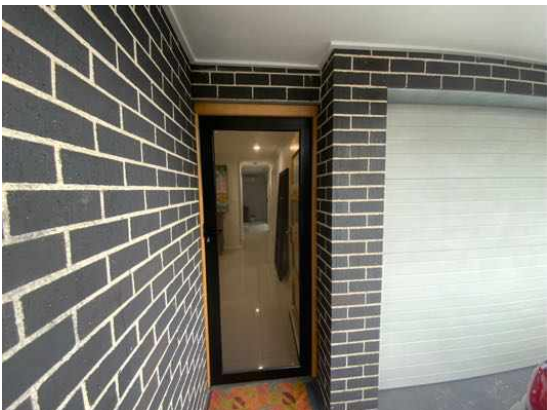
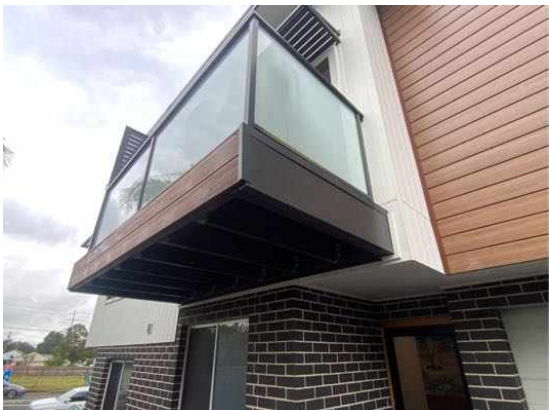
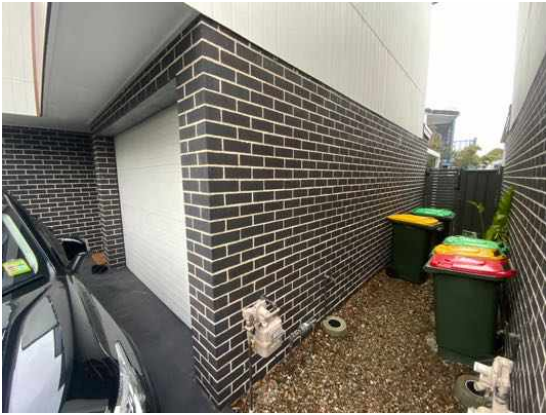
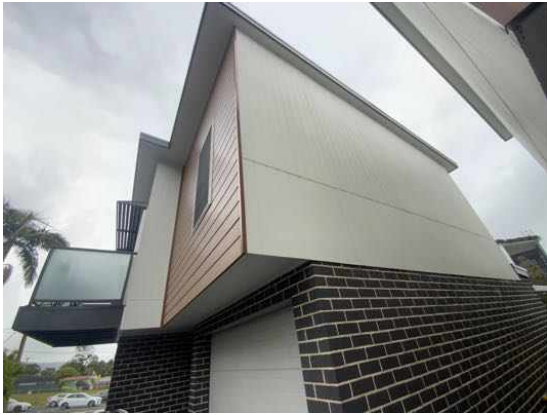
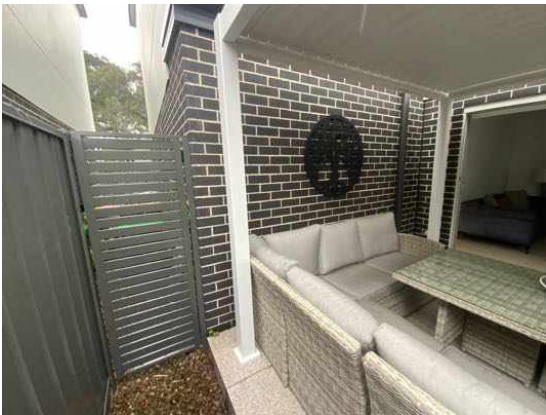
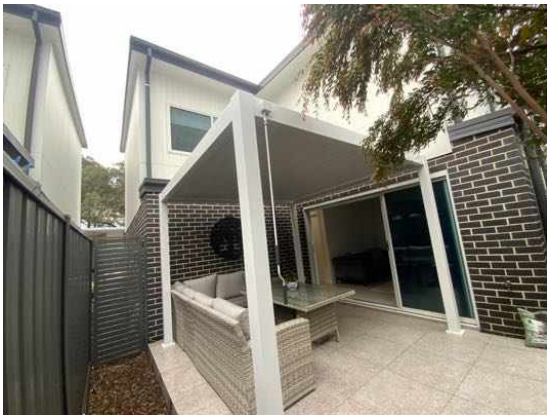
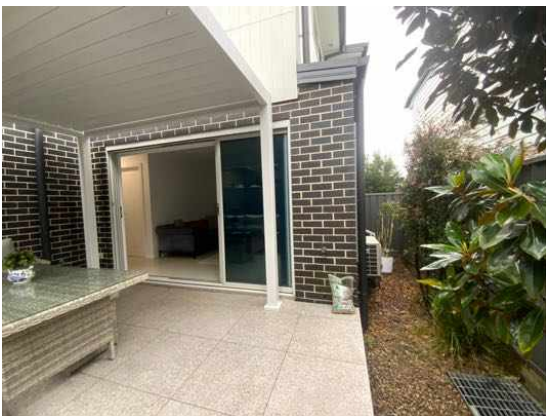
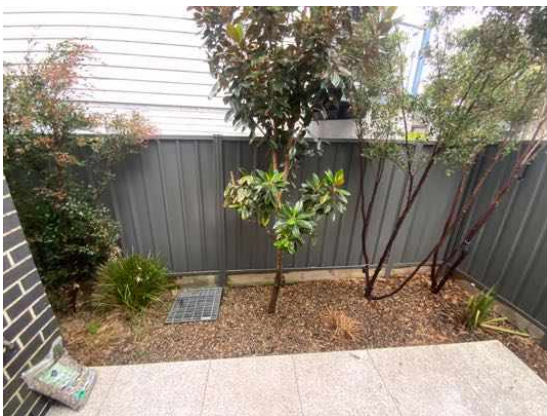
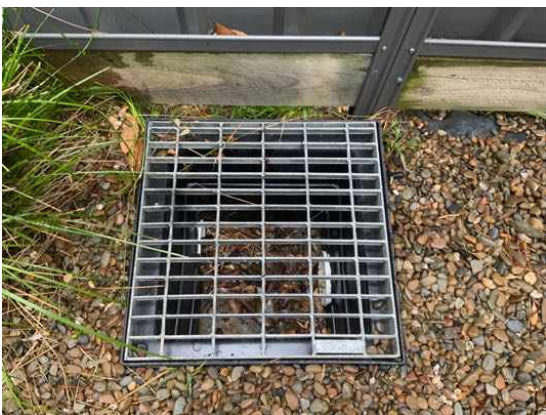
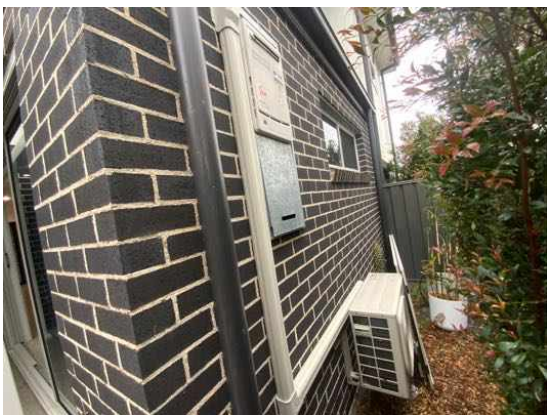
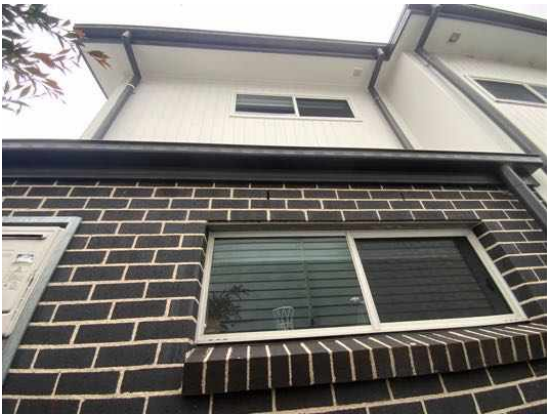
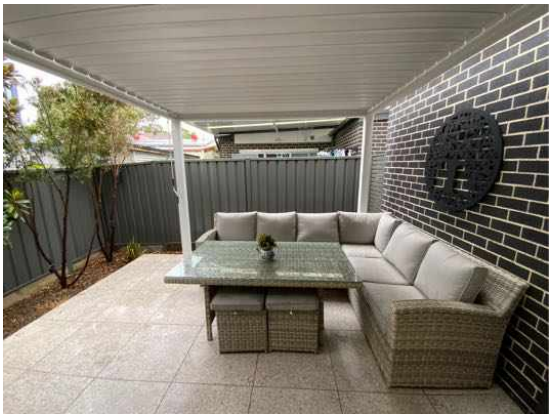
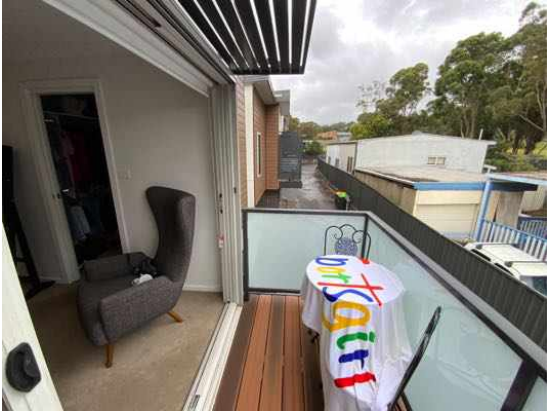
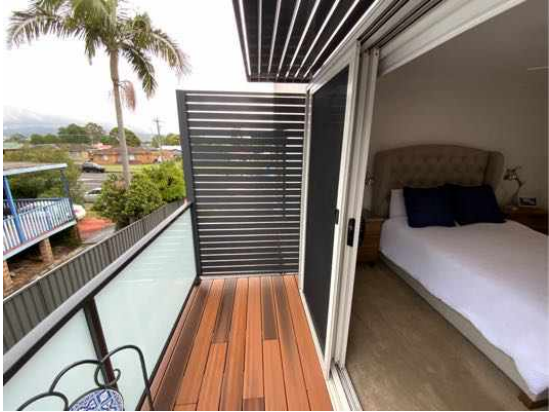
Building: Main Building
 Location: All Areas
 Finding: Additional Photos - Obstructions and Limitations
 Information: These photographs are an indication of the obstructions and limitations which impeded full inspection of the property at the time of inspection. These obstructions can hide an array of defects and should be removed to allow full inspection to be

carried out. A re-inspection is recommended once the areas are made accessible.

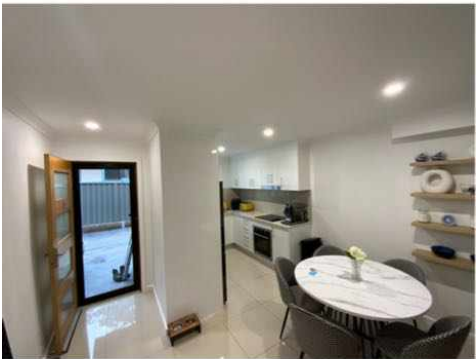
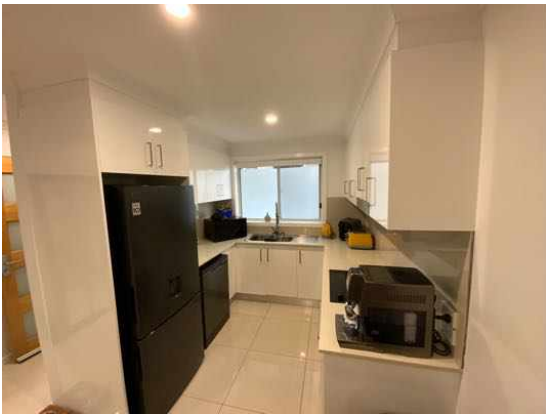
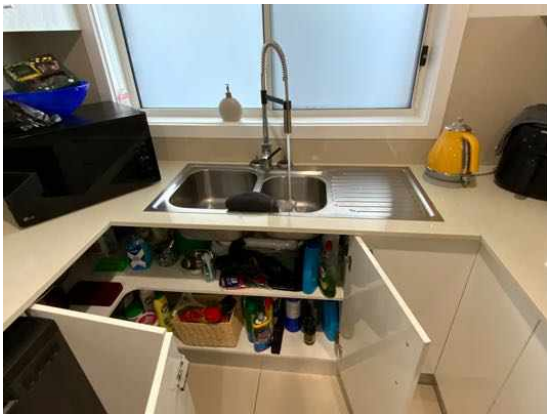
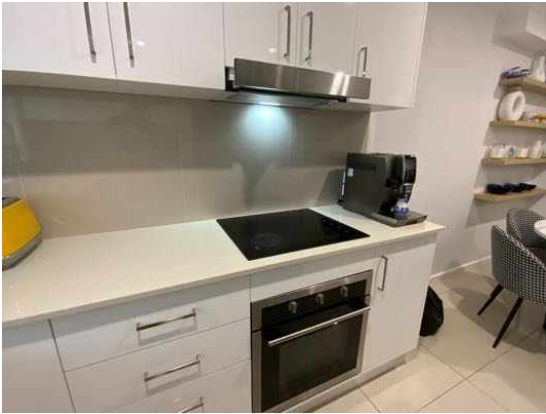
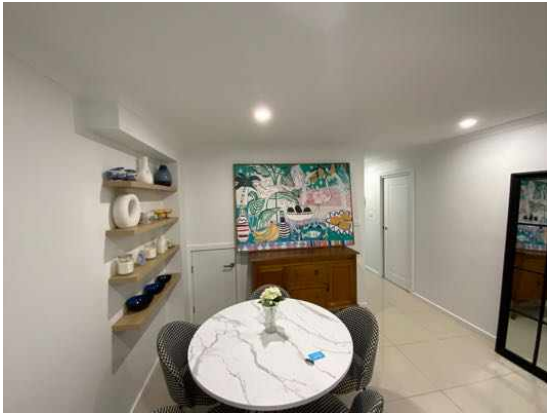
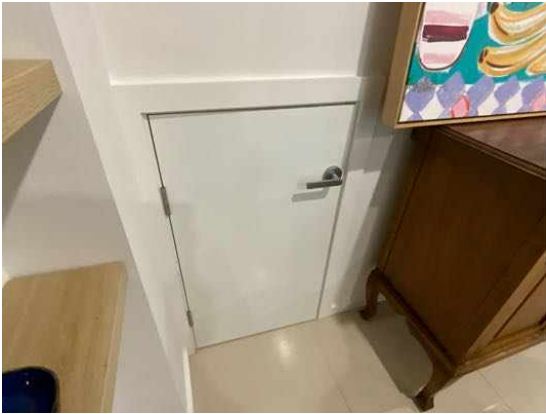
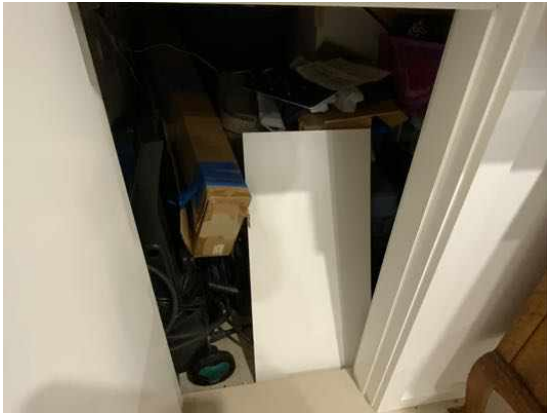
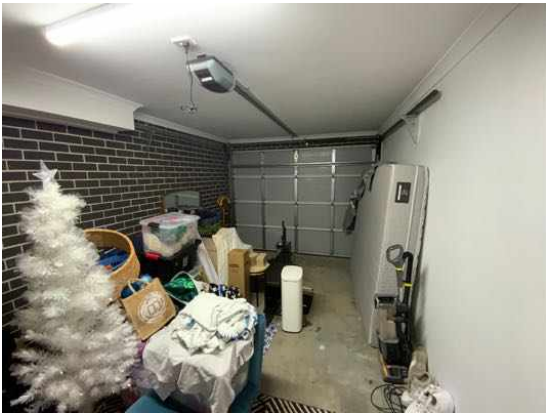
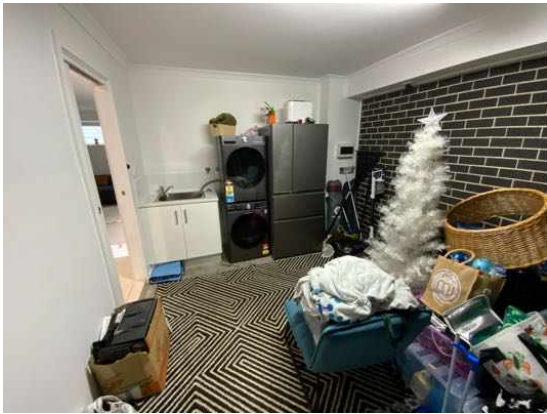
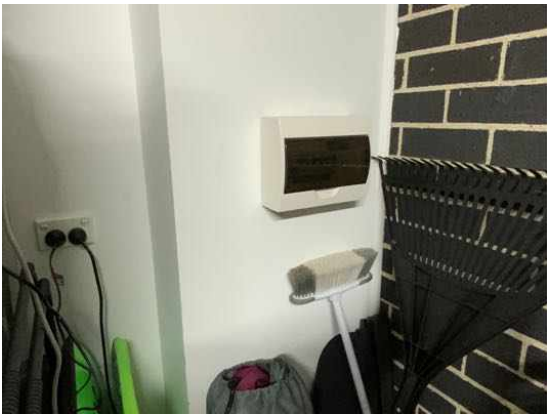
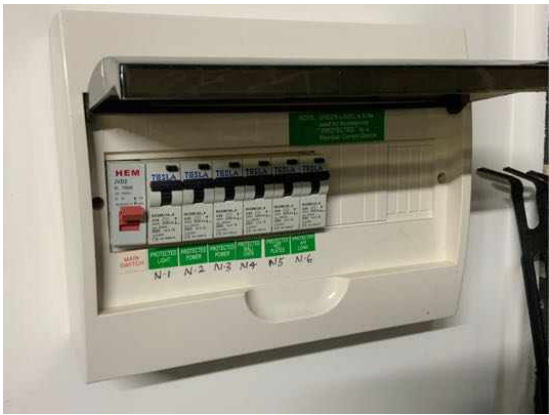
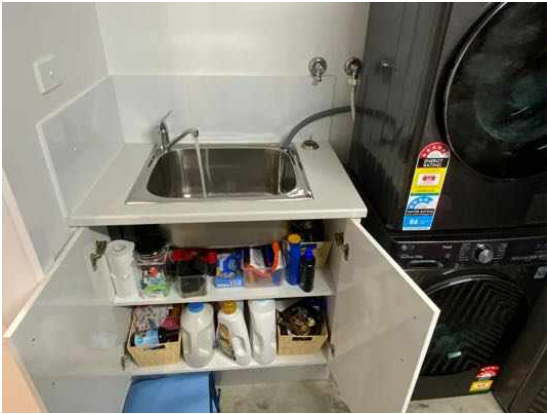
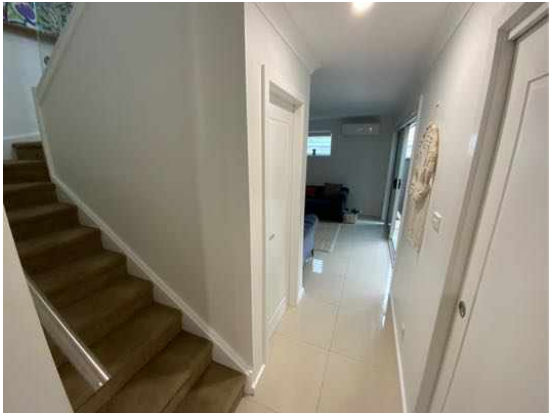
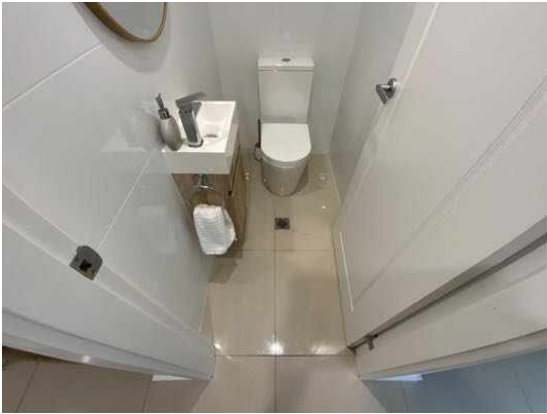
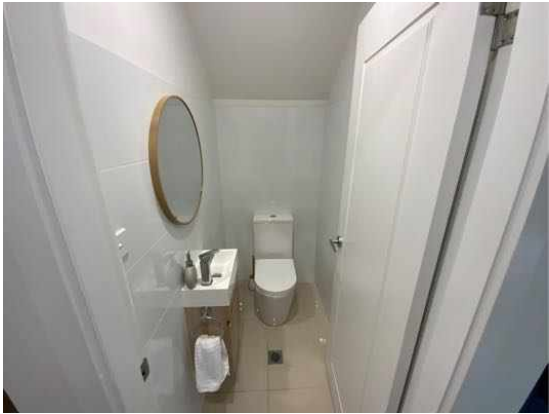
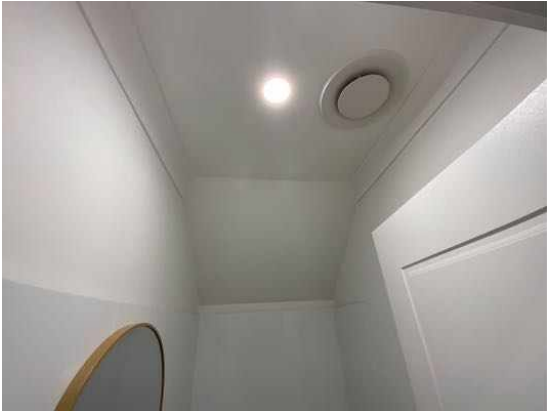
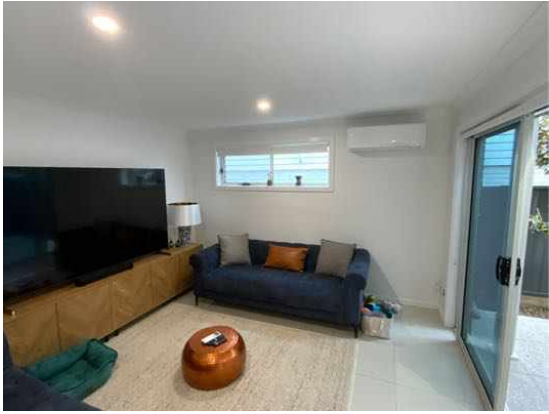
Building: Main Building
Location: All Areas
Finding: Additional Photos - Obstructions and Limitations
Information: These photographs are an indication of the obstructions and limitations which impeded full inspection of the property at the time of inspection. These obstructions can hide an array of defects and should be removed to allow full inspection to be carried out. A re-inspection is recommended once the areas are made accessible.

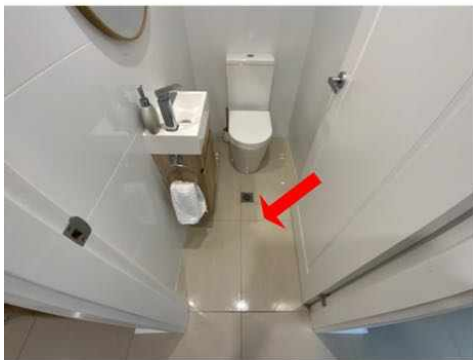
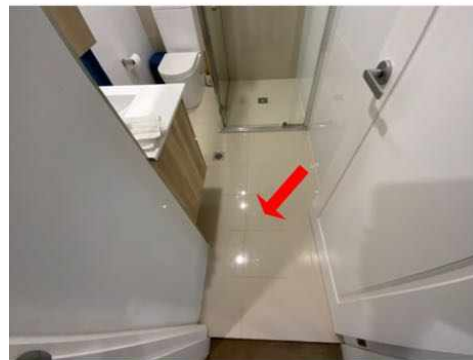
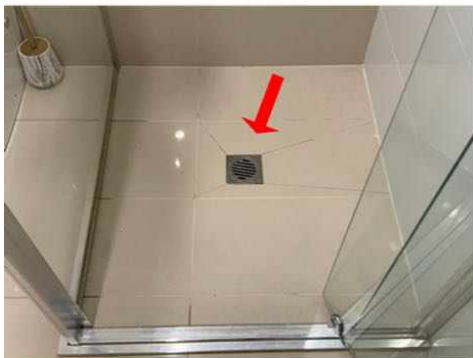
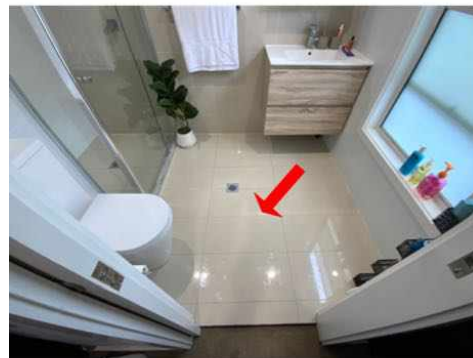
Building: Main Building
Location: All Wet Areas
Finding: Water Proofing Membranes - Information Only
Information: Internal Water Proofing Membranes, are crucial in preventing water ingress into the property is important to know that the Membrane System used is to Australian Standards and has been installed correctly.

With older property's where this information is unavailable all wet areas should be monitored. Generally waterproofing certificates are only valid for approximately 7-8yrs. If any leaks, water staining, peeling or bubbling of the paint become evident to any adjacent walls or ceilings below a licensed builder or waterproofing specialist is recommended to investigate further.

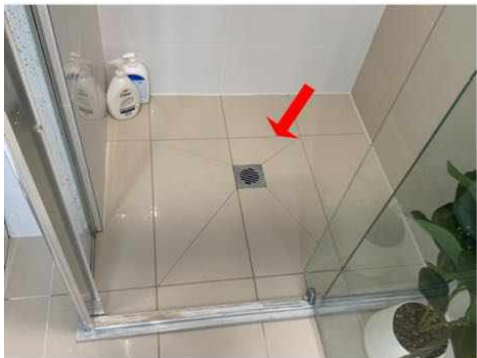
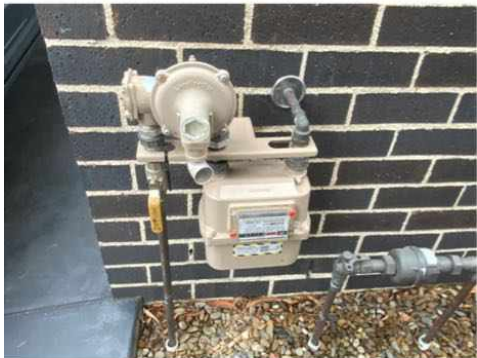
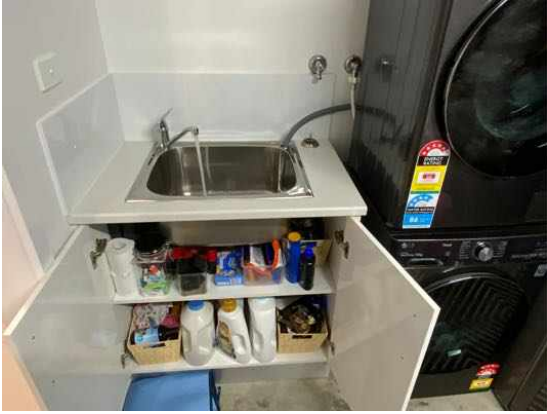
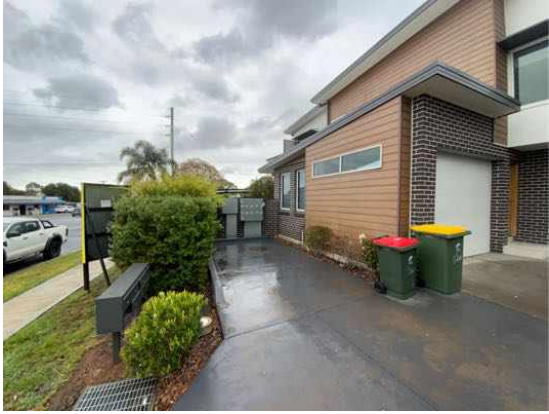
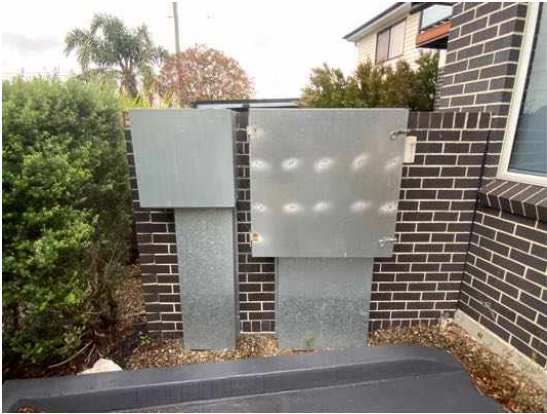
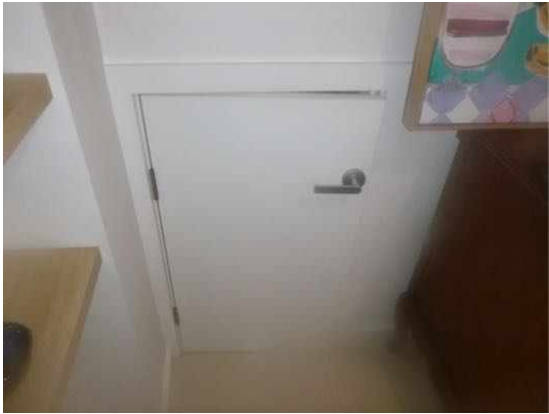
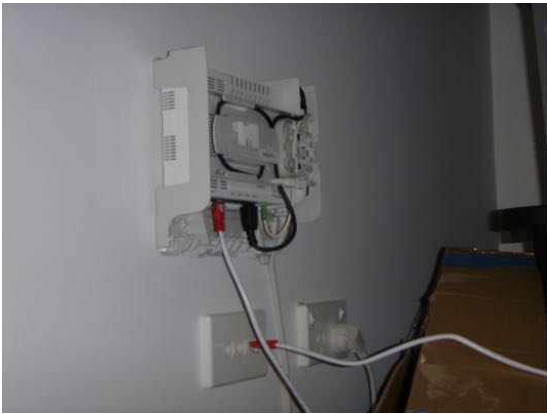
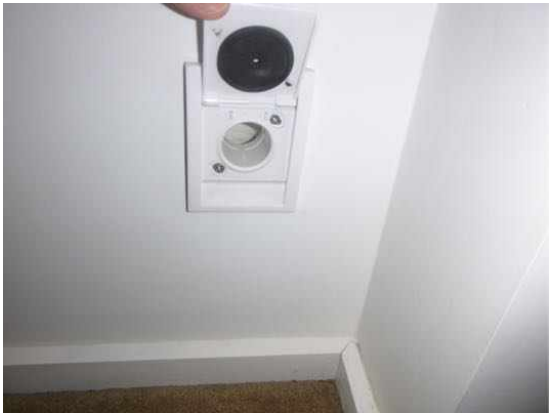
Additional photos are provided for your general reference. Arrows have been included to highlight areas of importance. Please discuss these photos with your building consultant for clarification.

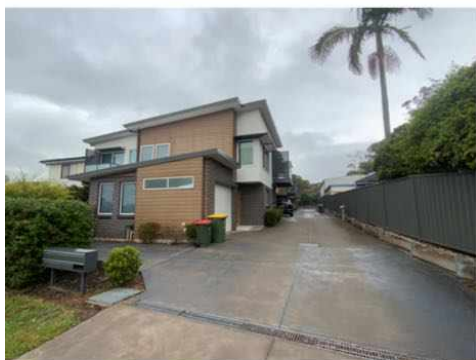
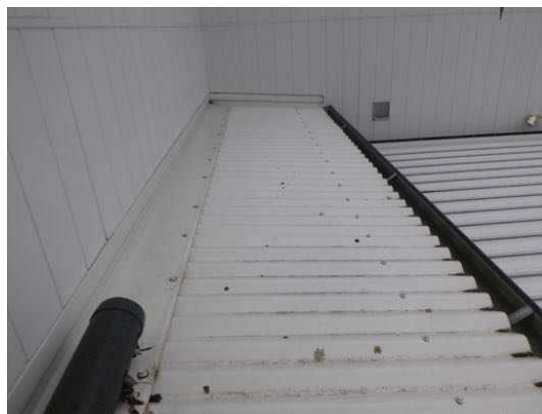
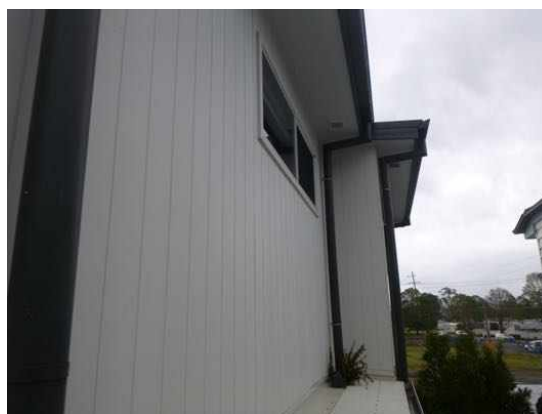
Information: The New South Wales area experiences major weather events annually. These periods of storms and torrential & driving rains from certain angles can overwhelm residential roofs, waterproofed areas, skylights, flashings & guttering causing water ingress into properties that other wise would not happen in normal rain conditions. Therefore no guarantee can be given against any future roof leak.

All roof coverings & plumbing, flashings, exterior guttering, box gutters and downpipes, even with gutter guard products installed, should remain free of all debris and possible blockages. Blockages may lead to pooling, accumulated water overflows, possible water ingress and the associated damage to adjoining building elements. Any areas of missing or aged/corroded guttering should be replaced.

A further inspection by a Licensed Roofing contractor is recommended to go over the complete roof covering and advise on the extent of replacement/ repair & maintenance items.
