Building and Timber Pest Inspection Report

Inspection Date: Thu, 15 Jan 2026

Property Address: 2/243 Tongarra Rd, Albion Park NSW 2527,
Australia

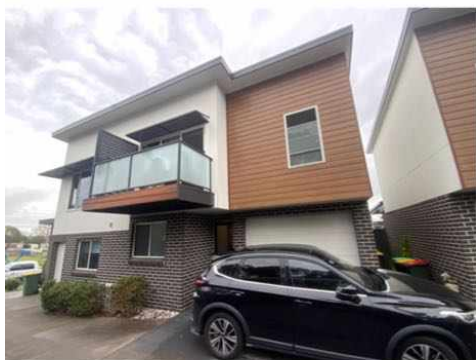
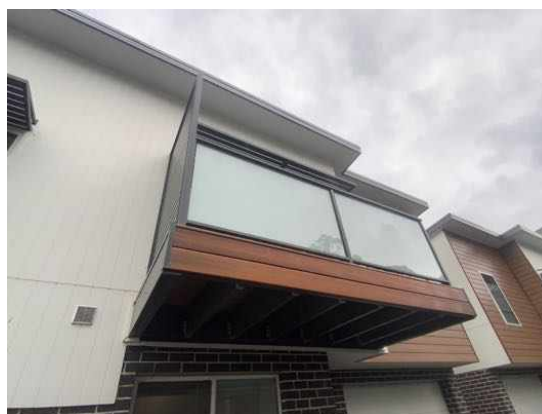
Building:	Main Building
Location:	Balcony, Deck, Verandah or Similar
Finding:	Elevated structure inspections (Elevated Structure)
Information:	Where any elevated Structure (deck, balcony, verandah etc) is present, and this elevated structure is designed to accommodate people, you MUST have this structure checked by an engineer or other suitably qualified person.

You should also arrange annual inspections of the structure by an engineer or other suitably qualified person to ensure any maintenance, that may become necessary, is identified. Care must be taken not to overload the structure.

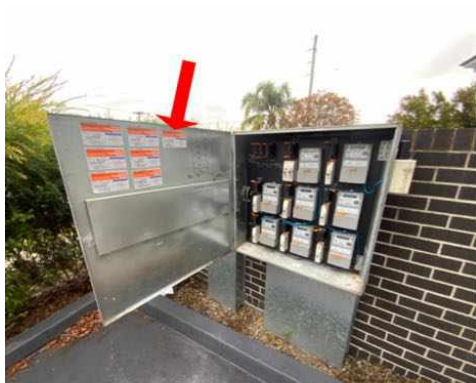
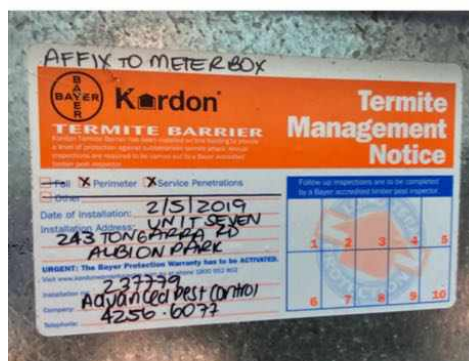
Where a Termite Management System has been identified you should refer to the type of barrier date of installation warranty conditions and any documentation provided by a builder or past owner. Consult the company who installed the barrier to confirm whether the system is still under warranty.

Most chemical termite management systems expire and require replenishment and all physical systems are primarily designed to prevent concealed entry.
