# Building and Timber Pest Inspection Report

Inspection Date: Wed, 1 Apr 2026

Property Address: 203 Lang St, Kurri Kurri NSW 2327, Australia

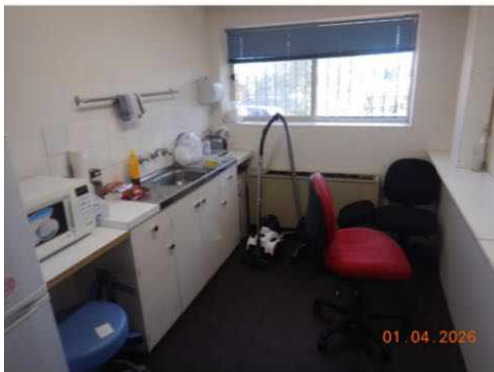
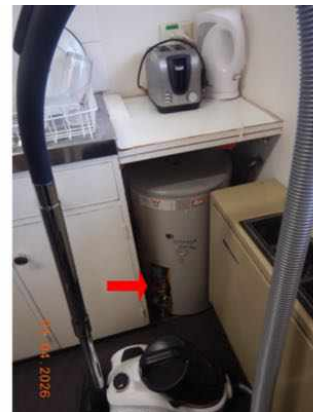
### Finding 1.02

Building: Main Building  
 Location: Staff Room > All Areas  
 Finding: Exposed Electrical Wiring  
 Information: The exposed electrical wiring associated with the hot water system in the downstairs staff room is a potential safety hazard and should be covered immediately.

Consultation with a licensed electrician is required as soon as practicable.

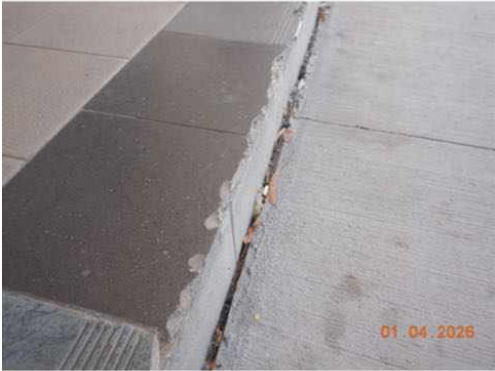
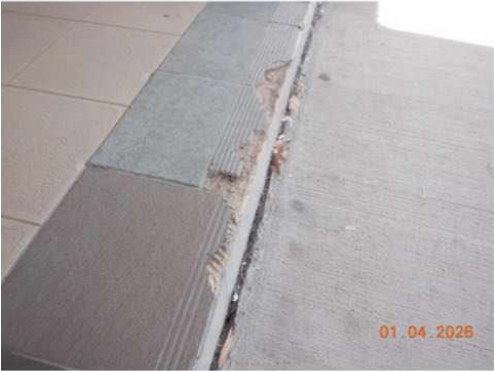
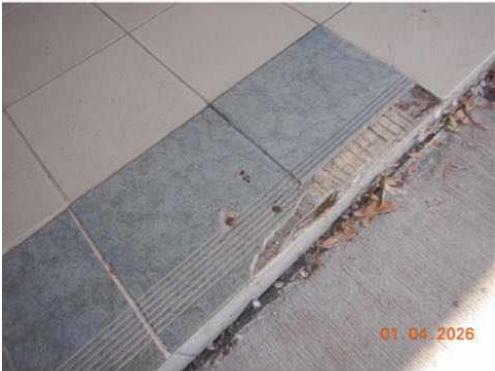
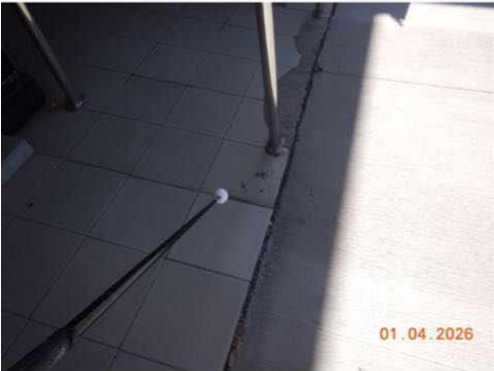
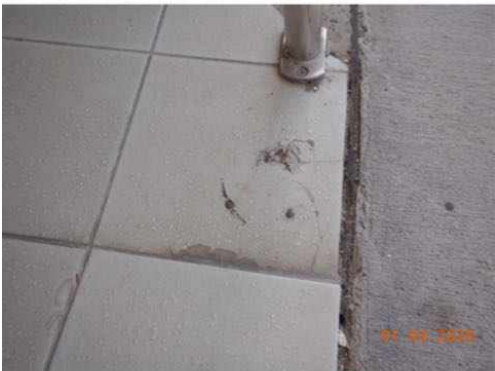
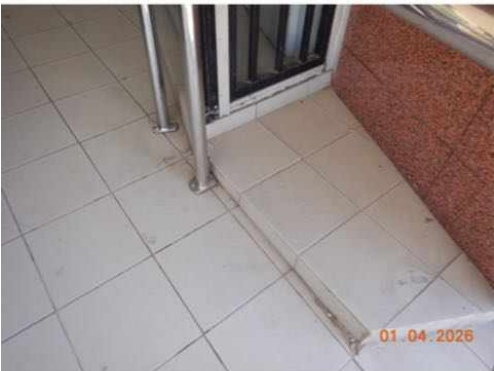
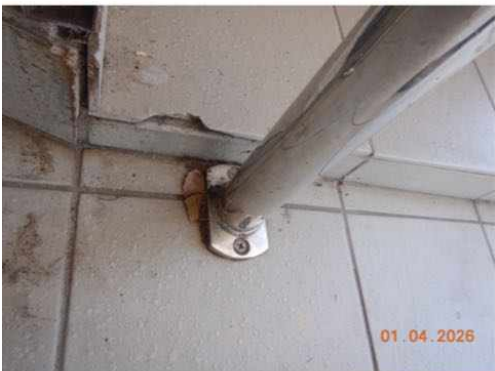
Finding 1.05

Building: Main Building  
 Location: Front Elevation > All Areas  
 Finding: Damaged Rendered Surfaces  
 Information: Damaged rendered surfaces were noted to the front of the building, repair is advised as soon as practicable to prevent possible falling debris onto the footpath.

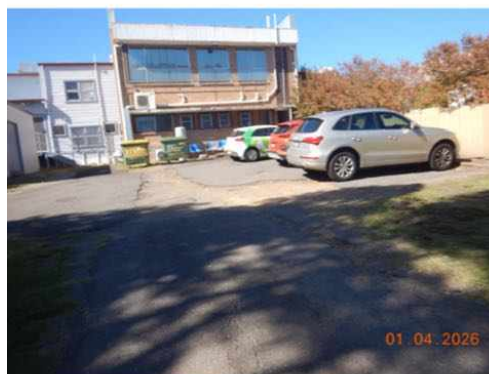
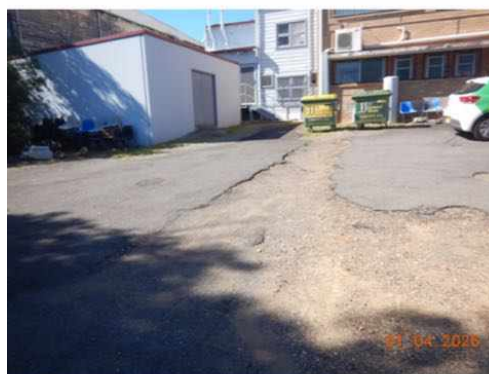
### Finding 1.06

Building: Main Building  
 Location: Rear Elevation > All Areas  
 Finding: Car Park - Deteriorated  
 Information: The deterioration to the car parking at the rear is a potential trip hazard and should be rectified as soon as practicable. Consultation with an asphalt contractor is advised at the client's discretion.

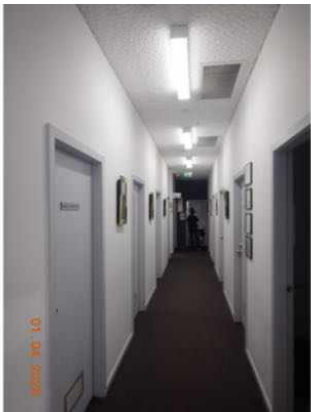
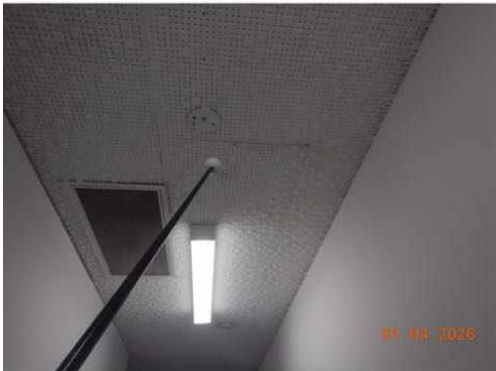
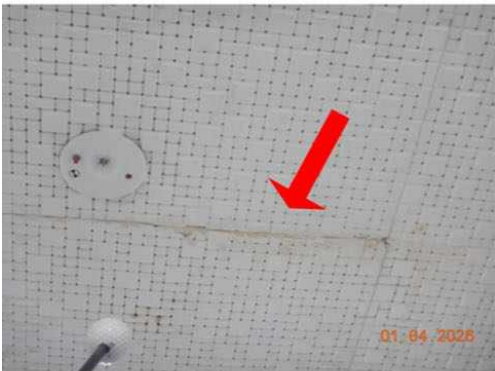
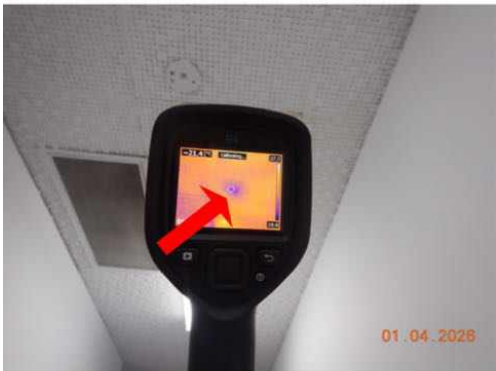
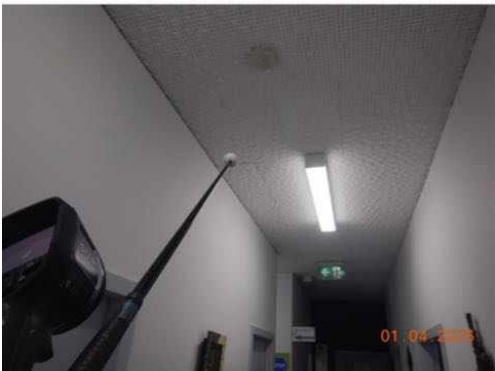
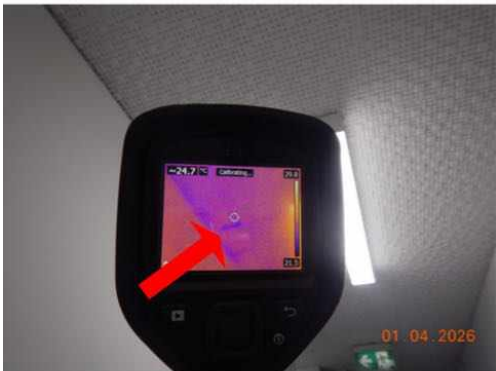
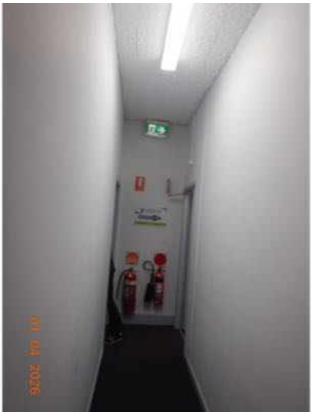
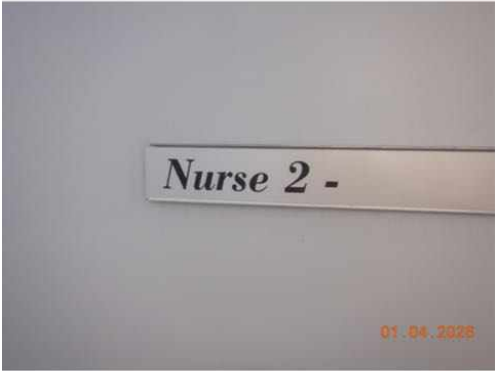
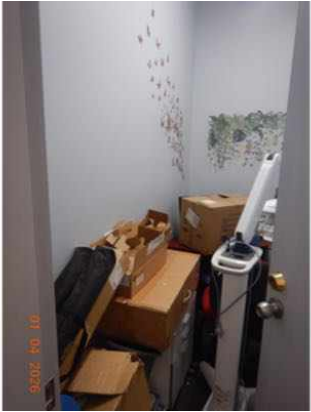
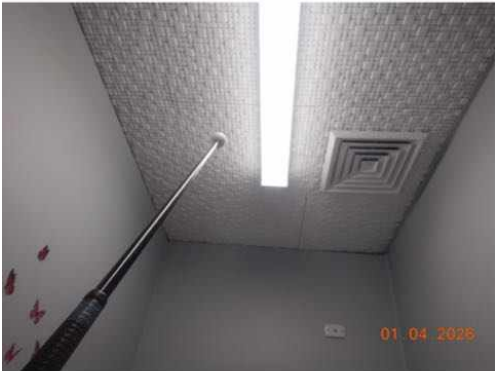
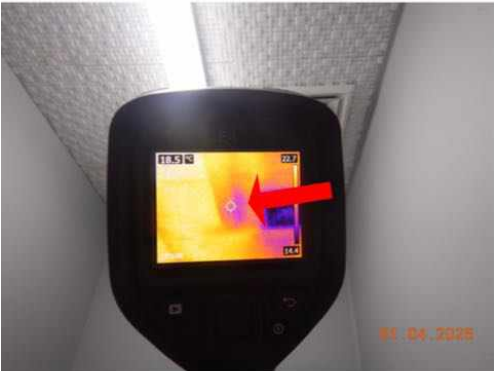
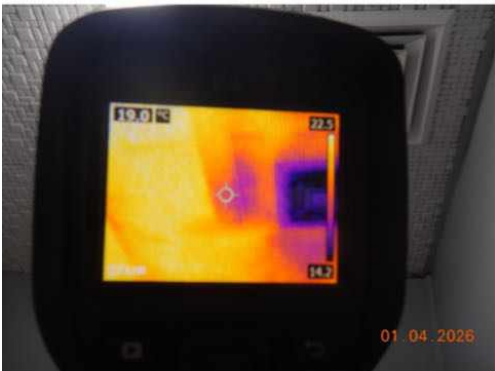
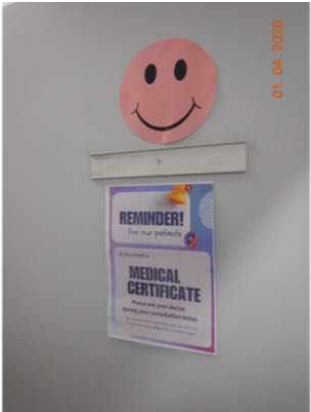
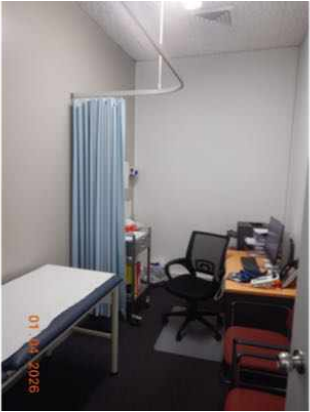
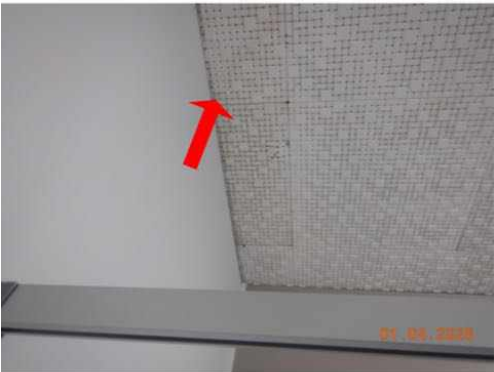
### Finding 2.01

Building:	Main Building
Location:	All Internal Areas upstairs > All Areas
Finding:	Air Conditioning - Leaking
Information:	At the time of inspection water staining and or moisture was detected on the ceiling tiles in selected areas of the medical practice. The moisture detected with the thermal imaging camera indicates that the air conditioning unit and or the associated ducting is leaking.

Please note that the purple images on the screen of the thermal imaging camera highlight the moisture. It is strongly advised that an air conditioning technician be engaged to rectify any issues as soon as practicable.

It is important to note that I overheard a staff member saying that the air conditioning unit is in poor condition and that there is only one technician who is able to service and repair this item.

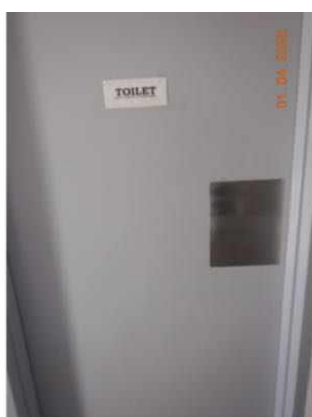
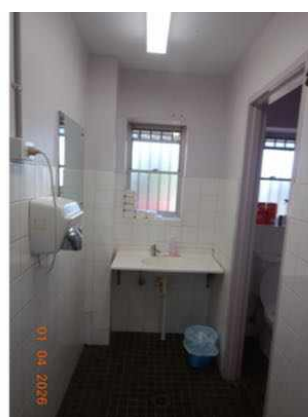
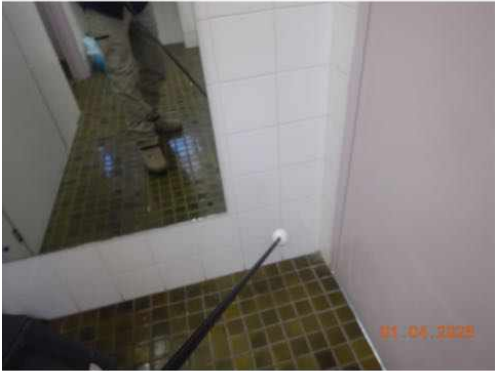
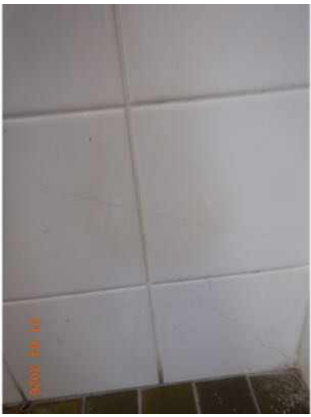
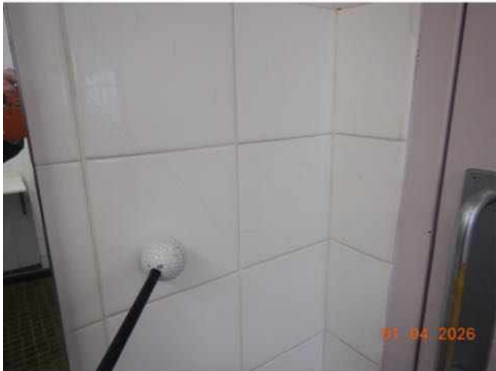
## Finding 2.02

Building:	Main Building
Location:	Toilet (WC) Downstairs > All Areas
Finding:	Tiles - Cracked or damaged
Information:	Cracking was evident to the tiling in this area at the time of inspection. While the cracking appears to be minor, this area is frequently exposed to water, allowing potential for water penetration into adjoining sections of walls or flooring.

If left unmanaged, water penetration to these areas may lead to subsequent water damage, which is likely necessitate repair work to affected building elements.

It is important to note that the majority of wall tiles in both downstairs toilet areas are cracked and or damaged.

A tiling contractor should be appointed to ensure that no further water damage occurs. The re-application of silicone and grouting throughout remaining tile work is also advised, to further protect the area against water penetration.

Where water penetration has led to water damage, appointment of a relevant tradesperson may be required to repair damaged building elements.

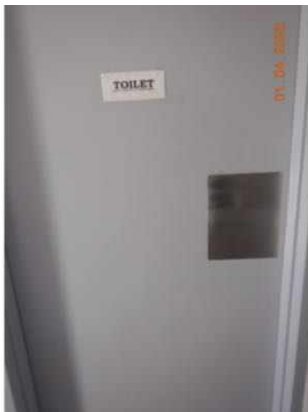
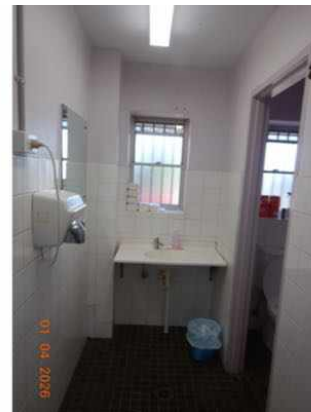
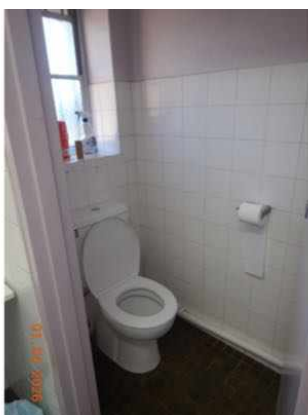
Finding 2.03

Building: Main Building  
Location: Toilet (WC) Downstairs > All Areas  
Finding: Mould - Present  
Information: What appears to be mould was noted to the toilet ceiling in the downstairs women's toilet, Moisture was detected in this area. Where evidence of mould growth was noted, there may be environmental, biological or health issues associated with the report. A specialist inspection by a suitably qualified environmental health inspector is warranted, where mould is extensive or where any queries regarding air quality spores or other related issues apply.

Please note that the highest detectable surface reading on this device is 999, the wet range starts at 200, the reading detected was 289.

Generally, the client is advised to ensure that the general environment is free of moisture and humidity to aid in the prevention of mould formation and development. Any mould found during the inspection should be cleaned immediately by a cleaning contractor or the homeowner as applicable.

Please note that severely affected building elements may require replacement by a registered builder or qualified carpenter.

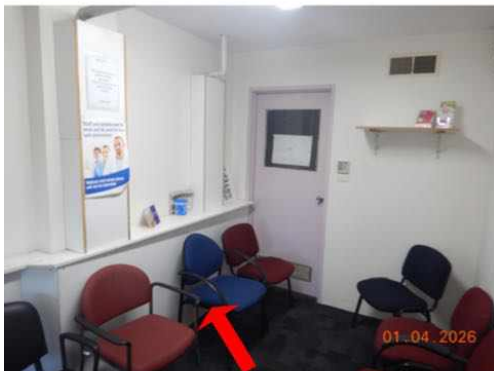
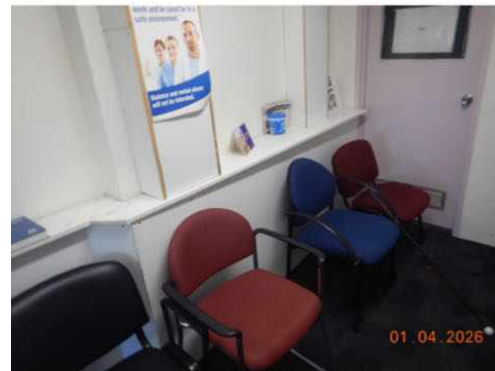
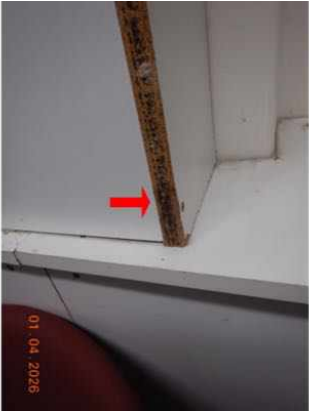
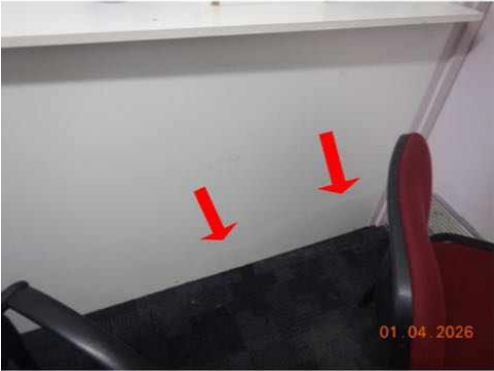
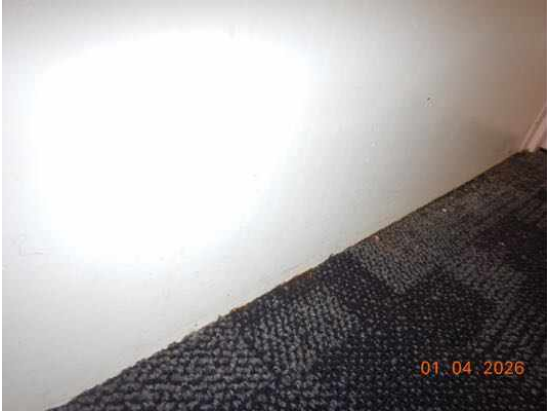
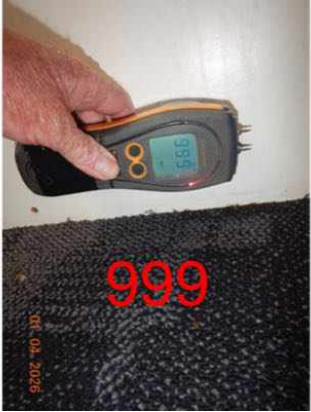
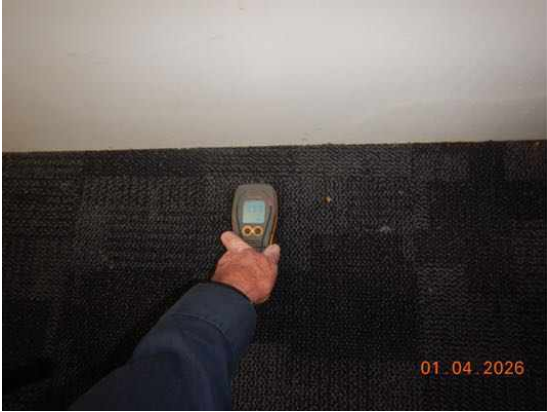
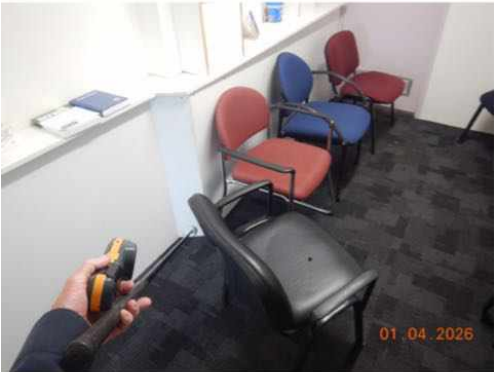
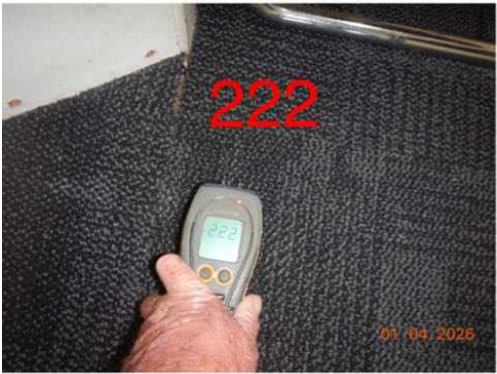
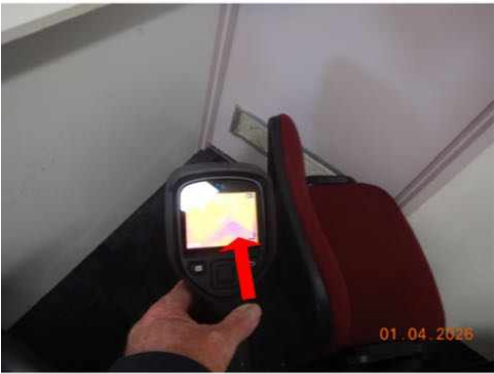
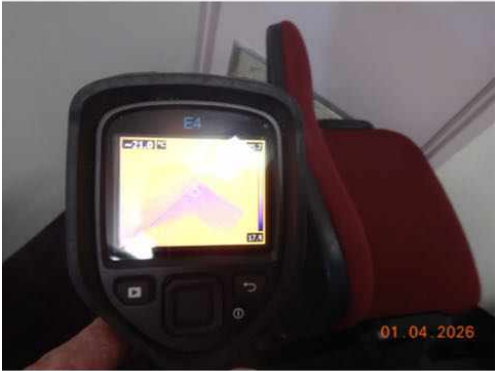
### Finding 2.04

Building: Main Building  
 Location: Pathology Waiting Room > All Areas  
 Finding: Water Damage  
 Information: Water damage to the melamine wall linings was noted from the subfloor access door towards the staff lunch room door. Excessive moisture was detected in the affected areas due to an active leak from the subfloor area. Please note that it is strongly advised that this room be closed off due to the concern of concealed mould between the melamine wall lining and the rendered brickwork and under the carpet flooring.

Consultation with a mould specialist and plumber is strongly advised as soon as practicable. Please note that the highest detectable surface reading on this device is 999, the wet range starts at 200.

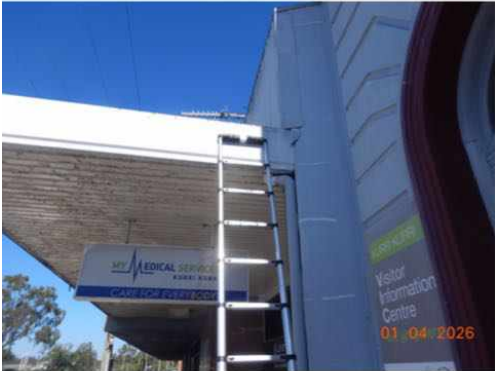
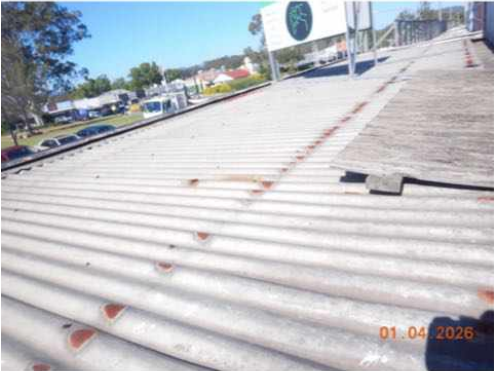
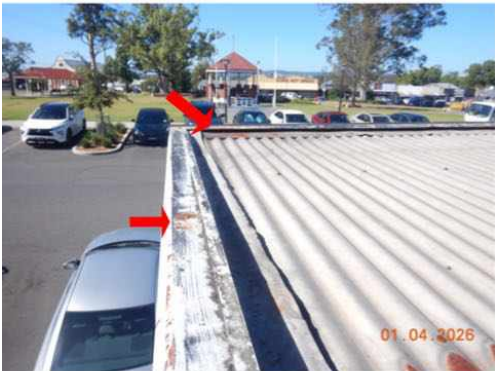
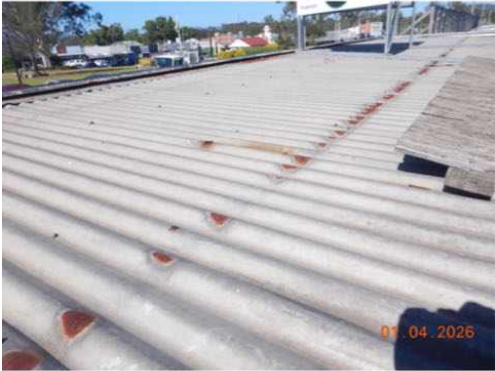
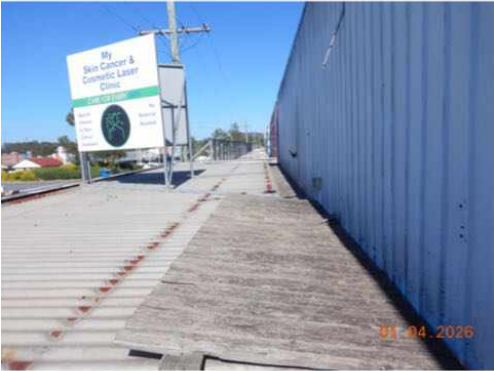
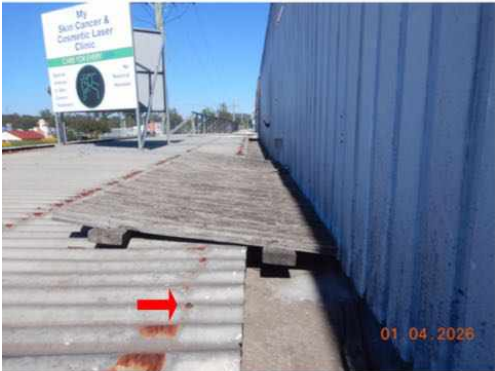
**Finding 2.05**

Building: Main Building  
Location: Roof Exterior > All Areas  
Finding: Roof Exterior  
Information: The roof sheets and the roofing screws on the awning roof were found to be in rusted and deteriorated condition. Replacement is advised, consultation with a metal roofing contractor is advised.

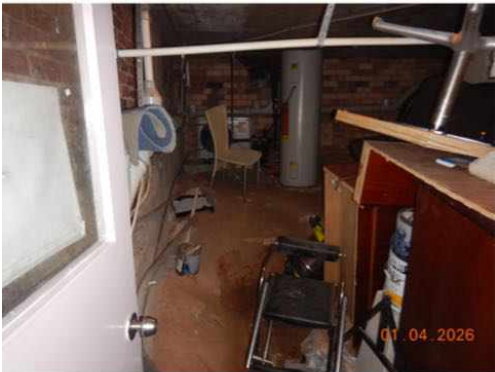
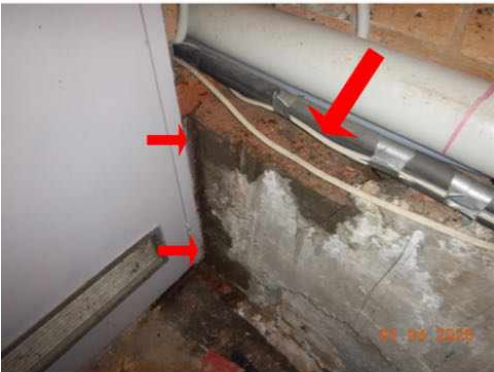
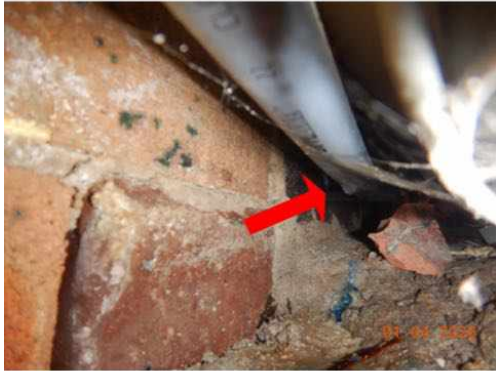
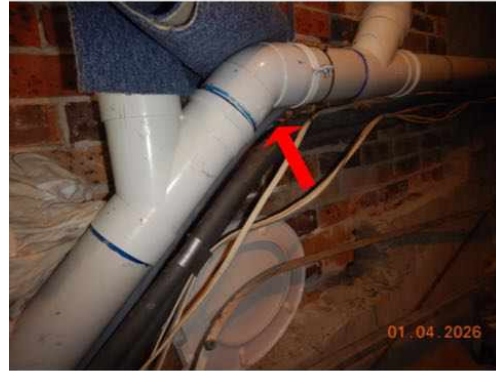
**Finding 2.06**

Building: Main Building  
Location: Subfloor > All Areas  
Finding: Active Leak  
Information: An active plumbing leak was noted in the subfloor area. It is important to note that this leak is causing the excessive moisture in the pathology waiting room.

A plumber is required as soon as practicable to rectify this leak.

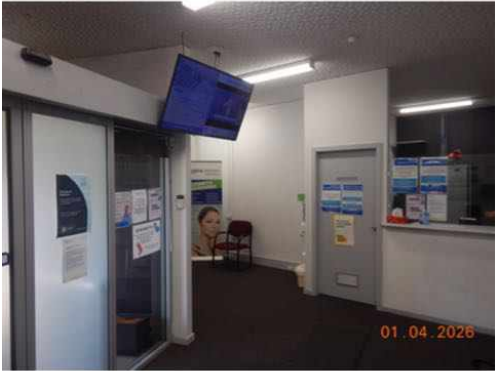
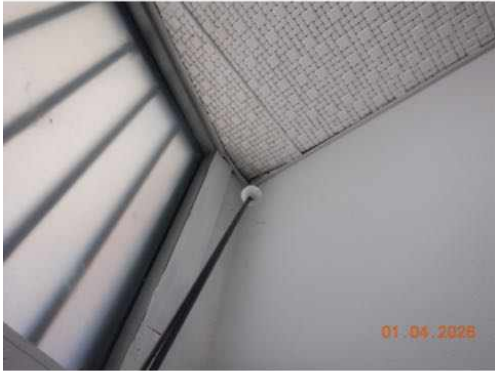
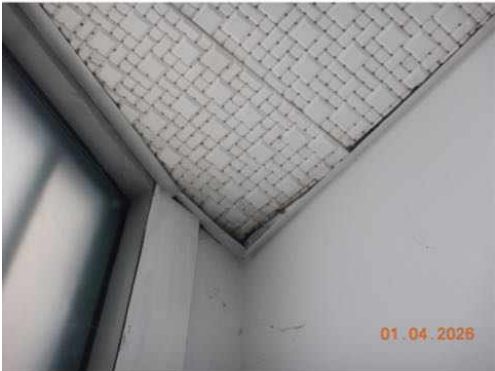
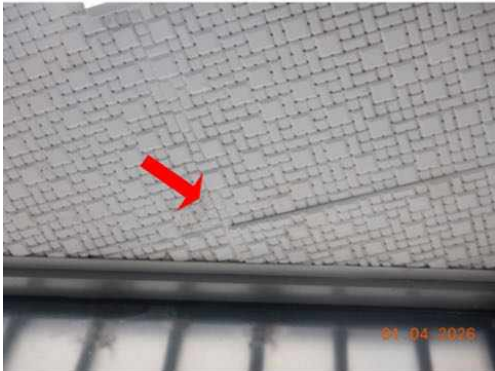
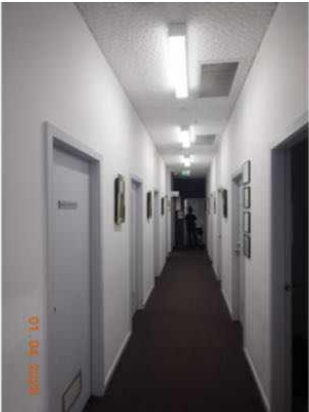
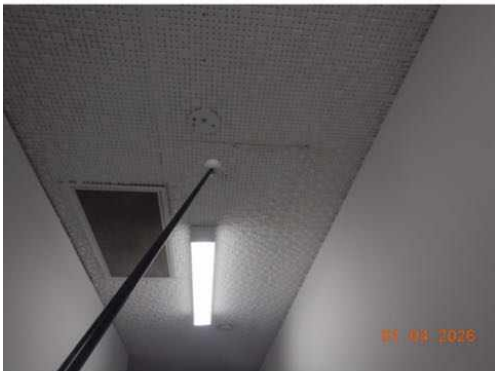
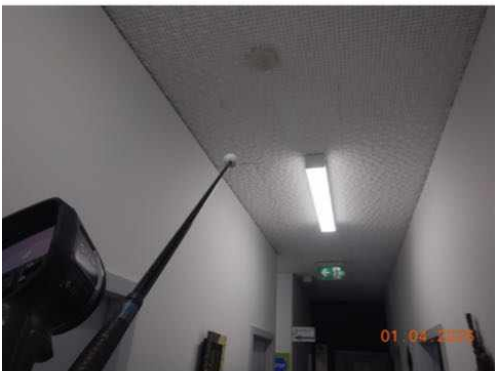
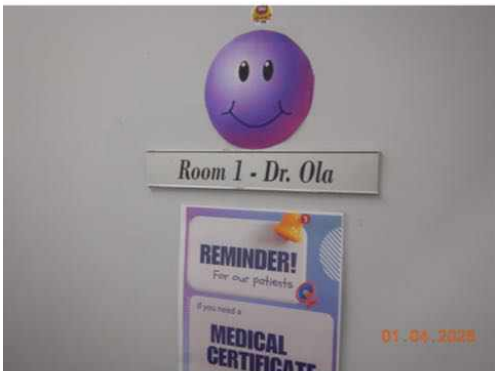
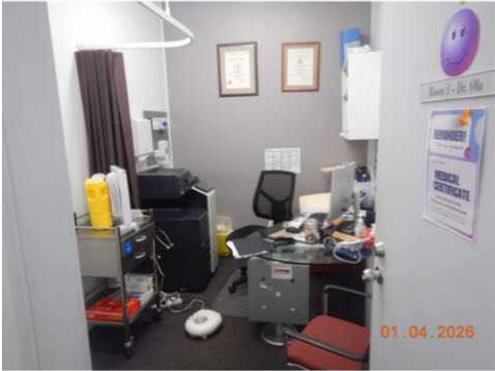
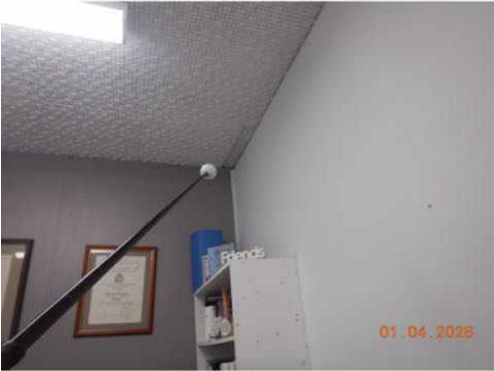
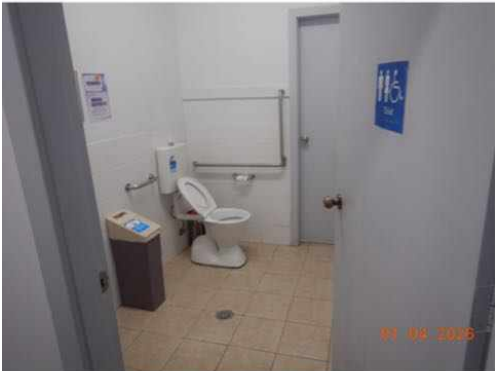
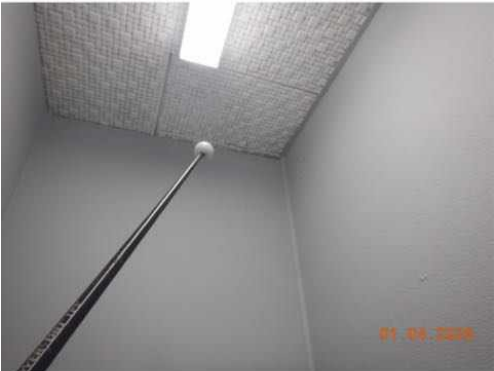
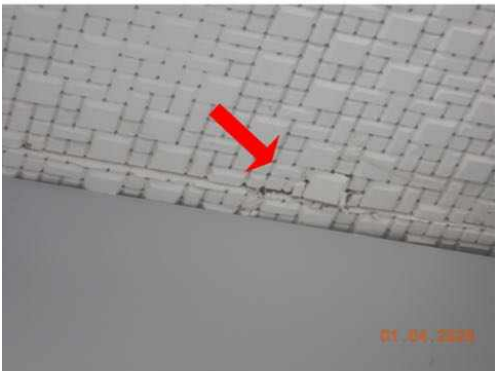
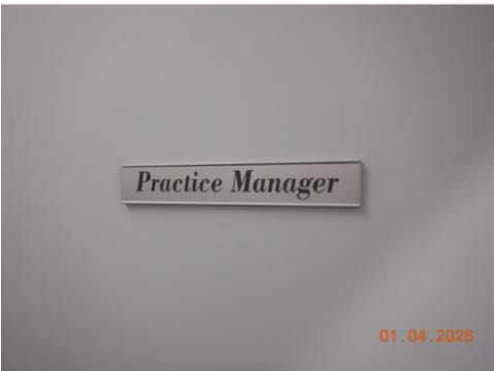
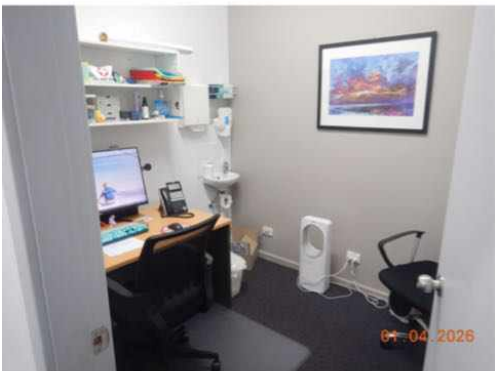
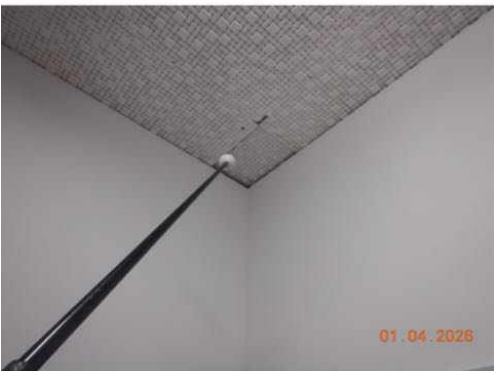
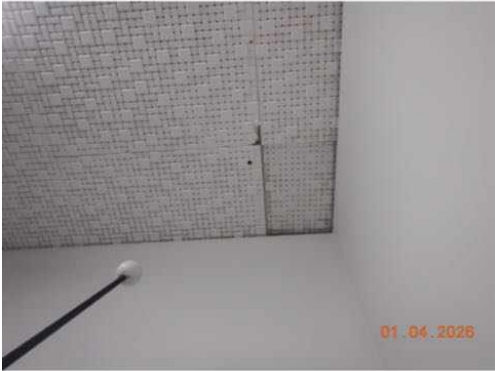
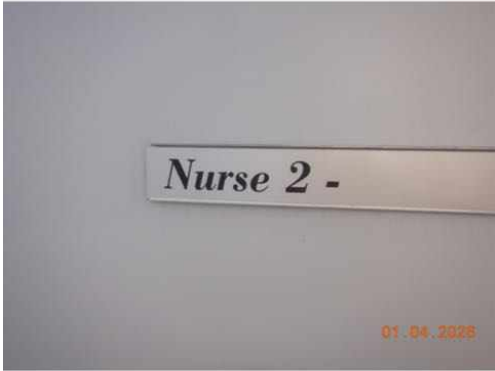
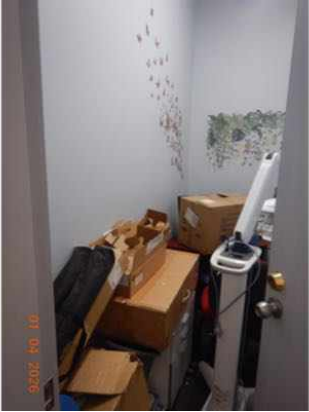
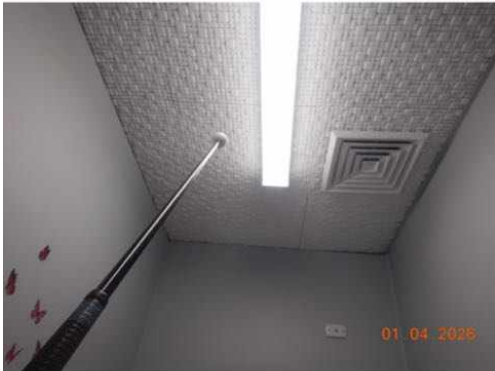
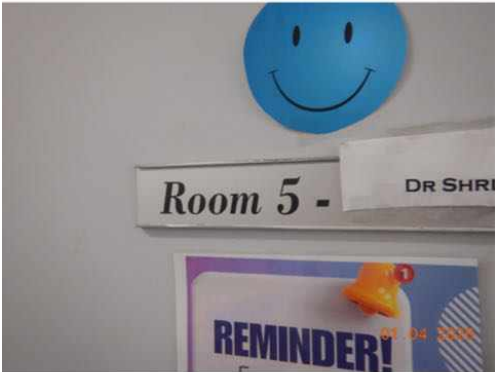
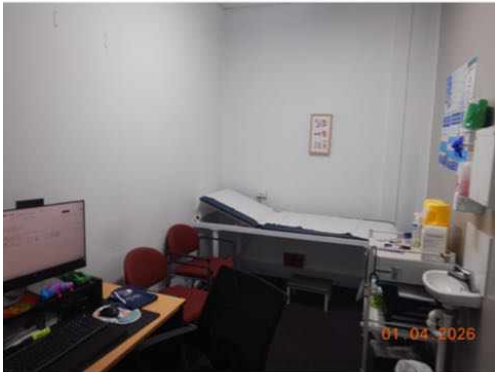
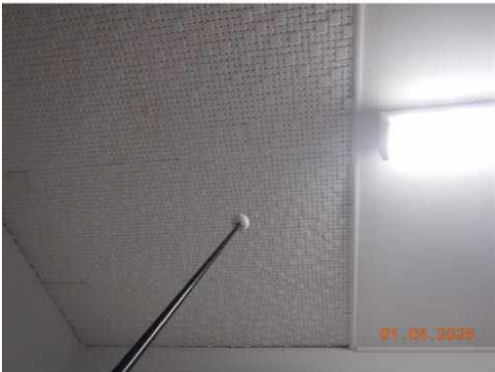
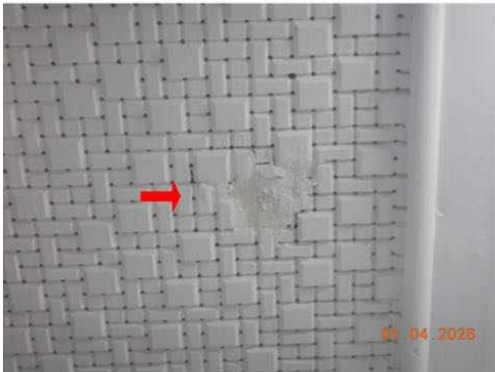
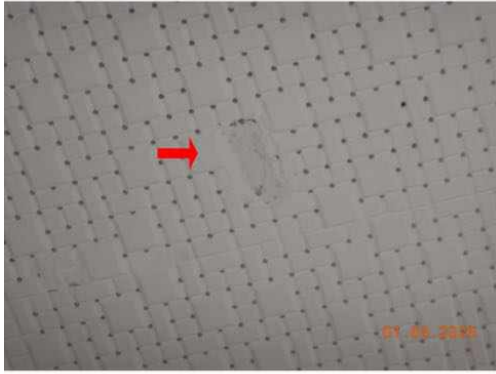
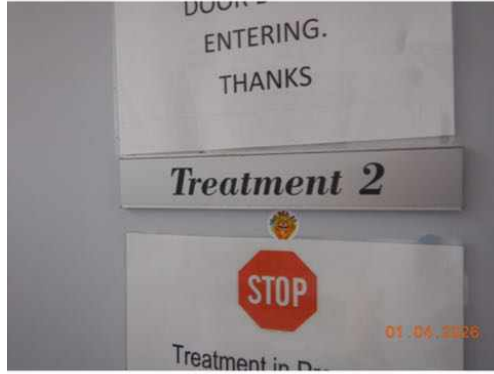
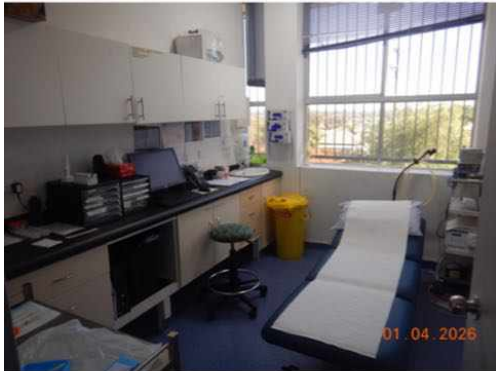
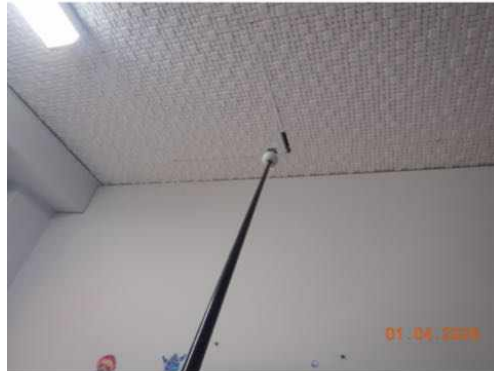
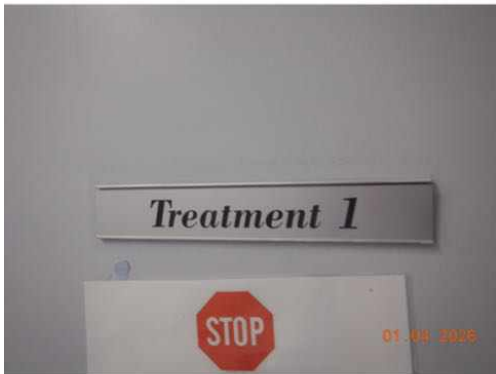
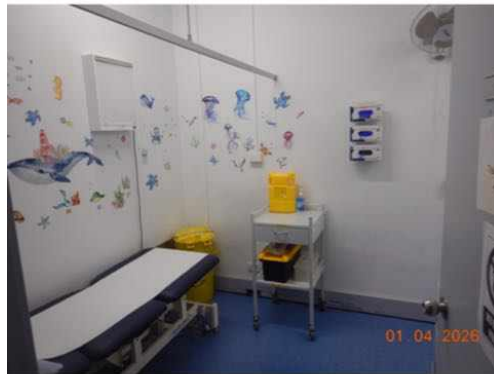
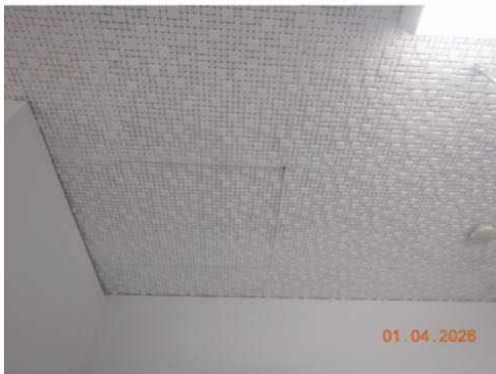
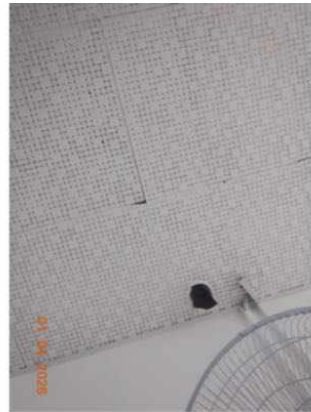
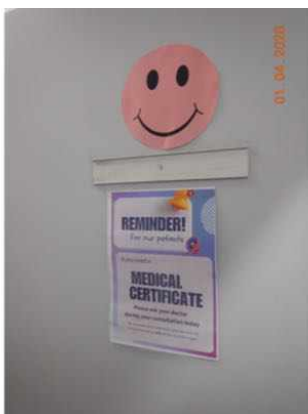
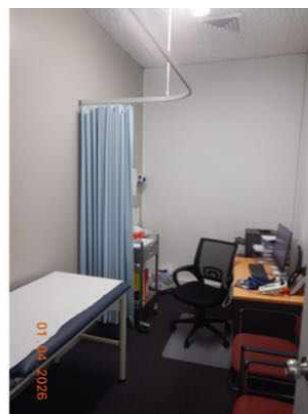
Building:	Main Building
Location:	All Internal Areas upstairs > All Areas
Finding:	Ceiling Tiles - Damaged / Deteriorated
Information:	Damaged and or deteriorated ceiling tiles were noted throughout the medical practice areas. While some of the damage is related to leaks from the air conditioning unit and associated ducting ( Please refer to defect related to Air Conditioning- Leaks ) the majority of the damage and or deterioration appears to be age appropriate.

Repair and or replacement of the affected ceiling tiles is at the client's discretion, consultation with a building contractor is advised.

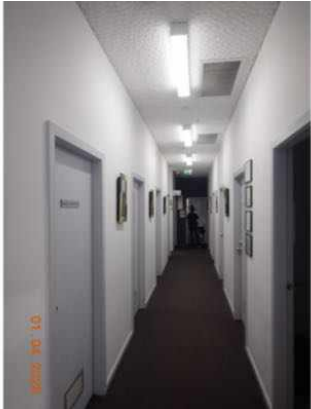
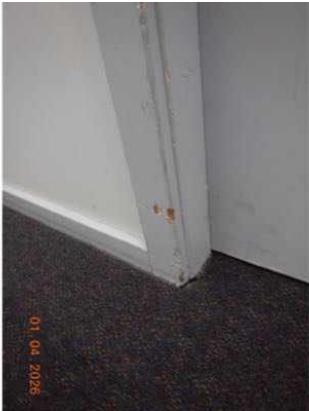
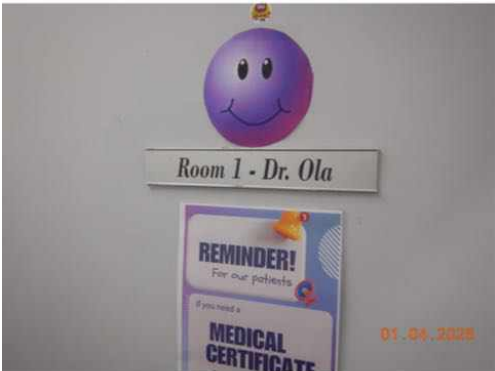
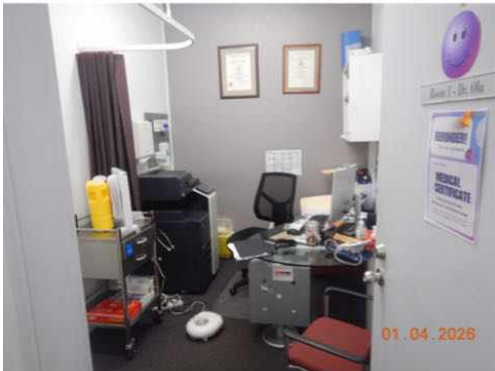
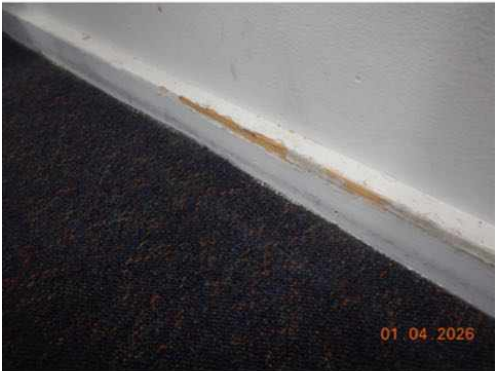
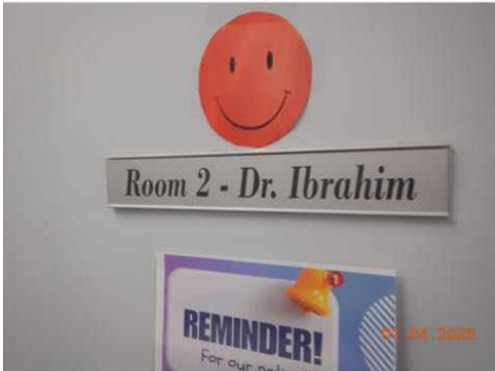
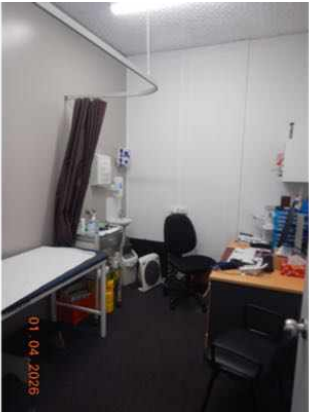
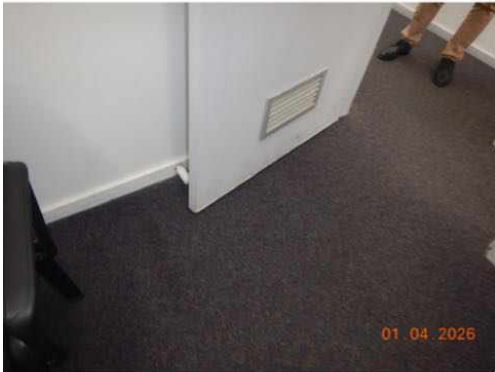
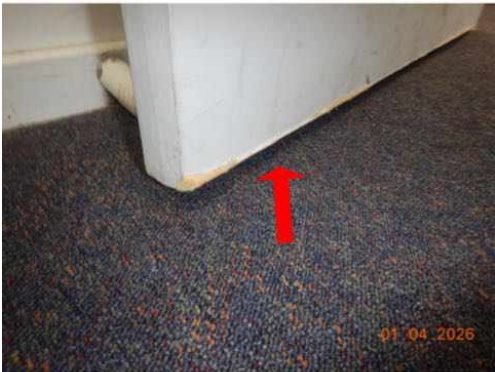
**Finding 3.03**

Building: Main Building  
Location: All Internal Areas upstairs > All Areas  
Finding: Minor Damage  
Information: Minor damage associated with general wear and tear was noted to architraves, skirtings and the bottom edge of a door. Replacement is at the client’s discretion.

Please note that the attached photos are not an exhaustive list, they are however an indication of the damage to these items throughout the medical practice.

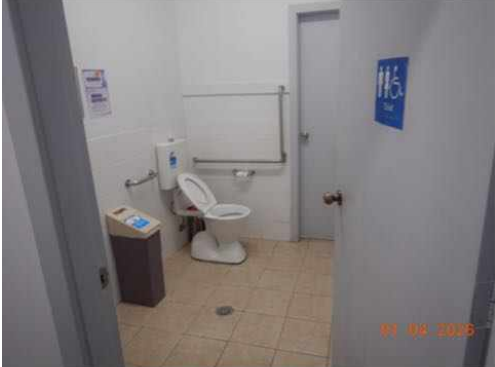
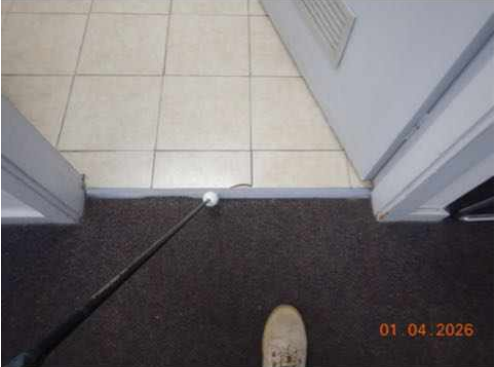
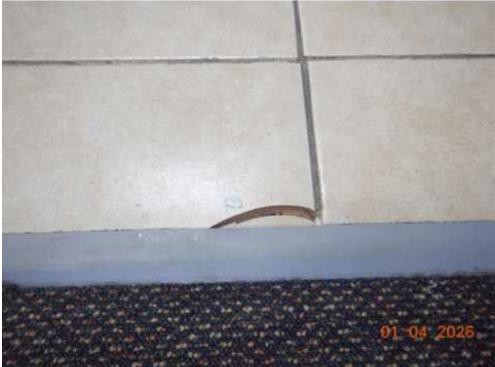
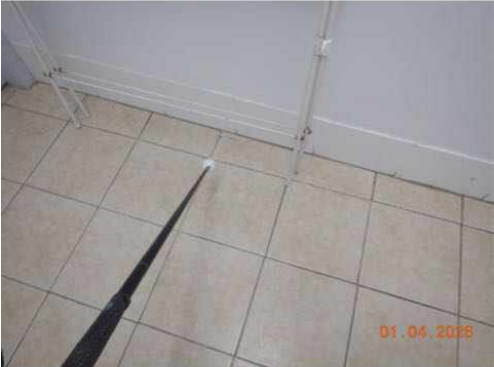
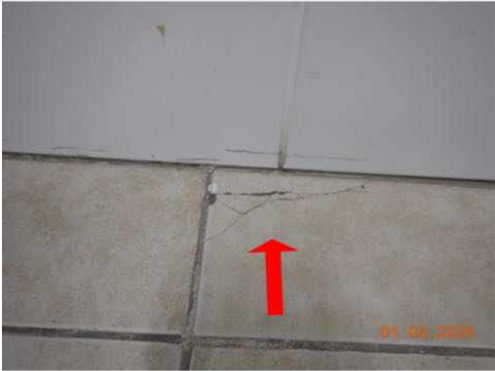
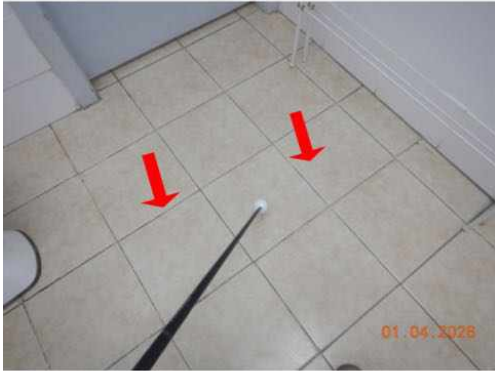
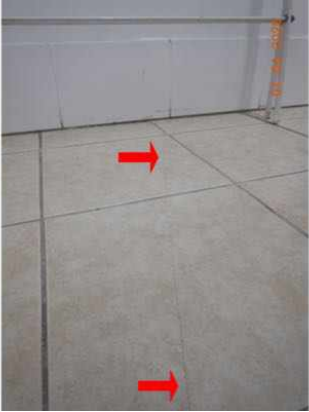
Finding 3.04

Building: Main Building  
Location: Toilet (WC) Upstairs > All Areas  
Finding: Tiles - Cracked or damaged  
Information: Cracking was evident to the tiling in this area at the time of inspection. While the cracking appears to be minor, this area is frequently exposed to water, allowing potential for water penetration into adjoining sections of walls or flooring.

If left unmanaged, water penetration to these areas may lead to subsequent water damage, which is likely necessitate repair work to affected building elements.

A tiling contractor should be appointed to ensure that no further water damage occurs. The re-application of silicone and grouting throughout remaining tile work is also advised, to further protect the area against water penetration.

Where water penetration has led to water damage, appointment of a relevant tradesperson may be required to repair damaged building elements.

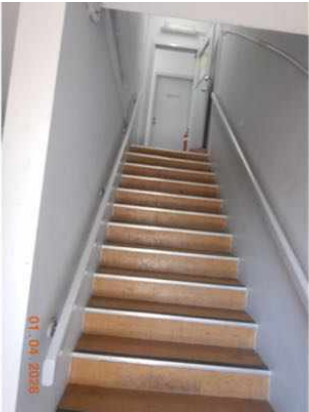
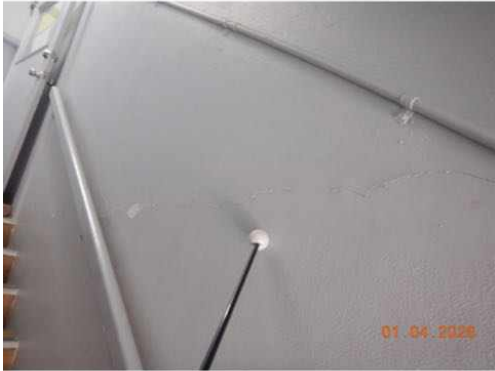
**Finding 3.05**

Building: Main Building  
Location: Stairs - Internal > All Areas  
Finding: Cracks to internal render - Category 3  
Information: It has been observed that cracking to internal rendered surfaces has occurred. The degree of damage falls within Category 3, described as cracks which can be repaired with consideration that a section of wall may need to re-rendered.

The cracks are generally 5-15mm in width, or may present as a number of cracks 3mm or more in a group. Damage of this category is a defect that requires rectification work, which may be more extensive.

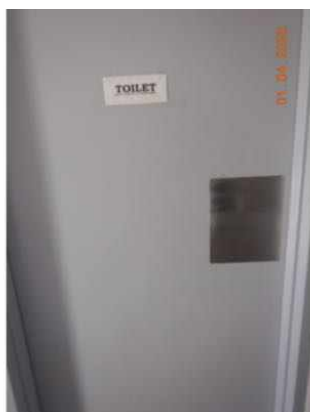
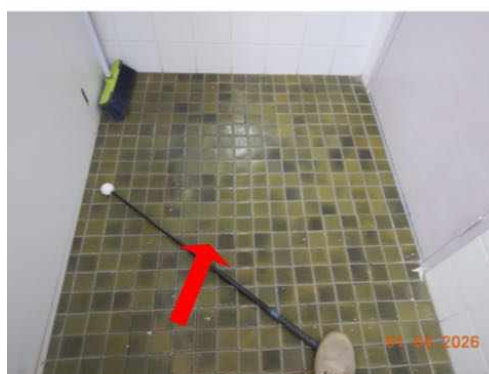
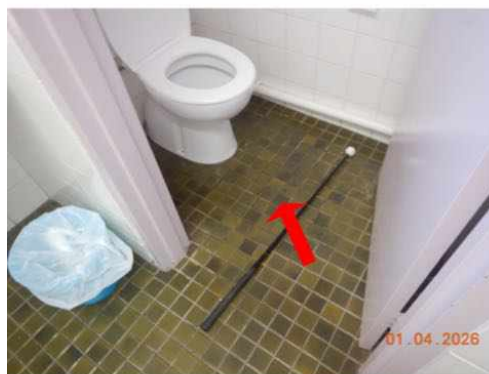
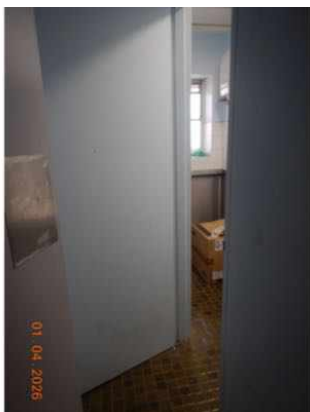
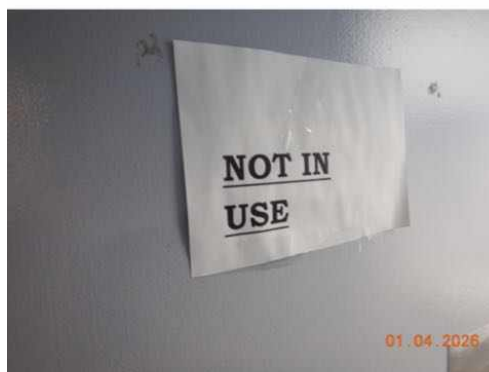
### Finding 3.06

Building:	Main Building
Location:	Toilet (WC) Downstairs > All Areas
Finding:	Tiles - Drummy
Information:	Drummy tiled areas were identified at the time of inspection. The term 'drummy' refers to tiles that have become detached from their fixing, despite otherwise being in relatively good condition. Such defects are generally caused by physical or moisture damage to the area. Drummy tiled areas may also be a direct result of poor workmanship during the construction process.

Tiled areas may swell and shrink with changes in air humidity if the area has sustained moisture damage. Any exposure to moisture is capable of causing tiled areas to become drummy and/or cracked over a prolonged period of time. Drummy tiled areas generally require removal and replacement of affected tiles, with adequate sealant and grouting.

Specialist trades are available for these types of services. A registered builder may be required to undertake works if damage is extensive or if secondary building defects have resulted. Otherwise, it is advised that a tiling contractor be appointed to perform works as necessary. Immediate action is recommended to ensure that no further damage is sustained in the affected area.

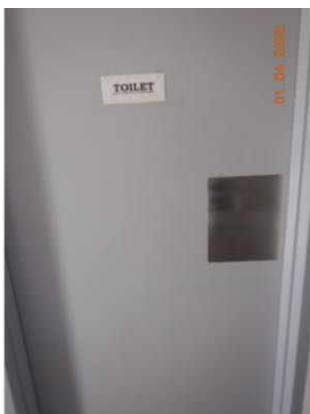
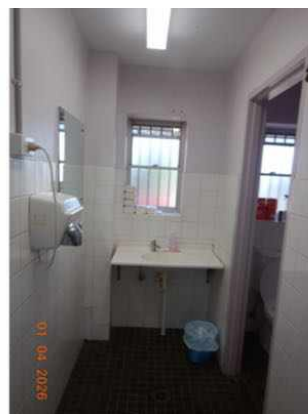
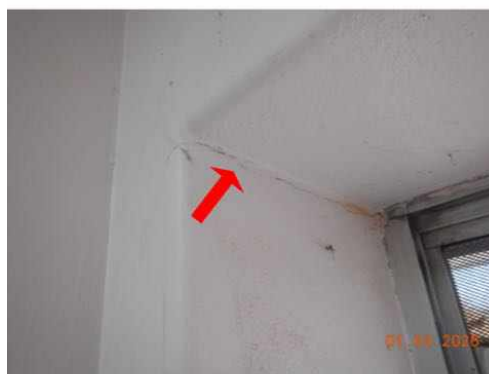
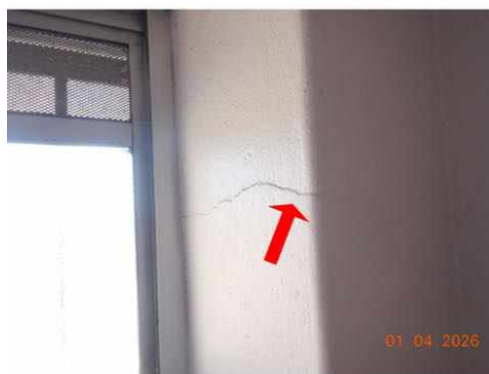
### Finding 3.07

Building: Main Building  
 Location: Toilet (WC) Downstairs > All Areas  
 Finding: Cracks to internal render - Category 1  
 Information: It has been observed that cracking to internal rendered surfaces has occurred. The degree of damage falls within Category 1, described as fine cracks that do not need repair and which are less than 1.0mm in width limit.

Damage of this category is not considered a defect for rectification. Always contact your building inspector should cracks widen, lengthen, or become more numerous.
