# Building and Timber Pest Inspection Report

Inspection Date: Wed, 1 Apr 2026

Property Address: 203 Lang St, Kurri Kurri NSW 2327, Australia

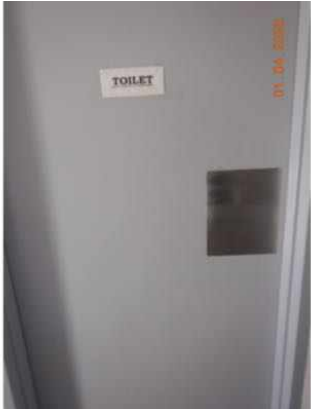
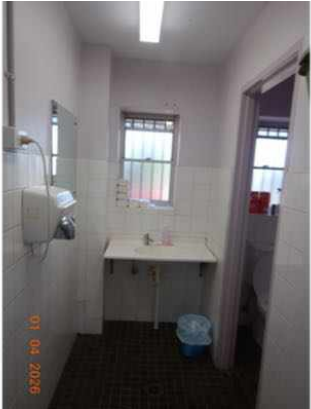
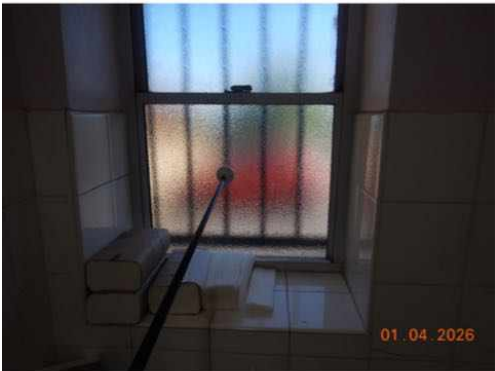
### Finding 3.08

Building: Main Building  
 Location: Toilet (WC) Downstairs > All Areas  
 Finding: Windows - Sash balances broken  
 Information: Sashes are the moveable panes of windows that primarily slide vertically over each other to expose one half of the window area. Each sash is provided with springs balances and/or compression weather-stripping, which act to hold the window in place in one position.

The sash balance mechanism will need replacement to allow the window to function as intended. Such works may be completed by a qualified carpenter or registered builder.

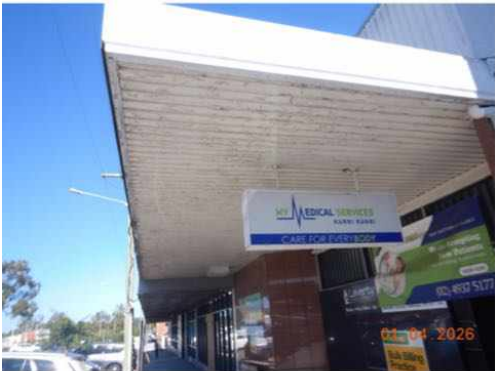
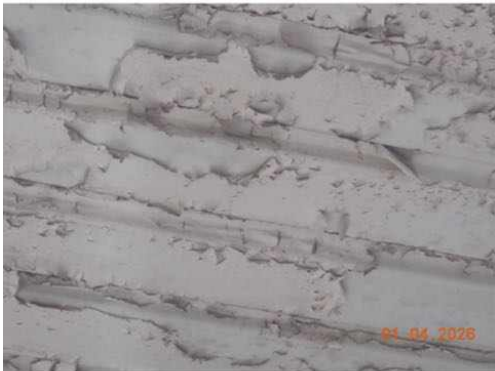
**Finding 3.09**

Building: Main Building  
Location: Roof Exterior > All Areas  
Finding: Awning Roof  
Information: The paint finish to the underside of the awning roof was found to be peeling and deteriorated. Consultation with a painting contractor is required to prevent further deterioration.

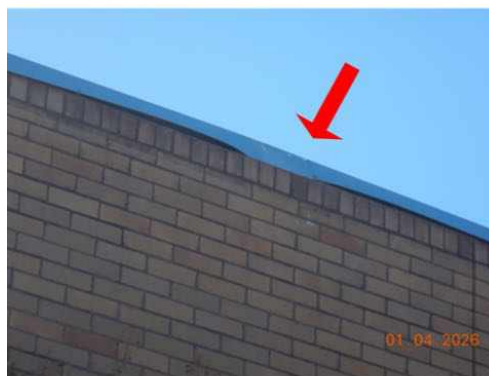
### Finding 3.10

Building:	Main Building
Location:	Roof Exterior > All Areas
Finding:	Roof Exterior
Information:	A flashing covering the top of an external brick wall on the right hand side of the building ( when looking from the rear of the building ) was found to have dislodged. Rectification is advised to prevent any damage from occurring. Consultation with a metal roofing contractor as soon as practicable is strongly advised.

It is important to note that the roof exterior was unable to be safely accessed, there is therefore a high risk of undetected defects in that area.

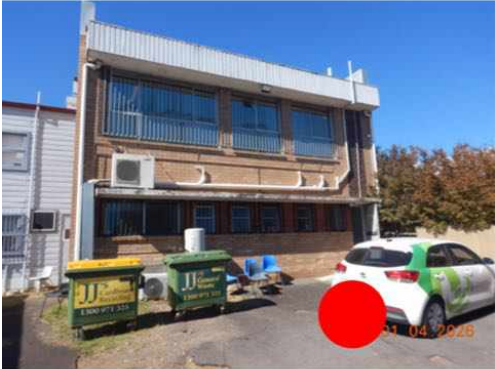
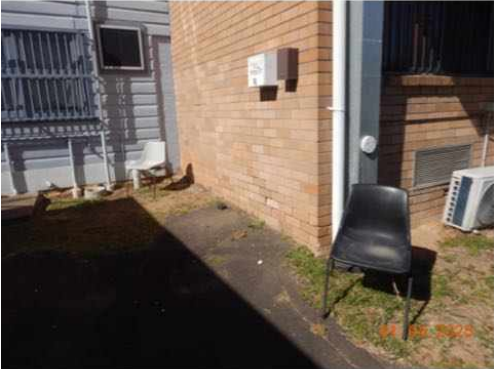
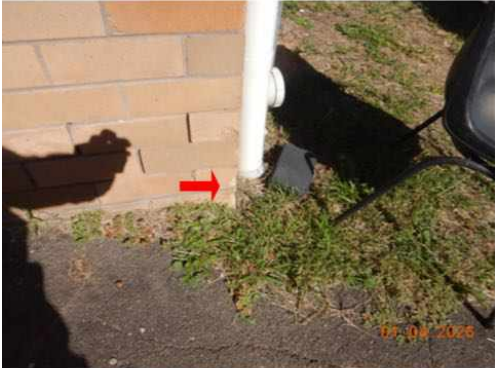
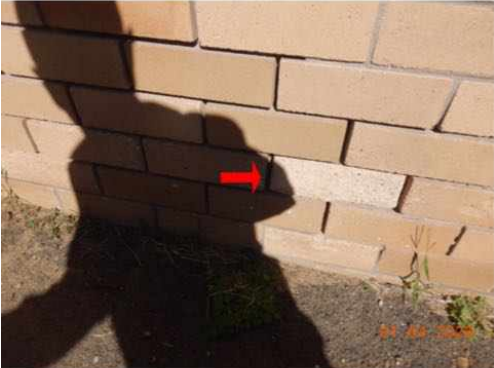
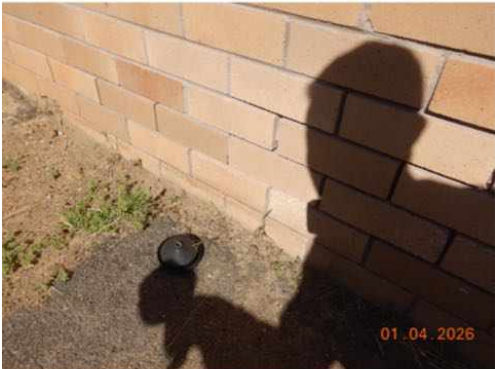
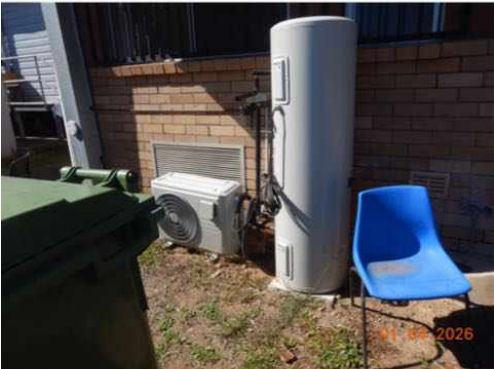
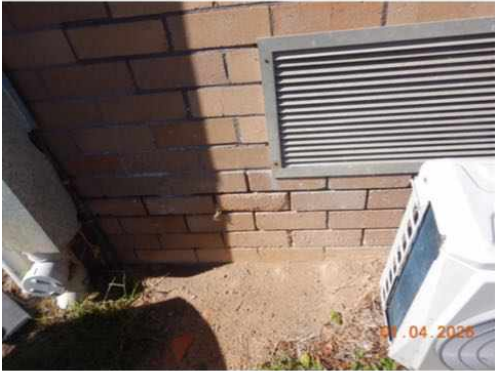
### Finding 3.11

Building:	Main Building
Location:	Exterior walls - rear > All Areas
Finding:	Brickwork - Deterioration
Information:	Deterioration was evident to sections of the brickwork in this area at the time of inspection. Commonly referred to as brick corrosion or erosion, the bricks are aged and likely to have been affected by a variety of factors, including weather exposure, damage, salt-based deterioration, and more.

Overtime, these factors can affect the bricks, causing them to become brittle and appear corroded or eroded. The mortar in the brickwork may also become powdery, further detracting from the structural integrity of the brickwork. If left unmanaged, potential implications include further deterioration of the building materials, the development of secondary defects, and potential development of structural instability of the wall.

Where this degree of damage has already occurred, you should consult a Building Surveyor or Engineer to seek advice regarding the structural stability and load bearing capabilities of the wall. Such consultation is always required prior to performing any remedial works on the affected brickwork.

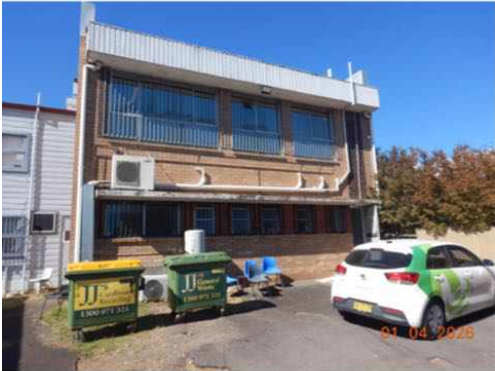
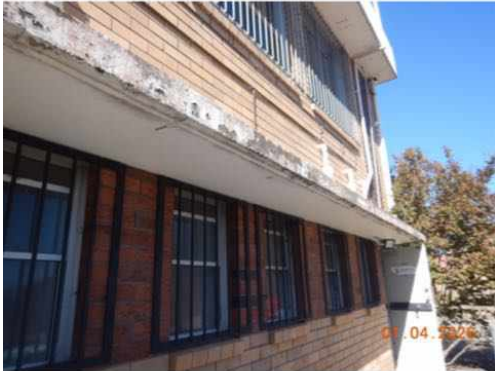
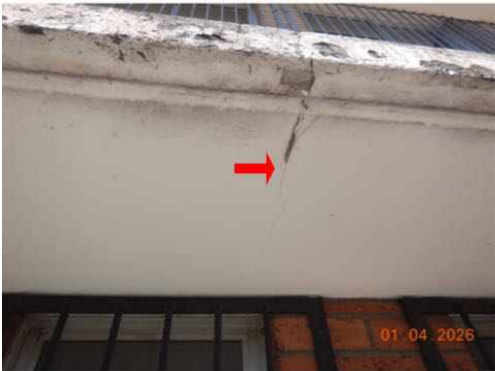
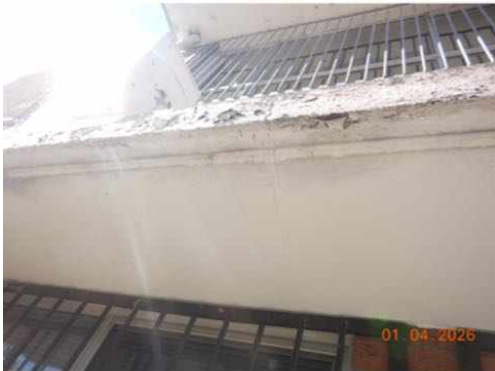
**Finding 3.12**

Building: Main Building  
Location: Exterior walls - rear > All Areas  
Finding: Concrete - Cracked  
Information: Cracking to the suspended concrete slab was noted at the rear of the building. Please note that the paint finish to the exposed part of the slab has deteriorated. Consultation with a painting contractor is advised.

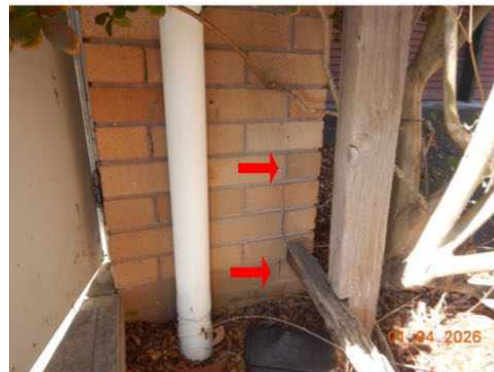
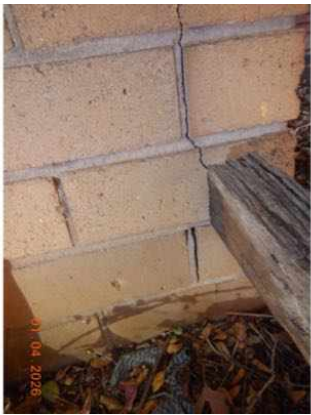
### Finding 3.13

Finding: Brickwork - Cracking [Fine]

Information: Although fine cracks are quite noticeable, they are often only considered to be an appearance defect and usually do not indicate any structural damage. Generally, the cause of a fine crack is indicative of a separation between brickwork and mortar throughout the structure, but single bricks may also show cracks of this nature.

Cracking of this nature can generally be repaired with minor filling and should be conducted by a qualified bricklayer.

Always contact a building inspector should cracks widen lengthen or become more numerous.

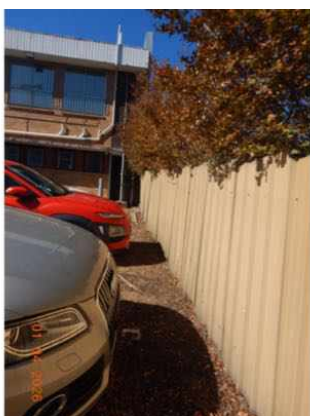
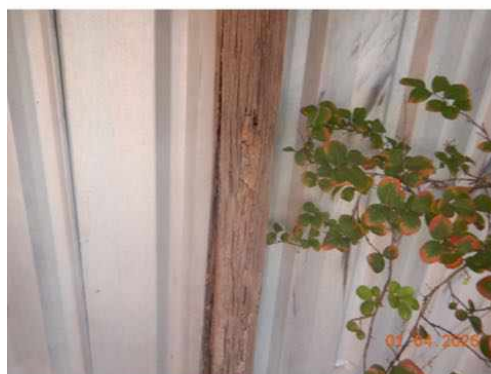
Building: Main Building  
Location: Rear Elevation > All Areas  
Finding: Fencing - Deteriorated

Information: It was noted at the time of inspection that sections of the fencing throughout the property have deteriorated. Typically fencing deteriorates due to age and or wear, rot and or rust which is generally expected for a structure of this age, due to prolonged exposure to weather conditions. Sometimes inadequate installation or maintenance can be to blame.

If left unattended, it is likely that further damage will occur. It is suspected that repair of several elements of the fencing may be required however replacement may be a consideration of the client also.

A licensed fencing contractor should be appointed to provide further advice and perform rectification works as necessary. Please note that the timber rails and posts have been severely damaged by termites.

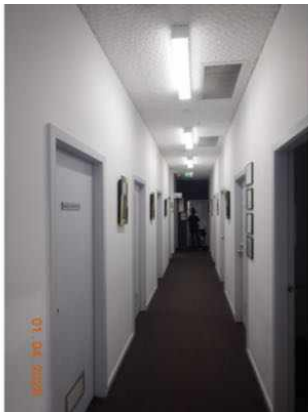
### Finding 6.01

Building: Main Building  
Location: All Internal Areas > All Areas  
Finding: Excessive moisture - identified  
Information: Excessive moisture can attract termites and produce conditions that promote fungal

growth and wood decay.

Excessive moisture is generally caused by deteriorated inadequate or missing roof drainage leaking plumbing pipes or fixtures poorly plumbed HWS overflows or condenser units and poor site drainage.

Please note that the highest detectable surface reading on this device is 999, the wet range starts at 200.

Prior to any remedial works being performed a qualified plumber should be appointed to further inspect the property and to identify the cause of the excessive moisture. Works to remove affected building elements may then be necessary and should be performed by an appropriate tradesperson.

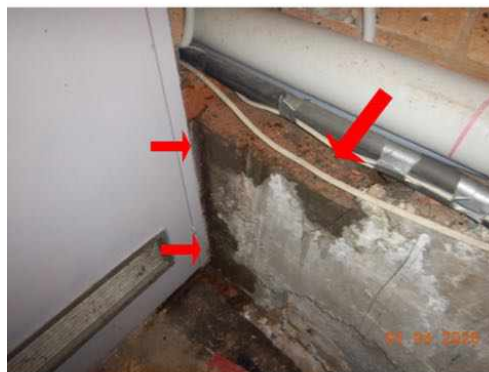
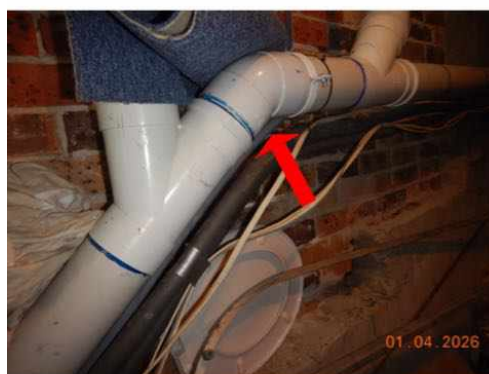
**Finding 6.02**

Building: Main Building  
 Location: Subfloor > All Areas  
 Finding: Excessive moisture - identified  
 Information: Excessive moisture can attract termites and produce conditions that promote fungal growth and wood decay.

Excessive moisture is generally caused by deteriorated inadequate or missing roof drainage leaking plumbing pipes or fixtures poorly plumbed HWS overflows or condenser units and poor site drainage.

Prior to any remedial works being performed a qualified plumber should be appointed to further inspect the property and to identify the cause of the excessive moisture. Works to remove affected building elements may then be necessary and should be performed by an appropriate tradesperson.

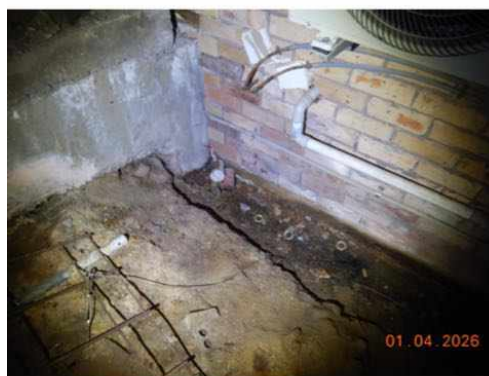
### Finding 6.03

Building:	Main Building
Location:	Subfloor > All Areas
Finding:	Damp
Information:	Damp (or structural damp) refers to the presence of unwanted moisture in the structure of a building, either as the result of intrusion from outside, or condensation from within the structure. Generally, structural damp is caused by rain penetration, rising damp, and leaks from plumbing pipes.

Unmanaged damp facilitates the formation and development of mould, fungi growth and wood rot, decaying associated building materials and compromising their structural integrity. Damage to finishes is also likely to occur, including lifting, bubbling, peeling and staining of paint, plaster and wallpaper.

The first step in addressing damp is to diagnose the cause. The identified cause should be addressed first prior to repairing the appearance and other defects which have resulted from the rising damp. If the original cause is not resolved, further cases of damp are likely to ensue, resulting in secondary defects.

Consultation with a qualified plumber is advised immediately to identify the cause of damp and perform remedial works as required. Where excessive mould growth is present, further inspection by a specialist environmental health inspector should also be considered.

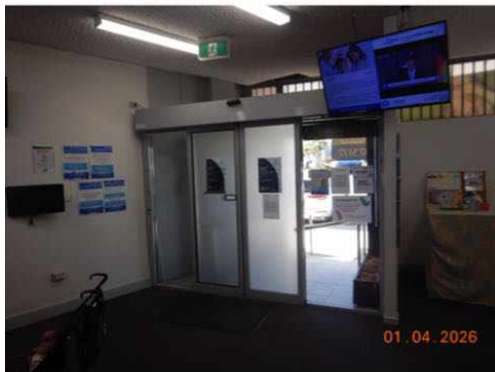
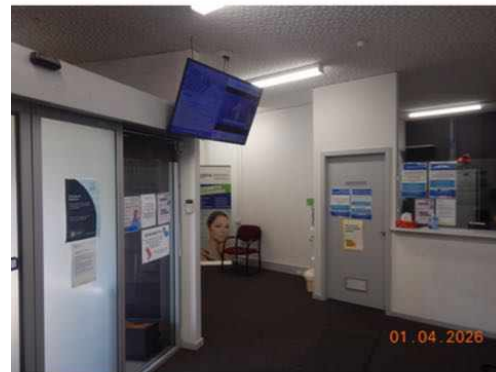
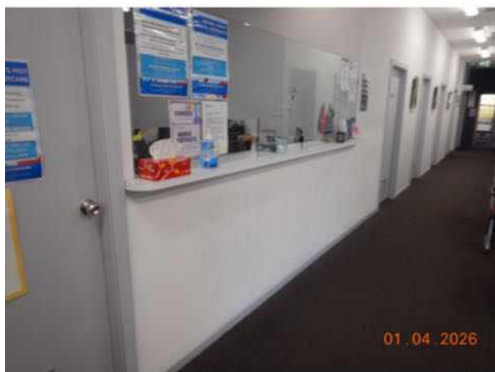
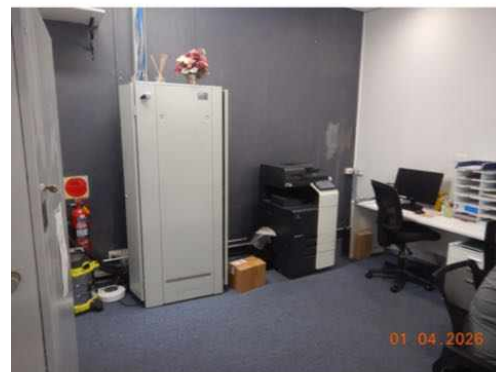
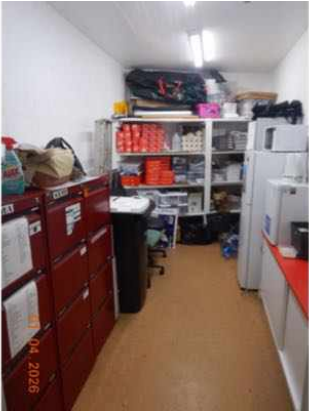
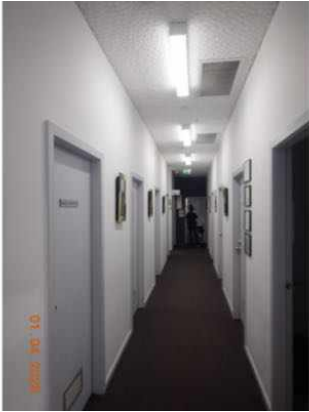
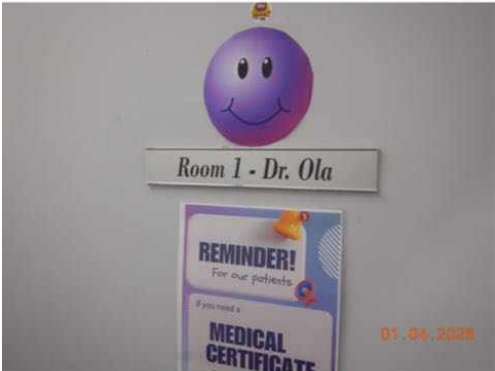
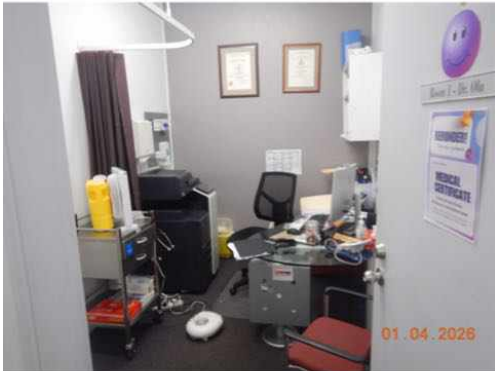
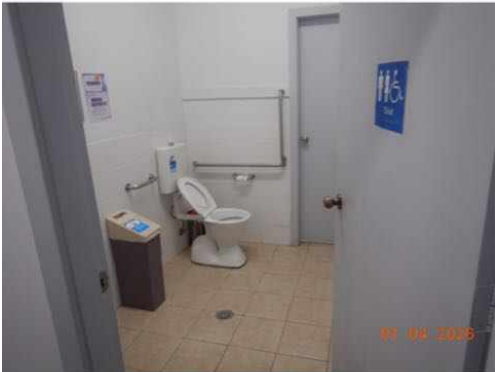
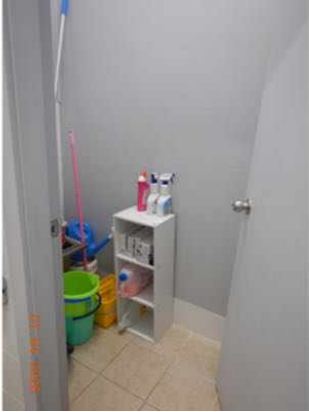
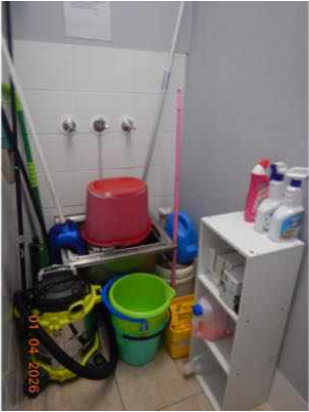
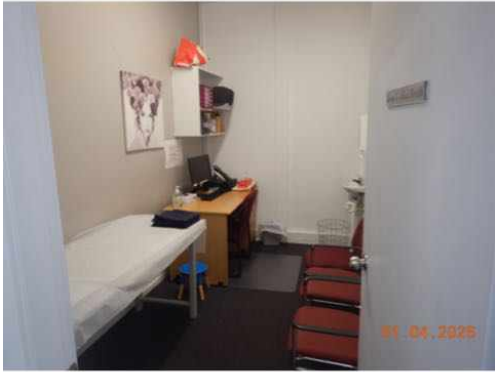
Building: Main Building  
Location: All Internal Areas upstairs > All Areas  
Finding: Additional Photos - Obstructions and Limitations  
Information: These photographs are an indication of the obstructions and limitations which impeded full inspection of the property at the time of inspection. These obstructions can hide an array of defects and should be removed to allow full inspection to be carried out. A re-inspection is recommended once the areas are made accessible. At the time of inspection staff and patients limited the access throughout.

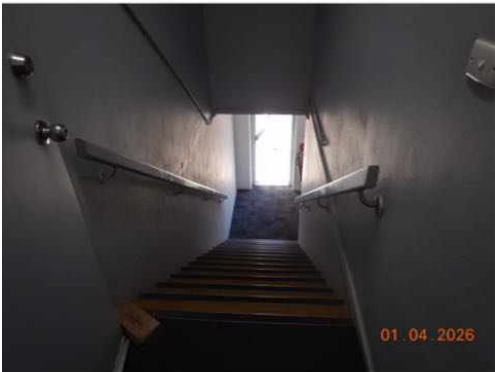
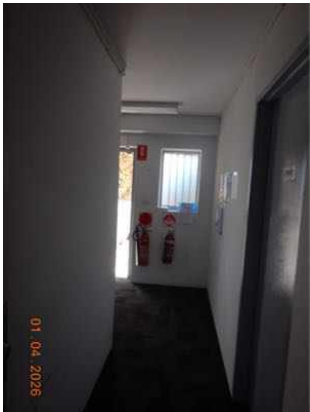
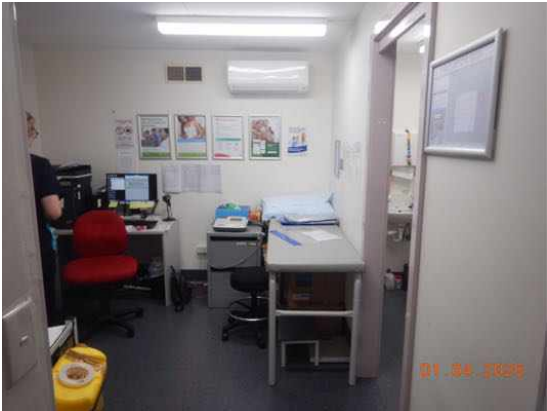
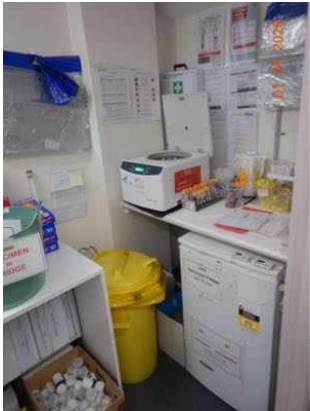
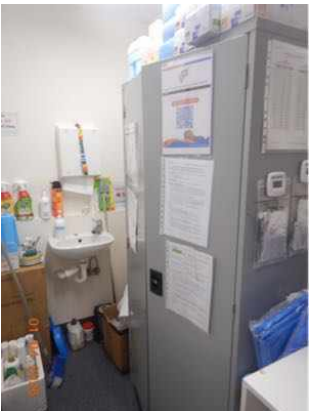
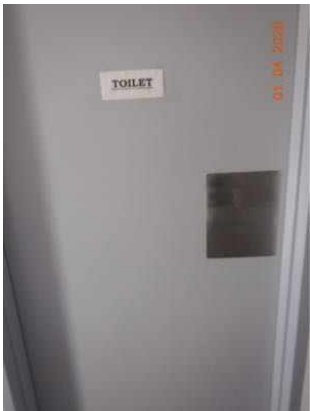
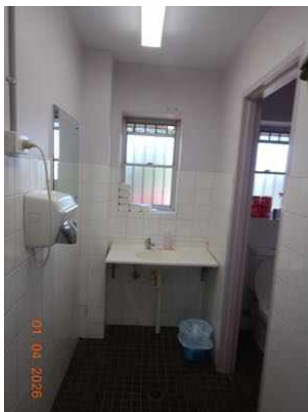
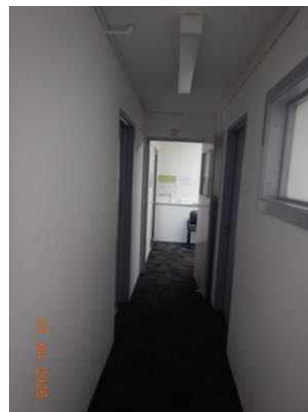
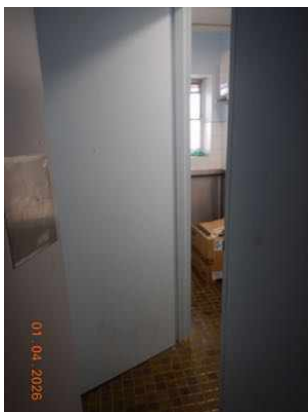
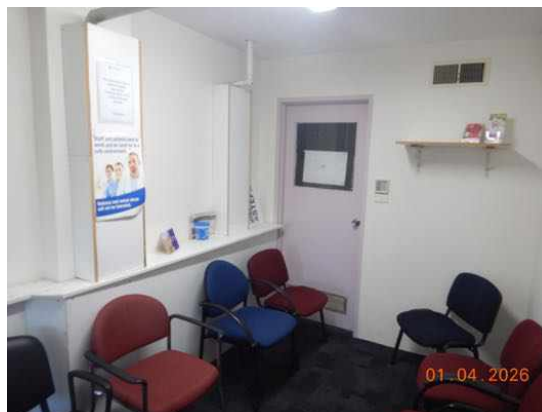
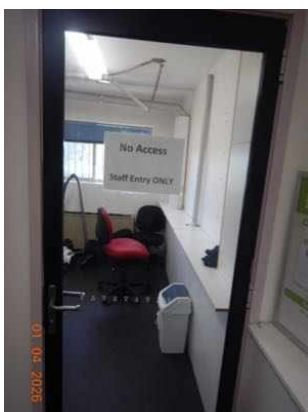
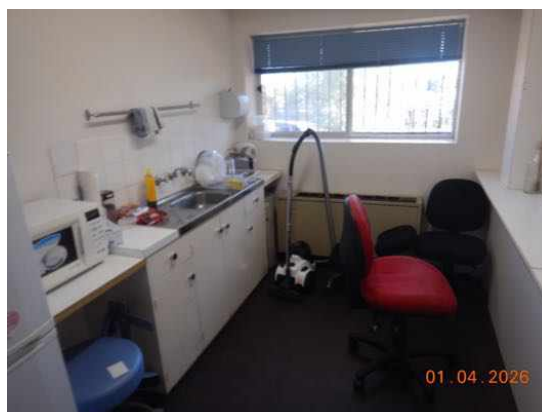
Building: Main Building  
Location: All Internal Areas Downstairs > All Areas  
Finding: Additional Photos - Obstructions and Limitations  
Information: These photographs are an indication of the obstructions and limitations which impeded full inspection of the property at the time of inspection. These obstructions can hide an array of defects and should be removed to allow full inspection to be carried out. A re-inspection is recommended once the areas are made accessible. At the time of inspection staff and patients limited the access throughout.

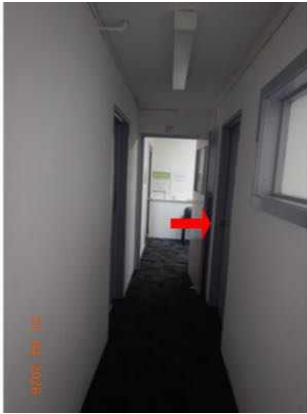
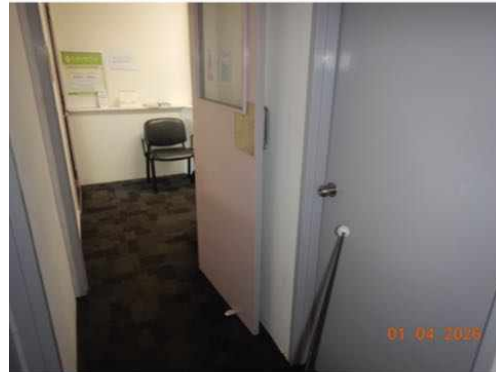
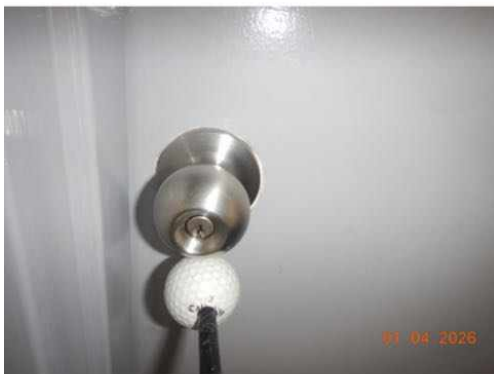
Building: Main Building  
 Location: Downstairs - Locked Room > All Areas  
 Finding: Additional Photos - Obstructions and Limitations  
 Information: These photographs are an indication of the obstructions and limitations which impeded full inspection of the property at the time of inspection. These obstructions can hide an array of defects and should be removed to allow full inspection to be carried out. A re-inspection is recommended once the areas are made accessible.

One of the downstairs rooms was found to be locked, I was advised by staff that Dr Ola lost the key to this room several years ago. As this room could not be accessed there is a very high risk of undetected defects within that area. A locksmith should be

engaged to allow access to enable this area to be inspected.

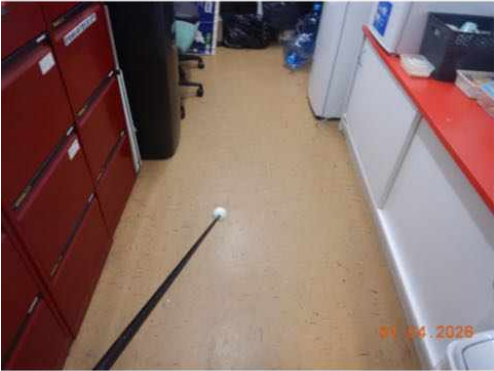
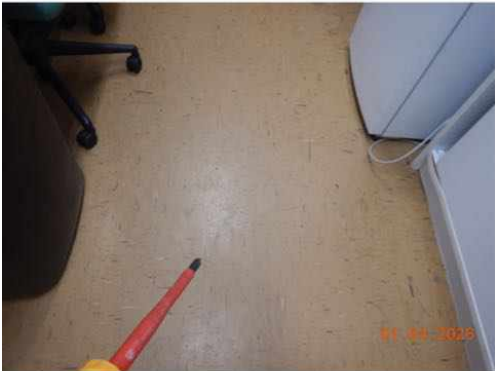
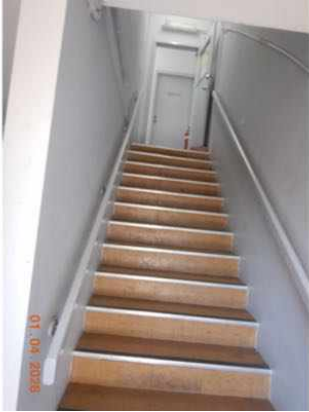
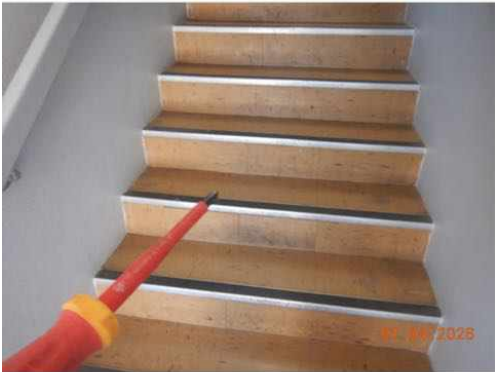
Building:	Main Building
Location:	All Internal Areas > All Areas
Finding:	Asbestos - Suspected ACM Identified on Site
Information:	The vinyl flooring in the old bank safe and on the internal stairs are suspected of being asbestos containing materials. Reporting on Asbestos is outside the Scope of this Report. This suspected defect is highlighted as a caution only. We suspect, based on our experience in the building industry, that there is a higher risk of the identified building element containing asbestos.

As Asbestos Reporting is outside the scope of this report, we advise that you consider a separate Asbestos Inspection and Condition Audit, which can include the taking of samples for definitive confirmation of the presence of Asbestos.

In the interim, the client is advised to act with caution, especially when considering any damage to building materials general wear and tear renovations extensions demolition and general maintenance activities due to the suspected presence of Asbestos.

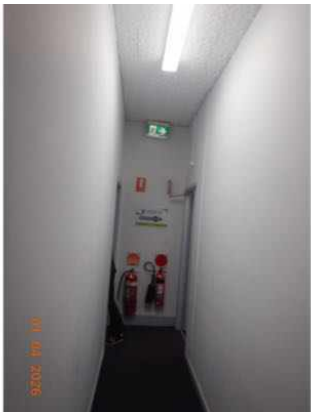
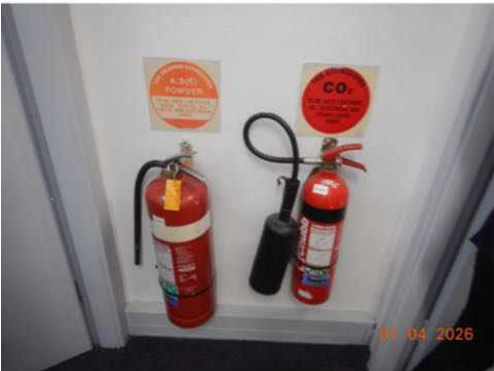
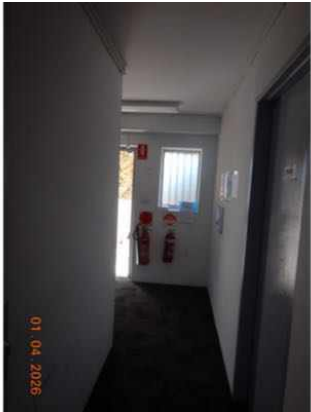
Building: Main Building  
Location: All Internal Areas > All Areas  
Finding: Fire Extinguisher Locations  
Information: Fire Extinguisher Locations

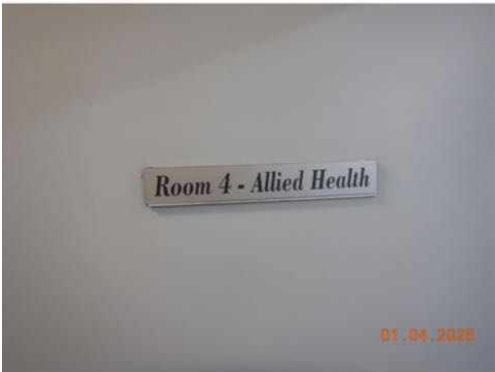
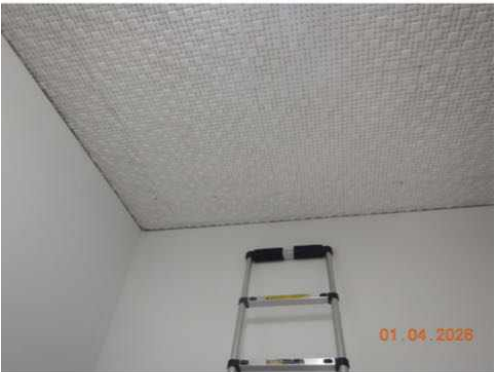
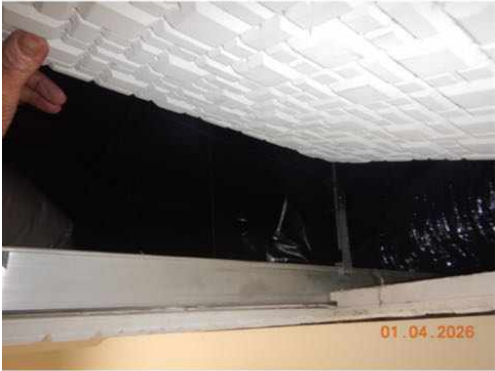
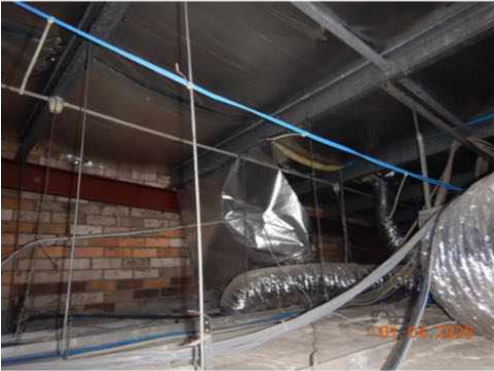
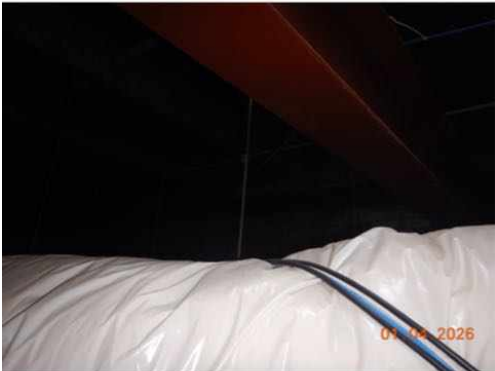
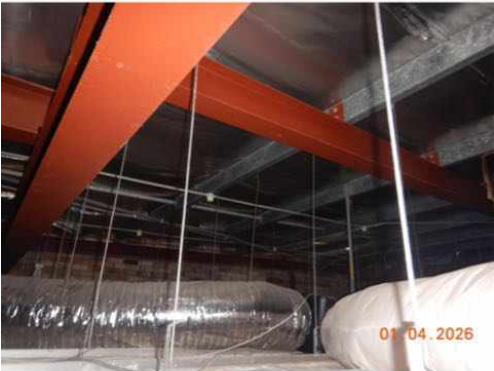
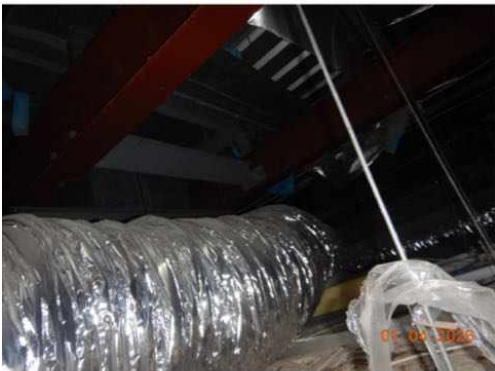
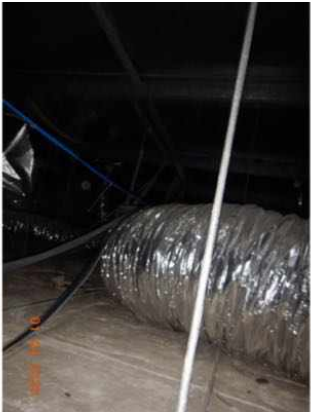
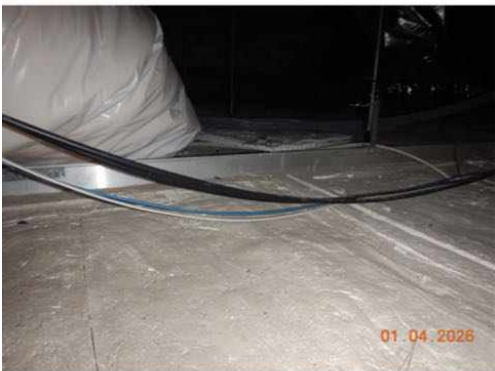
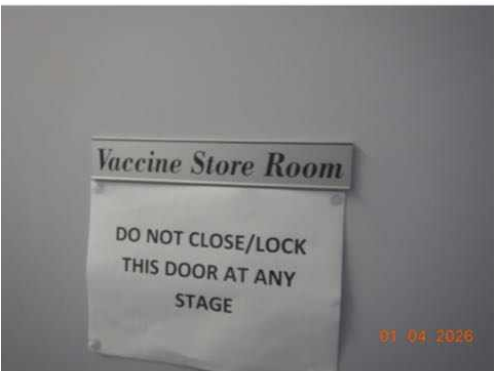
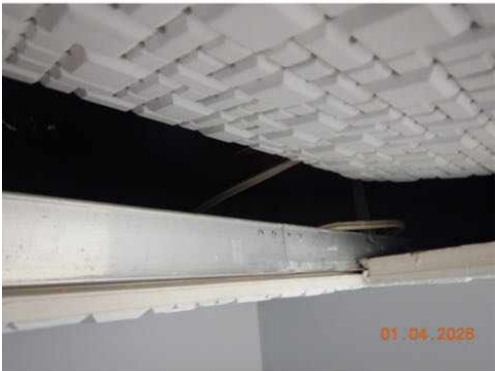
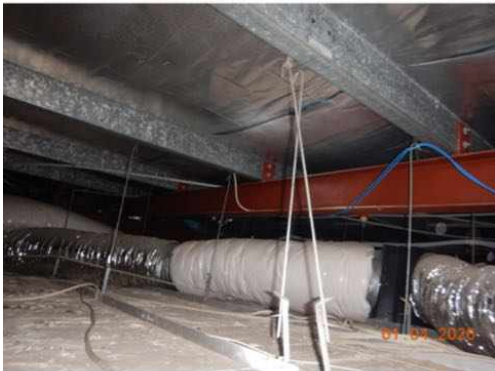
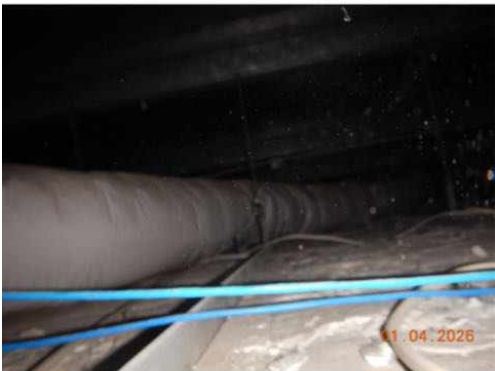
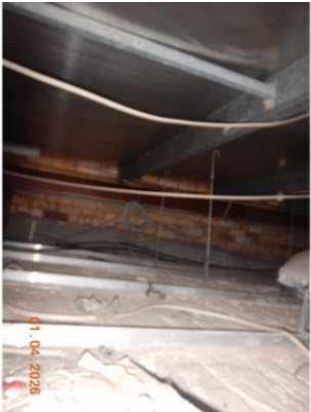
Building: Main Building  
Location: Roof Void > All Areas  
Finding: Roof Void  
Information: Please note that the roof void was unable to be safely accessed. The inspection of this area was strictly limited to photos from the top of the ladder in two locations. The ceiling tiles were not able to be removed to allow access.

Please note that there is a high risk of undetected defects within the roof void. A more invasive inspection of this area is required.

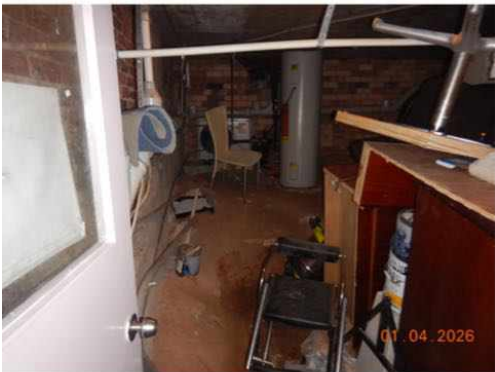
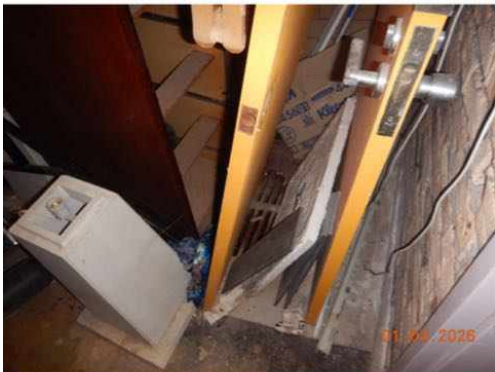
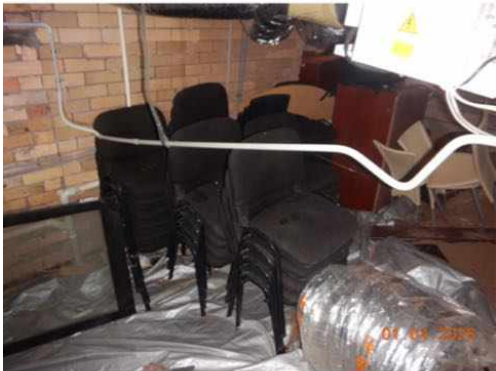
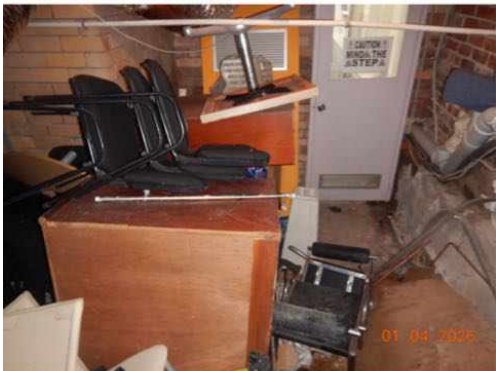
Building: Main Building  
Location: Subfloor > All Areas  
Finding: Additional Photos - Obstructions and Limitations  
Information: These photographs are an indication of the obstructions and limitations which impeded full inspection of the property at the time of inspection. These obstructions can hide an array of defects and should be removed to allow full inspection to be carried out. A re-inspection is recommended once the areas are made accessible.

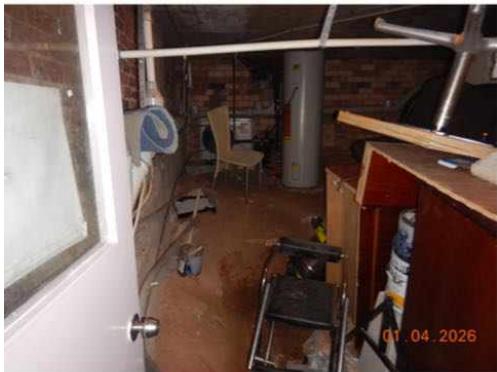
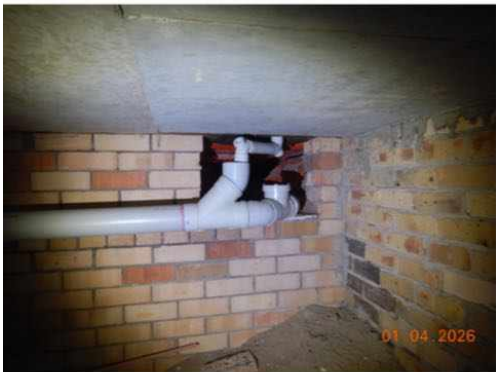
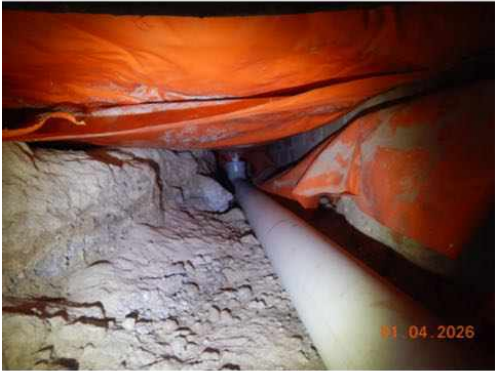
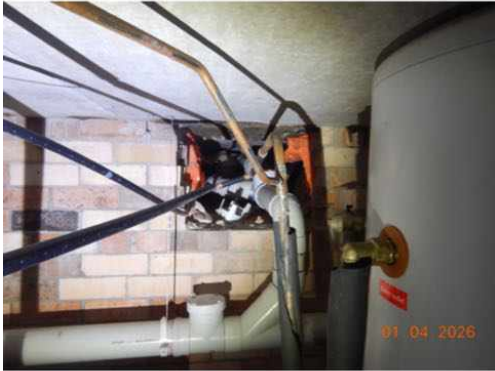
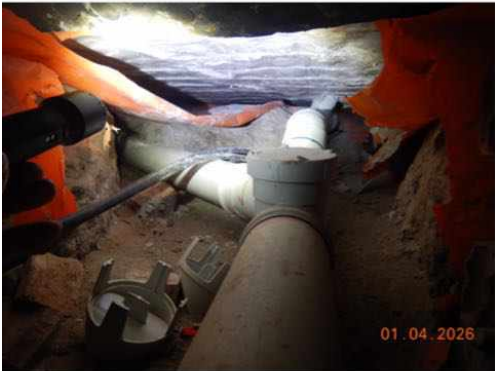
Building: Main Building  
Location: Subfloor > All Areas  
Finding: Additional Photos  
Information: Additional photos are provided for your general reference
