Building Inspection Report

Inspection Date: Mon, 16 Mar 2026

Property Address: 5/16 Landers Rd, Lane Cove North NSW
2066, Australia

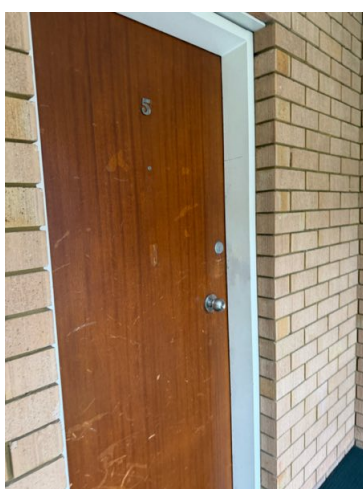
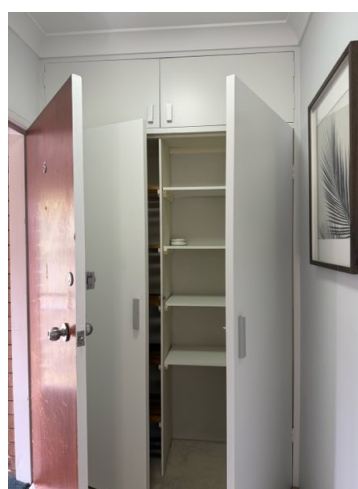
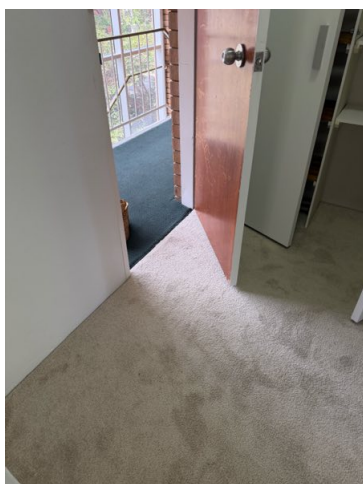
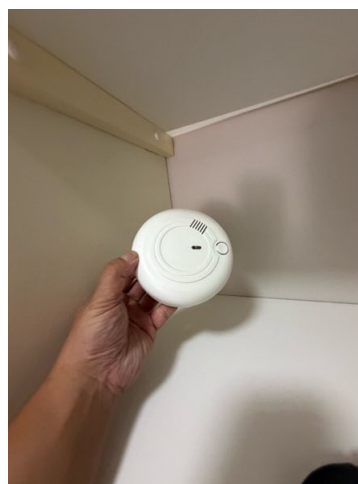
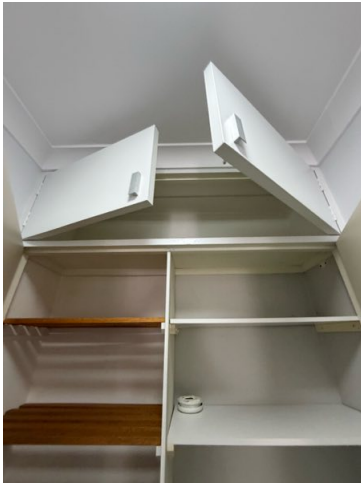
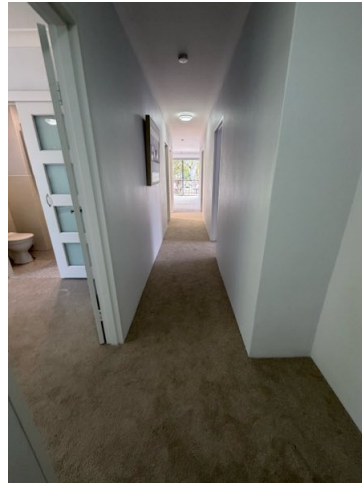
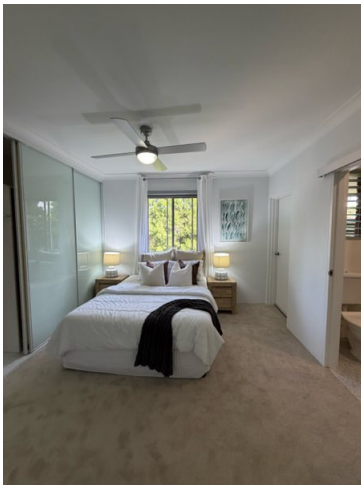
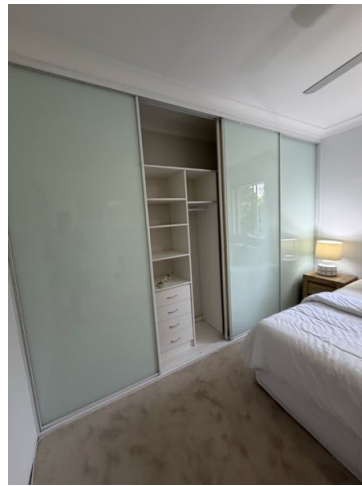
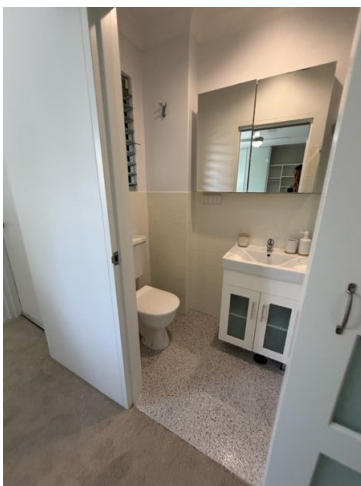
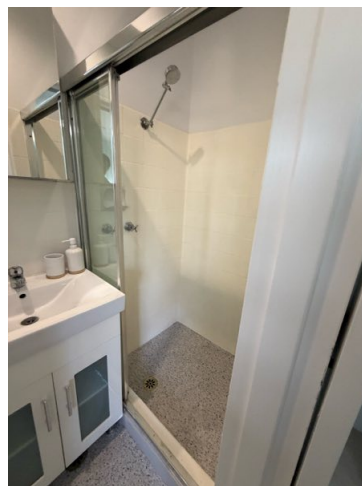
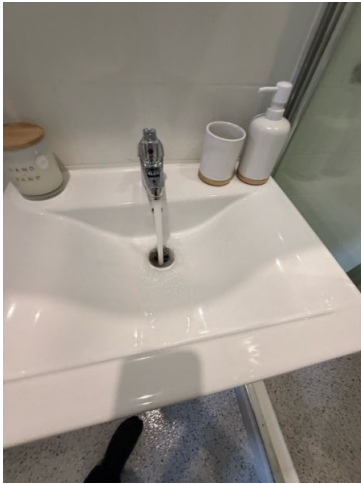
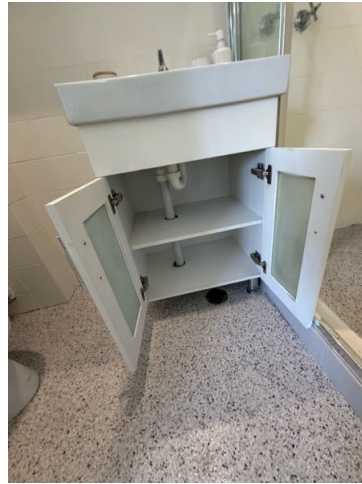
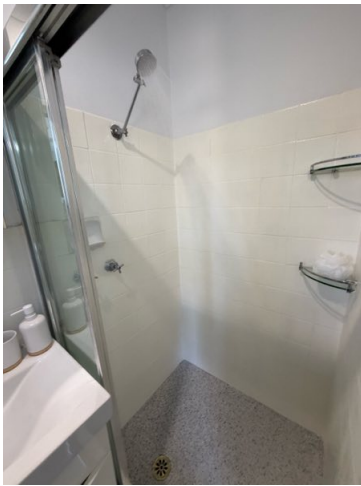
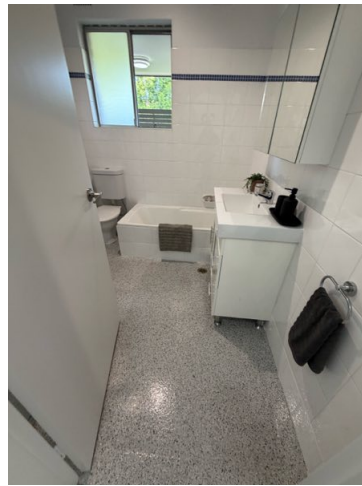
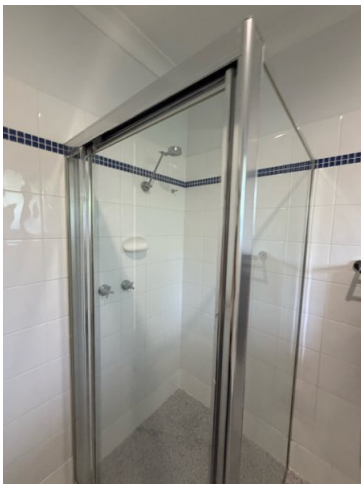
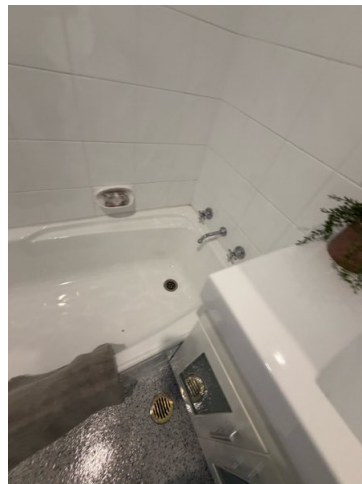
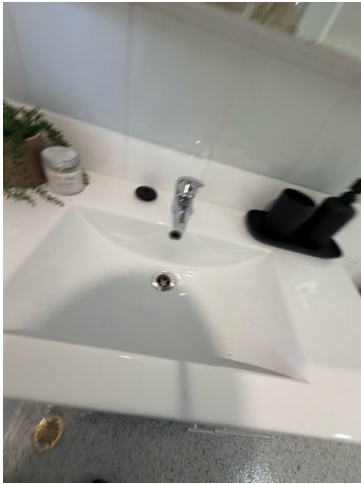
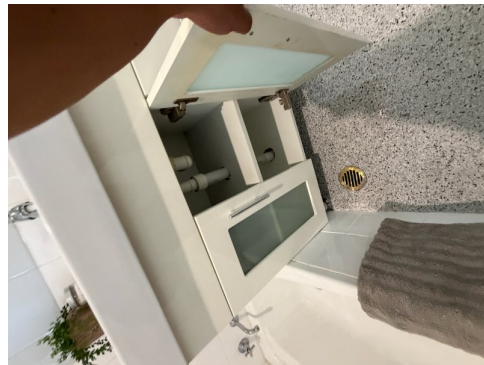
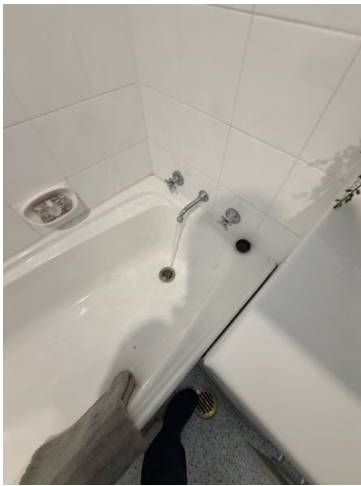
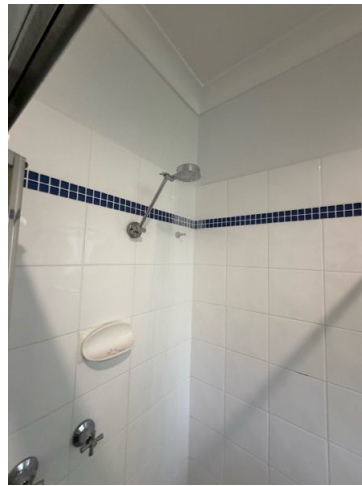
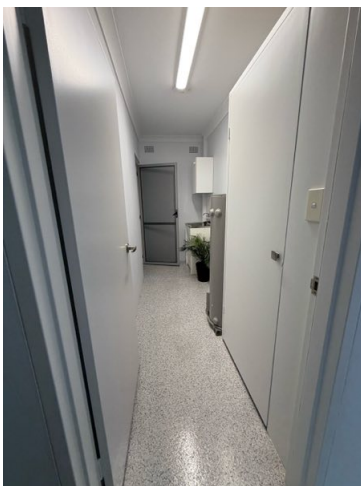
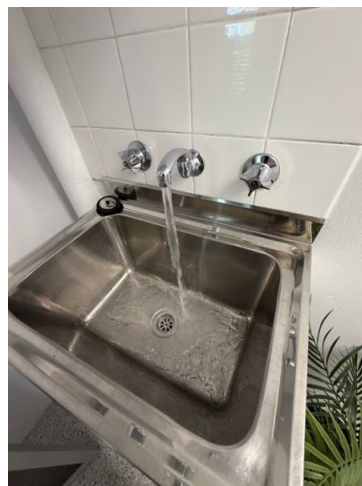
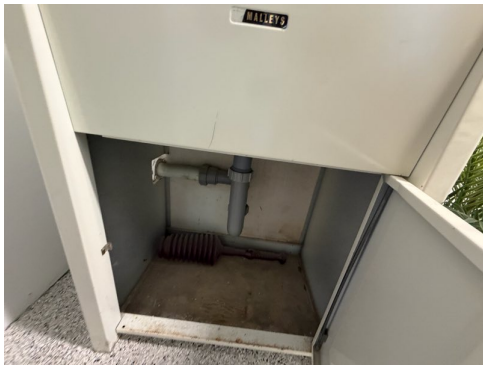
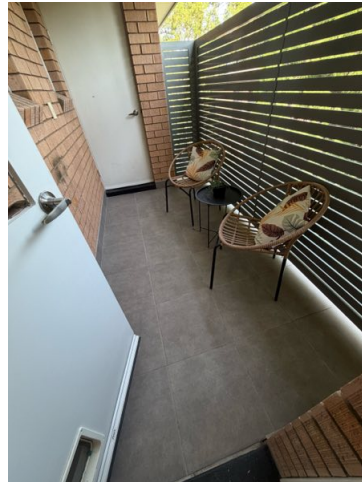
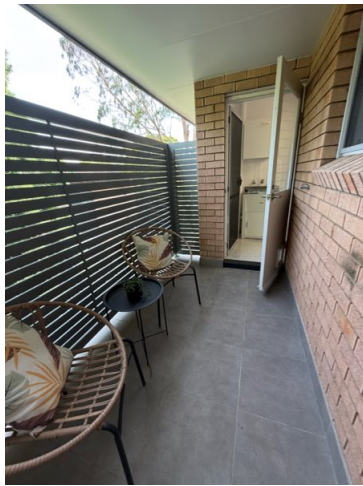
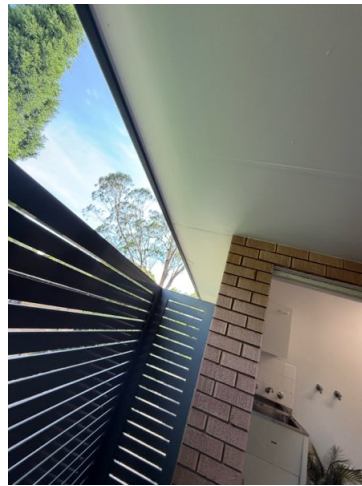
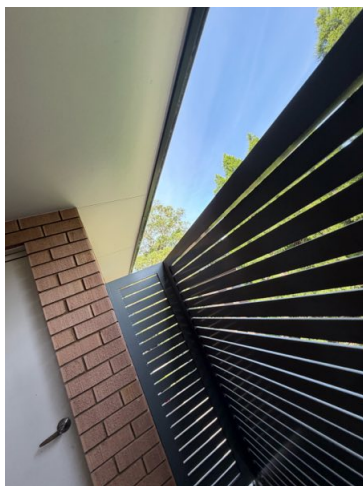
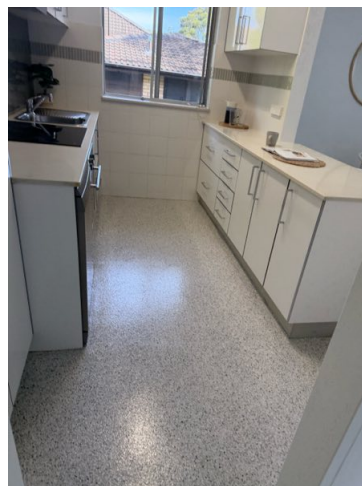
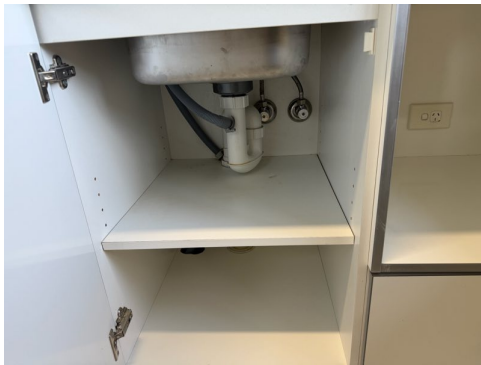
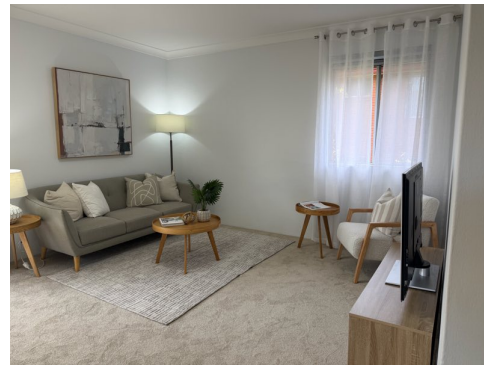
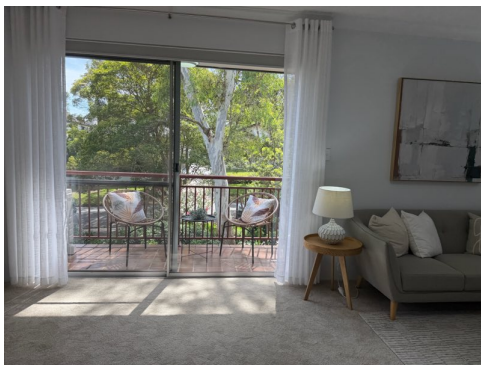
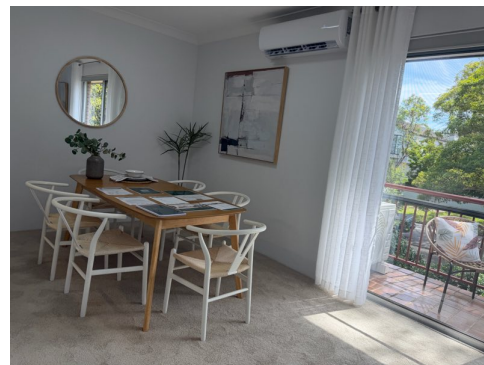
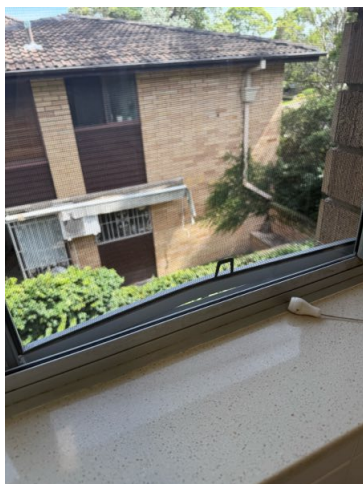
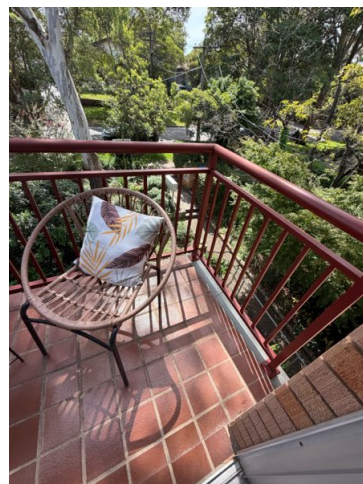
Finding: Additional Photos - Interior Area

Information: Additional photos are provided for your general reference and may include obstructions, limitations, testing of water, moisture readings or minor maintenance items.

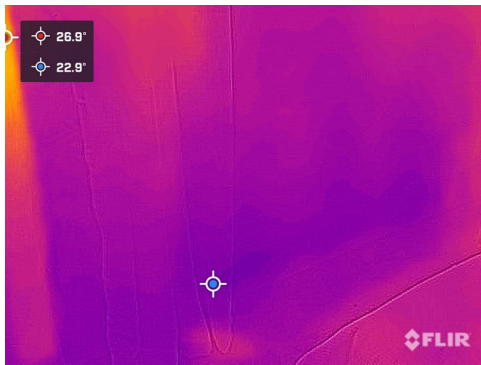
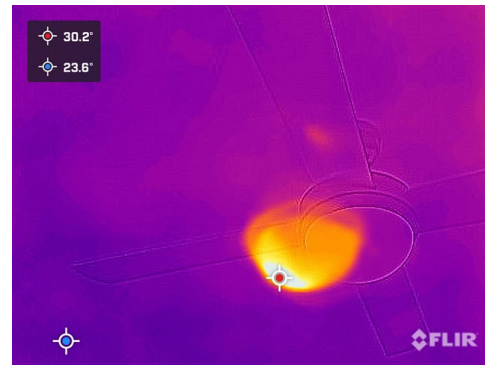
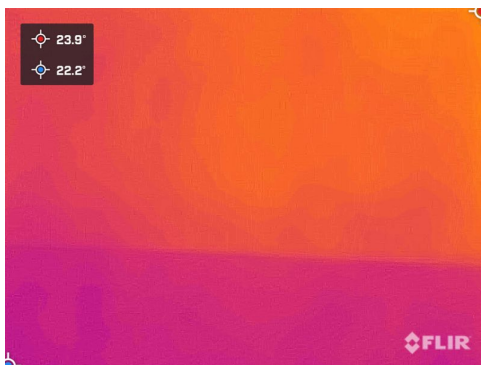
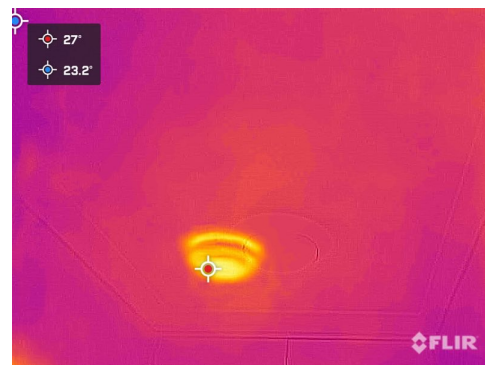
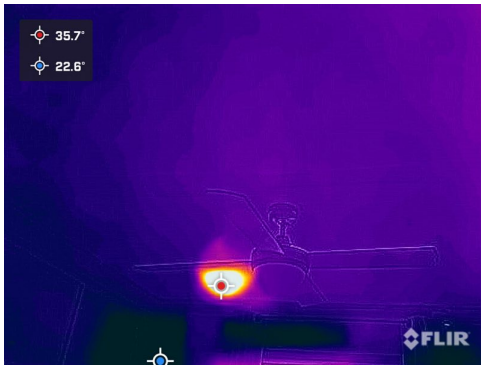
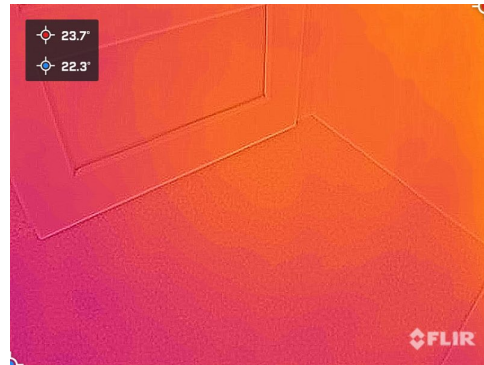
Finding: Additional Thermal Image Photos - Interior Area

Information: These Thermal Image photographs are an indication of the interior area at the time of inspection.
