Building and Timber Pest Inspection Report

Inspection Date: Wed, 4 Mar 2026

Property Address: 18 Lancaster St, Thornton NSW 2322,
Australia

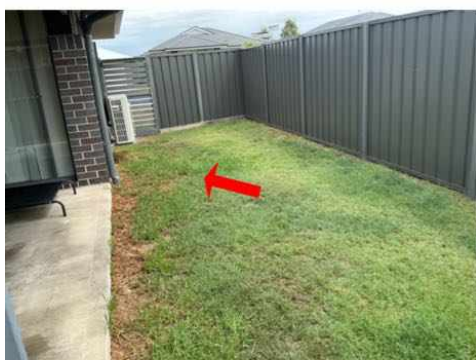
Building: Main Building
Location: Yard - Side
Finding: Inadequate Site Drainage - Exterior Areas
Information: At the time of inspection, inadequate site drainage was observed around the perimeter of the building, which can lead to water pooling and insufficient runoff management.

It is recommended that proper site drainage be installed, such as redirecting water flow away from the building or incorporating drainage systems, to prevent further damage and ensure the long-term stability of the structure.

To address the inadequate site drainage, a qualified landscaper or drainage specialist should be engaged to design and install appropriate drainage solutions, such as grading the ground away from the building or installing French drains, surface drains, or downspout extensions. If more complex issues are present, such as damage to the foundation or moisture entering the walls, a structural engineer may need to assess the situation, and a builder may be required for repairs.

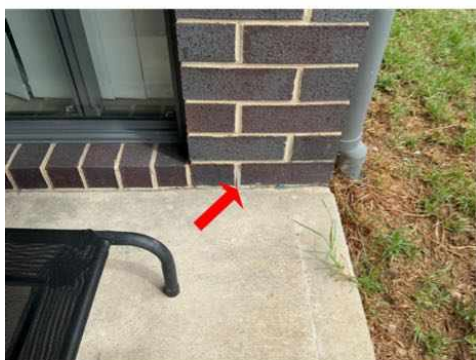
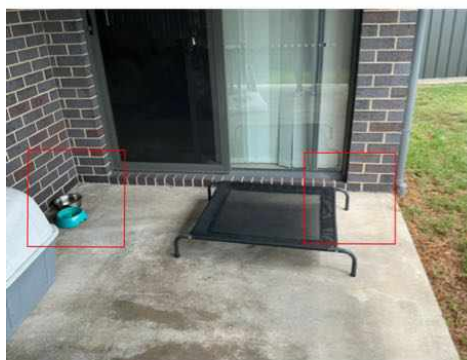
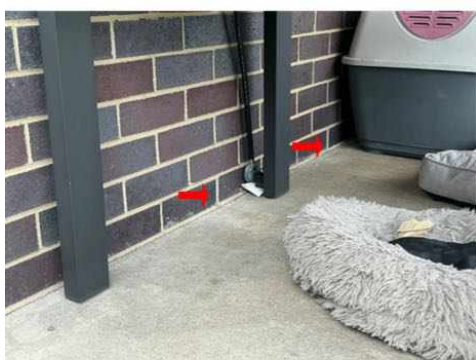
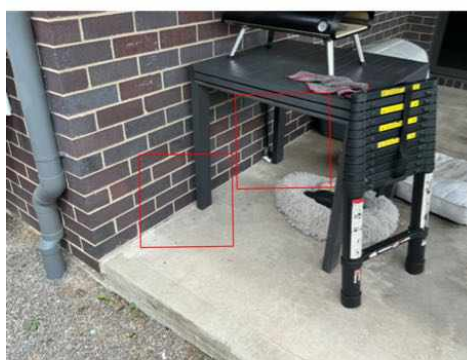
Finding 3.02

Location: Alfresco
 Finding: Weep Holes - At Ground Level
 Information: It was noted at the time of inspection, the weep holes have been identified at ground level, which constitutes a defect.

According to building standards, weep holes should be positioned above the finished ground level to ensure proper drainage and to prevent water ingress into the wall cavity. Weep holes located at ground level can lead to water entering the structure, causing potential damage to the masonry, insulation, and internal finishes. This placement fails to provide the necessary protection against moisture and does not comply with standard building practices.

The relevant tradesperson must address this issue by ensuring that weep holes are correctly positioned above ground level to meet the required standards and to maintain the integrity of the building.

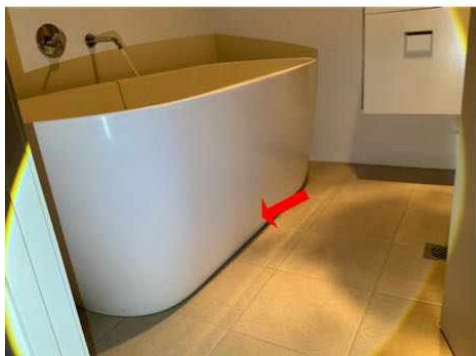
Finding 3.03

Building: Main Building
 Location: Bathroom
 Finding: Bathtub - Not Attached Securely
 Information: The bathtub in the bathroom is not securely attached to the ground, presenting potential stability and safety concerns.

Proper anchoring is essential to ensure that the bathtub remains firmly in place, preventing movement or tilting when in use. This installation defect may lead to damage over time or create risks for users, particularly if they lean against the bathtub's edge. To rectify this, it is recommended that the bathtub be correctly secured to the floor, in accordance with manufacturer specifications and building standards, to ensure safety and functionality.

The client is advised to engage services of a professional plumber to rectify this issue as soon as possible.

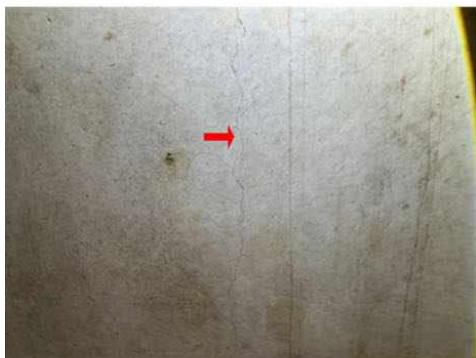
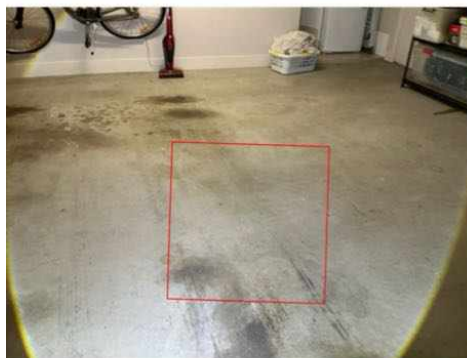
Finding 3.04

Building:	Main Building
Location:	Garage
Finding:	Crack in concrete slab - Category 1
Information:	A crack coded as Category 1 was identified in the slab. A Category 1 crack is described as a fine but noticeable crack, with the slab at an otherwise reasonable level.

To be considered Category 1, the approximate width of the crack is less than 1.0mm, or a less than 10mm change in offset when a 3m straight edge is placed over the defect.

Category 1 cracks should be monitored for a period of 12 months. At the end of the monitoring period, identified cracks that are rated greater than Category 2 are considered defects, and require rectification.

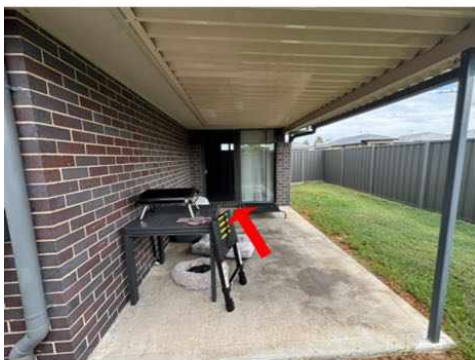
Finding 6.02

Building:	Main Building
Location:	Alfresco
Finding:	Bridging or Breaching of Termite Barriers - Adjacent Internal Flooring
Information:	Bridging is the spanning of a termite barrier or inspection zone so that subterranean termites are provided with passage over or around that barrier.

It is important for internal flooring to be raised above adjacent external ground levels. Where external ground levels are above or same level as internal flooring, water pooling and subsequent internal flooding is likely to occur which may attract termite activity to the internal area.

It is highly advised that a landscaper or relevant tradesperson be appointed to lower external grounds that are raised above or same as adjacent internal flooring. Alternatively if external grounds and internal flooring is level installation of a raised door sill may be appropriate in preventing any water pooling in the area. If the client wishes not to make any changes, then a qualified pest controller is recommended for termite treatment around the perimeter of the house and subfloor (if any) as soon as possible.

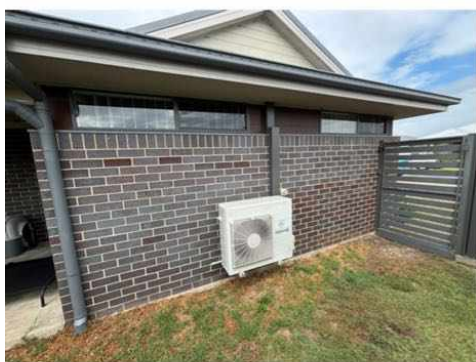
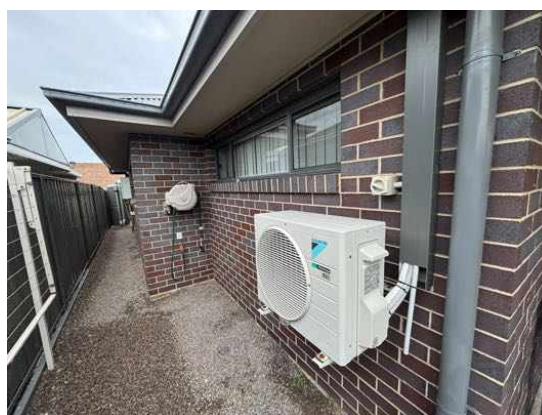
Finding 6.03

Building:	Main Building
Location:	Yard - Back
Finding:	Bridging Appliances - Attachment to Buildings
Information:	Bridging occurs when items against a building provide a concealed entry point for termites into the building or by passing around a termite management system.

Where any part of an attachment to a building is not isolated and is not provided with a clear gap of not less than 25mm from the building, bridging occurs. Attachments to buildings such as hot water services, downpipes, verandahs, decks, steps, fences, service conduits and the like provide the opportunity for concealed entry.

Building attachments of this nature need to be frequently inspected for termite activity by a qualified inspector.

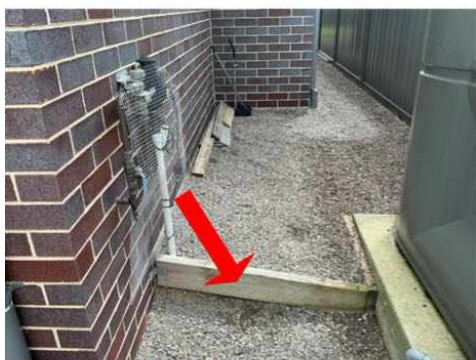
Finding 6.04

Building:	Yard
Location:	Yard - Back
Finding:	Building Materials in Direct Ground Contact - Conducive to Termites
Information:	Timber elements that are in direct contact with the ground and exposed to moisture or damp conditions are highly conducive to termite activity. This susceptibility arises because timber, when in contact with soil and dampness, creates an environment that is particularly attractive to termites, encouraging infestation and potential structural compromise. Whether the timber is used as a part of the building's construction or incorporated into fencing, its presence near or on the ground can become a pathway for termites to access and damage the property.

When exposed to excessive moisture, timber begins to deteriorate, developing conditions such as wood decay and rot. These compromised areas of timber are even more appealing to termites, as they are easier to infest and consume. This is especially true for untreated or non-durable timber, which lacks the protective treatments that can deter or withstand termite attacks. Termites can use these weakened, moisture-laden elements as a bridge into other parts of the structure, creating an entry point for potential infestations that can spread and cause extensive

damage if left unchecked.

For any timber in direct contact with the external ground, special attention is required. The combination of moisture, untreated wood, and direct ground contact not only accelerates the decay process but also provides subterranean termites with a straightforward means of ingress into the structure. This entry can lead to termites moving undetected into other vulnerable areas, resulting in potentially significant structural issues and costly repairs.

To mitigate the risk of termite activity, it is imperative that any such materials or timber elements be appropriately treated or removed as soon as possible. Timbers that are necessary for use should be made durable through appropriate treatments and maintained to ensure they do not create conditions conducive to termites. Additionally, the client is advised to schedule regular termite treatments to maintain an effective barrier against infestations and ensure ongoing protection.

The client is strongly advised to assess the property for any timber elements that may be in direct contact with the ground and ensure prompt action is taken to remove or treat them effectively. Regular inspections, proactive maintenance, and consistent termite treatment are essential steps in minimising the risk of termite attack and protecting the structural integrity of the property. Taking these preventive measures is crucial for maintaining a termite-free environment and avoiding potentially costly damage and future repairs.

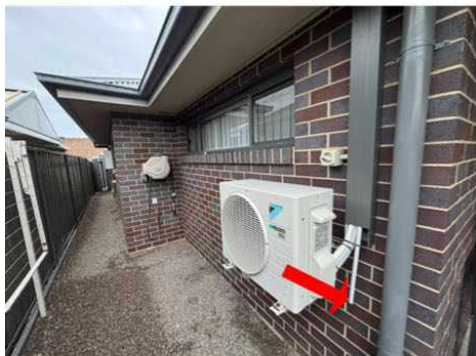
Finding 6.05

Building:	Main Building
Location:	Exterior walls - rear
Finding:	Overflow Disconnected - HWS/AC/Gas - Conducive Conditions to Termites
Information:	The overflow to this service was found to be disconnected from stormwater drainage and is creating excessive moisture in the surrounding area.

Such leaking creates an environment that is conducive to an array of defects, including water damage to associated building elements and the attraction of termite or timber pest infestation. These damp conditions can lead to secondary defects such as rot,

rust, or corrosion of associated building elements, the formation of fungal decay, or even the creation of potential slip hazards. When coupled with poor site drainage, pooling of water may also attract termite activity to this area.

It is highly recommended that a licensed plumber be appointed to connect the overflow in order to prevent such an environment from being created. These minor works should be carried out as soon as possible.

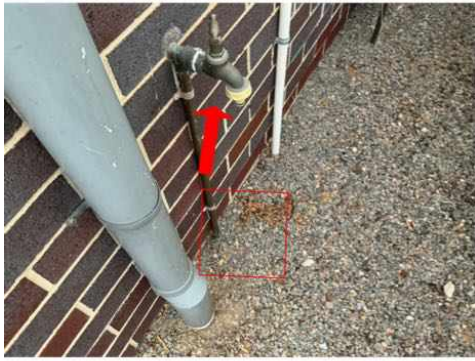
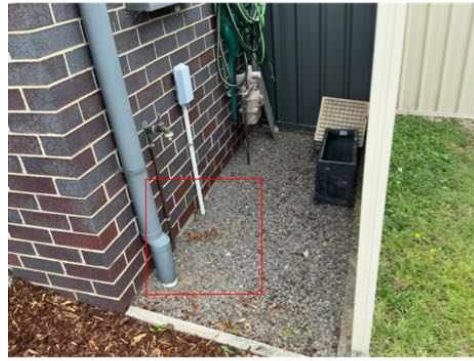
Finding 6.06

Building:	Main Building
Location:	Exterior walls - right side
Finding:	No Stormwater Drain - Under Exterior Tap
Information:	The inspection identified that the exterior tap is not connected to a stormwater drainage system, allowing water to pool around the base. This can lead to moisture-related issues such as deterioration of nearby building materials, mould growth, and increased risk of termite activity—each of which may compromise the property's structural integrity and create health or safety concerns.

To prevent these risks, it is strongly recommended that a licensed plumber be engaged to assess the area and install appropriate drainage, such as a stormwater connection or splash block, to redirect water away from the property. Ongoing maintenance and monitoring of external water sources are also advised to ensure long-term protection.

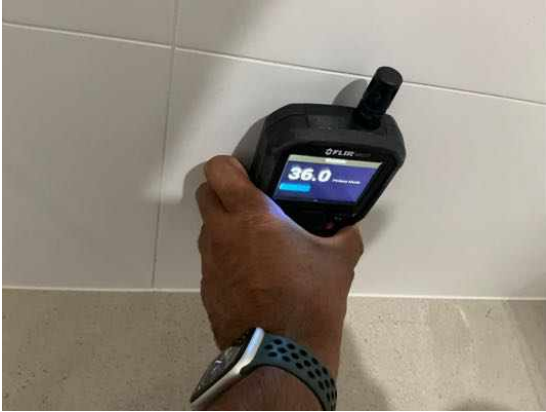
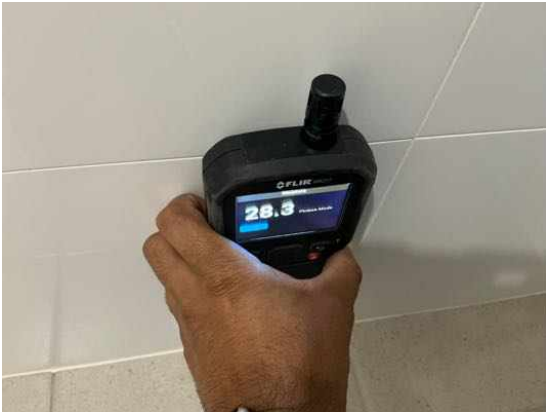
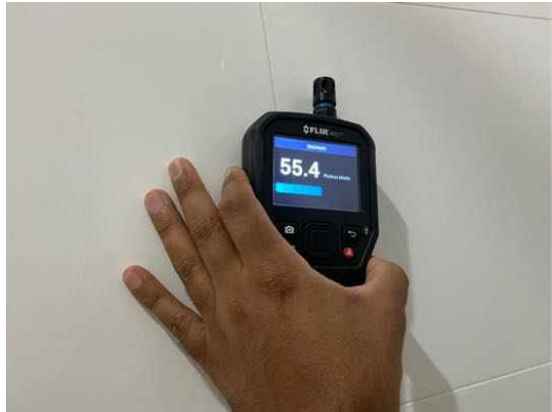
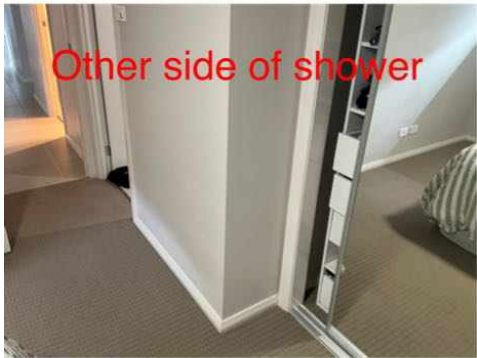
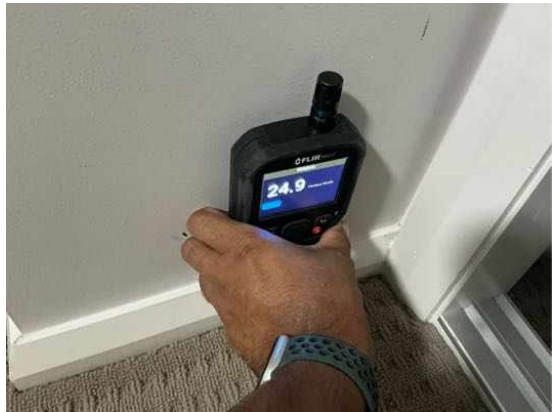
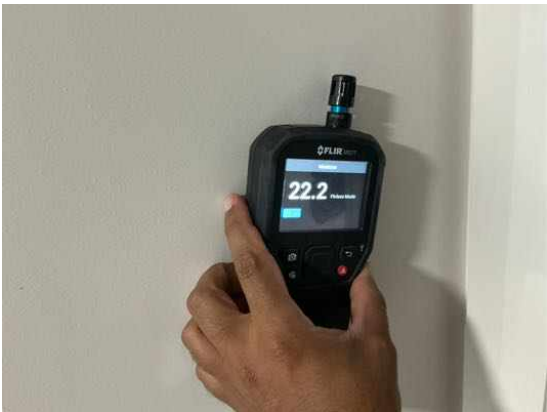
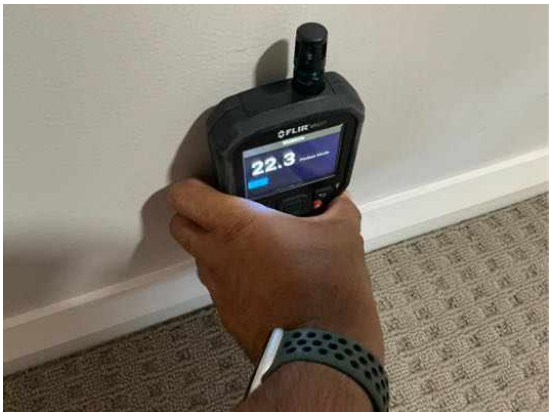
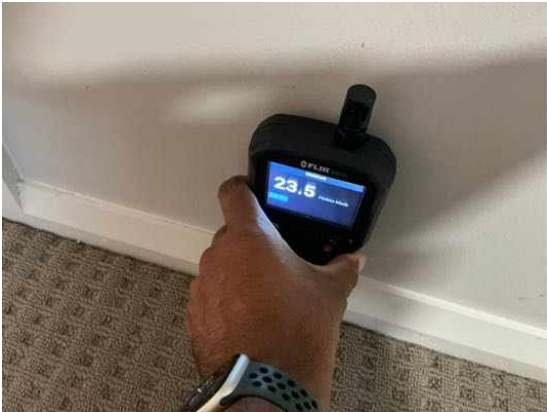
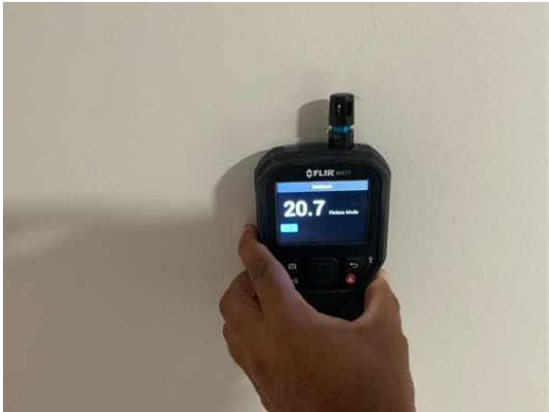
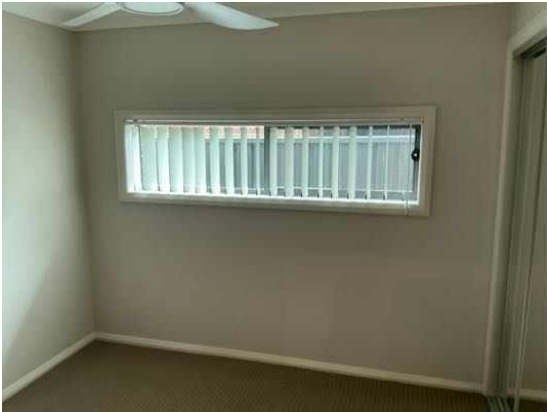
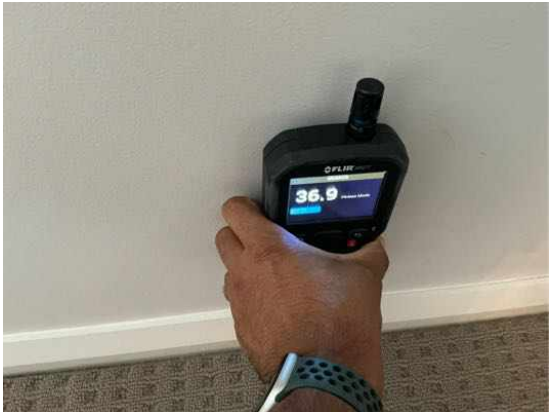
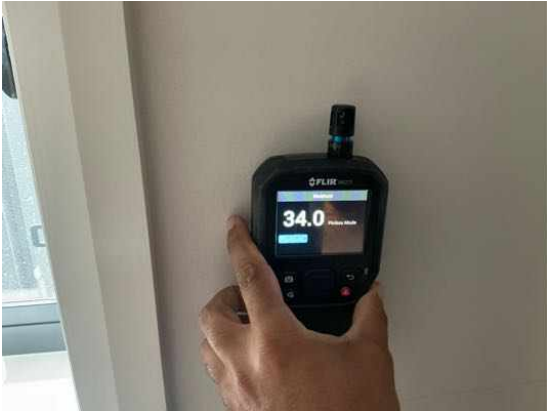
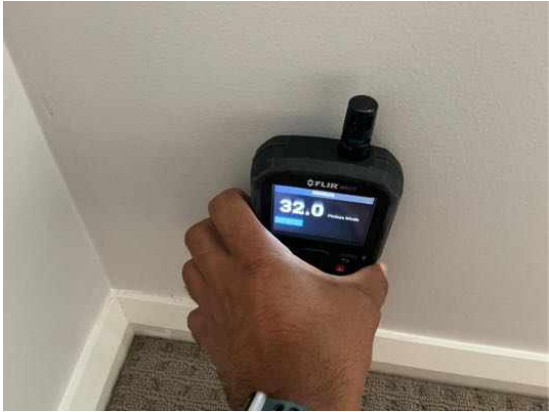
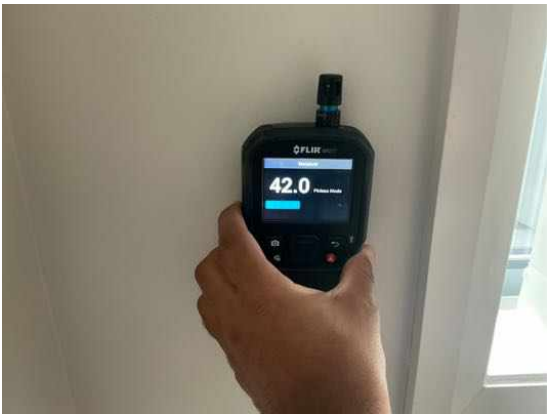
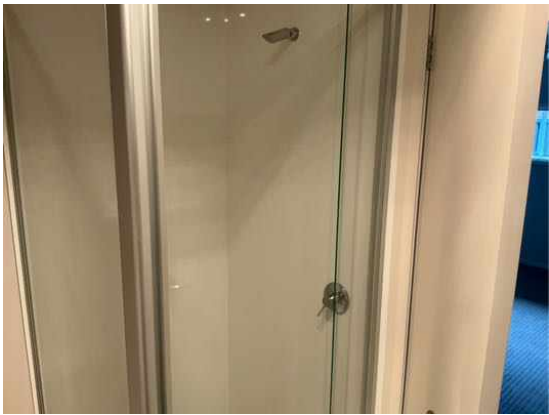
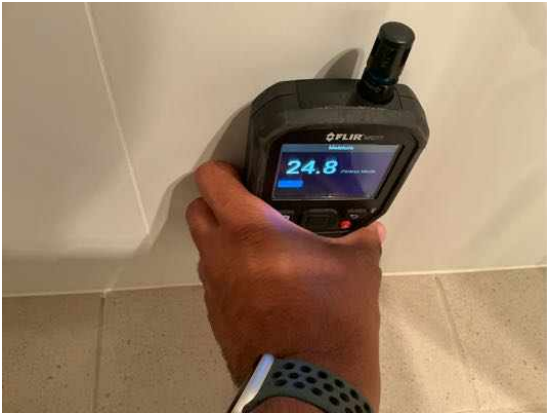
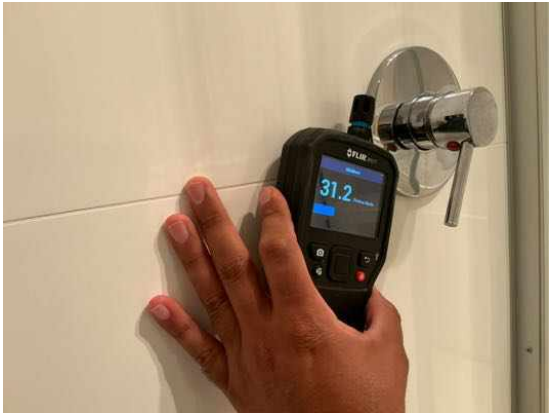
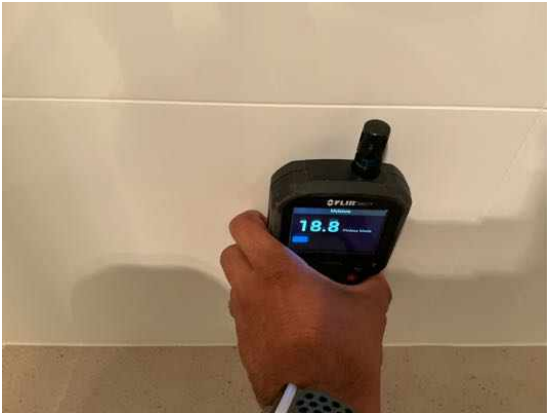
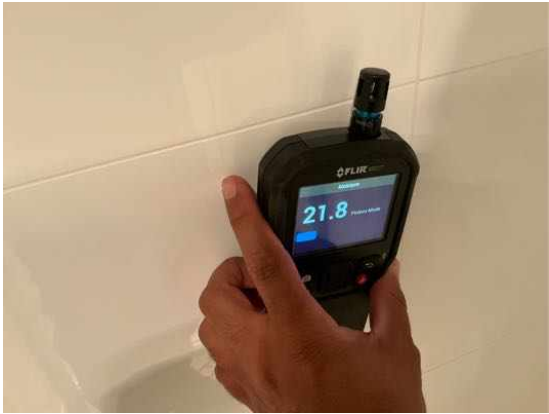
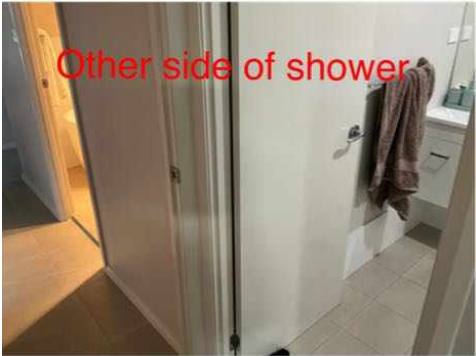
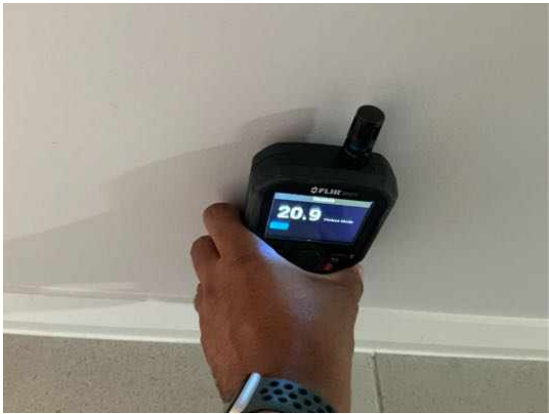
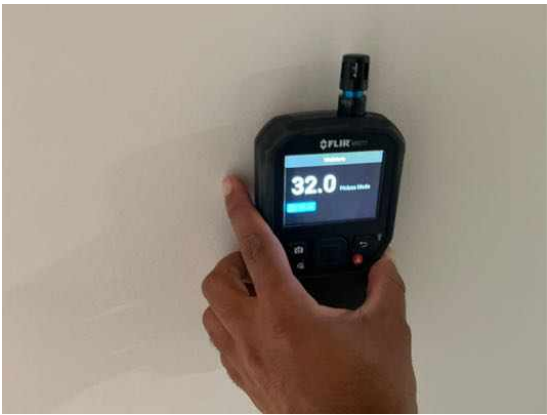
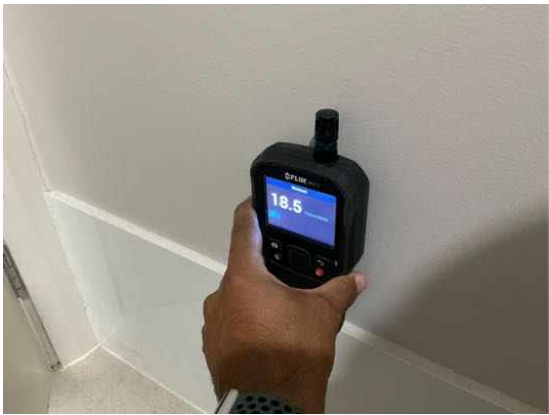
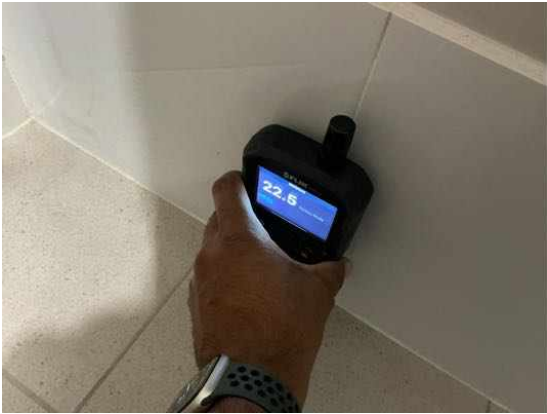
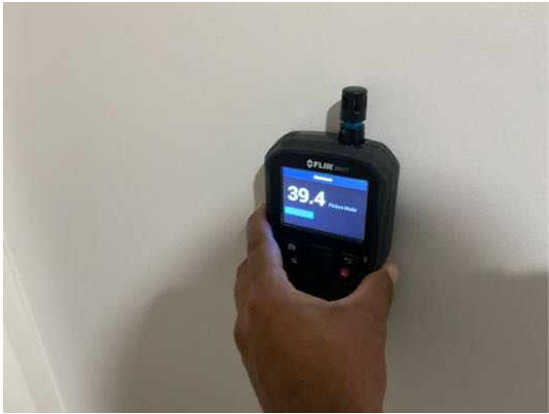
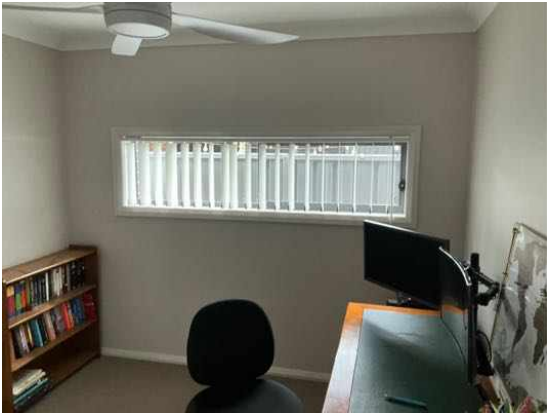
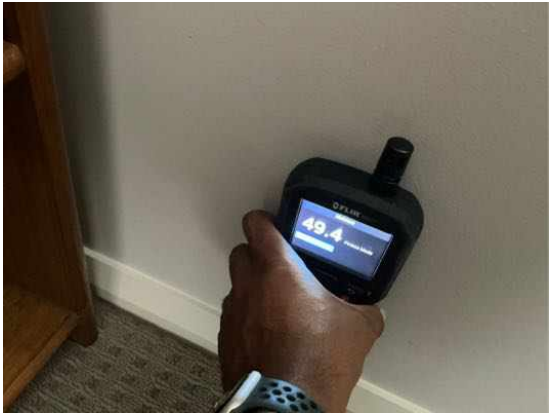
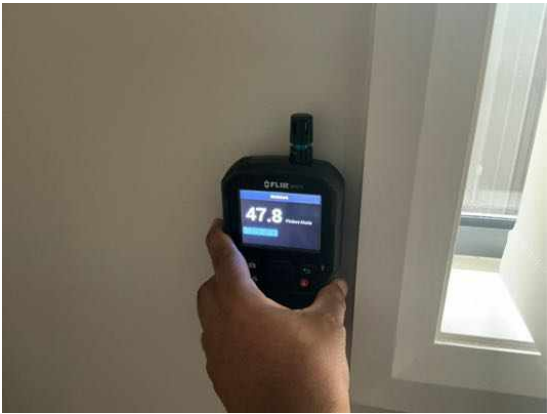
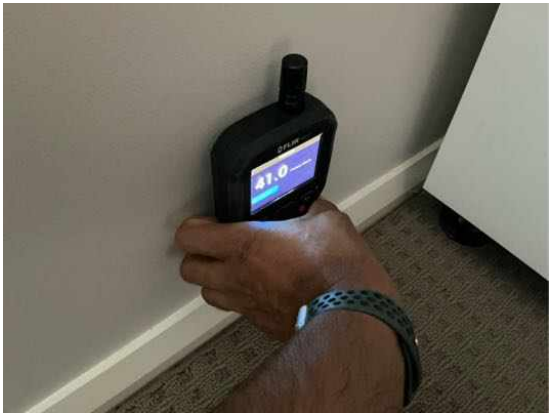
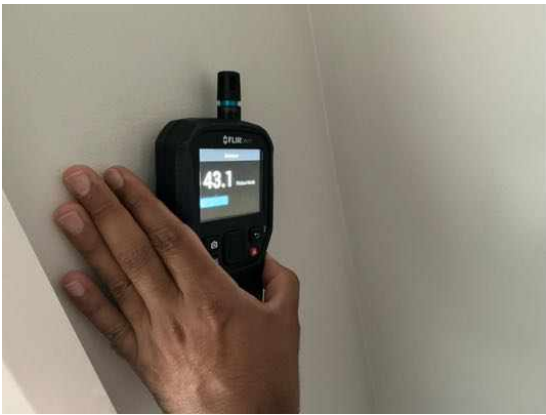
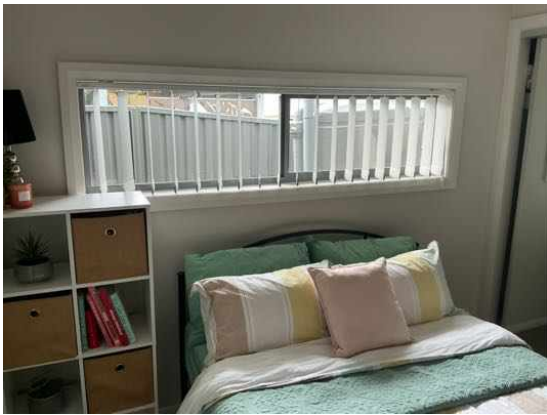
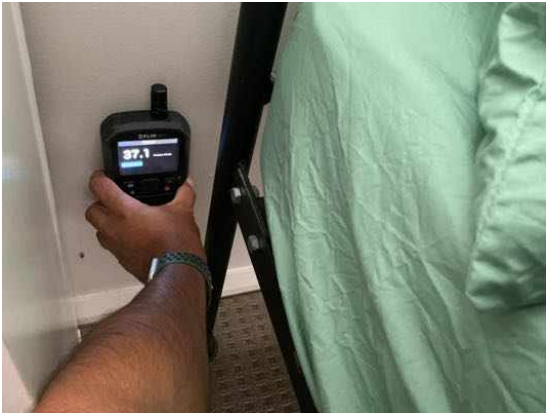
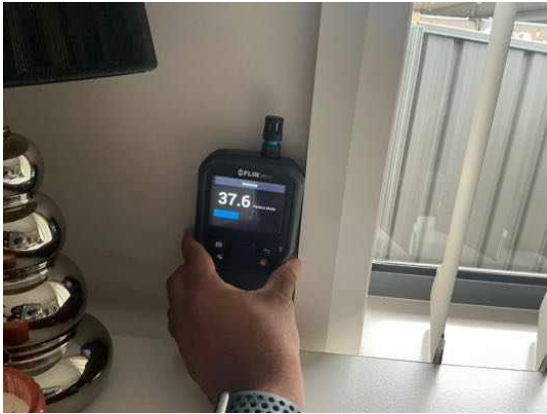
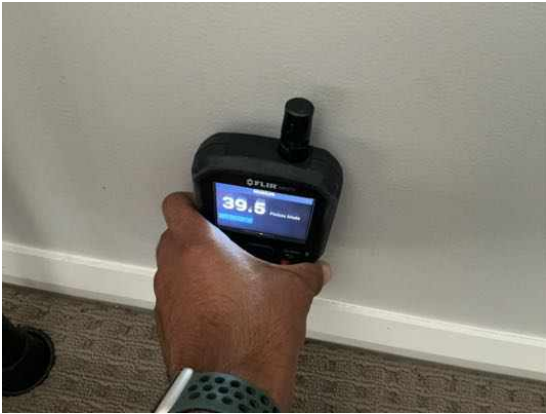
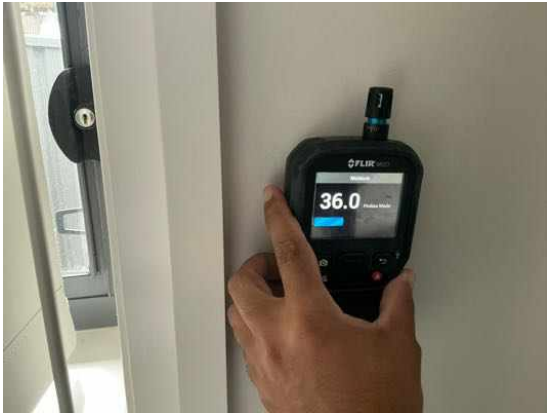
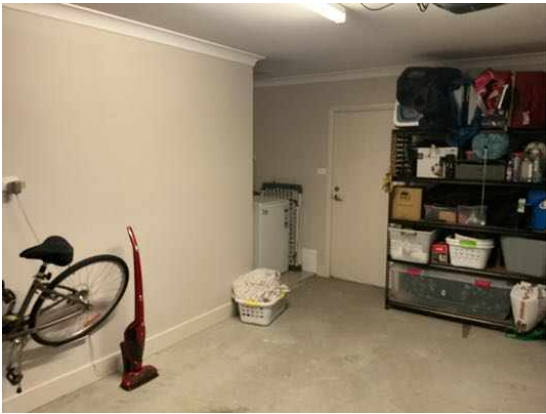
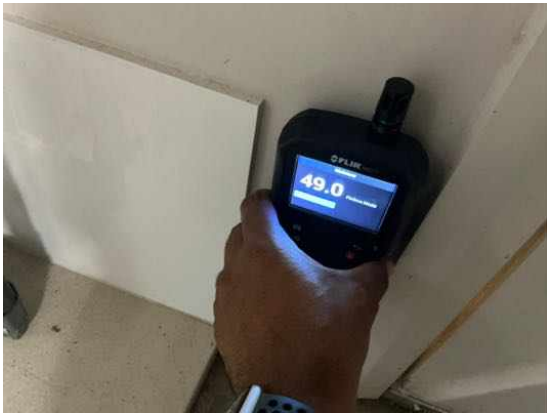
Building: Main Building
Location: All Areas
Finding: Additional Photos - Moisture Meter Readings
Information: Additional moisture meter reading photos have been provided for the property to offer further clarity on areas tested during the inspection. These photos are intended to give a visual reference for the specific locations where moisture levels were measured. These readings were taken at the time of the inspection to assess any potential moisture-related issues within the property. Any defects related to moisture that were identified during the inspection have been separately mentioned in the defect statements within the report.

It is important for the client to understand that moisture levels can fluctuate over time due to various factors, including changes in weather, humidity, and environmental conditions. While the readings reflect the property's moisture levels during the inspection, they may not represent future conditions, and increased moisture could lead to issues such as dampness, mould growth, or deterioration of building materials if left unmonitored.

For further clarification or additional information regarding the moisture readings, the client is encouraged to contact the building inspector directly. Regular monitoring of moisture-prone areas is recommended to ensure any emerging concerns are addressed promptly, particularly during wetter seasons or in high-humidity conditions.

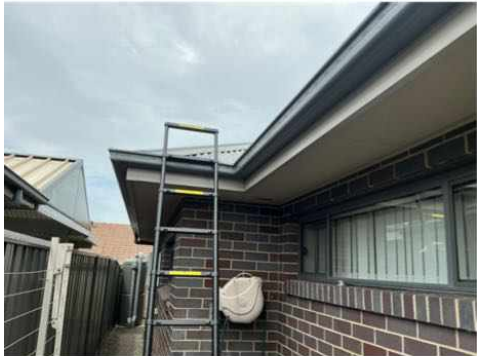
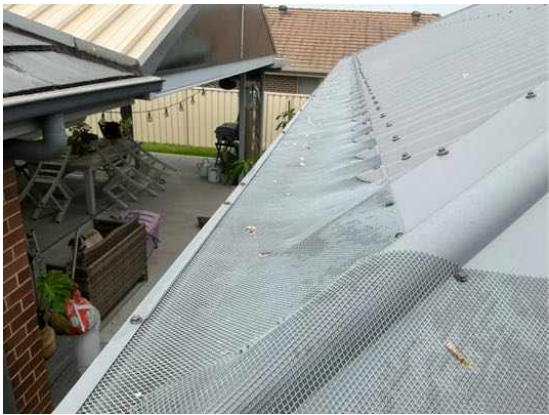
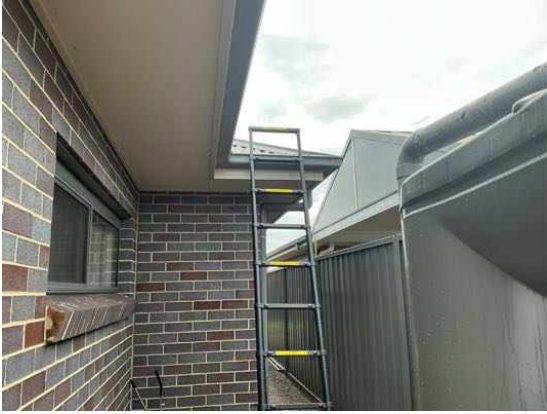
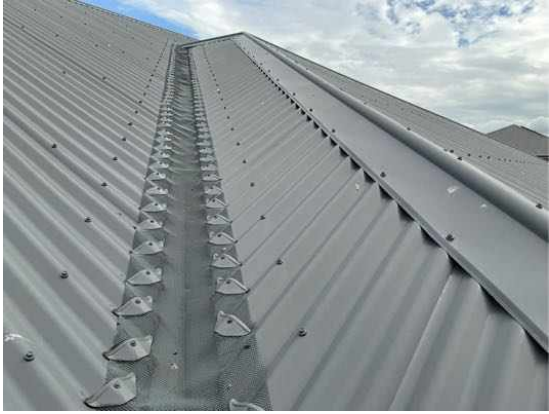
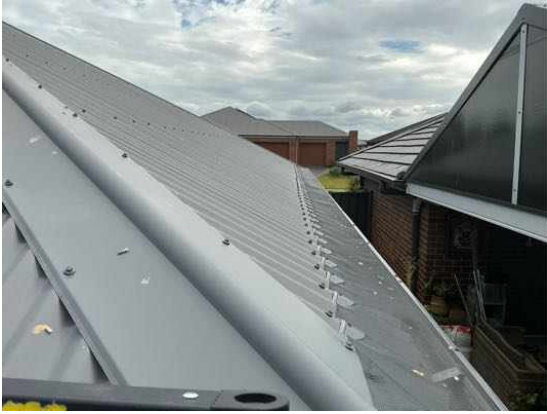
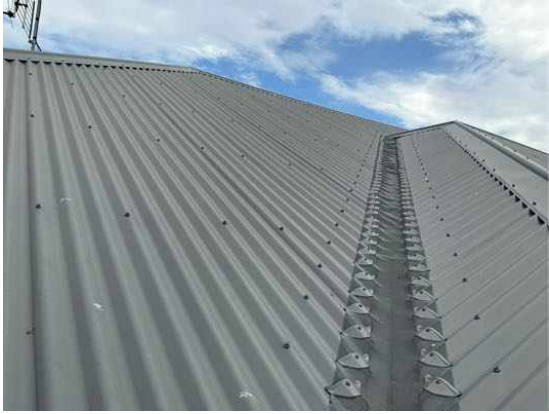
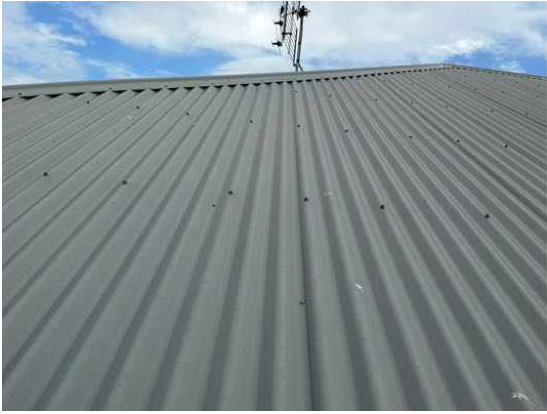
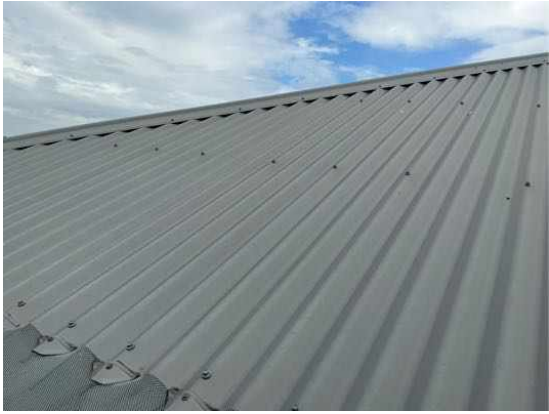
Building: Main Building
Location: Roof Exterior
Finding: Additional Roof Photos

Information: As part of the information provided, please note that the attached roof photos represent the condition of the roof at the time of inspection. These photos are for visual reference only and do not constitute a detailed roofing assessment. Any defects or issues identified with the roof are mentioned separately in the defect statements. It is strongly recommended that the client engage a qualified roofer to conduct a thorough inspection of the roof, ensuring that any potential issues, such as leaks, structural integrity, or wear and tear, are properly identified and addressed.

Additionally, the condition of the roof may change over time due to weather, natural wear, or other unforeseen factors. Regular maintenance and inspections by a licensed professional are advised to ensure the roof remains in good condition and to avoid costly repairs in the future. The information provided in these photos should be considered a snapshot of the roof's condition during the time of inspection and not a guarantee of its future performance.

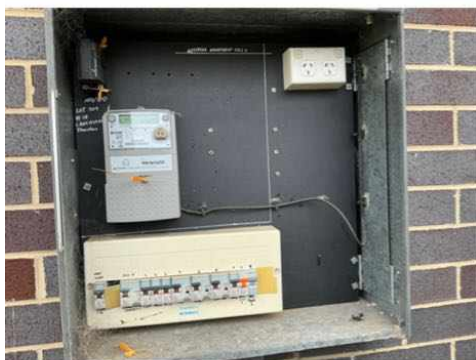
Finding: Termite Management Recommendation – No Evidence of Chemical Installation

In accordance with standard requirements, a durable notice should be located within the electrical switchboard to detail any termite protection systems applied, including chemical treatments. No such notice was observed during the inspection.

It is recommended that the client engage a licensed pest controller to assess the suitability of installing a chemical barrier, and to provide advice on associated costs and procedures. This should be considered a short-term priority, particularly if the property has any history of termite activity or is located in a high-risk area.

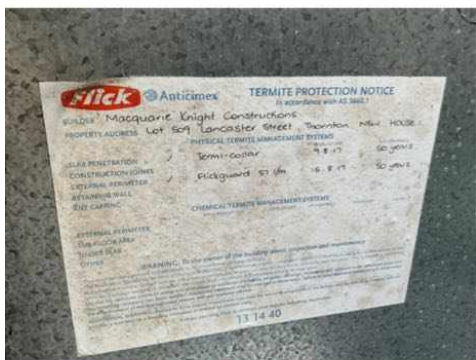
The following items were noted as - Evidence of a previous termite management program

Where a Termite Management System has been identified you should refer to the type of barrier date of installation warranty conditions and any documentation provided by a builder or past owner. Consult the company who installed the barrier to confirm whether the system is still under warranty.

Most chemical termite management systems expire and require replenishment and all physical systems are primarily designed to prevent concealed entry.
