Building and Timber Pest Inspection Report

Inspection Date: Thu, 5 Feb 2026

Property Address: 7 Jacaranda Avenue, Bradbury NSW 2560

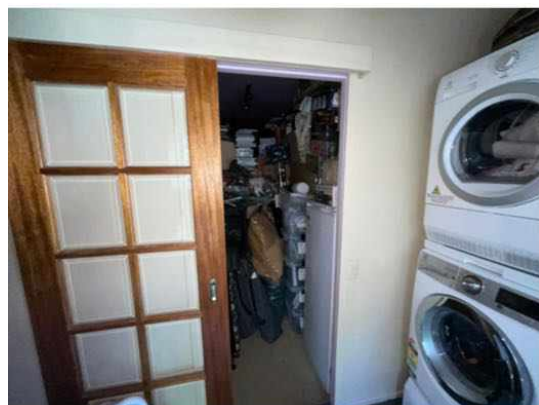
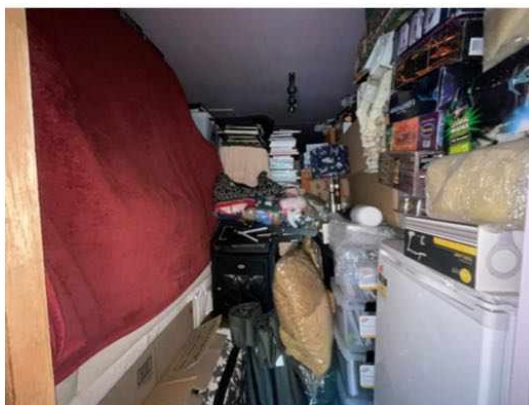
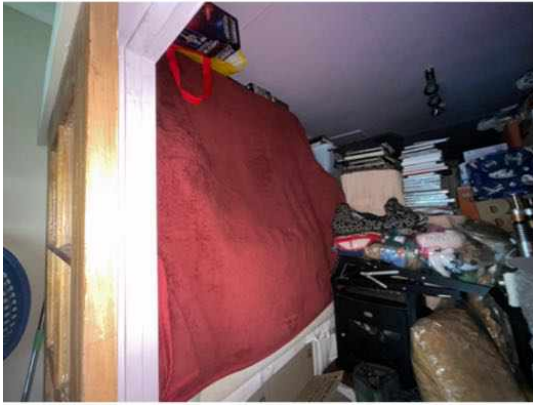
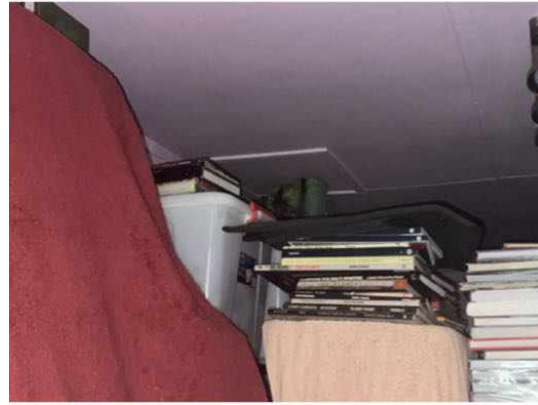
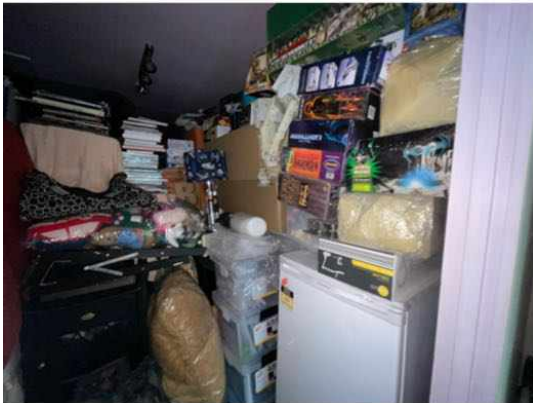
Building:	Main Building
Location:	All Areas
Finding:	Evidence of live termite activity was not visible at the time of the inspection..
Information:	Termite Activity – Important Advisory

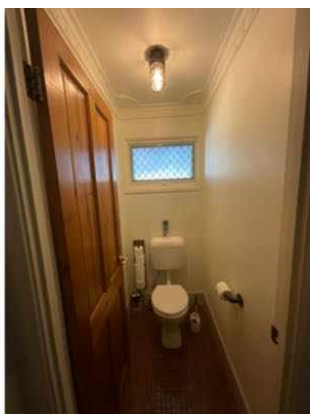
Building: Main Building
 Location: All Areas
 Finding: Water Pressure – Observation Only.
 Information: During the inspection, water pressure appeared to be within a normal operating range based on a basic functional check. However, this observation was made without the use of pressure testing equipment and does not constitute an assessment by a licensed plumber.

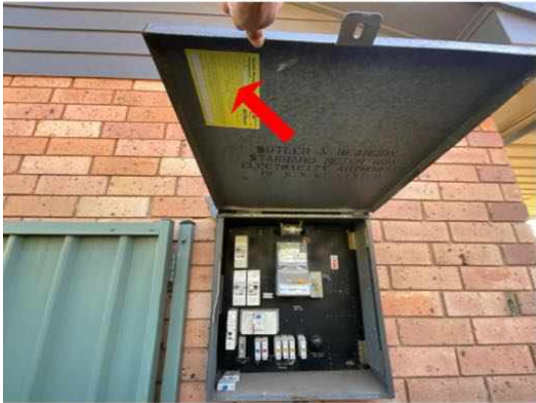
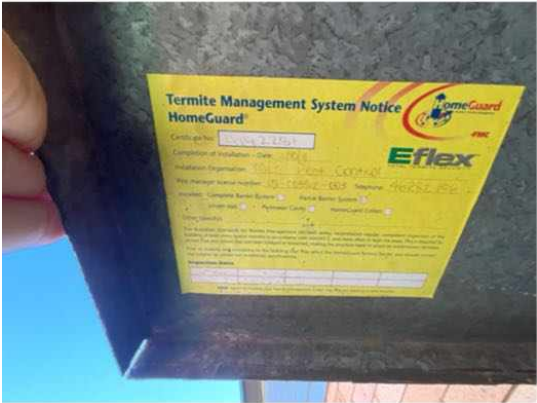
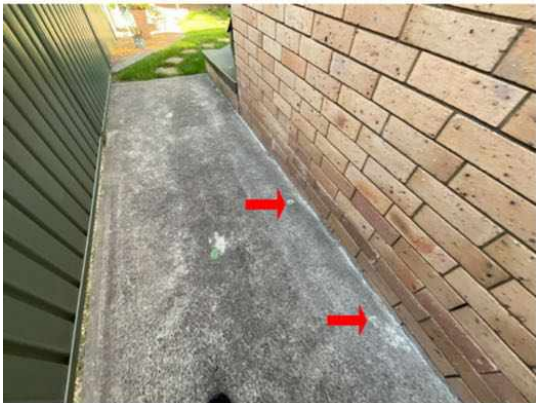
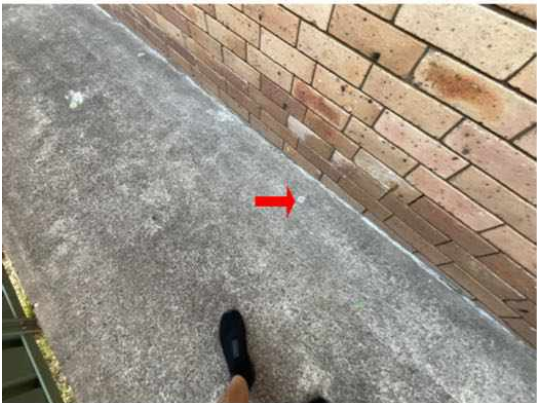
Building: Main Building
 Location: All Areas
 Finding: Termite Management System – Previous Barrier Noted..
 Information: Observation:

At the time of inspection, evidence of a previous termite management system was noted, indicated by the presence of a durable notice affixed to the electrical switchboard. It is suspected that the chemical treatment is out of date and should be further investigated.

- The installation of a termite management system is strongly recommended for all properties, particularly those with timber building elements. These systems provide a proactive defence against termite attack and are effective in minimising the risk of concealed termite entry and structural damage.
- The client is advised to contact the pest control provider listed on the durable notice (if identifiable) to obtain further information regarding:
 - The type of system installed (e.g., chemical barrier, baiting system, or physical barrier)
 - The installation date
 - Any warranty conditions, service history, or ongoing maintenance requirements
 - If no reliable information can be obtained, or if the existing system is found to be outdated or non-functional, it is recommended that a new termite management system be installed by a licensed pest control professional.
