Building and Timber Pest Inspection Report

Inspection Date: Thu, 22 Jan 2026

Property Address: 74 Australia St, Bass Hill NSW 2197,
Australia

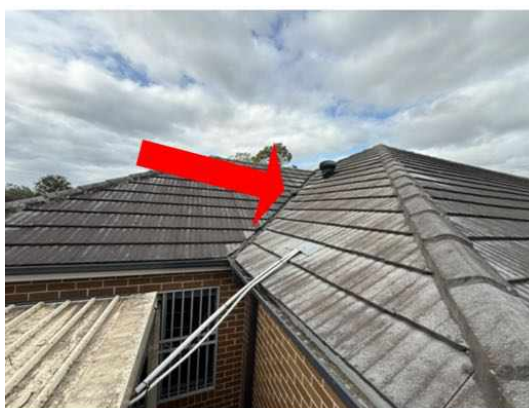
Building: Main Building
 Location: Roof Exterior
 Finding: Exterior roof - Leaking
 Information: Active roof leaks were evident at the time of inspection. Roof leaks can have a number of causes, including damage to roof coverings, deterioration of roof fixtures and fittings, or loosely associated materials (fascias etc.).

Where water leaks are active, rain penetration is likely to cause water damage to associated structures and building elements in this area, which can have a range of implications. If left unmanaged, the development of major structural damage to the roofing and associated structures may occur.

A roof plumber should be appointed as soon as possible to primarily identify the cause of the leak, and to provide subsequent repair works as necessary. Depending on the extent of the damage, replacement of sections of the roof covering and/or roofing structures may be required, and may be performed by a registered builder or qualified carpenter.

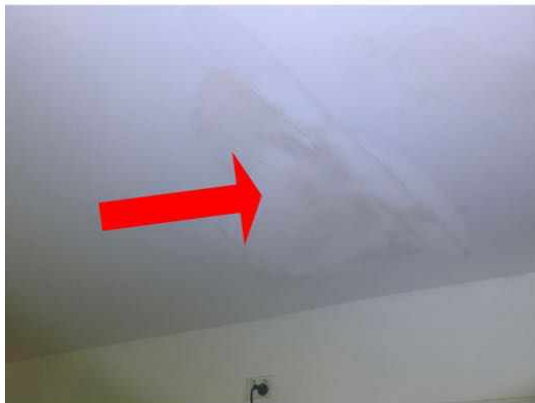
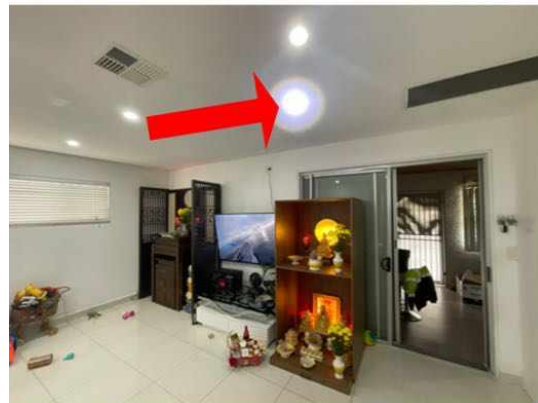
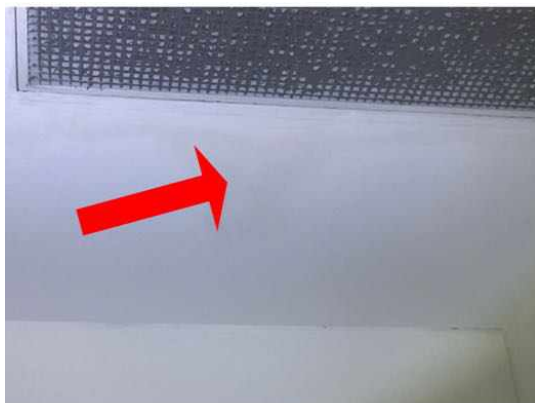
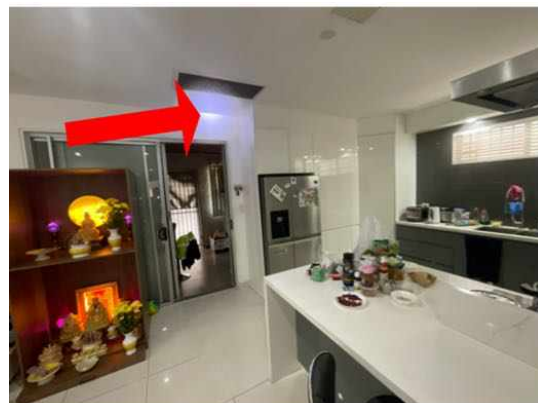
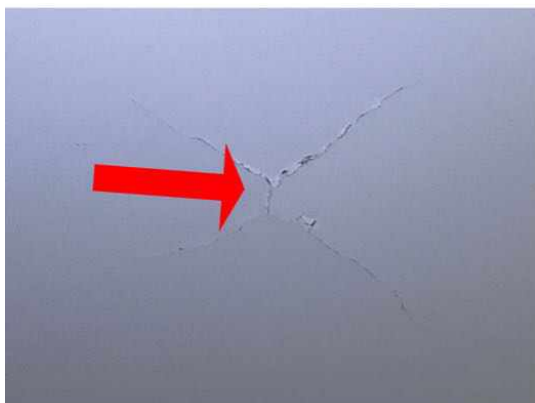
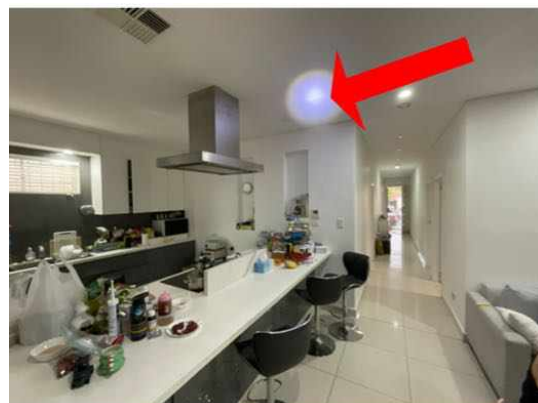
Finding 2.02

Building: Main Building
 Location: Kitchen
 Finding: Ceiling - Water damaged
 Information: Water damage to the ceiling lining is generally an indication of excessive moisture

being present in the roof void, usually via a leak to the roof covering.

Where water damage is evident to the ceiling, the primary requirement is to identify and rectify the source of the leak. A roofing plumber should be appointed as soon as possible to identify the leak and perform rectification works as necessary, ensuring the water damage is restricted.

Once the leak is repaired, consultation with relevant tradespeople, including plasterers and painters, is advised. Rectification works may include replacement of ceiling lining or minor repainting, depending on the extent of the damage.

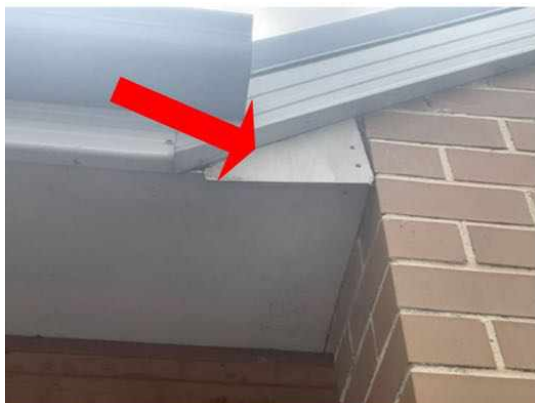
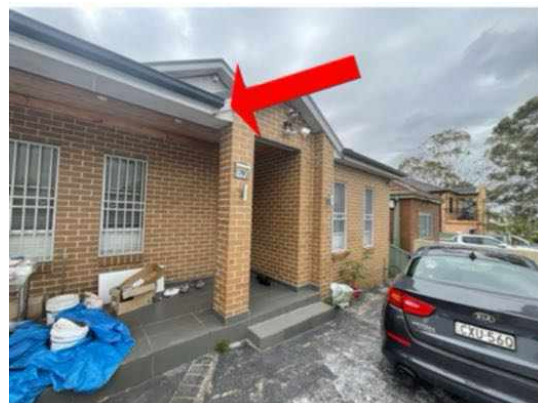
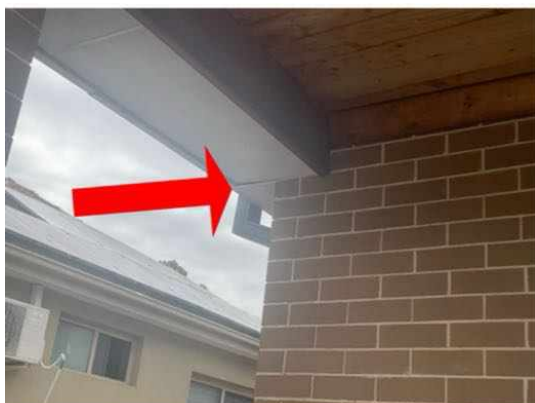
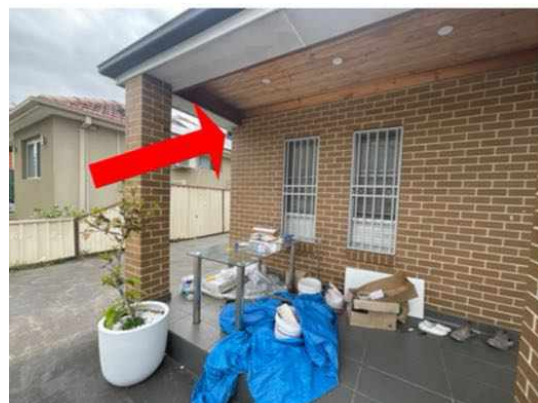
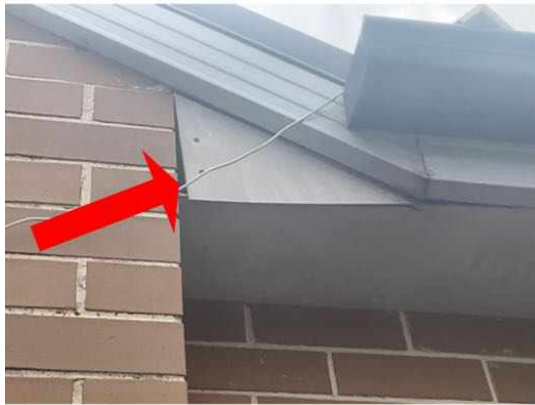
Finding 3.01

Finding: Eaves - Damaged

Information: The eaves around the external property were found to be in a visibly poor condition. The damage may have been sustained as a result of a number of possible causes, including poor roof drainage, leaking roof plumbing or minor impact damage.

The damage to the eave sheeting in this area detracts from the appearance of the structure, as well as potentially compromising the structural integrity of the roofing area.

Where eaves show moderate to severe damage, remedial works may be required. Where water damage is suspected as being the underlying cause, appointment of a licensed plumber is advised as a matter of urgency to identify the source of the water leak.

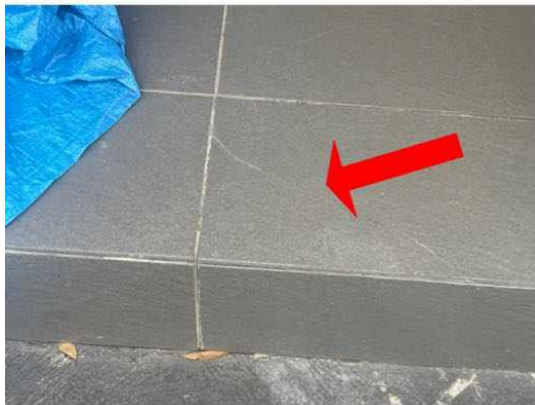
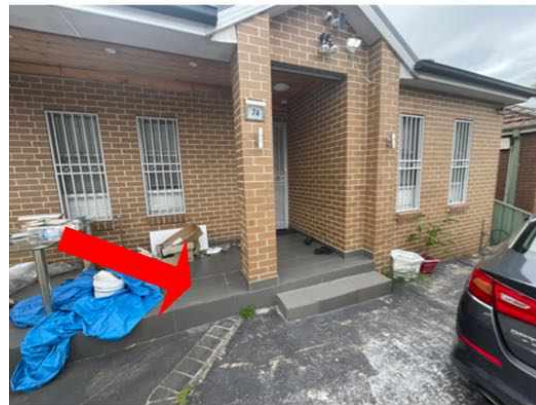
Finding: Tiles - Cracked or damaged

Information: Cracking was evident to the tiling in this area at the time of inspection. While the cracking appears to be minor, this area is frequently exposed to water, allowing potential for water penetration into adjoining sections of walls or flooring.

If left unmanaged, water penetration to these areas may lead to subsequent water damage, which is likely necessitate repair work to affected building elements.

A tiling contractor should be appointed to ensure that no further water damage occurs. The re-application of silicone and grouting throughout remaining tile work is also advised, to further protect the area against water penetration.

Where water penetration has led to water damage, appointment of a relevant tradesperson may be required to repair damaged building elements.

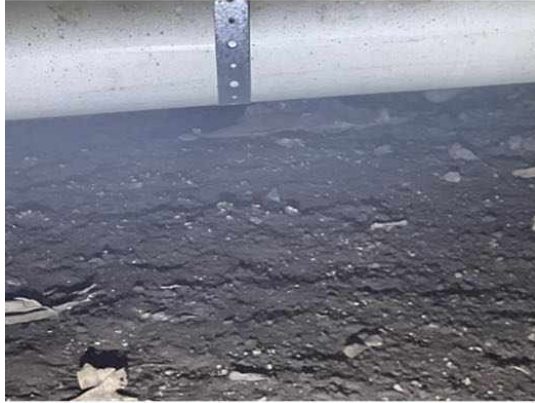
Finding 3.04

Information: It was noted at the time of inspection that the subfloor area lacks adequate ventilation. Ventilation can be restricted by a variety of minor defects, including obstructions in the subfloor space, a lack of vents or a low clearance.

A well ventilated subfloor aids in maintaining dry conditions, preventing secondary damage such as wood rot and pest activity, as well as preventing the development of mould and mildew (which can lead to respiratory safety hazards for occupants).

The initial step in improving ventilation is to ensure that the subfloor area is free of any debris or stored items. Where ventilation is still inadequate, it is advised to ensure that all vents are clear of blockages, and additional vents may be installed.

The client may also consider mechanical ventilation (powered fans) to improve subfloor airflow. Remedial works should be conducted as a matter of urgency to protect against the development of potentially harmful subfloor conditions.

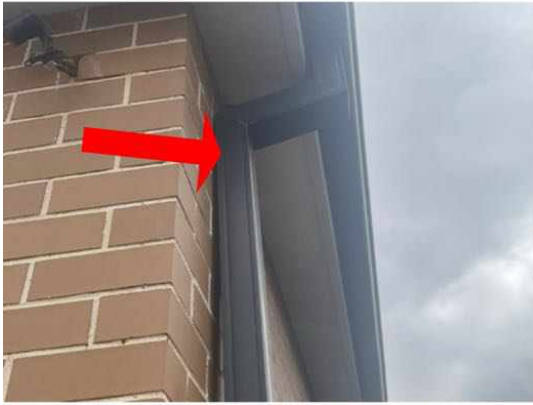
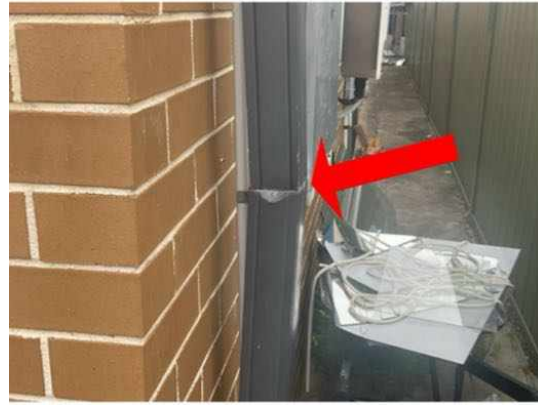
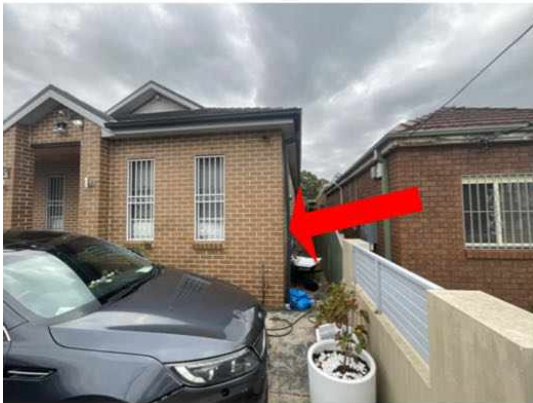
Finding 3.05

Building:	Main Building
Location:	All External Areas
Finding:	Downpipe fitting - Damaged
Information:	The downpipe in this area was found to be damaged at the time of inspection. Damage occurs generally may be indicative of impact damage to the building element (accidental or deliberate).

Left unmanaged, the fitting is unlikely to cause further damage to surrounding building elements.

Repair and/or replacement of the damaged fitting is advised. A Licensed Plumber should be appointed to repair/replace the light fitting at the client's discretion.

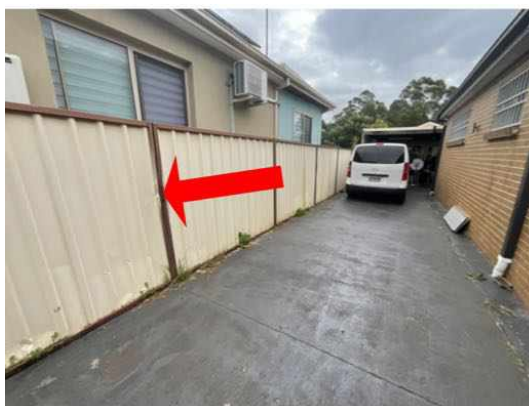
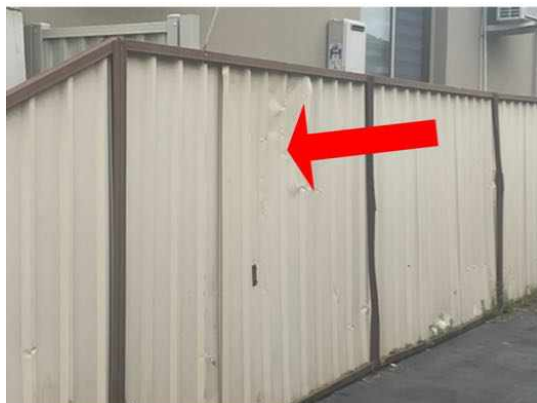
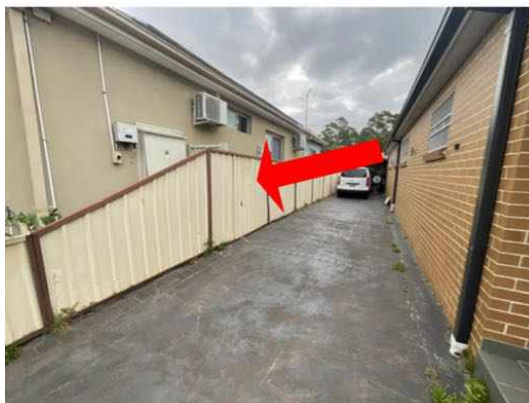
Finding 3.06

Building:	Main Building
Location:	All External Areas
Finding:	Fencing - Deteriorated
Information:	It was noted at the time of inspection that sections of the fencing throughout the property have deteriorated. Typically fencing deteriorates due to age and or wear and or rust which is generally expected for a structure of this age, due to prolonged exposure to weather conditions. Sometimes inadequate installation or maintenance can be to blame.

If left unattended, it is likely that further damage will occur. It is suspected that repair of several elements of the fencing may be required however replacement may be a consideration of the client also.

A licensed fencing contractor should be appointed to provide further advice and perform rectification works as necessary.

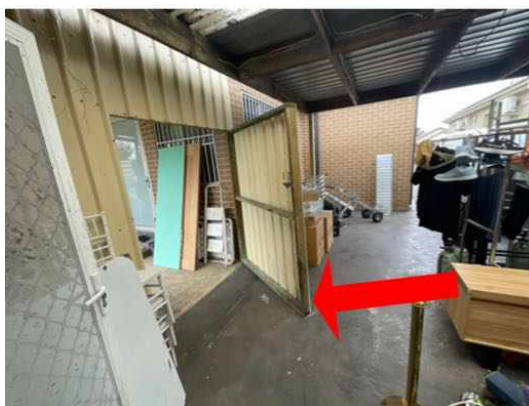
Finding 3.07

Building:	Main Building
Location:	All External Areas
Finding:	Gate - Binding / Jamming
Information:	Binding and/or jamming of this gate is evident during standard operation. This defect inhibits the functionality of the affected gate as well as creating potential for secondary defects to associated building elements, such as damage to the walls. A gate that binds to gate frame may have several causes, ranging from minor defects, such as poor installation of the gate or deteriorated hinges, through to major structural issues, such as damage to post or wall structures. For minor causes, a qualified carpenter or general handyperson should be appointed to perform minor rectification works at client discretion.

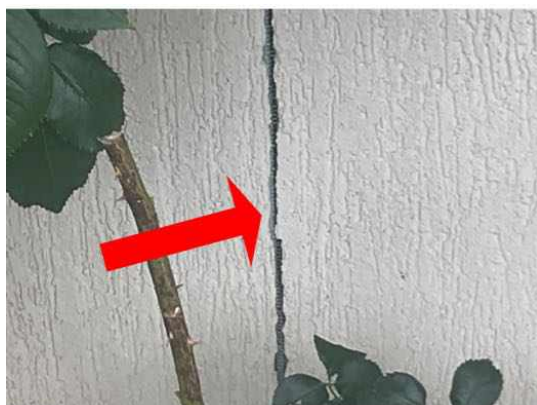
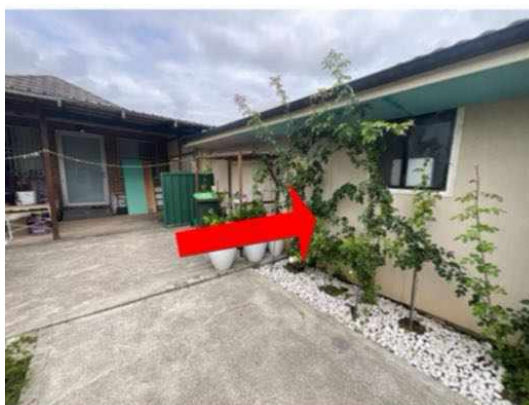
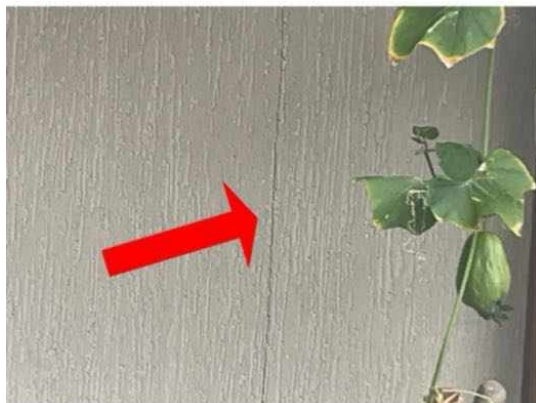
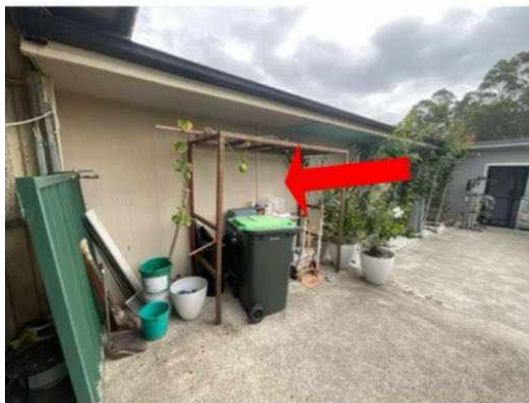
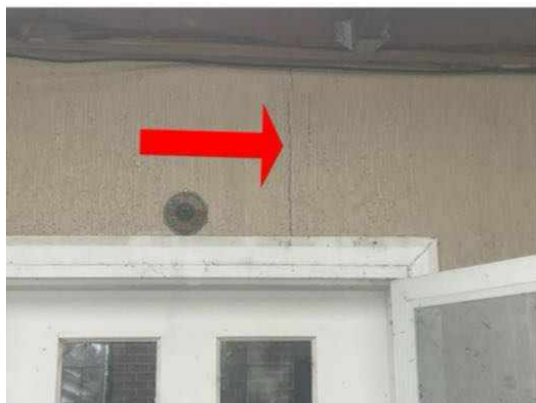
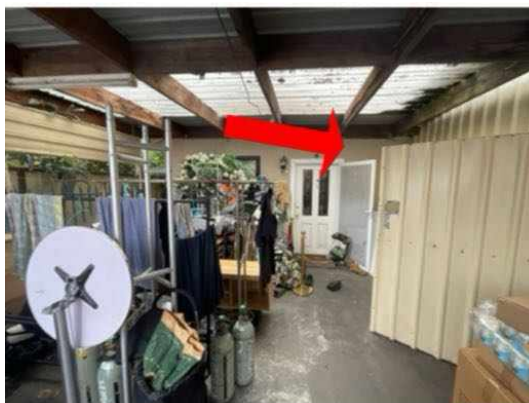
Finding 3.08

Building:	Out Building
Location:	All External Areas
Finding:	Cracking - Damage Category 2 - Noticeable (up to 5mm)
Information:	Noticeable cracks are a common occurrence as a result of many primary defects. Such causes may include age, general wear and tear, expected building movement, general expansion/contraction of building materials in different weather conditions, and/or minor failings in the installation or application of building materials.

Noticeable cracks may result in minor sticking or jamming of associated doors and windows, which require easement. However, noticeable cracks are easily filled and repaired. A plasterer can be consulted to install an expansion joint at this point to allow for this movement during different weather conditions.

Monitoring of all cracking should be conducted frequently. Always contact a building inspector should cracks widen, lengthen, or become more numerous. Additionally, your building inspector should also be contacted if associated building elements such as doors and windows become more difficult to operate over time.

Relevant tradespeople, such as carpenters, painters and plasterers, should be appointed to perform remedial works, as deemed necessary.

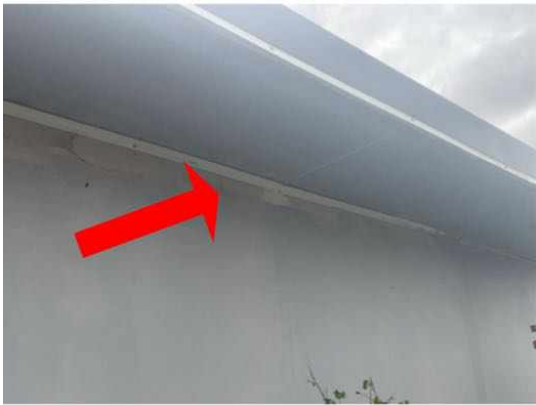
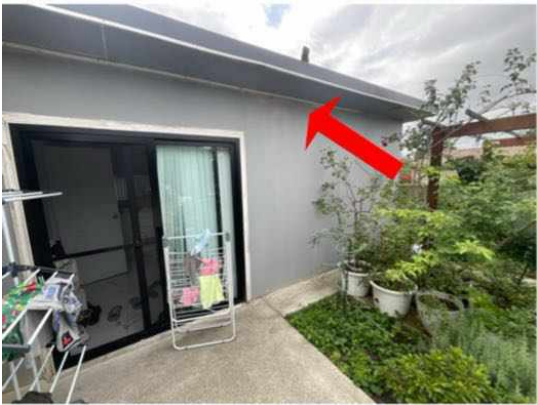
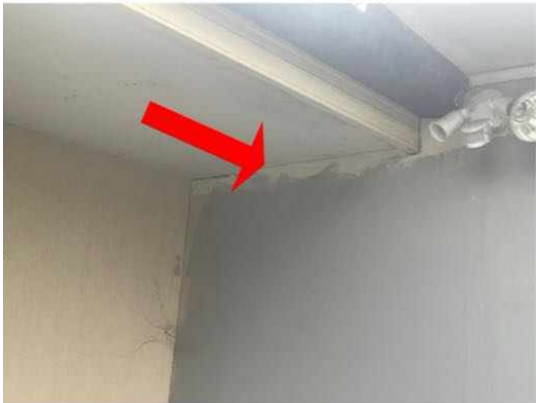
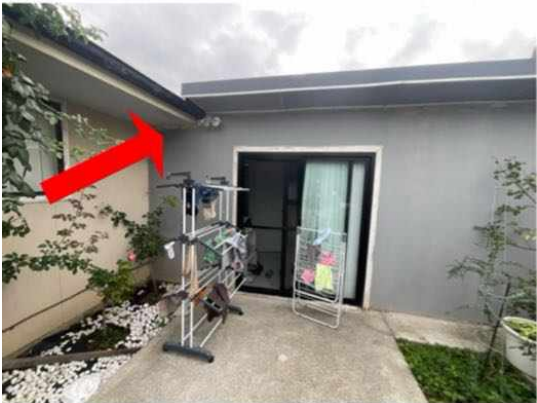
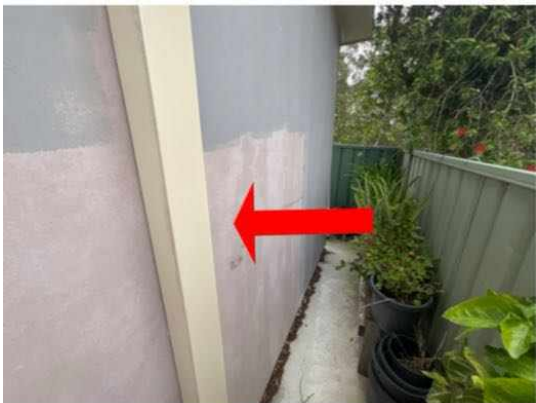
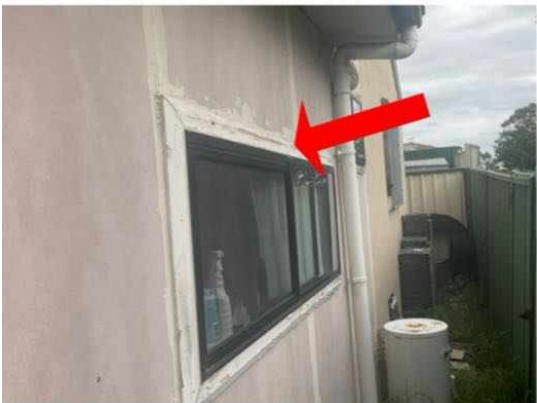
Finding 3.09

Building:	Main Building
Location:	All Areas
Finding:	Incomplete / Substandard construction
Information:	There are some Building elements that were identified as being incomplete or substandard works.

Sub standard and incomplete work are determined by identifying a failure to achieve the minimum requirement set out in the mandated Australian Standard as outlined in the Building Code of Australia and referenced by the Manufacturers Guideline.

Where a building element is installed in such as way that it fails to achieve the required minimum standard or level of finish at the time of the inspection, the builder needs to rectify the defect as soon as possible and and complete works to the required standard prior to continuing with the stage of construction.

All known defects need to be rectified by builder

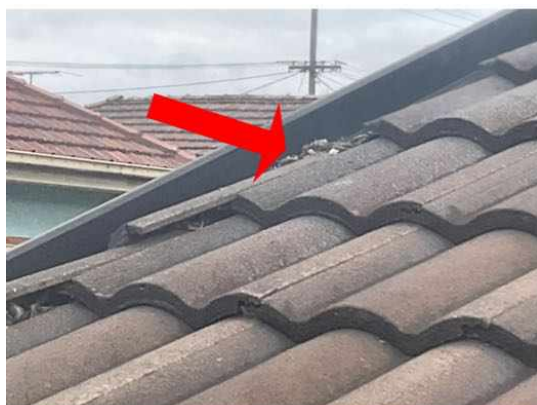
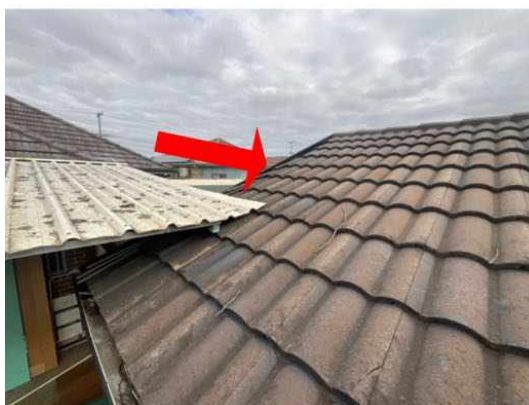
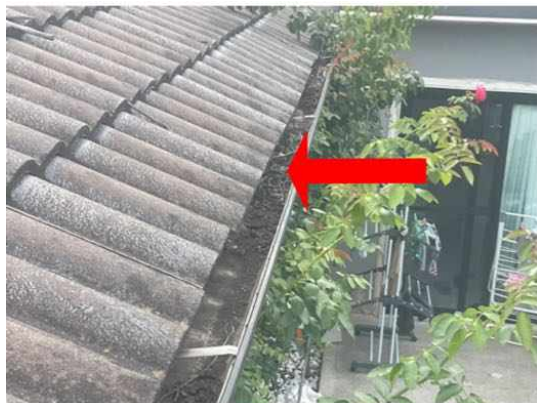
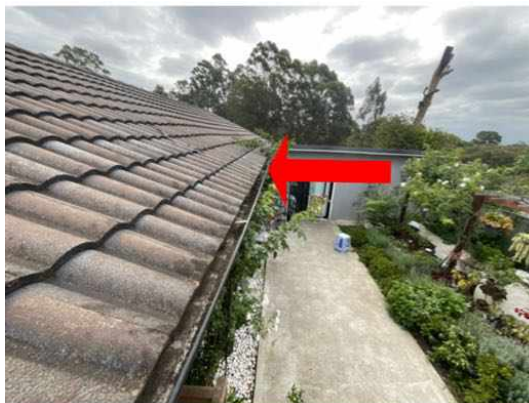
Blocked gutters are likely to lead to high levels of moisture in the affected areas. Such moisture will not only cause rust and decay of the associated building materials, but can also provide conditions that are conducive to termite and timber pest activity. Blockages in gutters should therefore be removed immediately to ensure dry conditions are maintained.

Consult a Licensed Plumber for further specific advice on remedial works that may be required. In the interim, it is highly advised that blocked gutters be removed by the homeowner or a general handyperson as a matter of urgency.

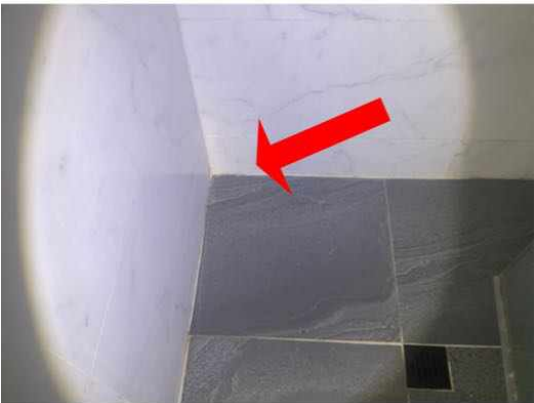
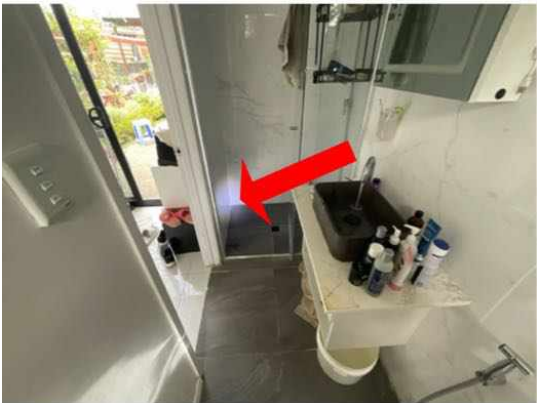
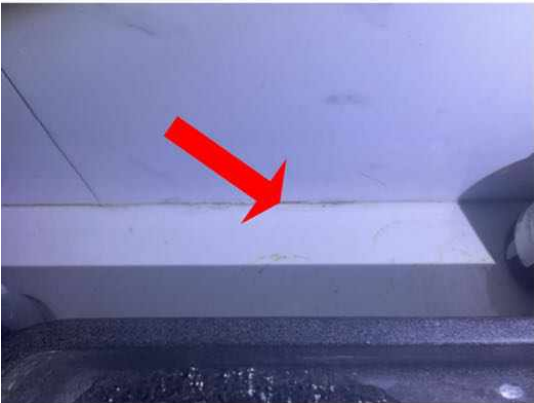
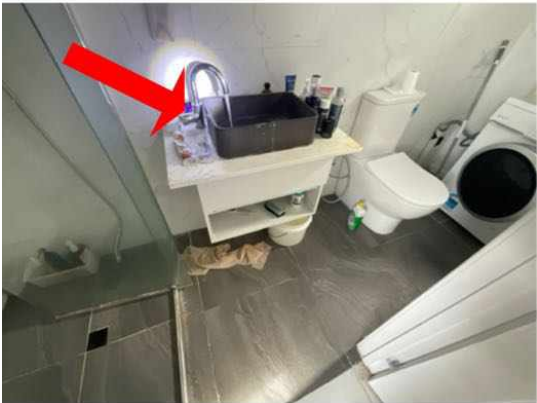
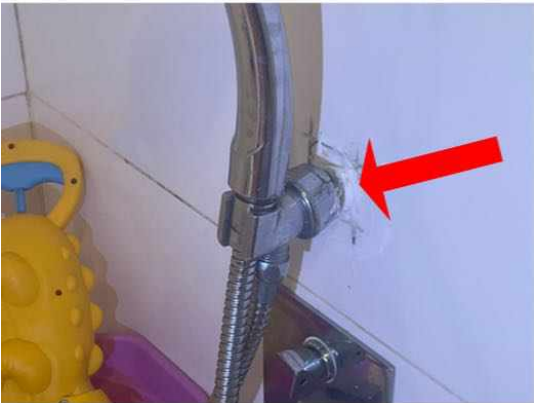
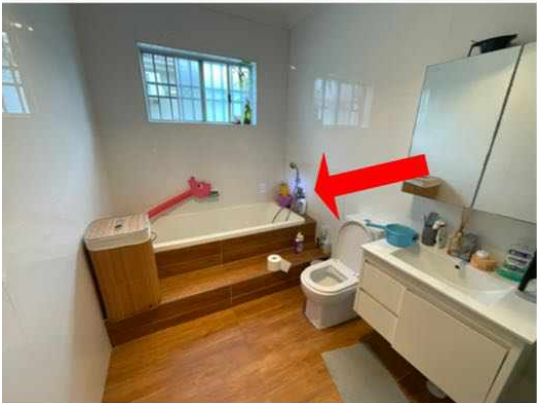
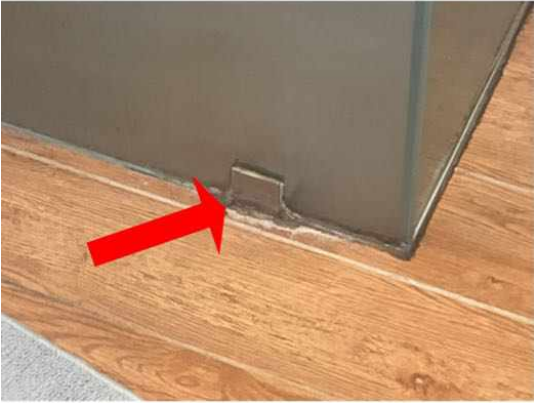
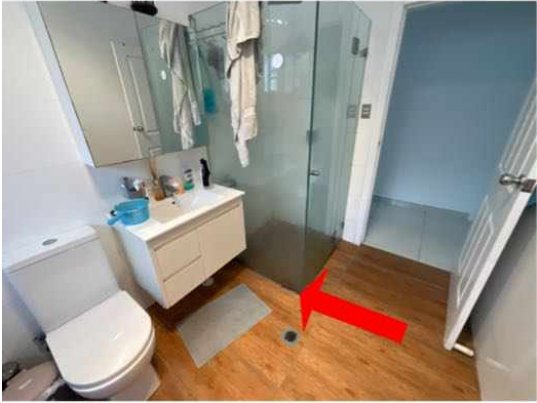
Finding 3.11

Building:	Main Building
Location:	Wet areas
Finding:	Sealant and grouting - Missing or damaged
Information:	It was noted on inspection that sealant or grout is degraded to the tiled shower alcove and or other areas of the bathroom.

Different materials and floor areas move at different rates, generally causing cracking to grout or sealant at this point. A flexible sealant is required to allow for expected expansion and contraction, while keeping the joint water tight and protective of all associated building materials.

There appears to be excessive mould to the sealant and grout which will likely require scraping out and replacement.

Flexible and mould resistant materials should be applied to affected areas to prevent any subsequent water damage that is likely to occur. Regular maintenance and replacement of damage or missing or damaged sealant and grout is highly recommended to the wet areas, as this is a regular wear and tear defect. Sealant and grouting in areas that come into regular contact with water should be maintained for the long term care of your property.

A sealant specialist or tiling contractor should be appointed to complete these works as soon as possible

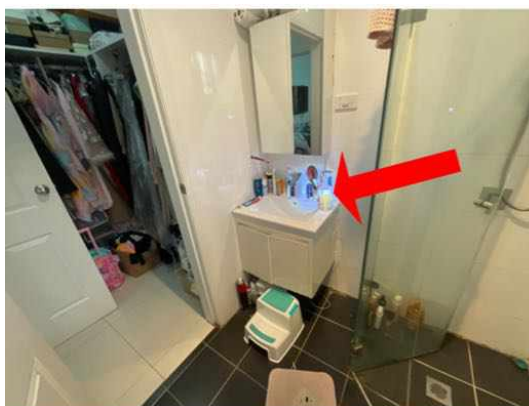
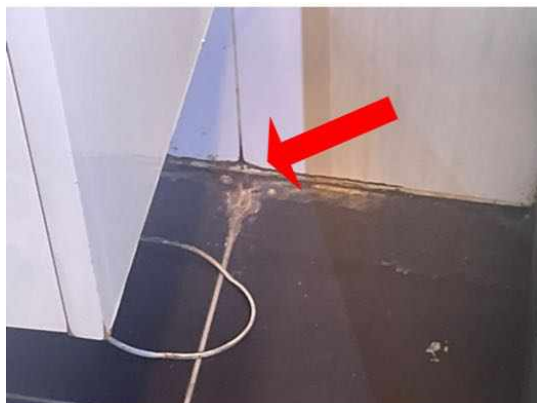
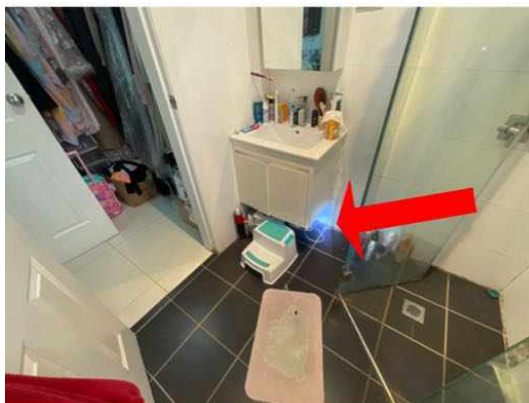
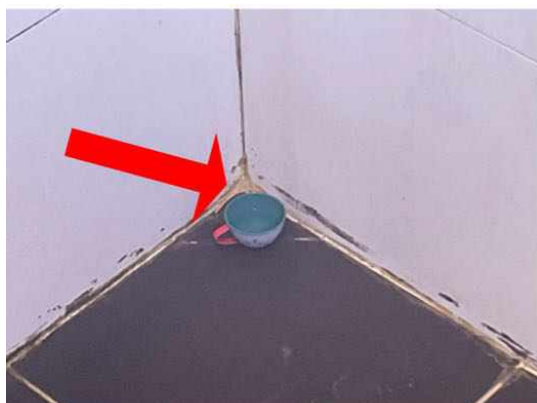
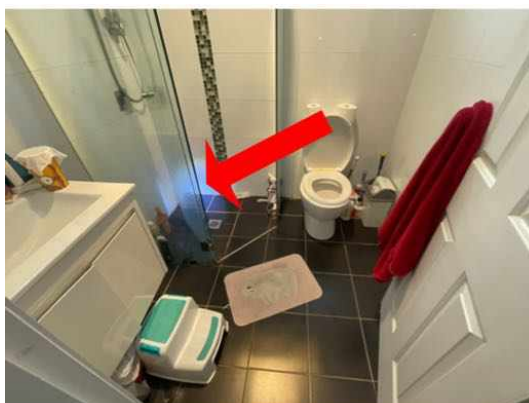
Finding 3.12

Building:	Out Building
Location:	All Internal Areas
Finding:	Installation - substandard or incomplete
Information:	The installation of this building element appears to have been completed to a substandard level of workmanship or is incomplete. Generally substandard repairs or installation are related to poor workmanship, the use of inappropriate materials, or a failure to complete installation to a suitable standard.

Where installation is substandard and/or incomplete, the client should contact the responsible trade to undertake rectification. Unfinished and substandard building works are likely to degrade more quickly and may create potential for secondary

defects to associated building elements.

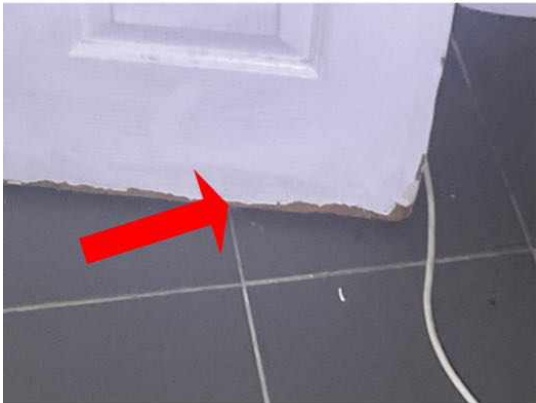
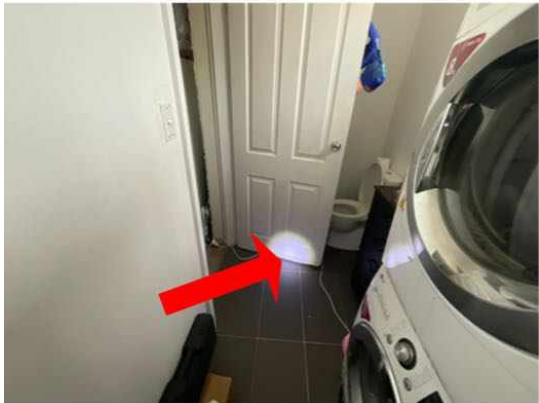
Finding 3.19

Building: Main Building
Location: Laundry
Finding: Door - swelling and damage at the bottom edge
Information: Swollen and damaged door base in bathroom due to moisture exposure. Edges show fraying and surface degradation.

Replace or seal the affected door. Ensure door edges are properly sealed to prevent future water damage.

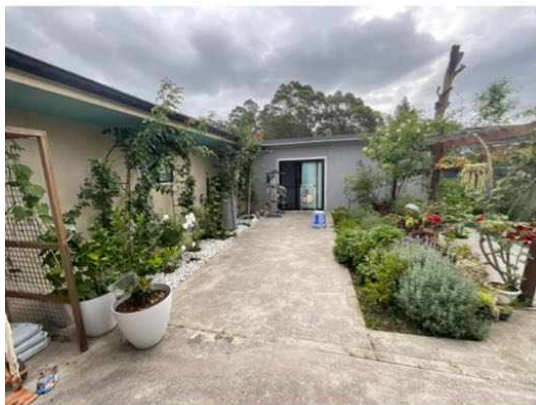
Finding 6.01

Building: Main Building
Location: All Areas
Finding: Garden Beds - Conditions Conducive to Termites
Information: Garden beds were found to be evident in the garden area. These garden beds can include untreated timber, and with a combination of moisture from watering hosing can make conditions conducive to termite activity and termite ingress.

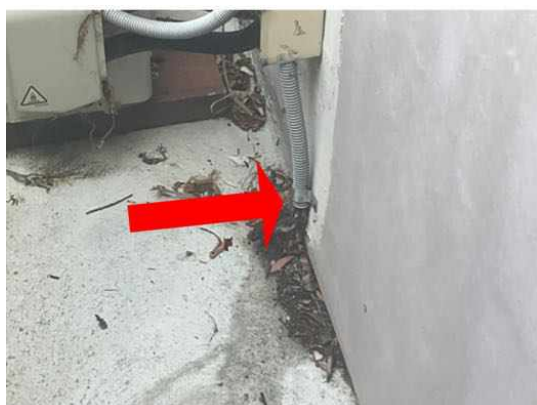
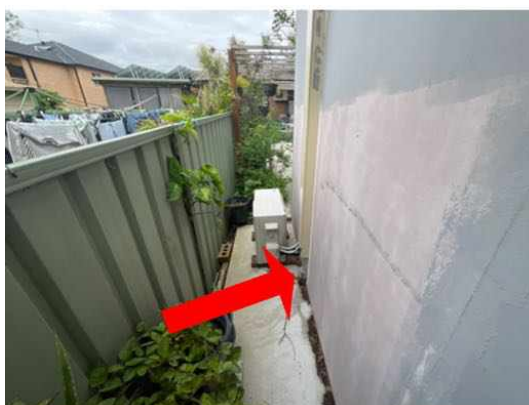
Finding 6.02

Finding: Air conditioner - Disconnected overflow
 Information: The Air Conditioner (A/C) overflow was found to be disconnected from storm water drainage and is creating excessive moisture in the surrounding area.

Such leaking creates an environment which is conducive to an array of defects, including water damage to associated building elements and the attraction of termite or timber pest infestation.

It is highly recommended that a licensed plumber be appointed to connect the A/C overflow in order to prevent such an environment from being created. These minor works should be carried out as soon as possible.

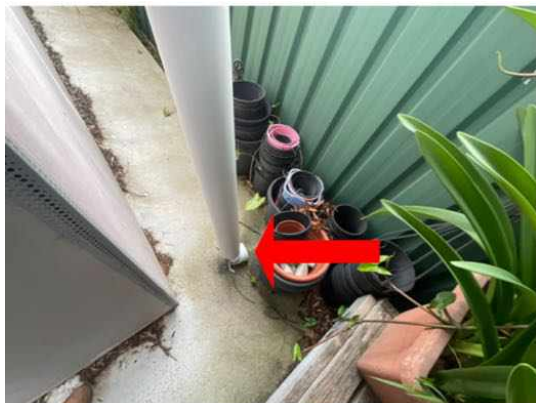
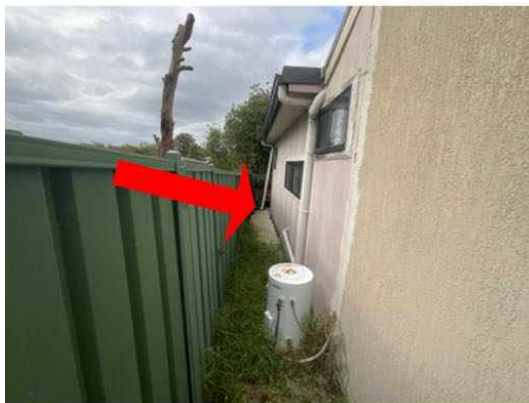
Finding 6.03

Building: Main Building
 Location: All Areas
 Finding: Overflow - Not plumbed for drainage
 Information: The overflow is not plumbed or connected to suitable drainage, which has resulted in the surrounding area becoming excessively damp. These damp conditions can lead to secondary defects such as rot, rust or corrosion of associated building elements, the formation of fungal decay, or even the creation of potential slip hazards. When coupled with poor site drainage, pooling of water may also attract termite activity to this area. It is highly recommended that a qualified plumber be appointed to install adequate drainage to the overflow. These works will ensure that the area remains dry and free of any secondary defects.

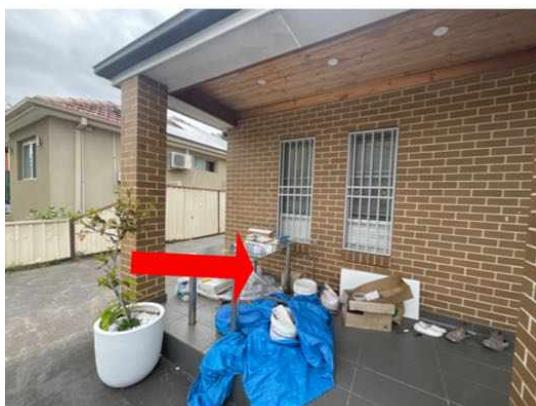
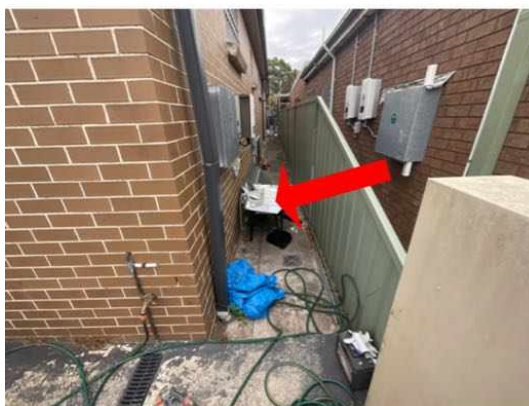
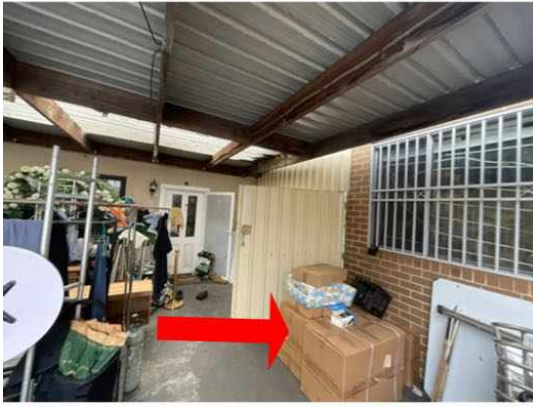
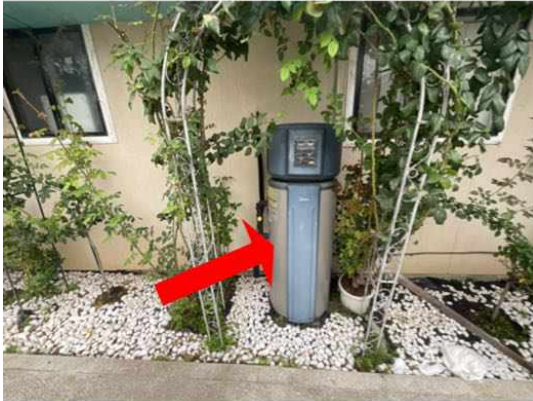
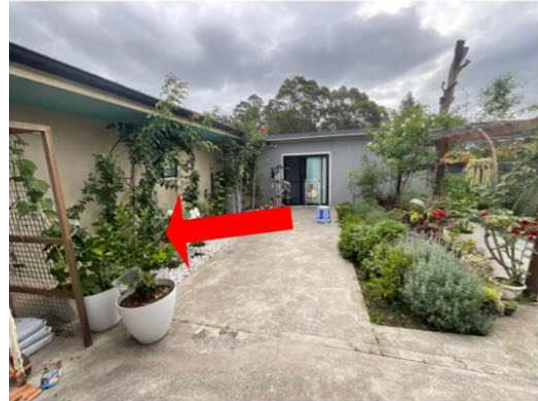
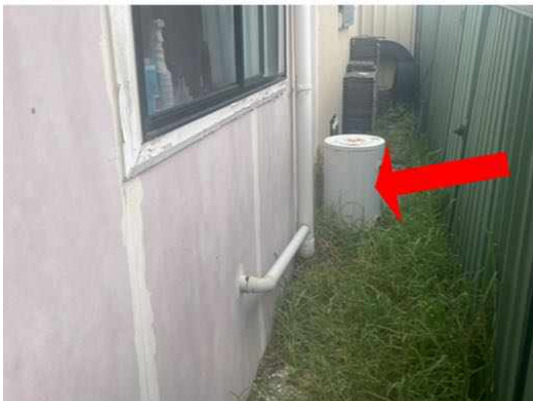
Finding 6.04

Building:	Main Building
Location:	All Areas
Finding:	Bridging of termite barrier/inspection zones
Information:	Bridging is the spanning of a termite barrier or inspection zone so that subterranean termites are provided with passage over or around that barrier.

Where bridging has occurred, full inspection is prevented and termites may enter a property in a concealed or undetectable manner.

It is recommended that minimum 75mm clearance below the bottom of weep or ventilation holes be maintained where possible, otherwise annual inspections should be conducted by a licensed pest control company. Vegetation should also be kept clear of walls to allow regular inspection of all areas.

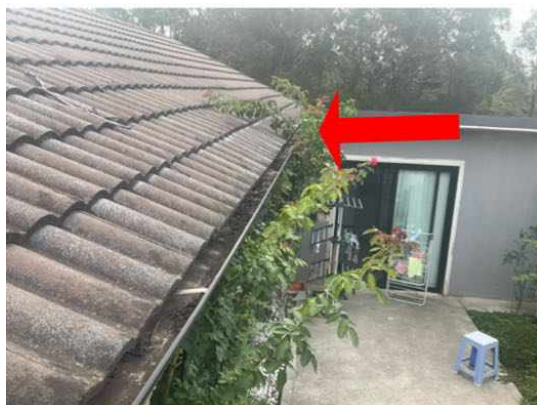
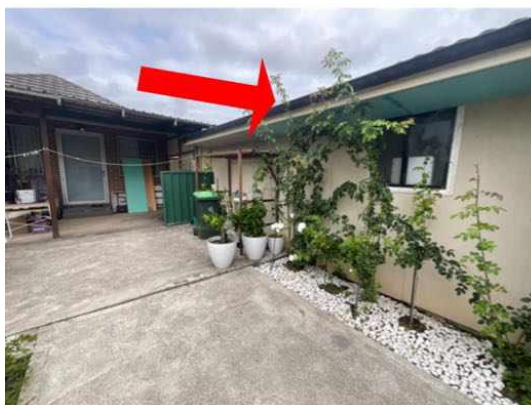
Finding 6.05

Building:	Main Building
Location:	All Areas
Finding:	Trees - Overhanging and filling gutters
Information:	Overhanging trees often result in excessive amounts of leaf debris accumulating in gutters.

Gutters are a critical part of the building's management of storm water and rain. It is therefore important that they be kept clear to prevent secondary damage to associated building elements, including exterior and interior walls, ceiling linings and any adjoining building elements. Where gutters are blocked, pooling of rainwater is likely to occur, fast-tracking rust and corrosion of the roof plumbing elements.

It is highly advised that all overhanging tree branches be removed as soon as possible to prevent any further damage. Repair and/or replacement of sections of damaged guttering may also be required where the extent of the damage necessitates.

Such works should be performed by the homeowner; however, appointment of a landscape contractor or an arborist may be required. Consultation with a licensed roof plumber is required where guttering has been damaged.

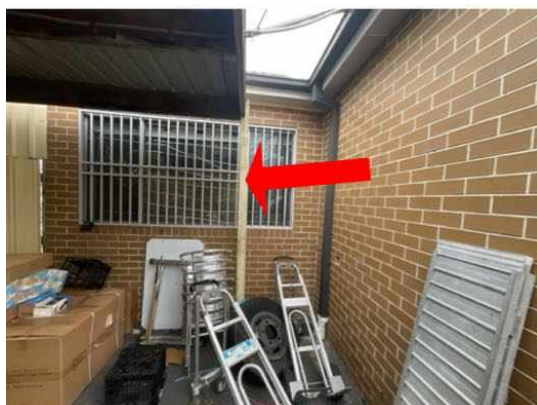
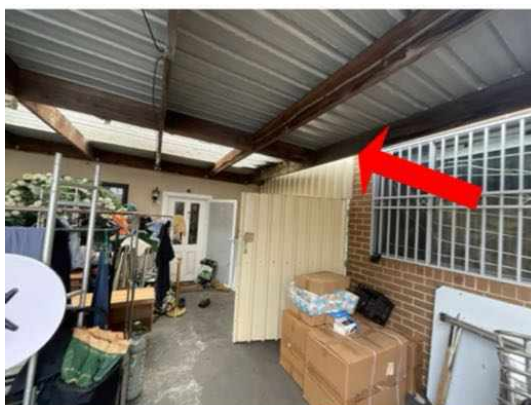
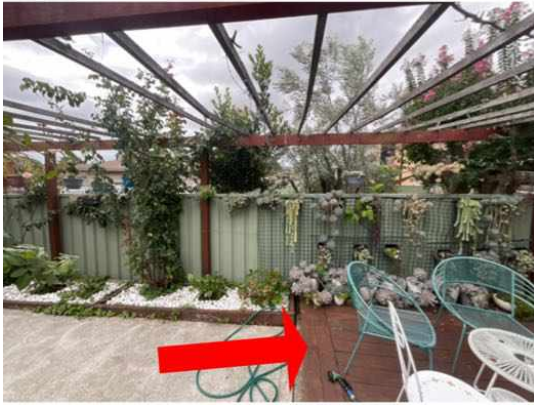
Finding 6.06

Building: Main Building
Location: All Areas
Finding: Timber - exposed to weather
Information: External timbers that are frequently exposed to harsh weather conditions require adequate protection in order to maintain their condition. Where timbers have not been painted or treated adequately, general deterioration is likely to occur at an accelerated rate.

If left unattended, replacement of these timbers is likely to be necessary in the short-term future. Adequate treatment of these timbers is required as soon as possible by a painting contractor or general handyman.

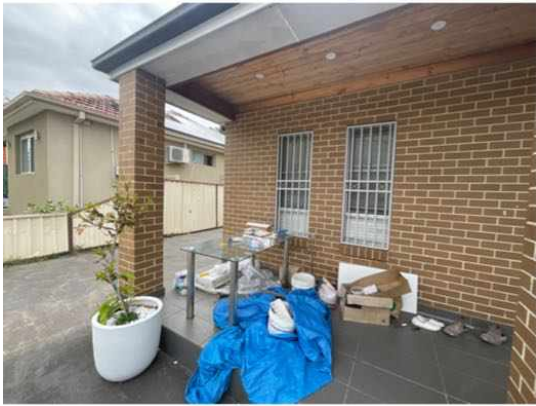
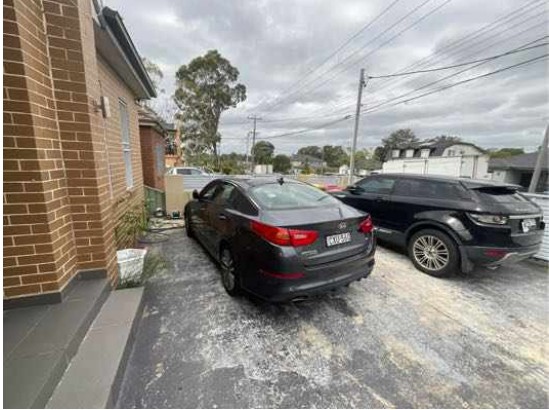
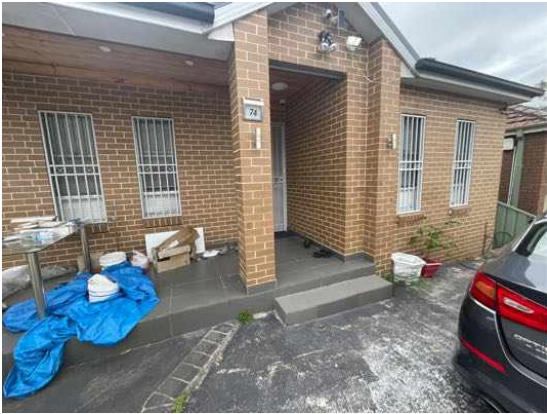
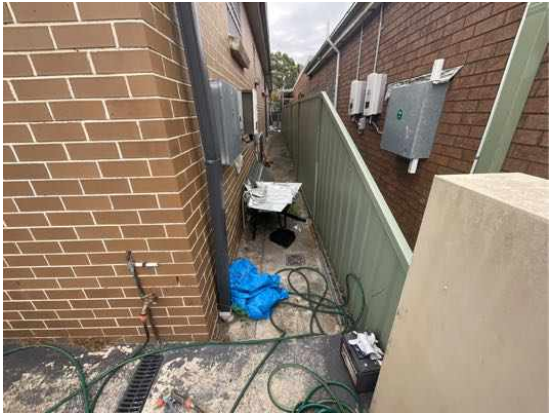
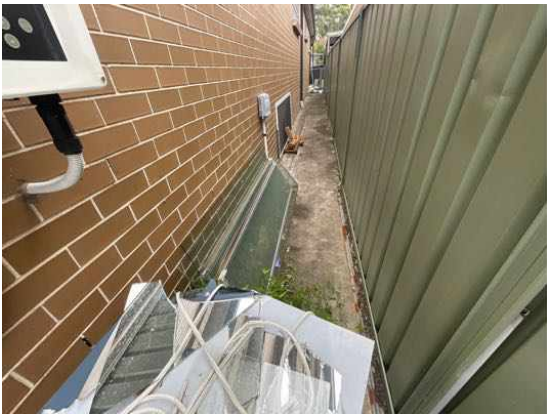
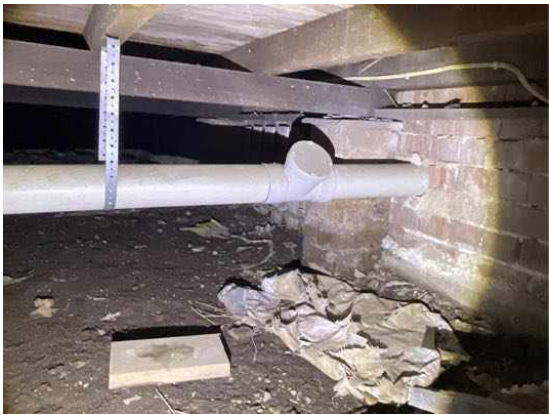
Noted Item

Building: Main Building
Location: All Areas
Finding: Additional Photos - Obstructions and Limitations
Information: These photographs are an indication of the obstructions and limitations which impeded full inspection of the property at the time of inspection. These obstructions can hide an array of defects and should be removed to allow full inspection to be carried out. A re-inspection is recommended once the areas are made accessible.

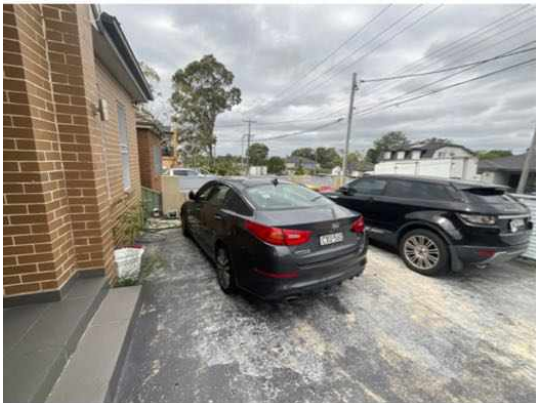
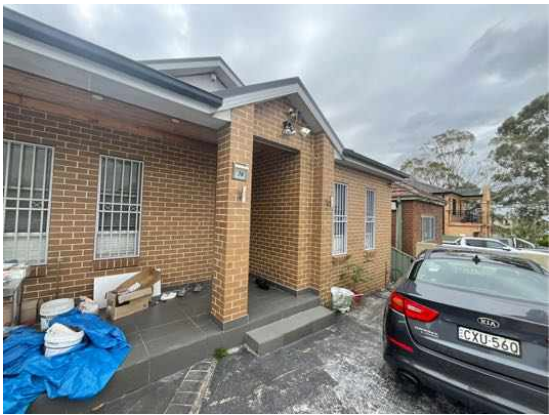
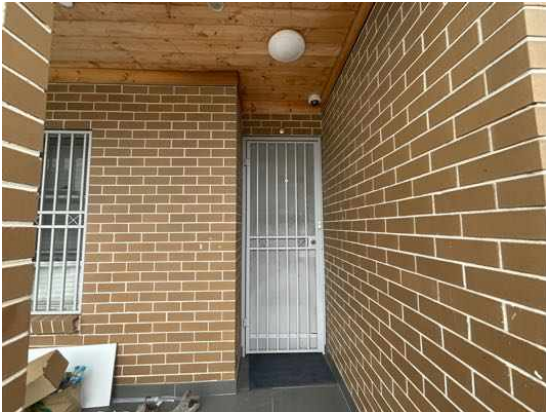
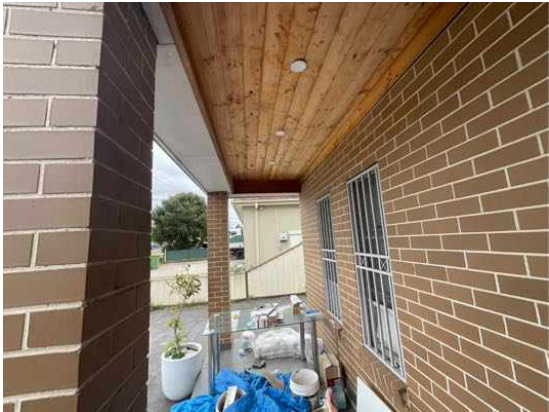
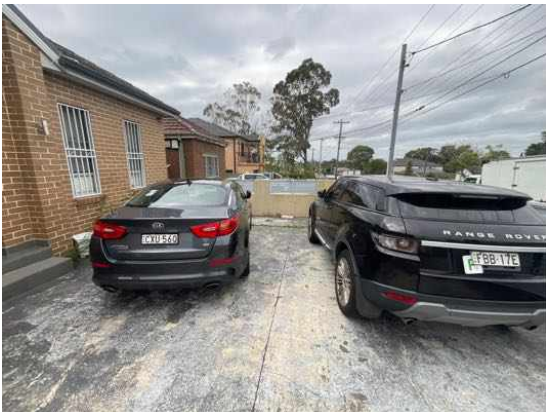
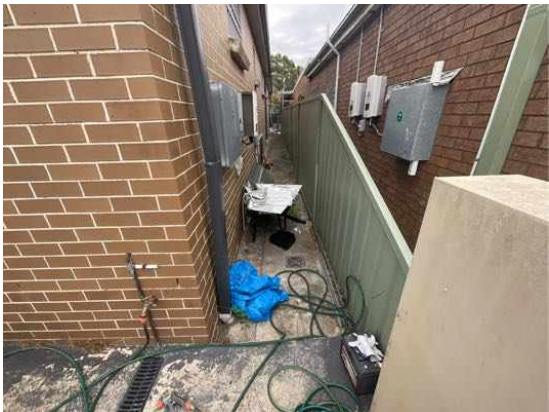
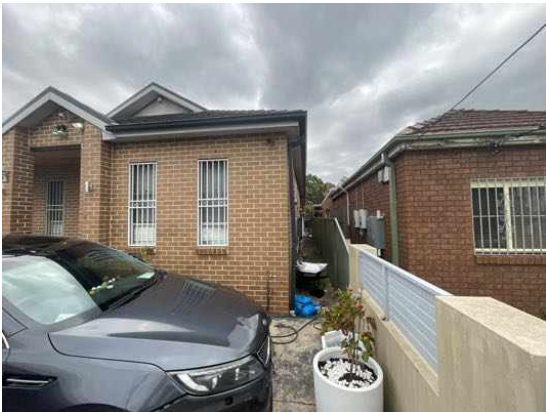
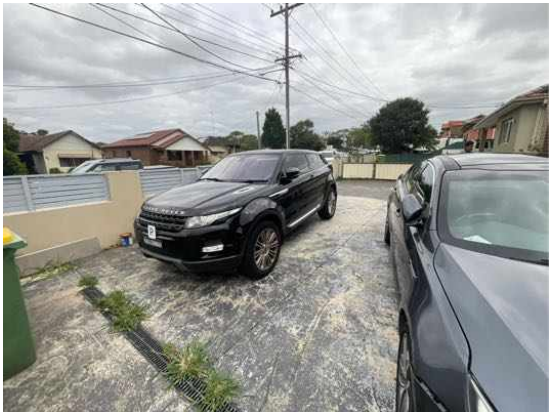
Building: Main Building
Location: All Areas
Finding: Additional Photos
Information: Additional photos are provided for your general reference
