Building and Timber Pest Inspection Report

Inspection Date: Thu, 22 Jan 2026

Property Address: 74 Australia St, Bass Hill NSW 2197,
Australia

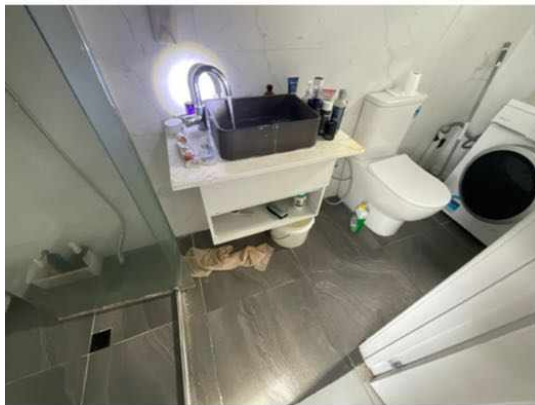
Building:	Main Building
Location:	All Areas
Finding:	Water Proofing Membranes - Information Only
Information:	Internal Water Proofing Membranes, are crucial in preventing water ingress into the property is important to know that the Membrane System used is to Australian Standards and has been installed correctly. Please refer to the original Building Documents or Maintenance Schedule for the relevant information including; - Membrane used and Manufacturers Specifications. - The Installer and Installation Certification. Especially with older property's where this information is unavailable, all wet areas should be monitored. Generally new waterproofing with a certificate may

only have a guarantee of 8yrs. If any leaks, water staining, peeling or bubbling of the paint become evident to any adjacent walls or ceilings below a licensed builder or waterproofing specialist is recommended to investigate further.

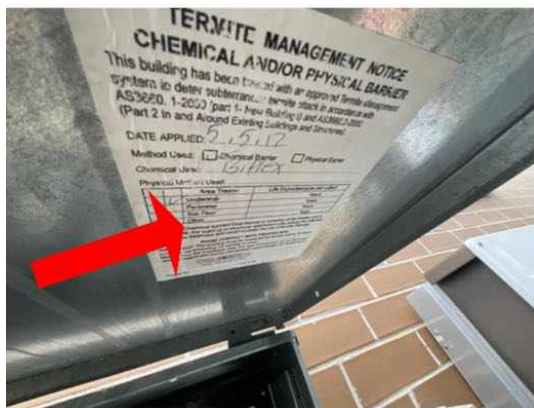
Building:	Main Building
Location:	All Areas
Finding:	Evidence of a chemical treated zone barrier was identified
Information:	During inspection of the property, it was noted that works to install a chemical treated zone barrier had previously been completed. A chemical treated zone barrier is likely to ensure effective protection against termites.

However, we strongly recommend annual inspections of the barrier and surrounding areas as there are several factors that can lead to deterioration of the barrier and decrease its effectiveness.

Where a Termite Management System has been identified, the client should identify to the type of barrier, date of installation, warranty conditions and any documentation provided by a builder or past owner. Consult the company who installed the barrier to confirm whether the system is still under warranty.

Most chemical termite management systems expire and require replenishment. All physical systems are primarily designed to prevent concealed entry.
