Building and Timber Pest Inspection Report

Inspection Date: Thu, 12 Feb 2026

Property Address: 18 Harrow St, Tumbarumba NSW 2653,
Australia

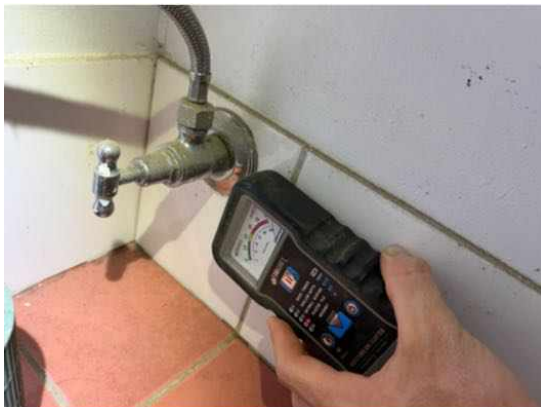
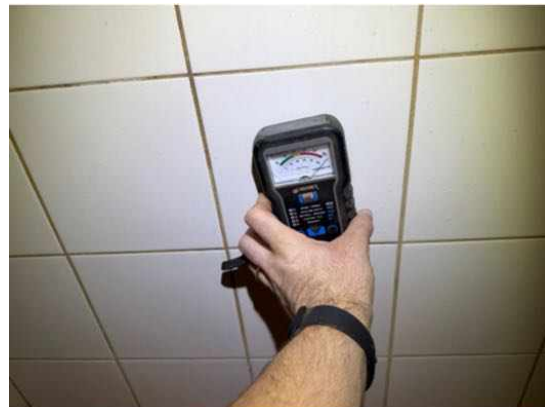
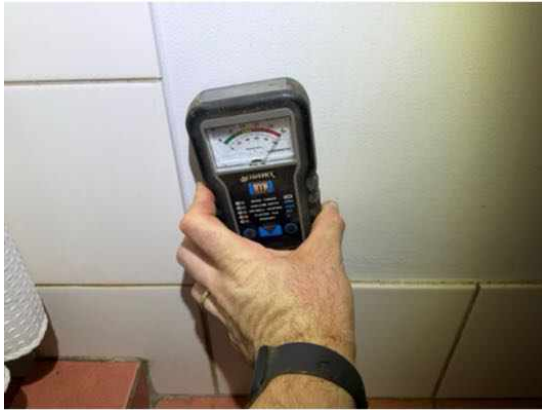
Building: Main Building
Location: Shower, Toilet & Bathroom Floor
Finding: Shower & Toilet - Leaking / High Moisture
Information: It appears that high moisture is present at but not limited to, the base of the shower walls, in the wall outside the shower, beneath the toilet plumbing & the bathroom floor. Potential causes of leaking include but are not limited to loose or damaged plumbing fittings and fixtures, and/or deteriorated seals or waterproofing. Areas of leaking and high moisture create an environment conducive to termite activity and therefore should not be neglected.

If neglected secondary building defects will ensue. A more invasive inspection may reveal secondary building defects.

A licensed plumber is required promptly, to provide remedial works where necessary, to ensure no further water damage occurs.

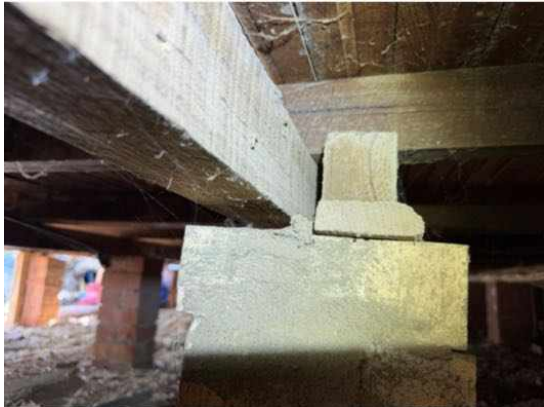
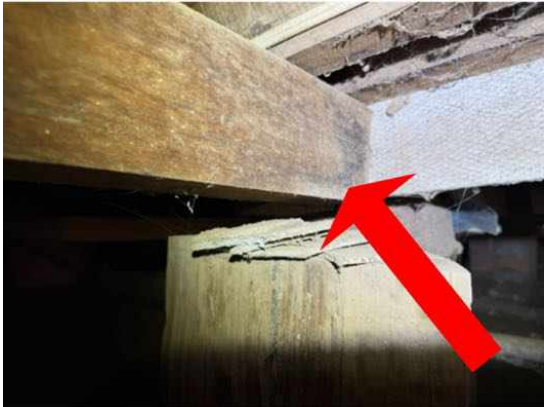
Finding 3.01

Building: Main Building
Location: Subfloor
Finding: Subfloor piers - Insufficient support
Information: It was noted that some piers were not fully supporting the bearers, with gaps in between the top of the pier and the bearer. Where bearers are not being fully supported by the piers, sagging of the subfloor structure is likely to occur overtime.

A registered builder or licensed carpenter should be engaged in the short term to install packing to these areas, to ensure the bearers are sufficiently supported.

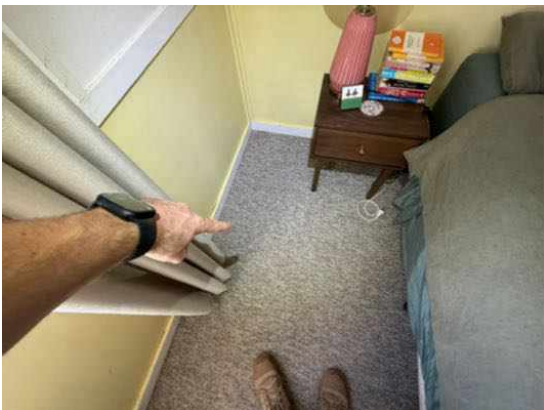
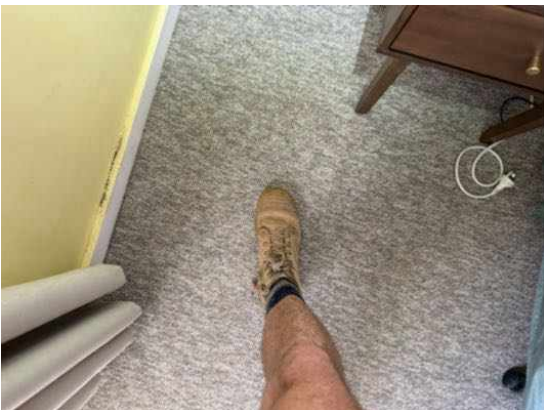
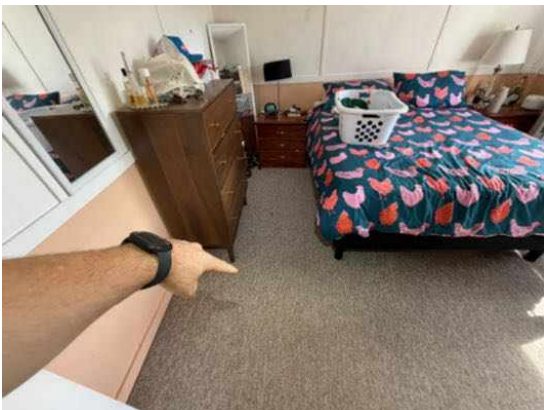
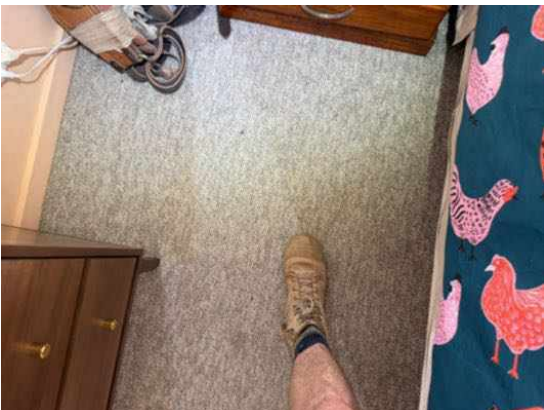
Finding 3.02

Building: Main Building
Location: All Areas
Finding: Flooring - Uneven
Information: Some areas, of the flooring & subfloor bearers throughout the building appear to be sagging & uneven. Recommend consulting with a structural engineer and/or registered builder in the short term, to provide further advice and remedial works where necessary.

Further sagging and the development of secondary building defects are likely to ensue, if neglected.

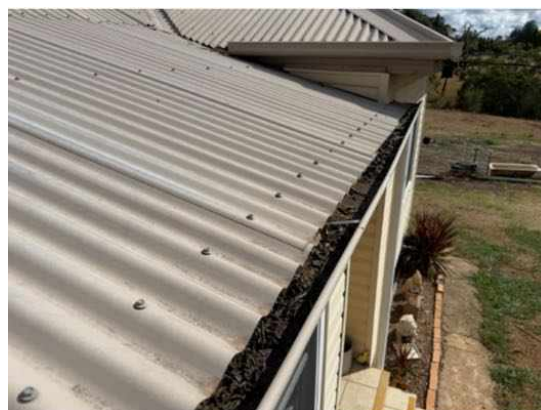
Finding 3.03

Building:	Main Building
Location:	Guttering
Finding:	Gutters - Debris & Water pooling
Information:	Water pooling and debris were noted in sections of the guttering at the time of inspection, likely due to sagging or blockages. Water pooling can lead to deterioration of the roof plumbing over time, if neglected.

A licensed roof plumber should be engaged in the short term, to provide further advice & maintenance works to ensure adequate roof drainage is achieved. All debris should be cleared promptly to ensure proper drainage and prevent overflows.

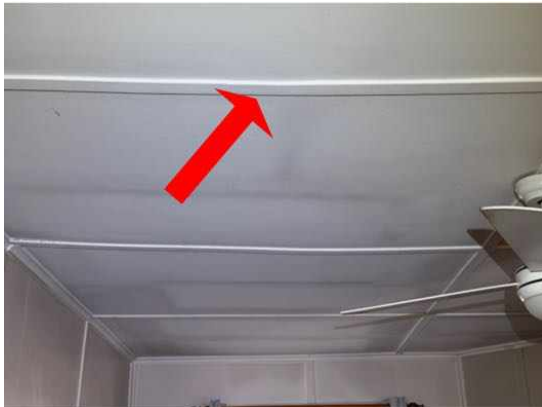
Building:	Main Building
Location:	Lounge room
Finding:	Ceiling - Sagging
Information:	Sections of the ceiling at but not limited to the lounge room appear to be slightly sagging at the time of inspection. Causes of ceiling sagging include fixings (e.g. nails or glue) that have become loose and require re-fixing.

Recommend the client to monitor the sagging and engage a licensed plasterer to provide maintenance works, should the sagging develop.

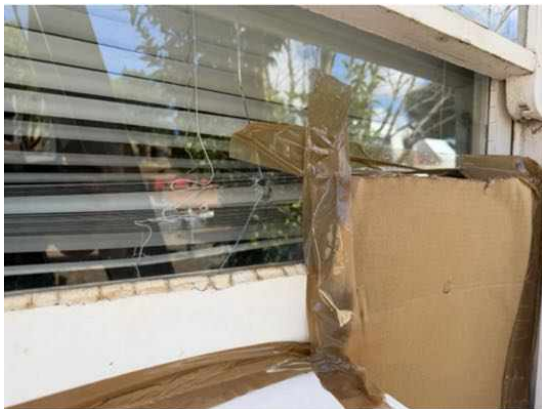
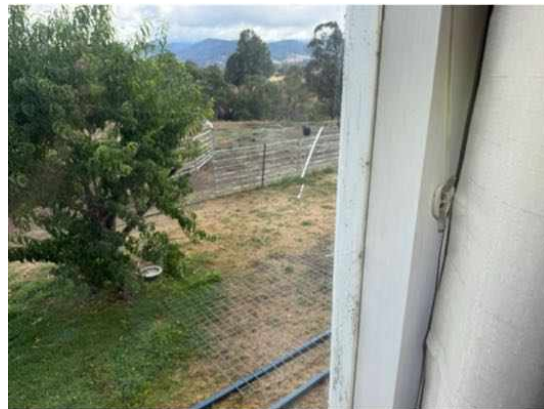
Finding 3.06

Building:	Main Building
Location:	Bedroom, Kitchen
Finding:	Window - Cracked
Information:	Minor cracking was evident at but not limited to, the bedroom & kitchen windows. Further impact may lead to additional cracking.

It is advised that the client monitor the condition of the window. Should further cracking occur, a qualified glazier should be engaged to replace the window

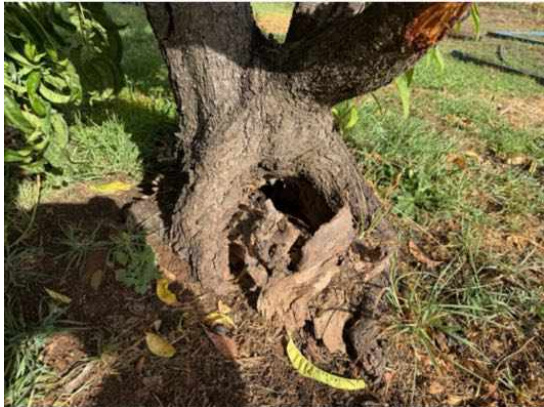
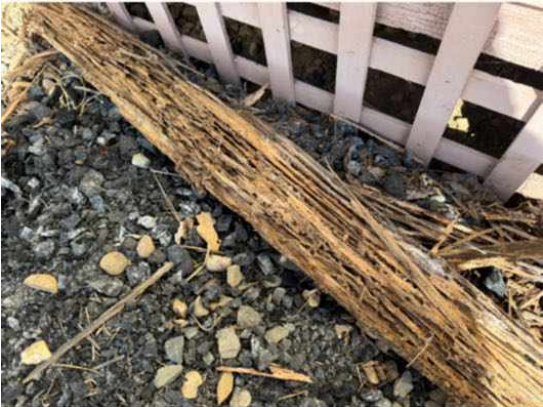
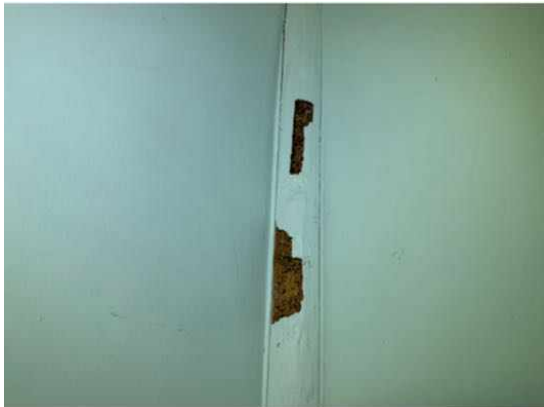
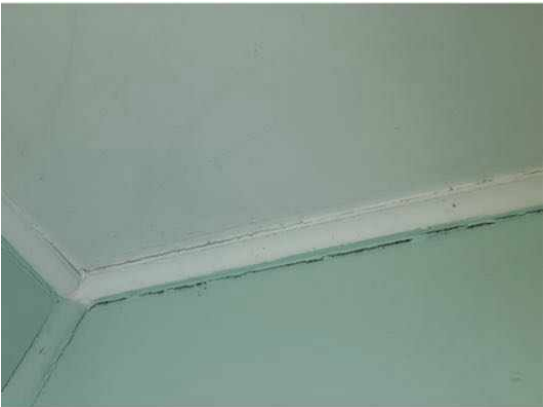
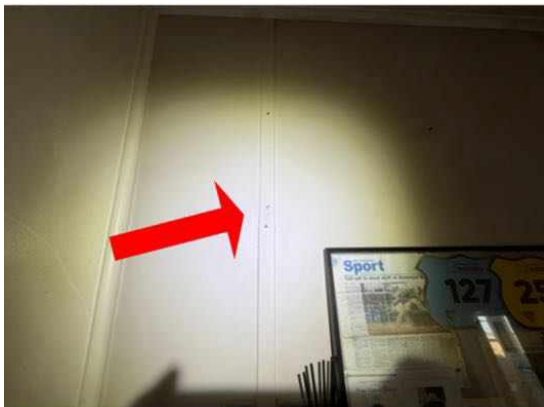
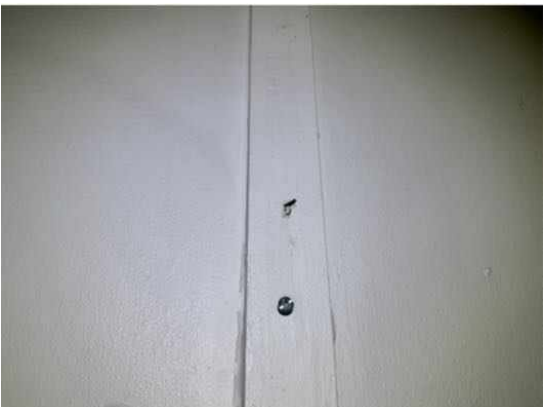
Building:	Main Building
Location:	Mantelpiece, landscaping timbers, front bedroom, lounge room
Finding:	Evidence of termite workings & damage
Information:	Although no live termite activity was identified at the time of inspection, termite

damage & workings were identified at, but not limited to, external trees & landscaping timbers, areas of the front bedroom & lounge room trims & mantelpiece.

It is advised that a more invasive inspection be conducted by a licensed pest controller, to identify the extent of the damage and confirm the damage is inactive and provide further advice regarding installation of a termite treatment. 6 monthly ongoing termite inspections, conducted by a qualified termite inspector, are also recommended

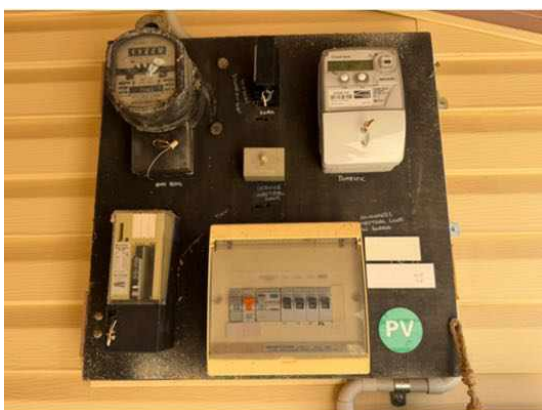
Finding 6.01

Building:	Main Building
Location:	Switchboard
Finding:	Termite Management System - no evidence of a chemical installation
Information:	The application of a termite barrier is strongly recommended, as it appears no termite management system has been installed, with no evidence or durable notice to suggest works taking place. Generally, a durable notice is placed in the meter box to indicate current termite barriers.

Such barriers are highly effective in preventing termite attack on the building and therefore should be installed.

Recommend seeking further advice from a licensed pest controller promptly.

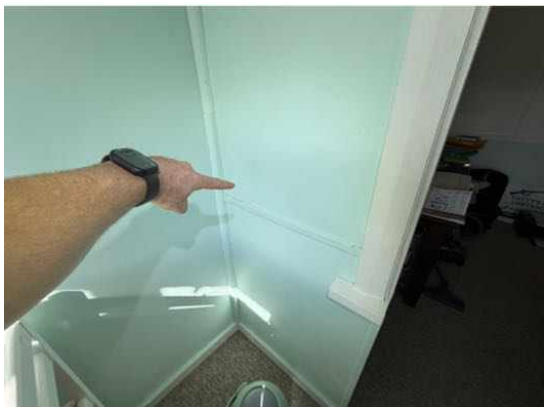
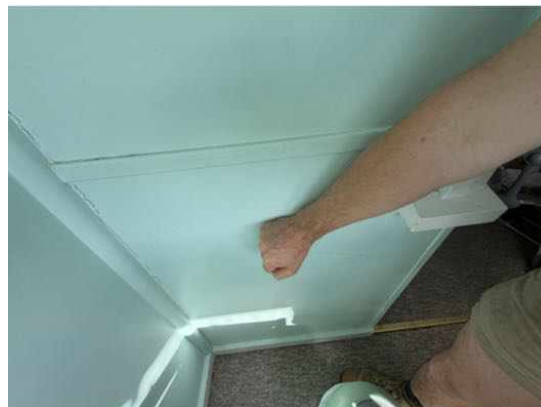
Finding 6.02

Building:	Main Building
Location:	Front Bedroom
Finding:	Audible Indications of Potential Termite Damage

Information: It appears areas of audible droppings in the wall cavities were identified at, but not limited to the front bedroom. This may be an indicator of potential termite damage in the wall cavity. Therefore, a more invasive inspection conducted by a licensed tradesperson is recommended to confirm, and identify the extent of the damage.

Should termite damage be confirmed, a registered builder should then be engaged to replace any affected building materials.

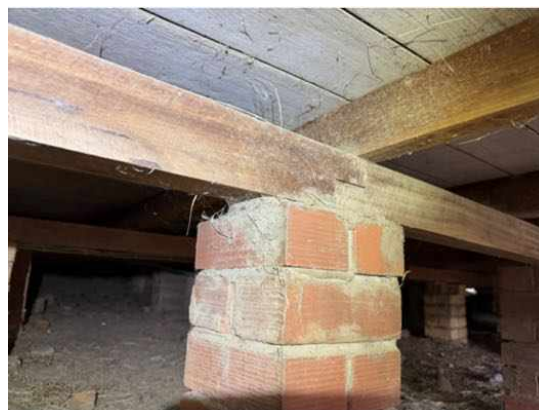
Finding 6.04

Building:	Main Building
Location:	Subfloor
Finding:	Ant caps - Not Installed
Information:	It was found that ant caps have not been installed to the piers. Ant caps are designed to easily identify termite ingress from piers to the adjoining bearers. Where ant caps have not been installed, this creates an obstruction for inspection and frequent monitoring of these areas should be carried out in order to identify any signs of termite workings. It is advised that sufficient ant caps be installed to the piers by a licensed carpenter.

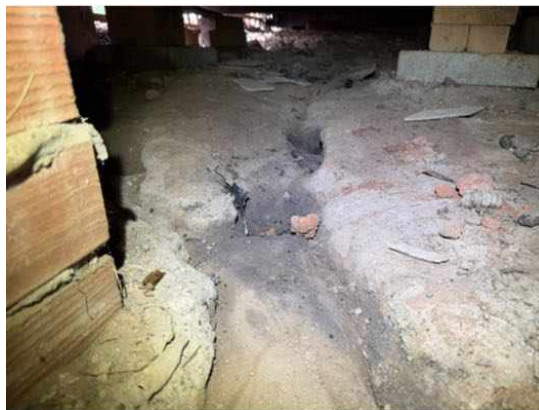
Where insufficient drainage of taps, hot water system & aircon overflows, insufficient site drainage, and garden beds against the house are present, water pooling is likely to occur, and can create areas conducive to timber pests and potential damage to the subfloor structure overtime, if neglected.

Recommend consulting with a licensed plumber in the short term to further assess and provide remedial advice.

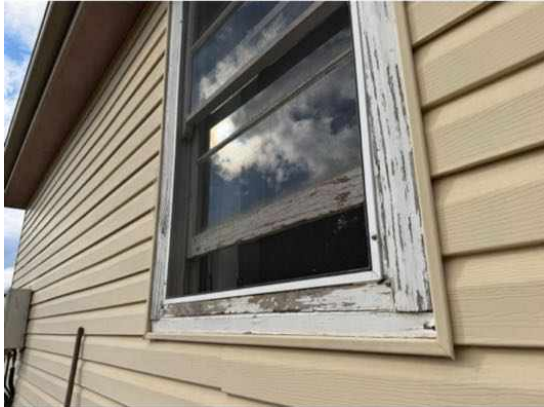
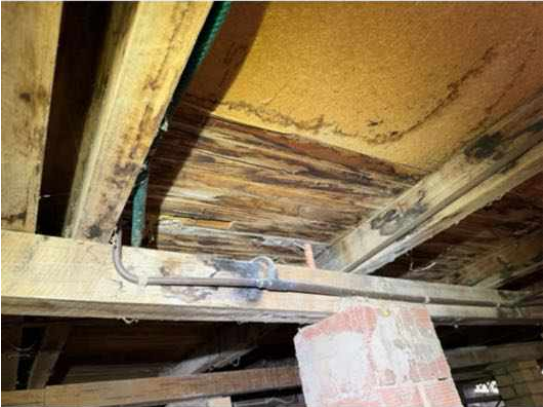
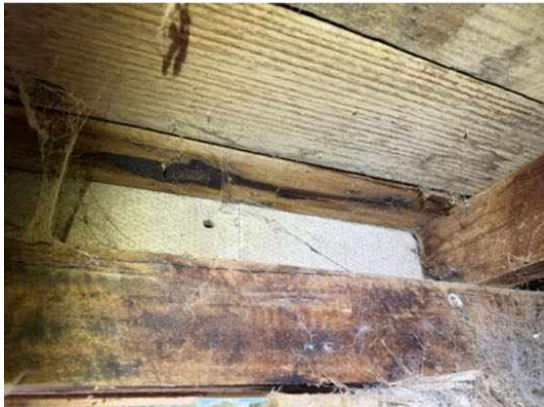
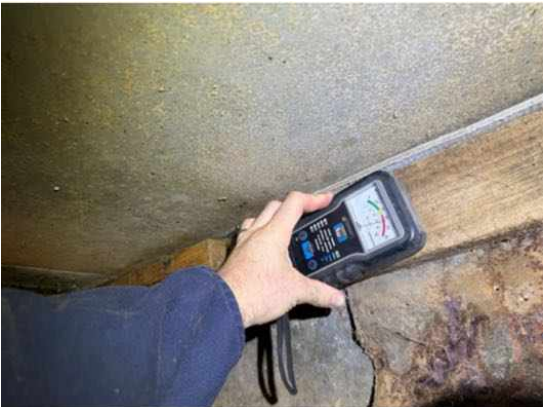
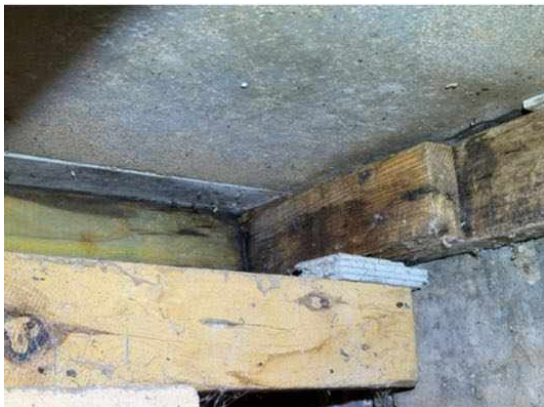
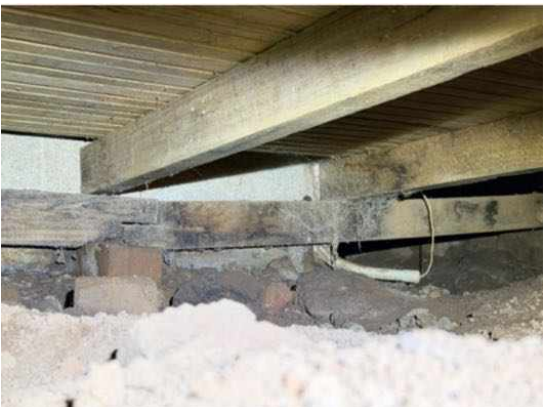
Finding 7.01

Building:	Main Building
Location:	Floorboards, bearers, window frames, external timbers, fascias
Finding:	Fungal decay & weathering
Information:	Areas of fungal decay (wood rot) & weathering were identified at but not limited to

some floorboards, timber bearers, window frames, external timbers & fascias. For areas where structural timbers are affected by wood rot (subfloor timbers) a registered builder should be engaged promptly to replace affected materials where necessary.

For areas where fungal decay is superficial, the client can engage a licensed carpenter at their discretion to replace affected materials.

For areas of general weathering, it is advised the client engage a licensed painter to apply protective sealant or coating to areas of weathered external timbers.

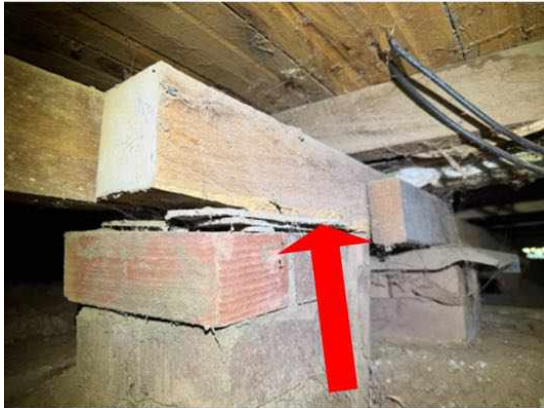
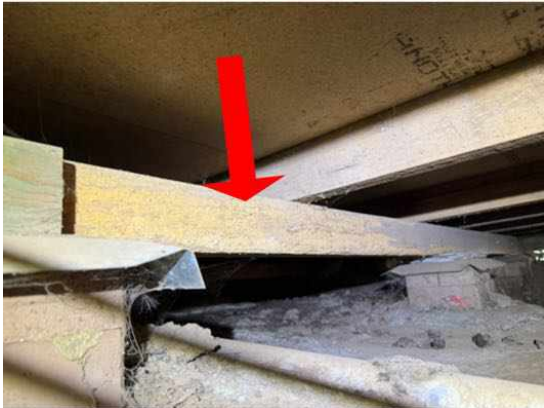
Finding 8.01

Building:	Main Building
Location:	Subfloor
Finding:	Evidence of wood borer damage identified (powder-post)
Information:	Evidence of previous Lyctus Borer (powder-post beetle) damage was identified at but not limited to the edge of some timber bearers in the subfloor.

As no live wood borer activity was identified treatment is not required.

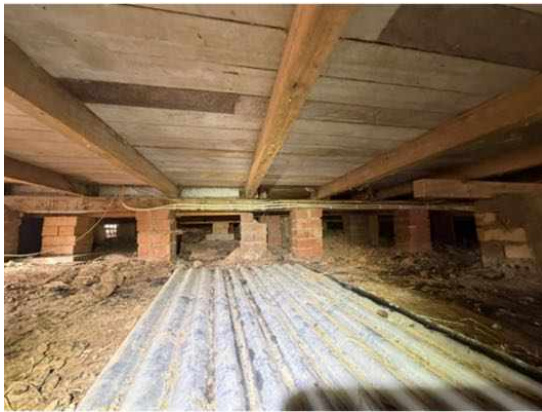
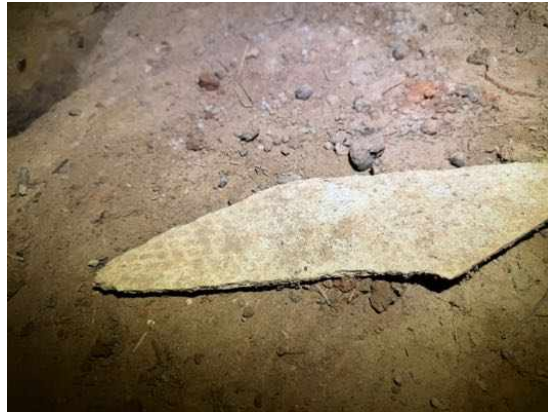
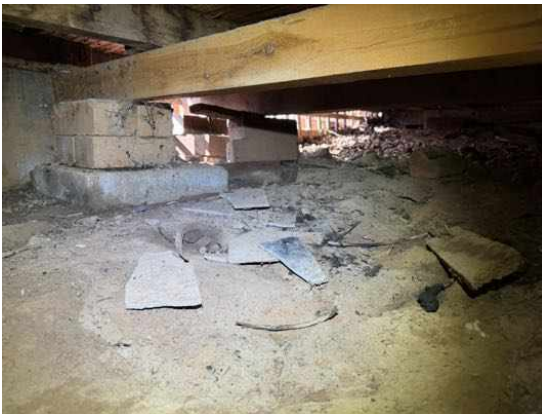
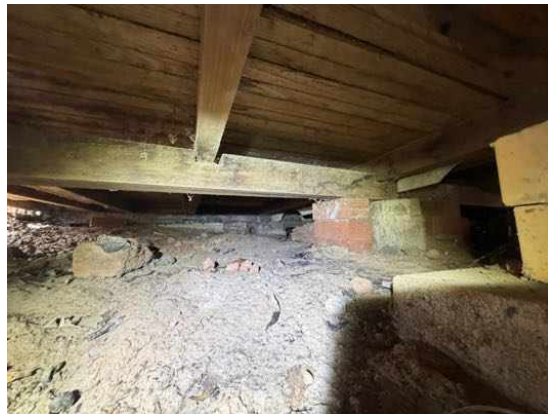
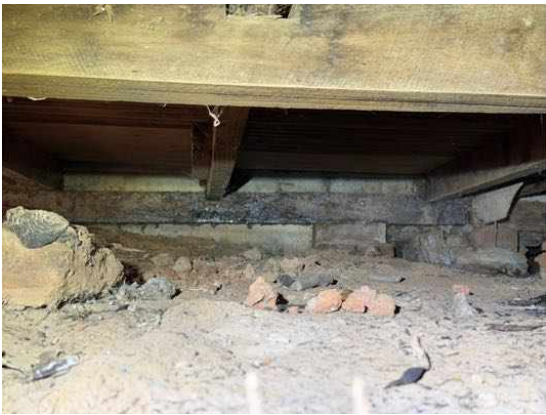
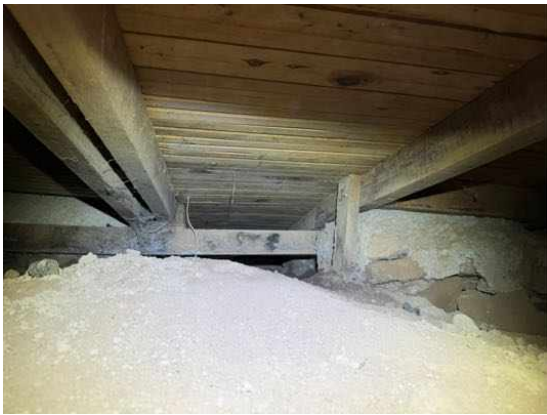
Building: Main Building
Location: All Areas
Finding: Additional Photos - Obstructions and Limitations
Information: These photographs are an indication of the obstructions and limitations which impeded full inspection of the property at the time of inspection. These obstructions can hide an array of defects and should be removed to allow full inspection to be carried out. A re-inspection is recommended once the areas are made accessible.

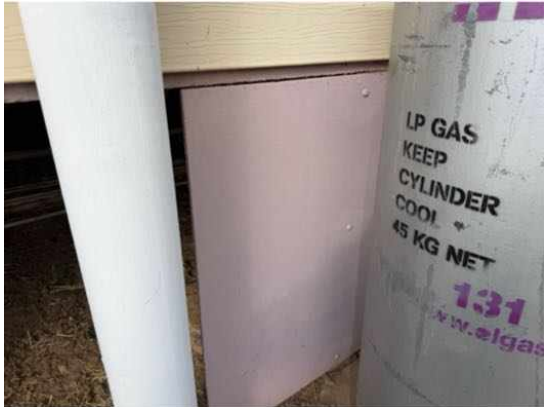
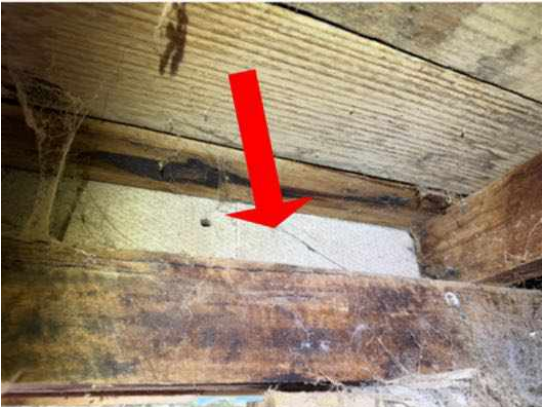
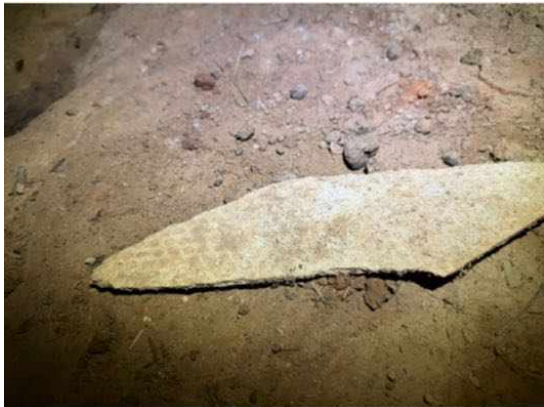
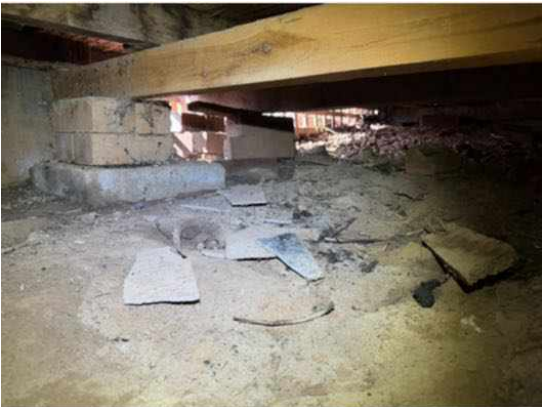
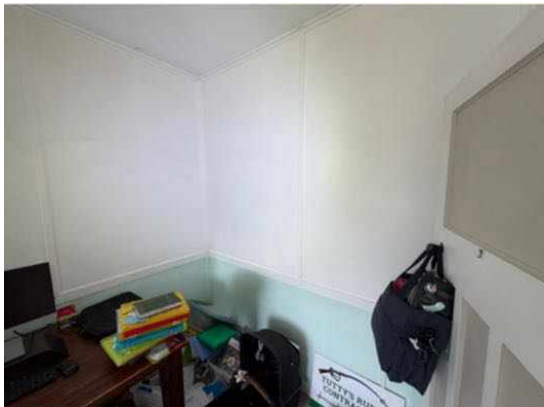
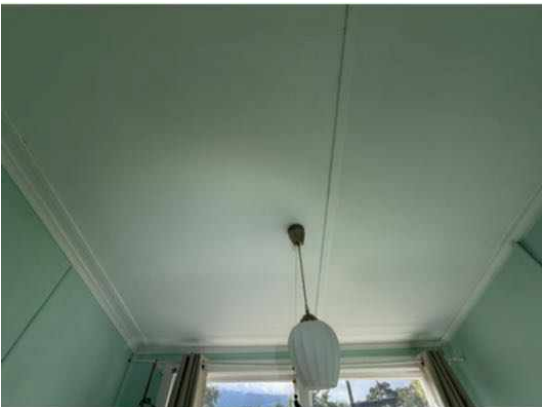
Building: Main Building
 Location: Original Cladding, Wall & Ceiling Linings, Debris Subfloor
 Finding: Asbestos - Suspected ACM Identified on Site
 Information: This suspected defect is highlighted as a caution only as reporting on asbestos is outside the scope of this report. It is suspected that the materials including but not limited to original cladding, wall & ceiling linings and packing & debris in the subfloor may be ACM's (Asbestos containing materials)

It is advised that the client consider a separate Asbestos Inspection and Condition Audit, which can include the taking of samples for definitive confirmation of the presence of Asbestos, carried out by a licensed Asbestos Inspector.

In the interim, no works should be conducted to these areas without further specialist advice.

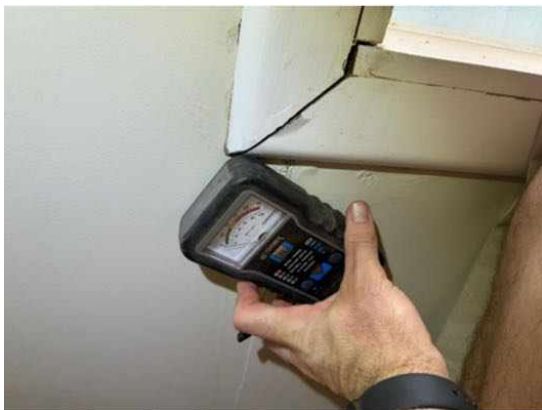
Building: Main Building
 Location: Window Frames, Skirting
 Finding: Water Staining Present
 Information: It appears that water staining / damage was present including but not limited to, some window frames & skirting boards. Potential causes of leaking include deteriorated roof cladding, deteriorated seals, or damaged plumbing fittings and fixtures. No high moisture was evident in these areas at the time of inspection.

It is recommended that the client monitor these areas and engage a licensed roof plumber and/or carpenter promptly, should the leak persist or return.
