Building and Timber Pest Inspection Report VR

Inspection Date: Tue, 17 Mar 2026

Property Address: 263 Prince St, Grafton NSW 2460, Australia

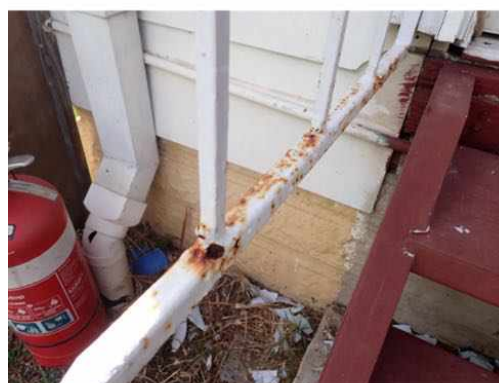
Finding 1.01

Building:	Main Building
Location:	Rear of building
Finding:	Rear Handrail – Poor Condition with Rust and Instability
Information:	The rear handrail was found to be in poor condition, with rust identified and the structure noted as unstable at the time of inspection. The condition is consistent with age, weathering, and lack of maintenance, and may result in further deterioration if not addressed. In plain English, the rear handrail is rusty and not secure. A licensed builder or suitably qualified tradesperson should assess and carry out repairs as required, which may include repair or replacement of affected sections and re-fixing to ensure stability. Ongoing maintenance will assist in preventing further deterioration. Maintenance and repairs should be undertaken as soon as possible.

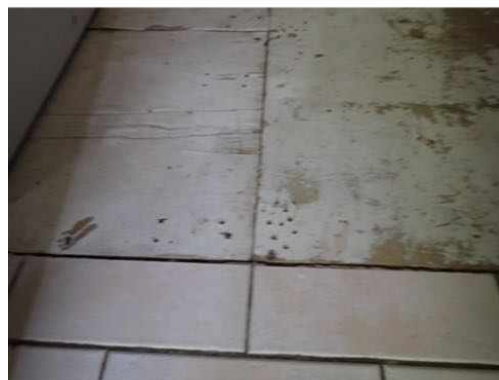
Finding 2.01

Building:	Main Building
Location:	Laundry
Finding:	Laundry Floor – Section of Tiled Area Replaced with Plywood
Information:	A section of the laundry floor tiled area has been removed and replaced with plywood flooring. The modification appears inconsistent with surrounding finishes and may indicate previous repairs or alterations. Further invasive investigation is recommended to gain a better understanding of why the tiled flooring was removed and replaced with plywood and to assess the condition of the underlying structure and materials. In plain English, part of the tiled laundry floor has been taken out and replaced with timber sheeting, and more investigation is needed to find out why. A licensed builder or

flooring contractor should assess the area and carry out repairs as required, which may include reinstating appropriate flooring and ensuring the substrate and waterproofing (if applicable) are adequate for a wet area. Ensuring suitable materials and finishes are used will assist in preventing deterioration and moisture-related issues. Maintenance and repairs should be undertaken where considered necessary.

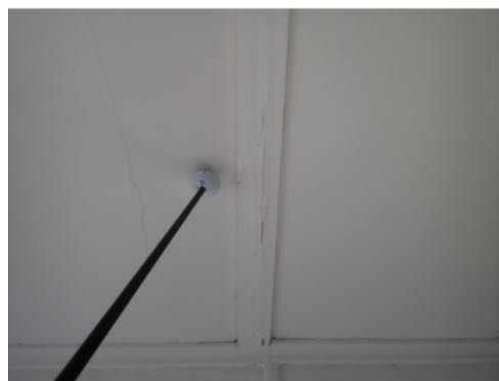
Finding 2.02

Building:	Main Building
Location:	Laundry
Finding:	Laundry Ceiling Damage – Cracking and Dropping
Information:	Damage was identified to the laundry ceiling, including visible cracking and areas of sagging/dropping. This may be indicative of moisture ingress, material deterioration, inadequate fixing, or structural movement and is a common defect with a home of this age. In plain English, the laundry ceiling is cracked and starting to sag. A licensed builder should assess and carry out repairs as required. Further investigation is recommended to determine the cause and extent of the damage, with repairs to be completed accordingly. Prompt repairs and maintenance will assist in preventing further deterioration. Maintenance and repairs should be undertaken at the owners discretion.

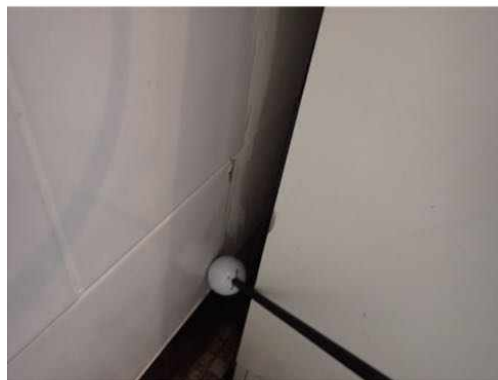
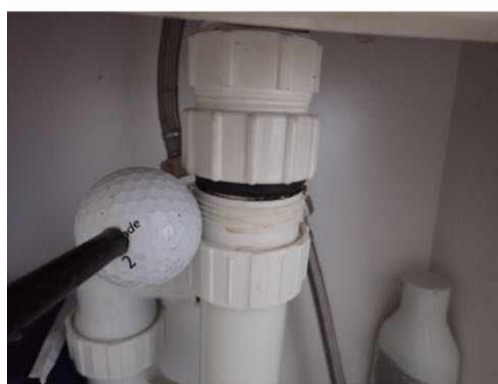
Finding 2.03

Building:	Main Building
Location:	Bathroom
Finding:	Bathroom Vanity Not Secured to Wall and Waste Pipe Poorly Installed
Information:	The bathroom vanity was found not to be adequately secured to the wall, and the associated waste pipe was poorly installed at the time of inspection. This may result in movement during use and could lead to leaks or damage to surrounding materials. In plain English, the vanity is loose and the waste pipe underneath has been installed poorly. A licensed plumber should assess and rectify as required, which may include securing the vanity to the wall and reinstalling the waste pipe using appropriate fittings and methods. Proper installation and maintenance will assist in preventing movement,

leaks, and further deterioration. Maintenance and repairs should be undertaken where considered necessary.

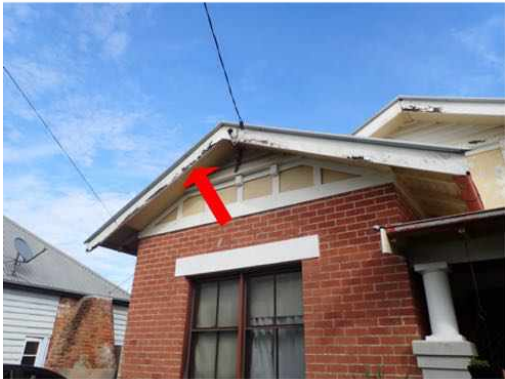
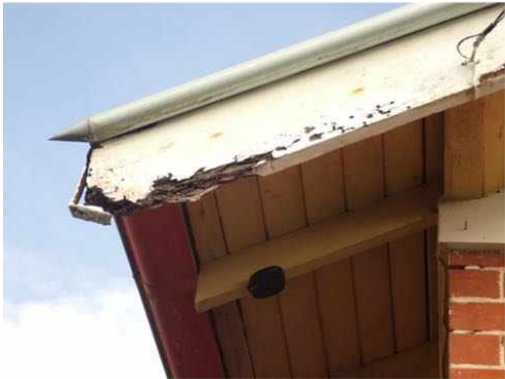
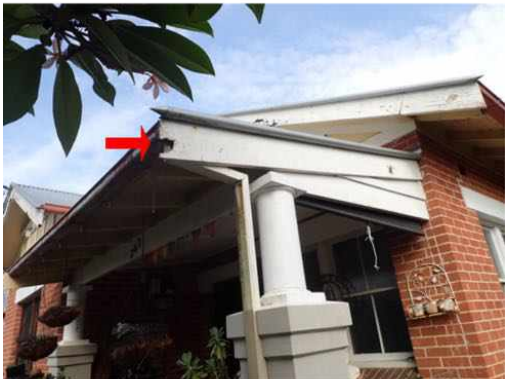
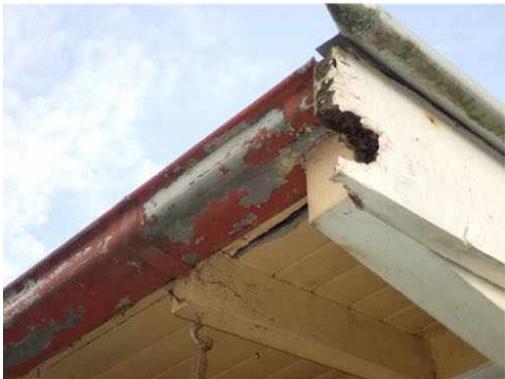
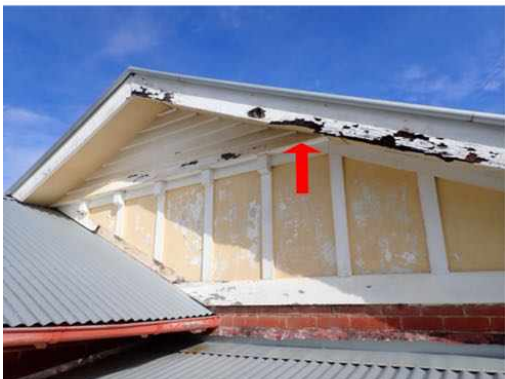
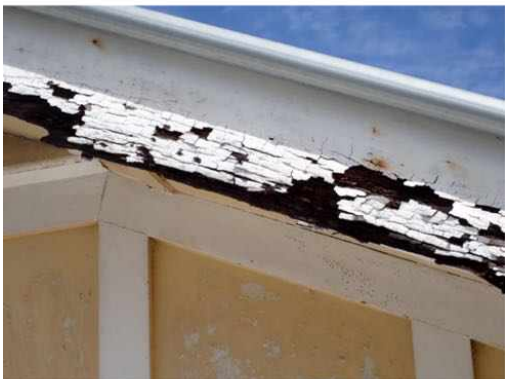
Finding 2.04

Building:	Main Building
Location:	Fascia boards
Finding:	Fascia Boards – Wood Rot and Deteriorated Paint Identified at Multiple Locations
Information:	Wood rot and deteriorated paintwork were identified to the fascia boards at multiple locations. This condition is typically caused by prolonged exposure to moisture, weathering, and lack of maintenance, and is a common defect with a home of this age. Deterioration of fascia boards may affect their structural integrity and ability to support roof drainage components. In plain English, sections of the timber along the roof edge are rotting and the paint is worn. A licensed builder or carpenter should assess and carry out repairs as required, which may include removal and replacement of affected sections and repainting/sealing to protect against further deterioration. Ongoing maintenance will assist in preventing recurrence. Maintenance and repairs should be undertaken where considered necessary.

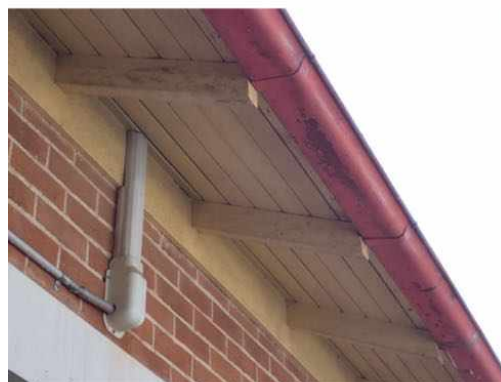
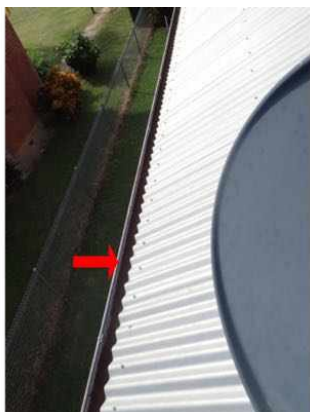
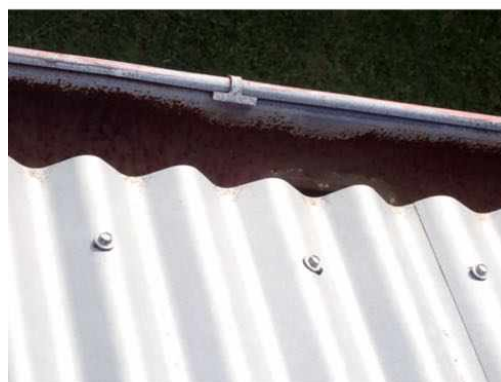
Finding 2.05

Building: Main Building
Location: Gutters
Finding: Gutters – Rust and Deteriorated Paintwork with Limited Inspection
Information: Rust and deteriorated paintwork were identified to the gutters. The condition is consistent with age, weathering, and lack of maintenance and may lead to further corrosion and reduced service life if not addressed. Inspection of the gutters was limited due to height restrictions at the time of inspection. In plain English, the gutters are rusty and the paint is worn, and they could not be fully checked due to access limitations. A suitably qualified tradesperson should assess and carry out repairs, including cleaning, rust treatment, sealing, repainting, or replacement of affected

sections as required. Ongoing maintenance will assist in preventing further deterioration. Maintenance and repairs should be undertaken where considered necessary.

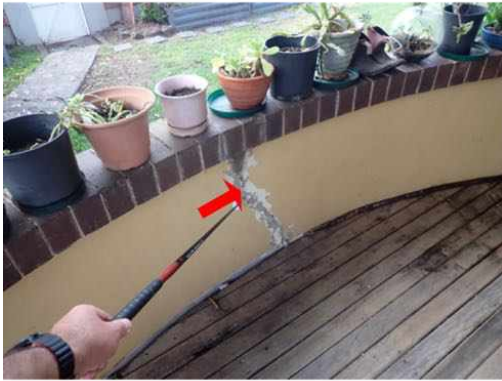
Finding 2.06

Building:	Main Building
Location:	Front porch balcony wall
Finding:	Front Porch Balustrade Wall – Large Crack Identified
Information:	A large crack was identified to the front porch balustrade wall. The extent of the cracking may indicate movement, material deterioration, or structural stress and is a common defect with a home of this age. In plain English, there is a large crack in the front porch balustrade wall. A licensed builder or suitably qualified tradesperson should assess and carry out repairs as required, which may include crack repair, reinforcement, or rebuilding of affected sections. Further investigation is recommended to determine the cause and extent of the cracking. Ongoing maintenance will assist in preventing further deterioration. Maintenance and repairs should be undertaken as soon as possible.

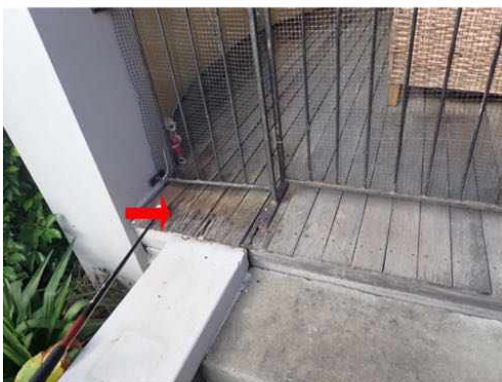
Finding 2.07

Building:	Main Building
Location:	Front porch balcony wall
Finding:	Front Porch Deck and Framing – Poor Condition with Wood Rot and Limited Subfloor Access
Information:	The front porch deck and supporting framing were found to be in poor condition, with evidence of wood rot, bouncy/unstable framing, and general deterioration. The condition may indicate loss of structural integrity and ongoing deterioration associated with age, moisture exposure, and lack of maintenance, and is a common defect with a home of this age. No access was available to the subfloor area at the time of inspection, limiting the ability to fully assess the extent of damage. In plain English, the front deck is in poor shape, with rotting timber and movement underfoot, and the area underneath could not be inspected. A licensed builder or carpenter should assess and carry out repairs as required, which may include replacement of affected timbers and structural rectification. Further invasive investigation is recommended to determine the full extent of the damage. Maintenance and repairs should be undertaken as soon as possible.

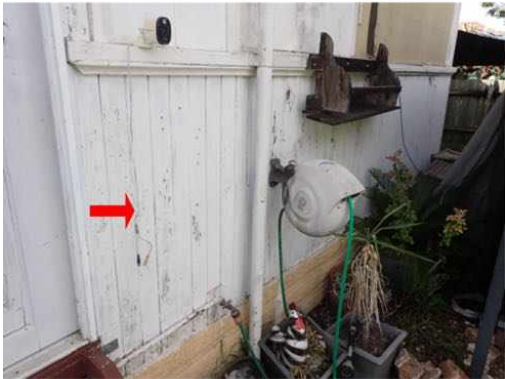
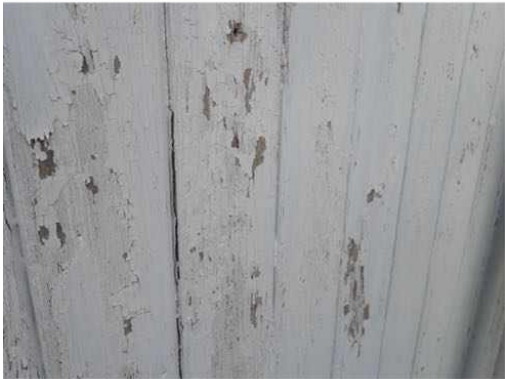
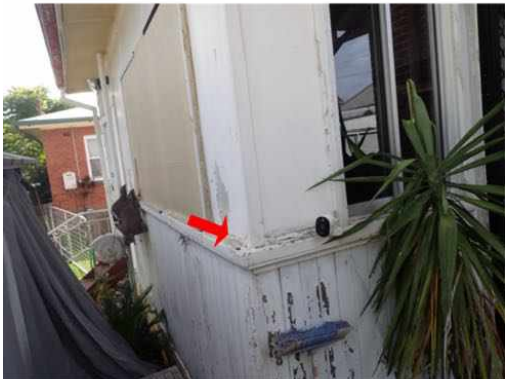
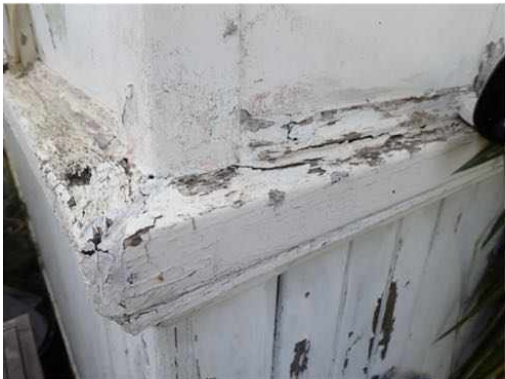
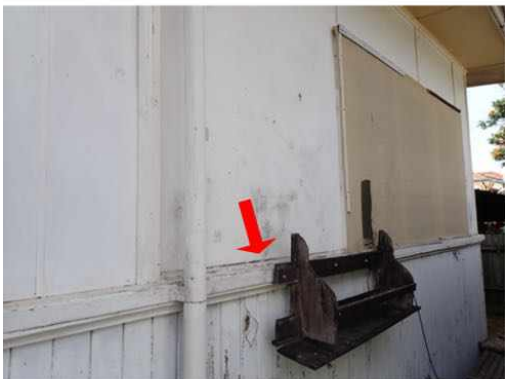
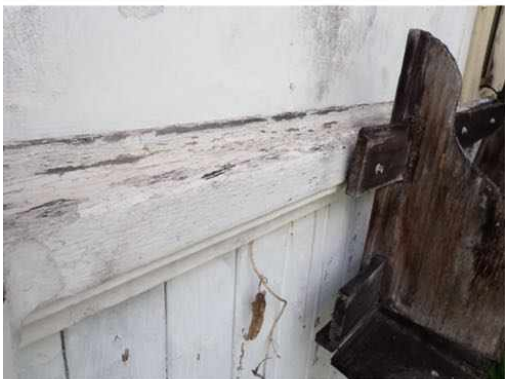
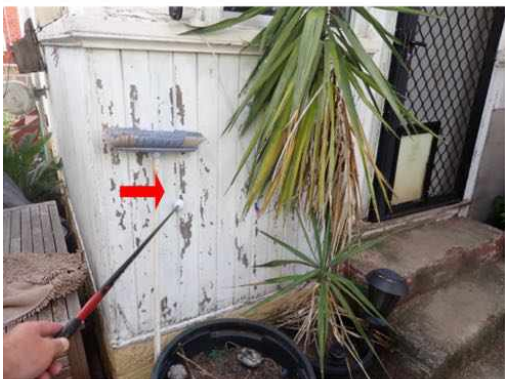
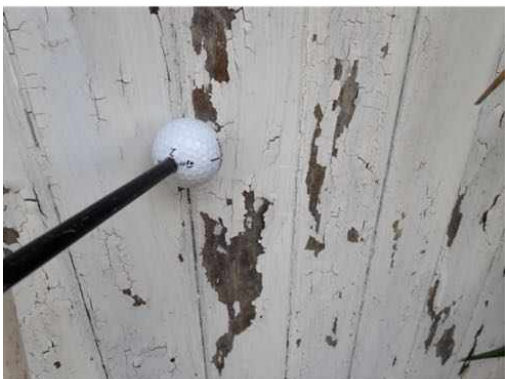
Finding 2.08

Building:	Main Building
Location:	Rear of building
Finding:	Laundry External Cladding – Poor Condition with Wood Rot and Deteriorated Paintwork
Information:	The external cladding around the laundry was found to be in poor condition, with wood rot and deteriorated paintwork identified. The condition is consistent with prolonged exposure to moisture, weathering, and lack of maintenance, and is a common defect with a home of this age. Deterioration of cladding may allow water ingress and further damage to underlying building materials. In plain English, the wall cladding around the laundry is affected by timber decay and the paint is worn. A licensed builder or carpenter should assess and carry out repairs as required, which may include removal and replacement of affected sections and repainting/sealing to protect against further deterioration. Ongoing maintenance will assist in preventing recurrence. Maintenance and repairs should be undertaken where considered necessary.

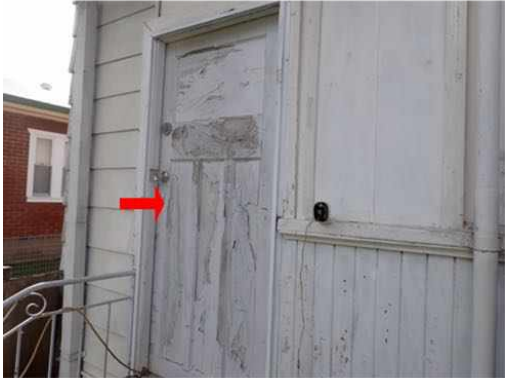
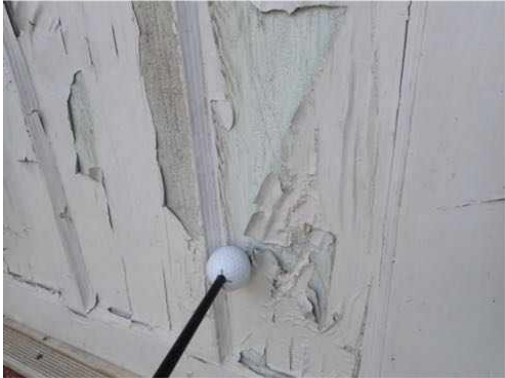
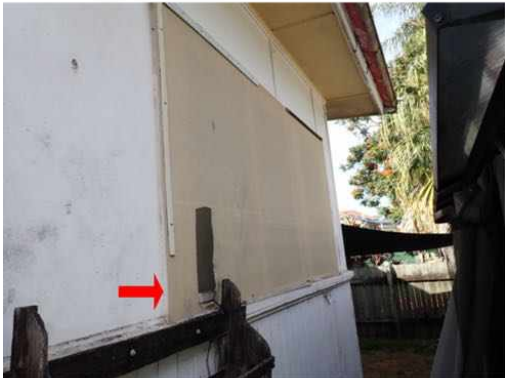
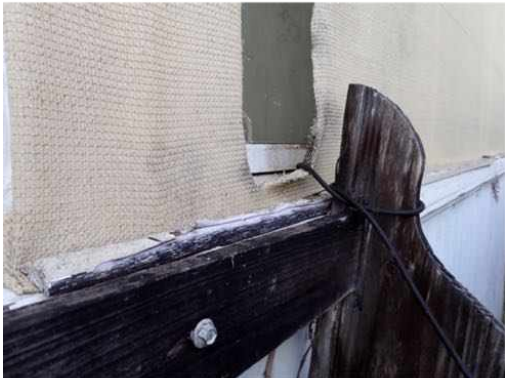
Finding 2.09

Building: Main Building
Location: Rear of building
Finding: Laundry Doors, Windows and Timber Trims – Poor Condition with Timber Decay and Deteriorated Paintwork
Information: The doors, windows and associated timber trims to the laundry were found to be in poor condition, with timber decay and deteriorated paintwork identified. The condition is consistent with age, weathering, and lack of maintenance, and is a common defect with a home of this age. Deterioration may affect operation and allow water ingress, leading to further damage of surrounding materials. In plain English, the laundry doors, windows and trims are in poor shape, with decayed timber and worn paint. A licensed builder, carpenter, or suitably qualified tradesperson should assess and carry out repairs as required, which may include repair or replacement of affected components and repainting/sealing to protect against further deterioration. Ongoing maintenance will assist in preventing recurrence. Maintenance and repairs should be undertaken where considered necessary.

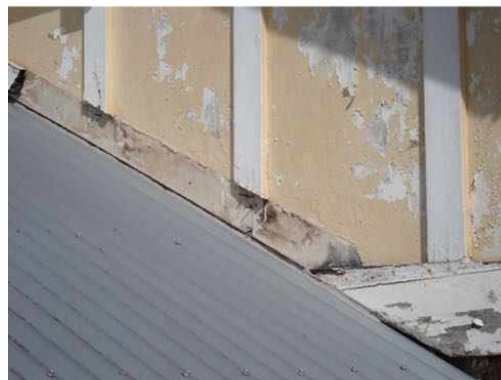
Finding 2.10

Building:	Main Building
Location:	End gables
Finding:	Roof End Gable Cladding and Timber Trims – Timber Decay and Deterioration
Information:	Timber decay and general deterioration were identified to the roof end gable cladding and associated timber trims. The condition is consistent with prolonged exposure to weather, moisture ingress, and lack of maintenance, and is a common defect with a home of this age. Deterioration of these elements may allow water ingress and further damage to underlying building materials. In plain English, the timber cladding and trims at the end of the roof are deteriorated and breaking down. A licensed builder or carpenter should assess and carry out repairs as required, which may include removal and replacement of affected sections and repainting/sealing to protect against further deterioration. Ongoing maintenance will assist in preventing recurrence. Maintenance and repairs should be undertaken where considered necessary.

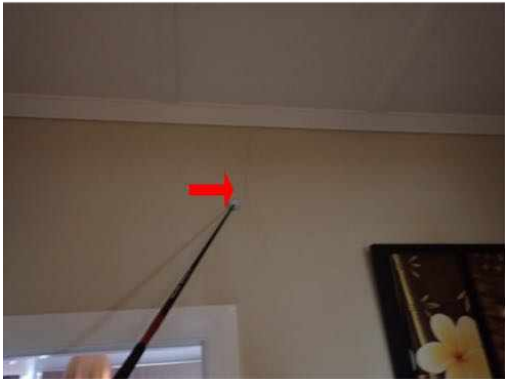
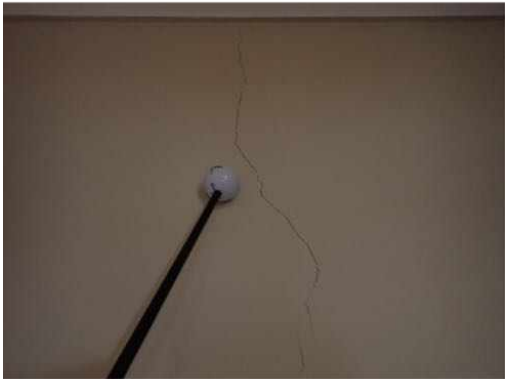
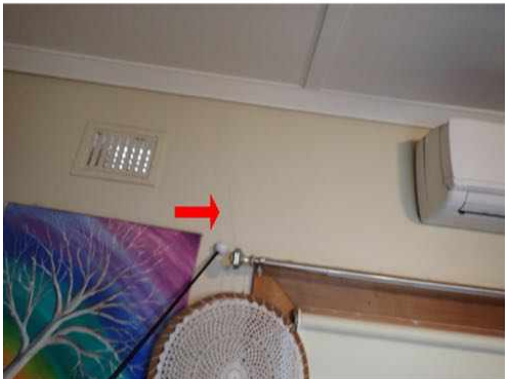
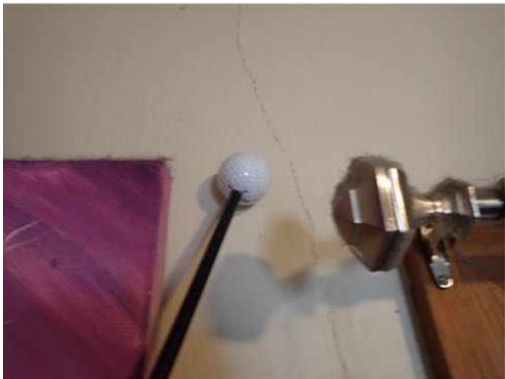
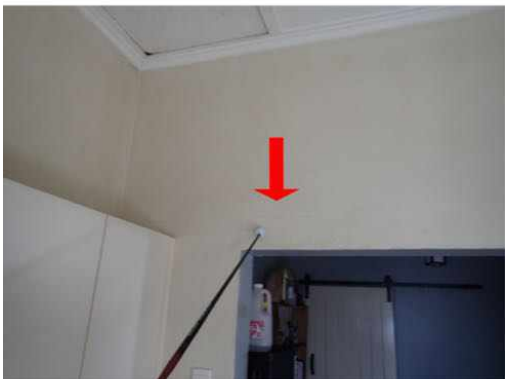
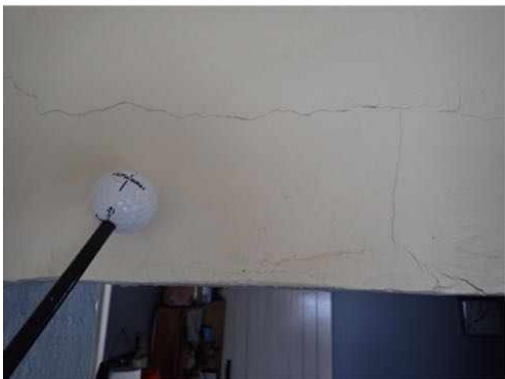
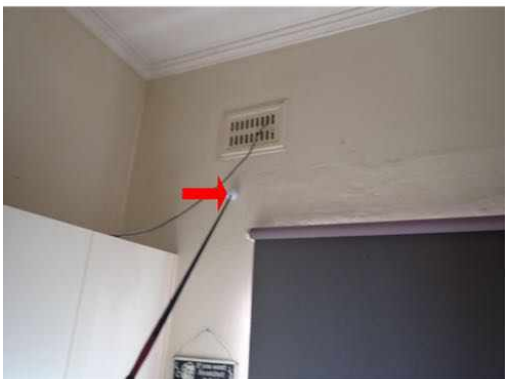
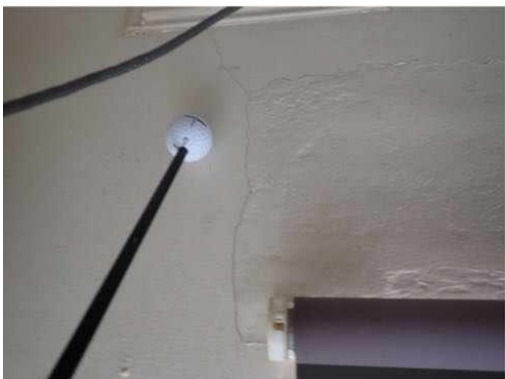
Finding 3.01

Building:	Main Building
Location:	All Areas
Finding:	Minor Internal Brick Walls and Render Cracking
Information:	<p>Minor cracking was identified to the internal brick walls and rendered surfaces at several locations. The cracking appears minor at the time of inspection and is commonly associated with normal building movement, minor settlement, material shrinkage, thermal movement, or age-related movement in the structure. In plain English, small cracks were seen in a number of internal wall areas. A licensed builder or suitable crack repair contractor should assess and repair as required. Repairs may include monitoring, filling, patching, and repainting where considered necessary. Ongoing maintenance and prompt repair of cracks can assist in preventing further deterioration. Owner discretion is advised regarding cosmetic repairs where the cracking remains minor and non-structural.</p>

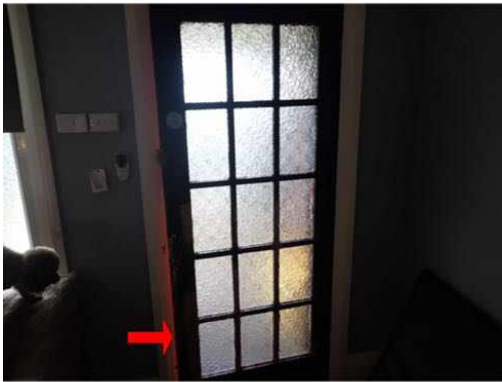
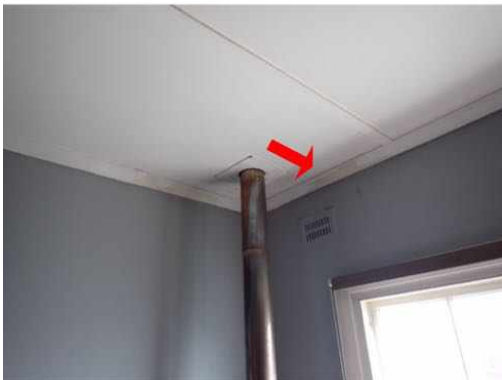
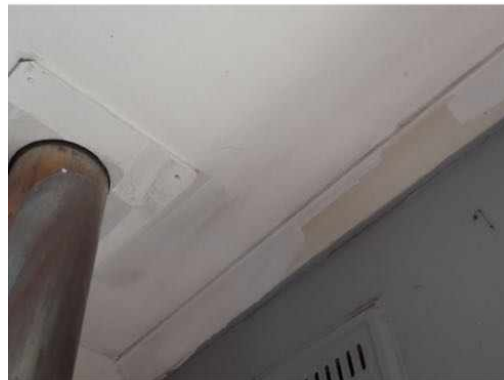
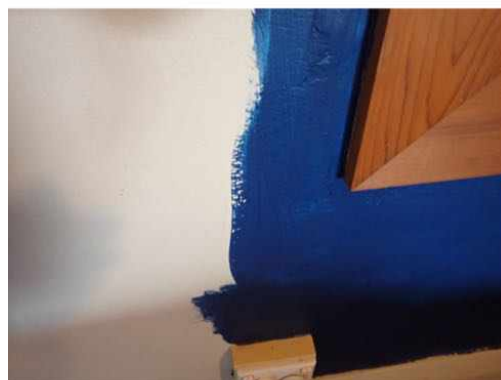
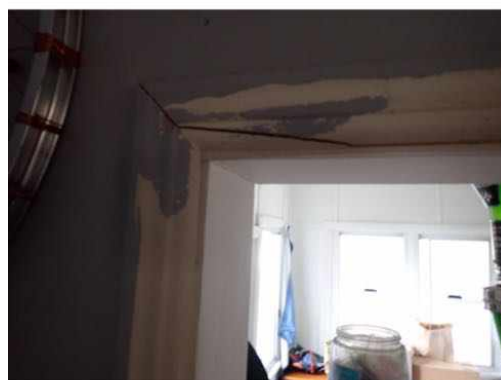
Finding 3.02

Building:	Main Building
Location:	All Areas
Finding:	Internal Painted Surfaces, Windows and Doors Requiring Repainting
Information:	Multiple internal areas were found to be in need of repainting, including sections of walls, and ceilings, as well as various windows and doors. The condition is consistent with general wear and tear, ageing of paint finishes, and lack of routine maintenance. In plain English, a number of areas inside the house, including some windows and doors, need a fresh coat of paint. A licensed painter or suitably qualified tradesperson should carry out preparation and repainting works as required. Proper surface preparation, including sanding, filling and priming, is recommended to ensure a durable finish and to prevent premature deterioration. Owner discretion is advised where the issue is considered cosmetic.

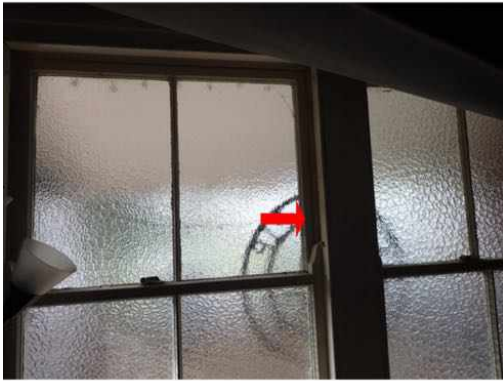
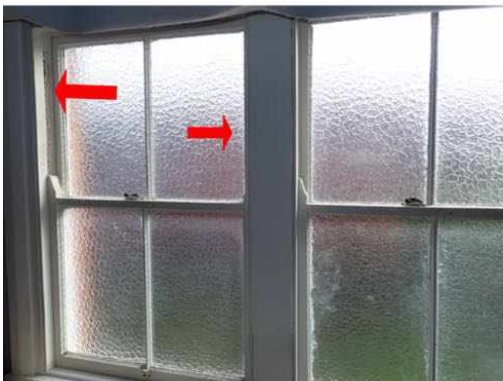
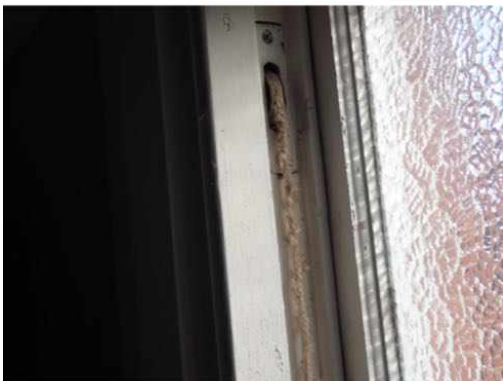
Finding 3.03

Building:	Main Building
Location:	Windows living room
Finding:	Double Hung Windows to Living Room Requiring General Maintenance
Information:	The double hung windows in the living room were operational at the time of inspection; however, they were found to be in need of general maintenance. Issues may include wear to cords, balances, tracks, or hardware, and deterioration to painted finishes consistent with age and use. In plain English, the windows open but need maintenance to keep them working properly. A licensed builder, carpenter, or window specialist should assess and carry out maintenance as required, which may include adjustment, repair or replacement of components and repainting. Ongoing maintenance is recommended to ensure continued operation and to prevent further deterioration. Maintenance should be undertaken as part of routine upkeep where considered necessary.

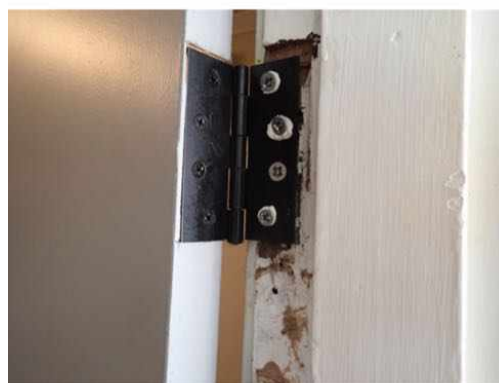
Finding 3.04

Building:	Main Building
Location:	Bedroom
Finding:	Bedroom Door Hinges Poorly Installed and Damage to Door Jambs
Information:	The bedroom door hinges were found to be poorly installed, with associated damage to the door jambs from previous hinge fixings. This may affect the alignment and operation of the door and is indicative of substandard installation and past repairs. In plain English, the hinges have been fitted poorly and have caused damage to the door frame. A carpenter, or handyman should assess and carry out repairs as required, which may include refitting or replacing hinges and repairing the damaged door jamb to ensure proper operation. Ongoing maintenance and correct installation practices

will assist in preventing further damage. Maintenance and repairs should be undertaken where considered necessary.

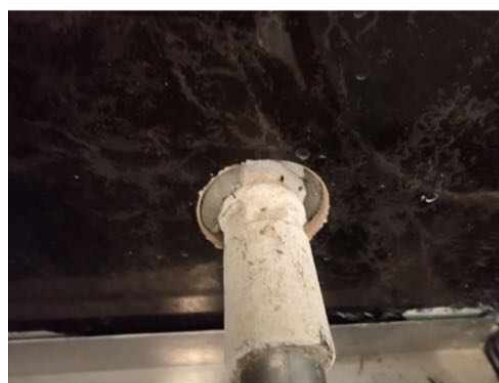
Finding 3.05

Building:	Main Building
Location:	Laundry
Finding:	Laundry Cabinet Tub Tap Wall Penetrations Not Sealed
Information:	Wall penetrations around the laundry tub tap within the cabinet were not sealed at the time of inspection. Unsealed penetrations may allow water ingress and contribute to deterioration of surrounding building materials. In plain English, the holes around the laundry taps are not sealed properly. A suitably qualified tradesperson should seal all penetrations using appropriate materials to prevent water ingress and maintain the integrity of the surrounding surfaces. Proper sealing and ongoing maintenance will assist in preventing deterioration. Maintenance and repairs should be undertaken where considered necessary.

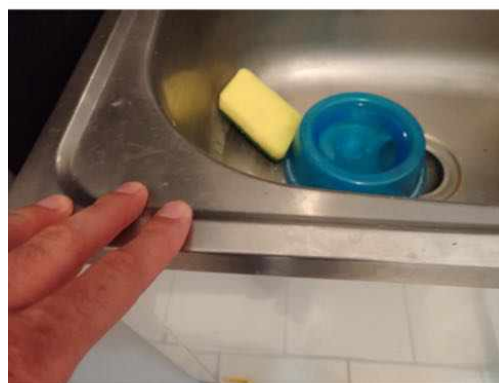
Finding 3.06

Building:	Main Building
Location:	Laundry
Finding:	Laundry Cabinet Tub Not Secured to Wall
Information:	The laundry cabinet tub was found not to be adequately secured to the wall at the

time of inspection. This may result in movement during use and could lead to damage to associated plumbing connections and surrounding finishes. In plain English, the laundry tub cabinet is loose and not fixed properly to the wall. A licensed plumber or suitably qualified tradesperson should secure the unit to the wall in accordance with standard installation practices and check for any associated damage. Proper installation and maintenance will assist in preventing movement and further deterioration. Maintenance and repairs should be undertaken where considered necessary.

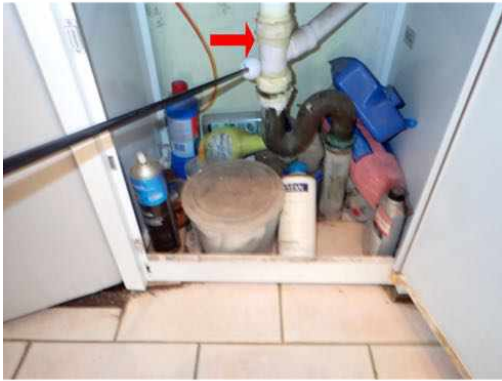
Finding 3.07

Building:	Main Building
Location:	Laundry
Finding:	Laundry Tub Waste Plumbing Poorly Installed with Excessive Silicone
Information:	The laundry tub waste plumbing was found to be poorly installed, with excessive silicone used around pipe penetrations and connections. This may indicate substandard workmanship and could lead to leaks, blockages, or difficulty in maintenance. In plain English, the waste pipes under the laundry tub have been installed poorly and have too much silicone around them. A licensed plumber should assess and rectify the installation as required, which may include refitting pipework and ensuring appropriate fittings and sealing methods are used. Proper installation and maintenance will assist in preventing leaks and ongoing issues. Maintenance and repairs should be undertaken where considered necessary.

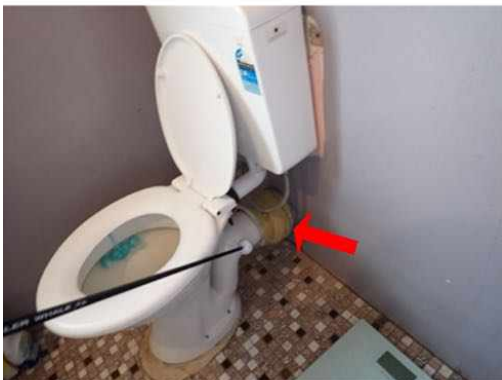
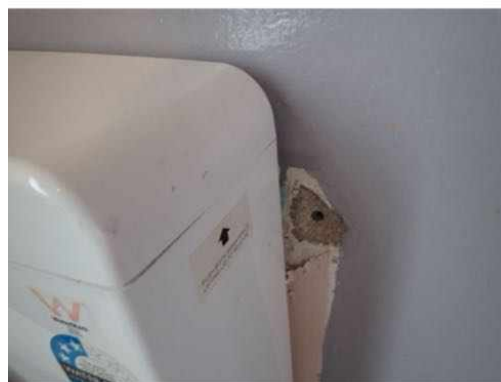
Finding 3.08

Finding: Toilet Wall Fitting Wrapped with Duct Tape and Wall Damage from Previous Installation

Information: Duct tape was wrapped around the toilet wall fitting at the time of inspection; although no active leaks were observed, this is not an appropriate or compliant repair method. Damage to the wall was also noted from a previous cistern installation. This may indicate prior plumbing issues and substandard repair works. In plain English, tape has been used on the toilet pipe instead of a proper fix, and the wall has been damaged from earlier work. A licensed plumber should assess and carry out proper repairs, which may include replacing or correctly sealing the fitting and repairing the damaged wall surface. Proper installation and maintenance will assist in preventing leaks and further deterioration. Maintenance and repairs should be undertaken where considered necessary.

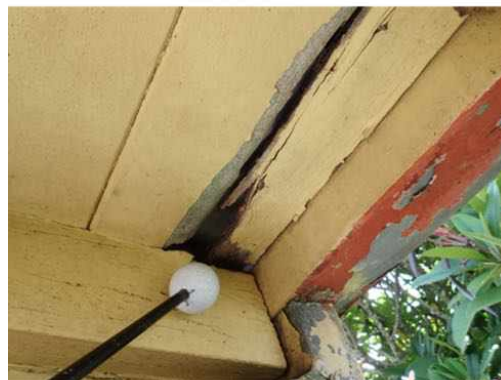
Building:	Main Building
Location:	Eaves
Finding:	Timber Eaves – Damage and Deteriorated Paintwork
Information:	Damage and deteriorated paintwork were identified to the timber eaves. The condition

is consistent with age, weathering, and lack of maintenance and may lead to further deterioration of the underlying timber if not addressed. In plain English, the timber eaves are damaged and the paint is worn. A licensed builder or carpenter should assess and carry out repairs as required, which may include repairing or replacing affected sections and repainting to protect the timber. Ongoing maintenance will assist in preventing further deterioration. Maintenance and repairs should be undertaken where considered necessary.

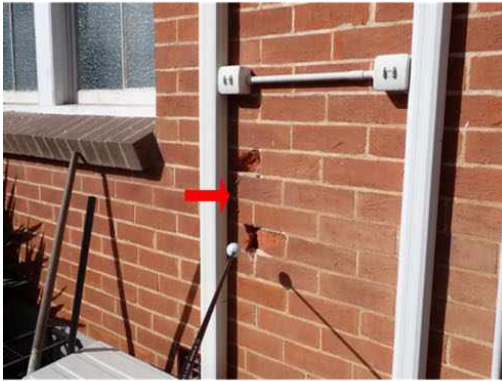
Finding 3.11

Building:	Main Building
Location:	Right hand side wall
Finding:	Right Hand Side Wall – Two Damaged Bricks
Information:	Two damaged bricks were identified to the right hand side wall. The damage appears localised and is most likely associated with a previous installation or removal of fixtures. In plain English, two bricks on the side of the house are damaged, likely from something that was previously installed. A suitably qualified tradesperson should assess and carry out repairs as required, which may include replacement or repair of the affected bricks and mortar. Ongoing maintenance will assist in preventing further deterioration. Maintenance and repairs should be undertaken where considered necessary.

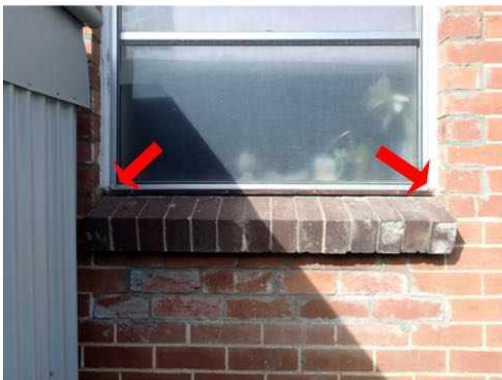
Finding 3.12

Building:	Main Building
Location:	Right hand side wall
Finding:	Kitchen External Window – Deterioration and Poor Silicone Sealing
Information:	The external kitchen window was found to be deteriorated, with poor silicone work identified around the frame. The sealant appears inadequately applied and may allow water ingress and contribute to deterioration of surrounding building materials. In plain English, the kitchen window is worn and the sealing around it has been done poorly, which may let water in. A suitably qualified tradesperson should assess and carry out repairs as required, which may include repair or replacement of deteriorated components and reapplication of silicone to achieve a proper watertight seal. Proper sealing and ongoing maintenance will assist in preventing water ingress and further deterioration. Maintenance and repairs should be undertaken where considered necessary.

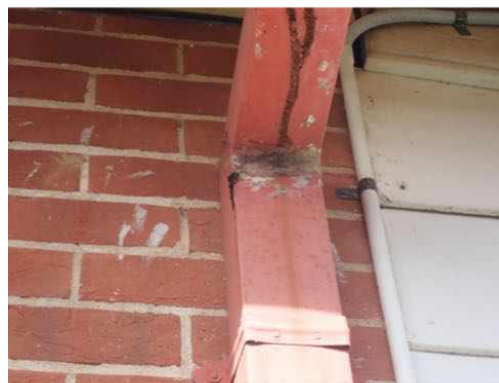
Finding 3.13

Building:	Main Building
Location:	Down pipes
Finding:	Downpipes – Minor Rust and Poorly Applied Silicone Work
Information:	Minor rust and poorly applied silicone work were identified to the downpipes. The condition is consistent with age, weathering, and substandard sealing practices, and may lead to further deterioration or water leakage if not addressed. In plain English, the downpipes have some rust and the sealing around them has been done poorly. A suitably qualified tradesperson should assess and carry out repairs as required, which may include cleaning, rust treatment, sealing, and reapplication of silicone using appropriate methods. Ongoing maintenance will assist in preventing further deterioration. Maintenance and repairs should be undertaken where considered necessary.

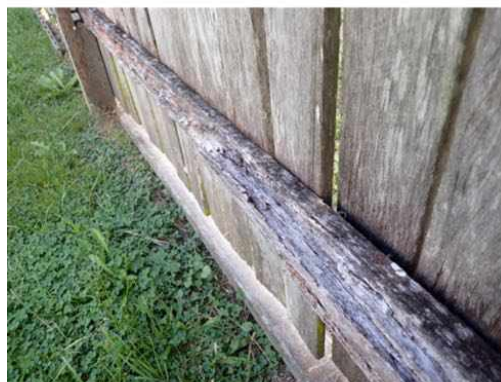
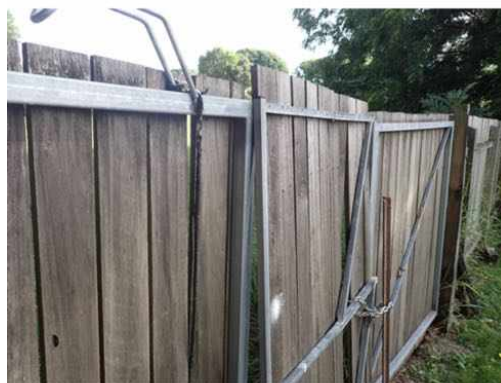
Finding 3.14

Building:	Yard
Location:	Boundary fences
Finding:	Timber Fence and Rear Gate – Sections in Poor Condition with Timber Decay
Information:	Sections of the timber fence and the rear gate were found to be in poor condition, with timber decay identified. The condition is consistent with age, weathering, and lack of maintenance and may affect functionality and ongoing serviceability. In plain English,

parts of the timber fence and rear gate are worn and have areas of decayed timber. A suitably qualified tradesperson should assess and carry out repairs as required, which may include repair or replacement of affected sections to ensure proper function. Ongoing maintenance will assist in preventing further deterioration. Maintenance and repairs should be undertaken where considered necessary.

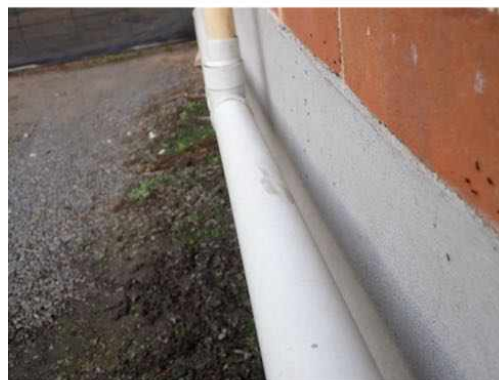
Finding 3.15

Building:	Main Building
Location:	Left hand wall
Finding:	External Bathroom Plumbing – Poor Installation and Not Secured to Wall
Information:	The external bathroom plumbing was found to be poorly installed and not adequately

clipped or secured back to the wall at the time of inspection. This may result in movement, strain on fittings, and potential for leaks or damage over time. In plain English, the pipes outside the bathroom are not installed properly and are not fixed to the wall. A licensed plumber should assess and carry out rectification as required, which may include securing pipework and ensuring correct installation in accordance with standard practices. Proper installation and maintenance will assist in preventing movement and further deterioration. Maintenance and repairs should be undertaken where considered necessary.

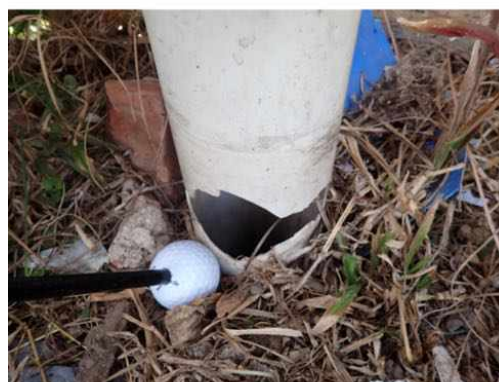
Finding 3.17

Building:	Main Building
Location:	Rear right hand corner
Finding:	Downpipe to Rear Right-Hand Corner – Damaged
Information:	The downpipe to the rear right-hand corner of the building was found to be damaged at the time of inspection. The damage may affect the effective discharge of roof water and contribute to water overflow or localised moisture issues if not addressed. A suitably qualified tradesperson should assess and carry out repairs or replacement as required to ensure proper operation. Ongoing maintenance will assist in preventing further deterioration. Maintenance and repairs should be undertaken where considered necessary.

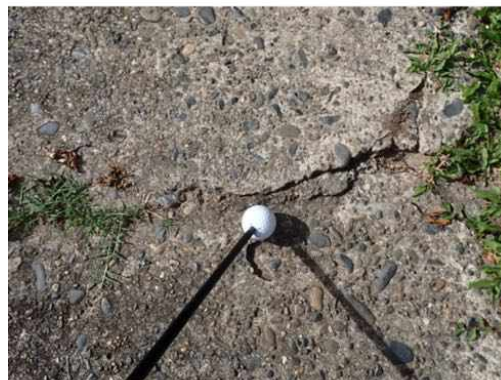
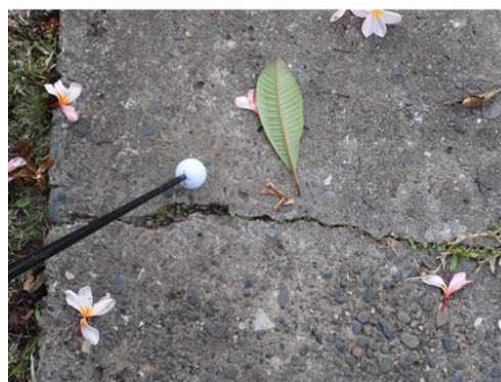
Finding 3.18

Building:	Main Building
Location:	Front concrete path
Finding:	Front Concrete Path – Large Cracks Identified
Information:	Large cracks were identified to the front concrete path. The cracking may be associated with ground movement, settlement, or age-related deterioration and is a common defect with concrete of this age. A suitably qualified tradesperson should assess and carry out repairs as required, which may include crack repair, resurfacing, or replacement of affected sections. Ongoing maintenance will assist in preventing further deterioration. Maintenance and repairs should be undertaken where considered necessary.

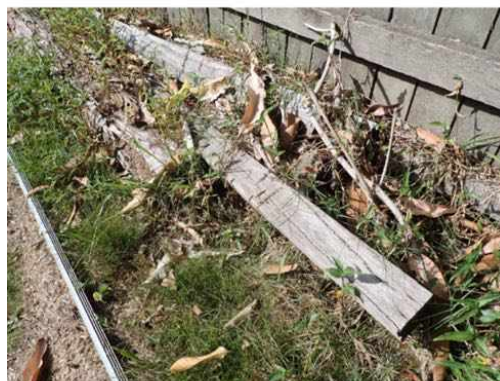
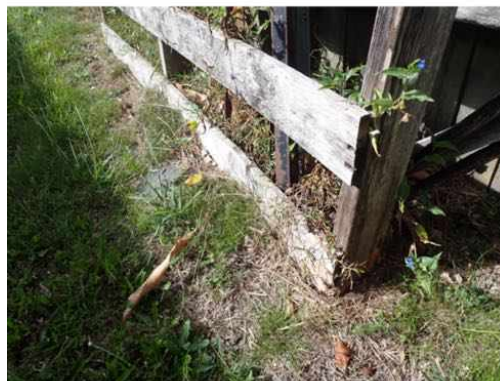
Building:	Yard
Location:	All areas
Finding:	Stored Timber and Structures in Contact with Ground – Conditions Conducive to Termite Attack
Information:	Stored timber was identified lying around the yard, and shed structures and fences were noted to be in direct contact with the ground. These conditions are conducive to termite attack, as they provide a food source and concealed access pathways for termites. In plain English, timber around the yard and structures touching the ground can attract termites. A suitably qualified tradesperson or timber pest specialist should assess and carry out recommendations as required, which may include removal of

stored timber and modifying structures to reduce ground contact. Implementing and maintaining a termite management plan will assist in reducing the risk of infestation. Maintenance and rectification should be undertaken where considered necessary.

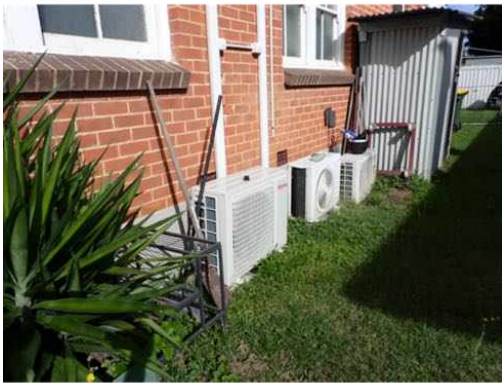
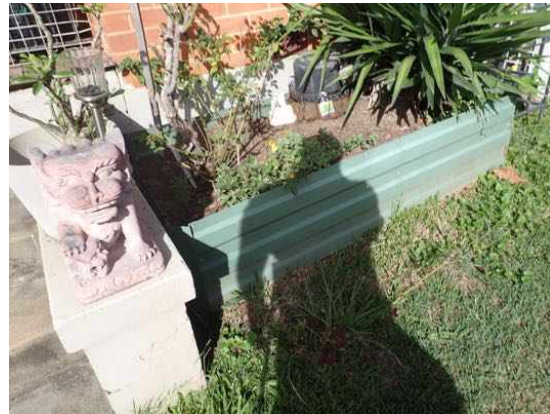
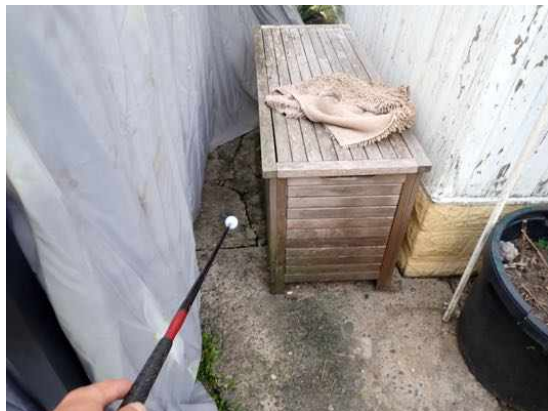
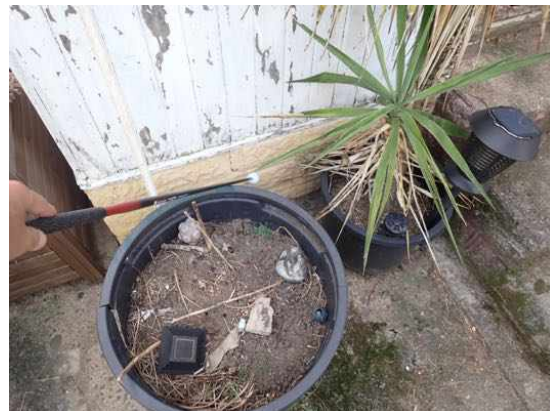
Building: Main Building
Location: All areas
Finding: Additional Photos - Obstructions and Limitations
Information: These photographs are an indication of the obstructions and limitations which impeded full inspection of the area at the time of inspection. These obstructions can hide an array of defects and should be removed to allow full inspection to be carried out. A re-inspection is recommended once the areas are made accessible. Multiple obstructions and limitations were identified in the internal of the building. No photos provide in the report due to the privacy of the home owners.
