Building Inspection Report

Inspection Date: Tue, 16 Dec 2025

Property Address: 11 Wilga Rd, Risdon Vale TAS 7016,
Australia

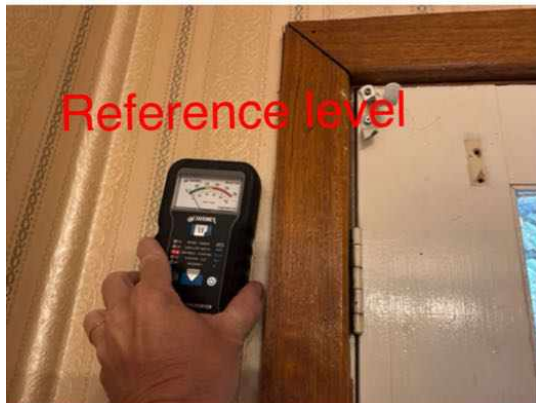
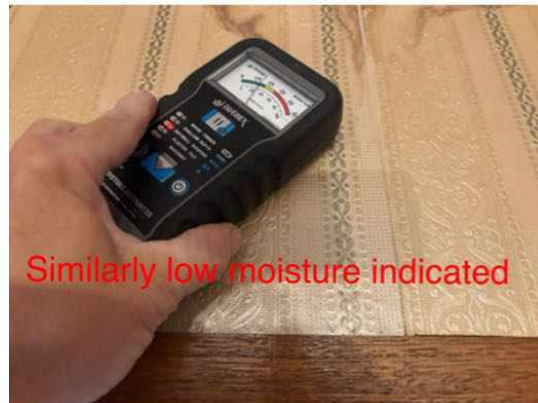
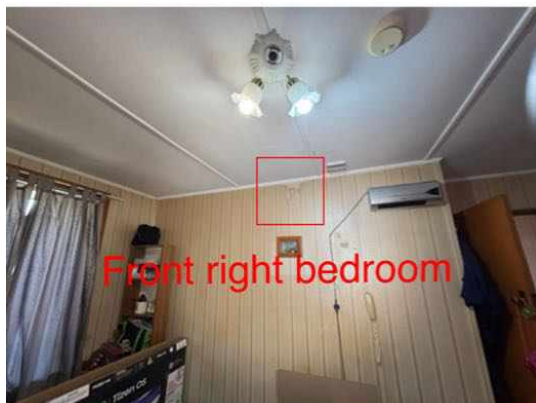
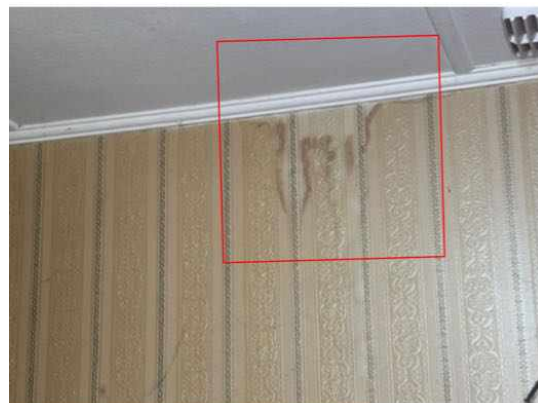
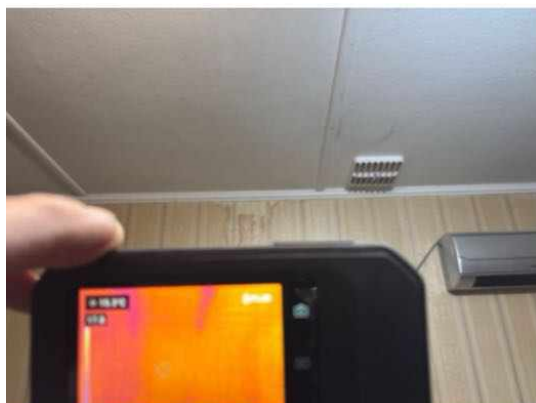
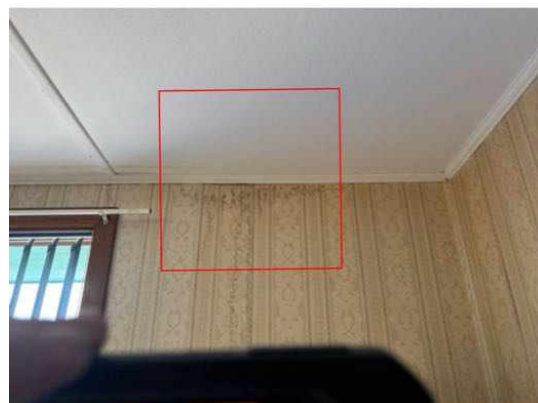
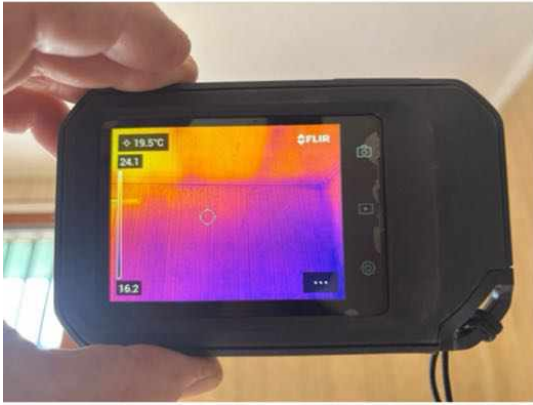
Defects 3.01

Finding: Water staining

Information: In the multiple locations there is water staining to the walls (in the hallway above the front door, the middle front bedroom and back bedroom). The staining was all dry at the time of inspection. The moisture meter or thermal imaging did not indicate any elevated moisture readings. These may have been old leaks or condensation events or vermin waste.

Water staining was evident in this area at the time of inspection. Water staining indicates that surfaces have been exposed to excessive moisture over time. The minerals and other elements in the water lead to staining, which may graduate to corrosion and deterioration if left unmanaged.

While mostly an appearance defect, water staining can be indicative of more serious defects, which may be currently concealed by other building elements.

Recommend client monitor.

If signs of moisture re-occurs, recommend client engage a Lic Plumber as soon as possible.

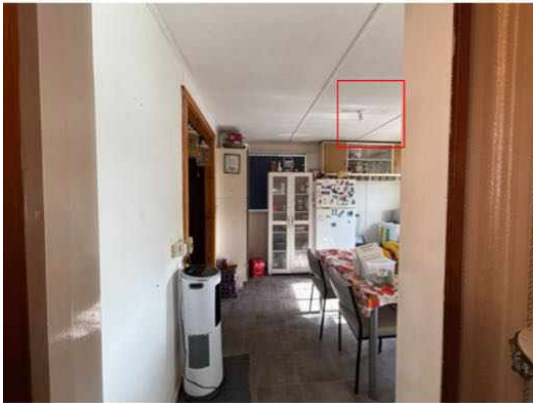
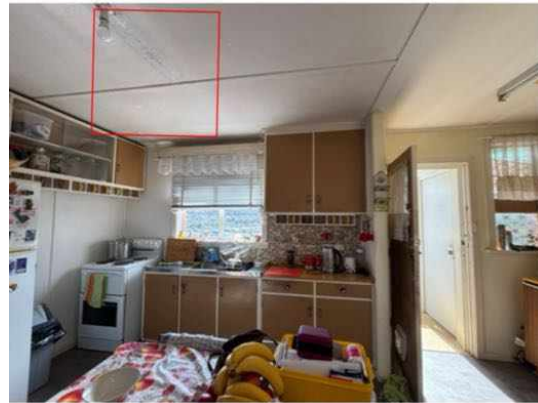
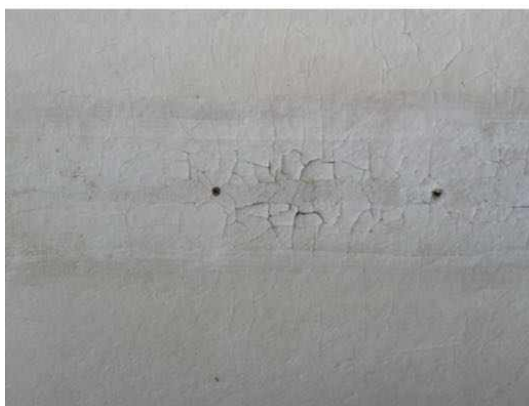
Defects 3.02

Building:	Main Building
Location:	Kitchen
Finding:	Kitchen paint deterioration
Information:	In the kitchen, the paint to the ceiling is deteriorated. There may have been an old light installed in this location in the past, that has been removed.

Paint deterioration is due to a lack of regular maintenance. Early intervention will prolong the useful life of these building elements.

Recommend client engage a Handy Person/Painter to rectify at clients convenience.

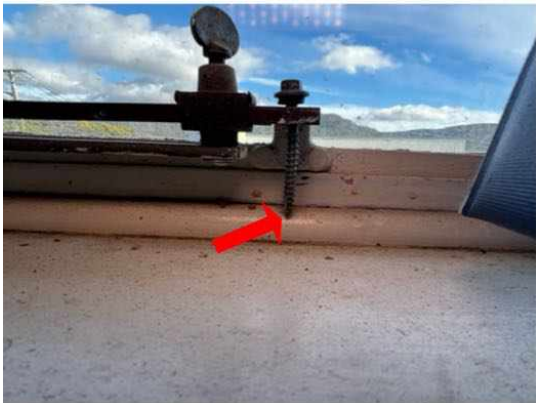
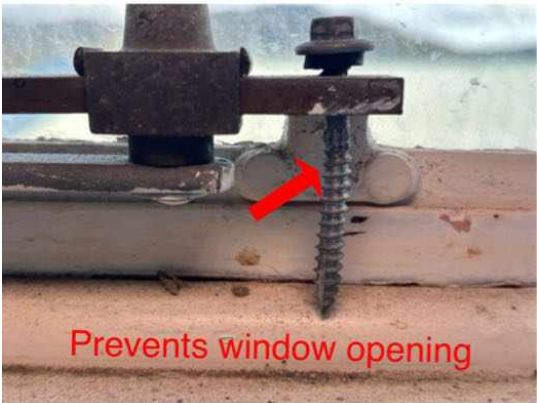
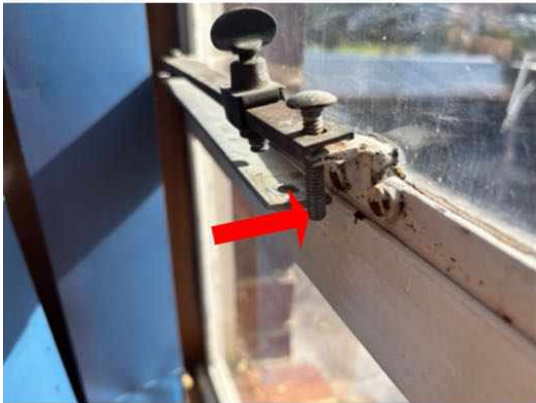
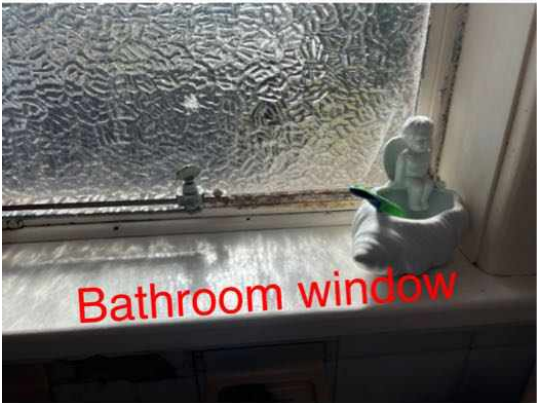
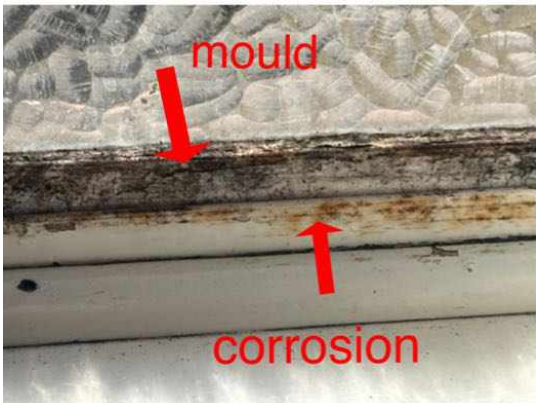
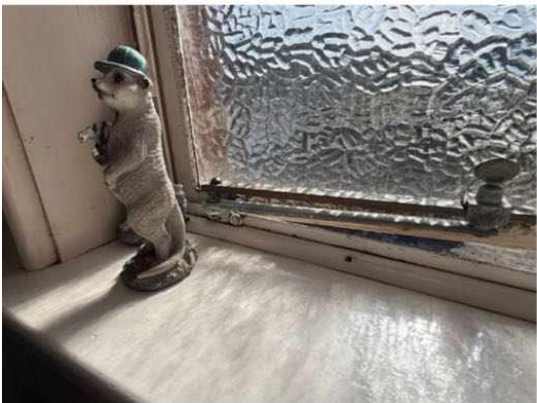
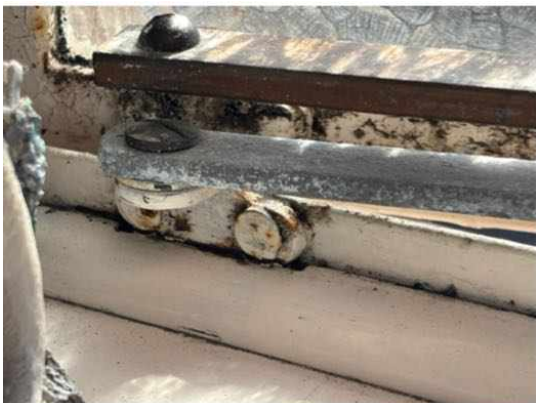
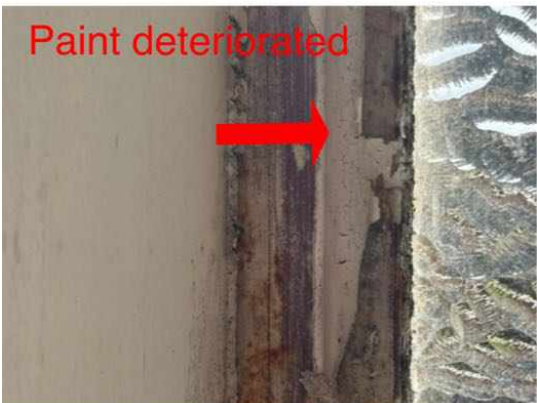
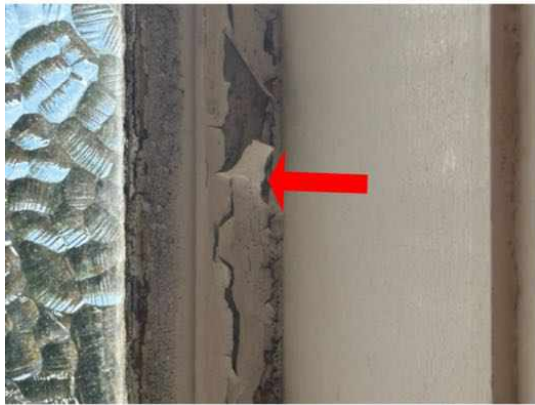
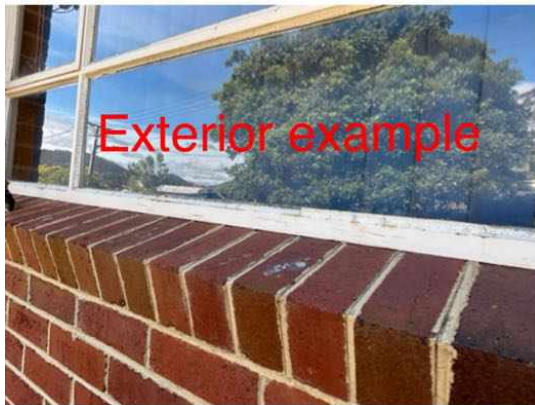
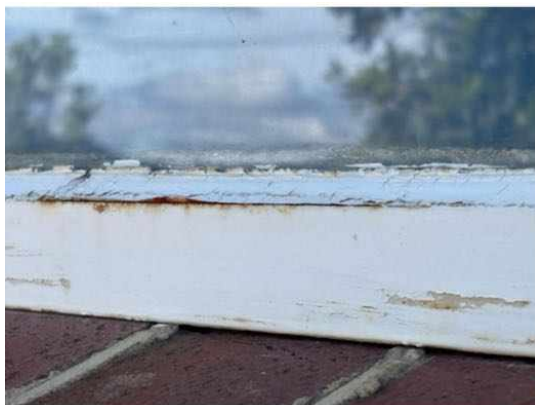
Defects 3.03

Building:	Main Building
Location:	Multiple locations
Finding:	Metal windows maintenance
Information:	In multiple locations through out the house, the windows require some maintenance. The windows are in fair condition on the interior and exterior.

There is some rust and corrosion due to the condensation where the water runs down the glass and onto the metal. The corrosion needs to be prepped, treated with rust neutraliser and painted.

Many of the windows have pivot screws missing from the window stays. Instead there are some improvised solutions, but they are preventing the windows from operating fully. Recommend that the current repairs be removed and have a short nut and bolt fitted (similar to the original pivot screws). This will improve the function of the windows.

The bathroom window in particular needs attention as the paint is very deteriorated, there is corrosion and mould.

Mould can cause health issues.

Windows provide ventilation to the adjoining area and should be at a fully operational level to ensure user comfort. Restricted function of the window may also pose as a potential safety hazard if required for emergency egress from the building.

Generally, factors such as general age of the building element and a lack of maintenance are the usual causes for this type of defect.

Recommend client engage a Handy Person to rectify as soon as possible.

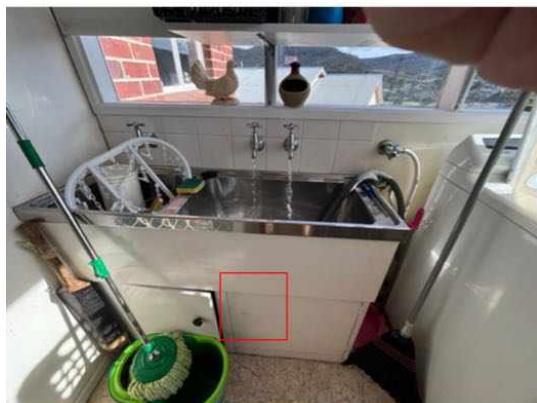
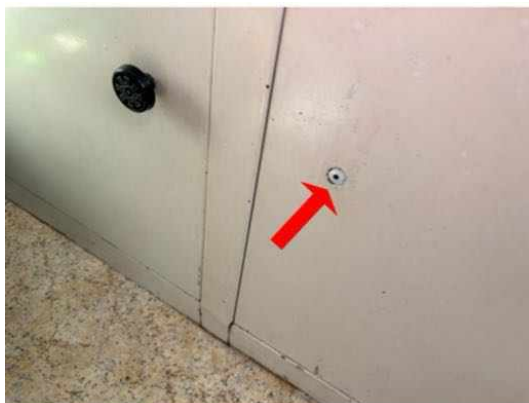
Defects 3.04

Building: Main Building
Location: Laundry
Finding: Cupboard door handle missing
Information: In the laundry the door handle was missing to laundry sink cupboard. This impedes the function of the door.

Recommend client engage Handy Person to rectify at clients discretion.

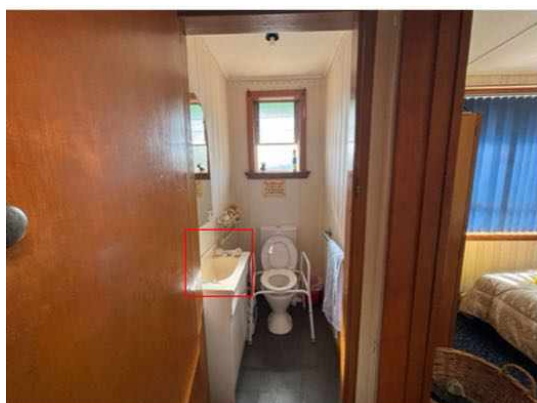
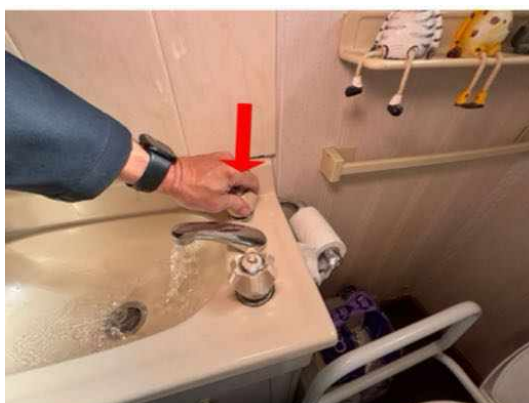
Defects 3.05

Building: Main Building
 Location: Toilet
 Finding: Toilet hot tap
 Information: The toilet hot tap wouldn't turn on with reasonable force. This impedes the function of the tap.

Recommend client engage a Handy Person to rectify as soon as practicable.

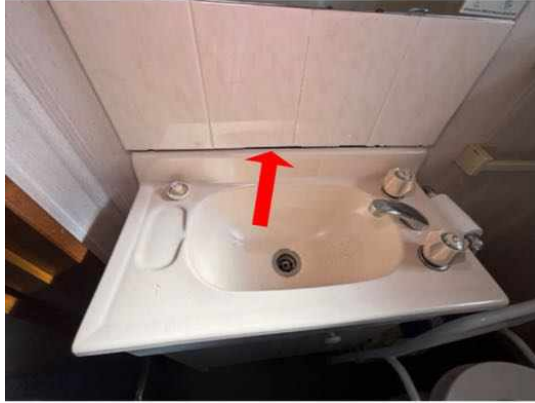
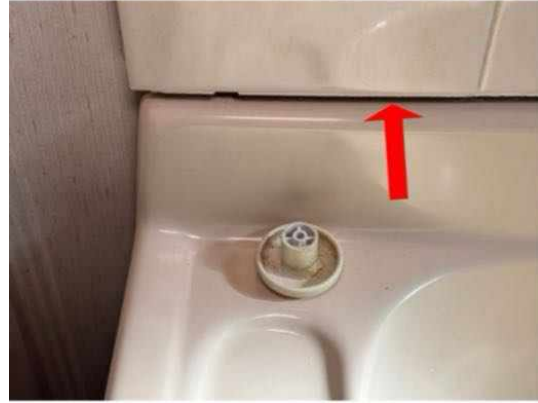
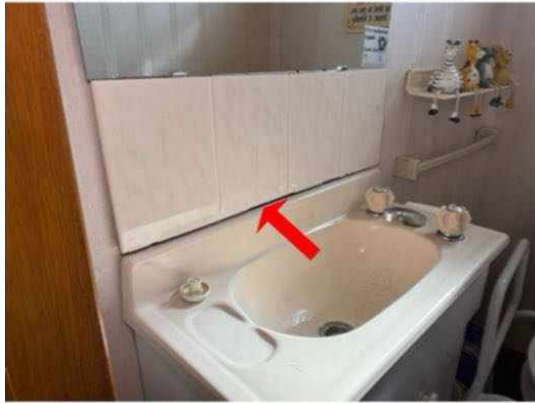
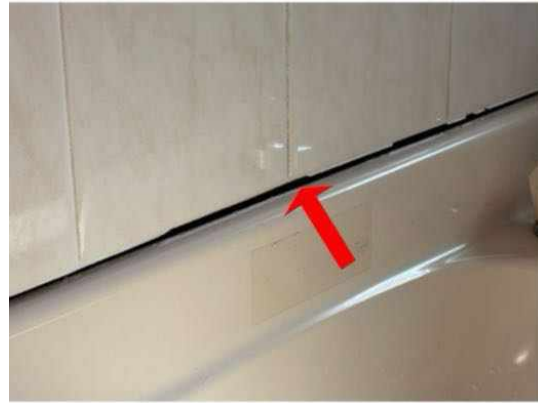
Defects 3.06

Building: Main Building
 Location: Toilet
 Finding: Silicone deteriorated to toilet vanity cabinet
 Information: In the toilet the silicone has deteriorated on the vanity cabinet, where sink meets the tiles.

Recommend client engage Handy Person to rectify at clients convenience.

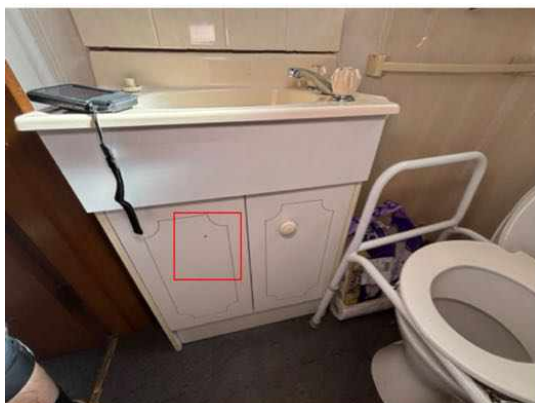
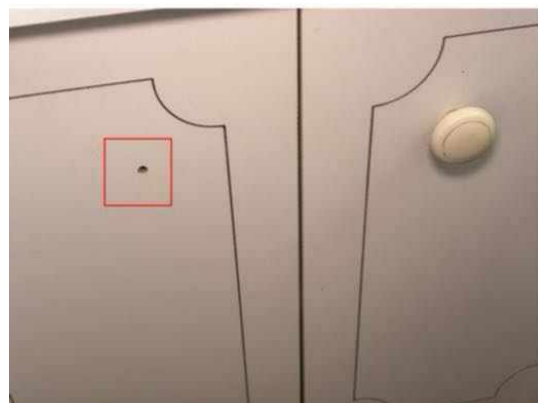
Defects 3.07

Building: Main Building
Location: Toilet
Finding: Door handle missing
Information: In the toilet the door handle was missing to vanity sink cabinet. These impedes the function of the door.

Recommend client engage Handy Person to rectify at clients discretion.

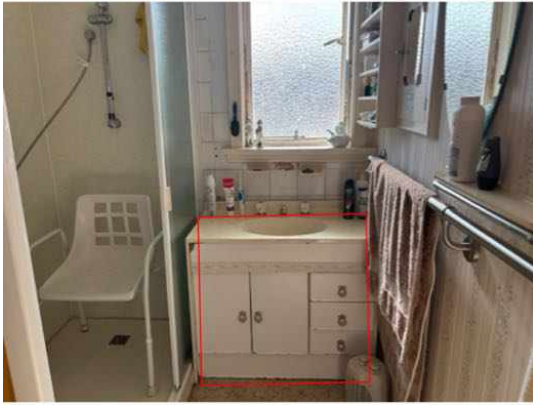
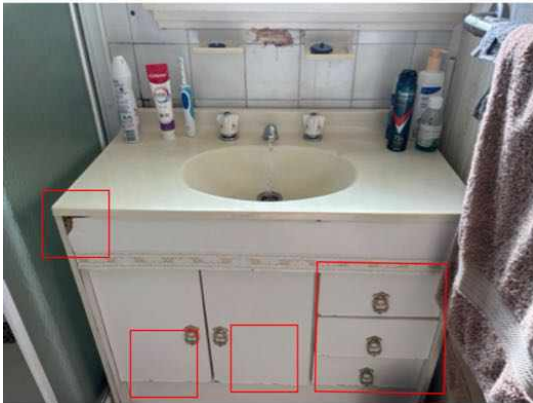
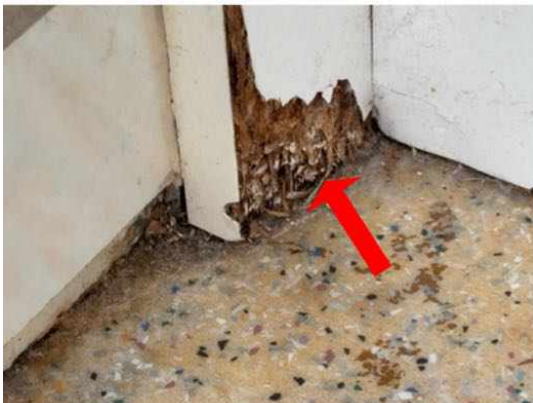
Defects 3.09

Building: Main Building
Location: Bathroom
Finding: Bathroom vanity sink cabinet
Information: The bathroom vanity sink cabinet is badly water damaged. It is still functioning however it will need replacement in the medium term.

I recommend that the client engage lic plumber to replace the cabinet /sink as soon as practicable.

When the cabinet is out, the missing tiles could be replaced and the wall and floor checked for any damage.

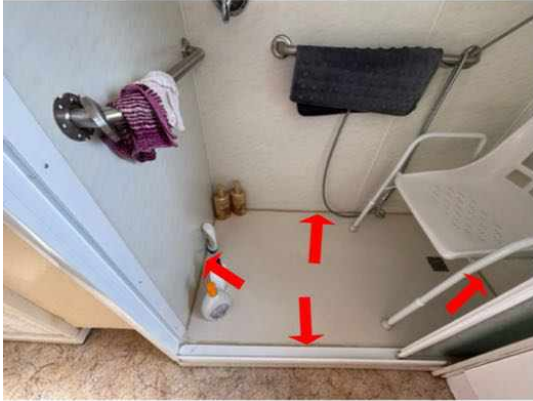
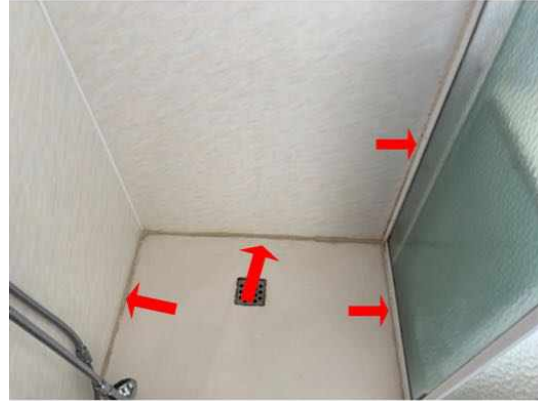
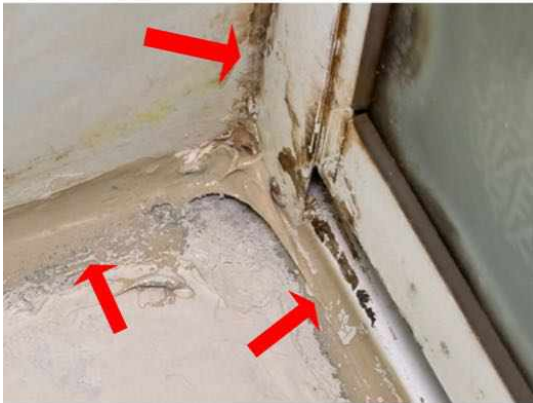
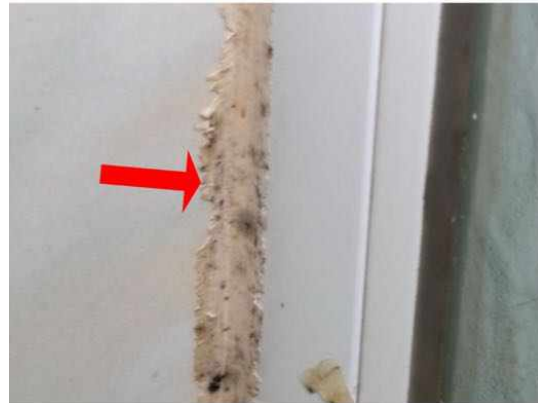
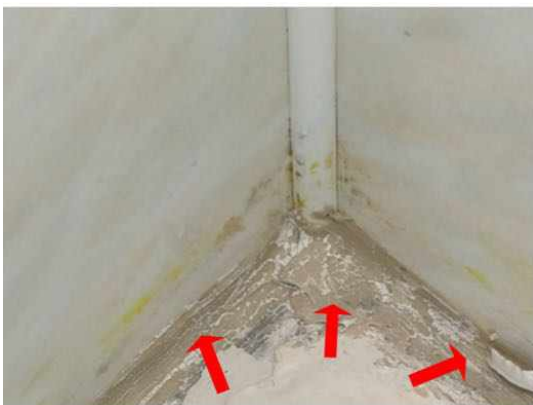
Defects 3.10

Building: Main Building
 Location: Bathroom
 Finding: Silicone to shower deteriorated
 Information: In the bathroom the shower silicone has deteriorated, on the floor and walls of the shower panels. There is also a gap visible to the silicone where the shower frame meets the glass. The silicone needs to be removed and re-caulked. There were elevated moisture readings behind the wall panels down low.

Failure to remedy could result in damage to surrounding building elements.

Recommend client engage a Handy Person to rectify as soon as possible.

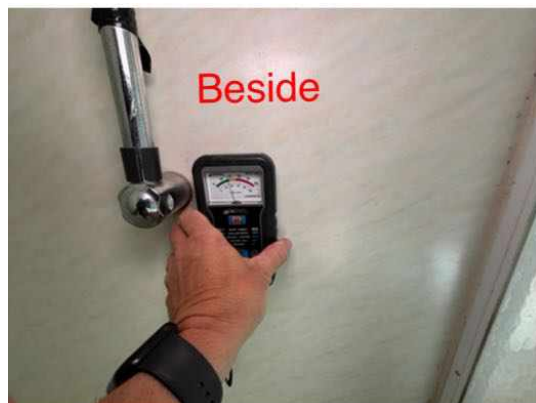
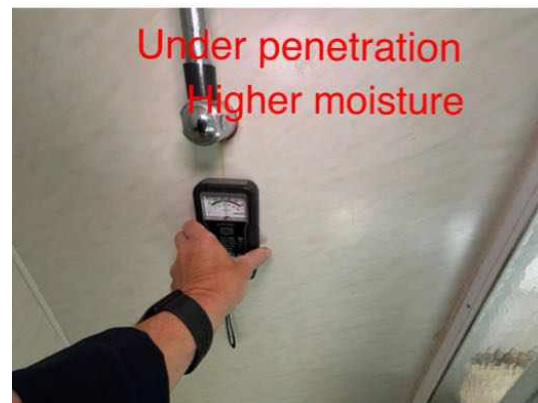
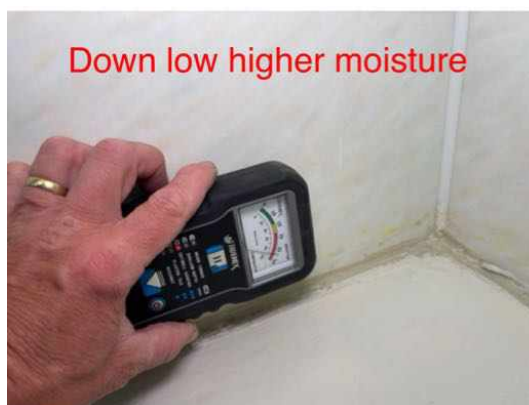
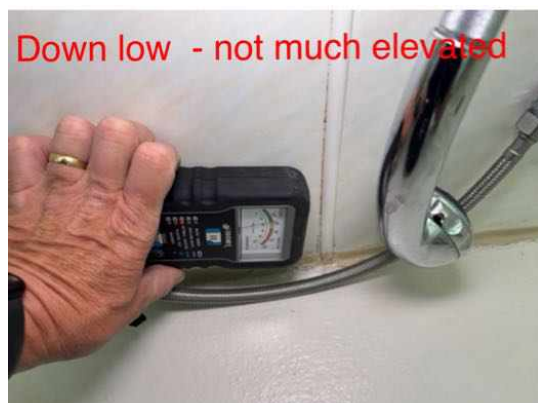
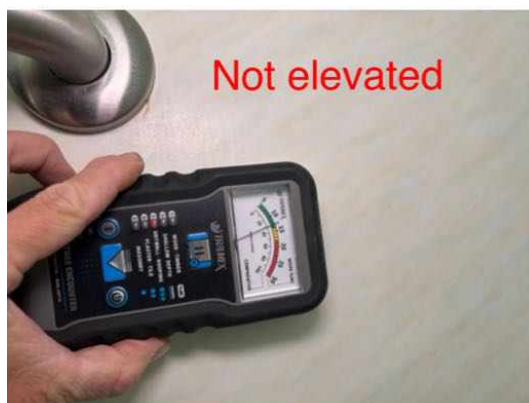
Defects 3.11

Building:	Main Building
Location:	Bathroom
Finding:	Shower penetrations elevated moisture indications
Information:	In the bathroom there were elevated moisture readings, behind the shower wall panels

If not rectified, water will continue to ingress and may lead to water damage and deterioration of the surrounding building elements if the water proofing membrane is not intact or absent. There may already be some damage. However our non invasive inspection is unable to determine the adequacy of the water proofing system.

Recommend client engage a Lic Plumber to remove the penetrations to the shower, and seal/silicone them as soon as possible. Whilst on site I also recommend that the plumber perform a more invasive inspection to determine if there is any damage inside the walls where there are elevated moisture indications behind the shower wall panelling.

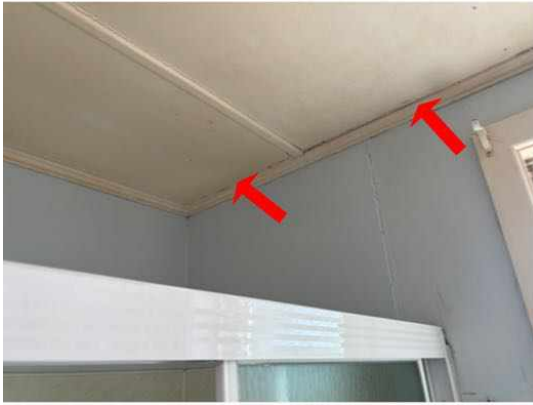
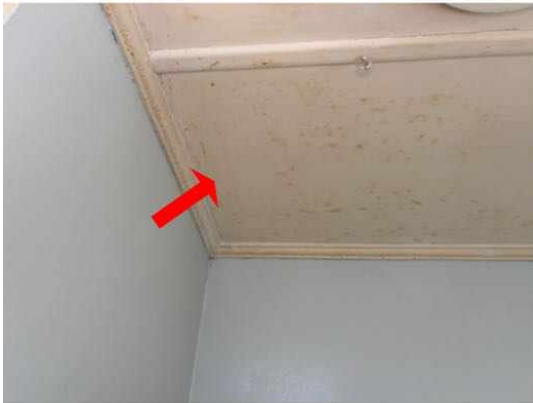
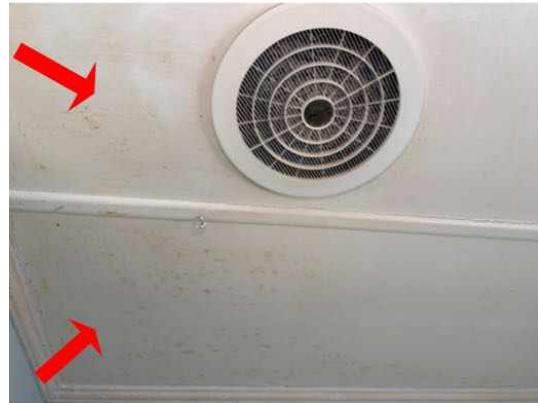
Defects 3.12

Building:	Main Building
Location:	Bathroom
Finding:	Water staining to bathroom ceiling
Information:	In the bathroom there is water staining to the bathroom ceiling. This is due to the bathroom being a high moisture environment.

Water staining was evident in this area at the time of inspection. Water staining indicates that surfaces have been exposed to excessive moisture over time. The minerals and other elements in the water lead to staining, which may graduate to corrosion and deterioration if left unmanaged.

Recommend client monitor.

If moisture re-occurs recommend client engage a Lic Plumber as soon as possible.

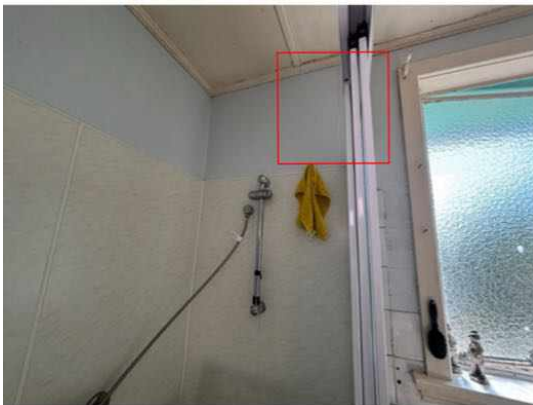
Defects 3.13

Building: Main Building
 Location: Bathroom
 Finding: Gap above shower
 Information: In the bathroom above the shower, there is no joining strip to the junction of two panels, the gap is caulked but not well. This may allow moisture ingress.

Recommend client engage a Handy Person to caulk and paint as soon as possible, to prevent water ingress.

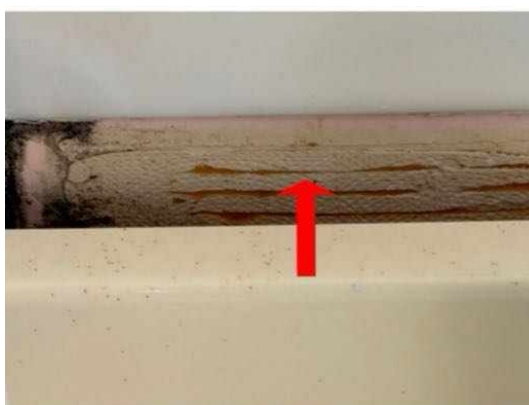
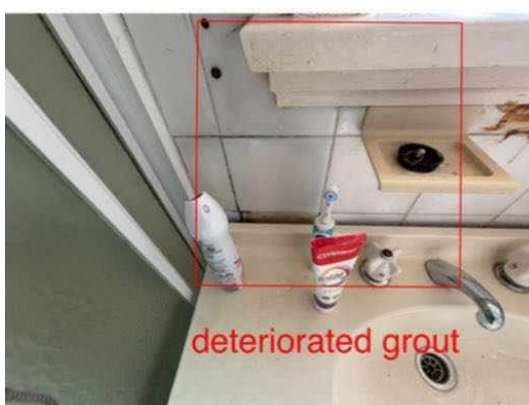
Defects 3.14

Building: Main Building
 Location: Bathroom
 Finding: Missing tiles/grout deteriorated and silicone missing
 Information: In the bathroom there are missing tiles behind the vanity cabinet. Also the grout has deteriorated to the wall tiles and there is no silicone to the gap between the sink and the wall.

Recommend client engage a Handy Person to rectify as soon as possible.

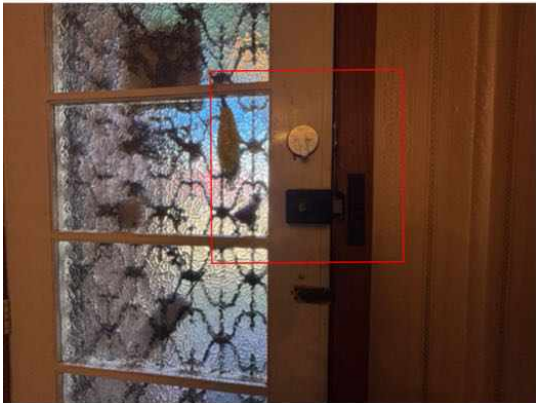
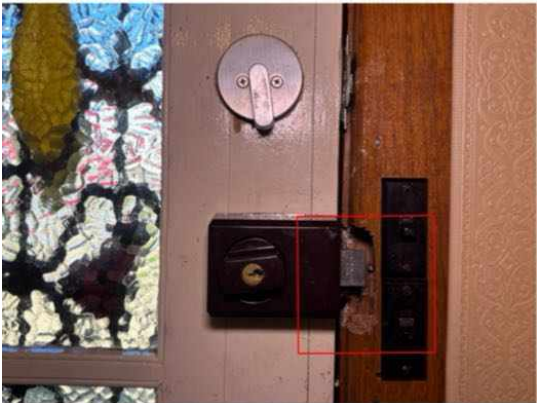
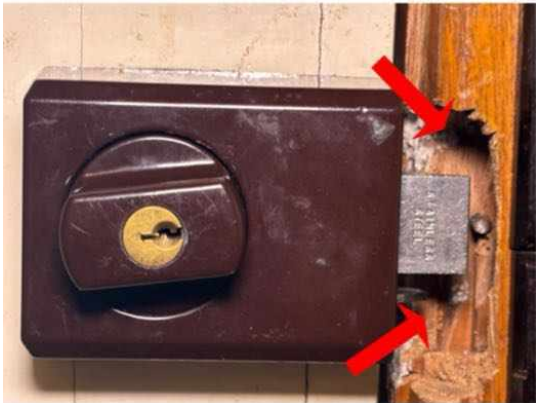
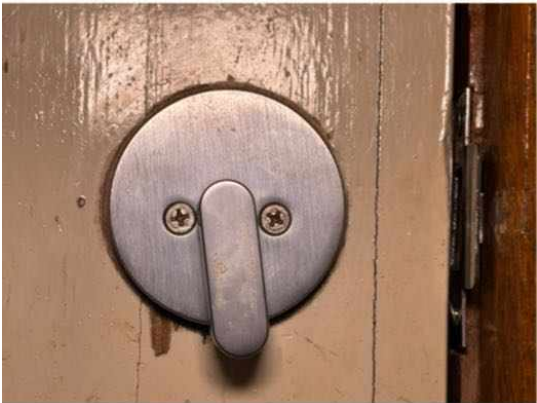
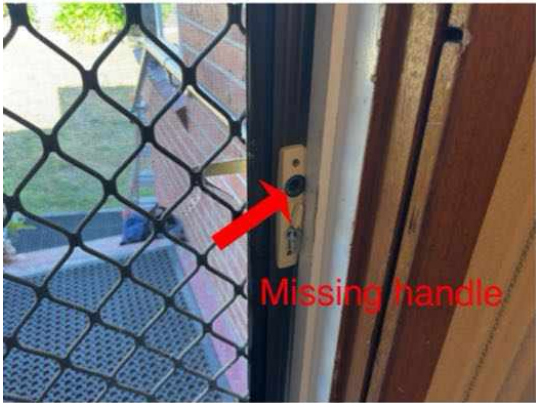
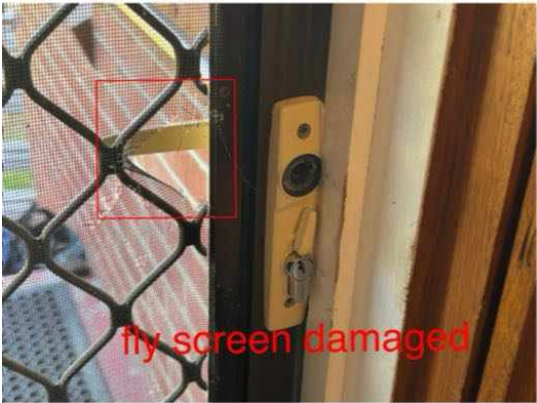
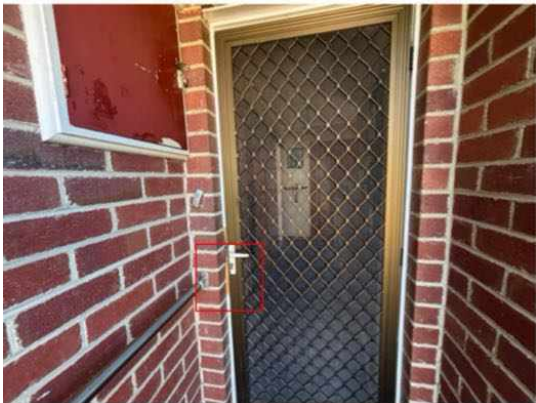
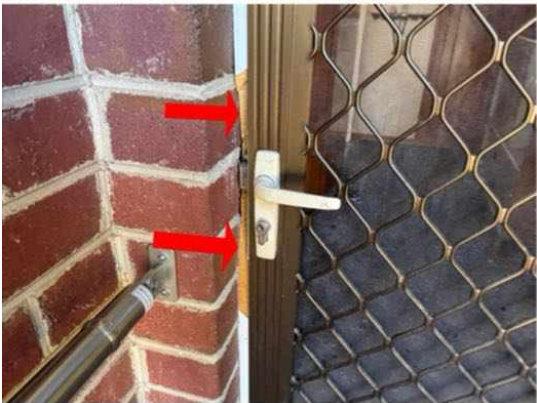
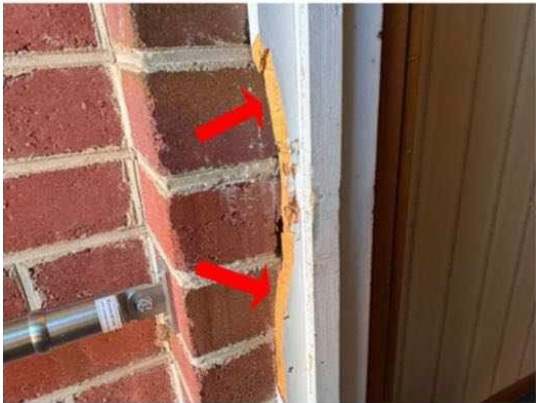
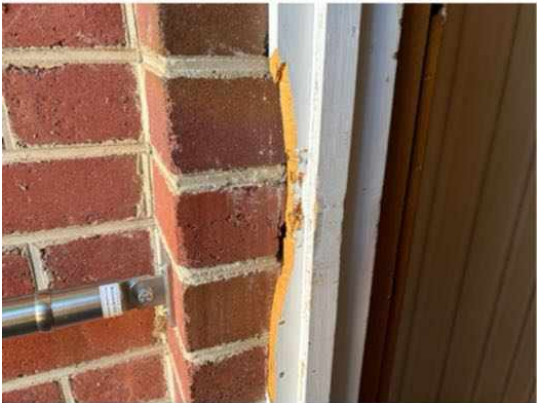
Defects 3.15

Building: Main Building
 Location: Bathroom
 Finding: Front entry door
 Information: The front entry door frame is damaged on the inside and outside, where the dead lock is fitted. Also where the screen door is fitted, the front door jamb has been damaged.

The screen door is also missing a handle on the inside and the fly screen is damaged.

Recommend client engage Handy Person to rectify at clients convenience.

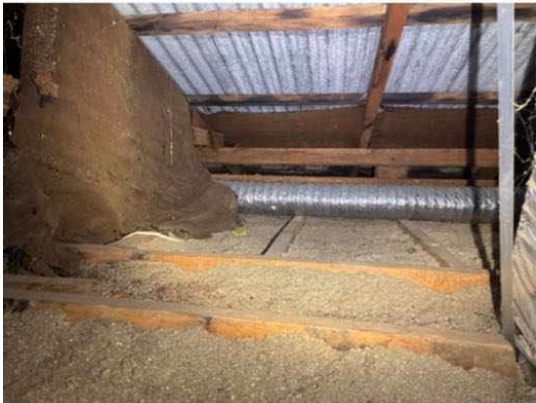
Defects 3.16

Building: Main Building
Location: Roof void
Finding: FYI roof void access
Information: FYI there was very little limited access to the roof void. Due to the low roof pitch and the way the timber is framed.

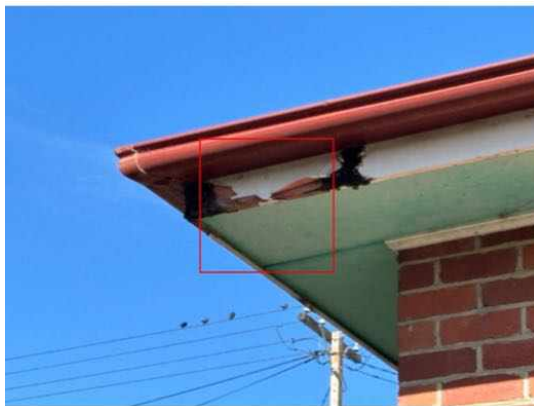
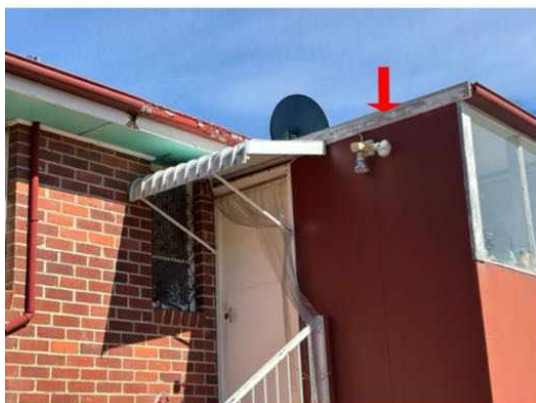
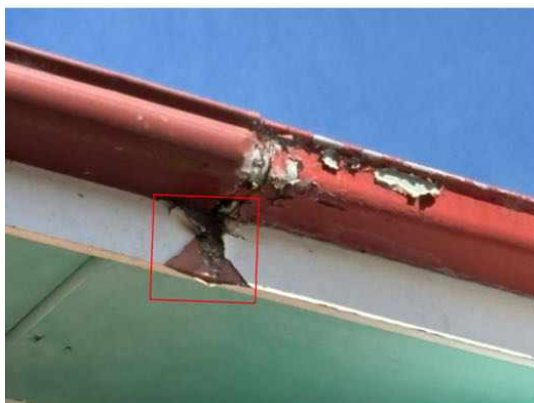
Defects 3.19

Building:	Main Building
Location:	Multiple locations
Finding:	Paint Deterioration to exterior timbers
Information:	On the exterior of the house, the paint is very deteriorated to exterior timbers including the subfloor access door, frame, fascias, laundry etc.

It is likely that paint deterioration has developed as a result of frequent exposure to rain and other weather conditions.

Failure to maintain the timbers over a prolonged period has resulted in them deteriorating at an accelerated rate, increasing their susceptibility to the development of wood rot. Early intervention and regular maintenance will prolong the useful life of these building elements.

Recommend client engage a Handy Person/Painter to rectify as soon as practicable.

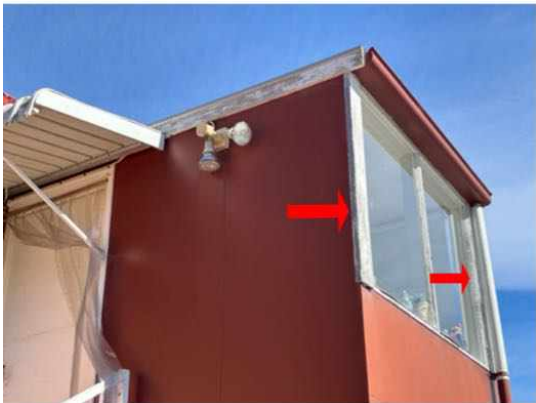
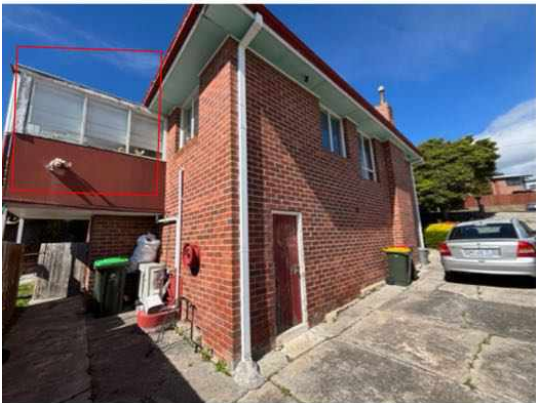
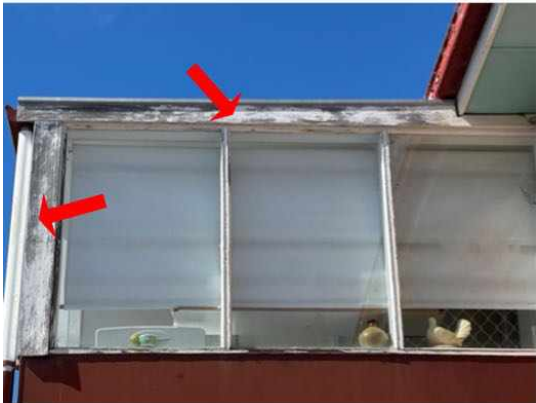
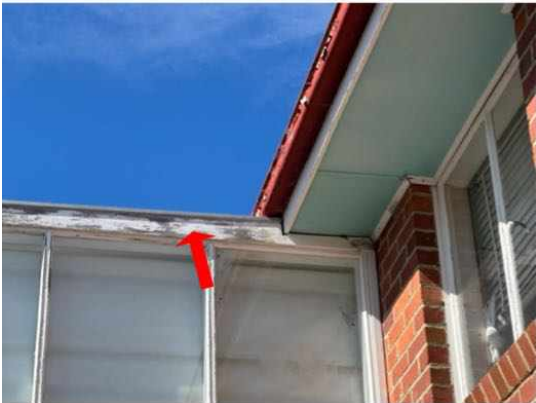
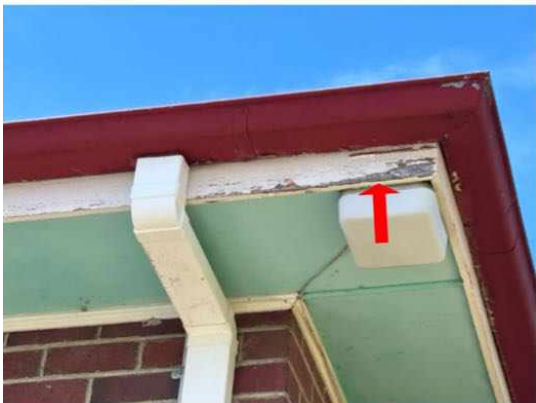
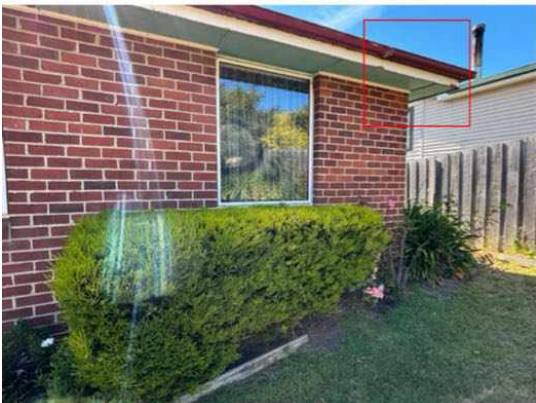
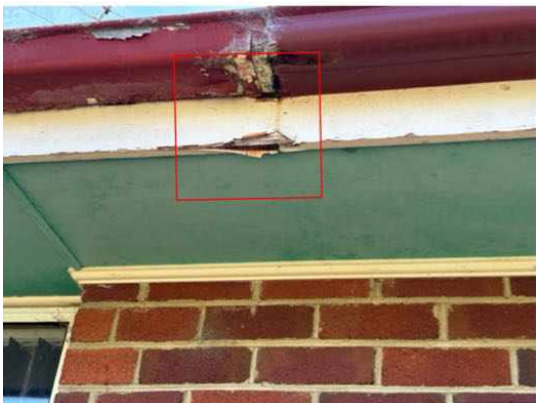
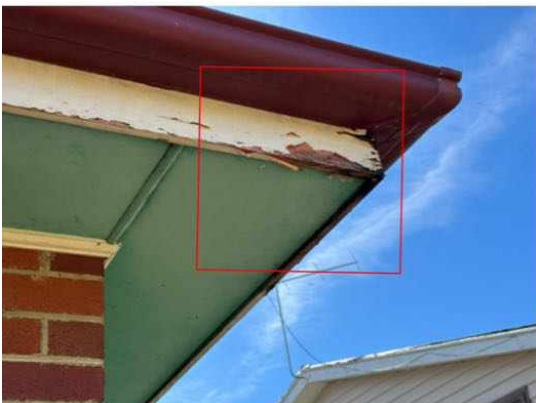
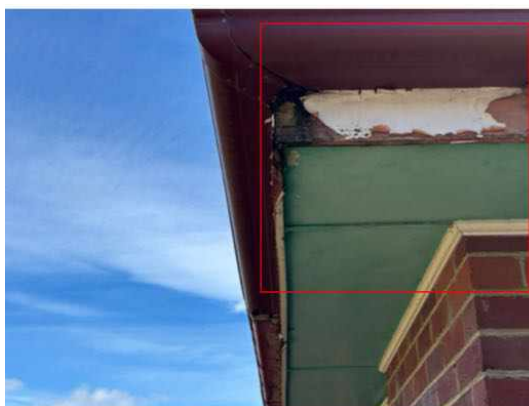
Paint is the only protection that timbers have from water ingress.

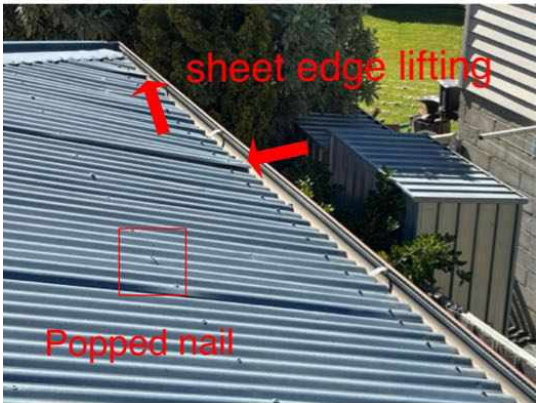
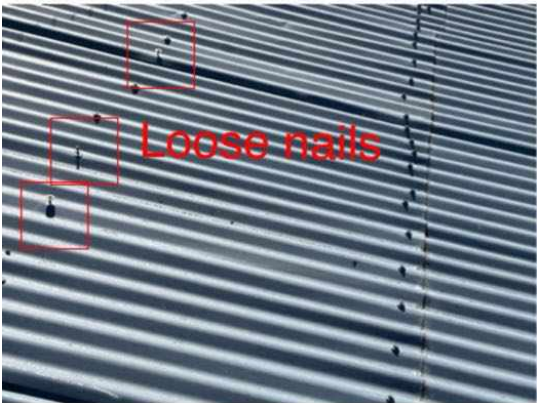
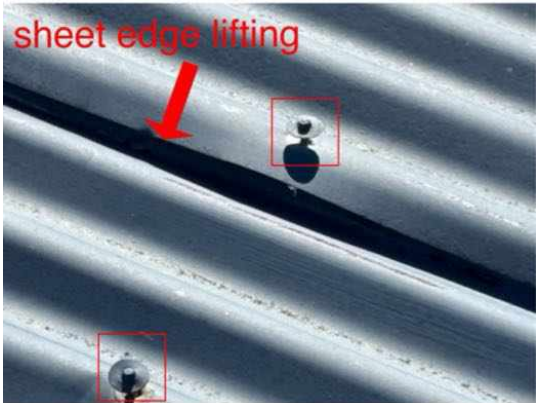
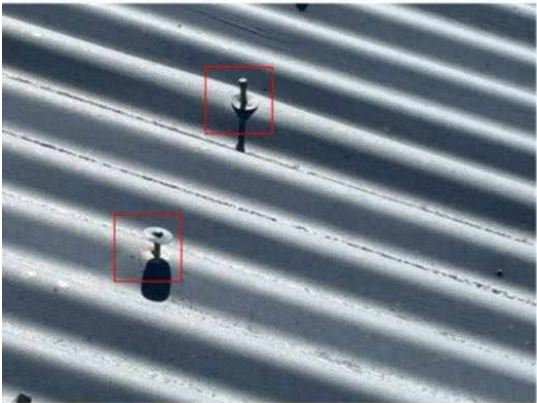
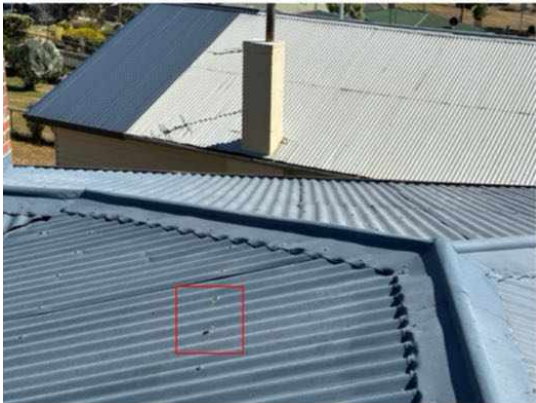
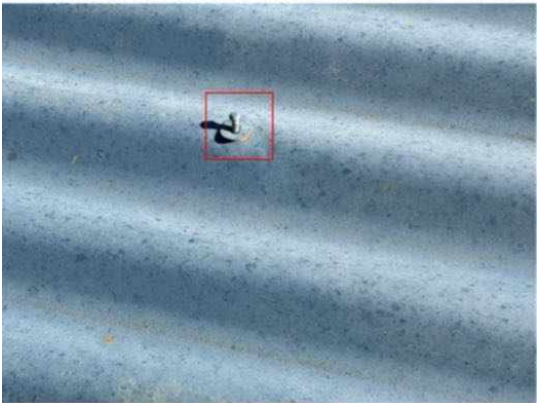
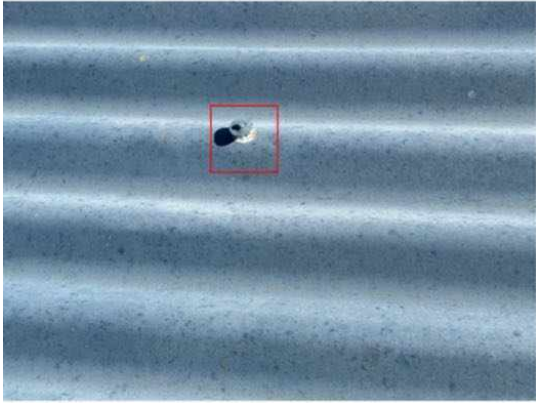
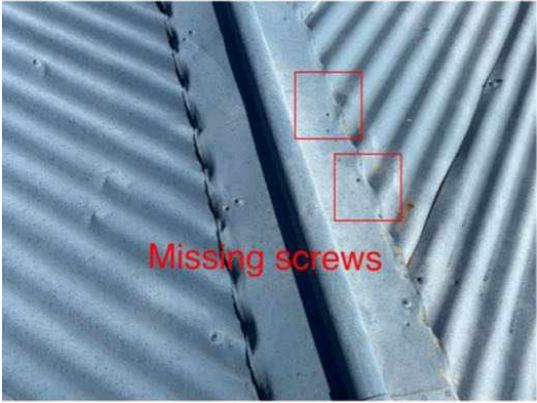
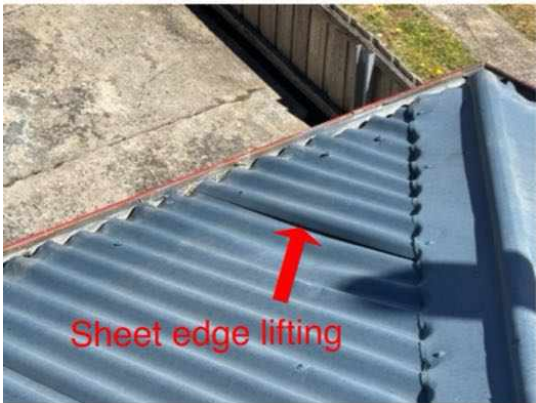
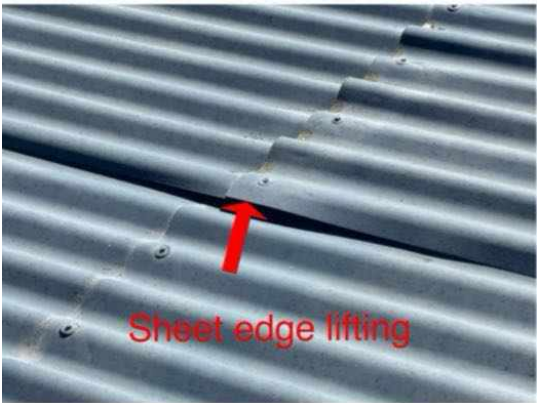
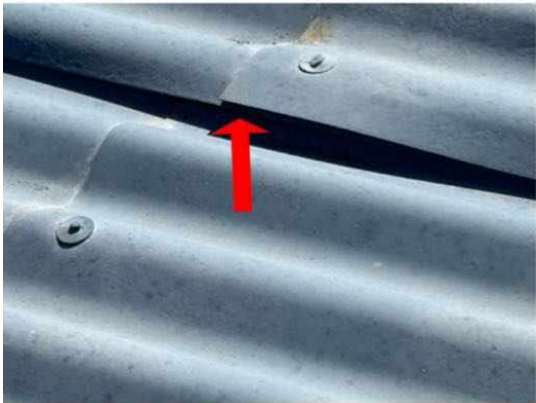
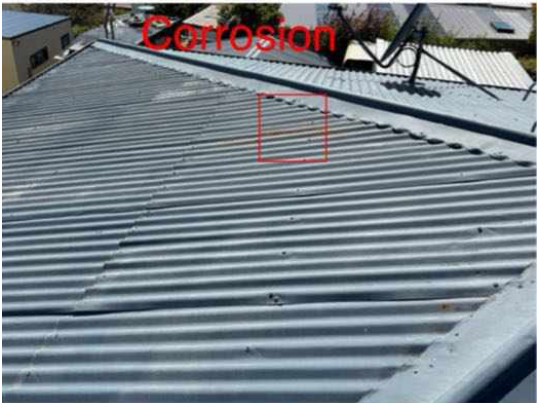
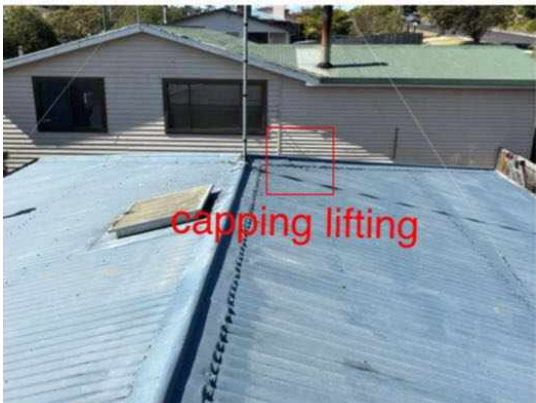
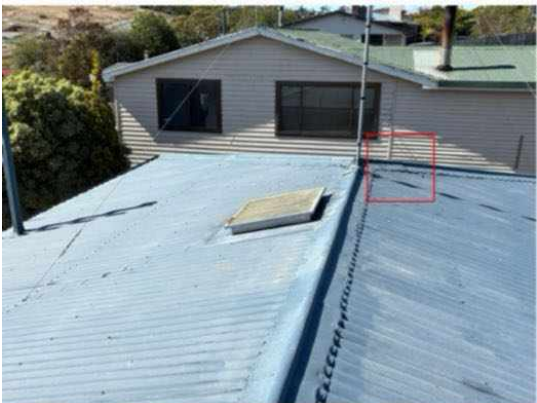
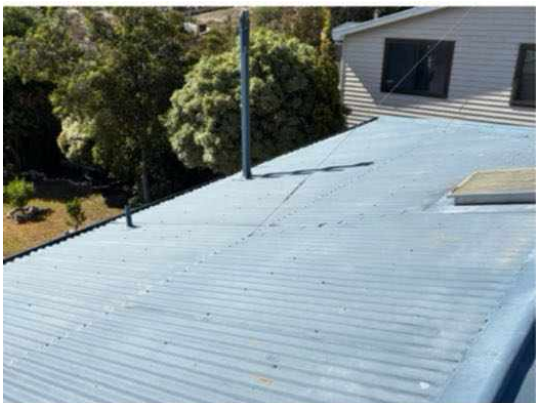
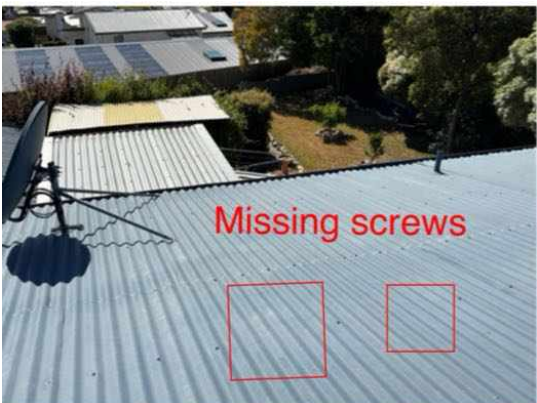
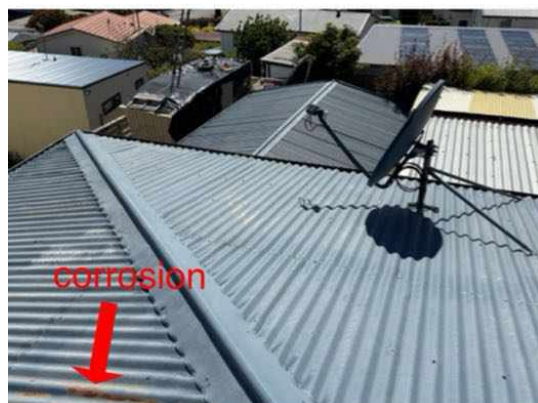
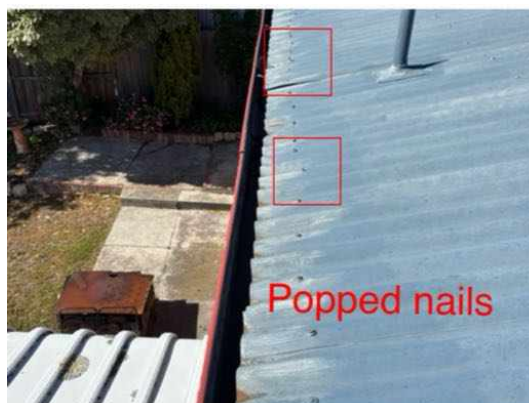
Defects 3.20

Building:	Main Building
Location:	Roof
Finding:	Roof maintenance required
Information:	The roof requires some maintenance work. It is the original roof that was installed when the house was built. It is in poor condition.

There are popped nails, rusted nails, missing screws, roof and capping sheet edges lifting and corrosion. However the sheets themselves had little sheet lap corrosion, and if the maintenance is kept up there should be many more years of serviceable life for this roof.

The roof is held down primarily by nails, which was normal practice at the time of construction. However as the timber dries and shrinks the nails and timber lose friction and the suction of the roof by winds, works the nails loose.

Recommend client engage a Handy Person to rectify as soon as possible.

Any loose nails should be replaced by roof screws which offer superior hold down power. This is the minimum recommendation.

Another option would be to take it further, such as replacing all nails with screws and then treating rust and coating with a membrane paint, this will further enhance the longevity of the roof.
