Building Inspection Report

Inspection Date: Tue, 16 Dec 2025

Property Address: 11 Wilga Rd, Risdon Vale TAS 7016,
Australia

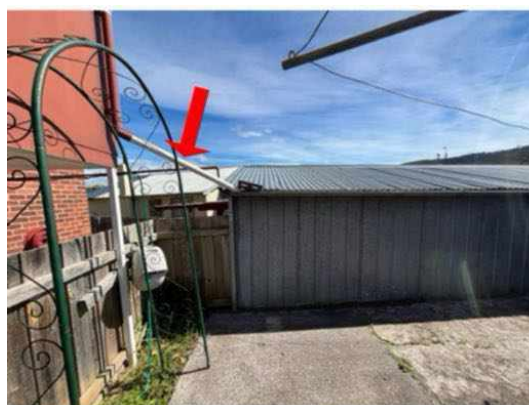
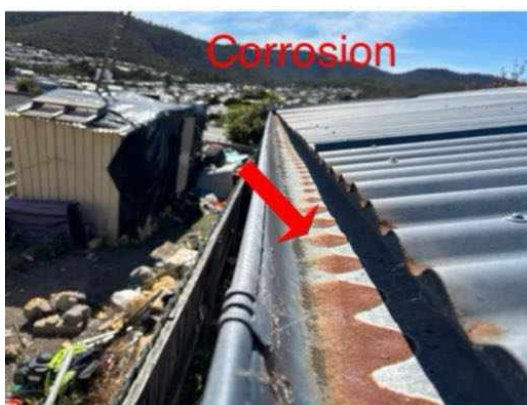
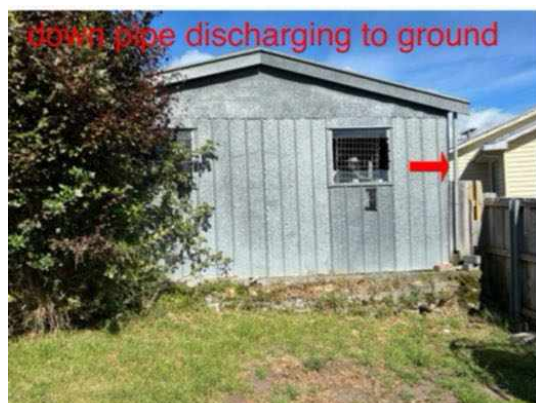
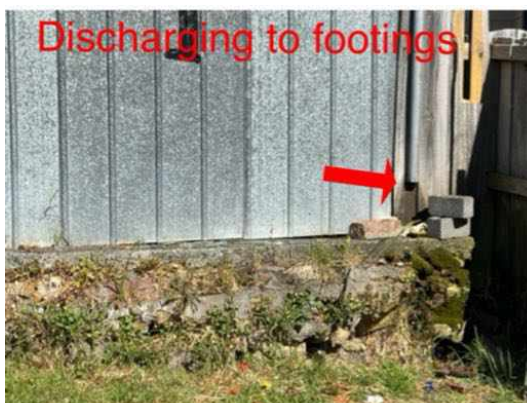
Defects 3.21

Down pipes discharging directly to the ground can cause damage to the footings of buildings and subsidence.

All plumbing work should be carried out by a Lic Roof Plumber.

Recommend client engage a Lic Roof Plumber to inspect and rectify as soon as possible.

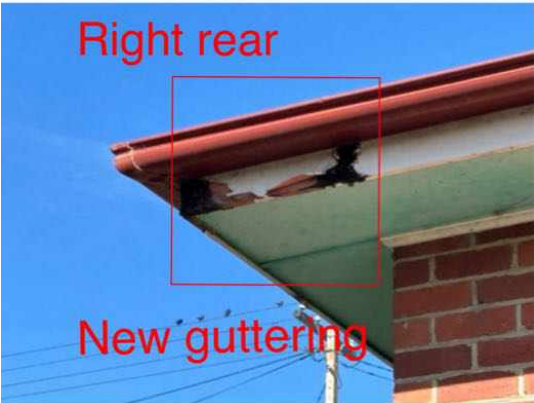
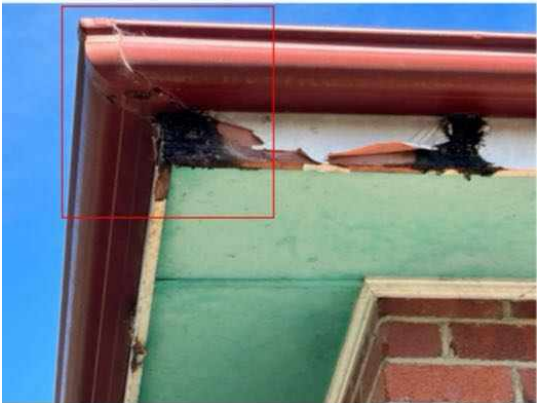
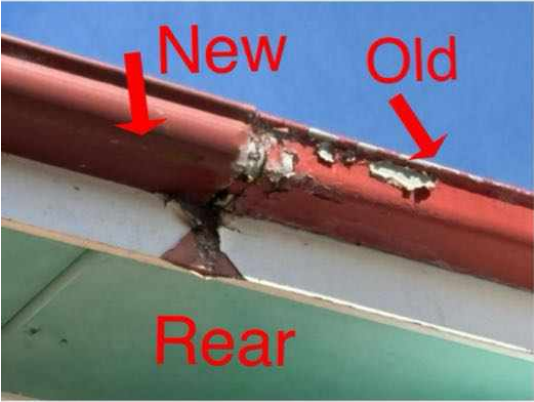
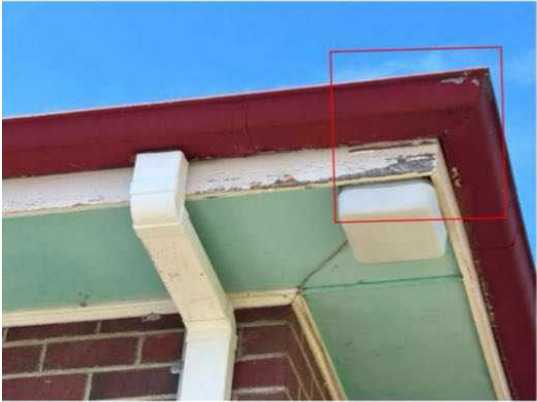
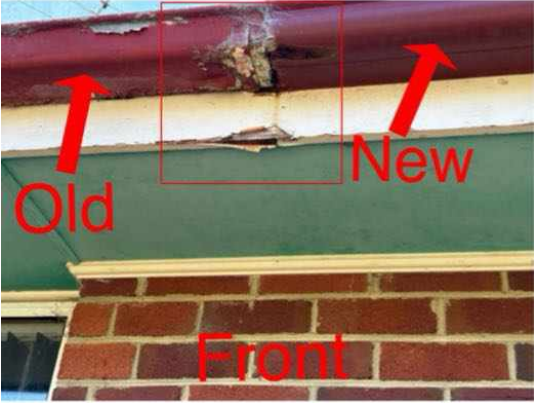
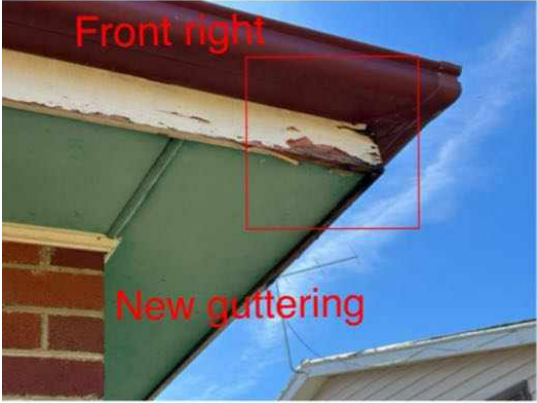
Defects 3.22

Building:	Main Building
Location:	Roof
Finding:	Gutter leaks
Information:	There are gutters leaks in multiple locations (right hand side rear and right hand side front of the house). Two gutter clips have come loose and need to be replaced/re-secured. Some of the guttering has been replaced in the recent past. Some of the staining and damage below the new sections may not be leaks at these locations, just the old damage that was not fixed when new guttering was installed. However the remaining guttering is in very poor condition, there is corrosion and there are holes in some sections. The remaining guttering needs to be replaced as soon as practicable.

Blocked gutters are likely to lead to high levels of moisture in the affected areas. Such

moisture can cause rust and decay of the associated building materials. Blockages in gutters should therefore be removed immediately to ensure dry conditions are maintained.

Recommend client engage a Lic Roof Plumber to rectify as soon as practicable.

Recommend client ensure that all gutters be maintained on a frequent basis to ensure the condition of roof plumbing.

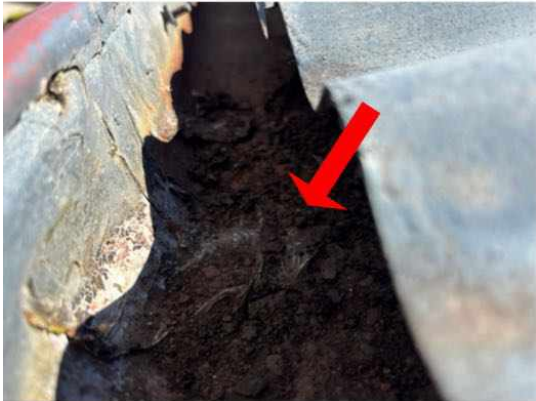
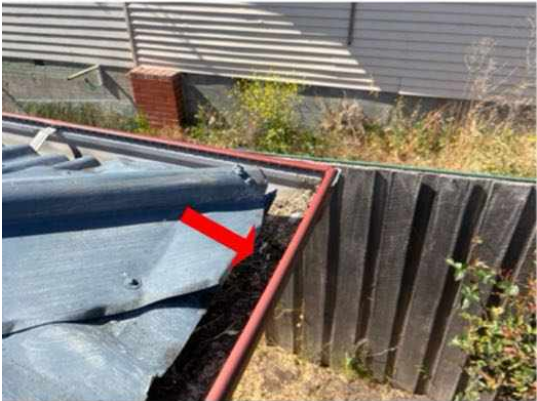
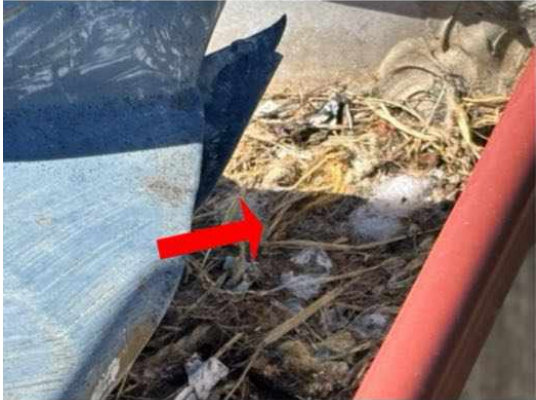
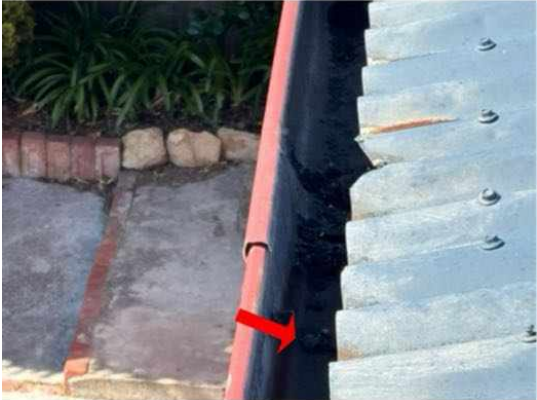
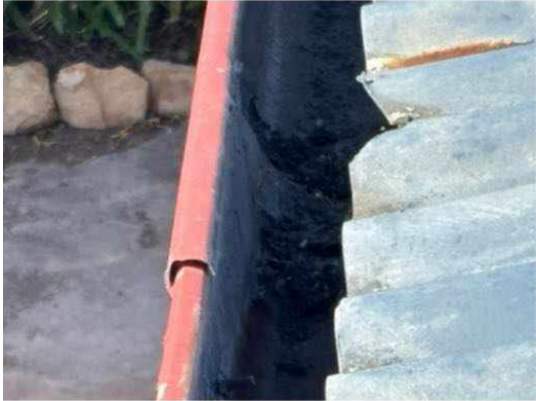
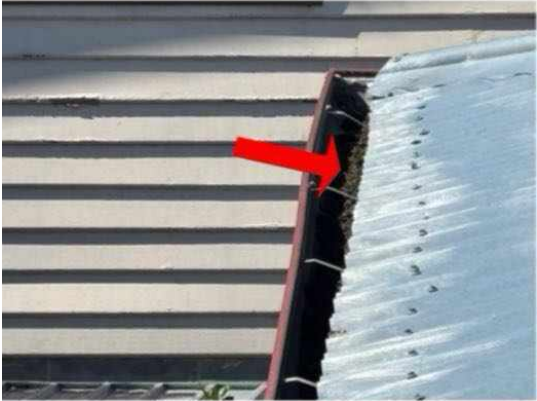
Defects 3.23

Building:	Main Building
Location:	Multiple locations
Finding:	House - gutters require cleaning
Information:	The gutters require cleaning. If client is going to replace them, then don't clean first just replace. However if you decide to defer replacement, then I recommend client engage a Handy Person to clean the gutters as soon as possible.

debris to prevent blockages. Blockages of the guttering and downpipes will lead to pooling and accumulated water overflows, which is likely to subsequently flood eaves and exterior walls.

Blocked gutters are likely to lead to high levels of moisture in the affected areas. Such moisture can cause rust and decay of the associated building materials. Blockages in gutters should therefore be removed immediately to ensure dry conditions are maintained.

Recommend client ensure that all gutters be maintained on a frequent basis to ensure the condition of roof plumbing.

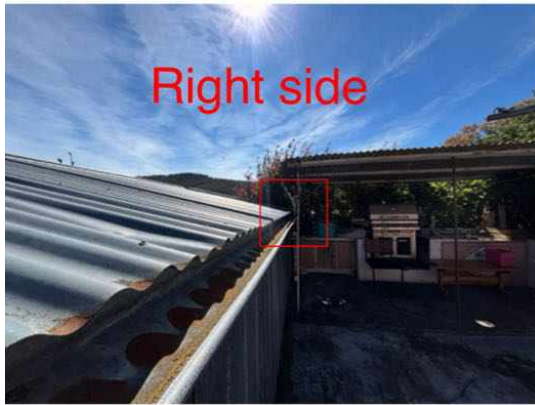
Right side

Building:	Garage
Location:	Garage
Finding:	Garage - gutters require cleaning
Information:	The garage gutters are sagging, right side is clogged and discharging to a small diameter pipe, that then discharges directly to the ground.

Roof plumbing structures, such as guttering and downpipes, should be free of all debris to prevent blockages. Blockages of the guttering and downpipes will lead to pooling and accumulated water overflows, which is likely to subsequently flood eaves and exterior walls.

Blocked gutters are likely to lead to high levels of moisture in the affected areas. Such moisture can cause rust and decay of the associated building materials. Blockages in gutters should therefore be removed immediately to ensure dry conditions are maintained.

Recommend client engage a Handy Person to clean the gutters as soon as possible.

Recommend client ensure that all gutters be maintained on a frequent basis to ensure the condition of roof plumbing.

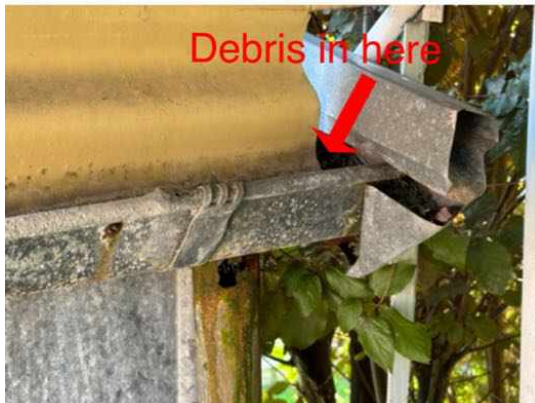
Debris in here

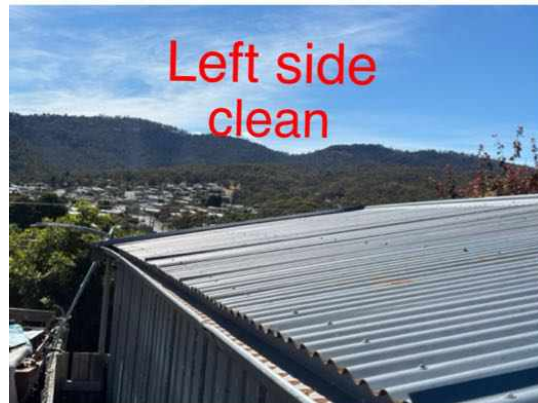
Left side
clean

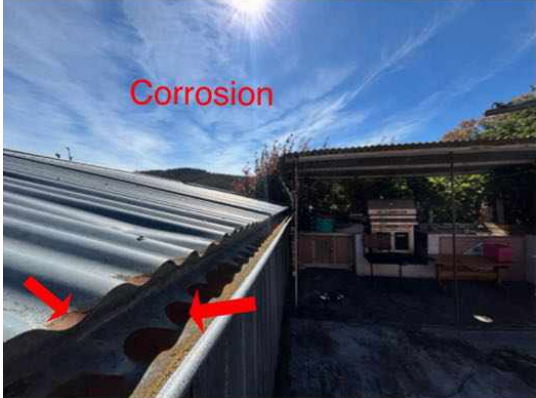
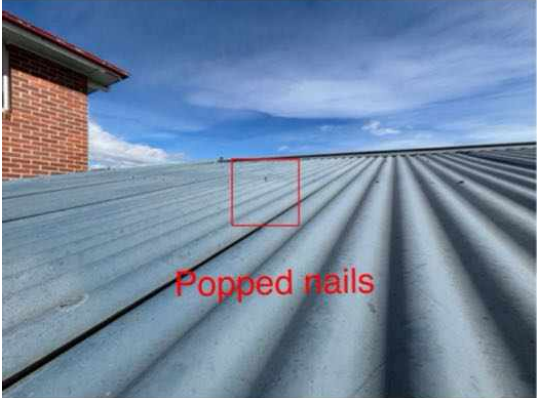
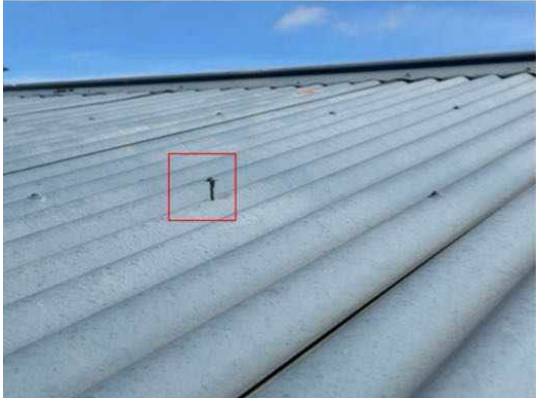
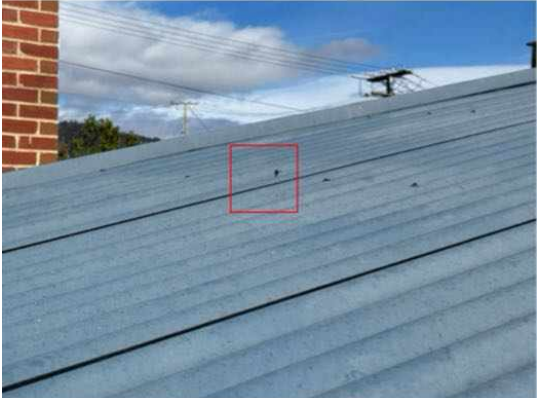
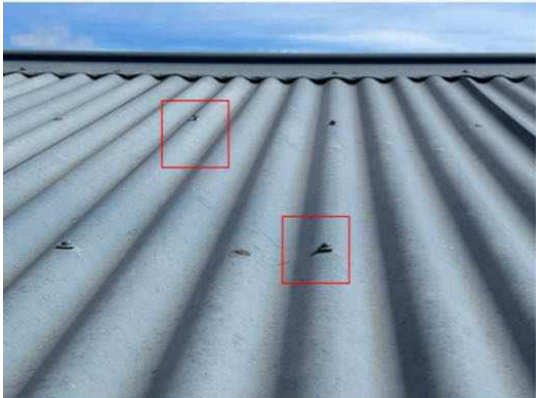
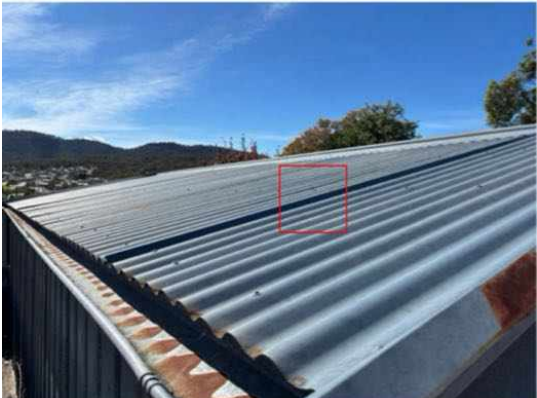
Defects 3.26

Building:	Garage
Location:	Garage
Finding:	Garage roof maintenance required
Information:	The garage roof requires some maintenance work. There are popped nails and roof sheet edges lifting.

The roof is held down by nails, which was normal practice at the time of construction. However as the timber dries and shrinks the nails and timber lose friction and the suction of the roof by winds, works the nails loose.

Roof plumbing structures protect the property from water ingress. Client should ensure these structures be maintained on a regular basis.

Recommend client engage a Handy Person to rectify as soon as possible.

Any loose nails should be replaced by roof screws which offer superior hold down power. This is the minimum recommendation.

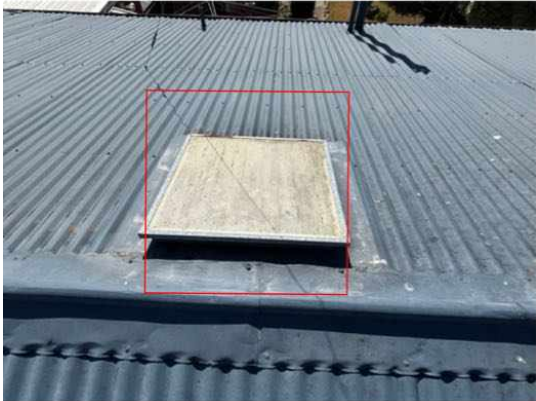
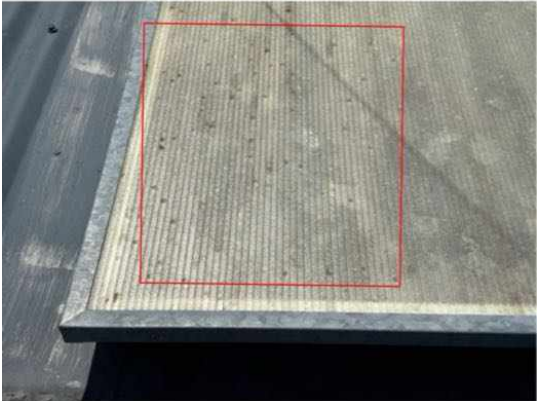
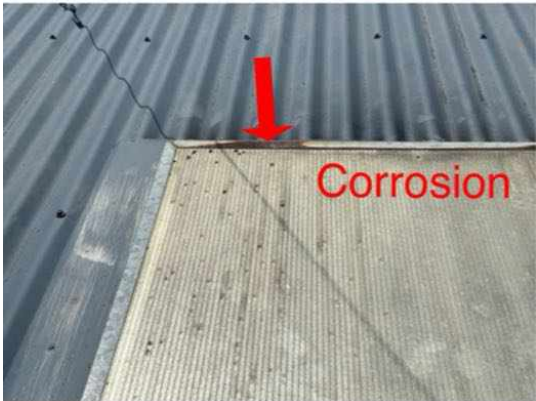
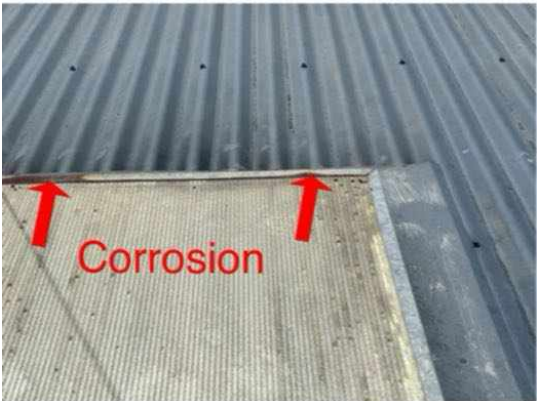
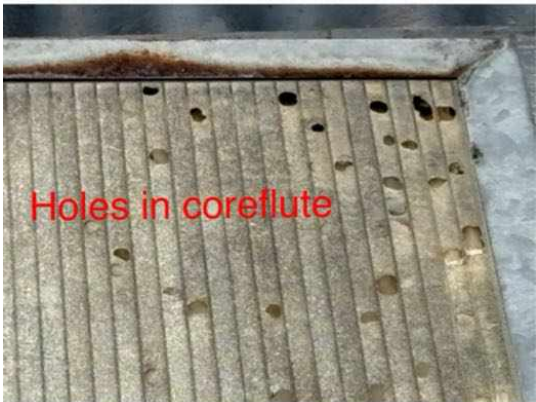
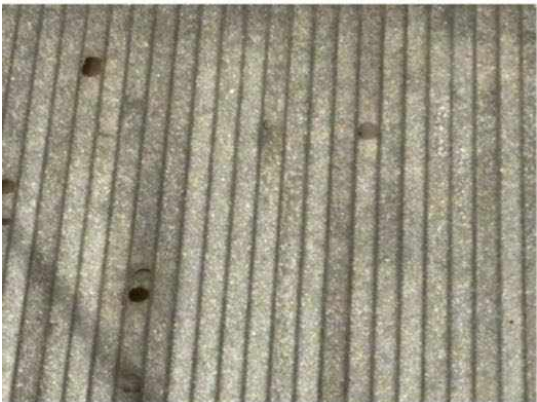
Defects 3.27

Building: Main Building
 Location: Roof
 Finding: Skylight deteriorated
 Information: There is a sky light fitted to the roof. The tops of the skylight are made of plastic coreflute material. The top layer of coreflute has been badly damaged by UV which has caused holes. The skylight frame is also corroding.

Failure to rectify will allow water into the roof in the near future.

- * Roof and gutter maintenance required as soon as possible.
- * Skylight corrosion to exterior frame and coreflute badly deteriorated needs attention as soon as possible.

Recommend client engage a Handy Person to treat and paint the corrosion and replace coreflute as soon as possible.

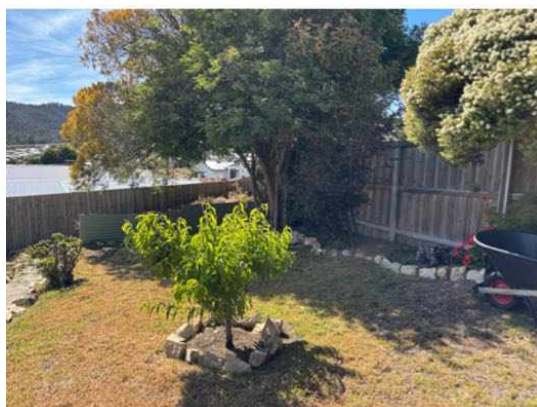
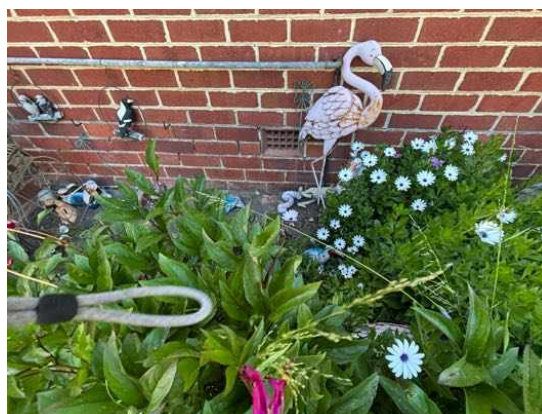
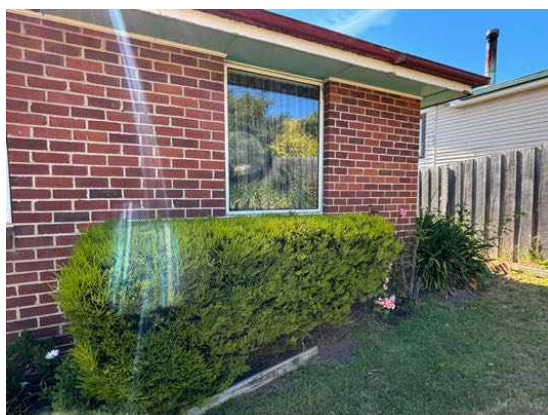
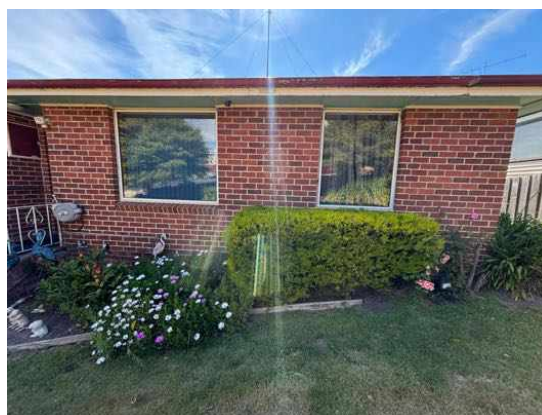
Building: Main Building
 Location:
 Finding: Additional Photos - Obstructions and Limitations
 Information: These photographs are an indication of the obstructions and limitations which impeded full inspection of the property at the time of inspection. These obstructions can hide an array of defects and should be removed to allow full inspection to be carried out. A re-inspection is recommended once the areas are made accessible.

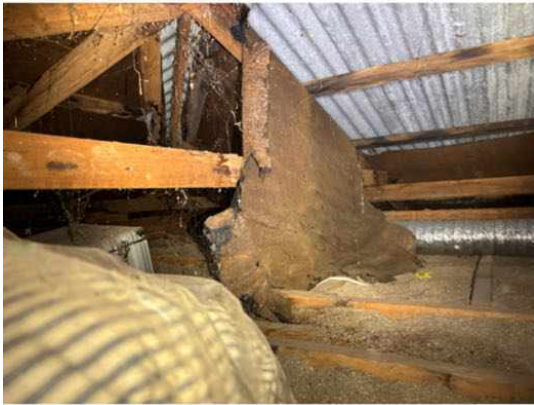
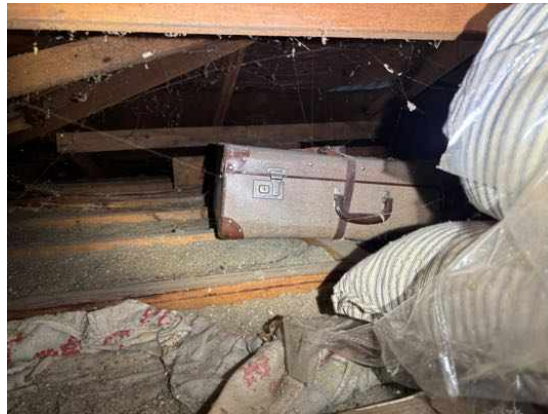
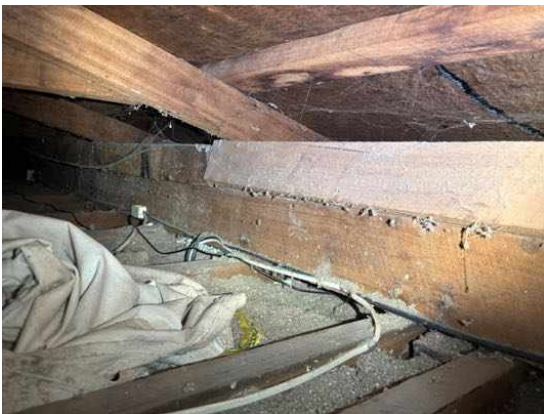
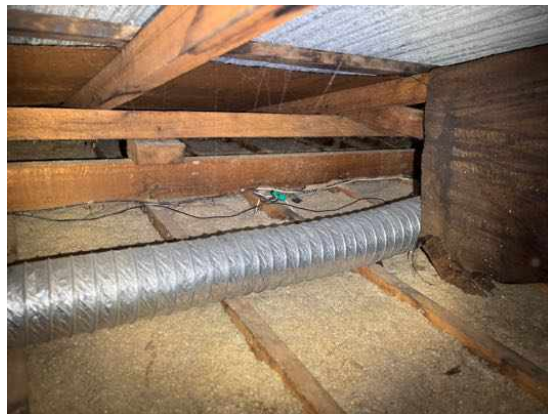
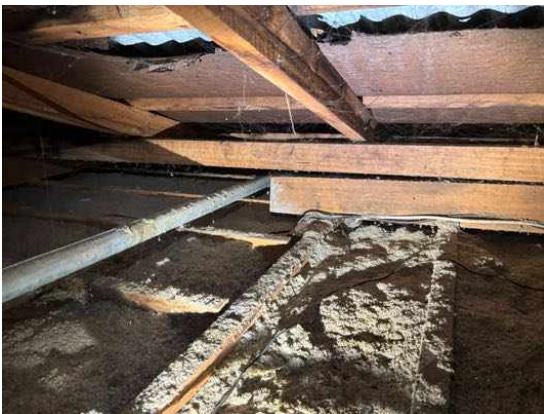
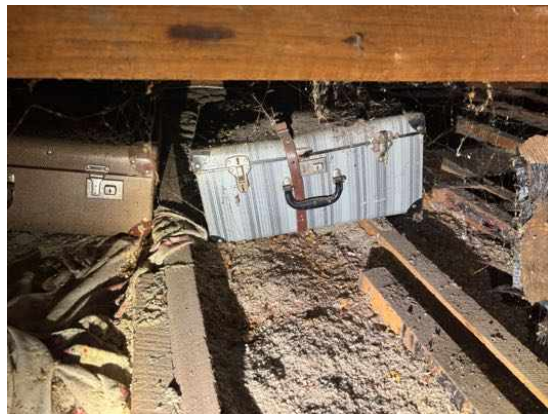
Building: Main Building
 Location:
 Finding: Additional Photos - Obstructions and Limitations
 Information: These photographs are an indication of the obstructions and limitations which impeded full inspection of the property at the time of inspection. These obstructions can hide an array of defects and should be removed to allow full inspection to be

carried out. A re-inspection is recommended once the areas are made accessible.

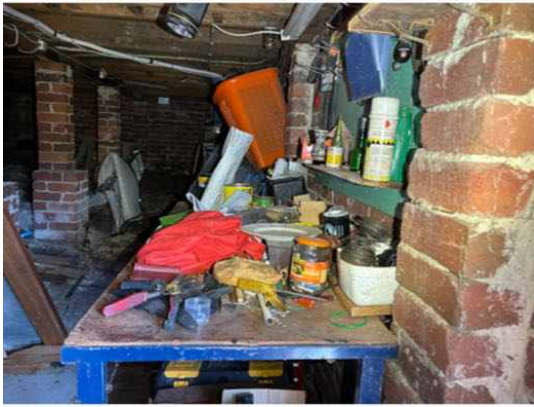
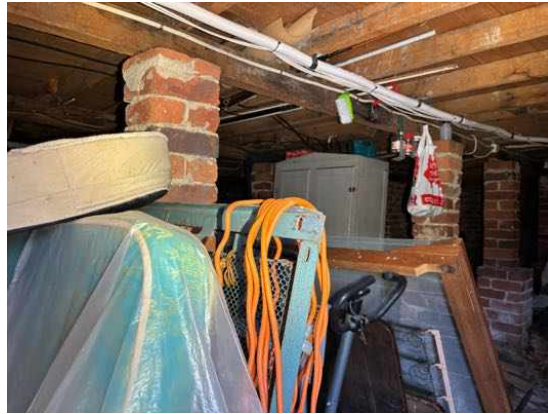
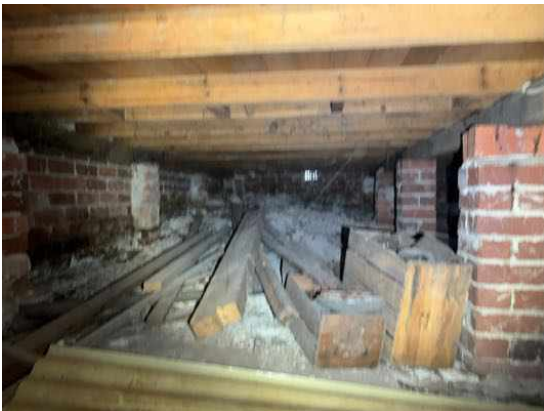
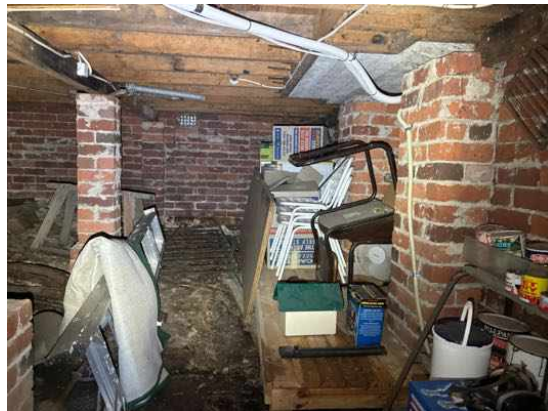
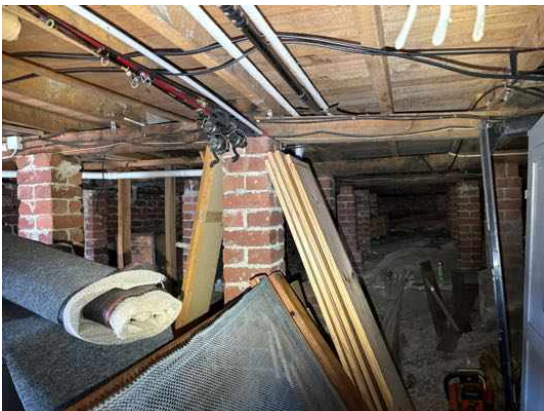
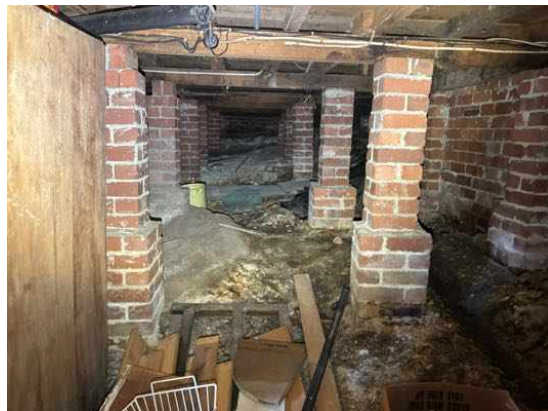
Finding: Additional Photos - Obstructions and Limitations

Information: These photographs are an indication of the obstructions and limitations which impeded full inspection of the property at the time of inspection. These obstructions can hide an array of defects and should be removed to allow full inspection to be carried out. A re-inspection is recommended once the areas are made accessible.

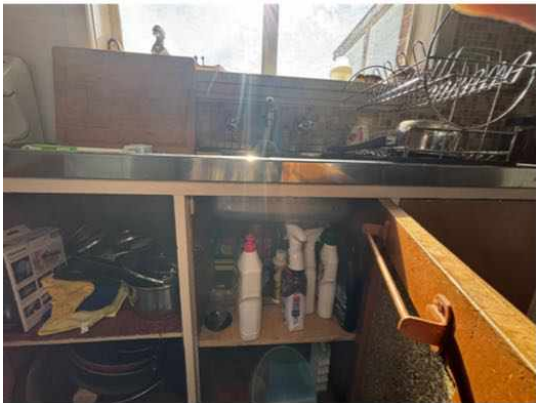
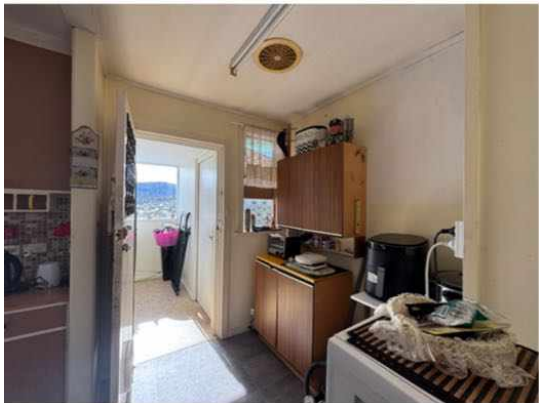
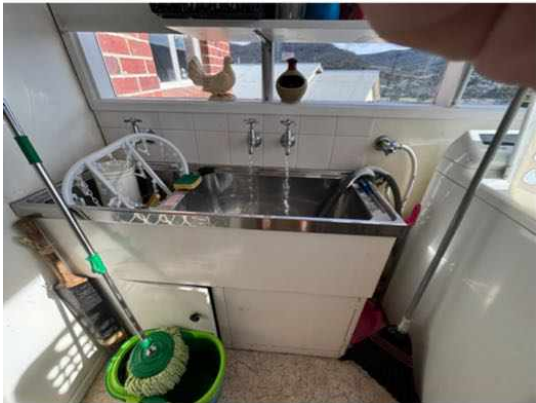
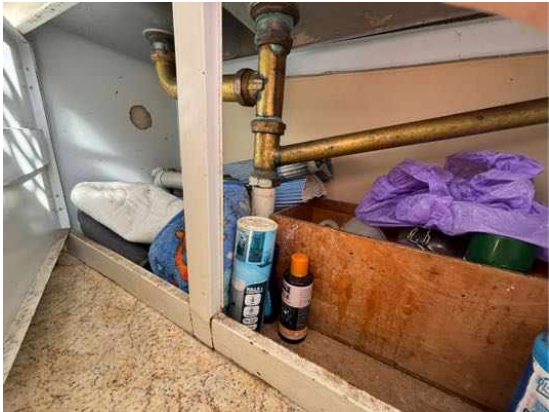
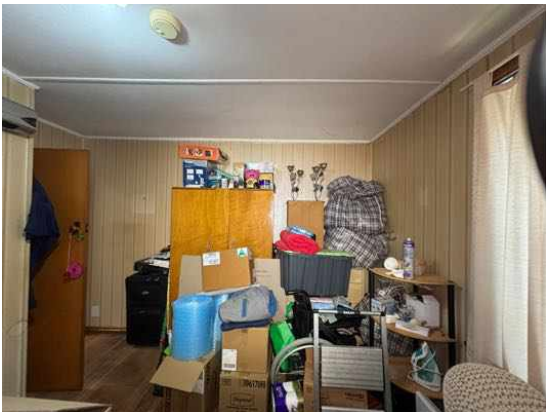
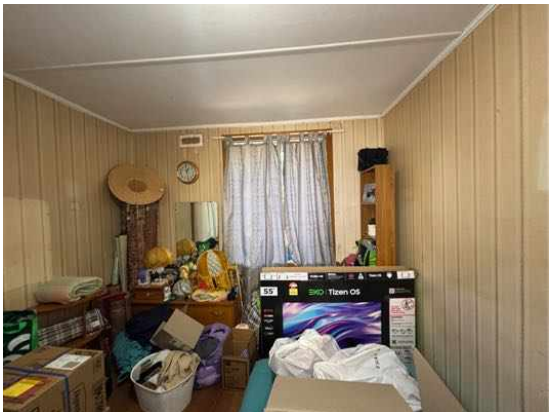
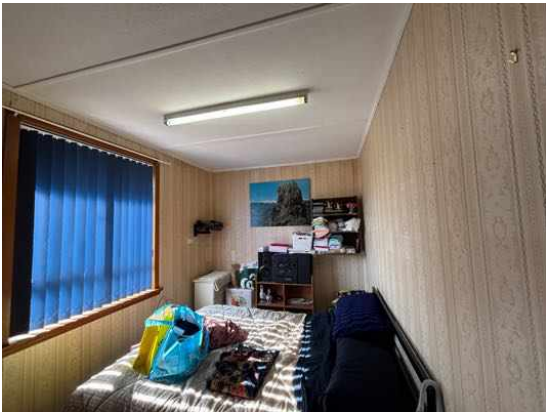
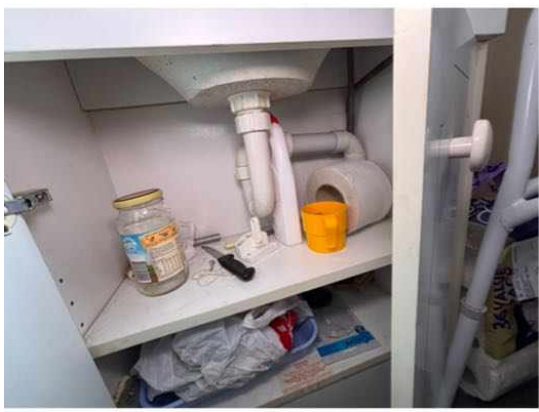
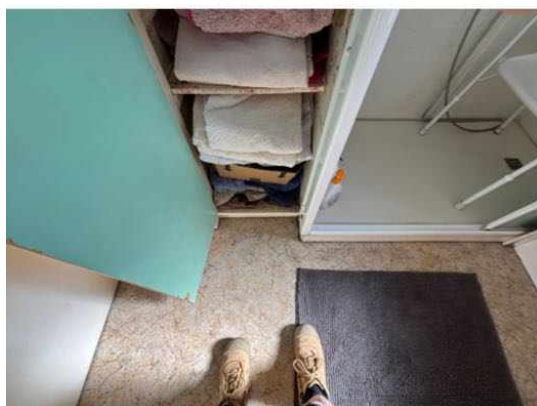
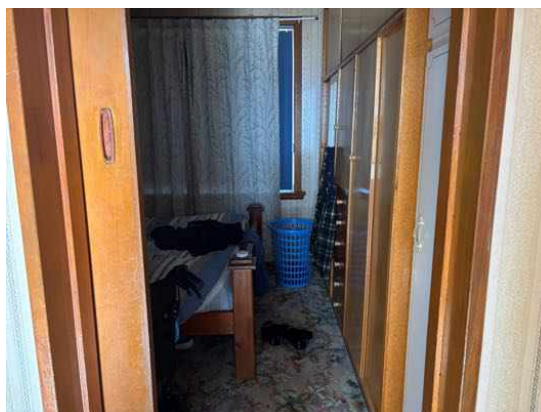
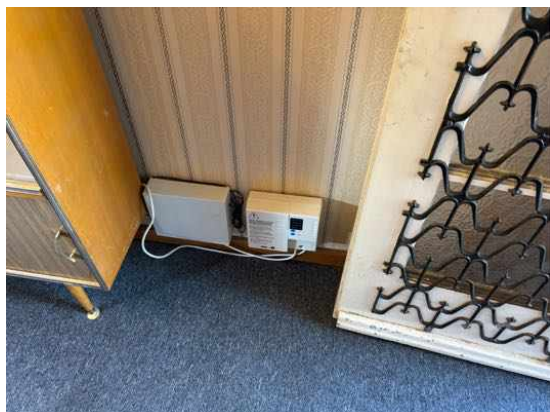
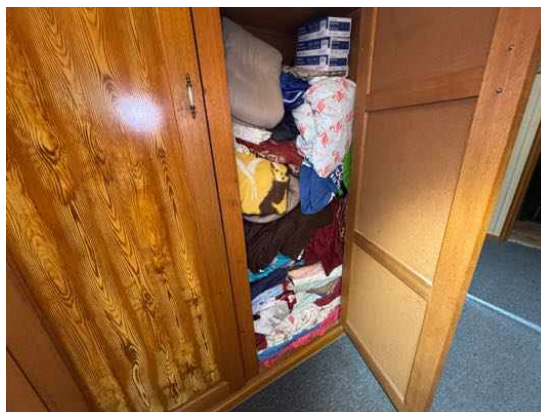
Finding: Additional Photos - Obstructions and Limitations

Information: These photographs are an indication of the obstructions and limitations which impeded full inspection of the property at the time of inspection. These obstructions can hide an array of defects and should be removed to allow full inspection to be carried out. A re-inspection is recommended once the areas are made accessible.

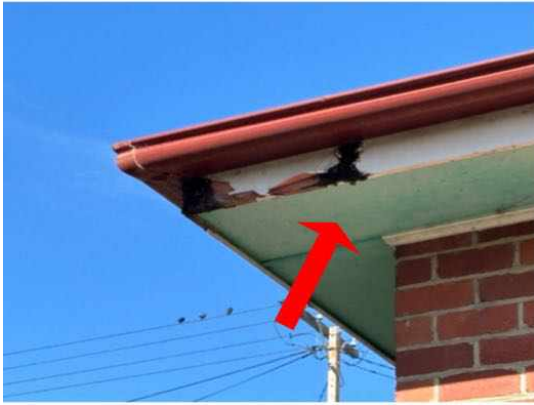
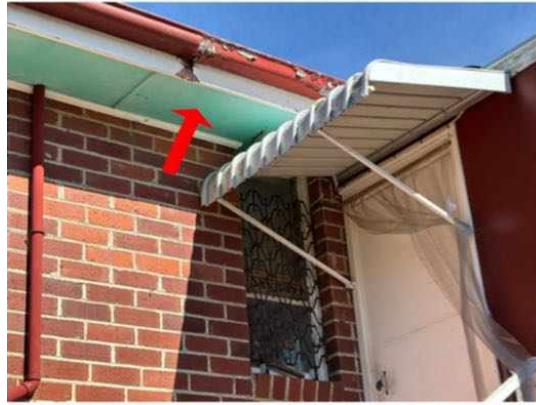
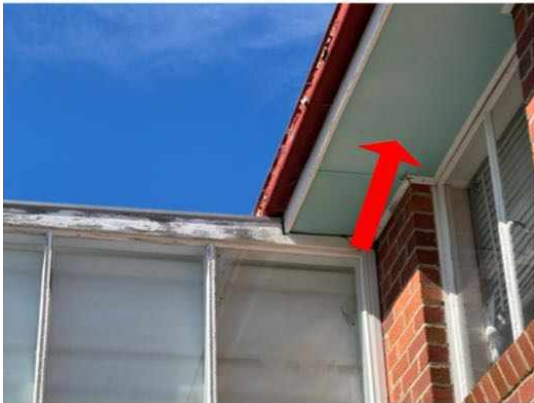
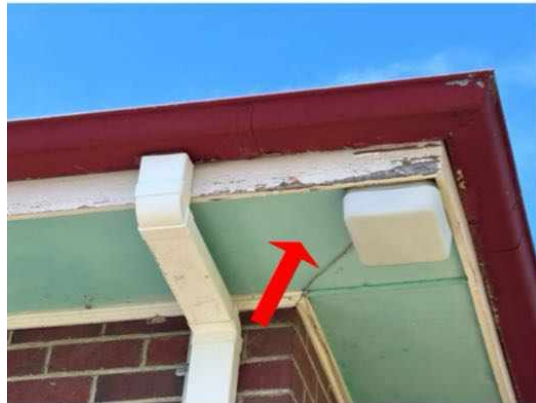
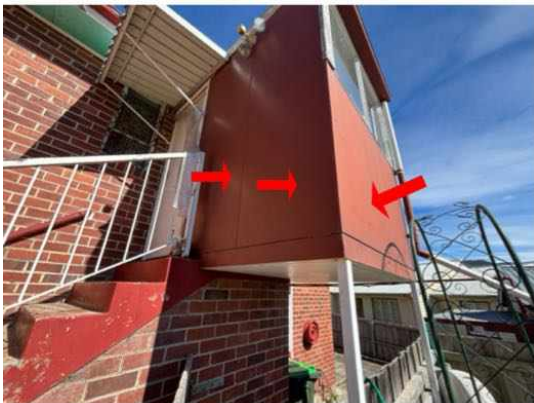
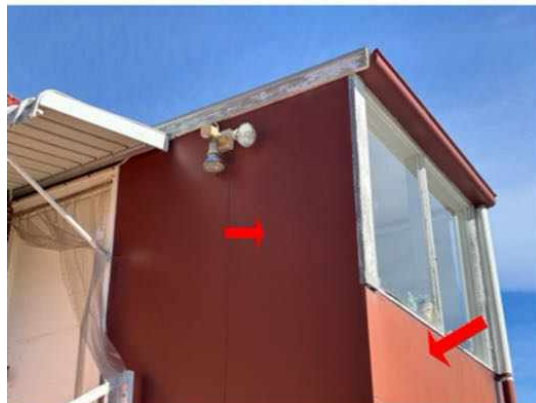
As definitive Asbestos Reporting is outside the scope of this report, we advise that you consider a separate Asbestos Inspection and Condition Audit, which includes the taking of samples for definitive confirmation of the presence of Asbestos. Only scientific testing of those samples of material by an accredited National Association of Testing Authorities (NATA) asbestos testing laboratory can confirm the presence of asbestos.

In the interim, the client is advised to act with caution when considering any damage to building materials general wear and tear renovations extensions demolition and general maintenance activities due to the suspected presence of Asbestos. Client should make any contractors aware of the suspected ACM before any works commence.

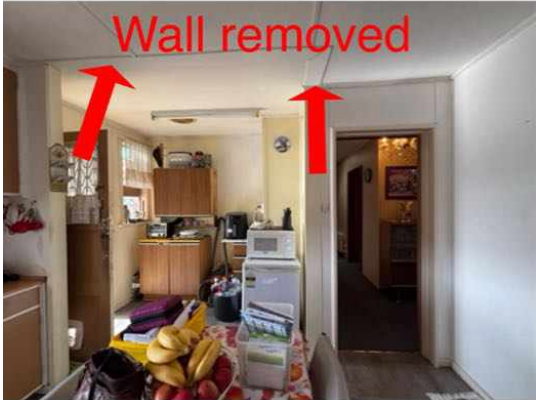
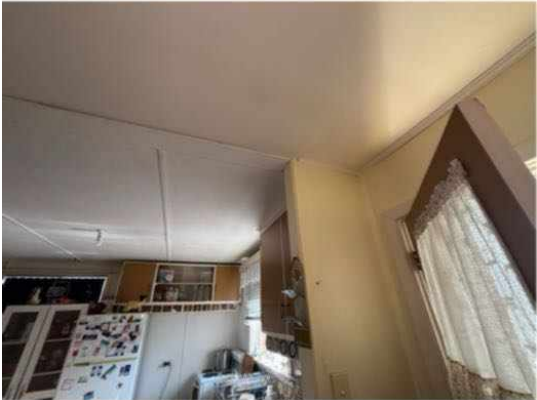
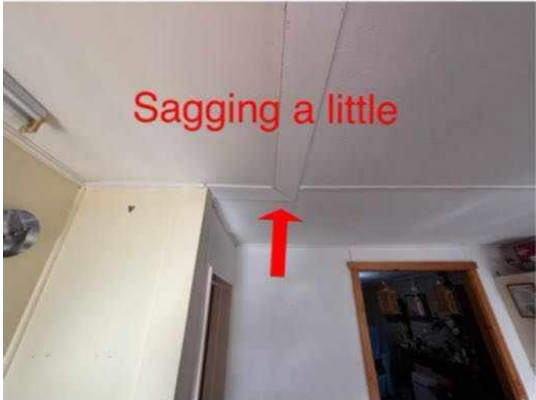
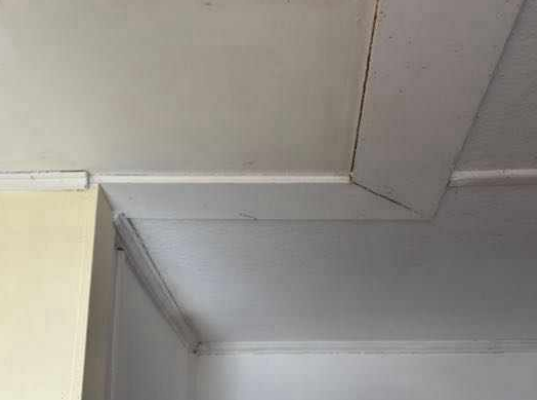
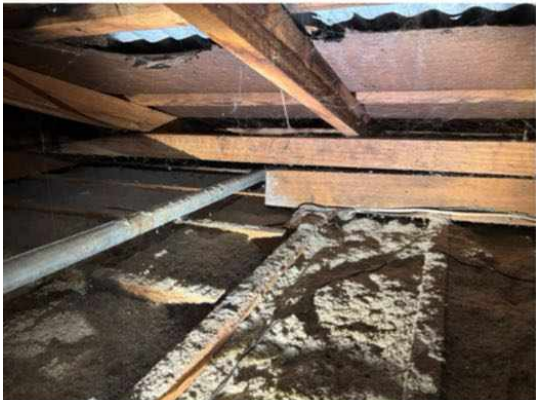
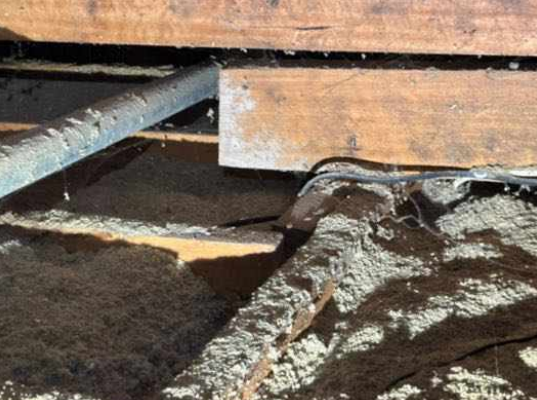
Failure to rectify could lead to further sagging of the ceiling.

Recommend client monitor.

If ceiling sagging or cracking increases, recommend client engage a Lic Builder to

rectify as soon as possible.

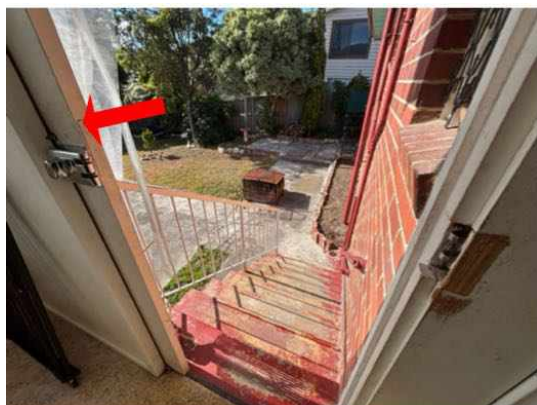
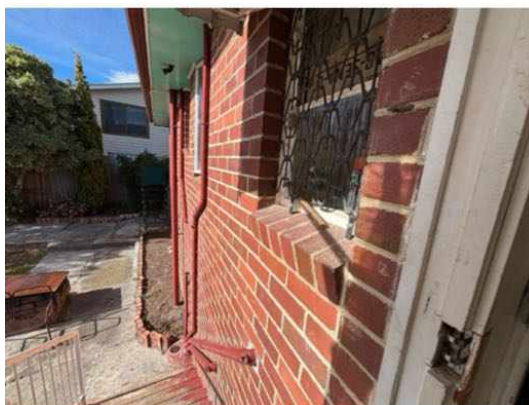
Building: Main Building
Location: Laundry
Finding: FYI Laundry exterior door
Information: FYI the laundry exterior door is a cavity sliding unit at the top of the stairs. This is not a traditional back door entry and would not comply with modern building standards. However it may have complied with the standards of the time. No action recommend,

just for your information.

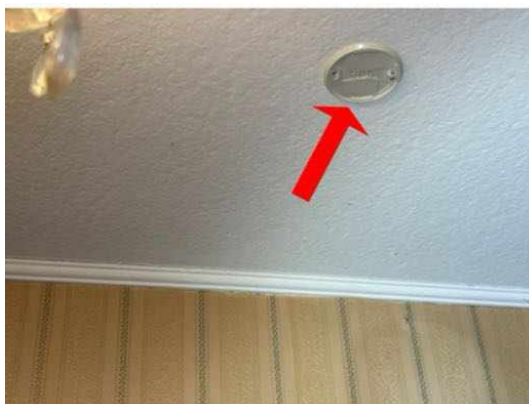
Please note that this defect is highlighted as a caution only. We suspect, based on our experience in the building industry, that the absence of smoke detectors, or their poor condition, should be addressed as a matter of urgency to improve occupant safety.

Always ensure sufficient working and suitable smoke detectors are installed prior to occupying any building.

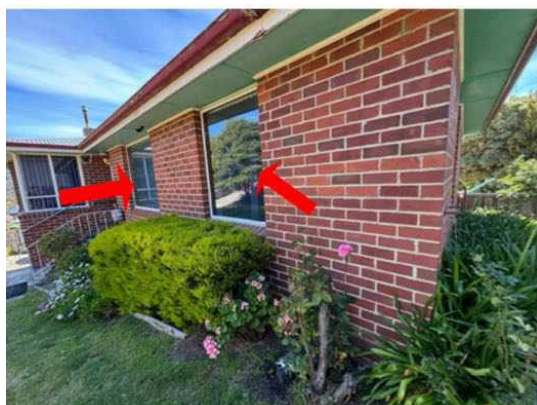
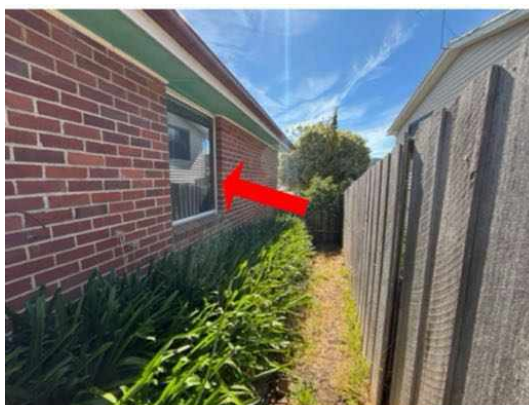
Building: Main Building
 Location: Multiple locations
 Finding: FYI - Fixed Windows
 Information: In the front right and middle bedrooms, the windows have been replaced with windows that are fixed (so they are unable to be opened). The minimum standards for rental property require suitable ventilation to rooms.

If this property is to be a rental, client will need to consult with the Real Estate Rental Manager to ascertain rules pertaining to ventilation. This will need to be done before the property is made available for rent. If ventilation is not compliant then windows may need to be replaced or modified.

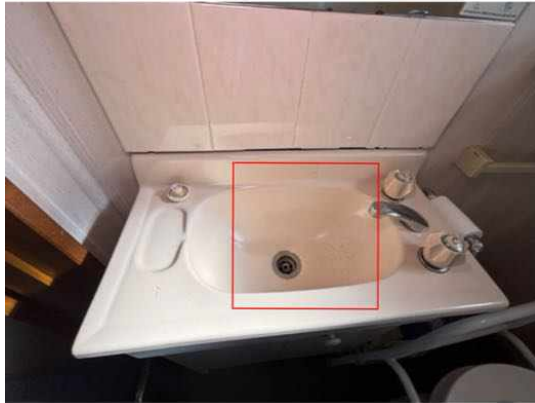
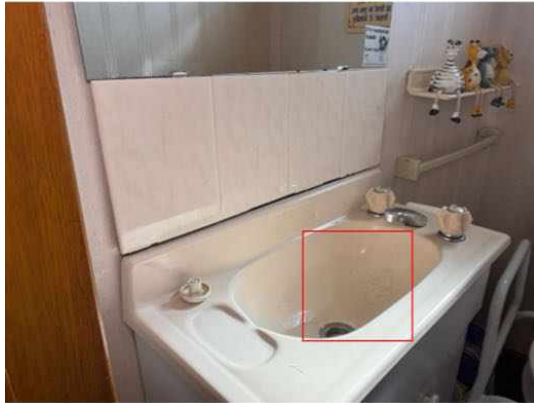
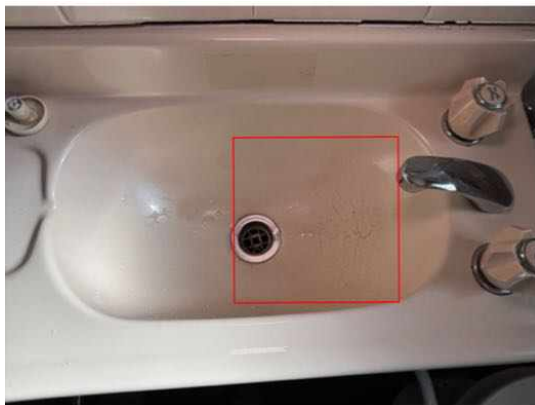
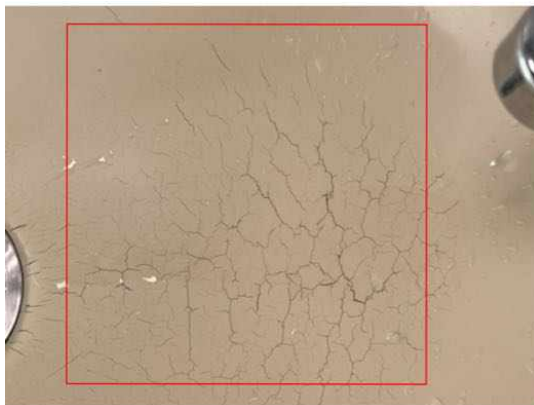
Building: Main Building
 Location: Toilet
 Finding: FYI Crazing
 Information: FYI Crazing was evident to the toilet vanity sink at the time of inspection. Crazing is cosmetic. The basin was not leaking at the time of inspection. Client could choose to engage a Bathroom Contractor to re-surface or replace the unit.

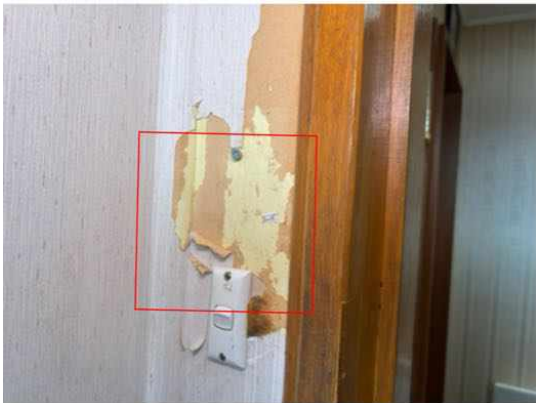
Building: Main Building
 Location: Toilet
 Finding: FYI wallpaper deteriorated
 Information: FYI the wall paper to the toilet has deteriorated.

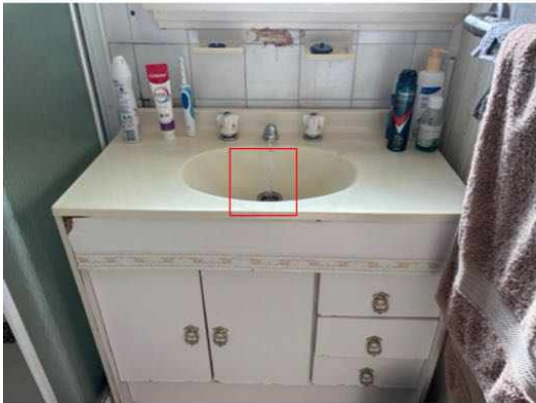
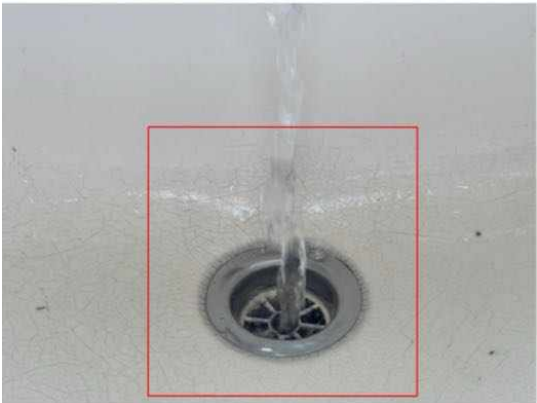
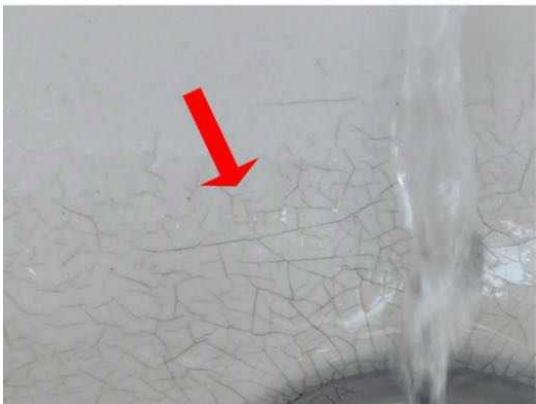
Building: Main Building
Location: Bathroom
Finding: FYI Craziing bathroom sink
Information: FYI Craziing was evident to the bathroom sink at the time of inspection. Craziing is cosmetic. The basin was not leaking at the time of inspection. However the cabinet is also very damaged and I have recommended replacement of the vanity cabinet/ basin by a plumber.

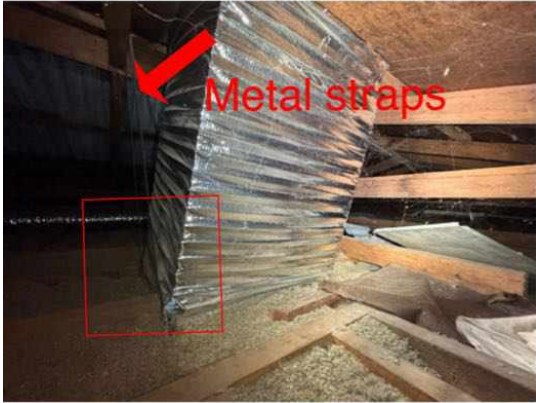
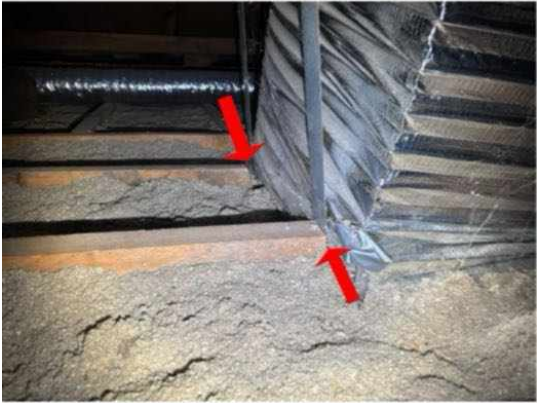
Building: Main Building
 Location: Roof void
 Finding: FYI - Joist compromised roof void
 Information: In the roof void two joists has been compromised/cut to install the skylight. These timbers are carrying the ceiling load, so not a lot of weight. However they are right near the access hatch, so someone kneeling on them could cause movement and ceiling damage. They appear to have metal straps connecting them to the roof framing as some method of supporting them, however this not a method I have seen before.

Joists are structural timbers that support the roofing structure. Failure to rectify could potentially cause damage to the surrounding building elements.

If a Carpenter is attending for other tasks, I suggest the client request the Carpenter inspect and rectify (if required).

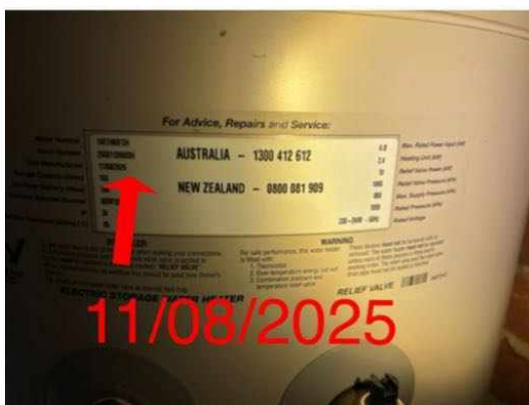
Building: Main Building
 Location: Subfloor
 Finding: FYI Hot Water System
 Information: FYI the hot water system was installed in 2025.

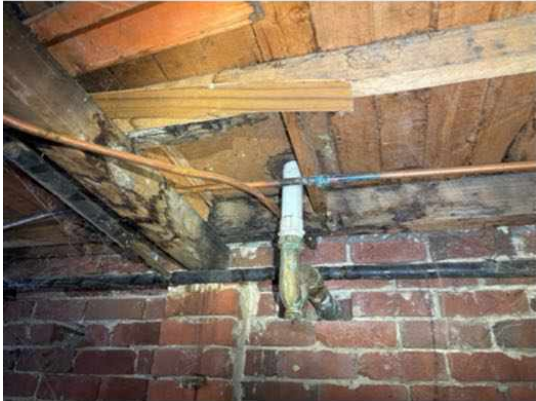
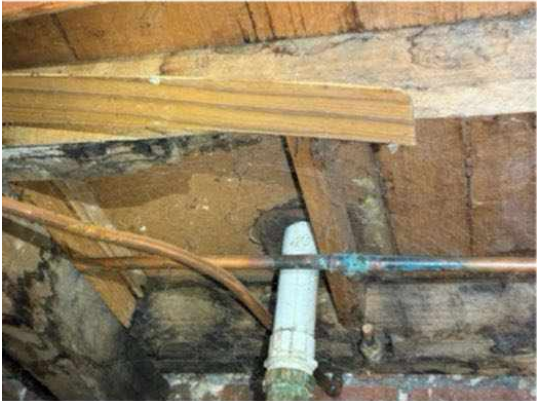
Building: Main Building
Location: Subfloor
Finding: FYI Water staining in subfloor - shower
Information: FYI In the subfloor there is water staining to the area underneath the shower. However it was dry to touch at the time on the inspection.

Water staining was evident in this area at the time of inspection. Water staining indicates that surfaces have been exposed to excessive moisture over time. The minerals and other elements in the water lead to staining, which may graduate to corrosion and deterioration if left unmanaged.

While mostly an appearance defect, water staining can be indicative of more serious defects, which may be currently concealed by other building elements.
