Building Inspection Report

Inspection Date: Tue, 16 Dec 2025

Property Address: 11 Wilga Rd, Risdon Vale TAS 7016,
Australia

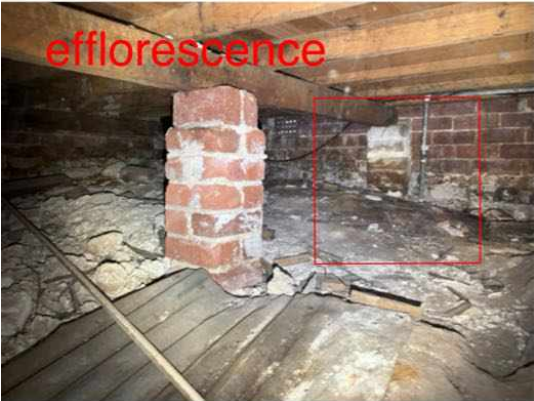
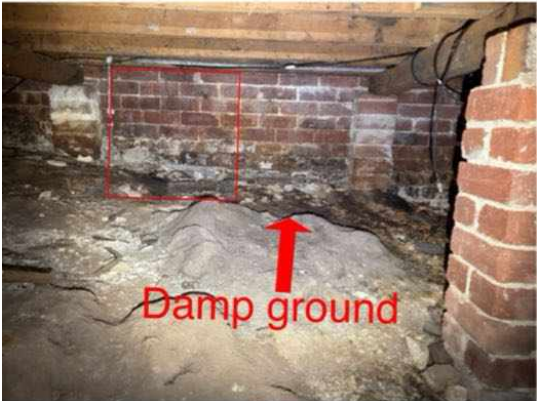
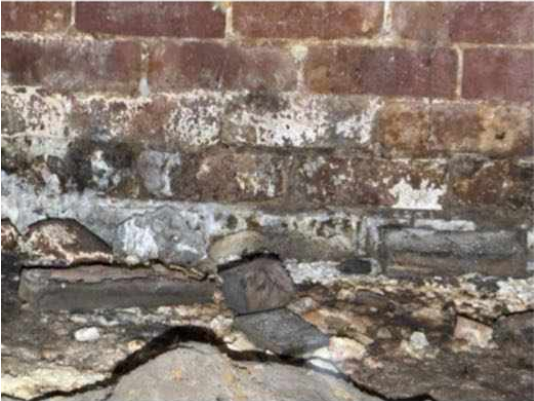
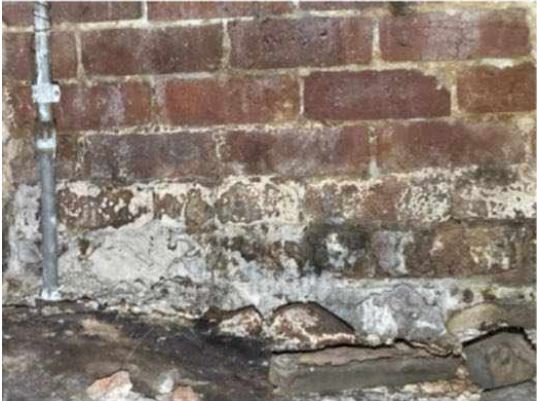
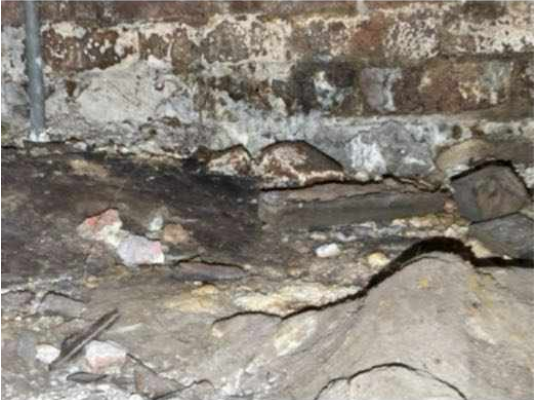
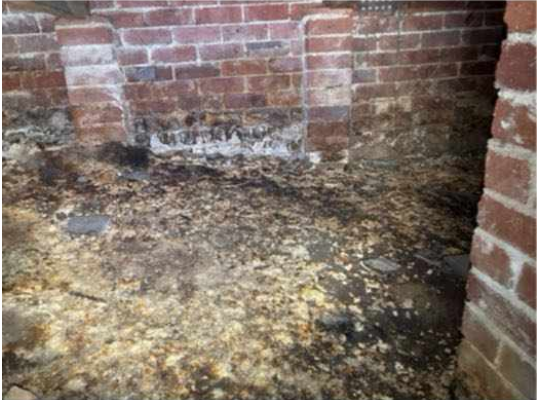
Building: Main Building
 Location: Subfloor
 Finding: FYI Efflorescence
 Information: FYI In the subfloor, efflorescence appears to be affecting the brickwork to the front wall and the surrounding ground. A channel has been dug to manage the water ingress. The front wall of the house is below the finished ground level and the natural ground slopes towards the house.

Efflorescence typically occurs when excess salts within the concrete or cement mortar is leached to the surface due to water transfer. It is typically seen as white salt deposits on the surfaces of concrete pavement or mortar between bricks or tiles.

Recommend that the client/tenants do not store items in this area where there is moisture present. If efflorescence even begins to affect the floor timbers then client should engage a Lic Builder/Carpenter to rectify as soon as possible.

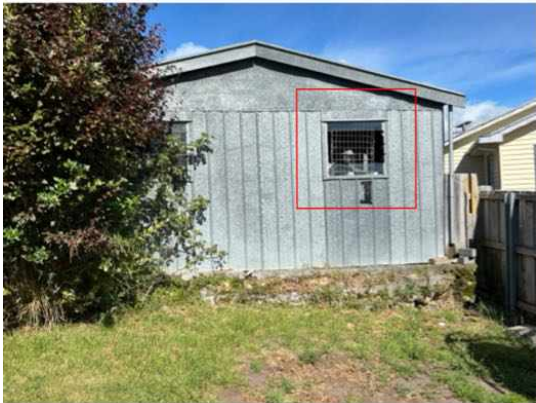
Building: Main Building
Location: Garage
Finding: FYI louvres missing
Information: FYI there are louvres missing to the window at the back of the garage.
