## Building and Timber Pest Inspection Report

Inspection Date: Thu, 12 Mar 2026

Property Address: 13/387 New Canterbury Rd, Dulwich Hill  
NSW 2203, Australia

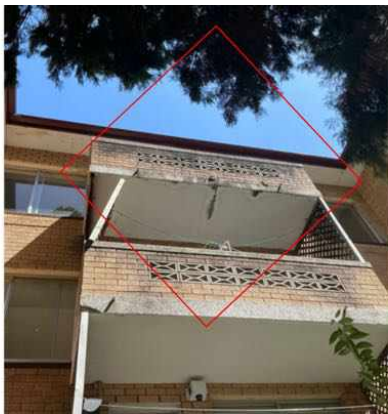
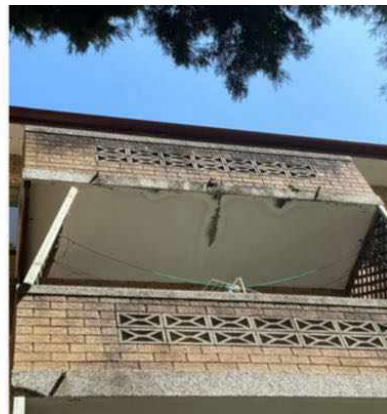
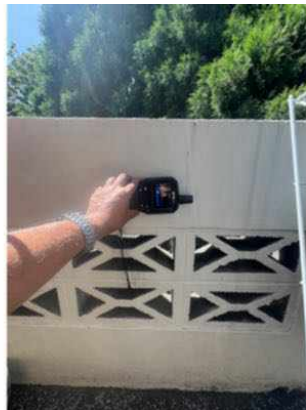
Finding: Balcony Moisture damage - Strata (Possible waterproofing)

Information: Elevated moisture was recorded at the base of the balcony wall and balcony soffit had damage and associated staining consistent with water exposure. While no internal damage was visible at the time of inspection, balconies in multi-unit dwellings are high-risk areas for waterproofing failure, which can lead to leaks into adjoining units and significant rectification costs. Further investigation by a licensed waterproofing contractor is strongly recommended.

Depending on the strata plan, this area may form part of the common property, in which case remedial responsibility may rest with the owners corporation (strata). Purchasers should seek clarification from the strata manager and legal adviser prior to purchase.

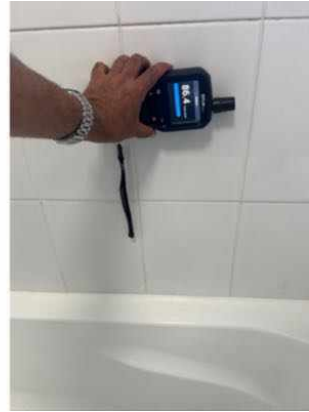
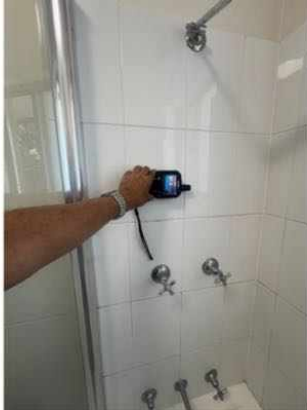
## Finding 2.02

Building:	Main Building
Location:	Bathroom
Finding:	Elevated Moisture Bathroom & Back of shower (Further investigation required)
Information:	Elevated moisture levels were detected to tiled surfaces in bathroom/shower areas. This may be due to porous or missing grout, cracked tiles or recent use, however the possibility of waterproofing membrane failure or plumbing leaks cannot be excluded. Persistent moisture ingress can lead to concealed damage, including timber rot and mould growth. The back of shower area also showed elevated moisture with visible minor deterioration and evidence of previous repairs evident at the time of inspection. Further investigation by a licensed plumber and/or waterproofing contractor is recommended as soon as possible.

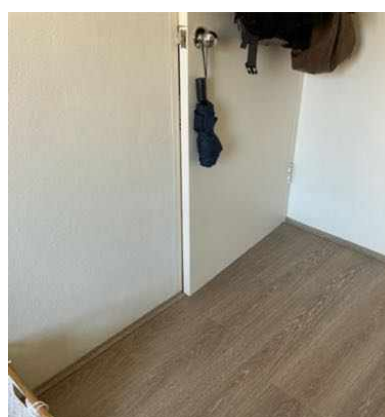
### Finding 3.01

Building:	Main Building
Location:	Bedroom
Finding:	Door - Binding/jamming
Information:	Binding and/or jamming of this door is evident during standard operation. This defect inhibits the functionality of the affected door as well as creating potential for secondary defects to associated building elements, such as damage to the floor covering.

A door that binds to flooring or to the associated door frame may have several causes, ranging from minor defects, such as poor installation of the door or deteriorated hinges, through to major structural issues, such as damage to subfloor structures.

Where door binding/jamming appears to indicate major structural issues, a registered builder specialising in re-stumping should be appointed to provide an estimate on the cost of rectification.

For minor causes, a qualified carpenter or general handyperson should be appointed to perform minor rectification works at client discretion.

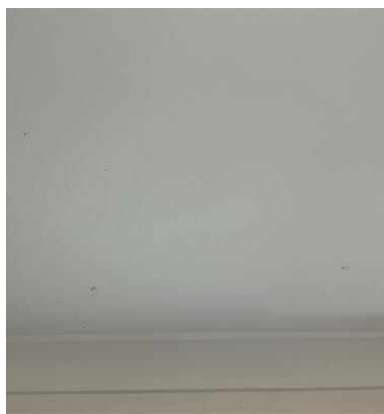
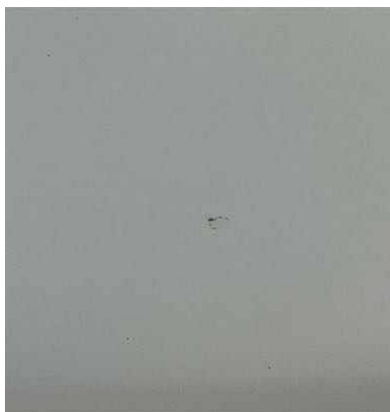
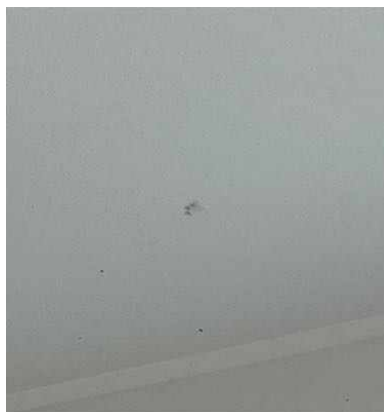
### Finding 3.02

Building:	Main Building
Location:	Bathroom
Finding:	Water Staining - Humidity or Ventilation
Information:	The ceiling surface shows peeling paint and water staining on the walls faint commonly consistent with humidity-related staining, often found in bathroom or wet areas with insufficient ventilation. While there is no visible sagging or major water damage, the pattern suggests prolonged moisture exposure, possibly due to steam accumulation or minor condensation issues. According to AS 4349.1–2007 (Appendix C), this would be classified as a minor defect unless further deterioration or active leaks are found. Recommend improving mechanical or natural ventilation, cleaning the surface with mould treatment, and monitoring for recurrence.

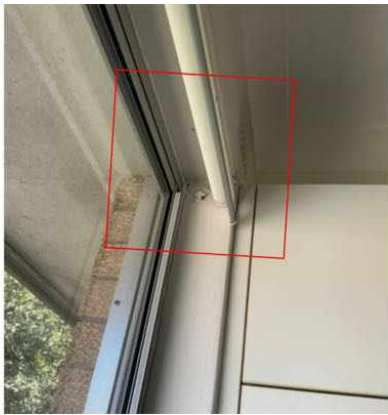
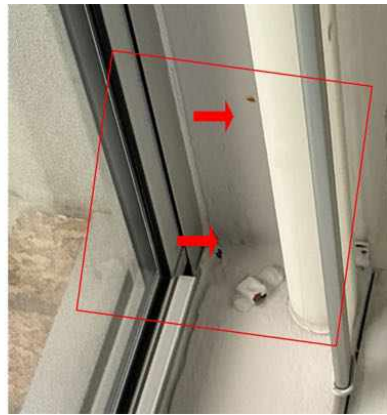
### Finding 3.03

Building:	Main Building
Location:	All External Areas - Balcony
Finding:	Water staining
Information:	Water staining was evident in this area at the time of inspection. Water staining indicates that surfaces have been exposed to excessive moisture over time. The minerals and other elements in the water lead to staining, which may graduate to corrosion and deterioration if left unmanaged.

While mostly an appearance defect, water staining can be indicative of more serious defects, which may be currently concealed by other building elements.

Where water staining is active, a licensed plumber must be consulted to identify the cause of the staining and to provide advice on any reparation works that may be required. Replacement of any broken or damaged structures is advised.

Conversely, where water staining is old and inactive, affected building materials may be repaired or replaced at client discretion. A qualified carpenter or registered builder may be appointed to perform these works.

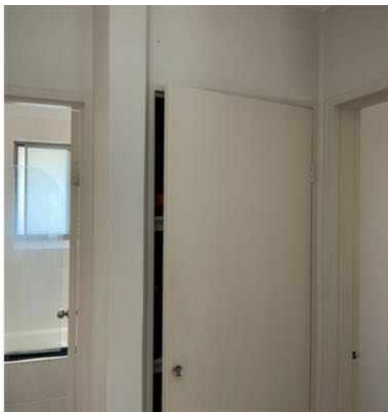
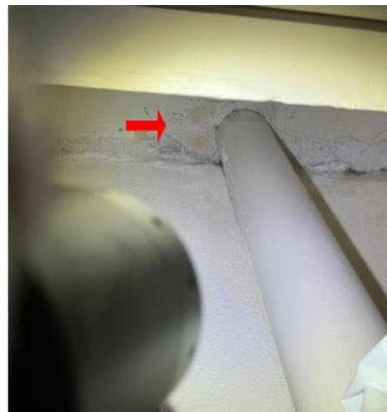
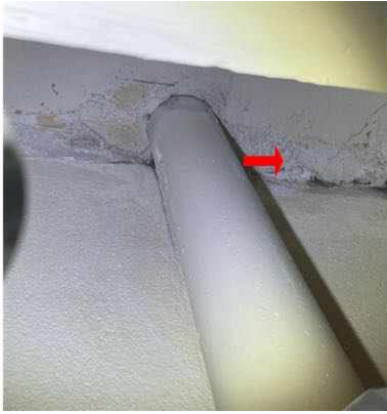
### Finding 3.04

Building:	Main Building
Location:	Linen Cupboard
Finding:	Building element - Damaged - possible moisture damage
Information:	Breakage occurs generally when the building materials have either aged and decayed, or as a result of damage (accidental or deliberate).

Repair and/or replacement of broken elements is advised to ensure that additional secondary defects do not arise as a consequence. Such works are necessary, as all building elements play a key role in the operation and function of the overall structure and its performance.

A relevant tradesperson should be appointed to repair or replace the affected building element prior to any subsequent damage being caused.

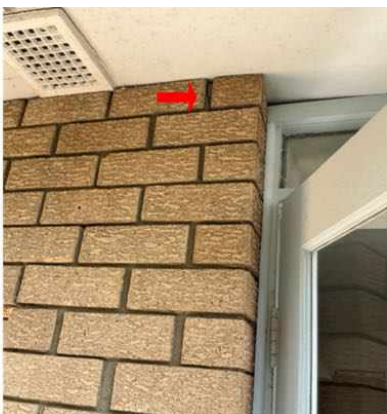
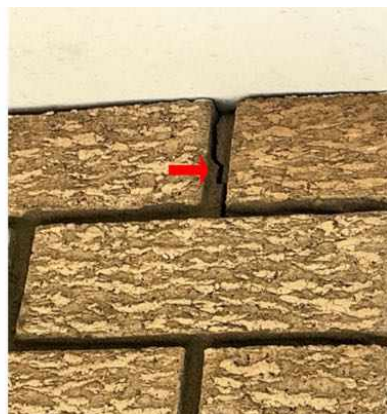
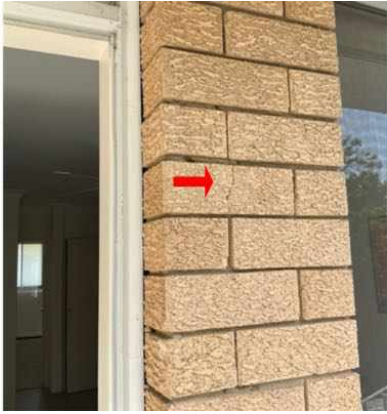
### Finding 3.05

Building:	Main Building
Location:	All Internal Areas
Finding:	Brickwork - Cracking noticeable
Information:	There were several cracks and or crack repairs evident to external brickwork.

Noticeable cracks are a common occurrence in external brickwork and are a likely result of age expected building movement, general expansion, and/or contraction of building materials in different weather conditions. Noticeable cracks in brickwork may develop if left unattended, with potential for necessitating major remedial works or replacement of the brickwork.

It is highly advised that a qualified bricklayer be appointed to provide necessary works to cracked brickwork to prevent any further damage. Such works should be conducted as soon as possible.

Always monitor these cracks and contact a building inspector should cracks widen, lengthen, or become more numerous.

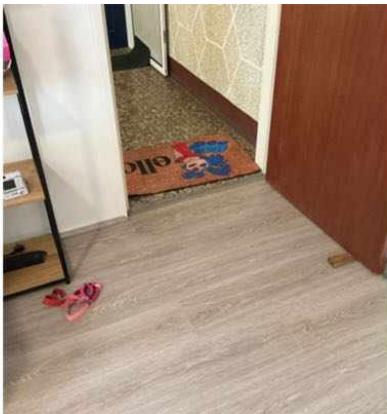
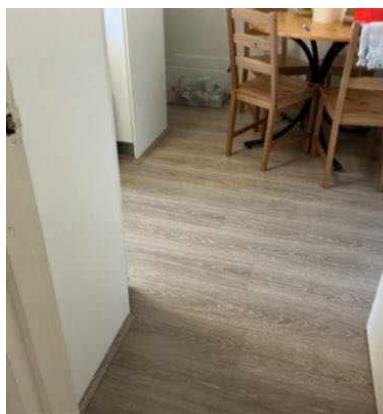
### Finding 3.06

Finding: Laminate Flooring Movement / Creaking

Information: Minor creaking and movement were noted when walking over sections of the laminate flooring. This condition is commonly associated with floating floor systems where slight movement occurs between boards or between the flooring and the underlying substrate, particularly if the subfloor is uneven or expansion clearances are limited. While this does not generally indicate a structural issue, ongoing movement may cause wear to the flooring over time. Monitoring is recommended, and rectification may involve lifting and reinstalling affected boards or improving subfloor preparation if the condition worsens.

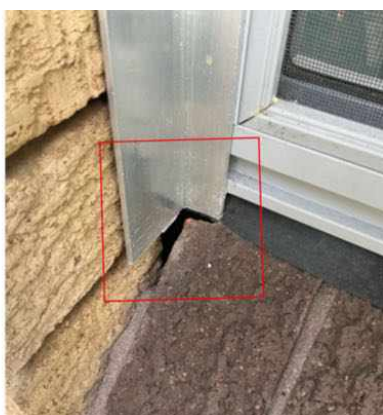
### Finding 3.07

Building:	Main Building
Location:	Balcony
Finding:	Gap Between door Frame and Masonry
Information:	A visible gap is present between the external door frame and the adjacent masonry wall. This gap may allow water ingress, air infiltration, and potential pest entry if not adequately sealed. Over time, such exposure can contribute to frame deterioration, internal water damage, or reduced thermal performance. Sealing or filling the gap with a suitable weatherproof compound is recommended to maintain the integrity of the building envelope, in accordance with good building practice and AS 4349.1

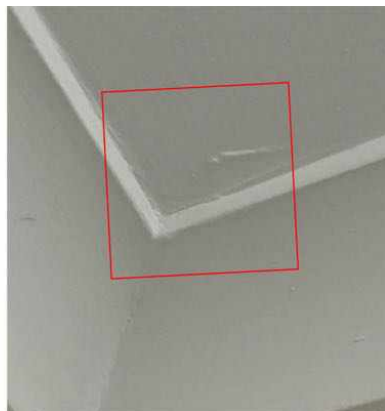
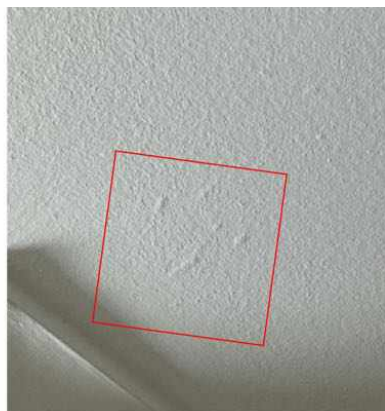
### Finding 3.08

Building:	Main Building
Location:	Kitchen
Finding:	Painted surface - Bubbling
Information:	Sections of paint in this area was found to have bubbled and deteriorated. Paint bubbling is generally an indication of excessive moisture in the area, that is currently hidden by the painted surface.

The presence of excessive moisture can have major implications on associated building elements if left unattended. While only seemingly minor at this stage, the

damage cannot be determined due to the paint obstructing any further inspection of the damage.

It is highly advised that the affected paint be cleaned to allow a further, more invasive inspection by a licensed plumber. Failure to act on this defect may necessitate major works in the future.

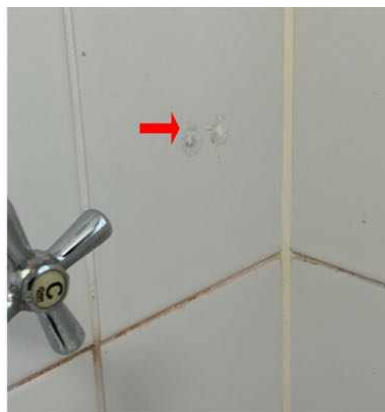
Building:	Main Building
Location:	All Internal Areas
Finding:	Building element - Damaged - Holes in tile
Information:	Breakage occurs generally when the building materials have either aged and decayed, or as a result of damage (accidental or deliberate).

Repair and/or replacement of broken elements is advised to ensure that additional secondary defects do not arise as a consequence. Such works are necessary, as all building elements play a key role in the operation and function of the overall structure and its performance.

A relevant tradesperson should be appointed to repair or replace the affected building element prior to any subsequent damage being caused.

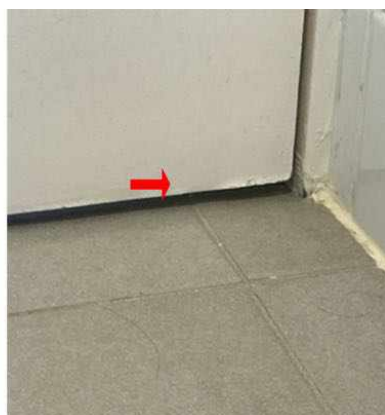
### Finding 3.12

Building:	Main Building
Location:	Bathroom
Finding:	Delamination of timbers
Information:	Localised delamination and surface deterioration were observed to sections of laminated joinery panels. This condition commonly occurs where moisture exposure or wear causes separation of laminate finishes from the underlying substrate. The defect is generally cosmetic in nature but may worsen over time if moisture exposure continues. Repair or replacement of affected joinery components may be considered as part of routine maintenance.

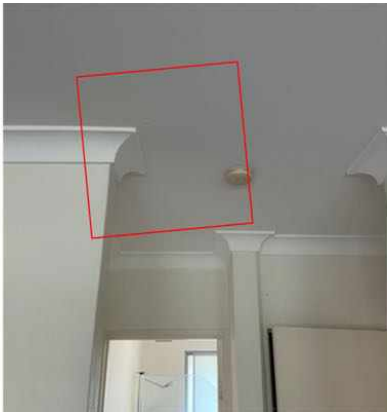
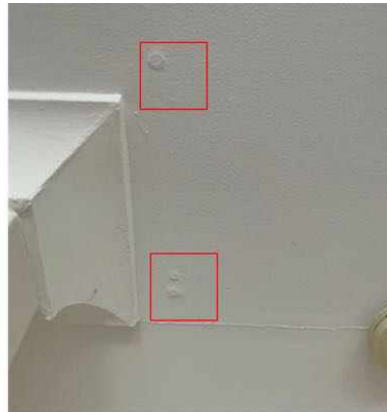
Information: Numerous popped nails were identified in the internal ceiling at the time of inspection. Nails and screws hold simply by the friction between them and the surface they are applied to. Over time, the nails and screws can back out, which is often a result of general ageing and deterioration of the building structure.

If left unmanaged, the ceiling sheets may become loose and unstable, increasing the rate of deterioration of the internal ceiling and creating potential for the development of secondary defects.

Re-fastening of popped nails will help to maintain the stability of the internal ceiling and associated building elements. Such minor works will also help to improve the appearance of the affected area and secure the ceiling sheets, so as to prevent the

onset of ceiling sagging. These works should be performed by a qualified carpenter or plasterer at client discretion.

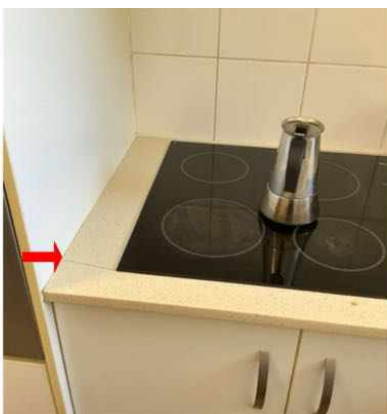
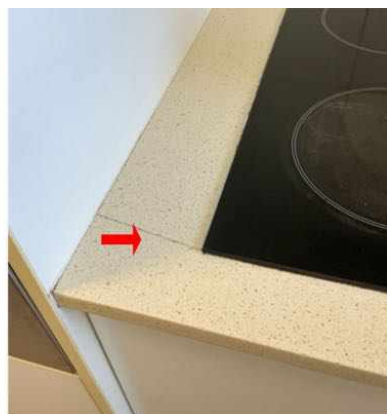
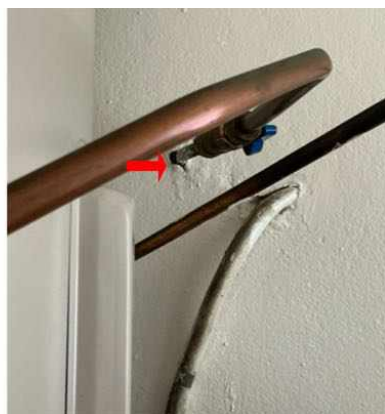
### Finding 3.15

Building:	Main Building
Location:	All Areas
Finding:	Building element - Damaged - kitchen top cracked , holes not sealed laundry
Information:	Breakage occurs generally when the building materials have either aged and decayed, or as a result of damage (accidental or deliberate).

Repair and/or replacement of broken elements is advised to ensure that additional secondary defects do not arise as a consequence. Such works are necessary, as all building elements play a key role in the operation and function of the overall structure and its performance.

A relevant tradesperson should be appointed to repair or replace the affected building element prior to any subsequent damage being caused.

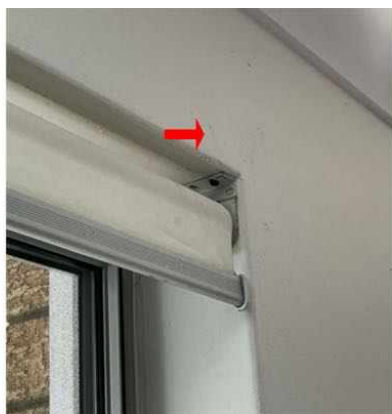
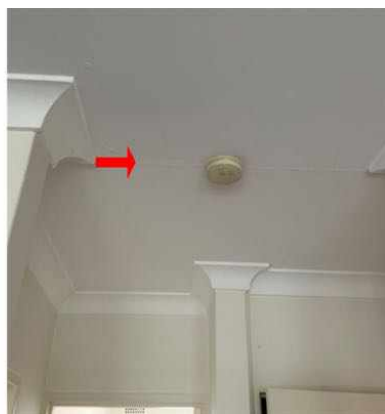
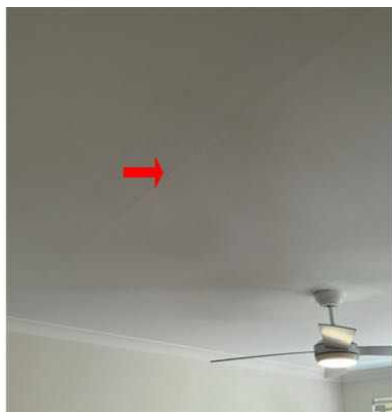
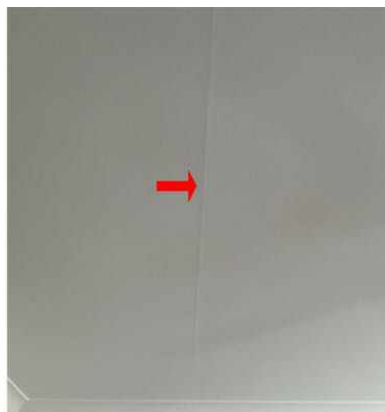
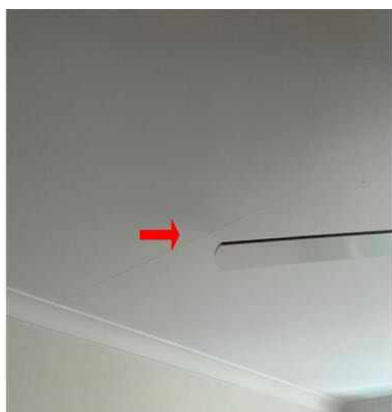
### Finding 3.16

Building:	Main Building
Location:	All Internal Areas
Finding:	Paint finish and hairline cracking
Information:	The paint finish in this area was identified as being incomplete at the time of inspection including some hairline minor cracking.

Whilst incomplete or missing paint finish is generally an appearance defect, it can also lead to the development of secondary building defects over time. Incomplete areas of paint finish expose the area to moisture, potentially accelerating the deterioration of underlying building materials.

Incomplete paint finishes should be sanded back, filled, leveled and painted, as applicable. Where inadequate or missing paint protection has led to the deterioration of the associated building element, repair and/or replacement of this building element may be required.

A painting contractor should be appointed as soon as possible to perform necessary works to aid the appearance of the affected area and to ensure the area is protected against further deterioration. Alternatively, the homeowner following manufacturer instructions may perform these works.

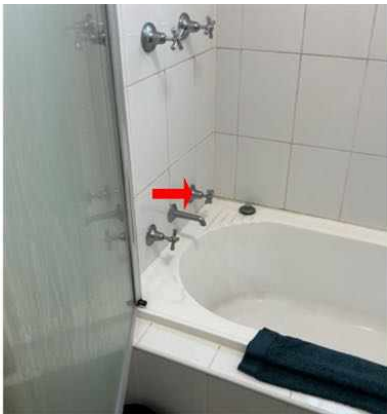
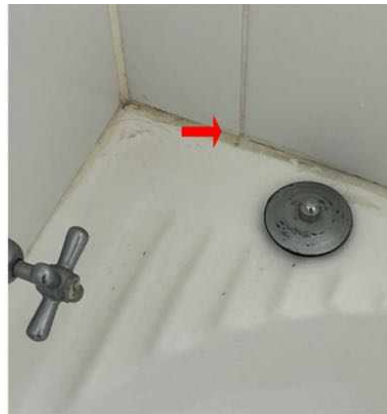
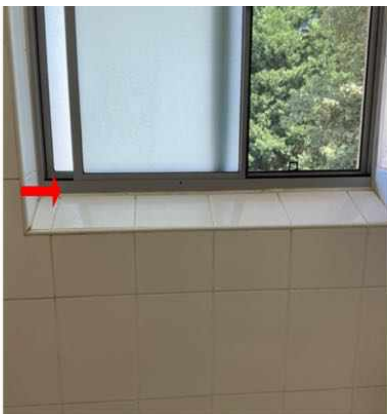
### Finding 3.17

Finding: Sealant and grouting - Missing or degraded

There appears to be excessive mould to the sealant and grout which will likely require scraping out and replacement.

Flexible and mould resistant materials should be applied to affected areas to prevent any subsequent water damage that is likely to occur. Regular maintenance and replacement of damage or missing or damaged sealant and grout is highly recommended to the wet areas, as this is a regular wear and tear defect. Sealant and grouting in areas that come into regular contact with water should be maintained for the long term care of your property.

A sealant specialist or tiling contractor should be appointed to complete these works as soon as possible

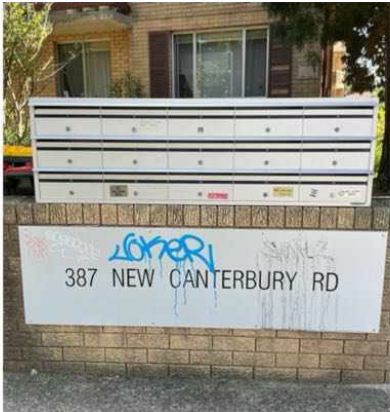
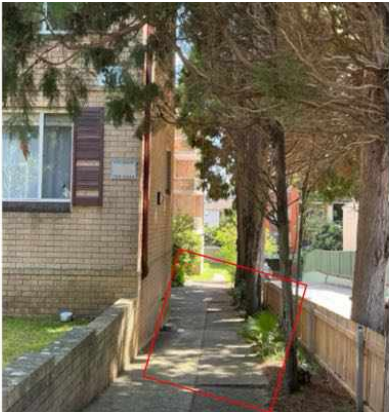
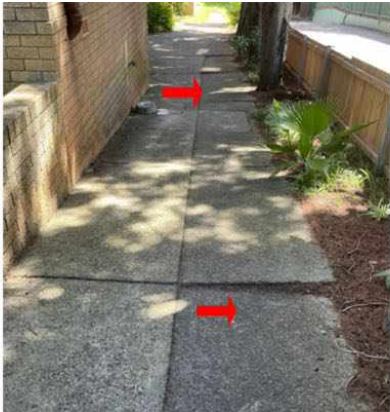
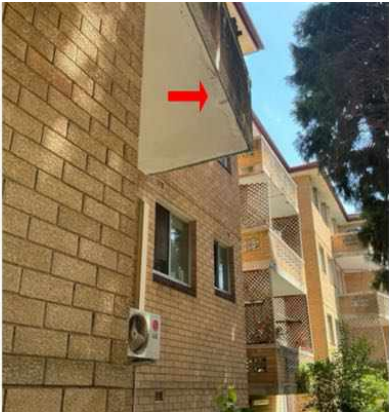
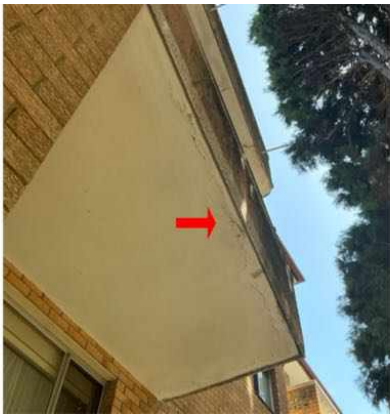
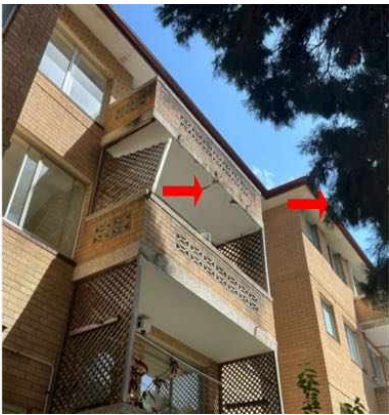
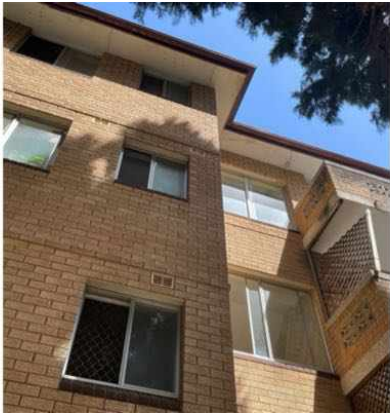
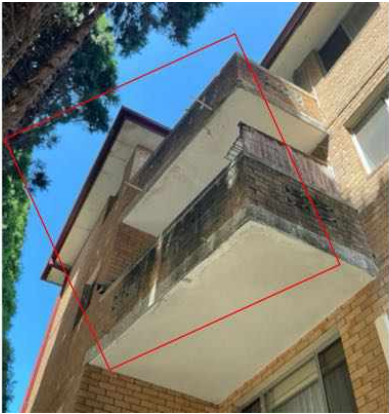
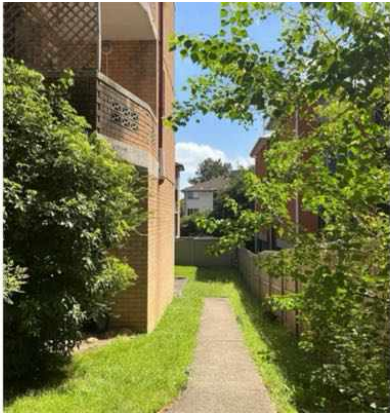
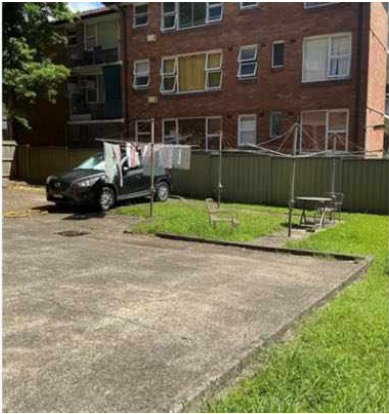
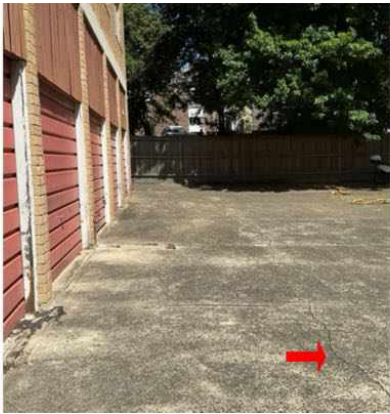
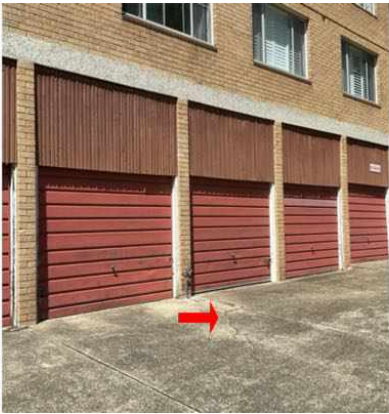
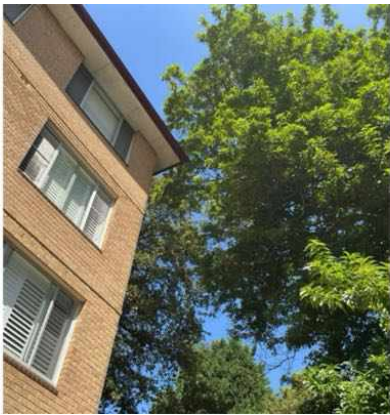
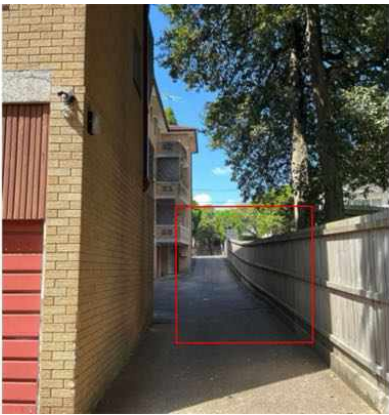
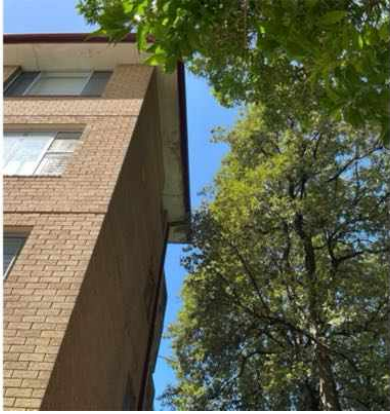
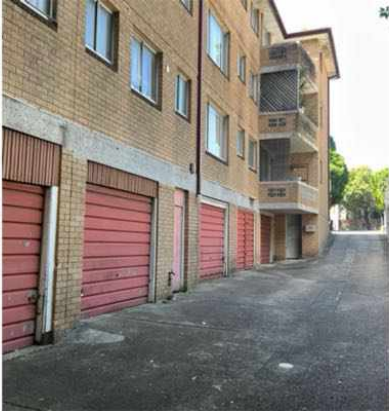
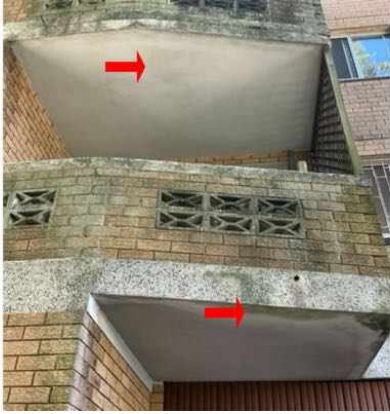
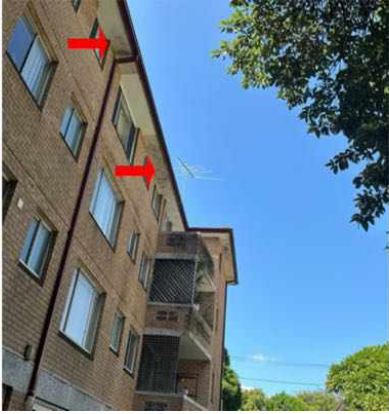
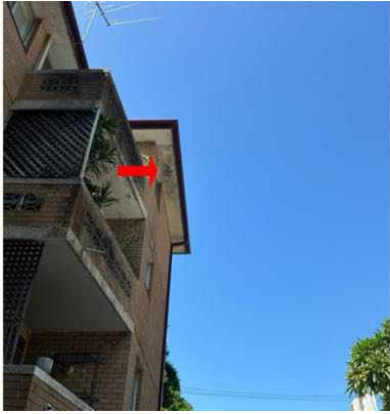
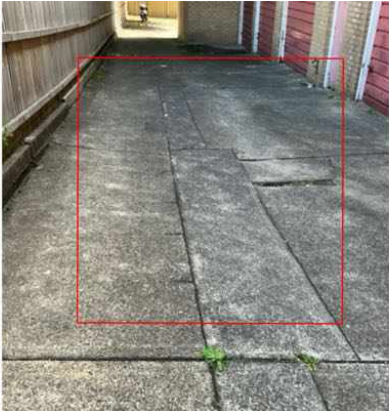
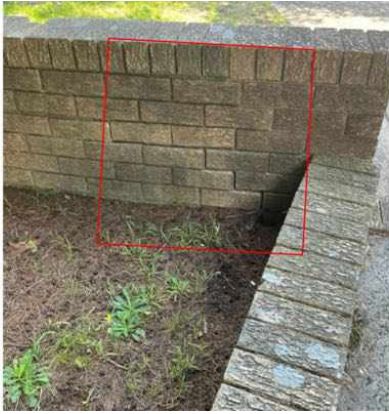
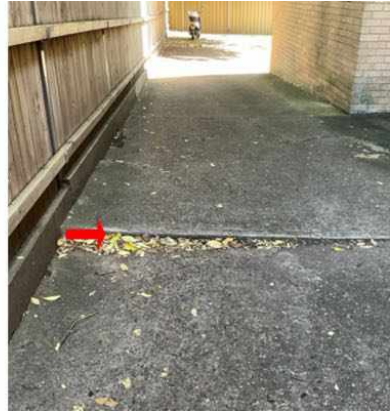
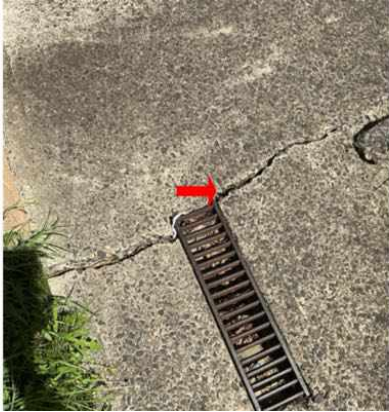
Building: Main Building  
Location: All External Areas  
Finding: Additional Photos - Obstructions and Limitations  
Information: These photographs are an indication of the obstructions and limitations which impeded full inspection of the property at the time of inspection. These obstructions can hide an array of defects and should be removed to allow full inspection to be carried out. A re-inspection is recommended once the areas are made accessible.

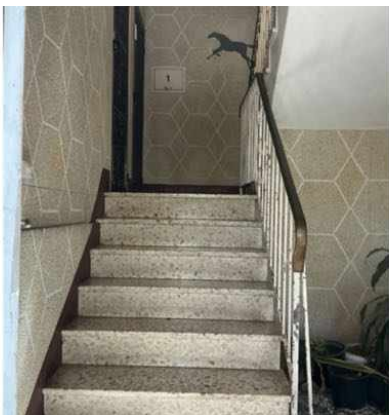
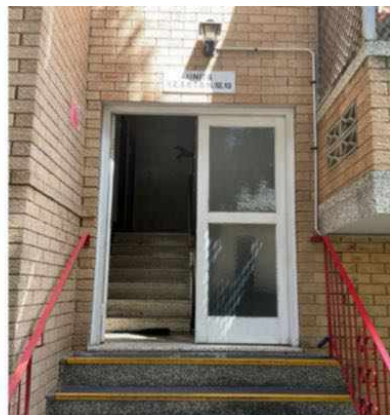
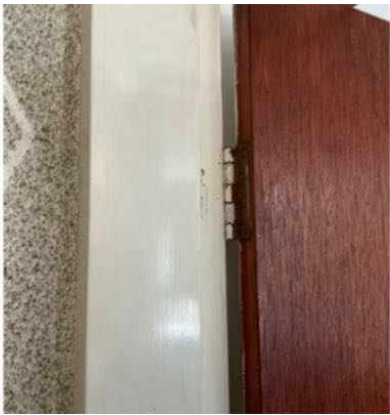
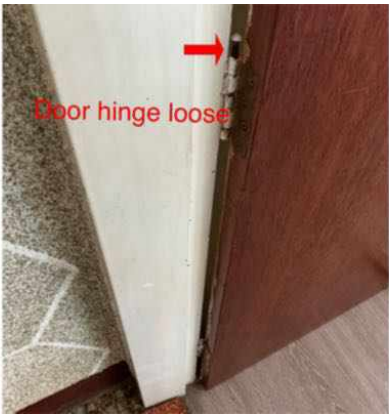
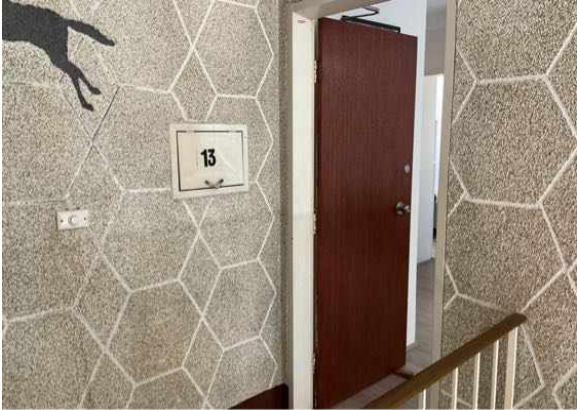
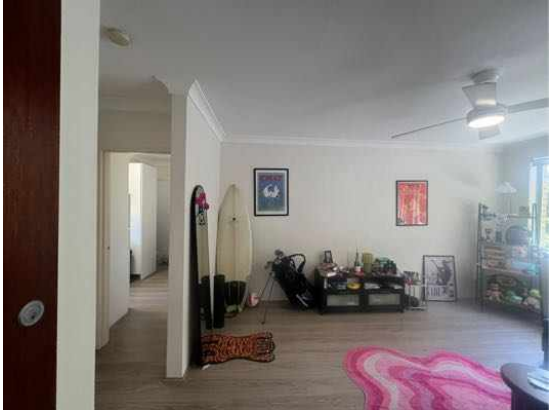
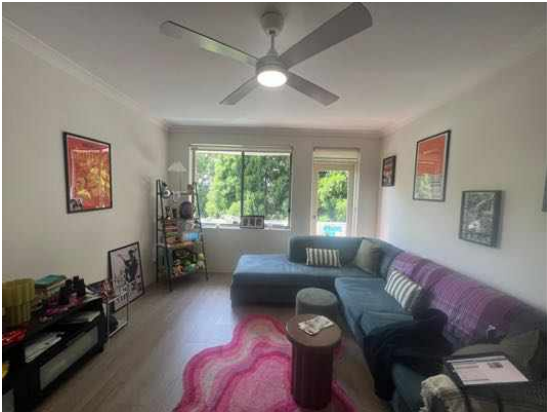
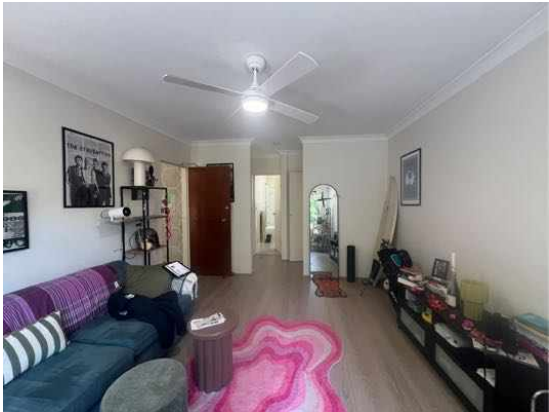
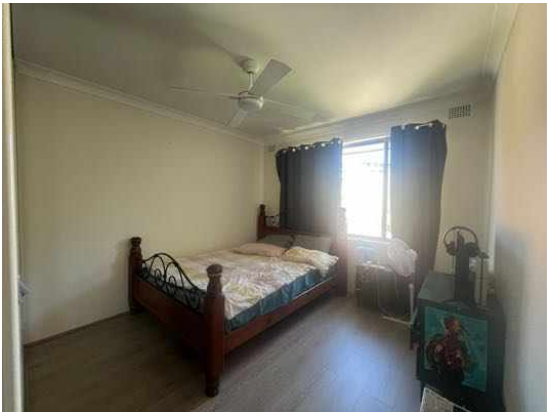
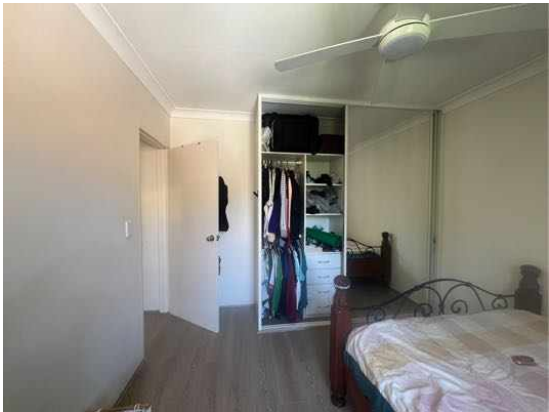
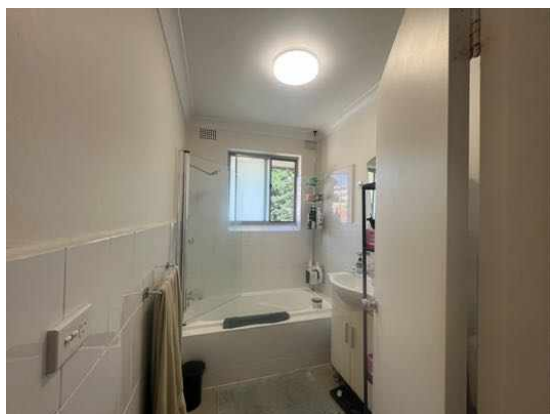
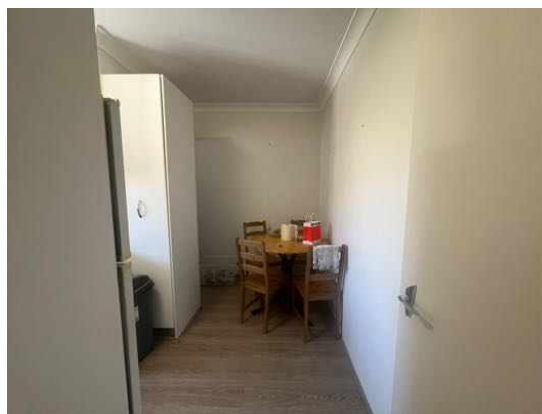
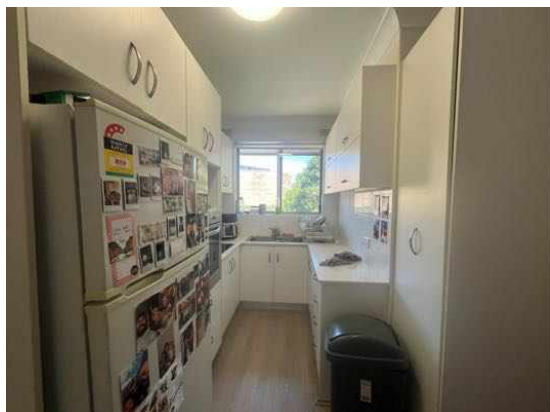
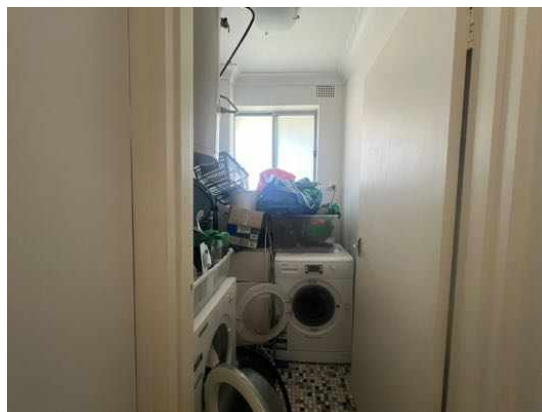
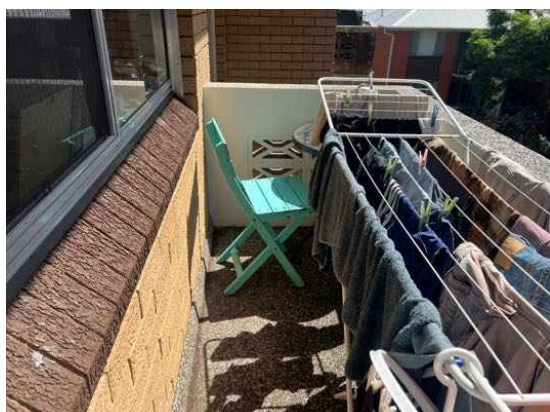
Building: Main Building  
Location: All Internal Areas  
Finding: Additional Photos - Obstructions and Limitations  
Information: These photographs are an indication of the obstructions and limitations which impeded full inspection of the property at the time of inspection. These obstructions can hide an array of defects and should be removed to allow full inspection to be carried out. A re-inspection is recommended once the areas are made accessible.

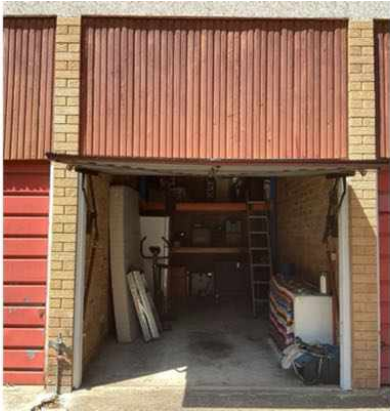
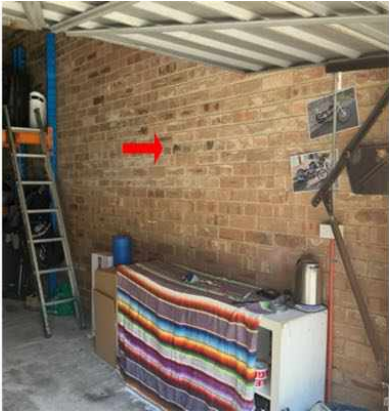
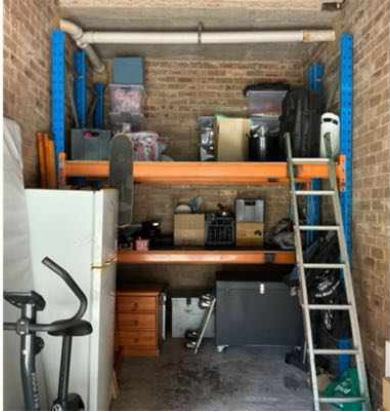
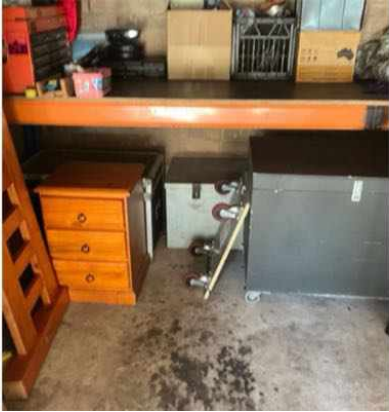
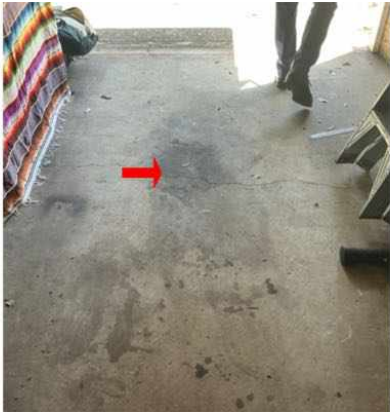
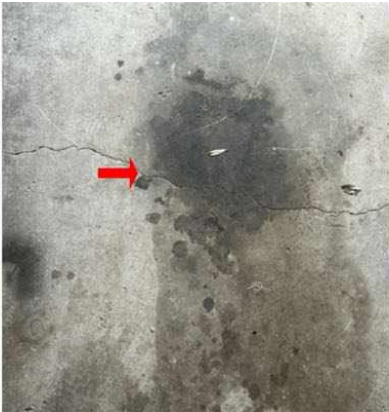
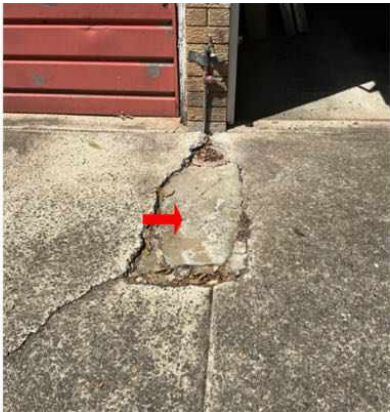
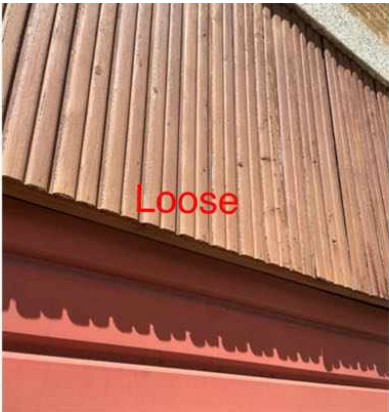
Building: Main Building  
 Location: Garage  
 Finding: Additional Photos - Obstructions and Limitations  
 Information: These photographs are an indication of the obstructions and limitations which impeded full inspection of the property at the time of inspection. These obstructions can hide an array of defects and should be removed to allow full inspection to be carried out. A re-inspection is recommended once the areas are made accessible.
