# Building and Timber Pest Inspection Report

Inspection Date: Fri, 6 Mar 2026

Property Address: 1460 Burraborang Rd, Oakdale NSW 2570,  
Australia

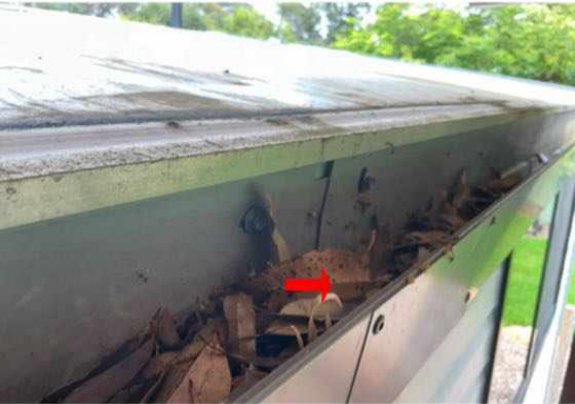
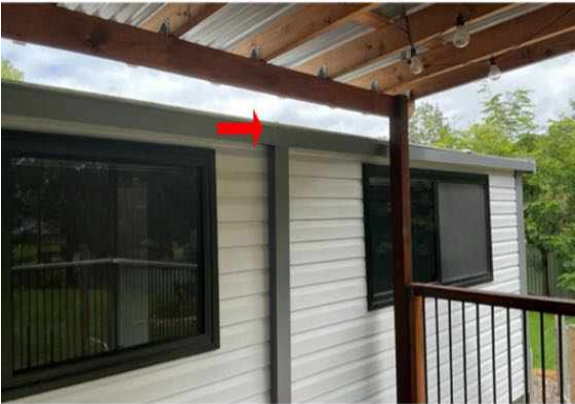
Building: Out Building  
Location: Portable Structure  
Finding: Gutters (Blocked)  
Information: Sections of the gutters were discovered to be blocked. Blocked gutters can result in high levels of moisture during stormy weather conditions. This moisture can lead to secondary issues such as wood decay and create an environment conducive to termite activity. Therefore, it's crucial to remove the blockages to maintain dry

conditions.

Appointing relevant contractors to perform necessary remediation works is essential to address this issue effectively.

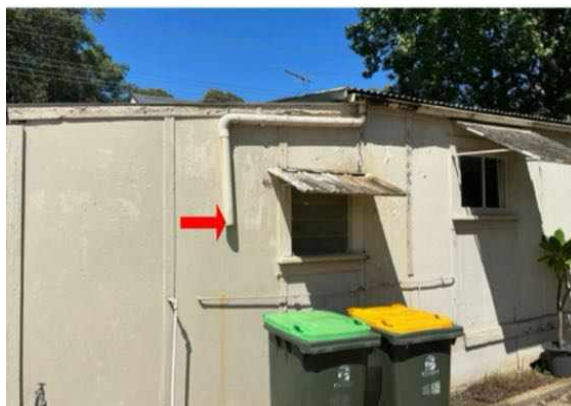
### Finding 3.03

Building:	Main Building
Location:	All Areas
Finding:	Veranda Roof Inadequate Downpipe Spreader
Information:

During the inspection, it was observed that the veranda roof drainage system has an inadequate downpipe spreader. Downpipe spreaders assist in directing rainwater evenly onto the lower roof surface and help prevent concentrated water flow.

An inadequate spreader may cause excessive water concentration in one area, increasing the risk of overflow, premature wear of roofing materials, or water ingress over time. It is recommended that a qualified roof plumber assess the installation and upgrade or extend the spreader as required to ensure effective rainwater distribution.

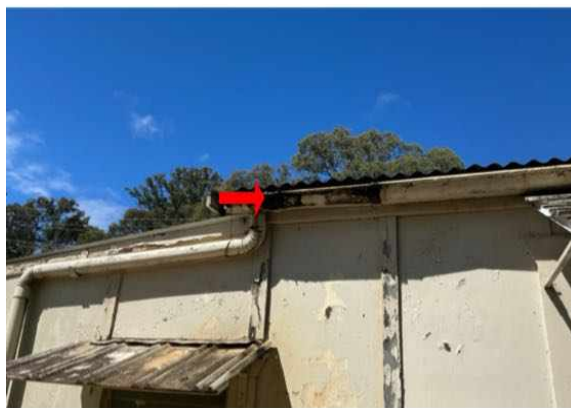
### Finding 3.10

Building:	Main Building
Location:	Exterior walls
Finding:	Gutters (Insufficient Downpipes)
Information:	During the inspection, gutters were found to have an insufficient number of downpipes, reducing the overall drainage efficiency of the roof system. This can lead to water pooling and overflow during heavy rainfall, increasing the risk of water ingress, damage to eaves and ceilings, and moisture accumulation around the building perimeter. These conditions also create an environment conducive to termite and timber pest activity.

This issue is common in properties of similar age and condition and, if left unaddressed, may result in moisture-related deterioration of building elements. To prevent further damage and ensure effective stormwater management, it is recommended to engage a qualified roof plumber to assess the current guttering system and install additional downpipes as required. Doing so will help maintain the structural integrity of the property and reduce long-term maintenance concerns.

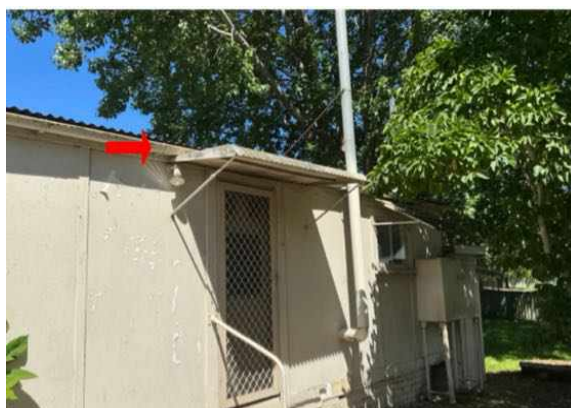
### Finding 3.11

**Finding:** Rising Damp / Poor Drainage / Inadequate Subfloor Ventilation

**Information:** During the inspection, damp or wet conditions were noted, likely resulting from inadequate site drainage, insufficient subfloor ventilation allowing moisture ingress, and rising damp characterized by moisture traveling upwards through porous building materials such as brick, sandstone, or mortar via capillary action. This issue commonly occurs in older buildings, particularly those constructed before modern Damp Proof Course (DPC) standards.

Maintaining dry conditions is essential to prevent secondary building defects. If left unresolved, persistent moisture can cause significant problems, including fungal decay, wood rot, and conditions conducive to termite and timber pest infestations.

A qualified builder should be engaged to thoroughly assess the affected areas and implement remedial measures, which may involve enhancing site drainage, improving subfloor ventilation, and installing or repairing a Damp Proof Course or moisture barriers. Prompt attention will ensure the property's long-term protection and structural integrity.

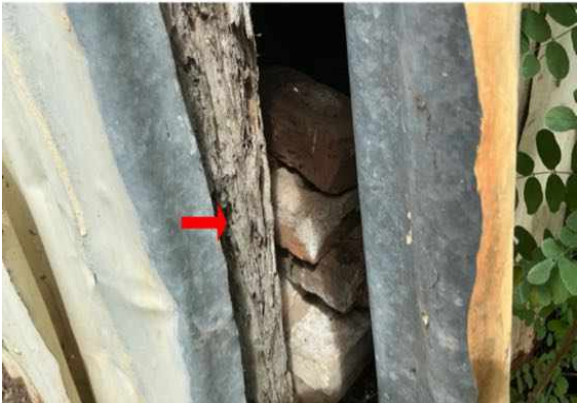
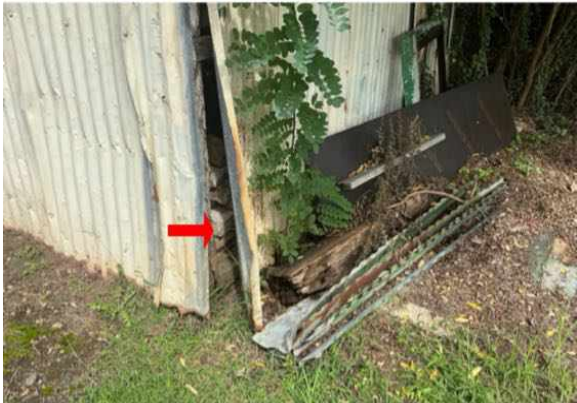
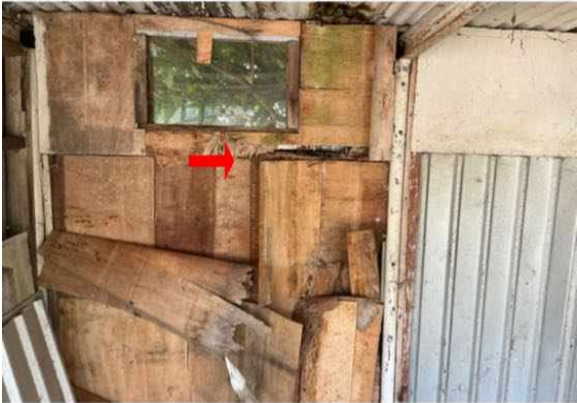
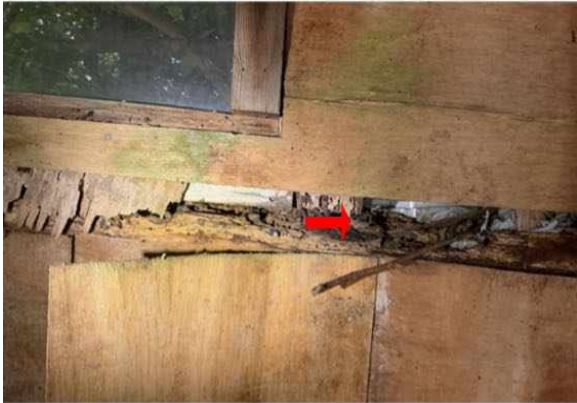
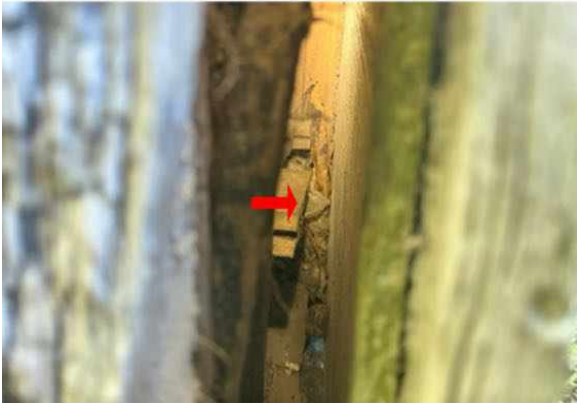
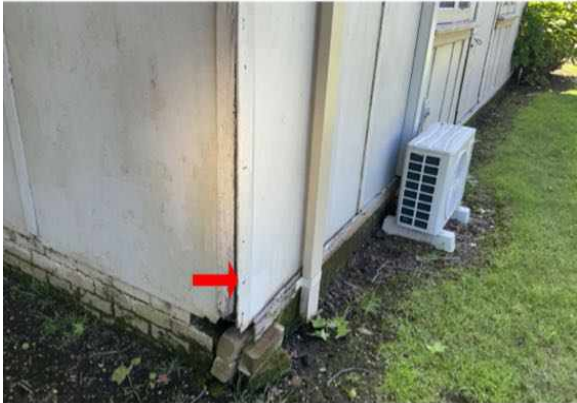
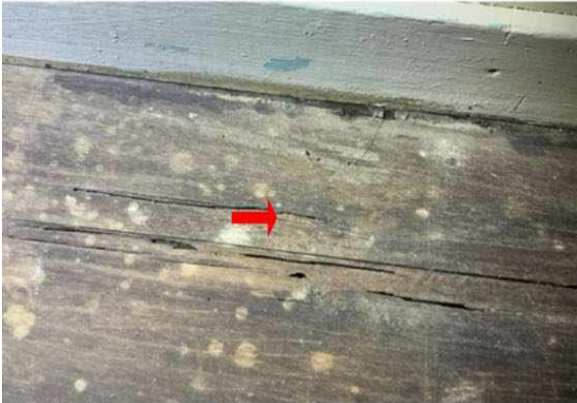
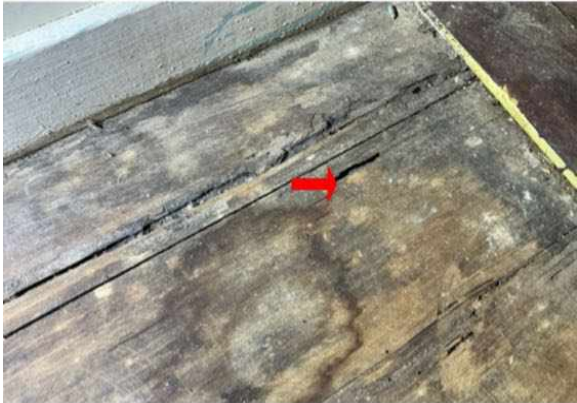
Building:	Main Building
Location:	Exterior walls
Finding:	Previous Termite Damage Observed (Structural Internal Damage)
Information:

During the inspection, evidence of previous termite damage was observed in several areas of the property, including internal floor bearers and joists, structural wall elements within the main building, and timber components in the shed and carport located at the rear of the property. Given the extent and distribution of the observed damage, a further invasive inspection is considered essential to properly assess the full impact on the structural integrity of the building.

In addition, the laundry door was observed to be binding and jamming during operation, and sections of the internal flooring near the affected areas appear uneven and out of level. These conditions may be associated with structural movement or deterioration resulting from previous termite damage.

As this inspection was limited to visible and accessible areas only, concealed sections of the structure could not be fully assessed. A detailed special-purpose inspection by a qualified builder or structural professional is strongly recommended to determine the full extent of the damage and identify any structural repairs that may be required.

Given the history of termite activity, it is recommended that quotations be obtained from a qualified builder prior to purchase to determine the scope and cost of the necessary rectification works. Ongoing termite management is also strongly advised, including regular timber pest inspections and consideration of installing a compliant post-construction termite management system to help reduce the risk of future termite

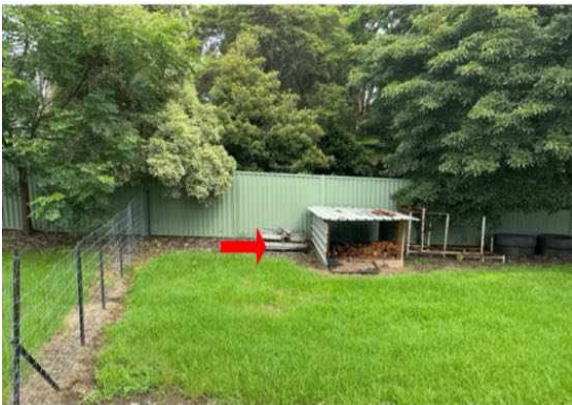
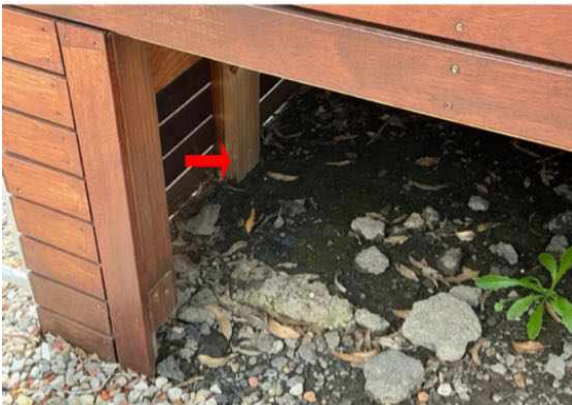
**Information:** During the inspection, wood and timber materials were observed in direct contact with the ground. This condition is highly conducive to timber pest activity, particularly termites, as it provides an ideal environment for infestation and timber decay due to elevated moisture levels, concealment, and direct access to cellulose material. Untreated or inadequately protected timber in ground contact significantly increases the risk of concealed termite entry and potential structural damage.

To reduce the risk of infestation, all ground-contacting timber should be promptly removed. It is recommended to engage a qualified pest control to assess the subfloor and implement appropriate termite management system, in accordance with AS 3660.2. Regular timber pest inspections, ideally every 90 days, are advised until all conducive conditions have been fully addressed.

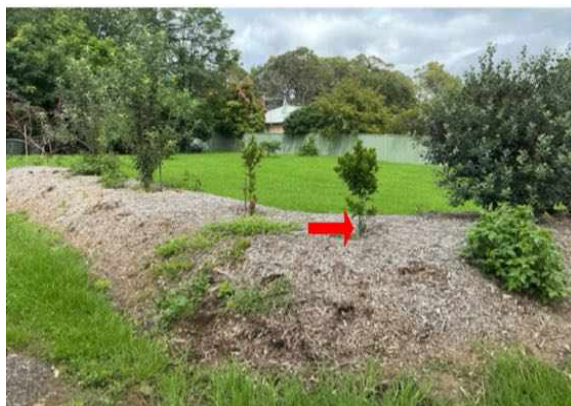
### Finding 6.05

Building:	Main Building
Location:	All Areas
Finding:	Trees / Tree Stumps
Information:	Trees and tree stumps located close to the building can provide ideal nesting conditions for termites. If left untreated, they may act as a direct pathway for termite access to the structure, increasing the risk of infestation.

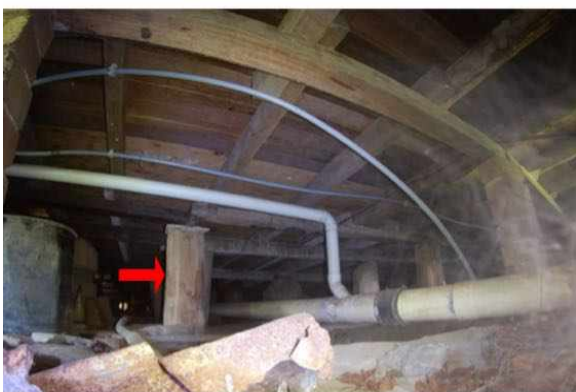
Timber stumps are susceptible to deterioration over time due to moisture exposure, wood rot, and termite activity. While the visible sections appeared serviceable at the time of inspection, the concealed portions below ground level could not be inspected, and deterioration may exist in areas that were inaccessible.

Regular monitoring and periodic invasive inspection of the timber stumps are recommended to assess their ongoing condition. If concerns arise, consultation with a qualified builder or structural professional is advised to determine whether repairs, treatment, or replacement may be required.

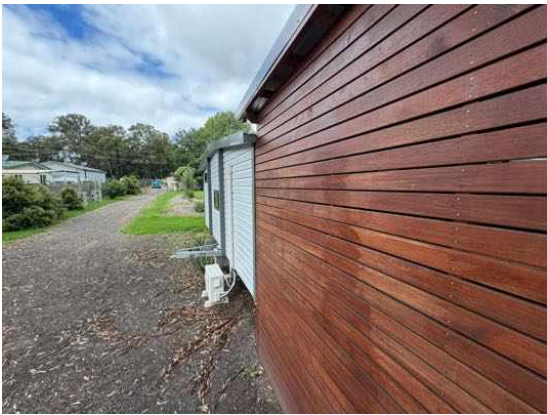
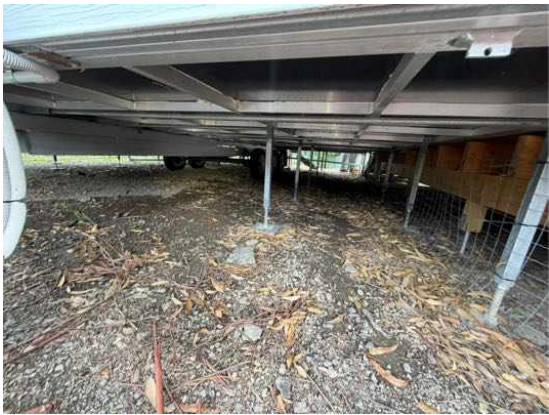
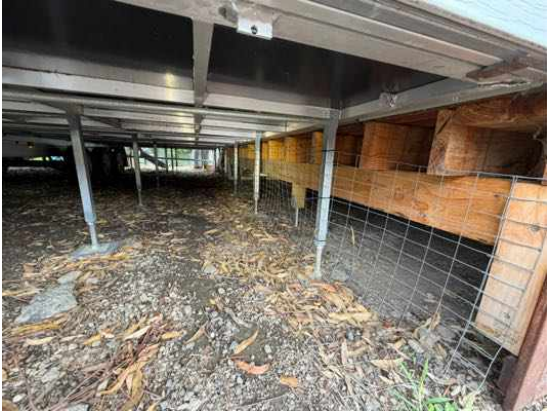
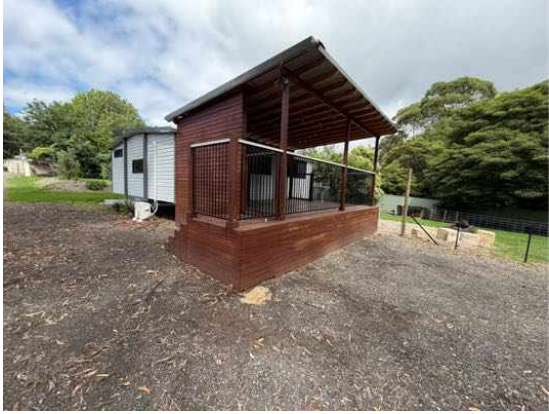
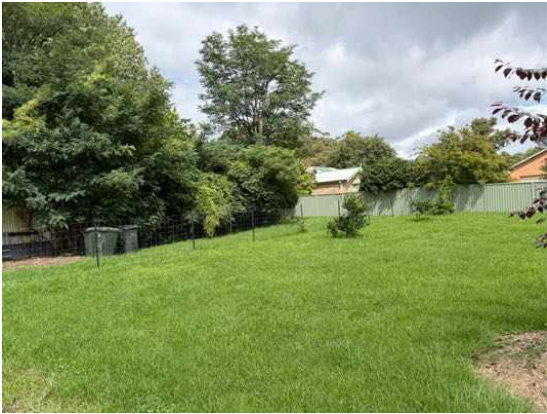
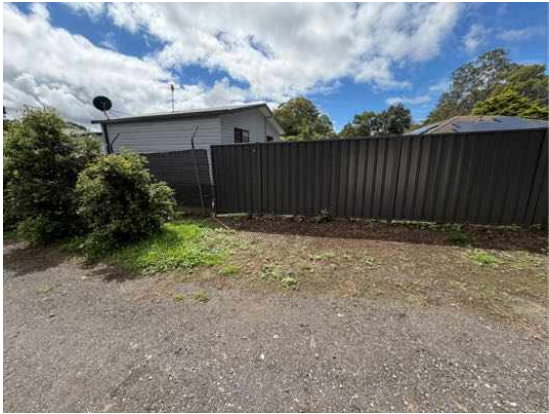
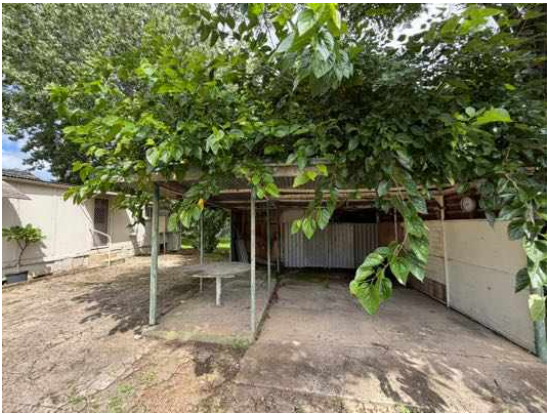
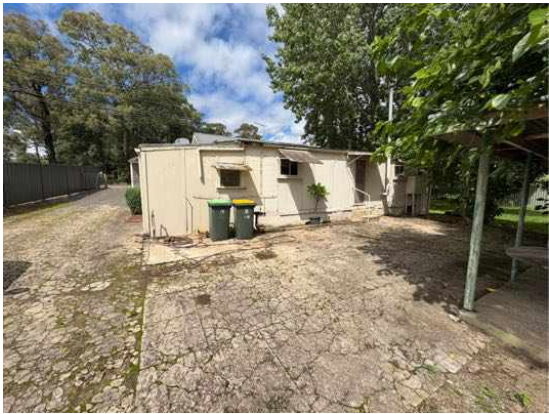
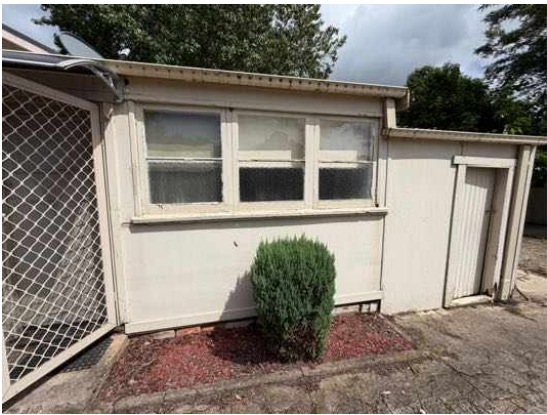
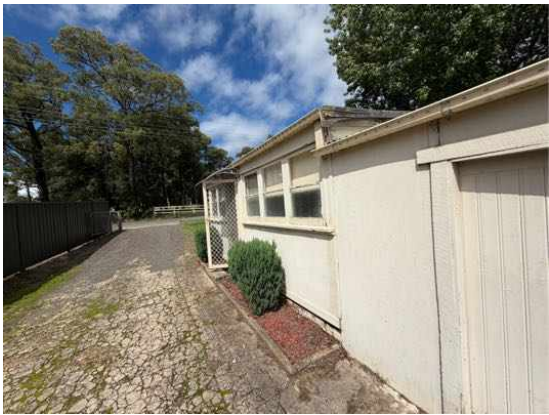
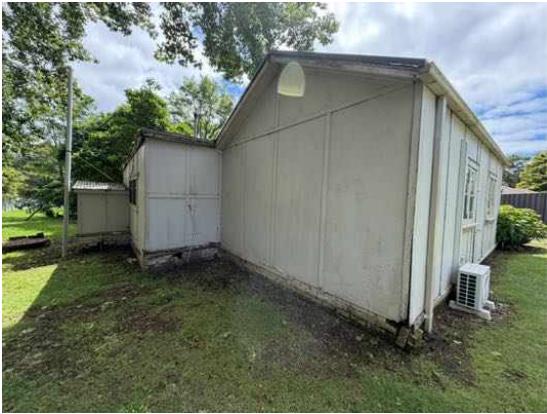
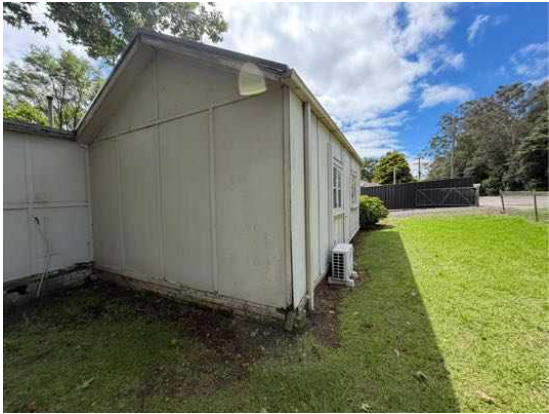
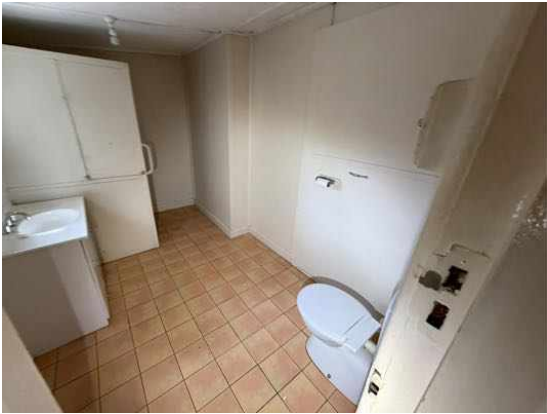
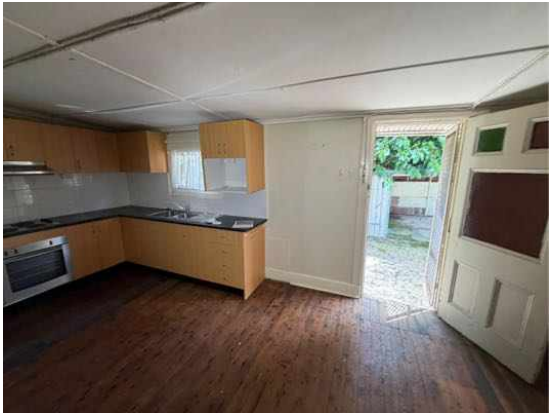
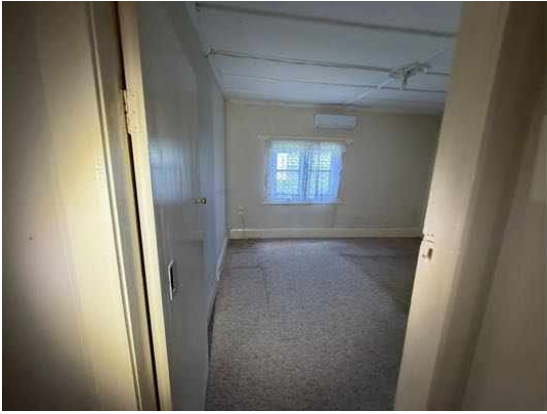
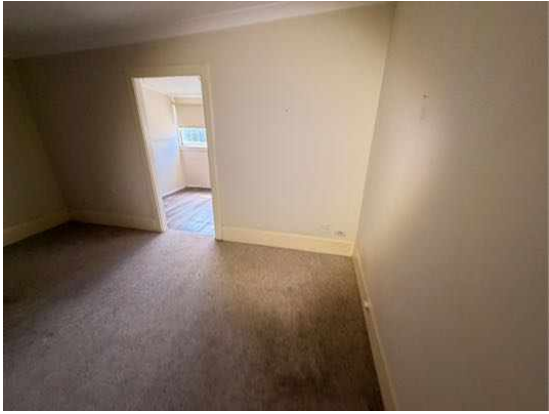
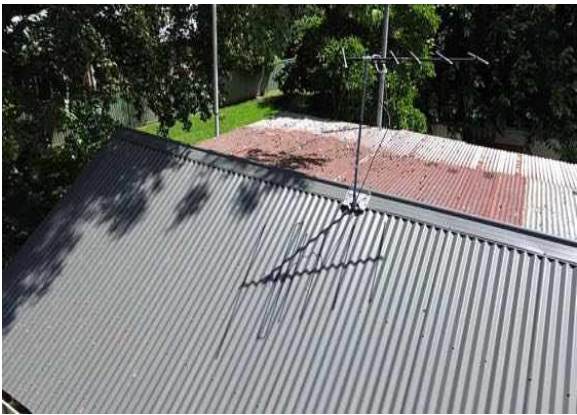
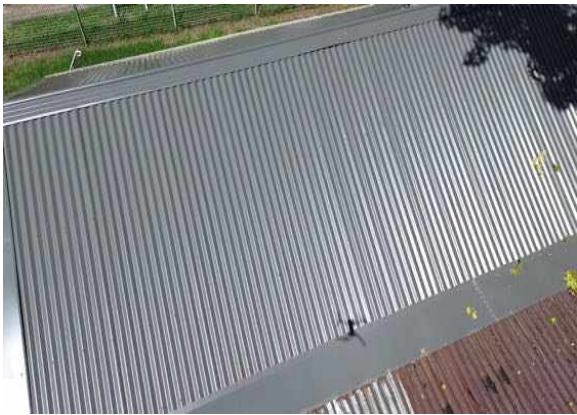
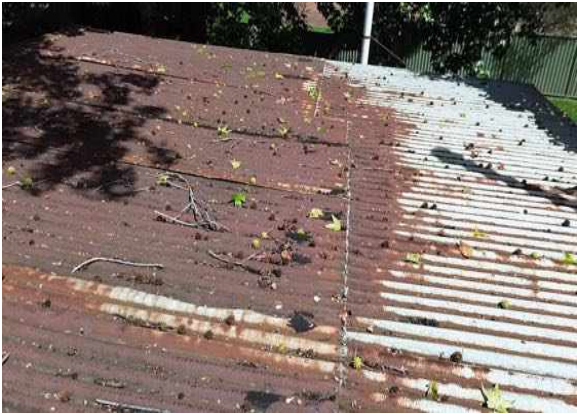
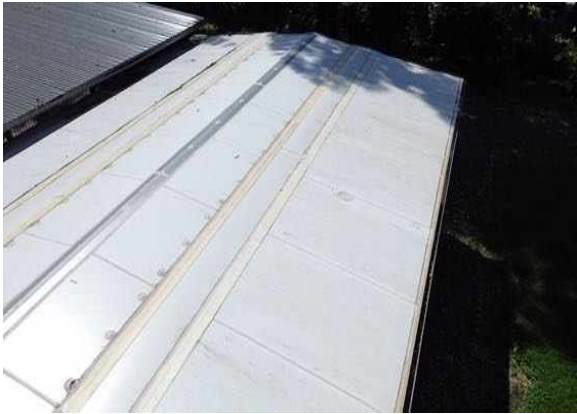
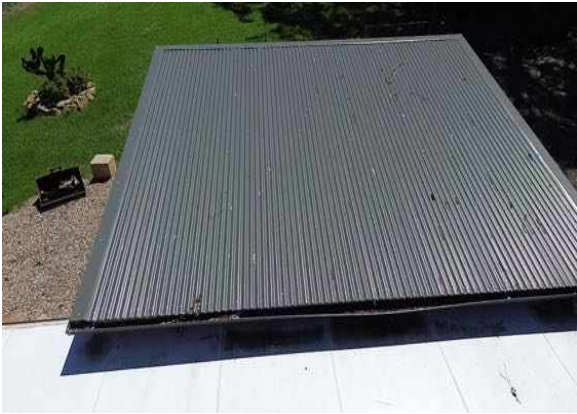
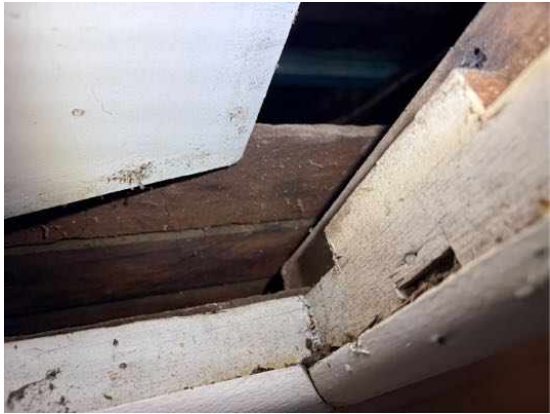
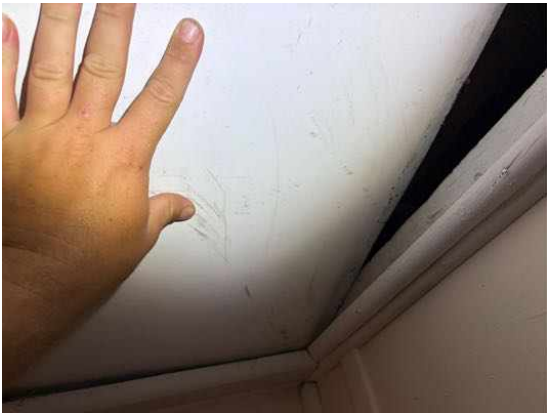
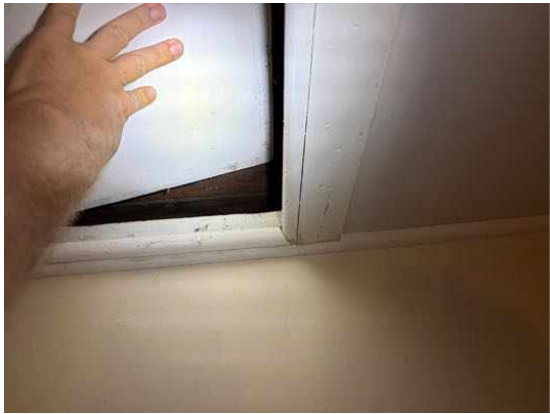
Building:	Main Building
Location:	All Areas
Finding:	Inspection Photos (Obstructions and Limitations)
Information:	Additional photos have been provided for your general reference, depicting the areas that were accessible during the inspection. Please note that this visual inspection was limited to readily accessible areas, as defined by the report's terms and conditions. The photos demonstrate the obstructions and limitations encountered, which may have impeded a comprehensive inspection and could potentially conceal various defects. For a more detailed and accurate assessment, a special-purpose inspection is recommended.
