Building and Timber Pest Inspection Report

Inspection Date: Wed, 18 Feb 2026

Property Address: 38 Ross St, Gladesville NSW 2111, Australia

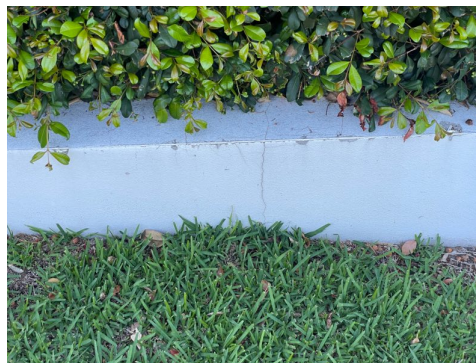
Finding 3.03

Building:	Main Building
Location:	Driveway / Footpath
Finding:	Cracking - External Concrete Paving Damage Category 1 - Fine (less than 2mm)

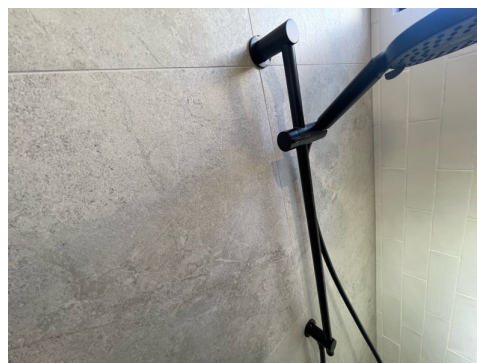
Finding 3.11

Building: Main Building

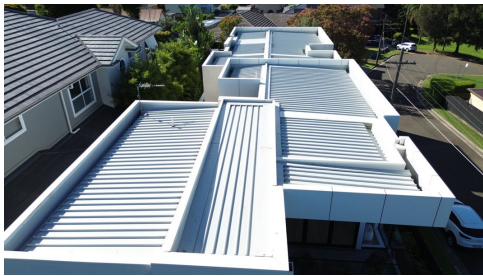
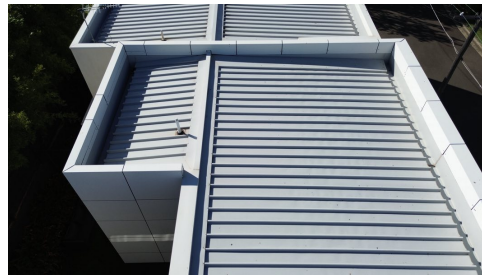
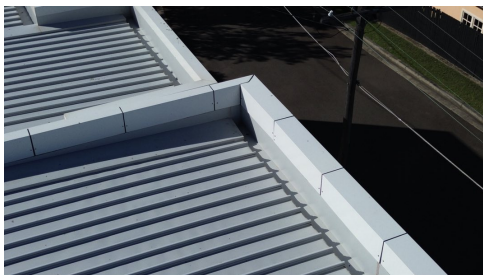
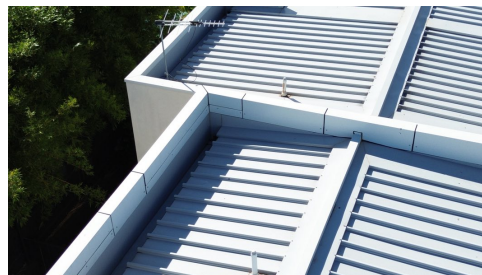
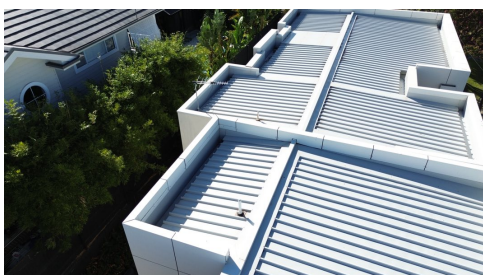
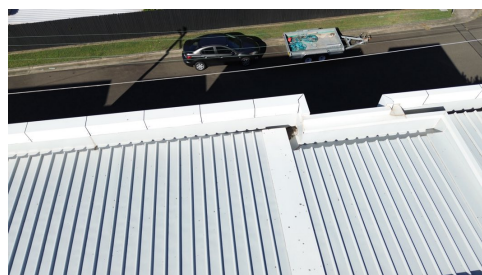
At the time of inspection, the corrugated steel roof sheeting appeared to be in good overall condition. No significant corrosion, loose or displaced sheets, missing fasteners, lifted flashings, or visible impact damage were observed from the accessible aerial viewpoints. The ridge and perimeter flashings appeared intact, and there were no obvious signs of active water ingress evident from the external inspection.

This assessment is limited to a visual external review undertaken by drone and does not include physical foot access, fastener torque testing, or inspection of the roof cavity unless otherwise stated. Based on the observations made, the corrugated steel roof covering appears to be maintained to a reasonable standard at the time of inspection.

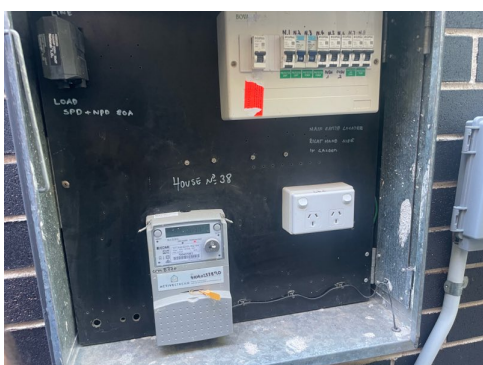
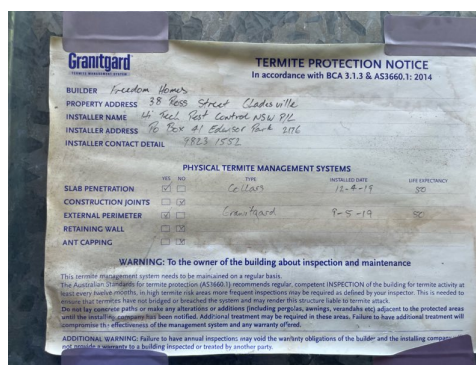
Finding 6.02

Building: Main Building

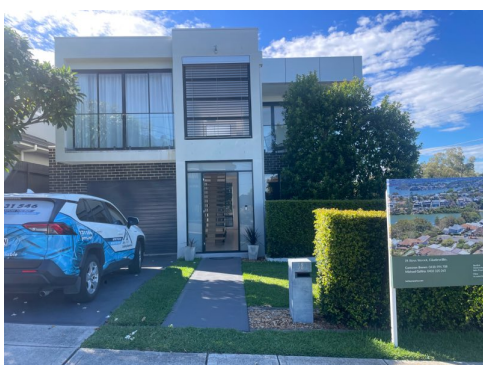
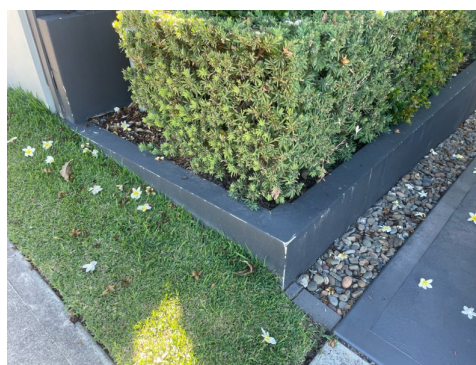
The subfloor area (where applicable) was not fully accessible due to restricted clearance, limited entry points, and/or stored items and services within the subfloor. As a result, only accessible sections were inspected, and concealed timbers, bearers/joists, damp conditions, or evidence of pest activity may exist in areas that could not be entered or clearly viewed.

The roof void inspection was also limited due to restricted access and obstructions such as insulation, ducting, low head height, and the absence of safe walkways. Similarly, roof exterior inspection may be limited where pitch, height, weather conditions, or access constraints prevent safe close-up inspection. Accordingly, concealed roof framing, sarking, flashings, and roof drainage components may have defects that were not detectable at the time of inspection.
