# Building and Timber Pest Inspection Report

Inspection Date: Wed, 18 Feb 2026

Property Address: 6/56 Old Bathurst Rd, Blaxland NSW 2774,  
Australia

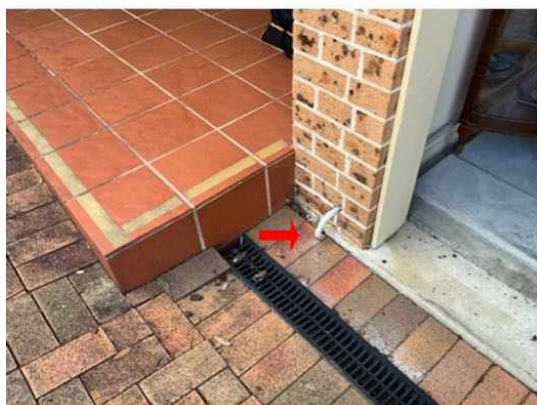
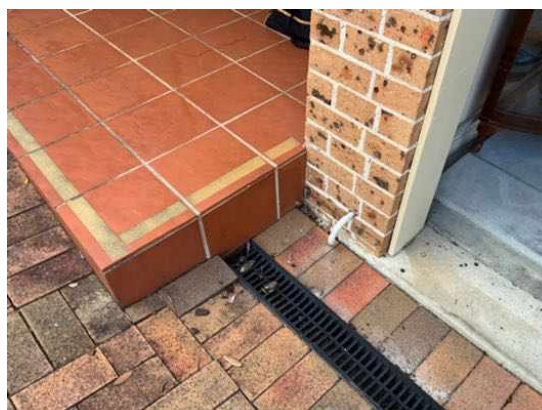
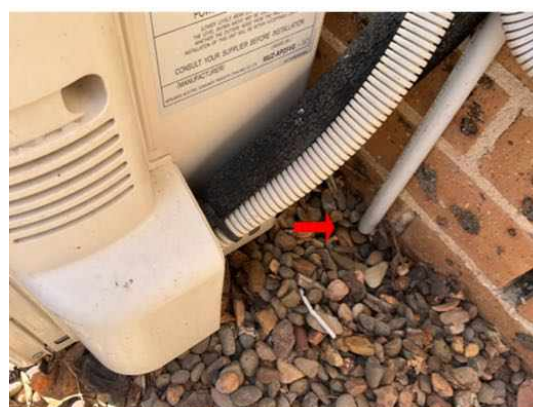
#### Finding 3.02

Building: Main Building  
 Location: All Areas  
 Finding: Air conditioner - Disconnected overflow  
 Information: The Air Conditioner (A/C) overflow was found to be disconnected from storm water drainage and is creating excessive moisture in the surrounding area.

Such leaking creates an environment which is conducive to an array of defects, including water damage to associated building elements and the attraction of termite or timber pest infestation.

It is highly recommended that a licensed plumber be appointed to connect the A/C overflow in order to prevent such an environment from being created. These minor works should be carried out as soon as possible.

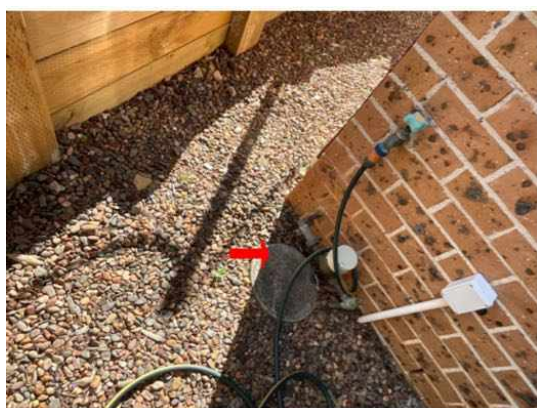
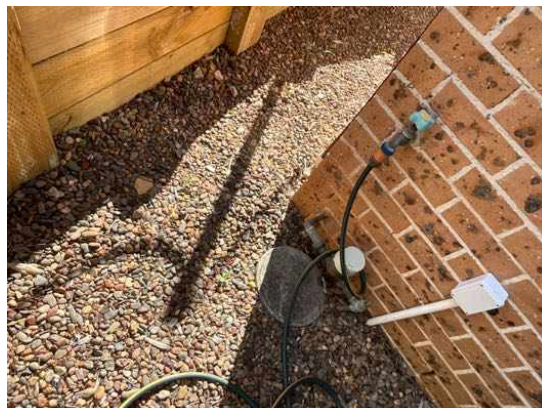
### Finding 3.03

Building:	Main Building
Location:	All Areas
Finding:	No Drain under tap
Information:	There is no drain installed under the tap, leading to water accumulation and creating conducive conditions for timber pests. This defect needs immediate attention to prevent potential damage and pest infestation.

1. Water Accumulation: Without proper drainage, water can accumulate around the base of the tap, leading to persistent dampness in the surrounding area.
2. Timber Pest Infestation: The damp environment created by standing water is highly conducive to timber pests, such as termites and wood borers, which thrive in moist

conditions and can cause significant damage to wooden structures.

3. Structural Damage: Prolonged exposure to moisture can lead to wood rot and deterioration of structural timber, compromising the integrity of the building.

A licensed plumber or a qualified building contractor can address this defect by:

3. Repair and Prevention: Inspecting and repairing any existing water damage and implementing measures to prevent future water accumulation and pest infestations.

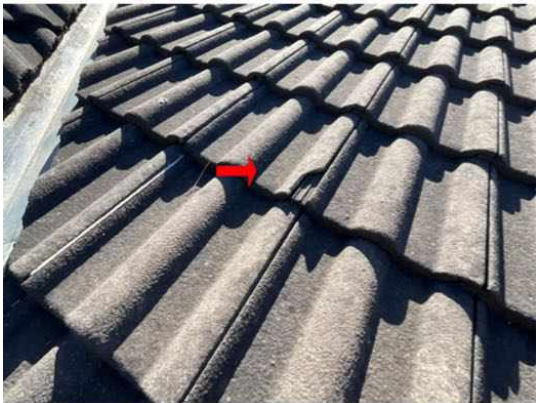
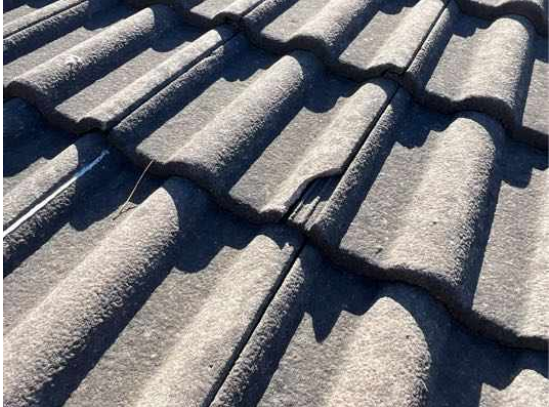
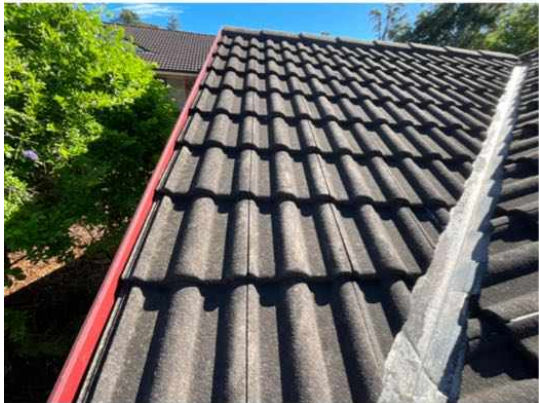
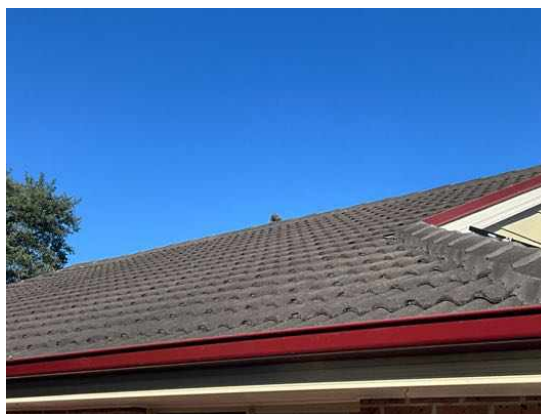
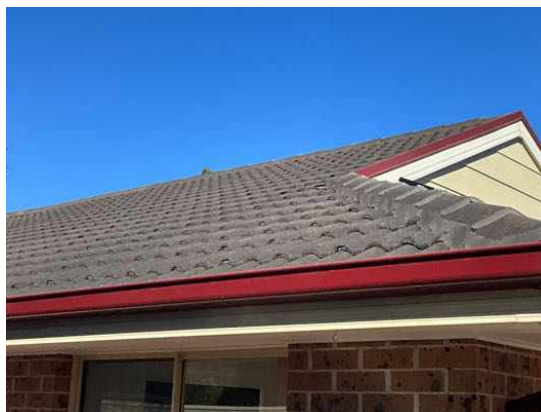
### Finding 3.04

Building:	Main Building
Location:	All Areas
Finding:	Roof Weathered
Information:	Inspection of the roof revealed widespread weathering to the tiled roof surface. The tiles show loss of surface finish, colour fading, and age-related deterioration typical of older roof coverings. Although no significant cracking was noted, weathering can lead

to increased porosity, reduced water-shedding capability, and a higher risk of future cracking or displacement during adverse weather conditions.

A licensed roofer should be engaged to undertake a closer inspection, carry out routine maintenance, and replace any tiles that may be compromised. Ongoing monitoring is recommended due to the age and condition of the roof covering.

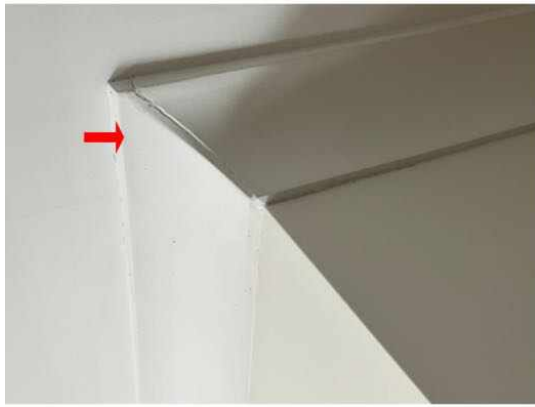
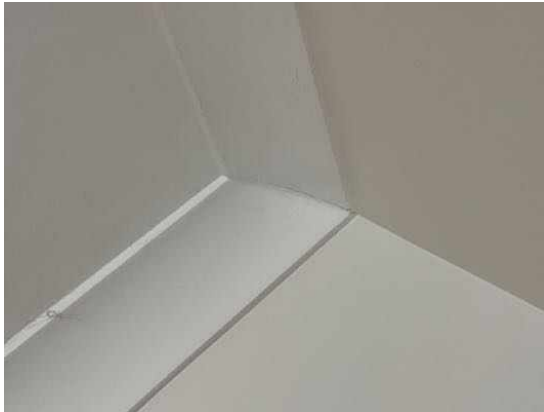
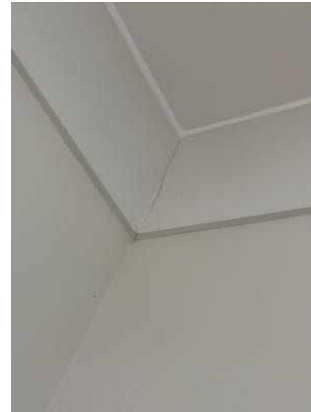
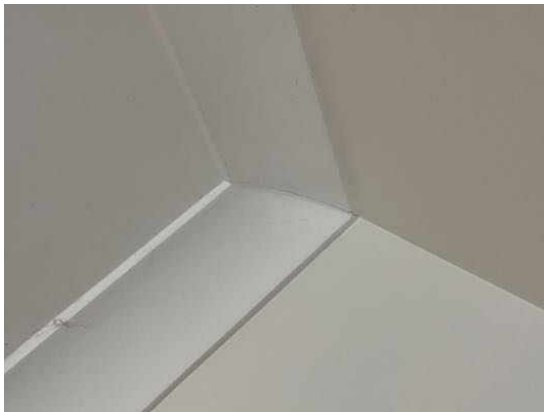
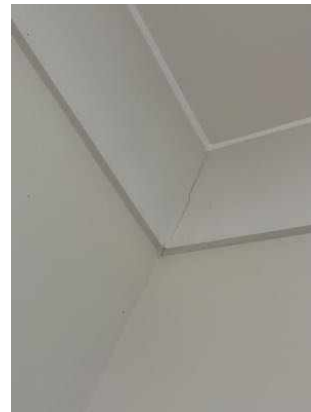
### Finding 3.05

Building:	Main Building
Location:	All Areas
Finding:	Cornice - Cracking [Fine]
Information:	Fine cracking observed in the cornice, indicating potential structural issues or settling concerns.

Fine cracks in the cornice may lead to aesthetic deterioration and, if left unaddressed, could contribute to more significant structural problems over time.

Engaging the services of a skilled plasterer or home renovation specialist is recommended to assess and repair the fine cracking in the cornice, ensuring proper restoration and preventing further issues.

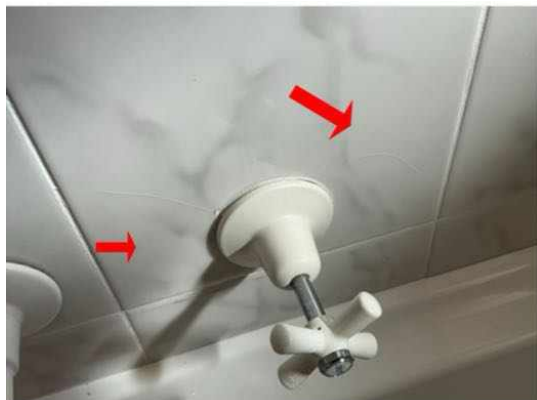
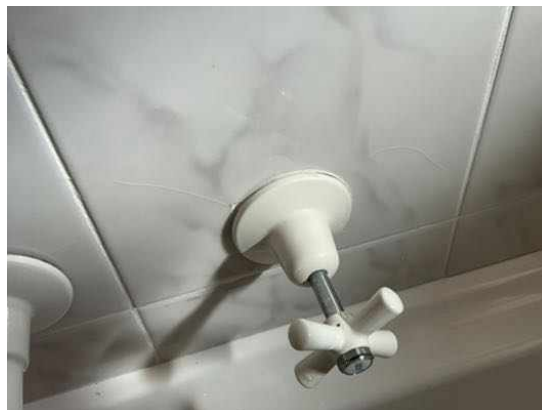
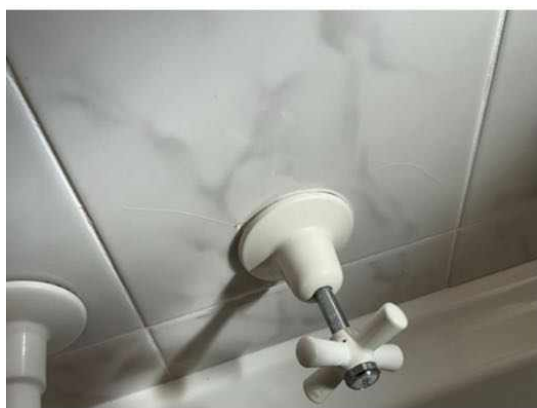
### Finding 3.06

Building: Main Building  
 Location: Bathroom  
 Finding: Tiles - Cracked or damaged

Information: Cracking was evident to the tiling in this area at the time of inspection. While the cracking appears to be minor, this area is frequently exposed to water, allowing potential for water penetration into adjoining sections of walls or flooring.

If left unmanaged, water penetration to these areas may lead to subsequent water damage, which is likely necessitate repair work to affected building elements.

A tiling contractor should be appointed to ensure that no further water damage

occurs. The re-application of silicone and grouting throughout remaining tile work is also advised, to further protect the area against water penetration.

Where water penetration has led to water damage, appointment of a relevant tradesperson may be required to repair damaged building elements.

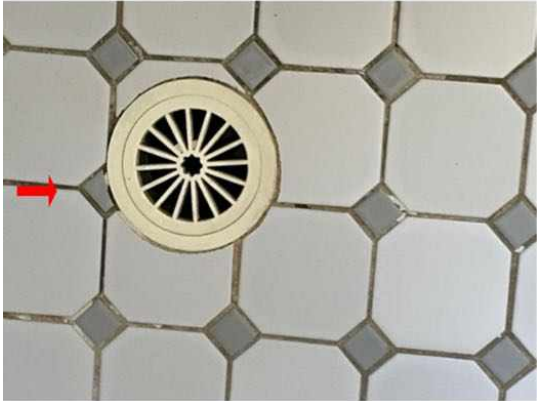
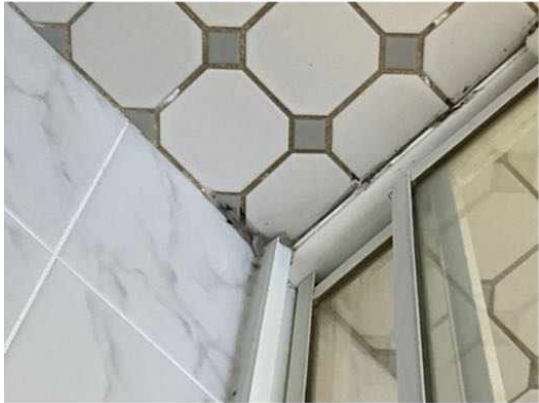
### Finding 3.07

Building:	Main Building
Location:	Bathroom
Finding:	Sealant and grouting - Missing or damaged
Information:	It was noted on inspection that sealant or grout is degraded to the tiled shower alcove and or other areas of the bathroom.

Different materials and floor areas move at different rates, generally causing cracking to grout or sealant at this point. A flexible sealant is required to allow for expected expansion and contraction, while keeping the joint water tight and protective of all associated building materials.

There appears to be excessive mould to the sealant and grout which will likely require scraping out and replacement.

Flexible and mould resistant materials should be applied to affected areas to prevent any subsequent water damage that is likely to occur. Regular maintenance and

replacement of damage or missing or damaged sealant and grout is highly recommended to the wet areas, as this is a regular wear and tear defect. Sealant and grouting in areas that come into regular contact with water should be maintained for the long term care of your property.

A sealant specialist or tiling contractor should be appointed to complete these works as soon as possible

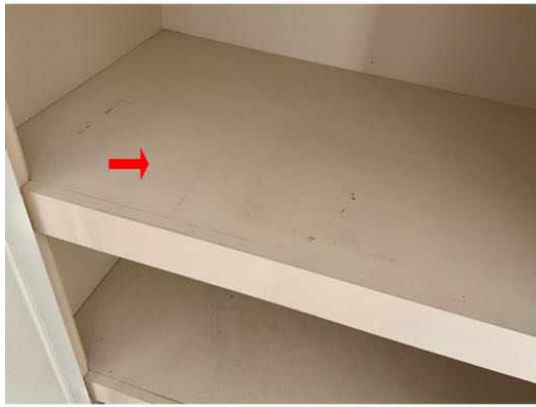
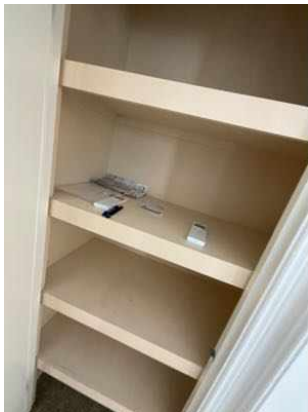
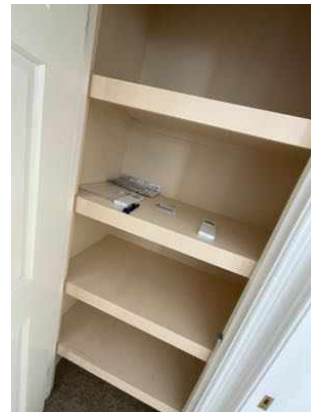
**Finding 3.08**

Building: Main Building  
Location: All Areas

Finding: Cabinetry noticeable signs of aging and wear and tear  
Information: “The cabinetry within the property is exhibiting noticeable signs of aging and wear and tear, manifesting as surface scratches, faded finishes, and worn edges. This degradation not only compromises the aesthetic quality of the cabinetry but also raises concerns about long-term durability and functionality.”

1. Aesthetic Deterioration: Visible signs of wear diminish the overall visual appeal of the cabinetry, affecting the aesthetics of the surrounding spaces.
2. Reduced Functionality: Wear and tear may impact the functionality of doors, drawers, and hinges, leading to difficulty in operation and potential disruptions in daily use.
3. Accelerated Deterioration: Ignoring aging signs can accelerate the deterioration process, increasing the likelihood of more extensive damage over time.

- Engage a professional cabinetry specialist or carpenter to assess the extent of wear and recommend refinishing or refacing options.
- This may involve repairing scratches, applying new finishes, or replacing worn-out components to restore the cabinetry’s appearance.

- In cases of severe wear, consider upgrading specific components or replacing the cabinetry to ensure long-term durability and aesthetic satisfaction.

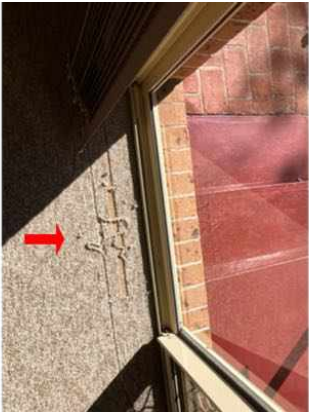
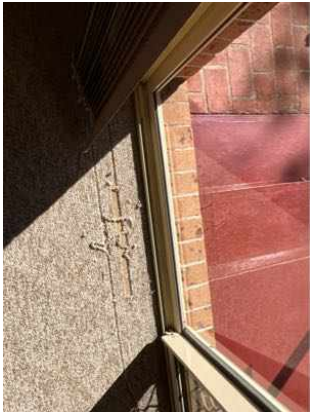
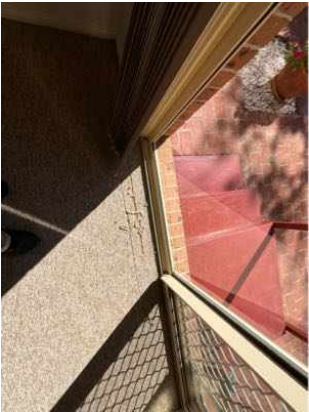
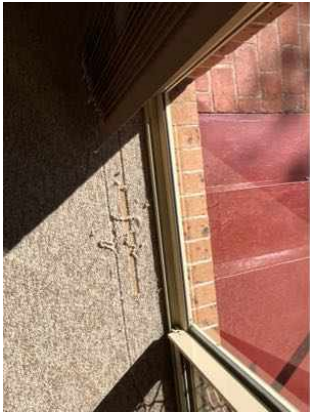
### Finding 3.09

Building: Main Building  
Location: Living Room  
Finding: Carpet - Tear  
Information: Tear observed in the carpet, posing a risk of further damage and creating an unsightly appearance.”

Risk: Potential tripping hazard, accelerated wear and tear, and a negative impact on the overall aesthetics of the space.

Resolution: A carpet repair specialist or professional installer should be engaged to assess and fix the tear, ensuring a seamless and safe carpet surface.

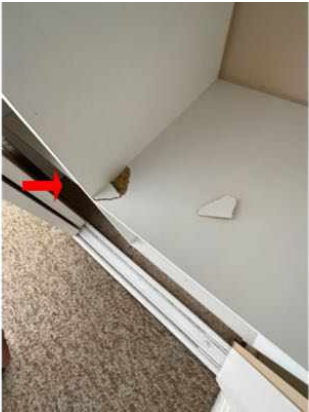
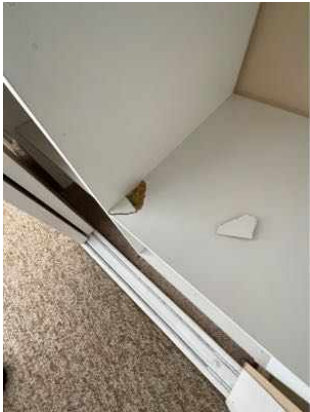
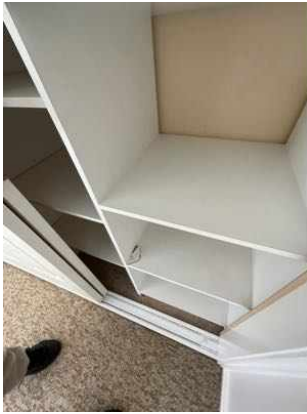
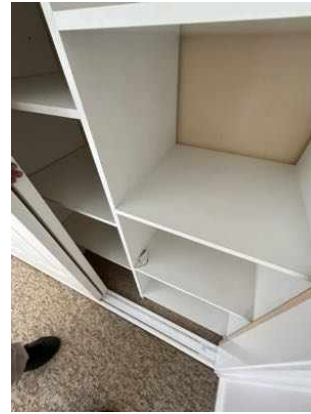
**Finding 3.10**

Building: Main Building  
Location: Bedroom 2  
Finding: Damaged cabinetry  
Information: A damaged cabinetry poses a risk of functional issues, reduced aesthetics, and potential further deterioration if left unaddressed.

Seeking assistance from a skilled carpenter or cabinet repair specialist is advisable to assess and repair the damaged cabinet door, ensuring proper restoration and maintaining the functionality and appearance of the cabinetry.

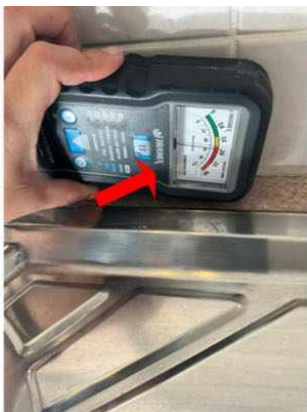
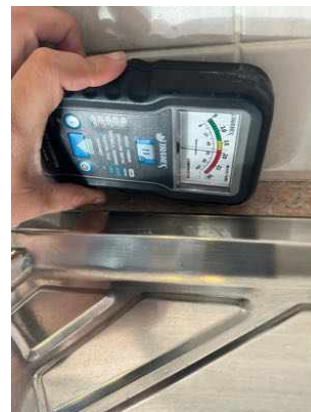
### Finding 3.11

Building:	Main Building
Location:	Kitchen
Finding:	Evidence of excessive moisture was present at the time of inspection
Information:	Excessive moisture is present behind the bathroom tiles, indicating a potential water leakage issue within the wall.

The prolonged presence of moisture can lead to mold growth, deteriorate the structure, and create an environment conducive to health hazards. Additionally, it may compromise the adhesive holding the tiles, leading to their detachment.

A licensed plumber or a qualified contractor specializing in water damage remediation should investigate the source of the moisture, fix any leaks, and address the damage. Additionally, replacing affected tiles and ensuring proper waterproofing are crucial to preventing future issues.

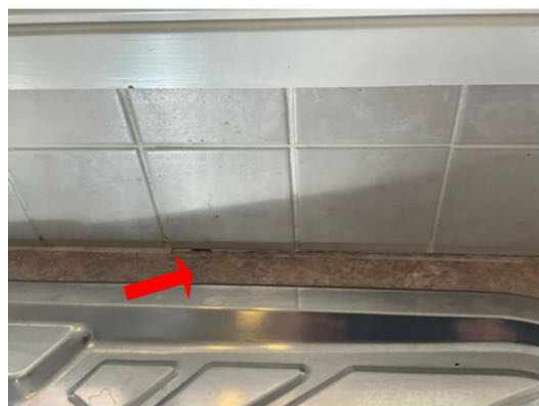
### Finding 3.12

Building:	Main Building
Location:	Kitchen
Finding:	Grouting - Missing or damaged
Information:	It was noted on inspection that sealant or grout is Missing or damaged. A flexible sealant is required to allow for expected expansion and contraction, while keeping the joint water tight and protective of all associated building materials.

Flexible and mould resistant materials should be applied to affected areas to prevent any subsequent water damage that is likely to occur. Regular maintenance and replacement of damage or missing or damaged sealant and grout is highly recommended , as this is a regular wear and tear defect.

A sealant specialist or tiling contractor should be appointed to complete these works as soon as possible

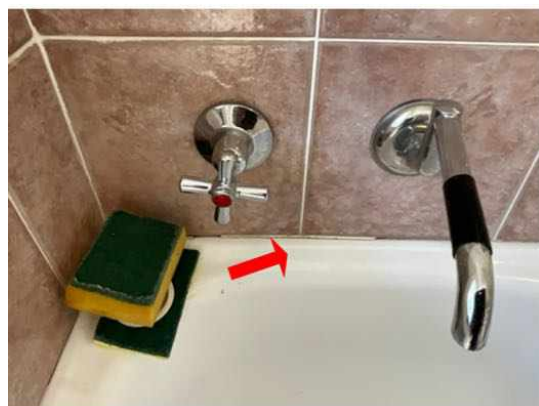
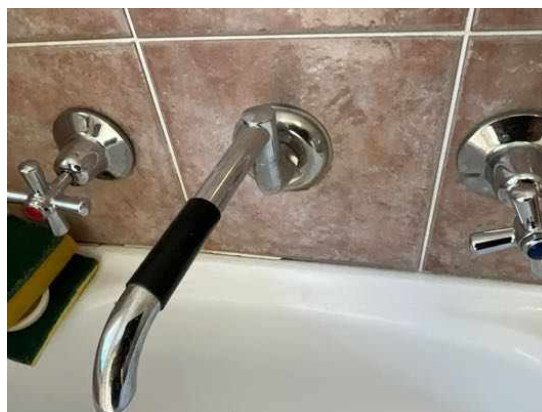
### Finding 3.13

Building: Main Building  
Location: Laundry  
Finding: Grouting - Missing or damaged  
Information: It was noted on inspection that sealant or grout is Missing or damaged. A flexible sealant is required to allow for expected expansion and contraction, while keeping the joint water tight and protective of all associated building materials.

Flexible and mould resistant materials should be applied to affected areas to prevent any subsequent water damage that is likely to occur. Regular maintenance and replacement of damage or missing or damaged sealant and grout is highly recommended , as this is a regular wear and tear defect.

A sealant specialist or tiling contractor should be appointed to complete these works as soon as possible

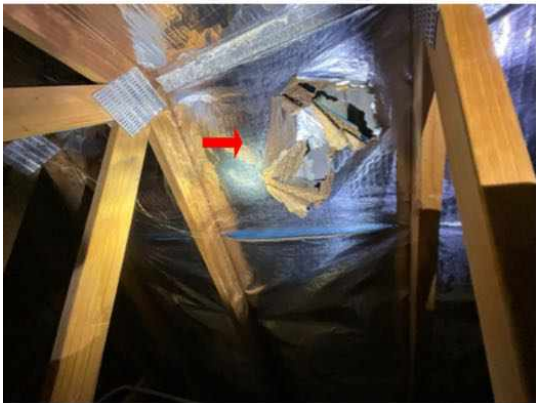
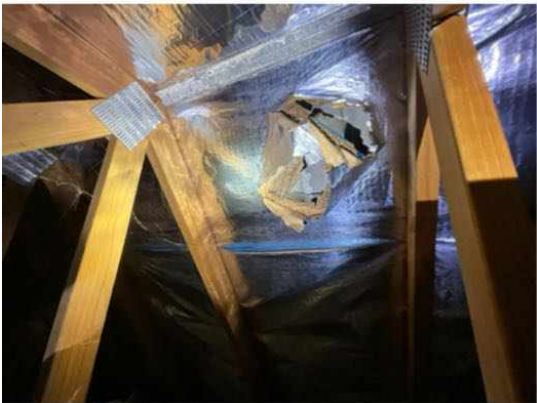
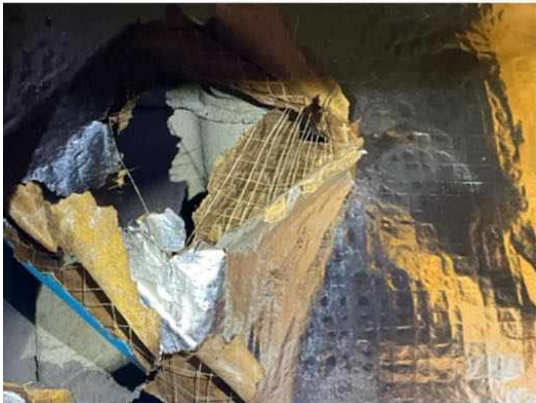
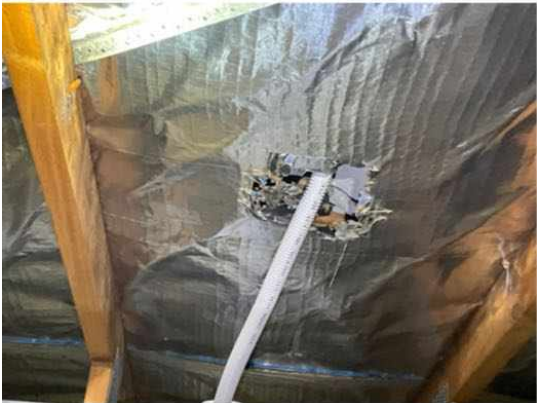
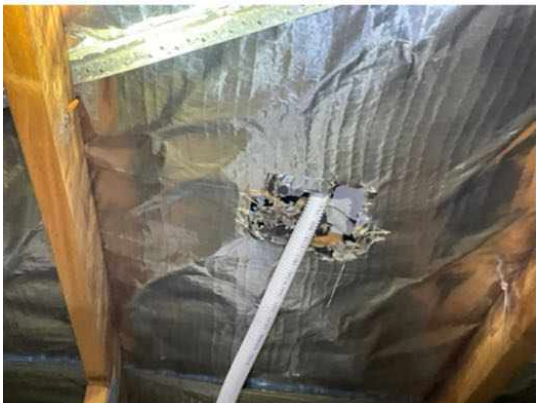
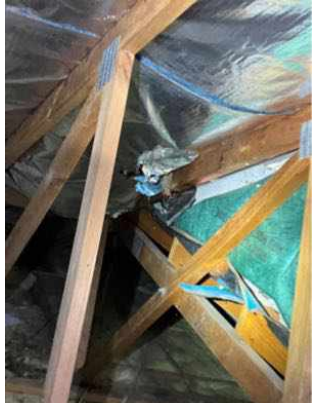
Building:	Main Building
Location:	Roof Void
Finding:	Sarking - Damaged
Information:	Sarking, a laminated aluminium foil applied to the interior of the roof covering, assists in insulating the property and acting as a vapour-barrier to the roof void and, subsequently, to the household.

Where sarking is damaged, both insulation and moisture protection of the property are inhibited. This creates a loss of energy and thus negatively impacts the energy efficiency of the property, allowing potential for moisture ingress from condensation or leaking roof tiles.

It is important to repair any holes or damaged sections of sarking to ensure that the building material is fully functional. A registered builder or qualified carpenter should be consulted to provide further advice on this defect and to perform rectification works at client discretion.

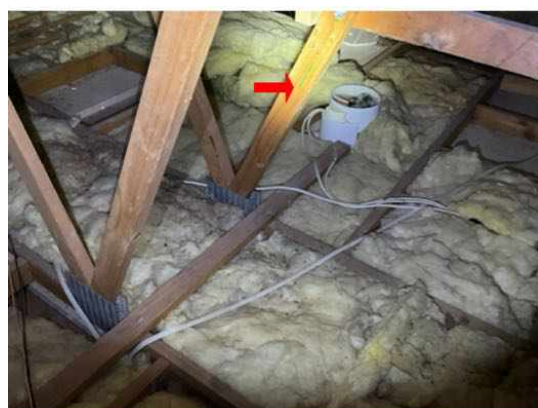
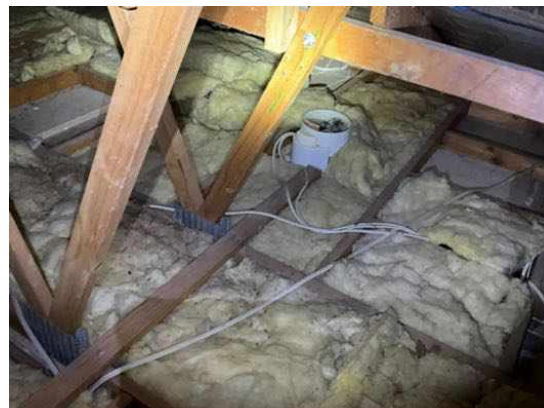
### Finding 3.15

Building:	Main Building
Location:	Roof Void
Finding:	Exhaust fan not vented out
Information:	The exhaust fan located within the roof void is not appropriately ducted to the external atmosphere and is currently discharging moist air directly into the roof space. This is considered a defect under AS 4349.1, as it does not meet the minimum standard of residential building performance expected under normal residential building practices.

This condition may lead to excessive condensation within the roof void, increasing the risk of mould growth, deterioration of insulation, timber decay, and overall reduced durability of building elements. It may also result in poor indoor air quality, potentially affecting occupant health.

It is recommended that the exhaust fan be modified by a licensed HVAC contractor or qualified builder, ensuring it is properly ducted to discharge externally in accordance with manufacturer specifications, the National Construction Code (NCC), and applicable Australian Standards.

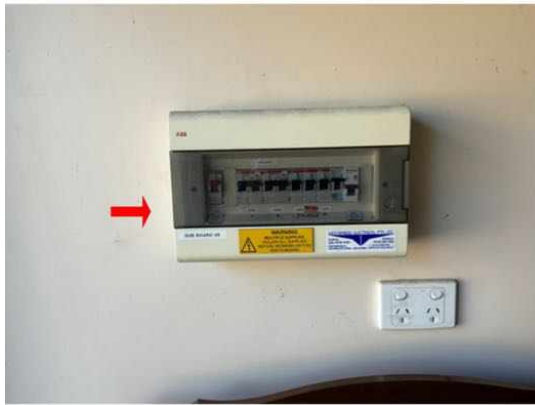
Building: Main Building  
 Location: Garage  
 Finding: No Evidence of Termite Management System - Durable notice / Legible Sticker  
 Information: The application of a pre & post-construction chemical termite barrier is highly recommended for all properties. Such barriers are highly effective in preventing termite attack on any timber building elements throughout the property.

A durable notice was not placed in the switchboard unit to indicate current termite barriers is legible at the time of inspection.

Client must seek further information from the vendor or real estate agent if the conditions of termite management systems were maintained.

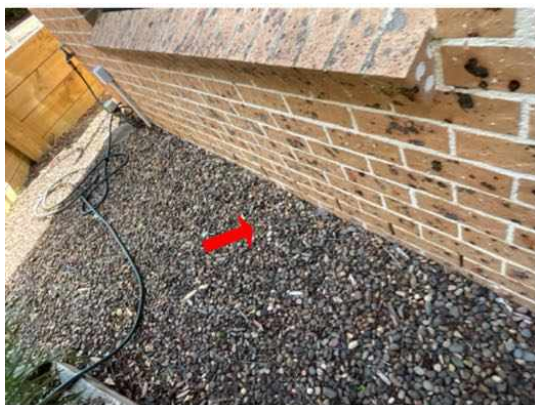
### Finding 6.02

If the slab edge is not properly exposed there is a high risk of termite attack. Sometimes, in order to determine the type of slab, a suitably qualified person such as an architect or builder may be required to consult the construction plans.

Where the slab edge cannot be properly inspected, it is highly recommended that termite or timber pest inspections be carried out every 6-12 months to aid protection of the property against infestation.

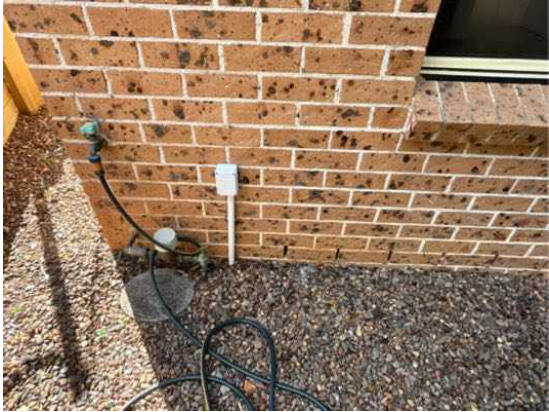
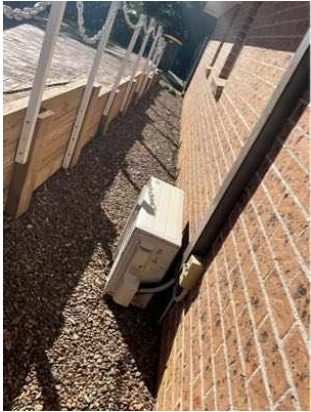
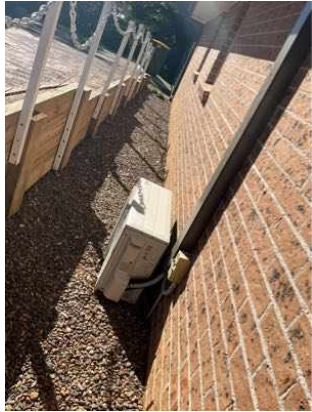
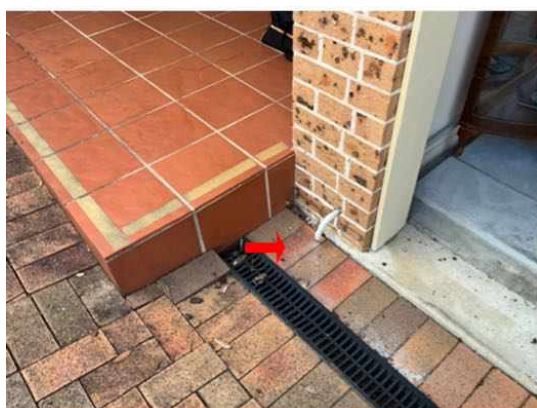
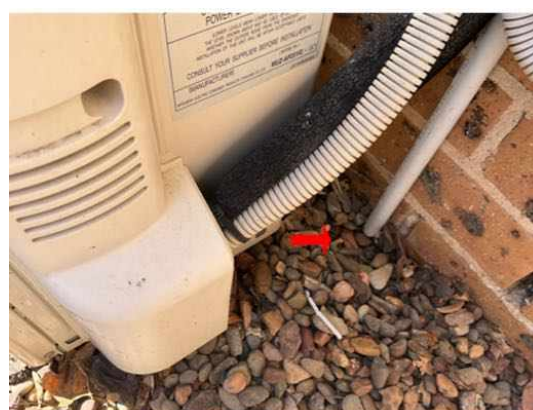
Finding 6.03

Building:	Main Building
Location:	Front Elevation
Finding:	Excessive moisture - Conducive to Timber pest
Information:	Excessive moisture can attract termites and produce conditions that promote fungal growth and wood decay.

Excessive moisture is generally caused by deteriorated inadequate or missing roof drainage leaking plumbing pipes or fixtures poorly plumbed HWS overflows or condenser units and poor site drainage.

Prior to any remedial works being performed a qualified plumber should be appointed to further inspect the property and to identify the cause of the excessive moisture. Works to remove affected building elements may then be necessary and should be performed by an appropriate tradesperson.

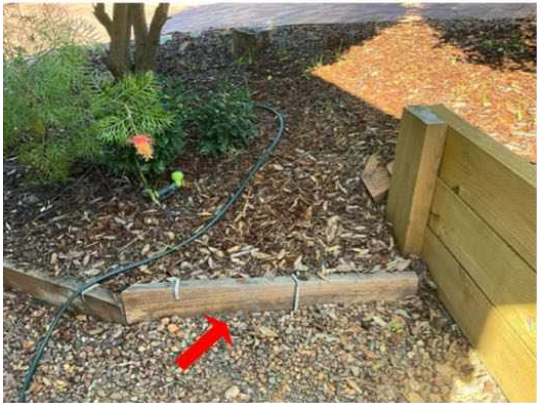
#### Finding 6.04

Finding: Timber on ground / conducive conditions to termite damage  
Information: Timber on the ground is indeed conducive to termite damage. Termites are known to thrive in moist environments, and wood in contact with soil or moisture is more susceptible to infestation.

To prevent this, it's important to keep timber elevated and away from direct ground contact. Regular inspections and proper termite control measures are also essential to protect your wooden structures from termite damage.

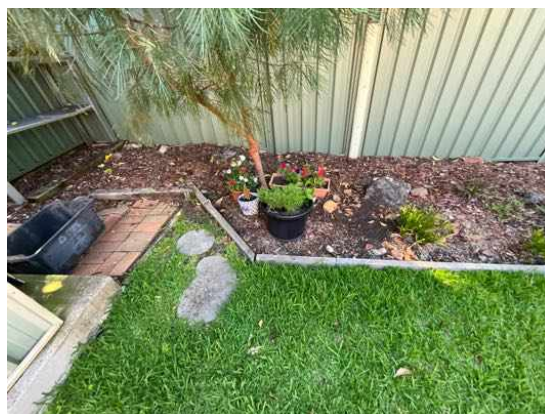
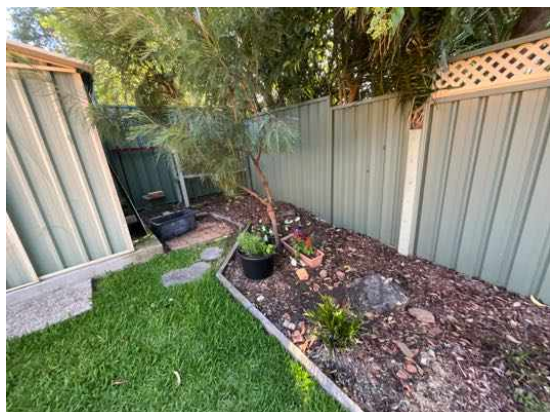
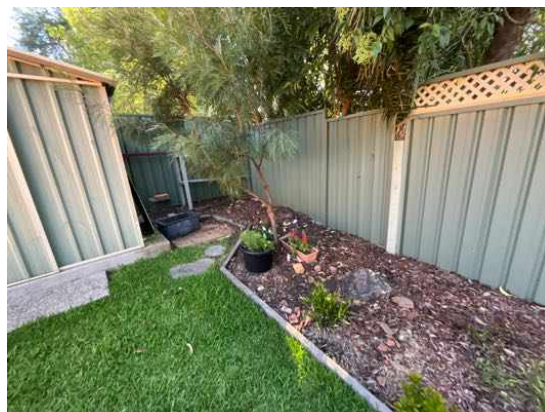
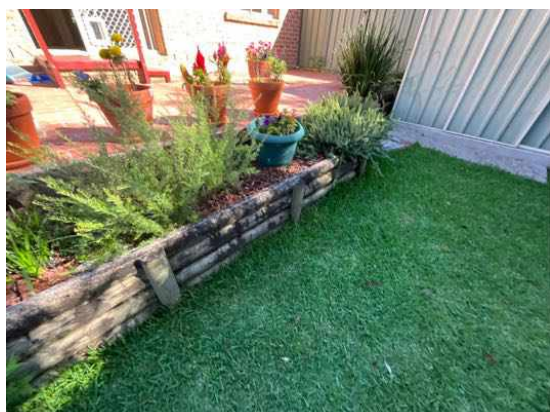
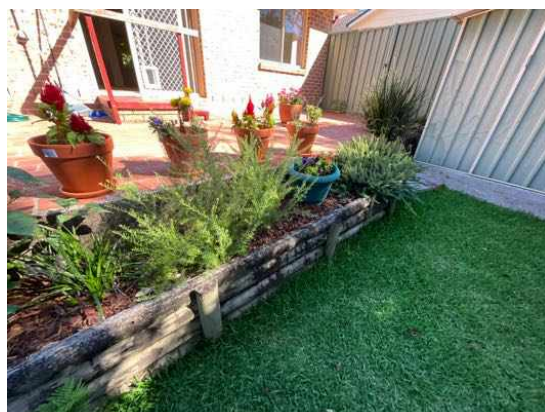
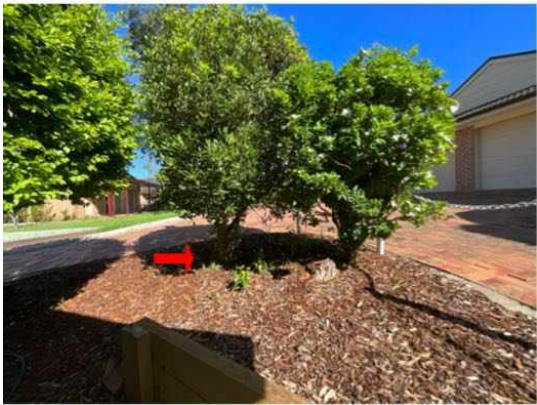
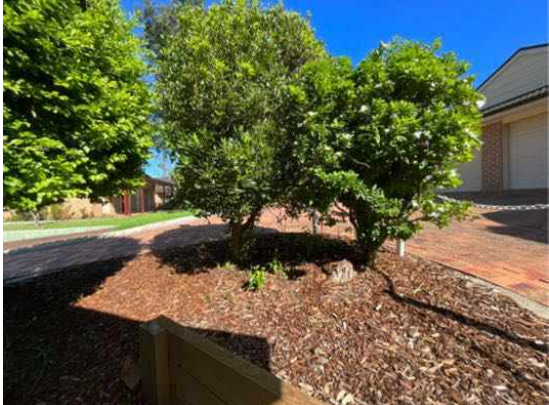
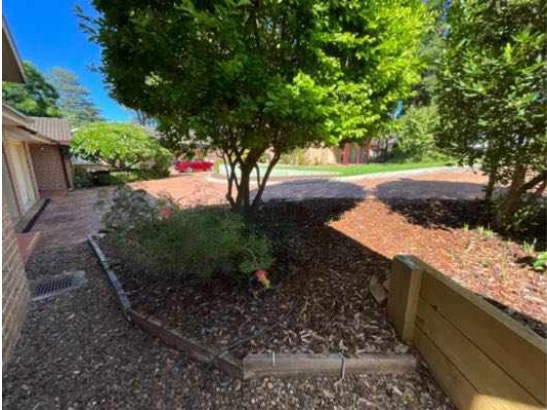
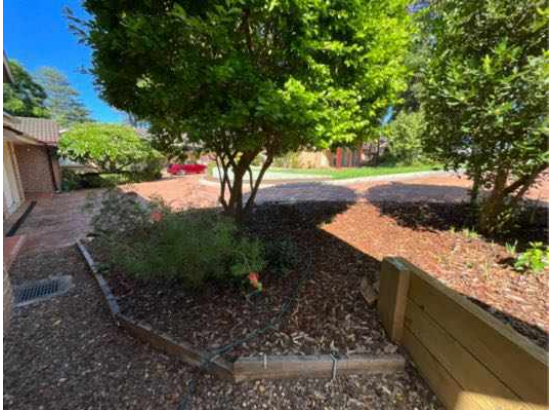
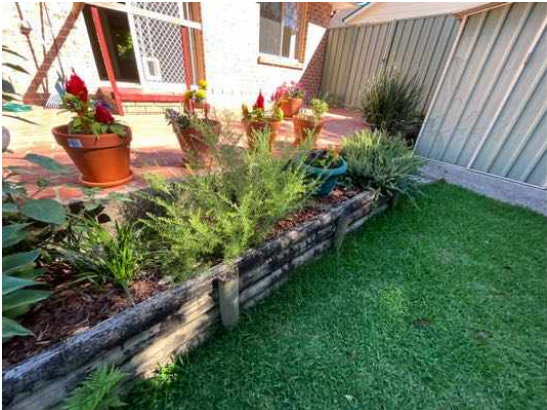
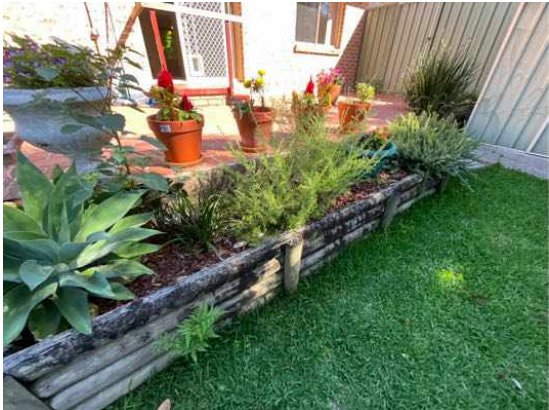
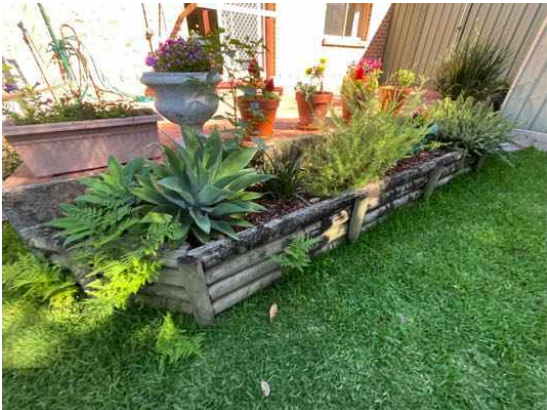
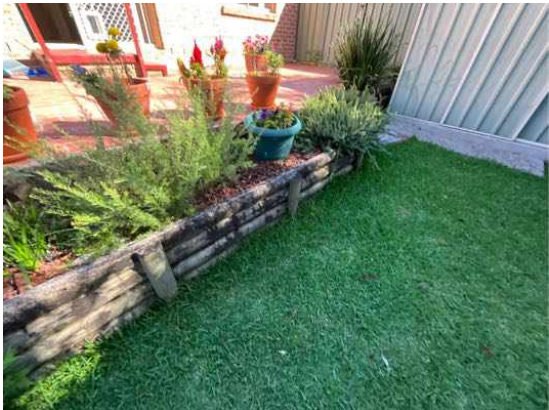
### Finding 6.05

Building:	Main Building
Location:	All Areas
Finding:	Dense vegetation around a property can increase the risk of termite infestation
Information:	The presence of dense vegetation around a property can increase the risk of termite infestation, as it provides a conducive environment for them. To address this, consider maintaining a clear space between the vegetation and your home. If you suspect a termite issue, it's advisable to consult with a licensed pest control professional for inspection and treatment.

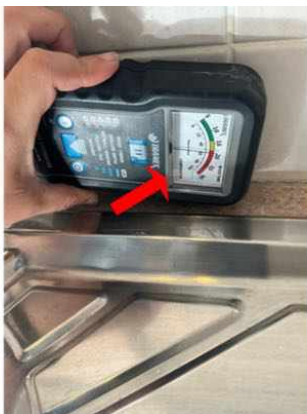
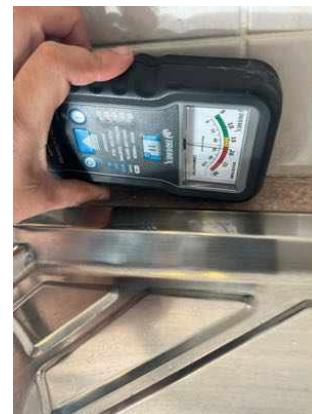
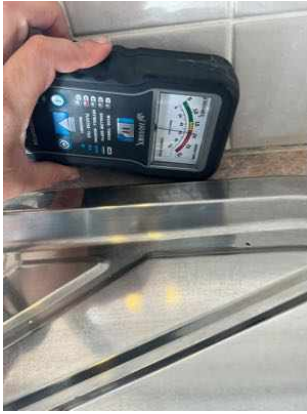
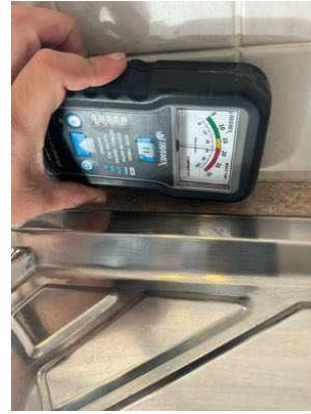
### Finding 6.06

Building:	Main Building
Location:	Kitchen
Finding:	Excessive moisture - Conducive to Timber pest
Information:	Excessive moisture can attract termites and produce conditions that promote fungal growth and wood decay.

Excessive moisture is generally caused by deteriorated inadequate or missing roof drainage leaking plumbing pipes or fixtures poorly plumbed HWS overflows or condenser units and poor site drainage.

Prior to any remedial works being performed a qualified plumber should be appointed to further inspect the property and to identify the cause of the excessive moisture. Works to remove affected building elements may then be necessary and should be performed by an appropriate tradesperson.

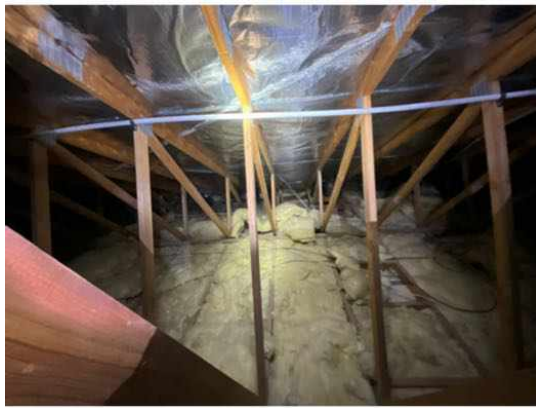
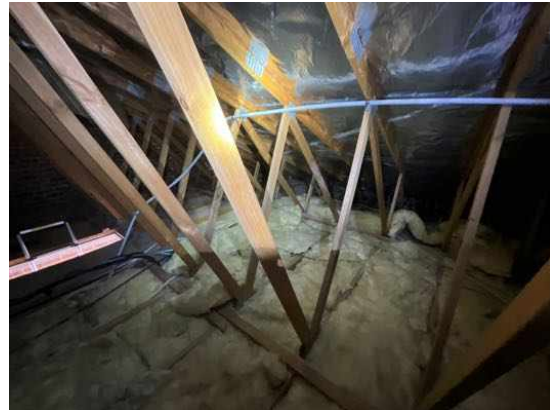
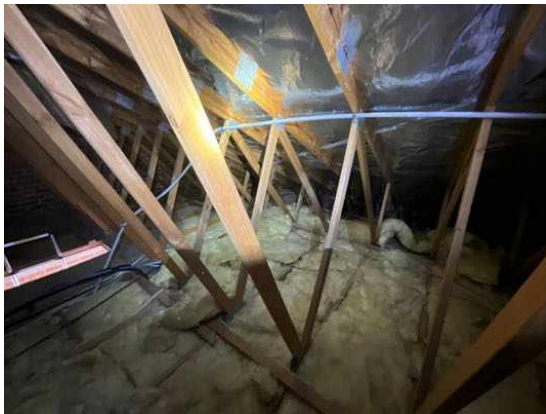
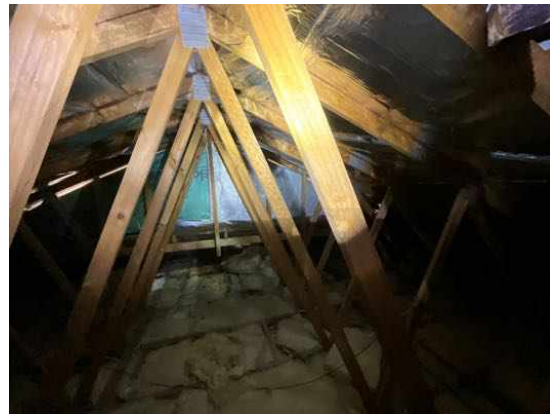
#### Noted Item

Building: Main Building  
Location: All Areas  
Finding: Additional Photos - Obstructions and Limitations  
Information: These photographs are an indication of the obstructions and limitations which impeded full inspection of the property at the time of inspection. These obstructions can hide an array of defects and should be removed to allow full inspection to be carried out. A re-inspection is recommended once the areas are made accessible.
