# Building and Timber Pest Inspection Report

Inspection Date: Wed, 18 Feb 2026

Property Address: 6/56 Old Bathurst Rd, Blaxland NSW 2774,  
Australia

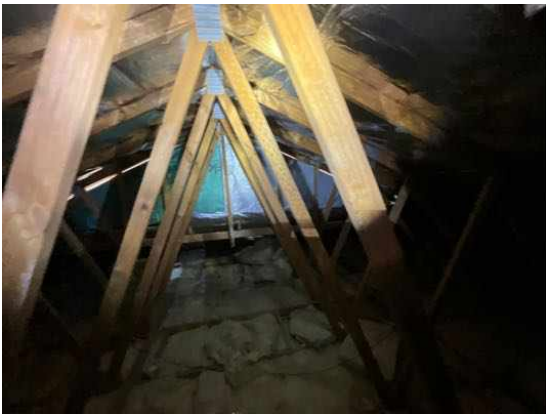
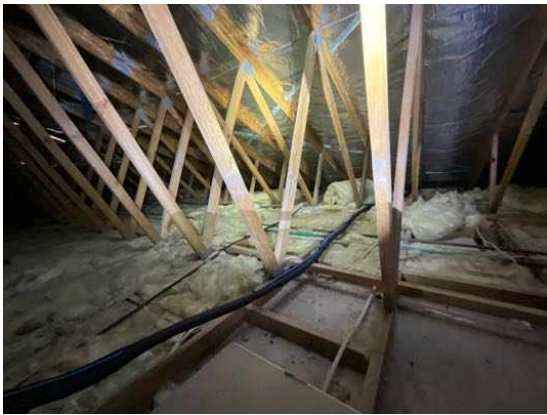
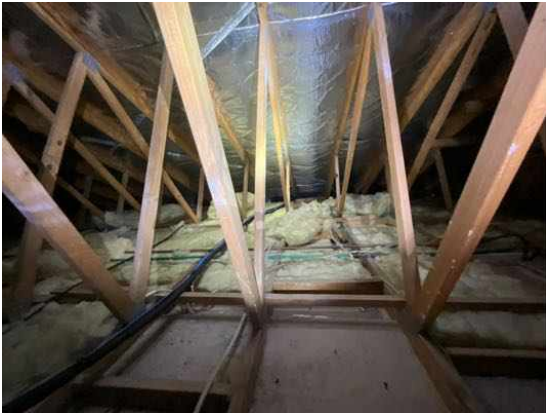
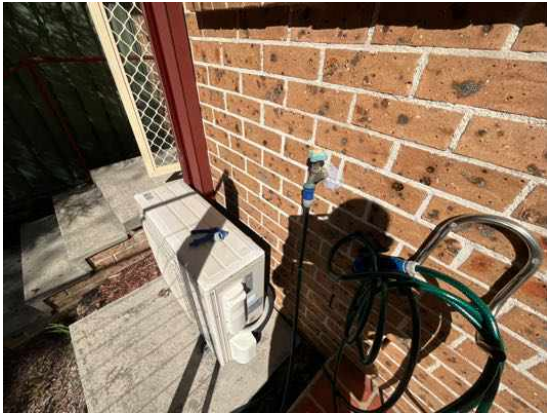
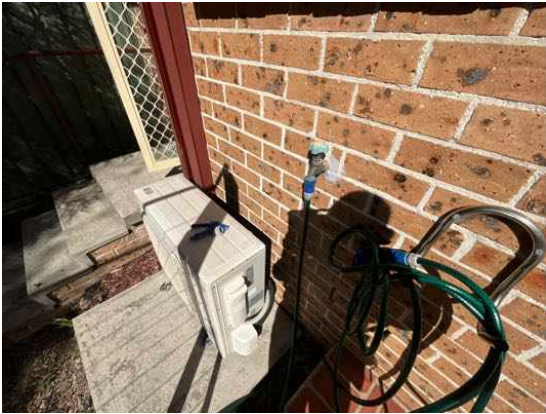
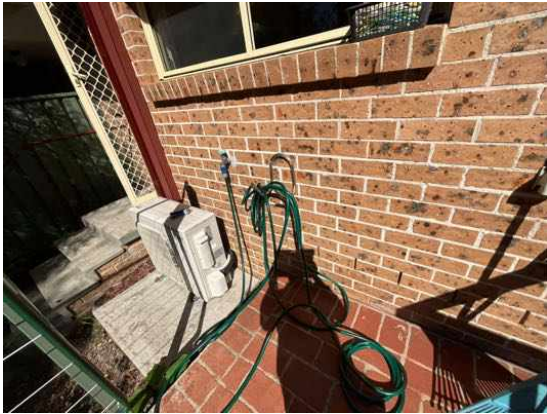
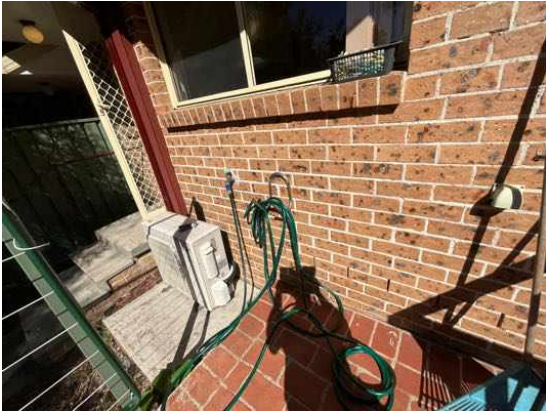
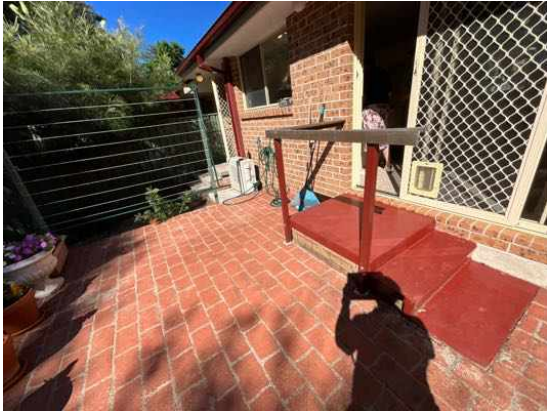
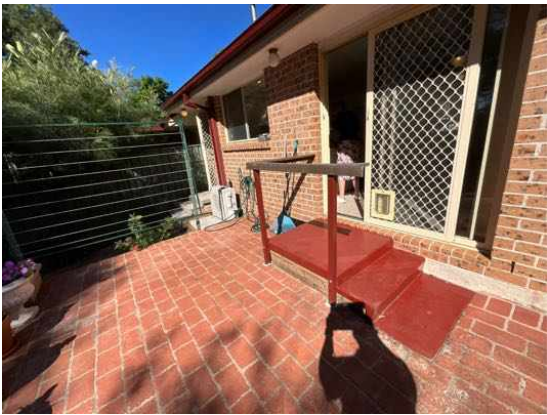
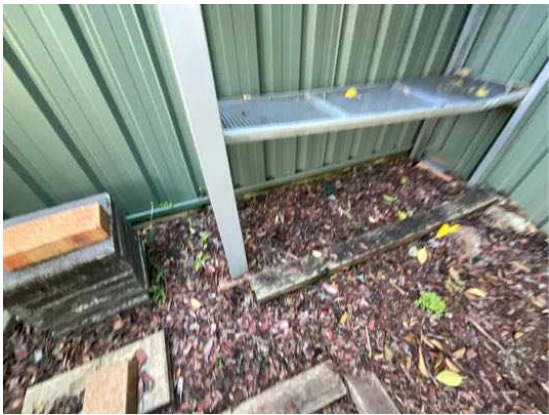
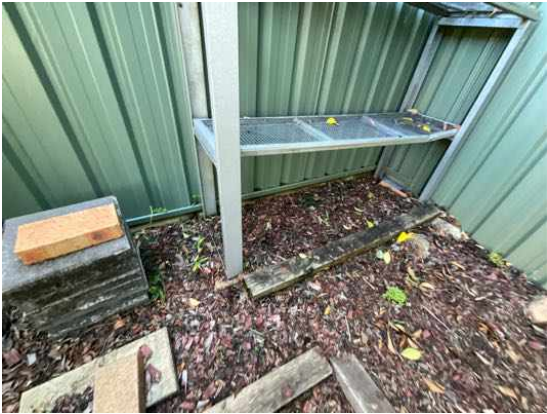
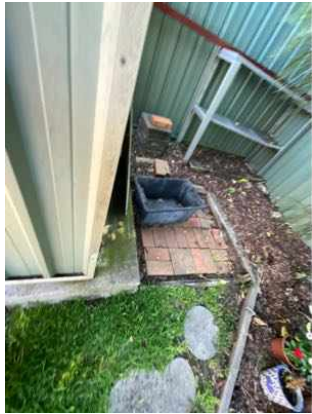
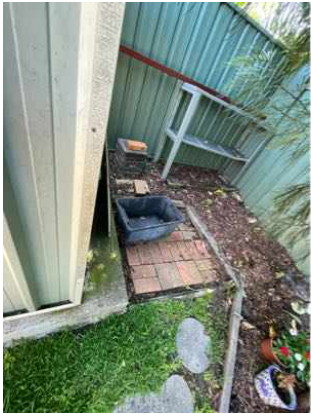
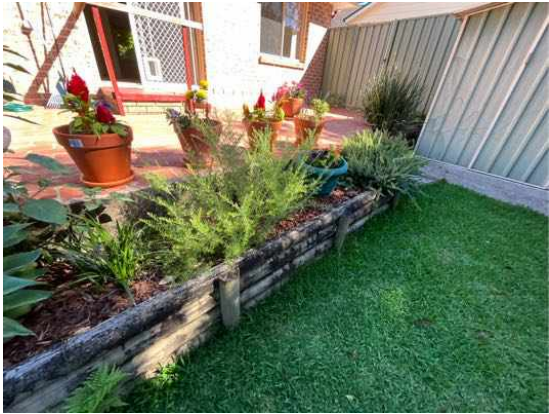
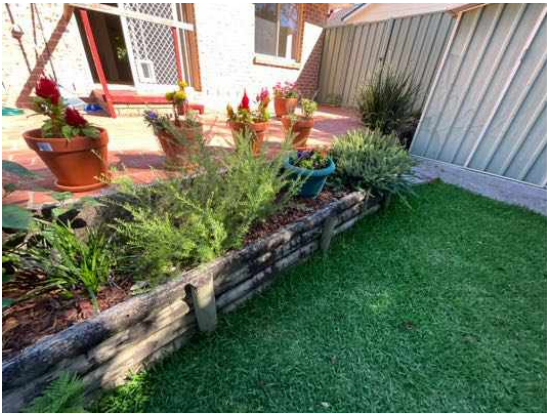
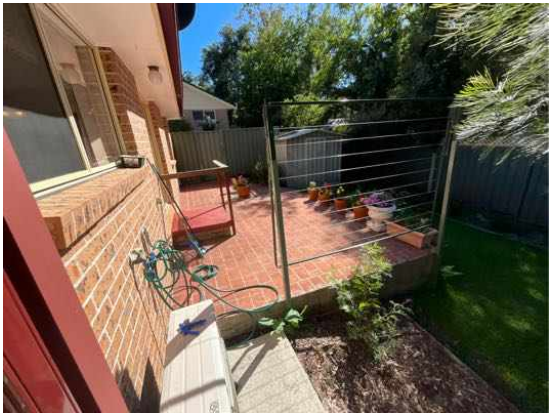
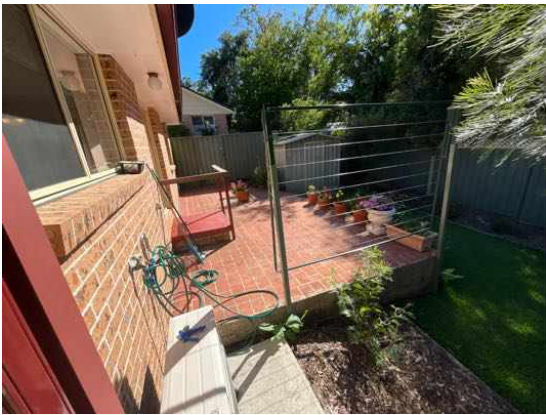
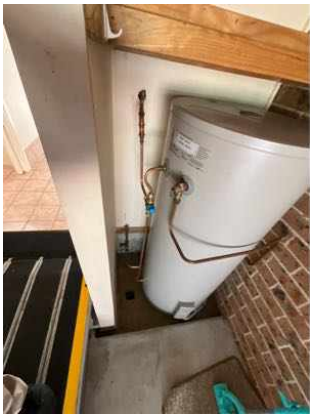
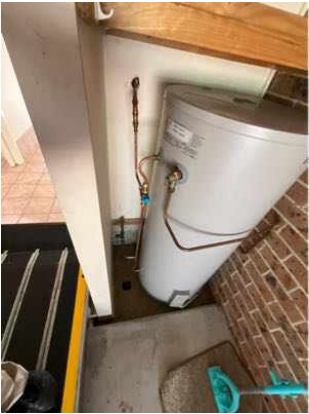
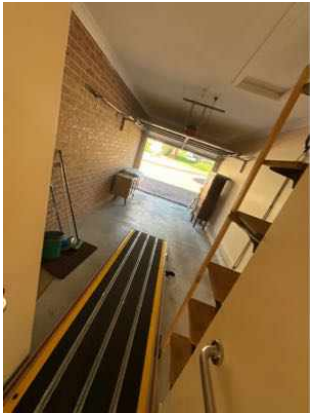
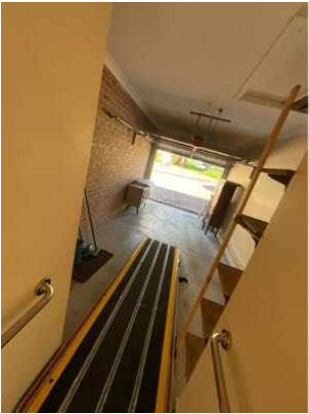
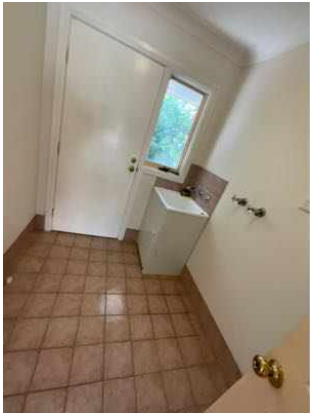
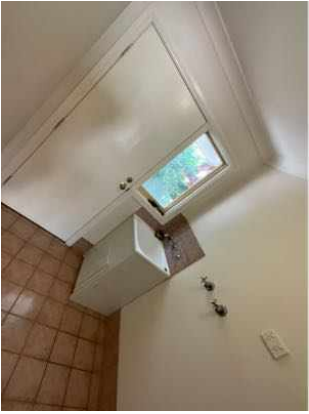
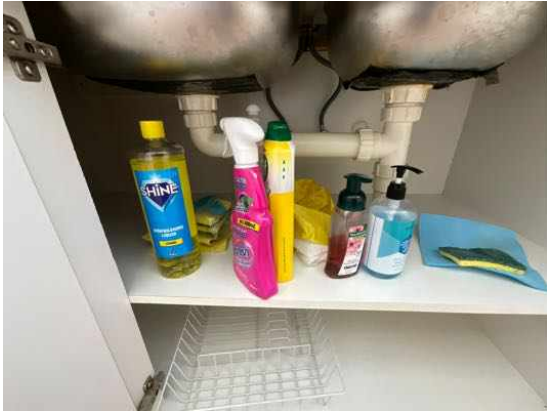
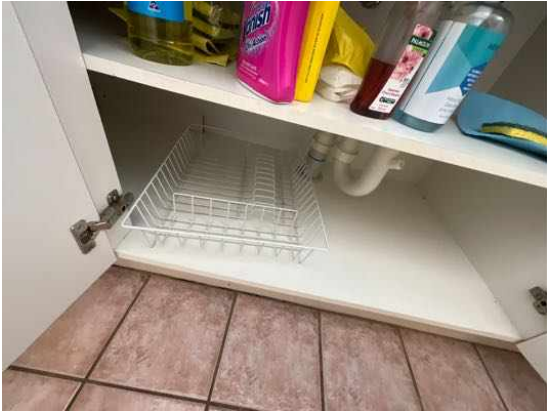
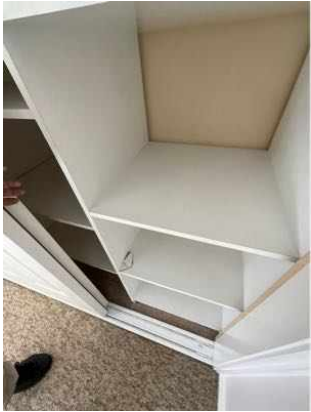
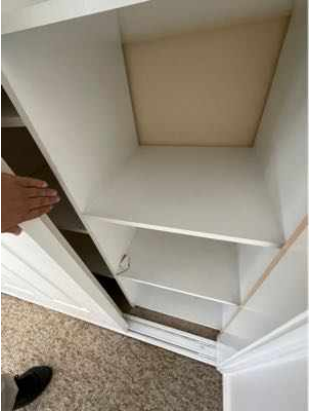
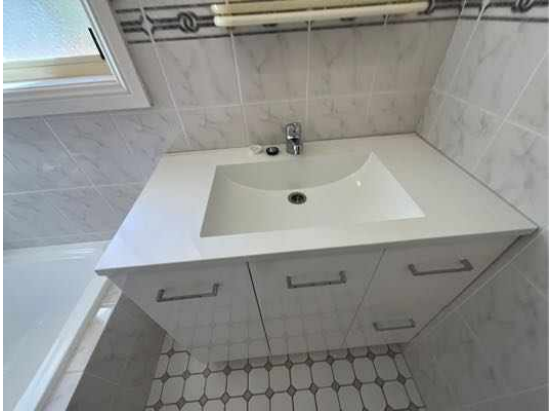
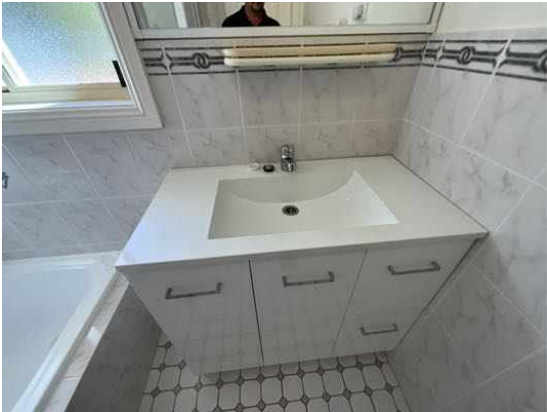
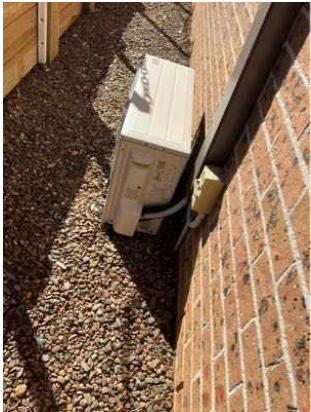
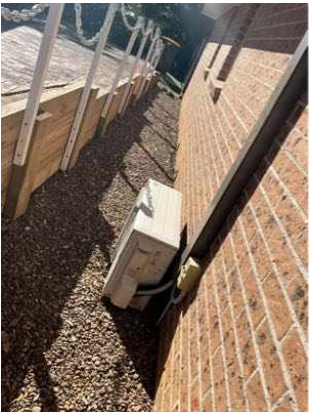
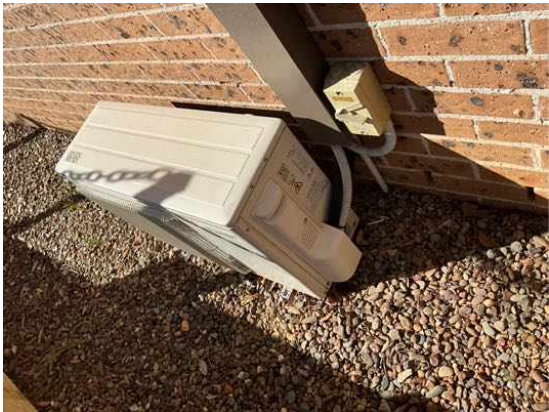
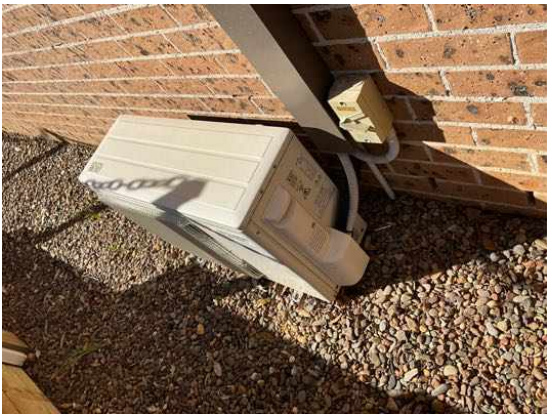
Building: Main Building  
Location: All Areas  
Finding: Additional Photos - Obstructions and Limitations  
Information: These photographs are an indication of the obstructions and limitations which impeded full inspection of the property at the time of inspection. These obstructions can hide an array of defects and should be removed to allow full inspection to be carried out. A re-inspection is recommended once the areas are made accessible.

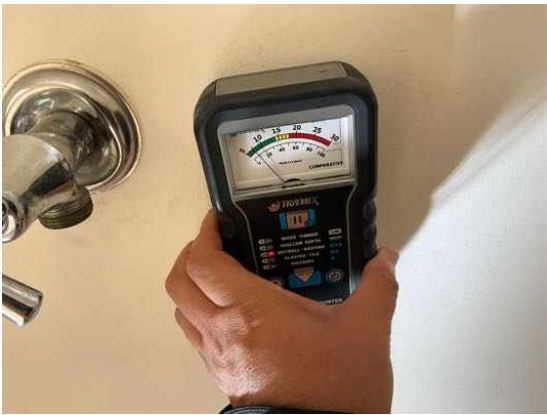
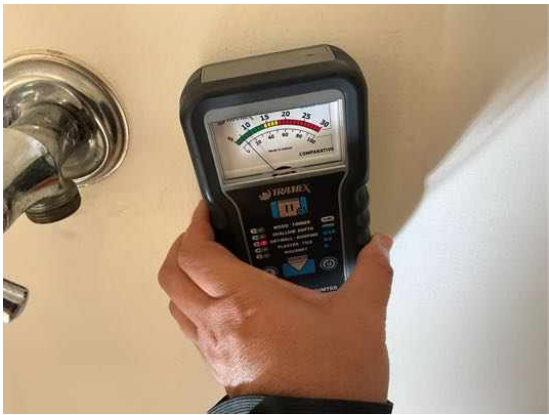
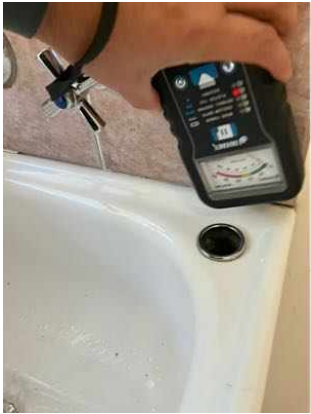
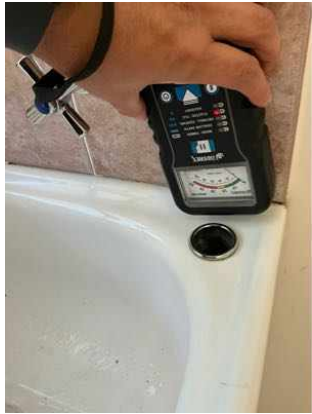
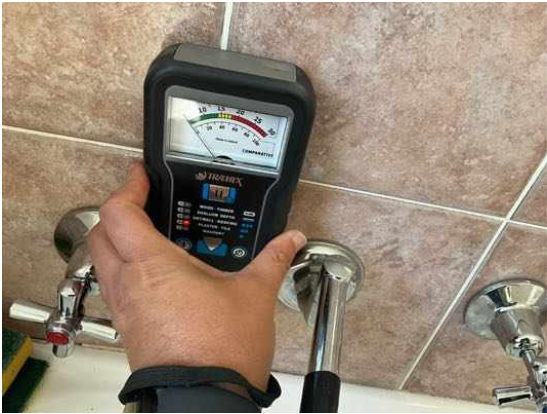
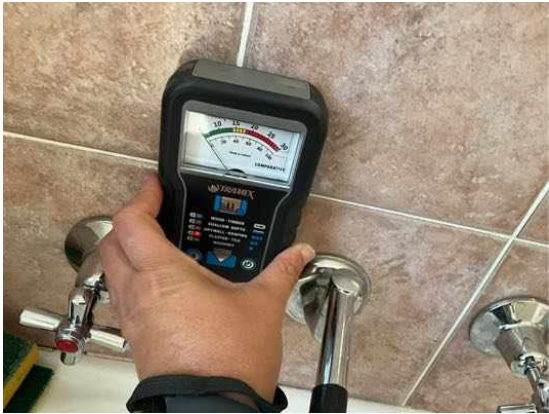
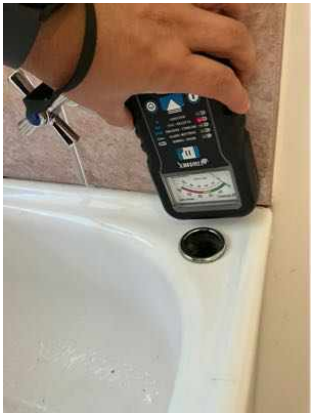
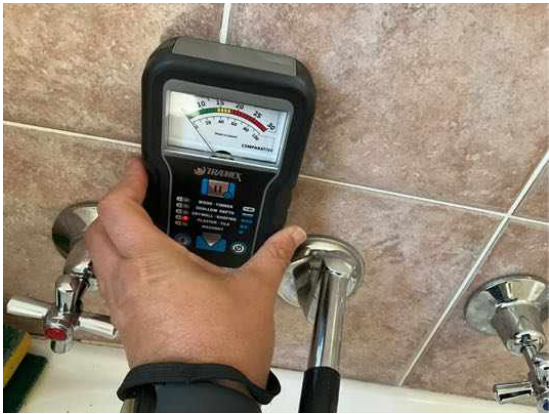
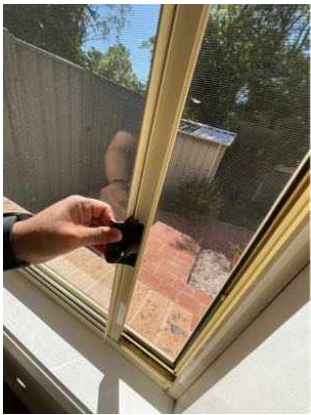
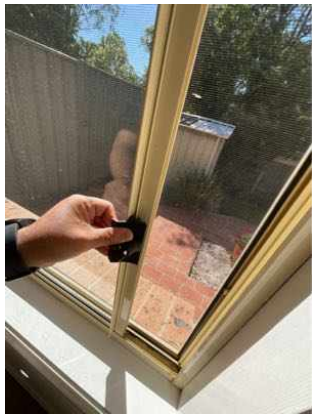
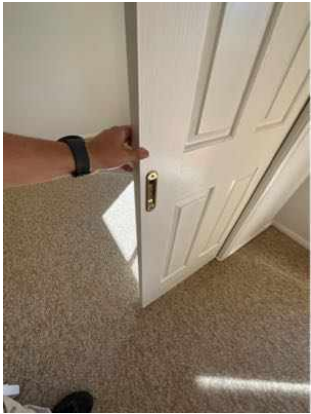
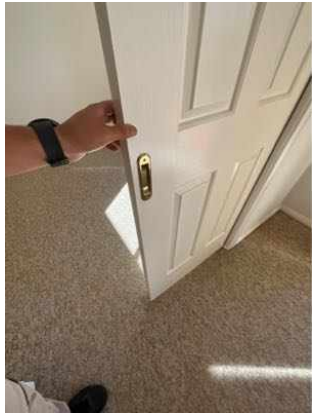
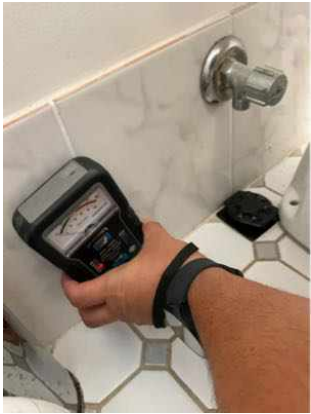
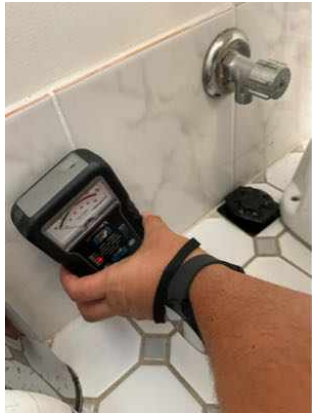
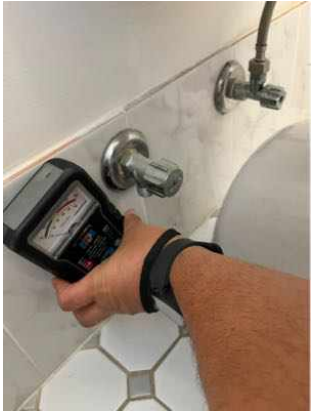
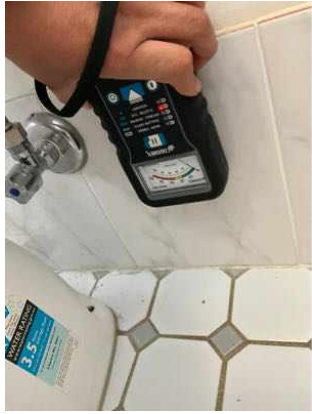
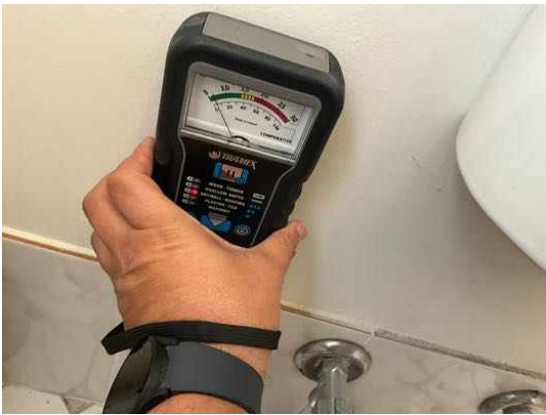
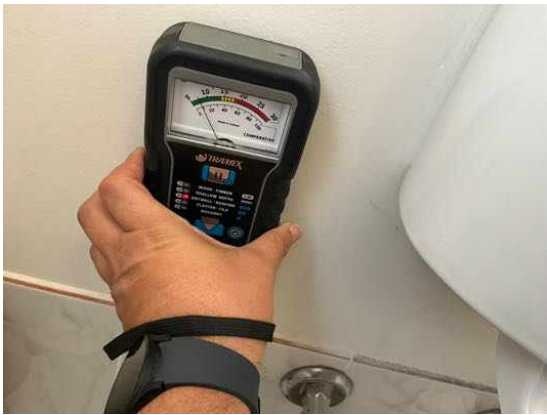
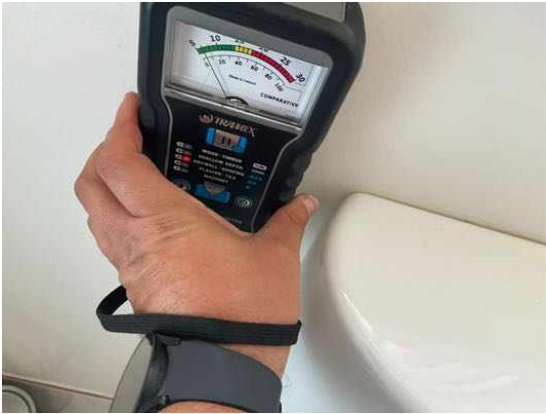
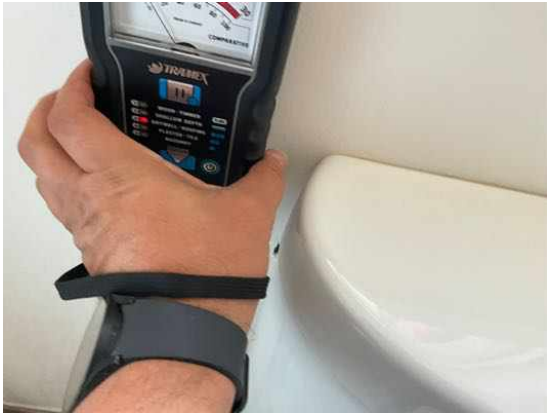
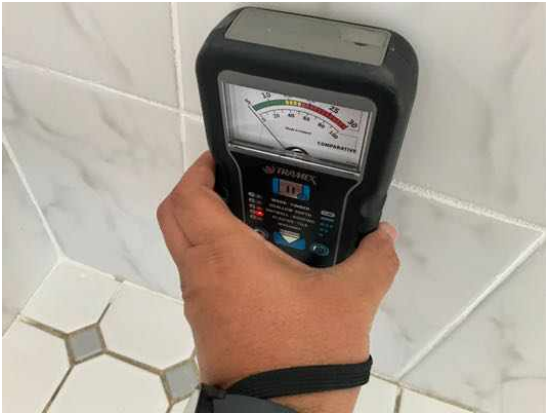
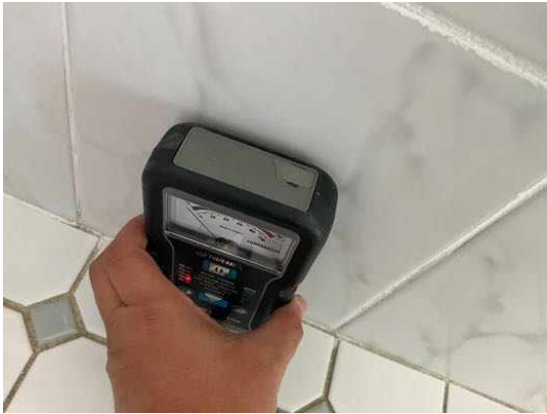
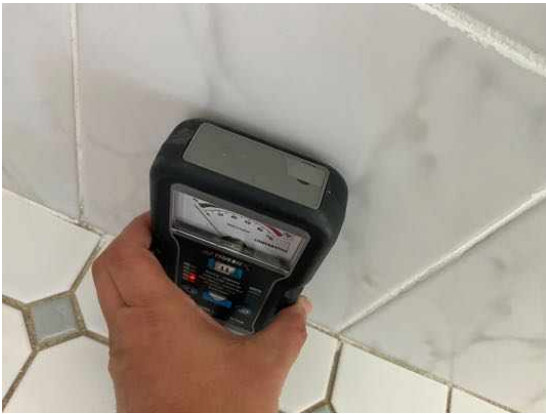
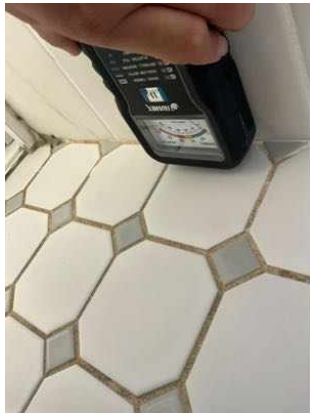
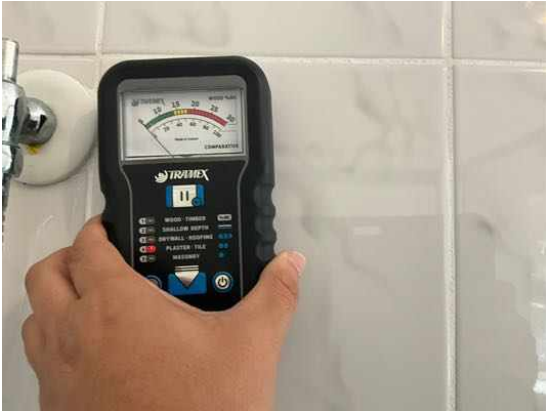
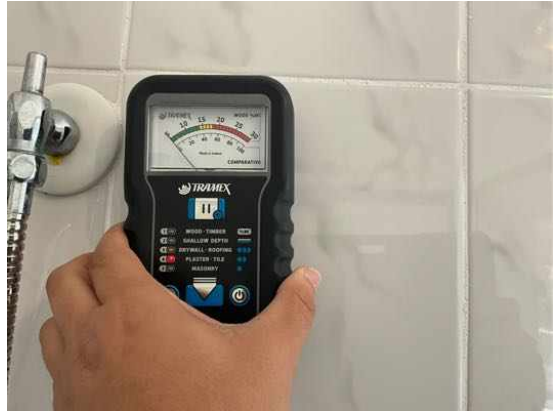
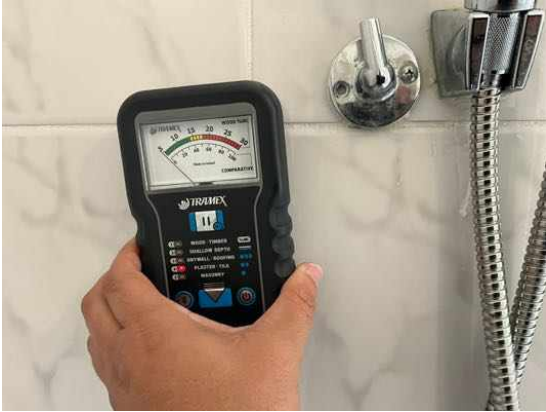
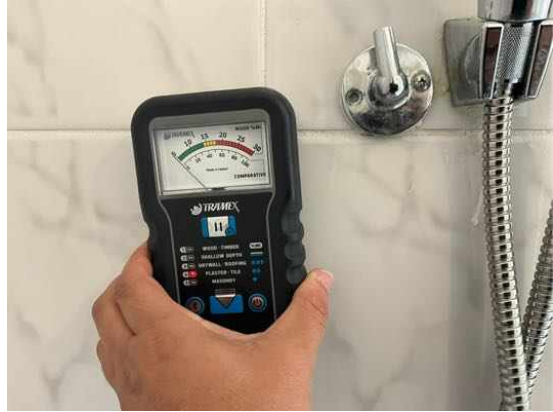
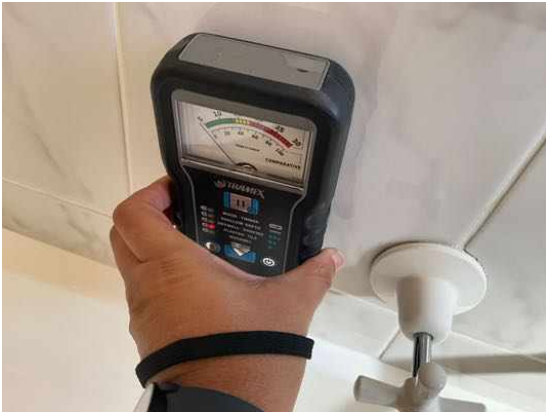
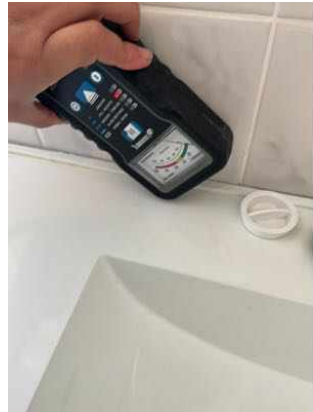
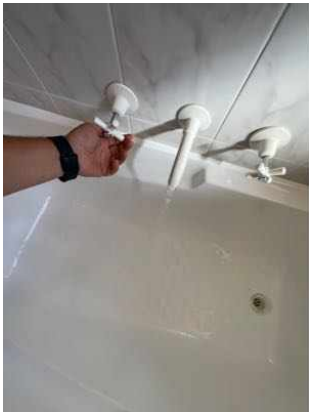
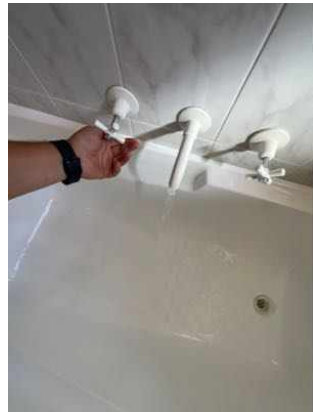
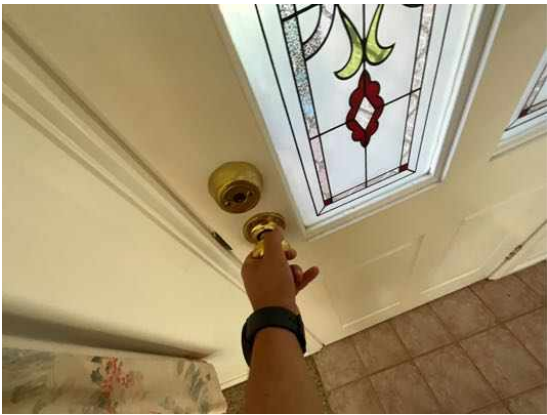
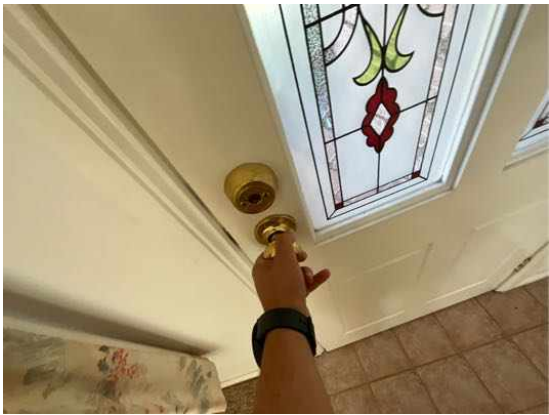
Building: Main Building  
Location: All Areas  
Finding: Additional Photos  
Information: Additional photos are provided for your general reference
