**BEFORE YOU BUY
BEFORE YOU BUILD**

Building and Timber Pest Inspection Report

Inspection Date: Mon, 2 Feb 2026

Property Address: 27 Royalden Cl, Boronia VIC 3155, Australia

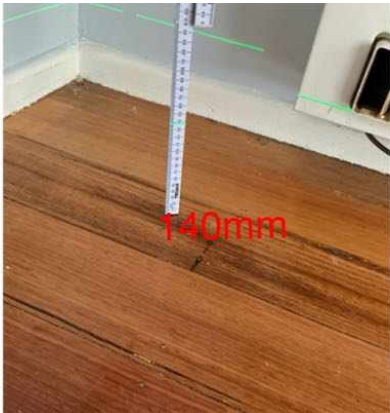
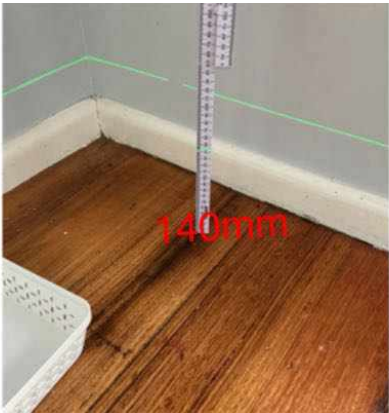
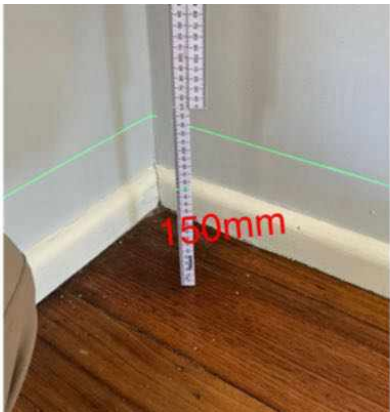
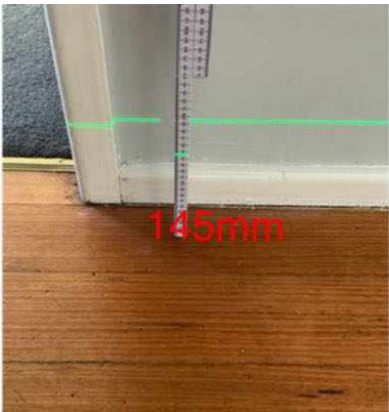
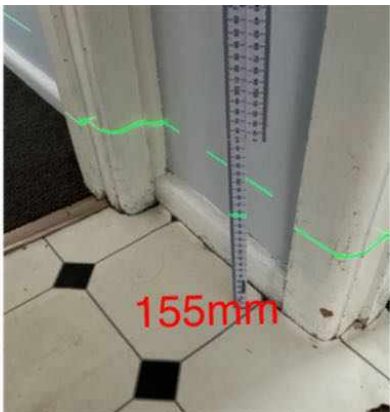
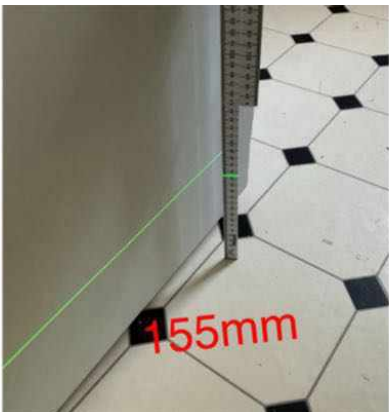
A standard laser level was set up at approximately 125 mm above the floor, as shown in the photo. Based on the readings taken, the floor level variation across the room is approximately 30 mm from the lowest point to the highest point, with the most pronounced deviation noted near the laundry doorway. This equates to roughly 30 mm per metre of floor deviation, which is indicative of significant subfloor settlement.

In addition, within the subfloor area, extensive water damage was observed (refer photos). Evidence of prior re-stumping works was also noted, including an abandoned timber stump left within the subfloor. A visible gap was observed between the stump and the floor joist, indicating the stump is not providing correct load support. Non-compliant packing/shimming was also observed at some supports.

Based on the above, these conditions are assessed as a major structural defect and should be investigated and rectified by a suitably qualified structural engineer and licensed building practitioner as a priority.

For further information or investigation, contact a licensed builder for cost estimation and a structural engineer to assess the extent of settlement and the condition of the stumps.

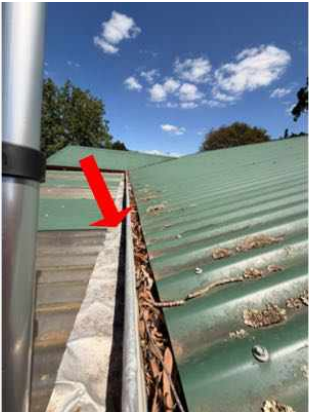
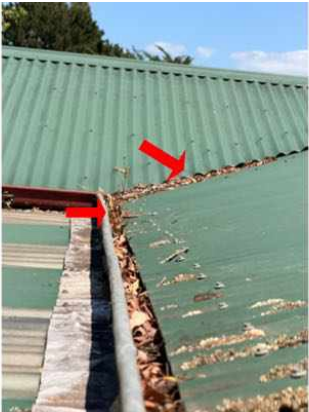
Finding 3.01

Building: Main Building
Location: Roof Exterior
Finding: Gutter debris accumulation and inadequate drainage
Information: The gutters exhibit debris accumulation (e.g., leaves, dirt) and green organic growth (algae/moss), indicating water pooling due to inadequate drainage. This poses risks of blockages, overflow during rainfall, and potential damage to fascia boards, walls, or foundations. Prolonged moisture retention may accelerate corrosion and attract pests. Immediate action is advised: clear debris, flush gutters and downpipes, remove organic growth, and inspect gutter slope/downpipe functionality.

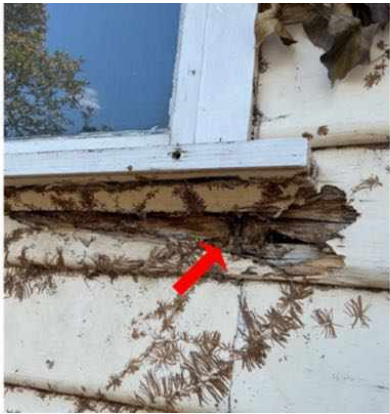
Building:	Yard
Location:	Yard
Finding:	Wood rot-external timbers
Information:	Wood rot which is technically known as Fungal Decay occurs when timbers and other cellulose building materials are exposed to damp conditions on an ongoing basis. This could be the result of exposure to weathering in the long term or the pooling of water or absorbed moisture from other abutting building materials. It is advisable to remove these affected timbers to prevent any chance of attack in the future.

Wood decay is more susceptible to termite attack and these timbers should be replaced to limit termite attack.

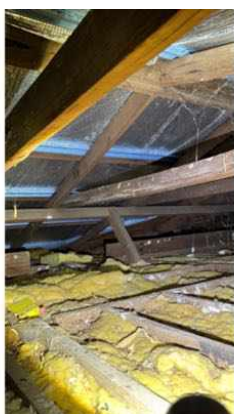
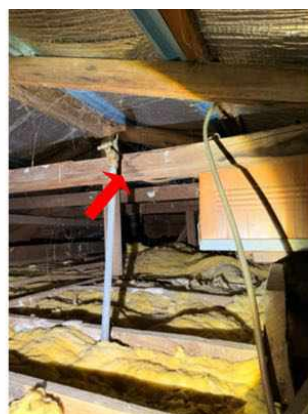
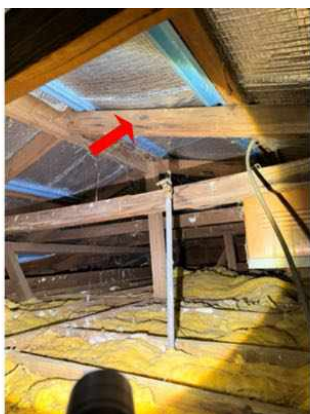
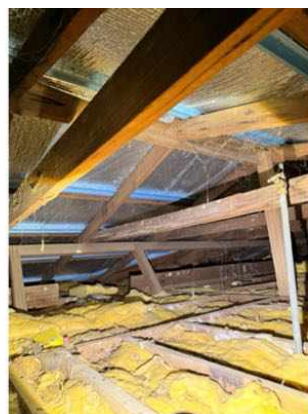
Information: At the time of inspection, the majority of roof void timbers were observed to be in generally acceptable condition when considered against the age of the property. Isolated timbers exhibited darker staining/discolouration, which may indicate past or active moisture ingress. No significant timber decay, softening, or wood rot was identified within the accessible roof void areas at the time of inspection. It is recommended that the client monitor the stained timbers during and after periods of heavy rainfall to confirm there is no ongoing moisture ingress and to help maintain the roof structure in a sound condition.

Insulation in roof void are in acceptable condition.

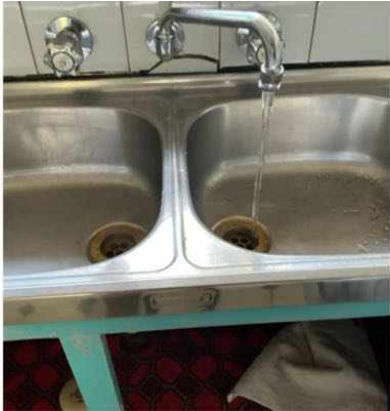
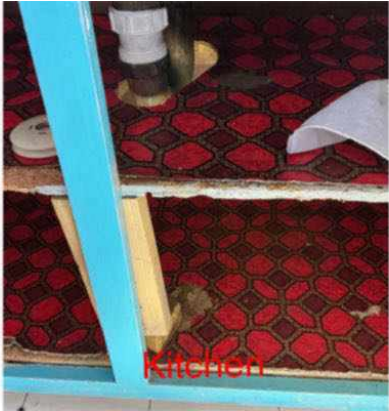
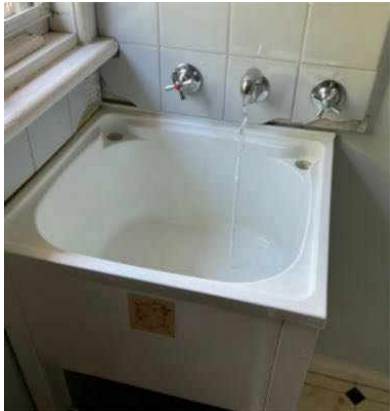
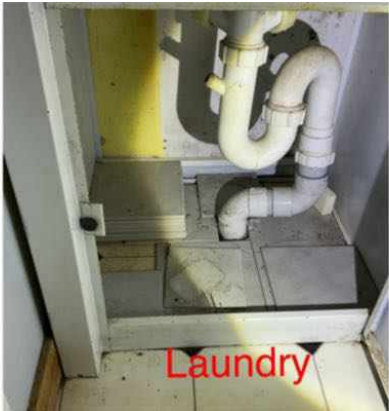
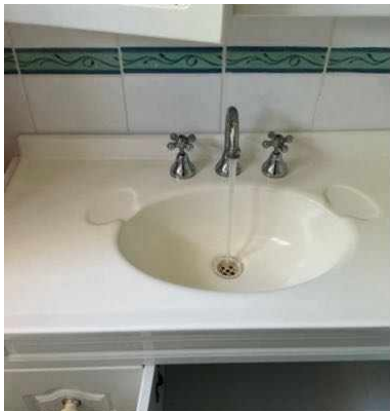
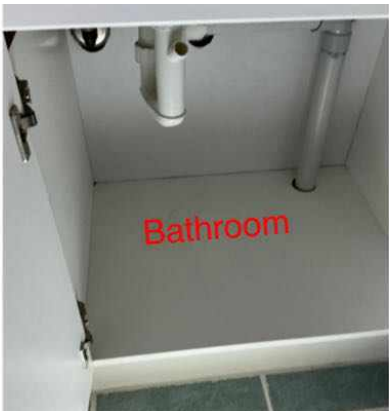
Building: Main Building
 Location: Cabinetry plumbing
 Finding: For your information
 Information: Cabinetry plumbing - No leaks evident

NOTE: Please be aware that although cupboards have had a thorough inspection, obstructions in cupboards may conceal potential water damage, prevent a full inspection and conditions can change after the initial inspection was carried out, therefore damage may be found after obstructions are removed.

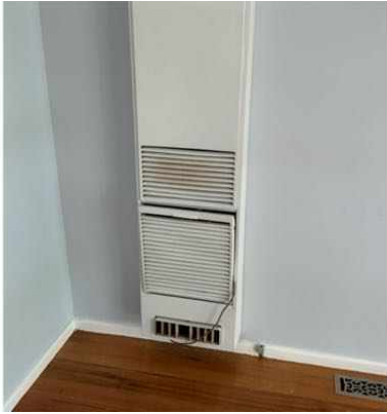
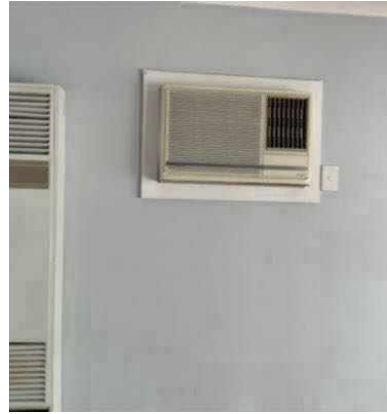
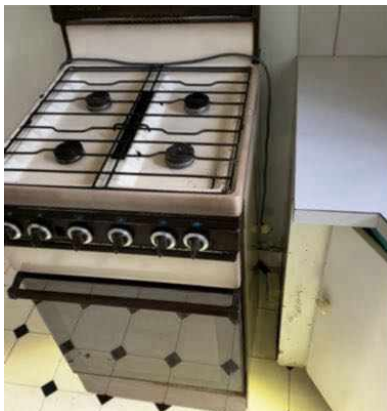
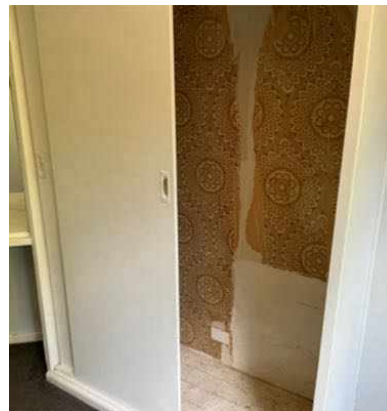
Building: Main Building
Location: All Areas
Finding: Additional Photos - Obstructions and Limitations
Information: These photographs are an indication of the obstructions and limitations which impeded full inspection of the property at the time of inspection. These obstructions can hide an array of defects and should be removed to allow full inspection to be carried out. A re-inspection is recommended once the areas are made accessible. Arrows and highlights have been included to identify minor defects. The purchaser can discuss further with the building inspector.
