# Building and Timber Pest Inspection Report

Inspection Date: Tue, 24 Mar 2026

Property Address: 2/9 Hart Dr, Constitution Hill NSW 2145,  
Australia

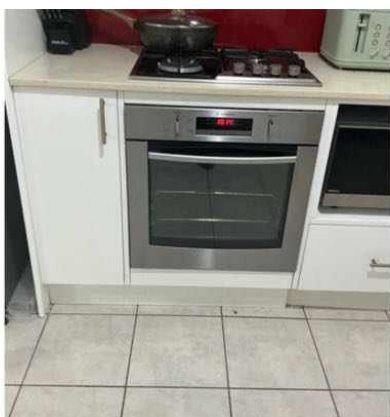
Building:	Main Building
Location:	Kitchen
Finding:	Unsecured Oven Installation
Information:	The electric oven located beneath the gas cooktop in the kitchen island was found to be unsecured.

During a light pull, the oven moved forward freely, presenting a potential safety hazard, especially if weight is applied to the open door. According to AS 4349.1–2007 Appendix C (C2.2 and C2.3), appliances should be properly installed to prevent movement or dislodgement.

This defect is considered a major safety concern due to the risk of injury or damage. Immediate rectification is recommended by a licensed kitchen installer or qualified tradesperson to properly secure the appliance in accordance with manufacturer installation instructions. Rectification should occur within 24–48 hours to eliminate the risk.

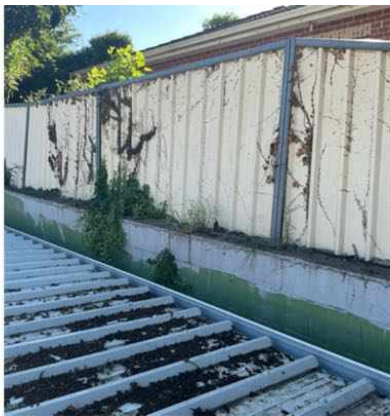
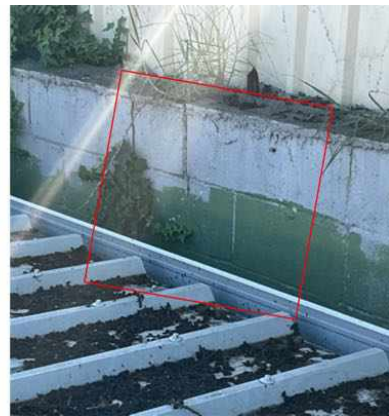
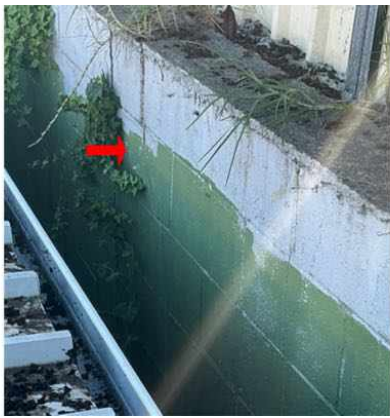
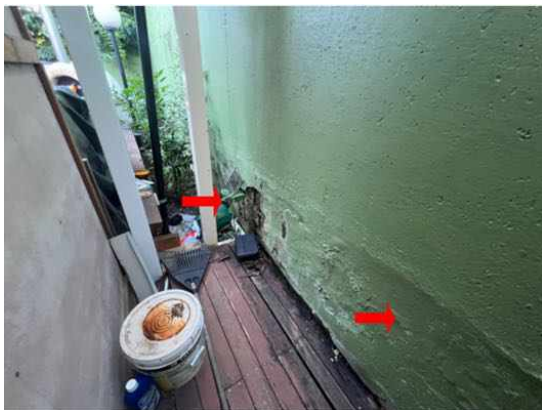
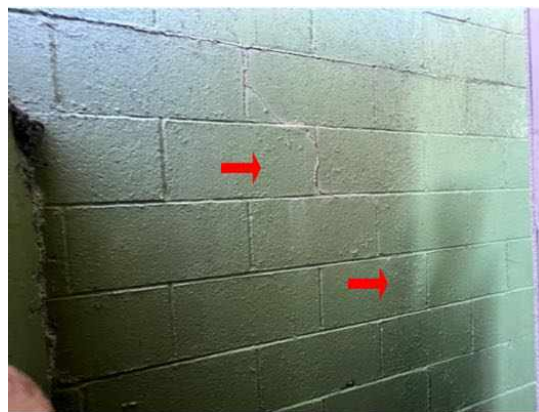
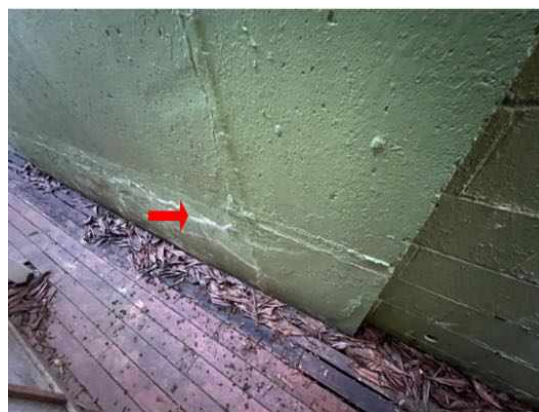
#### Finding 2.01

Building:	Main Building
Location:	All External Areas
Finding:	Retaining wall - Defective - Cracking , spalling concrete , damp and possible lean requires further investigation
Information:	The retaining wall in this area was found to be defective at the time of inspection. Generally, defective retaining walls are caused by poor original design or material use.

However, deteriorated retaining walls may also be a result of substandard construction, poor site drainage or unmanaged stormwater flows.

If left unmanaged, the retaining wall may become a safety hazard if it continues to destabilise. Where retaining walls further rot and decay, an environment is created that is conducive to termite and pest infestation.

Significant repair and replacement should be expected. Where retaining walls are considered structural walls, a structural engineer / surveyor should be consulted regarding required remedial works. Otherwise, a landscaper or retaining wall installer may be appointed to repair or replace the wall, at the discretion of the client.

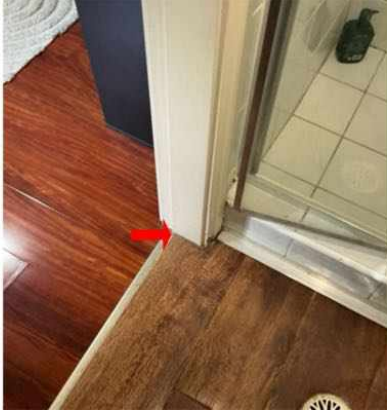
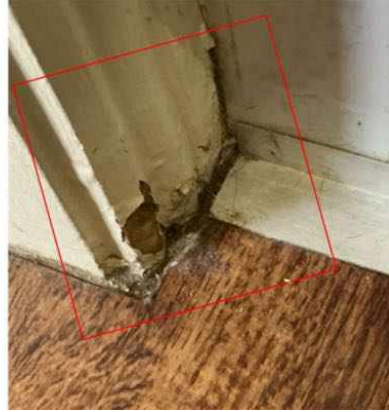
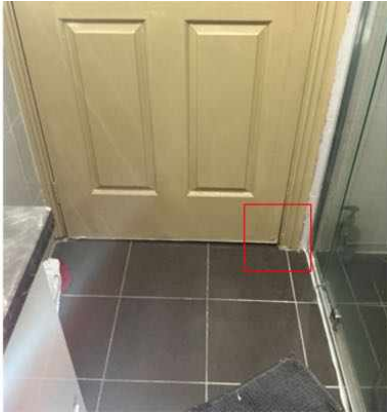
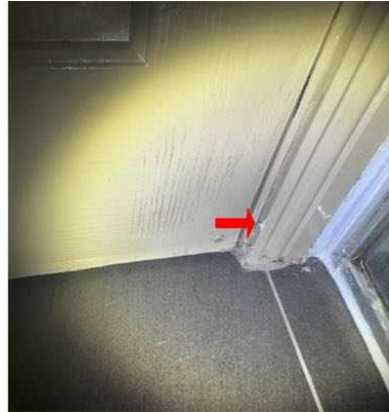
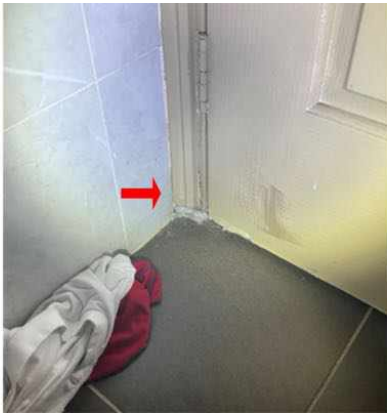
## Finding 2.02

Building:	Main Building
Location:	Bathrooms
Finding:	Wet-Area Door Jambs – Moisture Staining / Decay (Also refer to 3.1)
Information:	moisture staining and deterioration were observed at the base of the wet-area door jamb and architraves. This is commonly due to water splashing or moisture tracking from the bathroom floor into adjacent joinery or inadequate waterproof transition at the bathroom threshold.

Further inspection by a licensed waterproofing contractor is recommended to verify exact cause and remedial measures. A further invasive inspection by a licensed timber pest is also recommended to check for concealed activity.

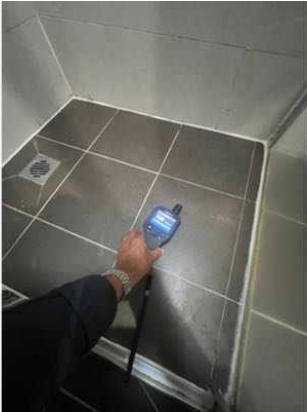
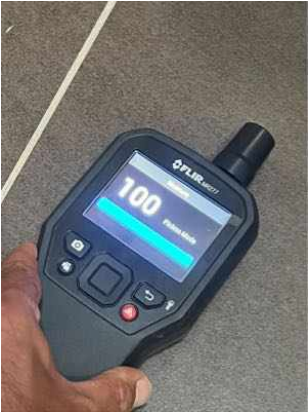
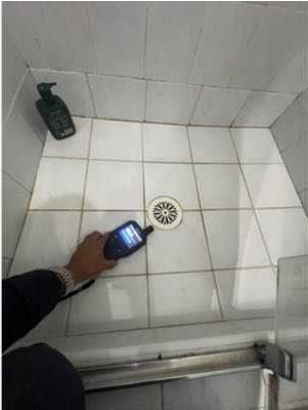
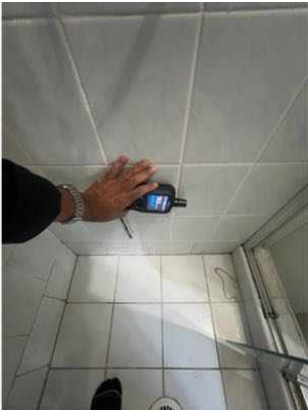
### Finding 3.01

Building:	Main Building
Location:	Bathroom, Ensuite
Finding:	Elevated Moisture Bathroom & Back of shower - Further investigation recommended (Possible waterproofing)
Information:	Elevated moisture levels were detected to tiled surfaces in bathroom/shower areas. This may be due to porous or missing grout, cracked tiles or recent use, however the

possibility of waterproofing membrane failure or plumbing leaks cannot be excluded. Persistent moisture ingress can lead to concealed damage, including timber rot and mould growth. Further investigation by a licensed plumber and/or waterproofing contractor is recommended as soon as possible. The back of shower area also showed elevated moisture but no visible deterioration was evident at the time of inspection.

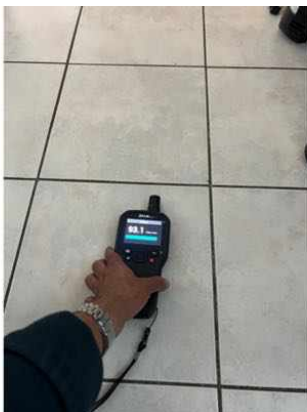
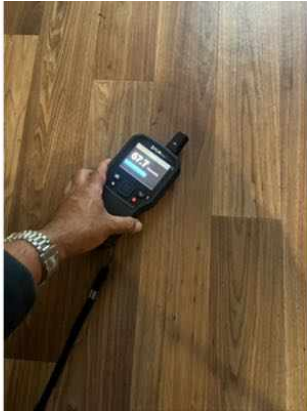
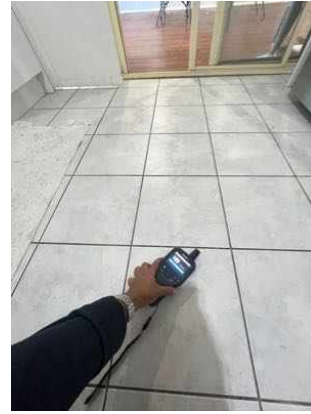
### Finding 3.02

Building:	Main Building
Location:	All Internal Areas - Flooring
Finding:	Elevated Moisture – Further Investigation Recommended
Information:	Elevated moisture readings were detected in several locations in the flooring, with no visible surface issues, although no significant structural damage was evident at the time of inspection, dampness can contribute to deterioration if left unaddressed.

Moisture meters can be affected by conductive materials beneath tiled finishes, including screeds, adhesives, salts, or embedded services, which may result in high readings that do not necessarily indicate active moisture ingress. However, consistently high readings across multiple areas may also indicate the presence of retained moisture beneath the tiled surfaces.

A further investigation by a licensed plumber or waterproofing specialist is recommended to confirm the source and ensure no concealed issues are developing.

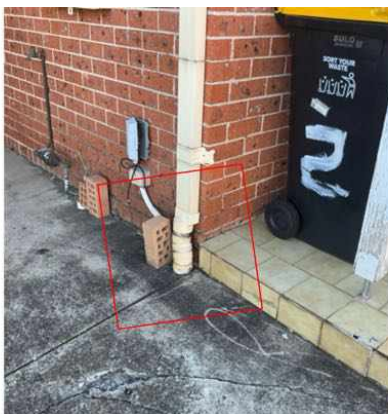
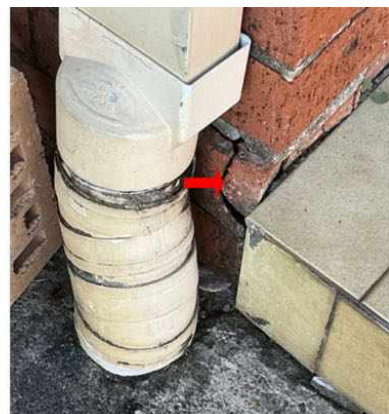
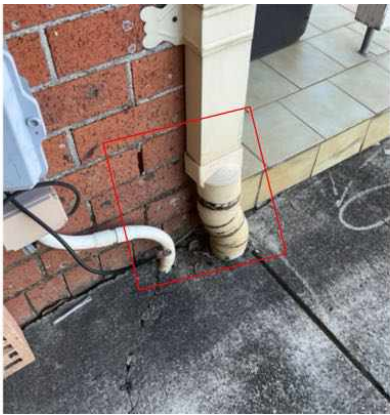
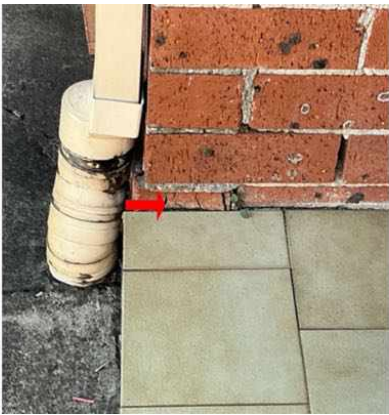
### Finding 3.03

Building:	Main Building
Location:	All External Areas
Finding:	Brickwork - Cracking noticeable to some areas
Information:	There were several cracks and or crack repairs evident to external brickwork.

Noticeable cracks are a common occurrence in external brickwork and are a likely result of age expected building movement, general expansion, and/or contraction of building materials in different weather conditions. Noticeable cracks in brickwork may develop if left unattended, with potential for necessitating major remedial works or replacement of the brickwork.

It is highly advised that a qualified bricklayer be appointed to provide necessary works to cracked brickwork to prevent any further damage. Such works should be conducted as soon as possible.

Always monitor these cracks and contact a building inspector should cracks widen, lengthen, or become more numerous.

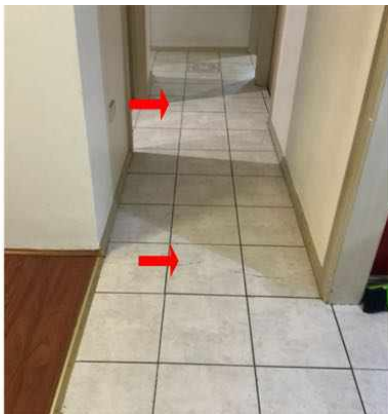
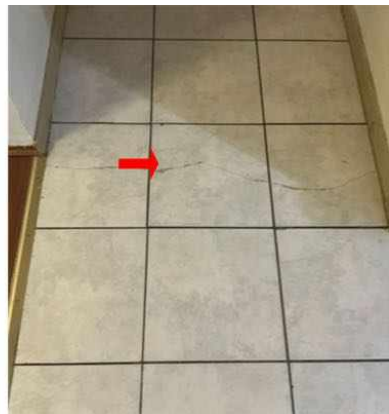
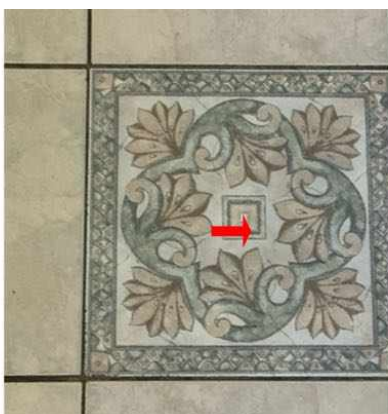
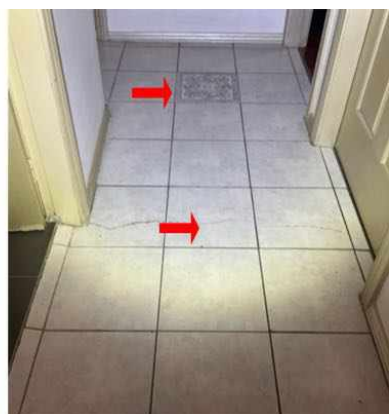
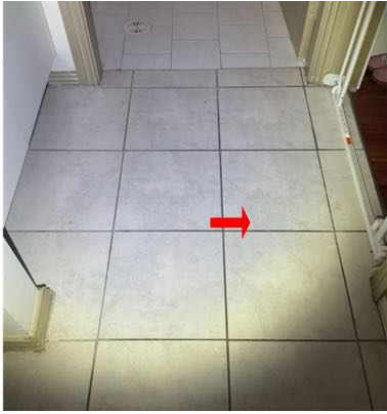
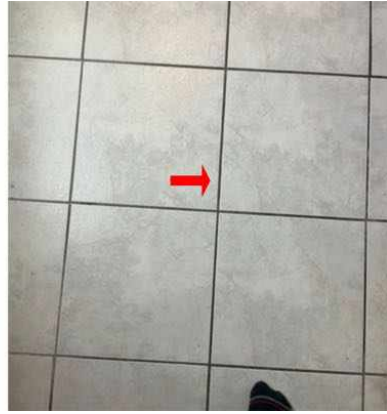
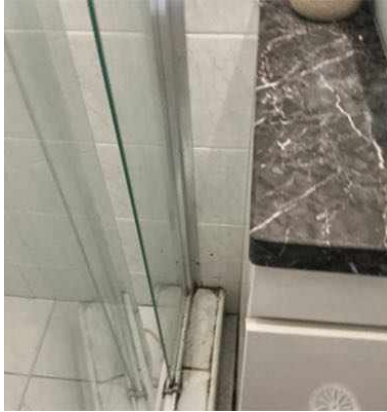
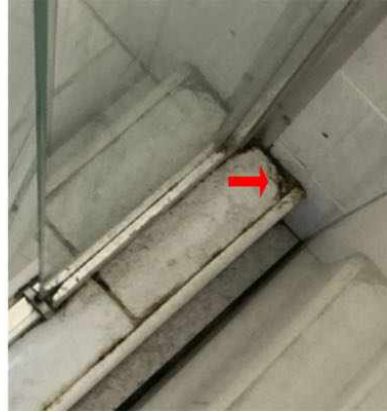
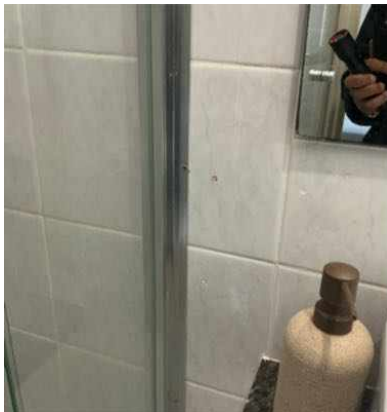
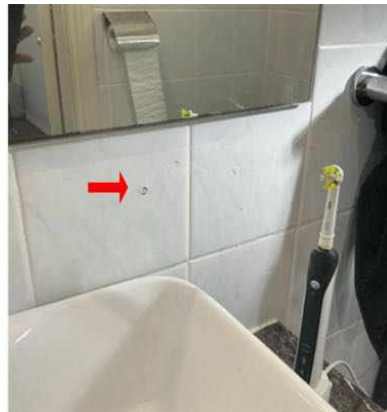
Finding 3.04

Building: Main Building  
Location: All Internal Areas  
Finding: Floor tiles - Cracked to some areas  
Information: Cracking in the floor tiles was evident in this area at the time of inspection. It is suspected that this cracking has occurred as a result of the floor being uneven and lacking a solid or suitable foundation for the tiles to be laid on. Settlement in the floor foundations may also have caused movement and resulted in the cracking of tiles in this area.

Cracked tiles throughout the household detract from the overall appearance of the affected areas, as well as creating potential for water penetration to adjoining building elements. If left unmanaged, water damage may occur as a result of constant water penetration over a prolonged period of time.

While not considered a matter of urgency, replacement of cracked floor tiles is advised as a solution. A tiling contractor or general handyperson may be appointed to perform these works at client discretion. Where cracks become more numerous, consultation with a registered builder specialising in re-stumping may be required.

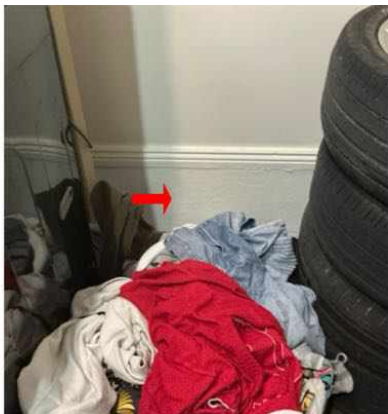
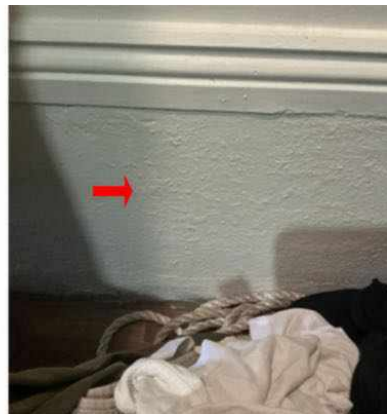
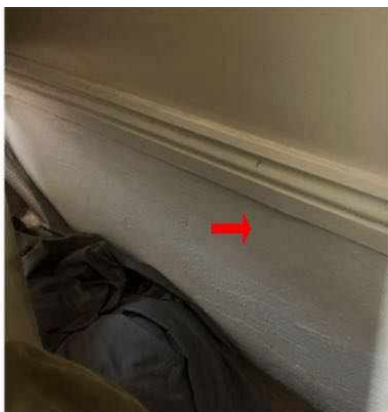
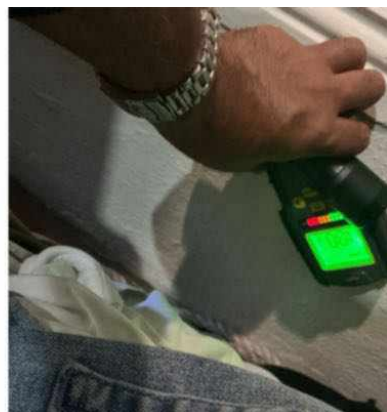
### Finding 3.05

Information: Damp (or structural damp) refers to the presence of unwanted moisture in the structure of a building, either as the result of intrusion from outside, or condensation from within the structure. Generally, structural damp is caused by rain penetration, rising damp, and leaks from plumbing pipes.

Unmanaged damp facilitates the formation and development of mould, fungi growth and wood rot, decaying associated building materials and compromising their structural integrity. Damage to finishes is also likely to occur, including lifting, bubbling,

peeling and staining of paint, plaster and wallpaper.

The first step in addressing damp is to diagnose the cause. The identified cause should be addressed first prior to repairing the appearance and other defects which have resulted from the rising damp. If the original cause is not resolved, further cases of damp are likely to ensue, resulting in secondary defects.

Consultation with a qualified plumber is advised immediately to identify the cause of damp and perform remedial works as required. Where excessive mould growth is present, further inspection by a specialist environmental health inspector should also be considered.

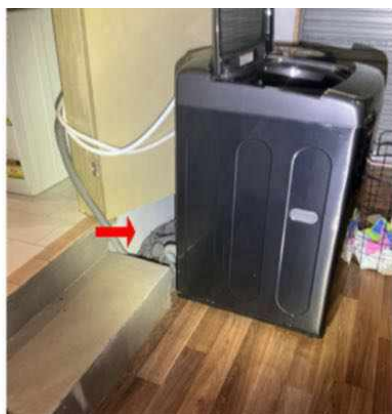
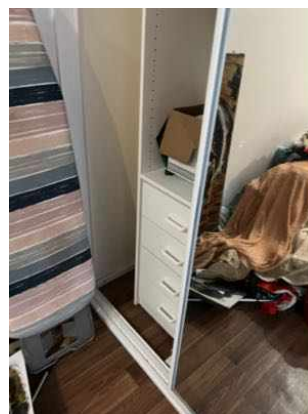
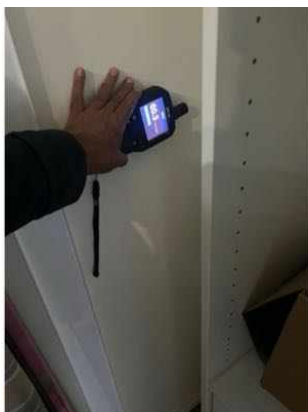
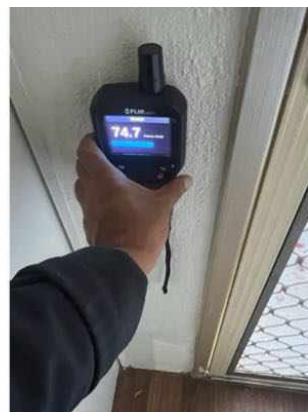
It is important to address damp conditions, as the World Health Organisation notes that excess moisture leads - on almost all indoor materials - to growth of microbes such as moulds, fungi and bacteria, which subsequently emit spores and other matter into the indoor air. Exposure to these contaminants is associated with a wide range of respiratory and other health-related problems. Additionally, the development of damp in timber building elements also provides an environment that is conducive to termite / timber pest attack.

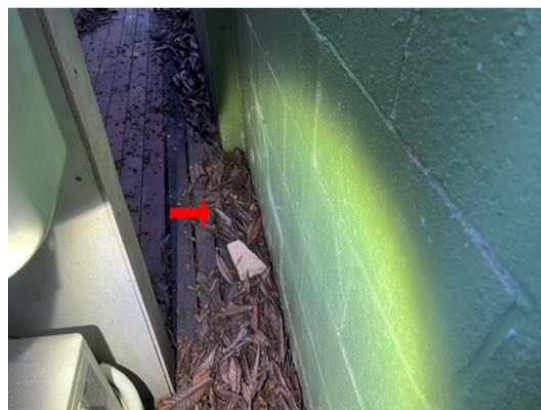
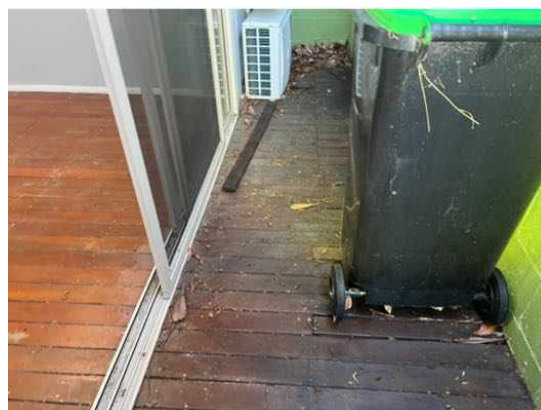
### Finding 3.06

Building:	Main Building
Location:	All External Areas
Finding:	Site drainage - Inadequate
Information:	The site drainage in this area was found to be inadequate at the time of inspection, creating potential for subsequent water damage to associated building elements.

It is important that water does not lie against the base of walls; surrounding paths and ground levels should be sloped to drain water away from walls. Downpipes should not discharge stormwater onto lower walls or plinths. Stormwater should be carried away by large, regularly cleaned drains. Ground levels may need to be lowered to expose a buried DPC.

Where site drainage is inadequate, installation of an Agricultural (Aggie) Drain may be required. A qualified plumber should be appointed to further inspect the property and perform any remedial works as necessary. Water damage and secondary defects are likely to occur if left unmanaged.

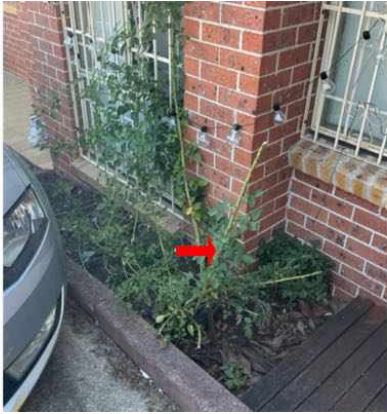
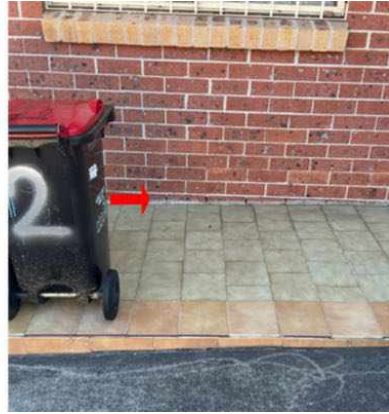
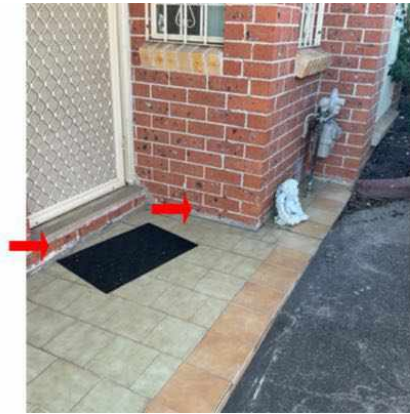
### Finding 3.07

Building:	Main Building
Location:	All External Areas
Finding:	DPC & Weep Holes
Information:	The ground level is nearly flushed or level with no visible step-down or separation from the weep holes or the damp-proof course (DPC). This presents a moisture risk, as AS 2870 and NCC Volume 2 Part 3.1.2 require ground levels or hard surfaces to be at least 75 mm below the DPC or the lowest course of brickwork with weep holes to prevent rising damp or lateral moisture ingress. Monitoring is recommended along with creating a 75 mm clearance or isolation gap along the wall line as required by NCC Vol 2 Part 3.1.2.3 and AS 2870 Clause 5.3.3. Monitor for any signs of rising damp or

efflorescence.

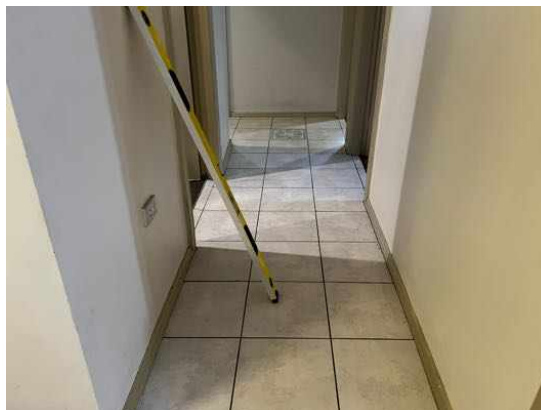
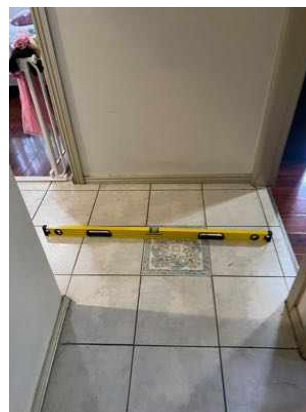
### Finding 3.08

Building: Main Building  
 Location: All Internal Areas  
 Finding: Flooring - Uneven  
 Information:

The internal flooring in this area is out of level and uneven. Uneven flooring is likely to indicate minor defects such as expected movement of the foundations of the property, but may also indicate subsidence of the associated subfloor stumps.

It is advised that the flooring be closely monitored to identify any further movement. Where flooring remains relatively unchanged for an extended period of time (i.e. several months), it is likely that this defect has been caused by expected movement of the foundations of the property.

However, where flooring is uneven further, potentially invasive inspection of the subfloor structures and stumps in this area is required. In this case, works to repair are likely to be required, and would be carried out by a registered builder

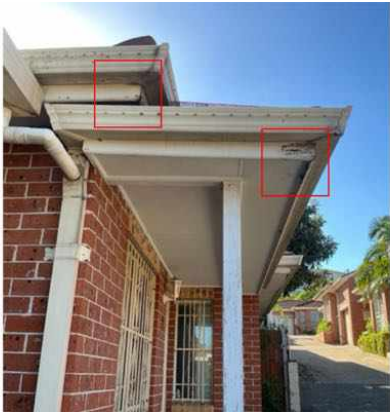
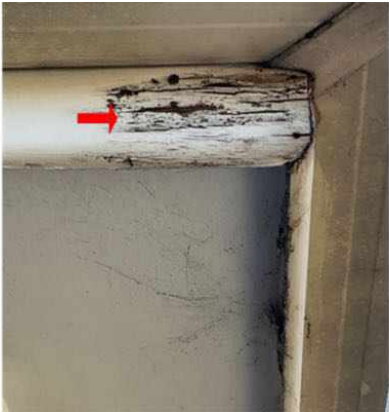
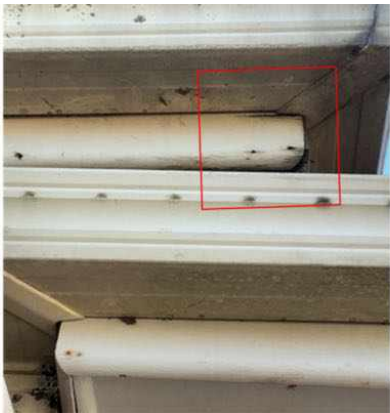
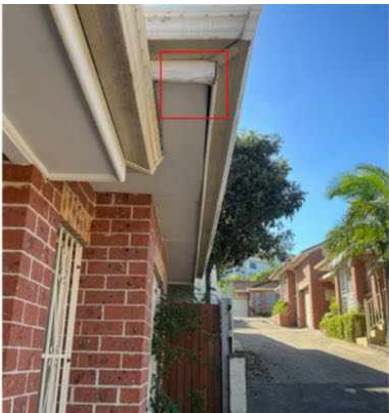
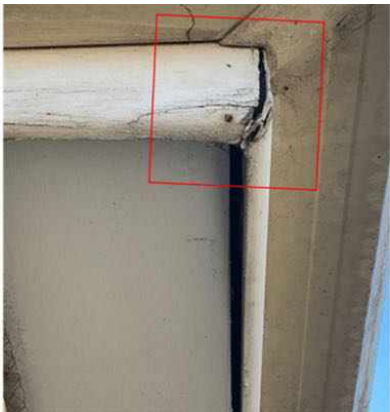
### Finding 3.09

Building:	Main Building
Location:	All External Areas
Finding:	Fascias - Wood rot
Information:	Wood rot was found to be affecting fascias and barges in this area, evidenced by the presence of mould on the surface in some areas. Wood rot, also known as Fungal Decay, occurs when timbers and other cellulose building materials are exposed to damp conditions on an ongoing basis.

It is likely that this wood rot has developed as a result of faults in the roof plumbing, creating excessive moisture in this areas. Frequent exposure to rain and other weather conditions also make fascias and barges susceptible to accelerated deterioration.

Early intervention and regular maintenance will prolong the useful life of these building elements. Prior to any works being performed, the cause of the moisture that has created the visible wood rot should be identified and addressed in a suitable manner.

It is advised that a roof plumber be appointed to inspect all roof plumbing and subsequently identify the cause of the wood rot. Replacement of affected fascias and barges may then be a necessary step in protecting surrounding building elements from such deterioration.

A qualified plumber may be appointed to assess the cause of excessive moisture and

to provide advice on any remedial works as required. A qualified carpenter or registered builder may also be required to replace affected building materials.

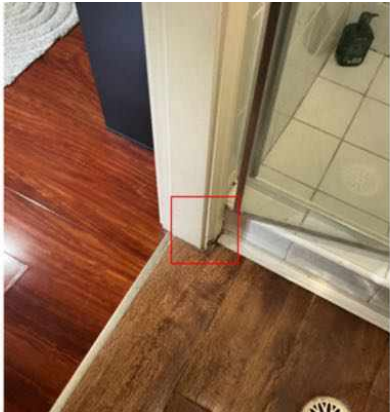
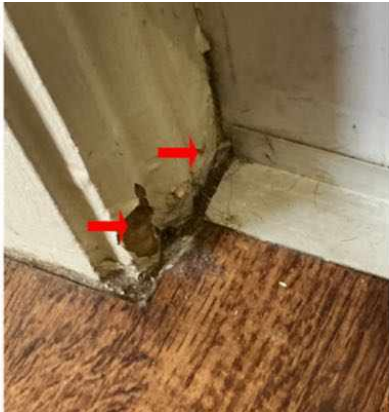
### Finding 3.10

Building:	Main Building
Location:	All Internal Areas
Finding:	Wood rot to some areas
Information:	This building element shows evidence of wood rot. Wood rot, also known as Fungal Decay, occurs when timbers and other cellulose building materials are exposed to damp conditions on an ongoing basis. This could be the result of exposure to weathering over a prolonged period of time, or the attraction of excessive moisture from other abutting building materials. Contributing factors also include poor air ventilation in the area.

Wood rot is often associated with general damp problems and is evidenced by a 'musty' smell or mould and mildew occurring on surfaces. If left unmanaged, damp conditions can lead to further health problems and the decay of timbers will continue.

Early intervention and regular maintenance, particularly of exterior timbers, will prolong the useful life of these building elements. Prior to any works being performed, the cause of the moisture that has created the visible wood rot should be identified and addressed in a suitable manner. Replacement of affected timbers may then be a necessary step in protecting surrounding building elements from such deterioration.

A qualified plumber may be appointed to assess the cause of excessive moisture and to provide advice on any remedial works as required. A qualified carpenter or registered builder may also be required to replace affected building materials.

Even though Liver termite activity was not visible. A further invasive inspection by a licensed termite technician its also highly recommended to eliminate possibility of potential termite activity.

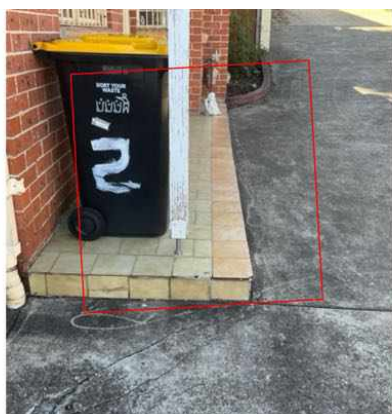
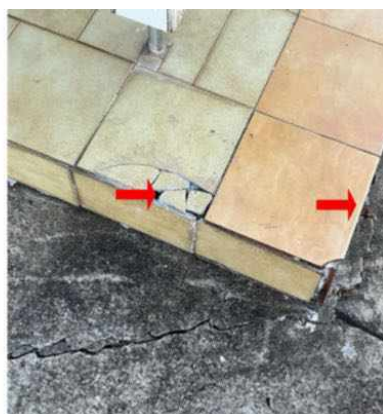
Finding 3.11

Building:	Main Building
Location:	All External Areas
Finding:	Floor tiles - Cracked
Information:	Cracking in the floor tiles was evident in this area at the time of inspection. It is suspected that this cracking has occurred as a result of the floor being uneven and lacking a solid or suitable foundation for the tiles to be laid on. Settlement in the floor foundations may also have caused movement and resulted in the cracking of tiles in this area.

Cracked tiles throughout the household detract from the overall appearance of the affected areas, as well as creating potential for water penetration to adjoining building elements. If left unmanaged, water damage may occur as a result of constant water penetration over a prolonged period of time.

While not considered a matter of urgency, replacement of cracked floor tiles is advised as a solution. A tiling contractor or general handyperson may be appointed to perform these works at client discretion. Where cracks become more numerous, consultation with a registered builder specialising in re-stumping may be required.

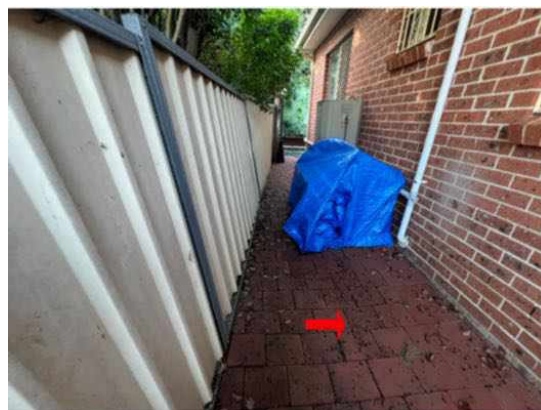
### Finding 3.12

Building:	Main Building
Location:	All External Areas
Finding:	Paving - Uneven
Information:	Sections of the external paved area are uneven, creating a potential trip hazard. It appears as though the area has been subject to rough installation, or that paving sections have lifted due to movements in the foundation of the property.

Where paving creates a trip hazard, personal injury may ensue if due caution is not taken by all persons within this area.

Re-paving of the area is required as soon as possible to remedy this situation. Further consultation with a specialist concreter is advised.

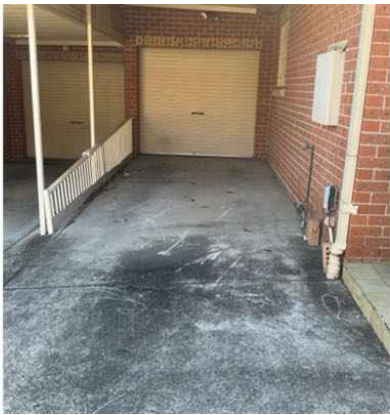
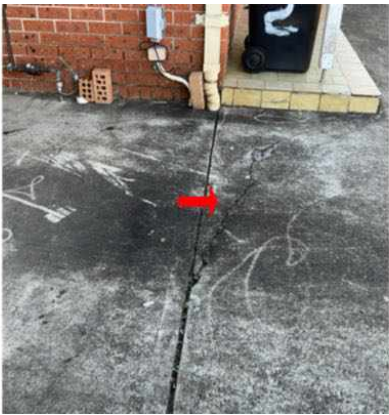
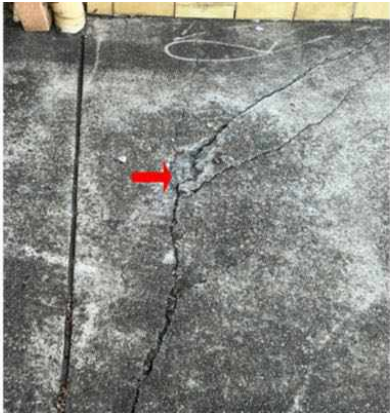
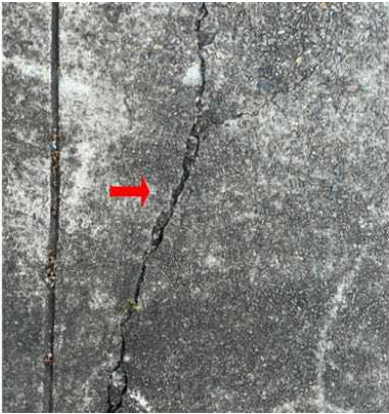
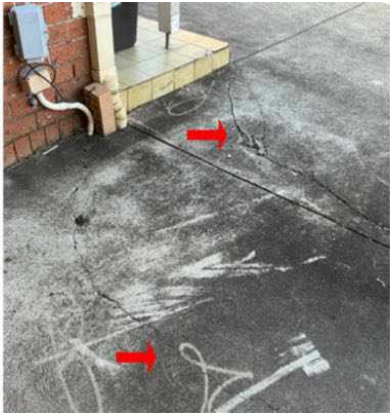
### Finding 3.13

Building:	Main Building
Location:	All External Areas
Finding:	Cracking - External Concrete Paving Damage Category 4 - Gaps in Slab (4mm - 10mm +)
Information:	Gaps in the slab were identified in external concrete paving. Gaps in the slab are significant and are likely to lead to the development of safety hazards and secondary defects if left unmanaged, such as the creation of a trip hazard.

General age and expected deterioration of the paved areas is a common cause of this type of cracking. However, expansion and contraction of the slab may also have occurred due to environmental factors. Such factors include variable moisture and weather conditions, the presence of trees and their roots having a settling or lifting affect on the soil, or the effect of load bearing, e.g. heavy vehicles over a sustained period of time.

Cracking to this degree may also be due to poor original installation of the concrete. Factors such as poor compaction of the sub surface and/or inadequate reinforcing of the slab may create cracking and other secondary defects. Gaps in the concrete paving may also have a more significant structural cause, such as subsidence of soils.

Where gaps in the concrete paving are adjacent to structural elements of the building, the advice of a Structural Engineer is advisable before undertaking repairs. Significant repair and likely replacement of the concrete paving is probable.

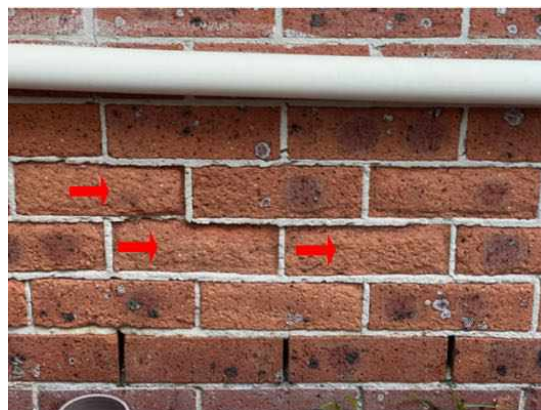
**Finding 3.14**

Building: Main Building  
Location: All External Areas  
Finding: Brick Erosion to some areas  
Information: The external brickwork exhibits signs of erosion at the base of the wall, with surface deterioration likely due to prolonged moisture exposure, or ground splashback. If left untreated, it may lead to further material loss and compromise the protective paint coating. It is recommended that affected bricks and mortar joints be assessed and remediated by a qualified bricklayer to ensure ongoing durability and to maintain the wall's weatherproofing function.

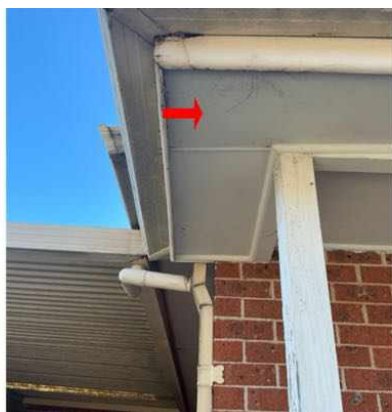
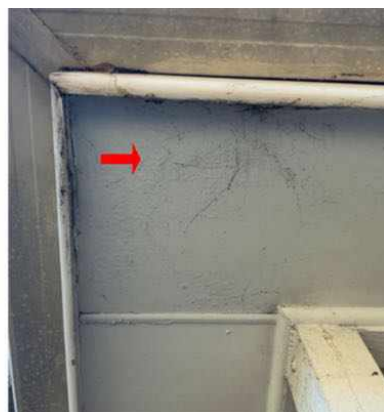
### Finding 3.15

Building:	Main Building
Location:	All External Areas - eave
Finding:	Painted surface - Bubbling
Information:	Sections of paint in this area was found to have bubbled and deteriorated. Paint bubbling is generally an indication of excessive moisture in the area, that is currently hidden by the painted surface.

The presence of excessive moisture can have major implications on associated building elements if left unattended. While only seemingly minor at this stage, the damage cannot be determined due to the paint obstructing any further inspection of the damage.

It is highly advised that the affected paint be cleaned to allow a further, more invasive inspection by a licensed plumber. Failure to act on this defect may necessitate major works in the future.

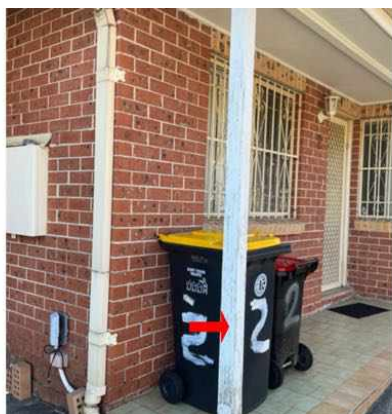
### Finding 3.16

Building:	Main Building
Location:	All External Areas
Finding:	External painting deteriorated

**Information:** Whilst incomplete or missing paint finish is generally an appearance defect, it can also lead to the development of secondary building defects over time. Incomplete areas of paint finish expose the area to moisture, potentially accelerating the deterioration of underlying building materials.

Degraded paint finishes should be sanded back, filled, leveled and painted, as applicable. Where inadequate or missing paint protection has led to the deterioration of the associated building element, repair and/or replacement of this building element may be required.

A painting contractor should be appointed as soon as possible to perform necessary works to aid the appearance of the affected area and to ensure the area is protected against further deterioration. Alternatively, the homeowner following manufacturer instructions may perform these works.

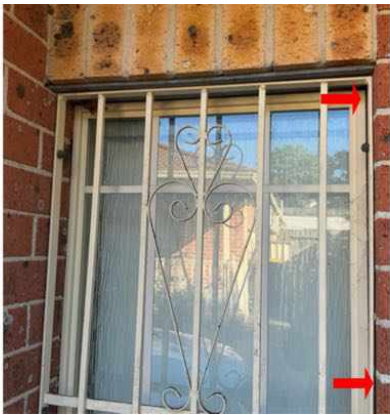
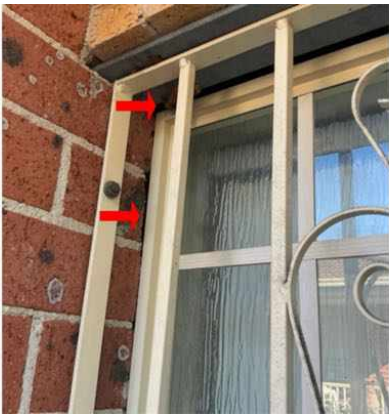
### Finding 3.17

**Building:** Main Building  
**Location:** All External Areas  
**Finding:** Gap Between Window Frame and Masonry to some areas  
**Information:** A visible gap is present between the external window frame and the adjacent masonry wall. This gap may allow water ingress, air infiltration, and potential pest entry if not adequately sealed. Over time, such exposure can contribute to frame deterioration, internal water damage, or reduced thermal performance. Sealing or filling the gap with a suitable weatherproof compound is recommended to maintain the integrity of the building envelope, in accordance with good building practice and AS 4349.1

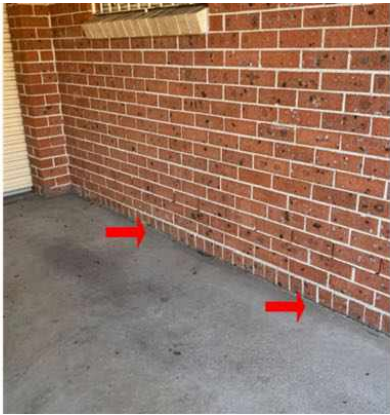
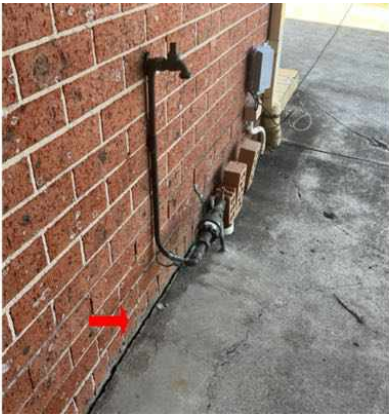
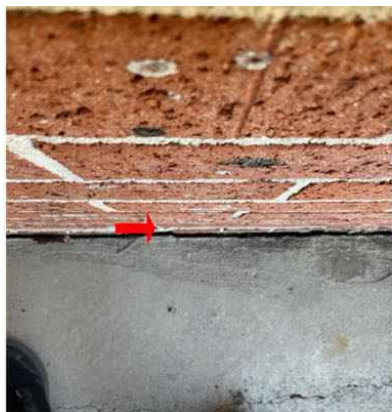
**Finding 3.18**

Building: Main Building  
Location: All External Areas  
Finding: Gap Between Concrete and External Wall - to some areas  
Information: Visible gaps were observed between the external masonry wall and adjacent concrete slab at the pathway.

This separation may permit water ingress and contribute to concealed moisture-related damage, pest ingress, or slab movement if left unsealed.

The defect appears consistent with common differential settlement or poor sealant detailing at the slab-to-wall junction. Recommend a licensed contractor seal the gap with an appropriate flexible, UV-stable exterior-grade sealant to prevent moisture entry and pest intrusion.

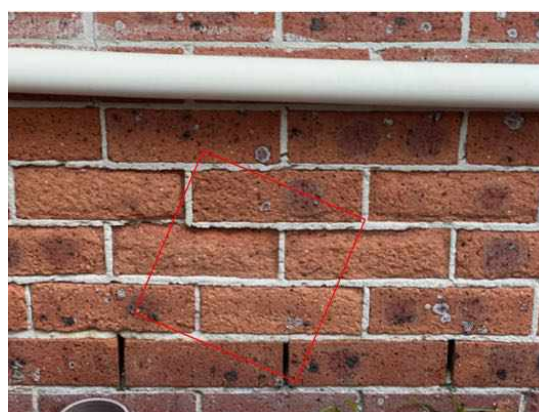
### Finding 3.19

Building:	Main Building
Location:	All External Areas
Finding:	Brickwork - Deteriorated mortar to some areas
Information:	Mortar, or 'bedding', is the material which fills joints and intersections between bricks in masonry walls and structures. Sections of mortar in this brickwork were identified as having deteriorated, which is generally expected for a property of this age and condition.

Mortar may deteriorate as a result of age of building materials, minor movement of bricks, or frequent exposure to weathering. Mortar should be replaced to ensure that bricks remain in their intended location and to prevent gaps, which would allow water or moisture ingress and secondary damage as a result.

Mortar deterioration can be addressed by a bricklayer where areas of deterioration are localised and easily accessible. Alternatively, appointment of a registered builder is advised, to repoint large areas of decaying mortar. Where secondary structural defects have become evident, consultation with a structural engineer may be required.

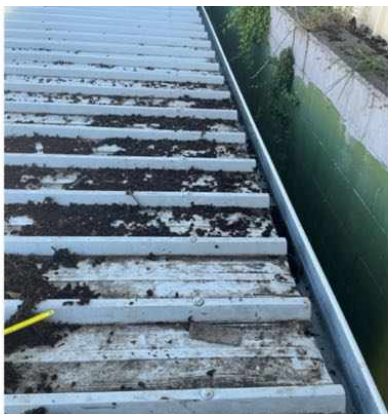
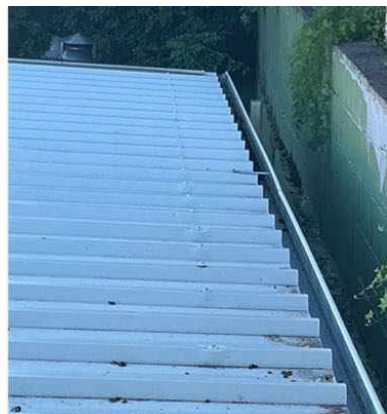
### Finding 3.20

Blocked gutters are likely to lead to high levels of moisture in the affected areas. Such moisture will not only cause rust and decay of the associated building materials, but can also provide conditions that are conducive to termite and timber pest activity. Blockages in gutters should therefore be removed immediately to ensure dry conditions are maintained.

Consult a Licensed Plumber for further specific advice on remedial works that may be required. In the interim, it is highly advised that blocked gutters be removed by the homeowner or a general handyperson as a matter of urgency.

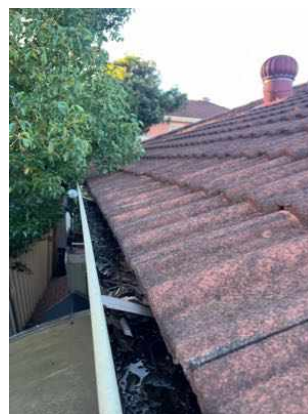
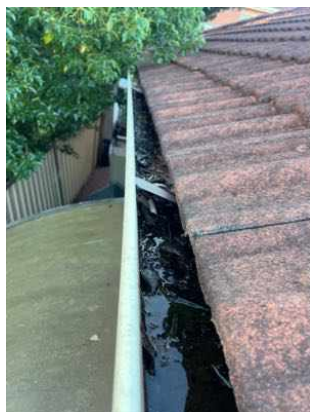
### Finding 3.21

Building:	Main Building
Location:	All External Areas
Finding:	Building element - Damaged - Eaves damaged to some areas
Information:	Breakage occurs generally when the building materials have either aged and decayed, or as a result of damage (accidental or deliberate).

Repair and/or replacement of broken elements is advised to ensure that additional secondary defects do not arise as a consequence. Such works are necessary, as all building elements play a key role in the operation and function of the overall structure and its performance.

A relevant tradesperson should be appointed to repair or replace the affected building element prior to any subsequent damage being caused.

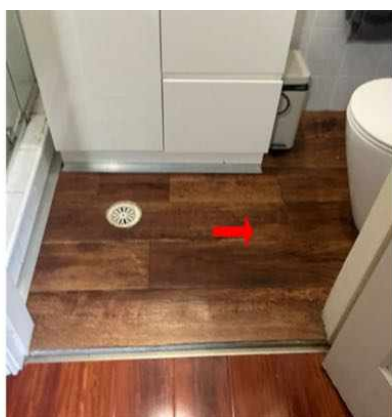
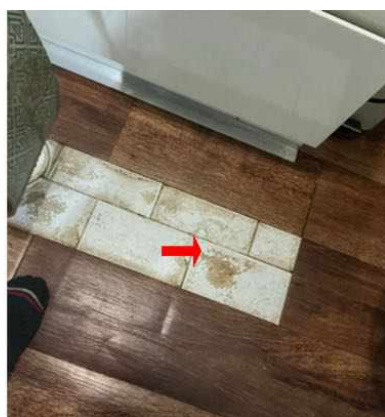
Finding 3.22

Building:	Main Building
Location:	Ensuite
Finding:	Incomplete or substandard works - Vinyl on tiles in bathroom
Information:	The works to this area appear to be incomplete or have been completed to a substandard level.

Works that have not been completed to a satisfactory level create potential for the development of building defects and may impede on the safety and integrity of the overall structure.

It is highly recommended that the relevant trades be appointed to complete these works and ensure the safety of the area and the longevity of all associated building elements.

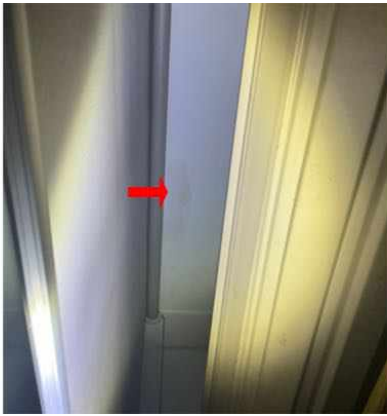
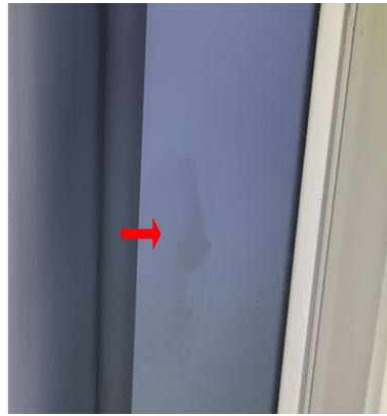
### Finding 3.23

Building:	Main Building
Location:	Garage
Finding:	Water staining
Information:	Water staining was evident in this area at the time of inspection. Water staining indicates that surfaces have been exposed to excessive moisture over time. The minerals and other elements in the water lead to staining, which may graduate to corrosion and deterioration if left unmanaged.

While mostly an appearance defect, water staining can be indicative of more serious defects, which may be currently concealed by other building elements.

Where water staining is active, a licensed plumber must be consulted to identify the cause of the staining and to provide advice on any reparation works that may be required. Replacement of any broken or damaged structures is advised.

Conversely, where water staining is old and inactive, affected building materials may be repaired or replaced at client discretion. A qualified carpenter or registered builder may be appointed to perform these works.

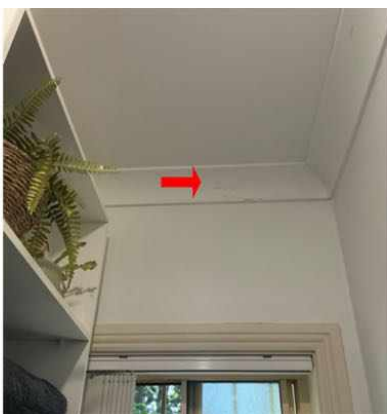
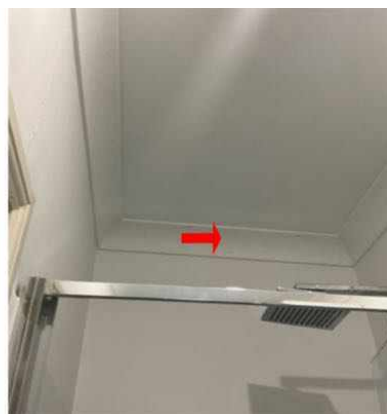
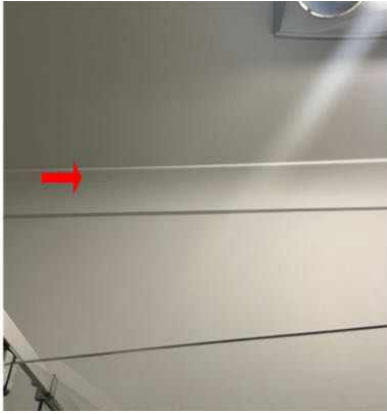
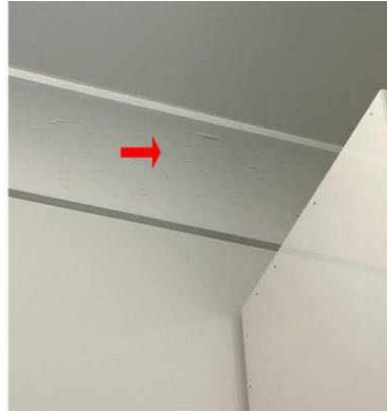
### Finding 3.24

Information: Sections of paint in this area was found to have bubbled and deteriorated. Paint bubbling is generally an indication of excessive moisture in the area, that is currently hidden by the painted surface.

The presence of excessive moisture can have major implications on associated building elements if left unattended. While only seemingly minor at this stage, the damage cannot be determined due to the paint obstructing any further inspection of the damage.

It is highly advised that the affected paint be cleaned to allow a further, more invasive inspection by a licensed plumber. Failure to act on this defect may necessitate major works in the future.

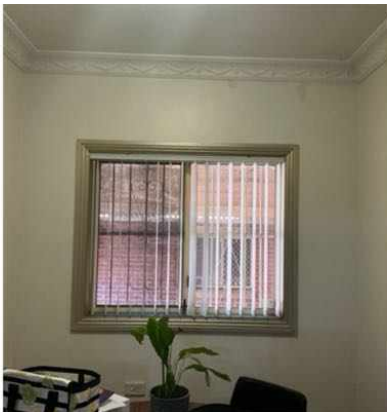
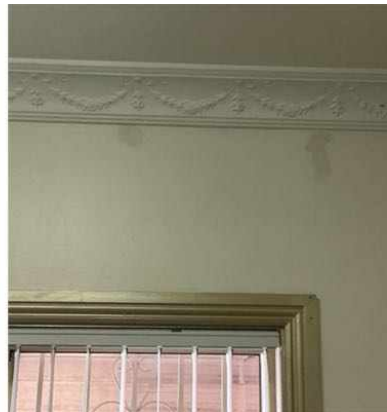
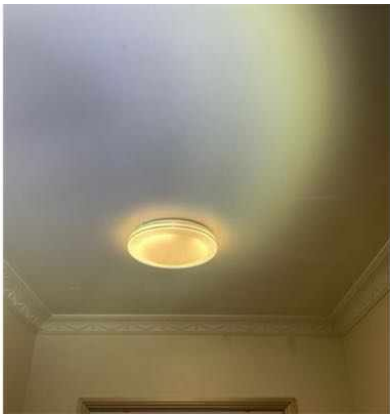
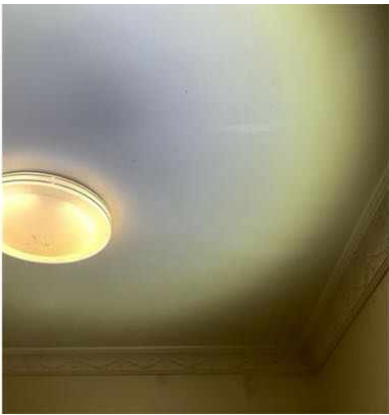
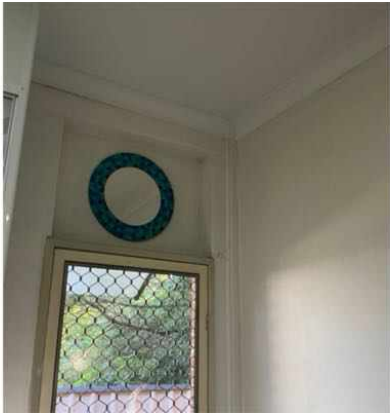
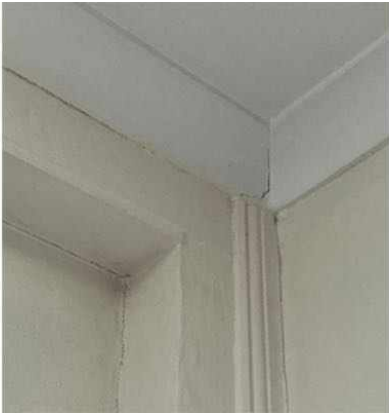
### Finding 3.25

Building:	Main Building
Location:	All Internal Areas
Finding:	Paint Finish & Hairline Cracking - To some areas
Information:	The paint finish in this area was identified as being incomplete at the time of inspection including some hairline minor cracking.

Whilst incomplete or missing paint and minor cracking and imperfections in finish is generally an appearance defect, it can also lead to the development of secondary building defects over time. Incomplete areas of paint finish expose the area to moisture, potentially accelerating the deterioration of underlying building materials.

Incomplete paint finishes should be sanded back, filled, leveled and painted, as applicable. Where inadequate or missing paint protection has led to the deterioration of the associated building element, repair and/or replacement of this building element may be required.

A painting contractor should be appointed as soon as possible to perform necessary works to aid the appearance of the affected area and to ensure the area is protected against further deterioration. Alternatively, the homeowner following manufacturer instructions may perform these works.
