# Building and Timber Pest Inspection Report

Inspection Date: Tue, 24 Mar 2026

Property Address: 2/9 Hart Dr, Constitution Hill NSW 2145,  
Australia

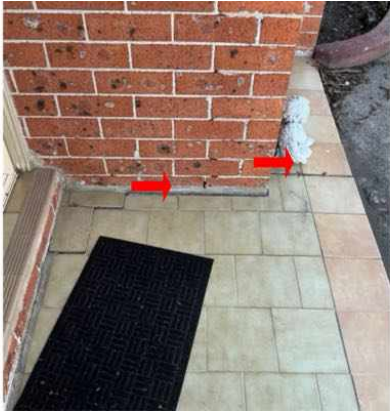
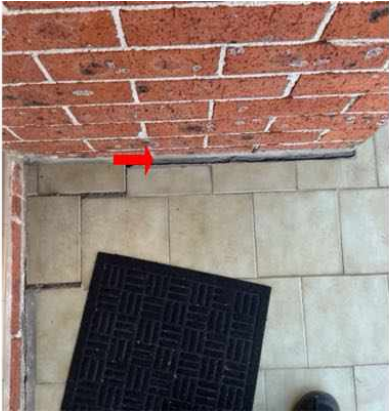
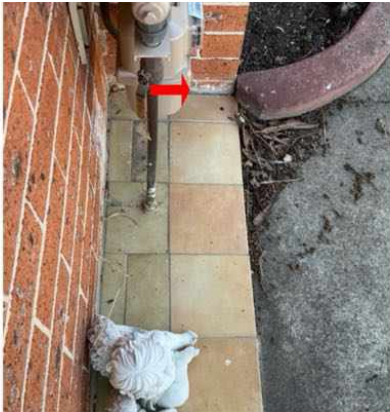
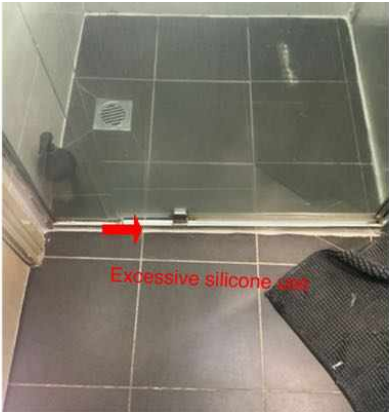
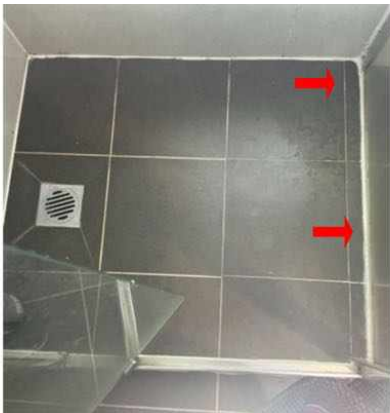
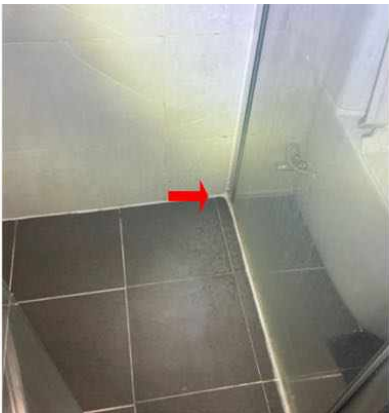
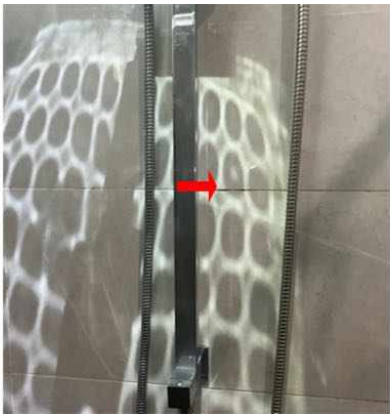
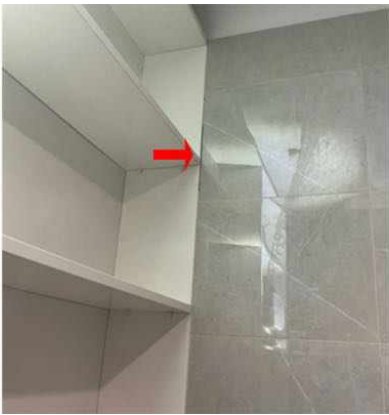
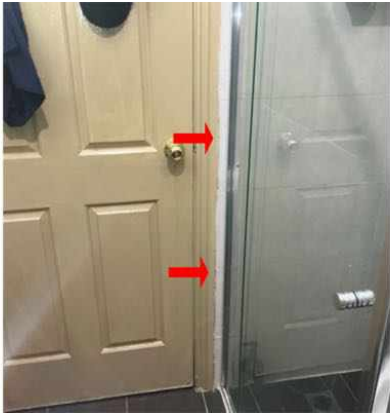
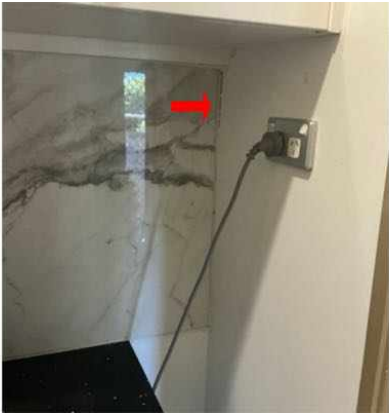
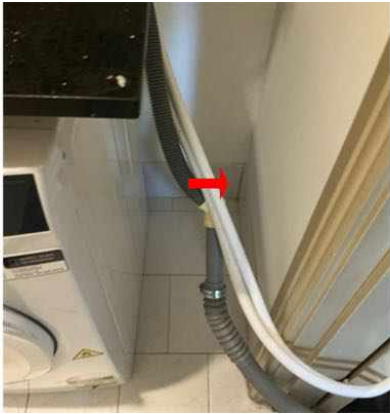
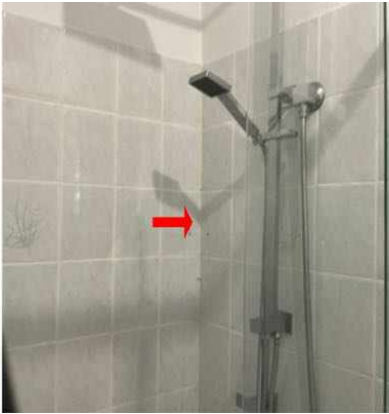
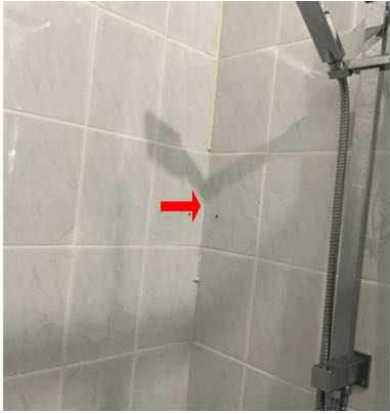
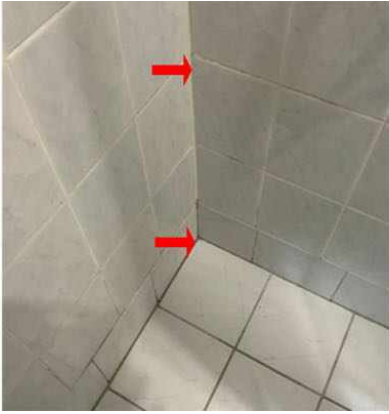
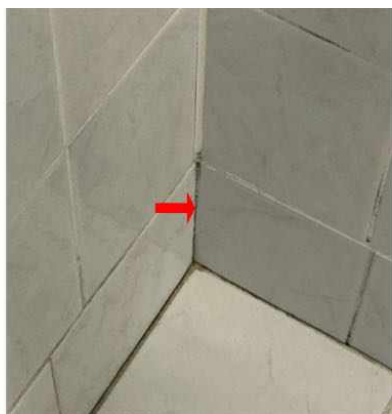
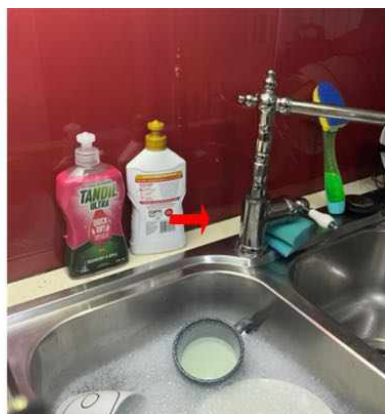
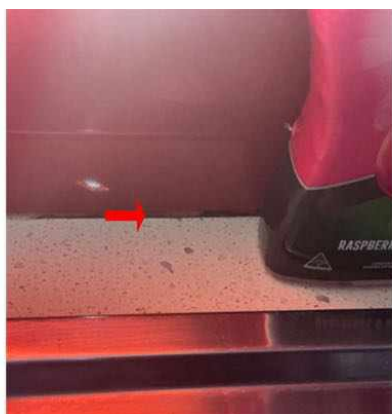
Building:	Main Building
Location:	All Internal Areas
Finding:	Sealant and grouting - Missing or degraded to some areas
Information:	It was noted on inspection that sealant or grout is degraded.

Different materials and floor areas move at different rates, generally causing cracking to grout or sealant at this point. A flexible sealant is required to allow for expected expansion and contraction, while keeping the joint water tight and protective of all associated building materials.

Excessive mould to the sealant and grout may require scraping out and replacement.

Flexible and mould resistant materials should be applied to affected areas to prevent any subsequent water damage that is likely to occur. Regular maintenance and replacement of damage or missing or damaged sealant and grout is highly recommended to the wet areas, as this is a regular wear and tear defect. Sealant and grouting in areas that come into regular contact with water should be maintained for the long term care of your property.

A sealant specialist or tiling contractor should be appointed to complete these works as soon as possible

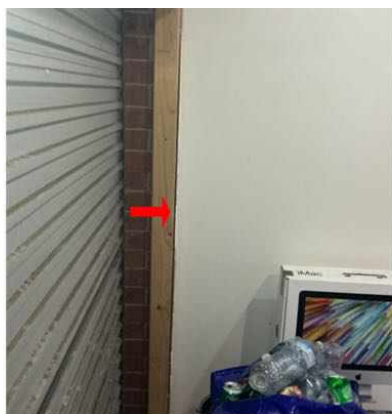
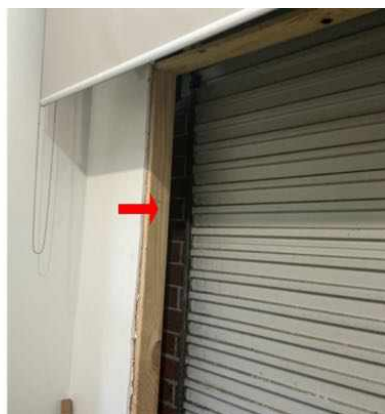
### Finding 3.27

Building:	Main Building
Location:	All External Areas - Garage , Right exterior
Finding:	Installation - substandard or incomplete
Information:	The installation of this building element appears to have been completed to a substandard level of workmanship or is incomplete. Generally substandard repairs or installation are related to poor workmanship, the use of inappropriate materials, or a failure to complete installation to a suitable standard.

Where installation is substandard and/or incomplete, the client should contact the responsible trade to undertake rectification. Unfinished and substandard building works are likely to degrade more quickly and may create potential for secondary defects to associated building elements.

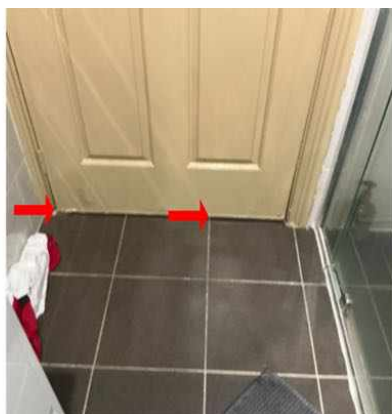
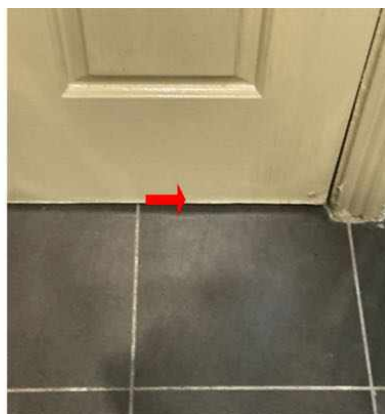
### Finding 3.28

Building:	Main Building
Location:	All Internal Areas
Finding:	Delamination of timbers
Information:	Localised delamination and surface deterioration were observed to sections of laminated joinery panels. This condition commonly occurs where moisture exposure or wear causes separation of laminate finishes from the underlying substrate. The defect is generally cosmetic in nature but may worsen over time if moisture exposure continues. Repair or replacement of affected joinery components may be considered as part of routine maintenance.

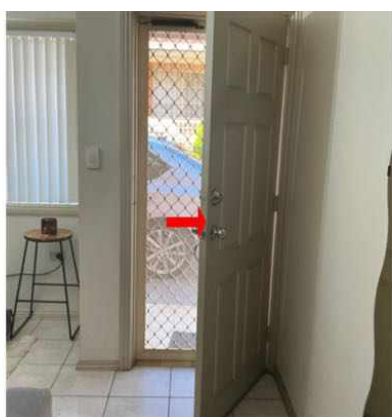
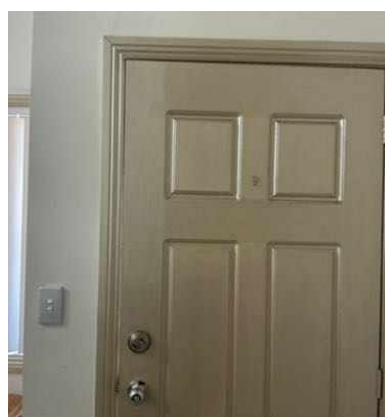
### Finding 3.29

Building:	Main Building
Location:	All Internal Areas - Front ,
Finding:	Doors - Binding/Jamming
Information:	Binding and/or jamming of several doors throughout the property were evident during standard operation. This defect inhibits the functionality of affected doors as well as creating potential for secondary defects to associated building elements, such as damage to the floor covering.

A door that binds to flooring or to the associated door frame may have several causes, ranging from minor defects, such as poor installation of the door or deteriorated hinges, through to major structural issues, such as damage to subfloor structures.

Where door binding/jamming appears to indicate major structural issues, a registered builder specialising in re-stumping should be appointed to provide an estimate on the cost of rectification.

For minor causes, a qualified carpenter or general handyperson should be appointed to perform minor rectification works at client discretion.

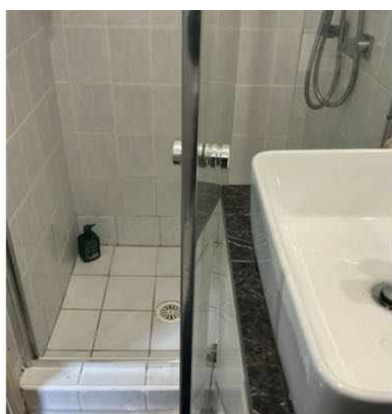
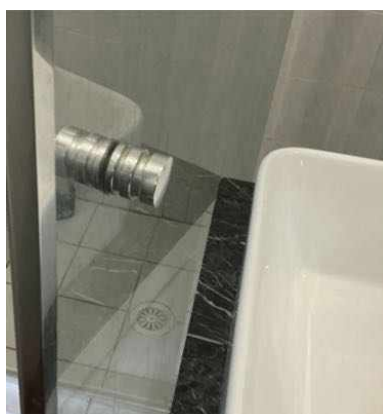
### Finding 3.30

Building:	Main Building
Location:	All Internal Areas
Finding:	Installation - substandard or incomplete - Shower
Information:	The shower screen door appears to be installed in close proximity to the vanity unit or adjacent walls, resulting in limited or no clearance between the glass panel and adjacent cabinetry. The current installation may restrict full door operation and compromise effective water containment within the shower area. Substandard installation can increase the risk of water escaping beyond the wet area, damage to door or cabinets/walls potentially affecting surrounding finishes over time. Adjustment or rectification by a qualified installer is recommended to ensure proper alignment and adequate clearance.

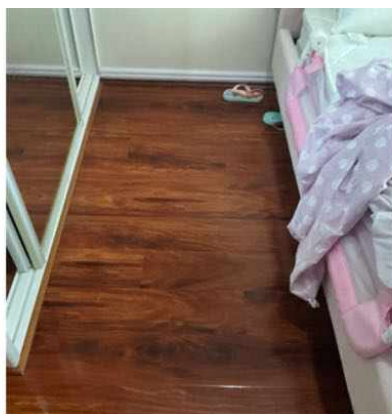
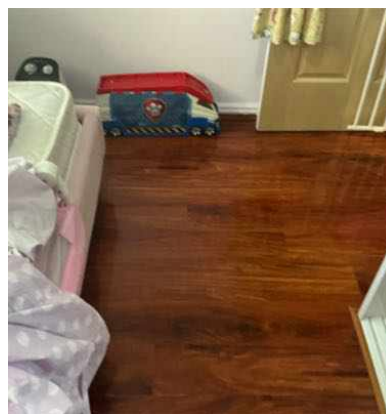
### Finding 3.31

Building:	Main Building
Location:	All Internal Areas
Finding:	Floors - bouncy or creaking
Information:	The internal flooring in this area was identified as being bouncy at the time of inspection. A bouncy floor surface generally presents as a discernible change in level as they are walked across, in noisy or creaking flooring, or in consequent movement of surrounding furniture and fixtures.

Bouncy floors generally indicate that the floorboards or the subfloor structures are coming loose from the joists that they are installed on. Bouncy flooring may also be the result of gaps between flooring and stumps or joist structures, which require packing.

The client is advised to seek quotations for required repairs from a Registered Builder specialising in re-stumping. The potential resolution may range from packing gaps in subfloor structures through to replacement of subfloors stumps and refixing of flooring.

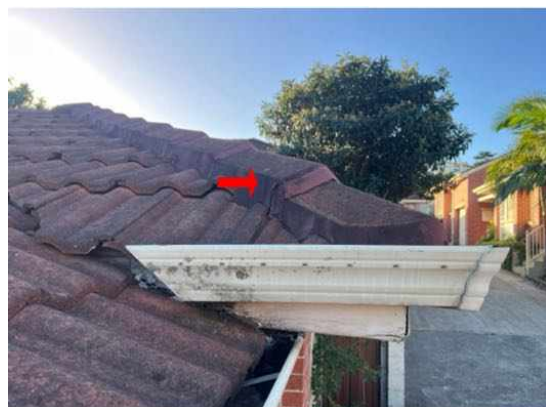
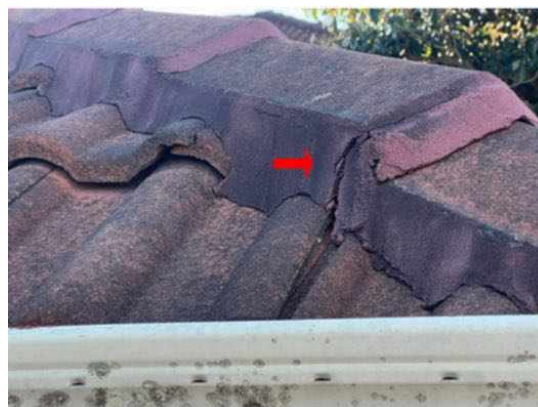
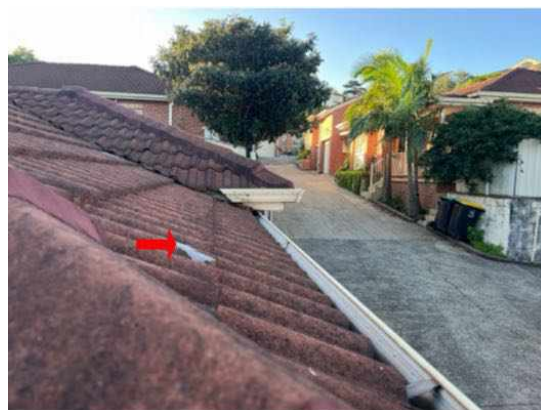
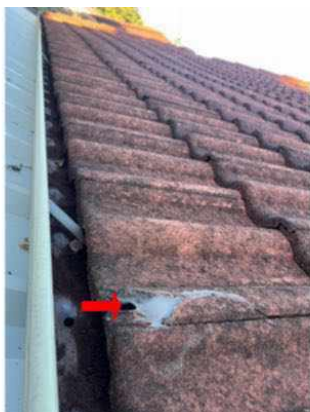
### Finding 3.32

Building:	Main Building
Location:	Roof Exterior
Finding:	Roof tiles - Broken and damaged mortar
Information:	Upon inspection of the exterior roof covering aging weathered , broken , lifting and/or misaligned roofing tiles were identified. Broken and friable roof tiles are generally the result of ageing and weathering of what is essentially a porous material.

If left to further deteriorate, broken and brittle roof tiles are likely to lead to water penetration via the roof into the ceiling space, causing secondary damage to ceiling linings, insulation and roof structures. Broken roof tiles are also likely to detract from the effectiveness of the roof drainage system, creating potential for secondary damage to the exterior roof covering and roof plumbing.

Replacement of broken tiles is required and should be performed by a roofing contractor as soon as possible.

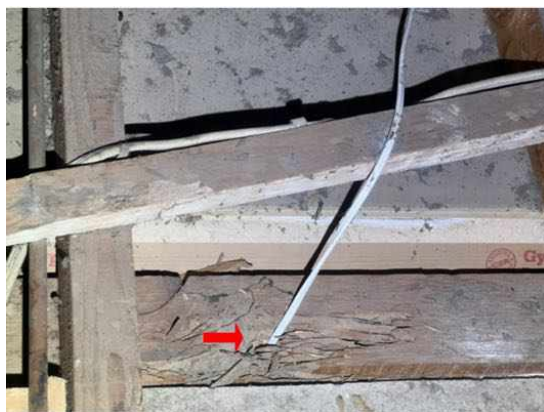
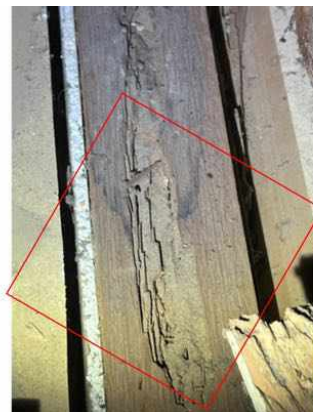
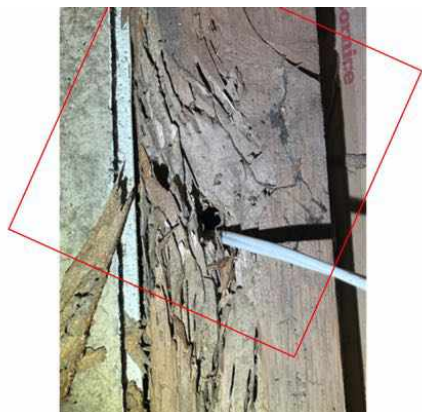
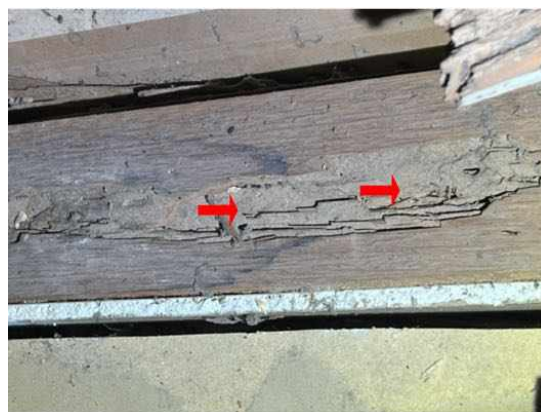
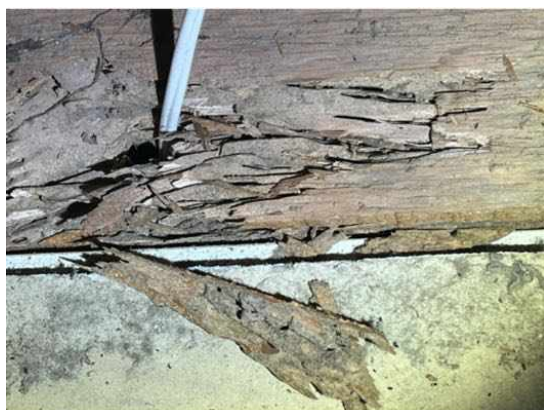
Building: Main Building  
 Location: Roof Void - Top plate above bathroom  
 Finding: Termite - damage identified  
 Information: Damage was found within timbers consistent with previous termite activity, though it appears inactive.

Recommend an invasive inspection of trees and concealed timber elements within the property by a licensed timber pest technician.

Installation of a chemical termite management system is also recommended.

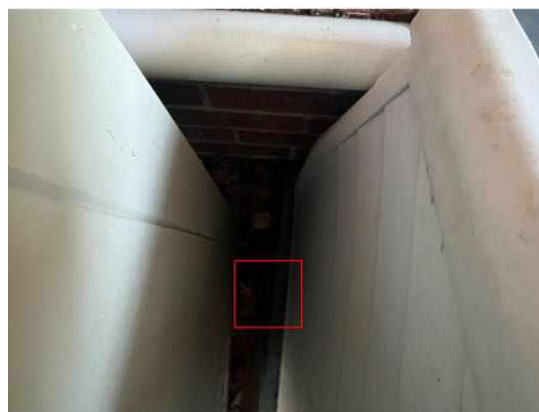
Information: The Hot Water System (HWS) overflow was found to be disconnected from storm water drainage and is creating excessive moisture in the surrounding area.

These damp conditions can lead to secondary defects such as rot, rust or corrosion of associated building elements, the formation of fungal decay, or even the creation of potential slip hazards. When coupled with poor site drainage, pooling of water may also attract termite activity to this area.

It is highly recommended that a licensed plumber be appointed to connect the HWS overflow in order to prevent such an environment from being created. These minor works should be carried out as soon as possible.

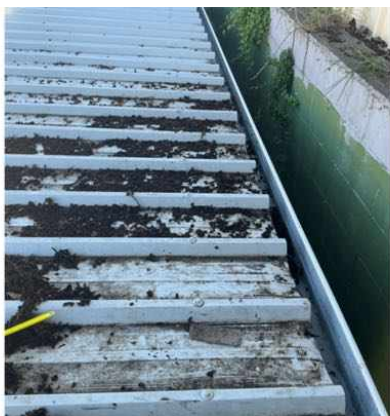
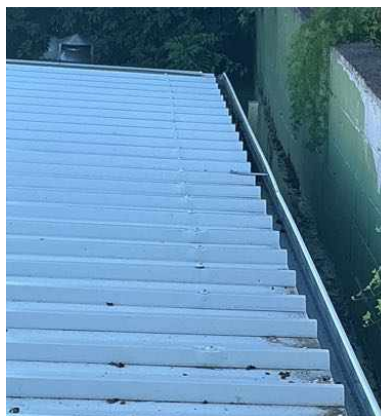
Blocked gutters are likely to lead to high levels of moisture in the affected areas. Such moisture will not only cause rust and decay of the associated building materials, but can also provide conditions that are conducive to termite and timber pest activity. Blockages in gutters should therefore be removed immediately to ensure dry conditions are maintained.

Consult a Licensed Plumber for further specific advice on remedial works that may be required. In the interim, it is highly advised that blocked gutters be removed by the homeowner or a general handyperson as a matter of urgency.

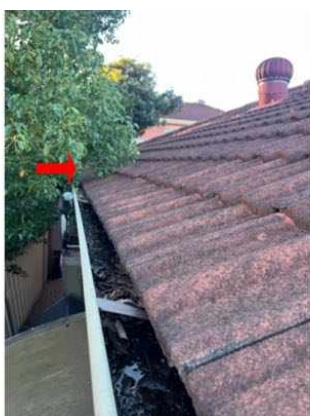
### Finding 6.07

Building:	Main Building
Location:	All External Areas
Finding:	Bridging - Vegetation to some areas
Information:	Where vegetation obstructs inspection of building elements, also known as bridging as it provides a bridging point for the access of termites, full inspection can not be achieved. Consequently moisture or dampness may be present and the areas becomes conducive to termite activity. Plants against or very close to buildings provide cover, shade and can provide an environment that is attractive to termite infestation.

The removal and replanting of species that do not provide "cover" or cutting back of existing vegetation will assist greatly in preventing Bridging from occurring.

The removal of any such materials that may be conducive to termite activity should be carried out as soon as possible and arrange re inspection to minimize the risk of termite attack.

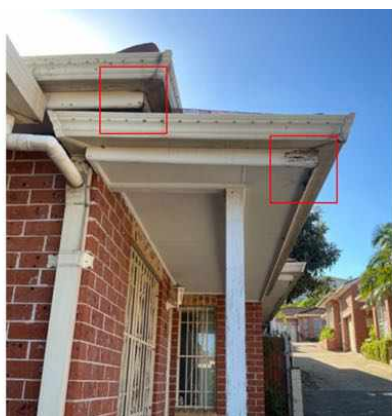
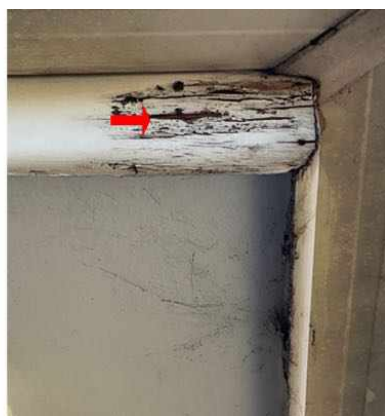
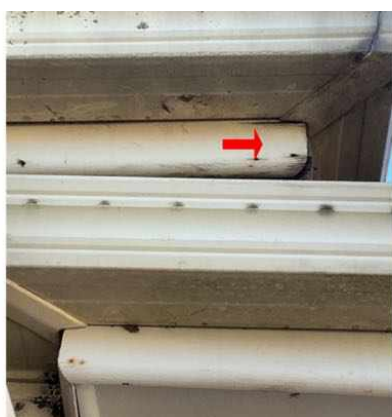
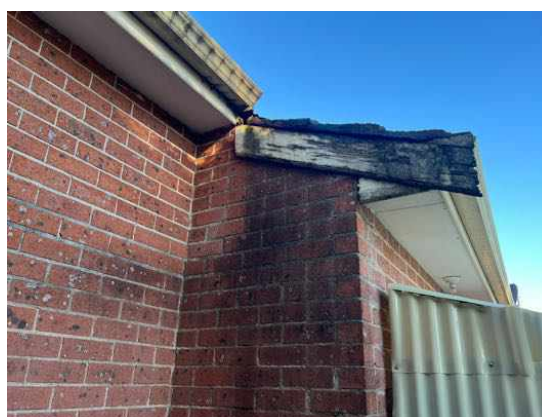
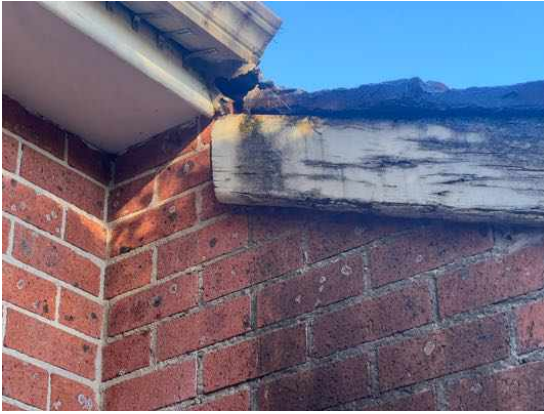
## Evidence of fungal decay activity and/or damage

In this case although the affected timber element is in a decaying state the extent of any visible damage appears to be localised to a specific area and is yet to spread to other parts of the building element or affect adjoining structures. The fungal decay is therefore likely to be of a relatively superficial nature with minimal impact on the structural integrity or tensile strength of the timber element.

A further invasive inspection by a licensed timber pest technician is highly recommended to check for concealed activity.

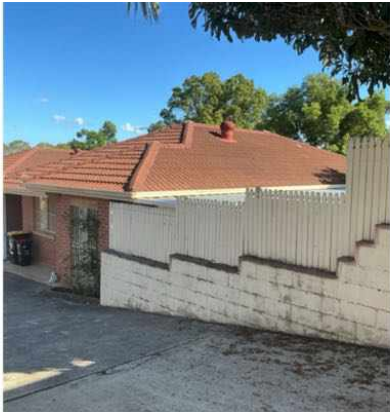
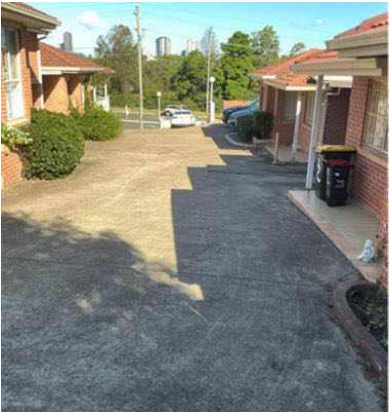
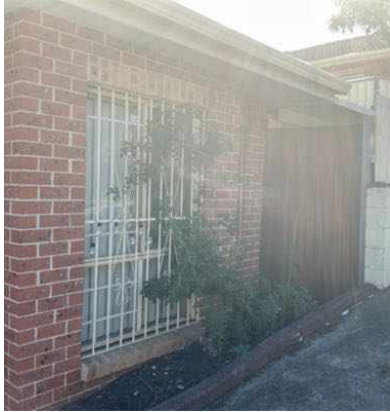
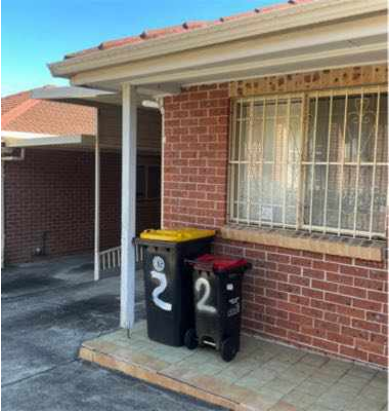
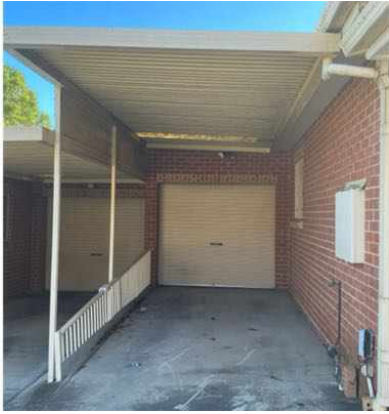
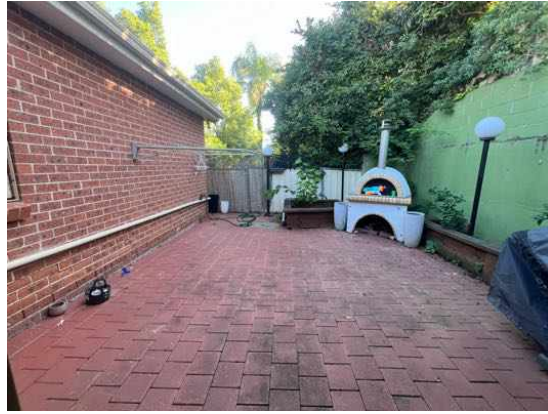
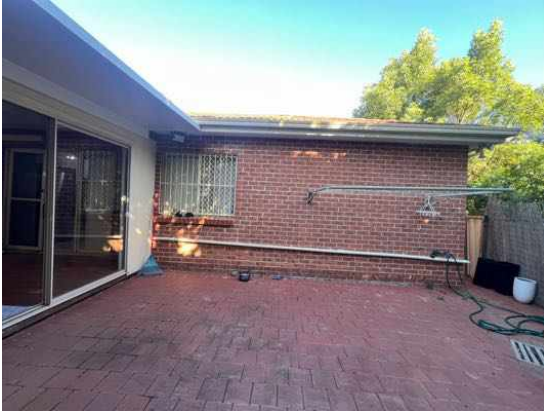
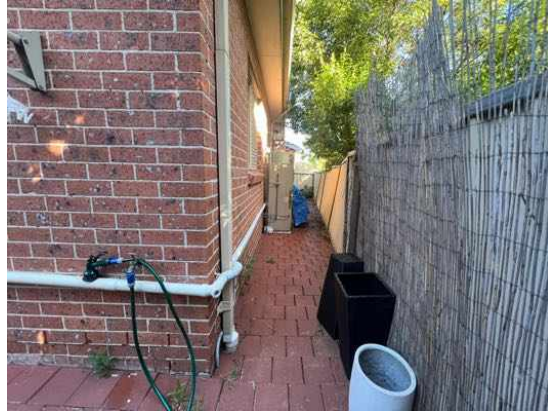
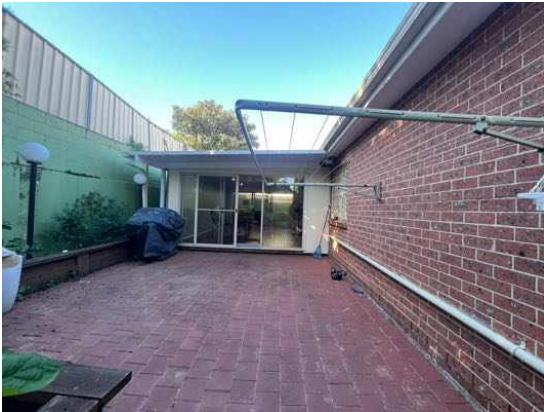
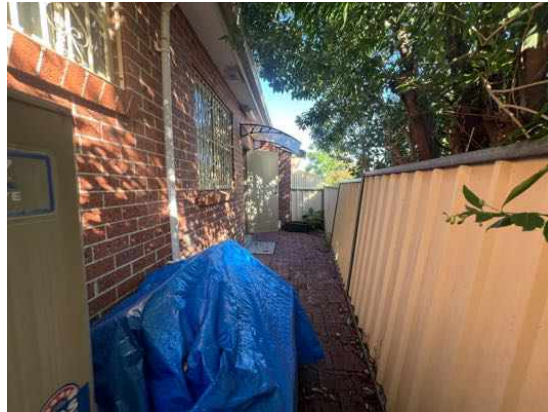
Building: Main Building  
Location: All External Areas  
Finding: Additional Photos - Obstructions and Limitations  
Information: These photographs are an indication of the obstructions and limitations which impeded full inspection of the property at the time of inspection. These obstructions can hide an array of defects and should be removed to allow full inspection to be carried out. A re-inspection is recommended once the areas are made accessible.

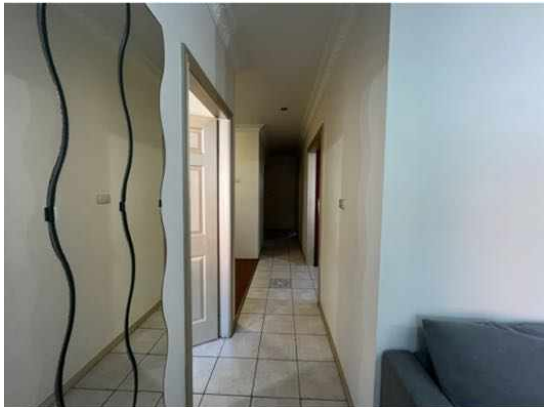
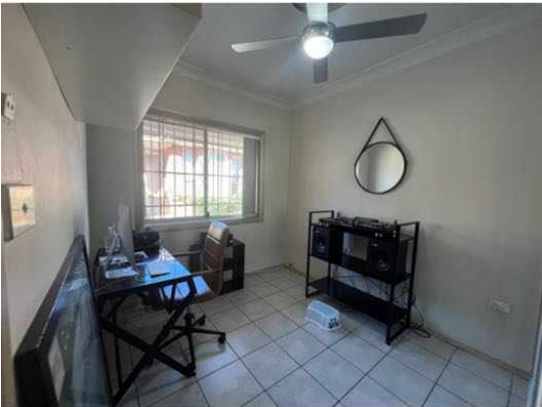
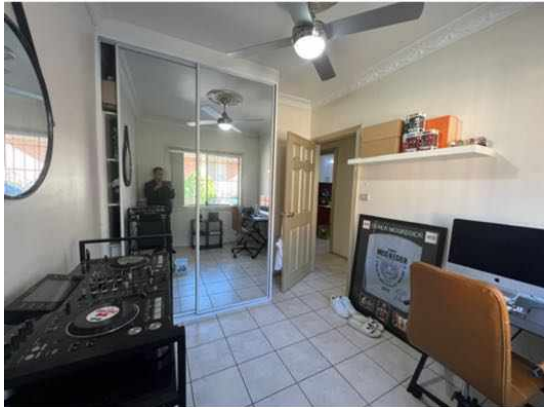
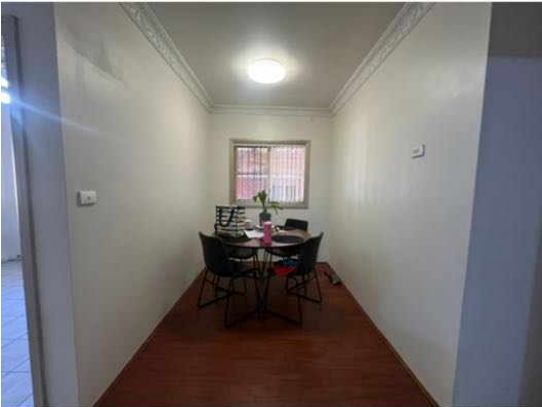
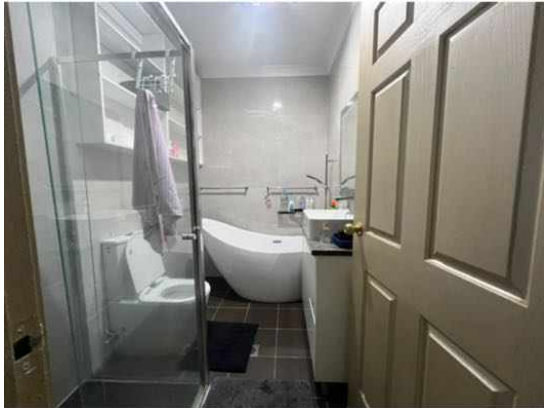
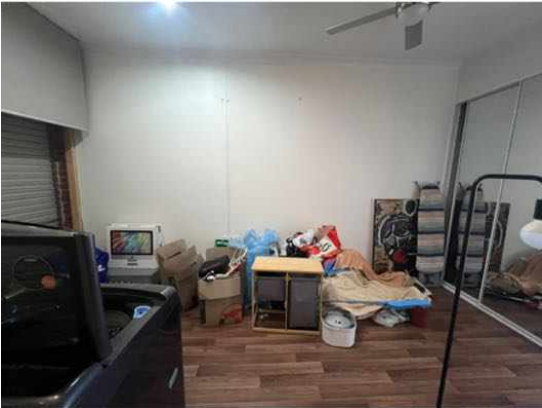
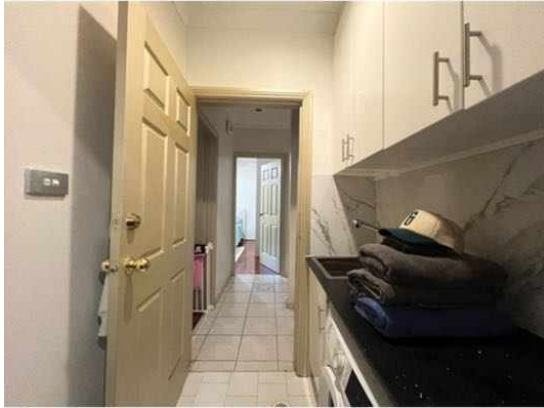
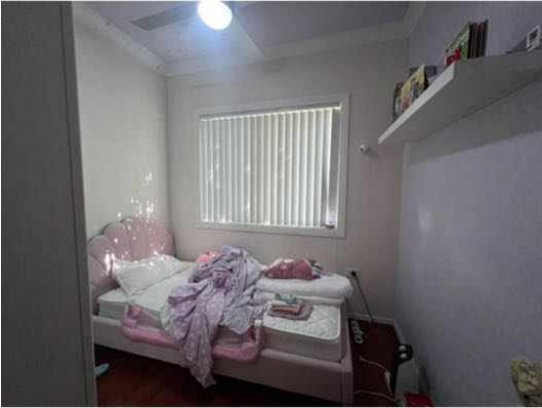
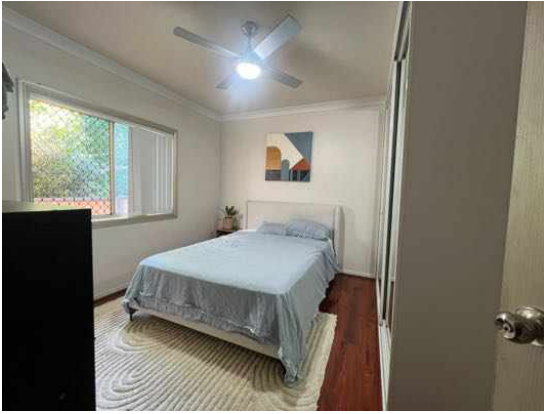
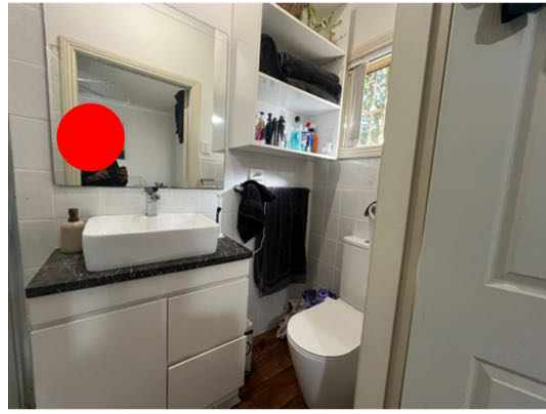
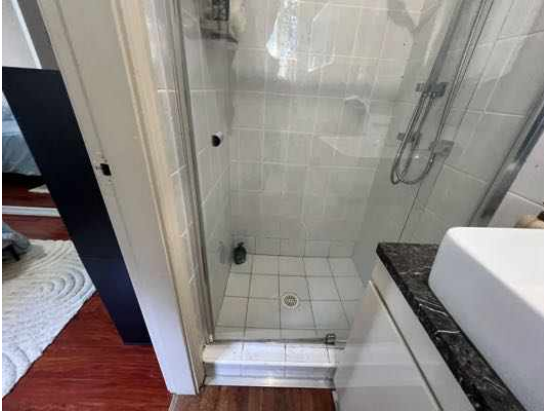
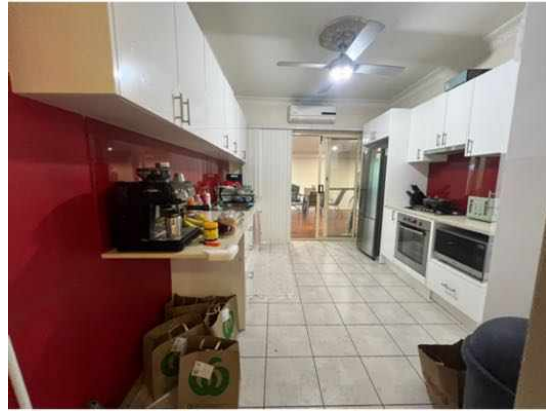
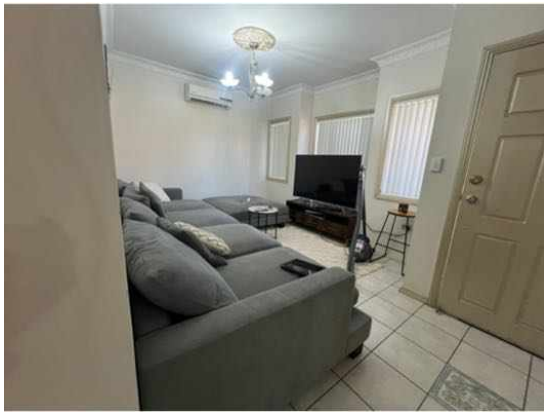
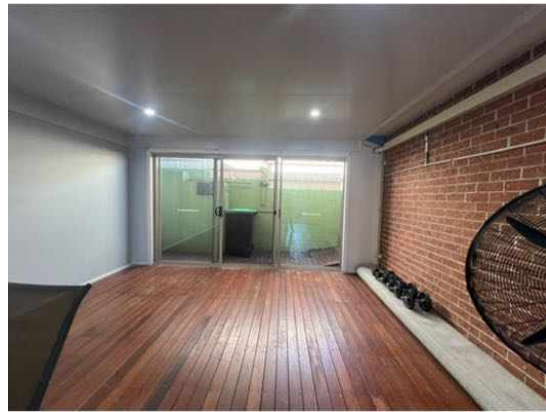
Building:	Main Building
Location:	All Internal Areas
Finding:	Additional Photos - Obstructions and Limitations
Information:	These photographs are an indication of the obstructions and limitations which impeded full inspection of the property at the time of inspection. These obstructions can hide an array of defects and should be removed to allow full inspection to be carried out. A re-inspection is recommended once the areas are made accessible.

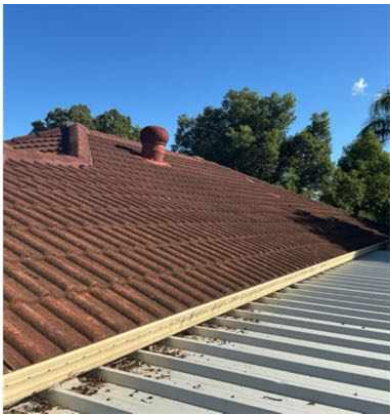
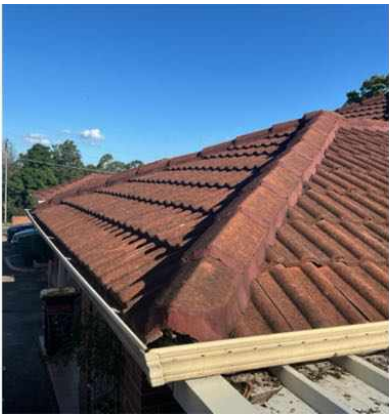
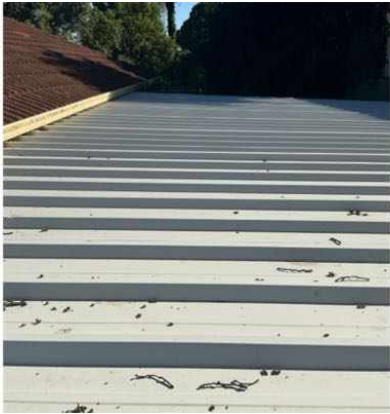
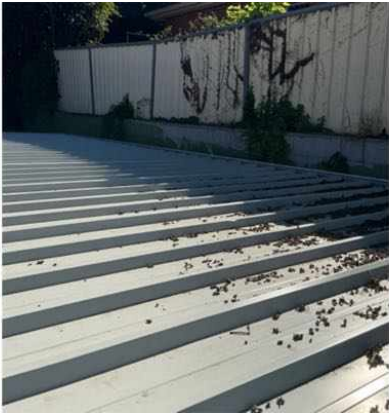
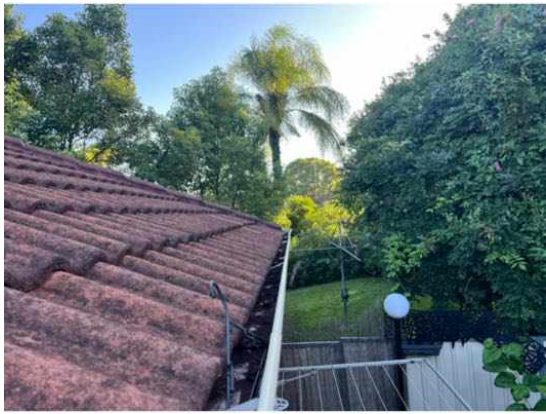
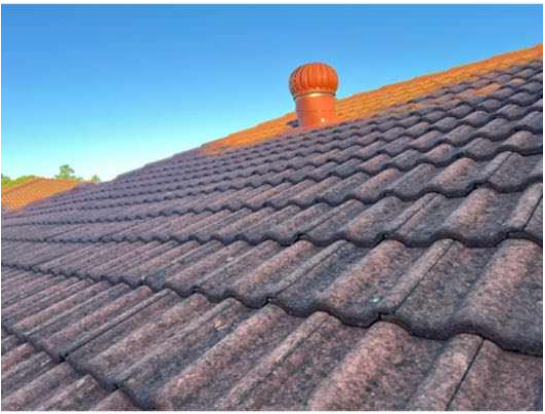
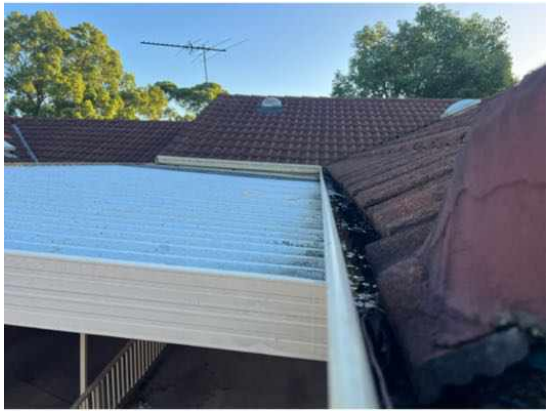
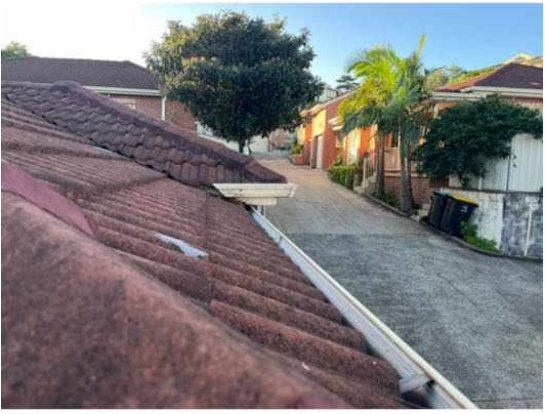
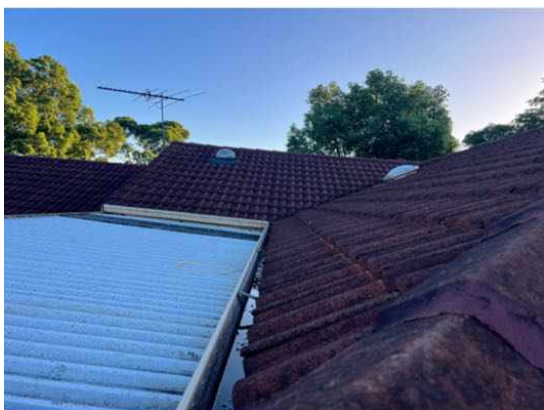
Building: Main Building  
 Location: Roof Exterior  
 Finding: Additional Photos - Obstructions and Limitations  
 Information: These photographs are an indication of the obstructions and limitations which impeded full inspection of the property at the time of inspection. These obstructions can hide an array of defects and should be removed to allow full inspection to be carried out. A re-inspection is recommended once the areas are made accessible.

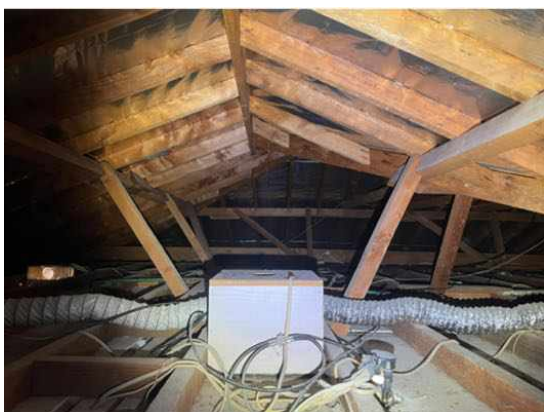
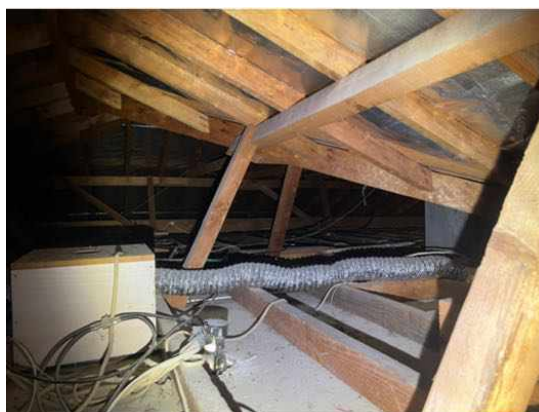
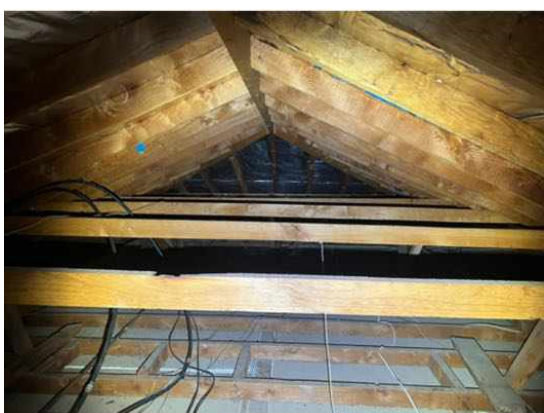
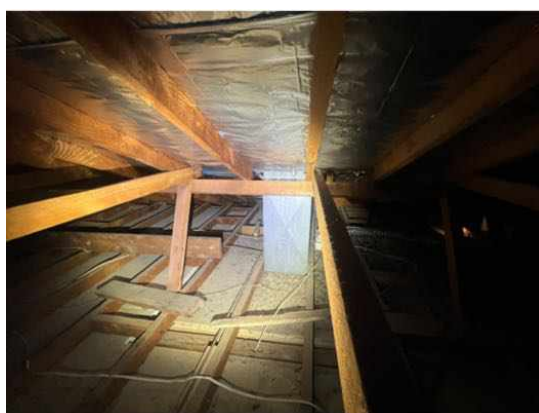
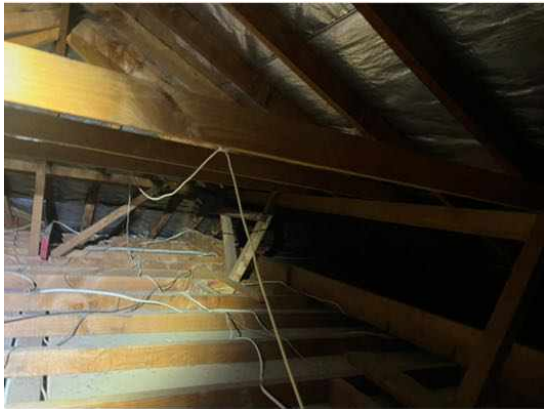
Building: Main Building  
Location: Roof Void  
Finding: Additional Photos - Obstructions and Limitations  
Information: These photographs are an indication of the obstructions and limitations which impeded full inspection of the property at the time of inspection. These obstructions can hide an array of defects and should be removed to allow full inspection to be carried out. A re-inspection is recommended once the areas are made accessible.
