Building Inspection Report

Inspection Date: Mon, 30 Mar 2026

Property Address: 303/48 Blenheim St Balaclava, VIC, 3183

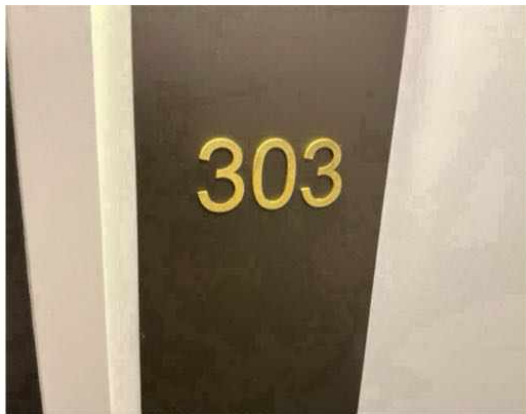
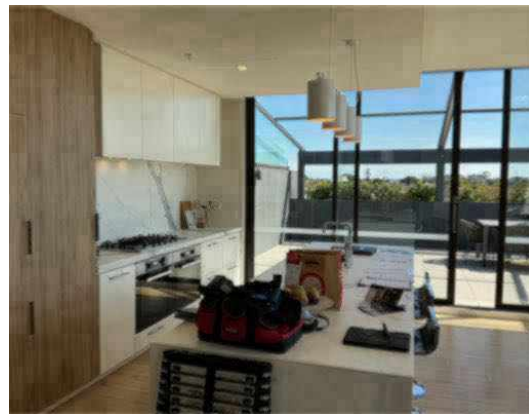
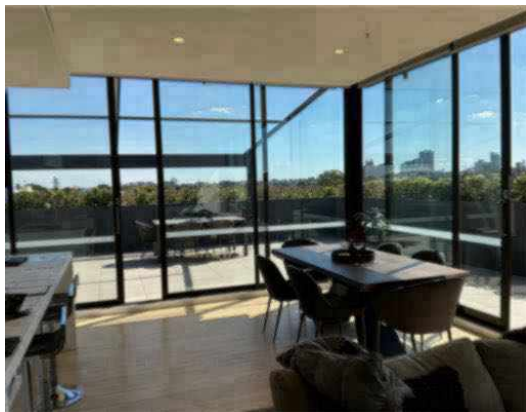
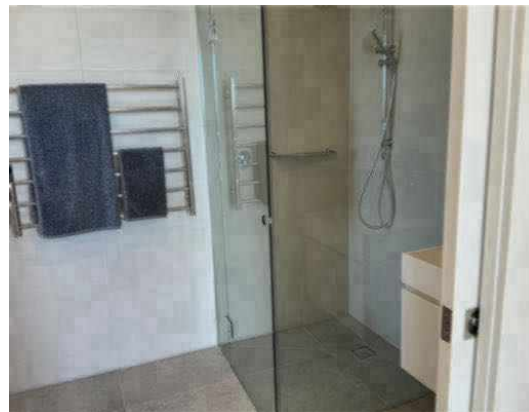
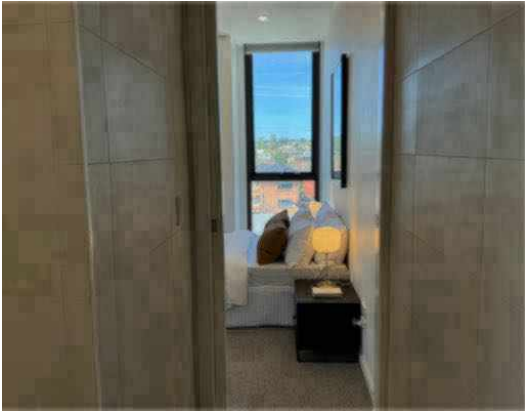
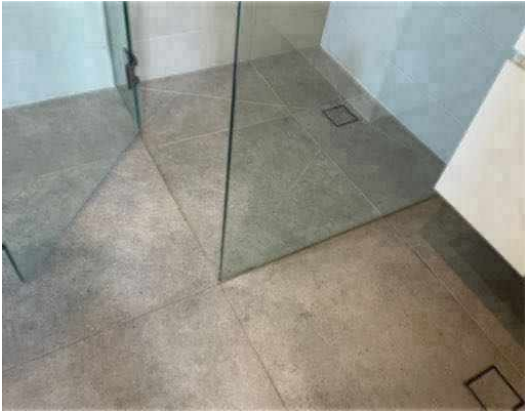
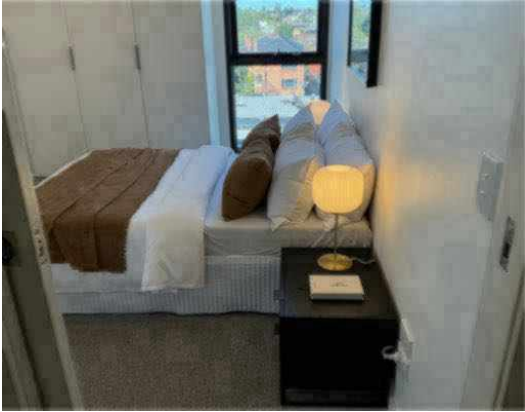
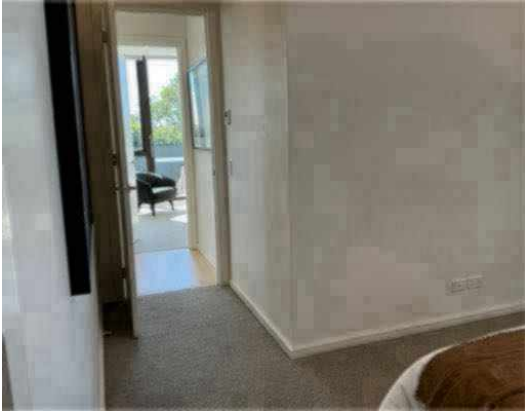
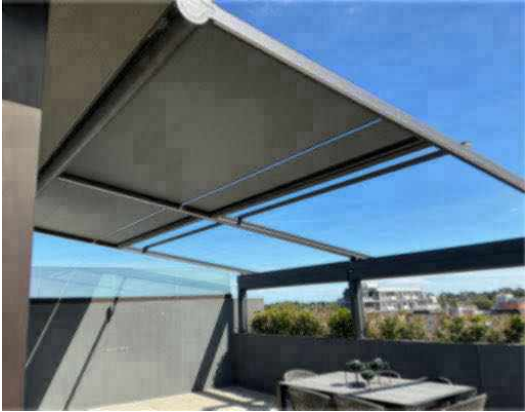
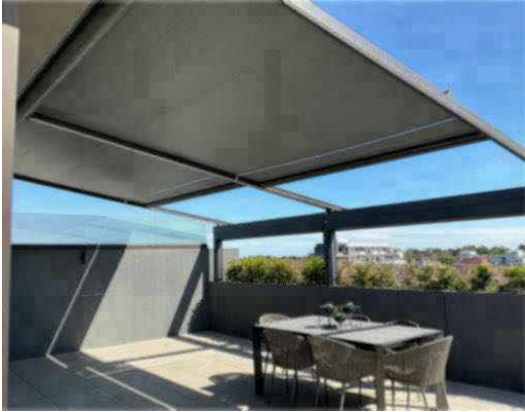
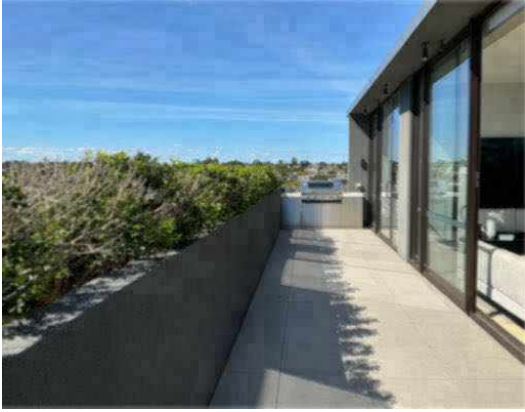
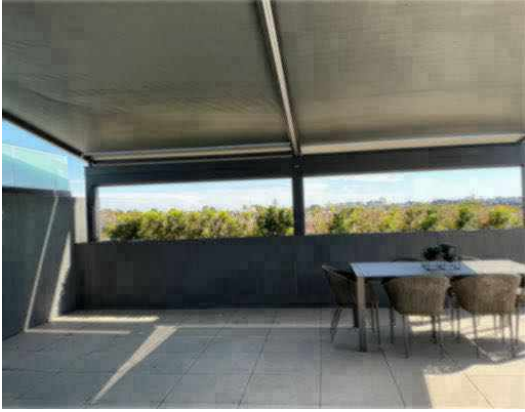
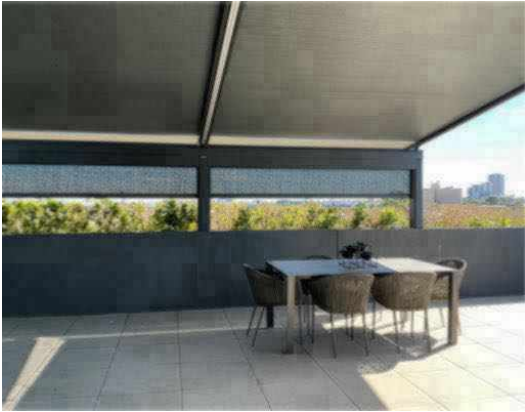
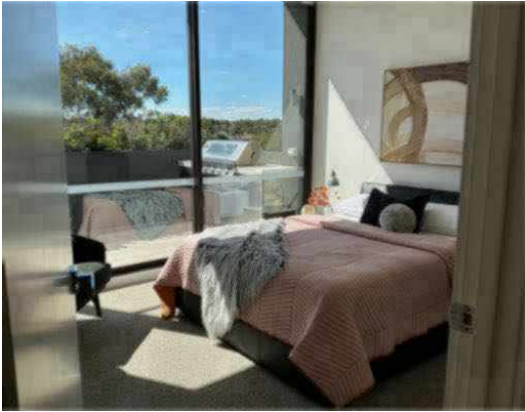
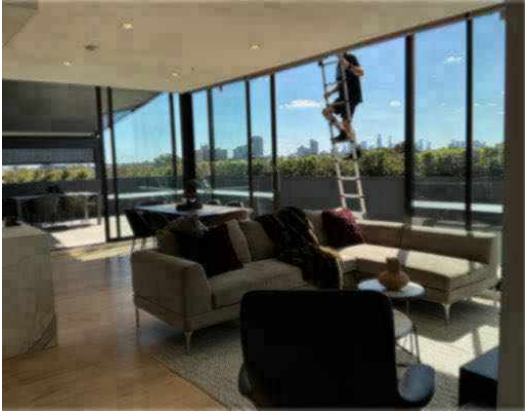
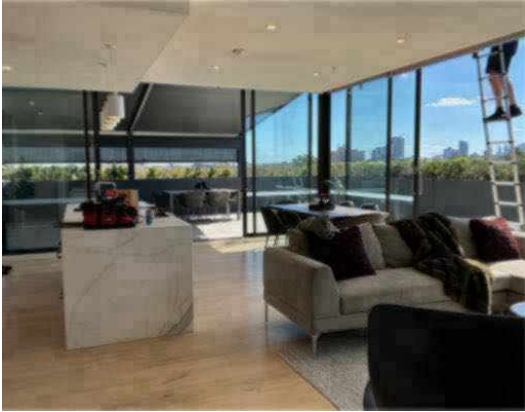
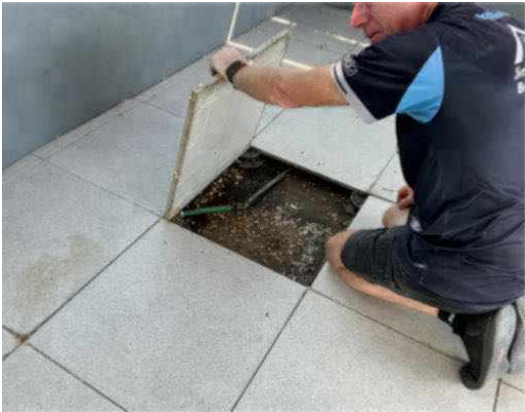
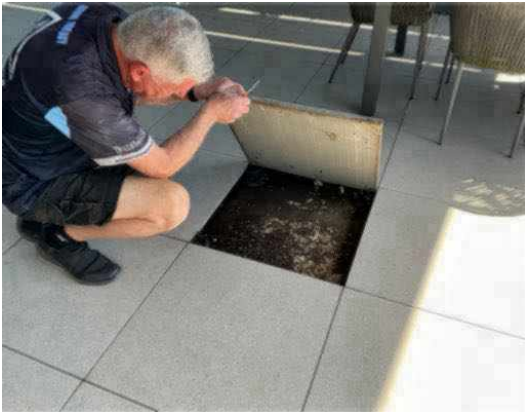
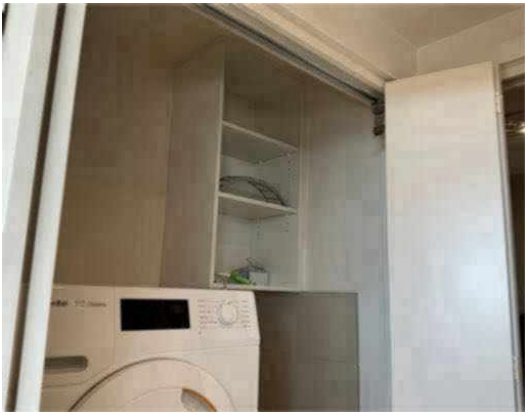
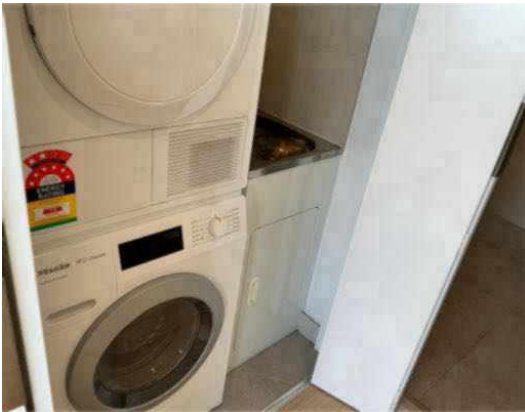
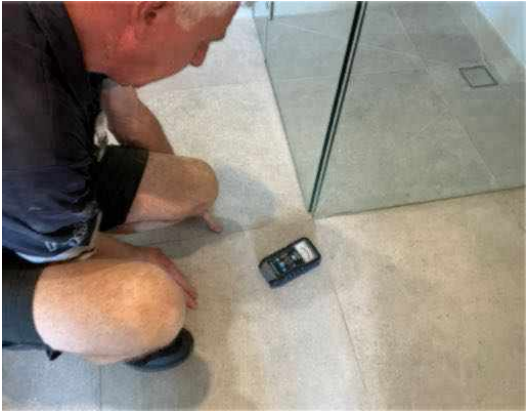
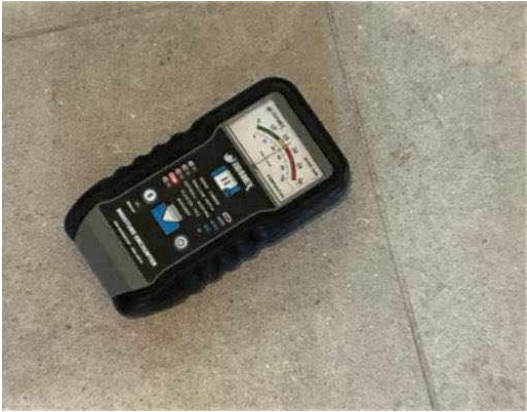
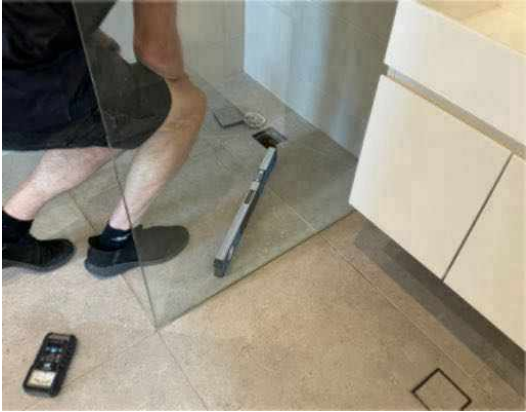
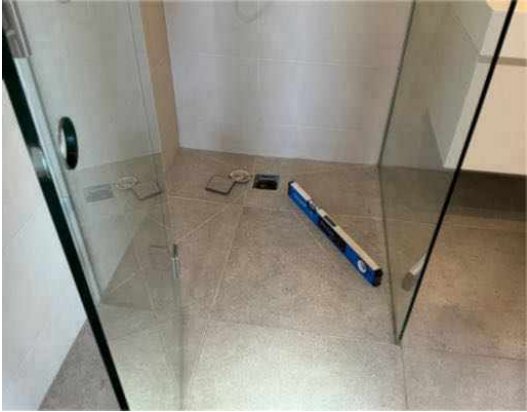
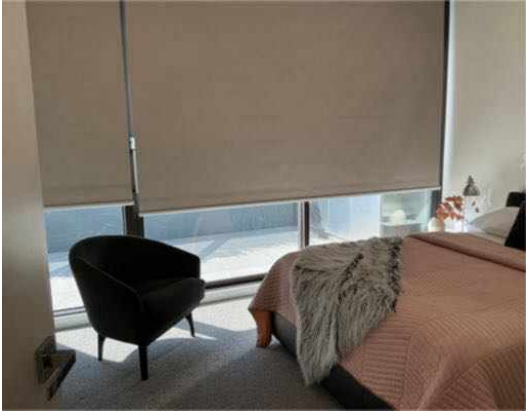
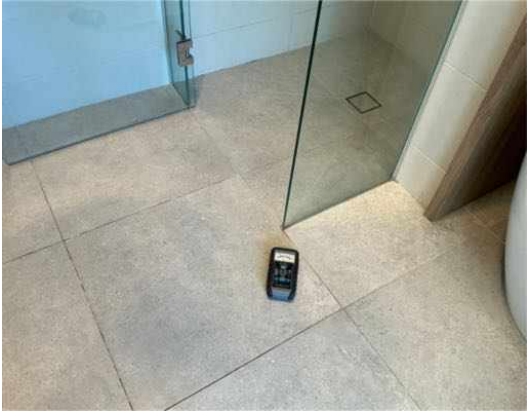
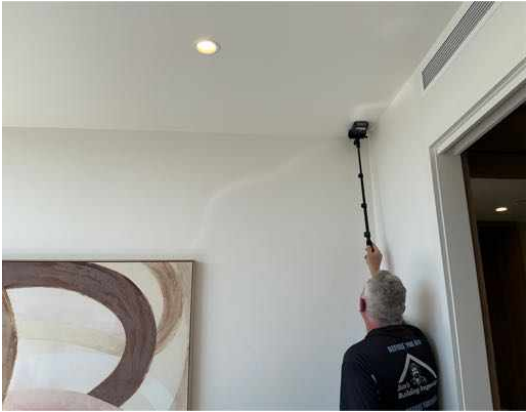
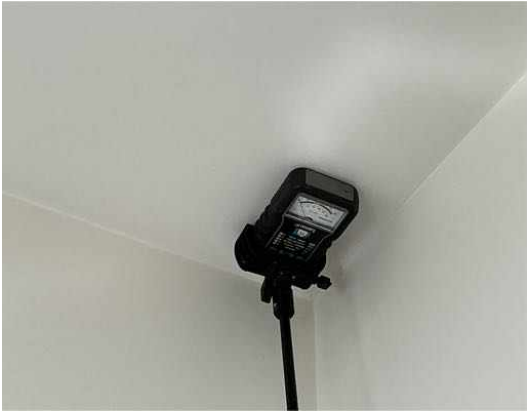
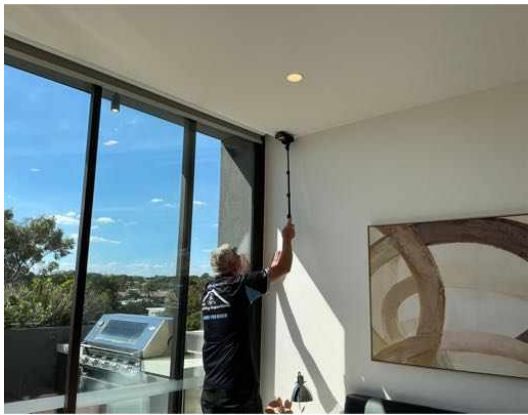
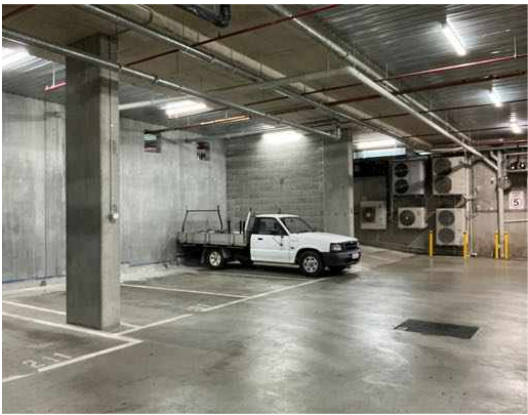
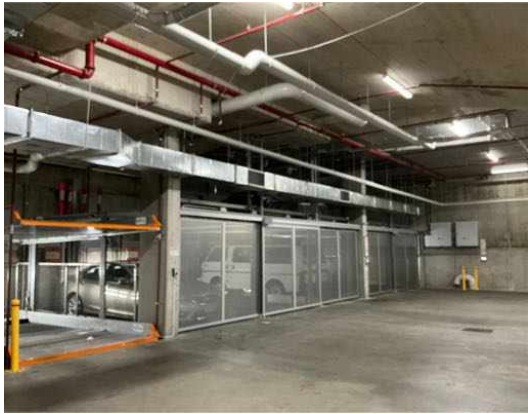
Building: Main Building
Location: All Areas
Finding: Additional Photos and Obstructions and Limitations
Information: These are additional photographs and photographs of the obstructions and limitations inside and outside (furniture, landscaping etc) which may impede full inspection of the property at the time of inspection. These obstructions can hide an array of defects and may be removed to allow full inspection to be carried out. A re-inspection may be made if clients require once the areas are made accessible.
