Building and Timber Pest Inspection Report

Inspection Date: Mon, 30 Mar 2026

Property Address: 10 Shirley St, Padstow NSW 2211, Australia

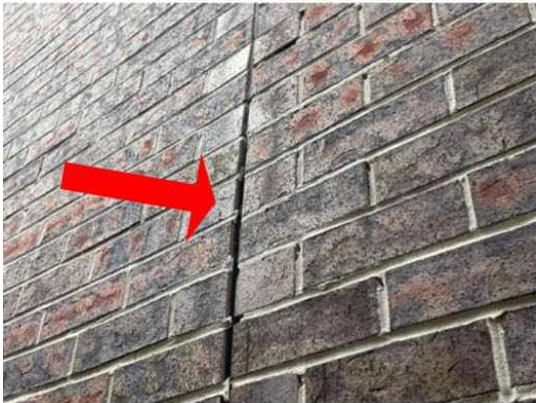
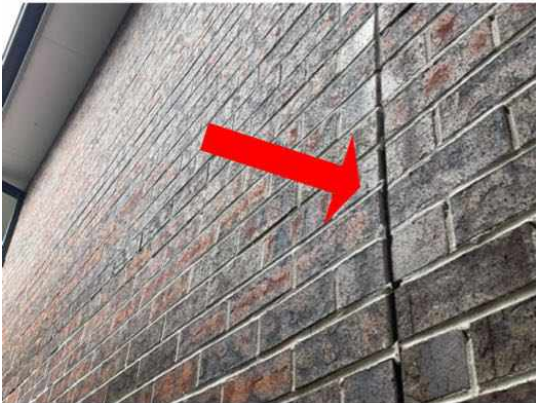
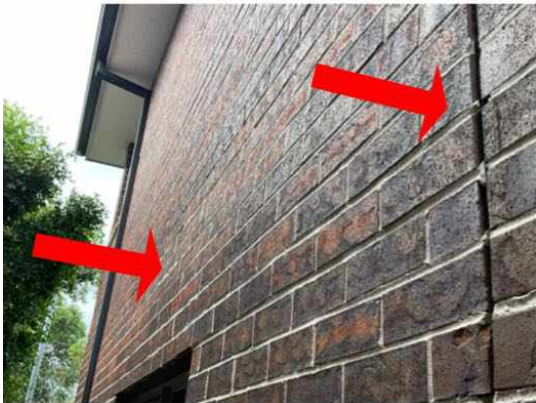
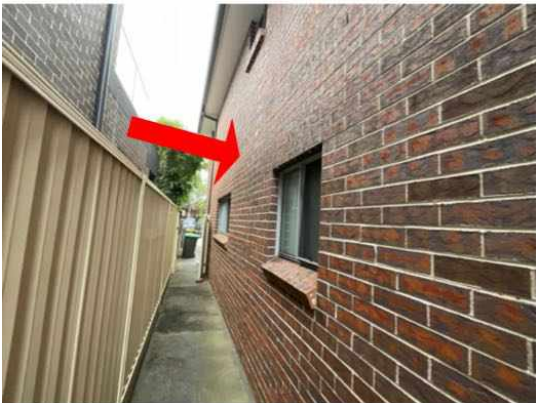
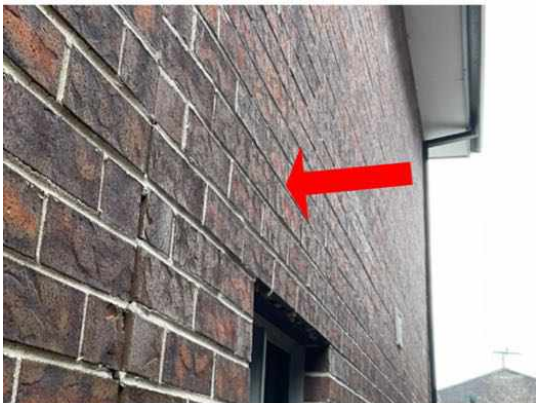
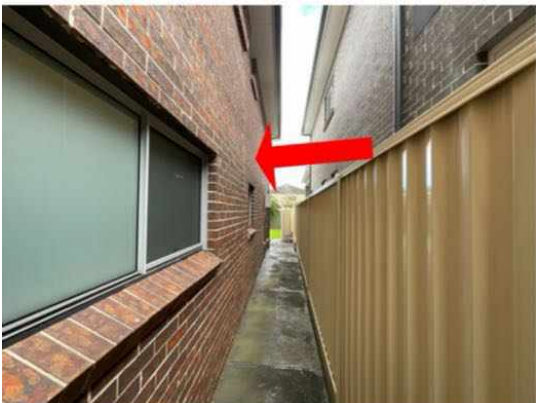
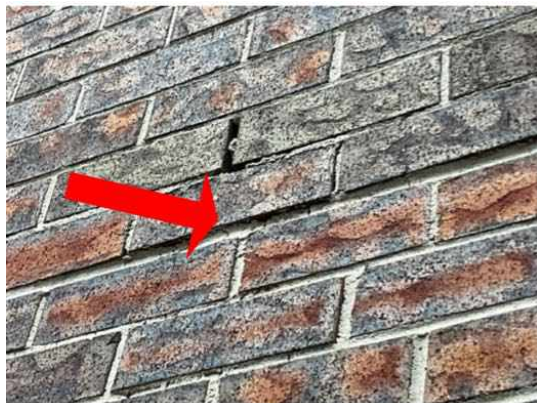
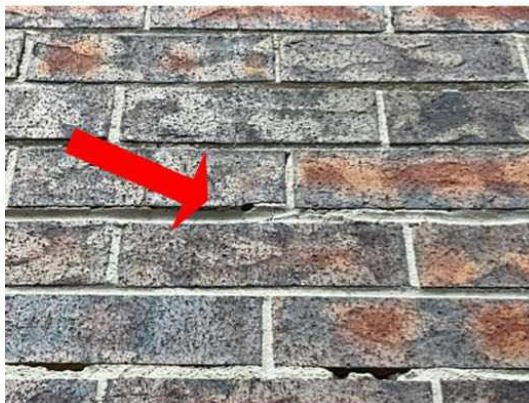
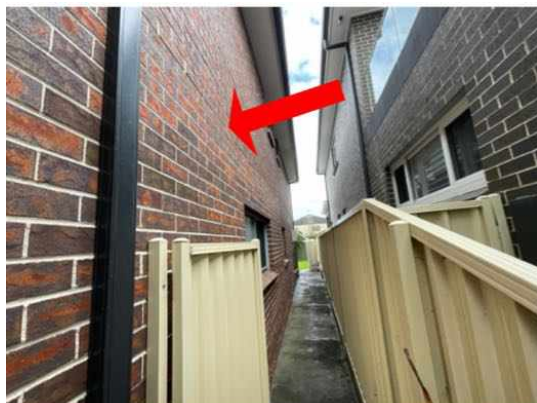
| Finding: | External Brickwork – Bowing / Movement (Major Defect) |
| Information: | Significant out-of-plane movement (bowing) observed to the external brick veneer wall, including horizontal cracking to bed joints and separation at vertical articulation joint. Brickwork around window openings also shows distortion and misalignment, indicating structural movement. |

This condition is considered a major defect as it may indicate:

- Inadequate wall tie restraint
- Lack of articulation/control joints
- Foundation / Slab movement or slab edge rotation
- Poor construction tolerance

Recommendation

- Installation/replacement of wall ties

- Introduction of articulation joints
- Partial demolition and reconstruction of affected wall sections

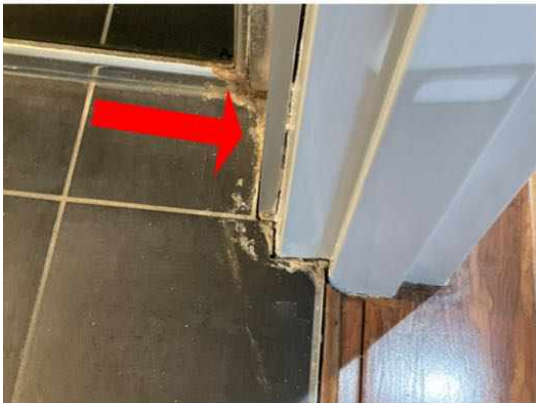
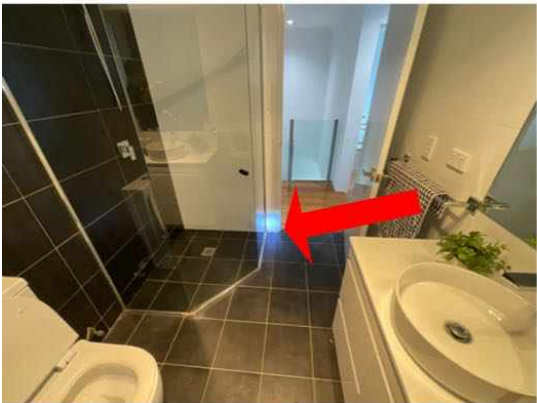
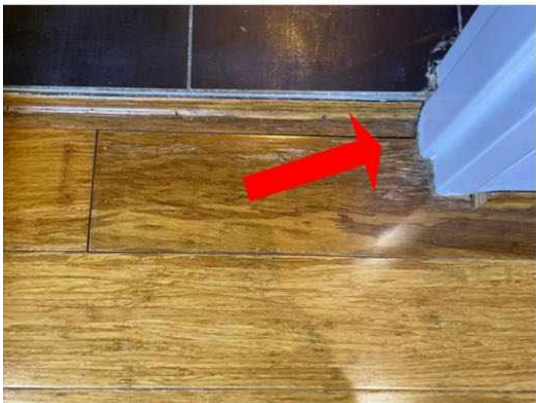
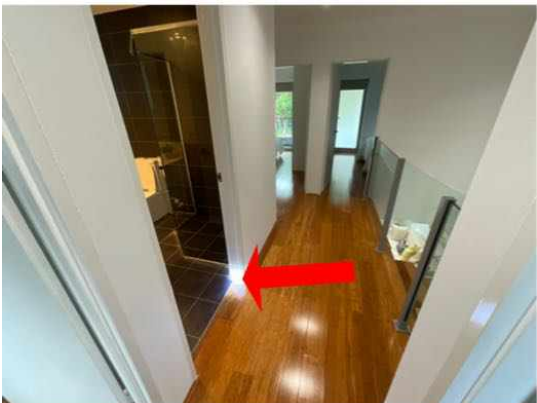
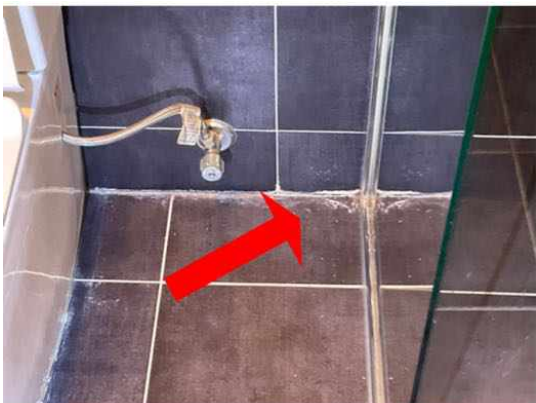
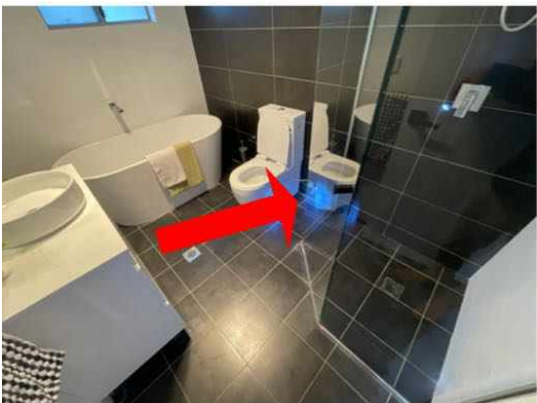
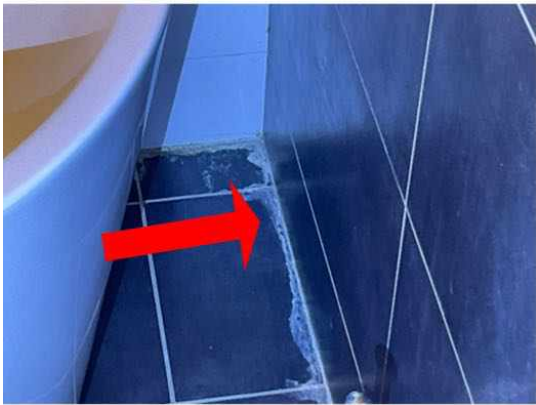
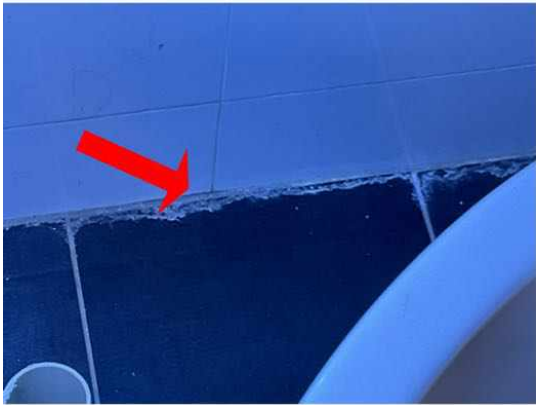
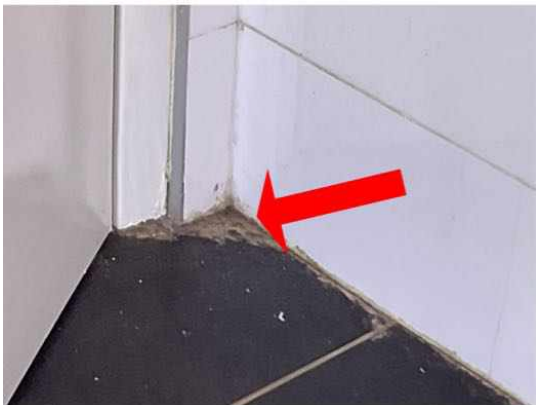
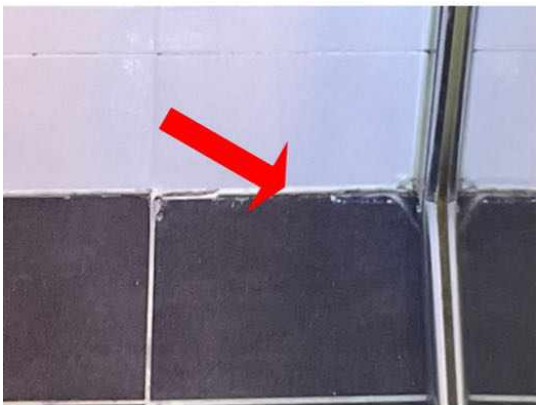
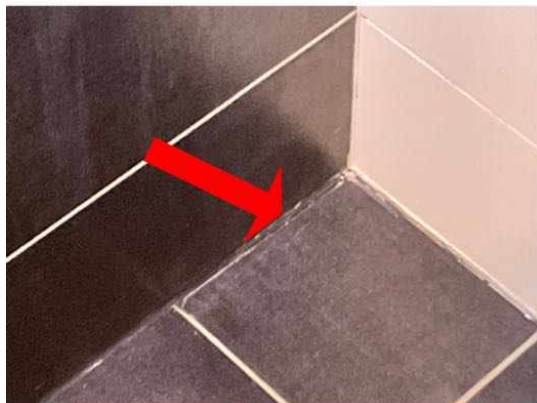
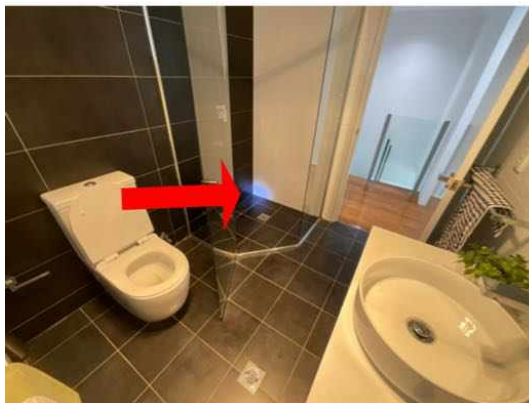
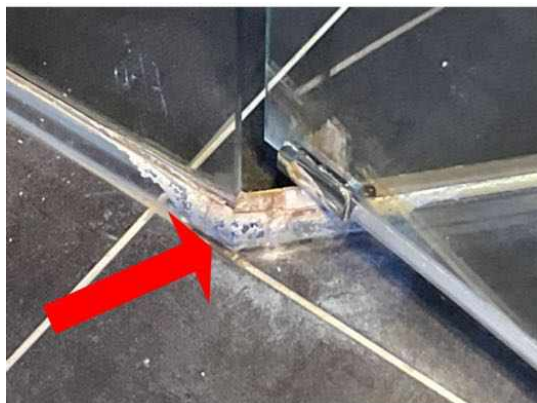
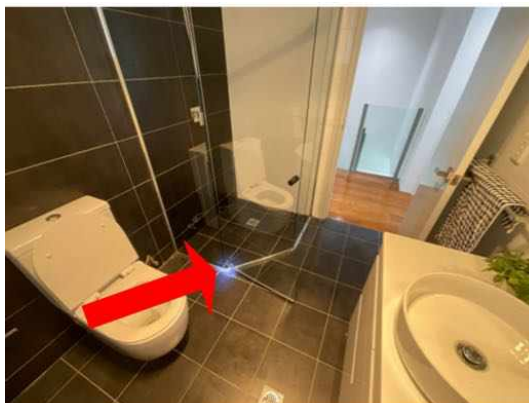
Finding 2.02

Building: Main Building
 Location: Bathroom
 Finding: Bathroom – Water Ingress / Waterproofing Failure (Major Defect)
 Information: Evidence of water ingress observed to bathroom floor and wall junctions, including:

Condition indicates failure of waterproofing system and inadequate sealing to wet area.

Recommendation

- Engage licensed waterproofer / tiler to assess
- Likely require:
 - Removal of affected tiles
 - Reinstallation of compliant waterproof membrane
 - Resealing of all junctions and penetrations
 - Inspect adjoining areas for concealed moisture damage

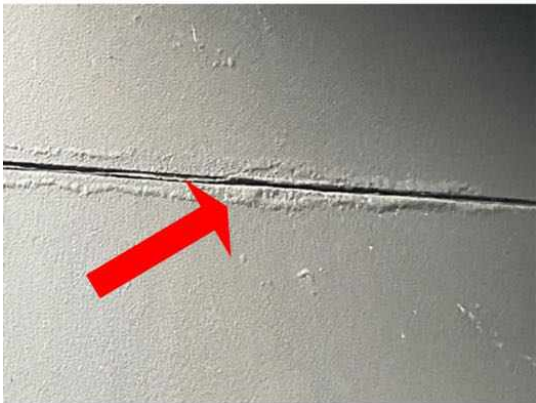
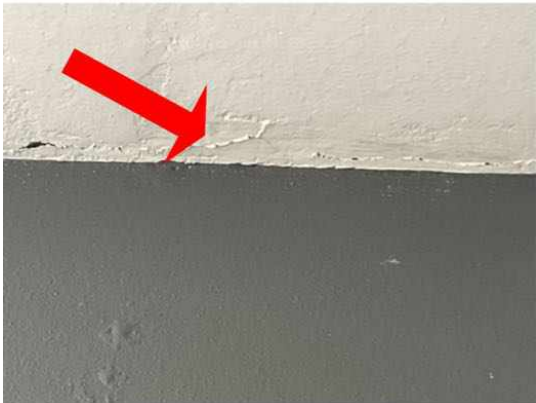
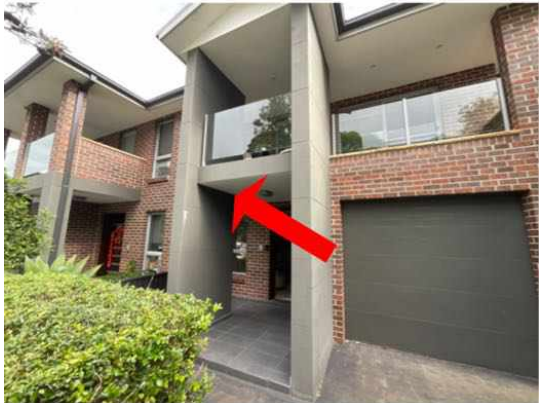
Finding 3.01

The presence of excessive moisture can have major implications on associated building elements if left unattended. While only seemingly minor at this stage, the damage cannot be determined due to the paint obstructing any further inspection of the damage.

It is highly advised that the affected paint be cleaned to allow a further, more invasive inspection by a licensed plumber. Failure to act on this defect may necessitate major works in the future.

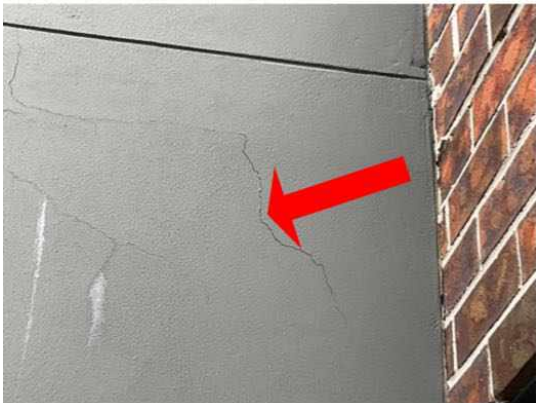
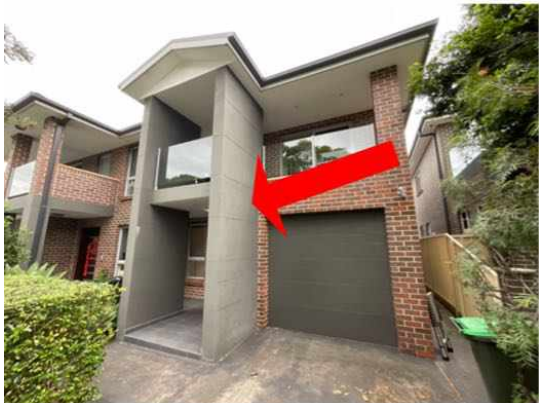
Finding 3.02

Building: Main Building
 Location: Exterior walls
 Finding: Cracks to external render - Category 1
 Information: It has been observed that cracking to internal rendered surfaces has occurred. The degree of damage falls within Category 1, described as fine cracks that do not need repair and which are less than 1.0mm in width limit.

Damage of this category is not considered a defect for rectification. Always contact your building inspector should cracks widen, lengthen, or become more numerous.

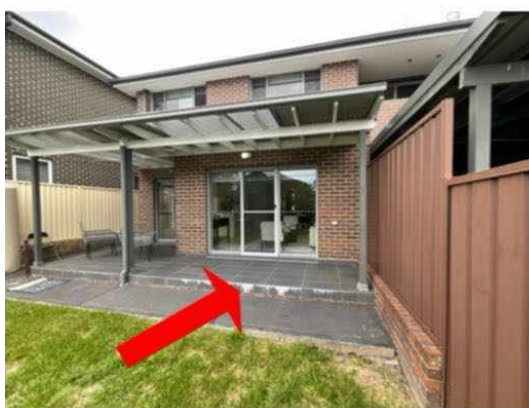
Finding 3.06

Building: Main Building
 Location: Alfresco
 Finding: Alfresco – Tiling & Wall (Evidence of Moisture Ingress)
 Information: Evidence of moisture-related deterioration was observed to the Alfresco area. Tile adhesive is lifting through grout joints, tiles show signs of debonding, and cracking is visible to the adjoining concrete wall. Water staining and efflorescence were noted to the base of the external brick wall.

The conditions observed are consistent with possible waterproofing failure and/or inadequate drainage to the balcony. Ongoing moisture ingress may result in further deterioration of tiling, substrate damage, and structural cracking over time.

An invasive inspection by a qualified waterproofing specialist is recommended to:

- Lift tiles as required
- Assess condition of waterproof membrane and substrate
- Check falls toward drainage point
- Rectify waterproofing and drainage defects as necessary

Monitoring is recommended to determine whether moisture intrusion is active.

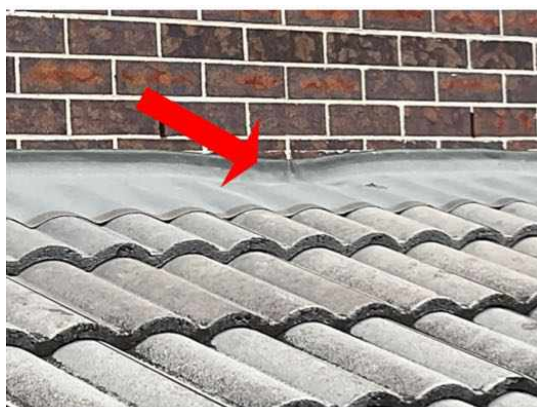
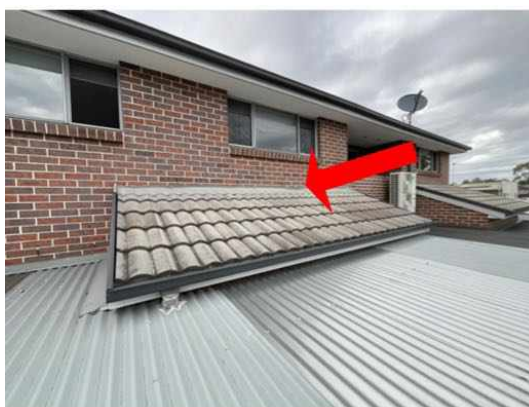
Finding 3.07

Building: Main Building
 Location: Roof Exterior
 Finding: Roof Flashing - Inadequacy
 Information: During the inspection, it was identified that the flashing to the Colorbond flat roof was

inadequate, potentially compromising the weatherproofing of the roofing system. This defect is non-compliant with NCC 2022 Volume Two Part H3.5, AS 1562.1:2018, and the manufacturer's installation requirements for Colorbond roofing. It is recommended that the flashing be replaced or adjusted to ensure proper weatherproofing and compliance. A follow-up inspection is required to verify rectification

- Ineffective flashing can allow water ingress, leading to:
- Structural damage.
- Mold or mildew growth.
- Compromised thermal insulation.

1. Replace or Adjust Flashing:

- Check all roof junctions, penetrations (e.g., vents, skylights), and valleys for similar flashing inadequacies.
- Rectify any deficiencies to ensure uniform compliance.

- Verify that the flashing meets the minimum performance requirements of AS 1562.1 and AS 4040.2.

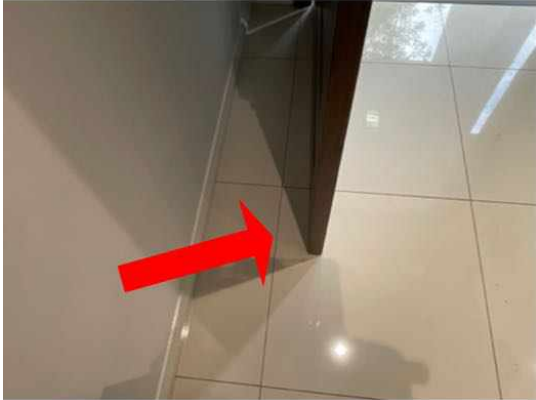
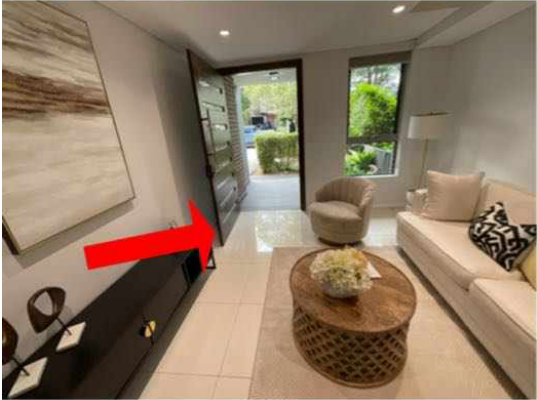
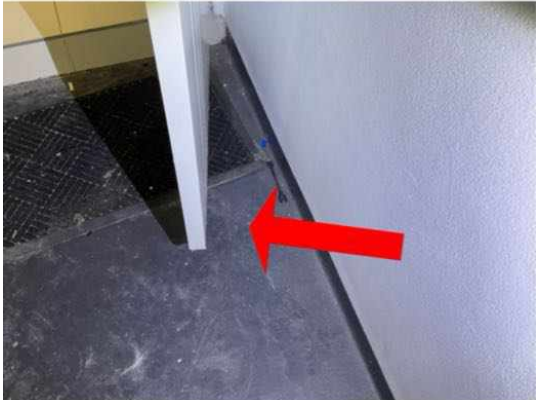
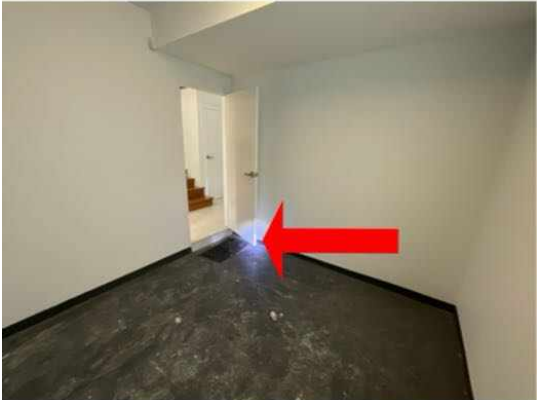
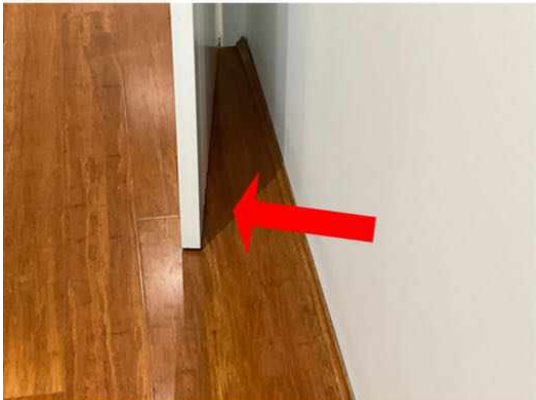
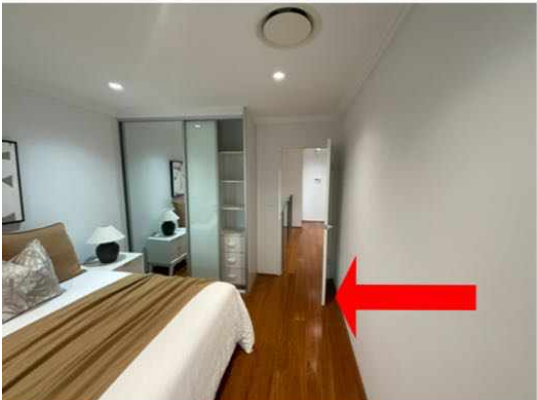
Finding 3.08

| Finding: | Door stop - Missing |
| Information: | The door stop is missing or is inadequate to stop the door handle from damaging the wall. Although some building elements may seem irrelevant or unnecessary, all |

Re-installation or replacement of the door stop is advised as soon as possible to prevent any subsequent damage to the door or associated structures. A general handyman may be appointed to perform these works at client discretion.

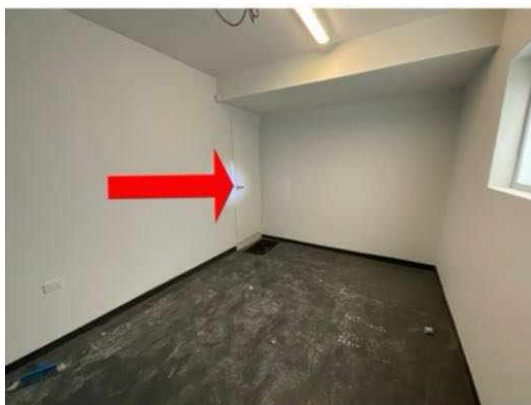
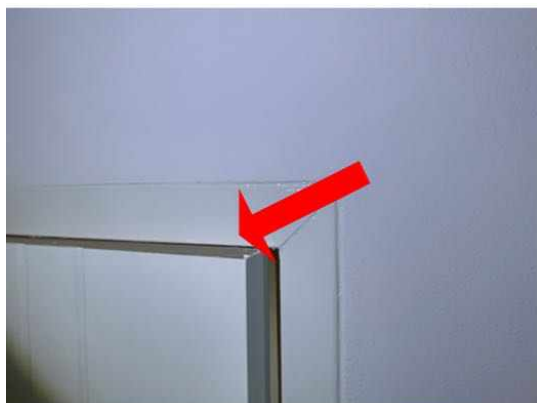
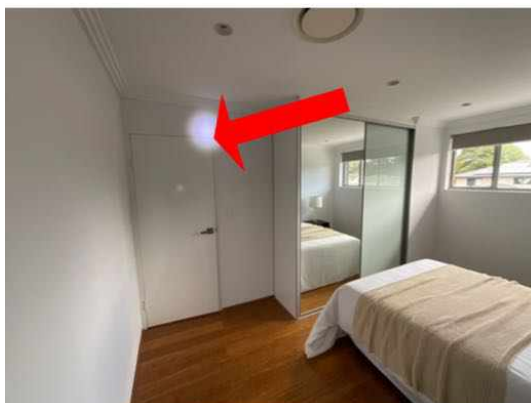
Finding 3.09

Building: Main Building
Location: Garage
Finding: Door - Binding/jamming

Information: Binding and/or jamming of this door is evident during standard operation. This defect inhibits the functionality of the affected door as well as creating potential for secondary defects to associated building elements, such as damage to the floor covering.

A door that binds to flooring or to the associated door frame may have several causes, ranging from minor defects, such as poor installation of the door or deteriorated hinges, through to major structural issues, such as damage to subfloor structures.

Where door binding/jamming appears to indicate major structural issues, a registered builder specialising in re-stumping should be appointed to provide an estimate on the cost of rectification.

For minor causes, a qualified carpenter or general handyman should be appointed to perform minor rectification works at client discretion.

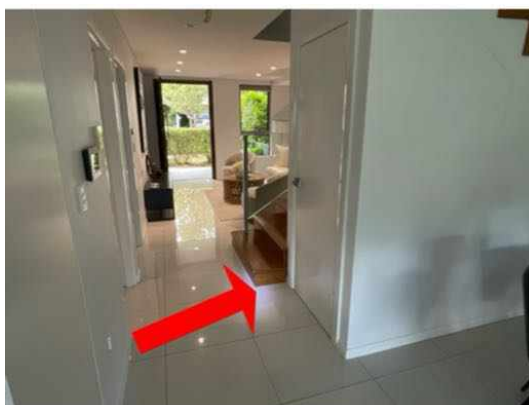
Finding 3.10

Building: Main Building
 Location: All Internal Areas
 Finding: Cracked floor tiles
 Information: Cracking in the floor tiles was evident in this area at the time of inspection. It is suspected that this cracking has occurred as a result of minor settlement or shrinkage

Cracked tiles throughout the household detract from the overall appearance of the affected areas however it is unlikely to create or lead to any secondary defects.

While not considered a matter of urgency, replacement of cracked floor tiles is recommended at the clients discretion. A tiling contractor may be appointed to perform these works. Where cracks become more numerous, contact a licensed building inspector for further investigation.

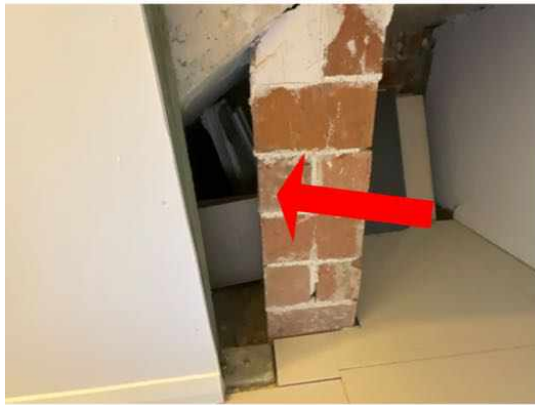
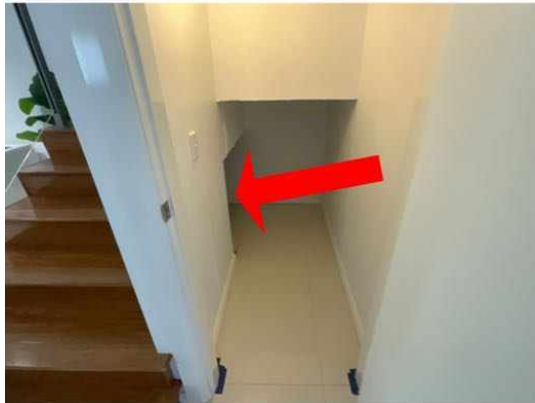
Finding 3.11

Sub standard and incomplete work are determined by identifying a failure to achieve the minimum requirement set out in the mandated Australian Standard as outlined in the Building Code of Australia and referenced by the Manufacturers Guideline.

Where a building element is installed in such a way that it fails to achieve the required minimum standard or level of finish at the time of the inspection, the builder needs to rectify the defect as soon as possible and complete works to the required standard prior to continuing with the stage of construction.

All known defects need to be rectified by builder

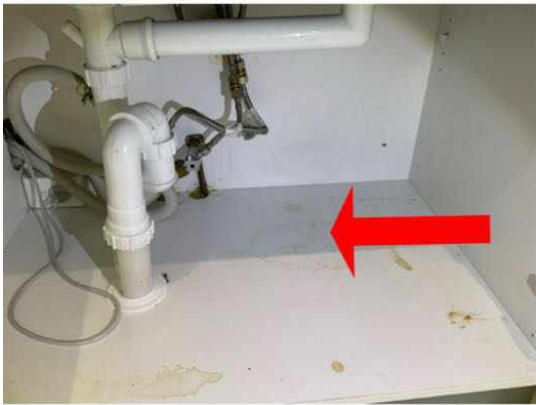
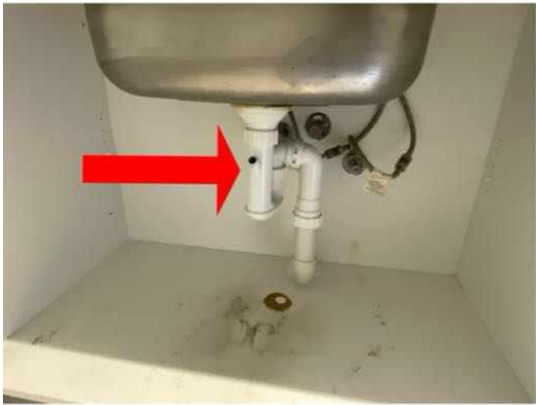
Finding 3.12

Building: Main Building
 Location: Kitchen / Laundry
 Finding: Water leak - Internal
 Information: A water leak was found in this area at the time of inspection. Internal water leaks can be detrimental to surrounding building elements; their potential causes include damage to plumbing fittings and fixtures, through to water damage and deterioration of associated building elements.

Rust, corrosion, decay and water damage are potential outcomes where a minor water leak is left unattended. More serious defects may also result, such as electrical hazards, or water damage to structural building elements.

In extreme cases, structural damage may develop due to a prolonged water leak. It is highly advised that internal water leaks be addressed by a licensed plumber as a matter of relative urgency.

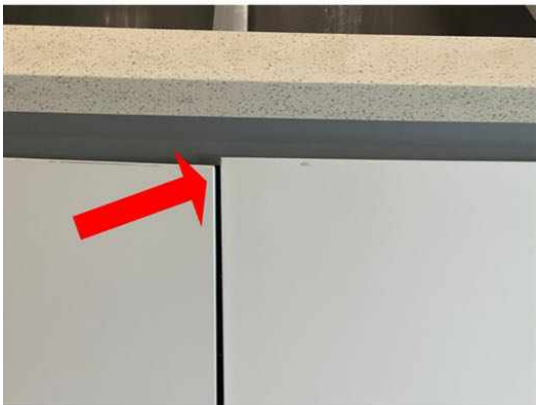
Finding 3.13

Building: Main Building
Location: Kitchen
Finding: Cabinet doors - misaligned
Information: It is observed that some of the cabinet doors are not aligned and / or have inconsistent gaps between the doors.

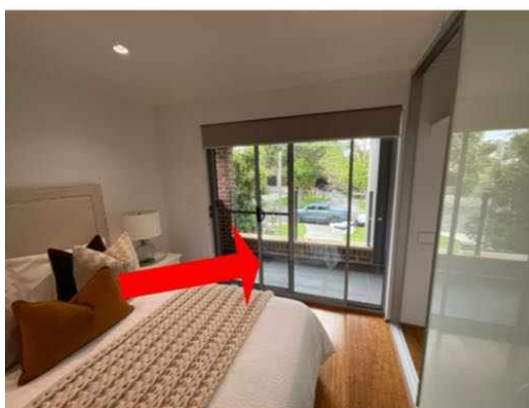
Finding 3.14

Building: Main Building
Location: Balcony

Finding: Sliding Door - Stiff to slide
 Information: The door in this area was jammed and difficult to slide along the associated tracks at the time of the inspection. Restricted function of the affected door may pose as a potential safety hazard if required for emergency egress from the building.

Generally, factors such as general age of the building element and a lack of maintenance are the usual causes for this type of defect.

Replacement of door hardware or tracks may be required, as well as minor repairs and cleaning. A registered builder or general handy person will be required to repair the affected doors.

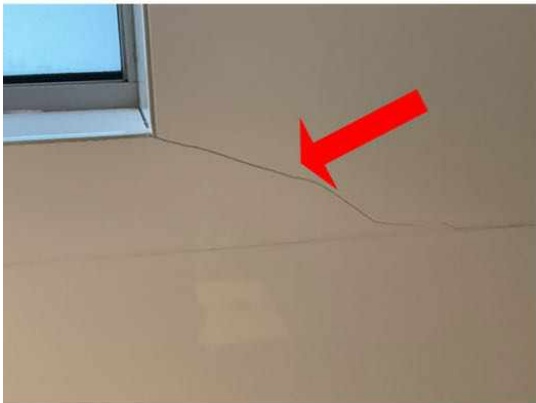
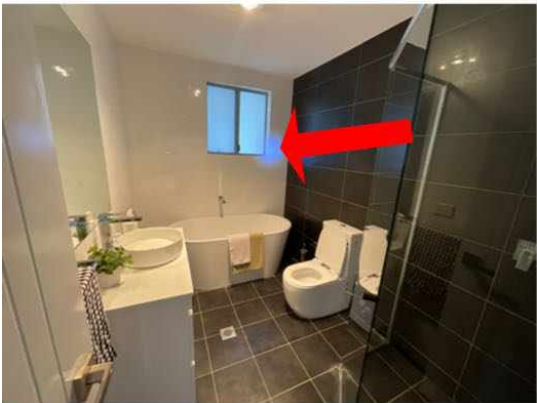
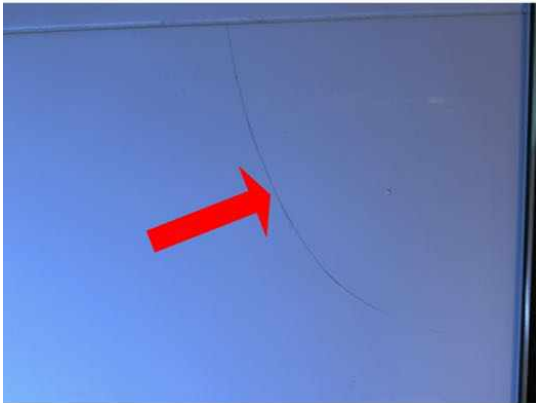
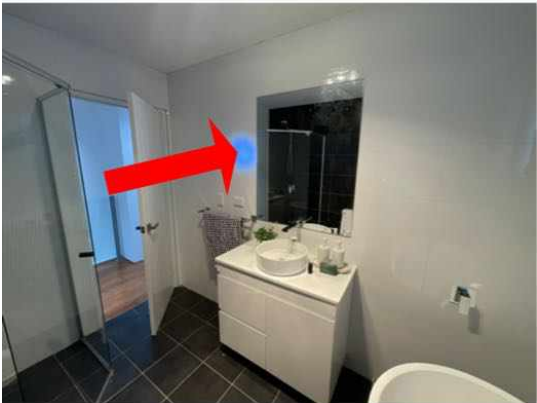
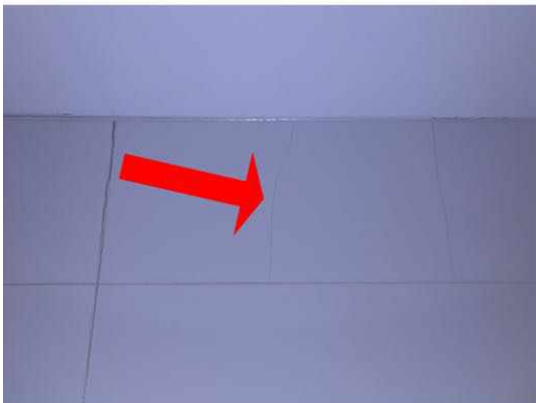
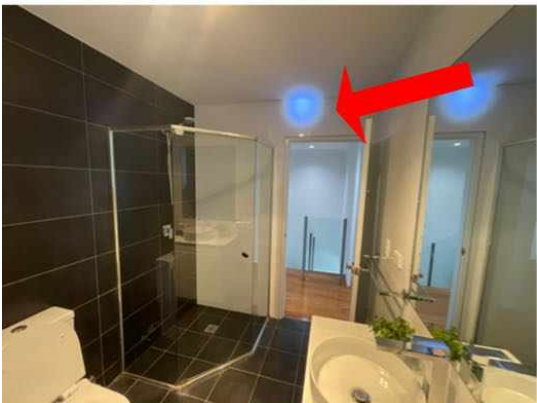
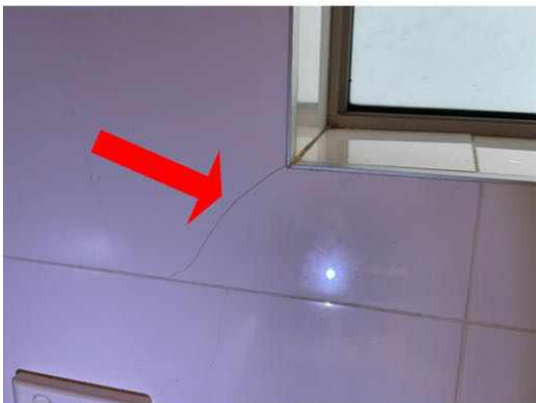
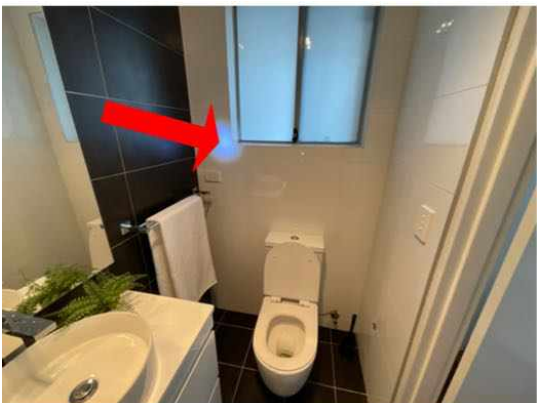
Finding 3.15

Building: Main Building
 Location: Bathroom / Ensuite
 Finding: Tiles - Cracked or damaged
 Information: Cracking was evident to the tiling in this area at the time of inspection. While the cracking appears to be minor, this area is frequently exposed to water, allowing potential for water penetration into adjoining sections of walls or flooring.

If left unmanaged, water penetration to these areas may lead to subsequent water damage, which is likely necessitate repair work to affected building elements.

A tiling contractor should be appointed to ensure that no further water damage occurs. The re-application of silicone and grouting throughout remaining tile work is also advised, to further protect the area against water penetration.

Where water penetration has led to water damage, appointment of a relevant tradesperson may be required to repair damaged building elements.

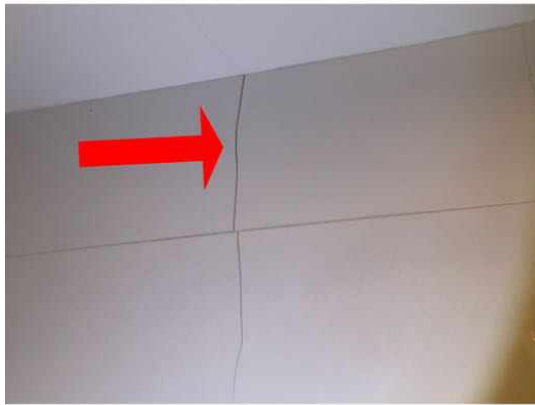
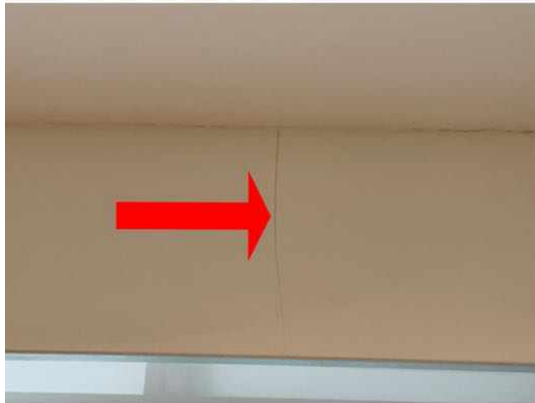
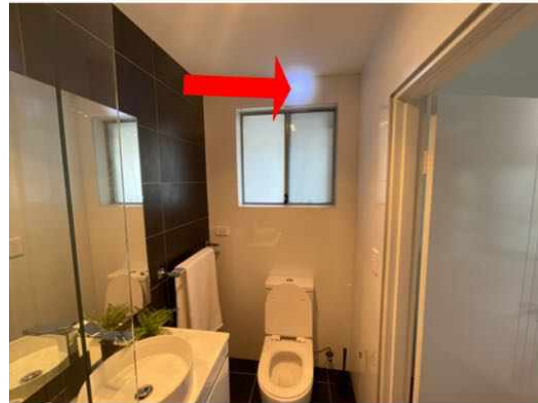
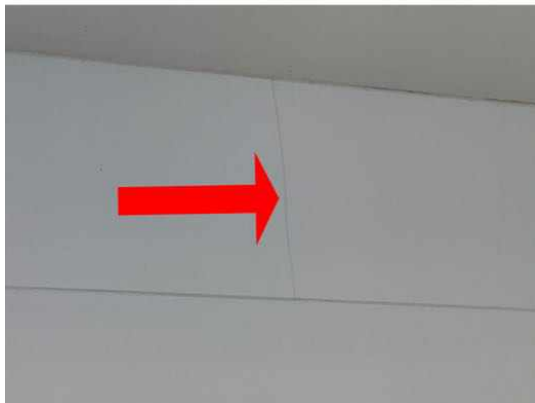
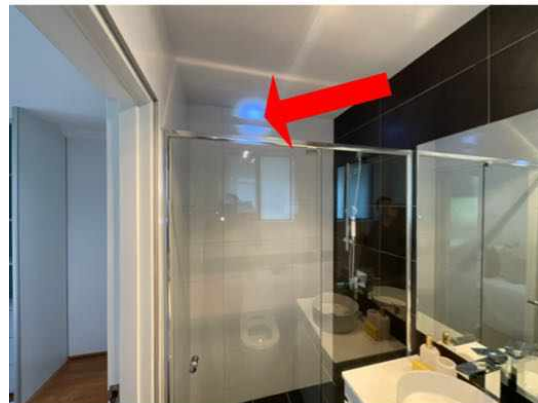
Finding 3.16

| Finding: | Sealant and grouting - Missing or damaged |
| Information: | It was noted on inspection that sealant or grout is degraded to the tiled shower alcove and or other areas of the bathroom. |

Different materials and floor areas move at different rates, generally causing cracking to grout or sealant at this point. A flexible sealant is required to allow for expected expansion and contraction, while keeping the joint water tight and protective of all associated building materials.

There appears to be excessive mould to the sealant and grout which will likely require scraping out and replacement.

Flexible and mould resistant materials should be applied to affected areas to prevent any subsequent water damage that is likely to occur. Regular maintenance and replacement of damage or missing or damaged sealant and grout is highly recommended to the wet areas, as this is a regular wear and tear defect. Sealant and grouting in areas that come into regular contact with water should be maintained for the long term care of your property.

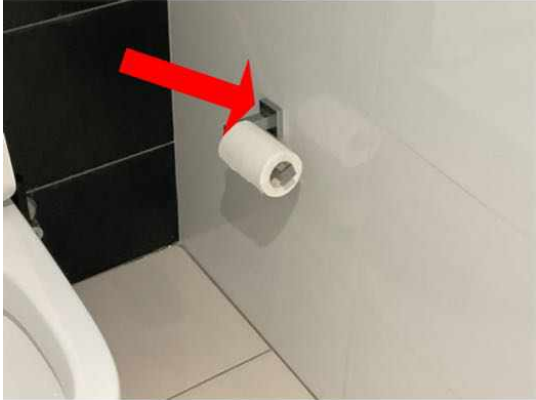
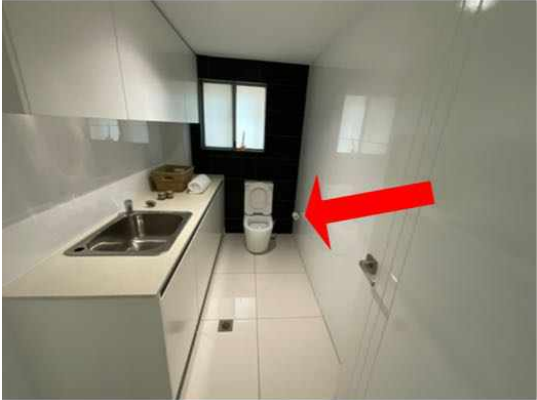
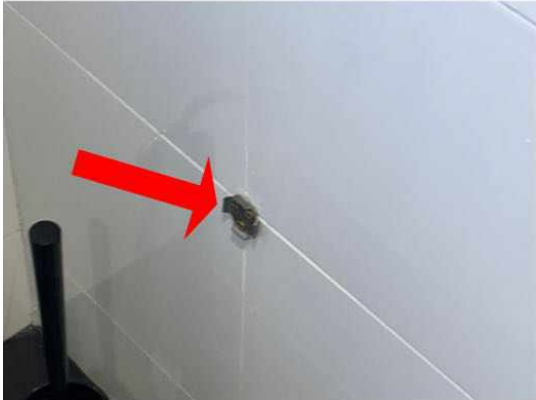
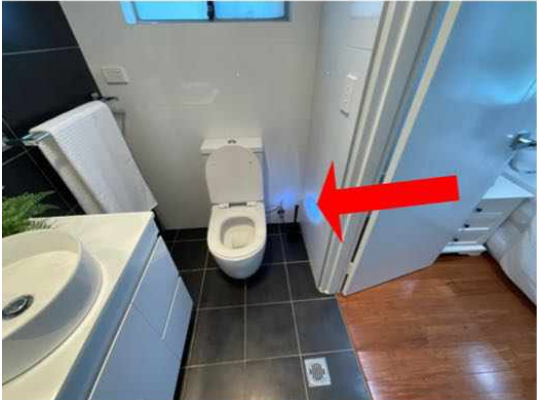
Finding 3.17

Building: Main Building
Location: Bathrooms
Finding: Bathroom holders - Loose
Information: The bathroom holder was found to be loose at the time of inspection. While not a major operational defect, function can deteriorate if the problem is left unmanaged.

It is advised that the homeowner performs remedial works to re-attach the bathroom holder to its original fixing. A general handyperson may be required to perform these works.

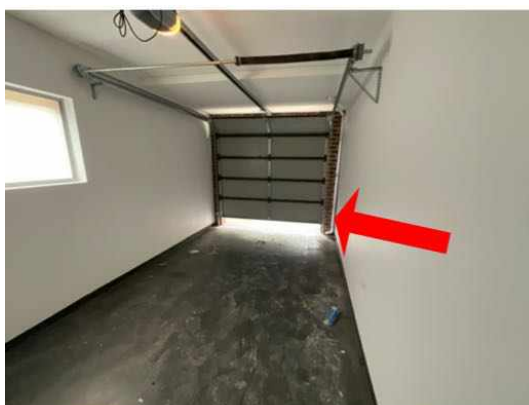
Finding 3.18

Building: Main Building
 Location: Garage
 Finding: Garage Door - not working properly
 Information: At the time of the inspection, Garage roller doors can fail when the building materials have aged with some concerns as below:

Spring Tension: If the springs responsible for counterbalancing the weight of the door are too loose or too tight, it can affect the door's operation. Adjusting the spring tension to the manufacturer's specifications can help resolve this issue.

Repair of the two garage doors would improve the condition of the garage but certainly not an urgent item

A qualified roller door installer or supplier should be engaged to check out the operation and overall condition of the doors to determine if repair is an option otherwise replacement may need to be considered.

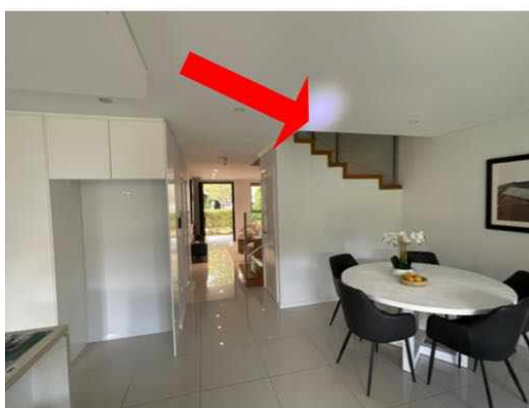
Finding 3.19

Building: Main Building
 Location: Stairs - Internal
 Finding: Ceiling - Water stained
 Information: Water staining to ceiling linings in this area was evident at the time of inspection. Water staining indicates that surfaces have been exposed to excessive moisture over time. The minerals and other elements in the water lead to staining, which may graduate to corrosion and deterioration if left unmanaged.

While mostly an appearance defect, water staining can be indicative of more serious

defects, which may be currently concealed by interior ceilings.

Where water staining is active, a licensed plumber must be consulted to identify the cause of the staining and to provide advice on any reparation works that may be required. Replacement of any damaged structures is advised.

Conversely, where water staining is old and inactive, affected building materials may be repaired or replaced at client discretion.

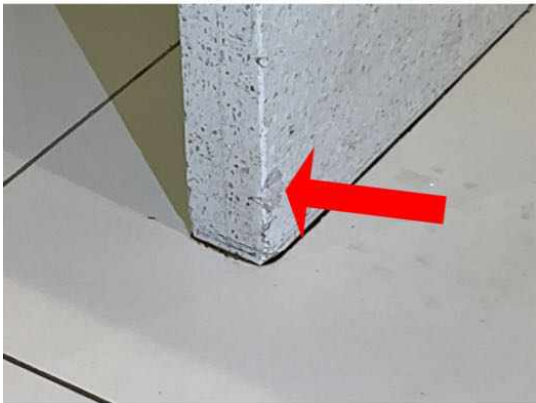
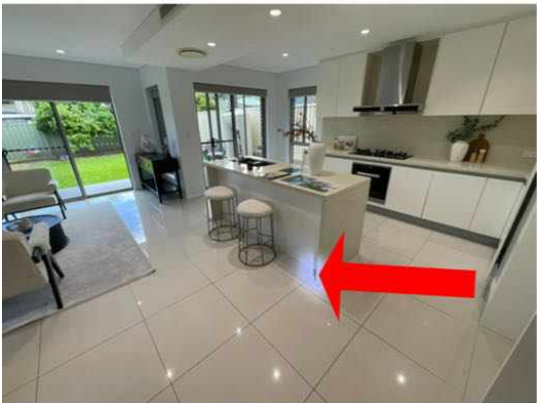
Finding 3.20

| Finding: | Benchtop - Crack or Damaged |
| Information: | Cracking was evident to the benchtop in the kitchen area at the time of inspection. While the cracking appears to be minor, this area is frequently exposed to water, allowing potential for water penetration into adjoining sections of benchtop. If left unmanaged, water penetration to these areas may lead to subsequent water damage, which is likely necessitate repair work to affected building elements. A qualified contractor should be appointed to ensure that no further water damage occurs. The re-application of silicone and grouting throughout is also advised, to further protect the area against water penetration. Where water penetration has led to water damage, appointment of a relevant tradesperson may be required to repair damaged building elements. |

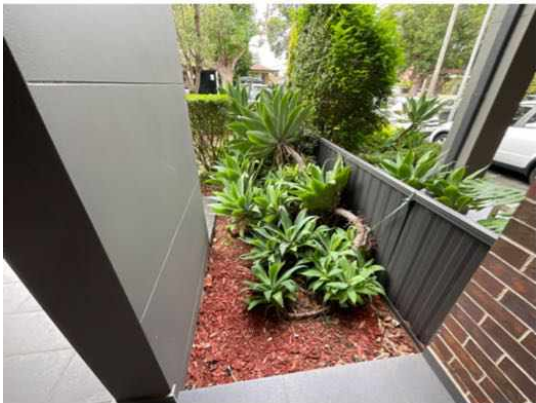
Finding 6.01

Building: Main Building
 Location: All Areas
 Finding: Garden Beds - Conditions Conducive to Termites
 Information: Garden beds were found to be evident in the garden area. These garden beds can include untreated timber, and with a combination of moisture from watering hosing can make conditions conducive to termite activity and termite ingress.
