Building and Timber Pest Inspection Report

Inspection Date: Mon, 30 Mar 2026

Property Address: 10 Shirley St, Padstow NSW 2211, Australia

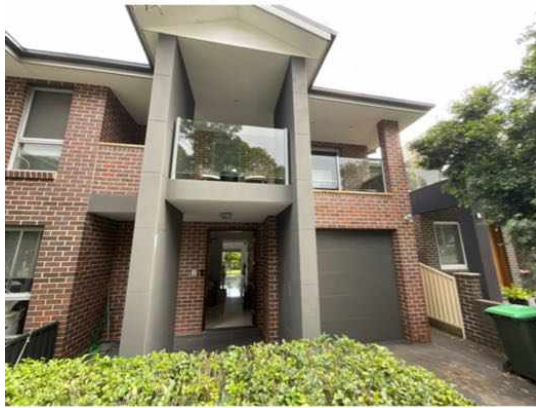
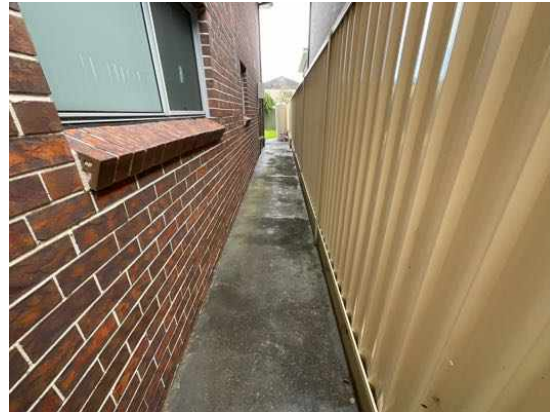
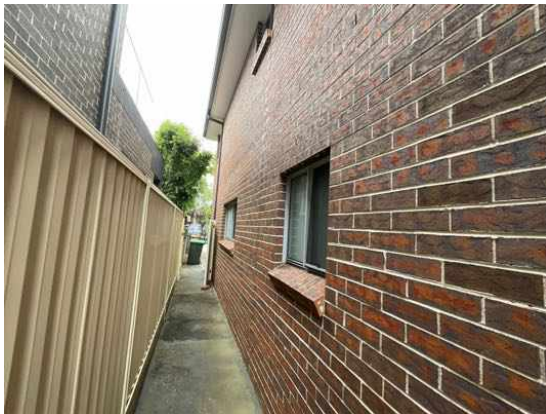
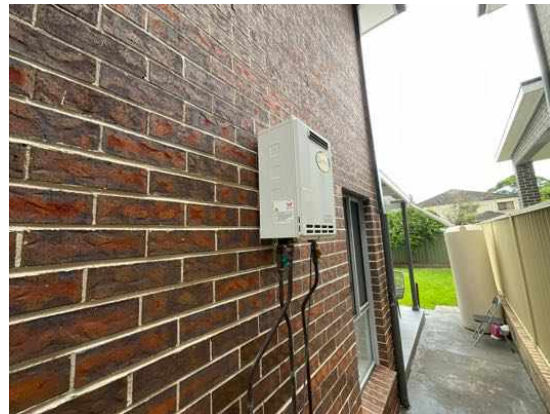
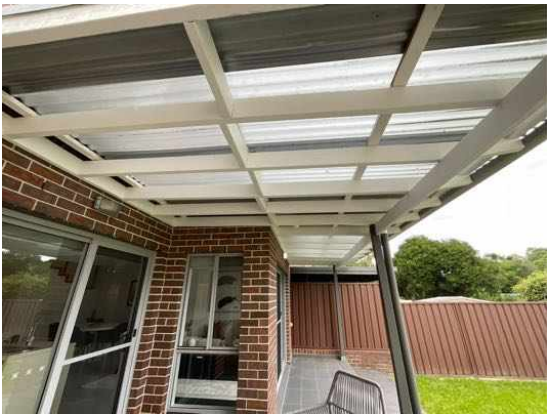
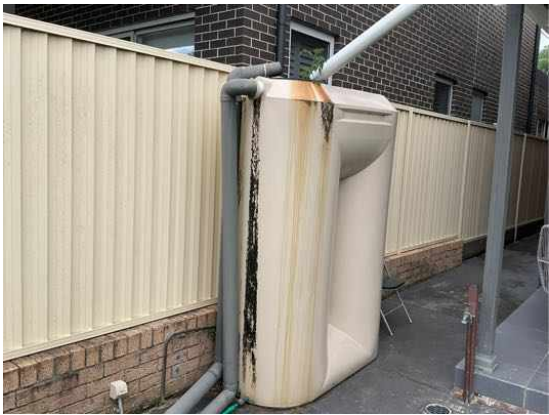
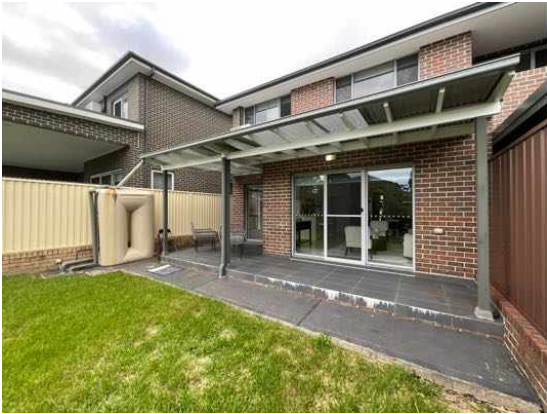
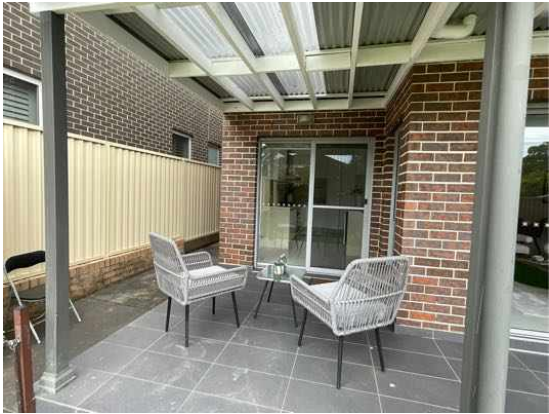
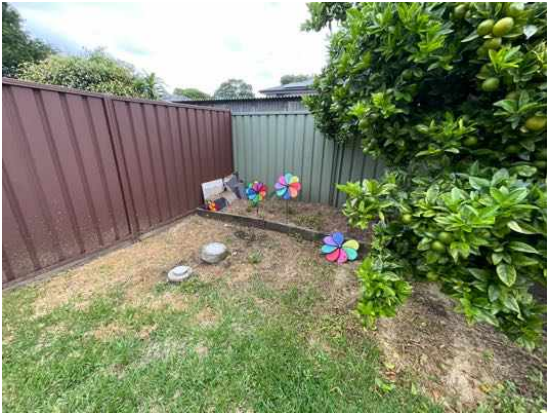
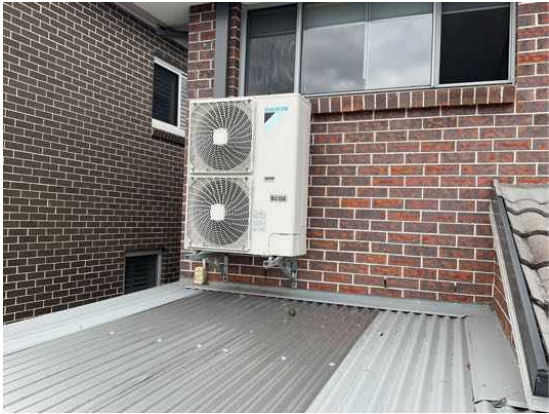
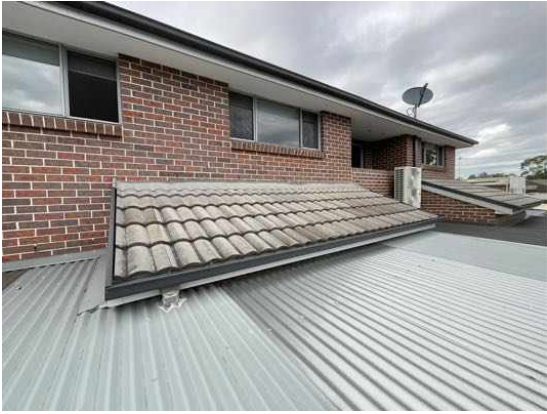
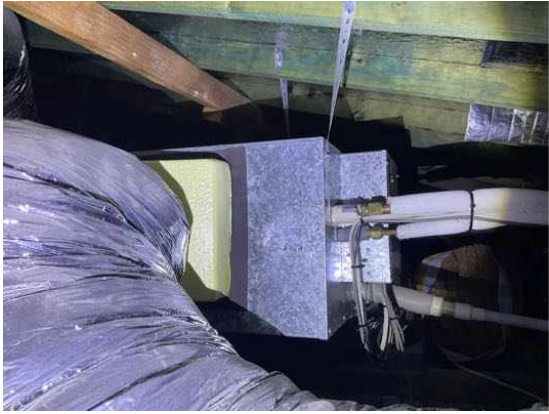
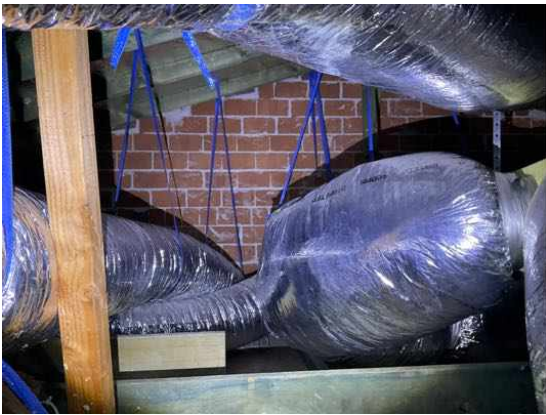
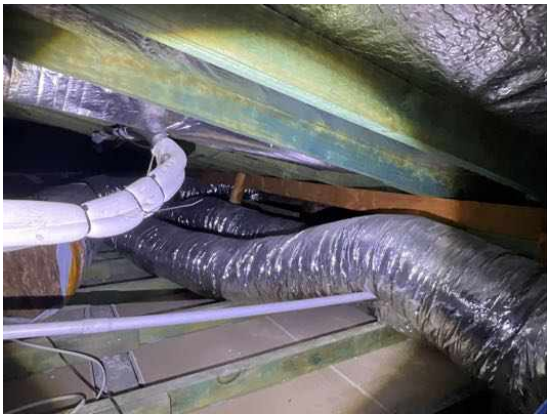
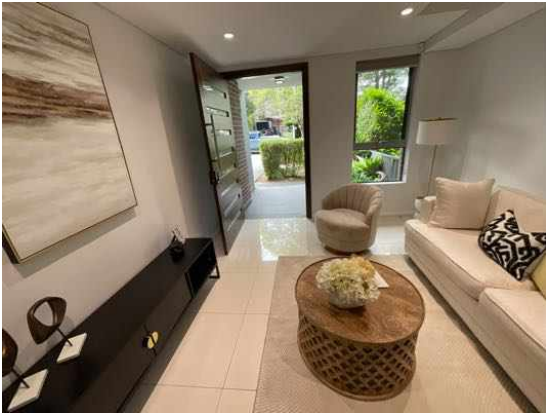
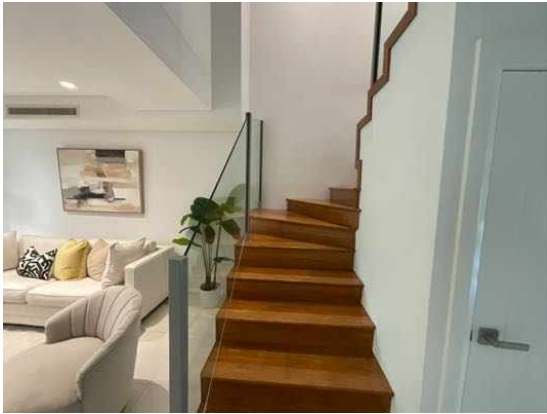
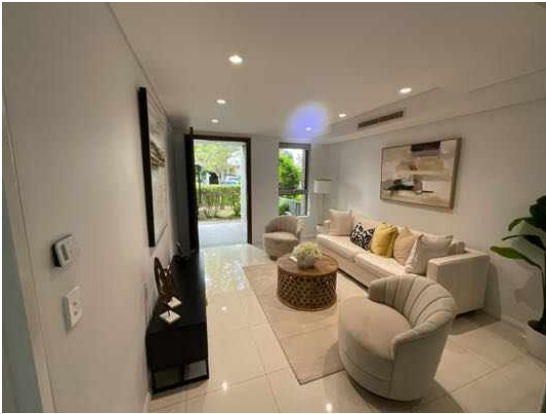
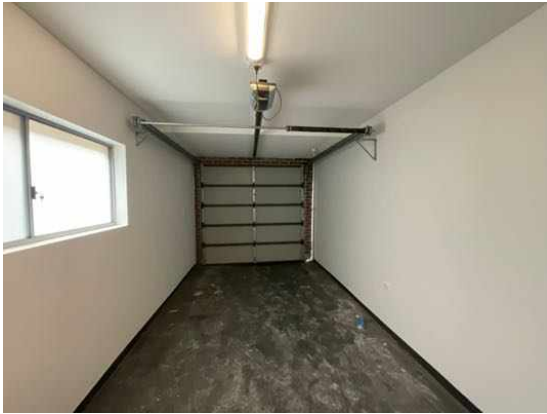
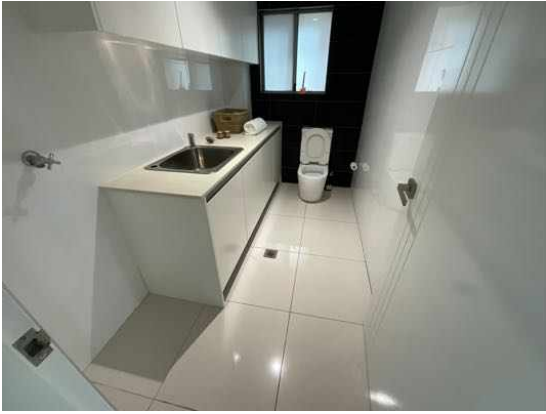
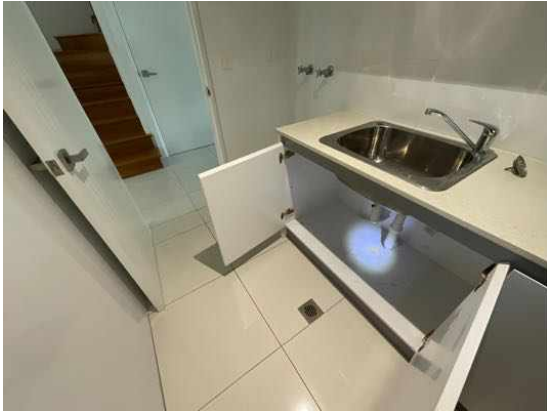
Building: Main Building
Location: All Areas
Finding: Additional Photos - Obstructions and Limitations
Information: These photographs are an indication of the obstructions and limitations which impeded full inspection of the property at the time of inspection. These obstructions can hide an array of defects and should be removed to allow full inspection to be carried out. A re-inspection is recommended once the areas are made accessible.

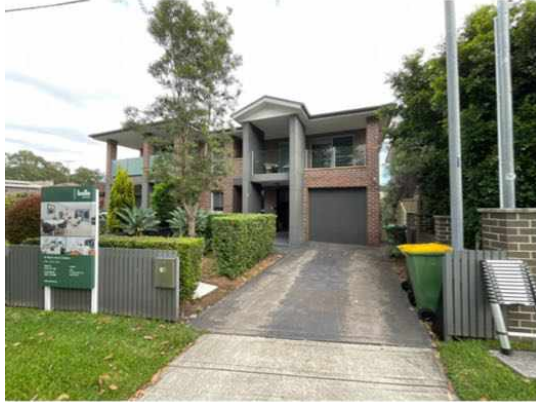
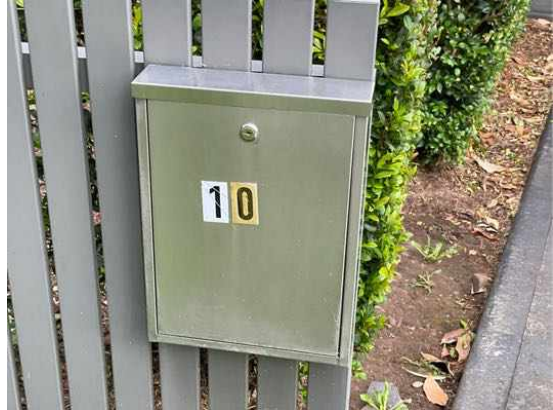
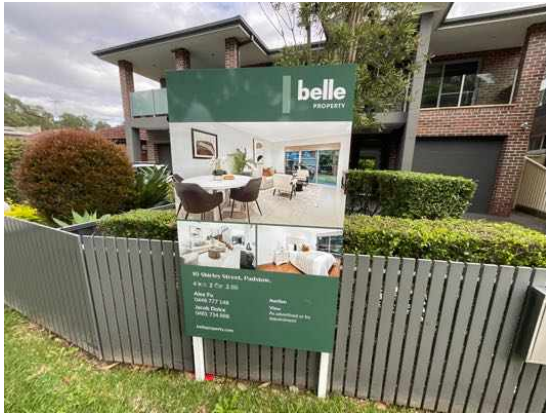
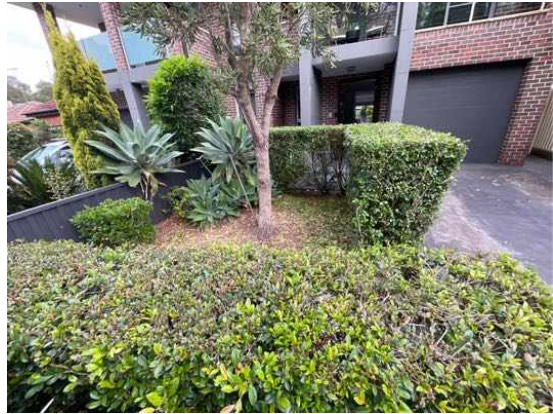
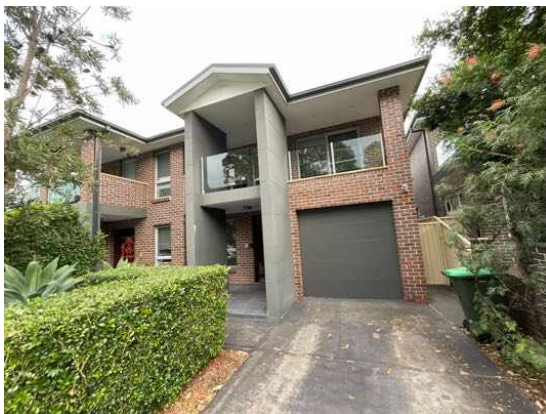
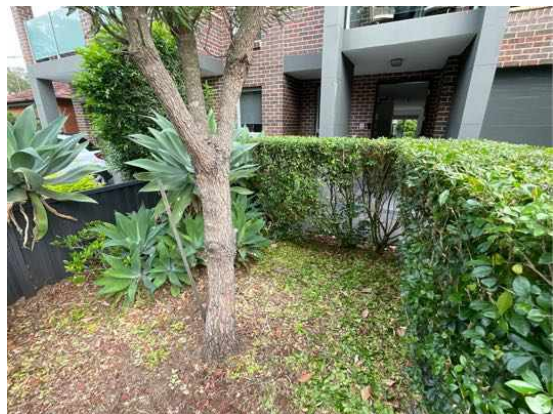
Building: Main Building
Location: All Areas
Finding: Additional Photos
Information: Additional photos are provided for your general reference

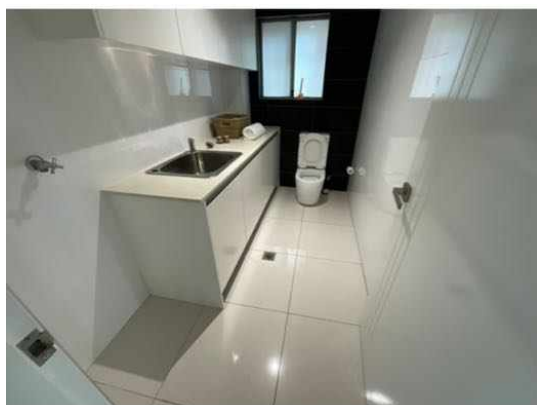
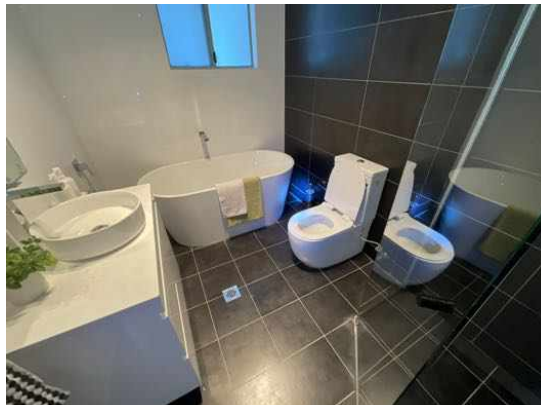
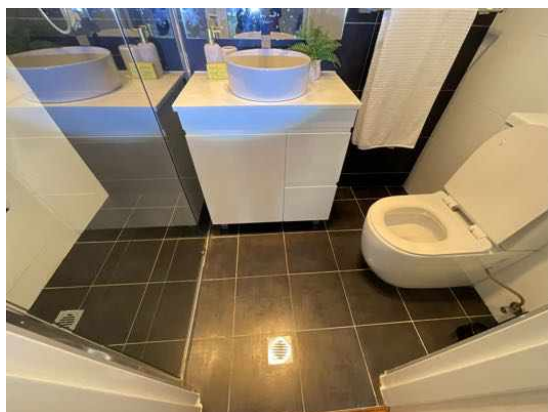
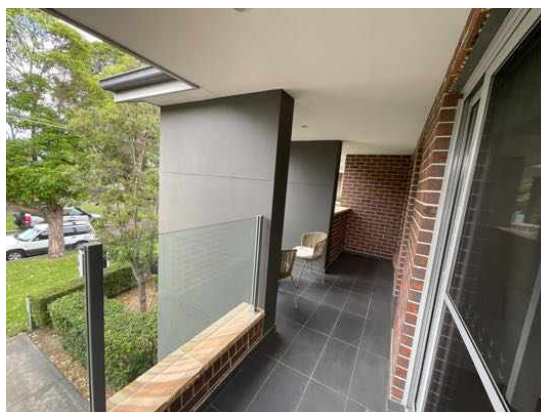
| Information: | Internal Water Proofing Membranes, are crucial in preventing water ingress into the property is important to know that the Membrane System used is to Australian Standards and has been installed correctly. Please refer to the original Building Documents or Maintenance Schedule for the relevant information including; - Membrane used and Manufacturers Specifications. - The Installer and Installation Certification. Especially with older property's where this information is unavailable, all wet areas should be monitored. Generally new waterproofing with a certificate may |

only have a guarantee of 8yrs. If any leaks, water staining, peeling or bubbling of the paint become evident to any adjacent walls or ceilings below a licensed builder or waterproofing specialist is recommended to investigate further.

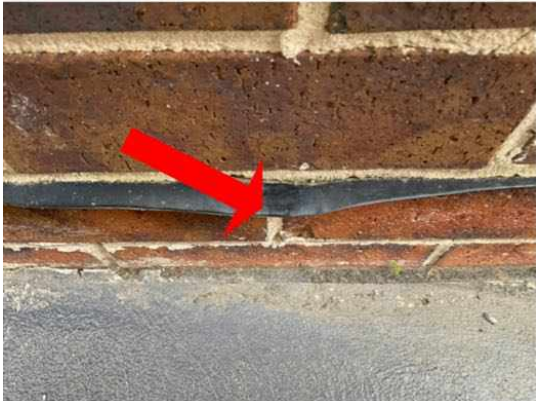
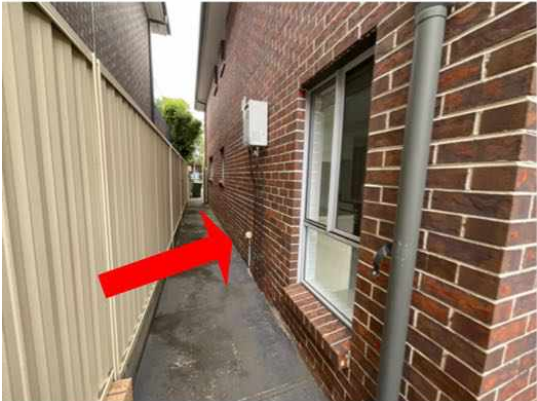
| Information: | During inspection of the property, it was noted that works to install a chemical treated zone barrier had previously been completed. A chemical treated zone barrier is likely to ensure effective protection against termites. |

However, we strongly recommend annual inspections of the barrier and surrounding areas as there are several factors that can lead to deterioration of the barrier and decrease its effectiveness.

Where a Termite Management System has been identified, the client should identify to the type of barrier, date of installation, warranty conditions and any documentation provided by a builder or past owner. Consult the company who installed the barrier to confirm whether the system is still under warranty.
